United States Fire Administration National Fire Data Center La Posada Hotel Fire McAllen, Texas (February 25, 1987)

Investigated by: Jeffrey M. Shapiro, P.E.

This is Report 001 of the Major Fires Investigation Project conducted by TriData Corporation under contract EMW-88-C-2277 to the United States Fire Administration, Federal Emergency Management Agency.

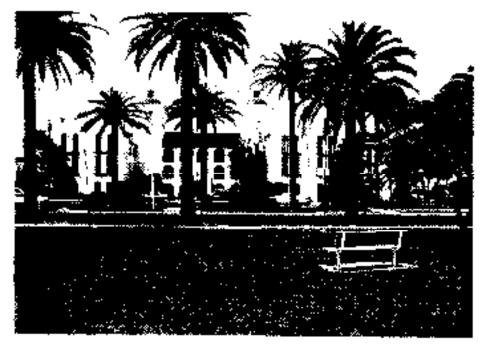
Figure 1. La Possada Hotel (view of the east end main entrance).

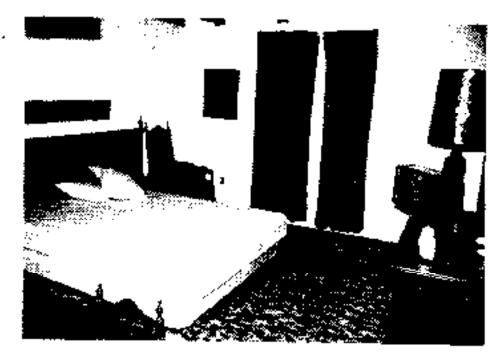
Figure 3. guest room identical to room of origin. Note exterior window and contents.
