Detroit Warehouse Fire Claims Three Firefighters

Detroit Warehouse Fire Claims Three Firefighters (March 12, 1987)

Investigated by: J. Gordon Routley

This is Report 003 of the Major Fires Investigation Project conducted by TriData Corporation under contract EMW-88-C-2277 to the United States Fire Administration, Federal Emergency Management Agency.

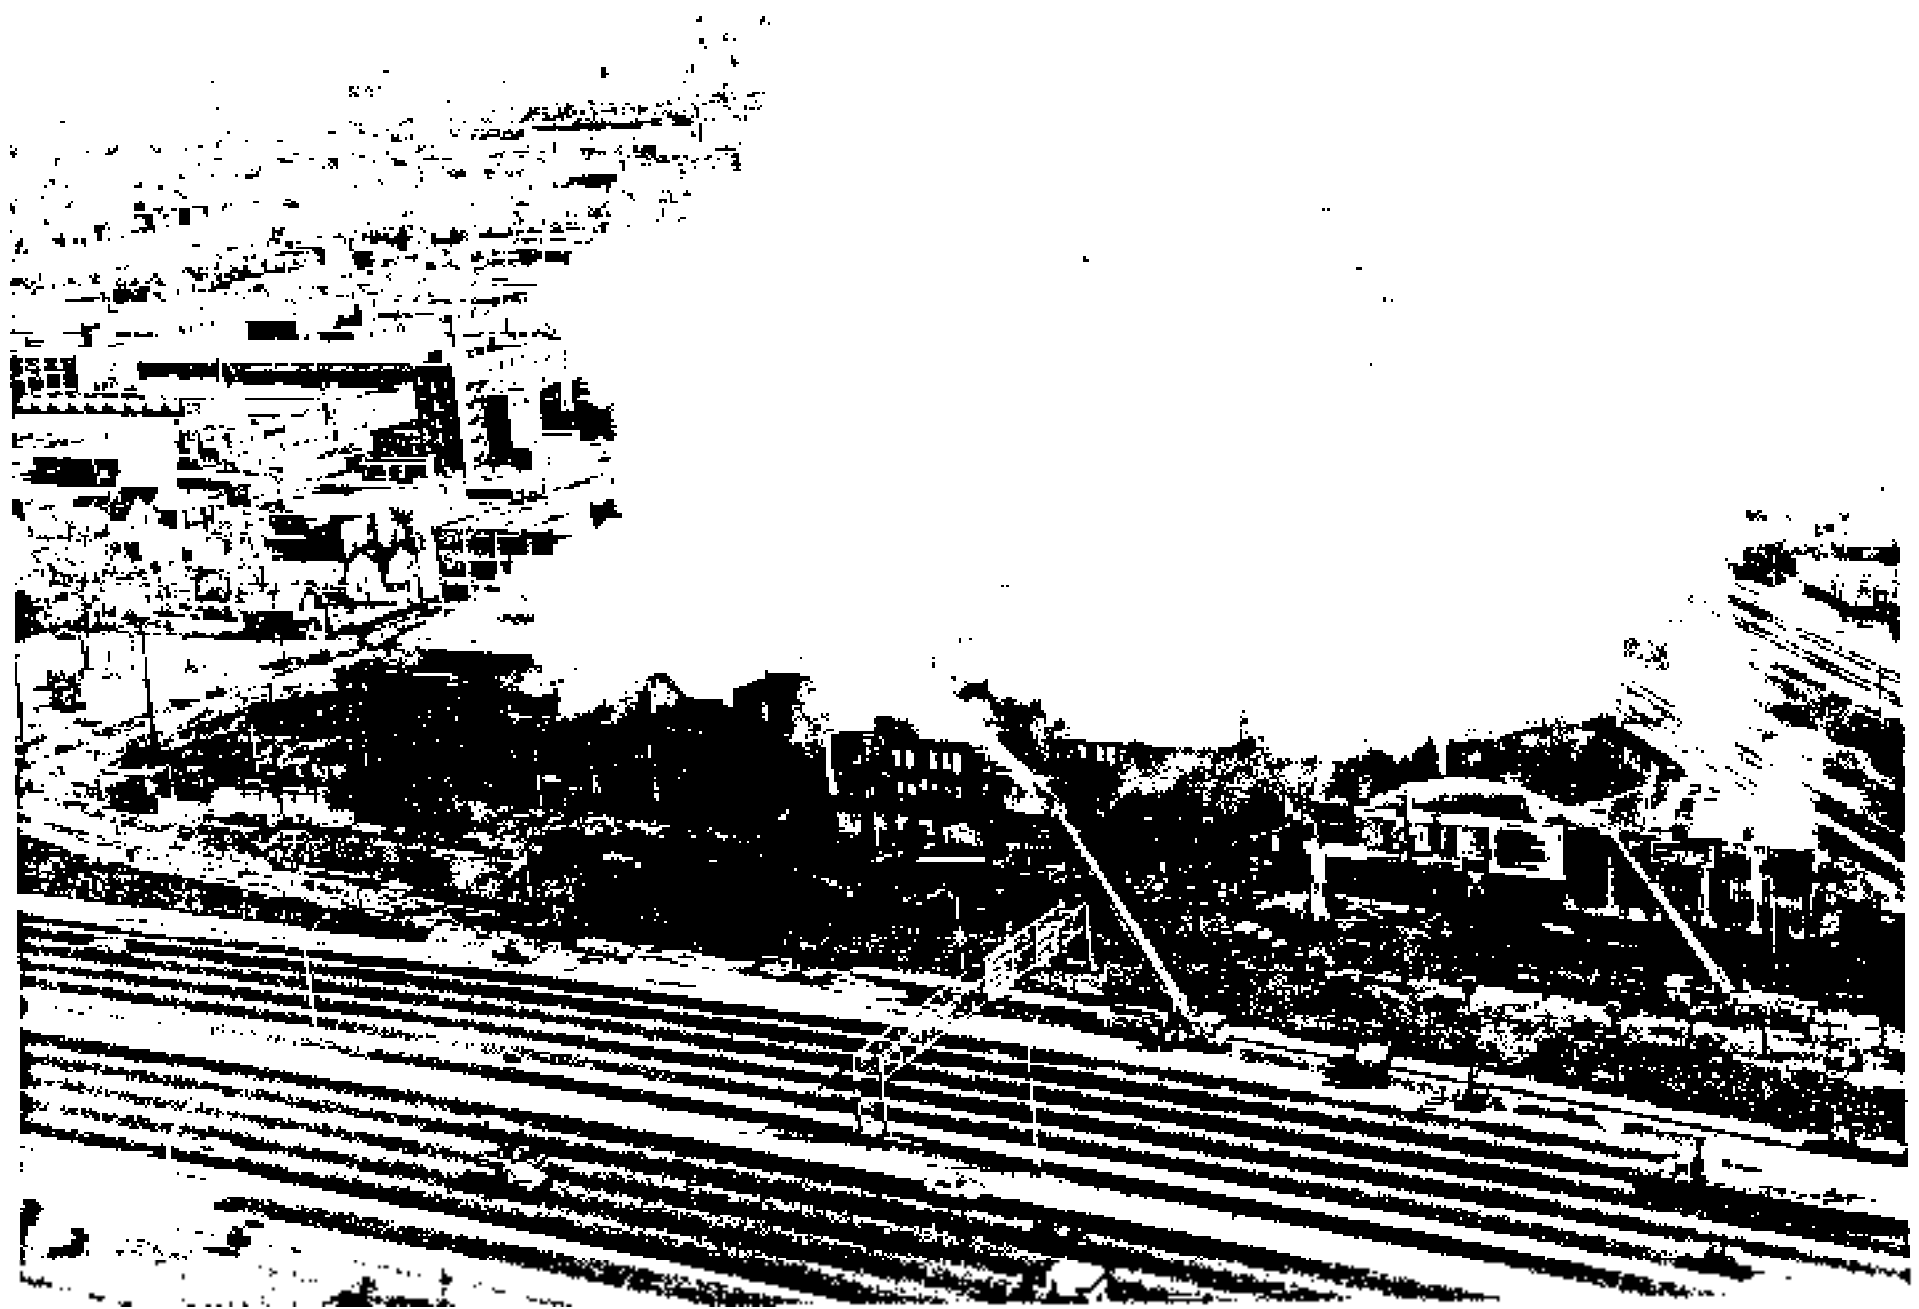
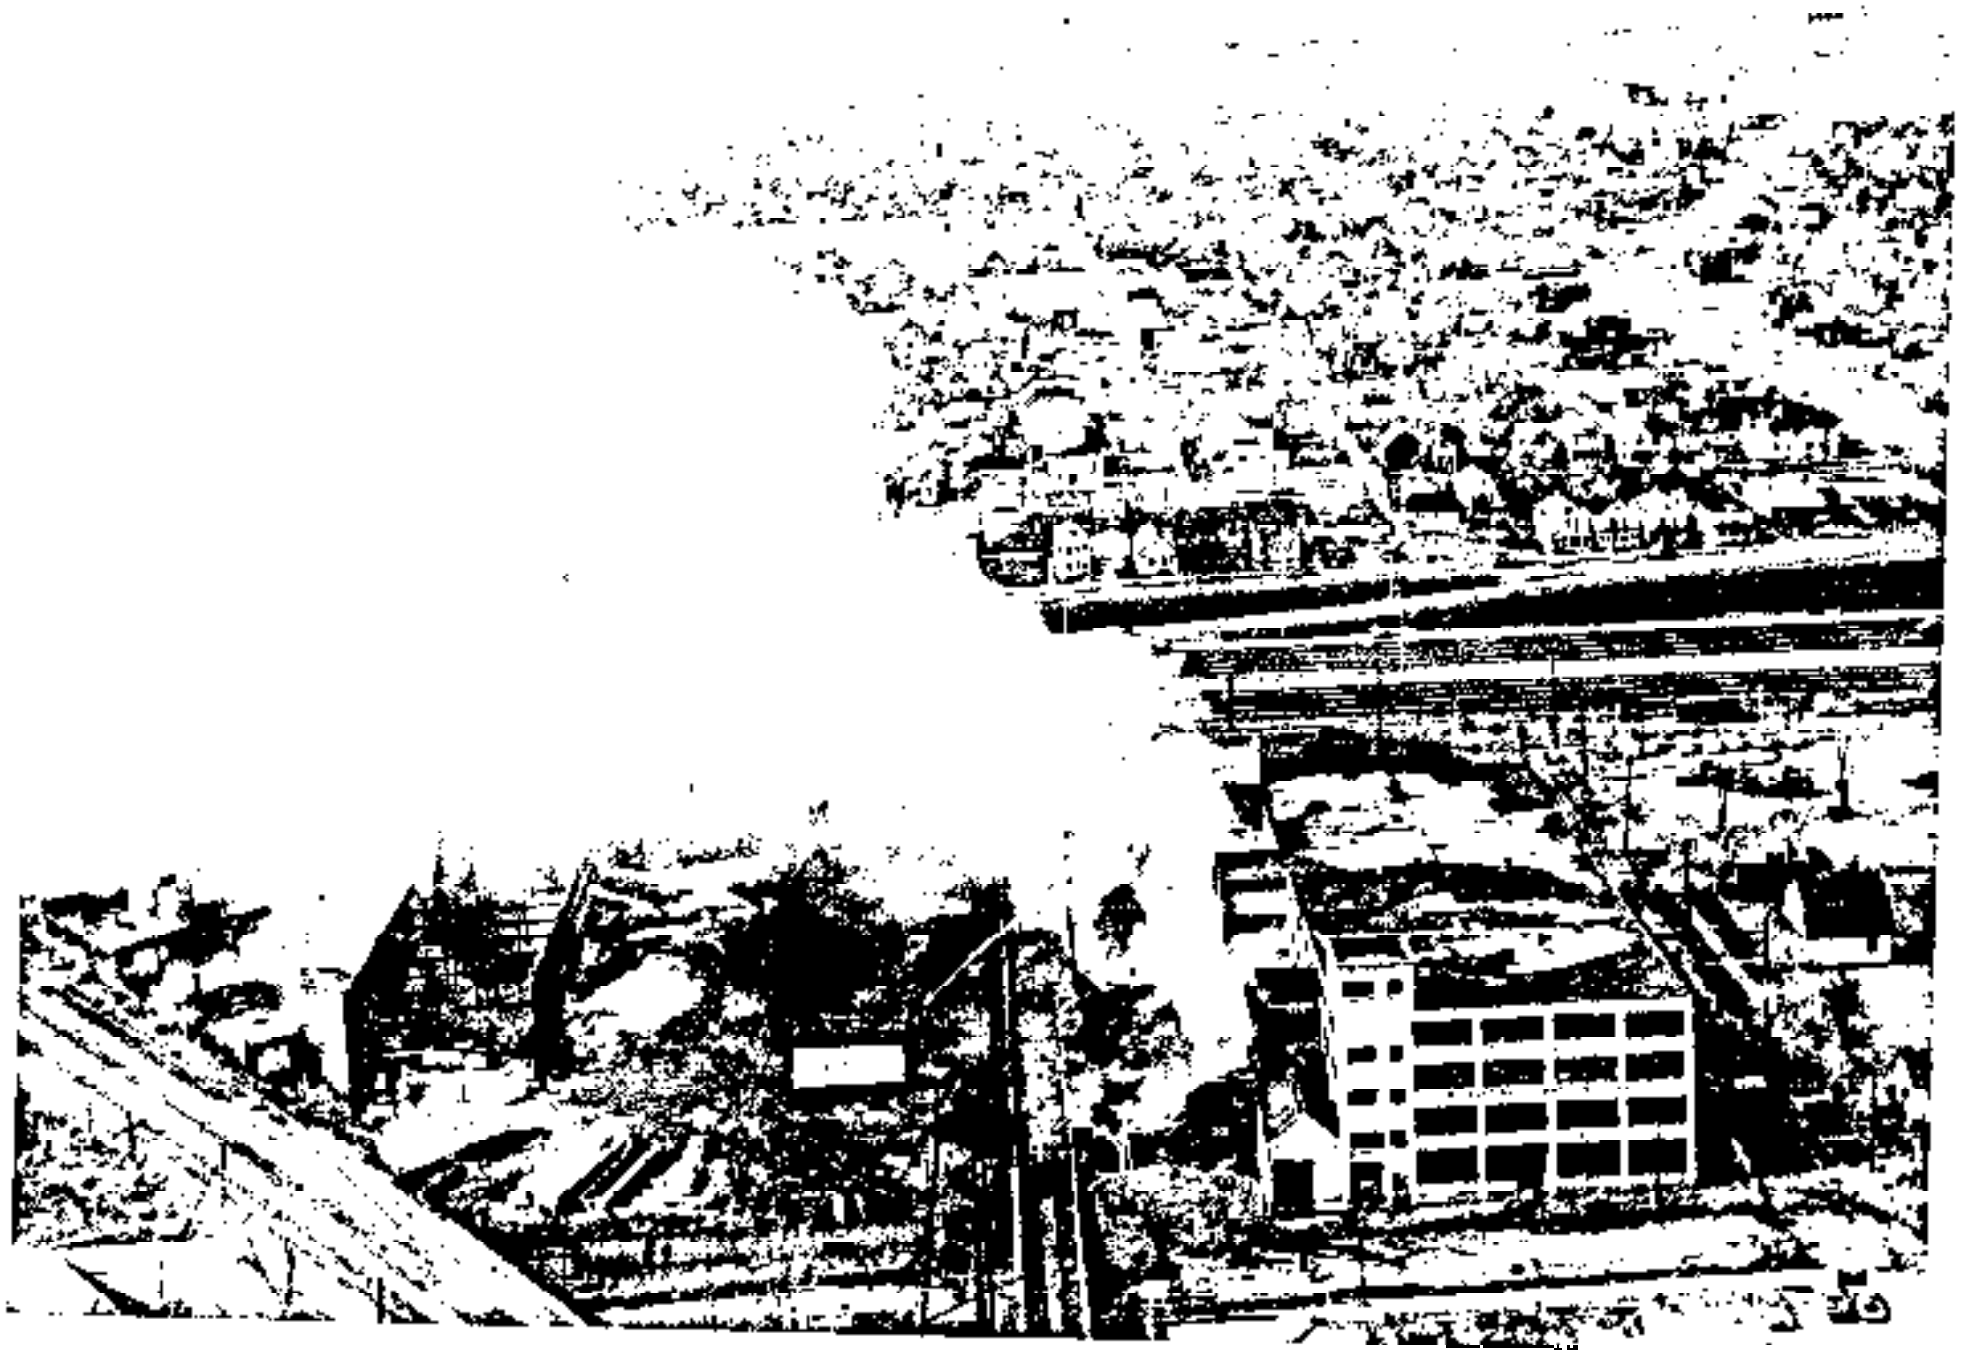
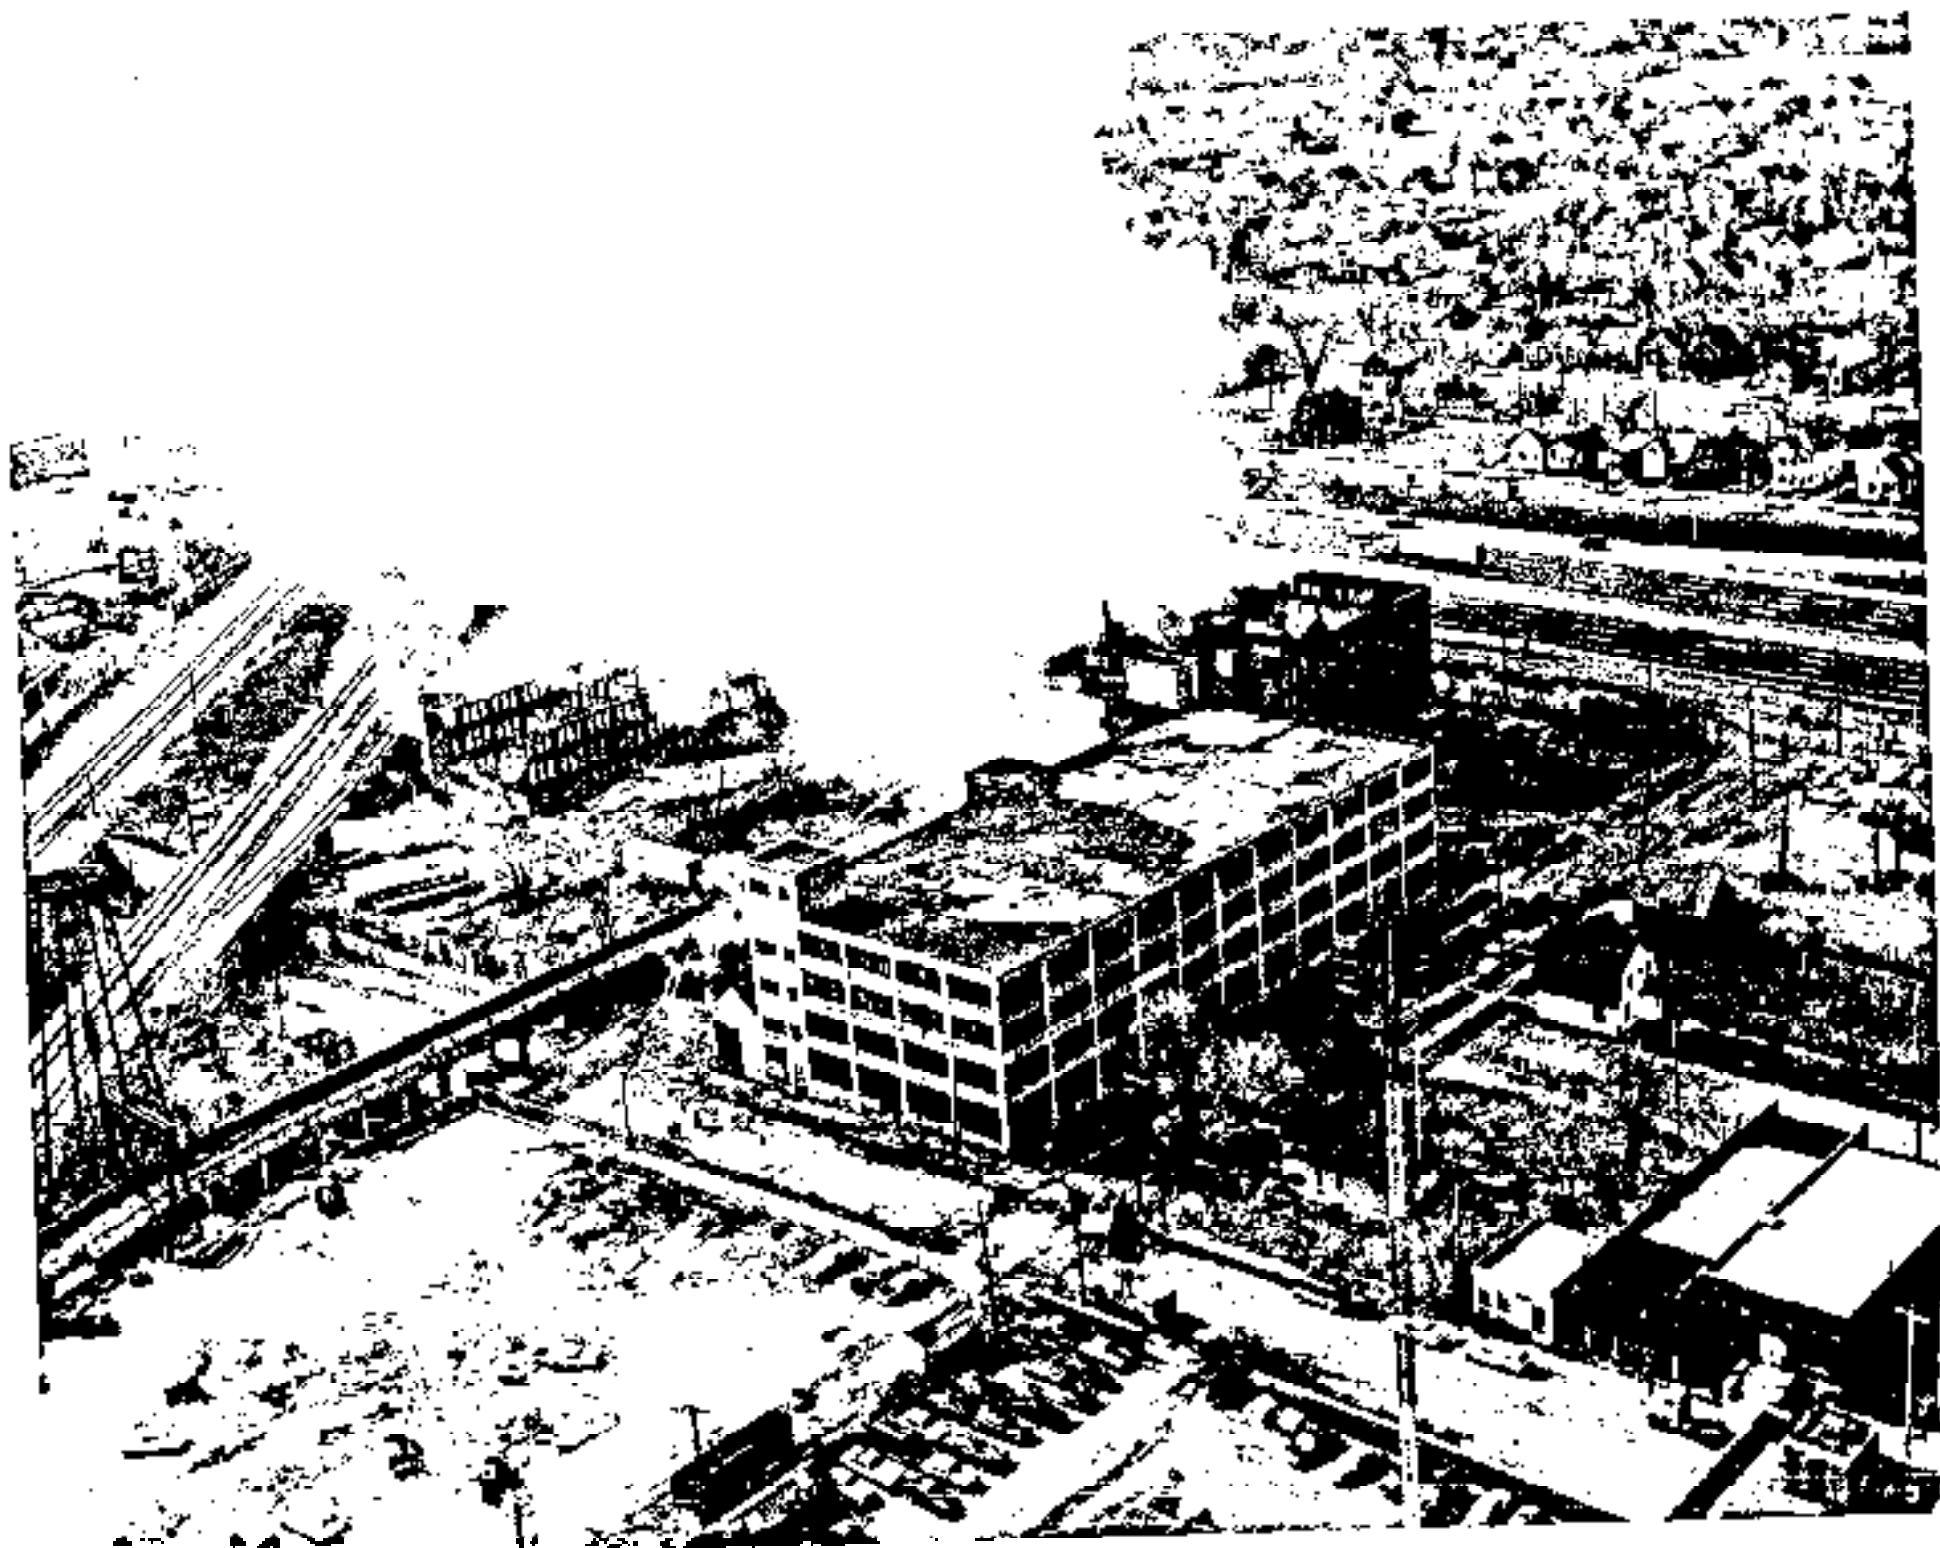
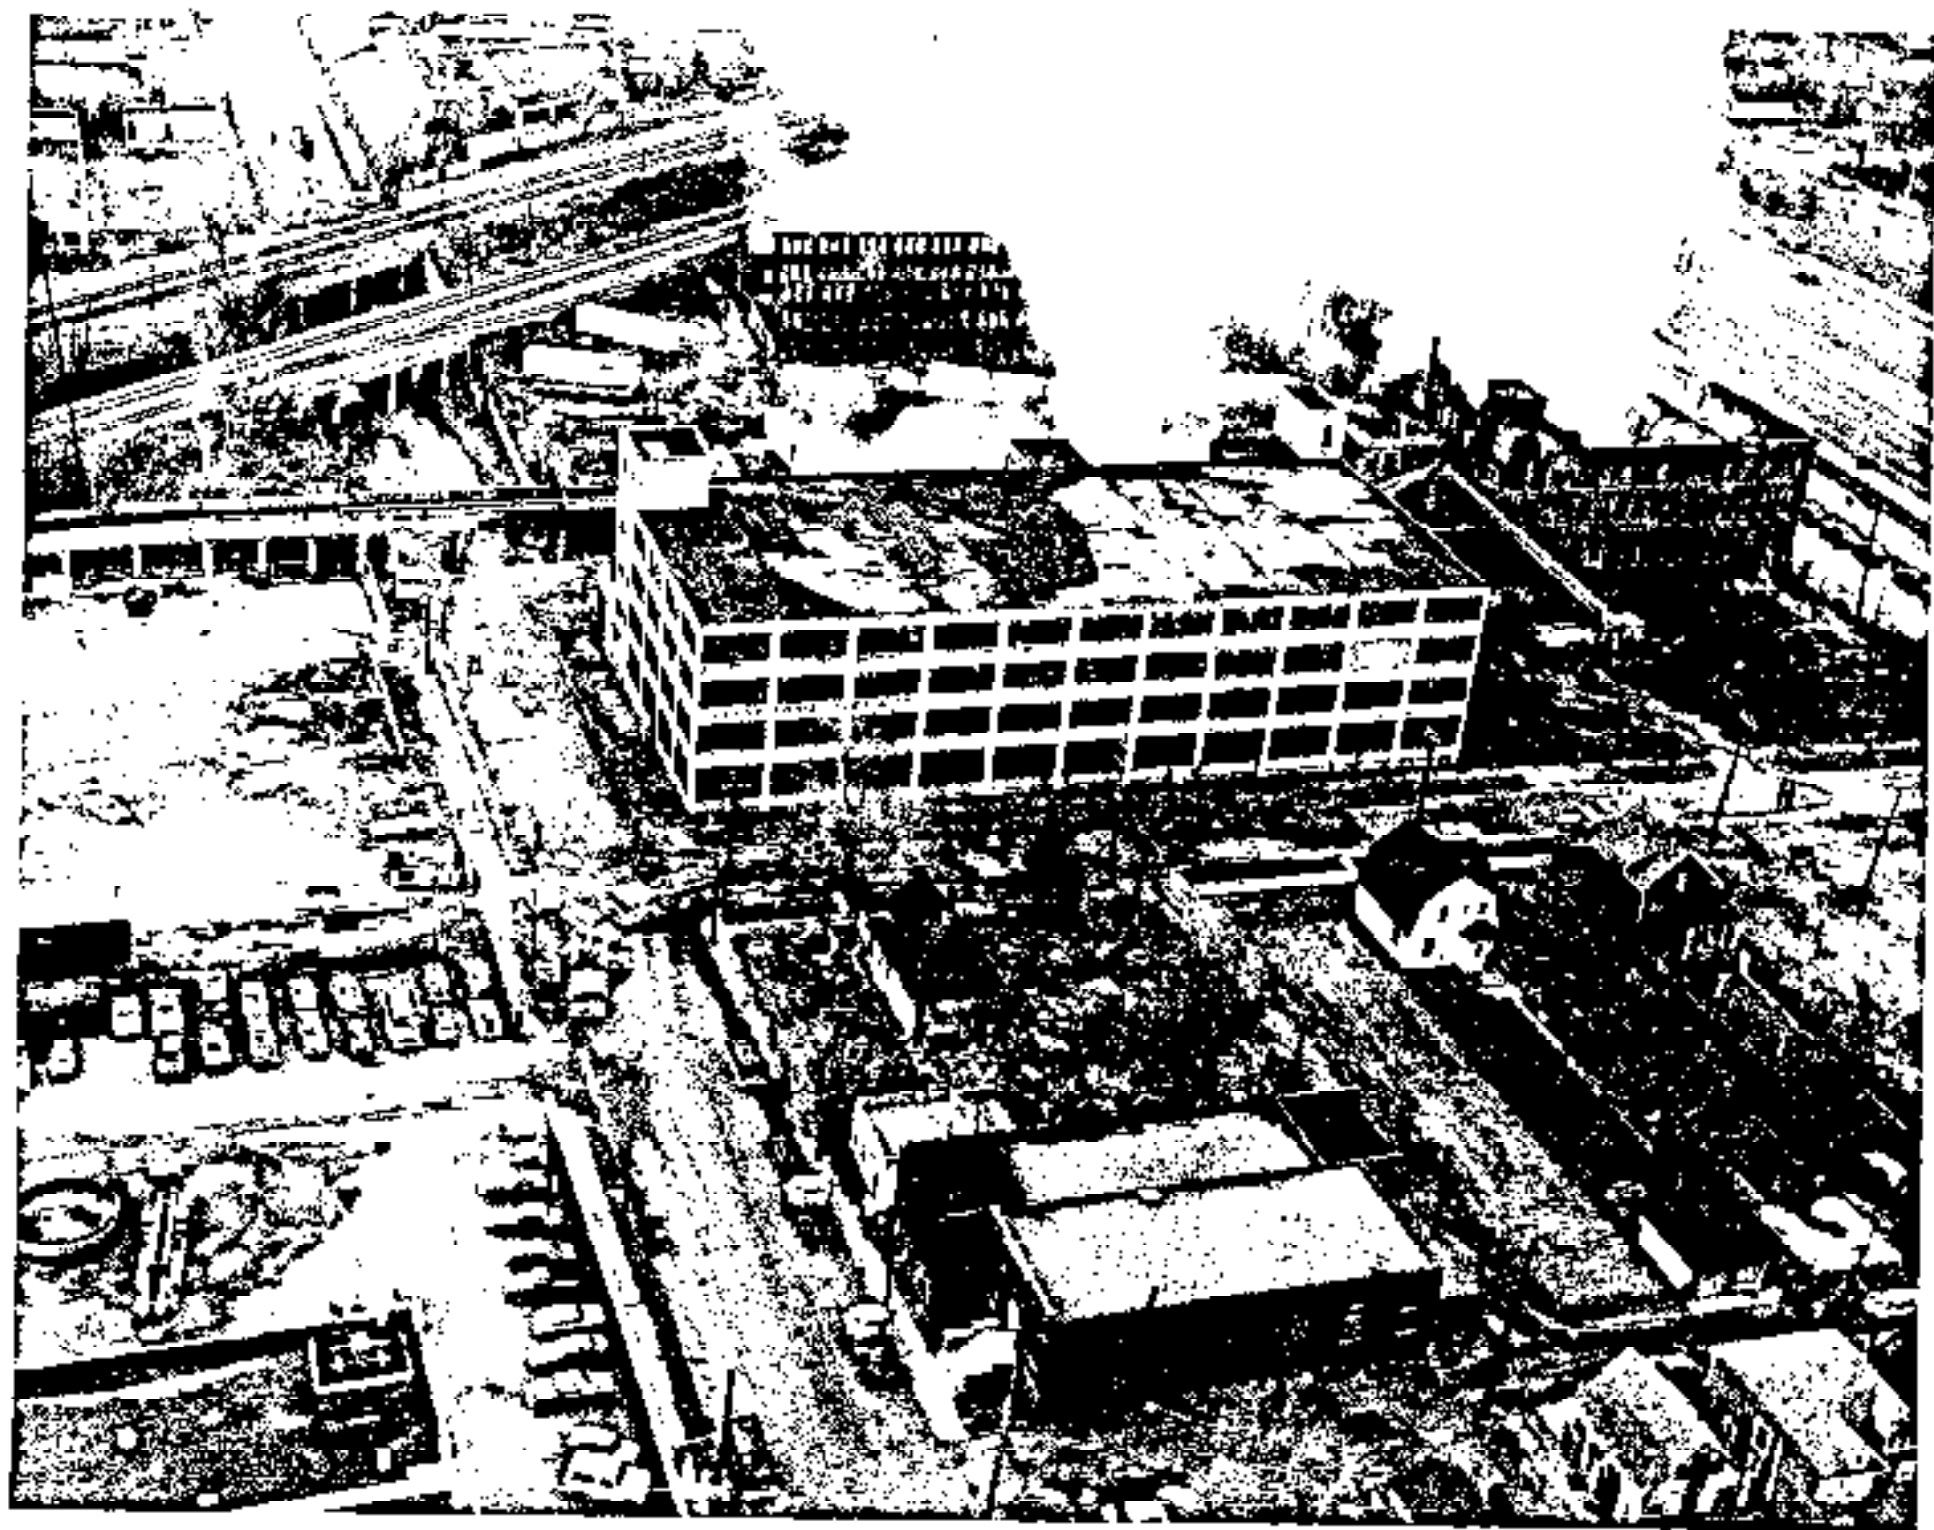
Photos 1-4

Aerial views of the incident scene - day after the fire.

In photo #1, note Detroit Fire Department Training Academy - 6 story building with radio tower, left of smoke plume.

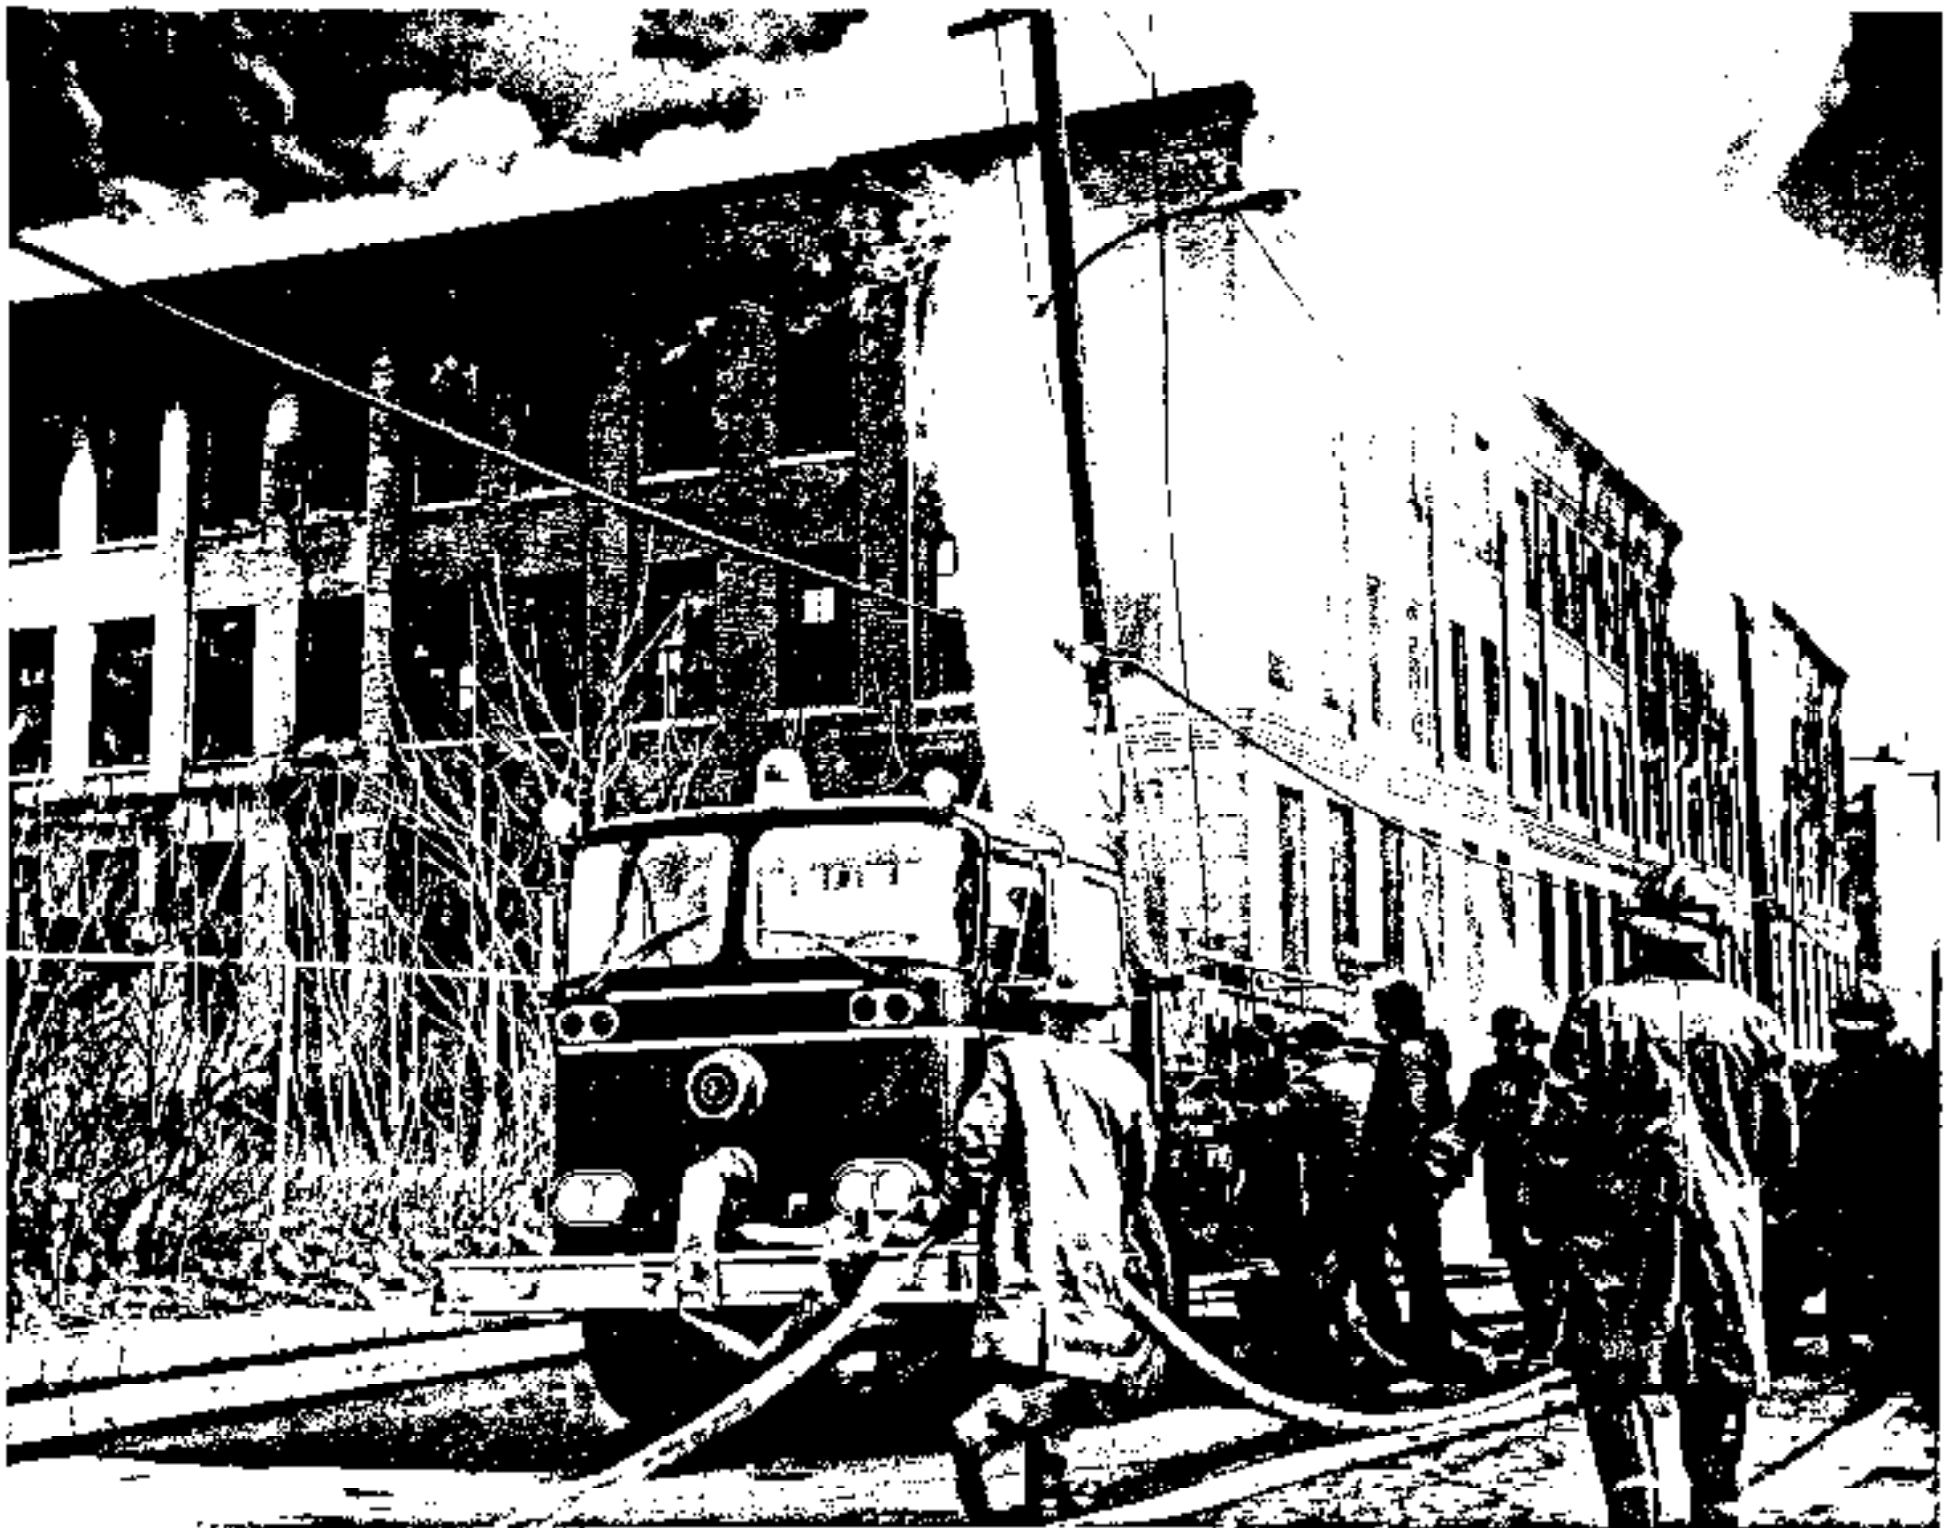
Fireground activity near N/W corner of original fire building, shortly after flashover and rescue operations.

PHOTO 5: Master stream on Engine 10 used to protect fire fighter in window prior to rescue. Also extension of flames to paper warehouse at eaves.

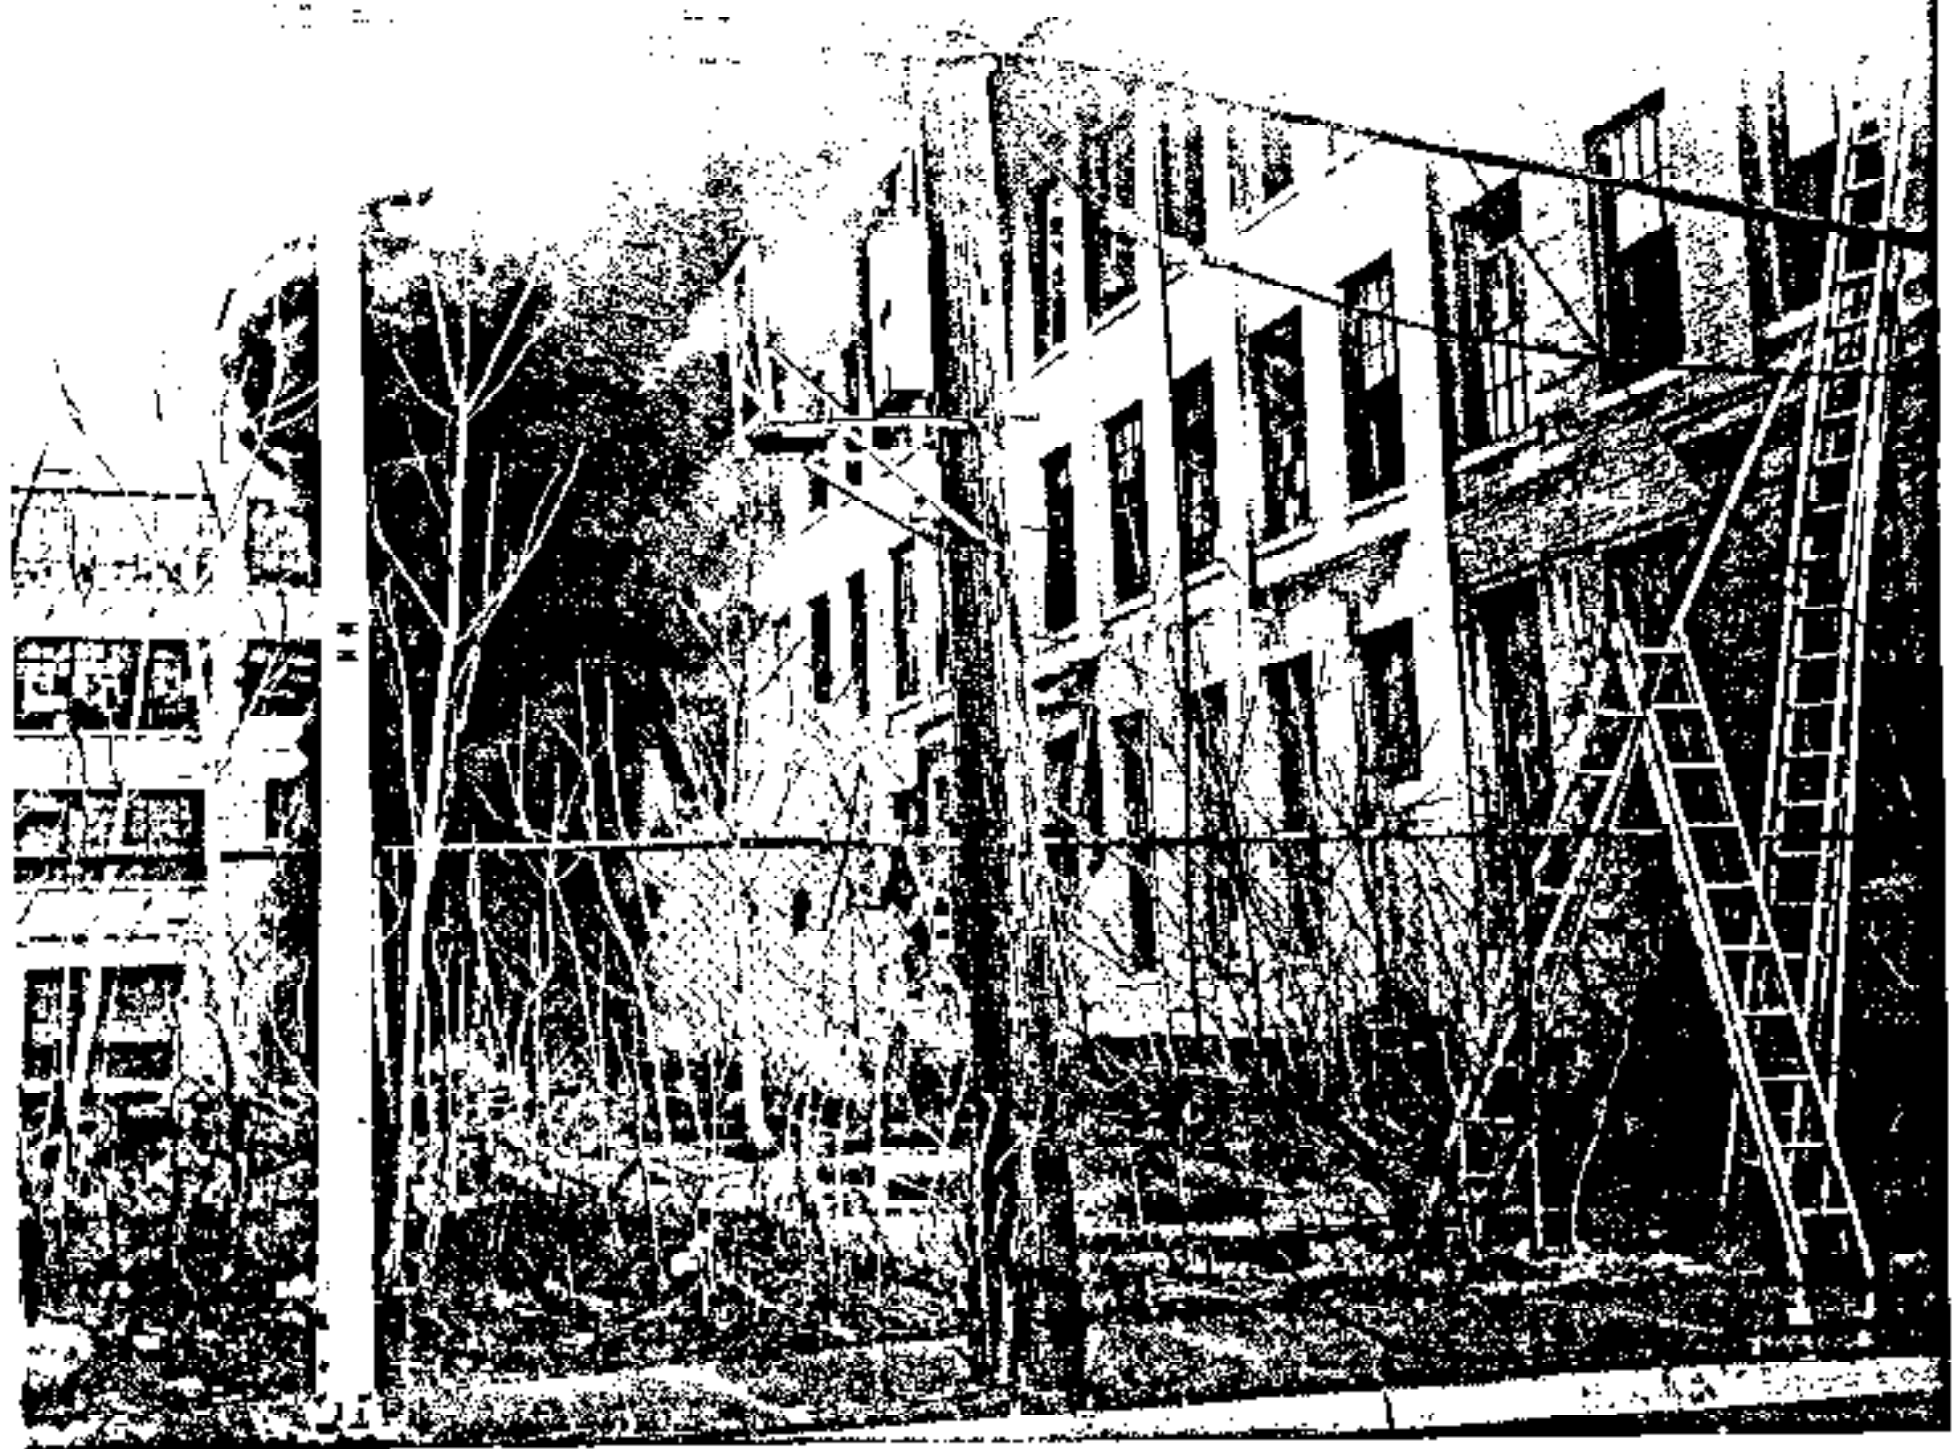
PHOTO 7: Fire in tires at ground level and fire spread on 2nd and 3rd floors.
