Detroit Warehouse Fire Claims Three Firefighters

Detroit Warehouse Fire Claims Three Firefighters (March 12, 1987)

Investigated by: J. Gordon Routley

This is Report 003 of the Major Fires Investigation Project conducted by TriData Corporation under contract EMW-88-C-2277 to the United States Fire Administration, Federal Emergency Management Agency.

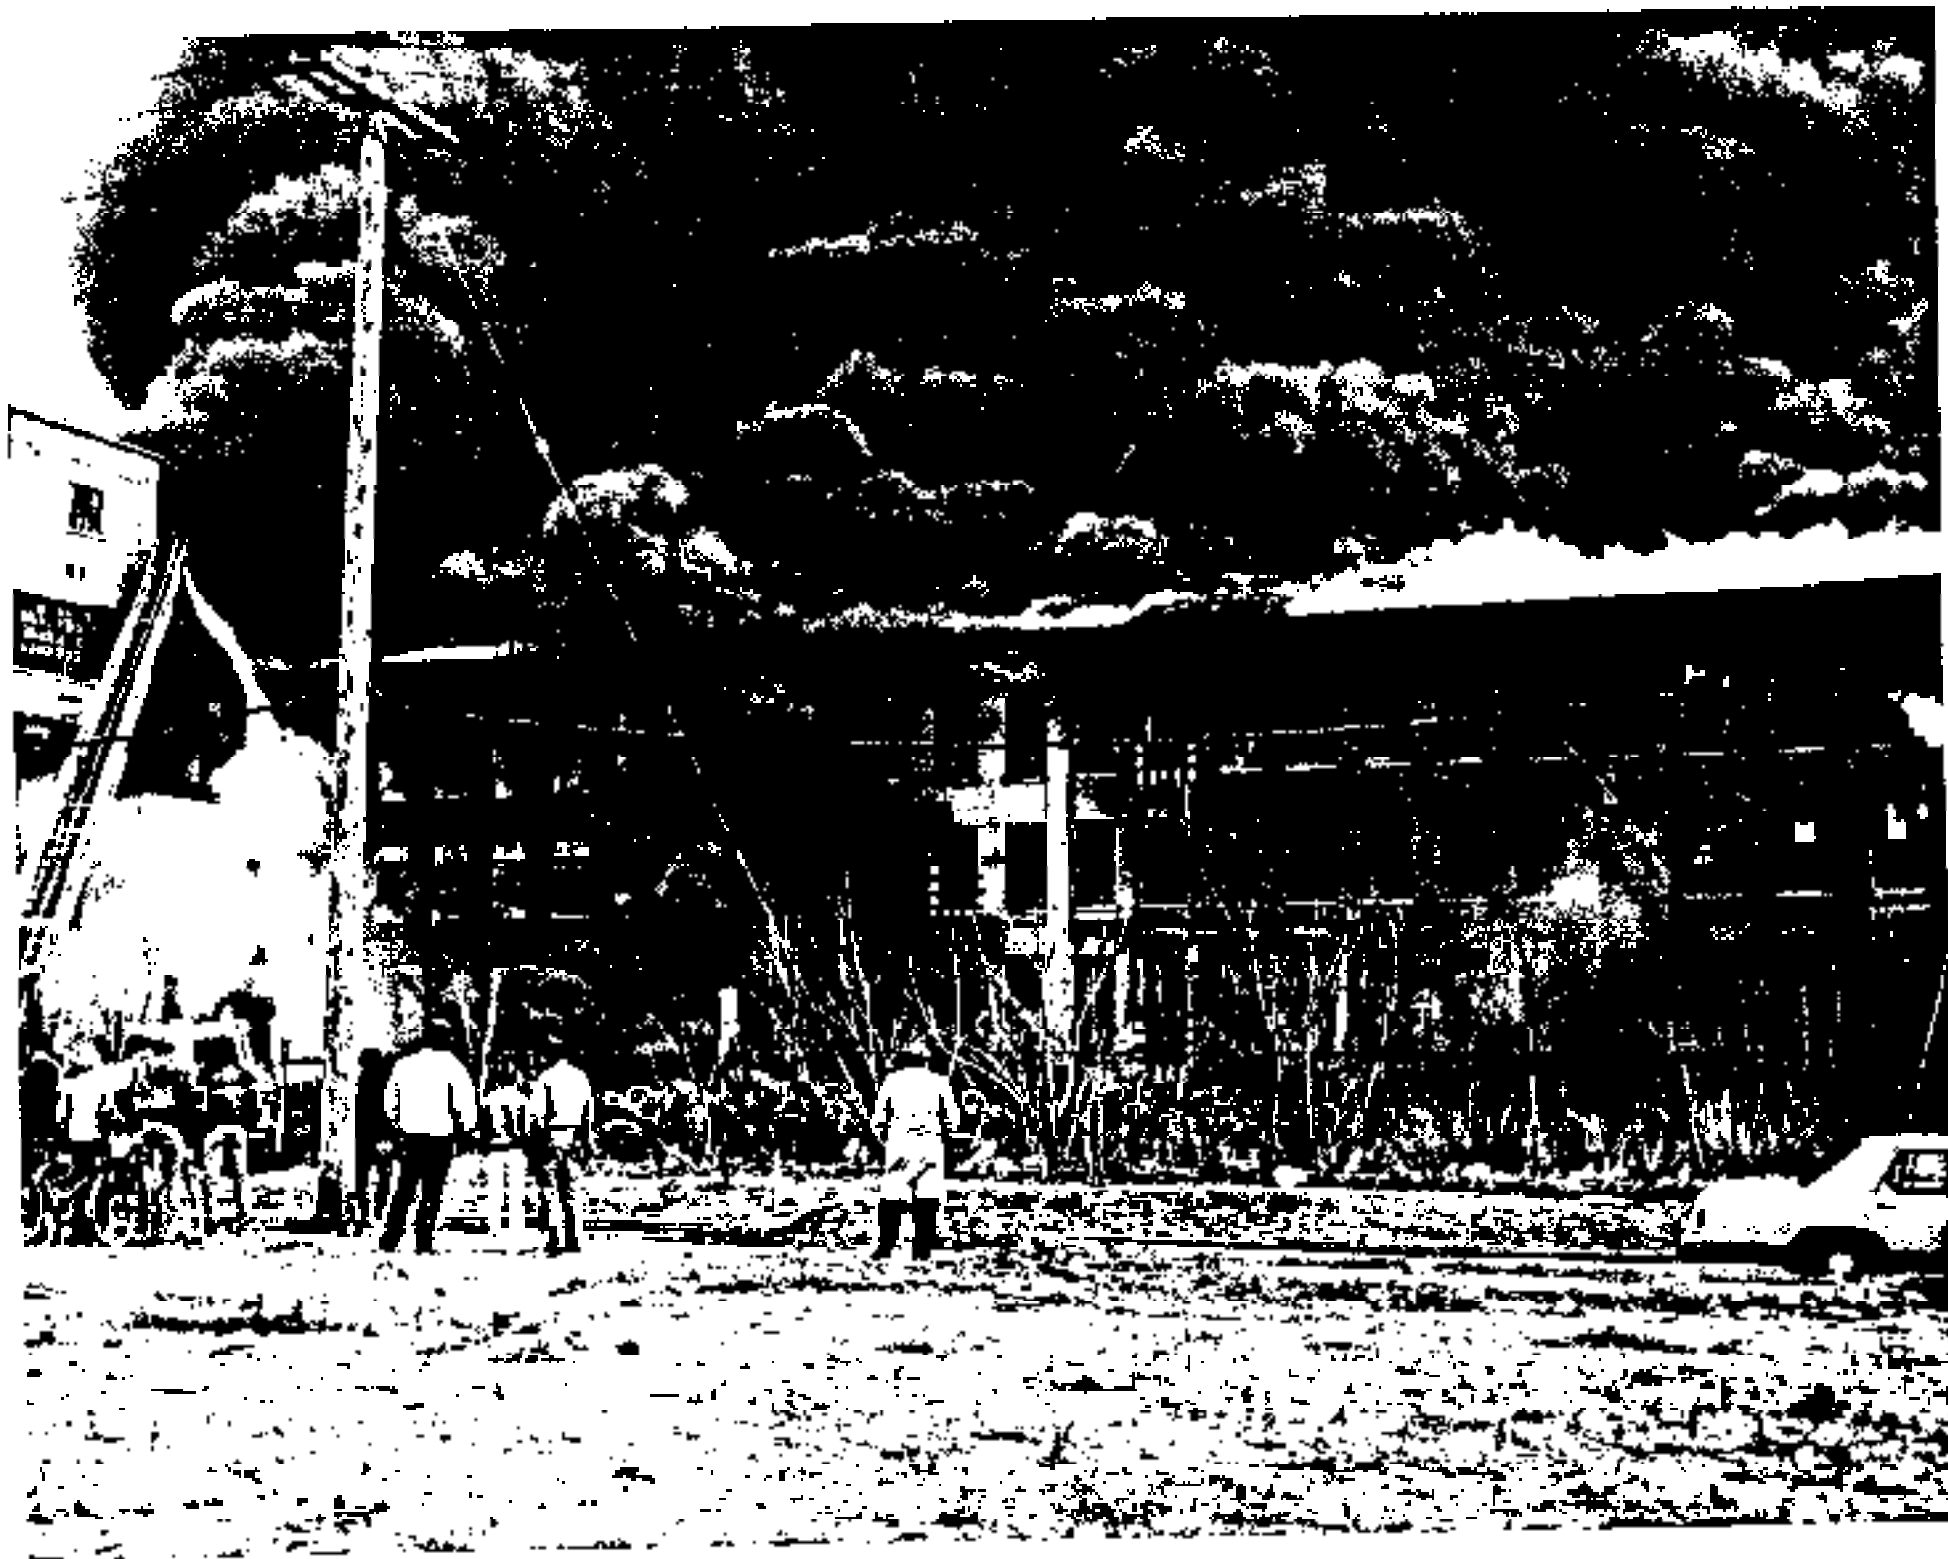
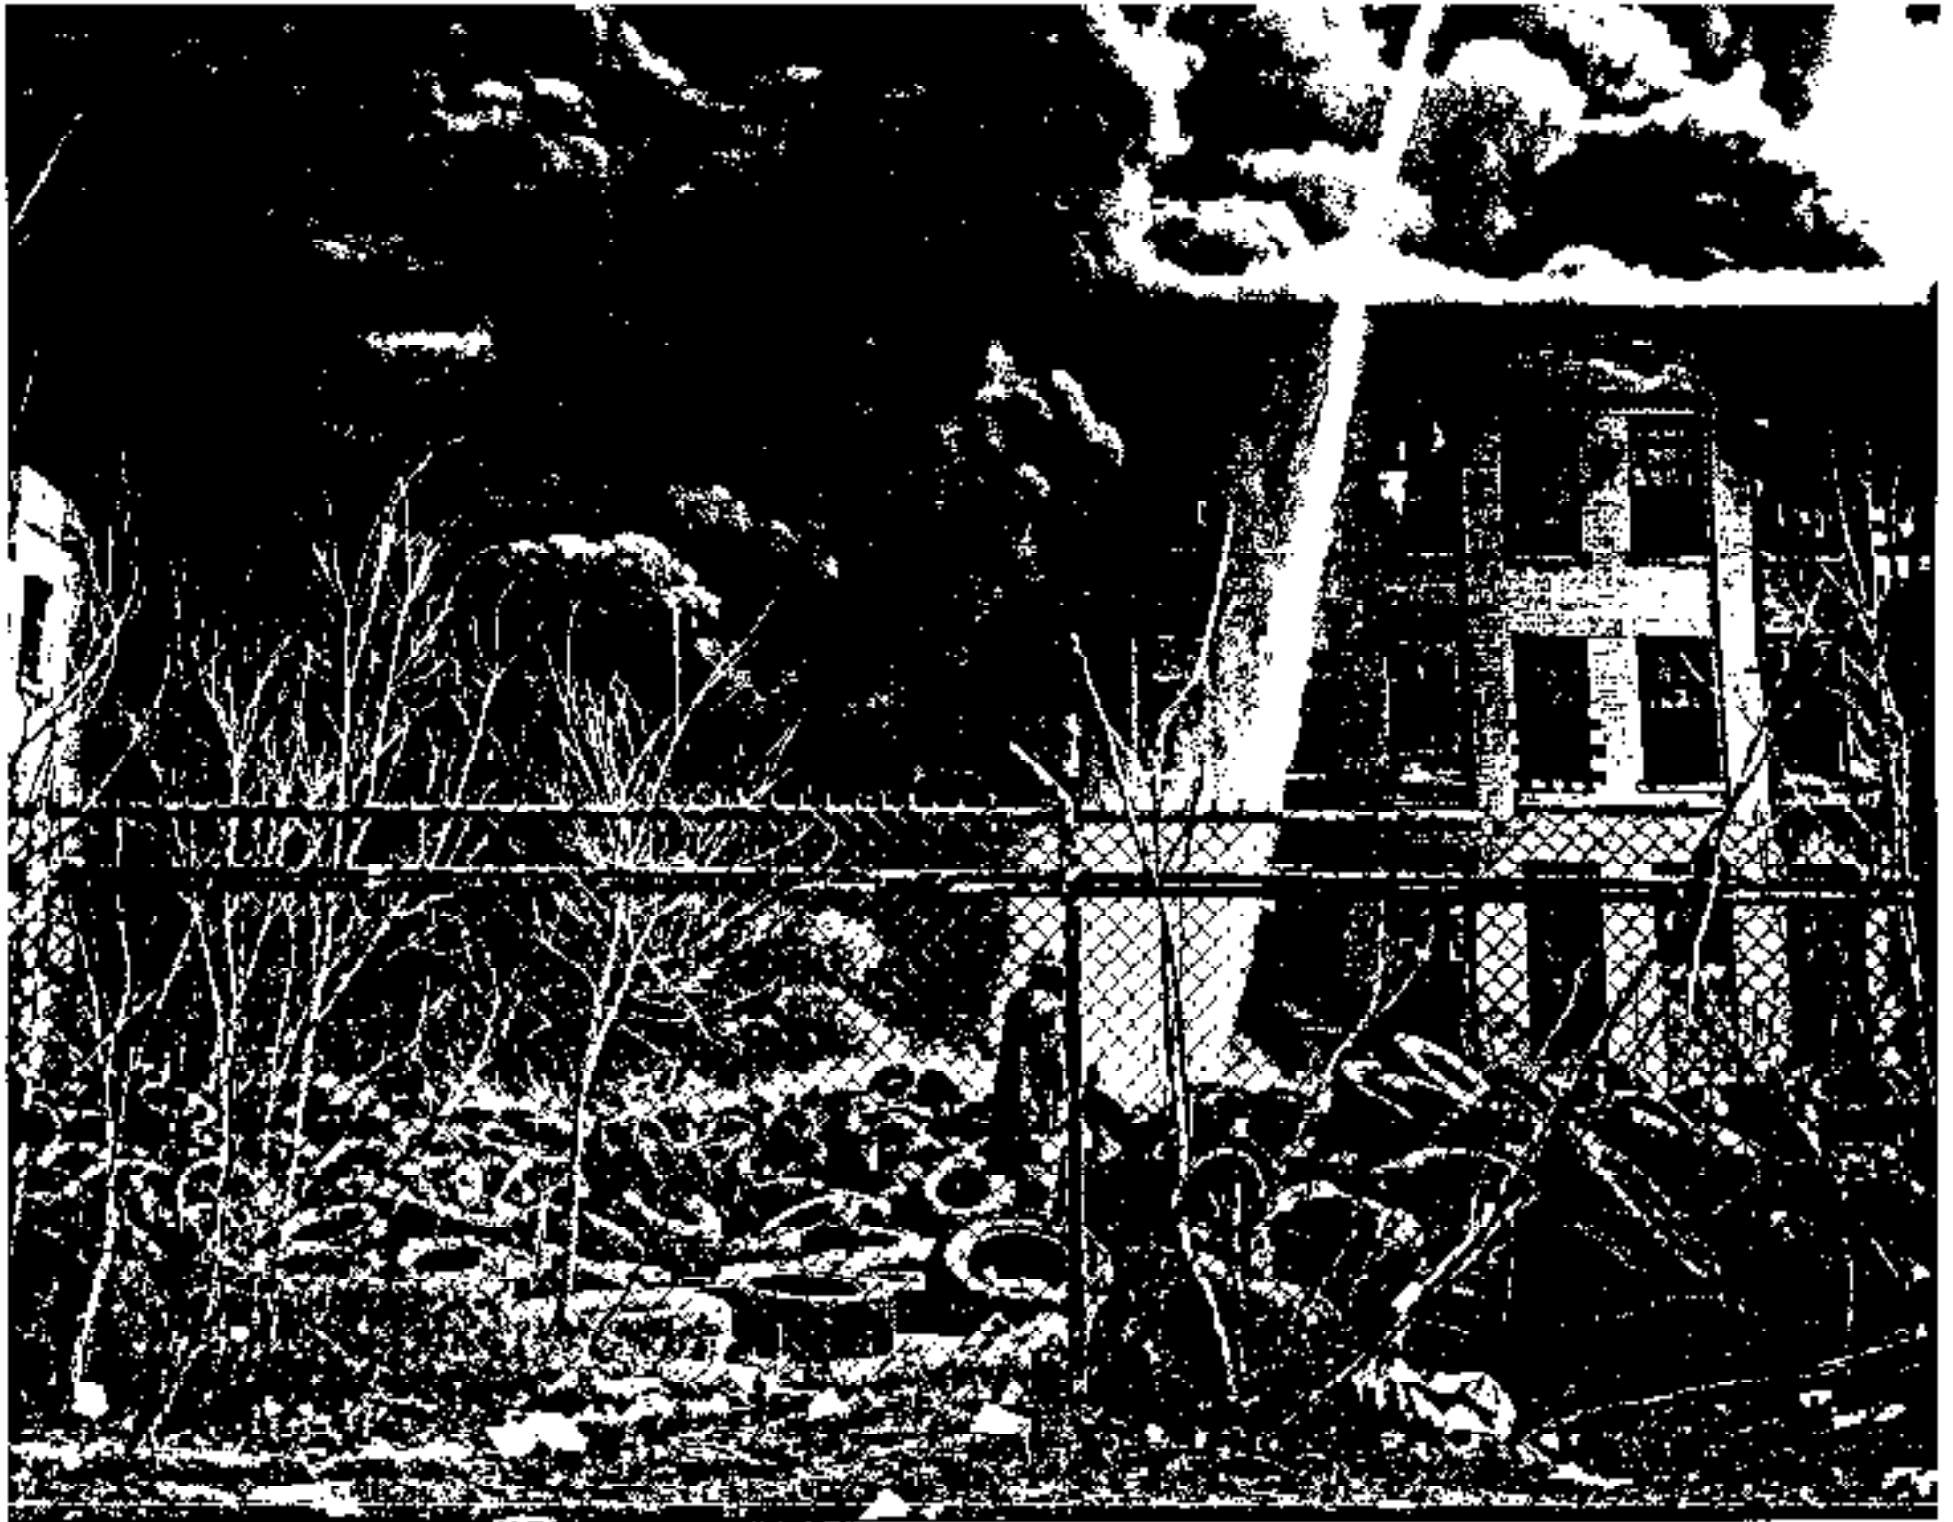
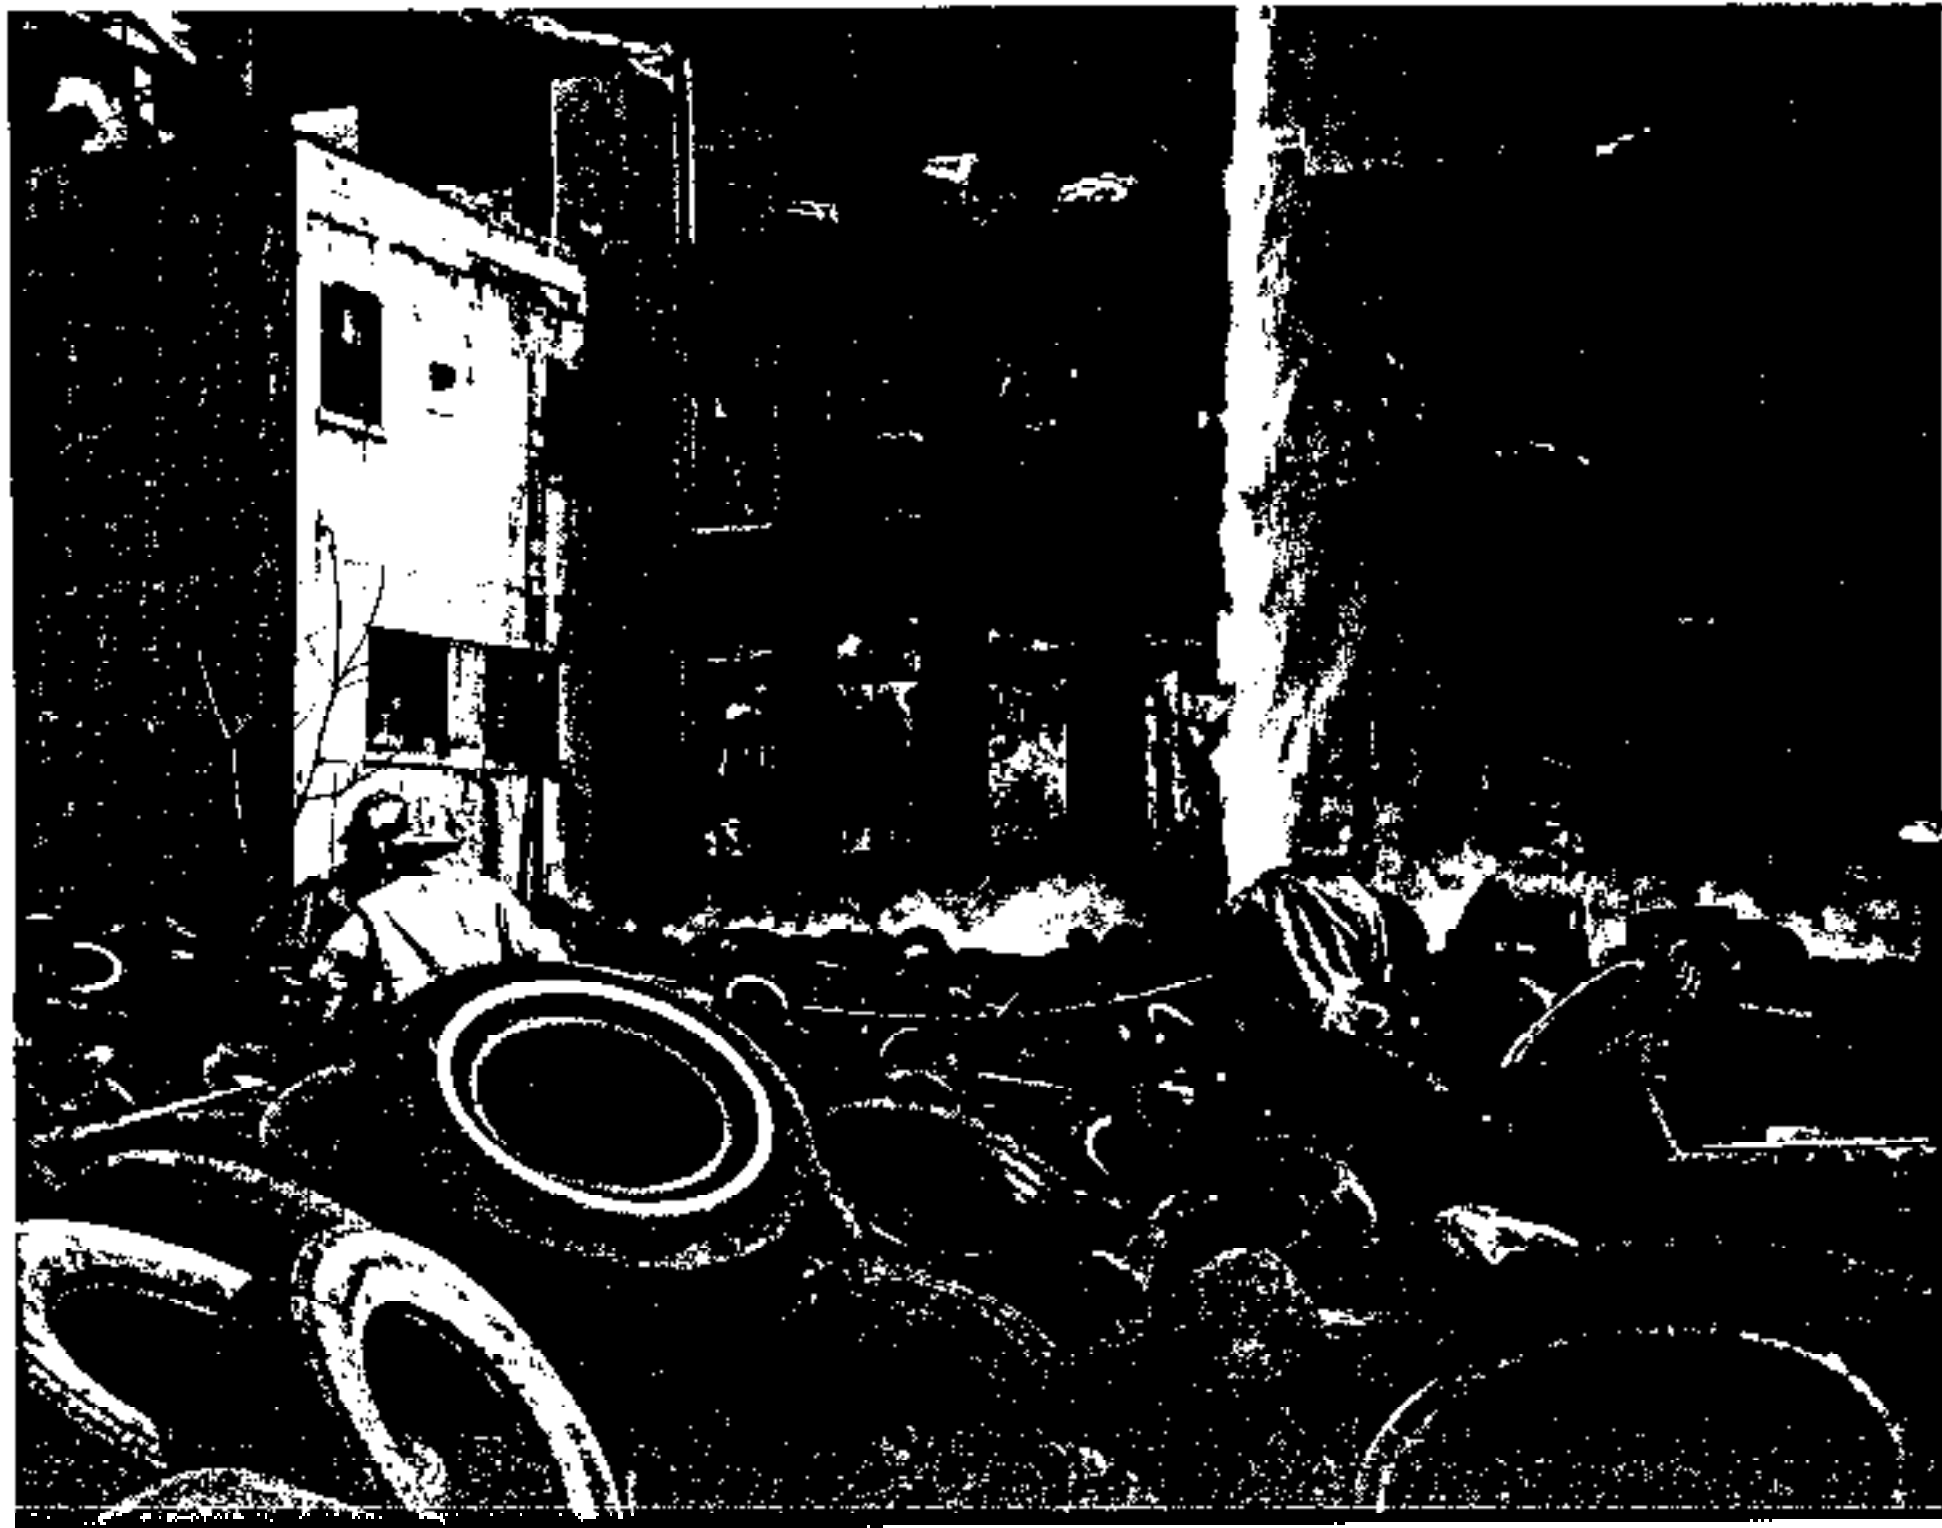
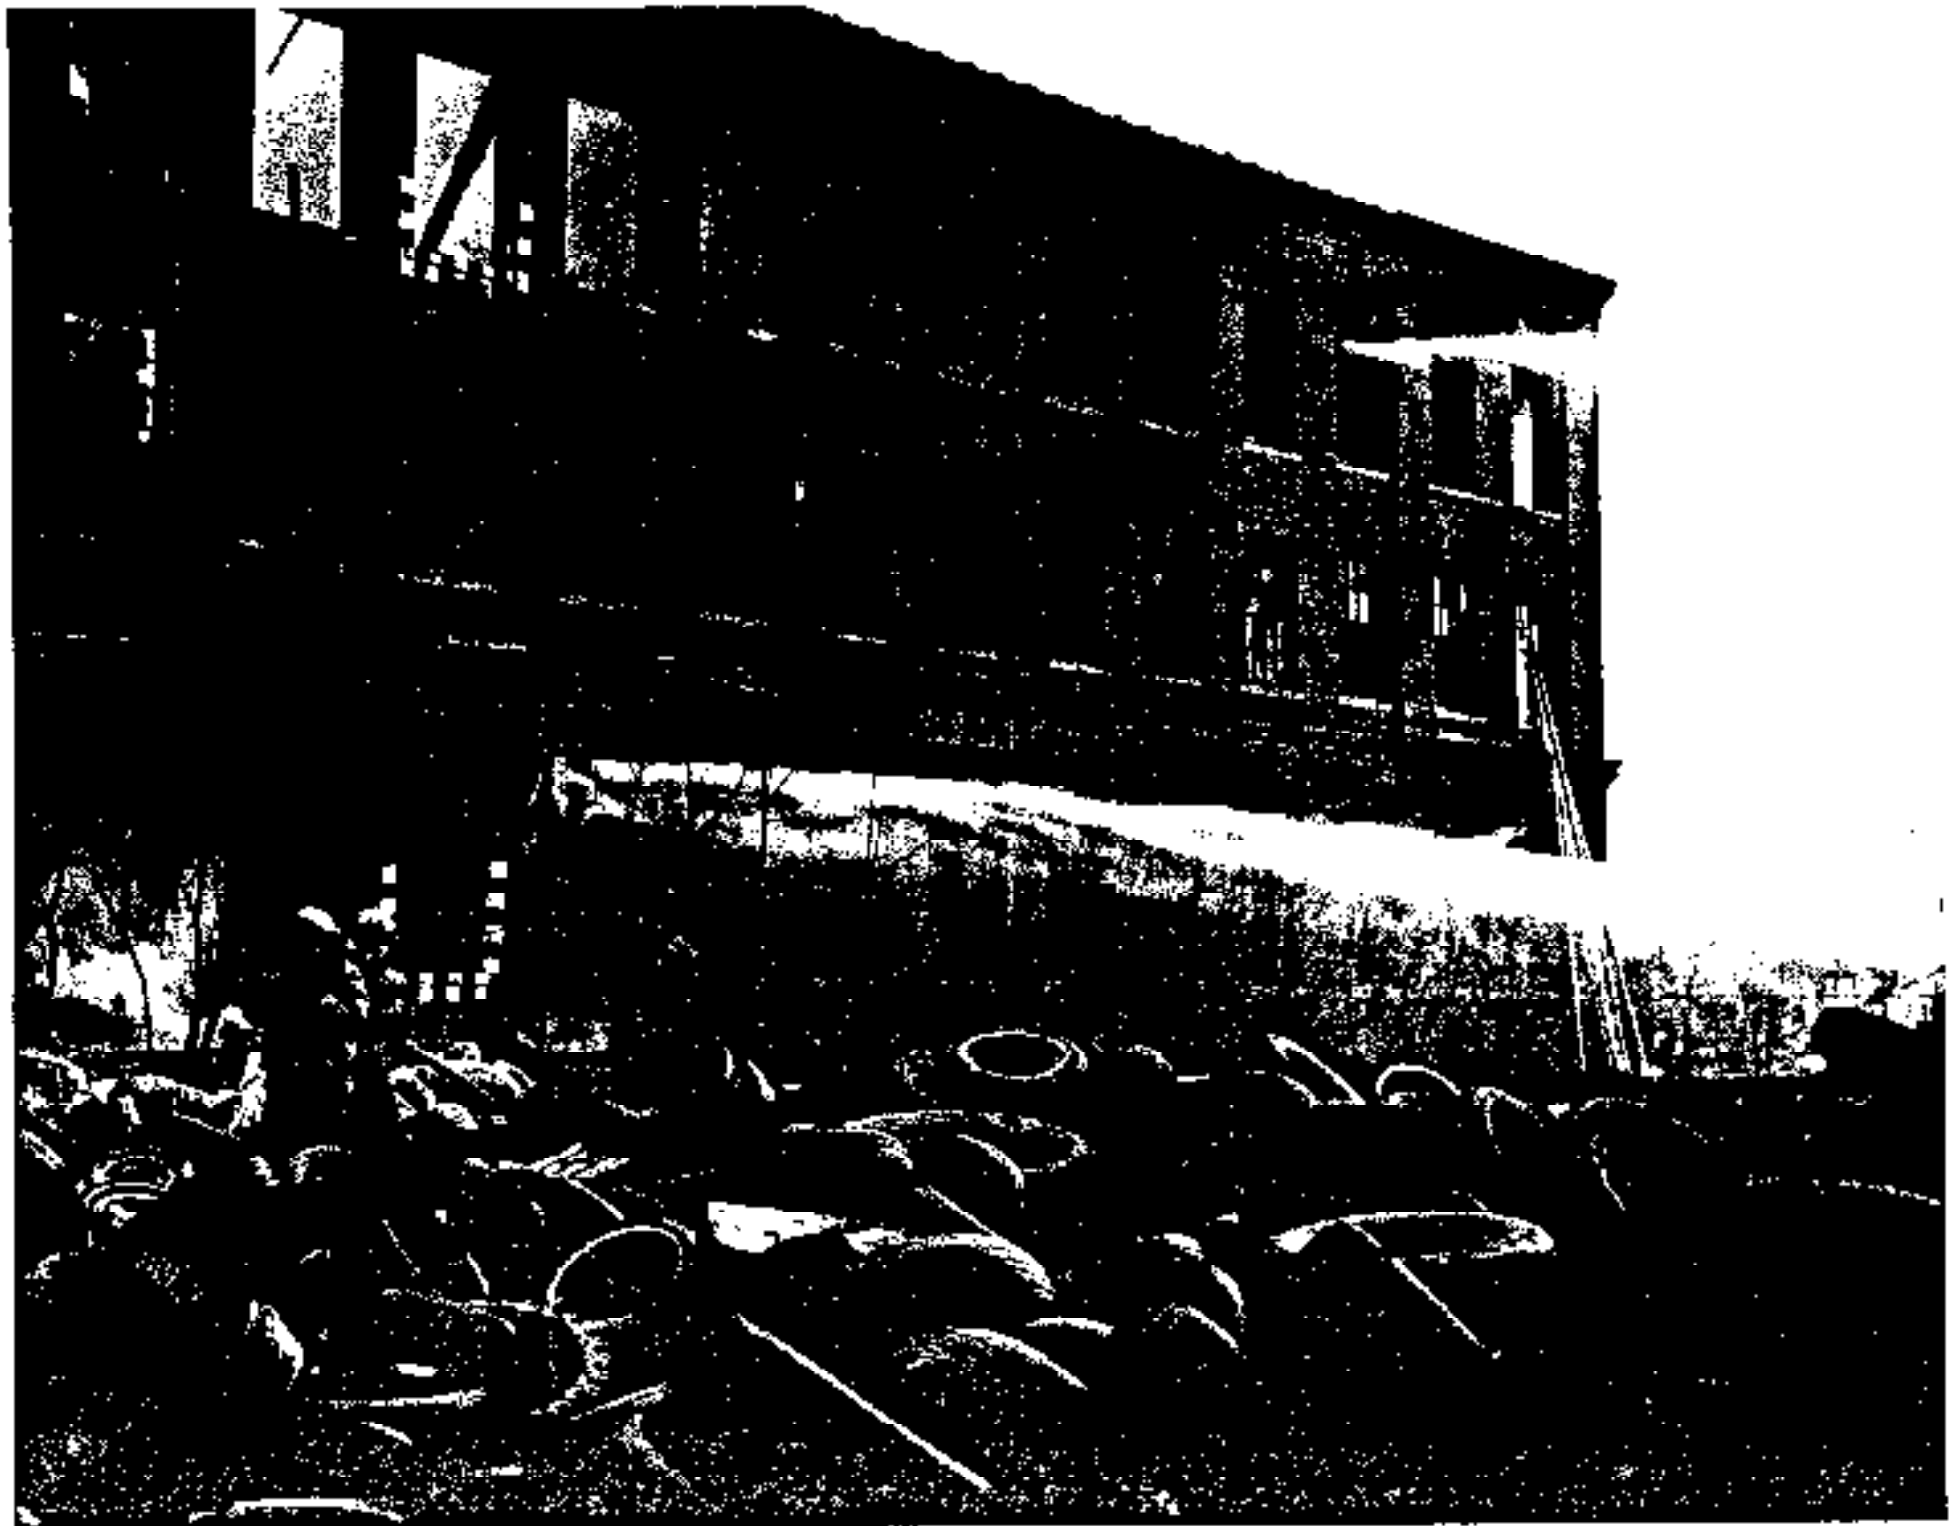
Photos 8-12

Continuing fire fighting activity,, Northwest part of complex.
