Schomberg Plaza Fire New York City (Harlem)

Schomberg Plaza Fire New York City (Harlem) (March 22, 1987)

By: Philip Schaenman

This is Report 004 of the Major Fires Investigation Project conducted by TriData Corporation under contract EMW-86-C-2277 to the United States Fire Administration, Federal Emergency Management Agency.

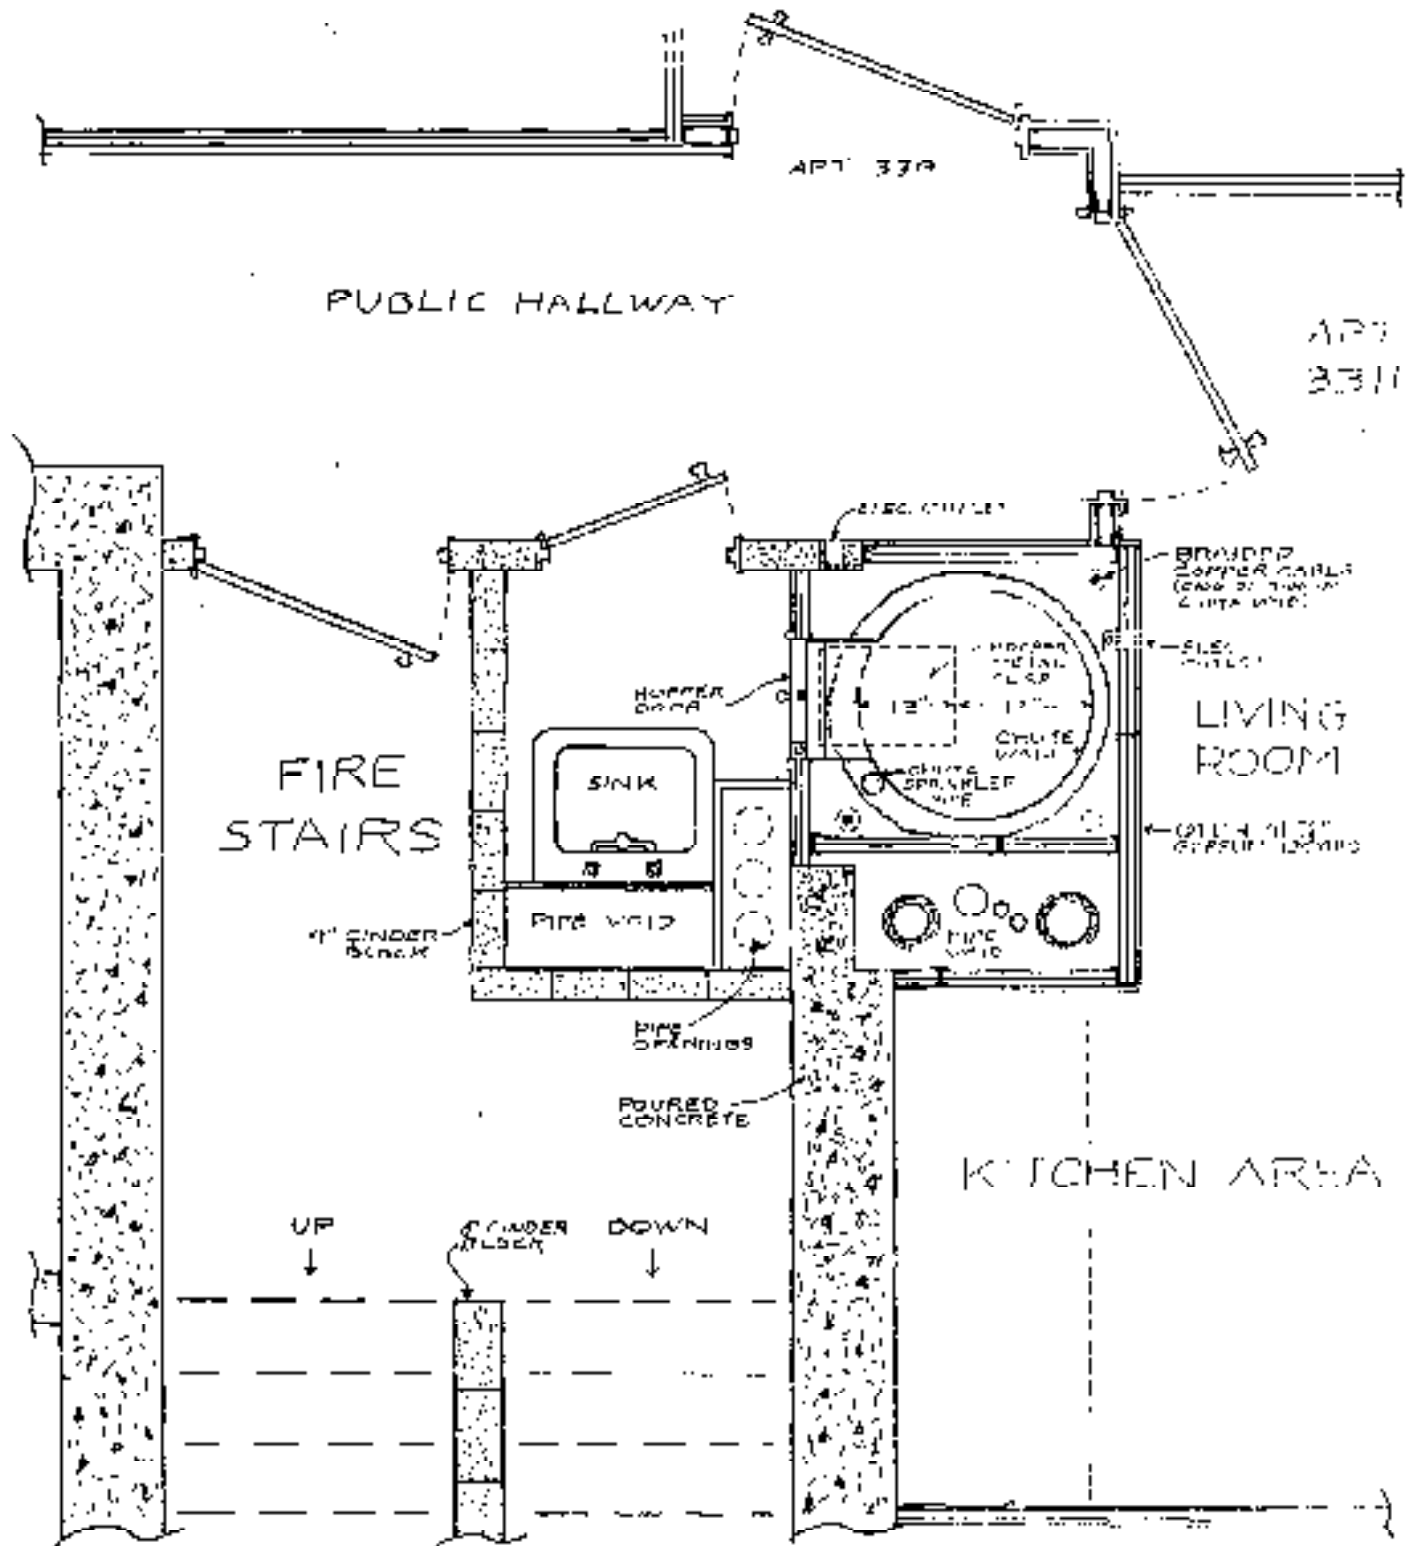
1295 5TH AVE MAN. 33RD FLOOR COMPACTOR CHUTE AREA*

The compactor chute investigation disclosed that the heat buildup from the fire within the chute was transferred to the metal chute itself. The heated metal chute radiated heat into the sheetrock chute enclosure and the adjoining pipe chase voids, which are adjacent to the "H" bank apartments. The heat buildup in the shaft enclosure compartment travelled

horizontally into the adjoining pipe chase void via a one and one-eighths inch (1 1/8") opening at the bottom of the partition wall between the shaft enclosure and the pipe chase void. This opening was created as a result of the two inch (2") sheetrock wall resting on top of various pipe brackets and chute anchors rather than being secured to the concrete floor. (See attached diagram). In addition, it was found that the chute penetrated each floor through a concrete opening of a slightly larger diameter thereby creating a space between the outside of the chute and the concrete opening which varied from floor to floor. These openings allowed for vertical heat transfer from floor to floor within the shaft.

Examination found additional openings in the sheetrock construction of the walls which divided the compactor chute enclosure and the pipe chase void from the kitchen and livingrooms of the "H" bank apartments. These openings allowed heat transfer from the chute enclosure and the pipe chase void into the "H" bank apartments. Further, the above mentioned metal pipe brackets extended from the pipe chase void into and under the kitchen broom closet, making contact with the combustible components of the broom closet.

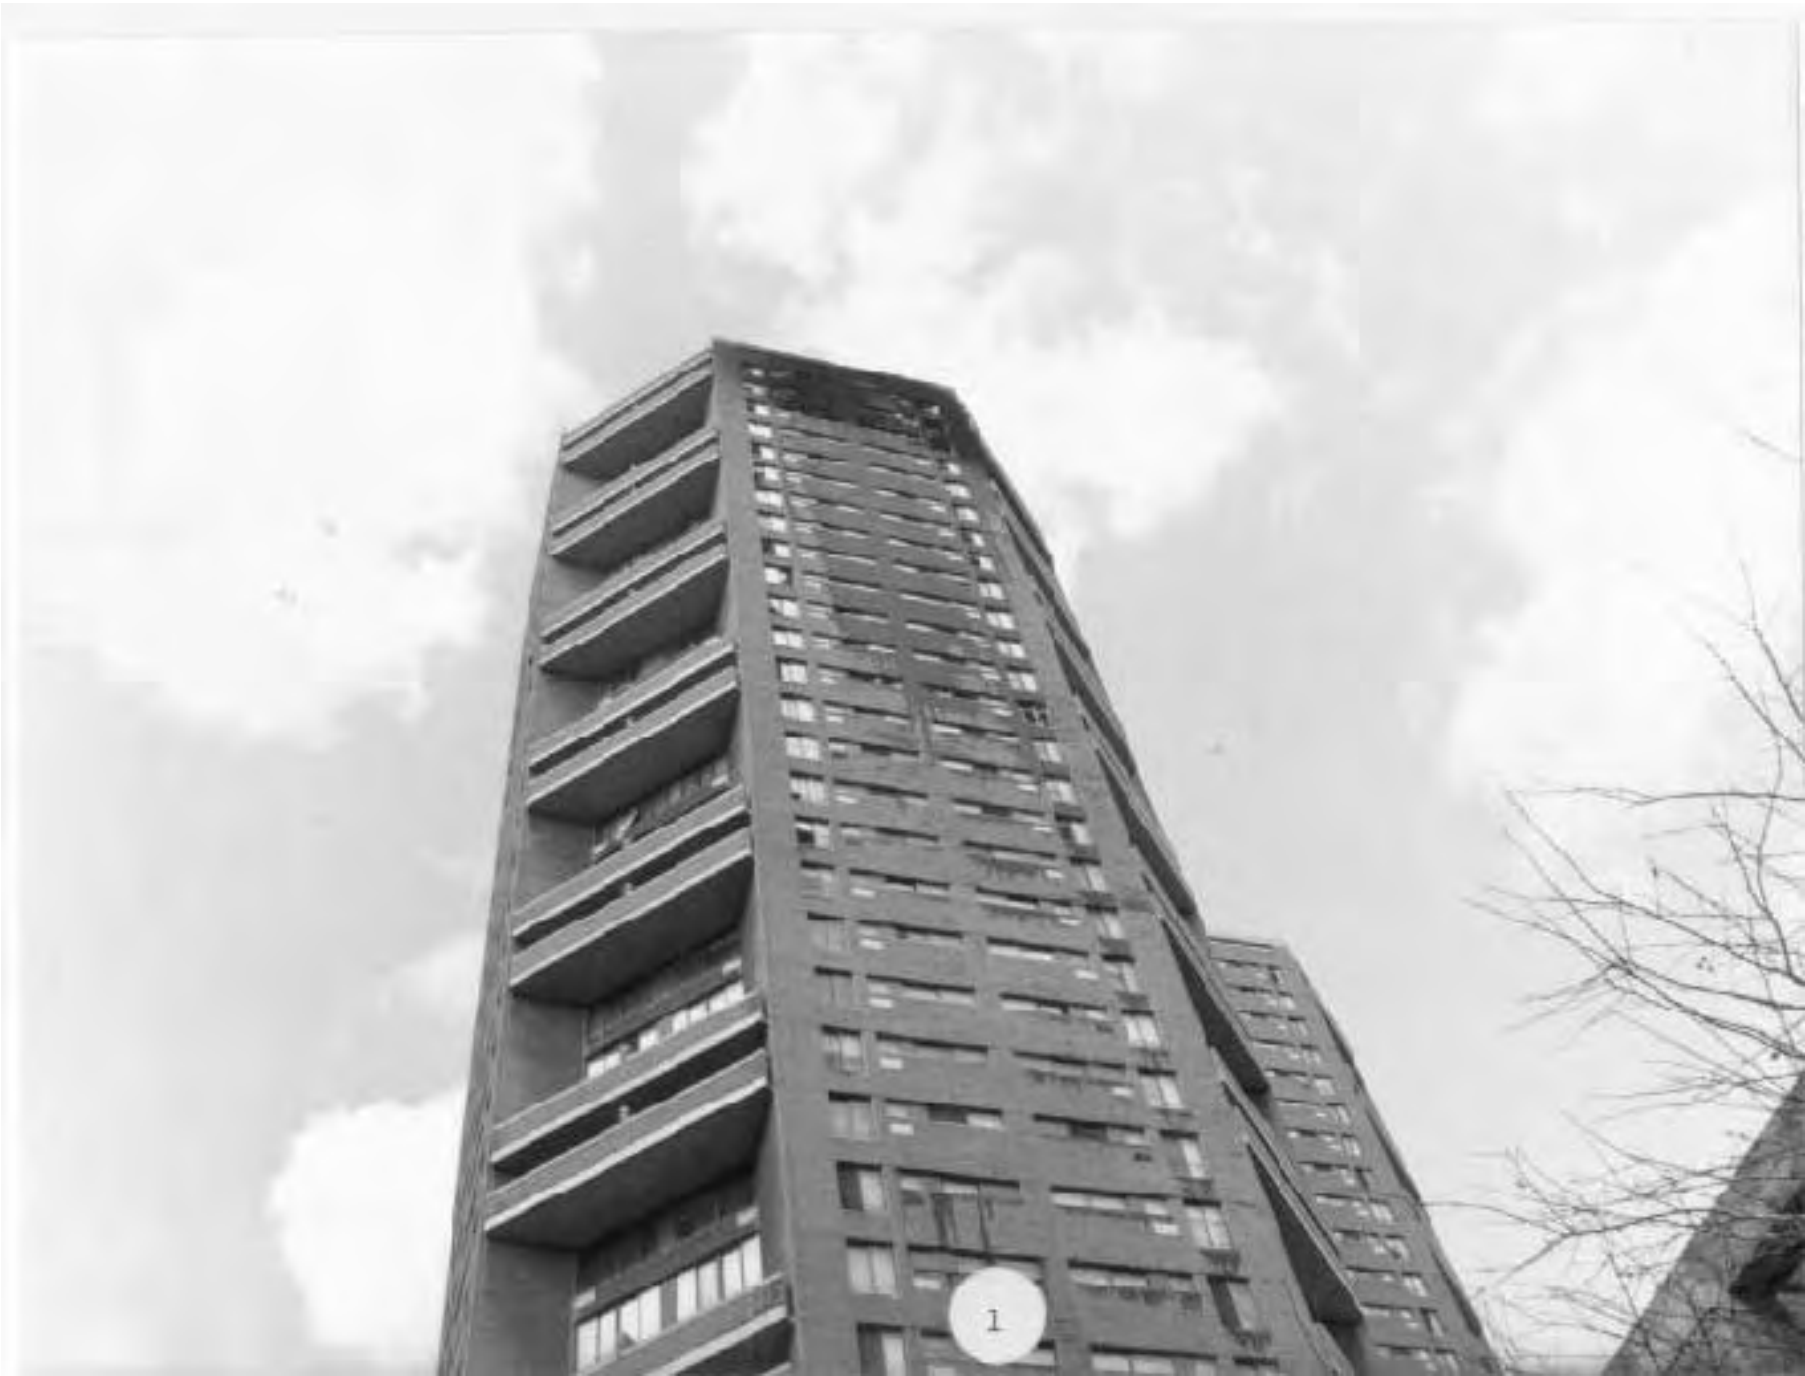
1. Exterior of fire building with water and burn patterns.
2. Compactor unit in the fire building (morning of fire).
3. Kitchen area, Apt. 23, adjoining compactor and pipe chase.

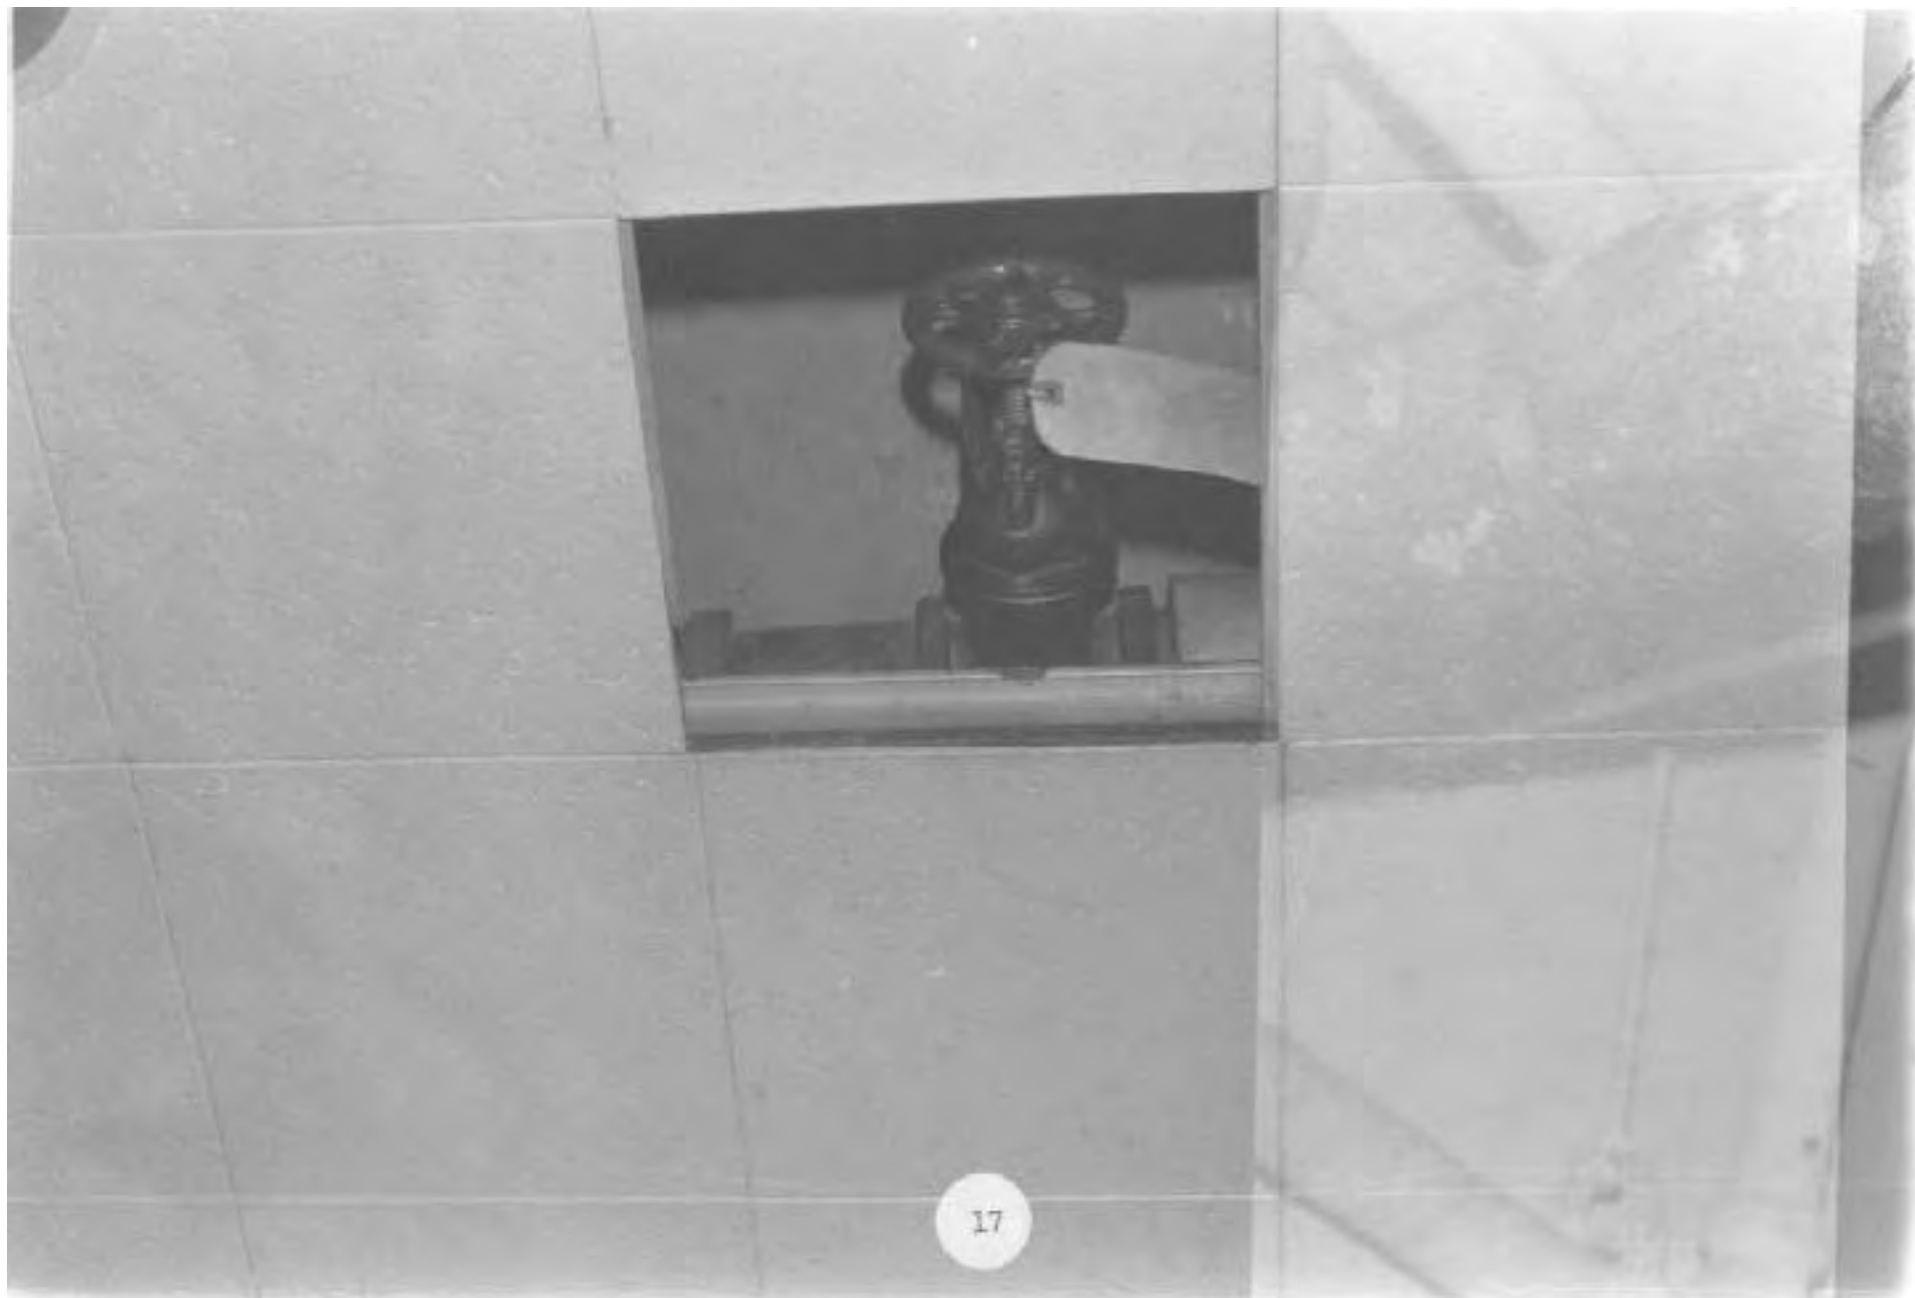
16

15. Horizontal piping with solidified silt and rust.
16. Evidence voucher. (Sample)
17. Sprinkler shut off valve in dayroom, 1st floor.
18. Sprinkler shut off valve in closet (compactor) on 35th floor at ceiling.

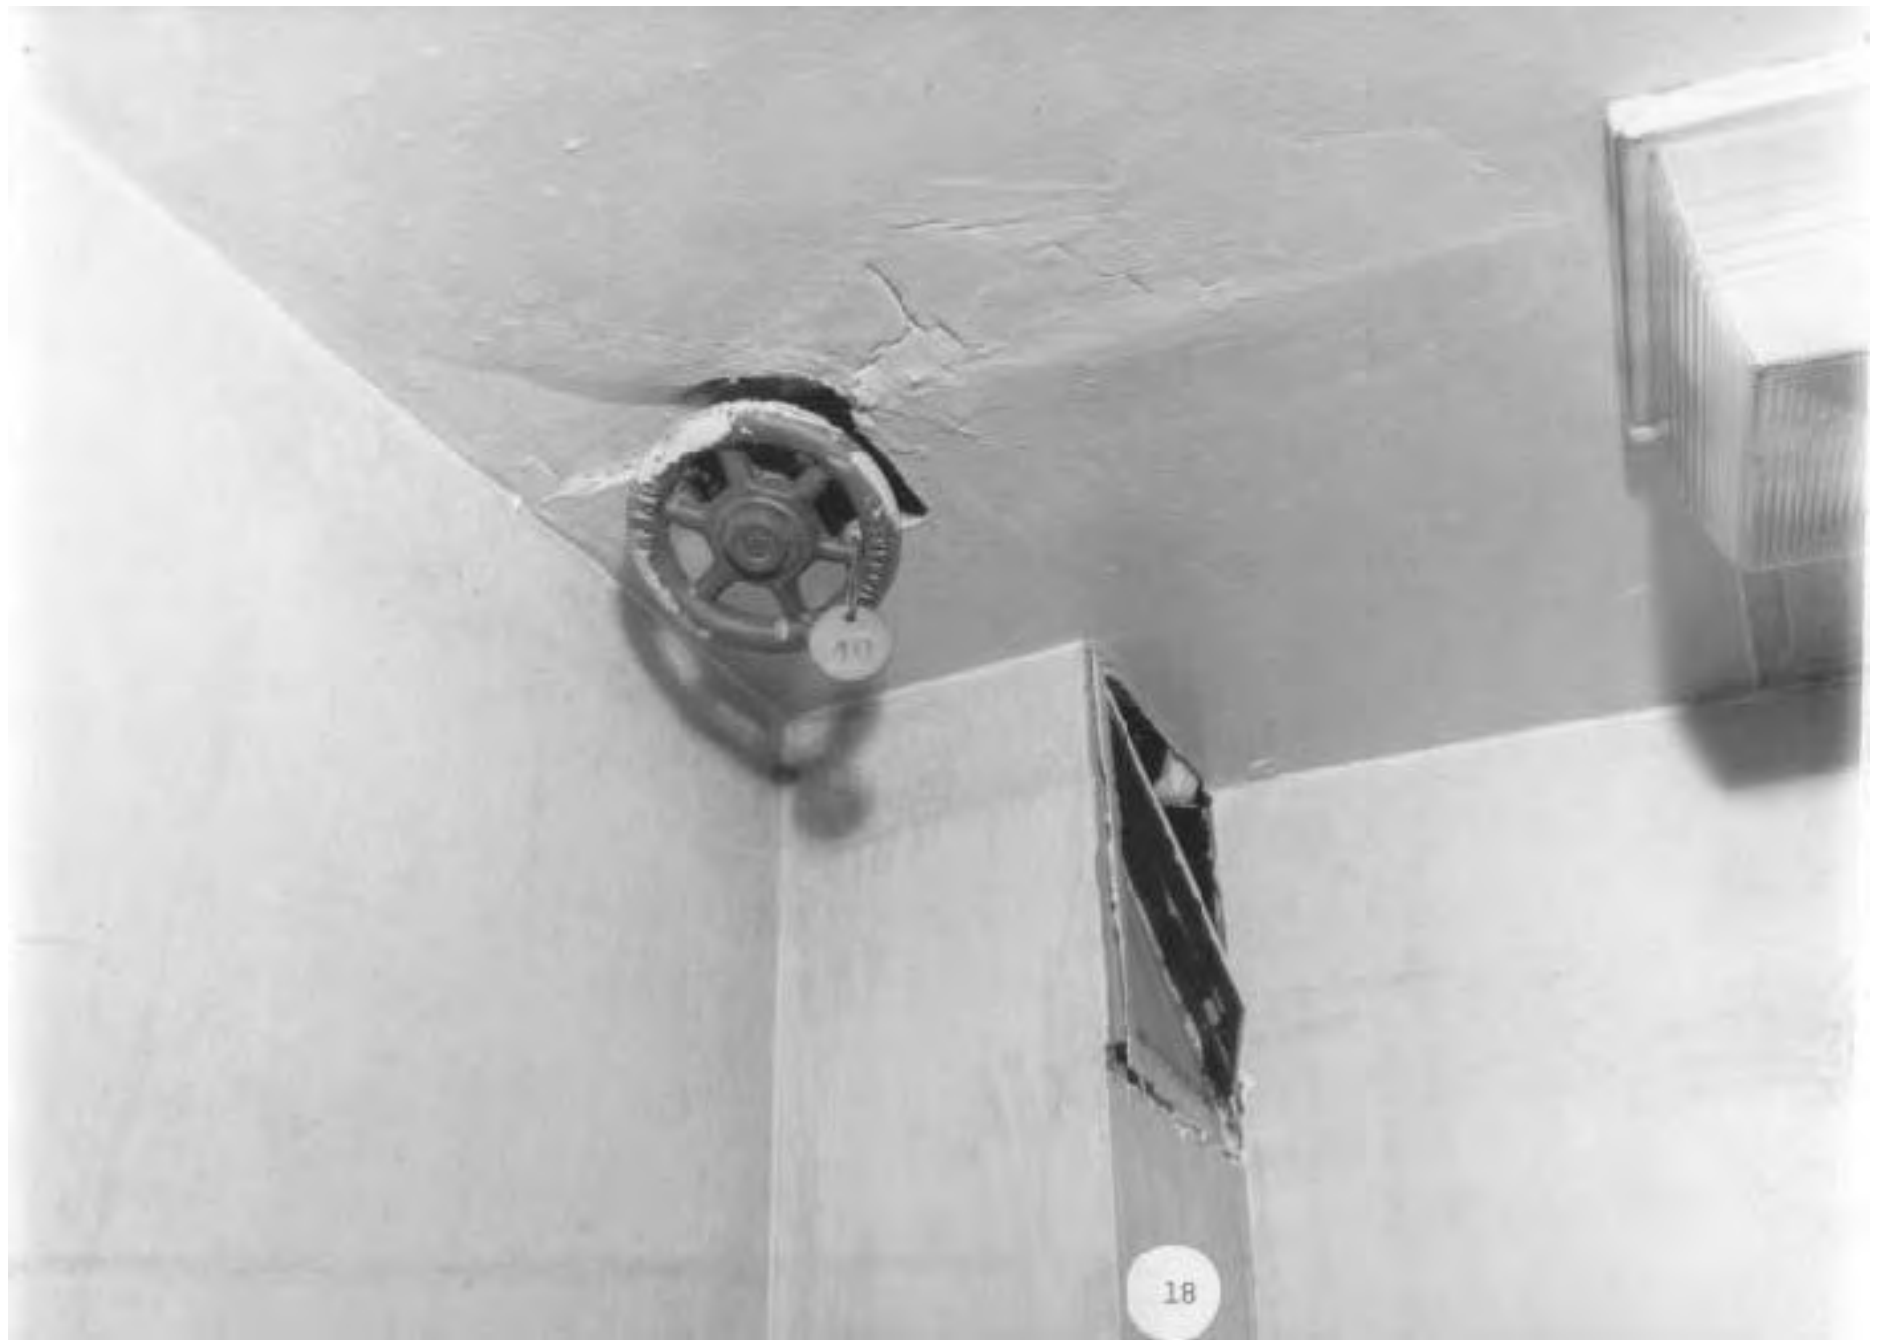
17

The Board of Inquiry has determined that at the time of the fire the compactor sprinkler system did not work and that neither of the two OS and Y valves which controlled the sprinkler system were open at the time of the inspection. While one of the firefighters believed that he had inspected an OS and Y valve for the compactor sprinkler system at 1295 Fifth Avenue, he had mistaken an open OS and Y valve which controlled the supply of domestic fresh water to the building, for the sprinkler valve. The valve was located in the basement next to the compactor.
