## Urban Wildlands Fire Pebble Beach, California

**Urban Wildlands Fire  
Pebble Beach, California  
(May 31, 1987)**

**Investigated by: Hugh W. Graham**

This is Report 007 of the Major Fires Investigation Project conducted by TriData Corporation under contract EMW-86-C-2277 to the United States Fire Administration, Federal Emergency Management Agency.

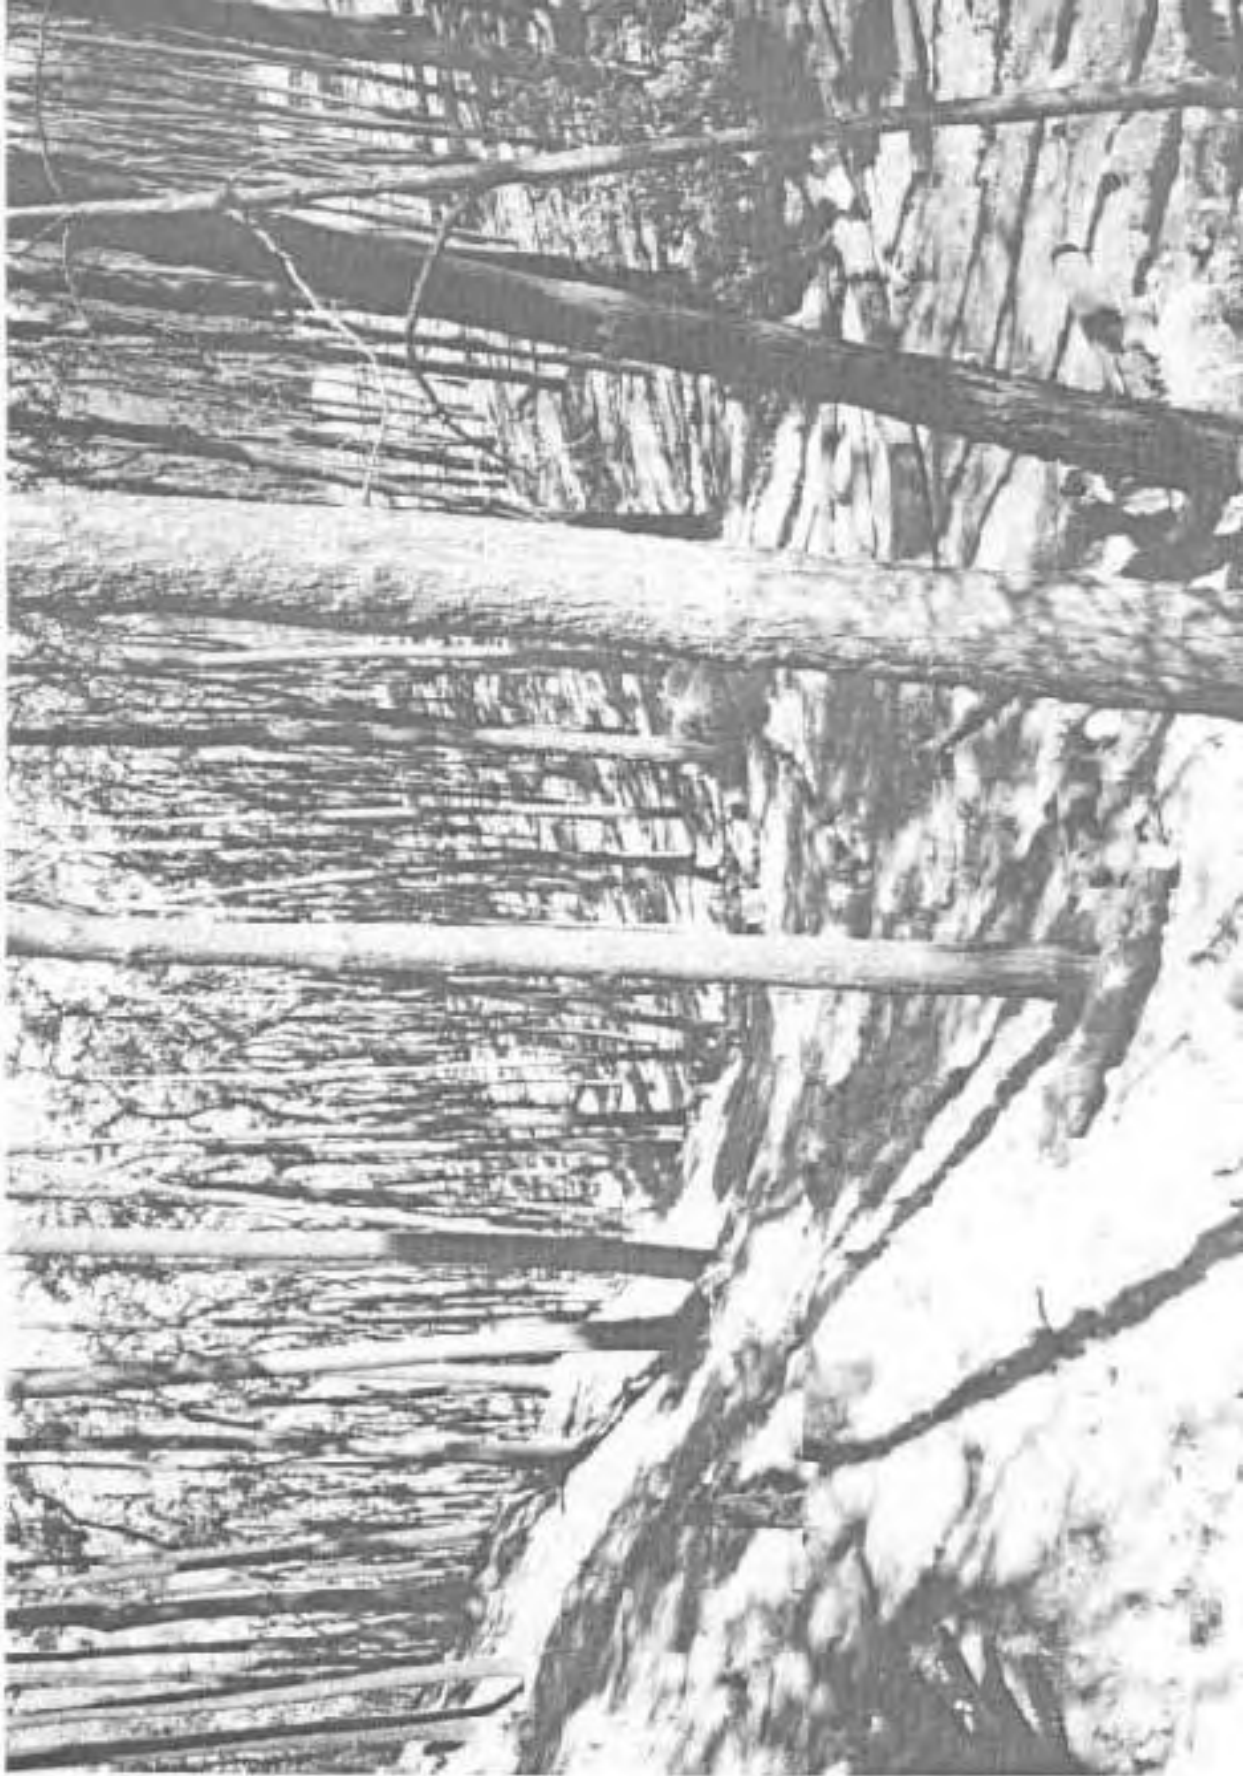
- \*R1x15 - A view looking west/southwest from Los Altos Drive down the canyon or chimney in front of 4011 Los Altos Drive. Notice the intensity of the fire indicated by the complete burning of all materials in the area. Drowning also occurred along this portion of the ridge.

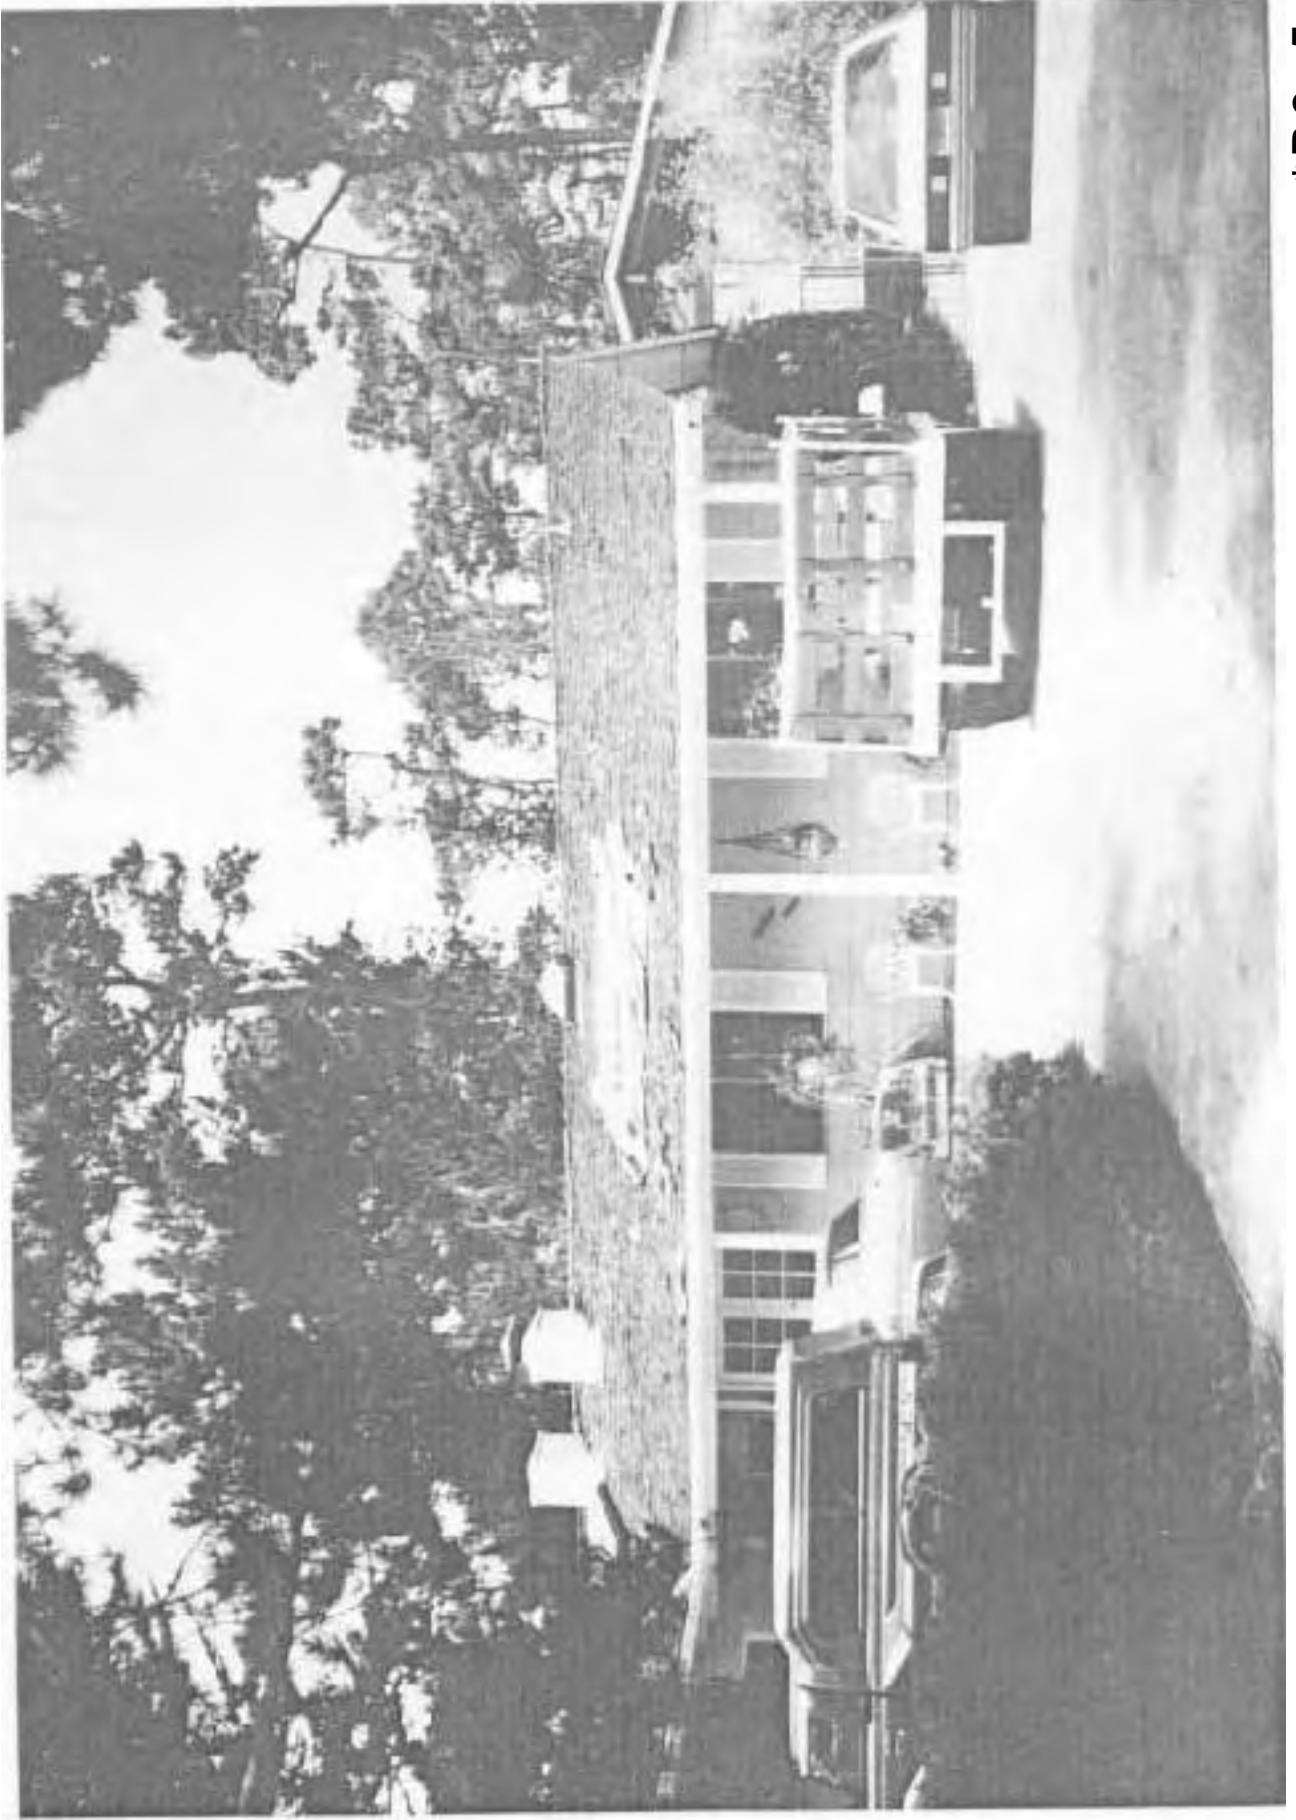
- \*R2x5 - A view of some of the typical spot damage to wood shingle or wood shake roofs around the area. Note the covering over an area where a hole has burned through the roof at this house.

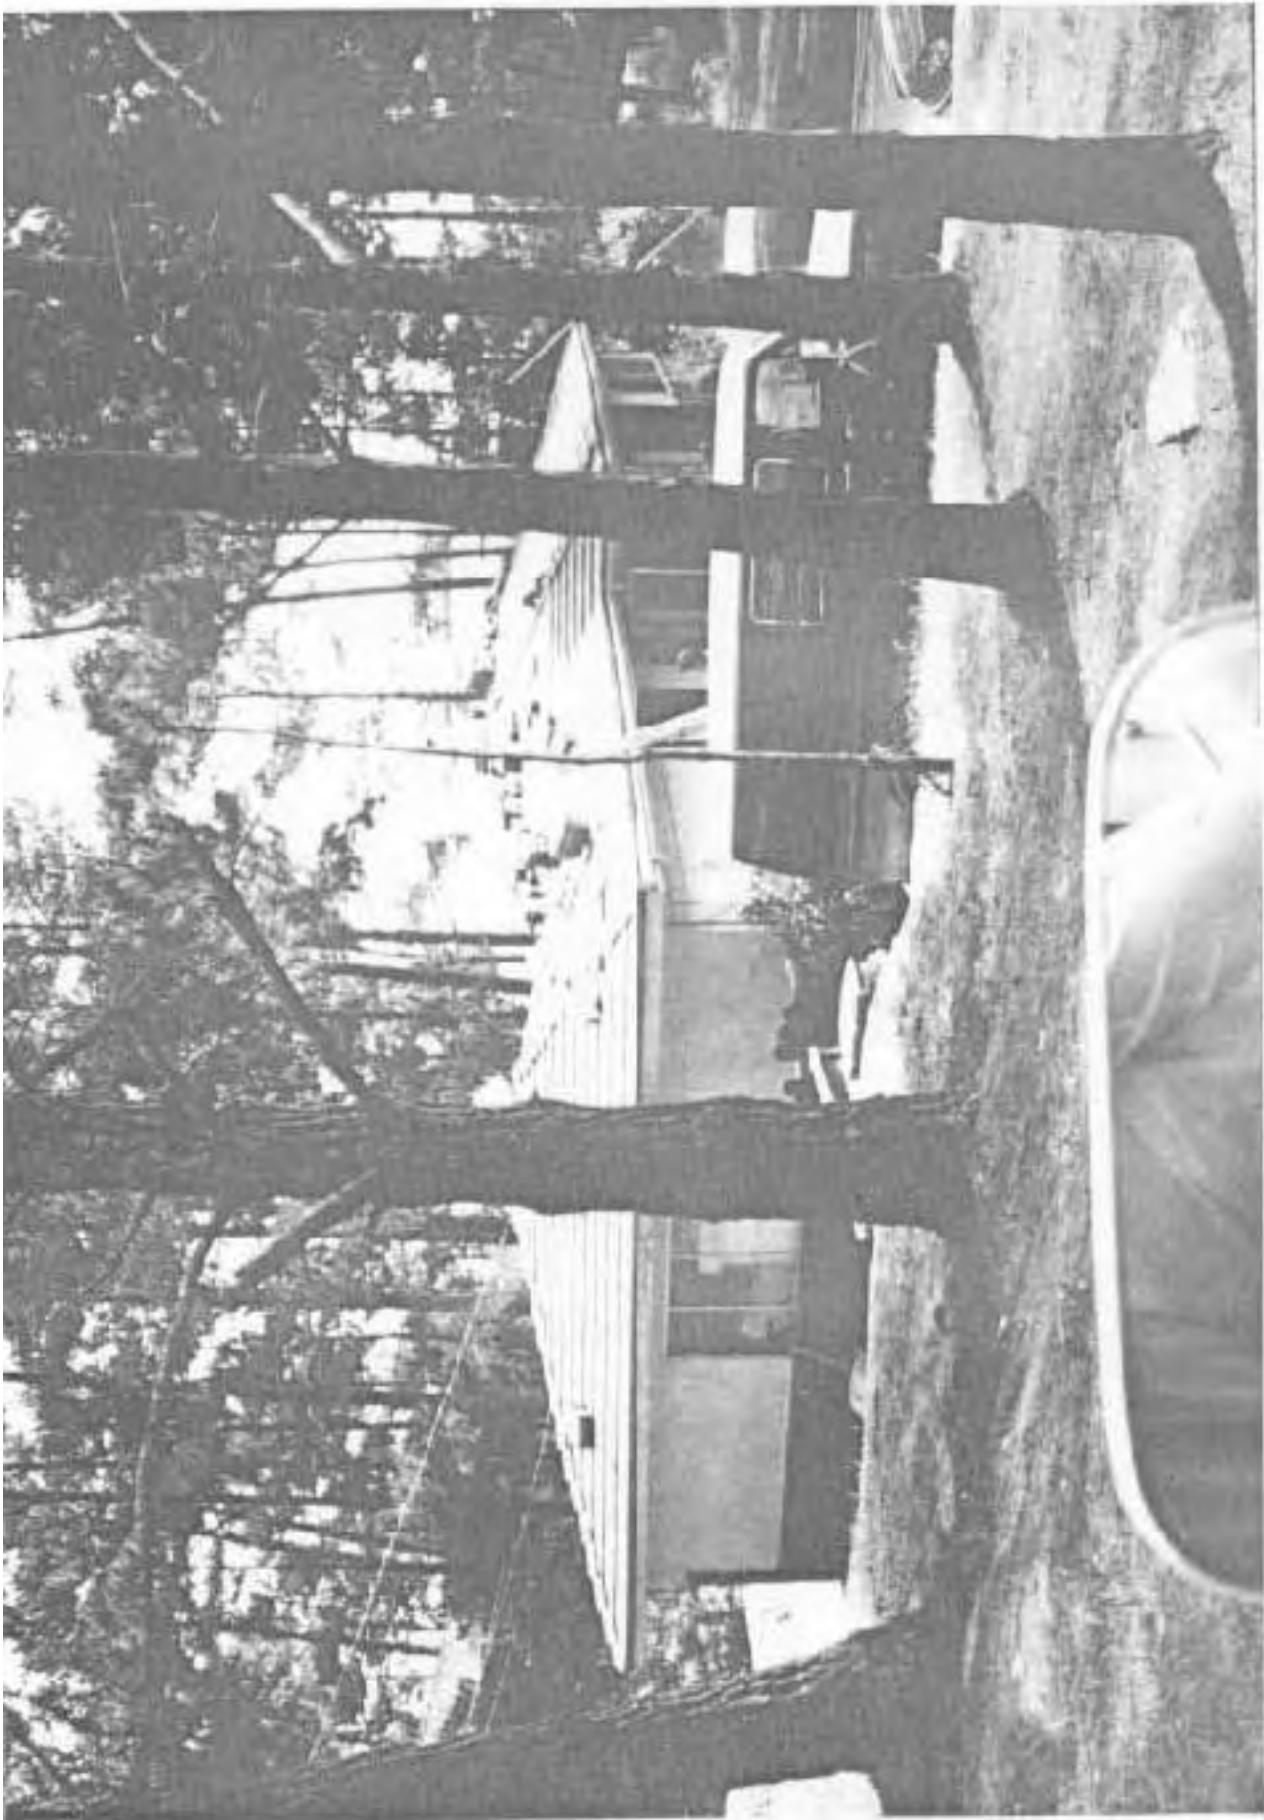
\* R 2x2

- \*R2x2 - An example of some of the aftermath of the fire. This house had minor roof damage and previously had a wood shingle roof. As can be seen, the house is now having the roof replaced with tile.
