Doubletree Hotel Fire New Orleans, Louisiana

Doubletree Hotel Fire New Orleans, Louisiana (July 19, 1987)

Investigated by: Jeffrey M. Shapiro, P.E.

This is Report 005 of the Major Fires Investigation Project conducted by TriData Corporation under contract EMW-86-C-2277 to the United States Fire Administration, Federal Emergency Management Agency.

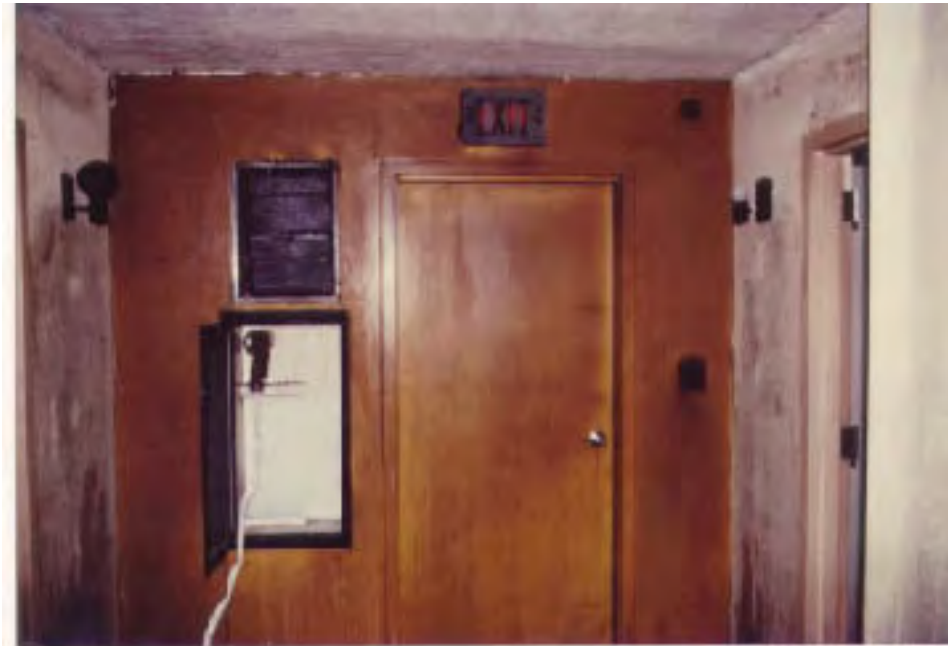
Figure 4. View of short corridor from area of origin toward Stairway 1 -- 9th floor.

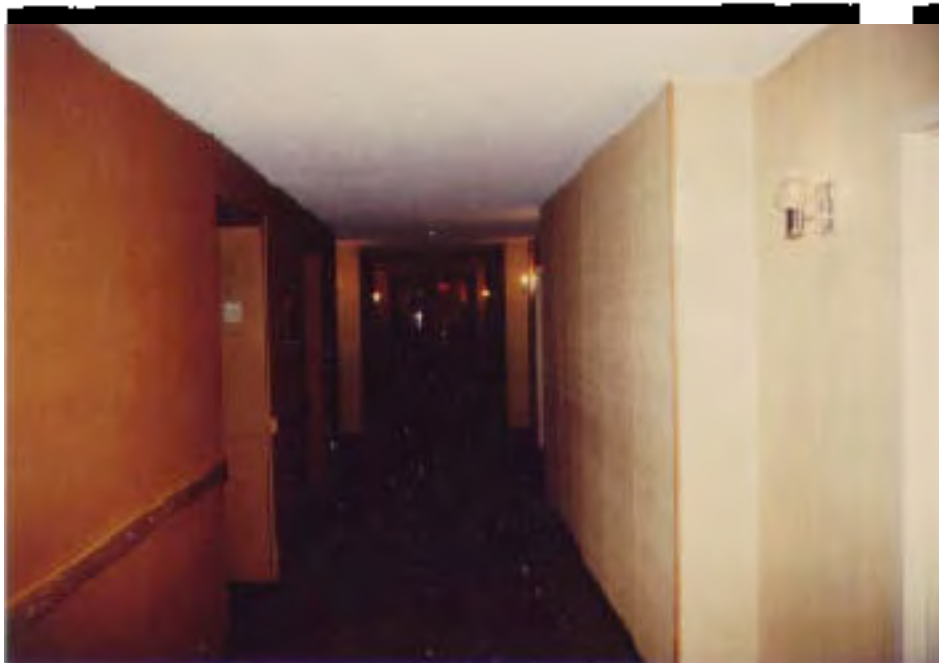
Figure 5. Entrance to exit Stairway 1 -- 10th floor. Note the ventilator opening (upper left) and fire hose/extinguisher cabinet (lower left).

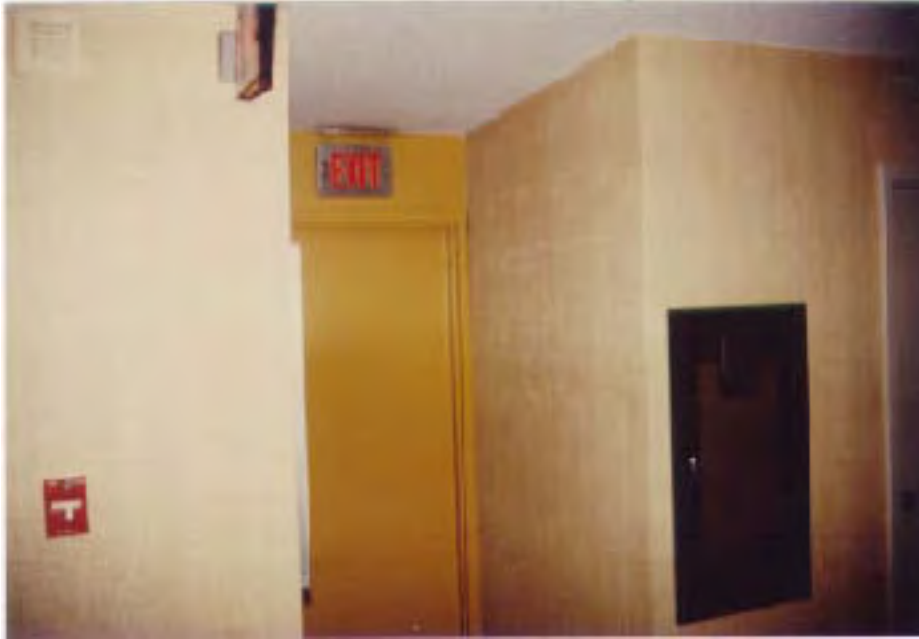
Figure 6. Entrance to exit Stairway 2 -- 9th floor. Compare with Figure 7 after fire.

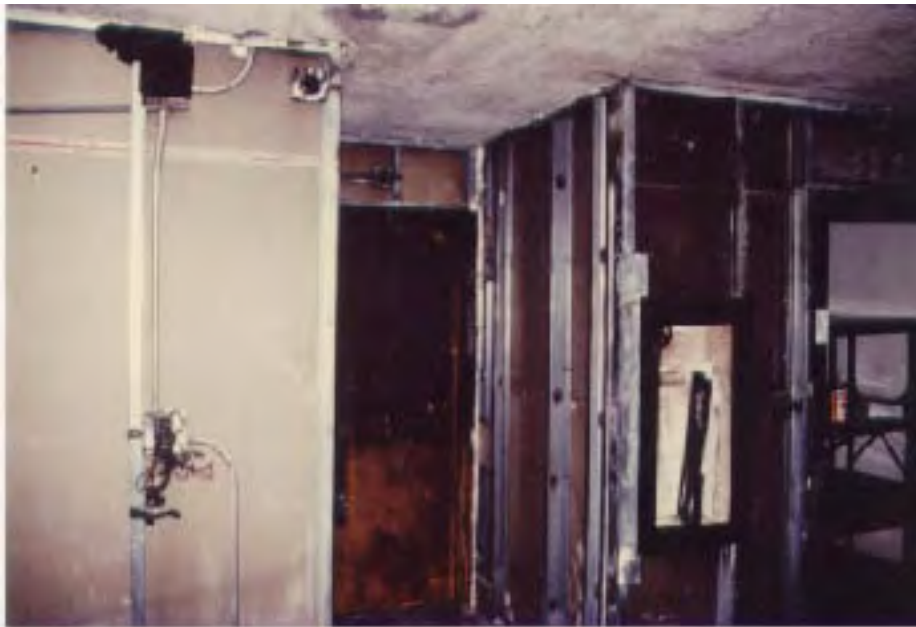
Stairway 2 because the manual alarm was only activated at a single location -- on the tenth floor immediately adjacent to Stairway 2 (see Figures 6 and 7). Given conditions likely to be present on the tenth floor at this point, it is assumed that the guard would have pulled the alarm as quickly as possible. The timing of the guard initiating the alarm in this sequence is relatively consistent with the other aspects of this scenario, since the family who had exited the ninth floor before the alarm had sounded began to encounter other guests entering the stairwell one or two minutes after leaving the ninth floor. This would have been enough time for the guard to go into Stairway 1, double back to Stairway 2, and get to the tenth floor.

Figure 7. Entrance to exit Stairway 2 -- 10th floor. Note pull station at left used to initiate local alarm by guard.

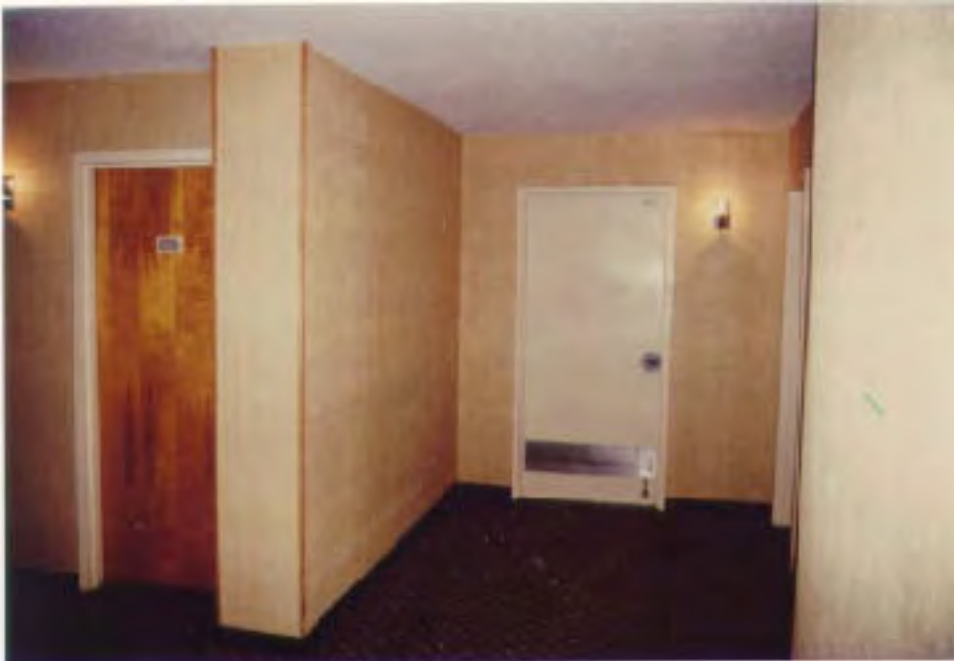
Figure 8. Area of origin on 9th floor, for comparison.

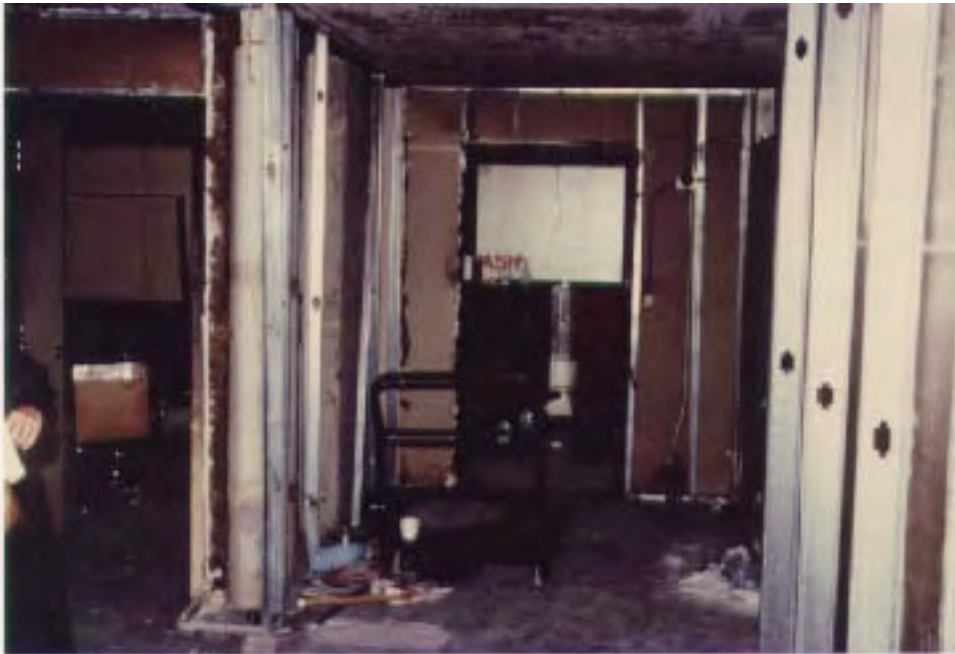
The fire is estimated to have originated sometime between 10:00 p.m. and 10:15 p.m. and is believed to have been caused by arson. The Fire Department determined that there were no other possible ignition sources present and that there was no possibility of an accidental smoldering fire because an eleventh-floor guest had been on the tenth floor to get ice less than ten minutes before the fire alarm sounded and had detected no sign of a fire. Figures 8 and 9 show the area of origin.

Figure 9. Area of origin on 10th floor.

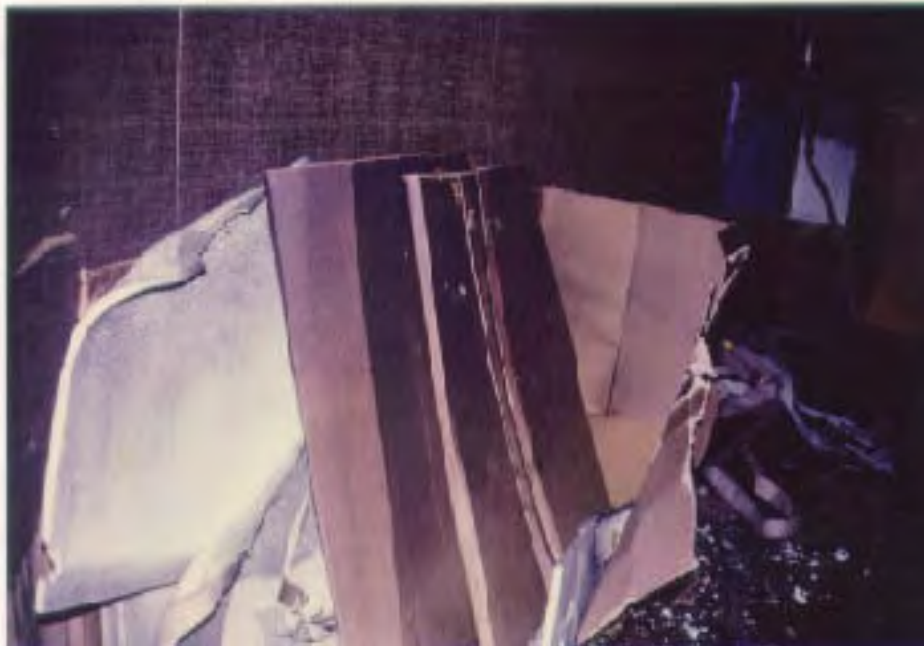
At the time of the fire, the tenth floor was unoccupied and undergoing renovation. As part of the renovation process, large wooden cabinets were being provided in each room. The cabinets were packaged in cardboard boxes and were packed with sheets of solid foam. Employees who had been installing the cabinets had stored the empty packaging material, most of which had been flattened and stacked against the wall, in the corridor (see Figure 10). An estimated 10 to 20 boxes that were stacked outside Room 1001 were probably burning when the guard entered the tenth floor.

Figure 10. Debris similar to that involved as first material ignited -- 10th floor.

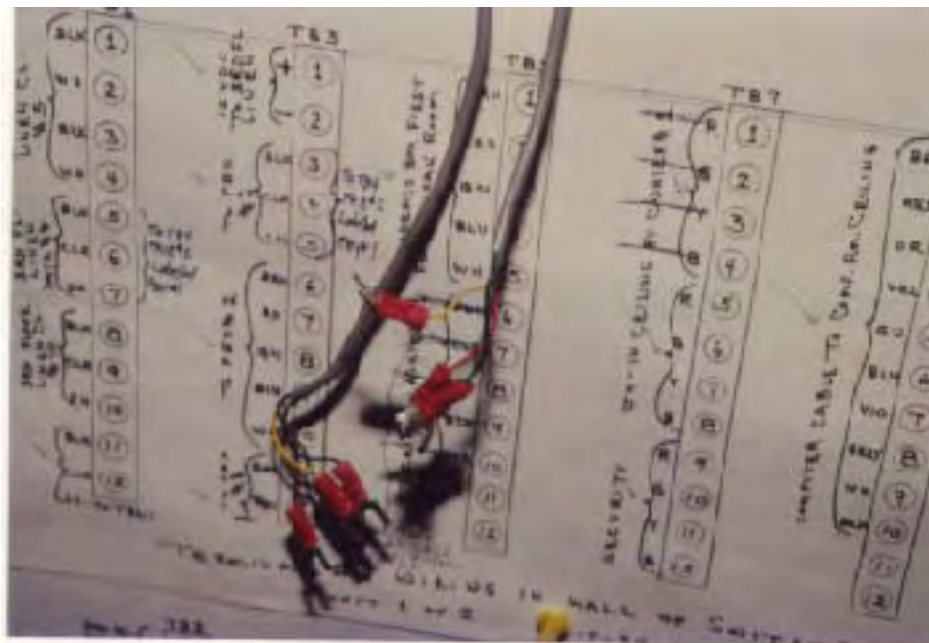
Typically, a four-wire detection circuit will use two wires for powering detectors and two wires for initiating an alarm. Supervision of the power circuit can be either directly at the alarm panel or at each individual detector. Normally, in this arrangement, a trouble signal will sound at the control panel if power is interrupted or if detectors are disconnected. However, if detectors are powered from a source that is independent of the alarm control panel, the control panel could be disconnected or fail, disabling the trouble signal and alarm-initiating capability, and the detectors could still have power. In such a situation, detectors with a power-indicating lamp would appear functional due to the illuminated lamp but would be incapable of initiating an alarm because of the disabled or disconnected alarm panel. It appears that the automatic alarm system in the Doubletree fit this scenario.

Figure 11. Telephone wire used for automatic fire alarm system, security system, and public address system.

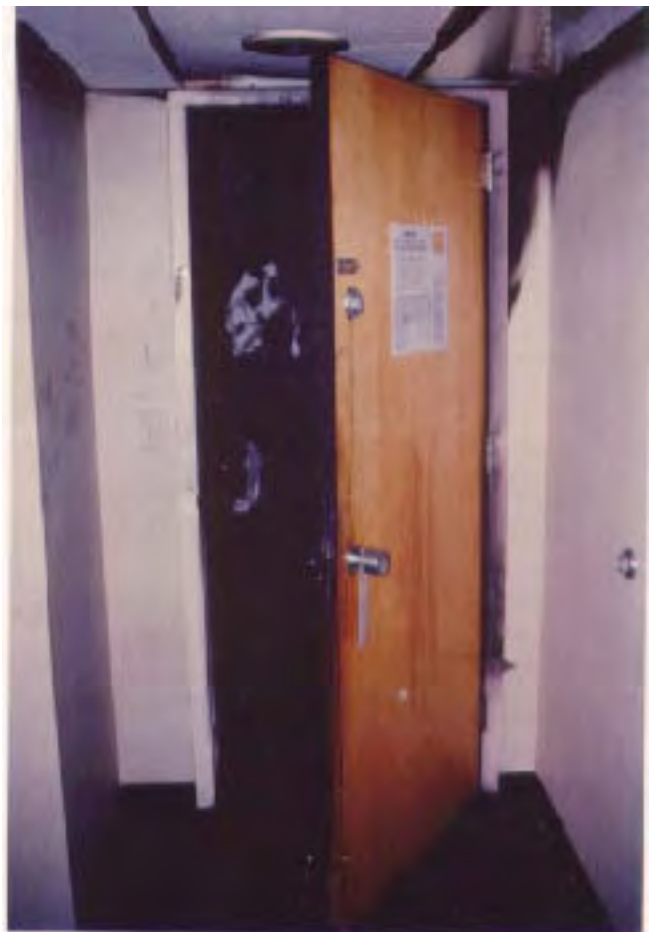
Figure 13 Guest rooms on 10th floor sustained minimal damage due to performance of doors.

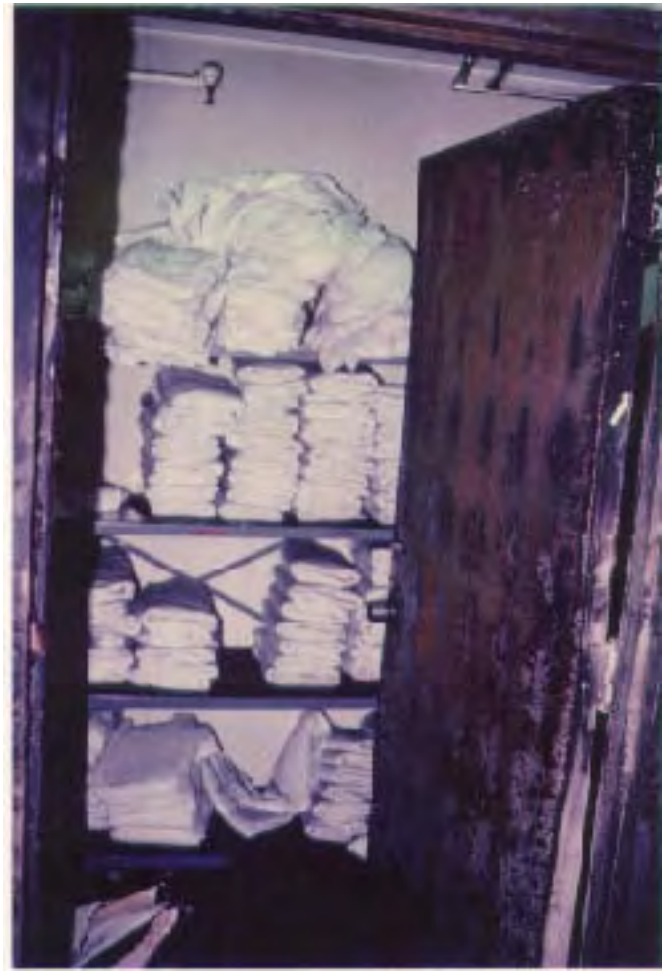
Figure 14. Fire door protected
linens in closet
only 20 feet from
area of origin.

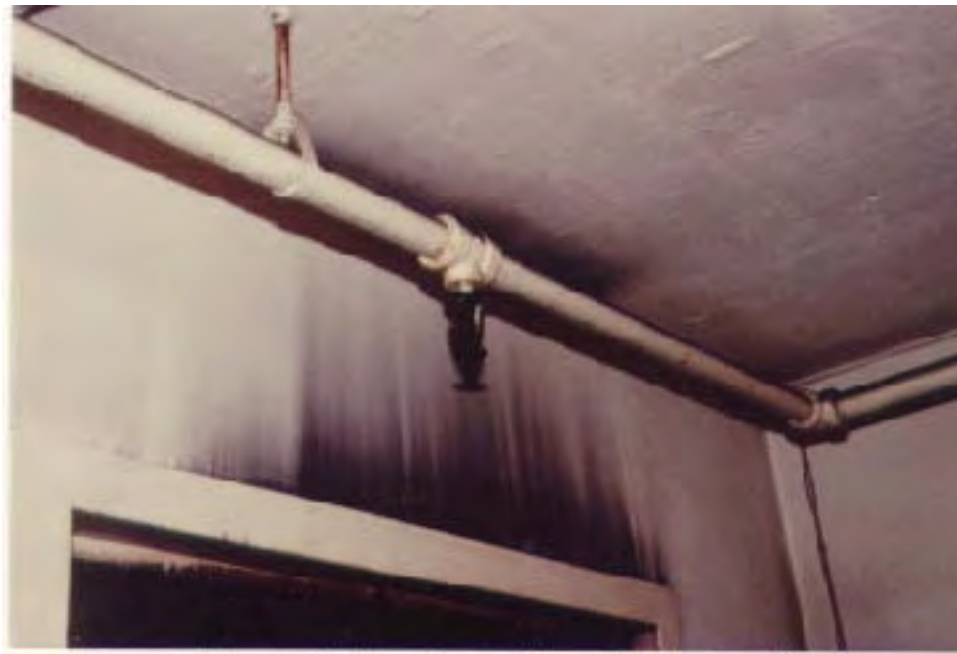
Figure 15. Sprinkler in maid's closet immediately
adjacent to area of origin was not
activated due to performance of fire door.
