Three Firefighter Fatalities in Training Exercise Milford, Michigan

**Three Firefighter Fatalities in Training Exercise
Milford, Michigan
(October 25, 1987)**

Investigated by: J. Gordon Routley

**This is Report 015 of the Major Fires Investigation Project conducted
by TriData Corporation under contract EMW-86-C-2277 to the U.S. Fire
Administration, Federal Emergency Management Agency.**

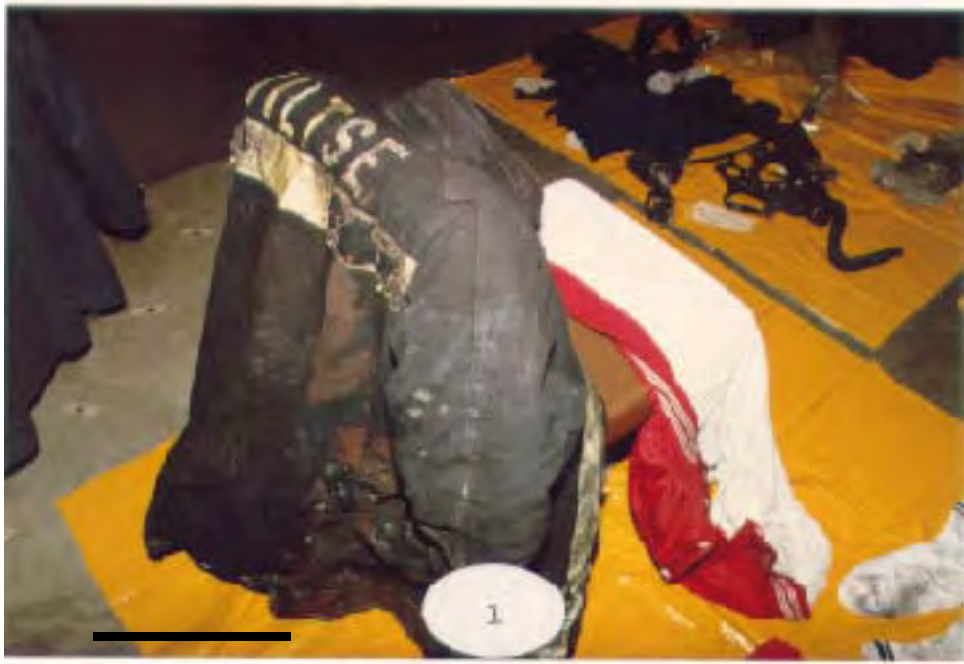
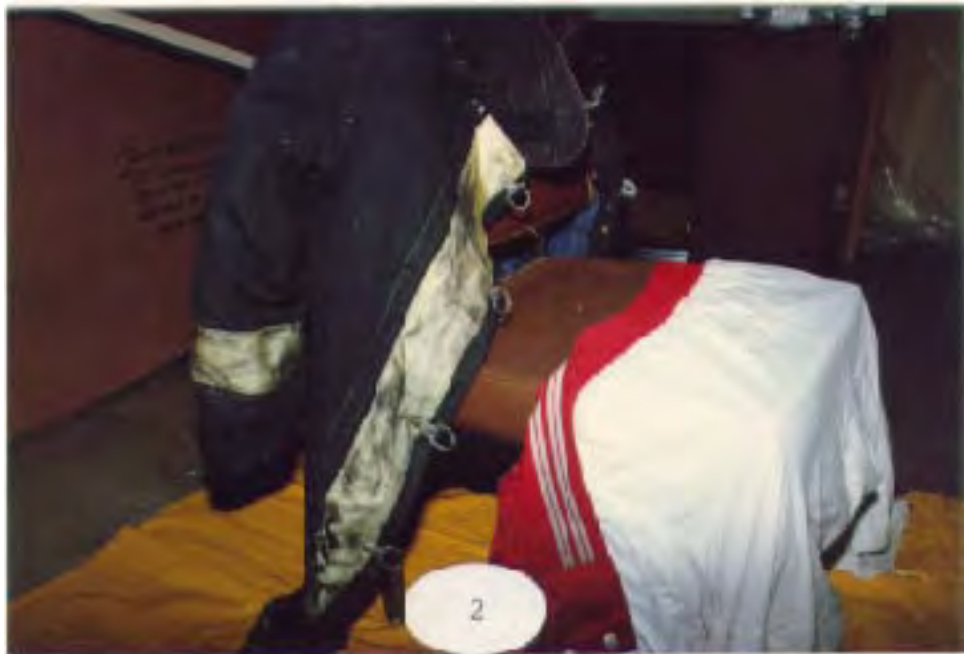
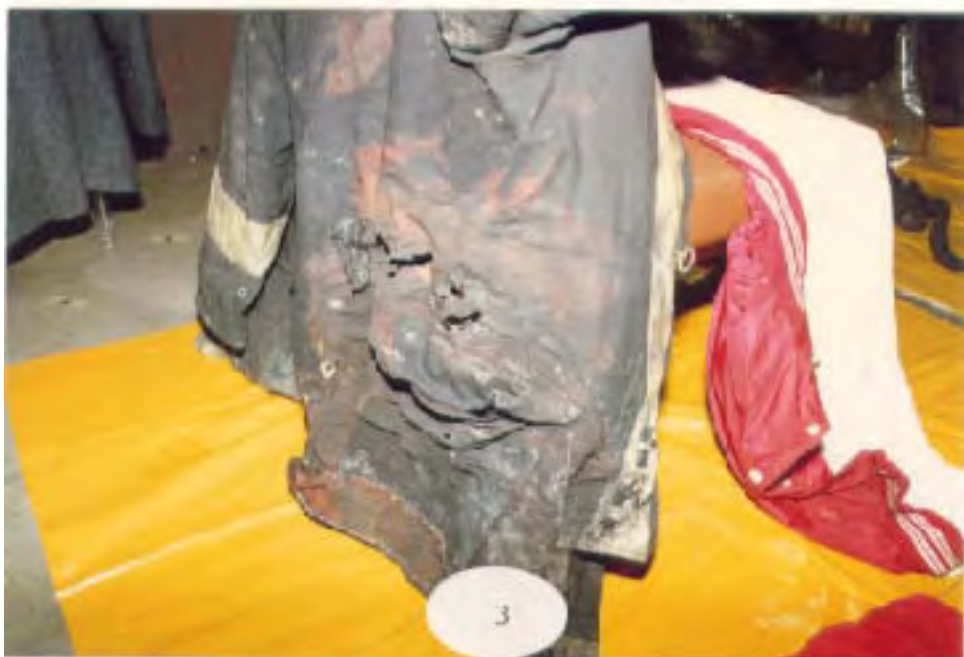
PHOTOS : 1,2,3

Coat was intact with some damage to reflective trim (Scotchlite) and some charring to lower right side of outer shell. Minor charring to bottom of inner liner material.

Short, rubber - no damage noted.

Nylon windbreaker Tee shirt: Hanes Beffy Tee 100% cotton. No fire damage noted to either item. Gloves not retrieved.

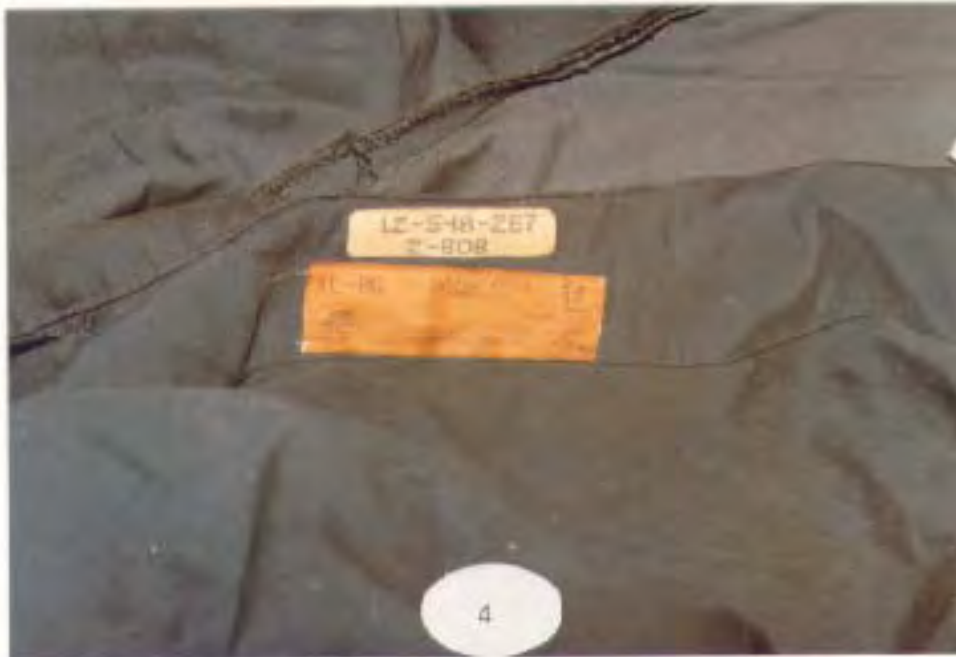
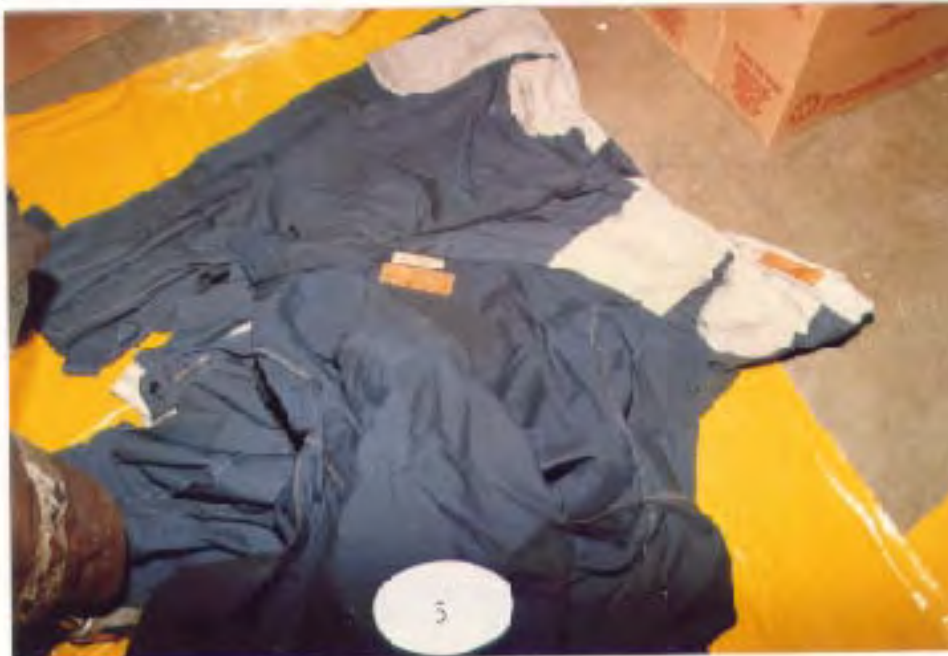
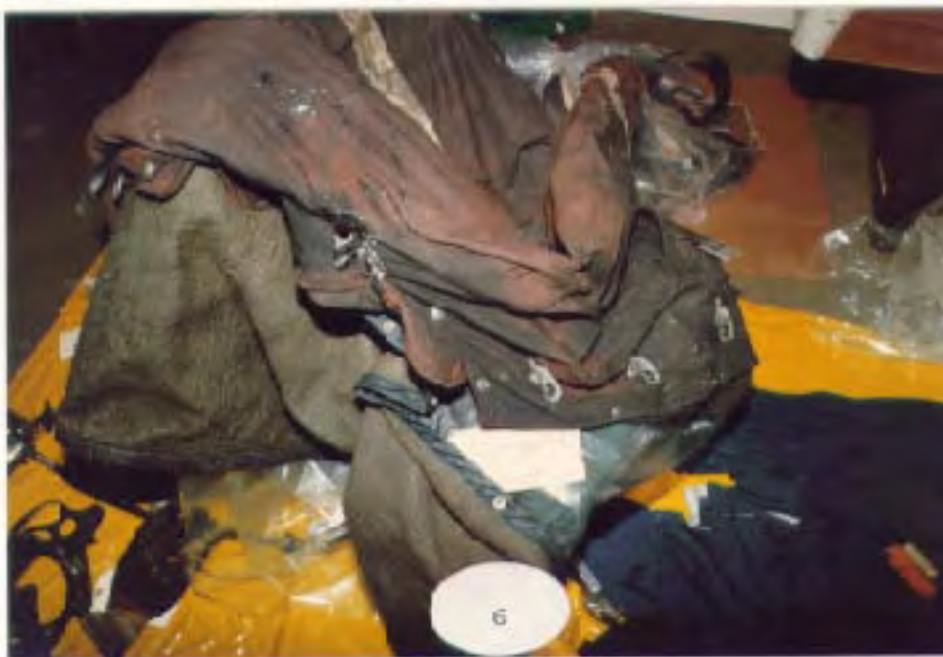
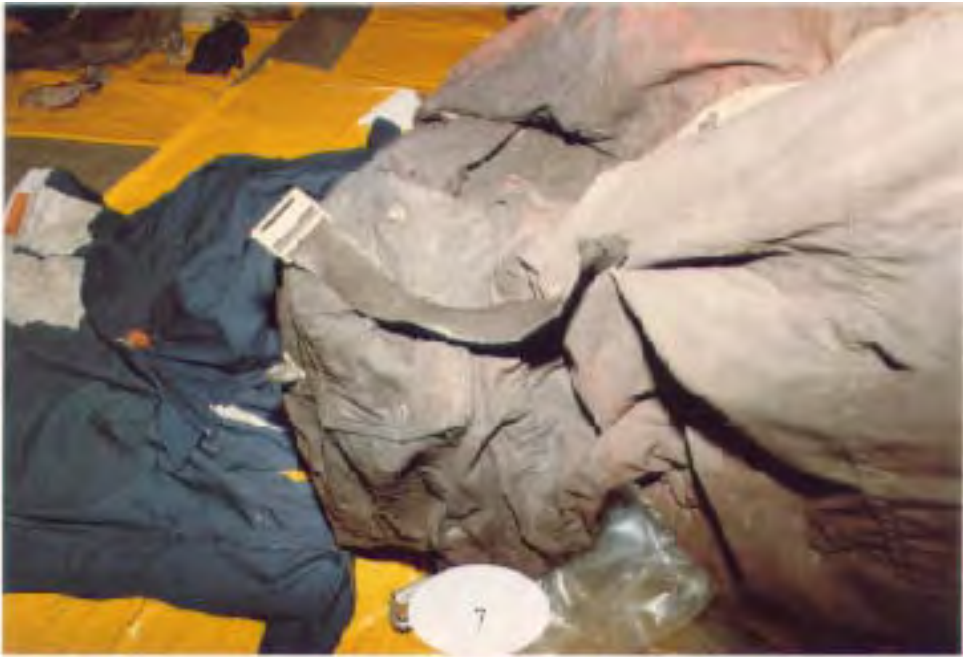
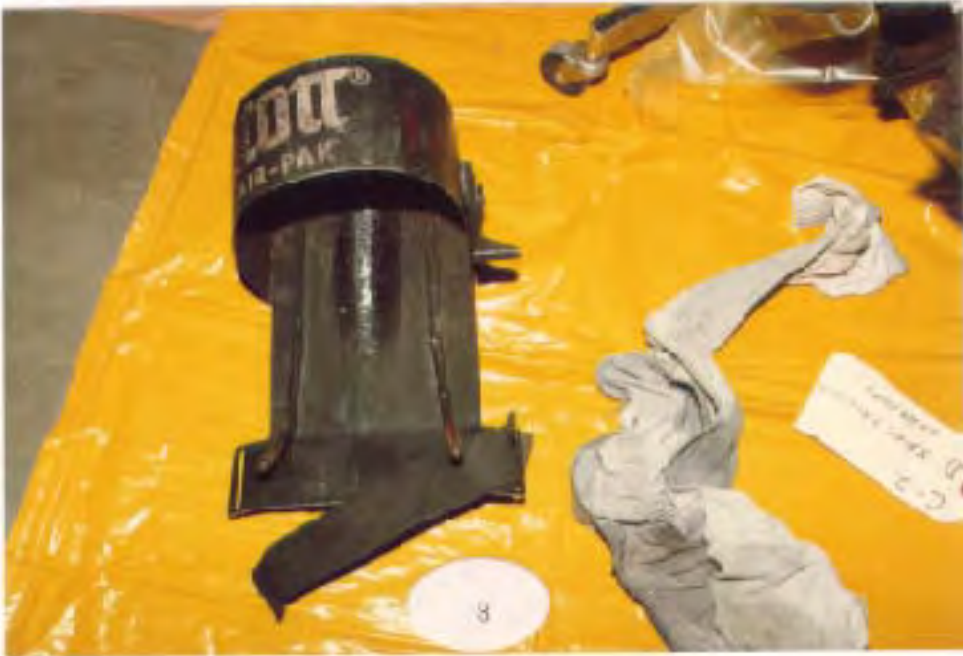
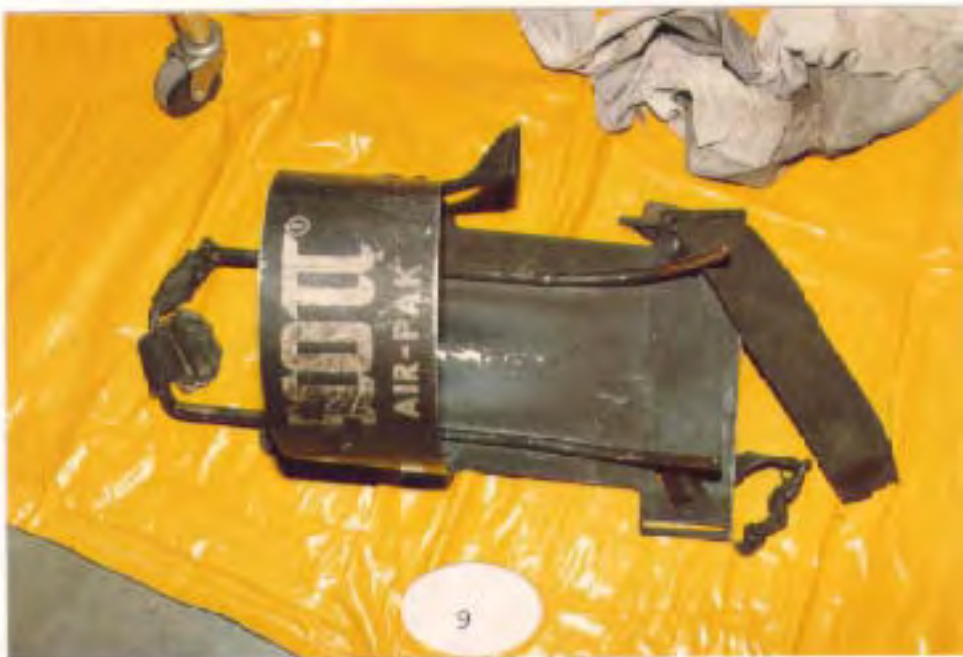
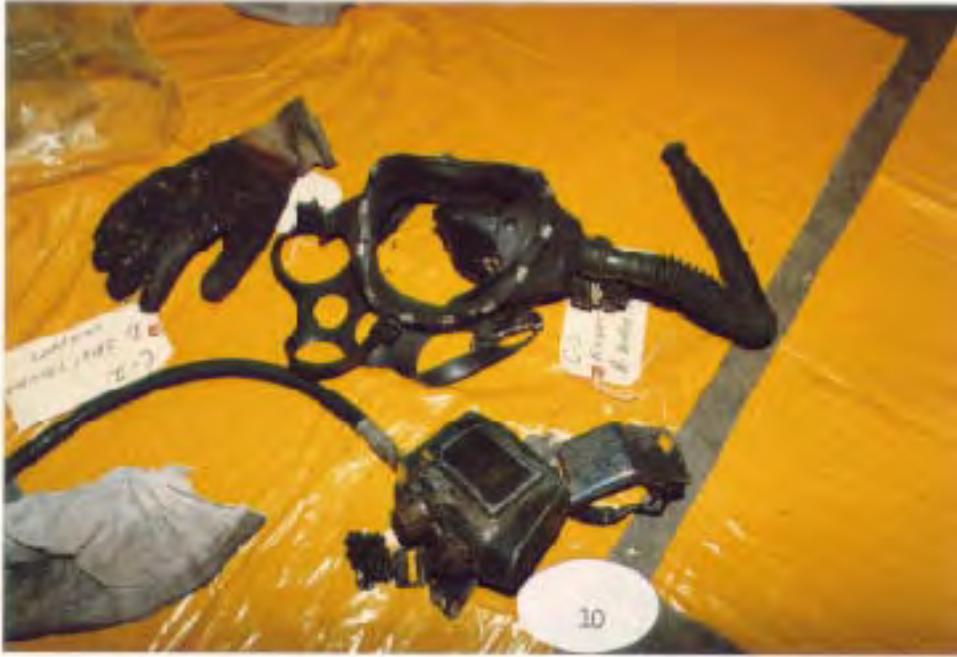
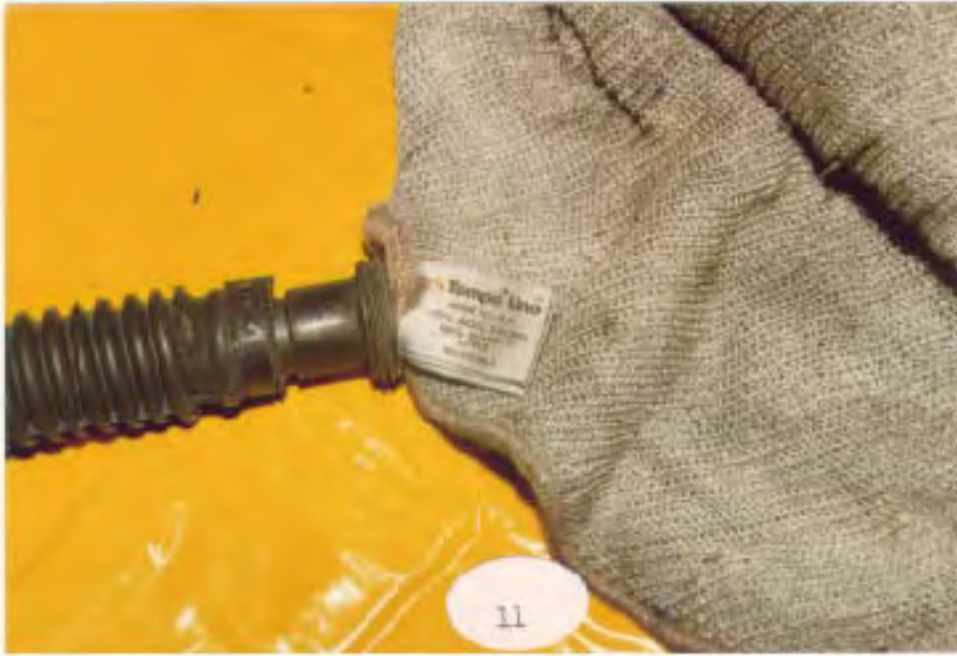
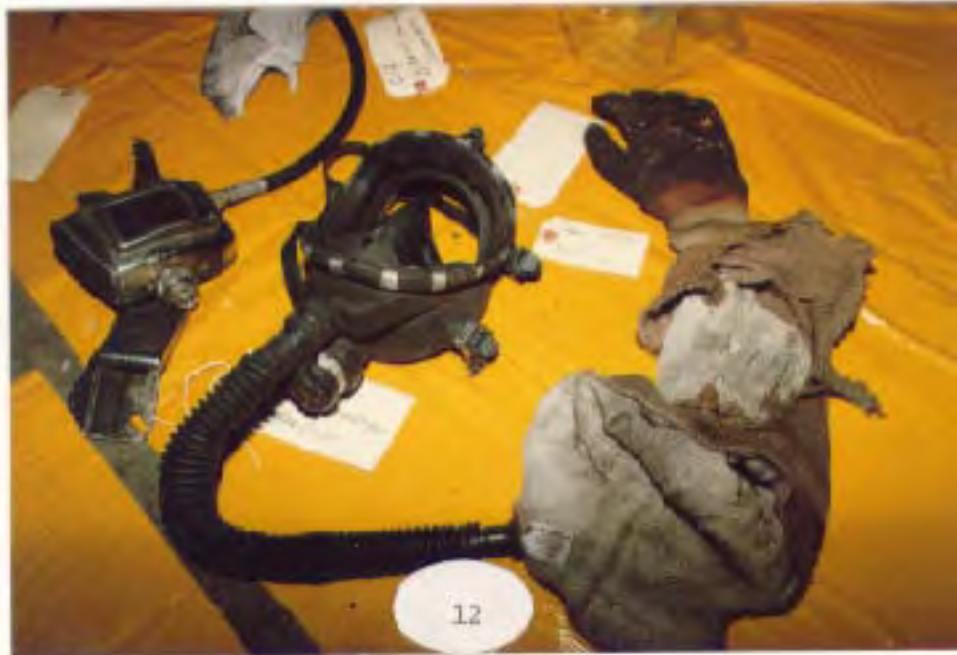
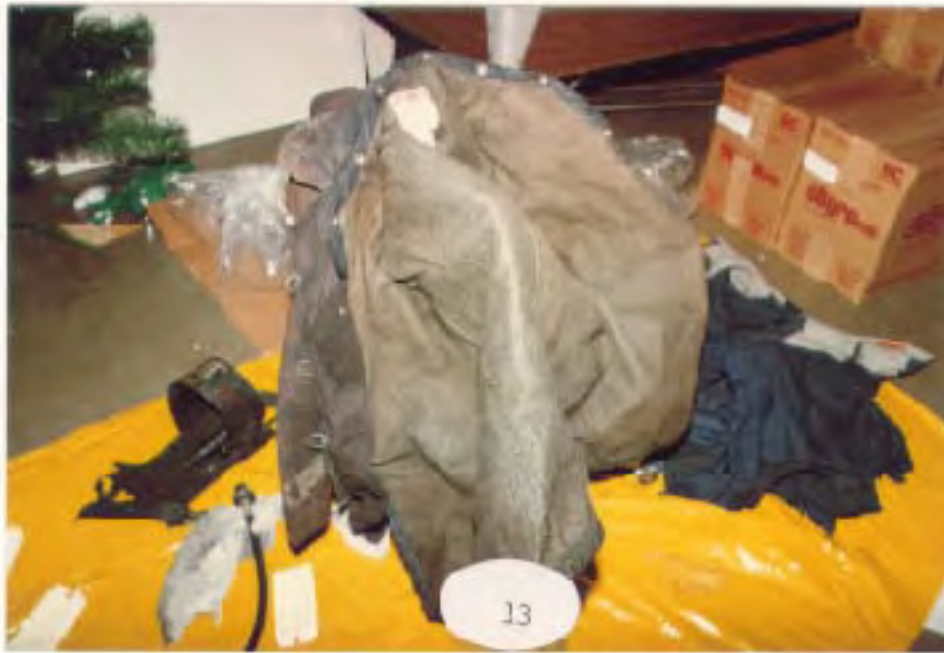
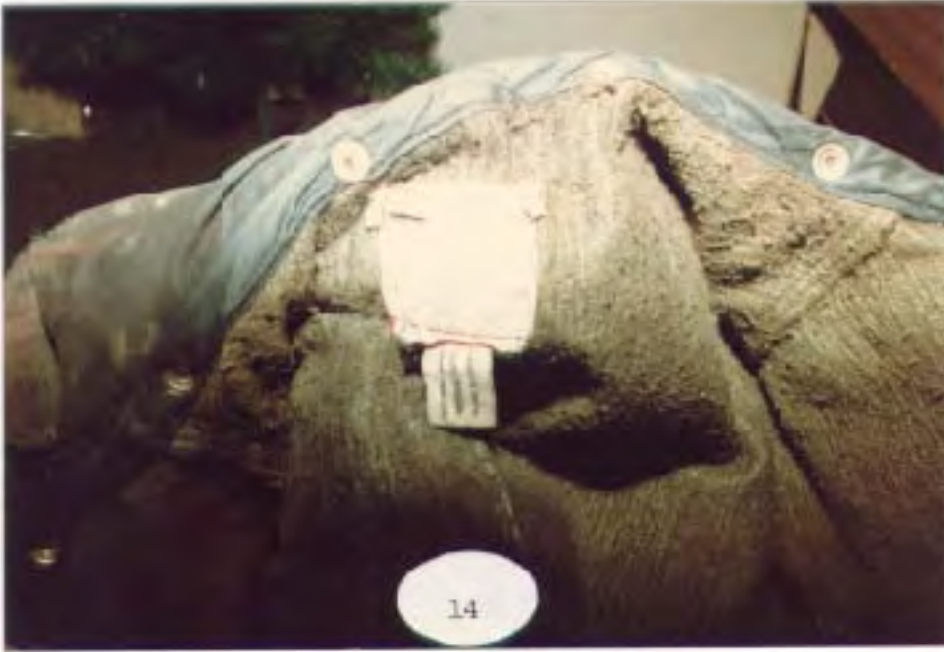
Photos: 4,5,6,7,8,9,10,11,12,13,14

Deceased due to inhalation of products of
combustion. Found in bedroom.

Label: Morning Pride - 100% Nomex.
Some char damage to outer shell. No damage
to liner noted. Parts of SCBA waist strap
fused to outer shell on left side.

(Right only) - lined rubber (no label). Fire
damage to rubber.

Tempo Uno - knit Nomex/Wool. Wool appears
to have been worn outside and is
approximately 50% charred or burned. Nomex
is intact.

Scott Air Pak II - Pressure Demand switch
on, Main Line Valve on, Bypass Valve off.
Part of waist strap attached to back plate
has been cut off. All other straps melted
off. Facepiece lens is missing with some
fire damage noted on retaining ring only.
Breathing tube is intact.

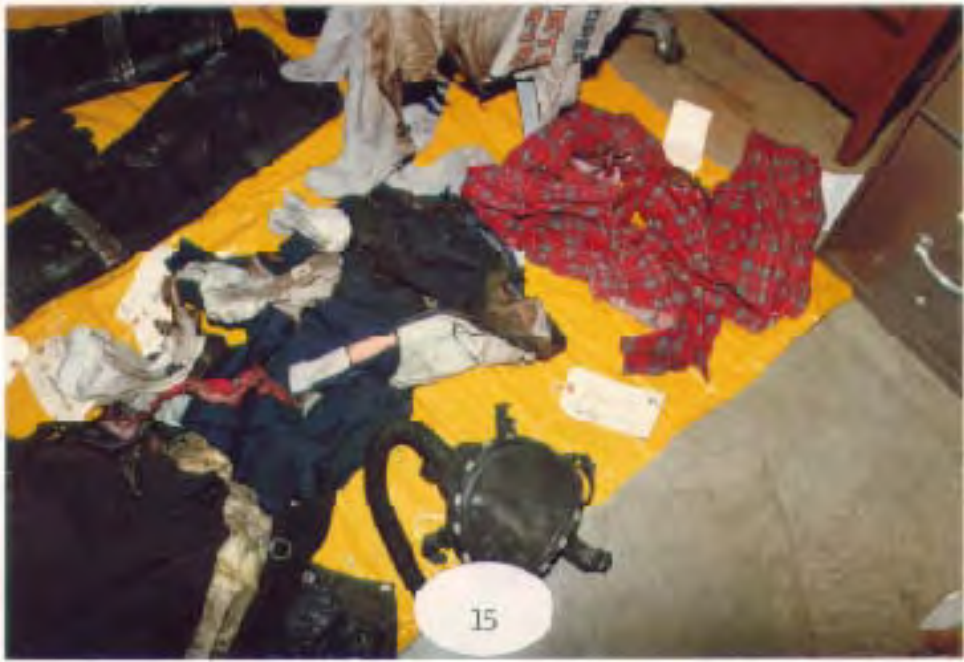
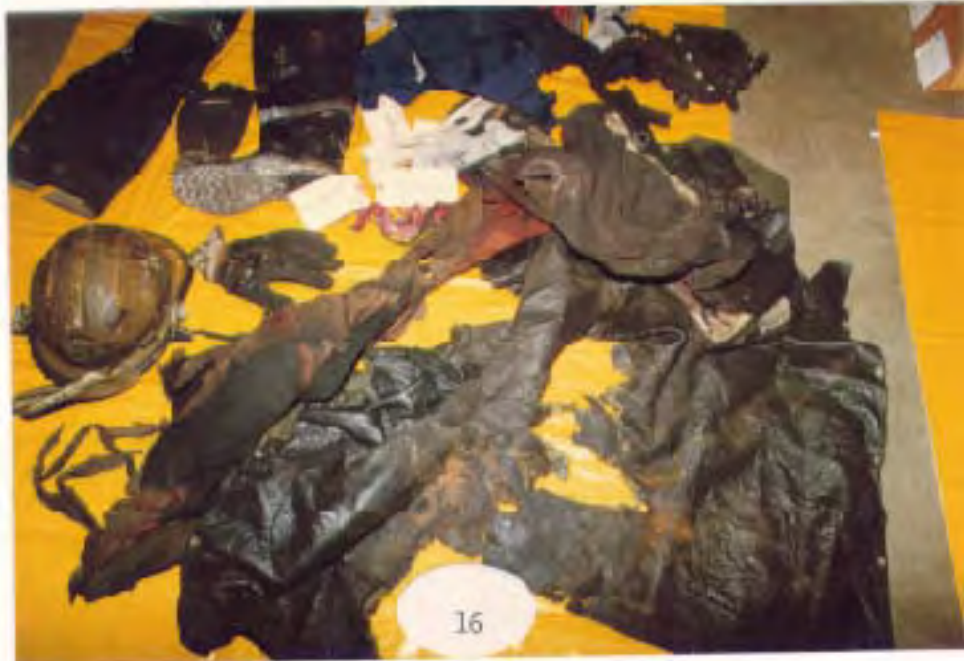
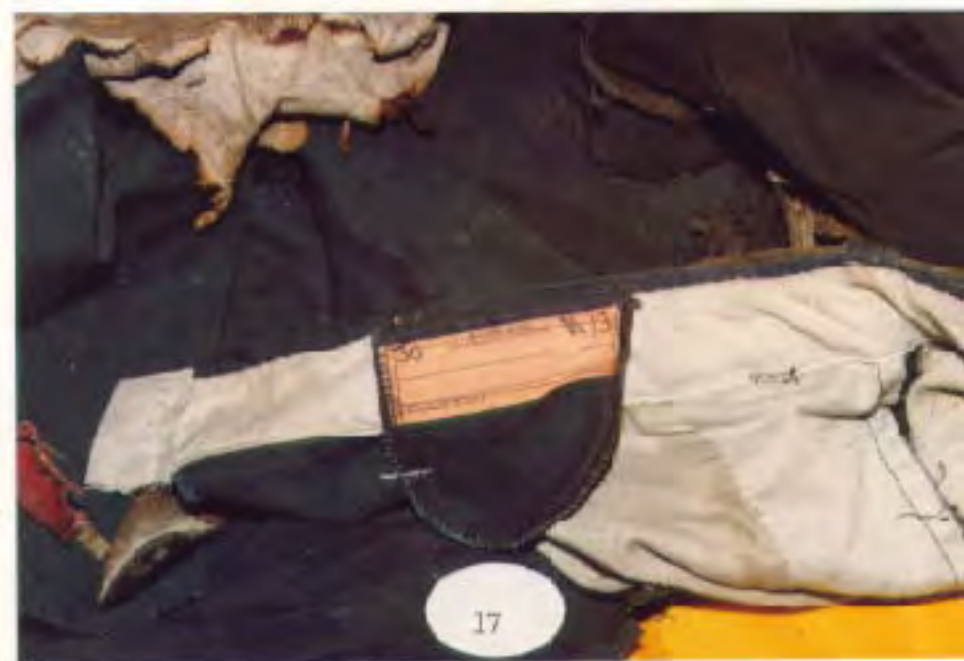
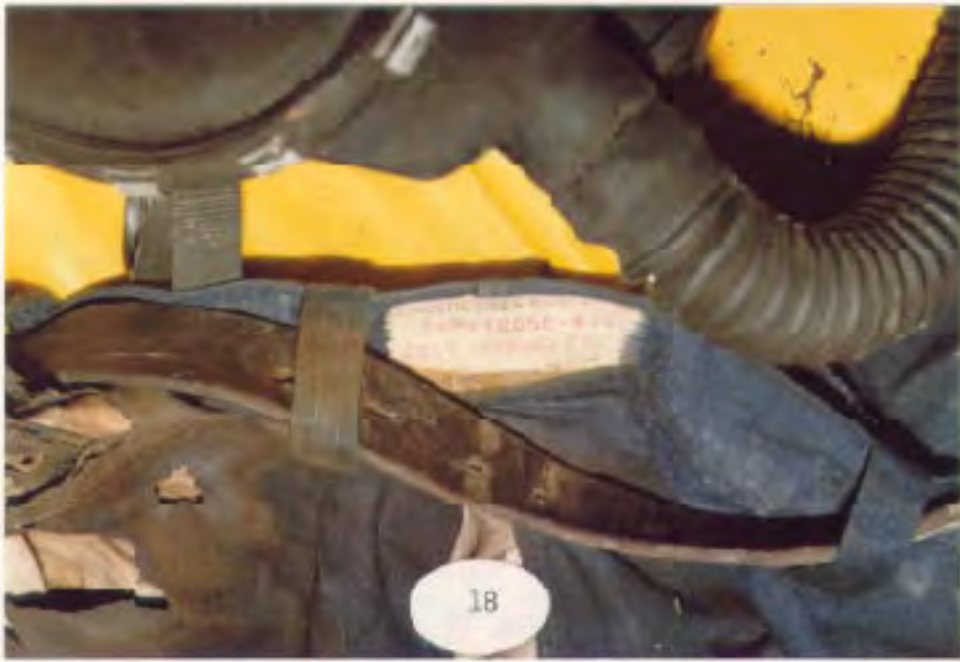
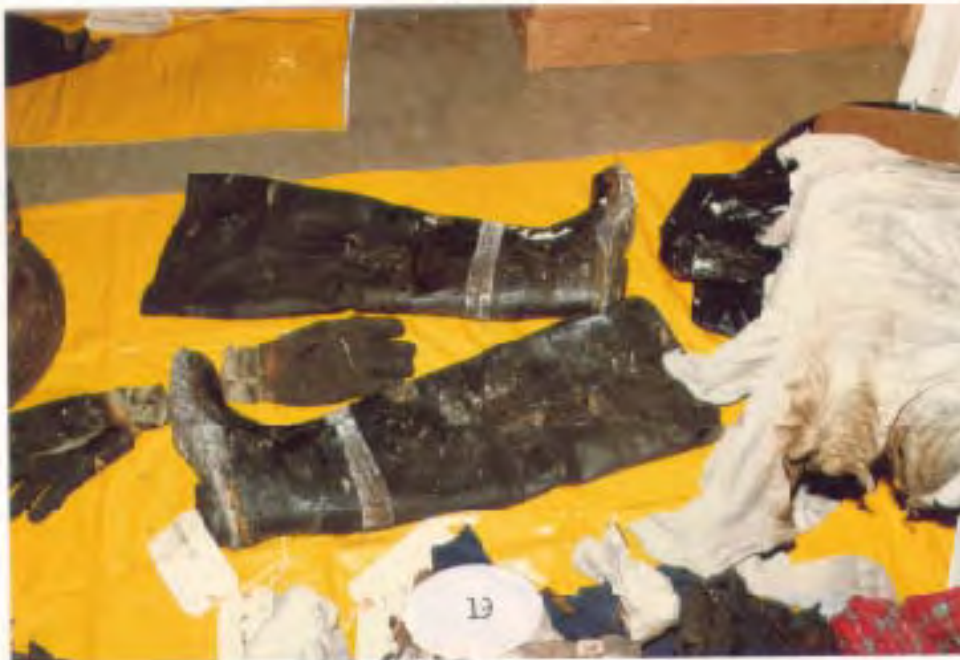
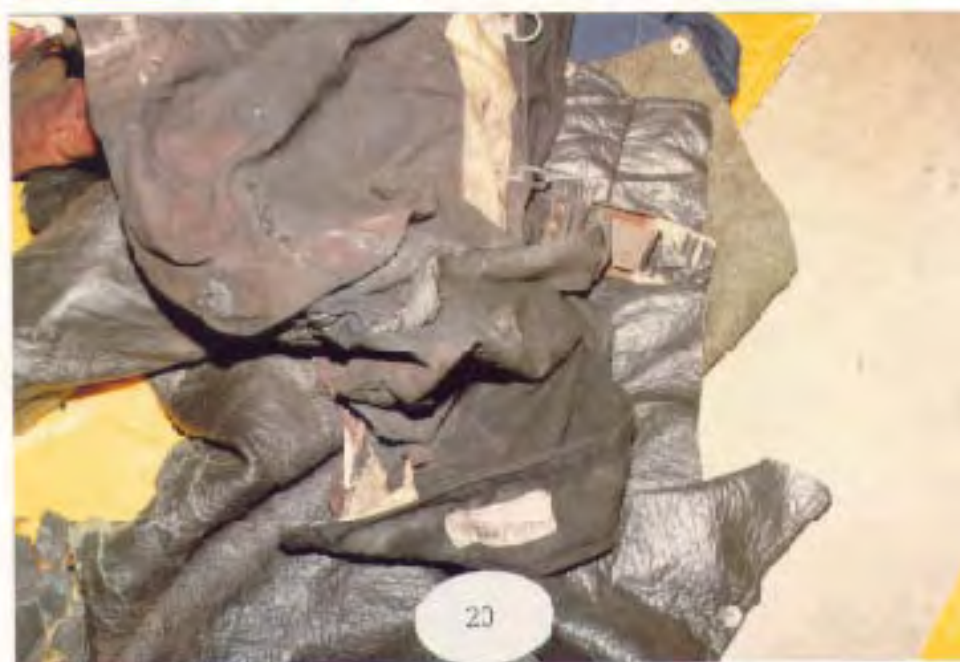
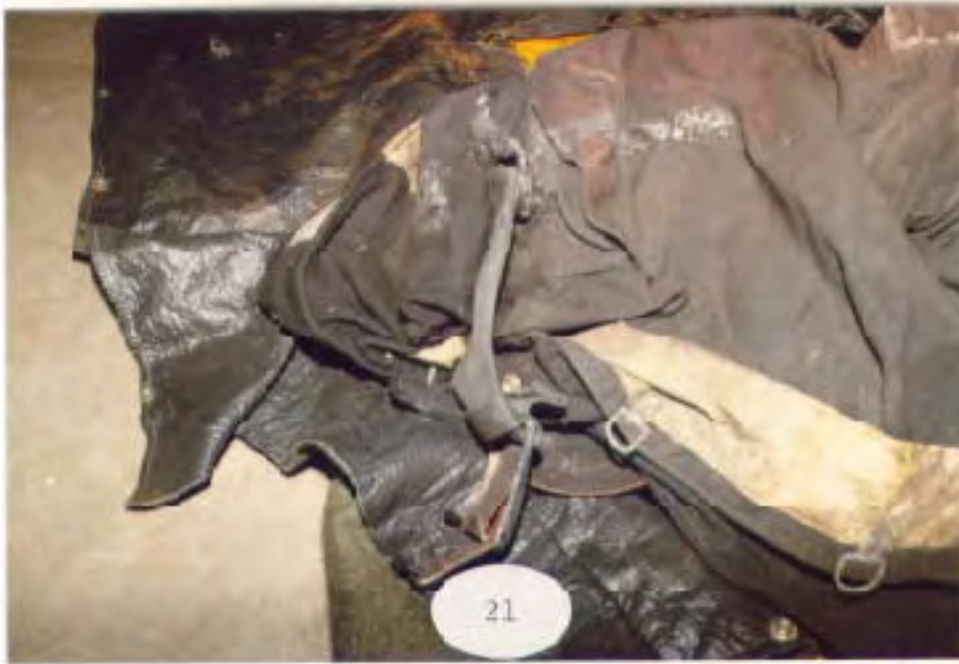
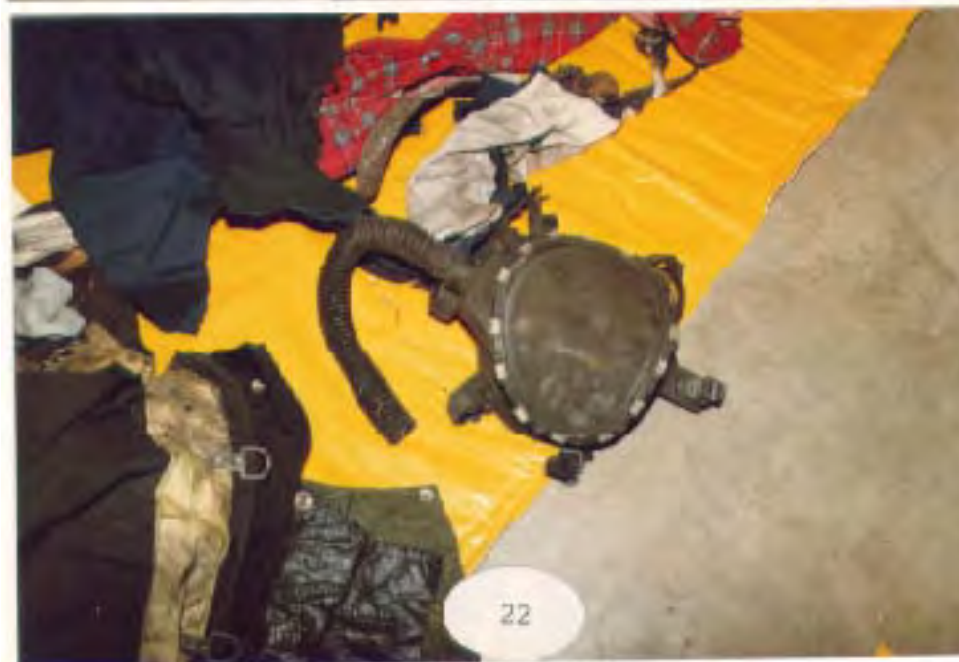
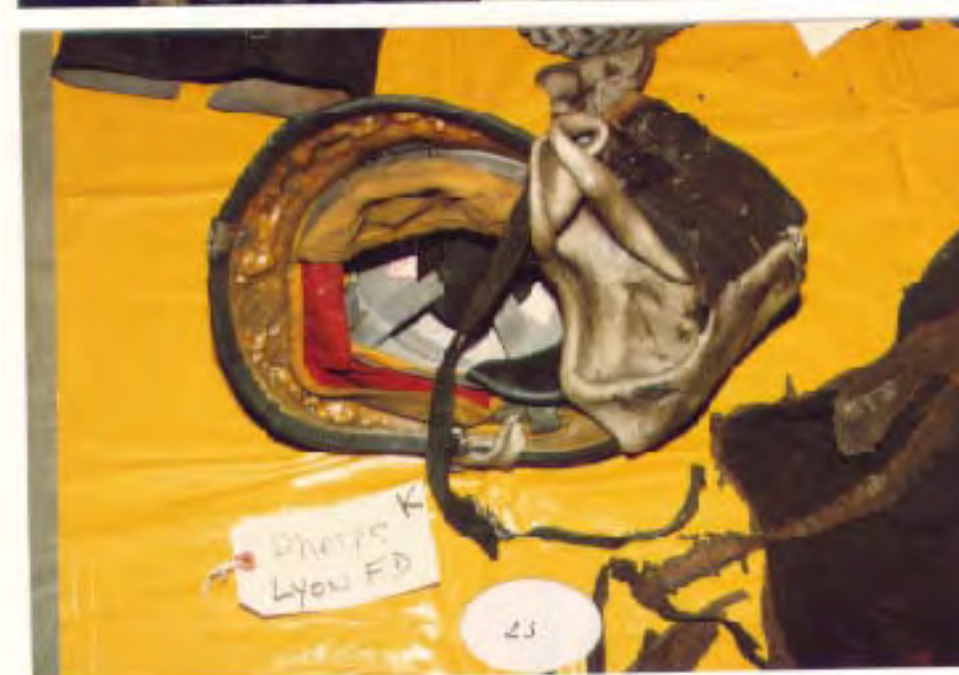
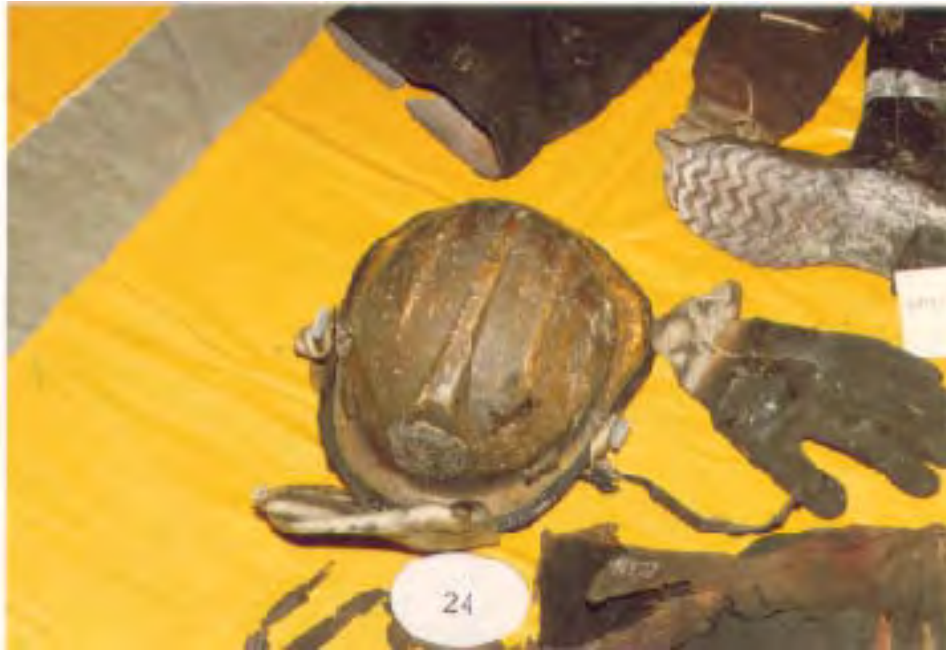
PHOTOS: 15,16,17,18,19,20,21,22,23,24

Deceased. Found in corridor adjacent to window.

Coat is heavily damaged by fire exposure, particularly back and bottom half of sides. SCBA straps and buckle fused to outer shell.

Lined rubber - some damage to rubber.

Scott Facepiece, soot covered inside and outside. Breathing tube is torn loose, approximately 12 inches from facepiece. No fire damage evident to facepiece.

Bullard - faceshield severely melted and deformed. Outershell partially melted. Damage to impact liner is not evident (not removed).
