Three Firefighter Fatalities in Training Exercise Milford, Michigan

**Three Firefighter Fatalities in Training Exercise
Milford, Michigan
(October 25, 1987)**

Investigated by: J. Gordon Routley

**This is Report 015 of the Major Fires Investigation Project conducted
by TriData Corporation under contract EMW-86-C-2277 to the U.S. Fire
Administration, Federal Emergency Management Agency.**

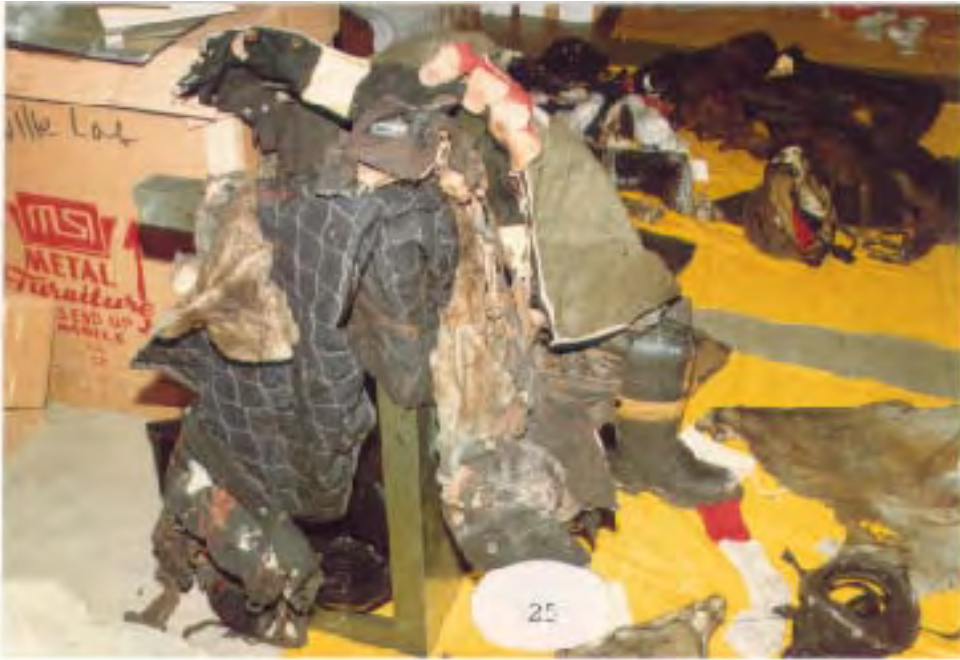
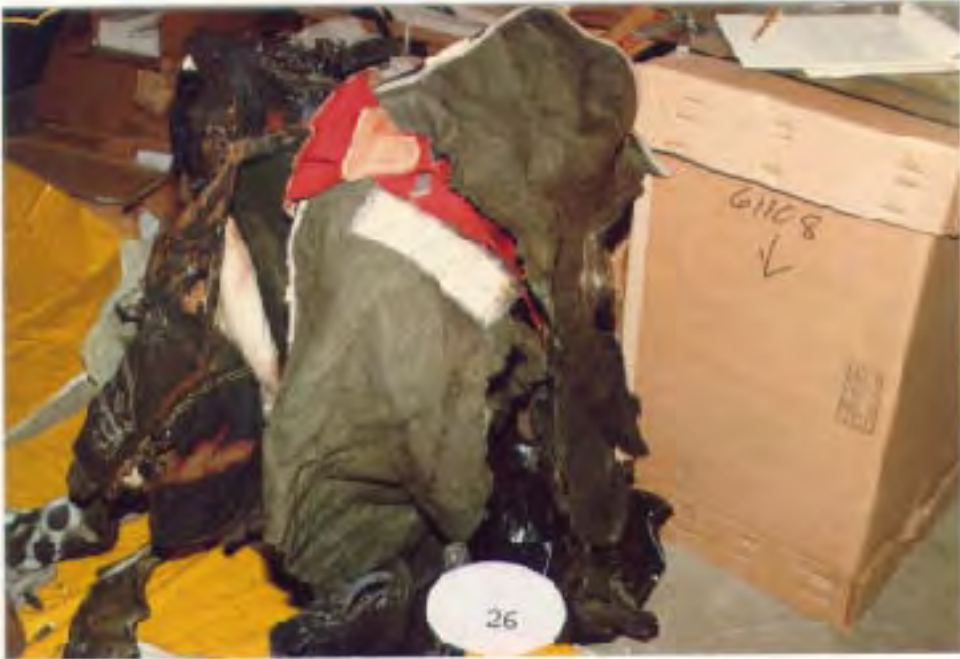
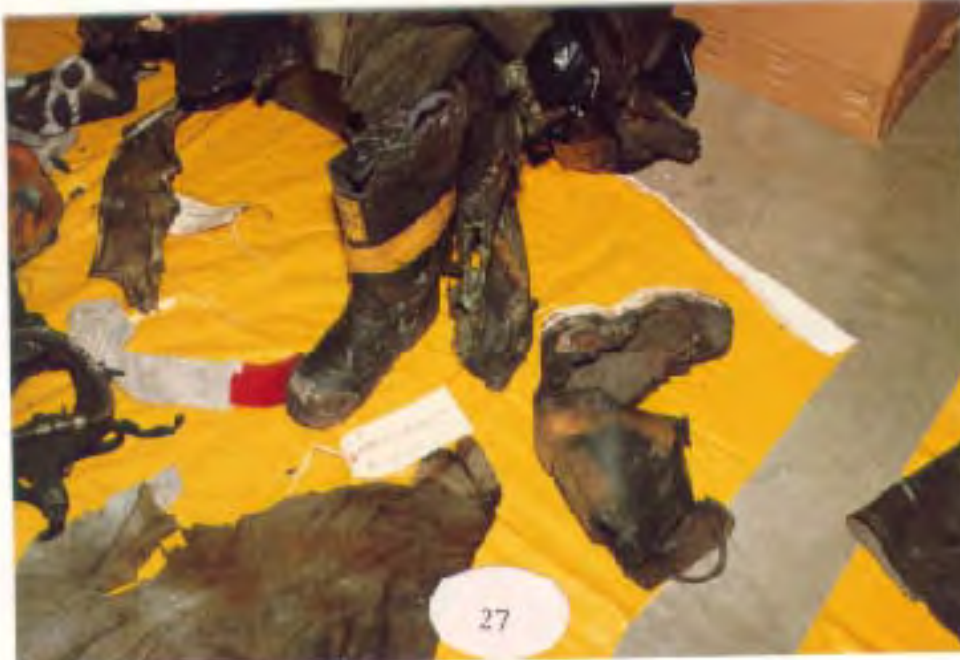
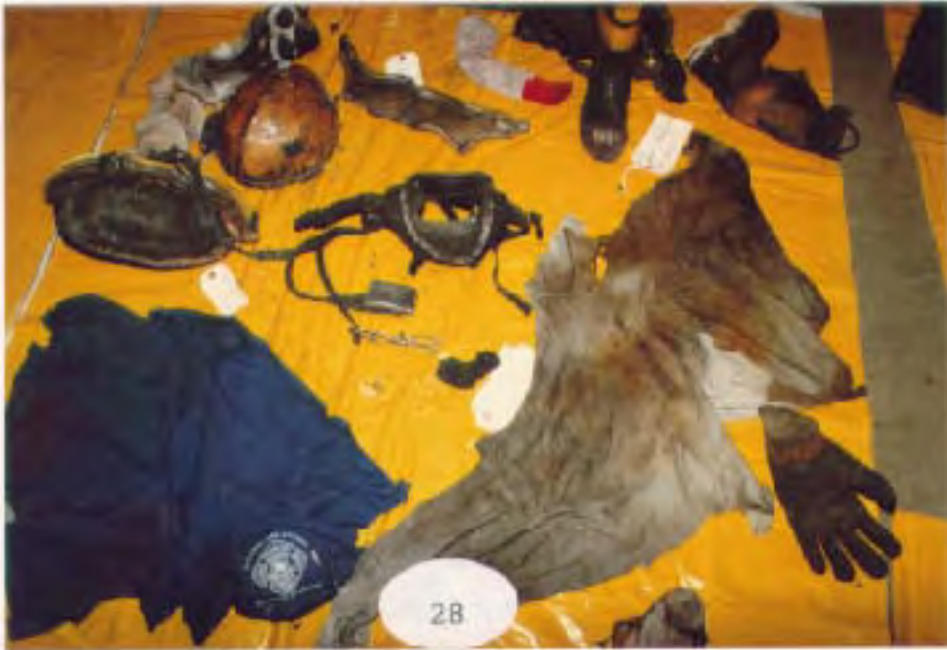
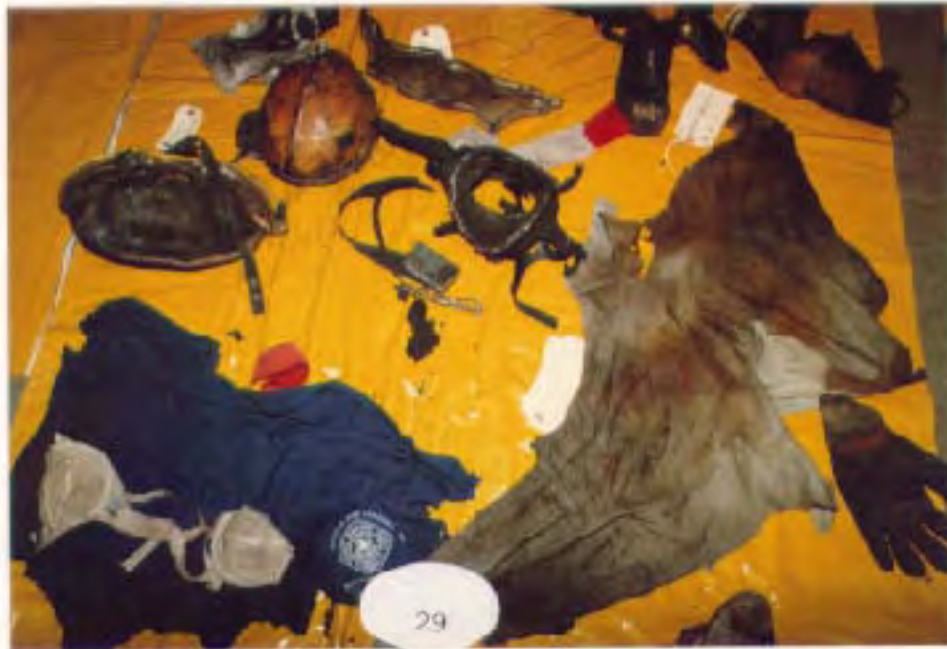
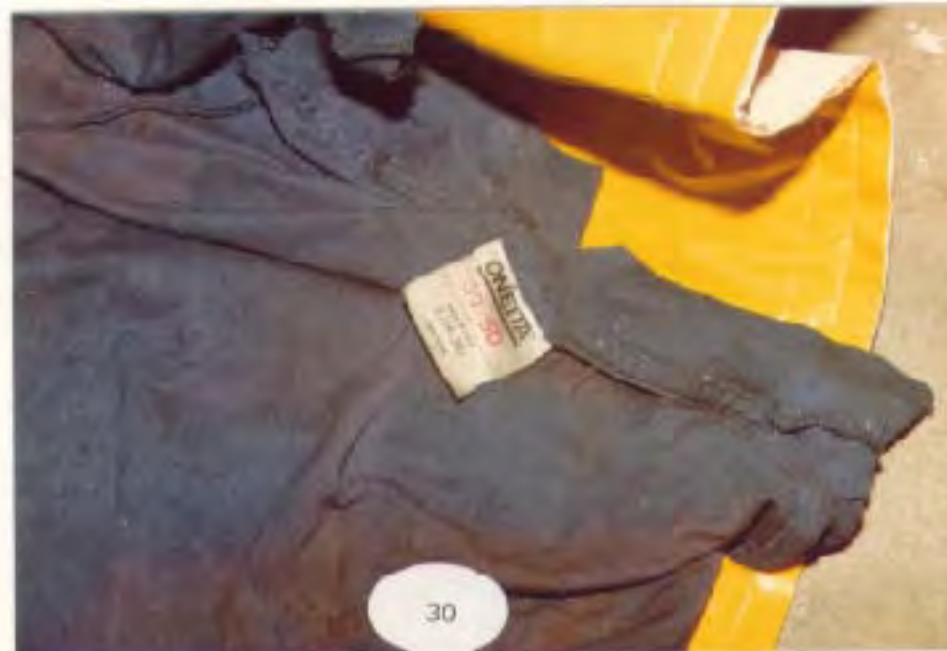
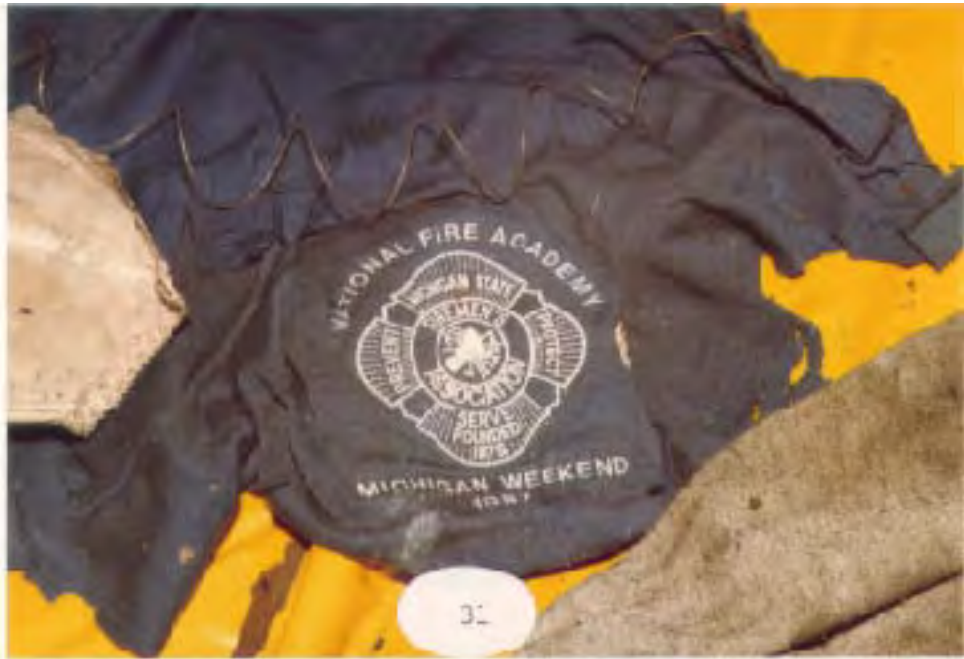
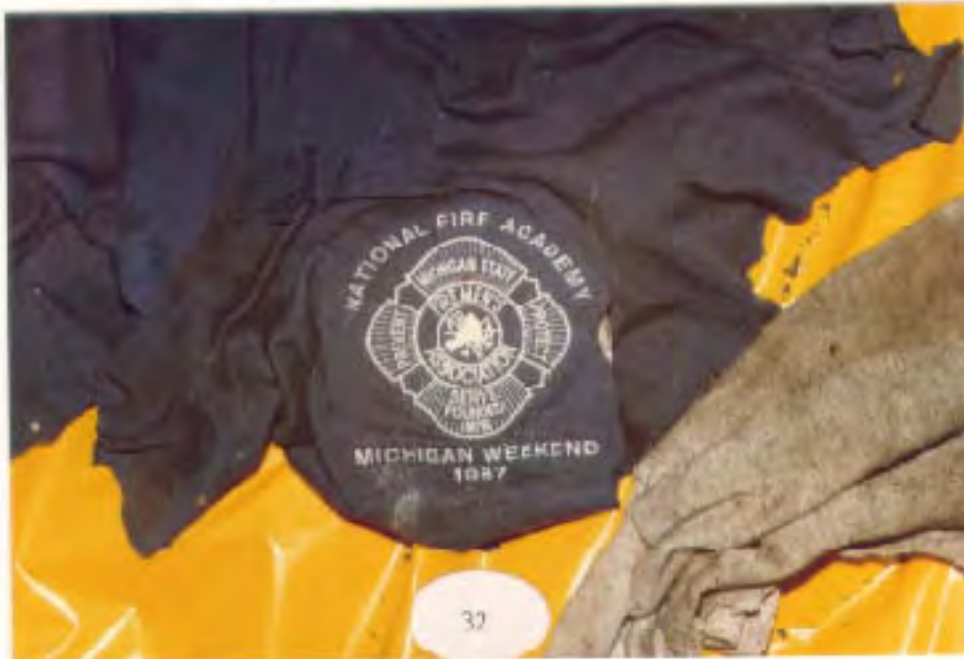
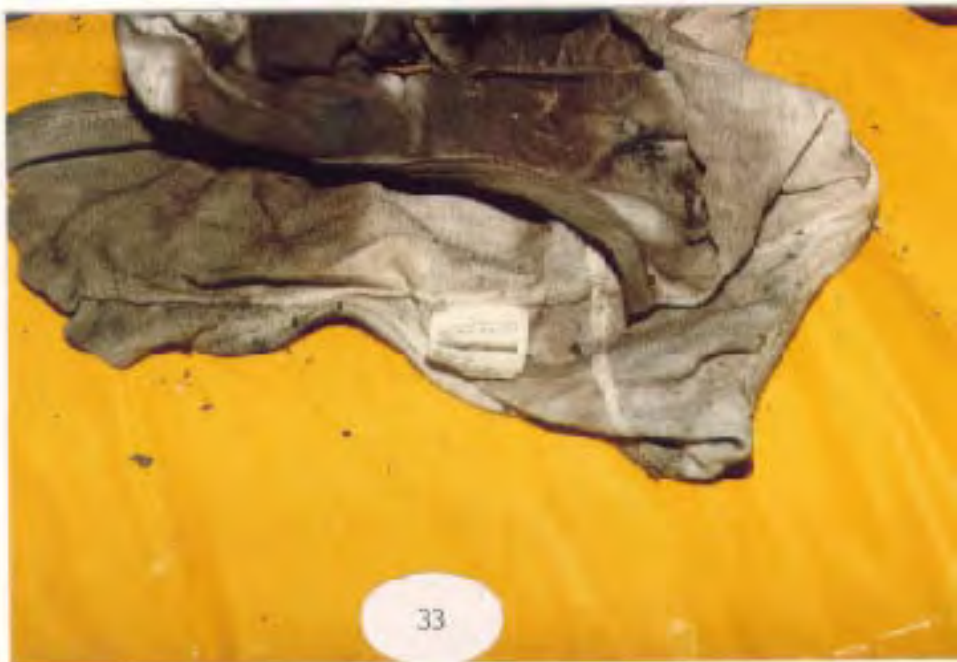
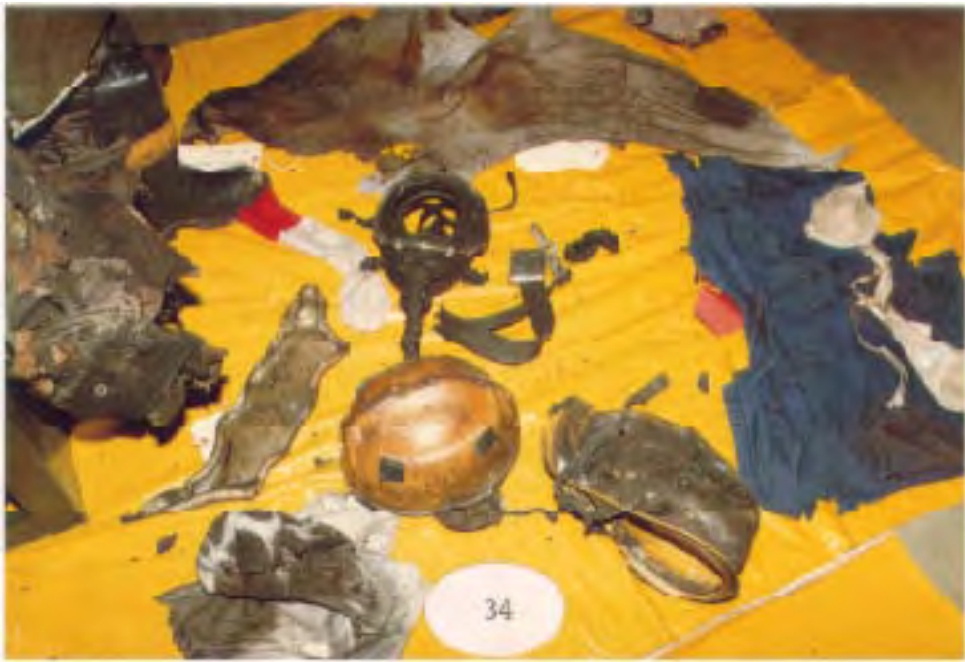
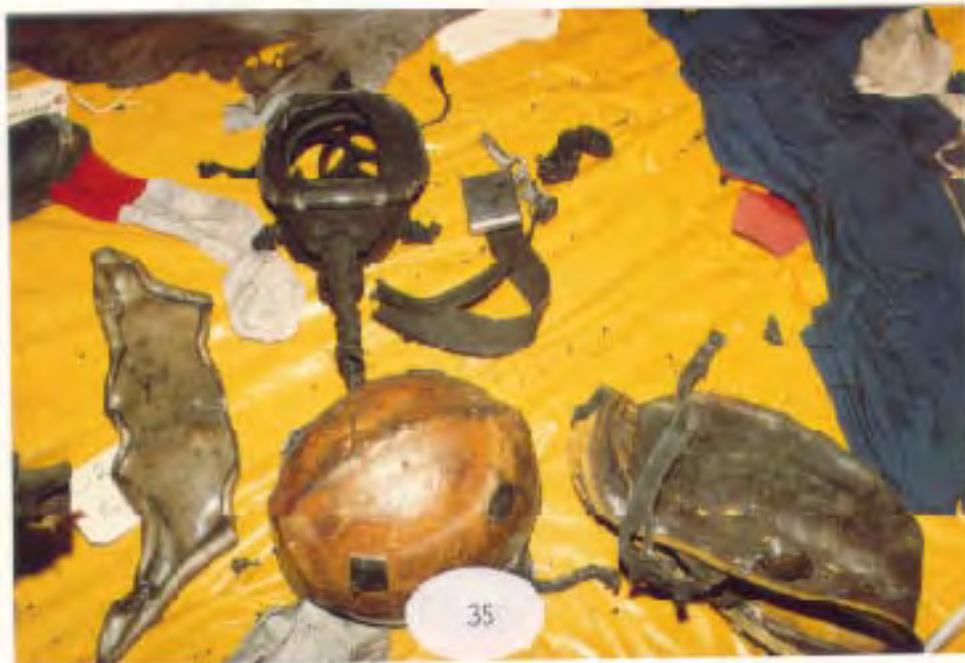
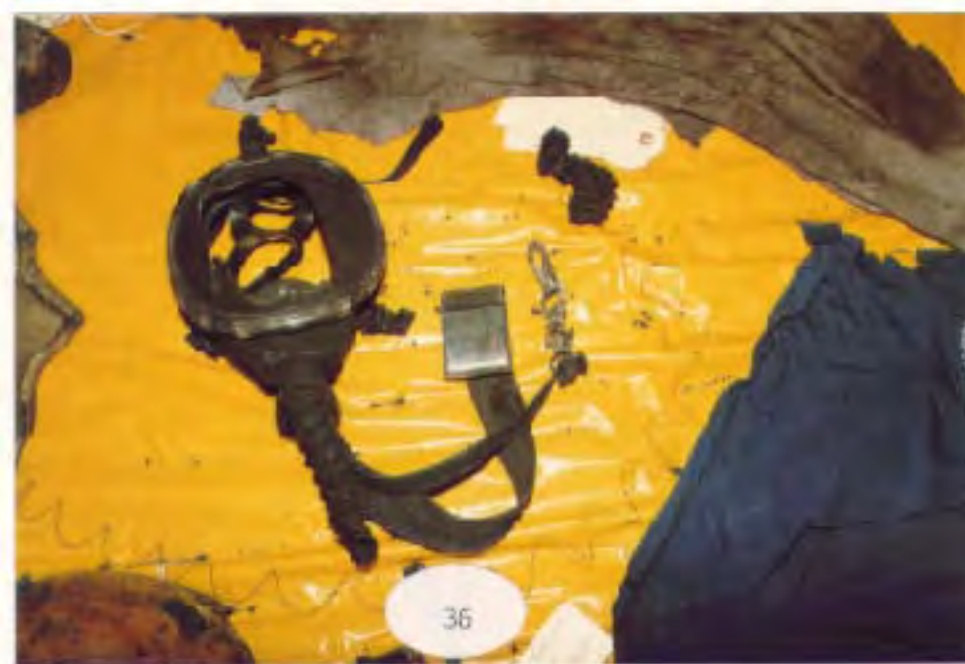
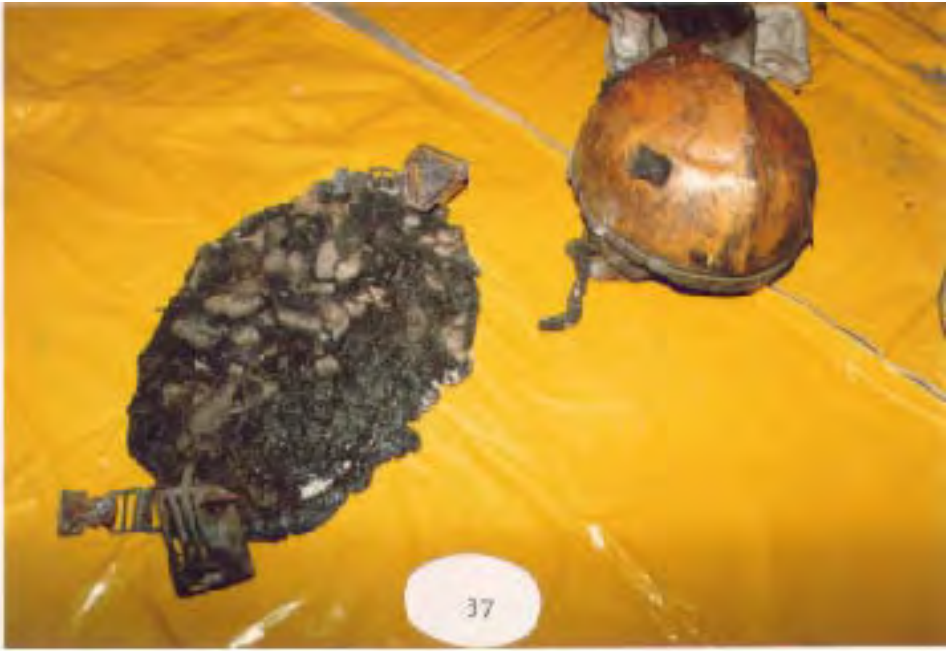
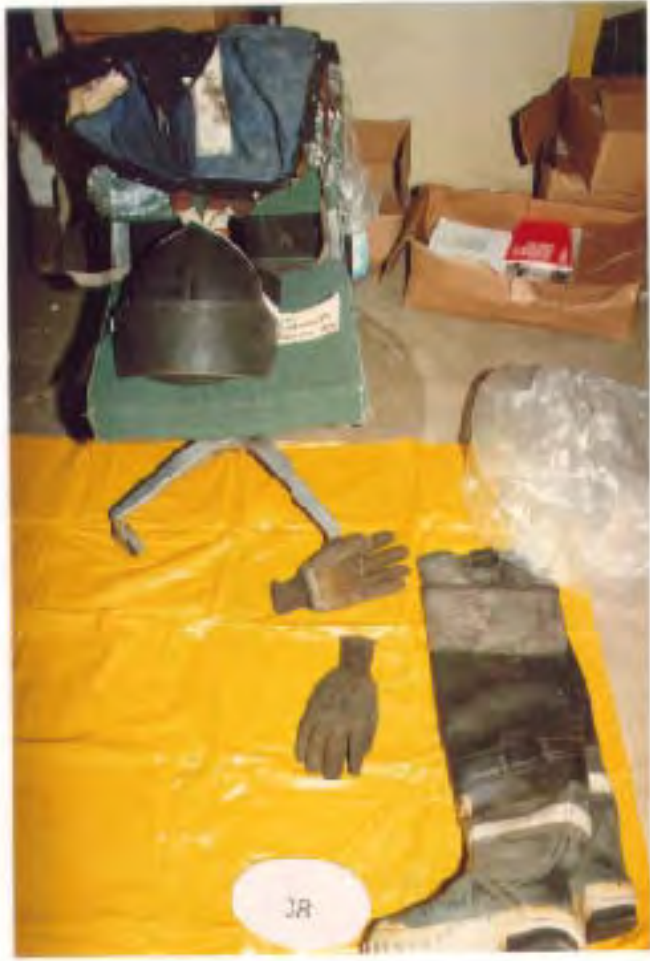
Deceased. Found with foot hanging over
stair opening.

Janesville with NFPA 1971 label. Nomex outer
shell, quilted Nomex inner liner with
Neoprene moisture barrier. Coat is
essentially destroyed; most of liner is
intact.

Charcate 2-ply Nomex. Some charring noted,
but intact.

Short rubber type. Left almost destroyed by
fire exposure. Right has minor damage.

Scott - lens broken and part missing.
Heavily soot covered, inside and outside.
Breathing tube destroyed by fire.

#37-Remnants of unidentified melted
helmet, fused to buckles from SCBA straps,
shown next to impact cap from Baczynski
articles.
