Interstate Bank Building Fire Los Angeles, California

Interstate Bank Building Fire Los Angeles, California (May 4, 1988)

Investigated by: J. Gordon Routley

**This is Report 022 of the Major Fires Investigation Project conducted
by TriData Corporation under contract EMW-8-4321 to the United
States Fire Administration, Federal Emergency Management Agency.**

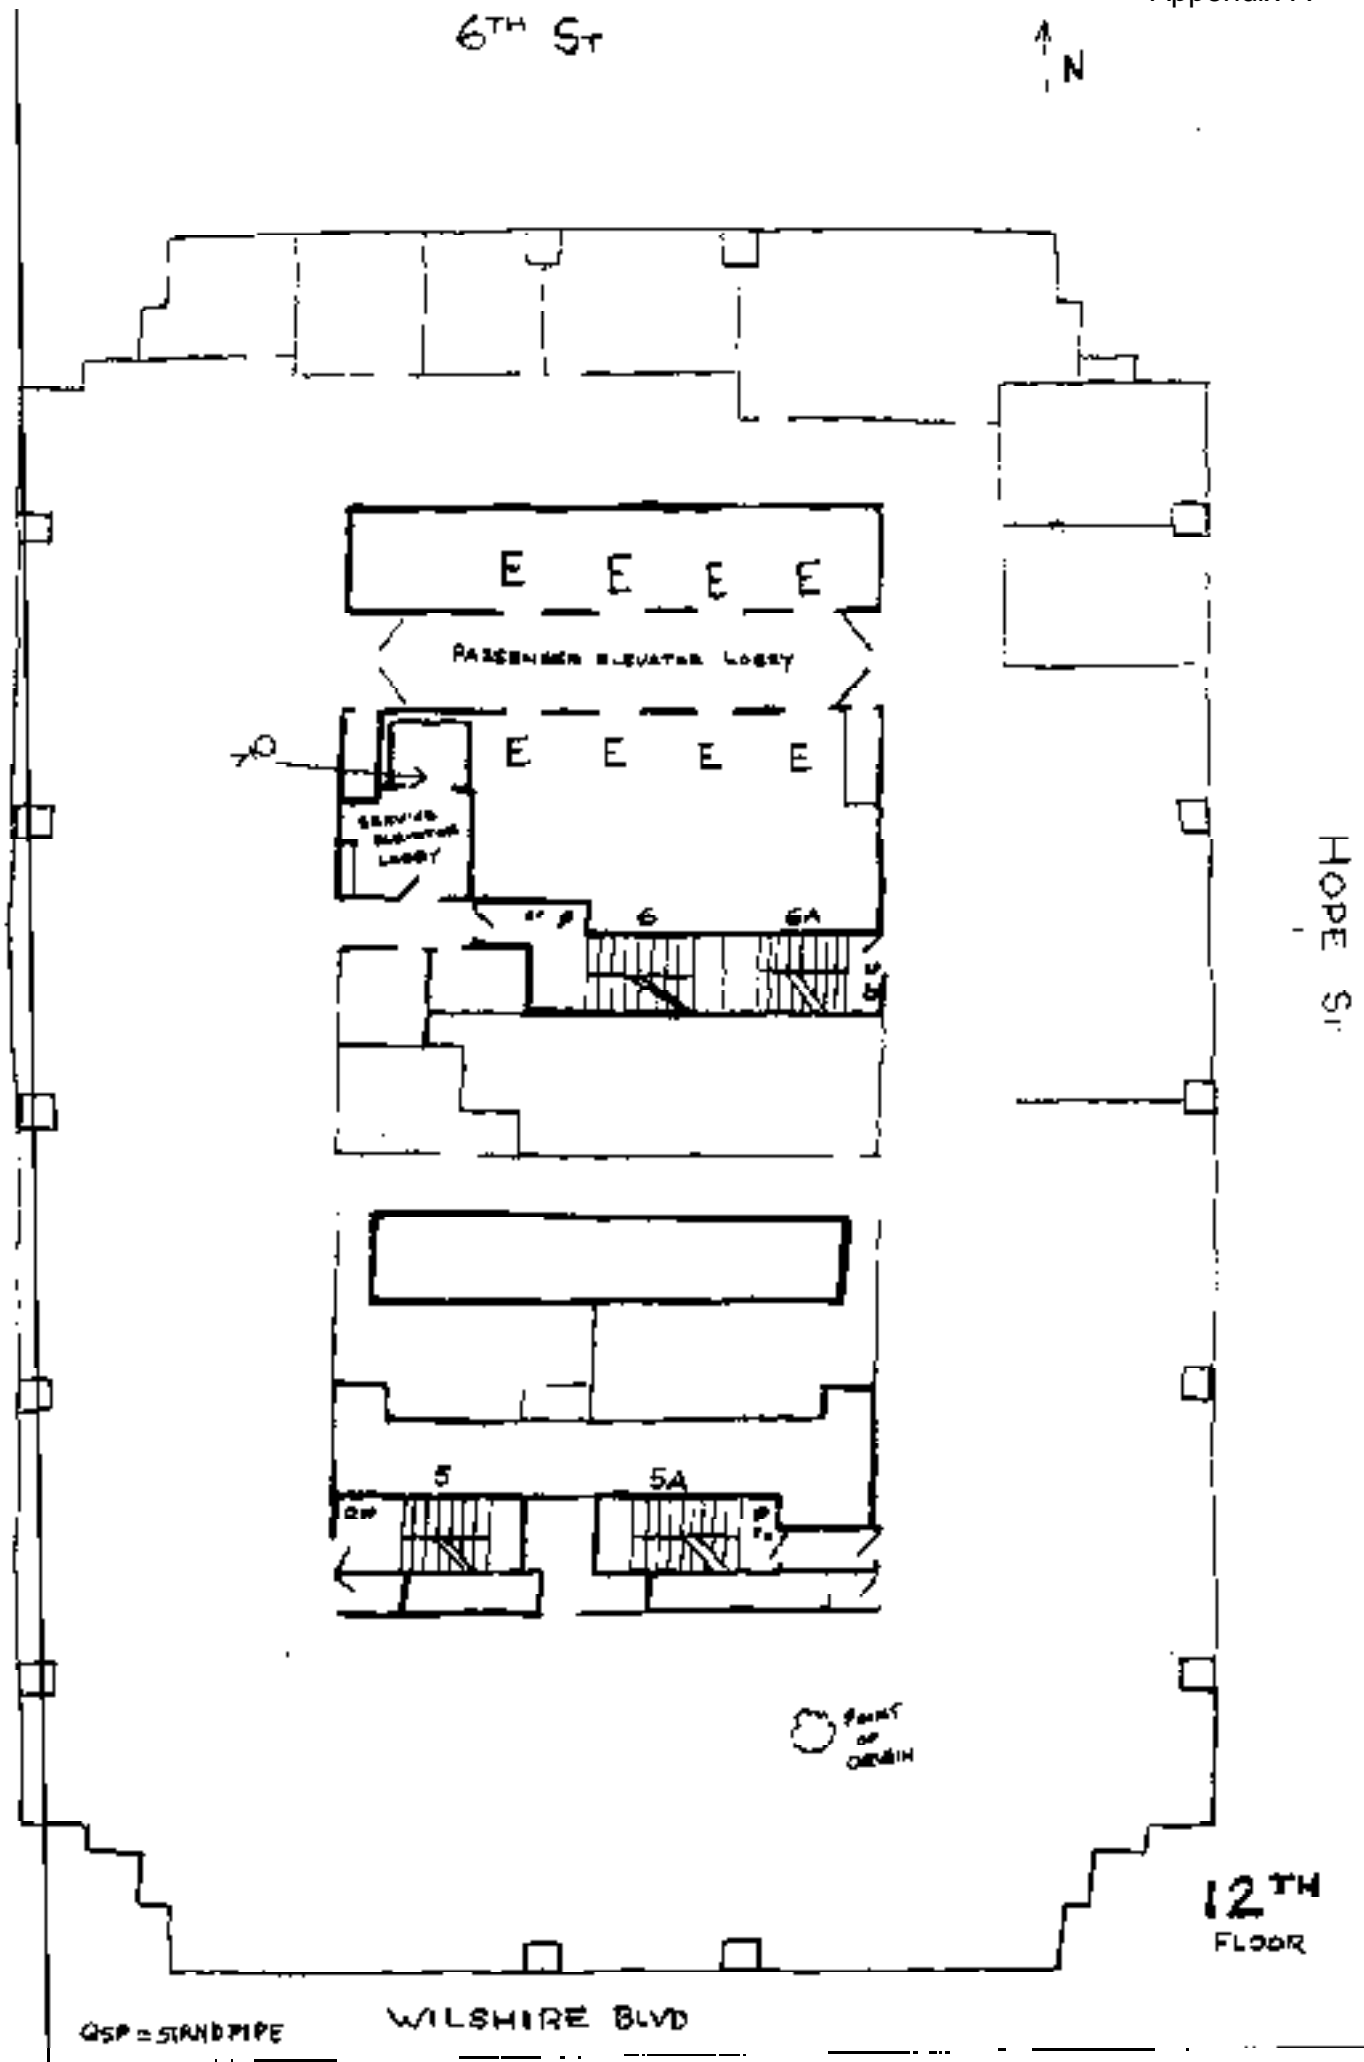
The fire originated in an open-plan office area in the southeast quadrant of the 12th floor. (See Appendix A.) The area of origin contained modular office furniture with numerous personal computers and terminals used by securities trading personnel. The cause is thought to be electrical in origin, but the precise source of ignition was not determined. The fire extended to the entire open area and several office enclosures to fully involve the 12th floor, except for the passenger elevator lobby, which was protected by automatic closing fire doors.

The single fatality was found in a service elevator. The building employee, who went to the 12th floor to investigate the alarm, was trapped and died when the elevator opened into a burning lobby. The lobby fire separation was compromised by a cleaner's cart blocking the door open. The victim was able to call for help on his portable radio, but other employees had no means to rescue him. This elevator was put on independent service through the use of a key by the building employee.

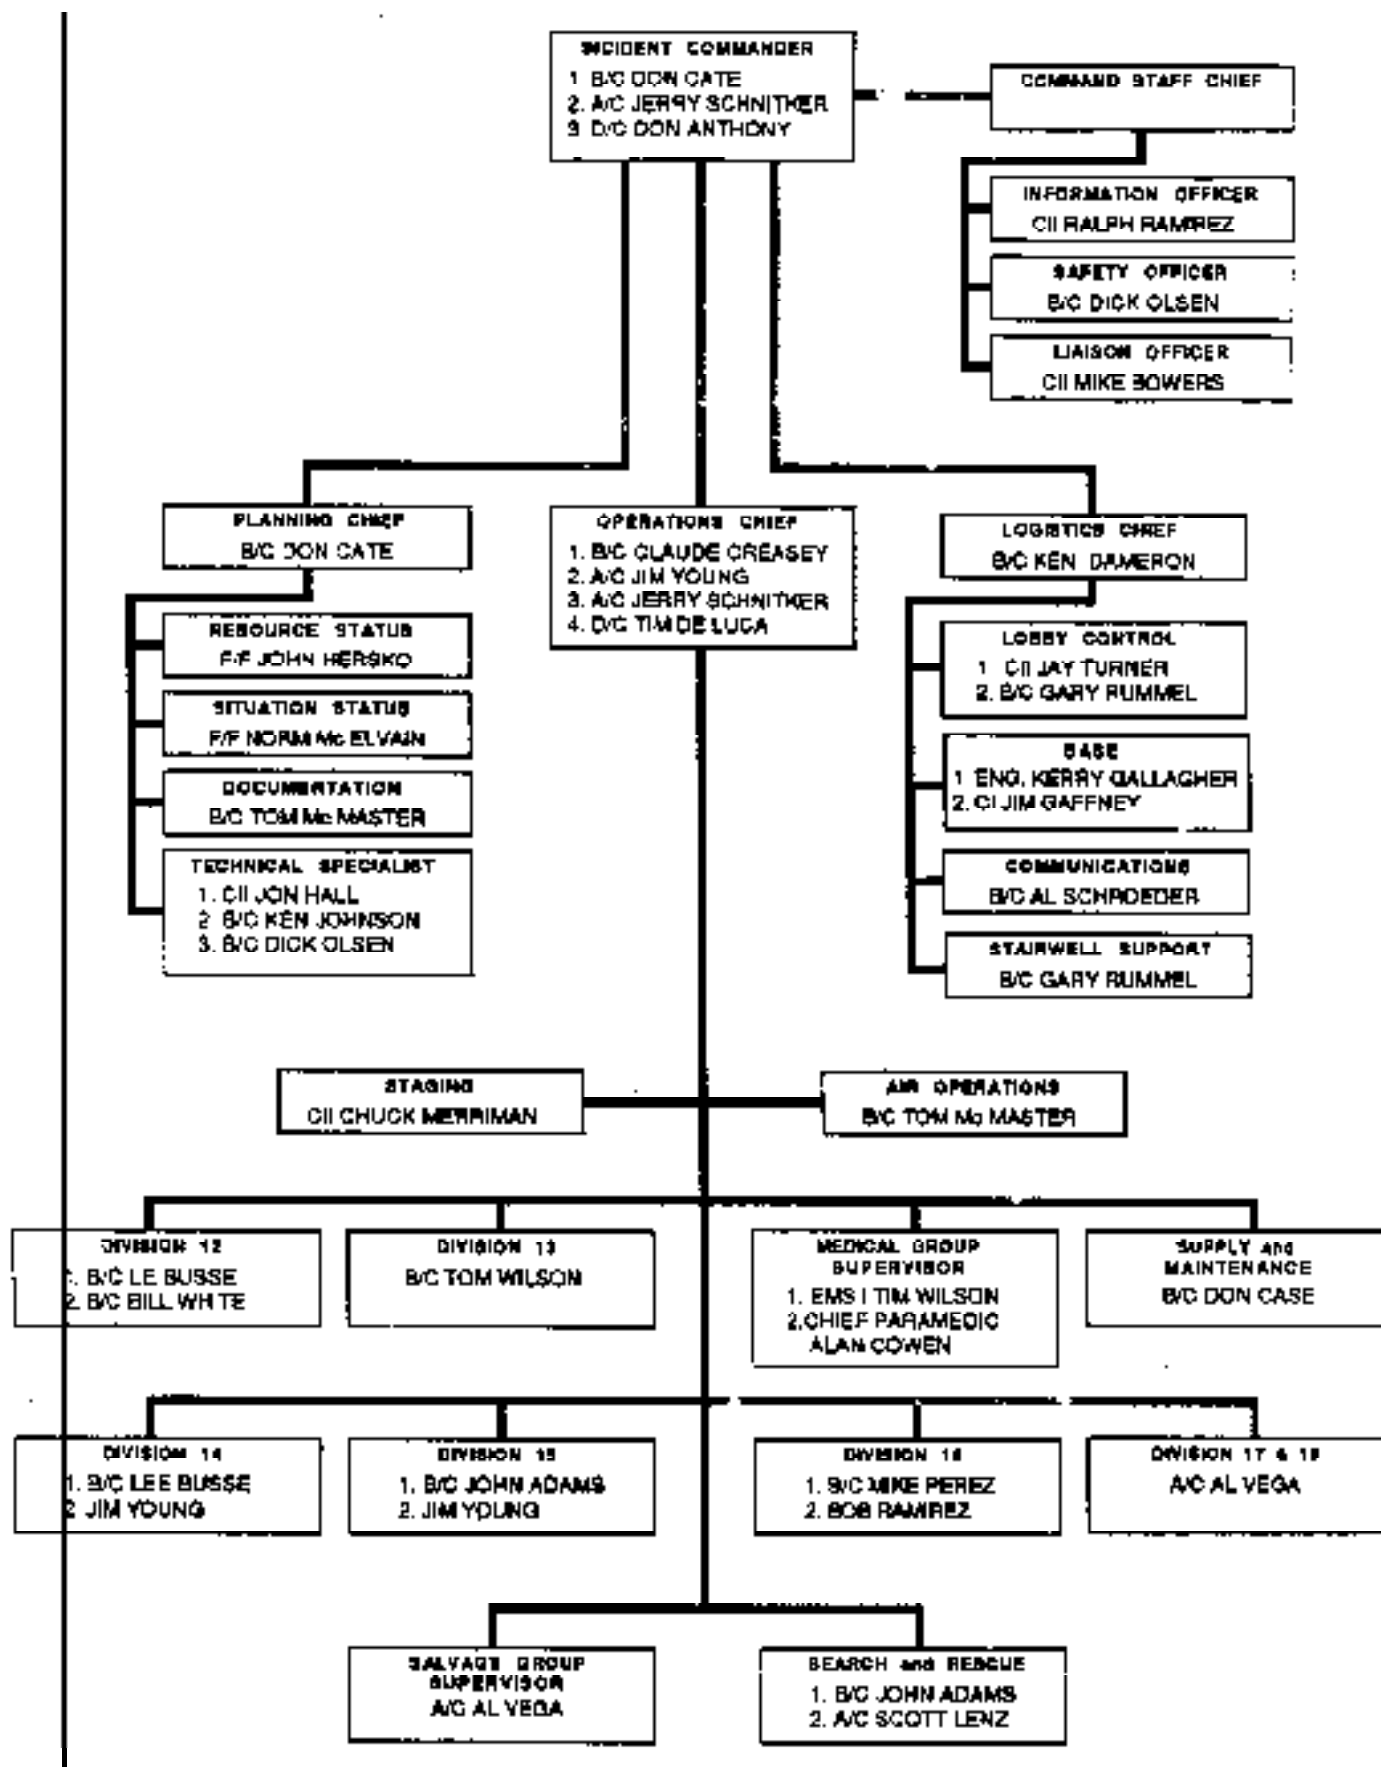
INCIDENT COMMAND ORGANIZATION

The High Rise Incident Command System was initiated with companies assigned to fire attack and to logistics and support functions from the outset. Appendix B shows the system and indicates the changes in command of various functions during the course of the incident.

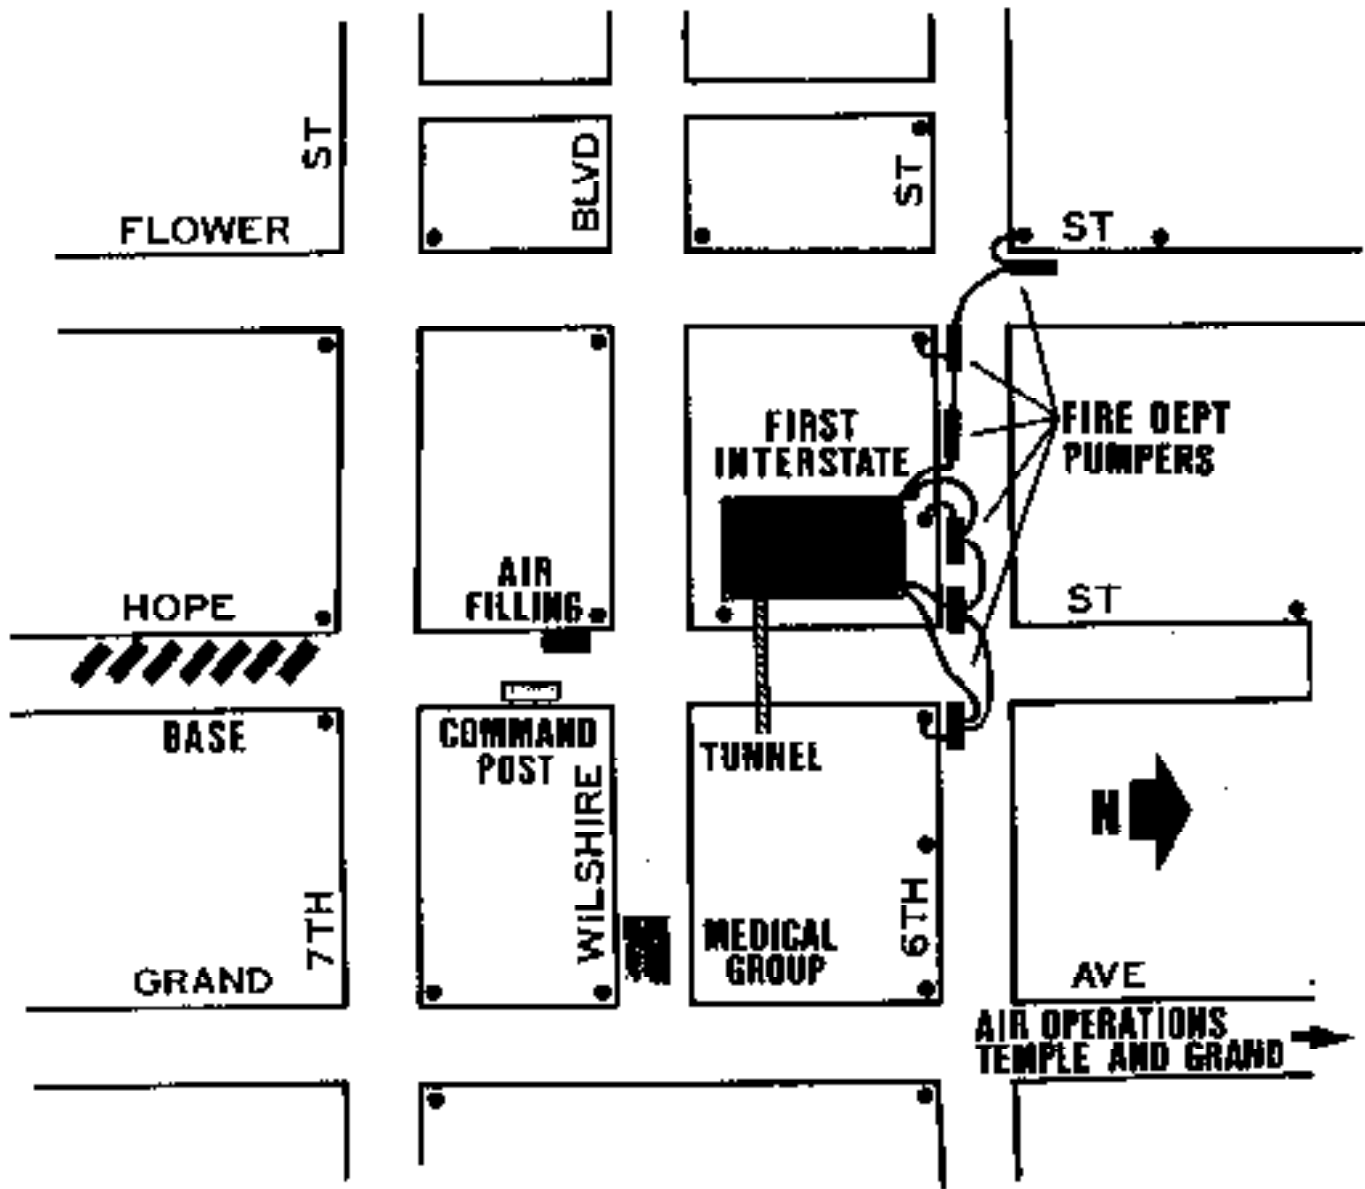
Appendix C shows the overall site and the location of the Command Post.

As the attack was put into operation, a Staging Area was established on the 10th floor and a Lobby Control was established at ground level. The "Base" for the operation was located a block south of the building (see Appendix C), following the High Rise Incident Command Plan.

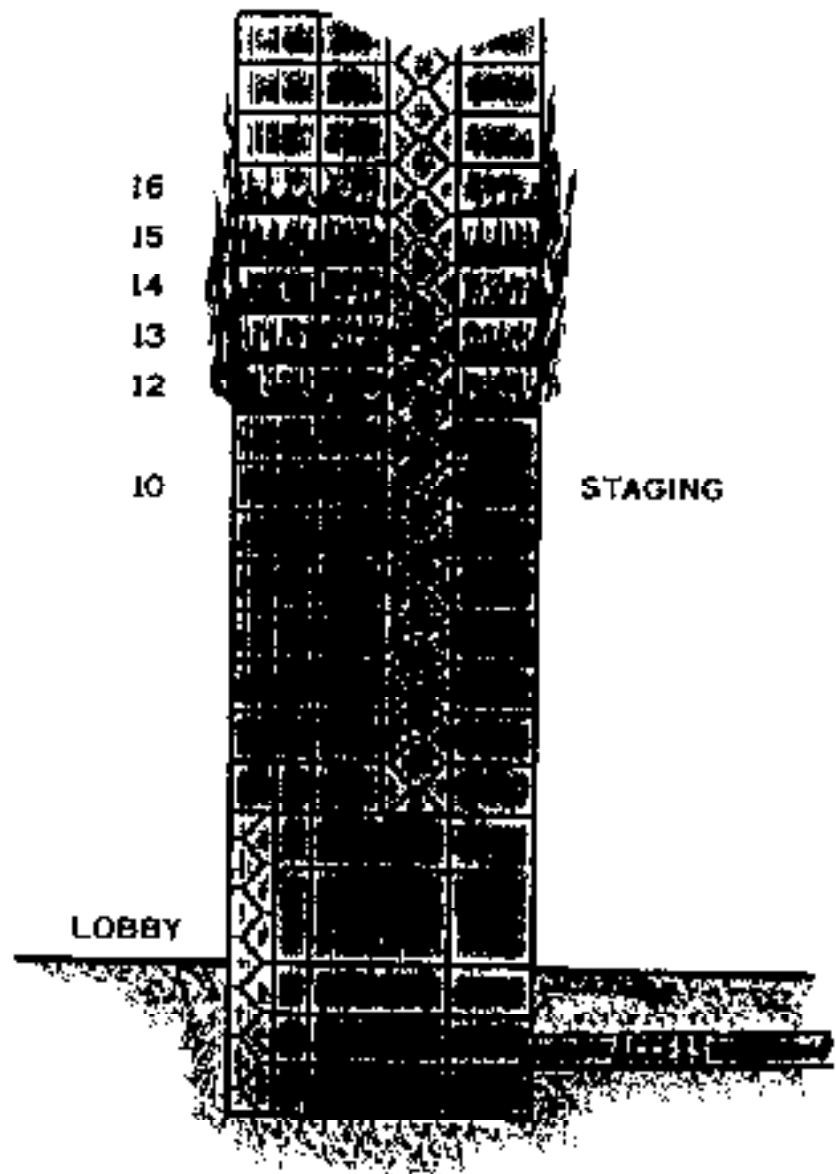
It soon became evident from the exterior and the interior that the fire was spreading upward. Companies successively launched attacks from all four stairways onto the 13th, 14th, 15th, and 16th floors, often encountering heavy fire from the point of entry and having to fight their way onto the floors with handlines. At times active suppression efforts were underway simultaneously on four levels as crews attempted to push the fire back from the central core to the perimeter of each floor. As more doors were opened, conditions in the stairways deteriorated with heat and smoke going up and water cascading down. (Appendix D shows a vertical cross-section of the building and the fire floors.)
