\$10 Million Marina Fire Bohemia Bay, Maryland

\$10 Million Marina Fire Bohemia Bay, Maryland (January 6, 1989)

Investigated by: Randolph E. Kirby

This is Report 026 of the Major Fires Investigation Project conducted by TriData Corporation under contract EMW-88-C-2649 to the United States Fire Administration, Federal Emergency Management Agency.

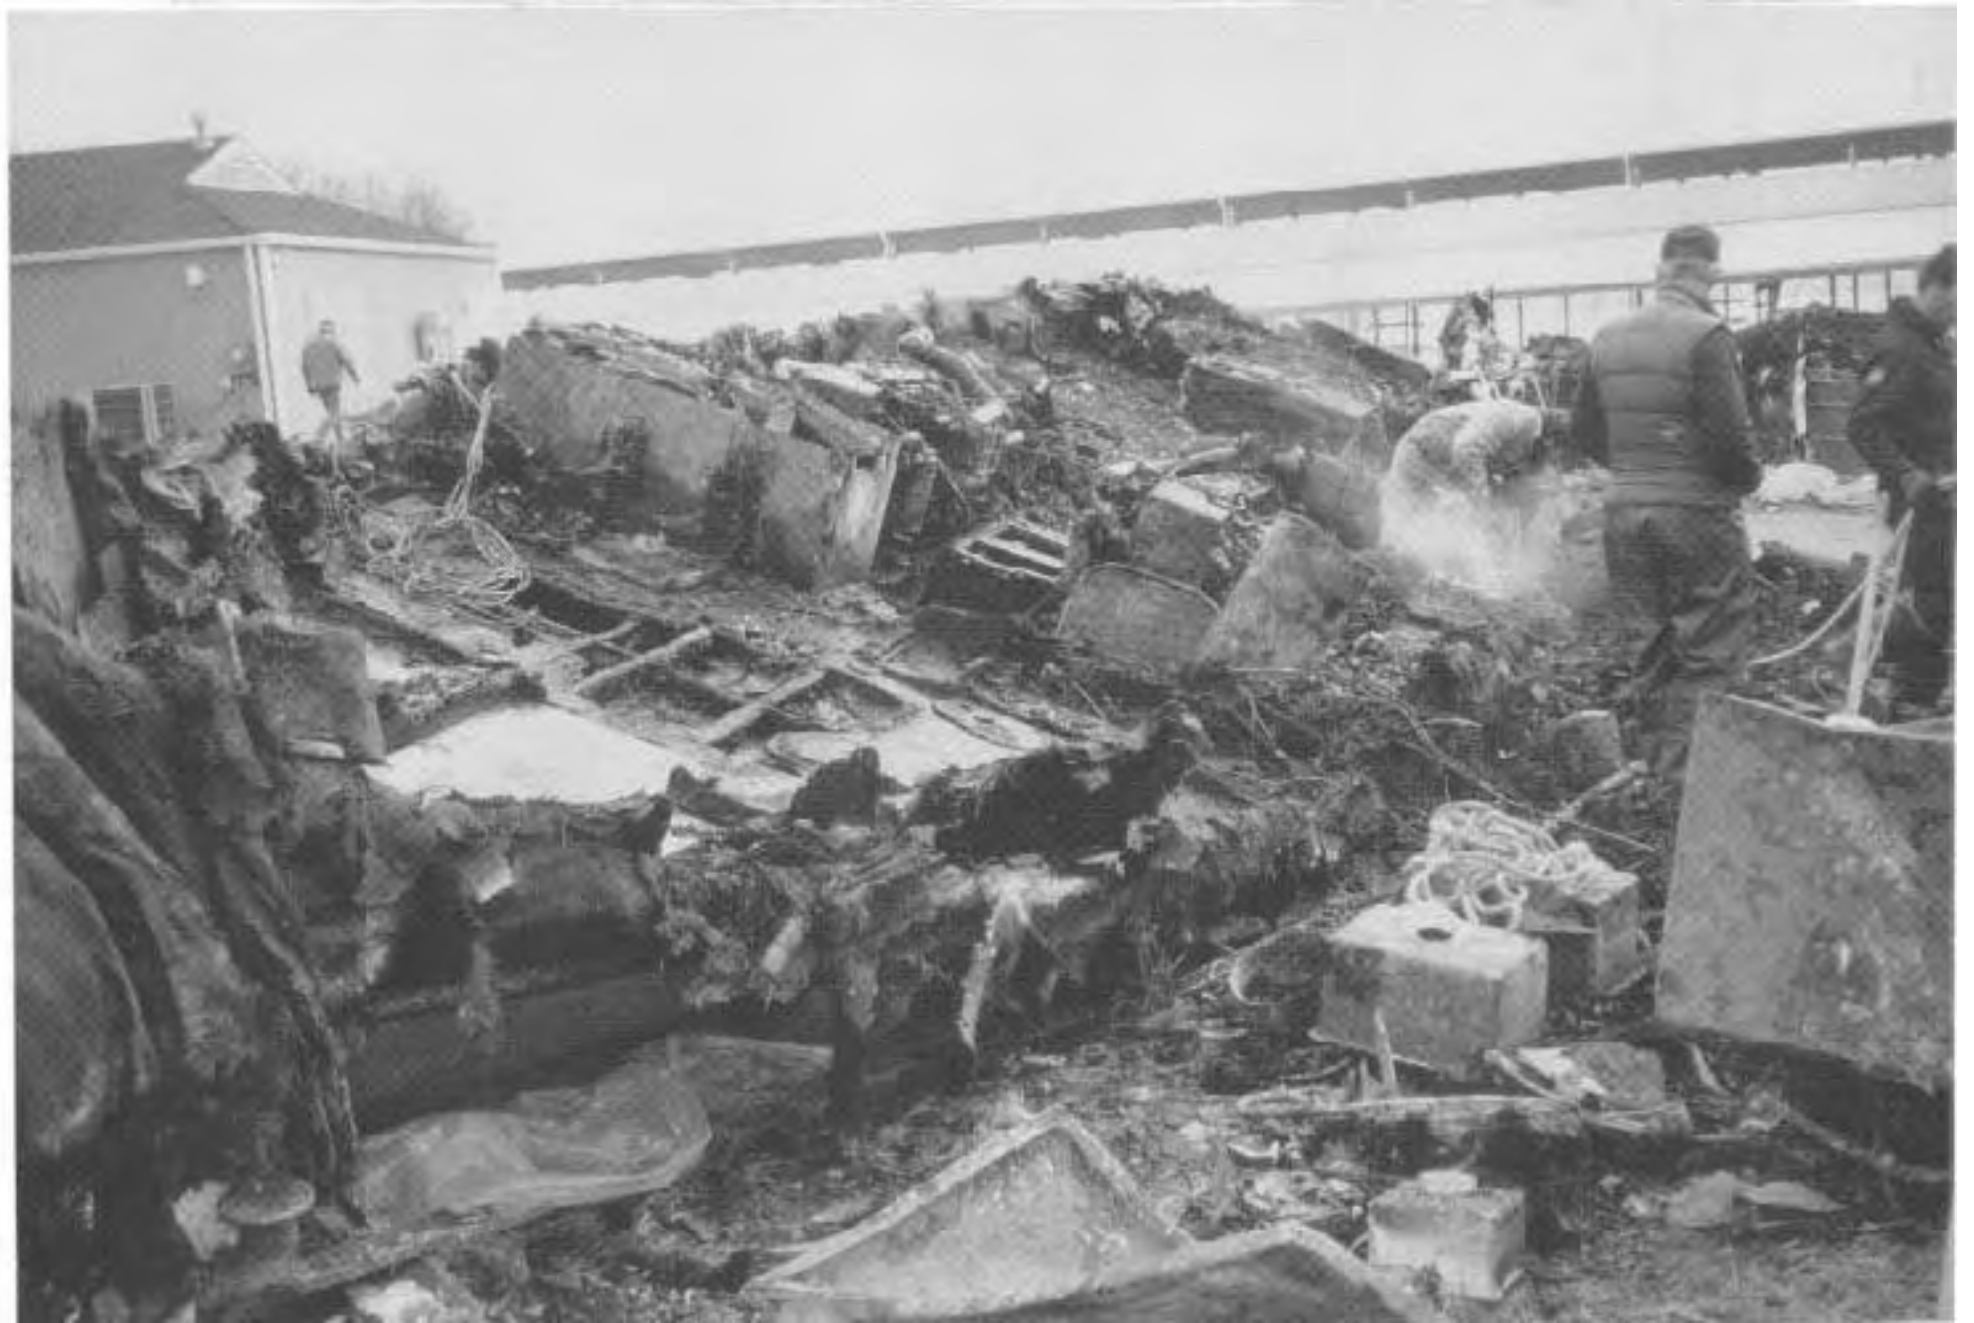
<u>Slides</u>	<u>Description</u>
1	Entrance to Bohemia Bay from Town Point Road.
2	Salvage operation - south end of 'E' dock.
* 3	Raised hull being examined by fire investigators (with boats typical of those that burned in background).

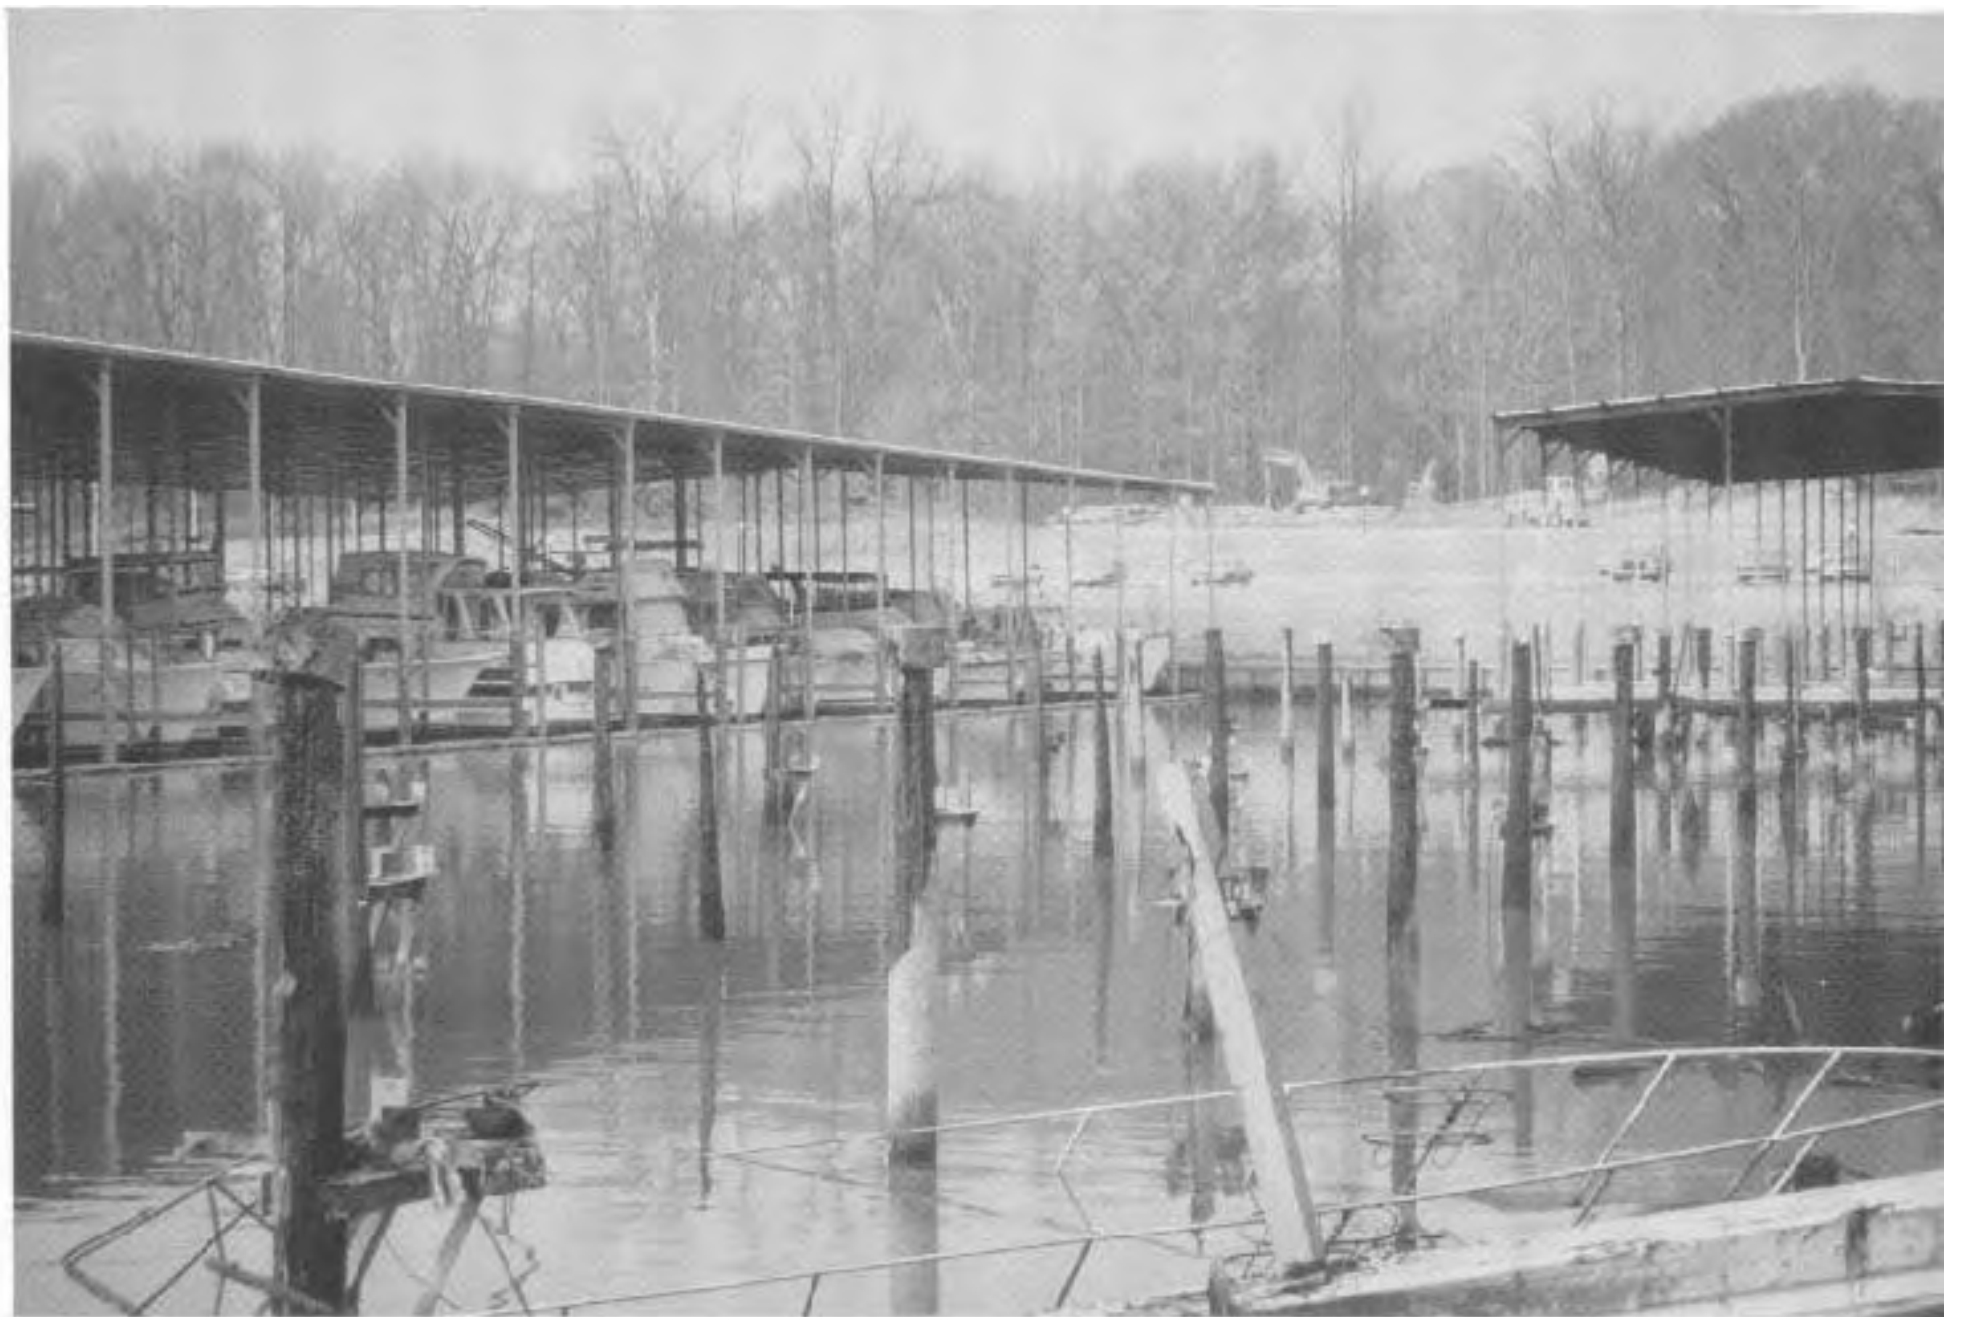
Approximately two-thirds of the metal structure of 'F' dock (250 feet) had to be removed before any investigative or salvage operations could begin. Even though the structure itself did not burn, the foundation was weakened and could no longer be used because of supporting piers burning.

Most of the finger piers, pilings, and walkways between slips 9 and 23 on 'F' dock were destroyed. Sixteen vessels were sunk. One vessel located at 'F' dock received heavy damage and two at 'C' dock received substantial damage as a result of fuel burning on the water. Approximately 100 boats received light damage from soot and burning embers. Their cleaning proved much more difficult and expensive than first thought.

* 4	Burned piers of 'F' dock.
5	South end of 'F' dock showing sunken vessels.
6	Sunken vessel being raised amidst burned piers - south end of 'F' dock.
7	Looking south between 'E' and 'F' docks.
8	Remains of north portion - 'F' dock roof structure.
9	North portion - covered slip areas. Note sloping terrain.
10	Heavy equipment required for conducting investigation and salvage work.
11	Carport section of remaining roof structure 'F' dock.
12	Remaining carport section of 'F' dock - note restricted access.
13	Remains of wooden pier - 'F' dock area.
14	Remains of vessel after being raised.
15	Remains of 'F' dock finger pier and sunken vessel.
16	Looking south at center pier of 'E' dock.
17	Damaged pier at 'E' dock, slip 21.

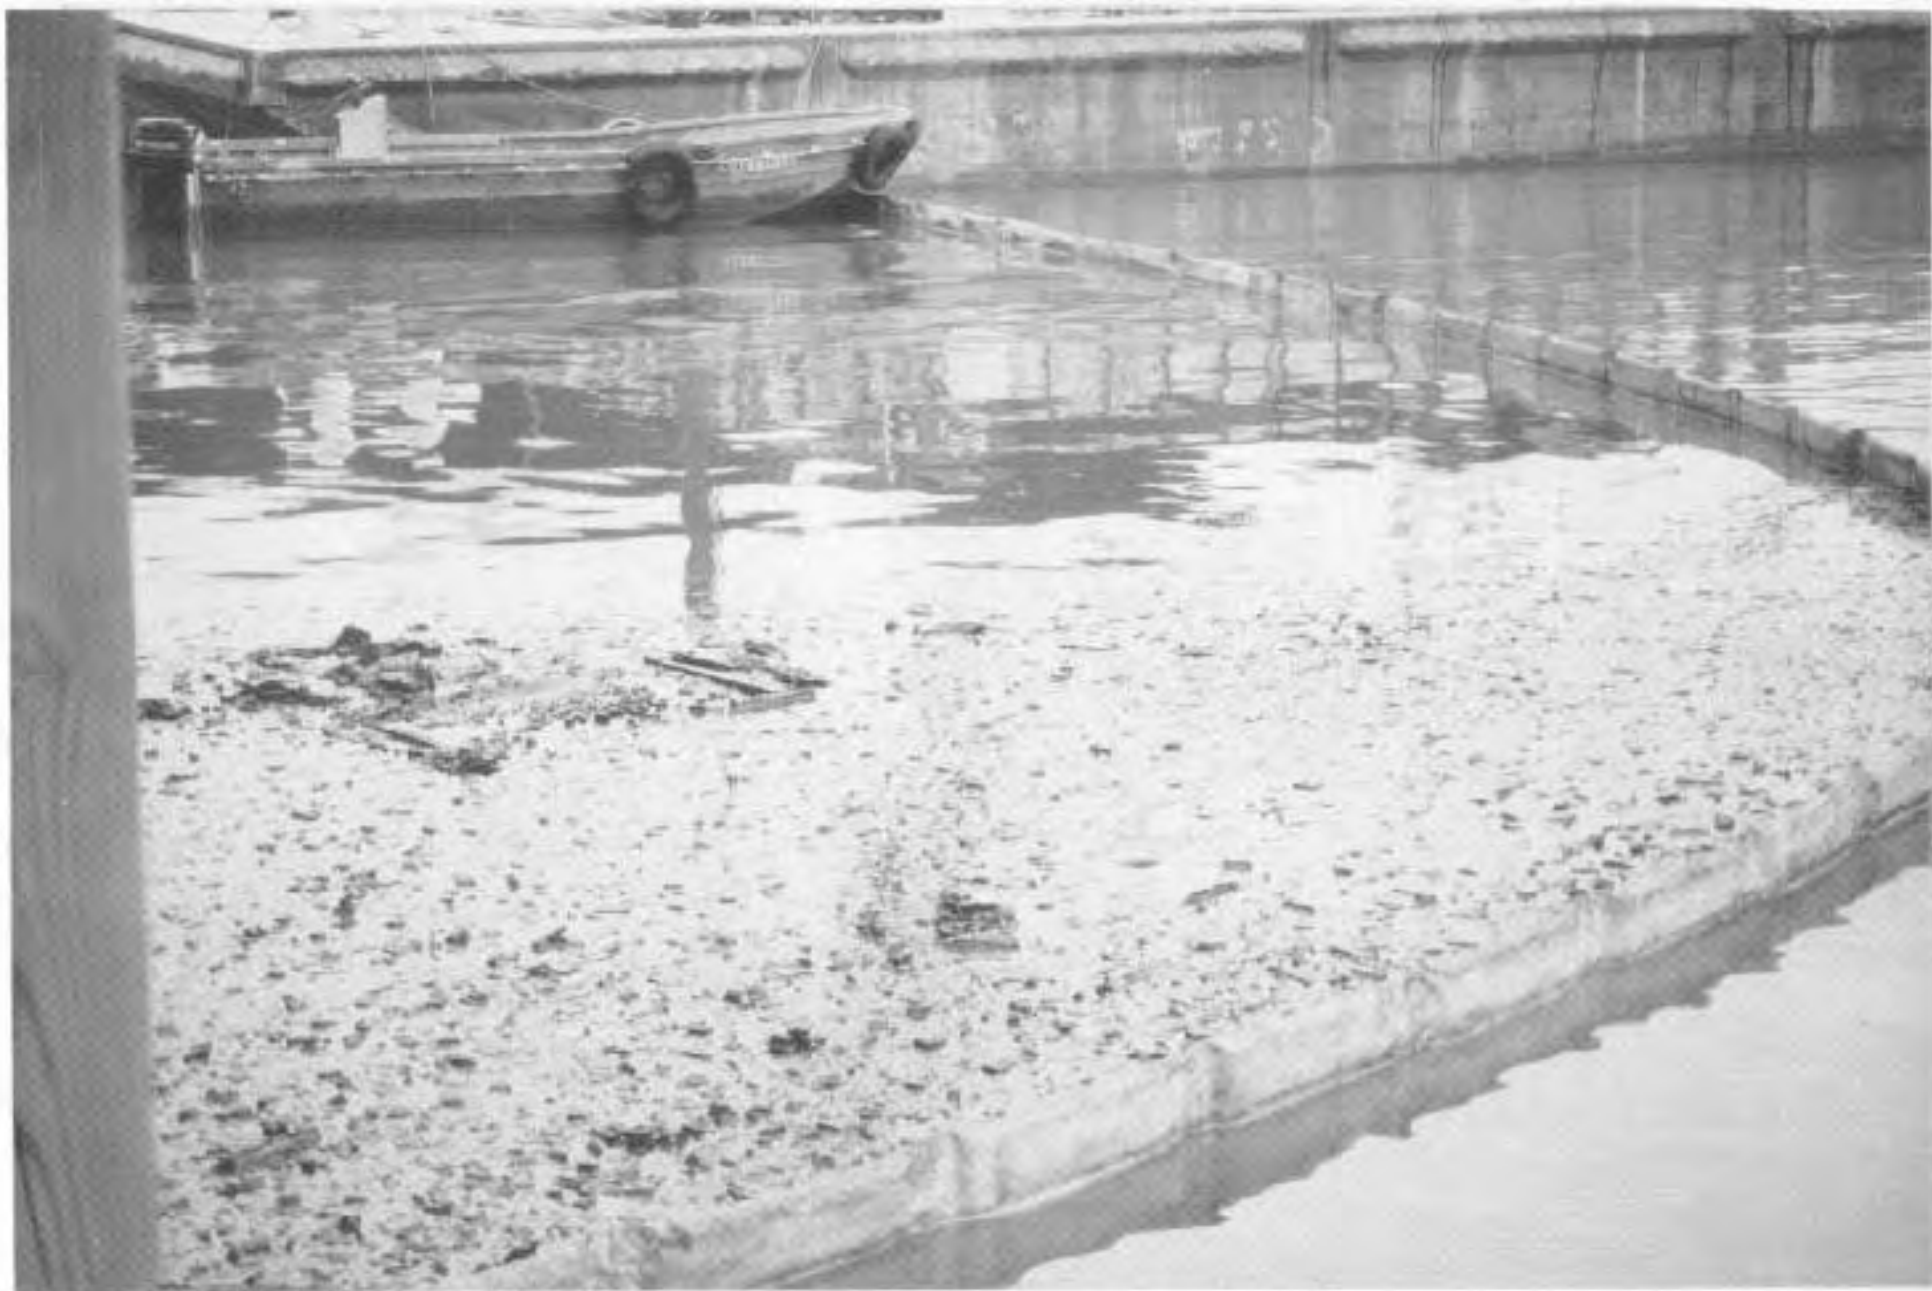
The possibility of surface fuel and burned debris reaching the river created an immediate need for a massive cleanup and containment operation. This operation involved containment ponds throughout the marina complex and daily maintenance of these ponds by several cleanup crews. Several weeks were required to complete the operation, which cost \$286,000.

* 18	Equipment used for containment ponds.
