Sprinklers Control Arson Fires in Rack-Storage Warehouse Mt. Prospect, Illinois

**Sprinklers Control Arson Fires
in Rack-Storage Warehouse
Mt. Prospect, Illinois
(October 16, 1988)**

Investigated by: April Berkol

This is Report 030 of the Major Fires Investigation Project conducted by TriData Corporation under contract EMW-88-C-2649 to the United States Fire Administration, Federal Emergency Management Agency.

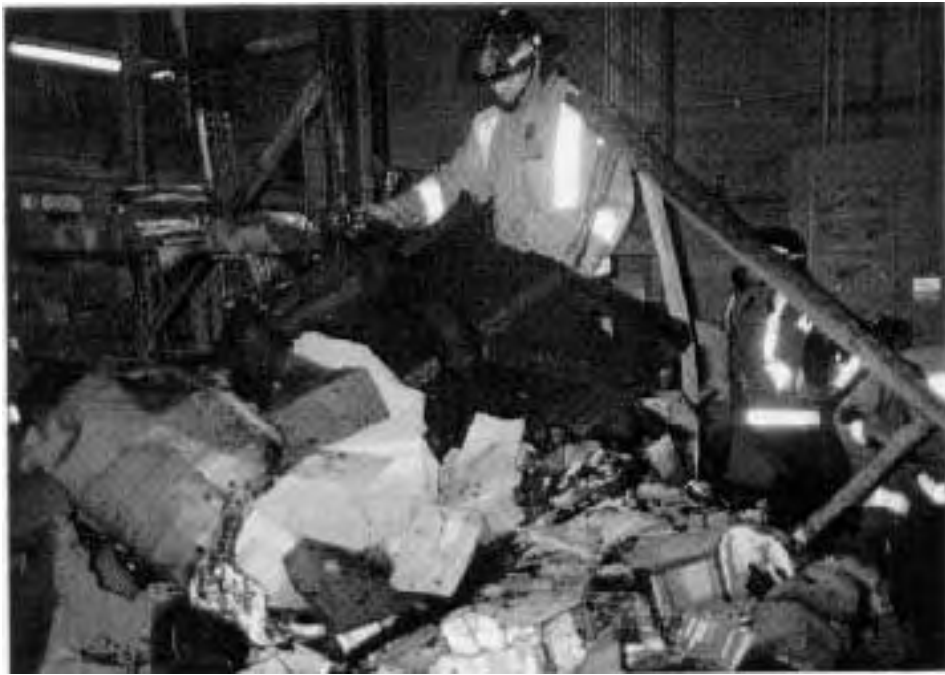
- *2. Looking due southwest from the second aisle. The main sprinkler riser is visible just above the firefighter's right hand.
3. Shows damage to goods stored.

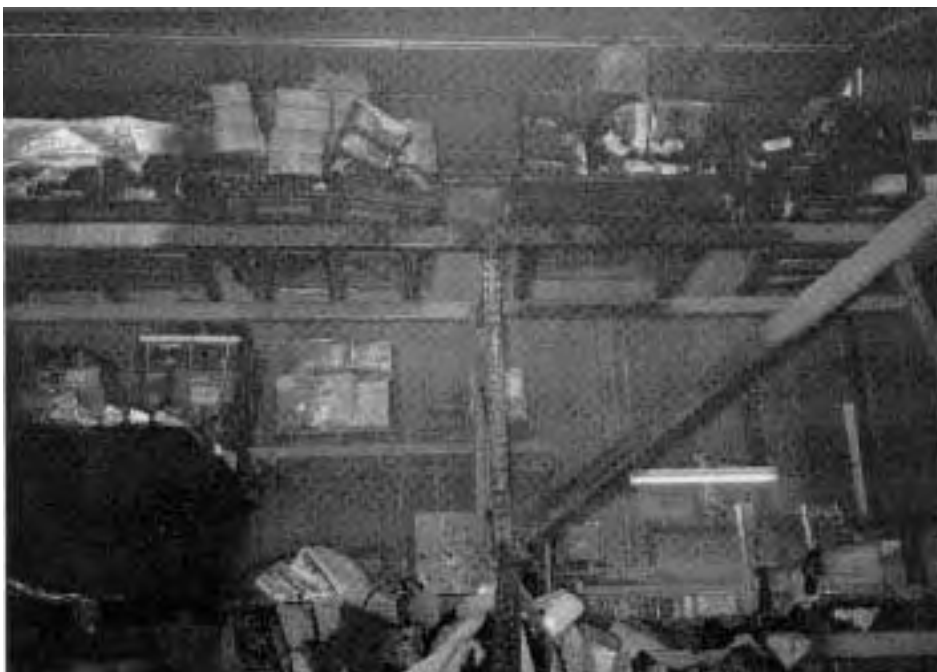
- *7. Typical damage to goods on upper level of racks.
8. Looking due south at door leading to warehouse section. Shows extent of water penetration due to fire.

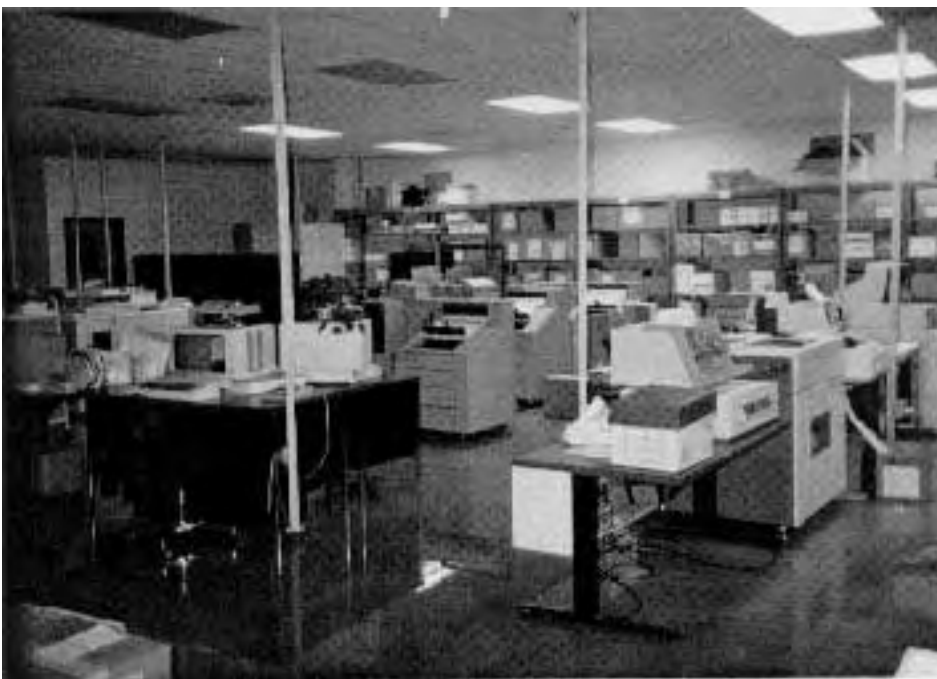
- *9. Data processing room, showing water accumulation on floor.
10. Data processing room. Shows extent of water penetration. No damage to equipment.
- 11-14. From aisle two showing fire damage to first double rack and single rack at southwest end of warehouse.

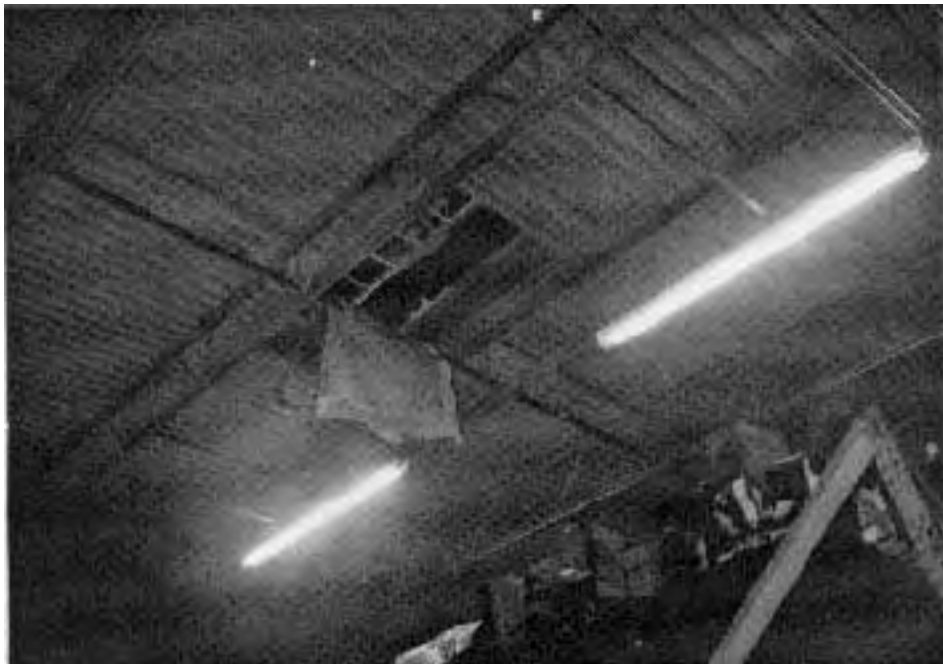
Although the building did not suffer any structural damage, a skylight located above the fire area failed prior to extinguishment. This failure is thought to have occurred soon after the time the first responding units arrived on the scene. This is based on the fact that no outward signs of

- *20. Failed skylight above aisle one. Note sprinkler piping.
