## **Gasoline Tanker Incidents in Chicago, Illinois and Fairfax County, Virginia**

**Case Studies in Hazardous Materials Planning**

# **Gasoline Tanker Incidents in Chicago, Illinois and Fairfax County, Virginia (March 30, 1989 and May 29, 1989)**

This is Report 032 of the Major Fires Investigation Project conducted by TriData Corporation under contract EMW-88-C-2849 to the United States Fire Administration, Federal Emergency Management Agency.

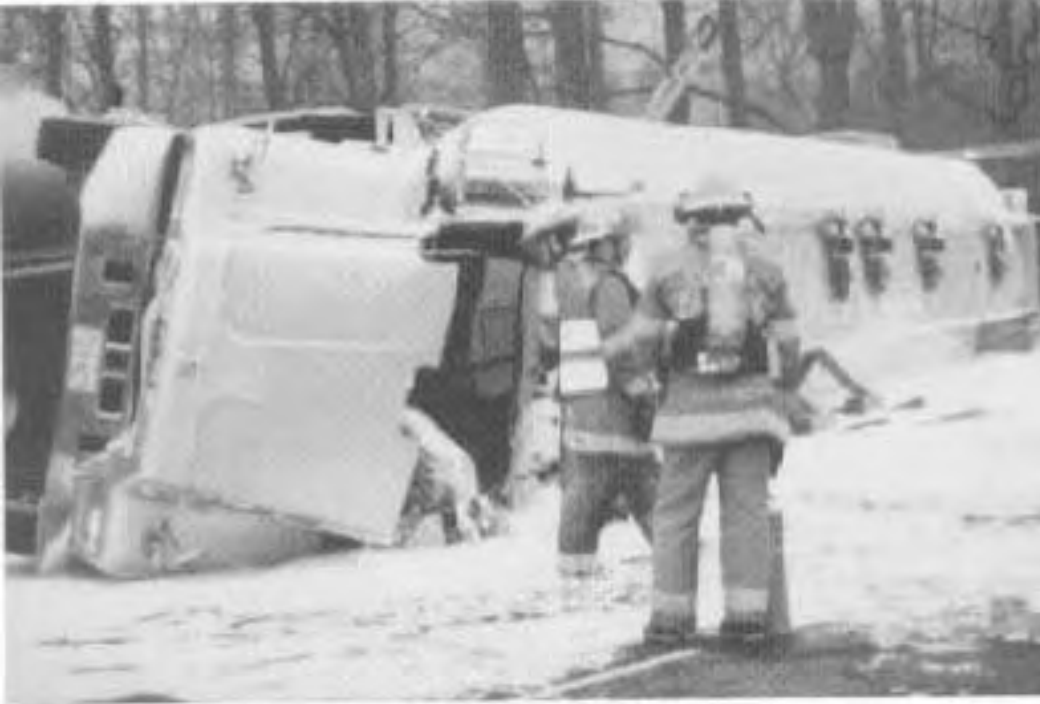
Because of the position of the tanker and the fact that the dome covers were damaged, it was decided that the best way to remove the product would be by cutting a hole in the side of the tank (see Fairfax County Hazardous Material Response Team Manual, Appendix D).

1. Overturned tanker showing dome covers

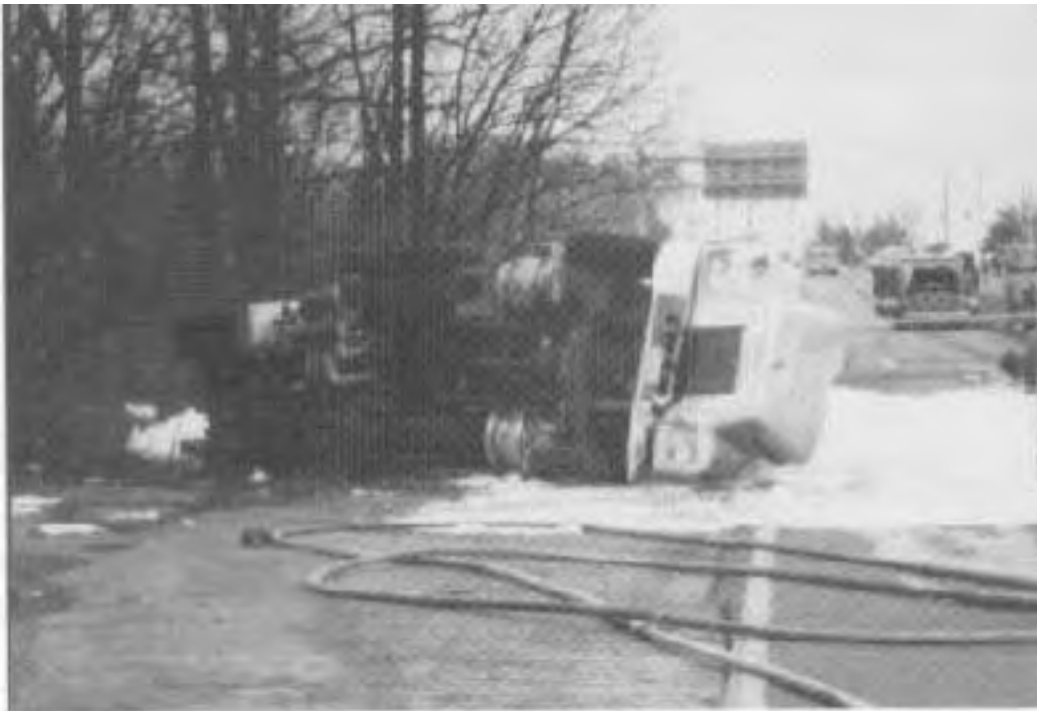
2. Tanker, sprawled on roadway; hazmat unit is in background.
3. (next page) Aerial view of accident scene. I-495 across center of photograph, Route 7 runs vertically in center of photograph.

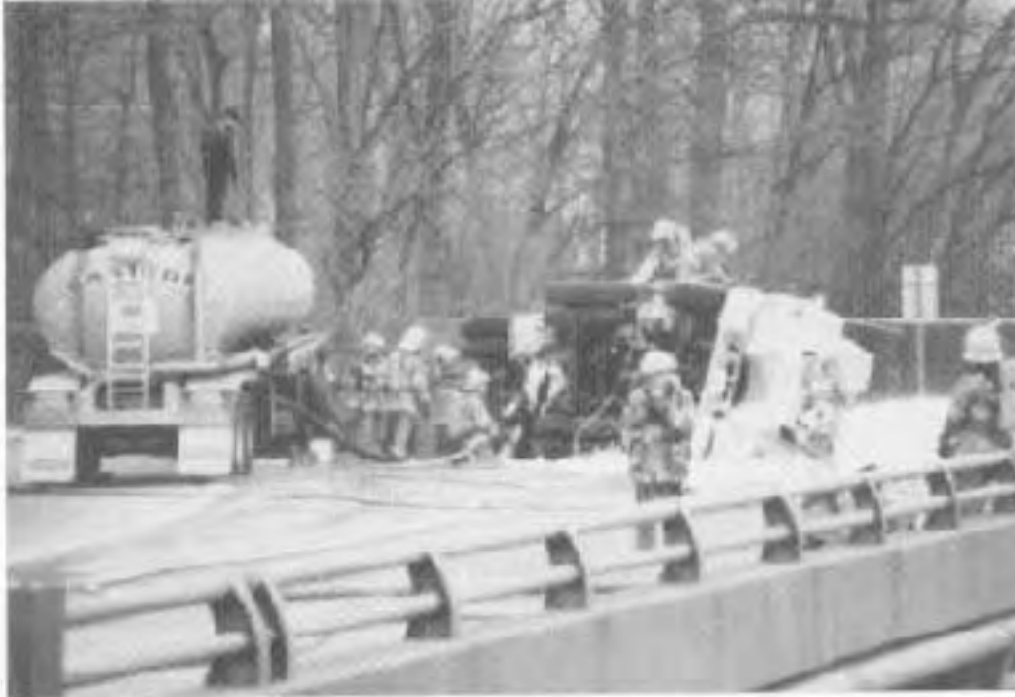
4. Second tanker pumping fuel from the overturned tanker.

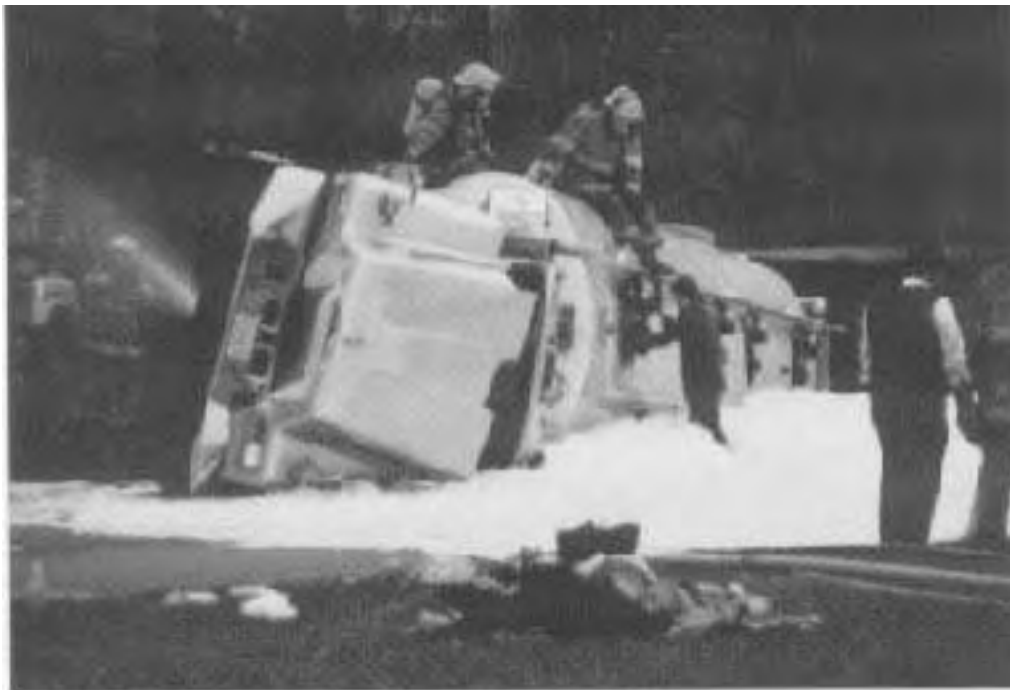
Fairfax County maintains a list of contractors who specialize in the removal and recovery of hazardous materials. In this incident, fire department personnel secured the scene and supervised contractor personnel who actually drilled the hole in the tanker and pumped the gasoline out. Chief Isman states that his team performs hands-on work of this type only as a "last resort."

5. Contractor personnel complete off-loading operation. Firefighters atop tank are at position of hole that was drilled. Note water spray directed at exhaust pipe of the recovery tanker.

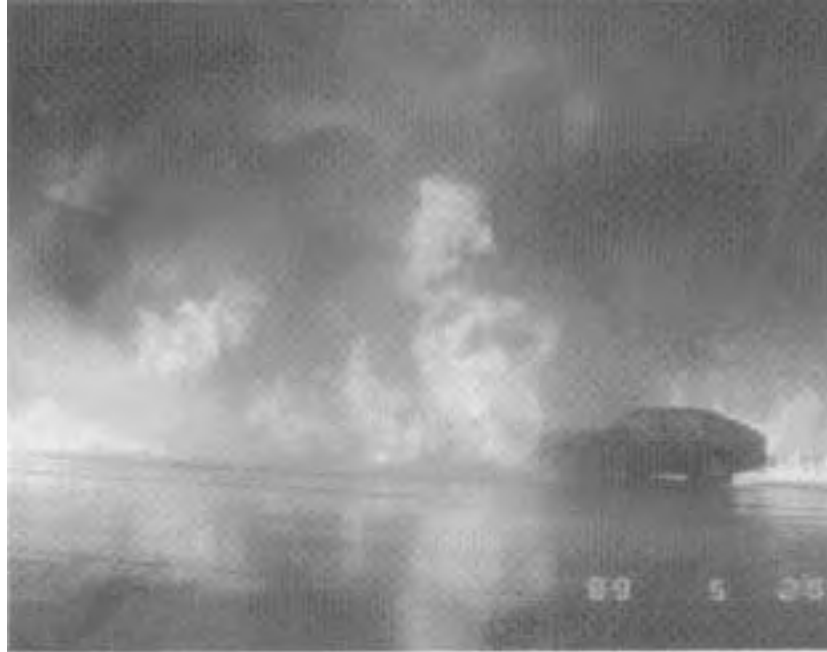
1. Fire conditions along Fullerton street between tanker and "el" tracks.

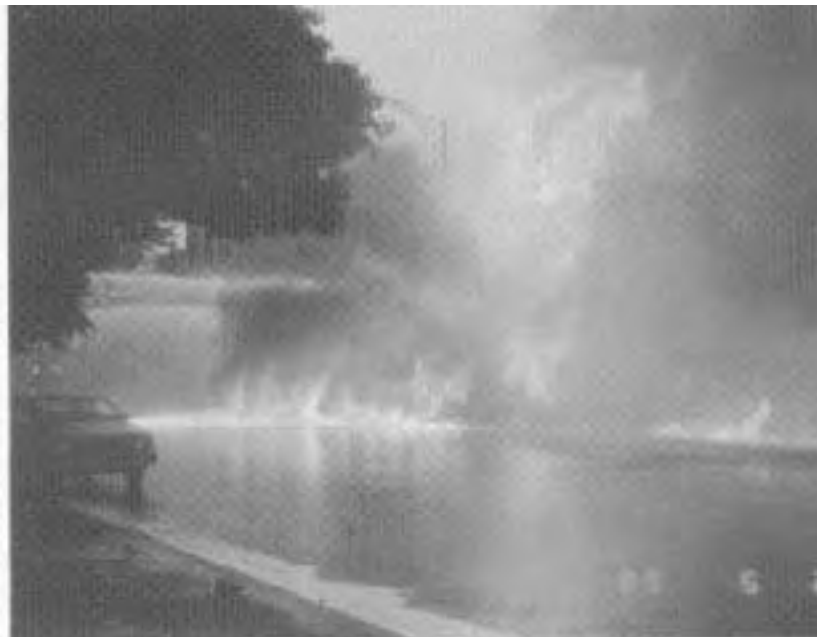
2. First streams (arrow) in operation on tanker; 2 story exposure building is obscured by fire and smoke.

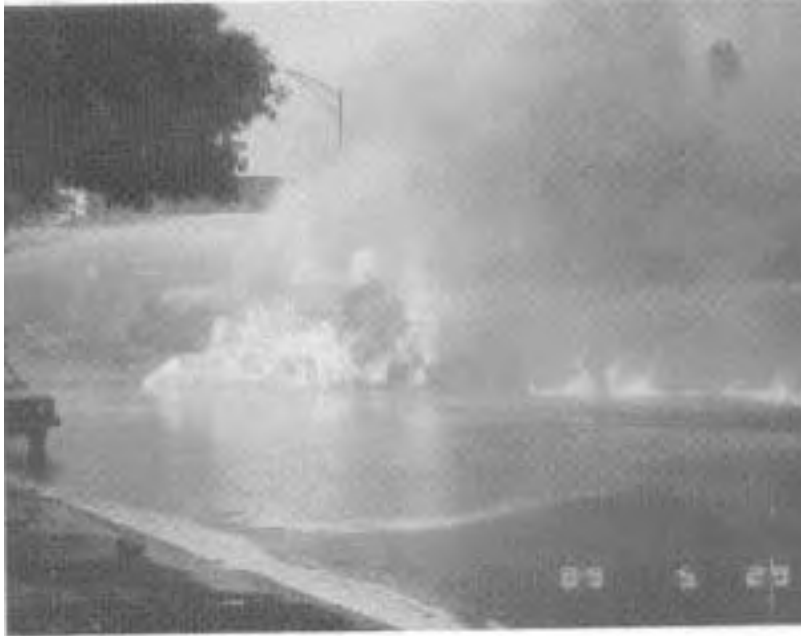
3. Another view of the tanker; Snorkel Squad 2 is visible at upper right.

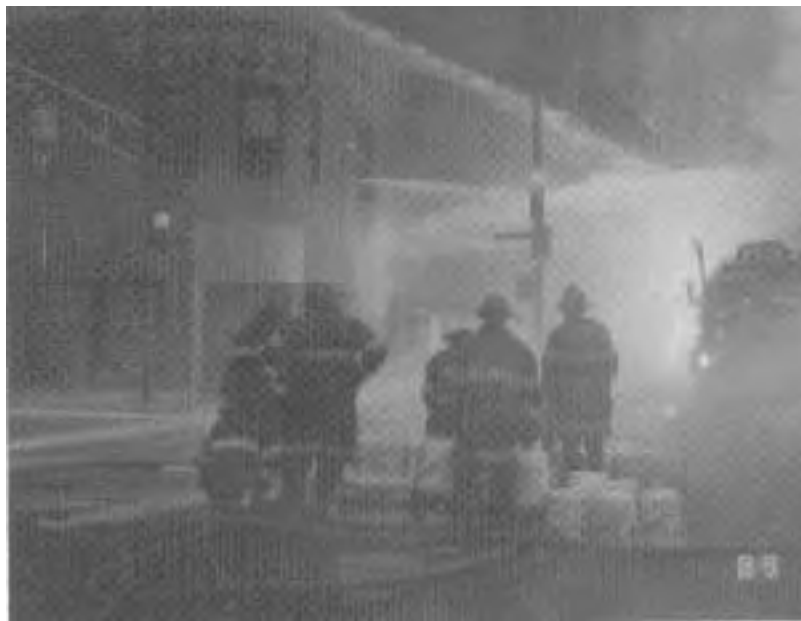
4. Firefighters operate foam handline to control spill fire. Note streams directed at exposure and tanker, including from second floor of exposure.

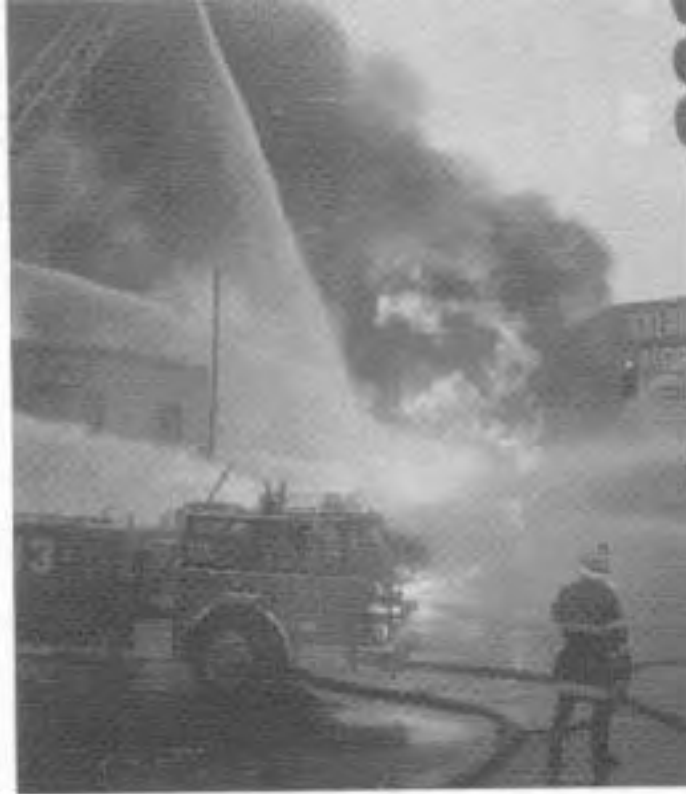
5. Tanker surrounded by streams.

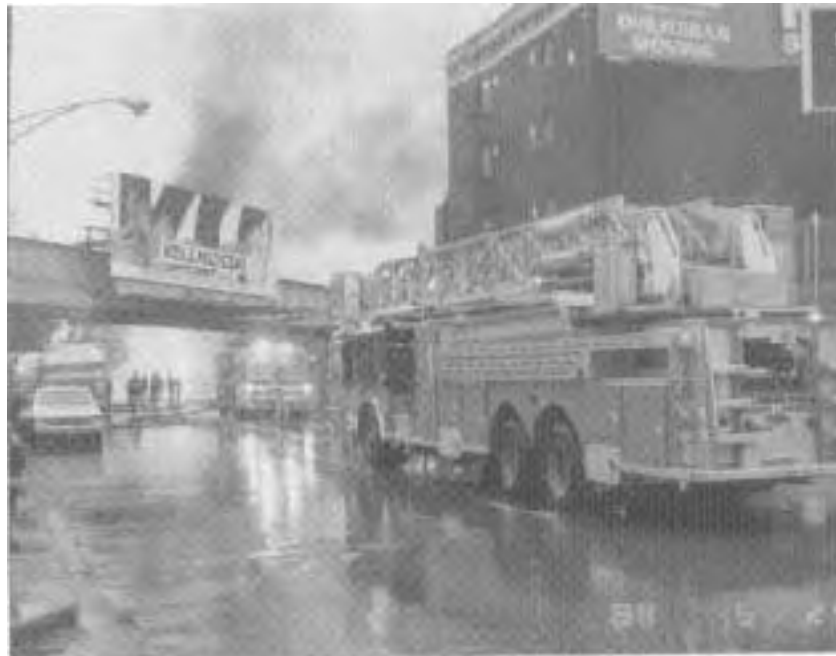
6. View of incident from Fullerton Street. Tanker is on other side of railroad overpass.

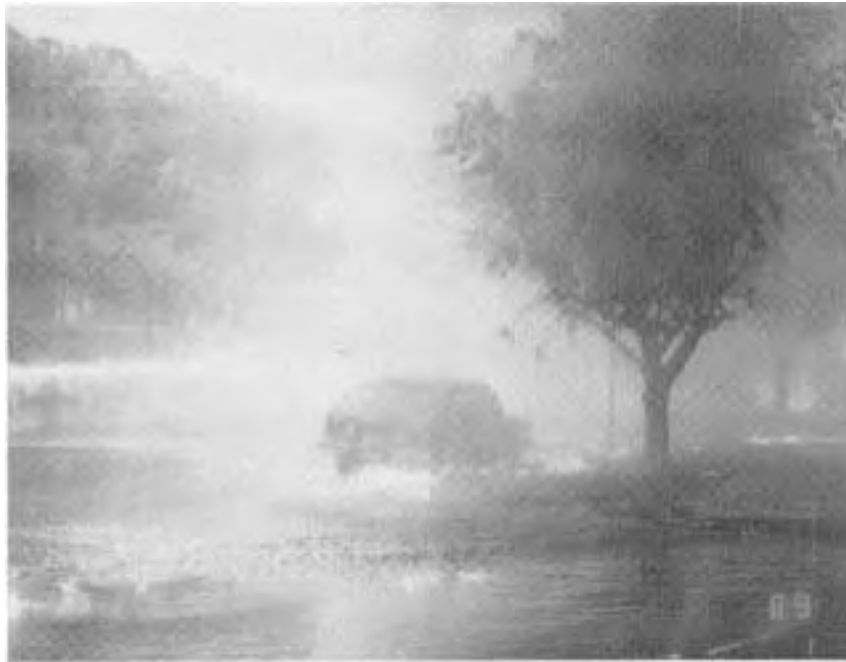
7. Spill fire flares up as it flows around parked car. Note runoff in foreground.

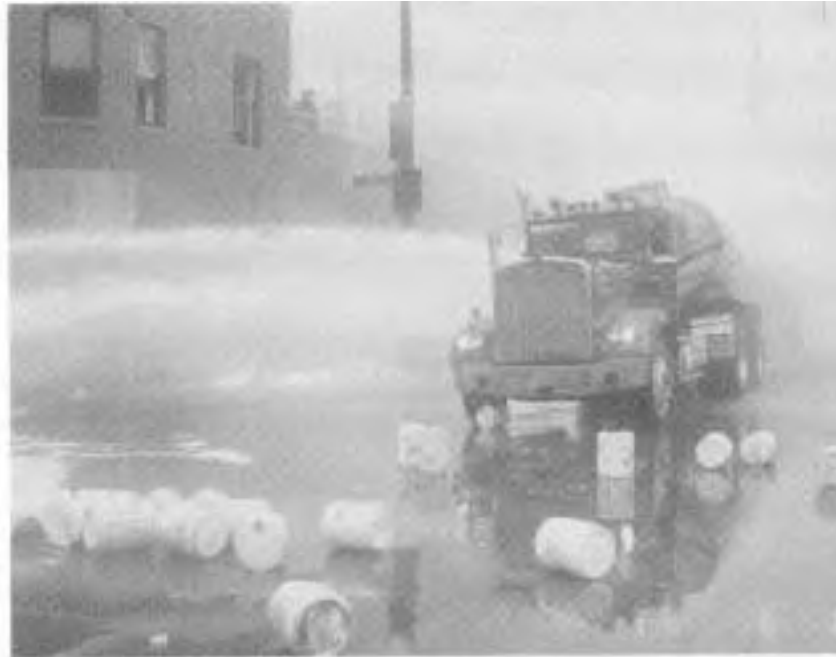
9. Knockdown complete, foam lines are going for the rest of the spill.

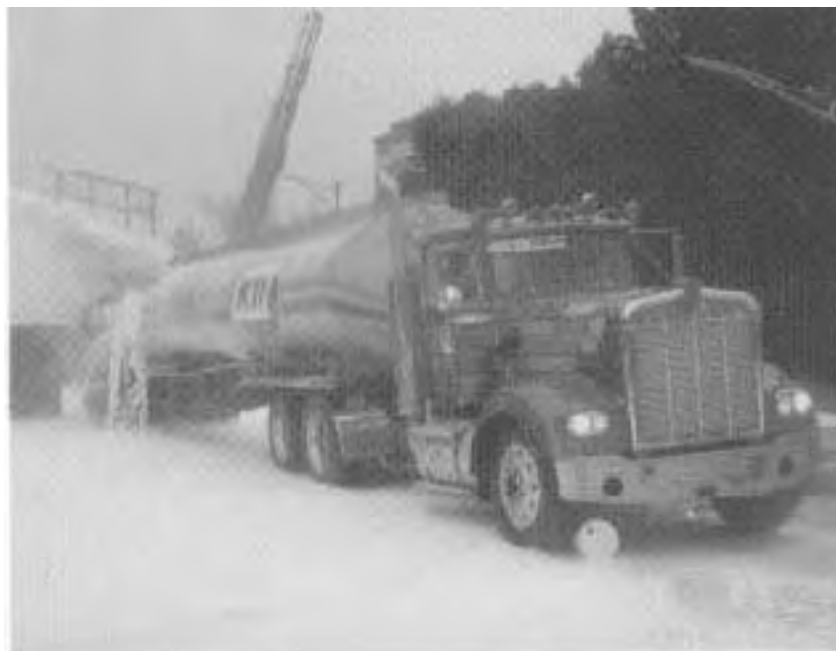
10. Fire out, but product continues pouring from tank trailer.

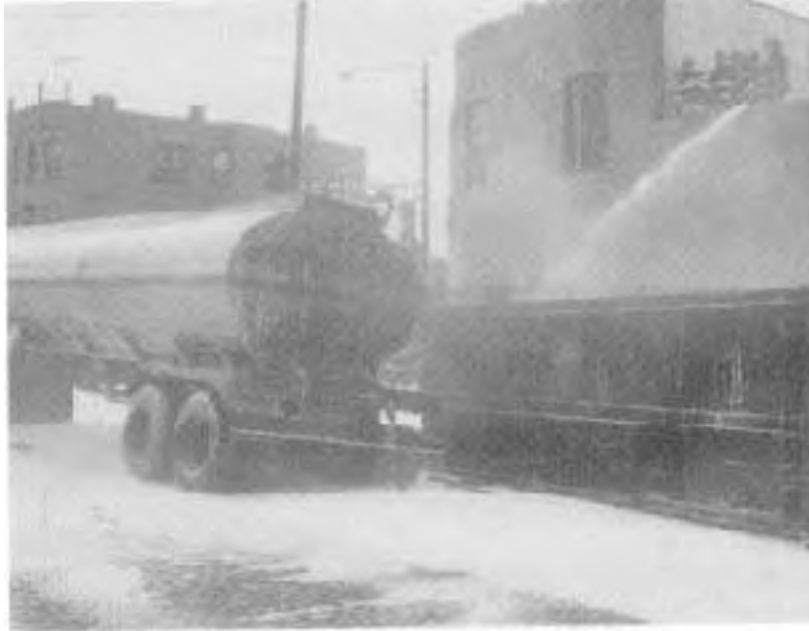
11. Firefighters flood debris in dumpster to prevent reignition of gasoline.

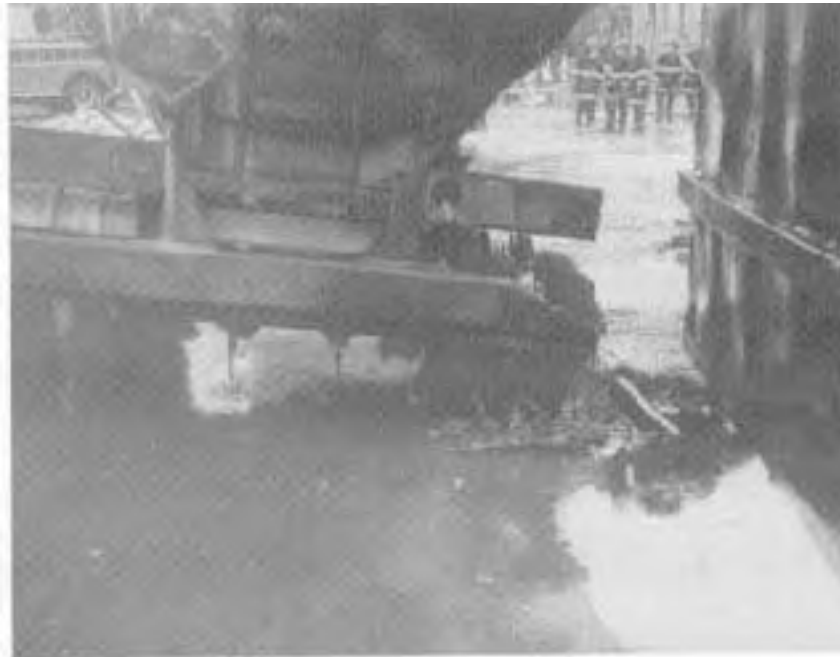
13. Rear of tanker, left side tires are intact.

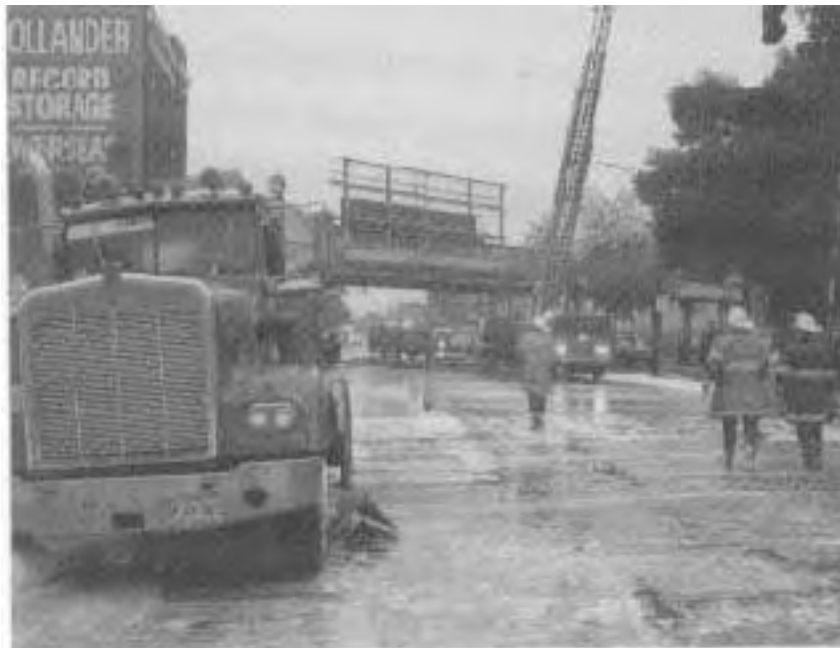
14. Fire out, units standing by.

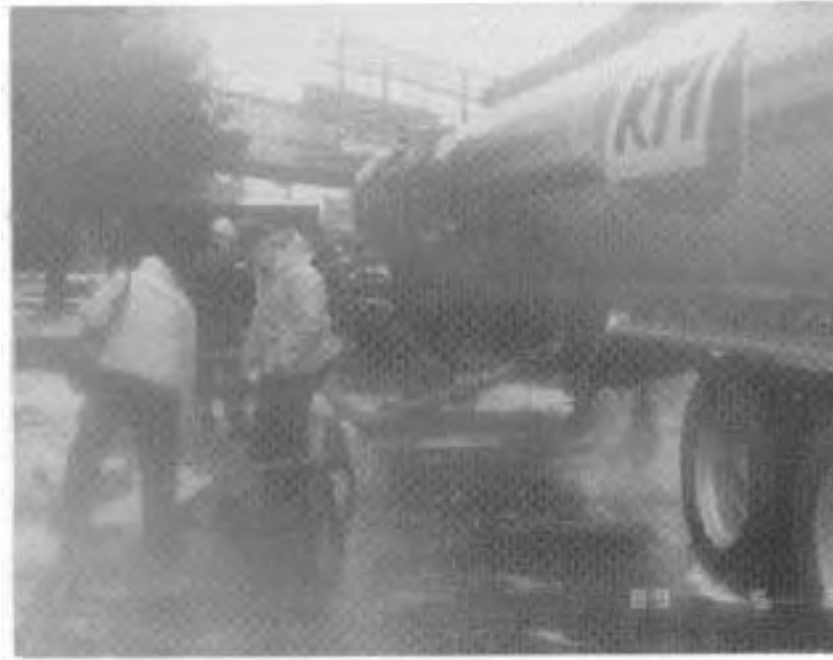
15. Off-loading in progress, Water Department employees check manhole for explosive vapors.

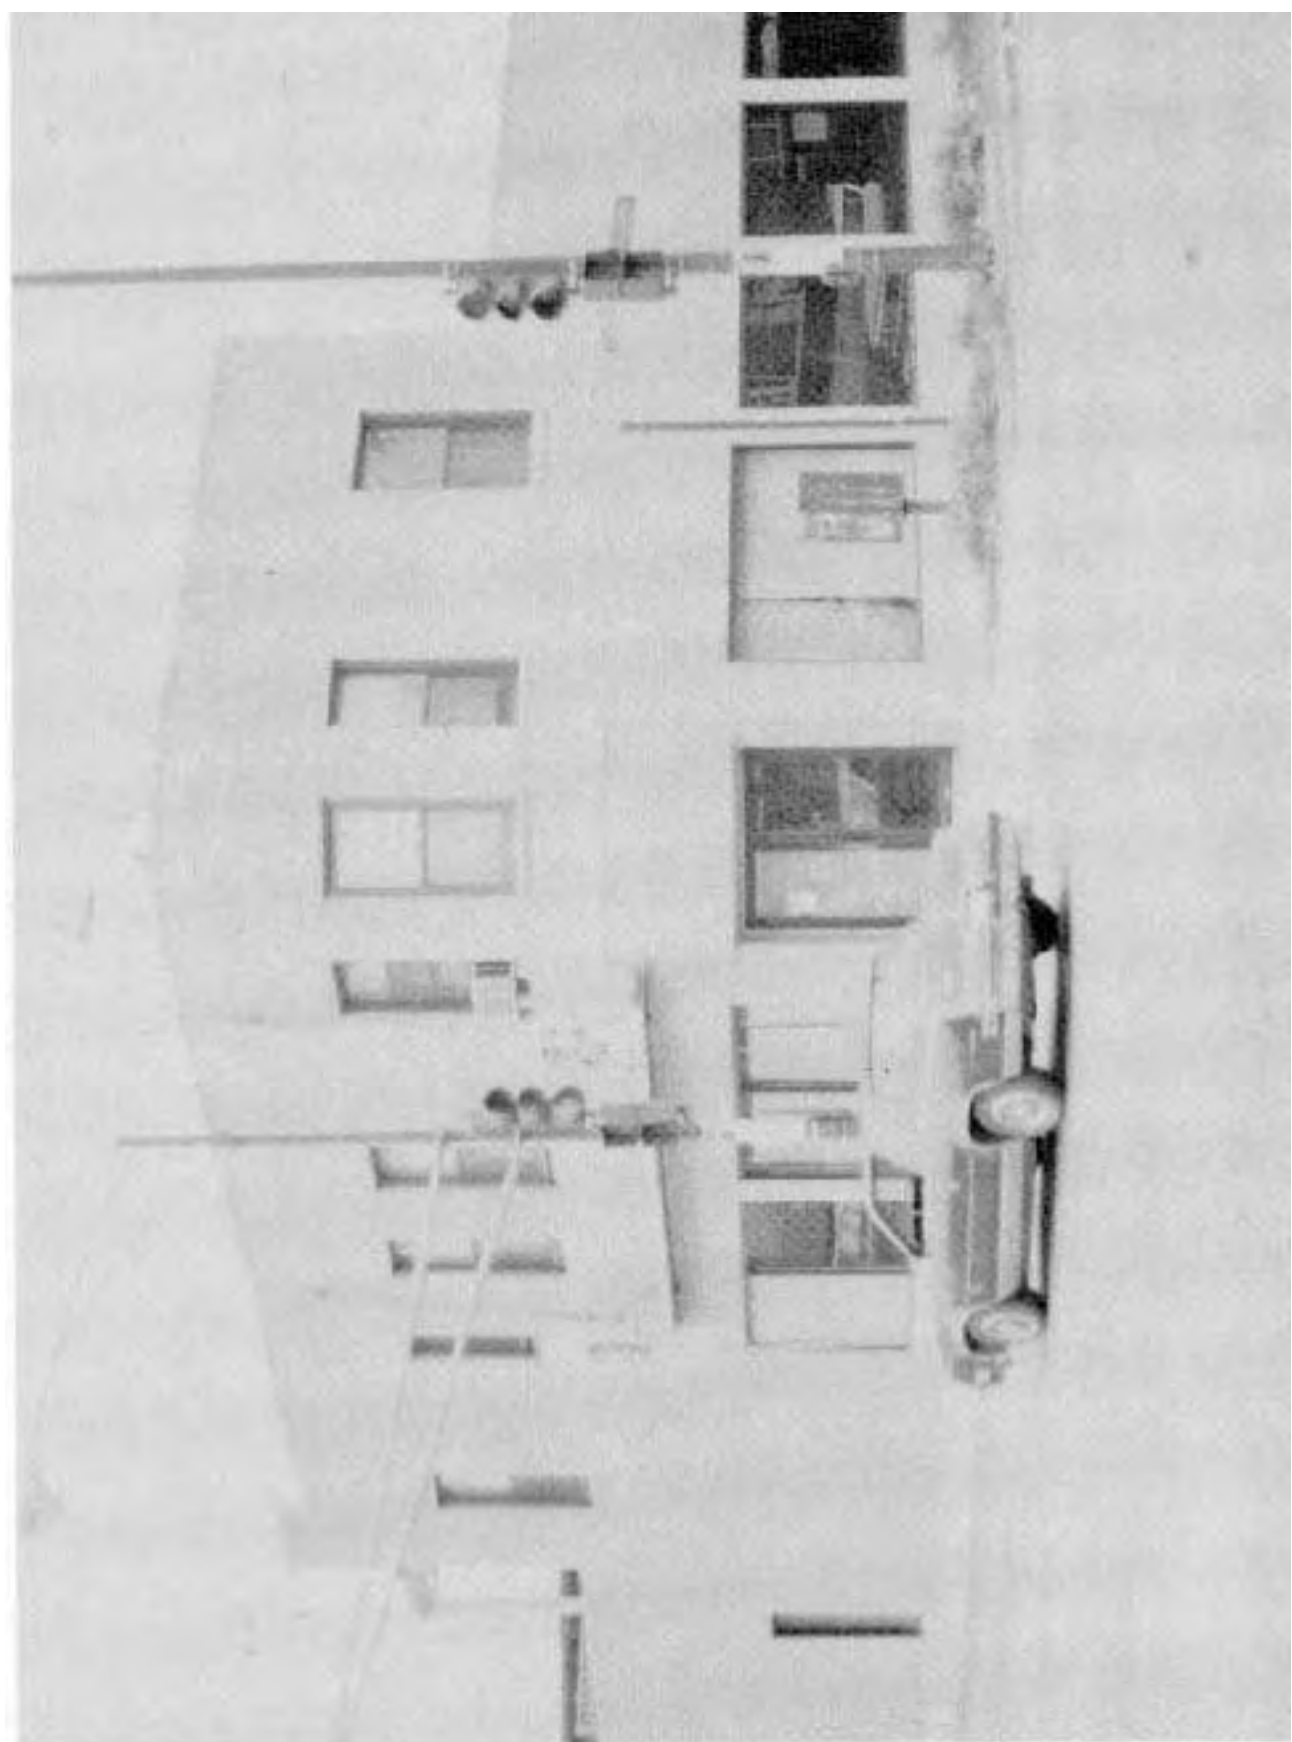
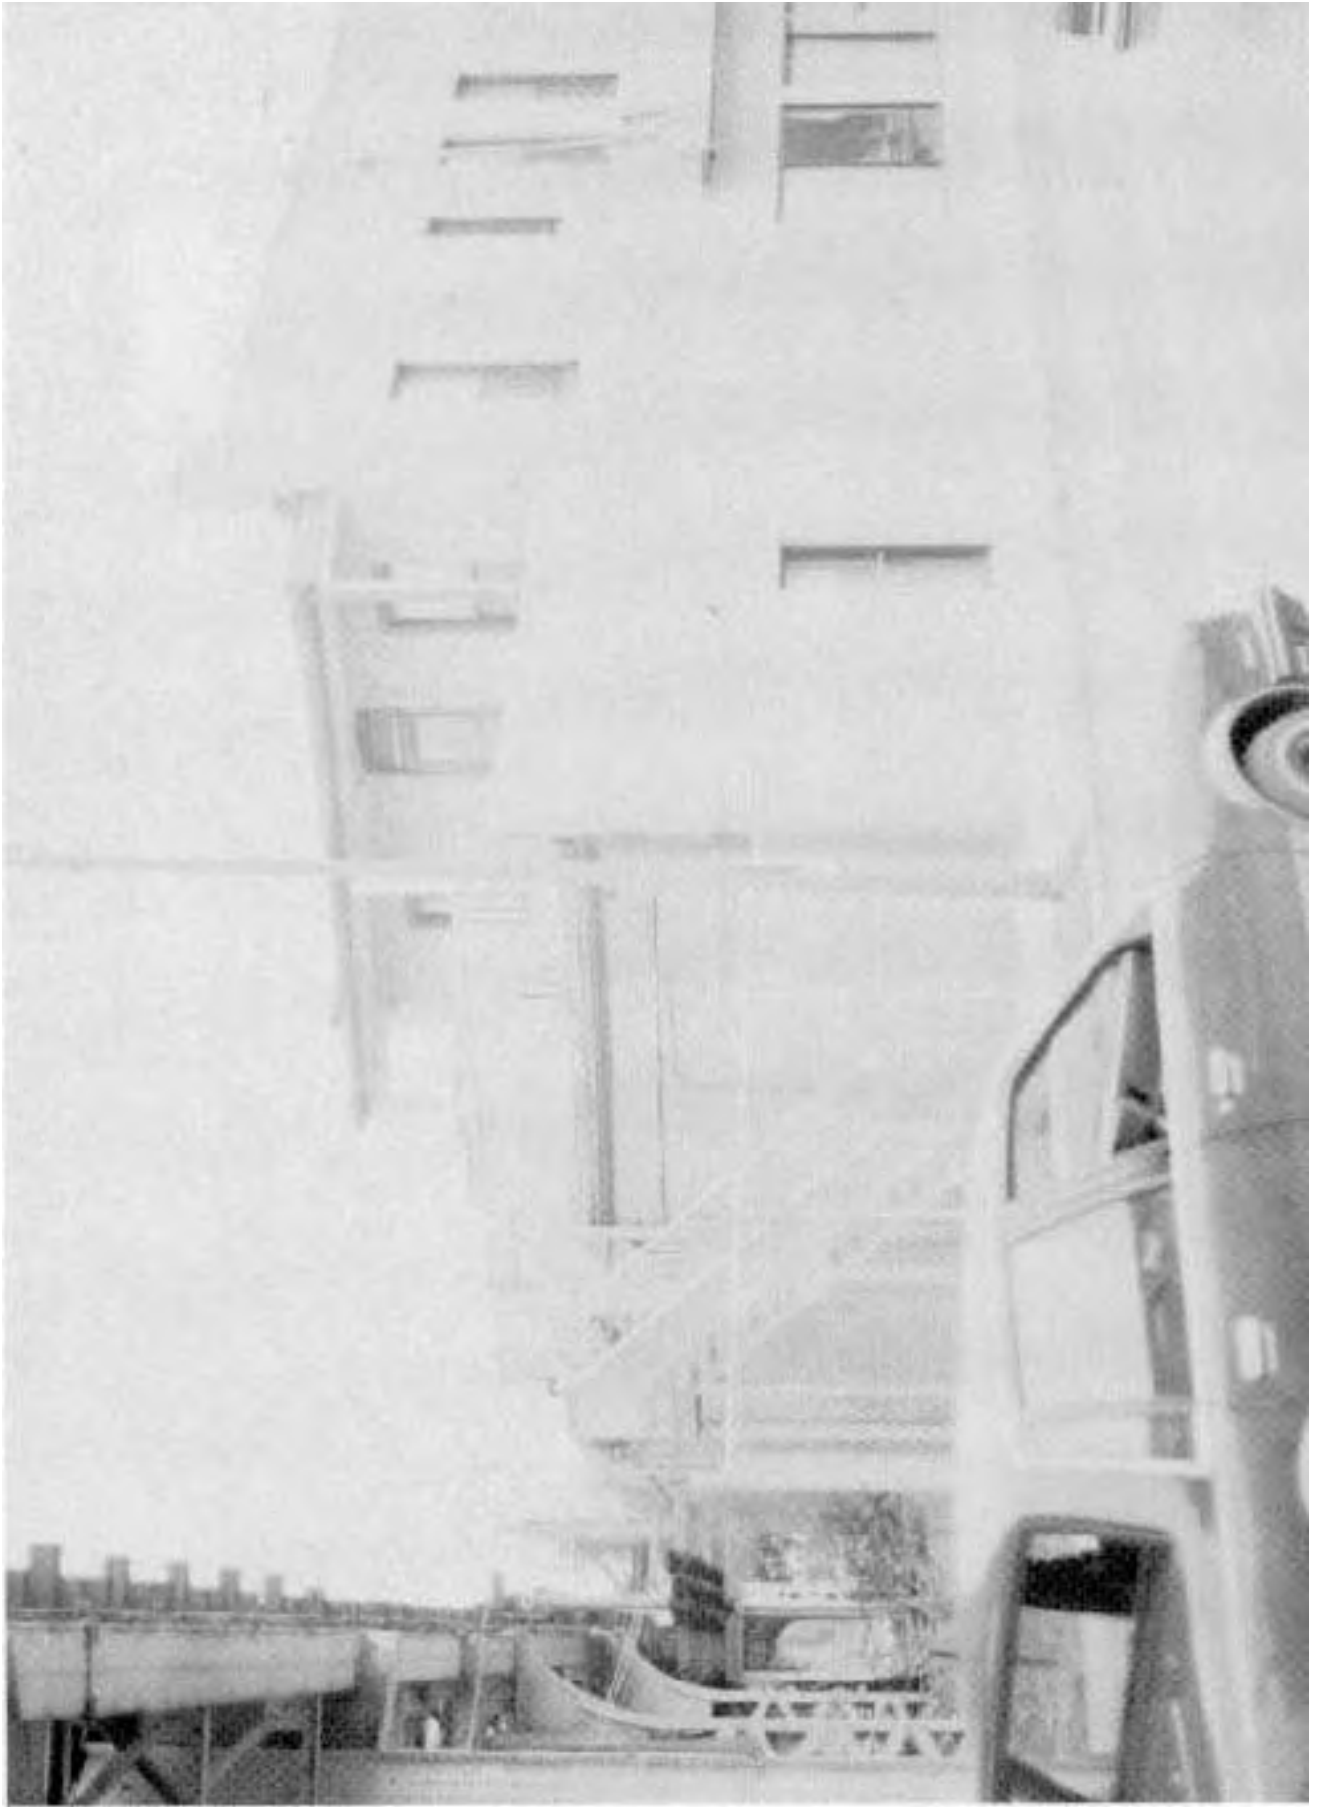
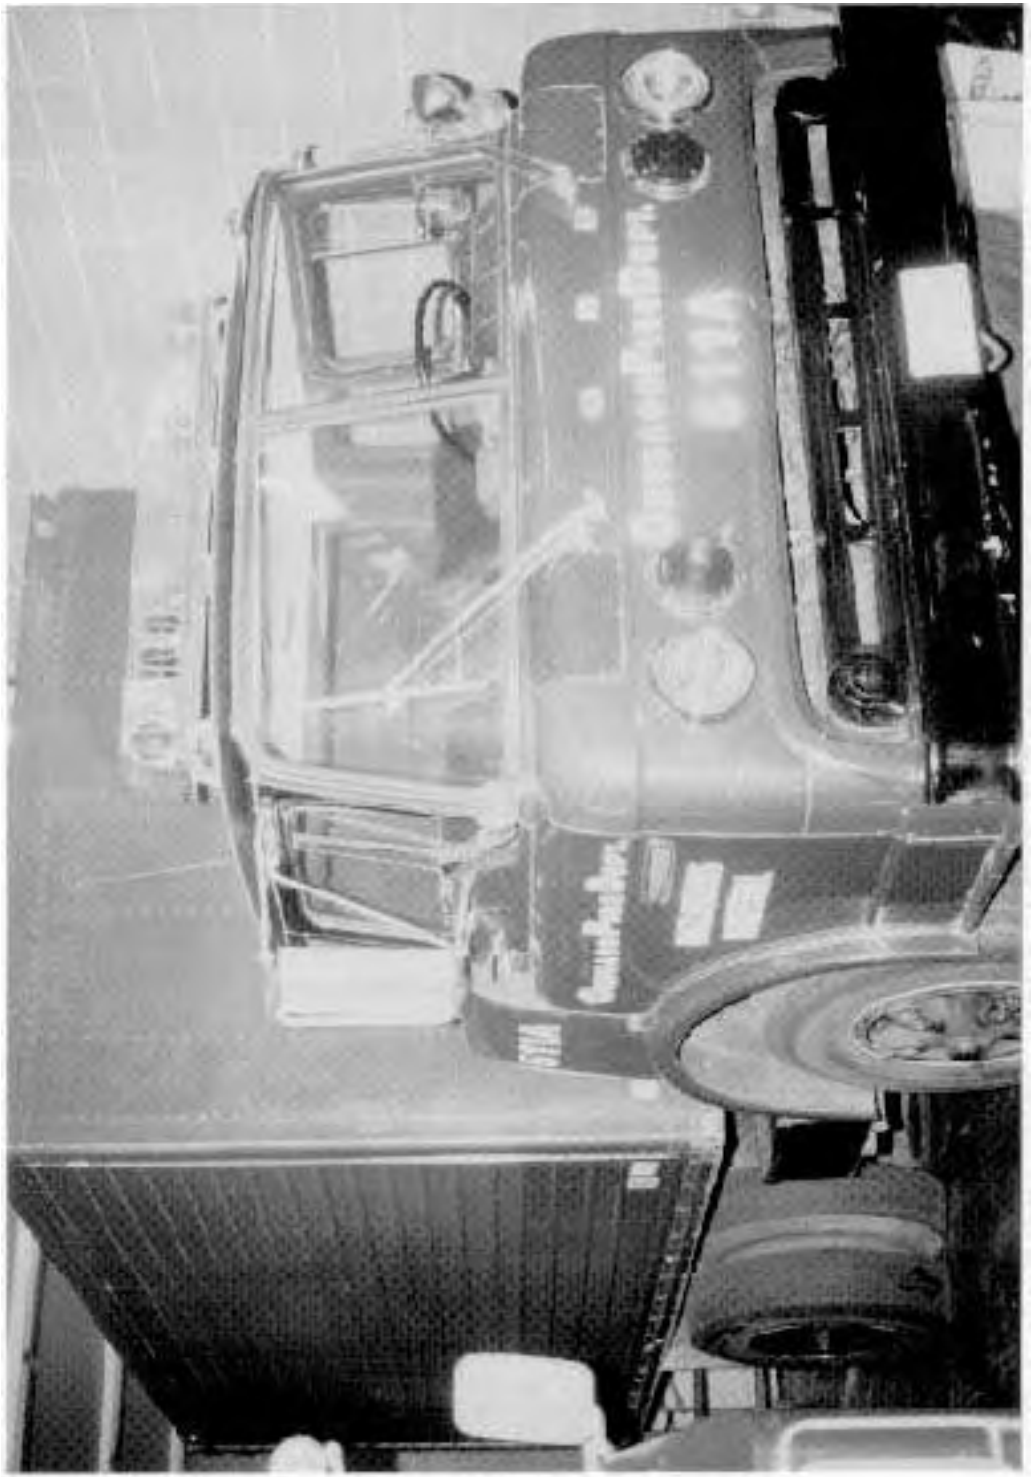
16. Primary exposure building weeks after the incident. Note reflection of dumpster in windows on right hand side.
17. Rear of primary exposure building showing proximity to "el" and access to second floor/roof.
18. 511A, Chicago's second piece of the Hazardous Incident Team. This unit carries absorbent, various supplies, and foam concentrate.
