Five-Fatality High-rise Office Building Fire Atlanta, Georgia

Five-Fatality High-rise Office Building Fire Atlanta, Georgia (June 30, 1989)

This is Report 033 of the Major Fires Investigation Project conducted by TriData Corporation under contract EMW-88-C-2649 to the United States Fire Administration, Federal Emergency Management Agency.

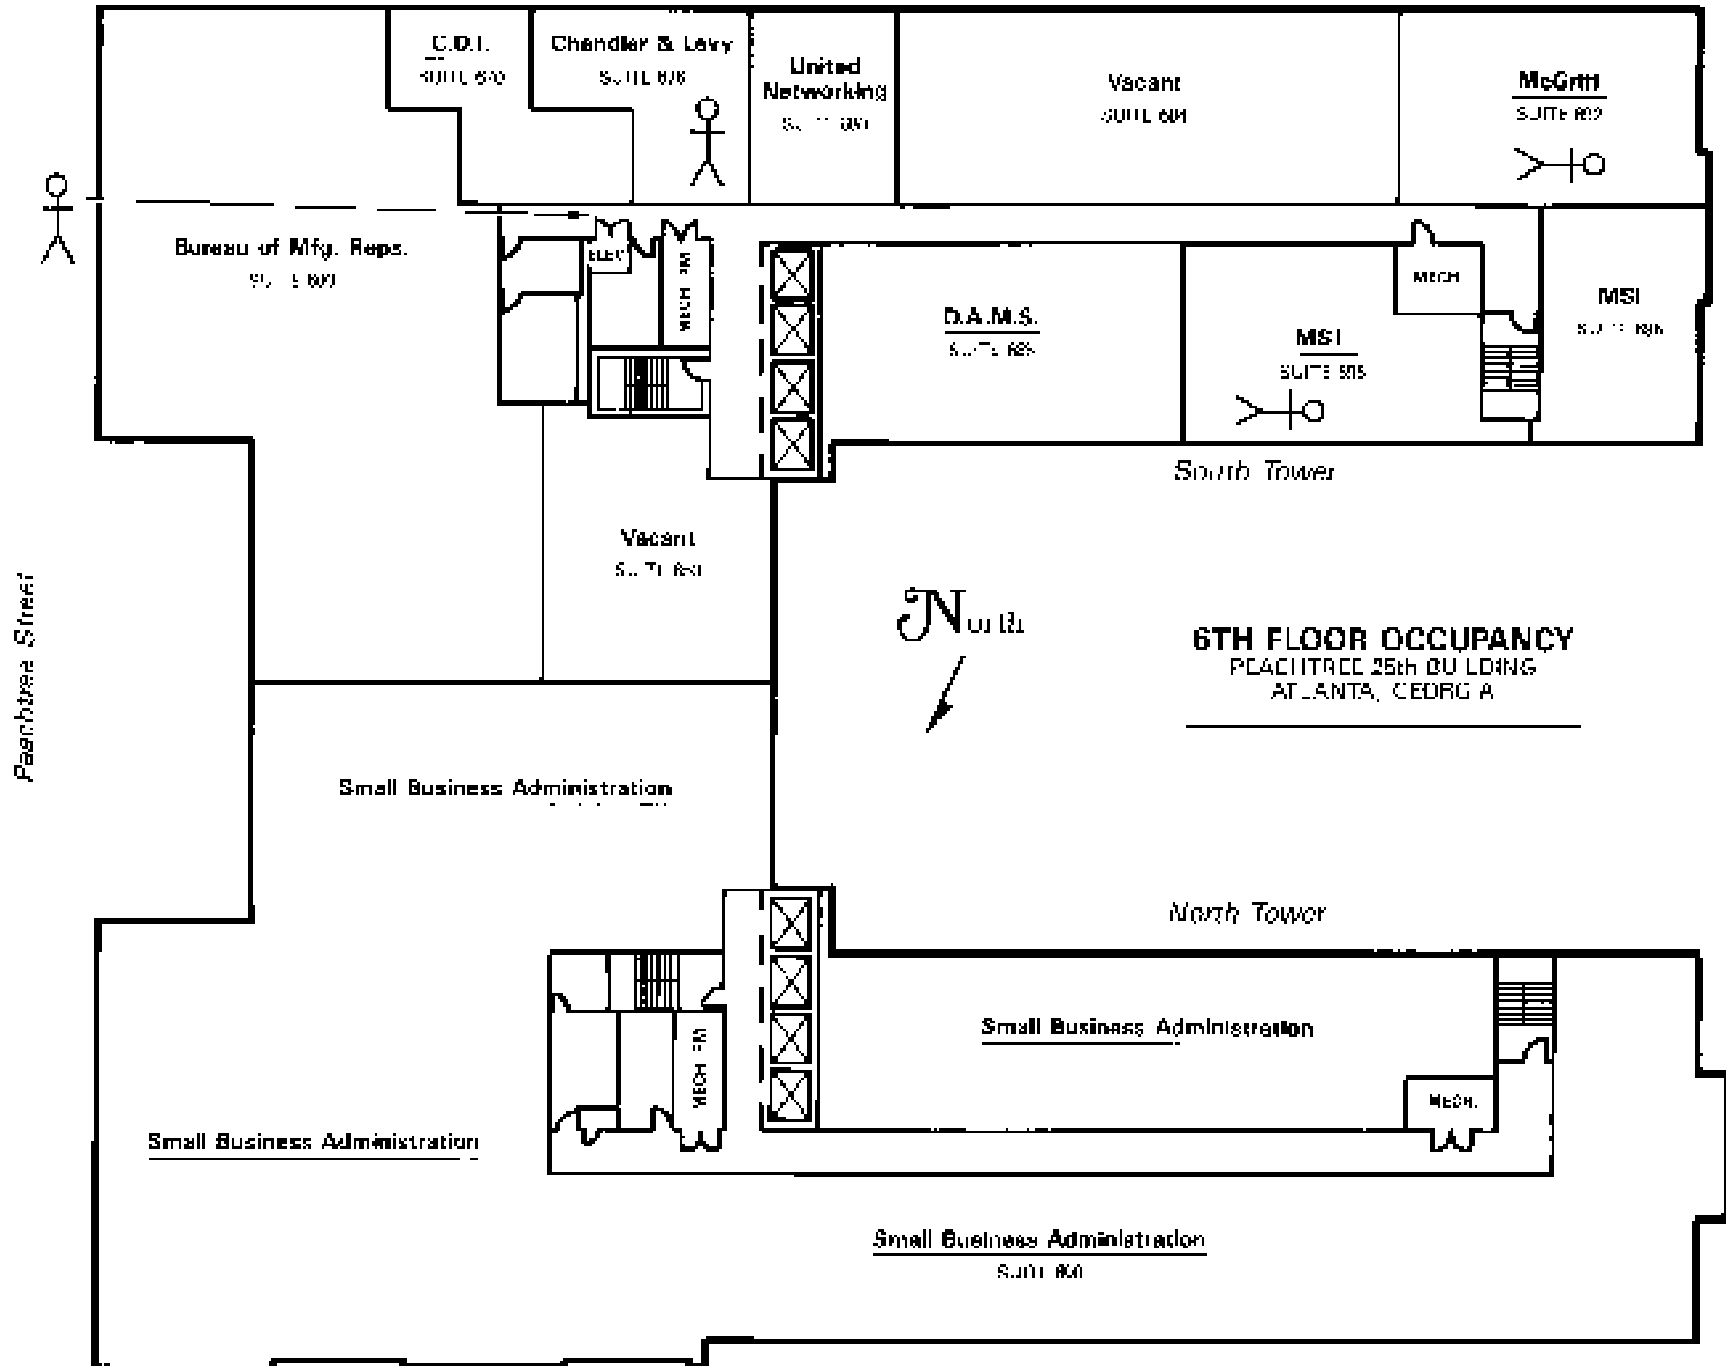
APPENDIX B

A worker who was directly across the hall from the electrical closet (Suite 676) remained in his office and did not break a window. This worker was found dead after the fire.

The one occupant who remained in his office throughout the fire without breaking a window died from smoke inhalation. Heat apparently never reached an excessive level in this office -- there was no damage to plastic items stored on bookshelves near the ceiling.
