Twelve-Fatality Nursing Home Fire Norfolk, Virginia

Twelve-Fatality Nursing Home Fire Norfolk, Virginia (October 5, 1989)

**Investigated by: Randolph E. Kirby
Hollis Stambaugh**

**This is Report 034 of the Major Fires Investigation Project conducted
by TriData Corporation under contract EMW-88-C-2649 to the United
States Fire Administration, Federal Emergency Management Agency.**

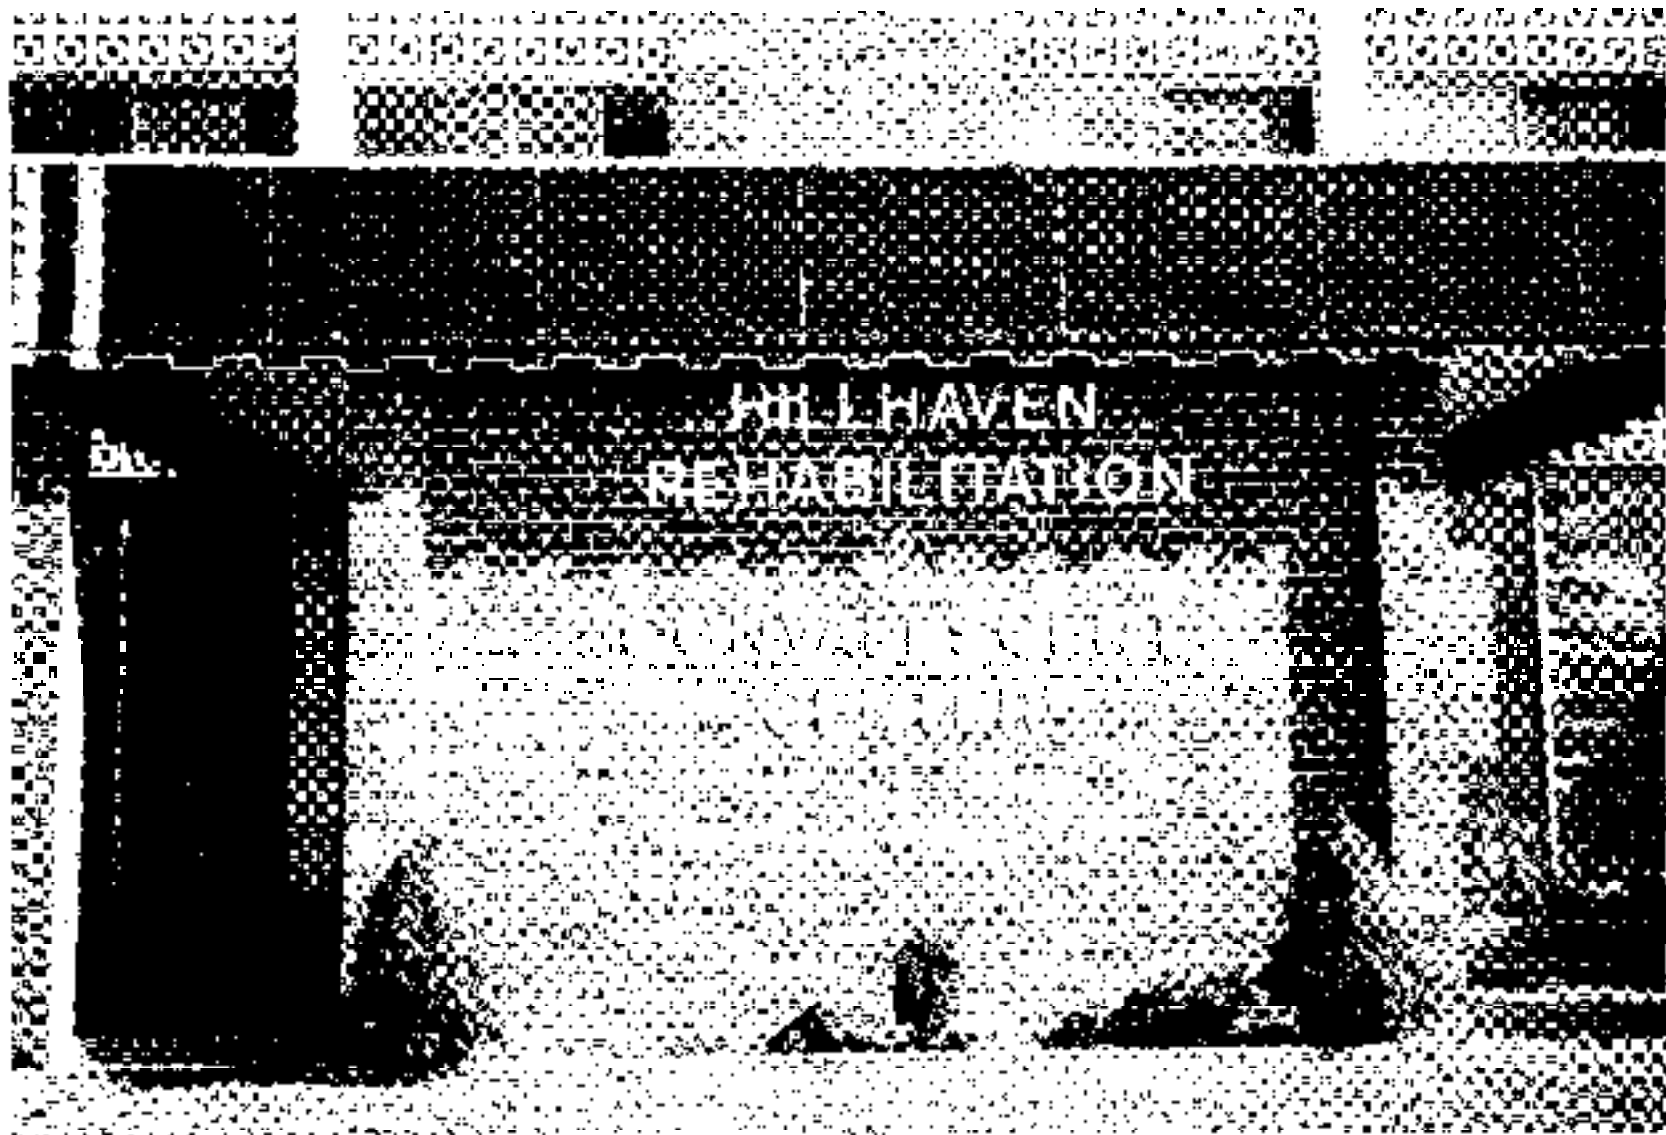
- *1. Main entrance to Hillhaven Home
2. South portion of building, facing Westover Avenue
- *3. South end of building, indicating second floor window where fire originated

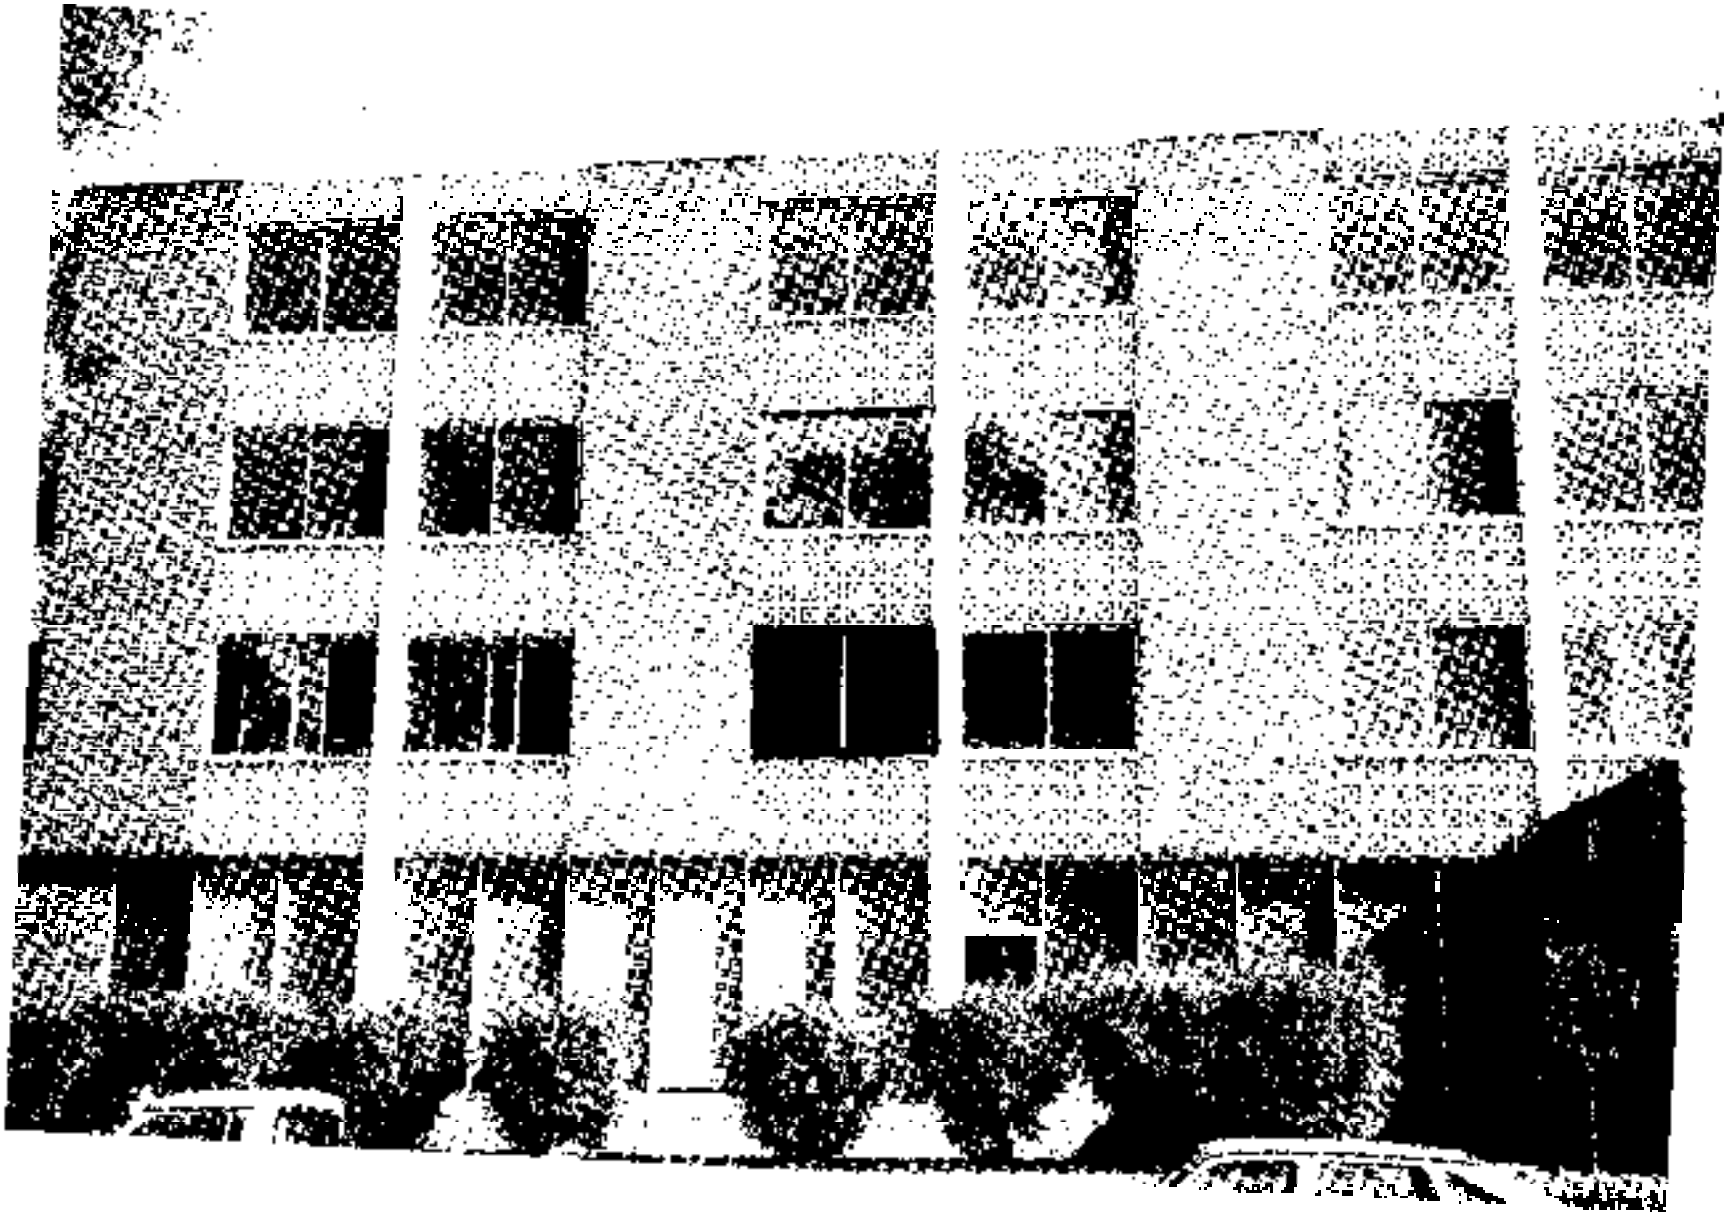
*5

4. East end of building facing Hampton Avenue
- *5. Northeast end of building looking southwest (Note defective fire hydrant)
6. West end of building and parking lot

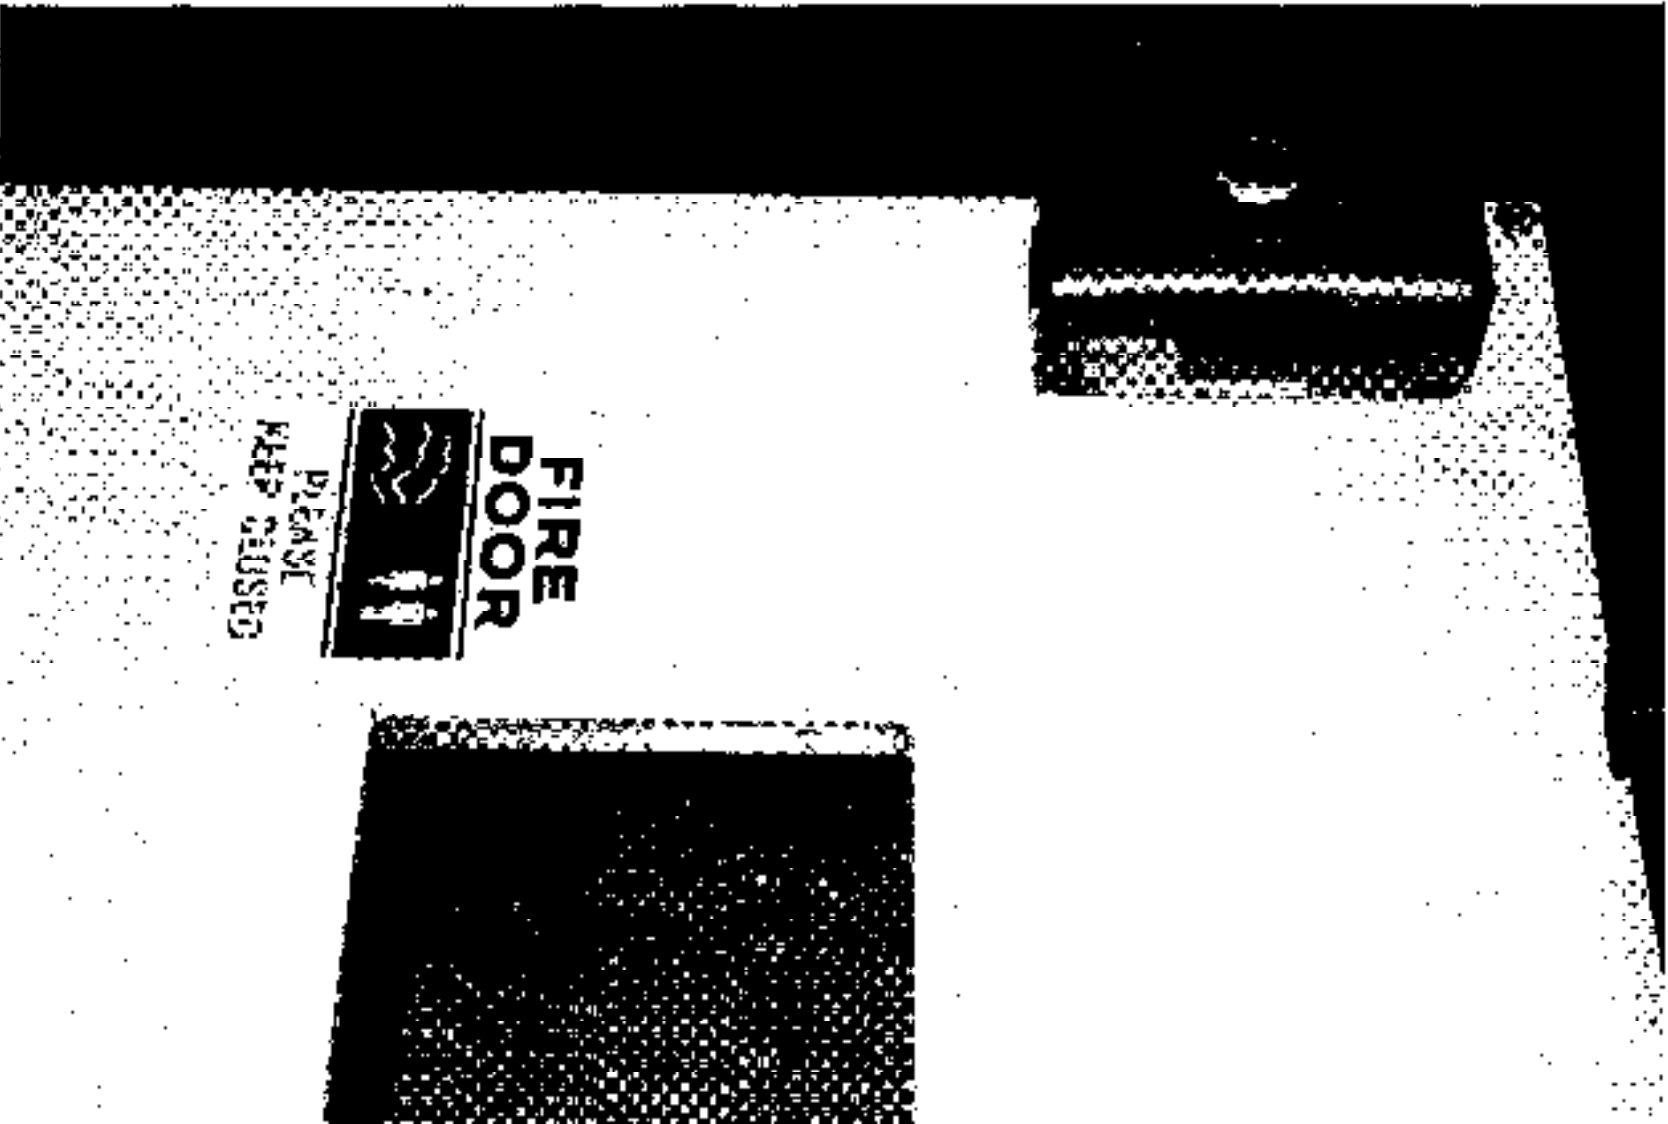
10. Emergency generator set
11. Siamese connection to standpipe system on east side of buidling (Note obstructions)
- *12. Typical door alarm on each stairwell door

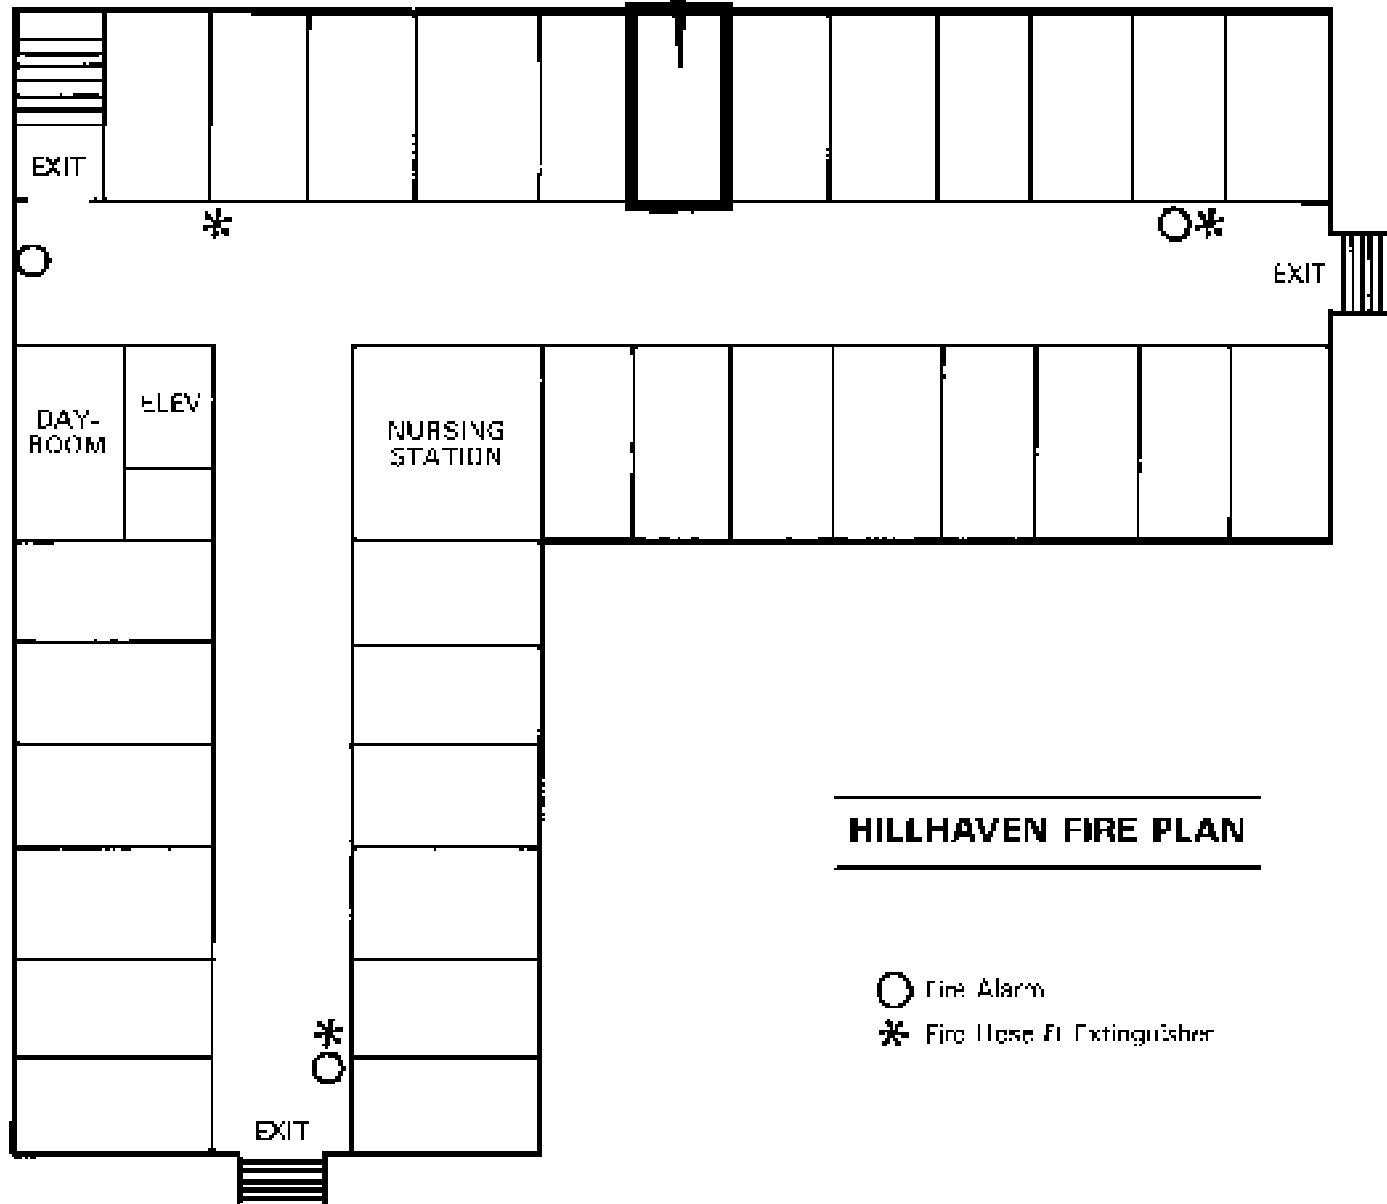
ROOM OF ORIGIN

Dollar loss is estimated at \$100,000. Fire completely gutted the room of origin and caused moderate fire damage to ceiling and walls on portions of the second floor. There was heavy smoke damage throughout the second floor, with moderate smoke damage to the third and fourth floors. There was no apparent structural damage.

16. Hallway looking north from front of building on third floor
- *17. Smoke detector and smoke barrier located on second, third, and fourth floors
- *18. Fire damage to smoke barrier doors and to ceiling from room of origin on right

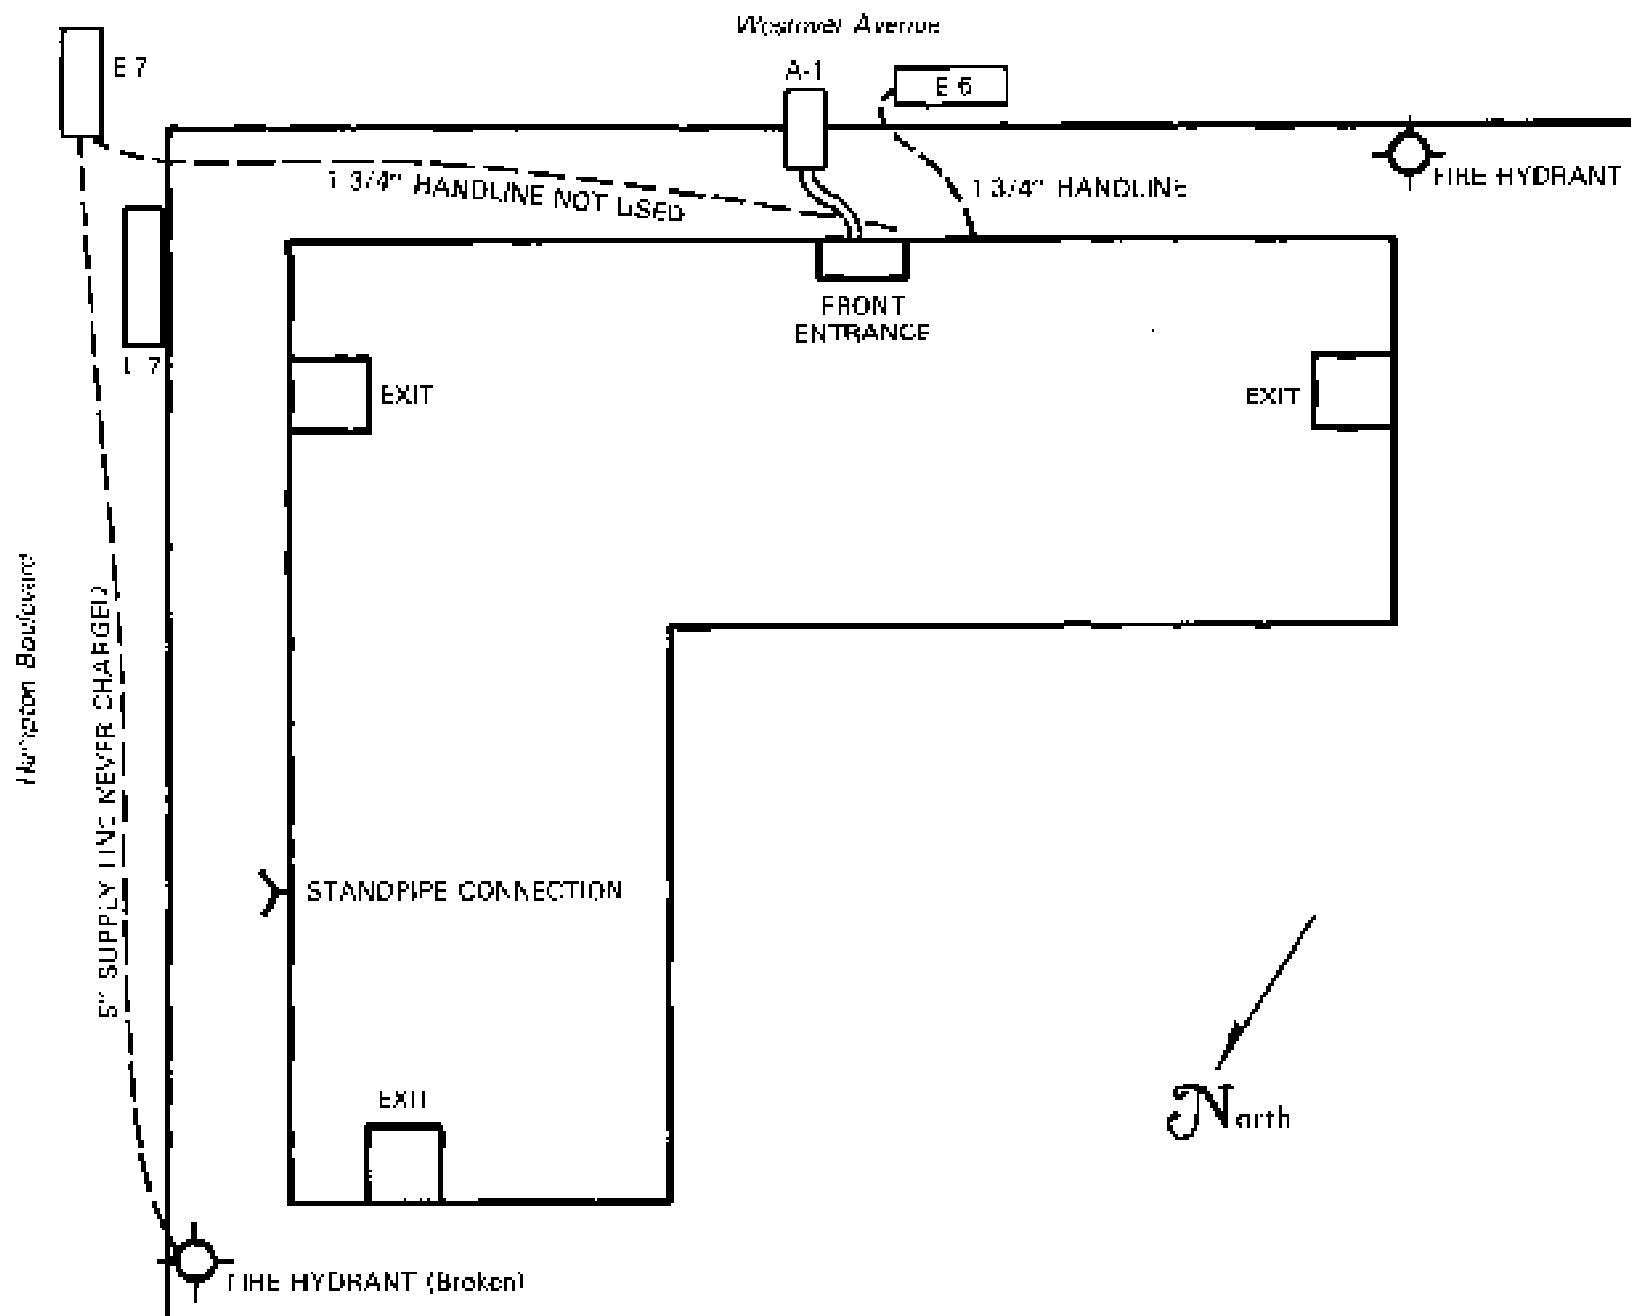
HILLHAVEN FIRE PLAN

The fire originated in Room 226, believed to be as a result of a patient accidentally discarding a lighted match onto his bed (after missing the waste can) and igniting the bed linen and the polyurethane mattress pad, which is a highly combustible and smoke-generating material when subjected to open flame. The fire intensified very rapidly, generating

Smoke barrier doors, located in the hall and within 20 feet of the room of origin, failed to close, allowing smoke to completely penetrate the second floor. The interior fire alarm system was pulled. Due to a blown fuse in the main fire alarm control panel, that system also failed to operate and no alarm was sounded.
