Shenandoah Retirement Home Fire Roanoke County, Virginia

Shenandoah Retirement Home Fire Roanoke County, Virginia (December 14, 1989)

Investigated by: Randolph E. Kirby

This is Report 038 of the Major Fires Investigation Project conducted by TriData Corporation under contract EMW-88-C-2649 to the United States Fire Administration, Federal Emergency Management Agency.

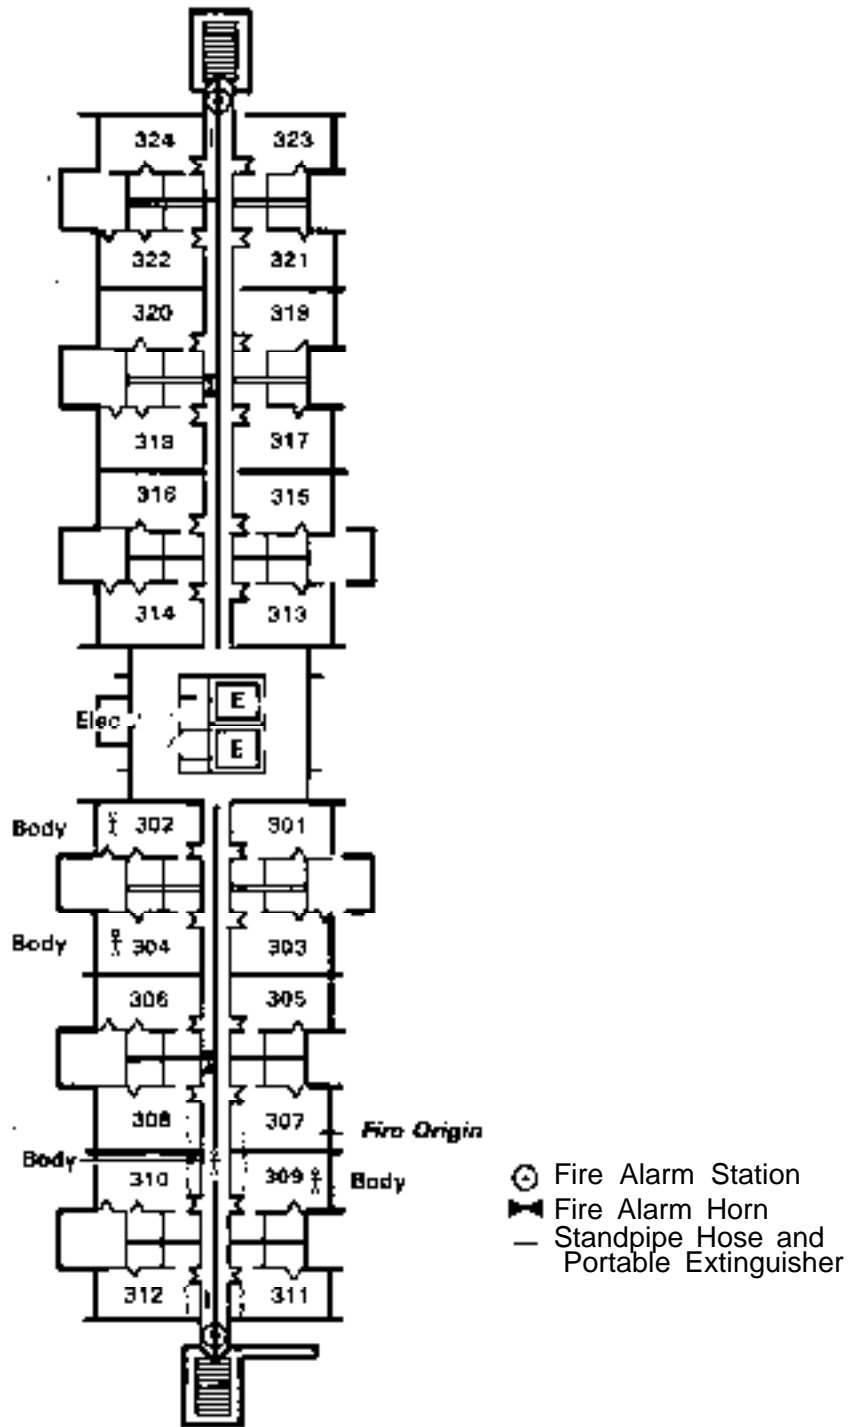
Shenandoah Retirement Home
Third-Floor Plan and Location of Fatalities

Four elderly residents from the third floor died as a result of smoke inhalation -- three women and one man, ranging in age from 79 to 87 years. The body of the resident of Apartment 307, (area of origin), who was confined to a wheelchair, was found in the hall a few feet south of his apartment door. One female victim of apartment 309 was found in her unit on the floor next to her bed. The third victim (female) was found in Apartment 302. The fourth victim, (female), was found in Apartment 304, between the rear of the television and the window. This person was actually having a telephone conversation with the fire dispatcher while fire operations were taking place in the building. She was provided with instructions by the dispatcher regarding covering her nose and putting towels under the apartment door. Meanwhile, the dispatcher was advising firefighters on the scene of the woman's situation and her location. Because of heavy smoke conditions and locked doors, rescuers were unable to locate her in time to save her (see Appendix A).

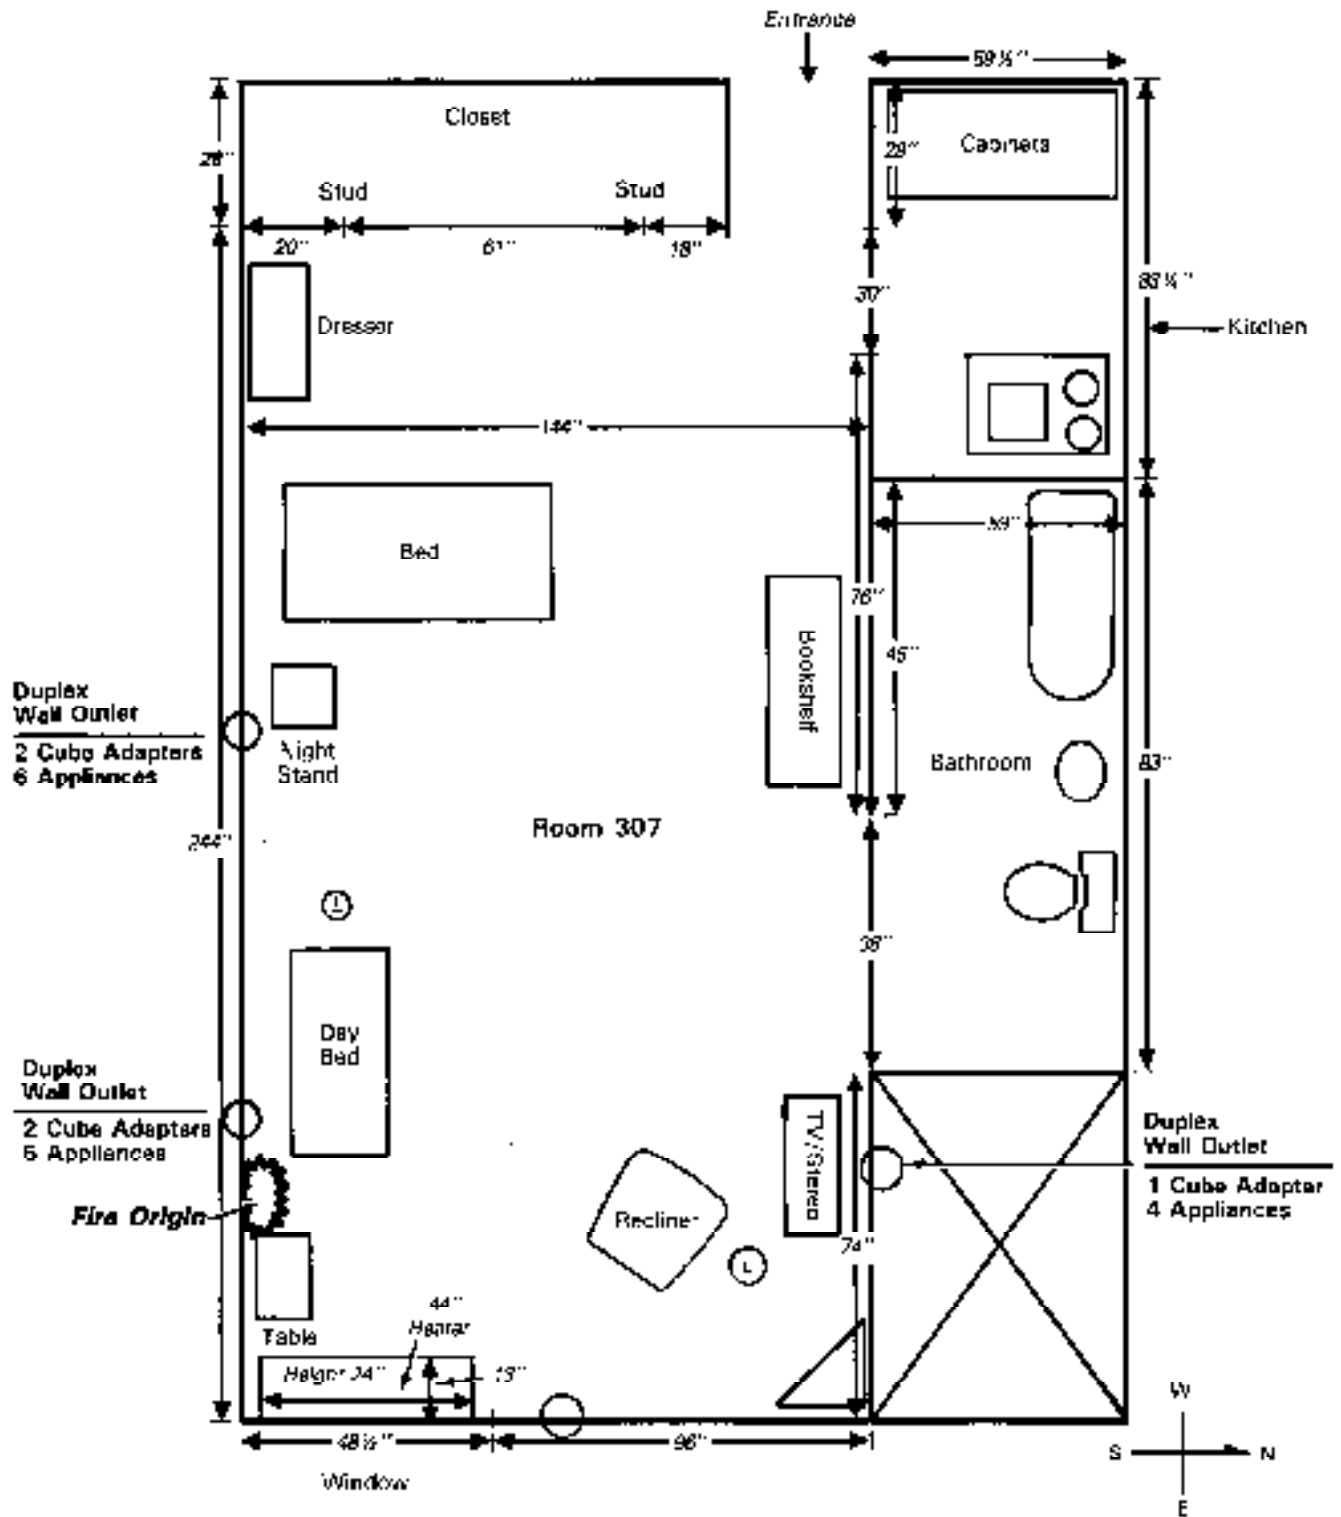
Room of Fire Origin

The fire originated in apartment 307 and is believed to be the result of an electrical overload which caused ignition of wood paneling; This particular one-room unit had 17 appliances of various types connected to the electrical receptacles provided for the unit (see Appendix B).
