## **Nine Elderly Fire Victims in Residential Hotel Miami Beach, Florida**

**Nine Elderly Fire Victims  
in Residential Hotel  
Miami, Florida  
(April 6, 1990)**

**This is Report 041 of the Major Fires Investigation Project conducted  
by TriData Corporation under contract EMW-90-C-3338 to the United  
States Fire Administration, Federal Emergency Management Agency.**

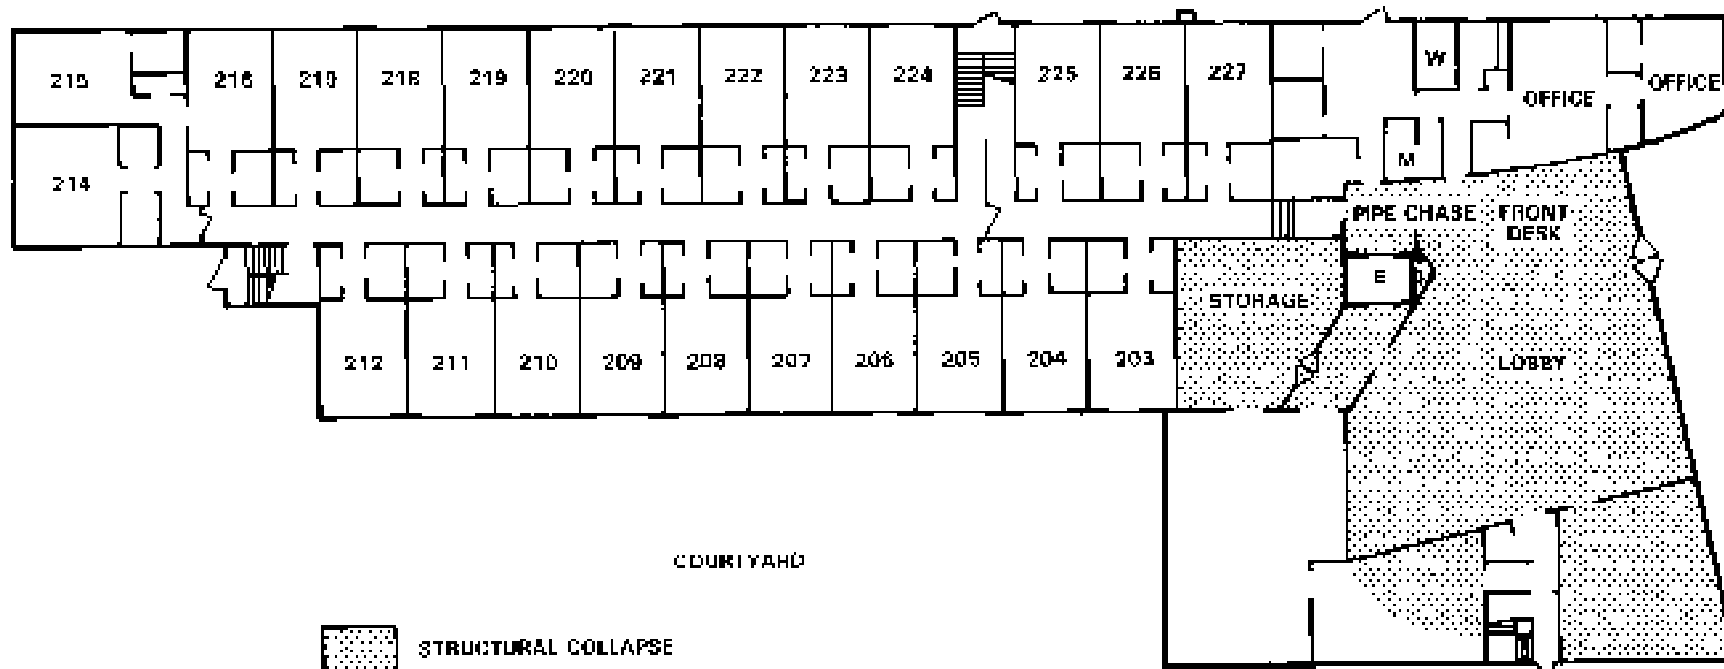
LOBBY FLOOR PLAN - FONTANA HOTEL, MIAMI BEACH, FLORIDA

Attack on the fire was finally changed to a defensive mode due to deteriorating conditions within the structure. The fire had made significant headway in concealed spaces and the attic before it was discovered. The second floor had collapsed into the lobby about an hour into the blaze. The fire extended into the attic and burned the length of the building over the next several hours. Fire dropped from the attic into the third floor as it consumed the roof. The fire burned about four and one-half hours before being brought under control. Ultimately, much of the roof was destroyed as fire spread through the attic space. The front section of the building was basically gutted, with the fire burning through the room and causing collapse of the upper floors into the lobby area. (See Appendix A.)

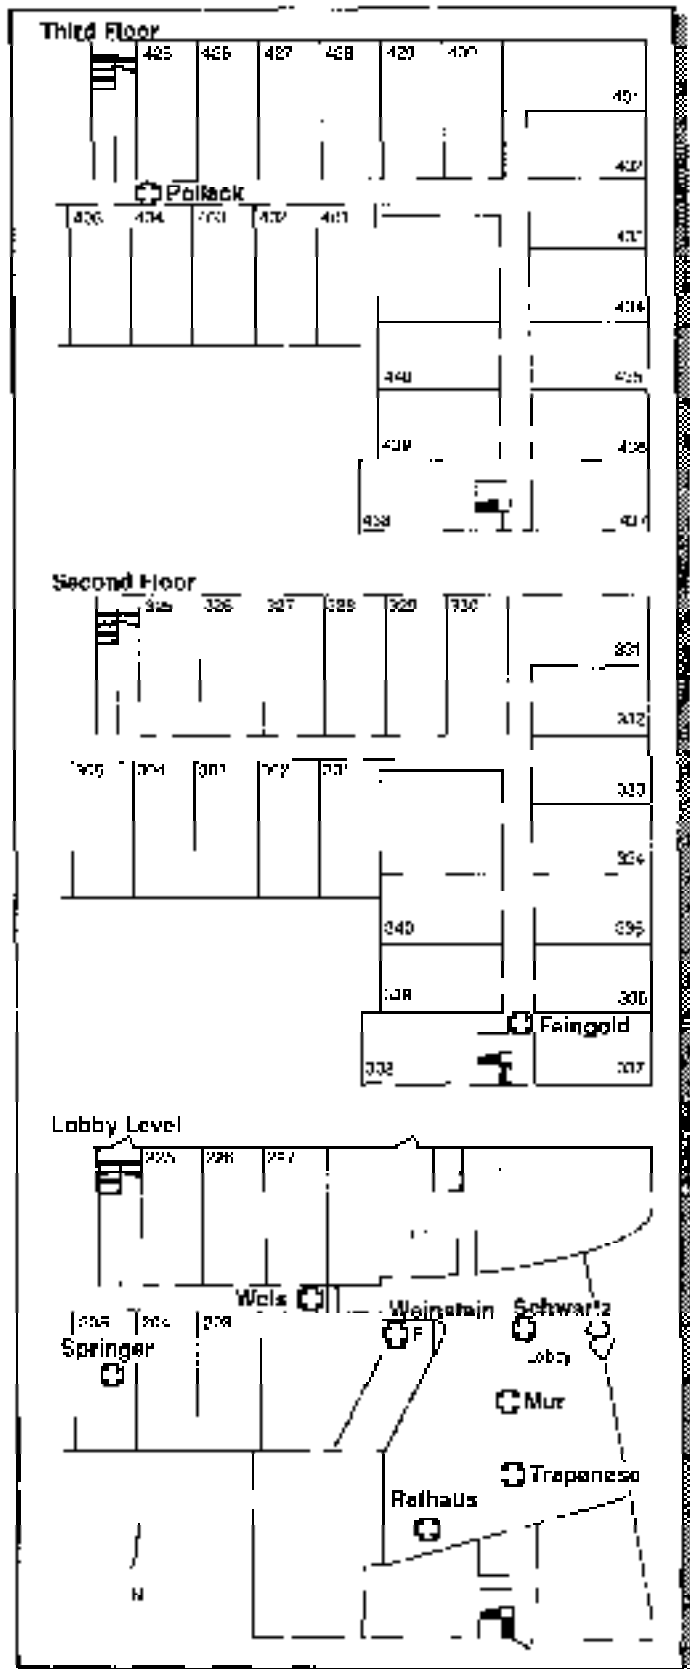
Location of Bodies

It is believed that most of the victims found in the lobby were originally on upper floors. Their bodies were recovered amid the burned debris from the collapse of the second and third floors in the lobby area. It is not clear whether they had attempted to evacuate before they were overcome.

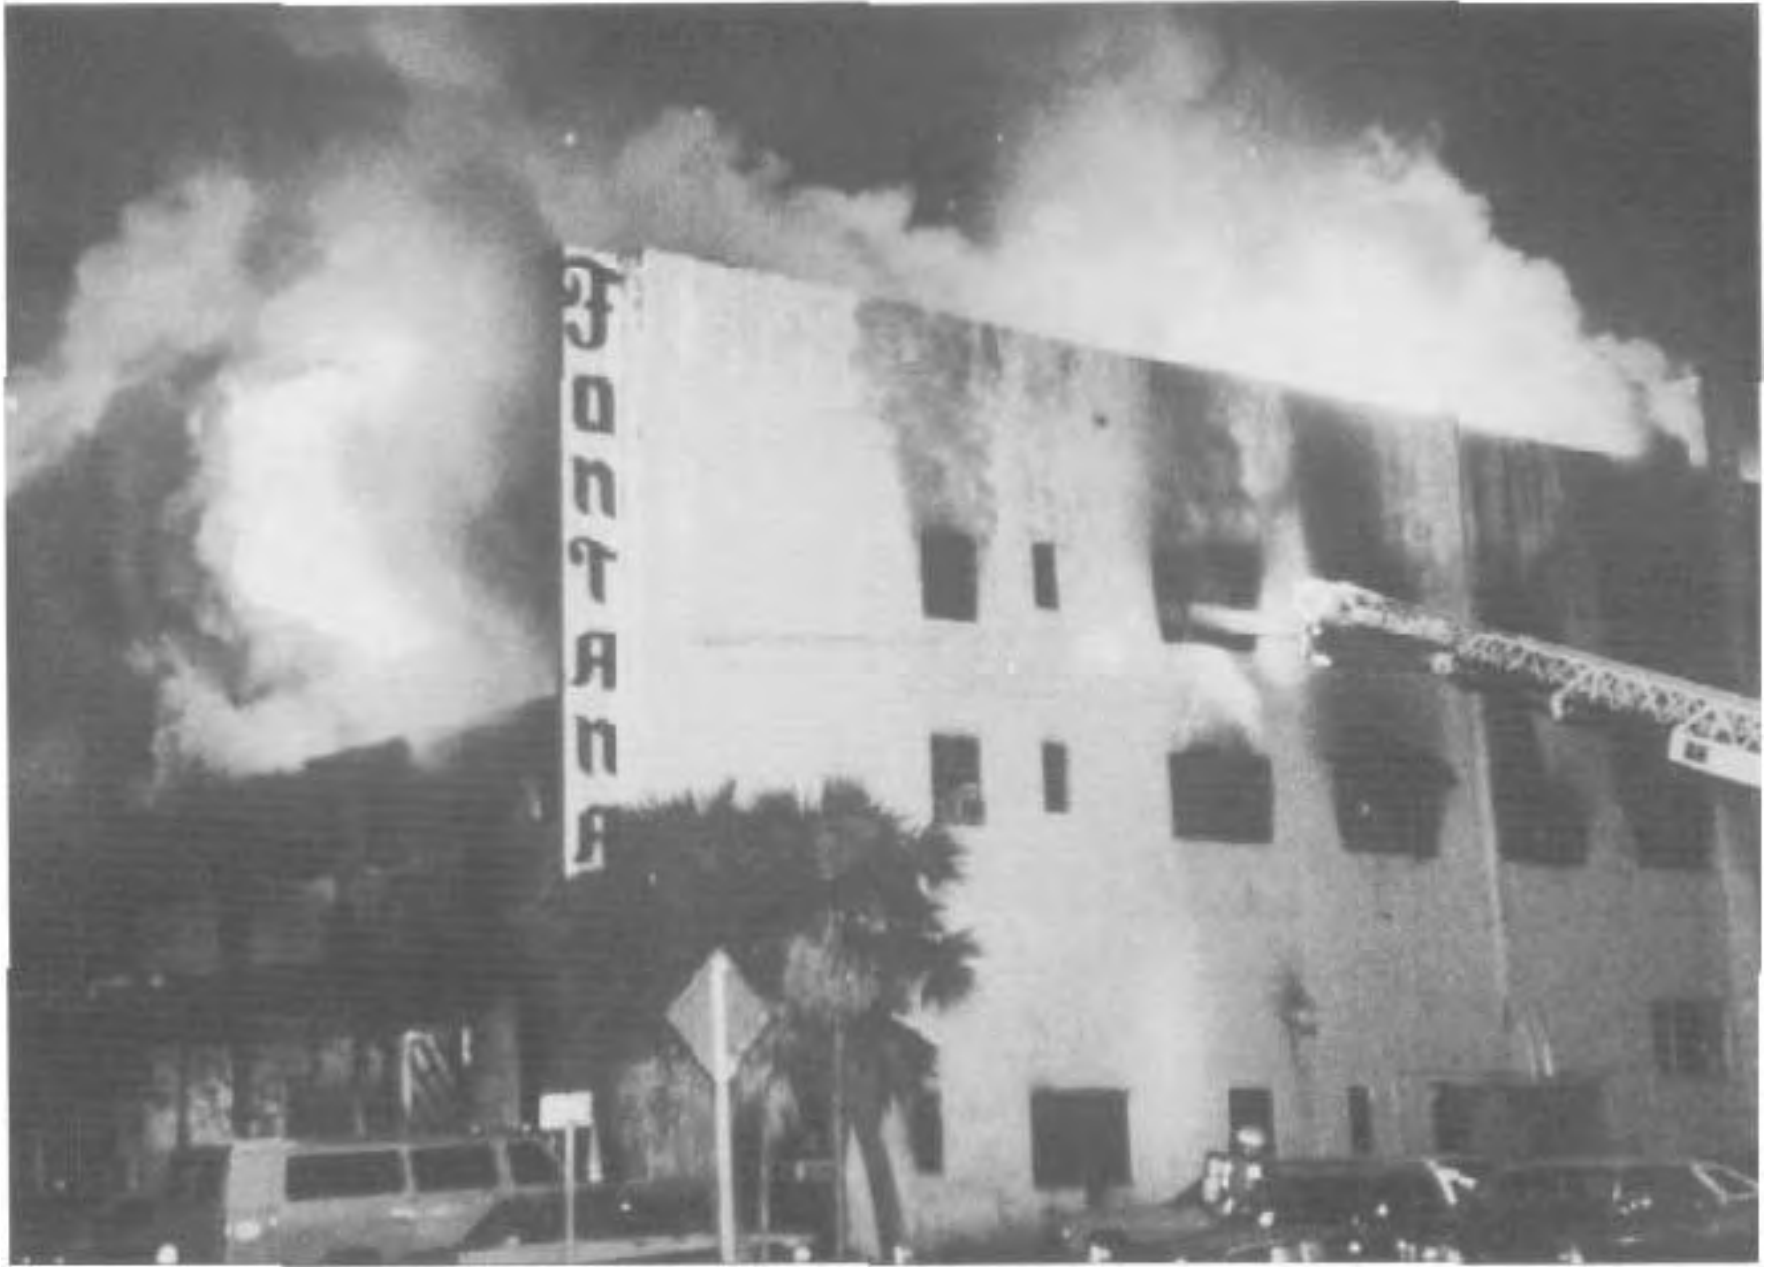
Exterior attack in progress, note fire involvement of attic.

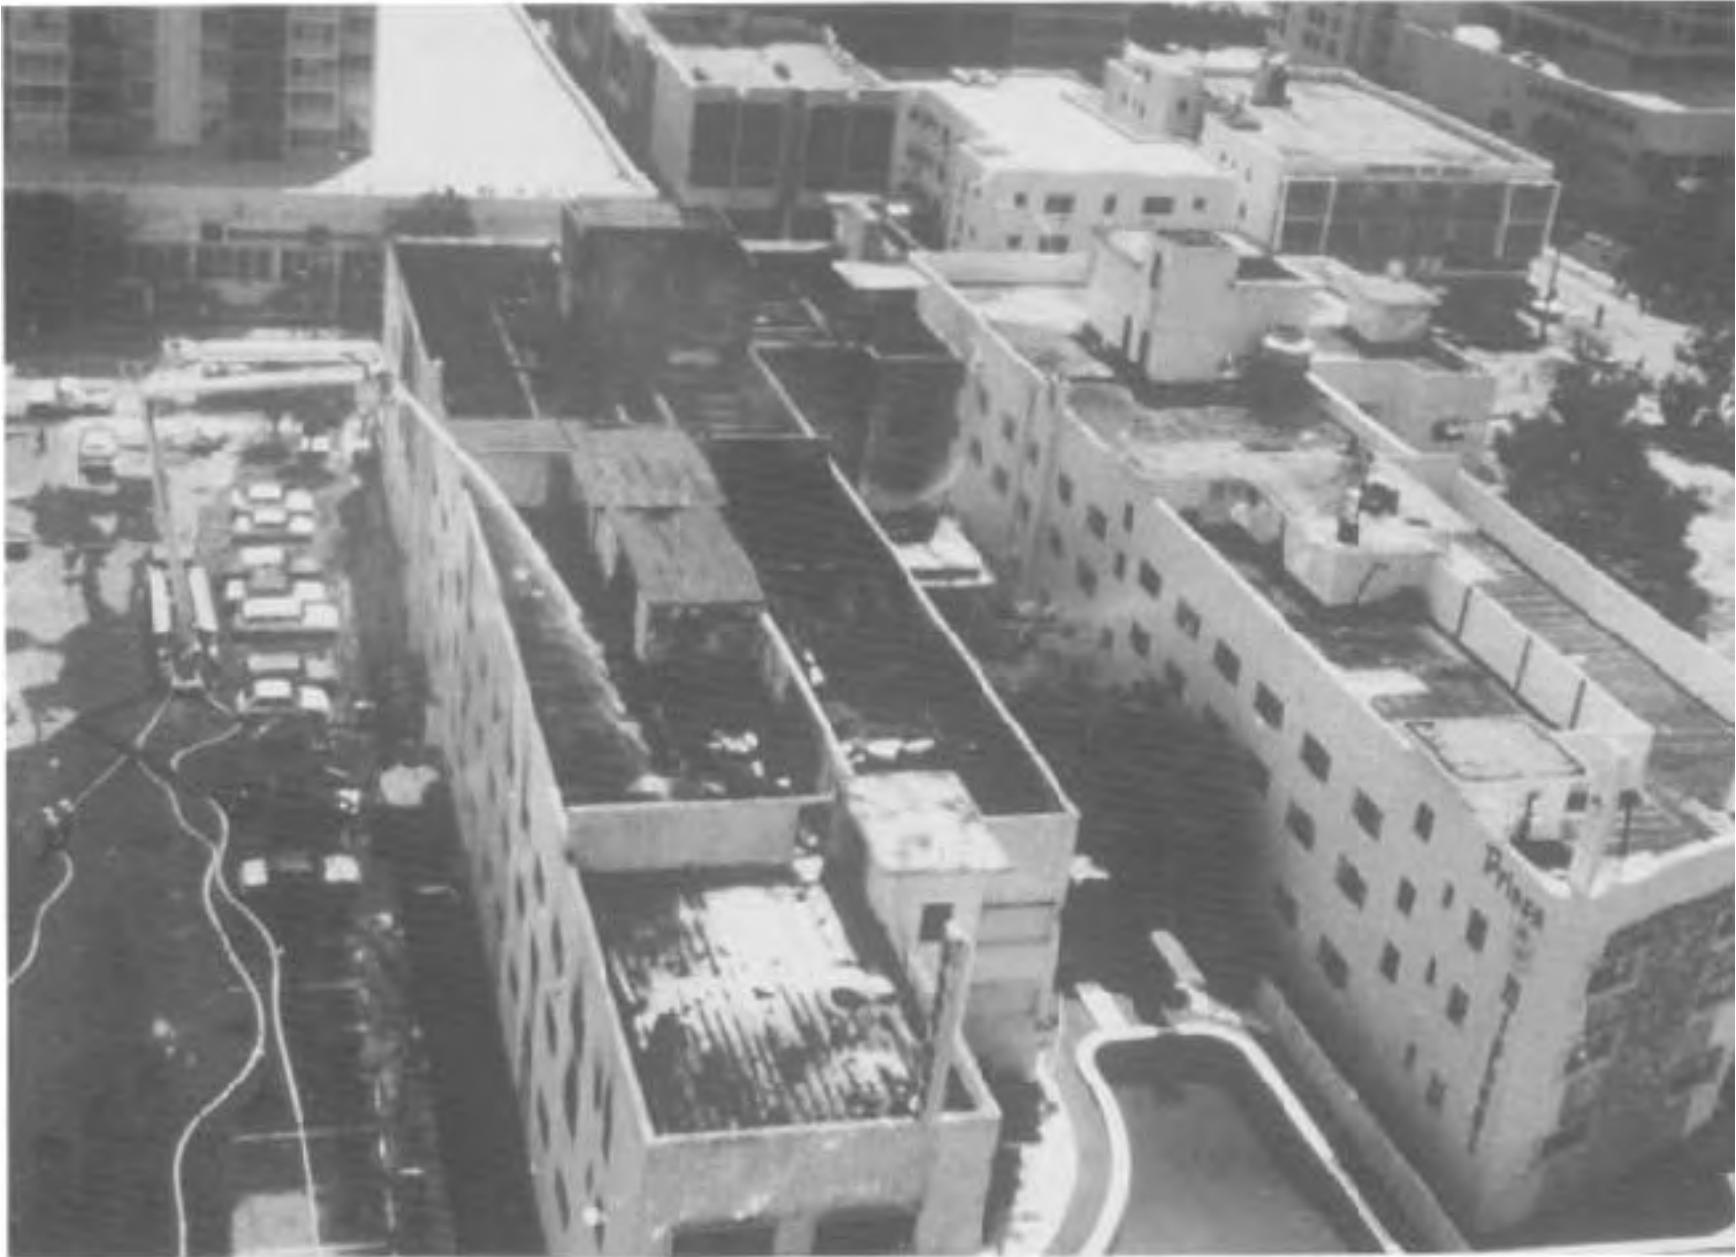
The fire destroyed the front portion of the structure, burning through the roof. The remainder of the hotel received smoke and heat damage, although many of the rooms were spared from fire damage.

Aerial view of Hotel after the fire. Note destruction of the roof and proximity of the Prince Michael Hotel. *(MBFD photo)*

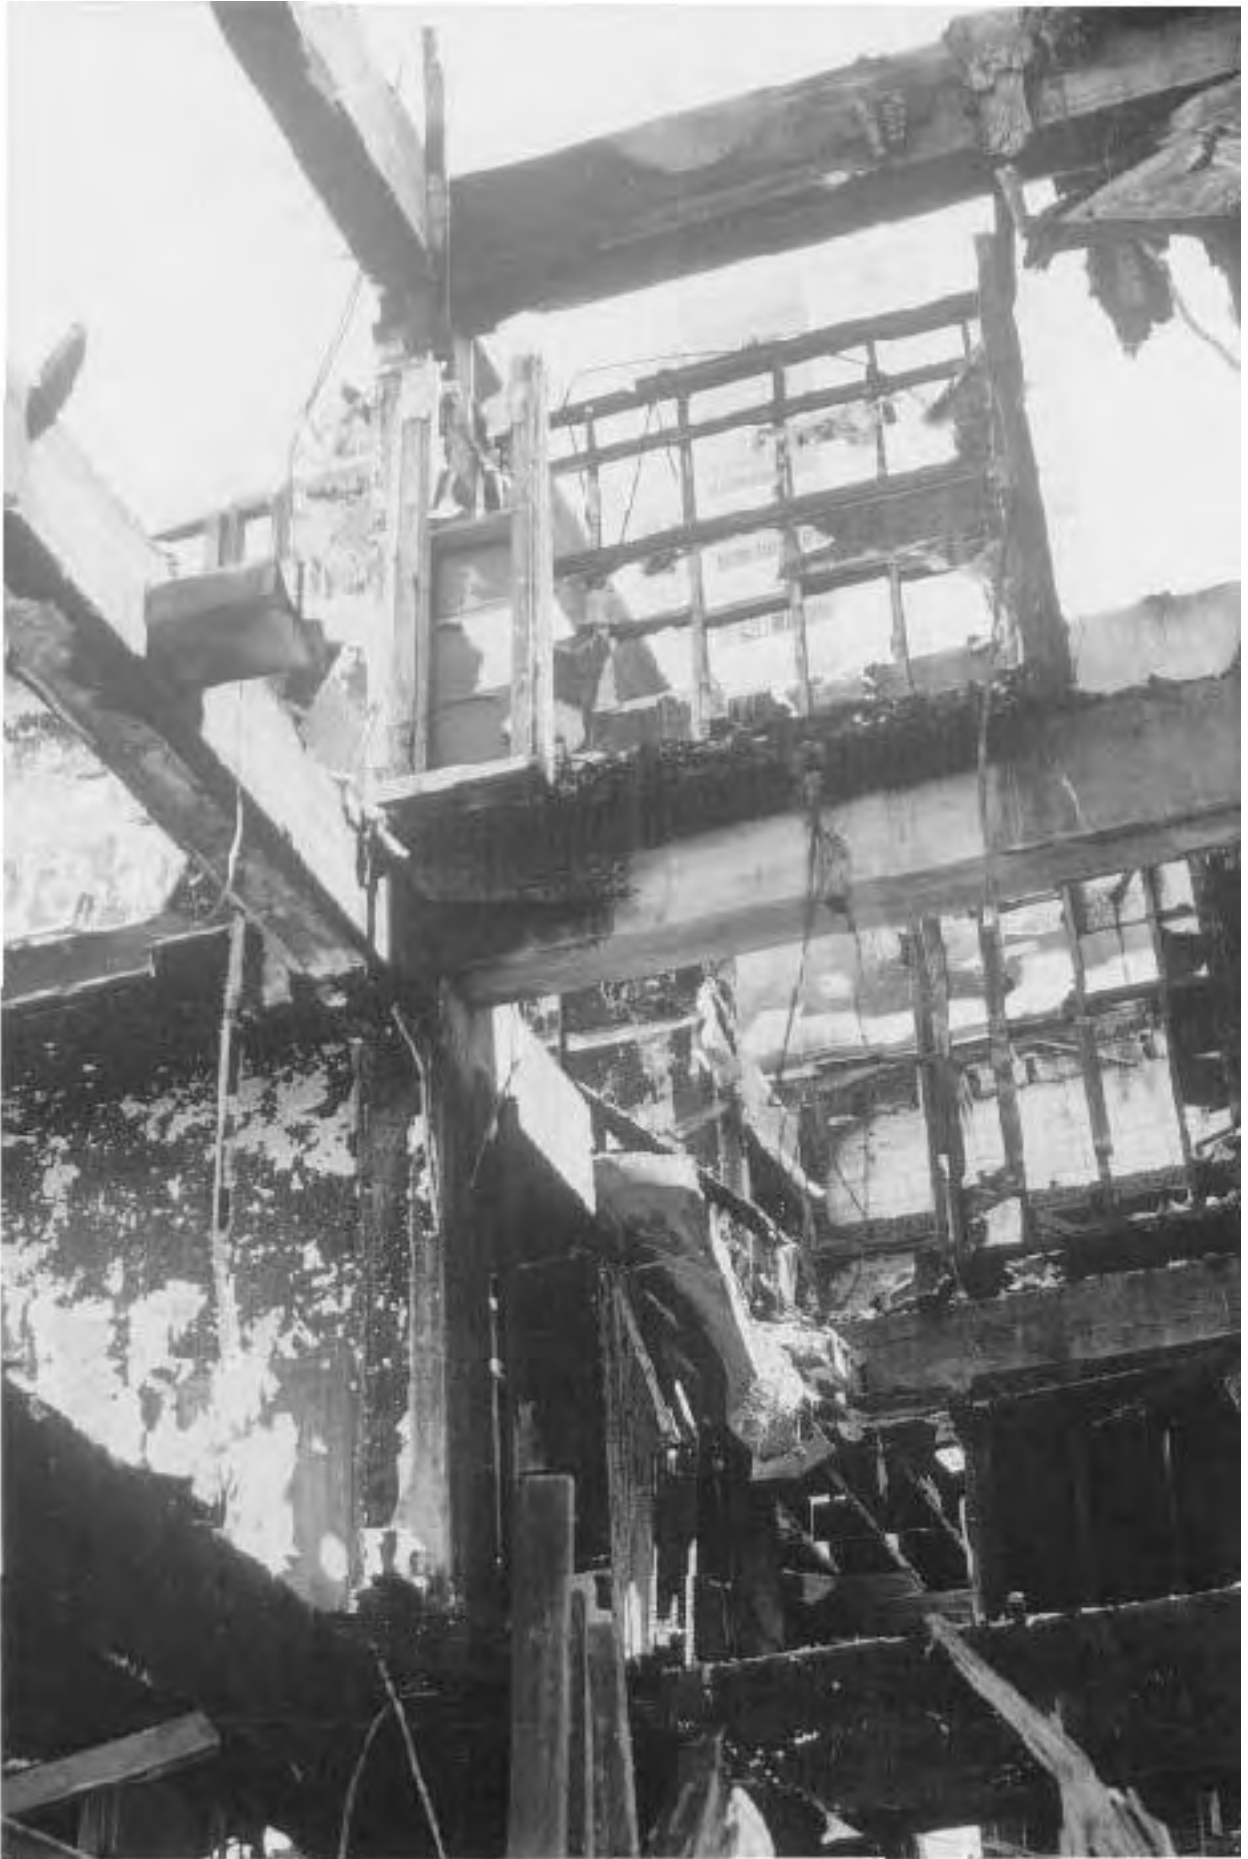
Lobby, looking up through roof facing Collins Street.

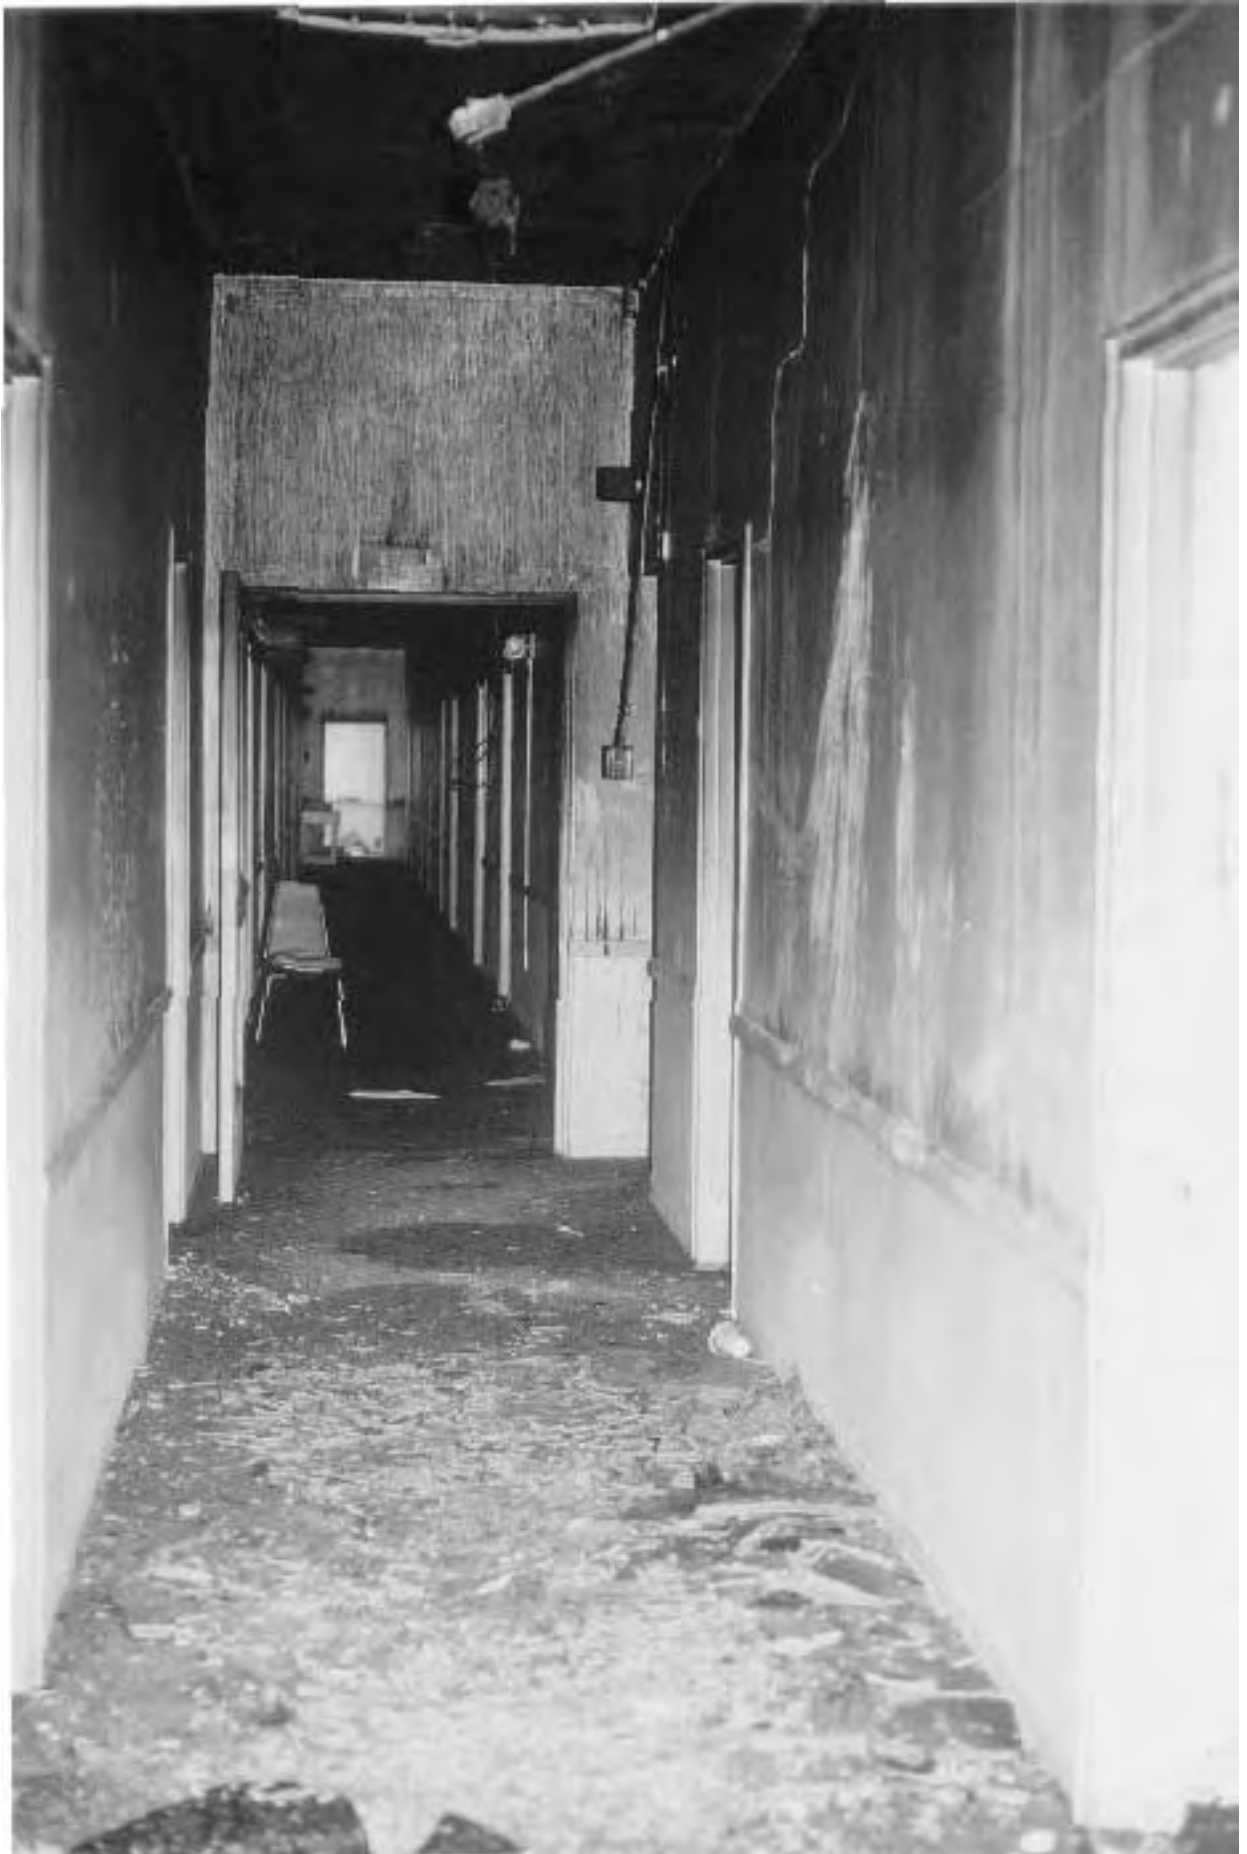
First floor corridor, looking to rear of building from lobby. Fire door in foreground was closed throughout much of the fire.

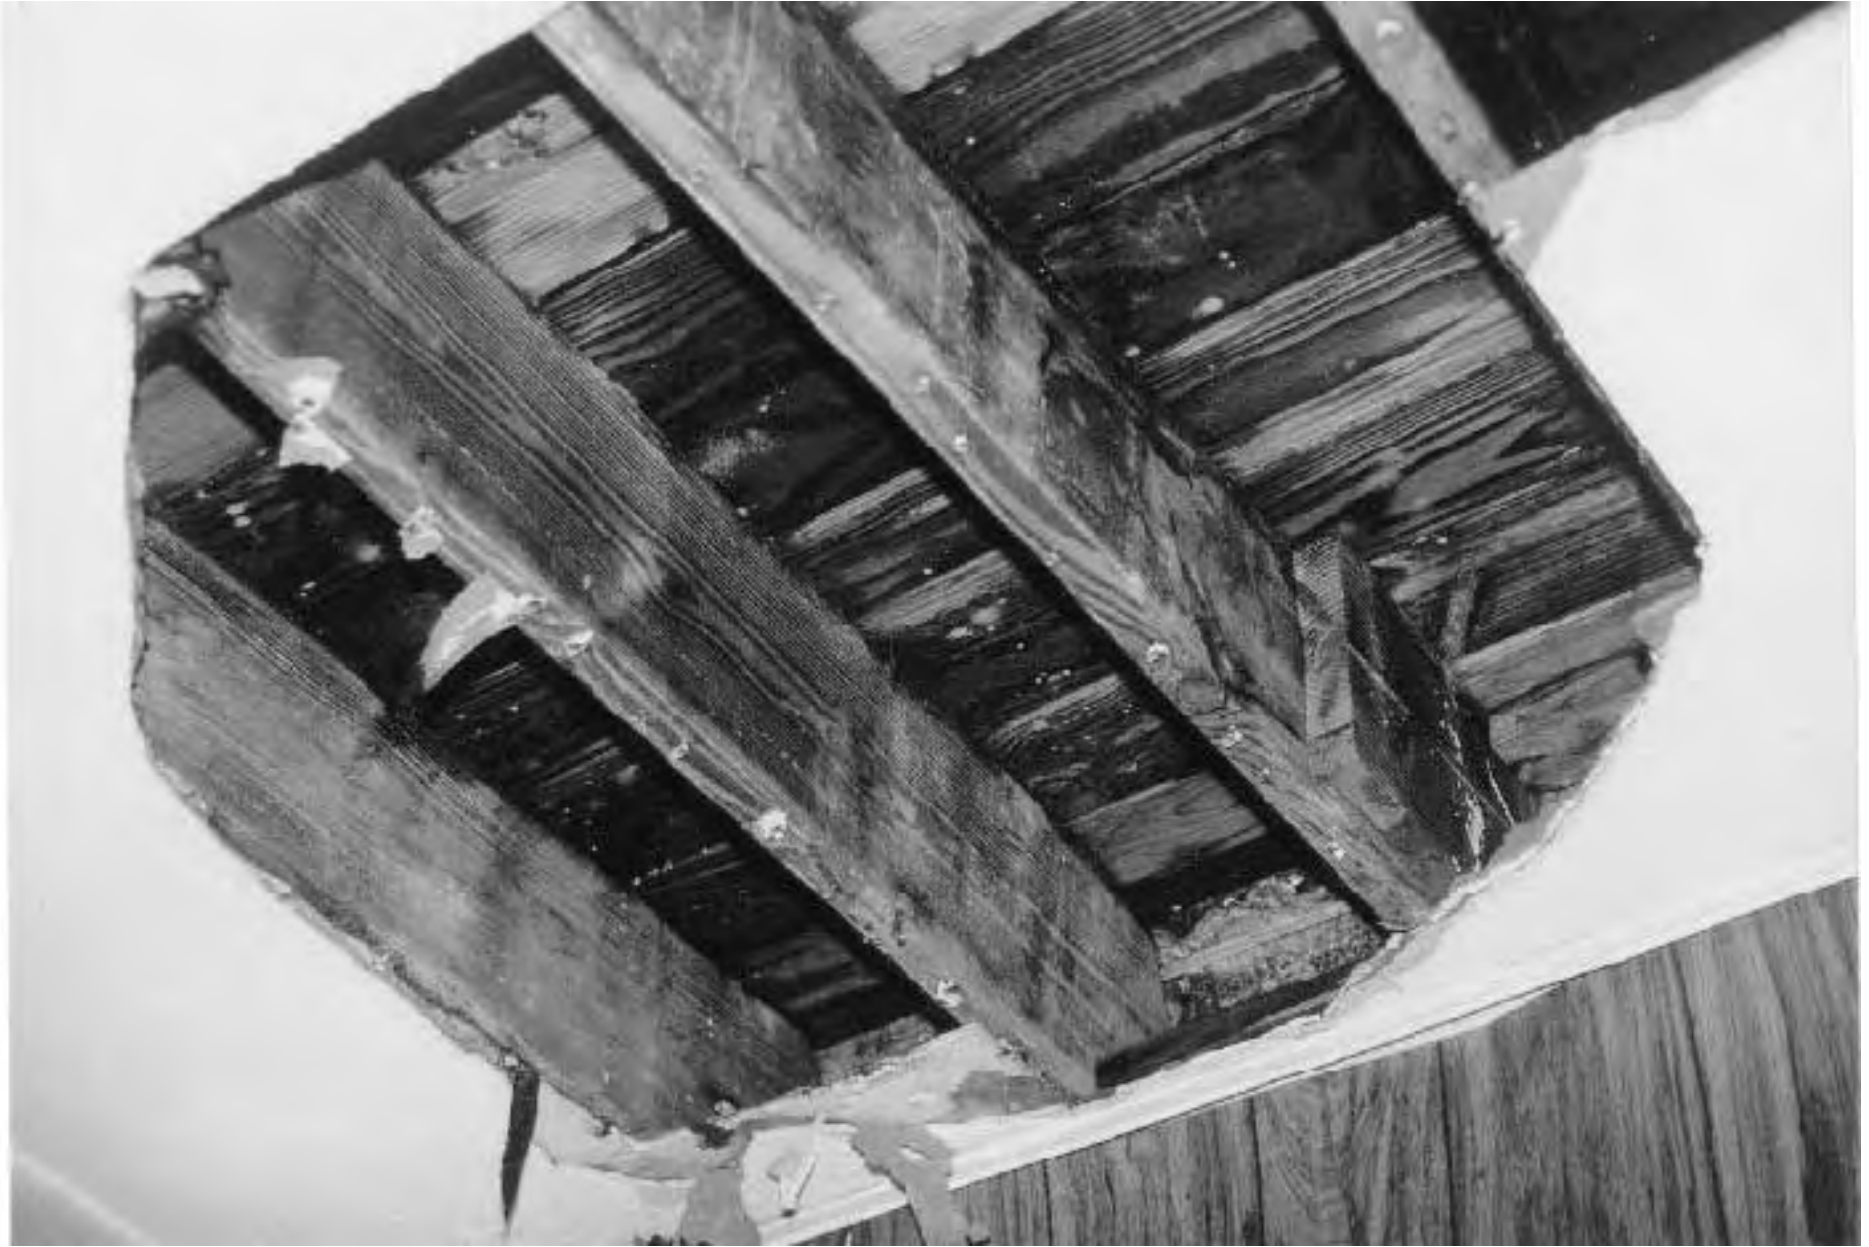
The construction of the building created concealed spaces which ran the length of each floor in the space between the floor and ceiling. In addition, there was a major pipe chase which ran from the first floor ceiling to the attic. This pipe chase, which was adjacent to the elevator shaft, was approximately live by ten feet and carried plumbing and other building services (see floor plan, Appendix A). The interior framing of this pipe shaft was exposed wood. The openings on to each floor were not fit-estopped.

This pipe chase and the construction of the floors effectively created a single concealed space that ran the length of the building from the first floor to the attic. A photograph of typical floor construction is included in Appendix E.

Typical floor construction, shown from ceiling of first floor room.

Providing combustible concealed spaces with detection or suppression systems can prevent these types of fires from spreading before being detected.

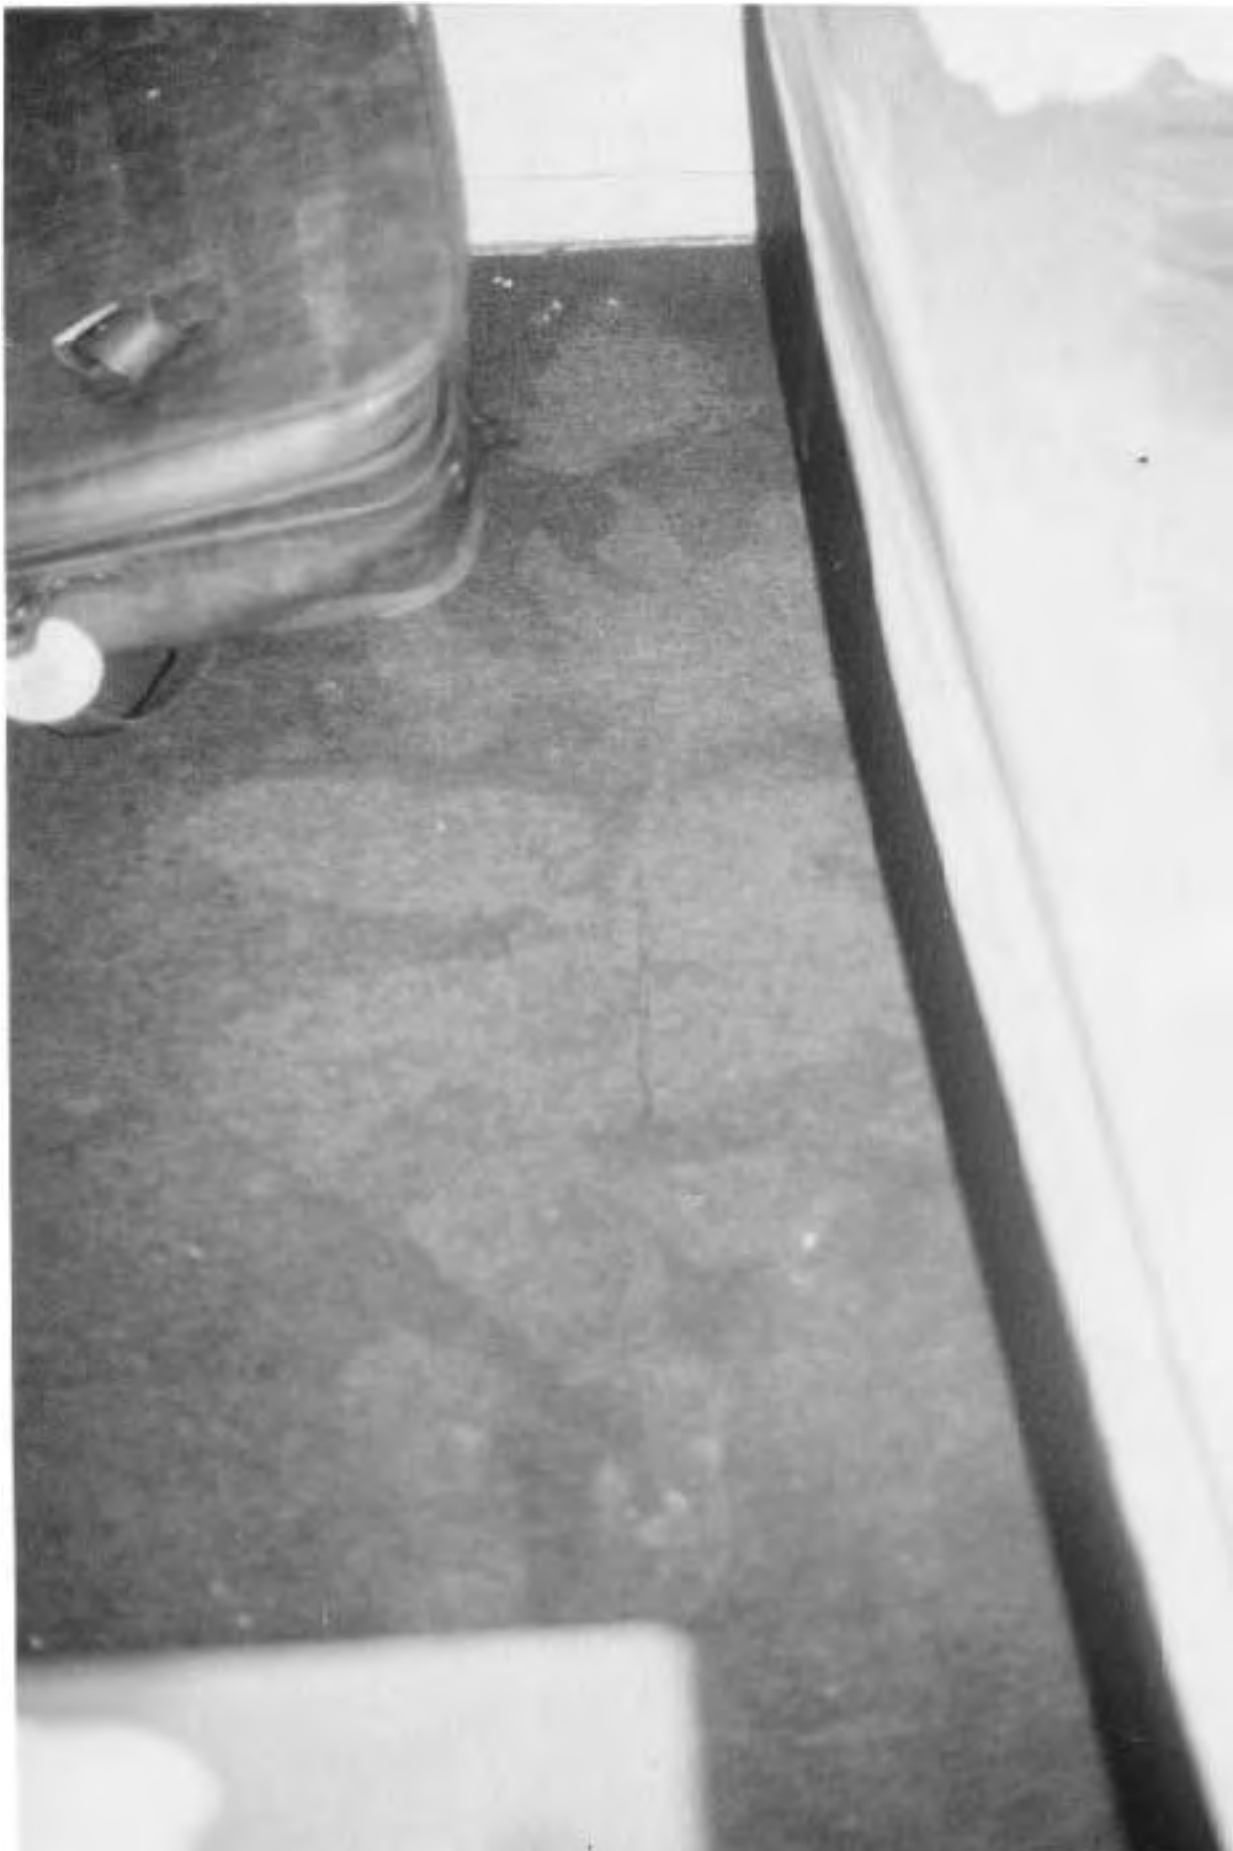
One fatality, whose room was located across the hall from an exit, was discovered fully dressed, with coat and shoes, and had a purse containing valuables. Apparently, she took time to get dressed and collect valuables before leaving. She was found on the floor of her room carrying a flashlight, which was still on when she was removed. Her delay to gather belongings cost her her life. A photograph of her room (205) showing its closeness to the exit is included in Appendix E.

Outline of victim in smoke stain, Room 205. Victim was reportedly found carrying a flashlight (still on) and personal belongings in a purse.

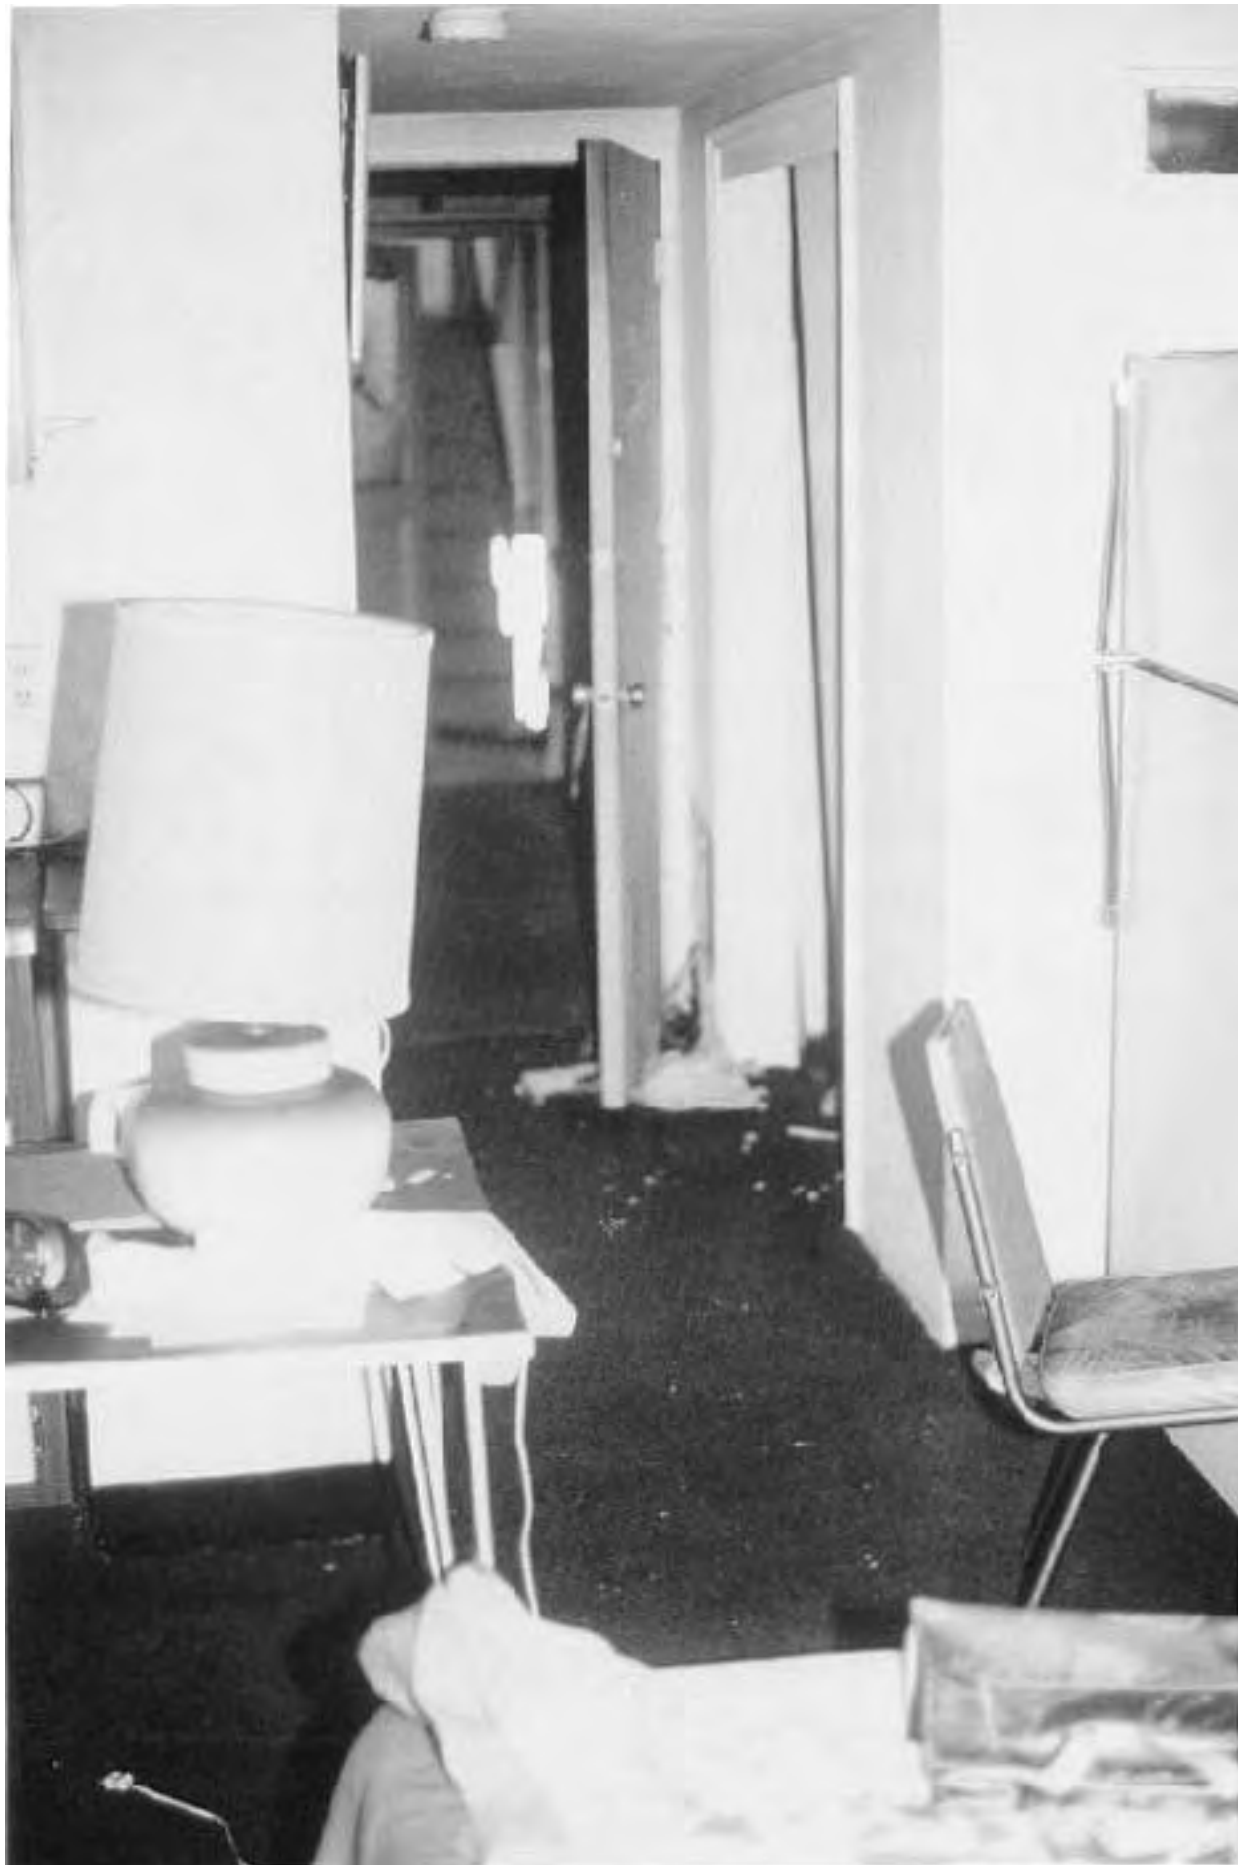
View of Room 205, fire exit is visible across corridor.

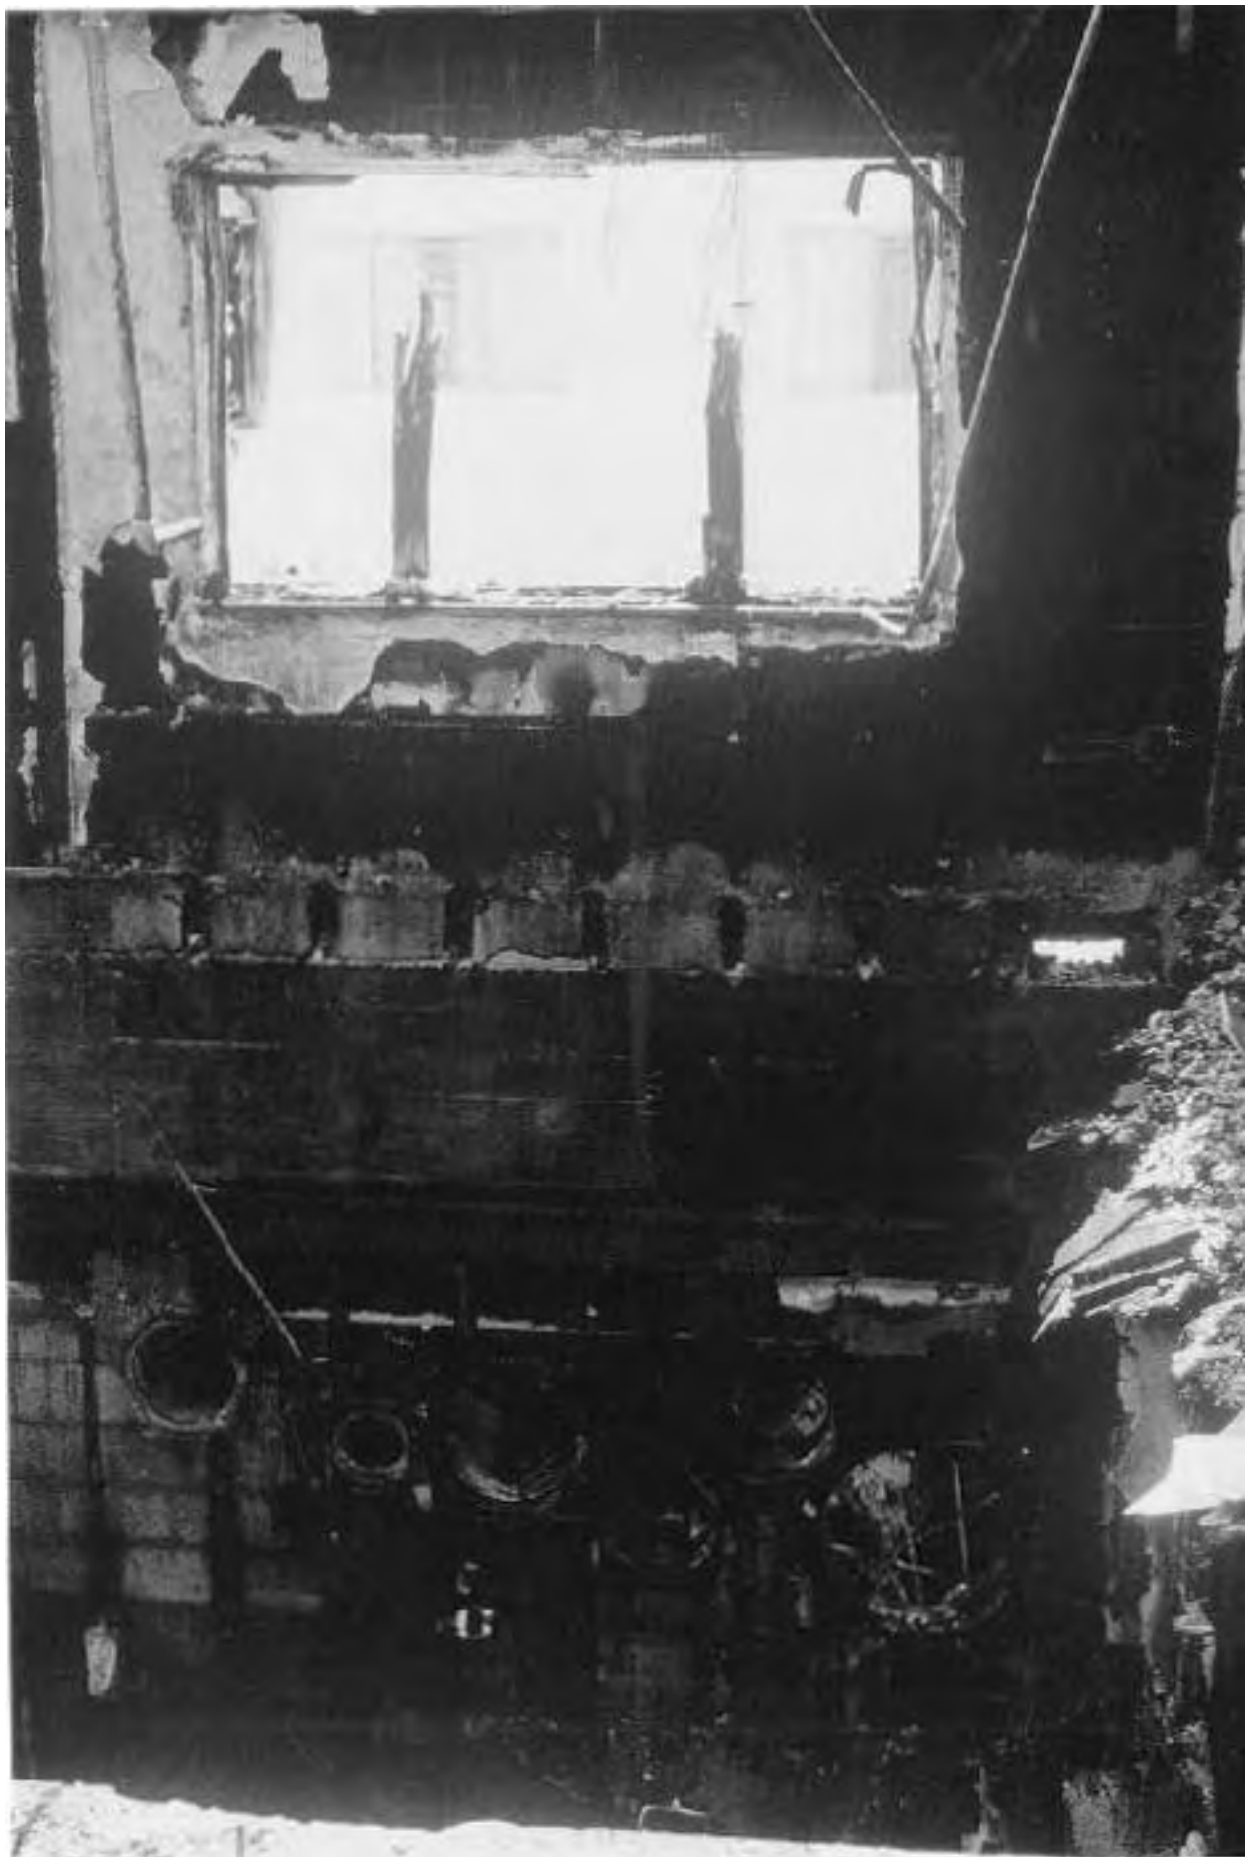
Second floor, looking across to Room 301 from front stairway, area of origin is at base of photo.
