## **Nine Elderly Fire Victims in Residential Hotel Miami Beach, Florida**

**Nine Elderly Fire Victims  
in Residential Hotel  
Miami, Florida  
(April 6, 1990)**

**This is Report 041 of the Major Fires Investigation Project conducted  
by TriData Corporation under contract EMW-90-C-3338 to the United  
States Fire Administration, Federal Emergency Management Agency.**

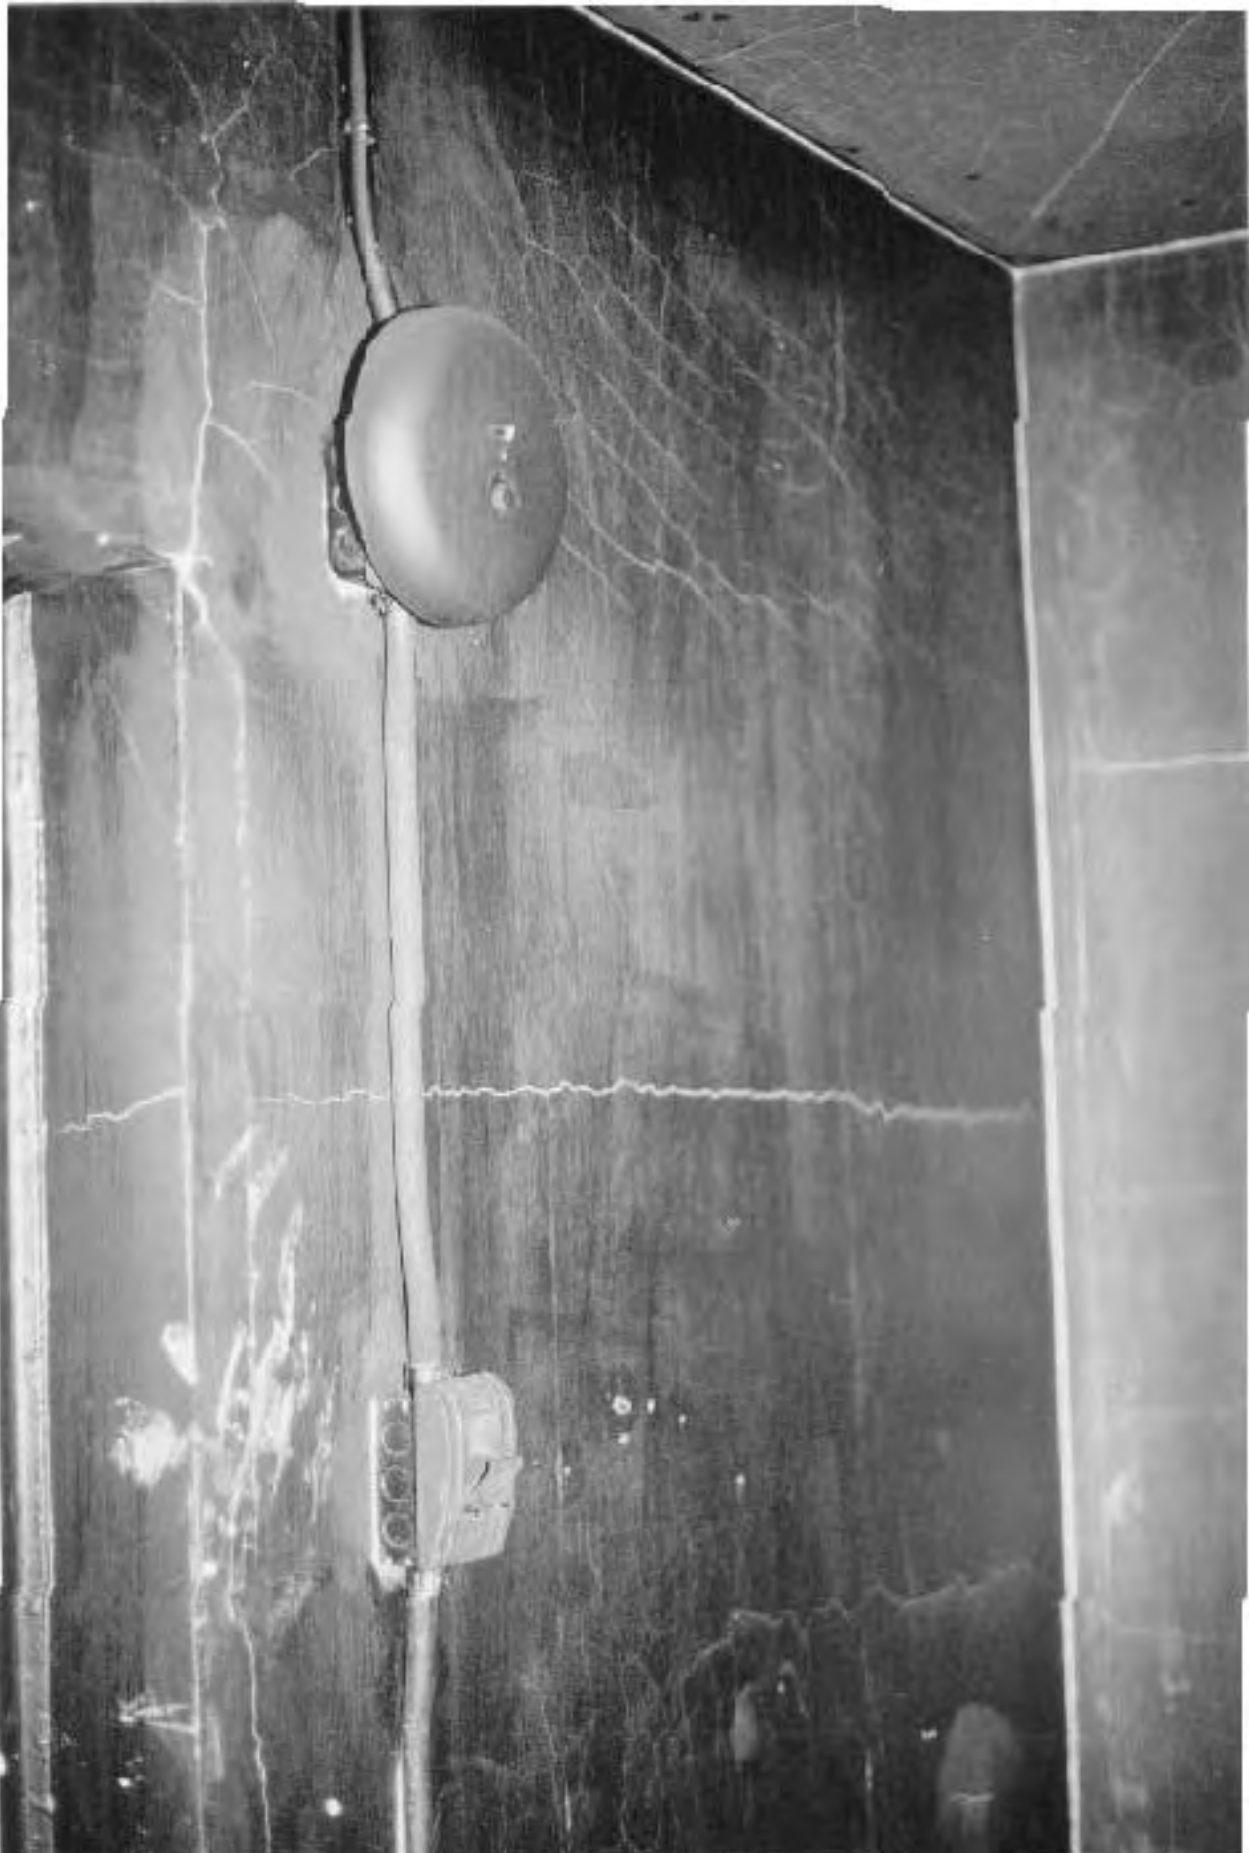
This fire demonstrates the potential for loss when a fire originates in an area that is not provided with detection or suppression systems. When the fire reached a stage when it would activate the smoke detectors, it had grown to such a degree that the occupants had little time to escape. Additionally, the wiring for the fire alarm was compromised by the fire so that even manual activation of the alarm was not possible.

Manual fire alarm station and bell, third floor, at rear stair. Note extensive darkening soot.

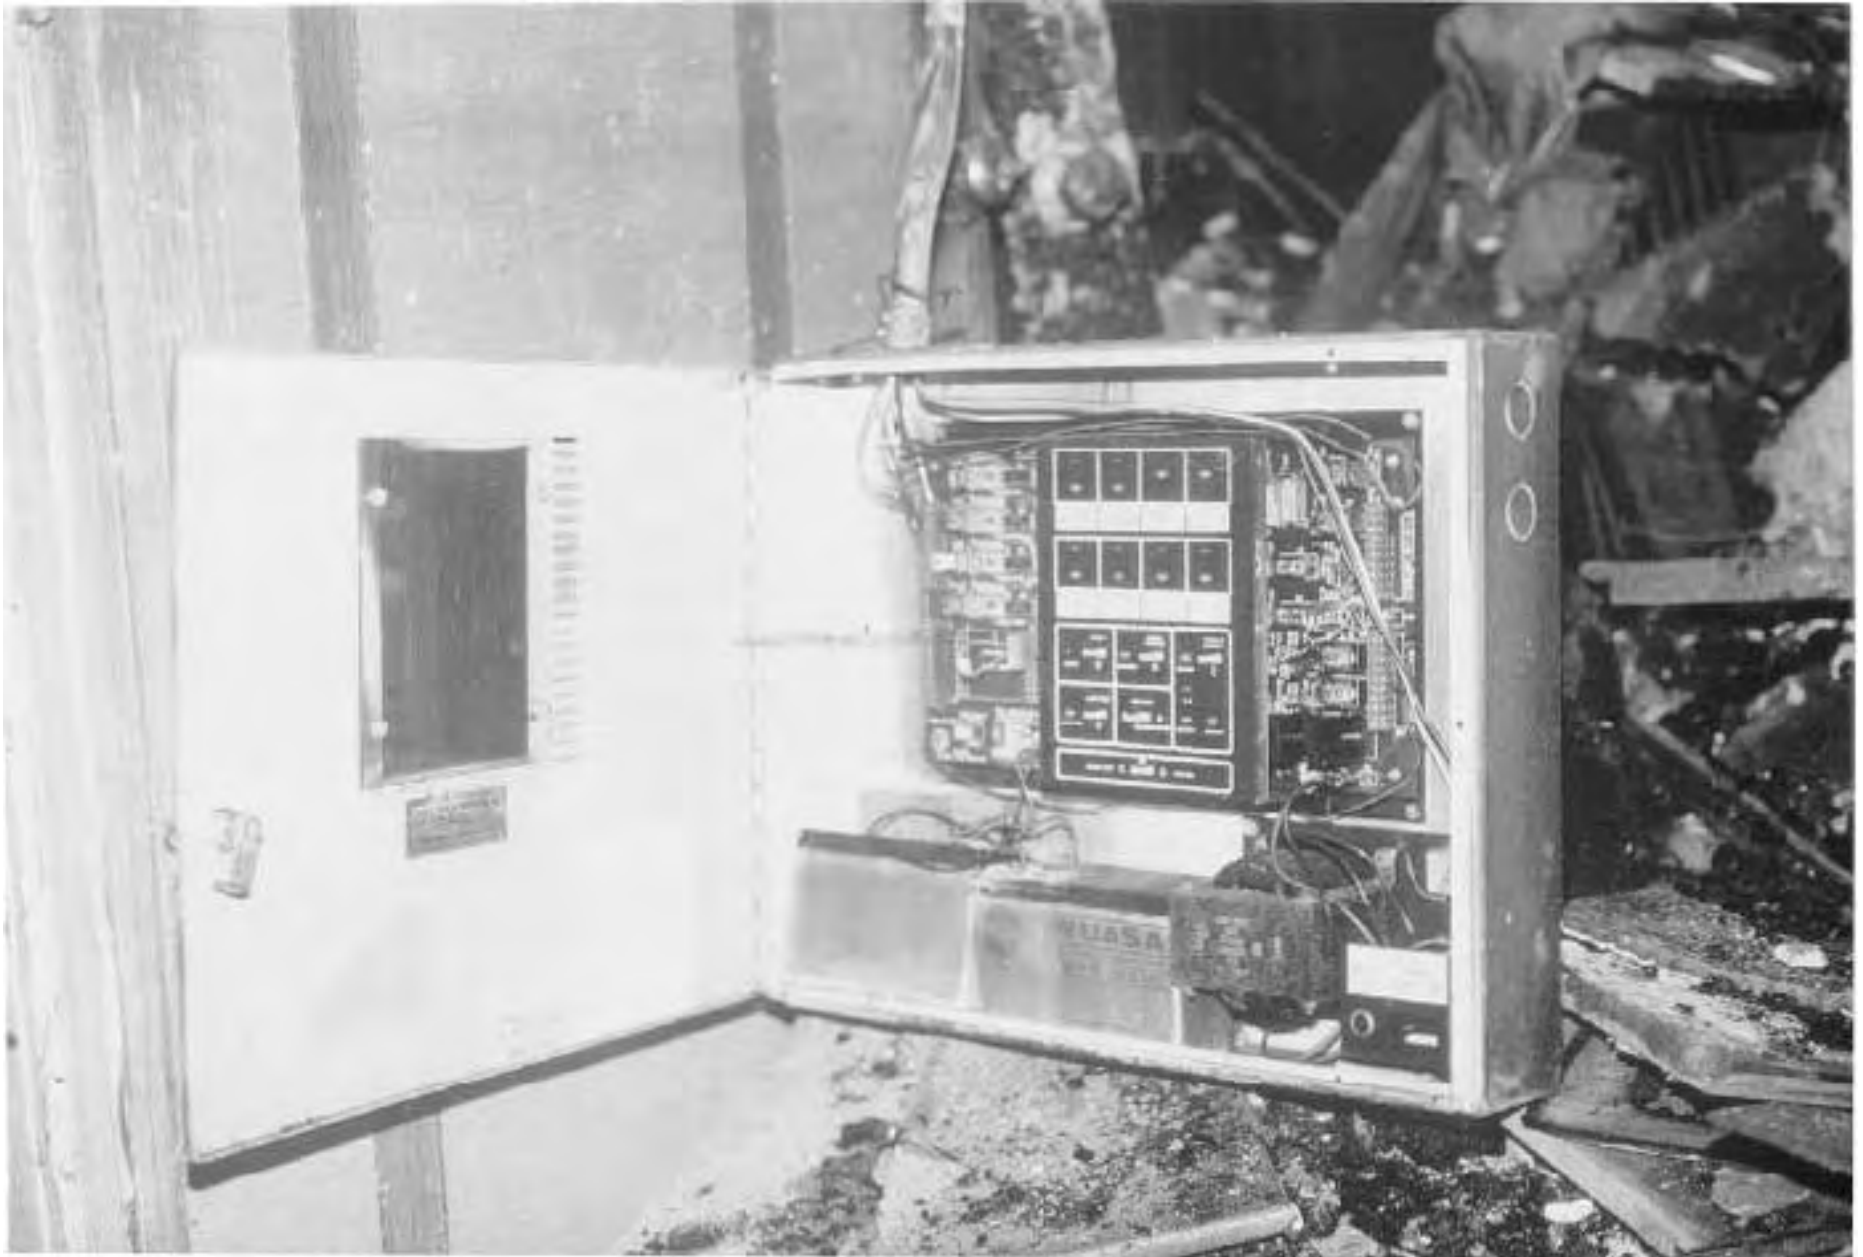
Single station hard-wired smoke detectors in guest rooms did activate. There were conflicting statements as to whether the building fire alarm was activated. The control wiring for the alarm ran through the concealed space where the fire originated, leading some to believe that by the time a manual station was pulled, the fire alarm wiring was destroyed. The fire alarm control panel was located in an office behind the front desk and remained basically intact throughout the fire. (See photograph, Appendix E.) The fact that corridor smoke detectors did not activate was consistent with the development of fire.

Remains of fire alarm control panel.
