Seven-Fatality Christmas Tree Fire Canton, Michigan

**Seven-Fatality
Christmas Tree Fire
Canton, Michigan
(December 22, 1990)**

This is Report 046 of the Major Fires Investigation Project conducted by TriData Corporation under contract EMW-90-C-3338 to the United States Fire Administration, Federal Emergency Management Agency.

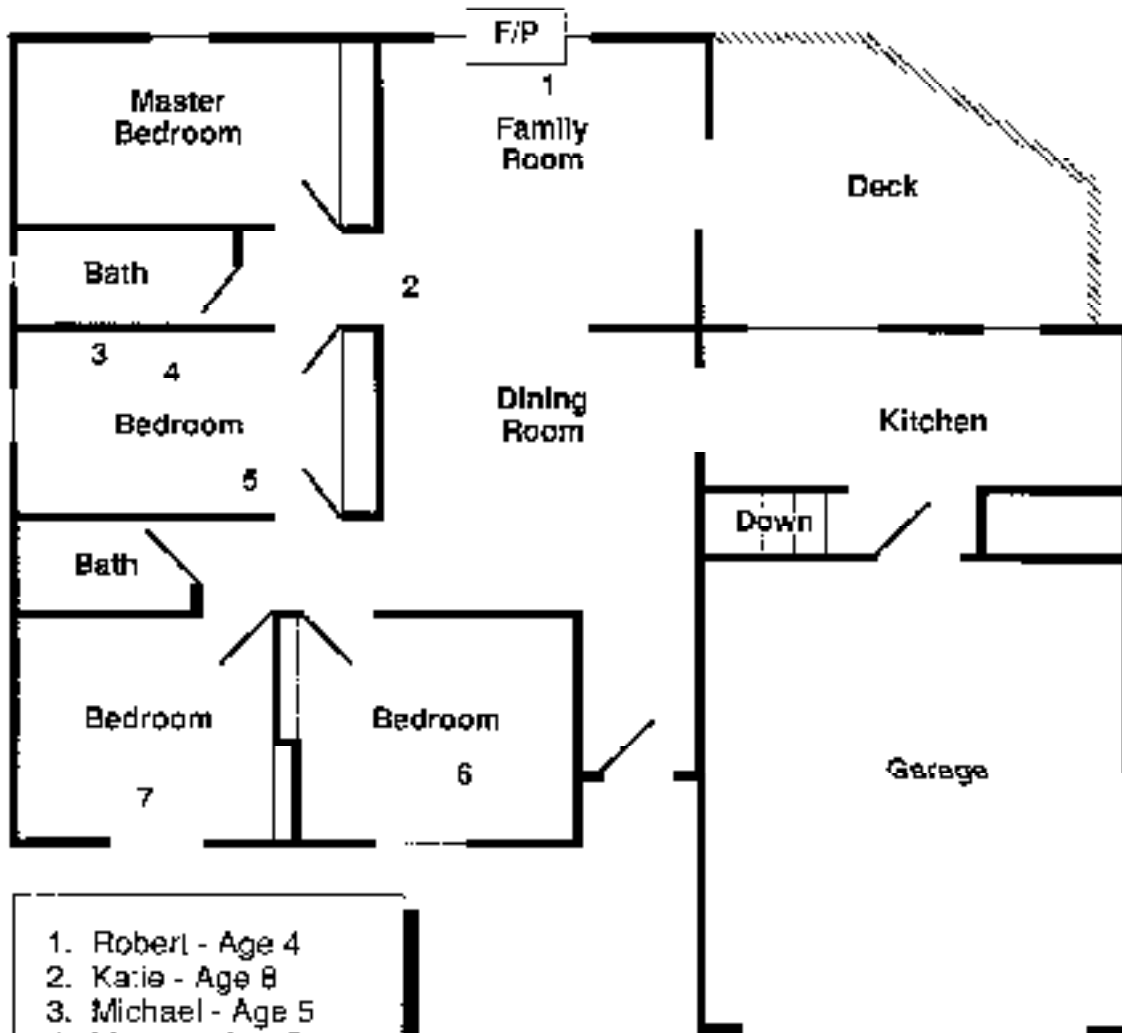
**DELL'ORCO HOME
LOCATION OF VICTIMS**

After the fire, the bodies of six children and their father were located amongst the charred remnants of the home. A four-year-old boy was found within the remains of the family room where the Christmas tree had been. The body of a female child was found at the archway into the family room. Three more children were found in a heavily charred bedroom adjacent to the family room. Another child's body was found in a heavily smoked front bedroom. The father's body was found just a few feet inside the front bedroom window that he was last seen entering.

- 1. Robert - Age 4
- 2. Katie - Age 8
- 3. Michael - Age 5
- 4. Megan - Age 5
- 5. Sara - Age 9
- 6. Bonnie - Age 12
- 7. Martin - Age 38

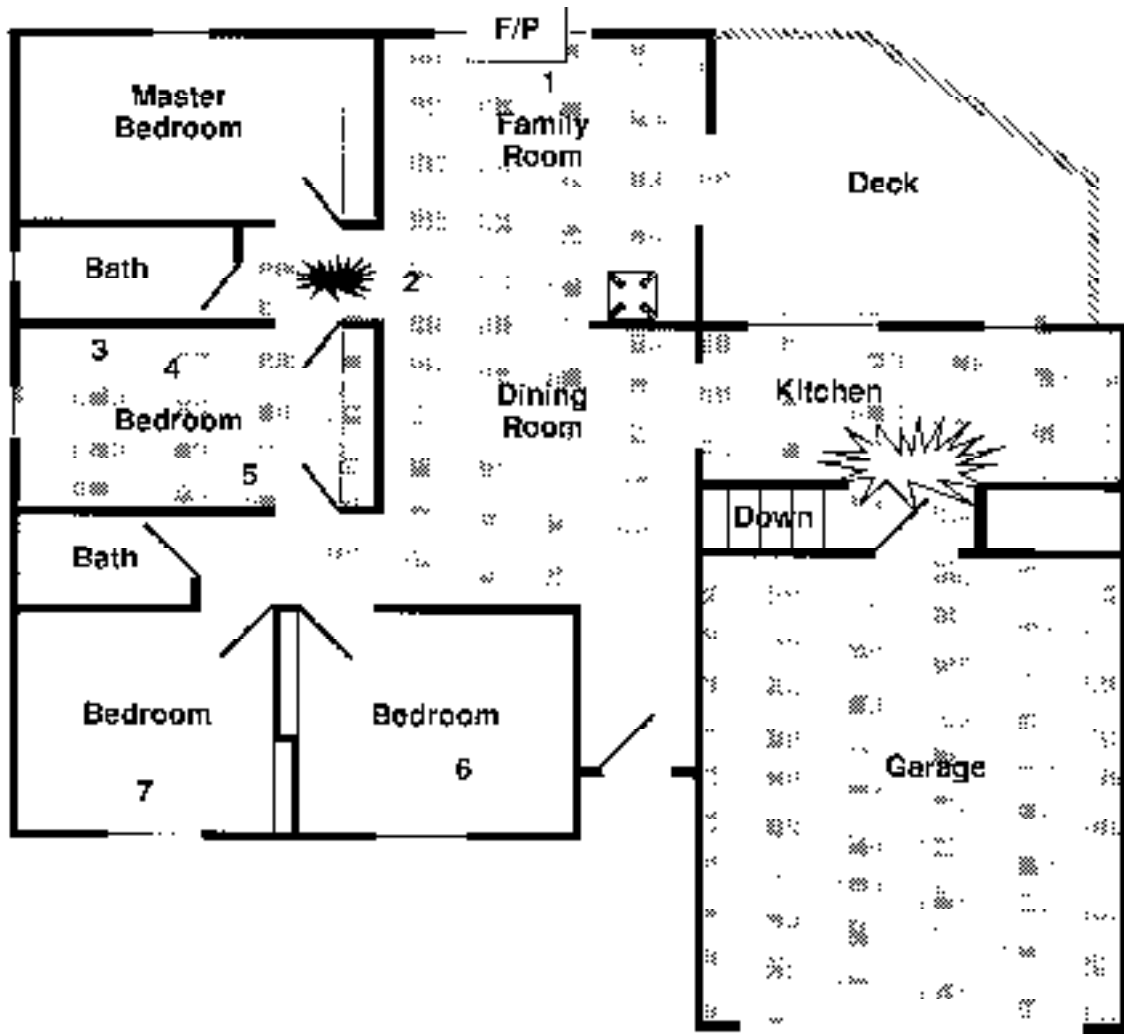
FIRE ORIGIN AND SPREAD

The Canton Fire Department has determined the origin of this fire to be a Christmas tree located in the corner of the family room adjacent to the dining room. The suspected ignition source of the fire was overheated or defective Christmas tree lights that were purchased this year and used for the first time. A contributing factor to the quick fire development was the unusual dryness of the Christmas tree. The fire consumed all available combustibles within the family room.

The horizontal fire spread was from the family room to one bedroom, dining room, kitchen, and garage. The fire consumed most of the combustible material in its path. Factors that may have influenced the horizontal fire spread could have been the wind direction and ventilation of the fire. The wind direction during the fire was not documented by the investigators but the predominate wind in this area is from the west. The fire was vented by the occupants in their attempts to remove the burning tree and the various rescue attempts that left doors and windows open.

The vertical fire spread was from the family room into the concealed attic space and then through the roof to the outside of the home. The fire spread into the attic space was through an attic fan penetration of the ceiling, which was located in the master bedroom hallway a few feet off

the family room. The fire then vented to the outside along the roof ridge above the kitchen. The structural components of the concealed space, including roof and ceiling structure, were partially consumed by fire. The structural components at the point of outside ventilation were consumed by fire.

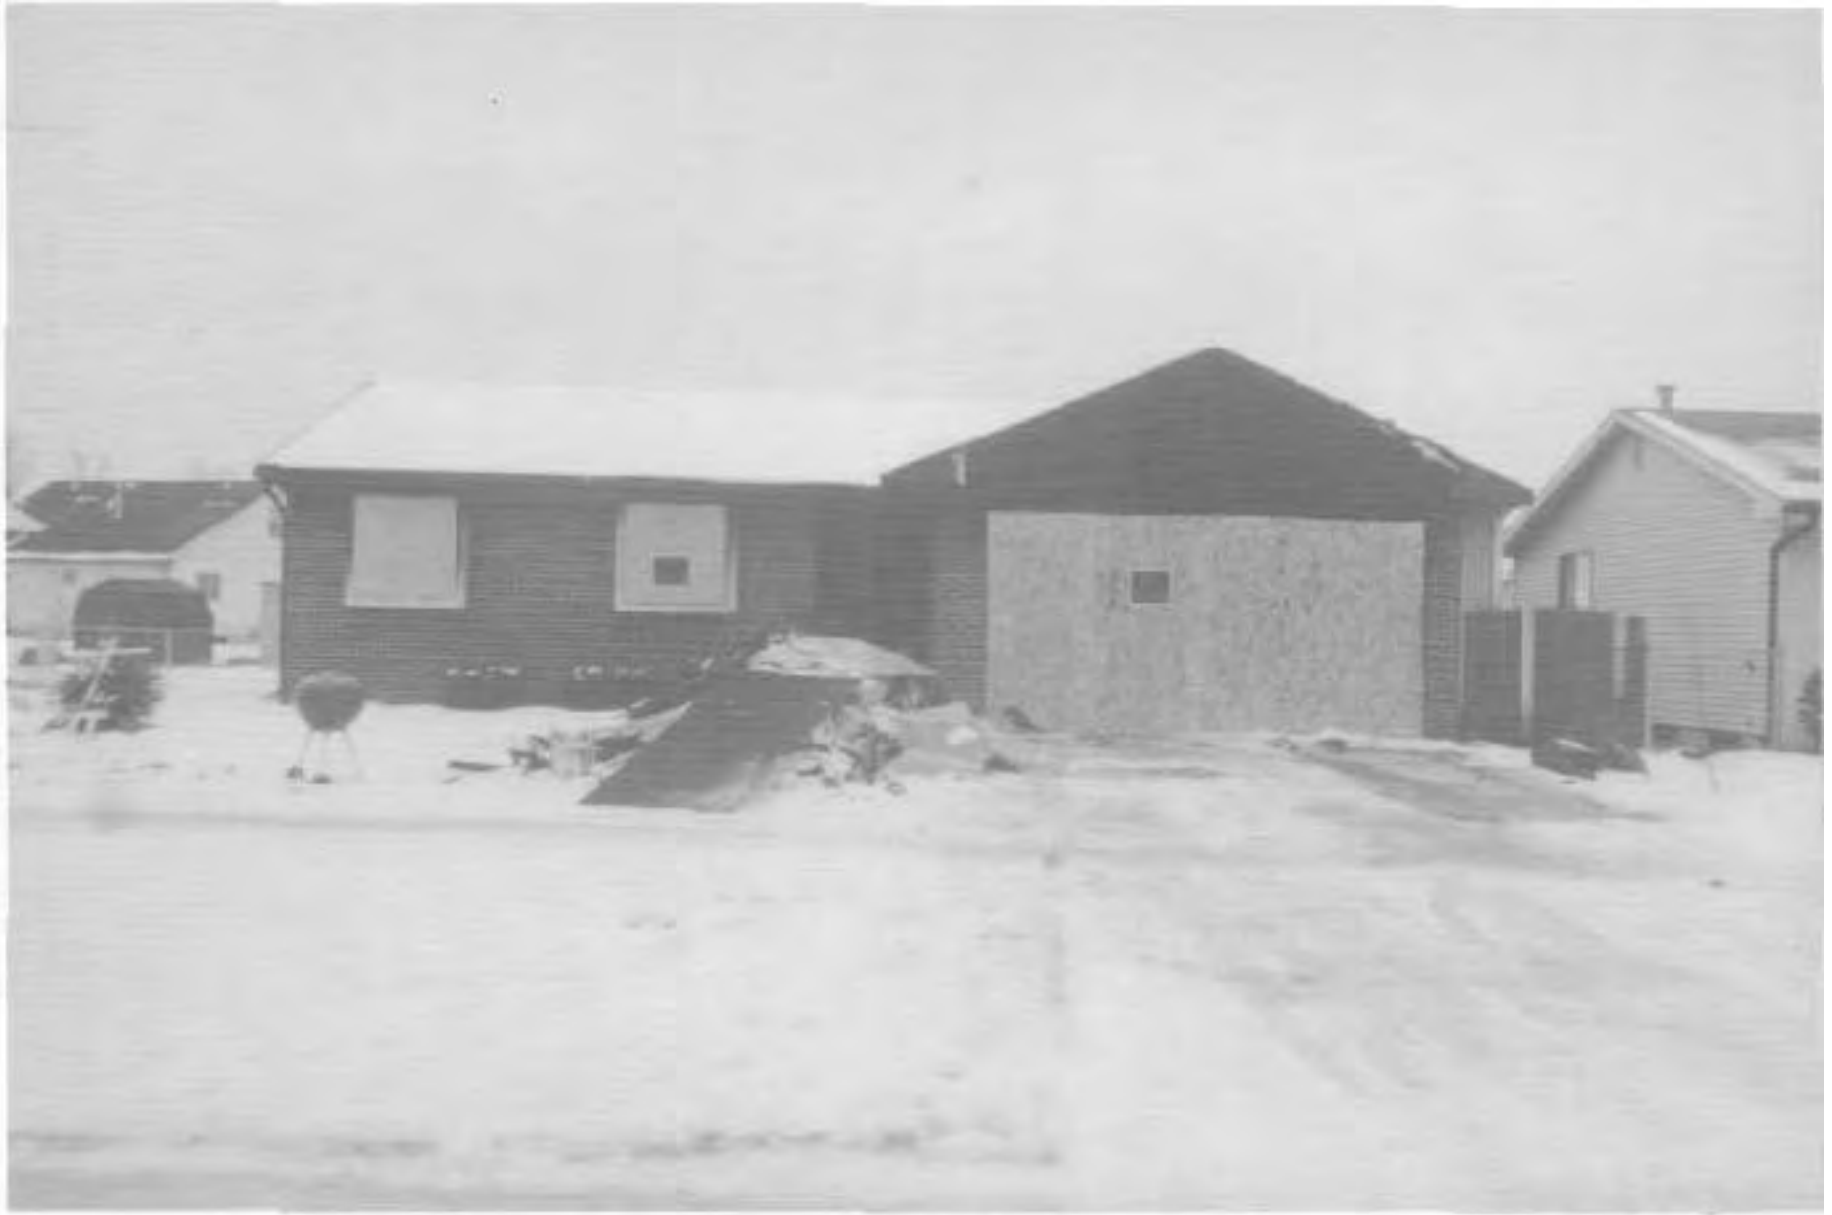
Front view of the Dell'Orco home, with evidence of fire venting through the garage door opening.

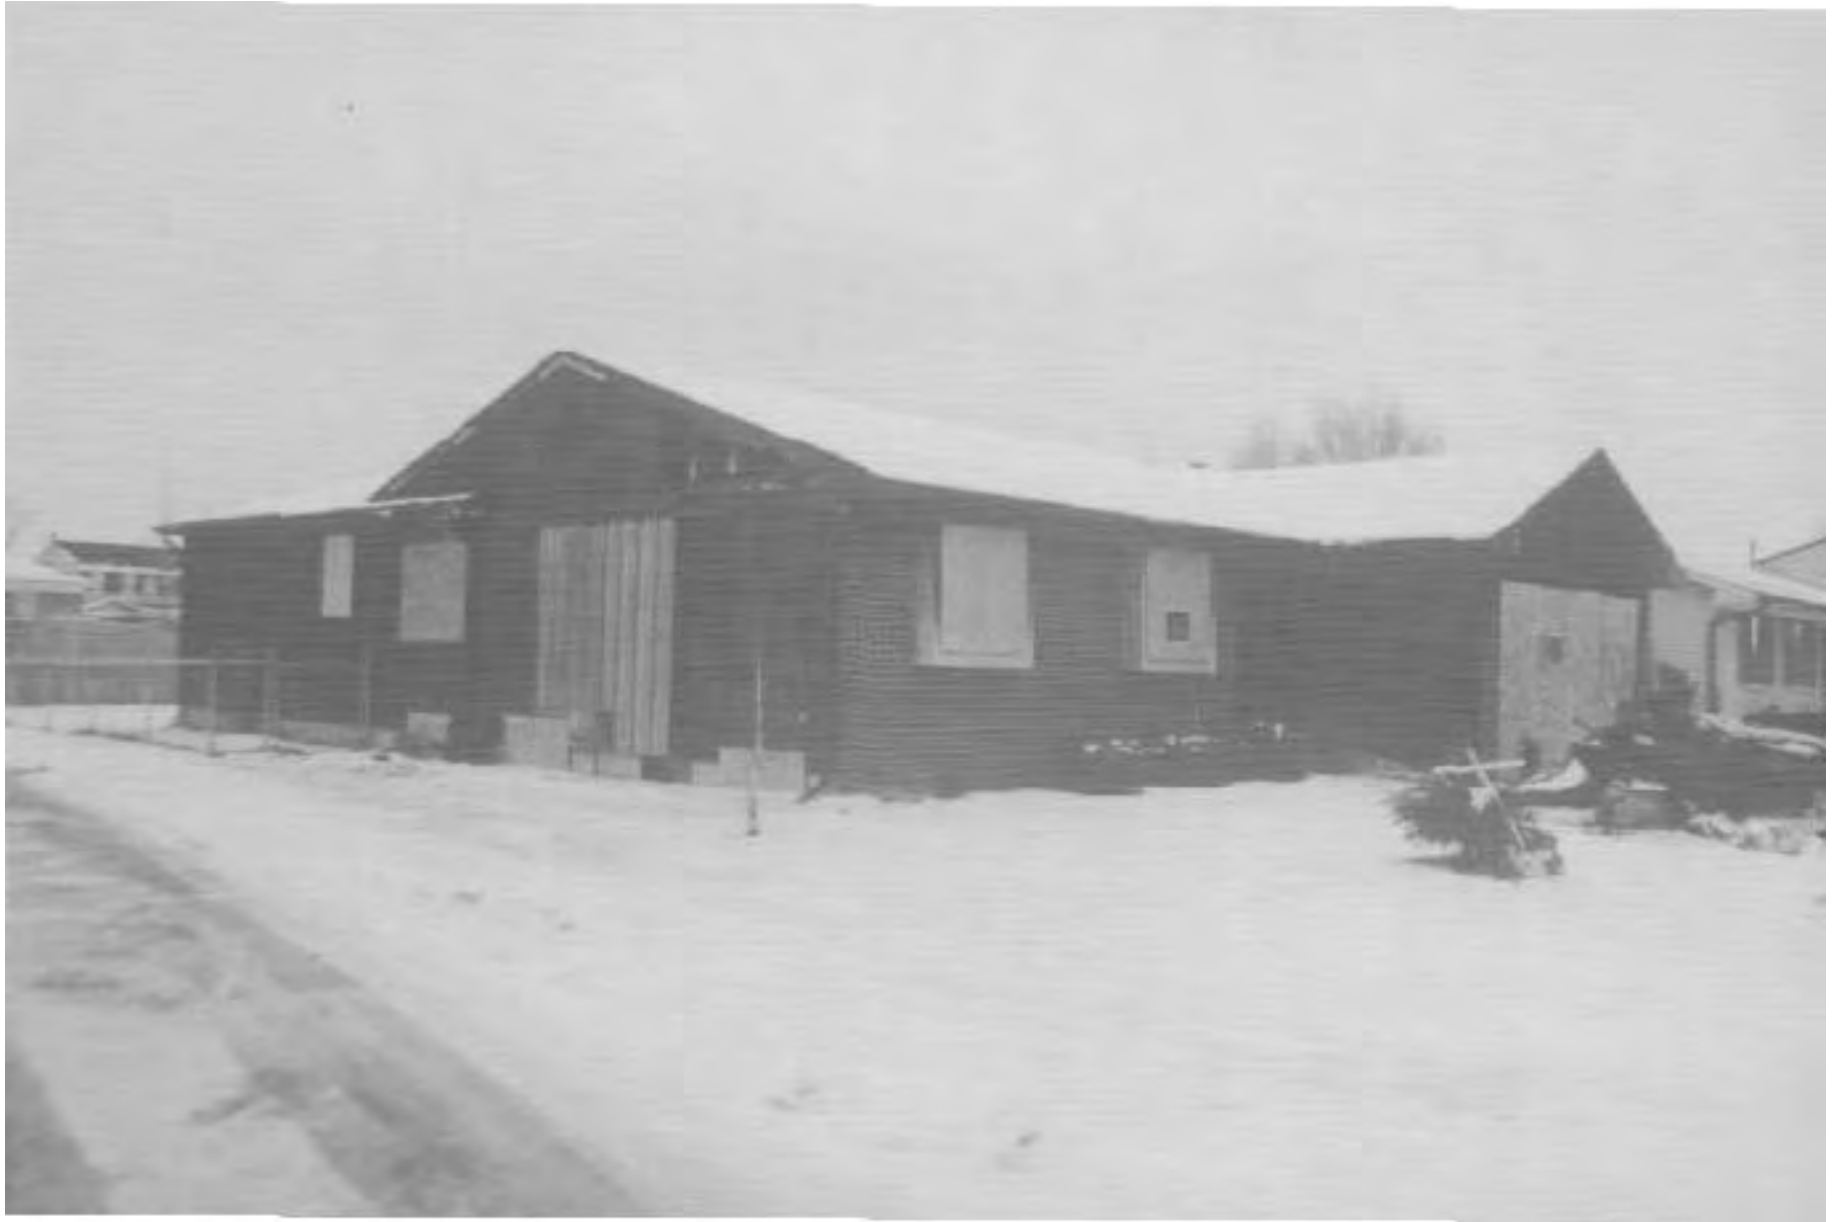
Front view of the home and exposure side two.

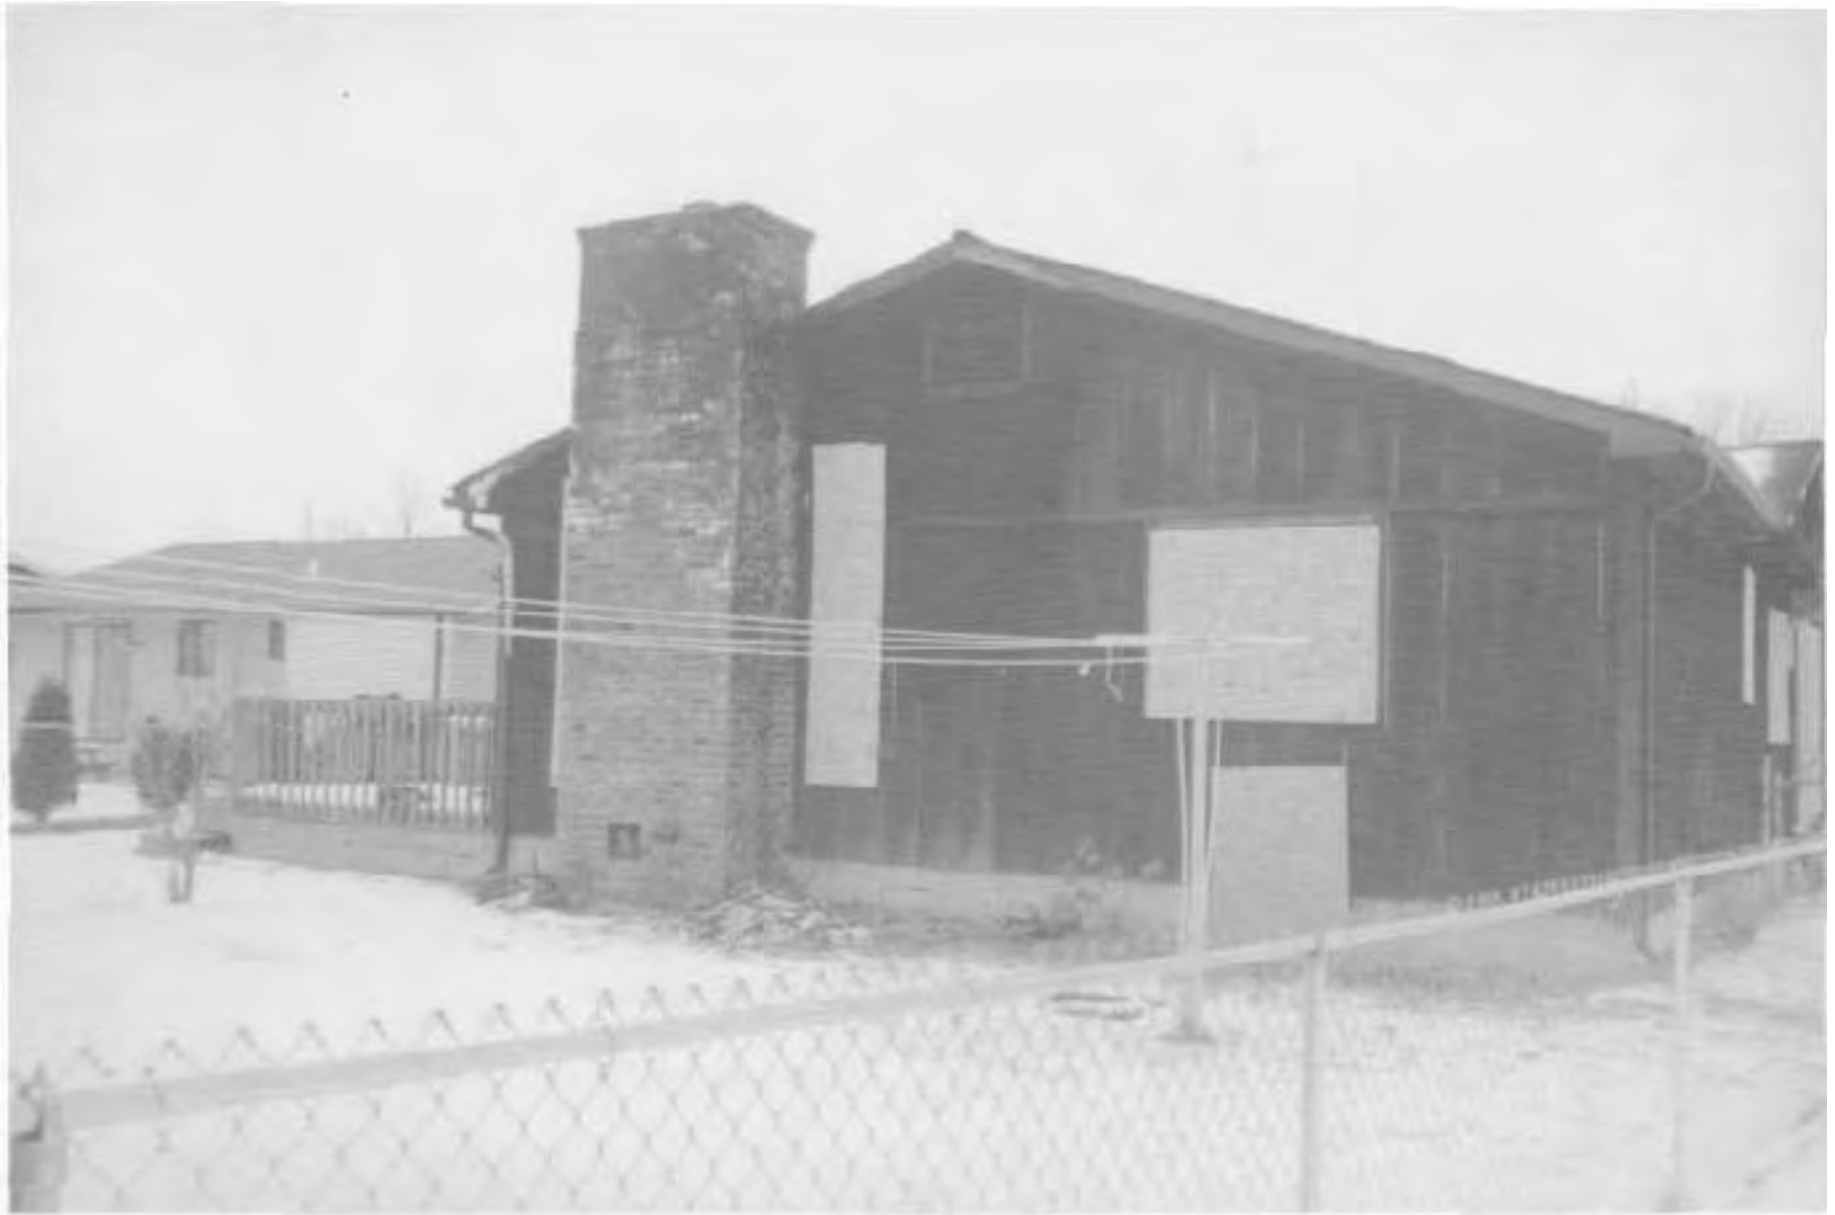
Rear view of the home, with no evidence of fire venting through the rear bedroom window.

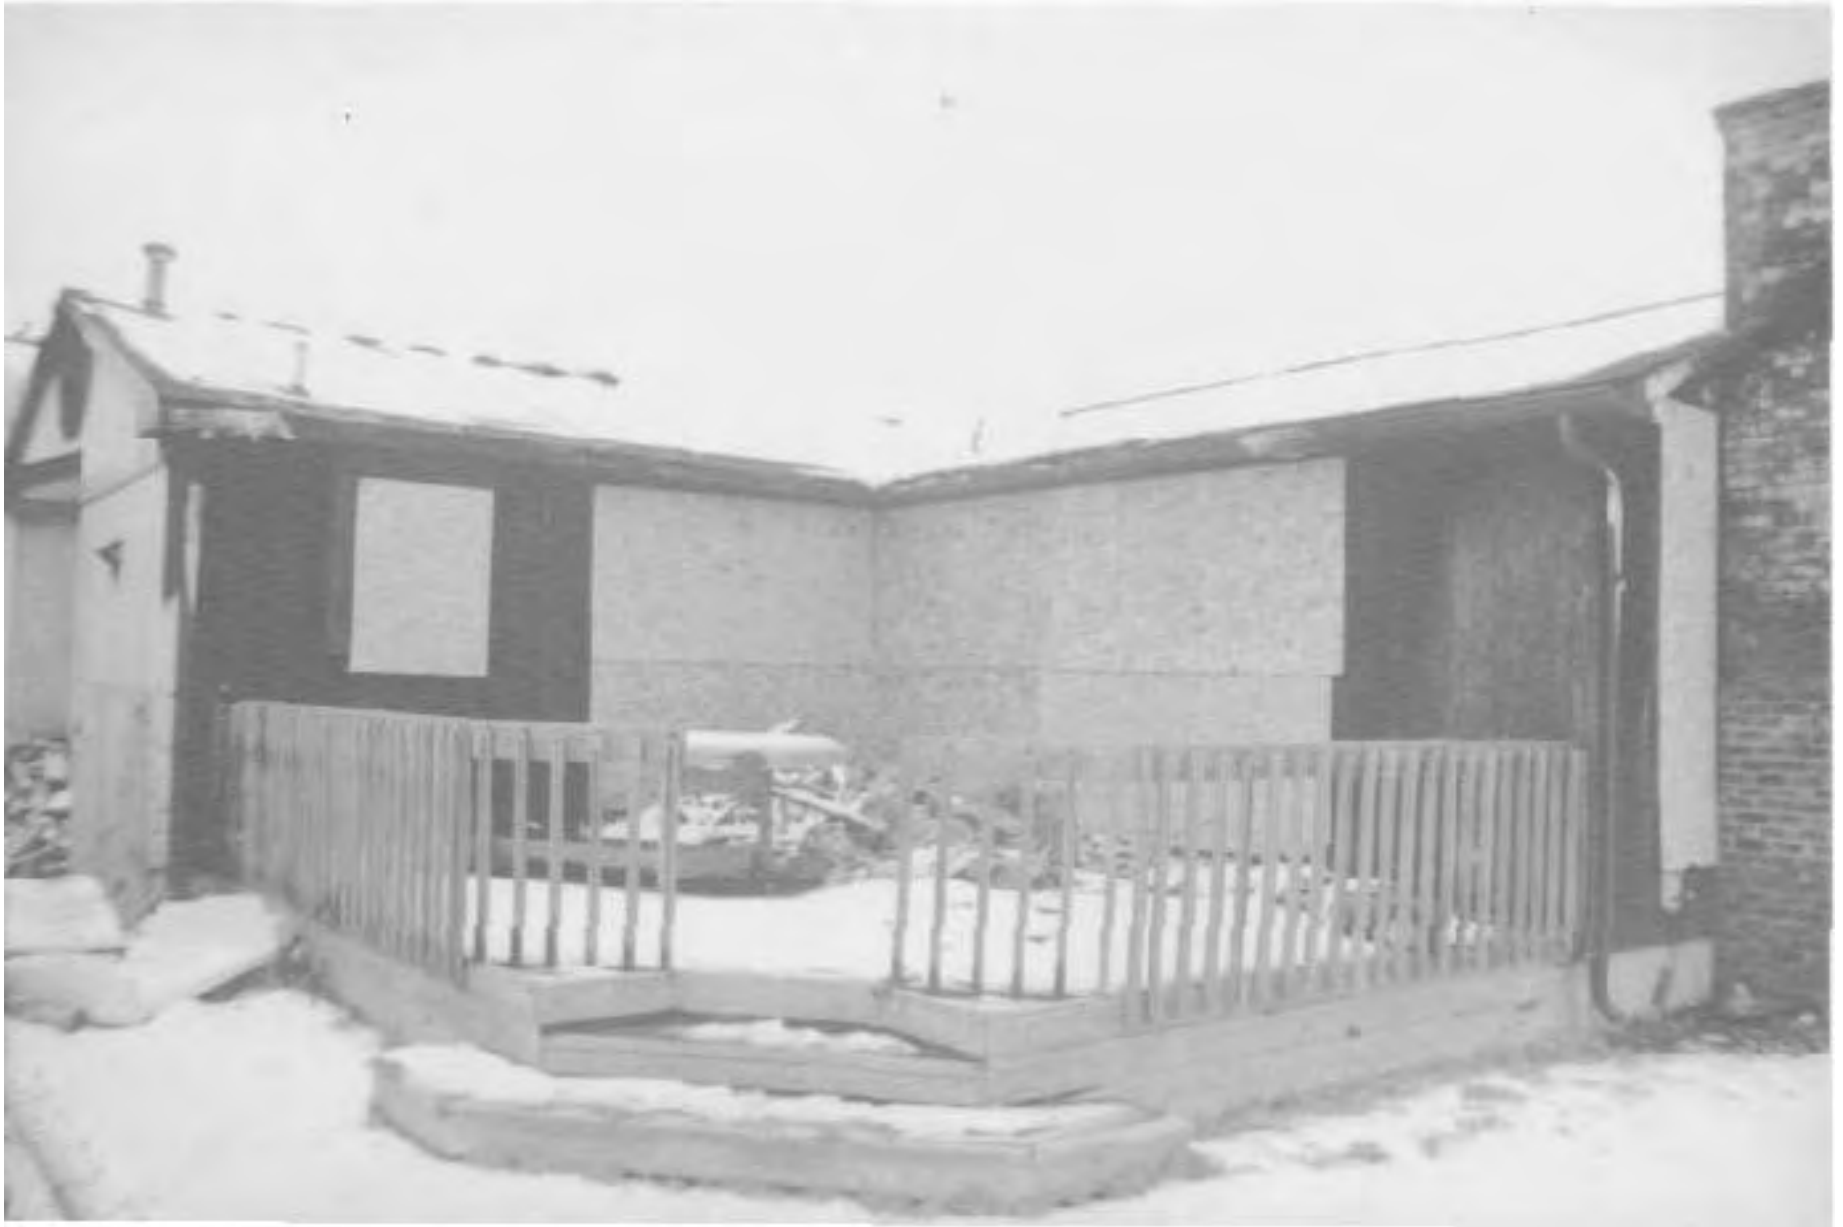
Rear deck. The French door opening to the family room is on the right, and the doorwall to the kitchen on the left,
