United States Fire Administration

Technical Report Series

High-rise Office Building Fire One Meridian Plaza Philadelphia, Pennsylvania

A fire on the 22nd floor of the 38-story Meridian Bank Building, also known as One Meridian Plaza, was reported to the Philadelphia Fire Department on February 23, 1991 at approximately 2040 hours and burned for more than 19 hours. The fire caused three firefighter fatalities and injuries to 24 firefighters. The 12-alarms brought 51 engine companies, 15 ladder companies, 11 specialized units, and over 300 firefighters to the scene. It was the largest high-rise office building fire in modern American history -- completely consuming eight floors of the building -- and was controlled only when it reached a floor that was protected by automatic sprinklers. A table summarizing the key aspects of the fire is presented on the following pages.

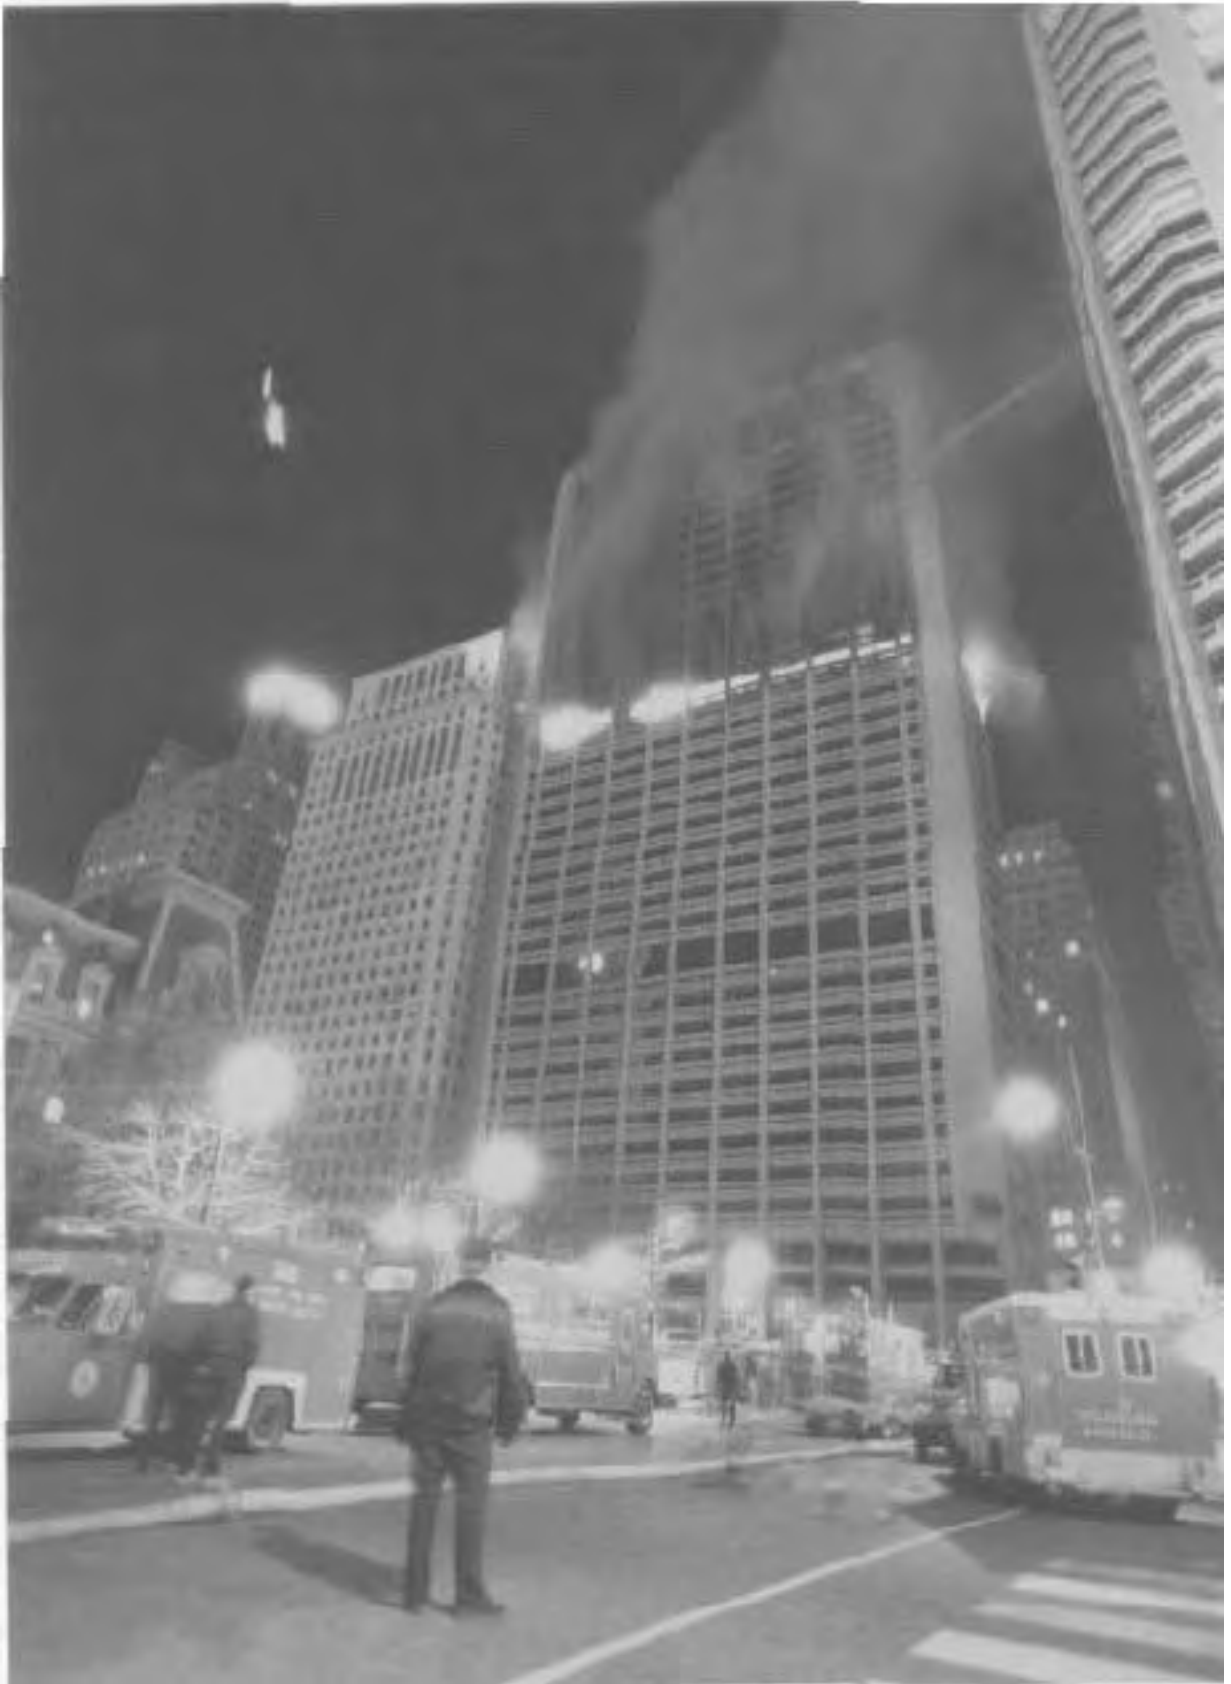
Exterior view of One Meridian Plaza and fireground operations in the early morning hours of February 24, 1991. Fire involves the 22nd, 23rd, 24th, and part of the 25th floors. Note the heavy stream played on the exterior from an adjacent building.

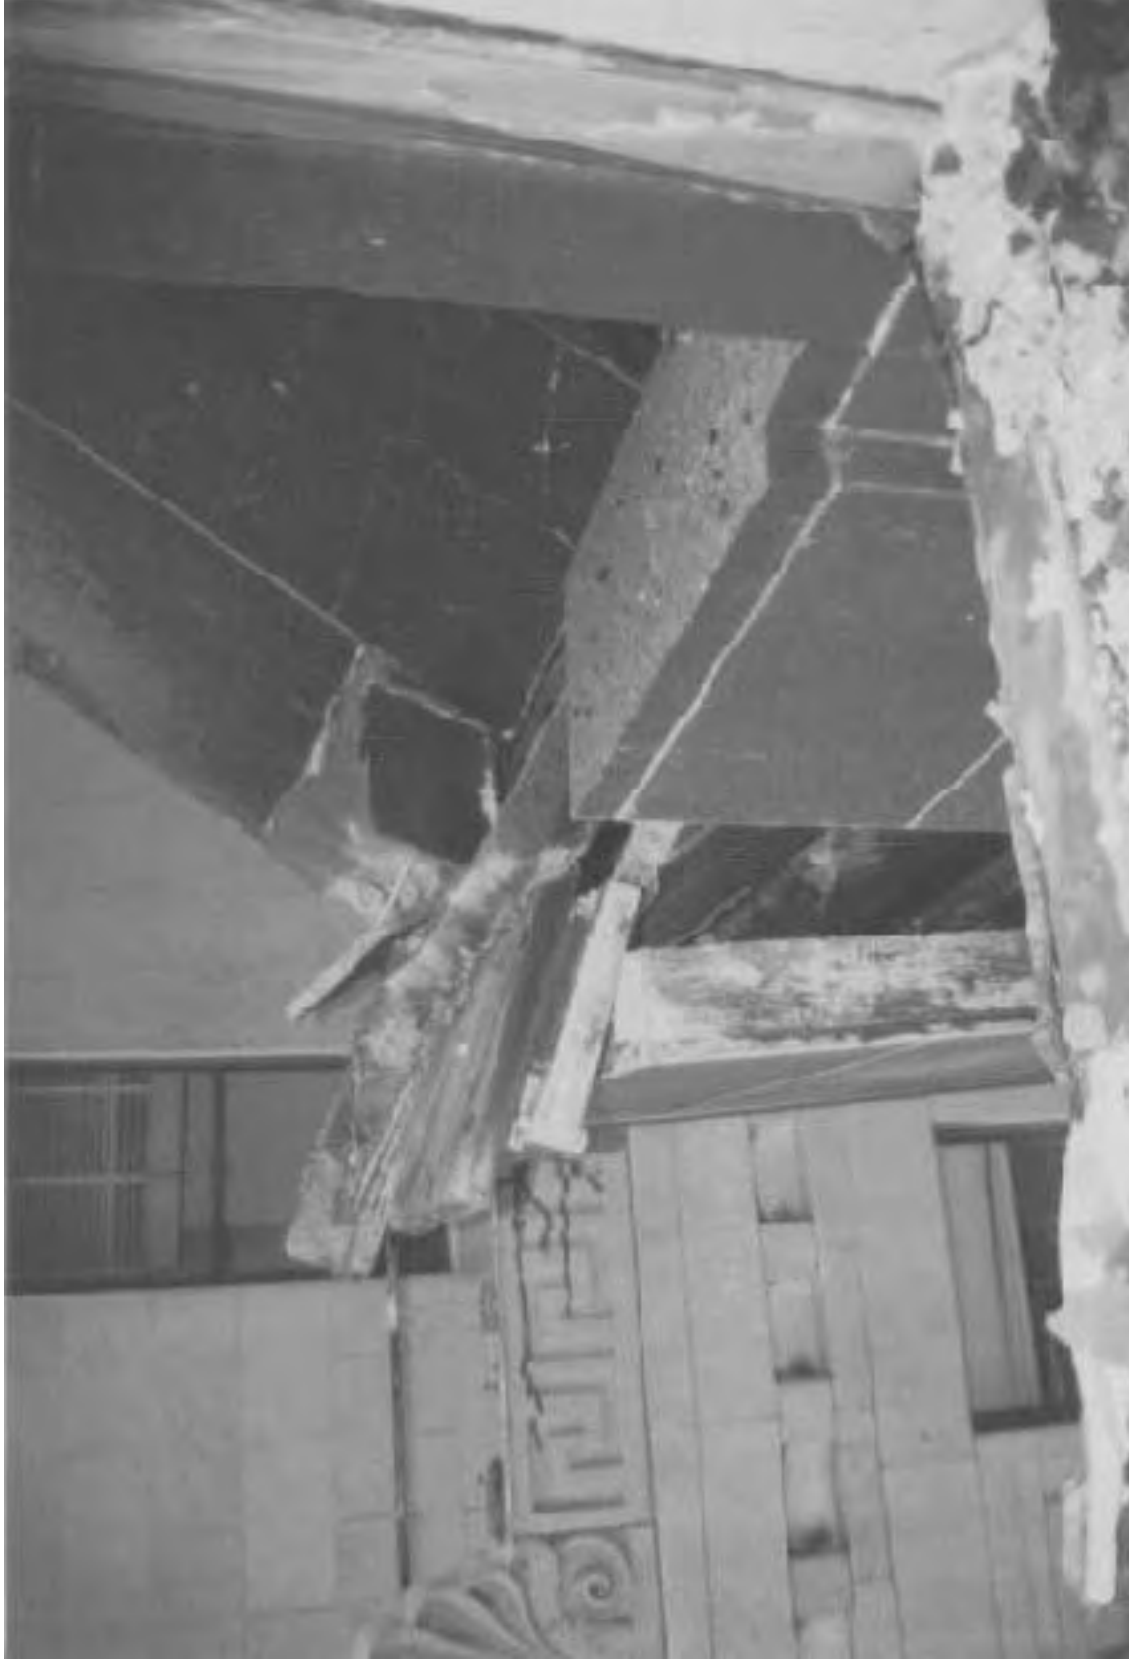
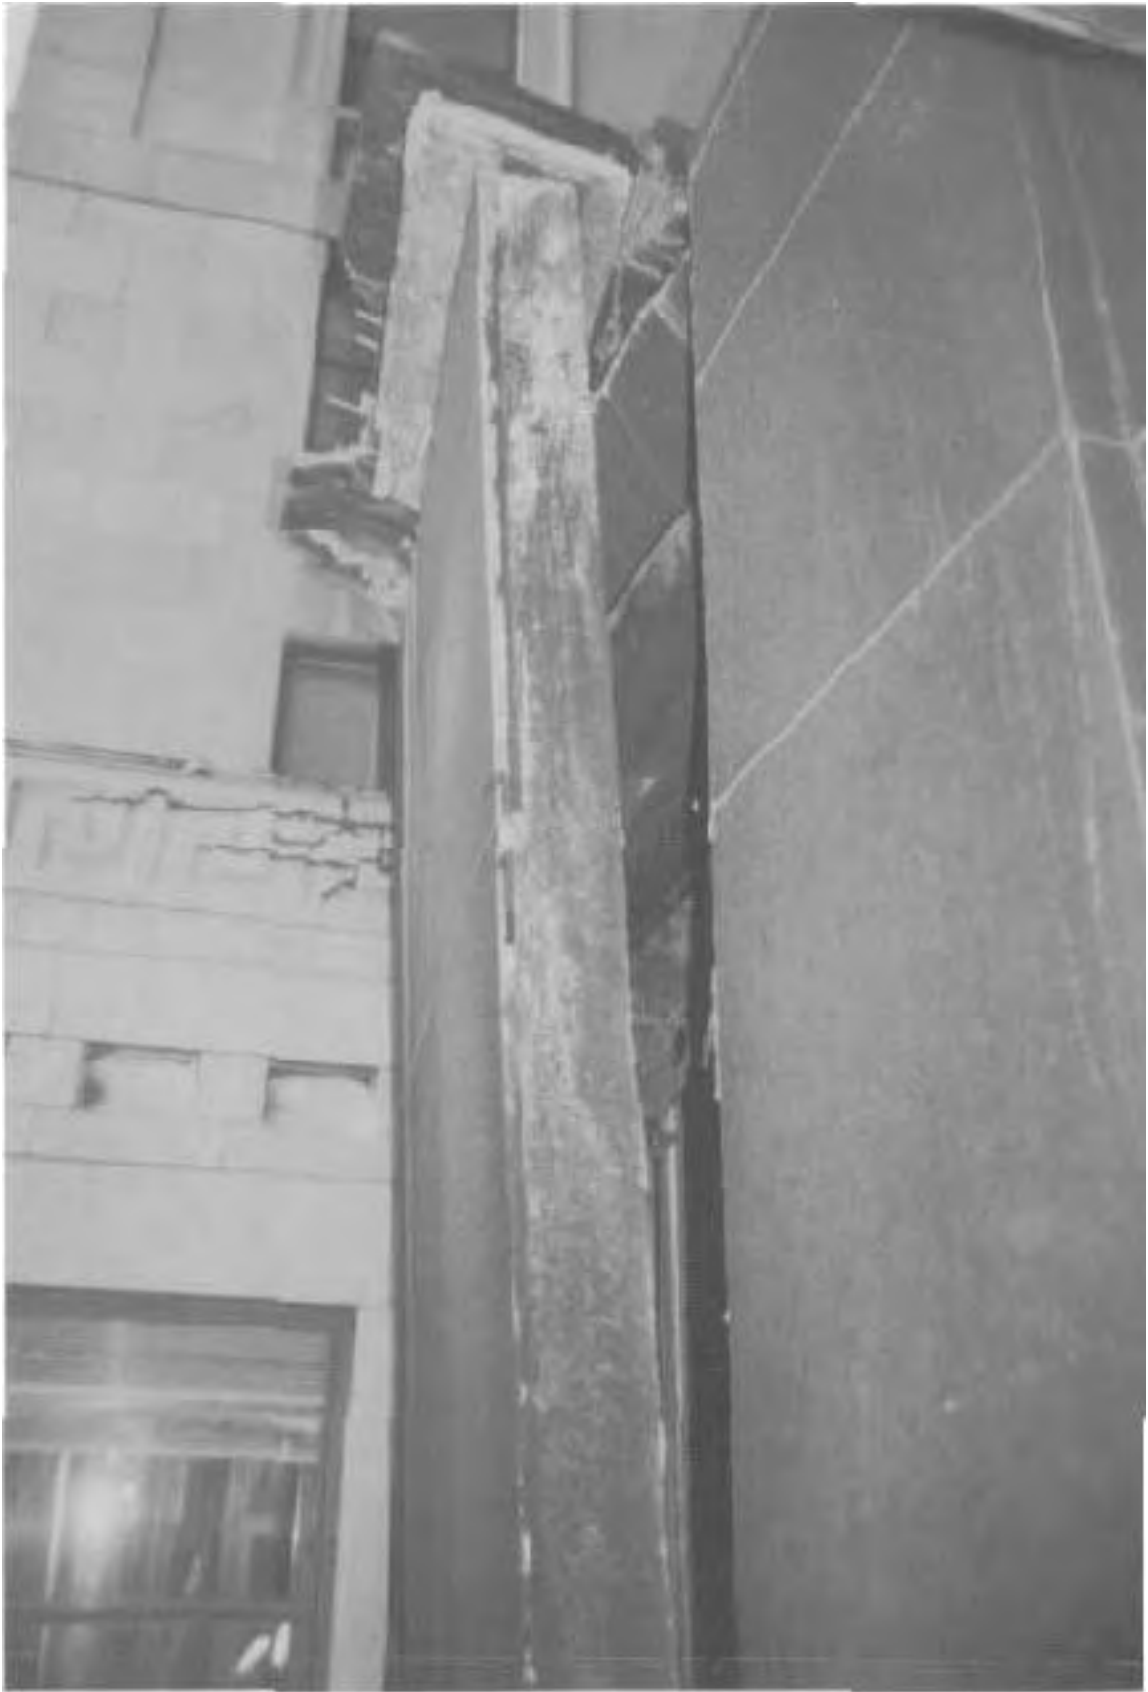
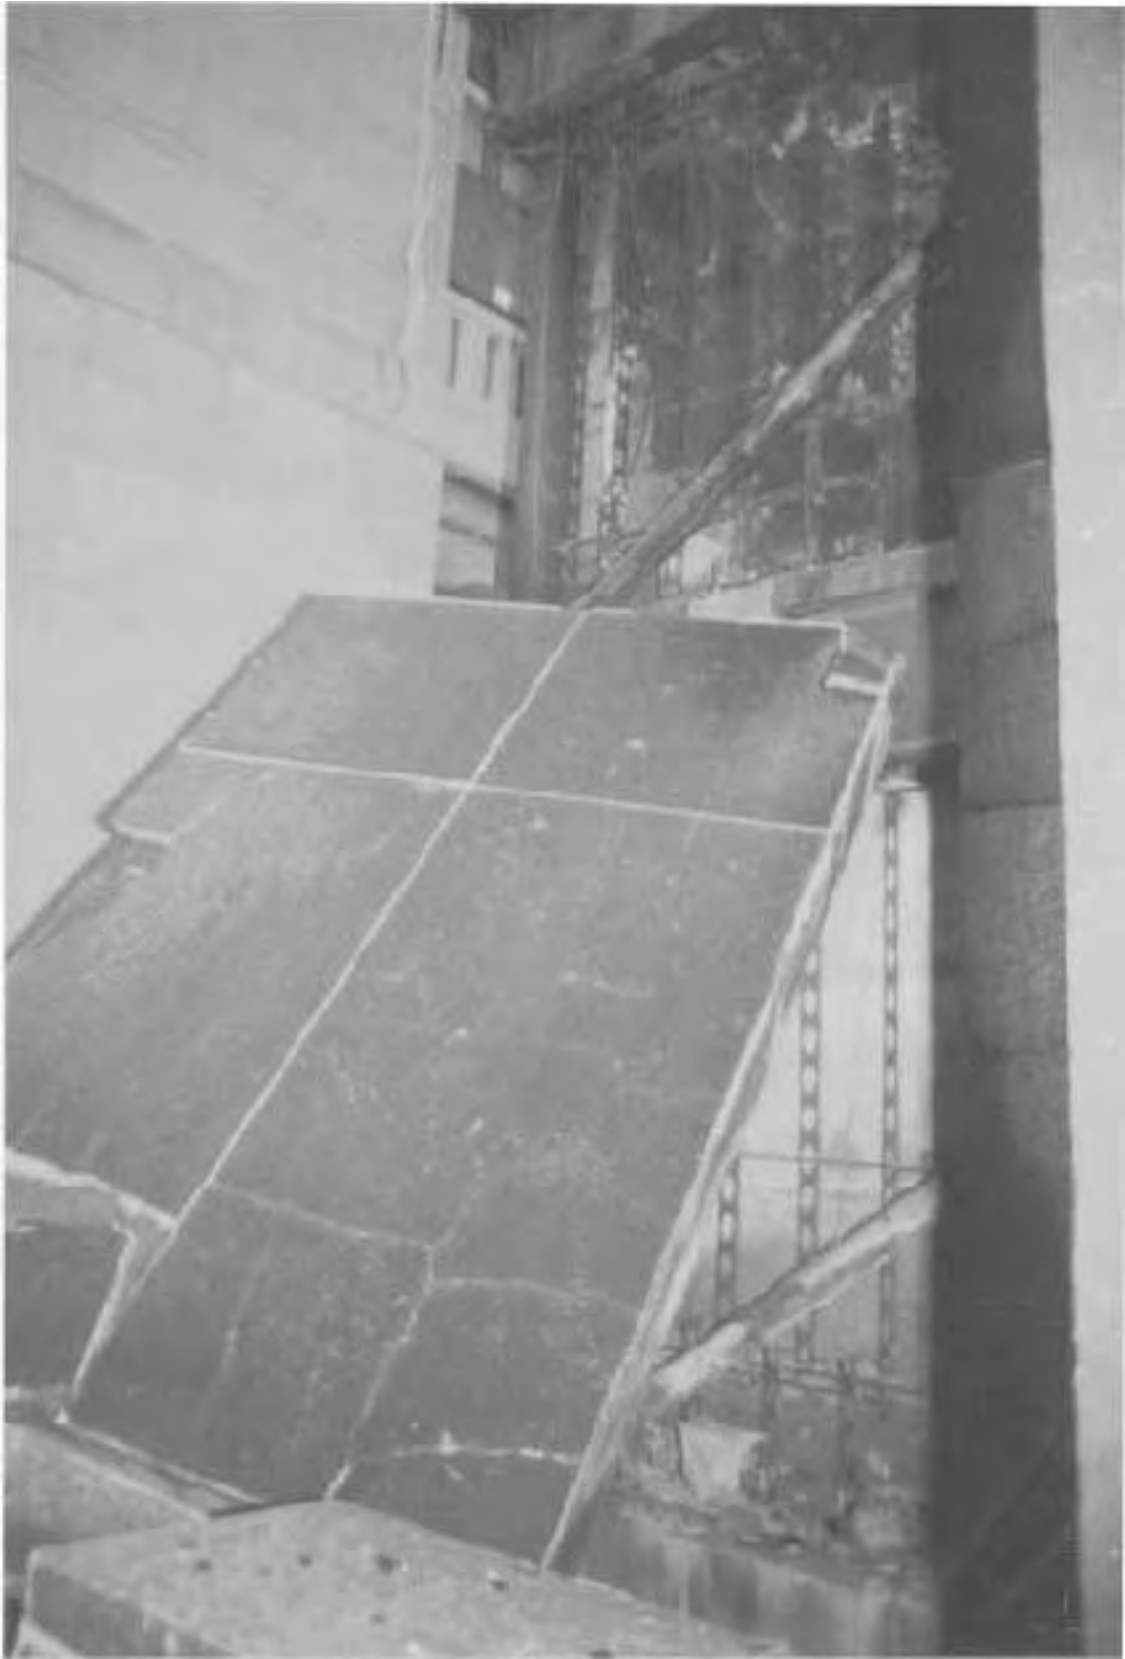
Here and in the next two photos exterior granite panels from the east stair tower were dislodged due to the thermal expansion of the steel frame of the building.

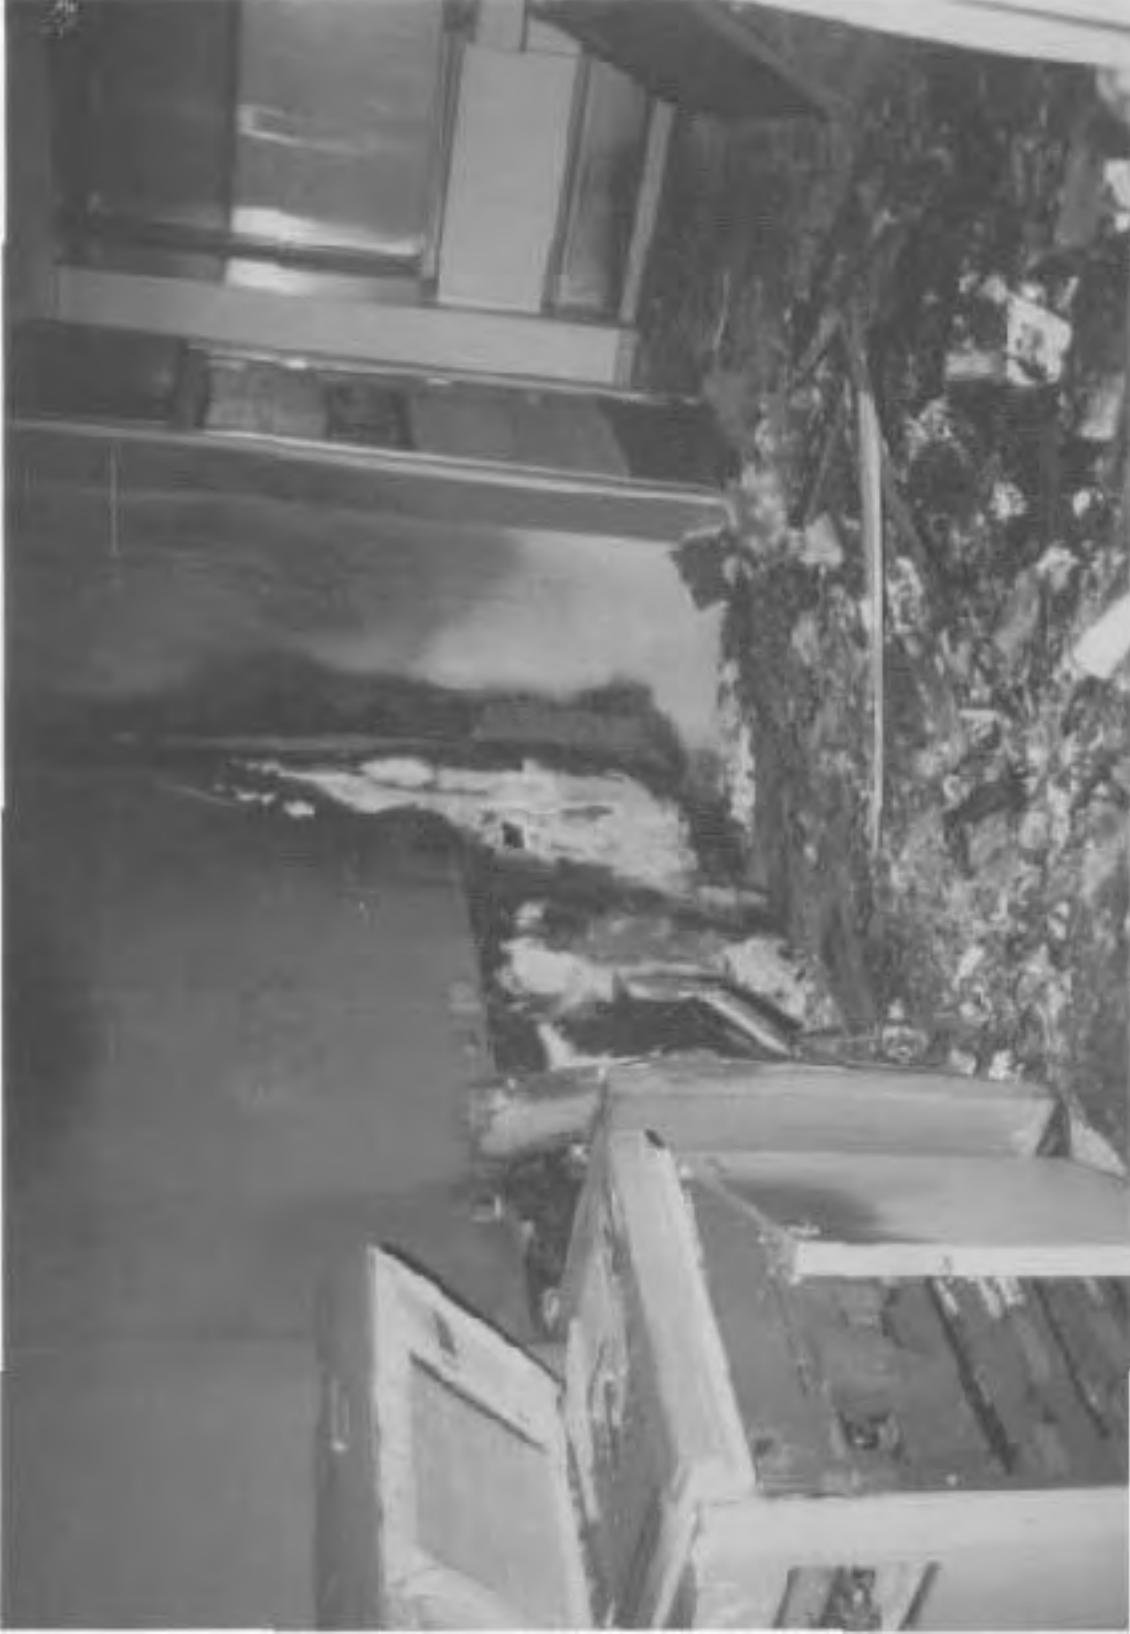
One of the areas of fire penetration on the 30th floor where a single sprinkler head activated to stop the upward extension of the fire.

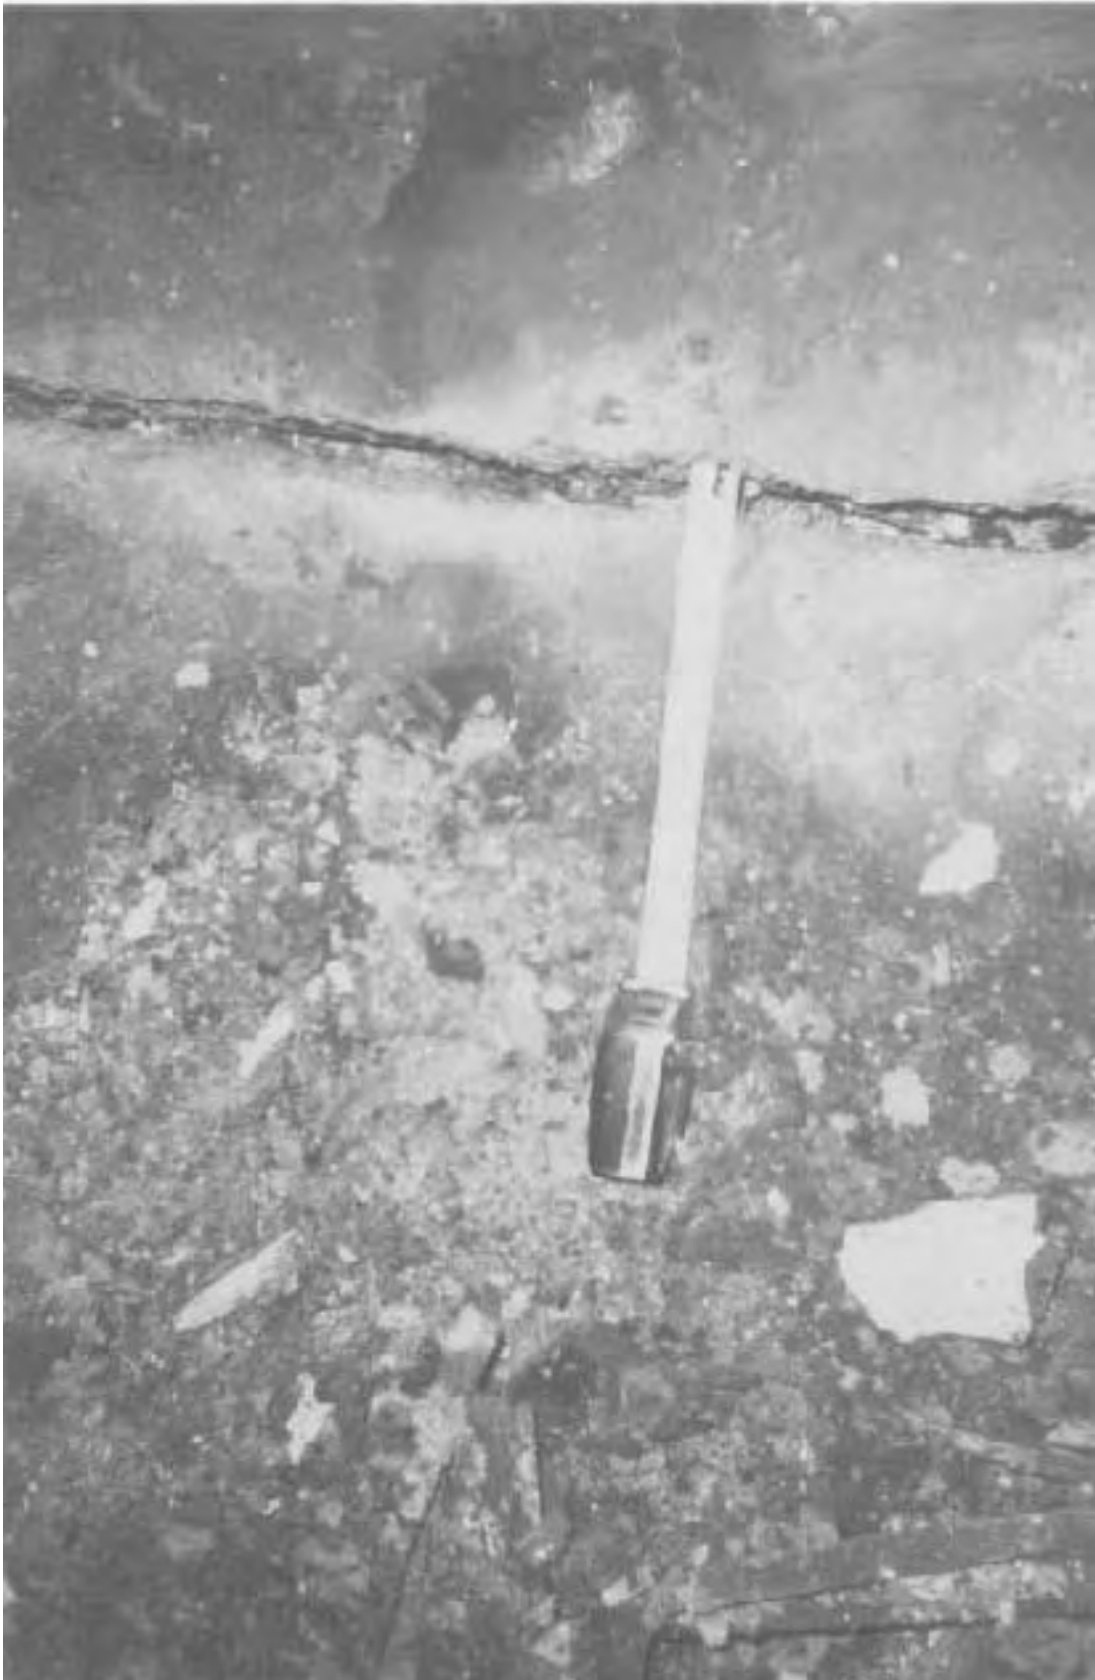
Prior to deciding to evacuate the building, firefighters noticed significant structural displacement occurring in the stair enclosures. A command officer indicated that cracks large enough to place a man's fist through developed at one point. One of the granite exterior wall panels on the east stair enclosure was dislodged by the thermal expansion of the steel framing behind it. After the fire, there was evident significant structural damage to horizontal steel members and floor sections on most of the fire damaged floors. Beams and girders sagged and twisted -- some as much as three feet -- under severe fire exposures, and fissures developed in the reinforced concrete floor assemblies in many places. Despite this extraordinary exposure, the columns continued to support their loads without obvious damage.

Close-up of crack in concrete floor, 28th floor.

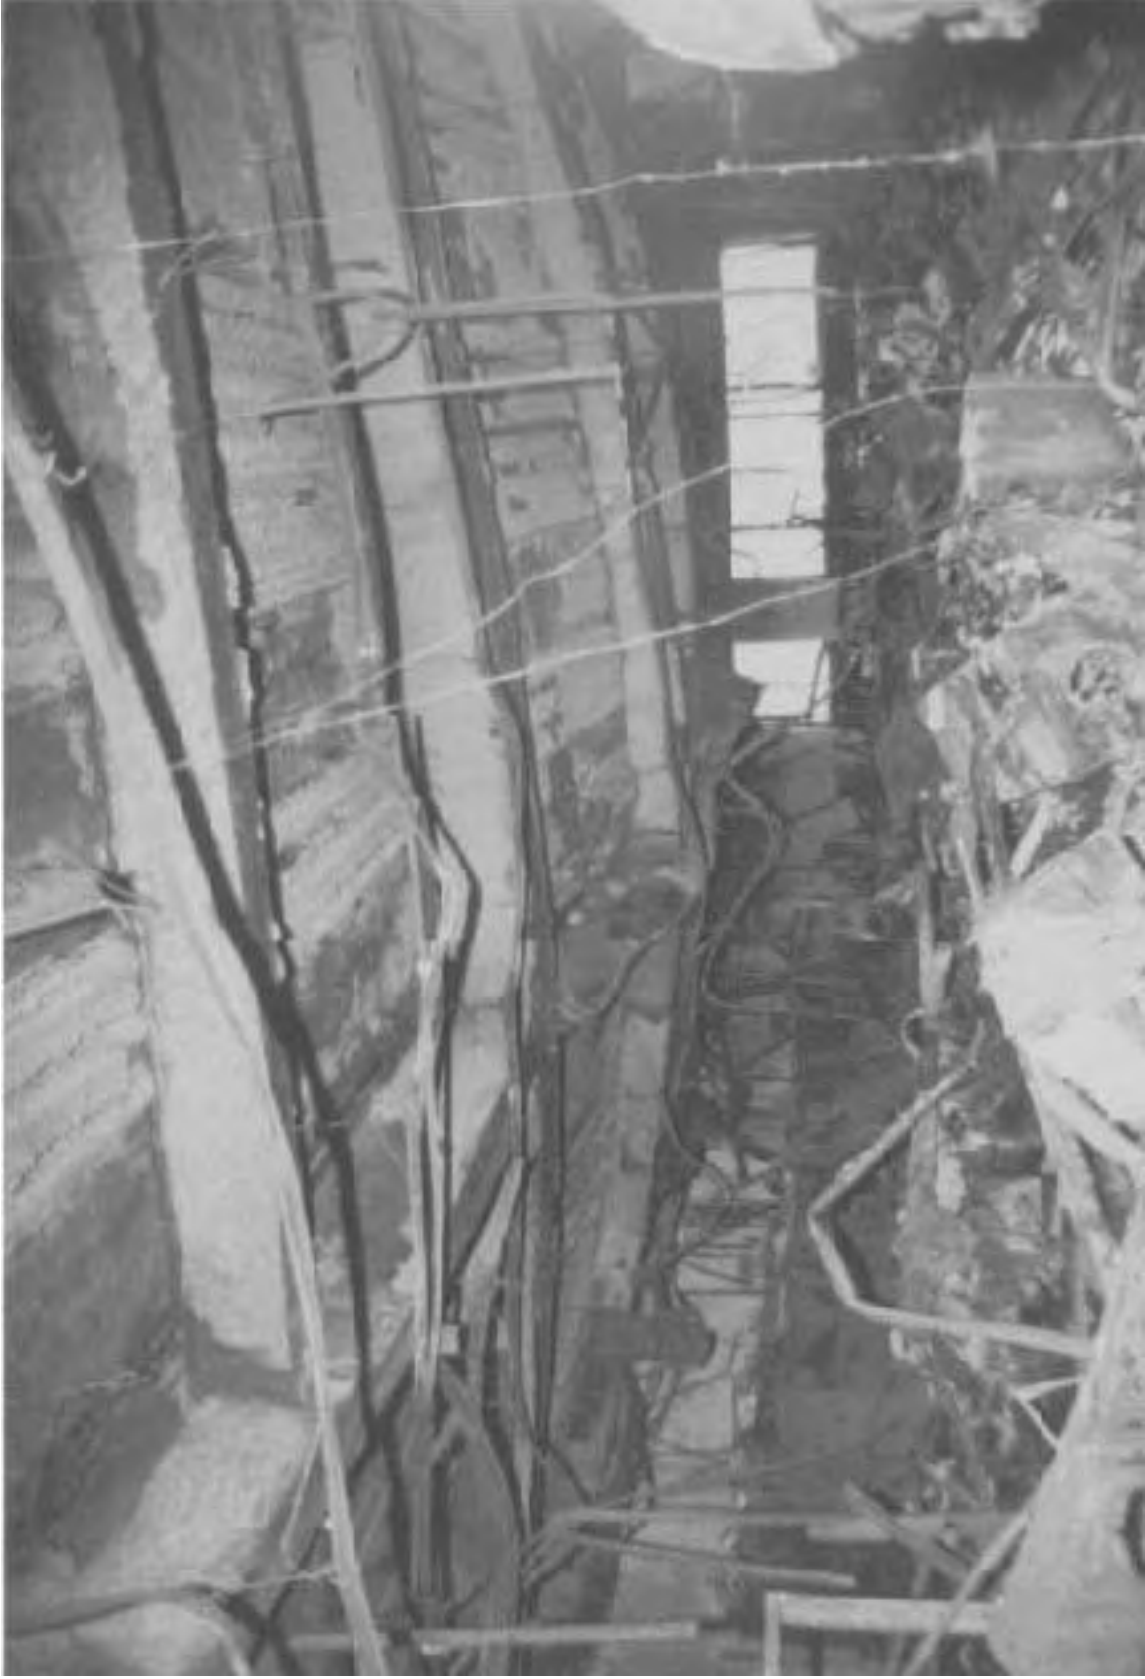
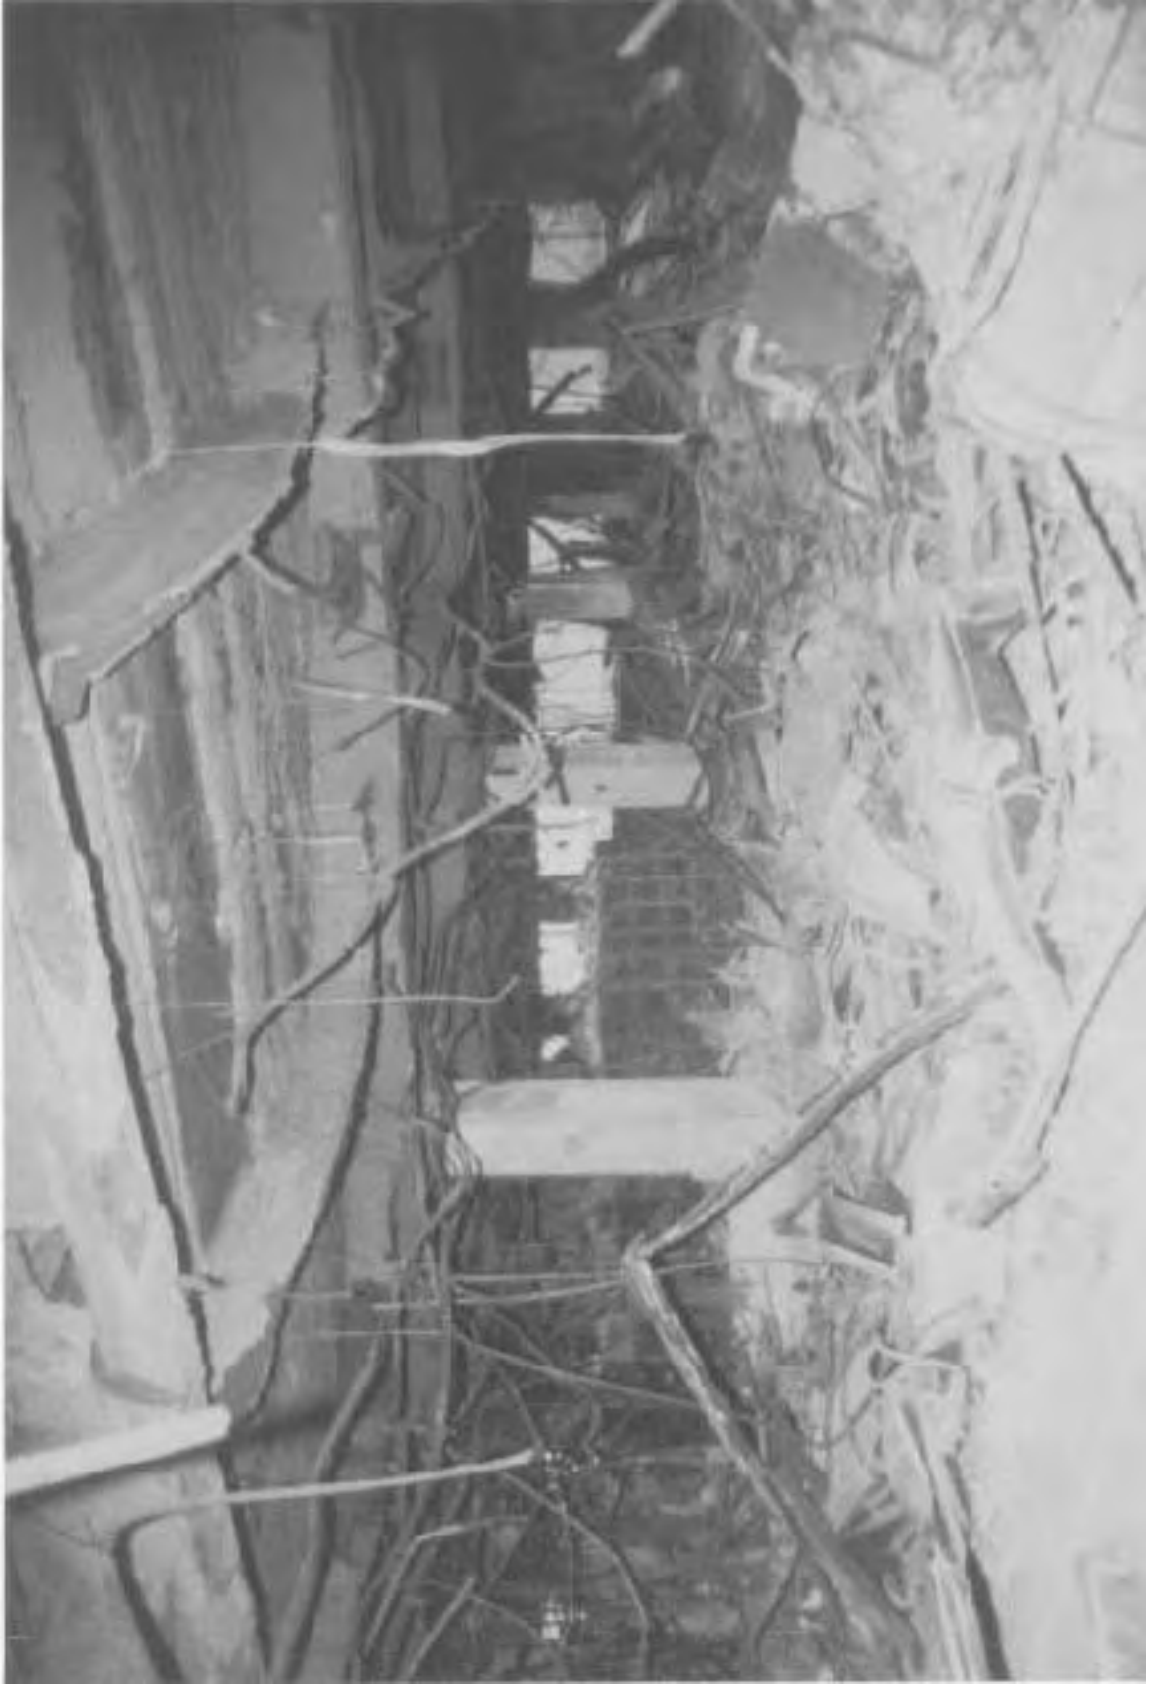
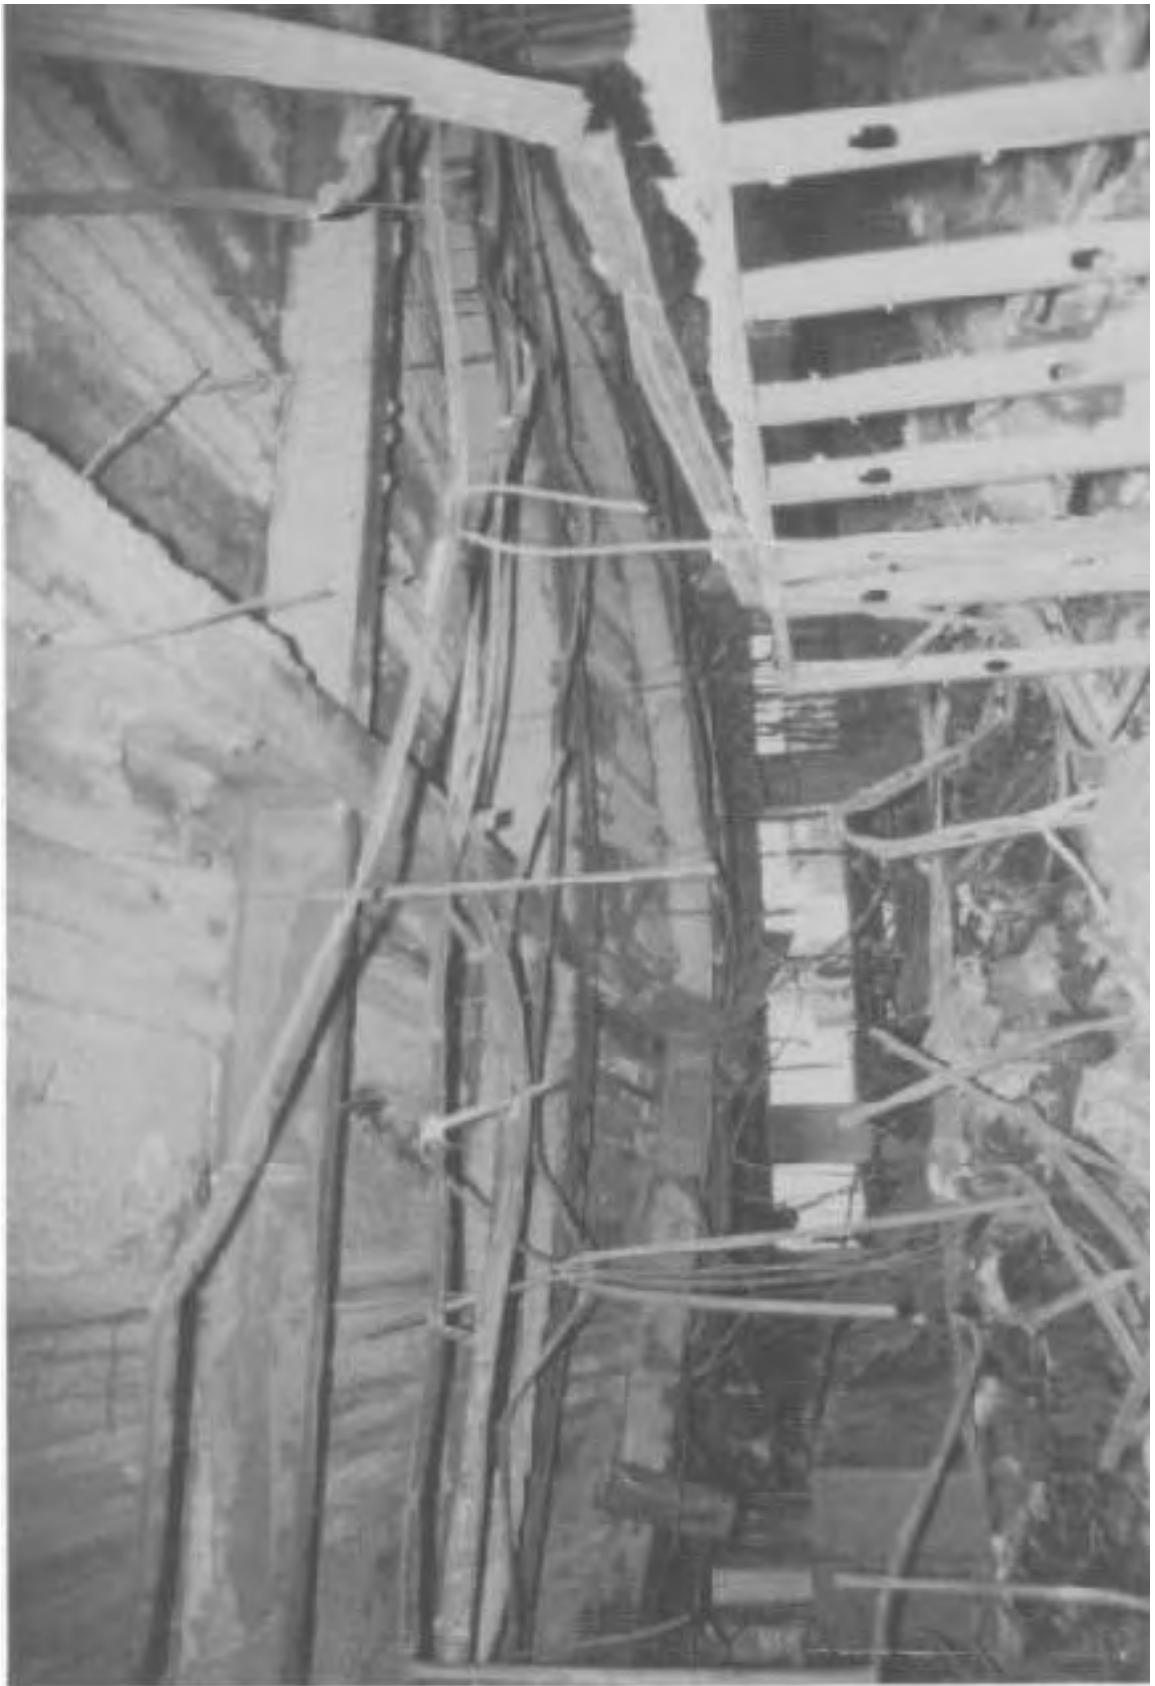
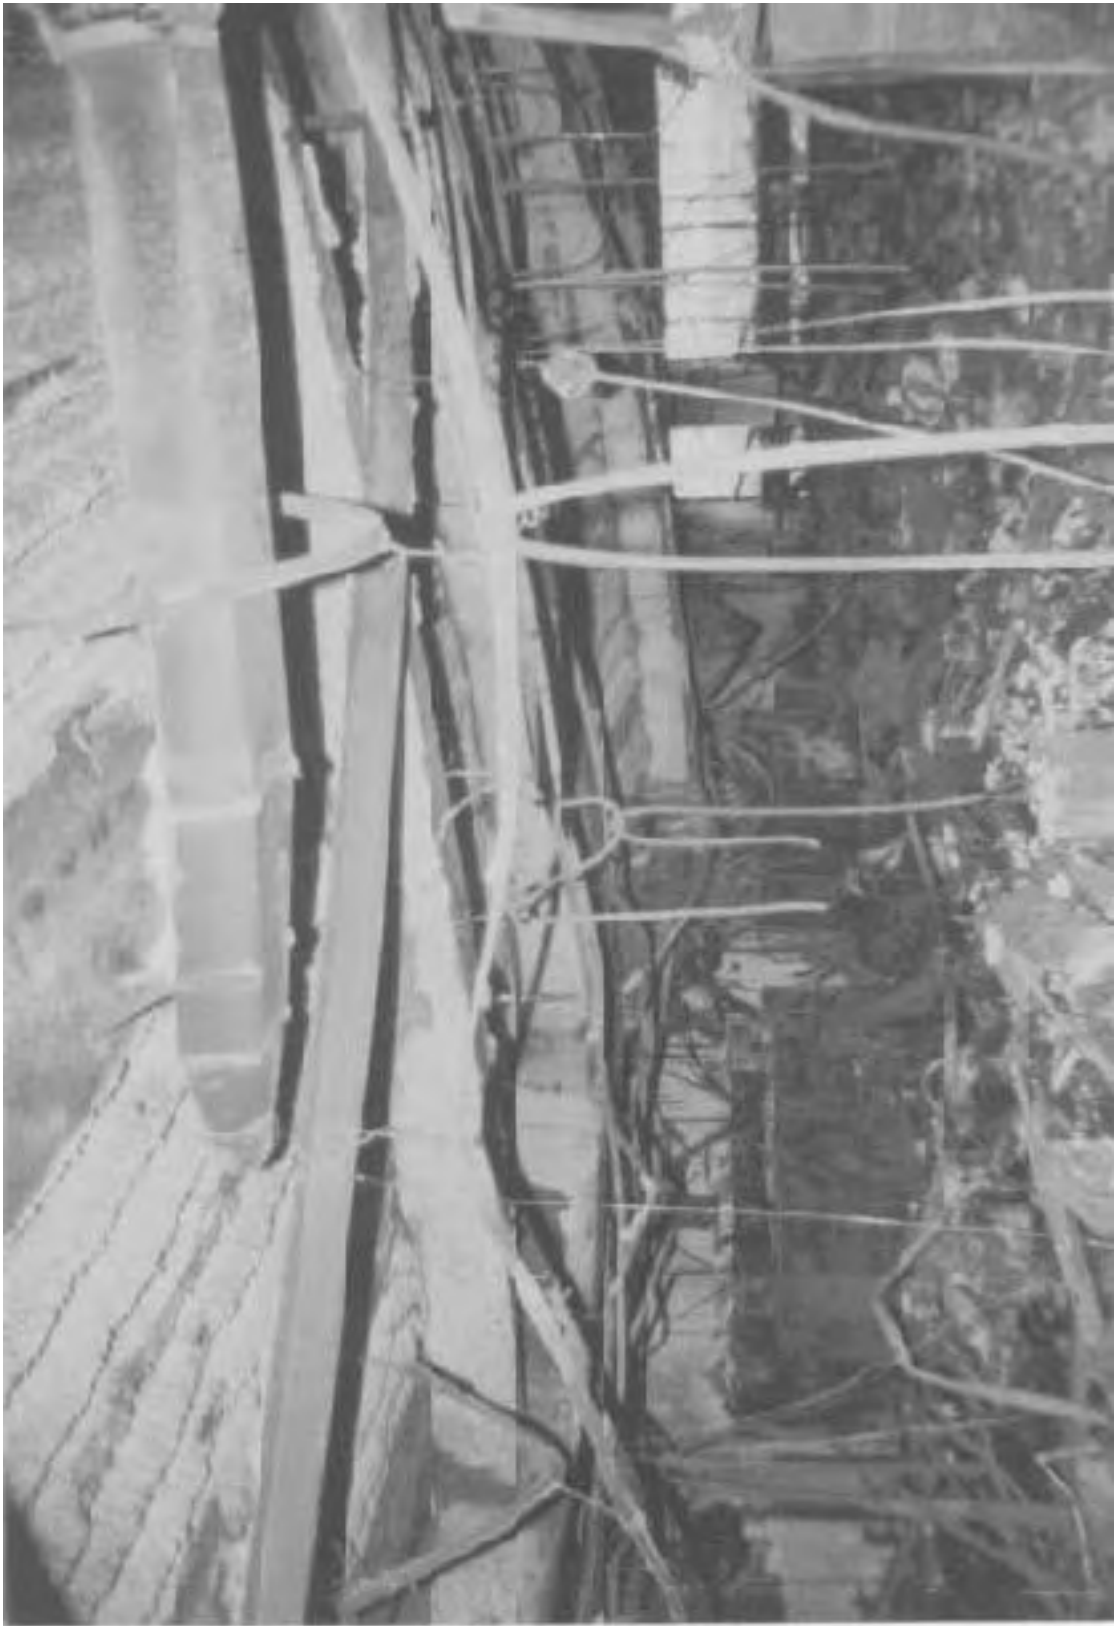
Here and in the next three photos are interior views of floor areas after the fire. Note the total consumption of the available fuel and sagging of the floor deck of up to three feet between columns.

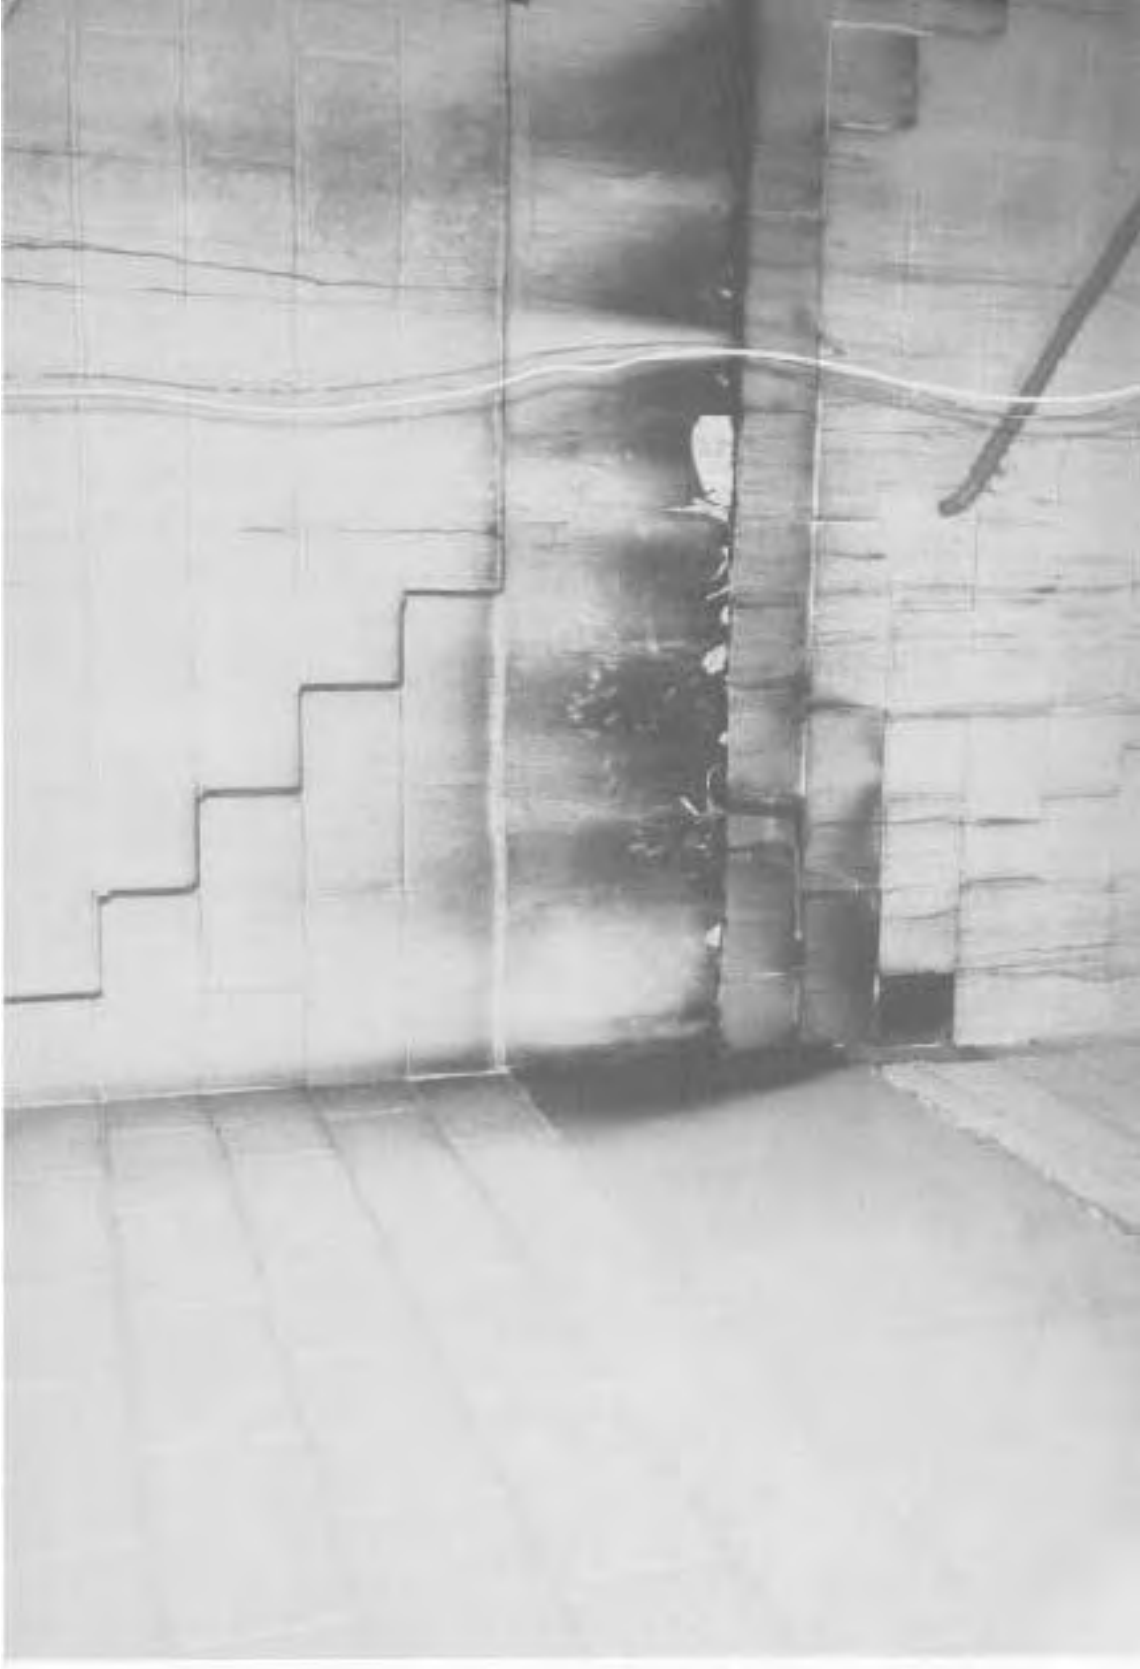
Fire tower between 25th and 26th floors. Note heavy fire and smoke damage.
