United States Fire Administration

Technical Report Series

High-rise Office Building Fire One Meridian Plaza Philadelphia, Pennsylvania

A fire on the 22nd floor of the 38-story Meridian Bank Building, also known as One Meridian Plaza, was reported to the Philadelphia Fire Department on February 23, 1991 at approximately 2040 hours and burned for more than 19 hours. The fire caused three firefighter fatalities and injuries to 24 firefighters. The 12-alarms brought 51 engine companies, 15 ladder companies, 11 specialized units, and over 300 firefighters to the scene. It was the largest high-rise office building fire in modern American history -- completely consuming eight floors of the building -- and was controlled only when it reached a floor that was protected by automatic sprinklers. A table summarizing the key aspects of the fire is presented on the following pages.

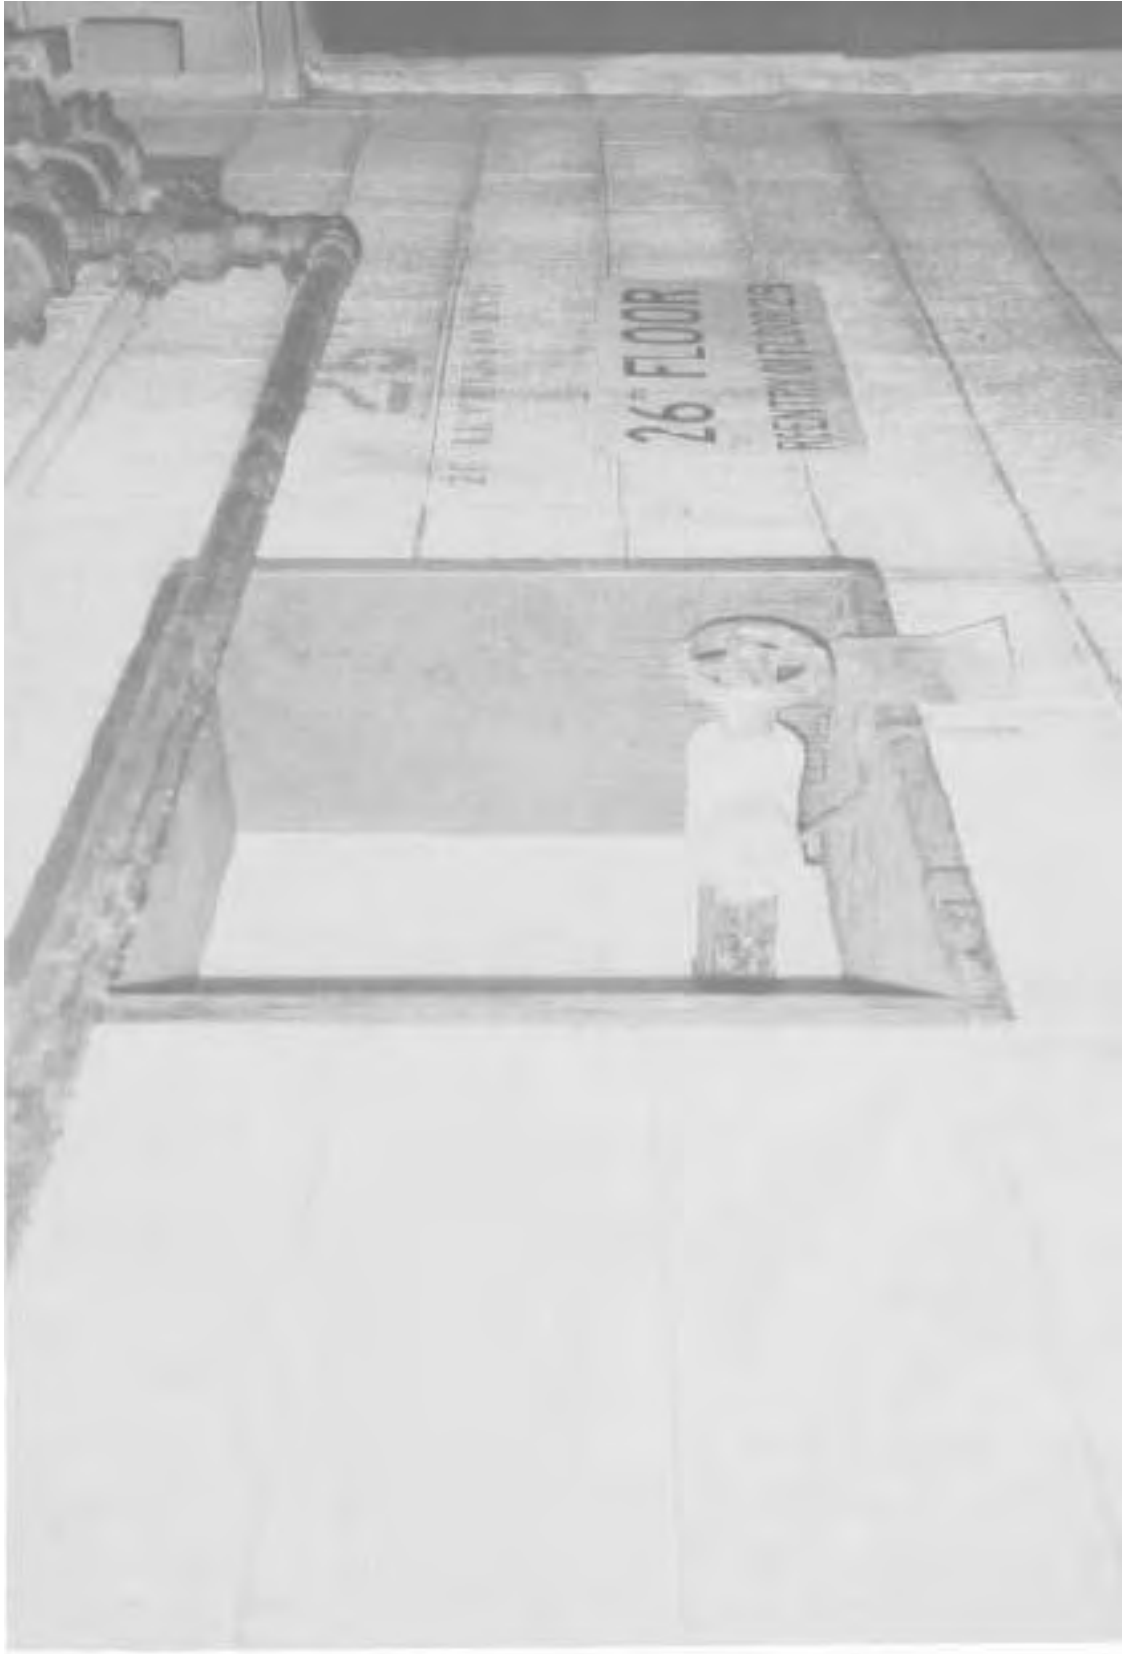
When the PRVs were originally installed, the pressure settings were improperly adjusted. Index values marked on the valves did not correspond directly to discharge pressures. To perform adjustments the factory and field personnel had to refer to tables in printed installation

The PRV equipped hose outlets on the 22nd floor of One Meridian Plaza, adjusted as reported at the time of the fire, would have produced nozzle pressures of approximately 40 psi. This is insufficient for a straight stream device and dangerously inadequate for a fog nozzle.

Standpipe hose outlet with pressure reducing valve (PRV), 26th floor.

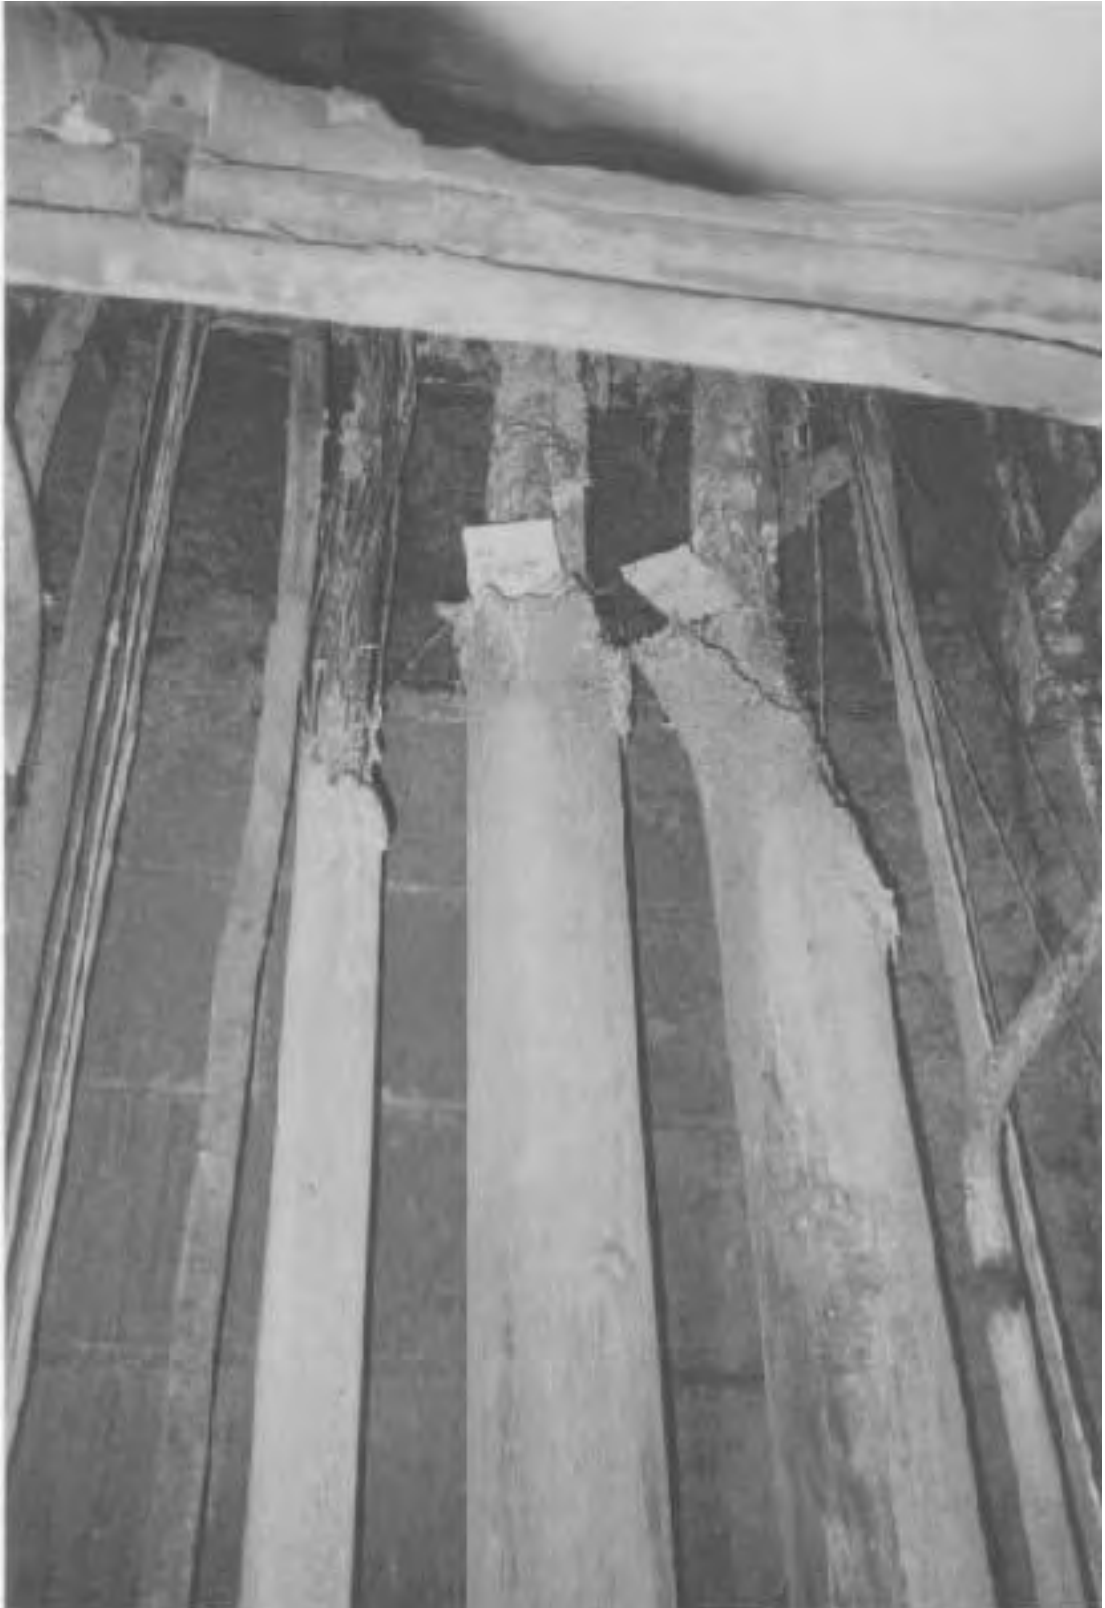
Electrical Systems	Installation of the primary and secondary electrical power risers in a common unprotected enclosure resulted in a complete power failure when the fire-damaged conductors shorted to ground. The natural gas powered emergency generator also failed.

Shortly after the battalion chief and the attack team reached the 11th floor there was a total loss of electrical power in the building. This resulted when intense heat from the fire floor penetrated the electrical room enclosure. The heat caused the cable insulation to melt resulting in a short between the conductor and the conduit in both the primary and secondary power feeds, and the loss of both commercial power sources. The emergency generator should have activated automatically, but it failed to produce electric power. These events left the entire building without electricity for the duration of the incident in spite of several efforts to restore commercial power and to obtain power from the generator.

Electrical shaft enclosure on the 30th floor, showing side-by-side risers for the two power supplies, both damaged by fire penetration at the plenum level of the adjoining office space.

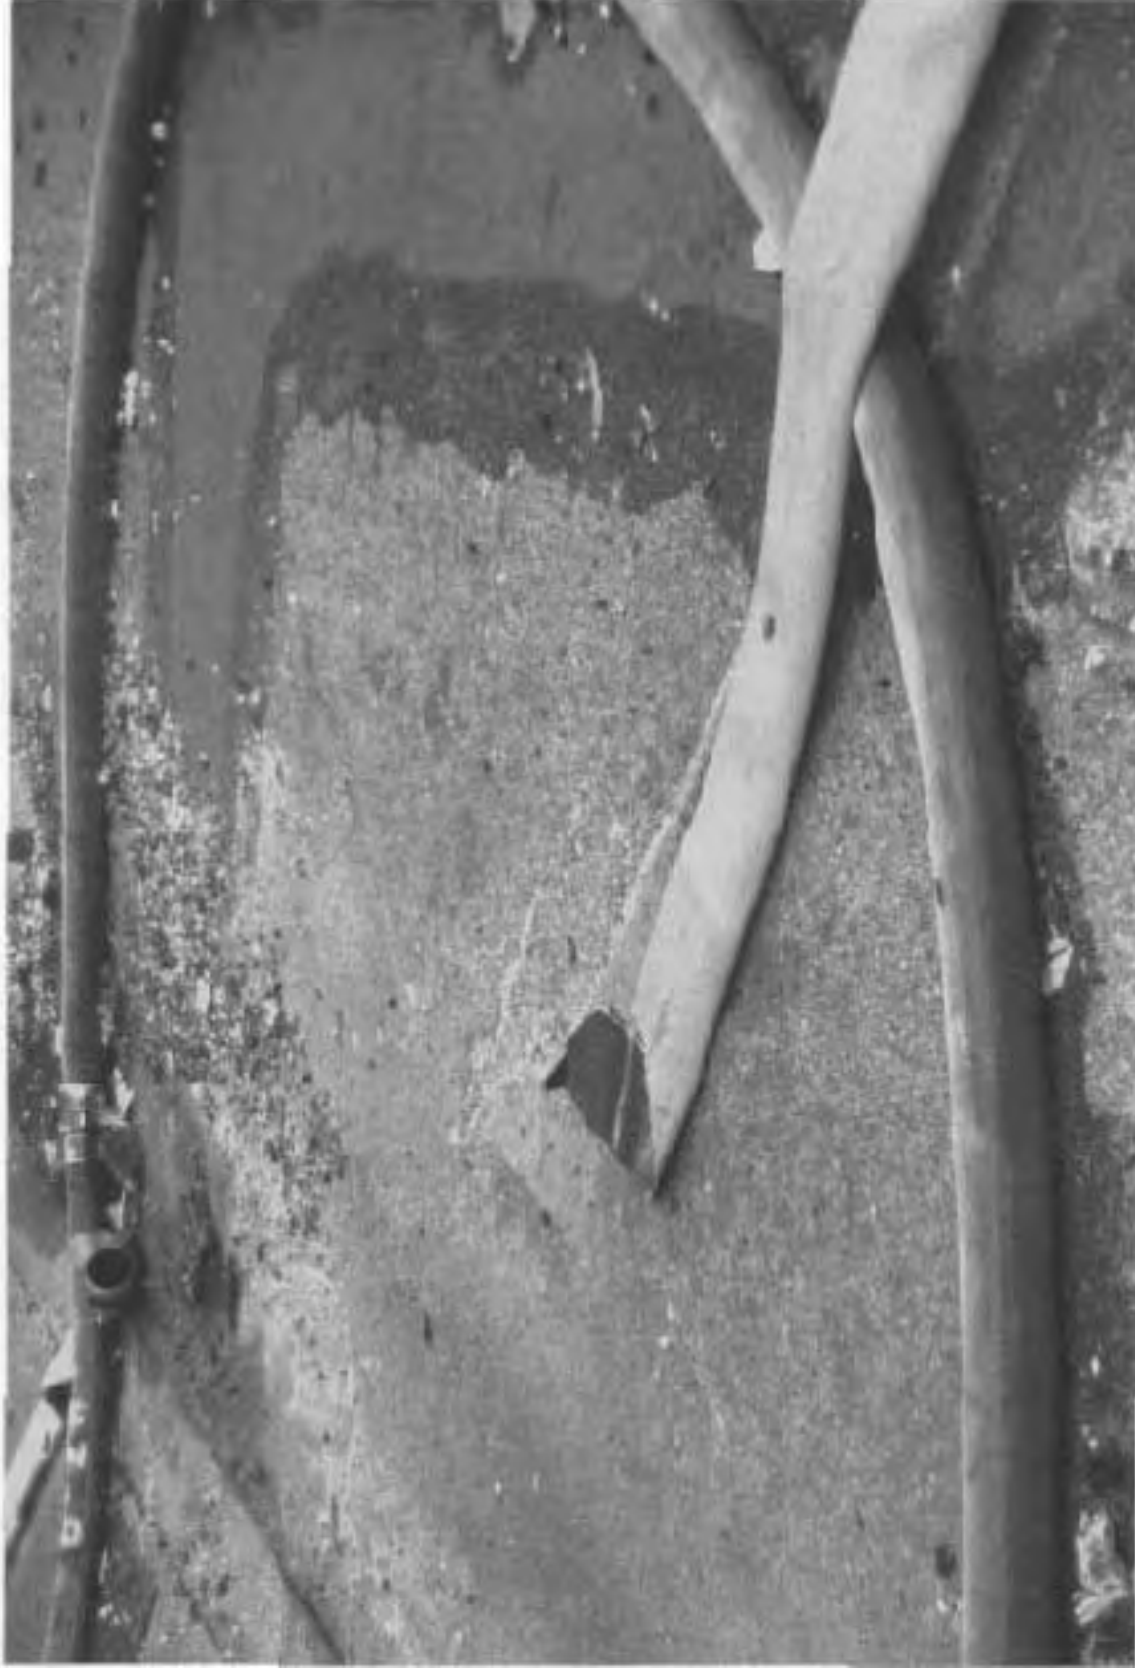
Section of 5-inch hose that was ruptured by falling debris outside the building. Hose lines feeding the standpipes and entering the stairways were damaged several times and had to be replaced at great risk to firefighters.

(Shoring boards were later used to protect the hose lines.)

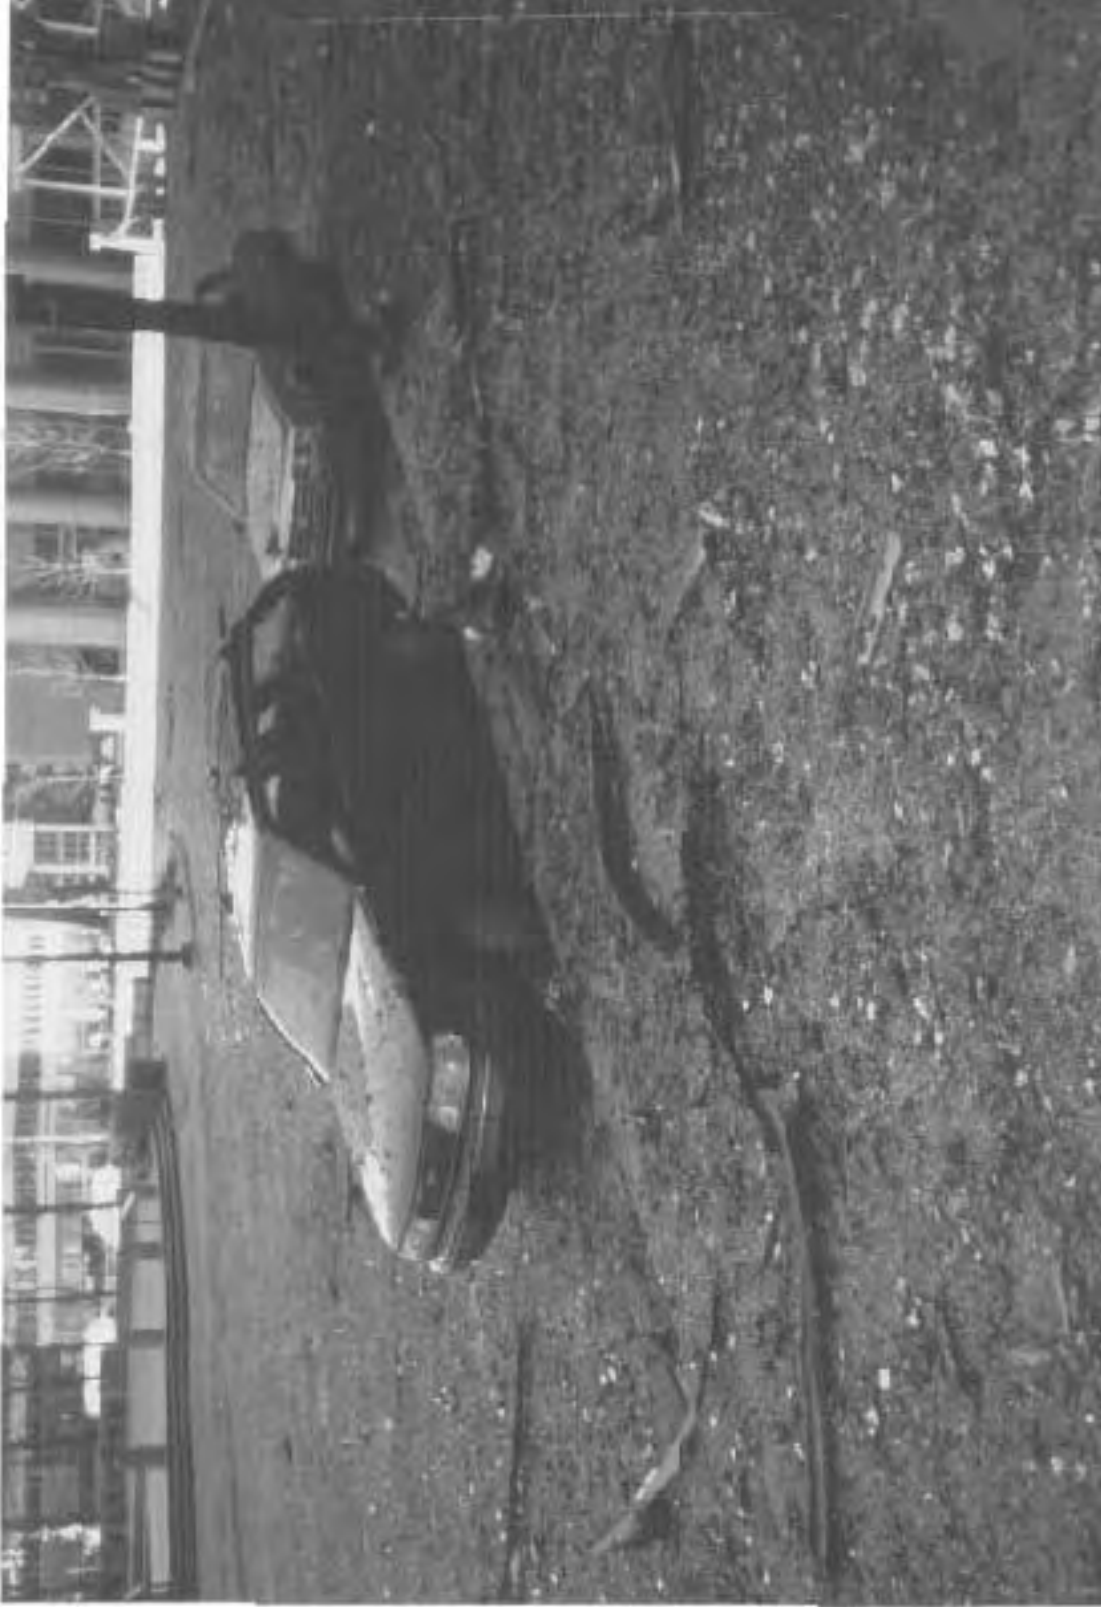
Street in front of the building from front steps showing stranded autos and debris in street.
