## **Fire Apparatus/Train Collision Catlett, Virginia**

## **United States Fire Administration Fire Investigations Program**

**Fire Apparatus/Train Collision  
Catlett, Virginia  
(September 28, 1989)**

**September 28, 1989**

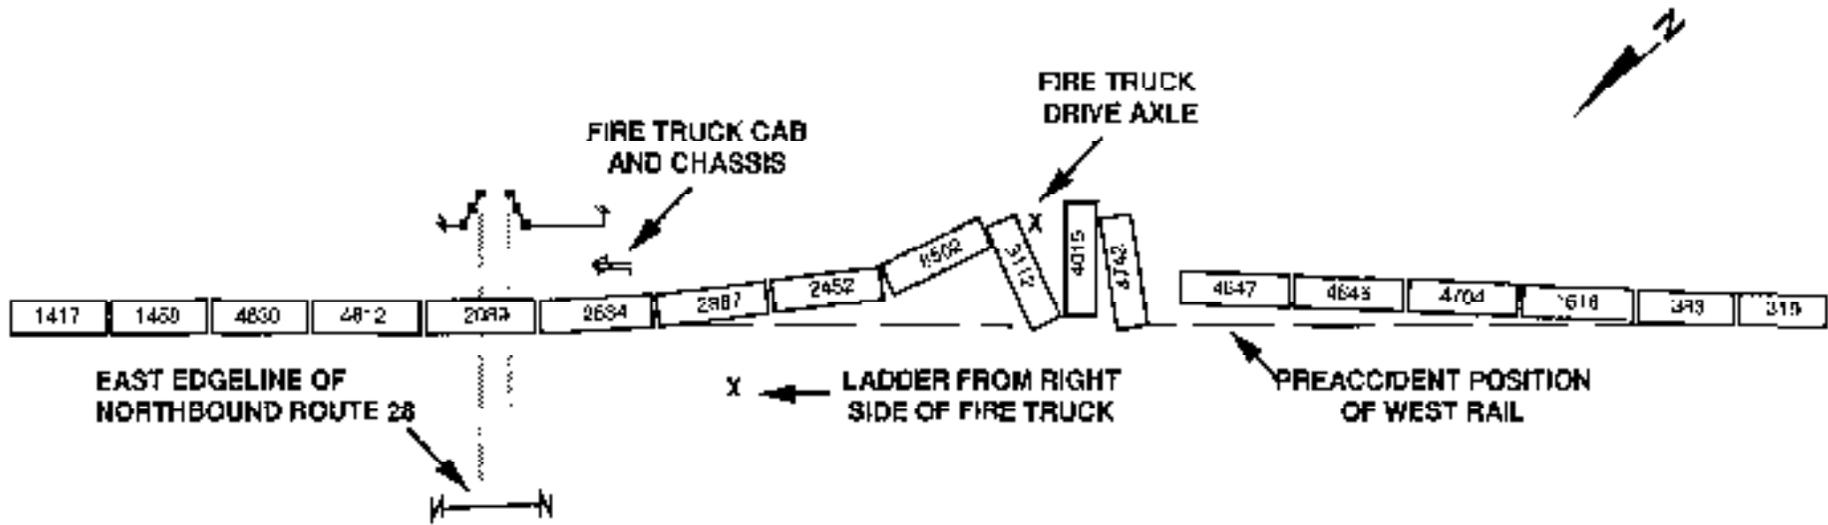
**Diagram Showing Final Rest Positions of Wagon 7  
and Railroad Cars, and Chart of Type of Rail Car  
Number and Order in Train**

# FINAL REST POSITIONS OF WAGON 7 AND RAILROAD CARS

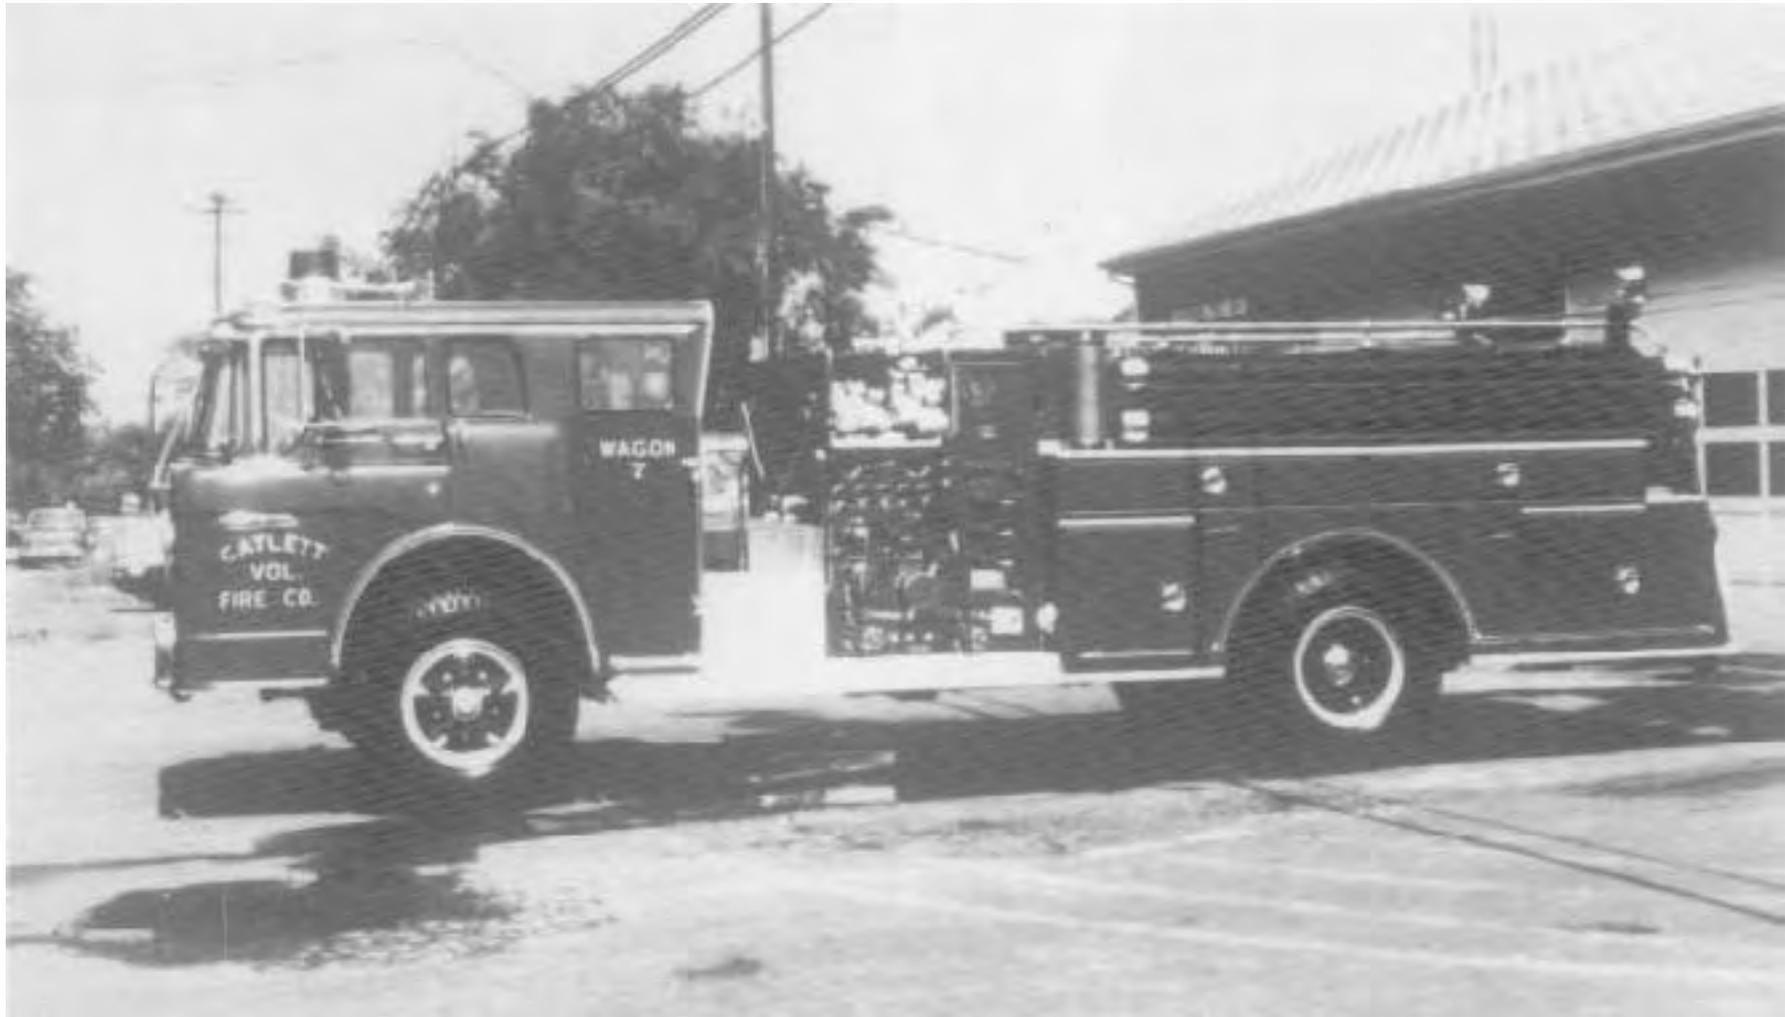
Left side of Wagon 7

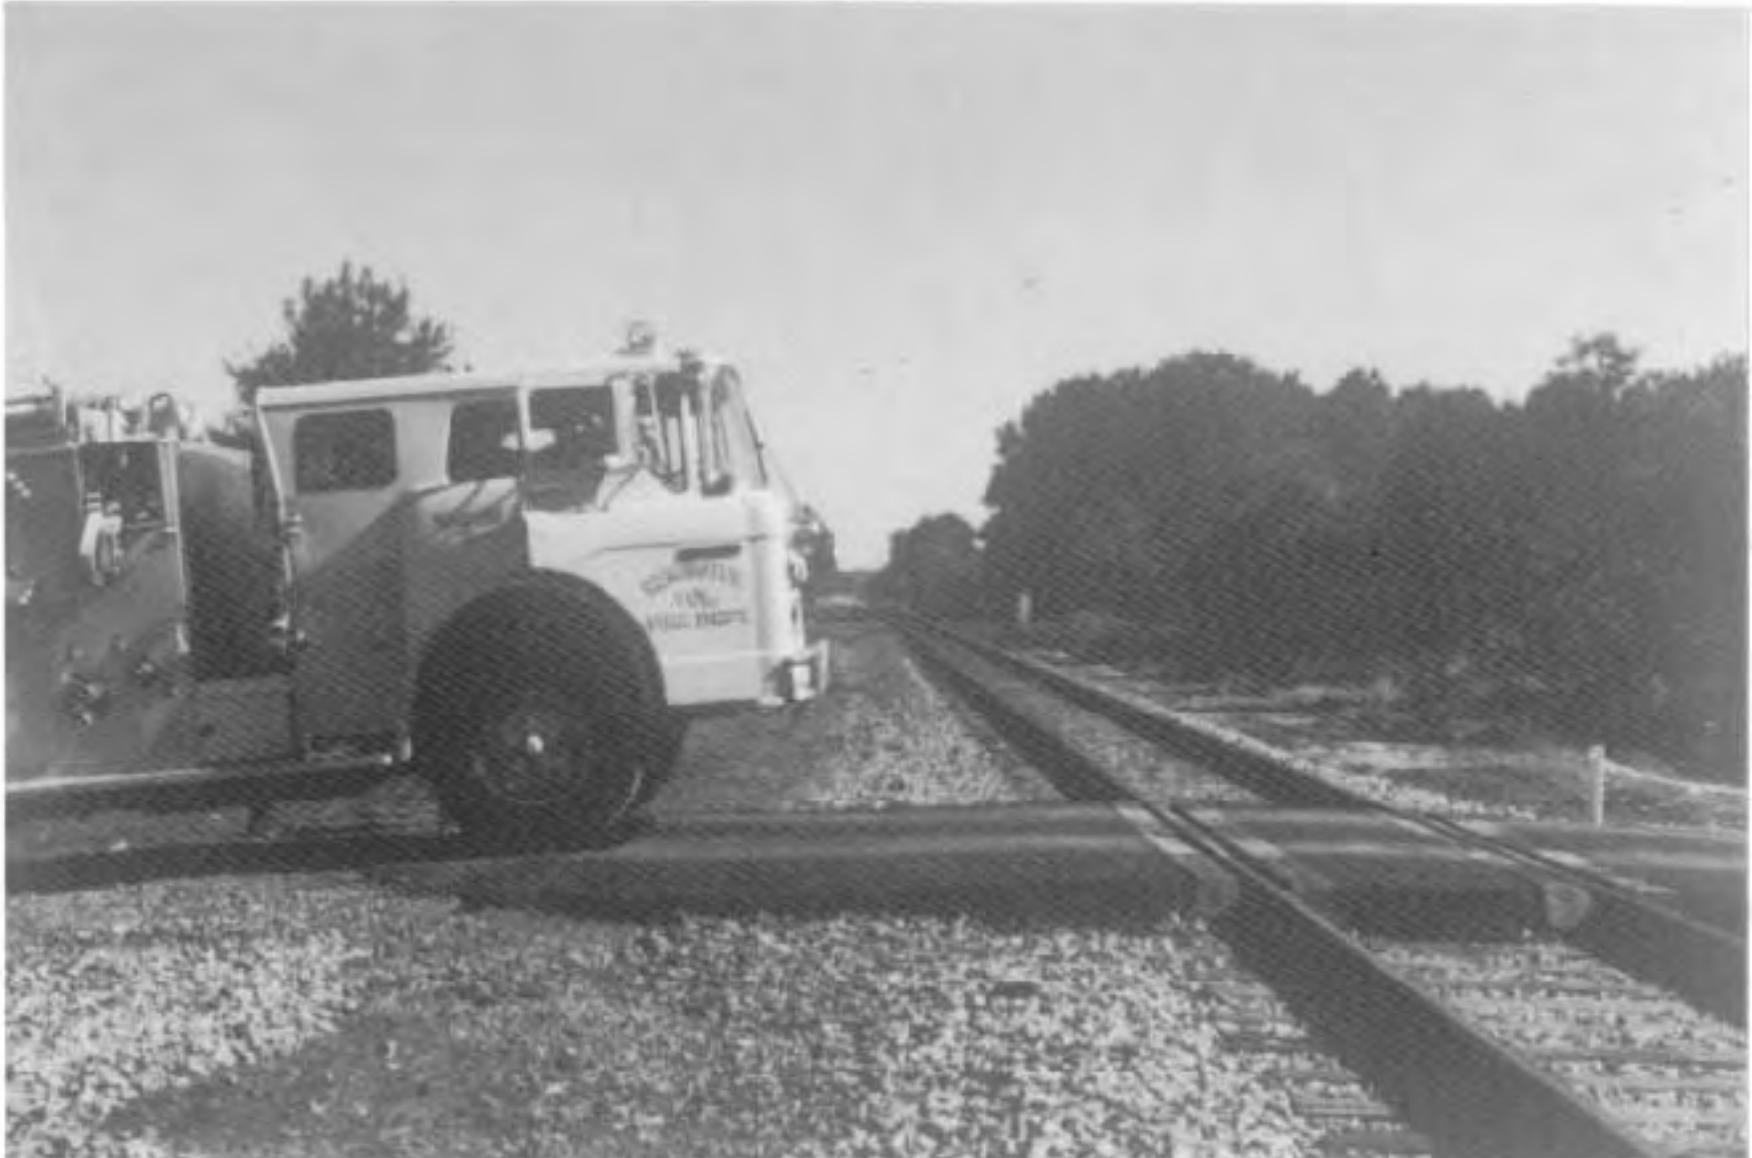
Wagon 2 at accident crossing - camera facing north

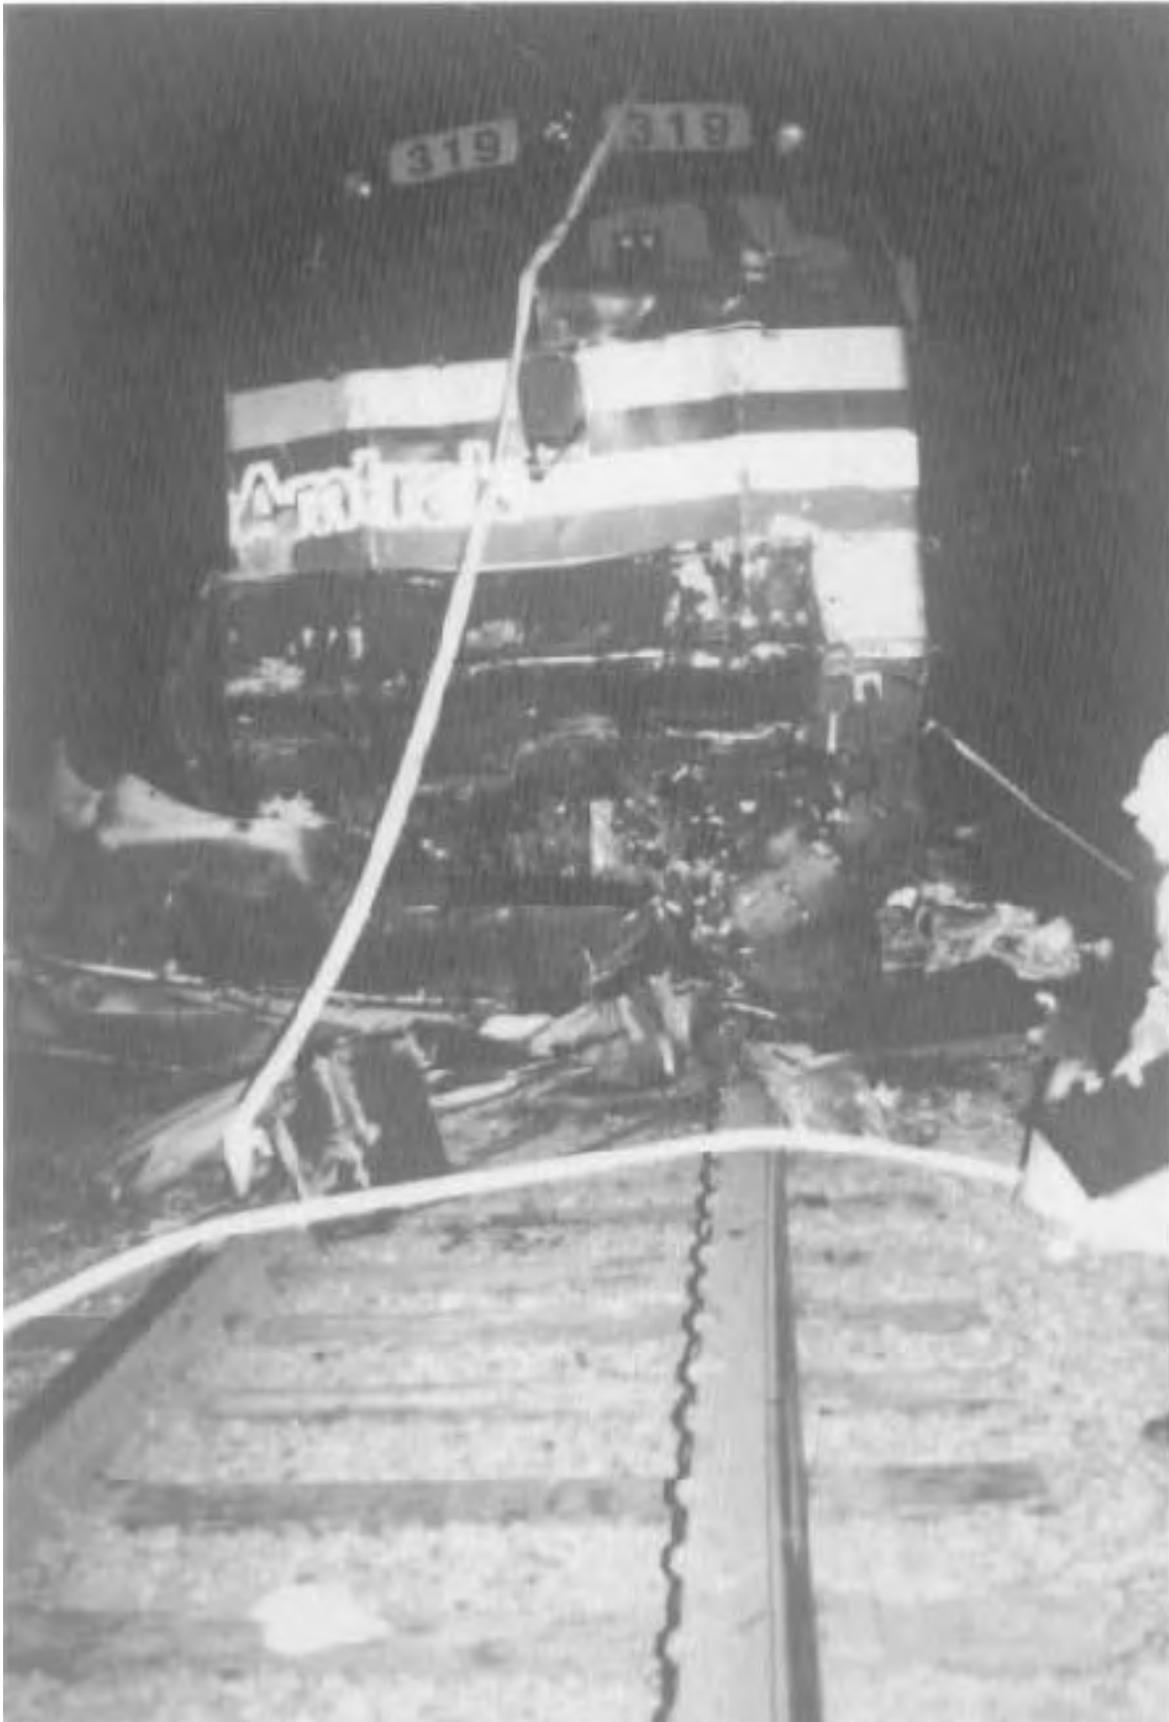
Front of locomotive 319

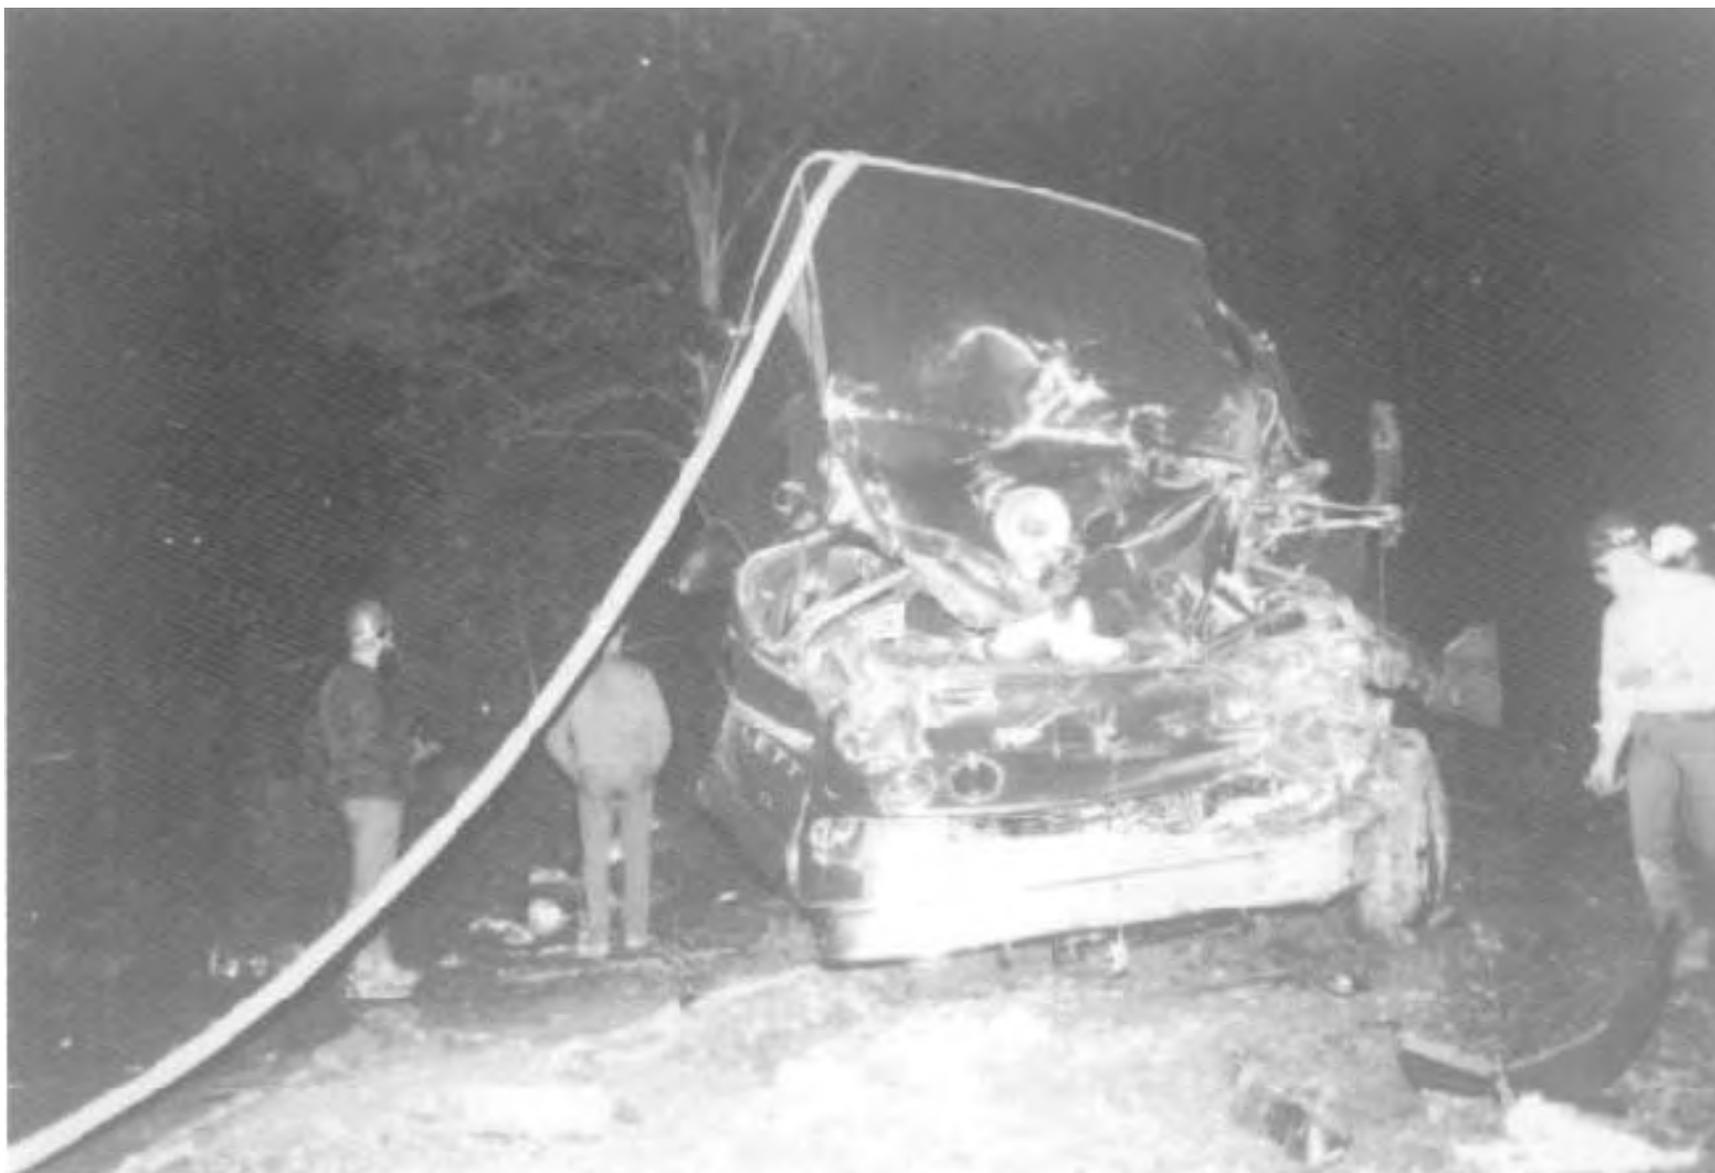
Cab of Wagon 7 - camera facing southeast

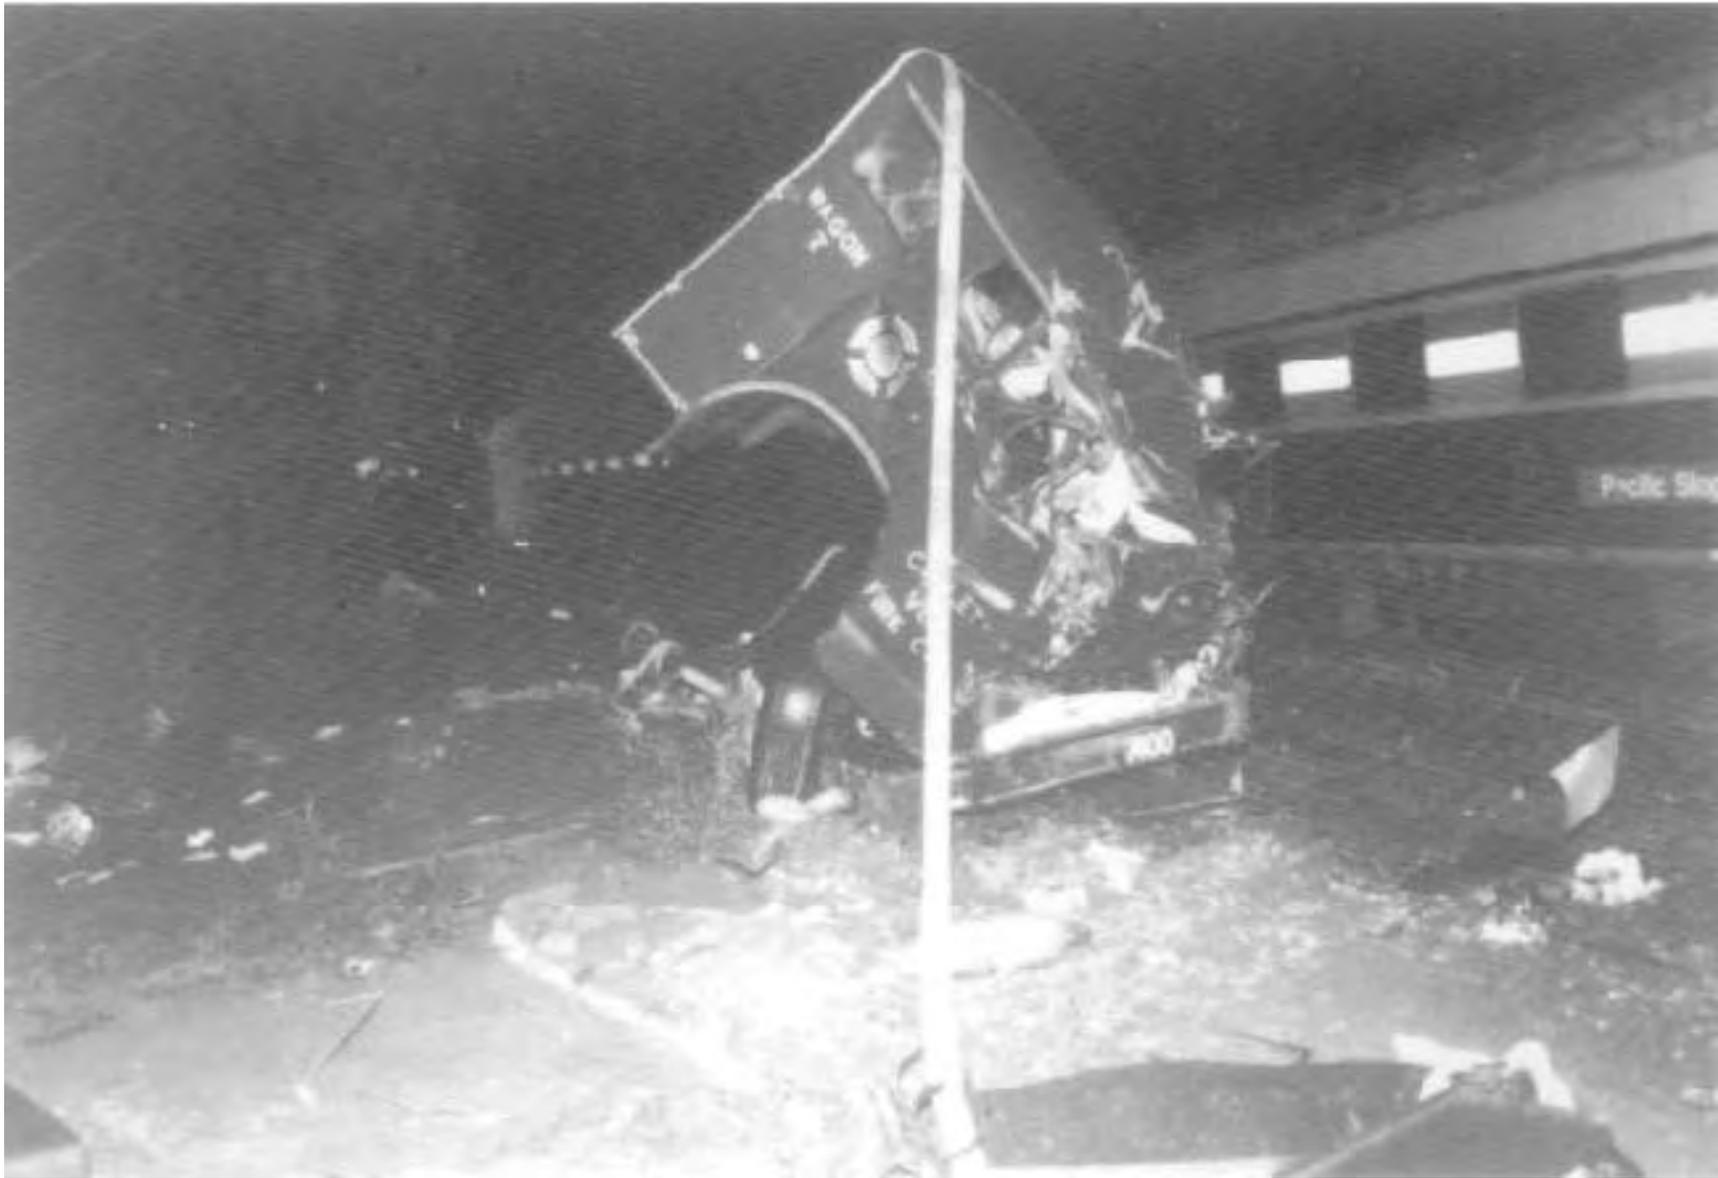
Cab of Wagon 7

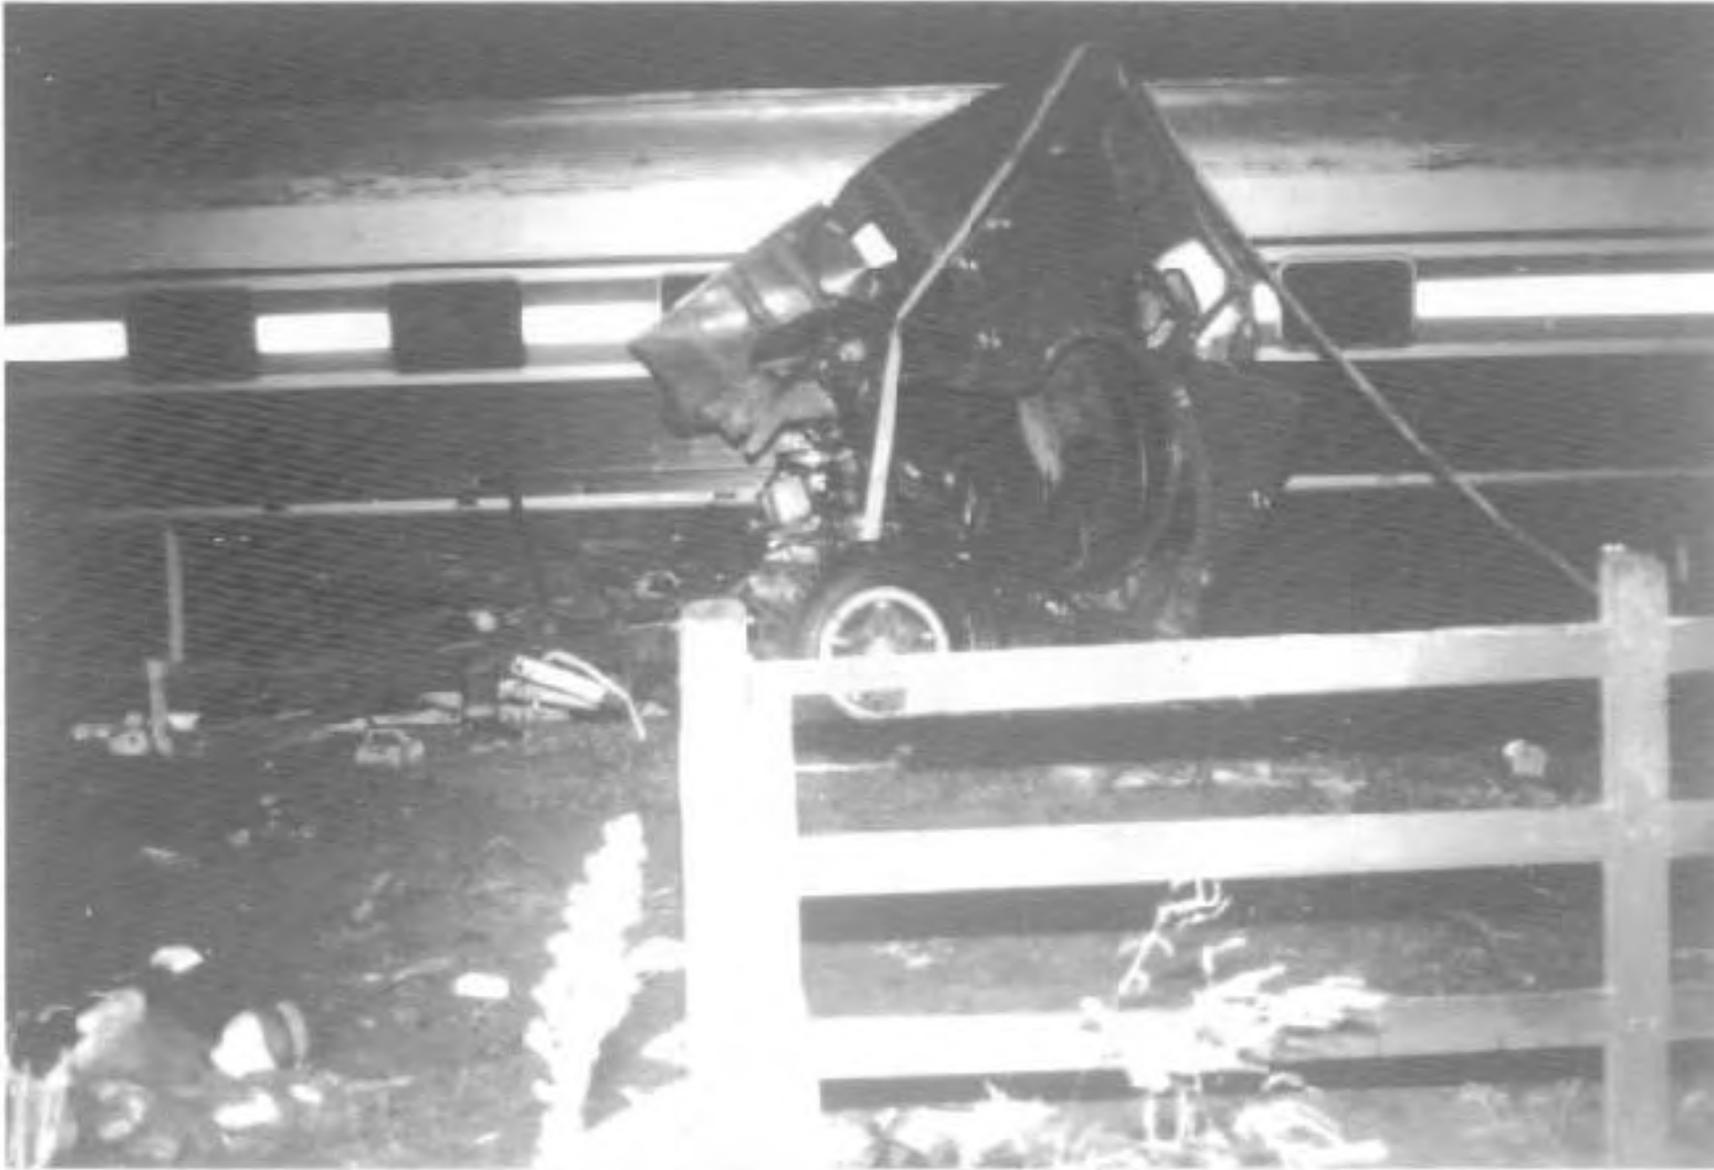
Cab and chassis of Wagon 7  
Southwest corner of fence around private residence is in center foreground.

NOTE: Injured firefighters were found in the area at the bottom left of the photo.

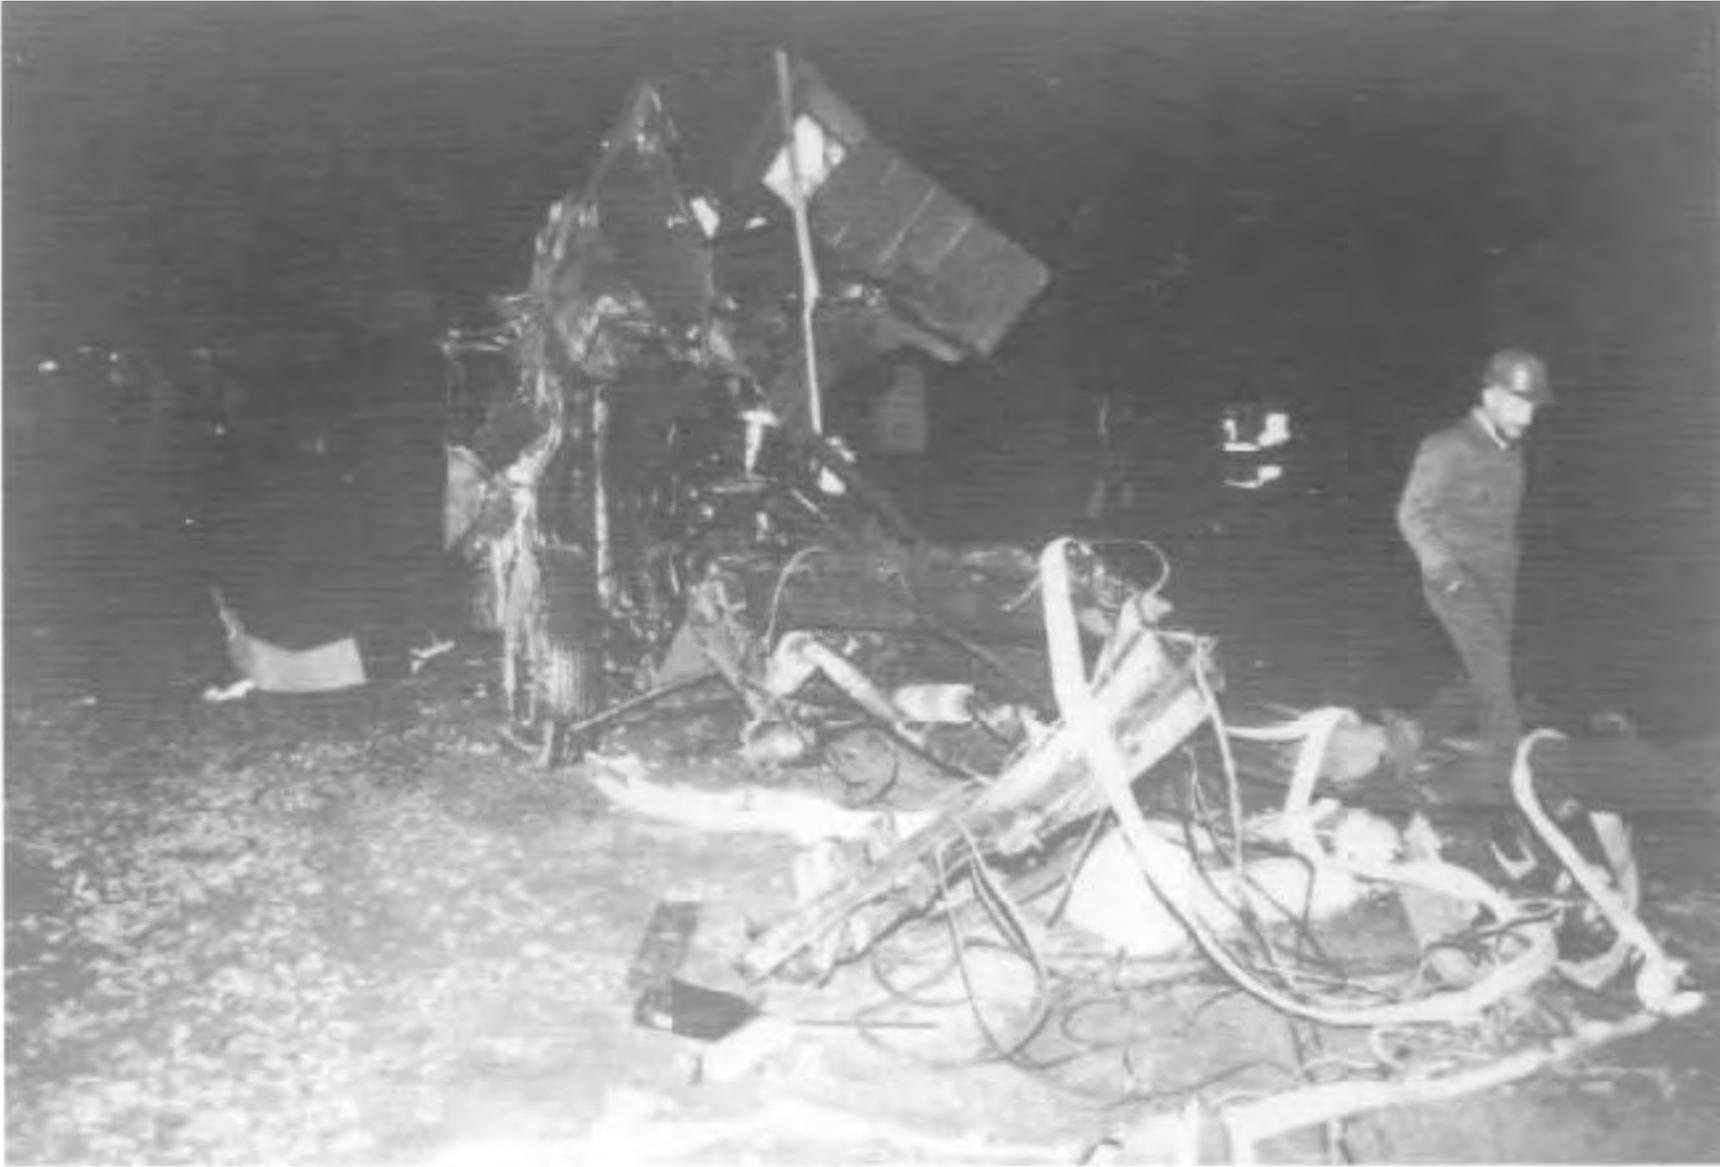
Chassis and cab of Wagon 7

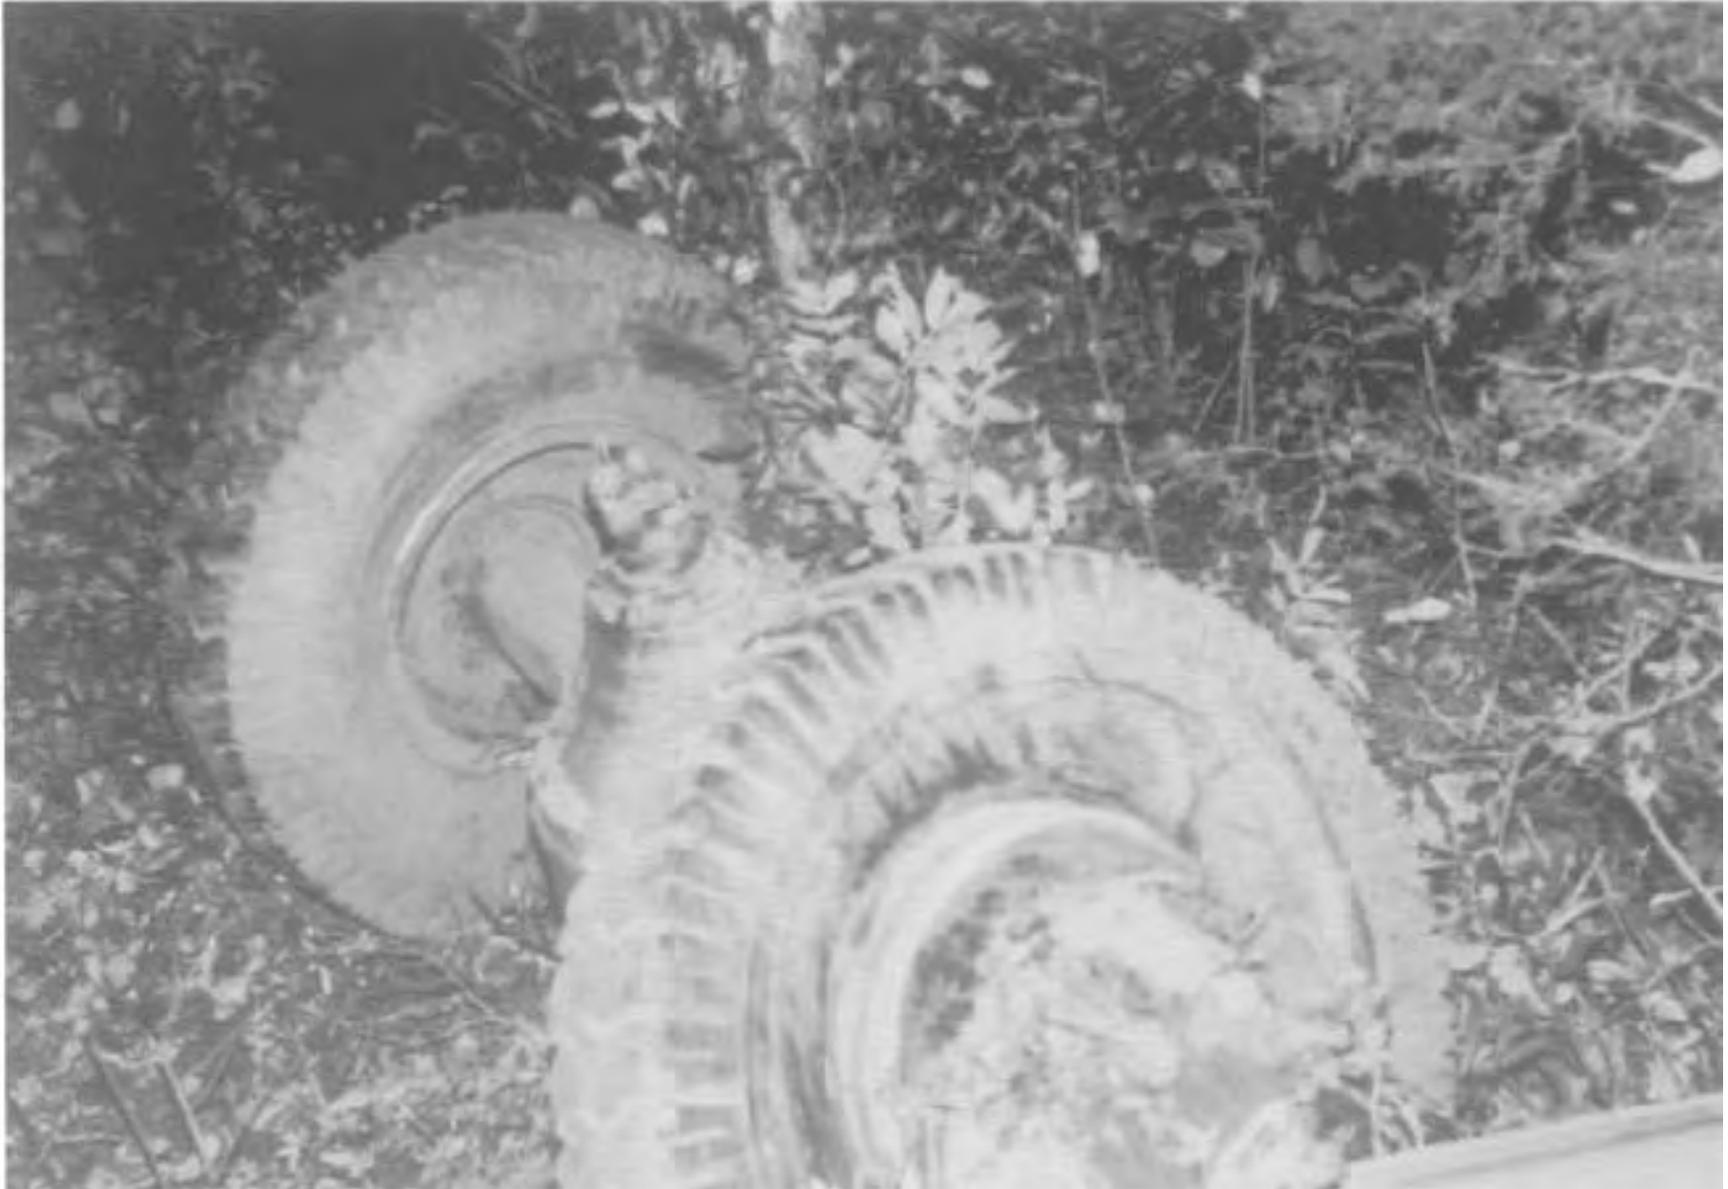
Closeup of fire truck drive axle

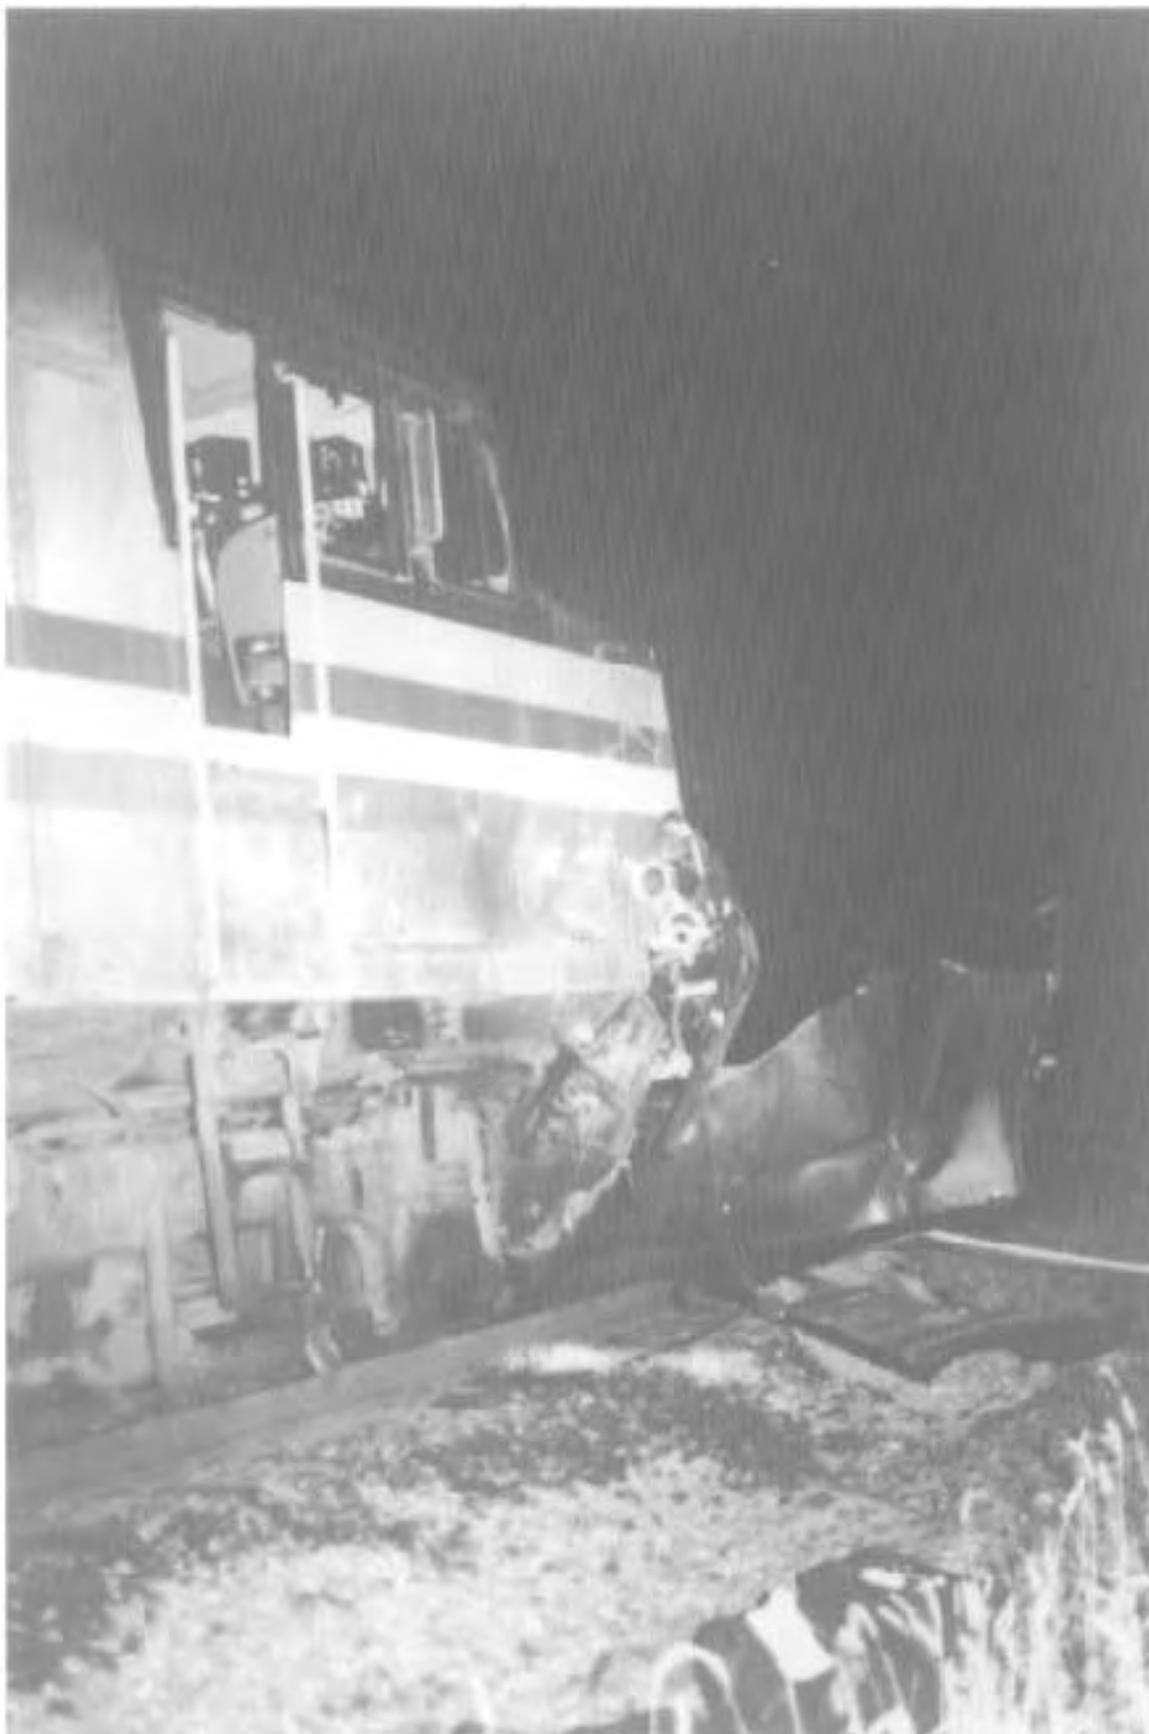
Right front of locomotive 319

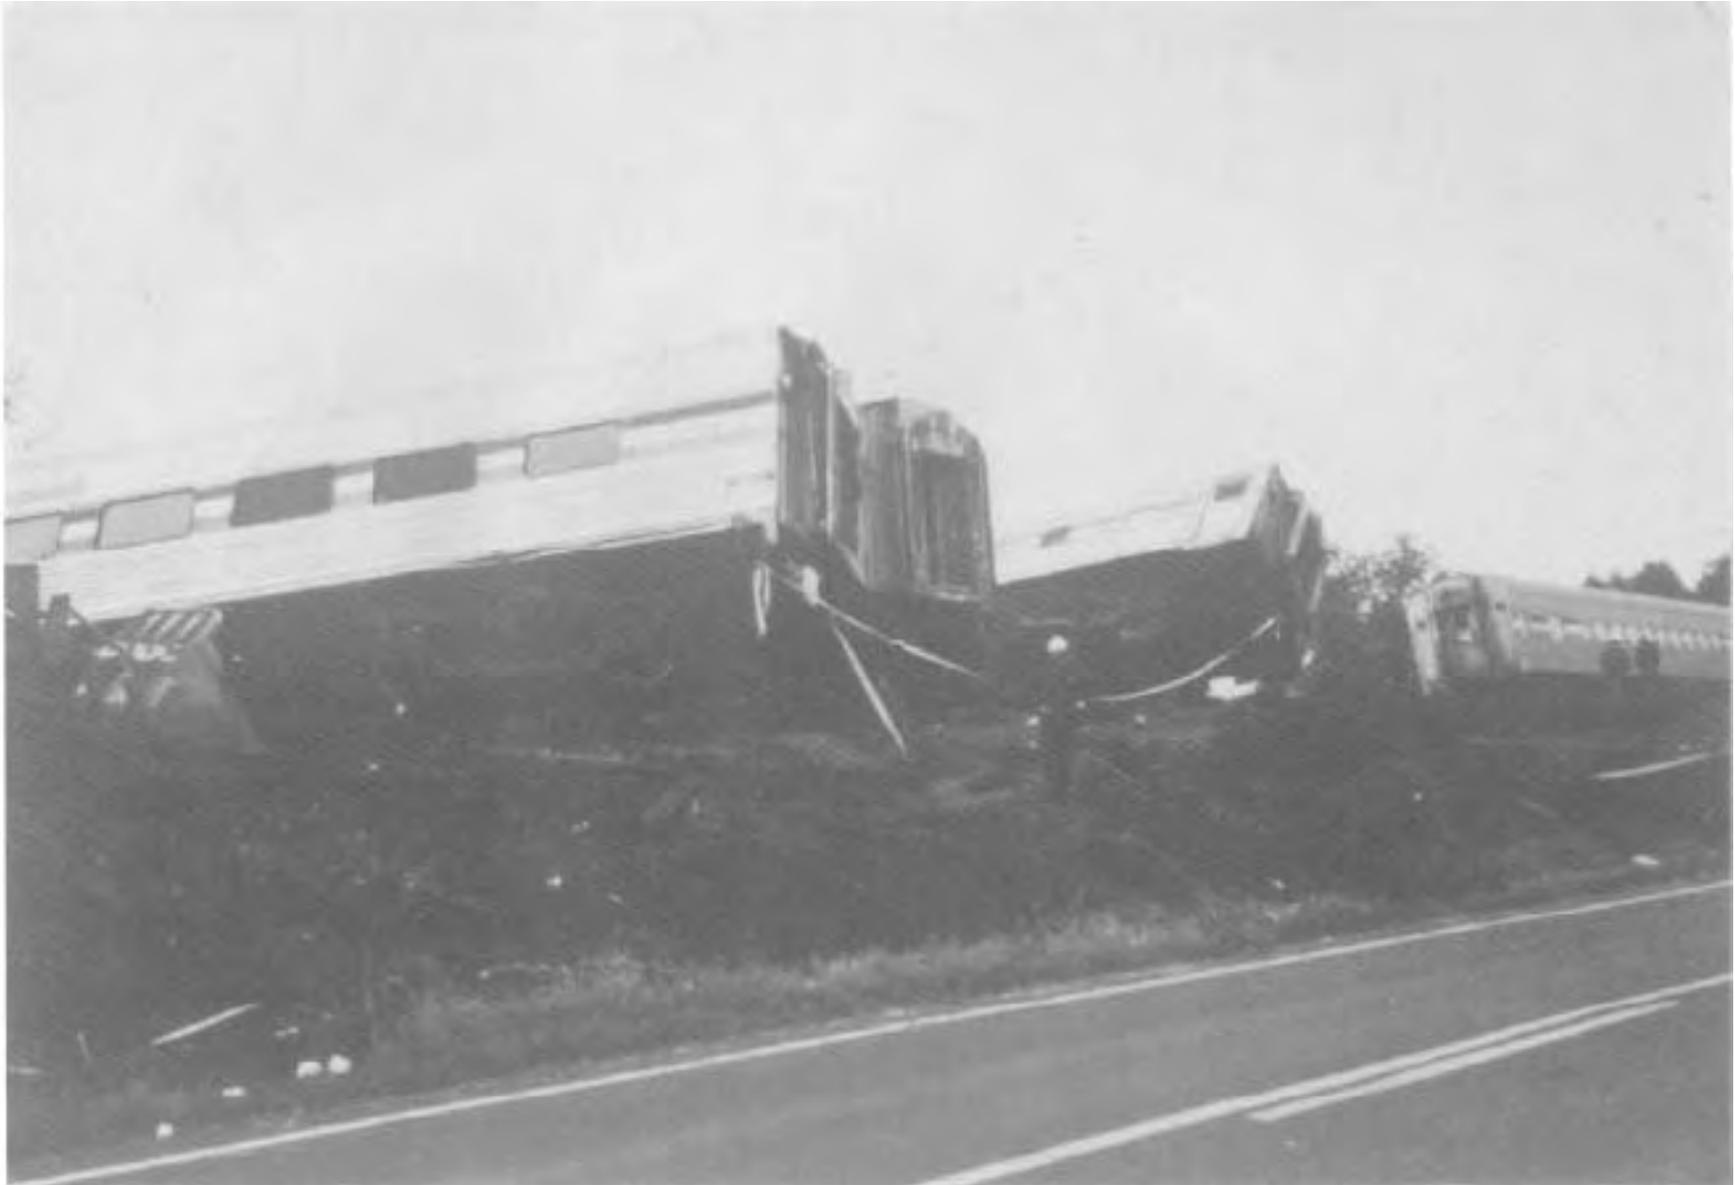
West ends of cars 3112, 4019, and 4742

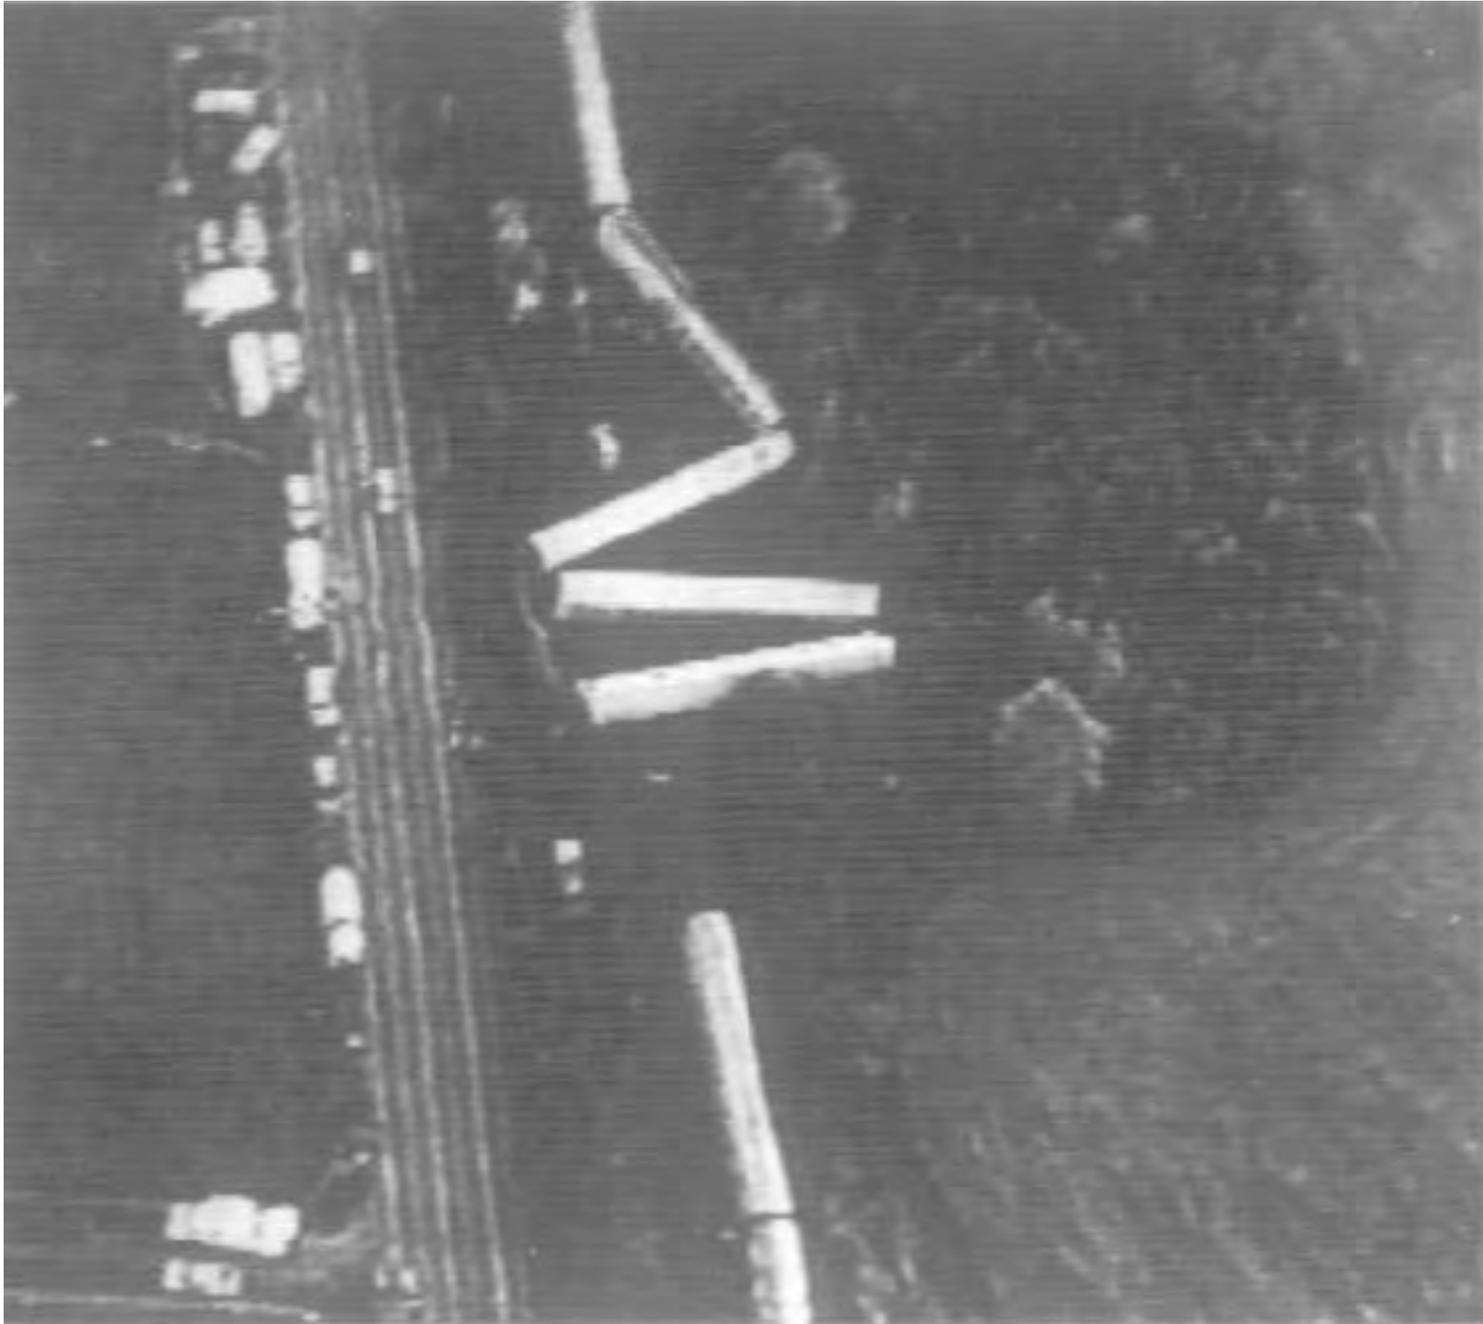
Aerial view of accident site
