## **Fire Apparatus/Train Collision Catlett, Virginia**

## **United States Fire Administration Fire Investigations Program**

**Fire Apparatus/Train Collision  
Catlett, Virginia  
(September 28, 1989)**

**September 28, 1989**

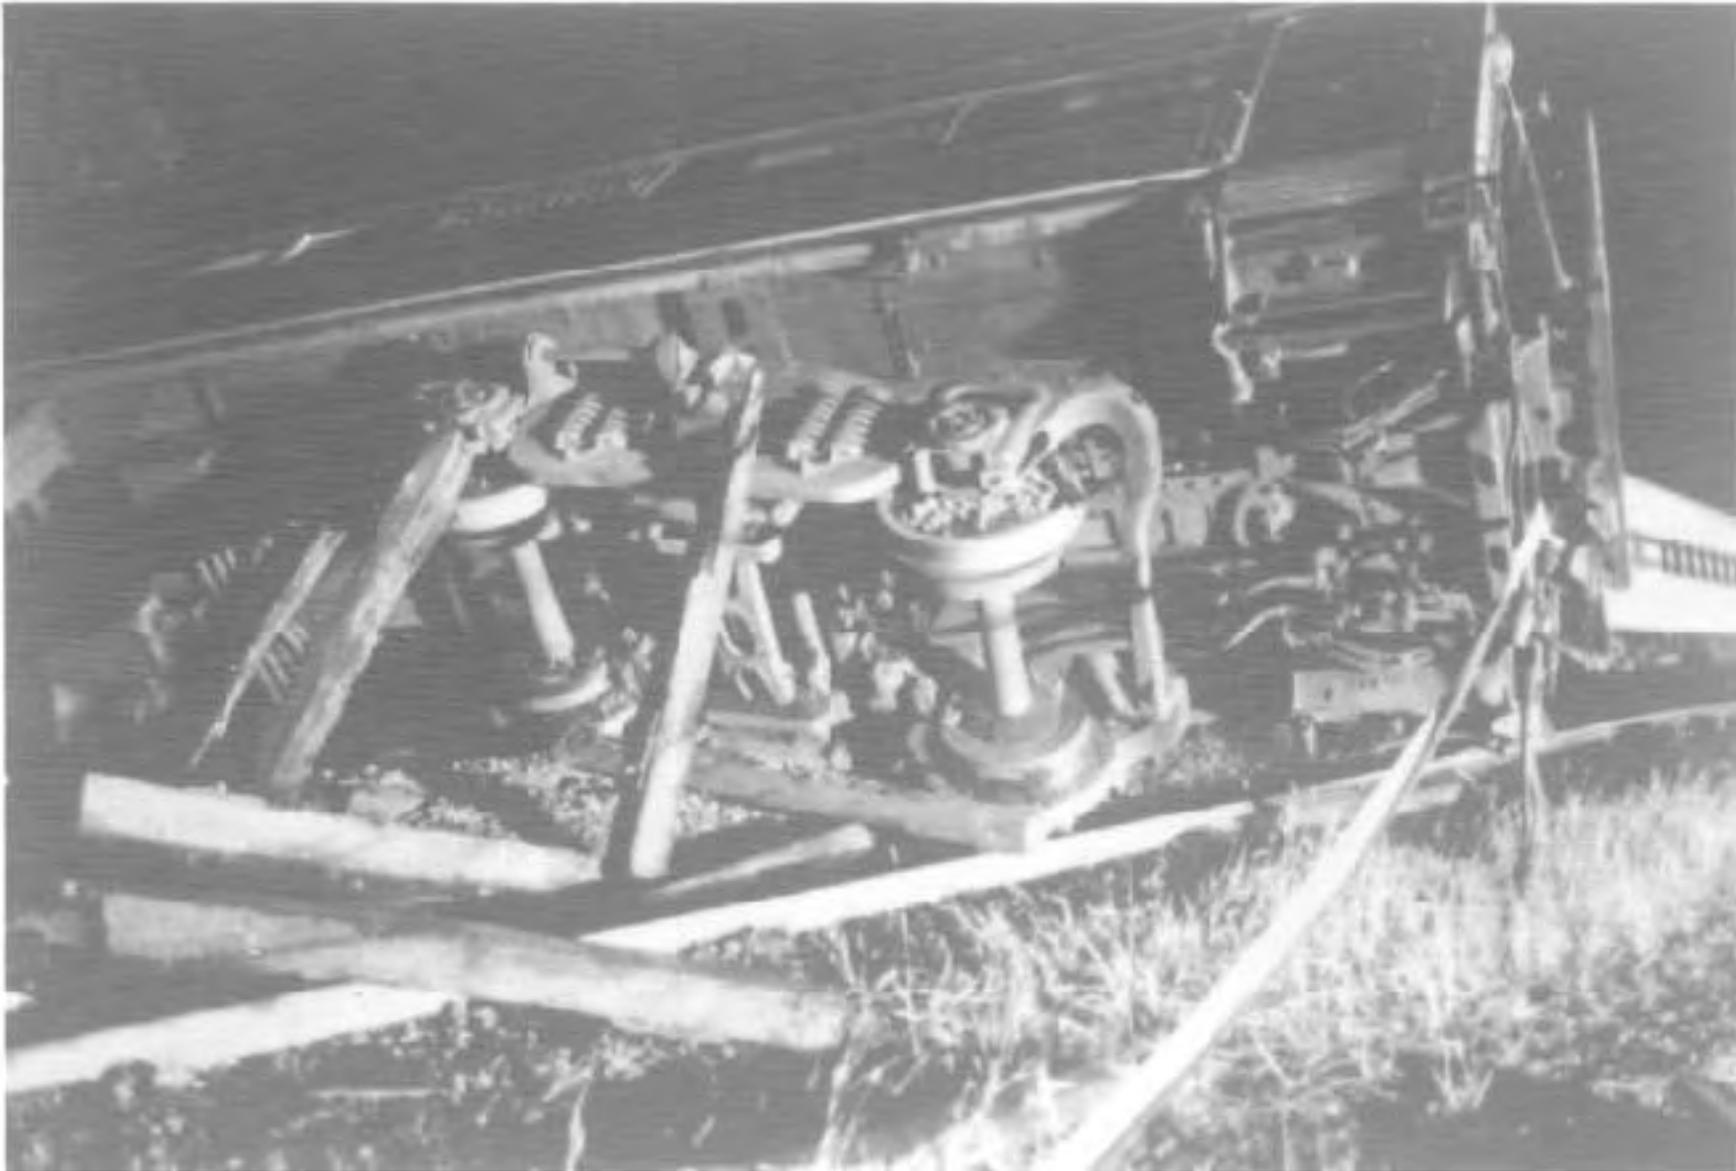
North side of car 4742

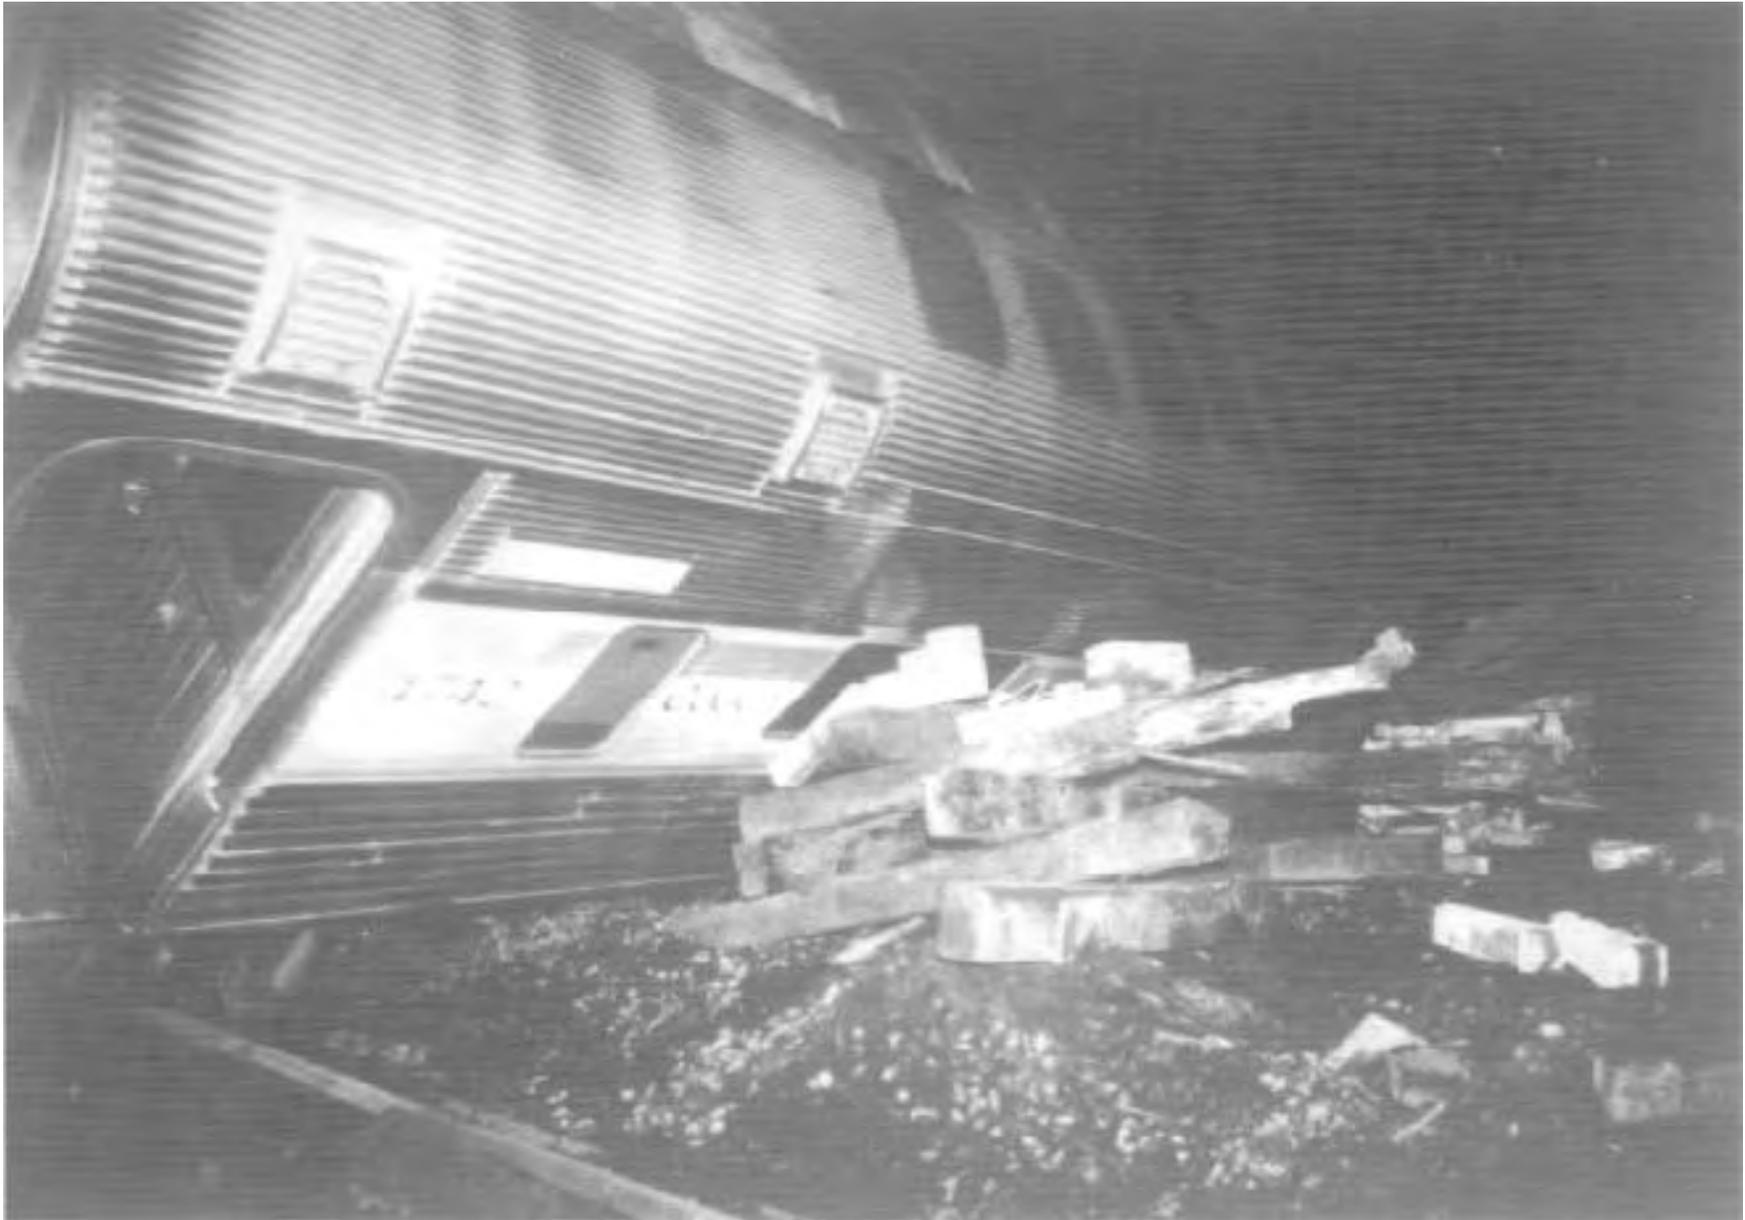
South side of car 4742

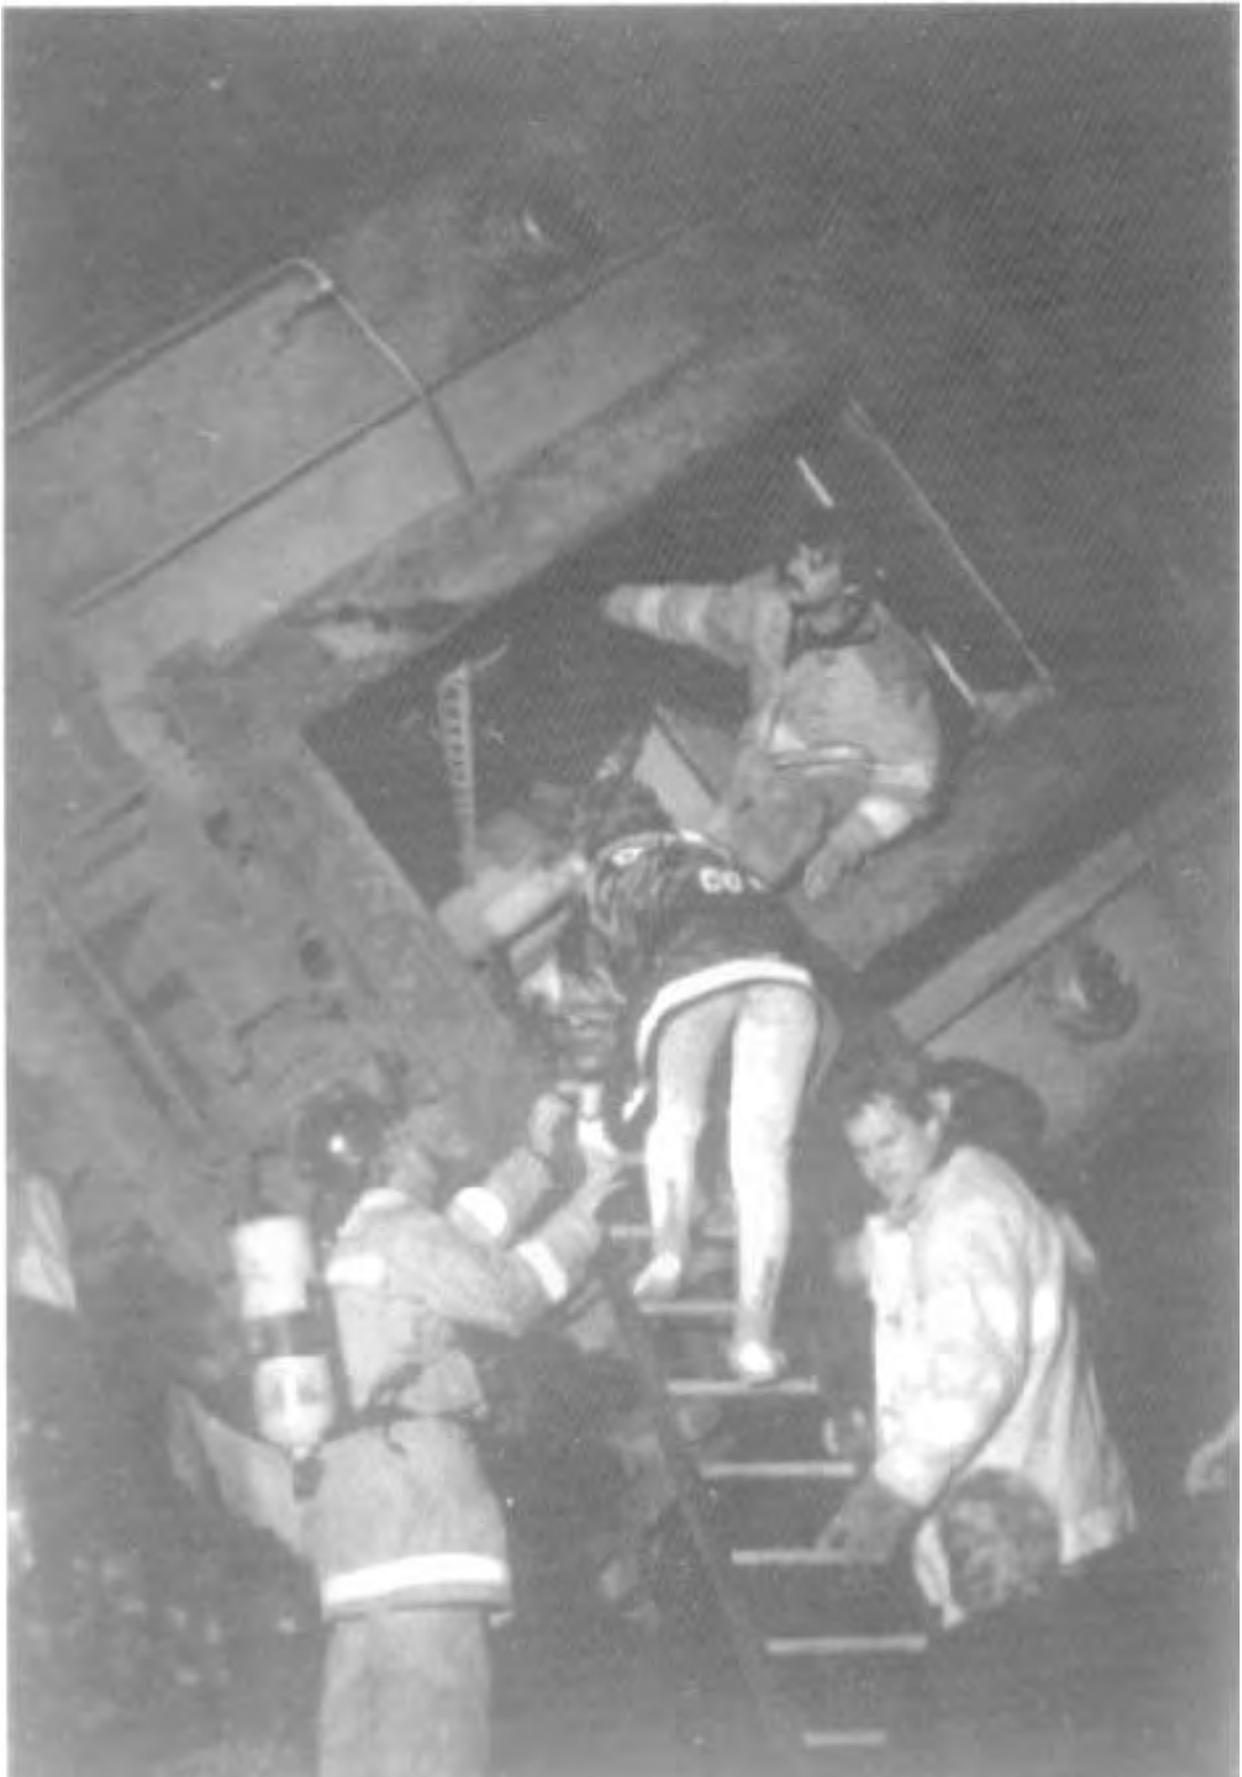
Evacuation operations from west end of car 4742

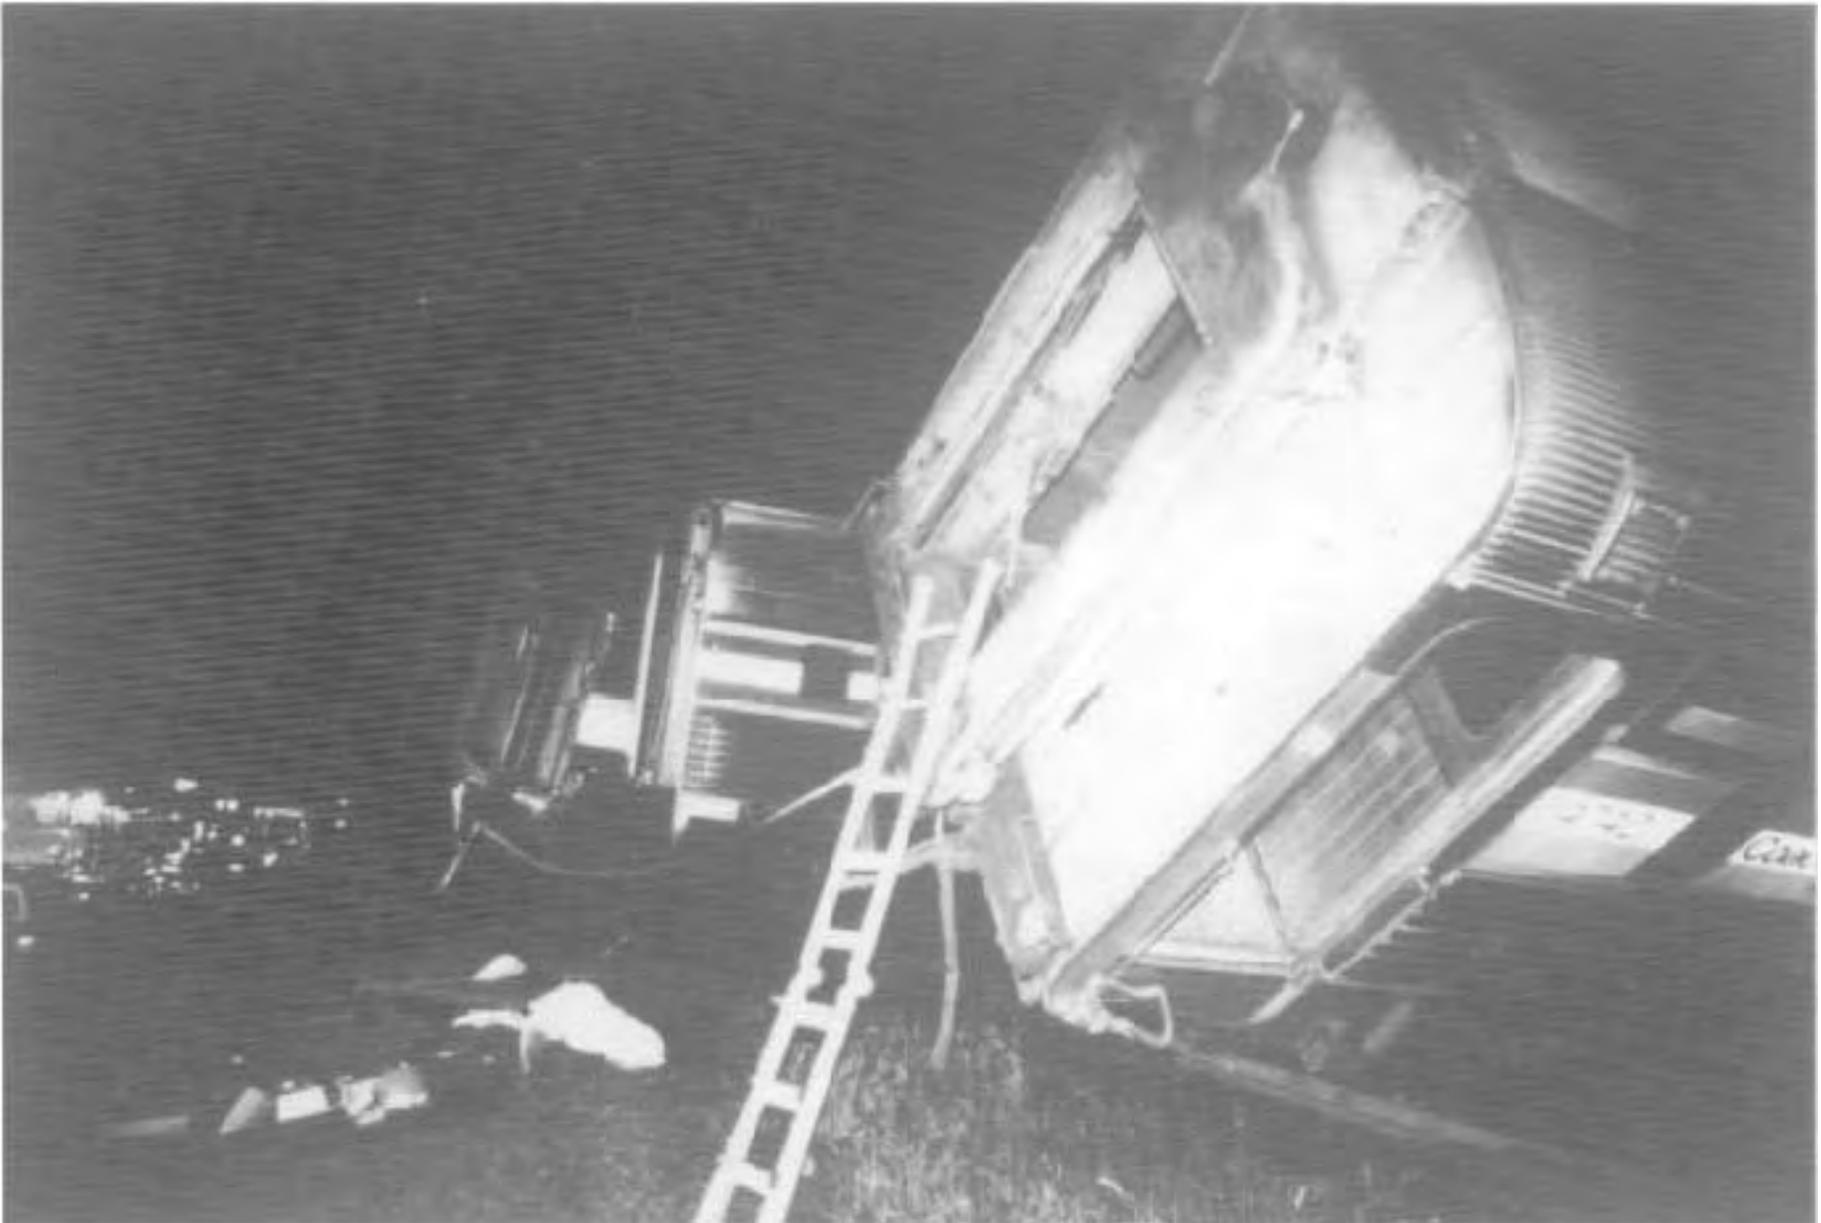
West end of car 4742

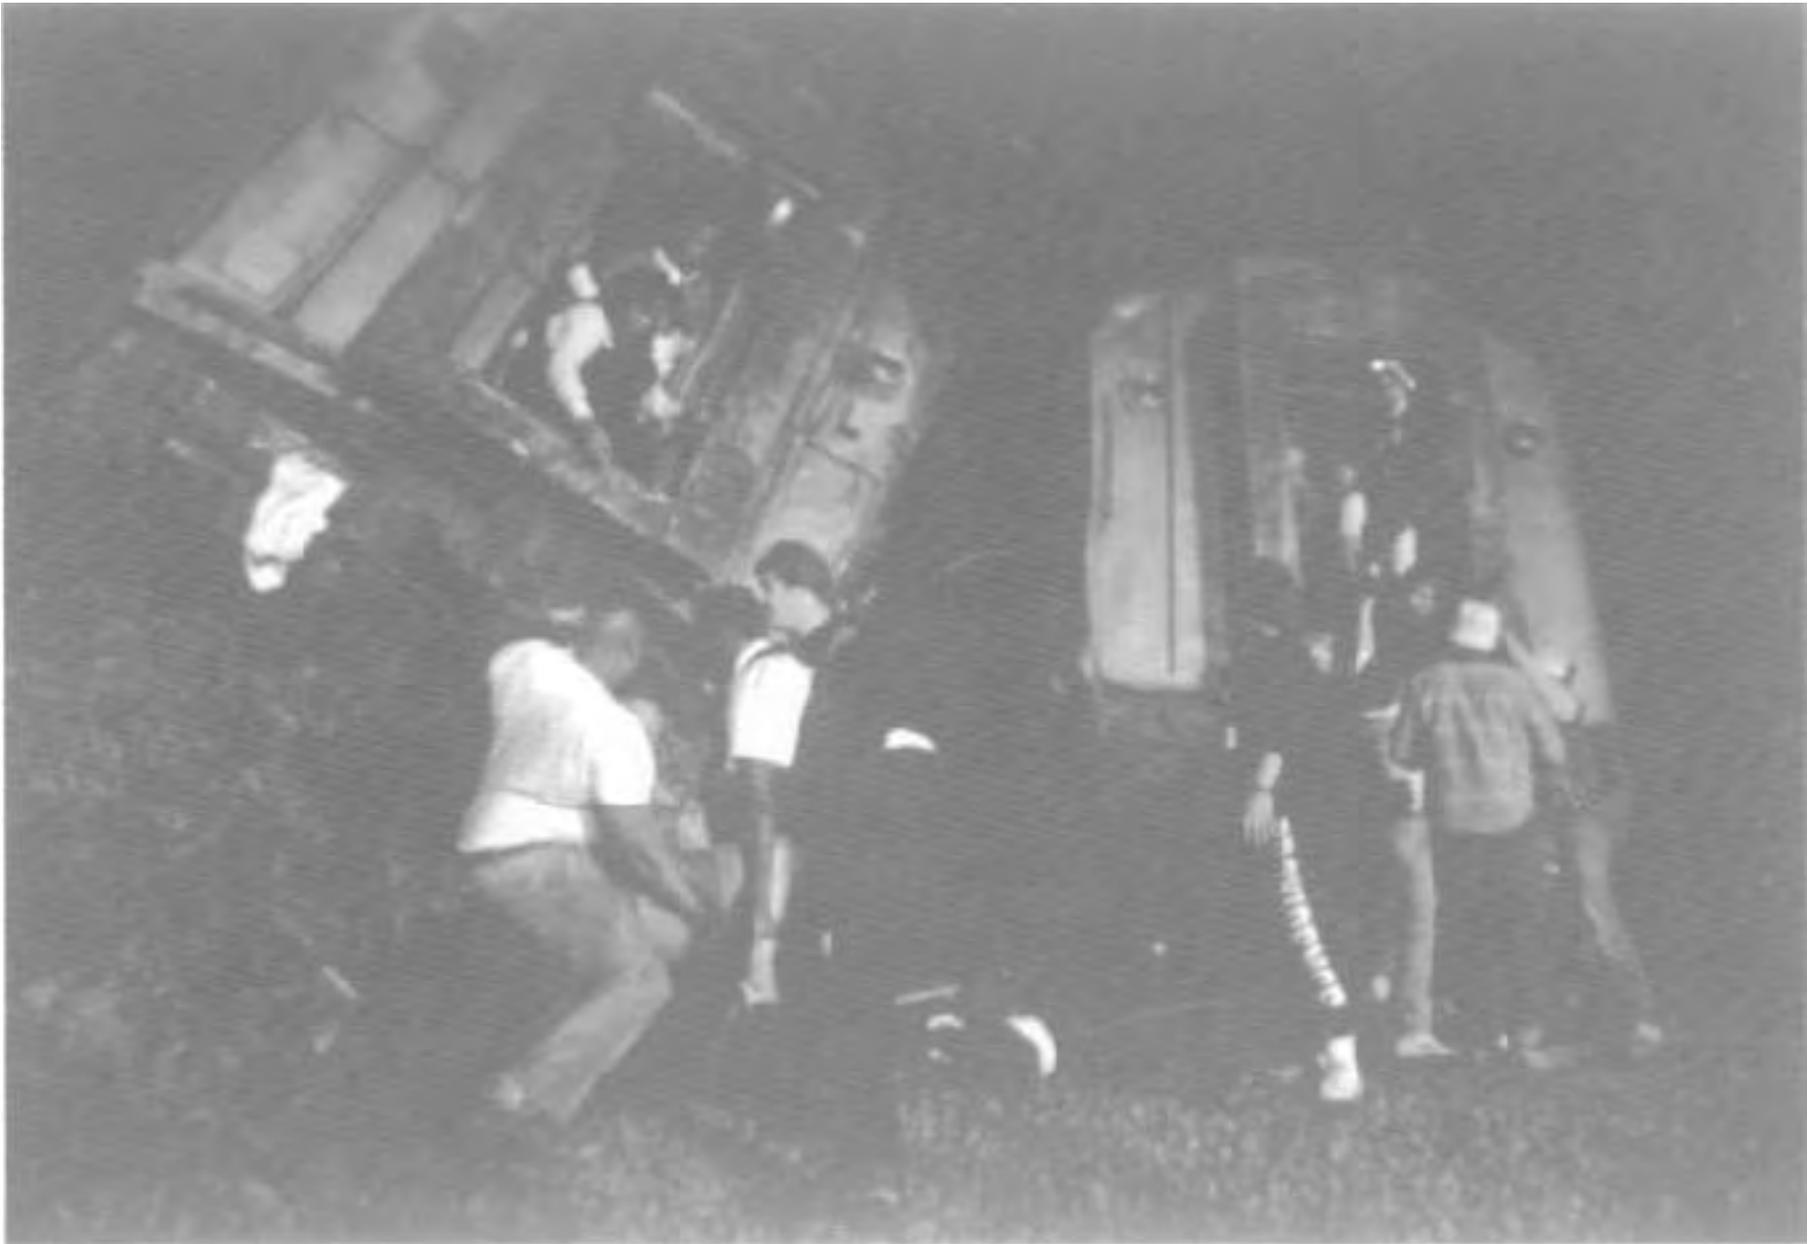
Evacuation of passengers from west ends of cars 4019 and 3112
