Technical Report Series

Ten Elderly Victims from Intermediate Care Facility Fire Colorado Springs, Colorado

Ten Elderly Victims from Intermediate Care Facility Fire Colorado Springs, Colorado (March 4, 1991)

This is Report 050 of the Major Fires Investigation Project conducted by TriData Corporation under contract EMW-90-C-3338 to the United States Fire Administration, Federal Emergency Management Agency.

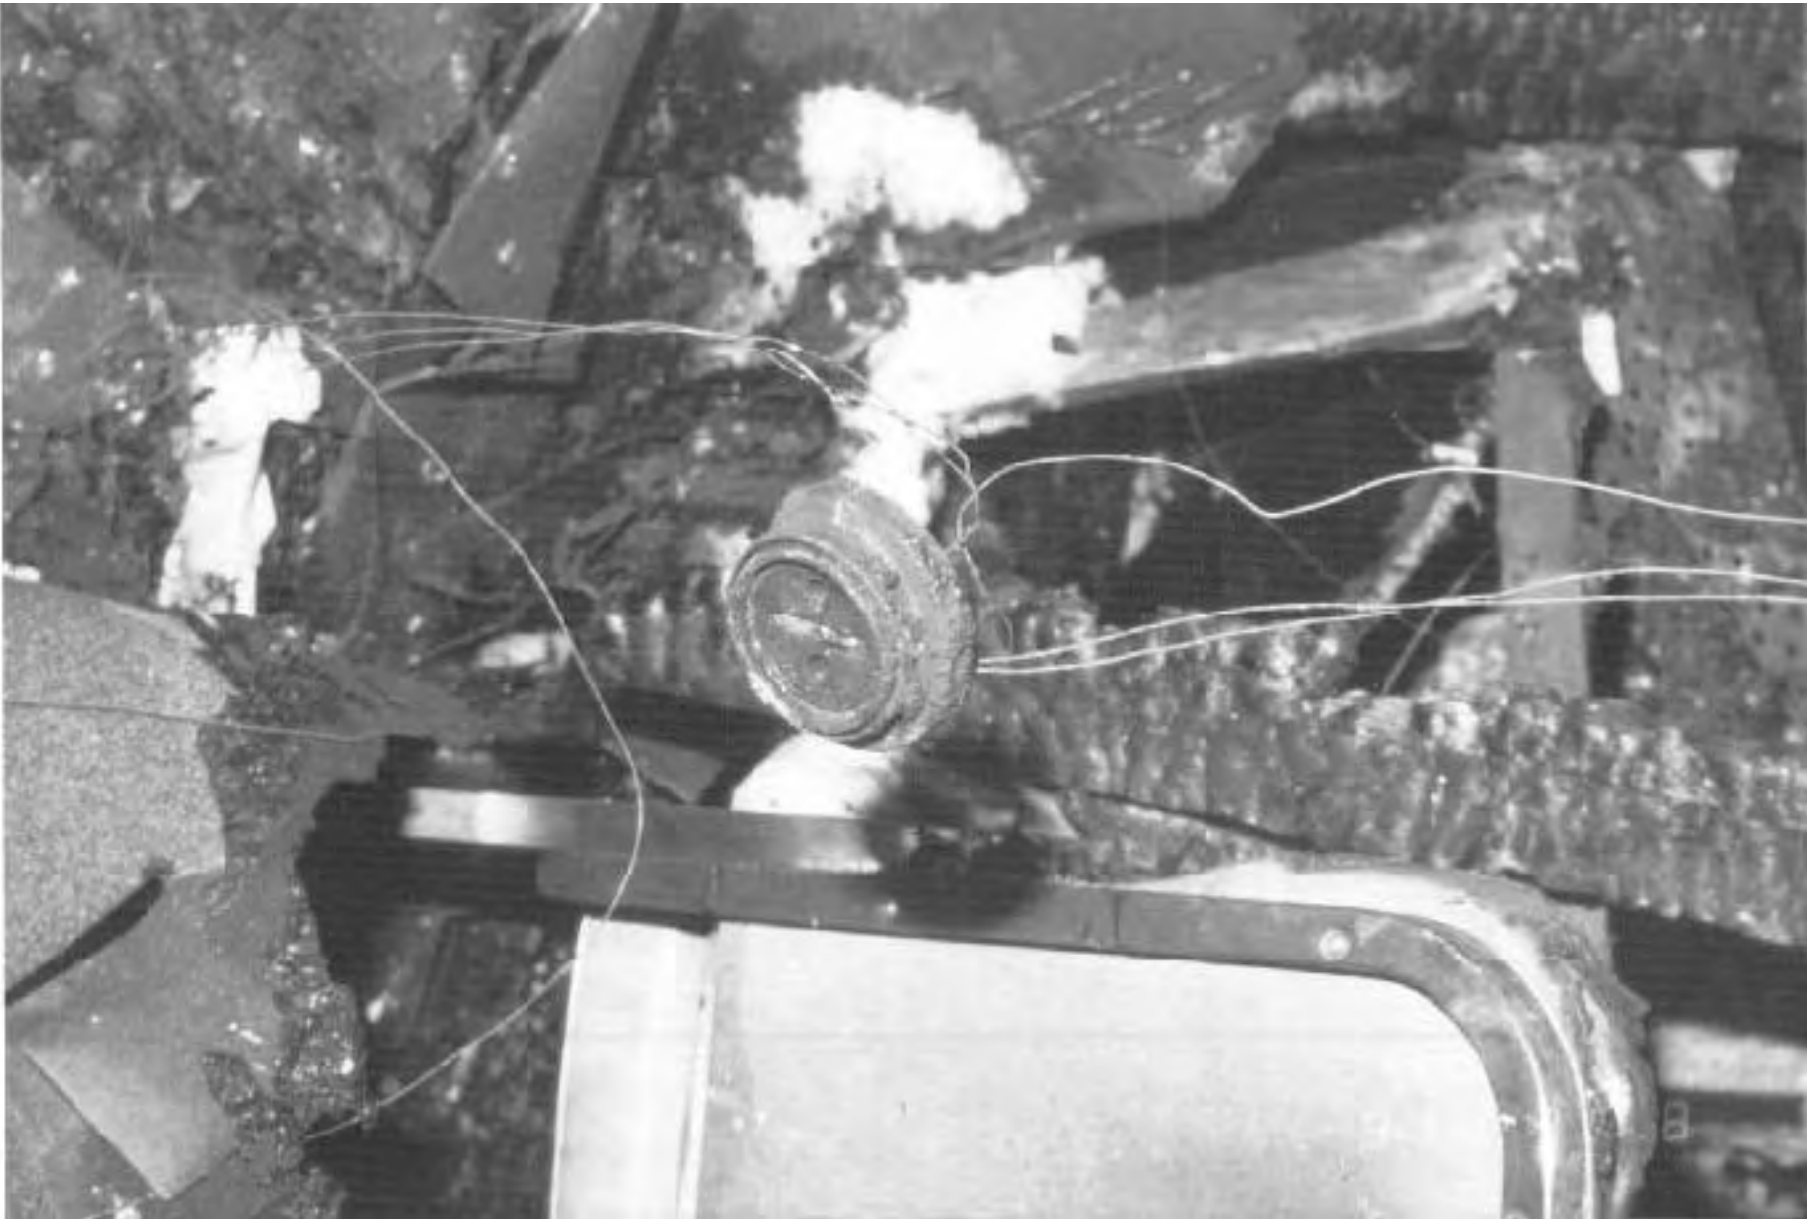
(Photo by Jack Yates)

It is unknown why the heat detectors found in the attic area of the east wing did not warn of the fire in that area. Inspection of the alarm panel revealed 2 fuses which were blown at some unknown time. The condition of the system before the fire has not been established.

Heat sensors from the attic, either not hooked up or not working as there was no early warning to any panel.

All detection equipment in place must be kept in working condition. The system must be checked on a scheduled basis by trained personnel. Battery assistance to hard wired heat/smoke detectors offers the greatest safety. Although not a factor in this loss, the scenario of this incident illustrates the threat of loss of power.

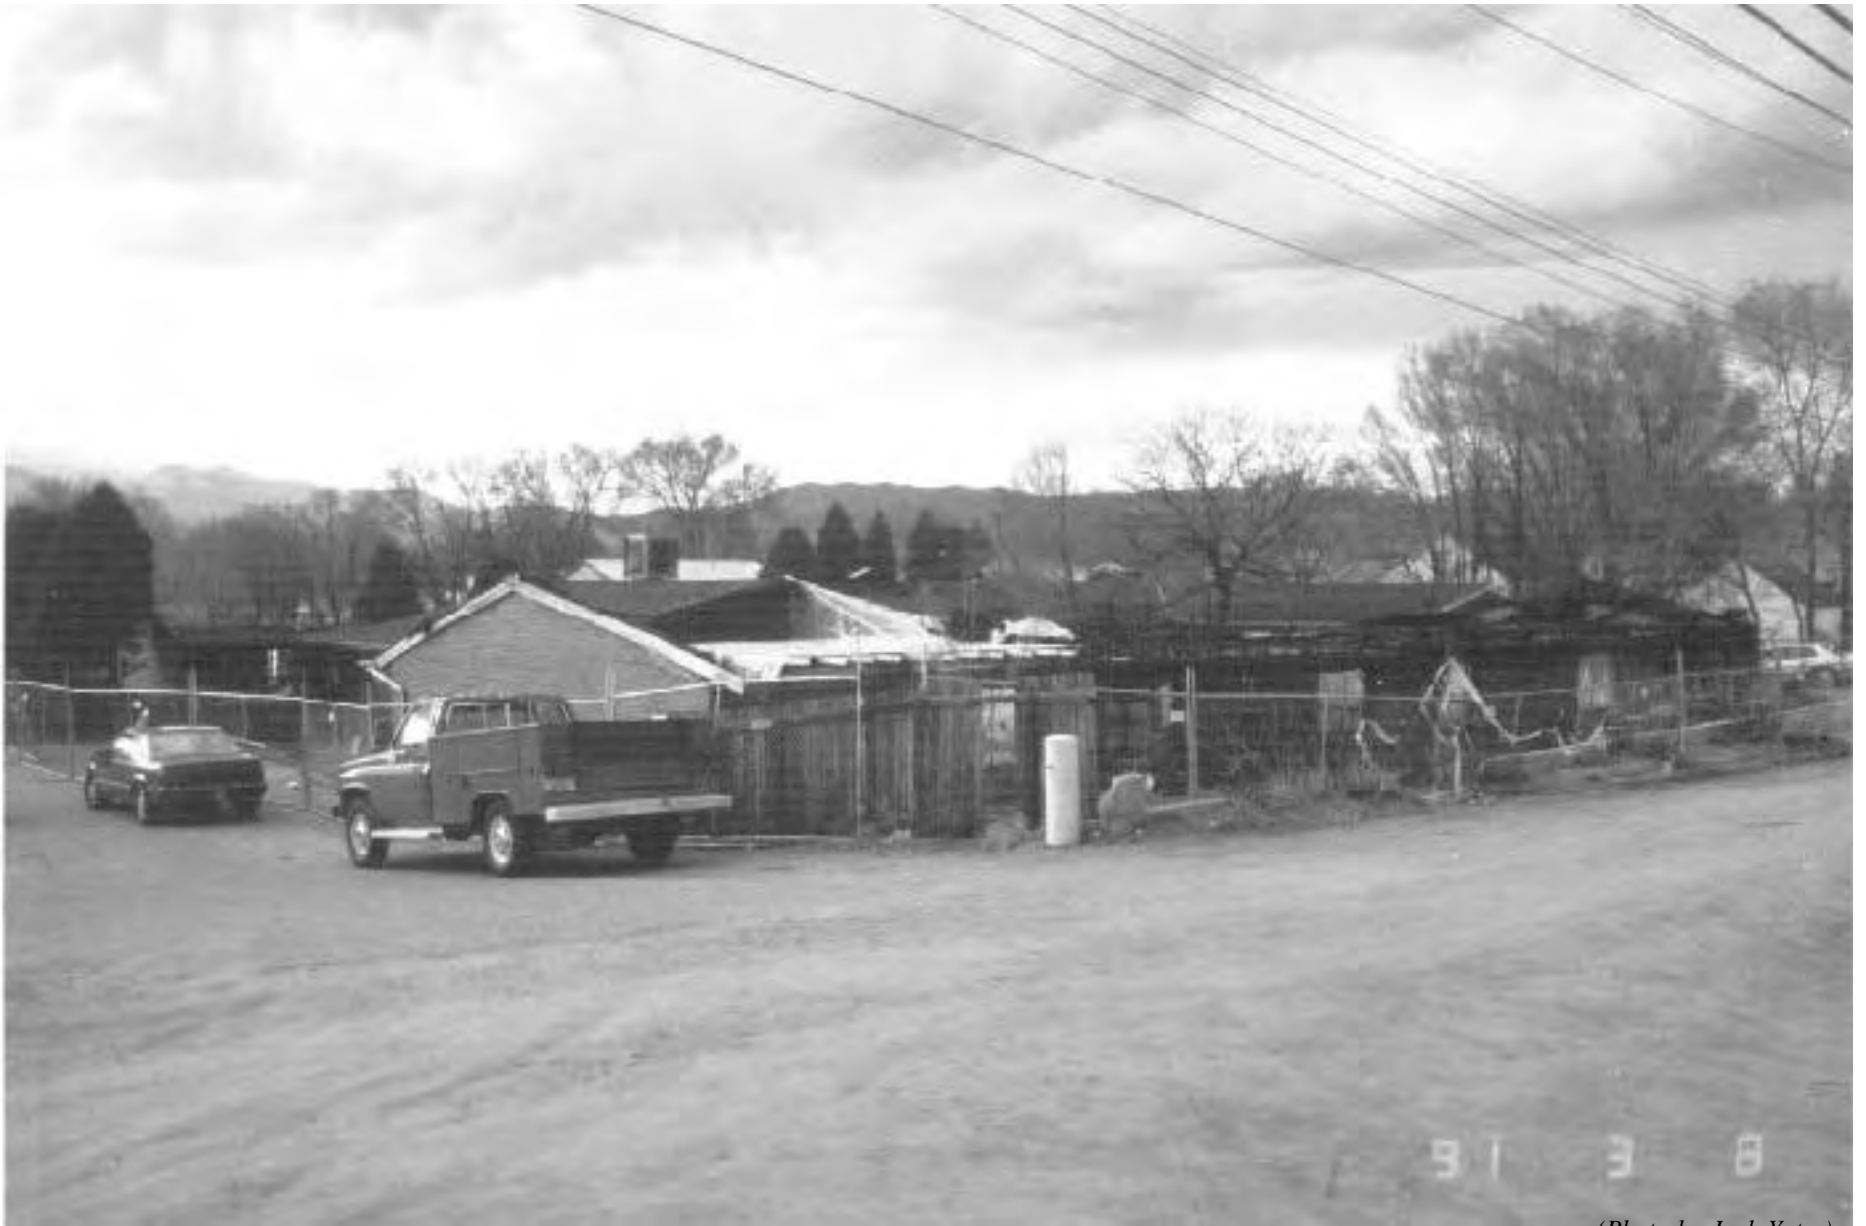
(Photo by Jack Yates)

Exterior of the structure as seen from the southeast and looking to the northwest. The east wing is to the right and the south wing is to the left.

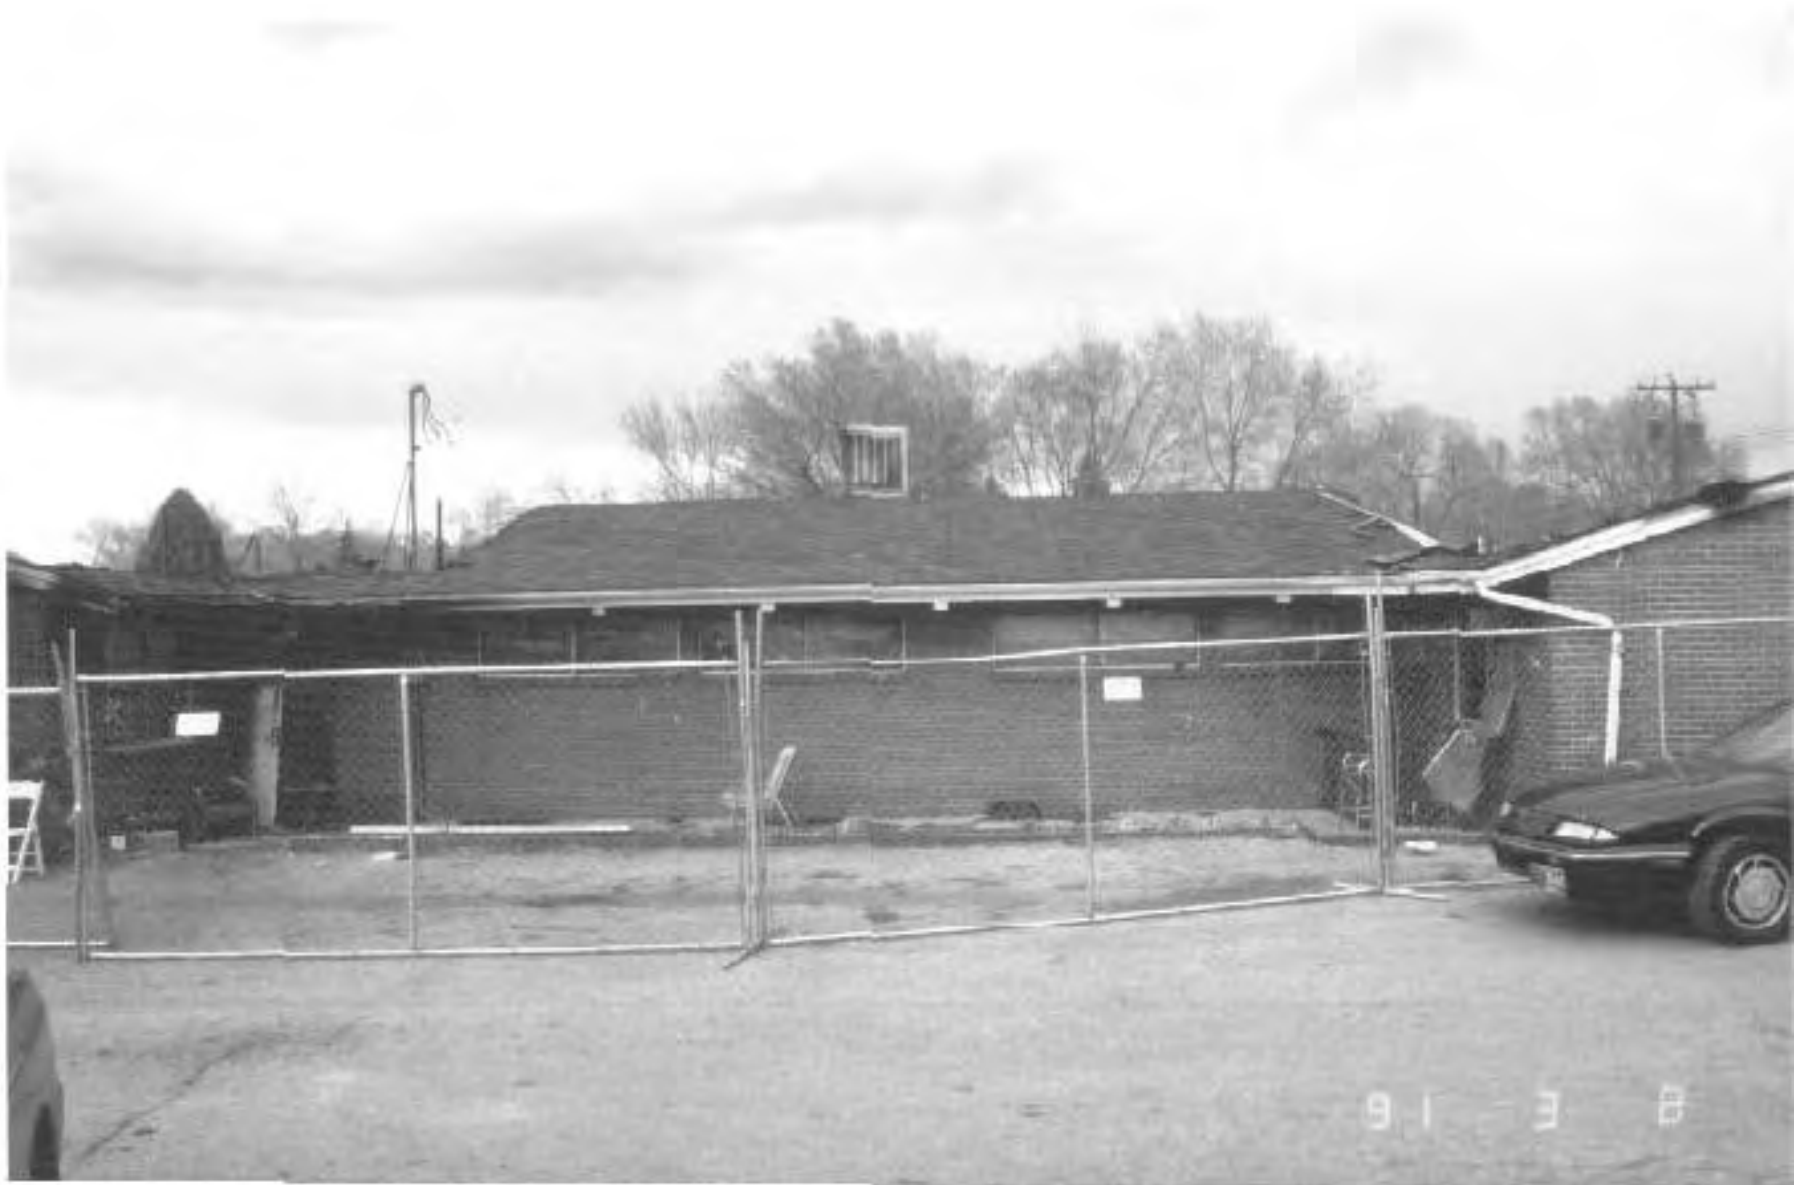
(Photo by Jack Yates)

The dining room burned at a very high temperature due to its heavy timber roof/ceiling construction and possible cooking grease/oil deposits which had adhered to it over time. Fire further extended into the west wing, burning north until being stopped by the brick wall subdividing the attic space.

Exterior as viewed from the south and looking north at the wall and roof area over the dining room.

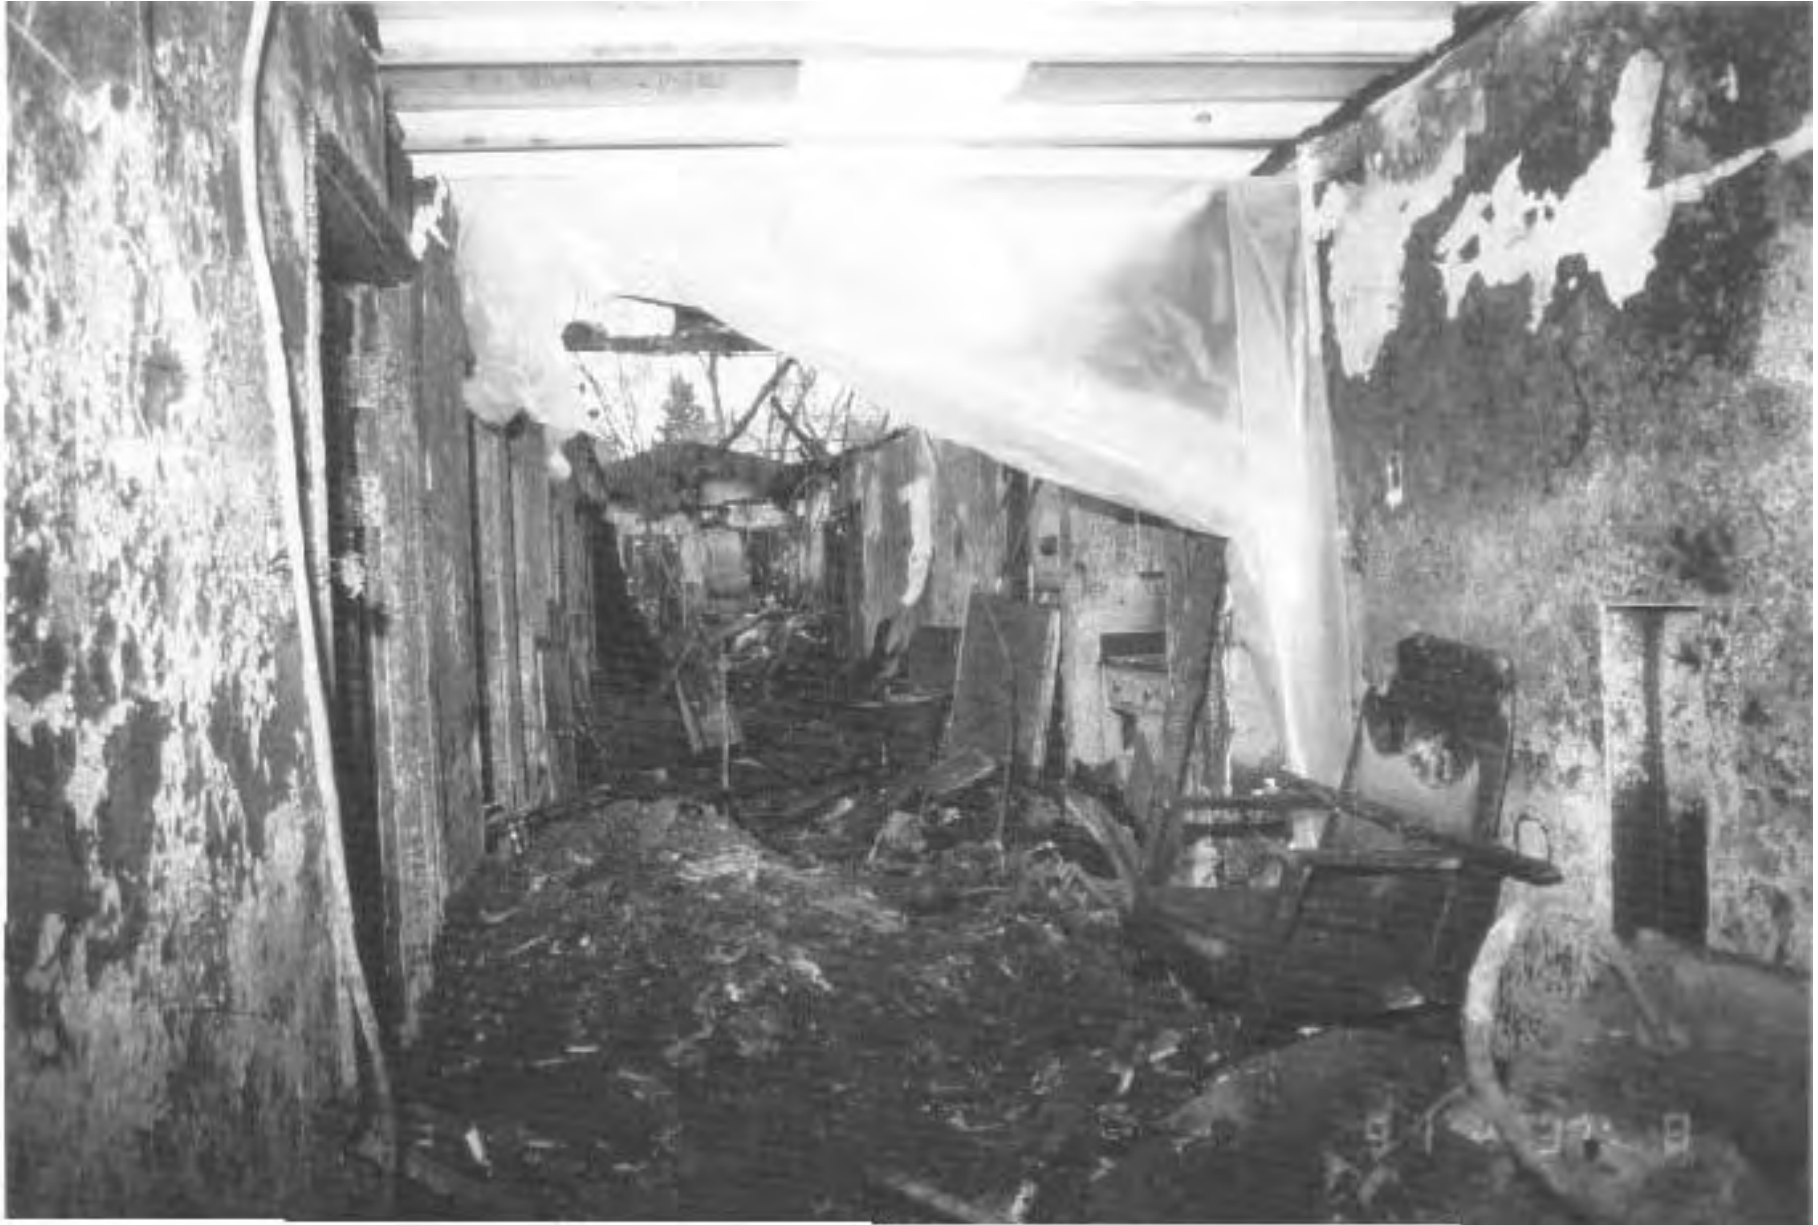
(Photo by Jack Yates)

View of the east wing hall as seen from the south to the north.
The smoking room where the fire began overhead is the first door on the left.

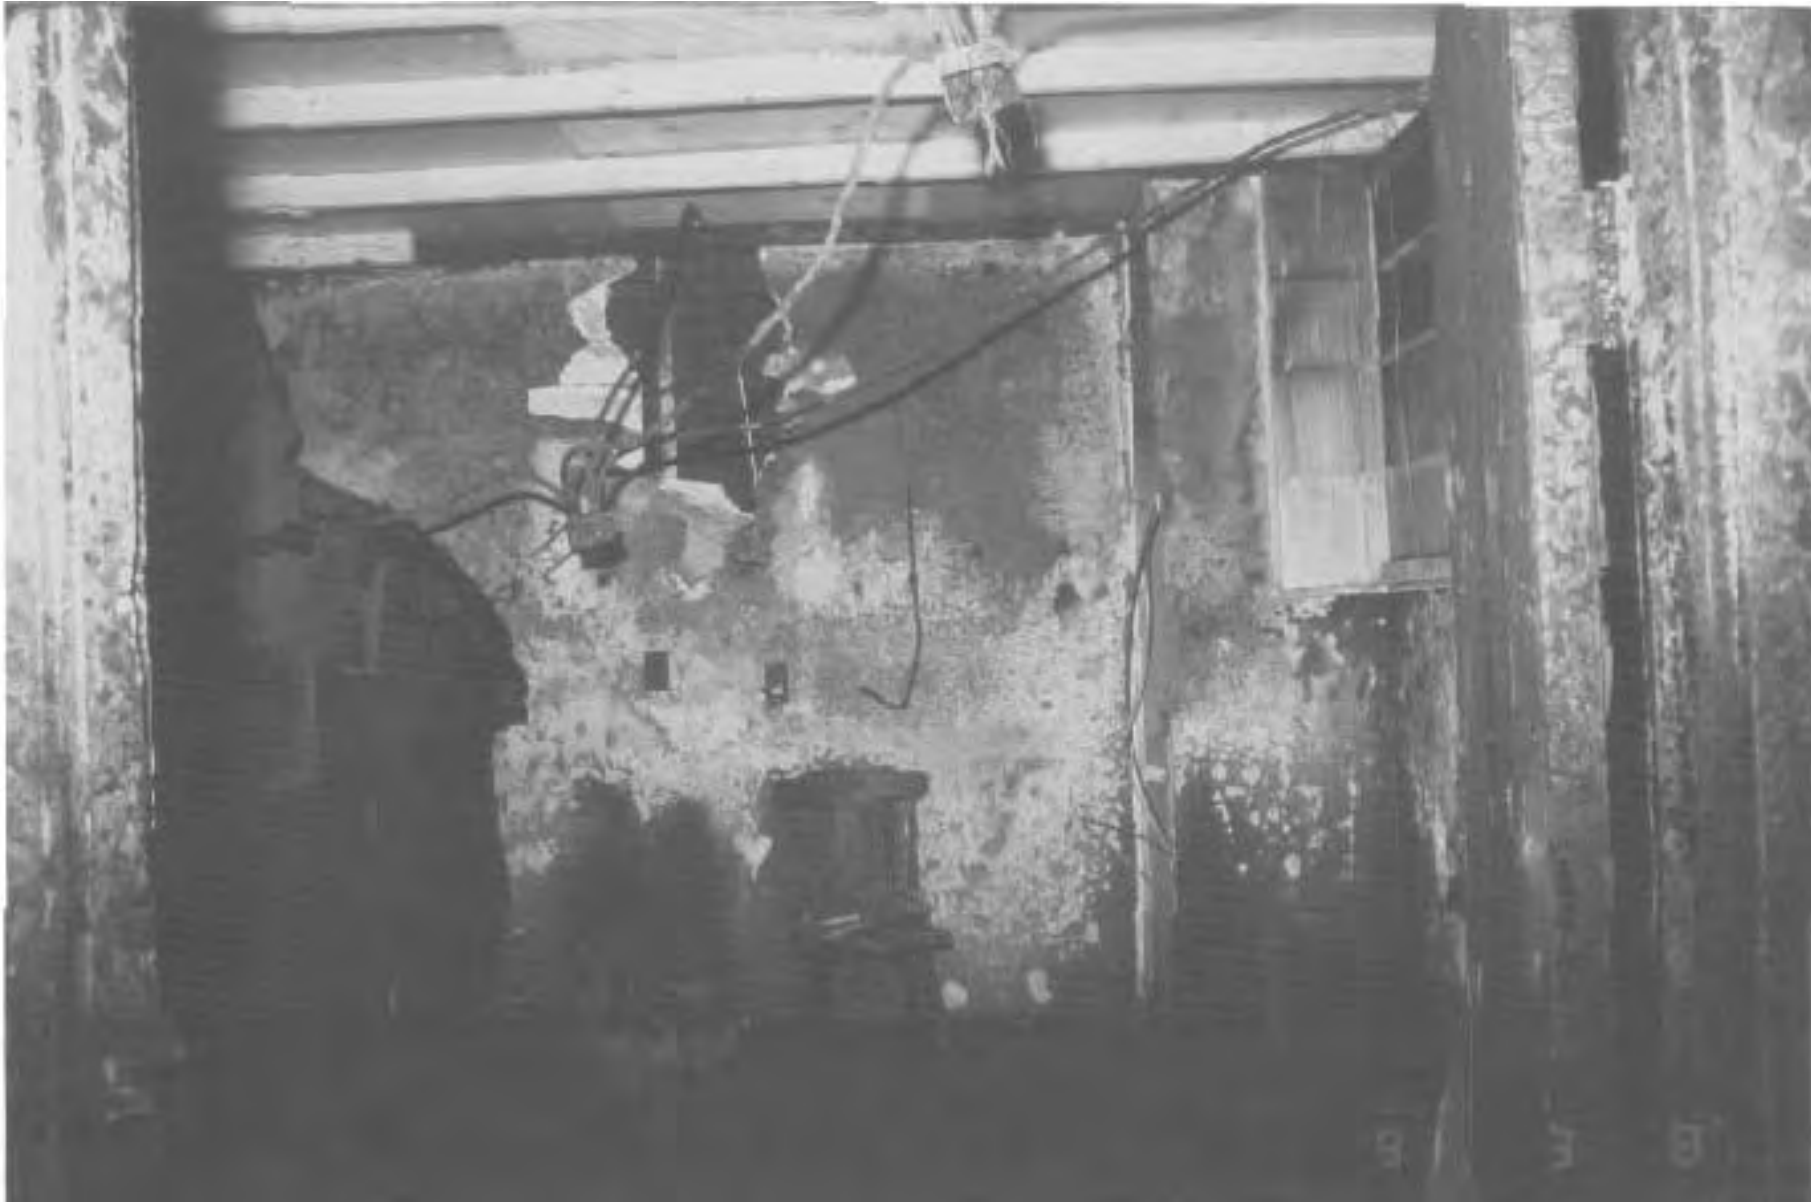
(Photo by Jack Yatm)

A second area of severe burning was located approximately 8' west of the exhaust fan, at the enclosure to the furnace flue extending from the basement. This flue is immediately next to the extreme east end of the dining room. The top plate surrounding this flue revealed extreme burning on the north side where a support strap

A representative of the National Fire Protection Association, upon viewing the two areas of burn, theorized that the fire burned deeply near the flue because the enclosure was open and unrestricted from the basement to the attic. This permitted a sustained flow of fresh air into the attic at this point, which allowed very hot, and efficient, burning to take place.

The smoking room. The corner to the right is the northwest corner where the vent stack to the heating unit below is located. This was thought originally to be the Area of Origin.

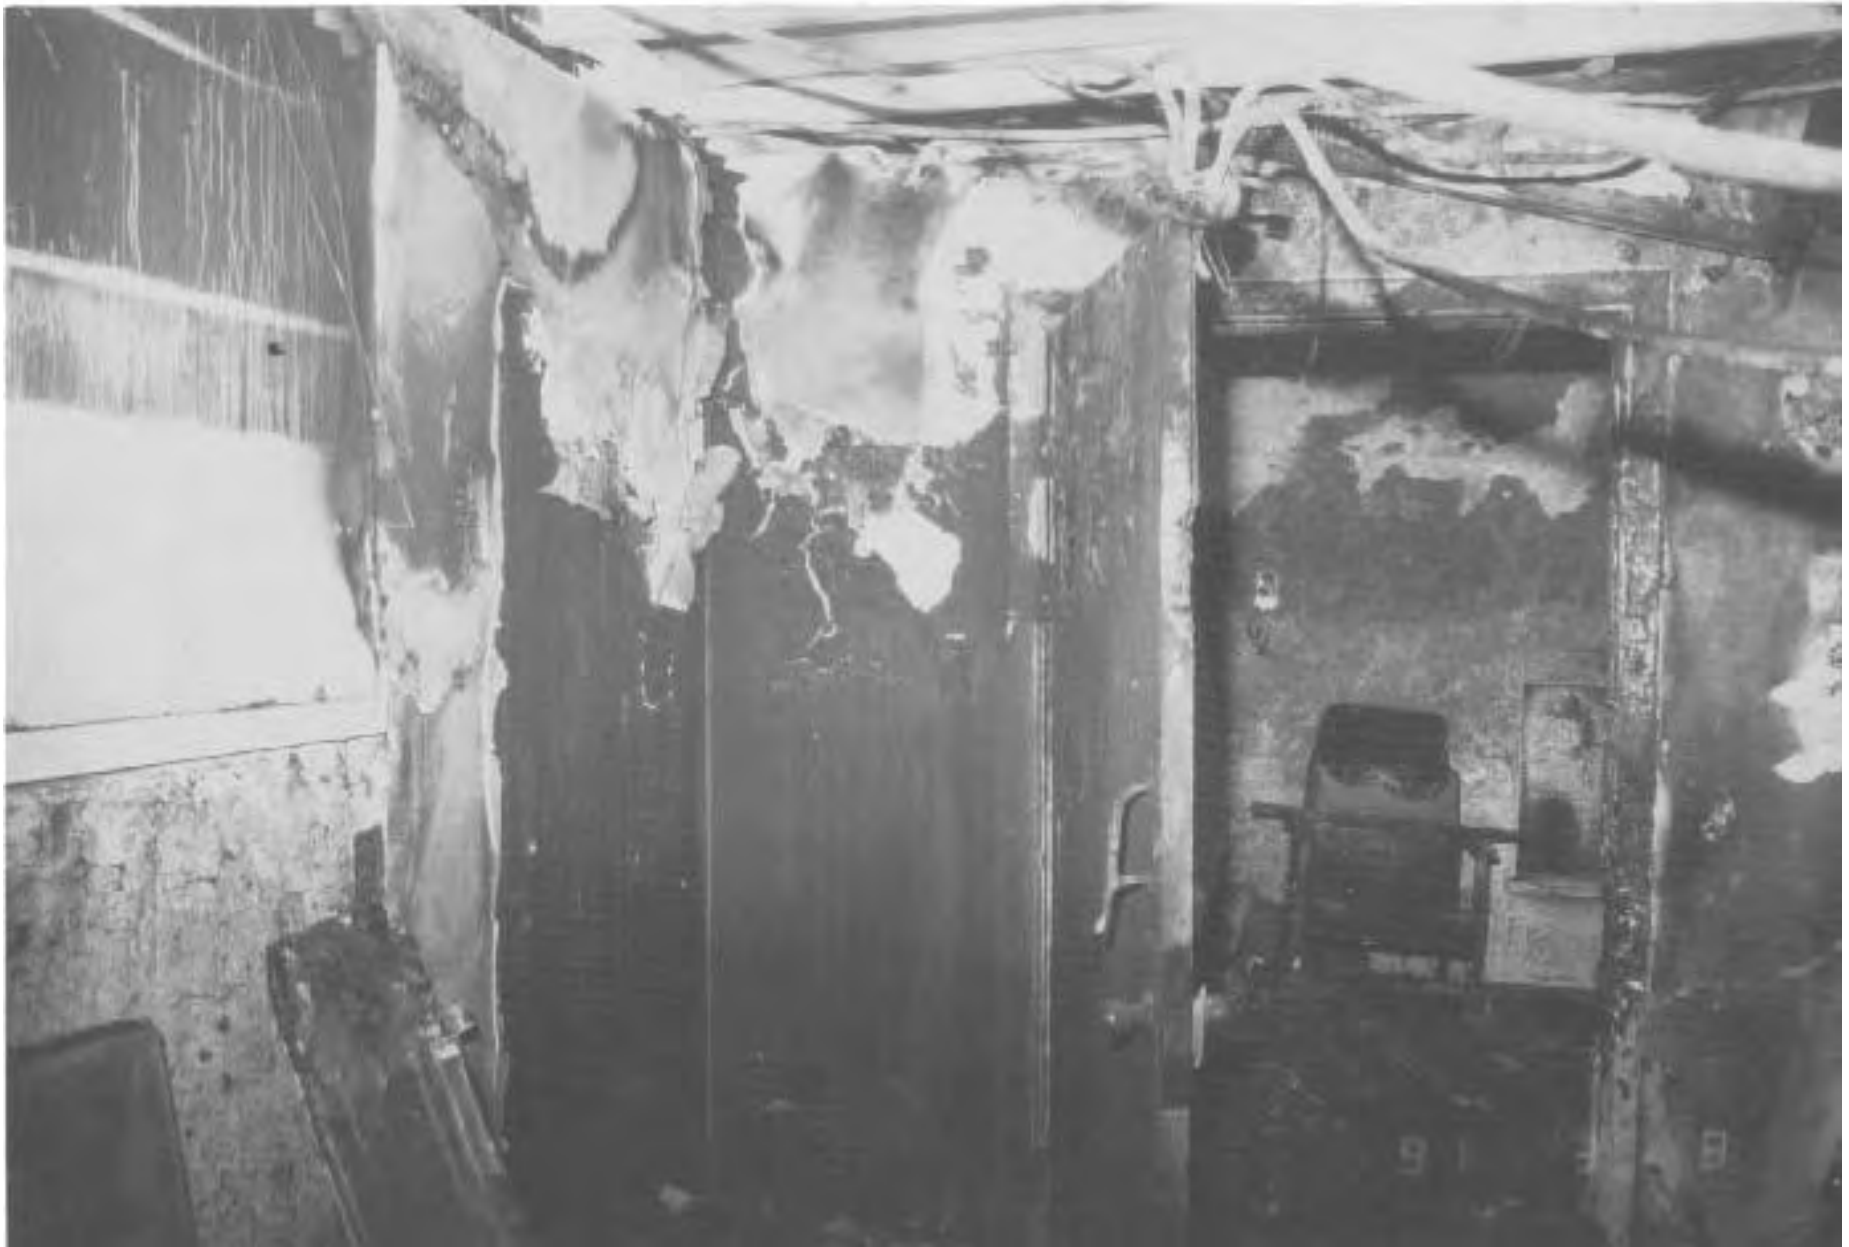
(Photo by Jack Yates)

A "consumer grade" 110 volt ceiling exhaust fan, similar to that found in residential bathrooms, was recovered from the debris in the smoking room. An employee informed investigators that the ceiling fan was controlled by the overhead lighting and was very noisy. She also said the fan was present when the building was purchased by the current owners.

Closer inspection revealed that the bearing assembly to the fan showed evidence of extreme wear, with the bearing/bushing being worn into an oblong shape. An owner later stated that approximately 1 month before the fire, the exhaust fan became very noisy so someone removed the fan cover and sprayed WD-40 into the motor housing. This reduced the amount of noise the fan made.

The double 2"x 4" top plate on the north wall of the smoking room showed evidence of extreme heat and near total destruction above the location where the ventilating fan was found. Distinct burn patterns were also found on the wall beneath this area of the room's north wall. A wall mounted cabinet was also burned at its top, east edge immediately adjacent to the exhaust fan area.

An electrician inspected the circuit to the overhead lighting and exhaust fan and found them to be powered by the only 15 amp circuit breaker in the electrical panel. The breaker was tripped sometime during the fire and showed evidence of extreme internal heat. The electrician stated the breaker was no longer functional and indicated that it may have been operating very near its capacity for a long time. Adjacent breakers showed no signs of heat and appeared to remain functional.

View of the northeast corner of the smoking room. The light switch behind the door (just under the white spot in the center) controlled the fluorescent lights and the ventilation fan. The fan was located in the northeast corner. When the lights were on the fan was on. Since the switch location was difficult to get to, the lights and fan stayed on for hours and sometimes days at a time.

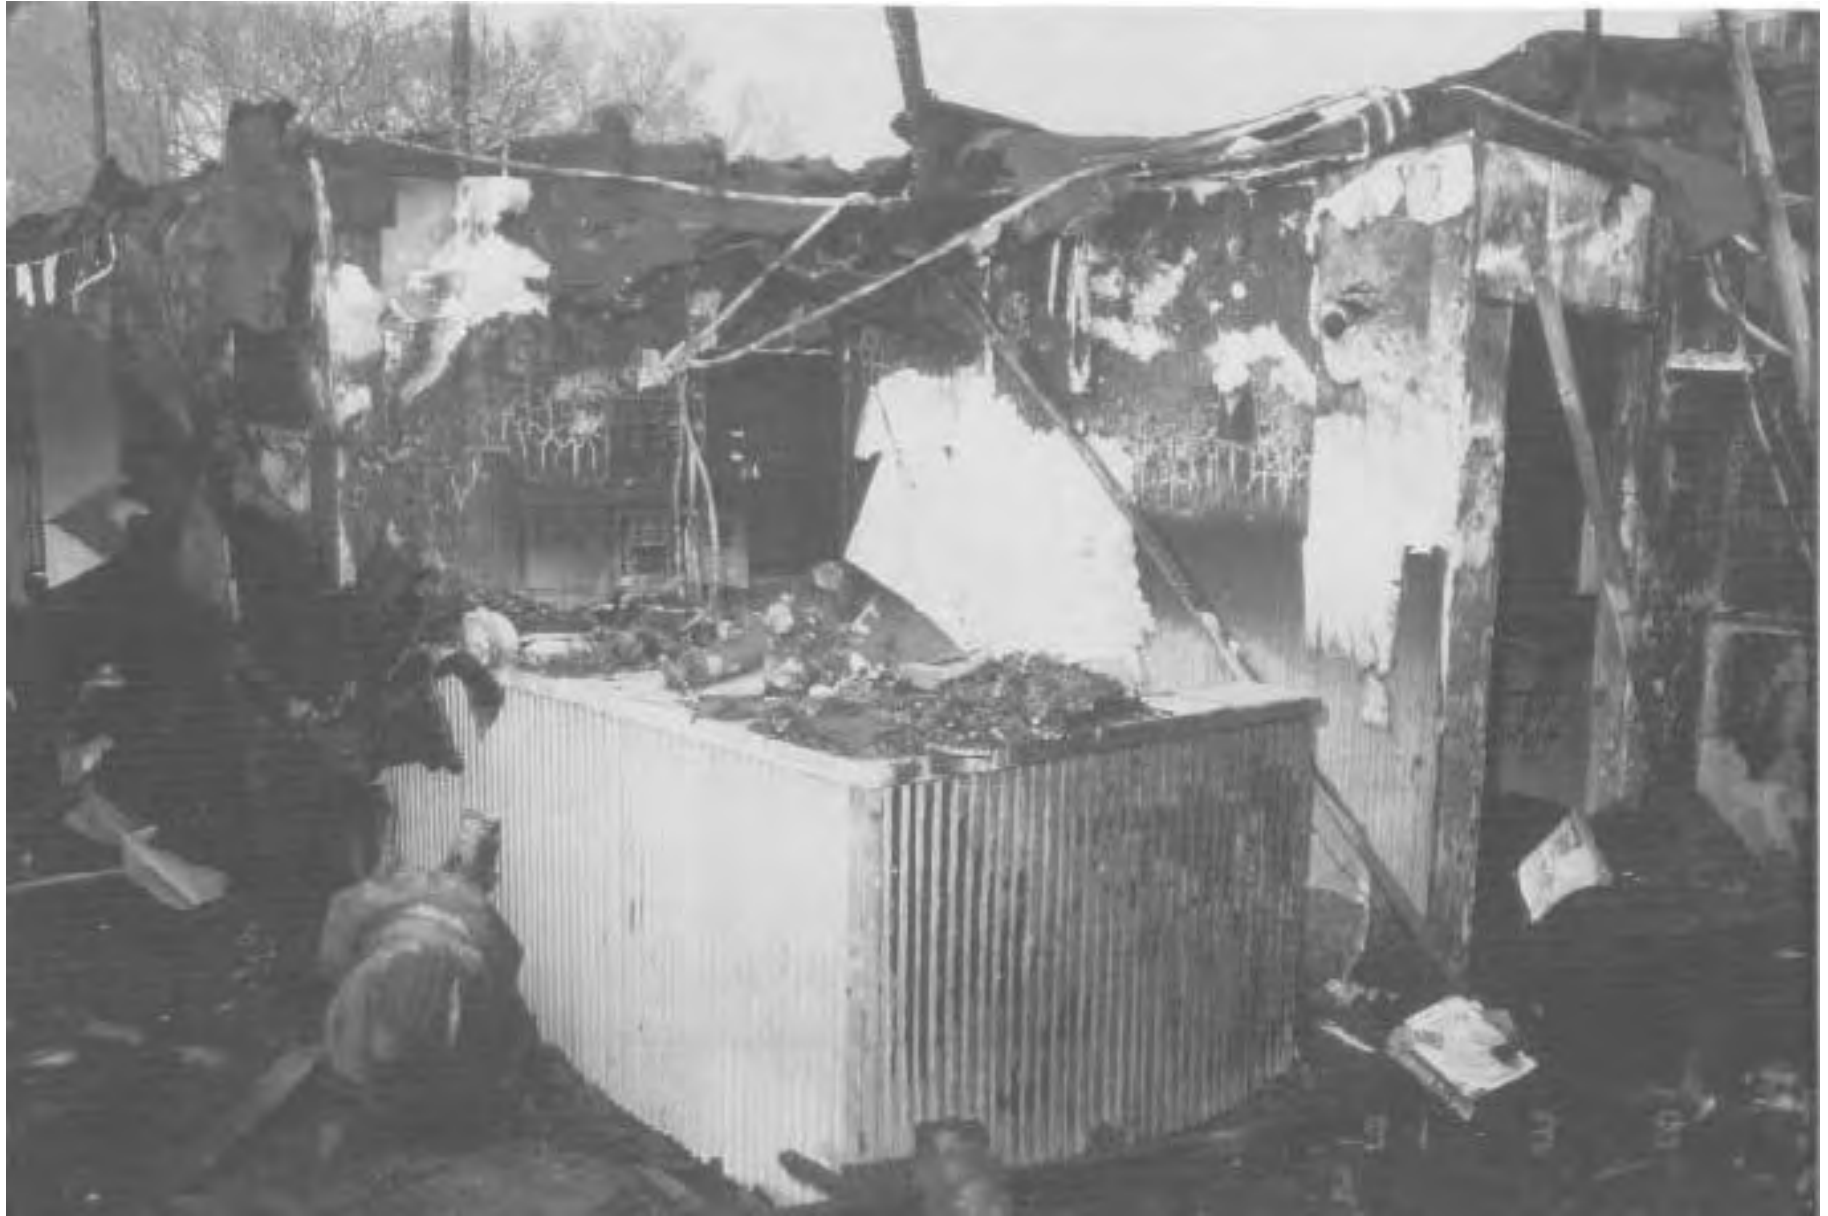
(Photo by Jack Yates)

Nurses' station just inside the front (southwest) door. The alarm panel is at this station. View is toward the northeast.

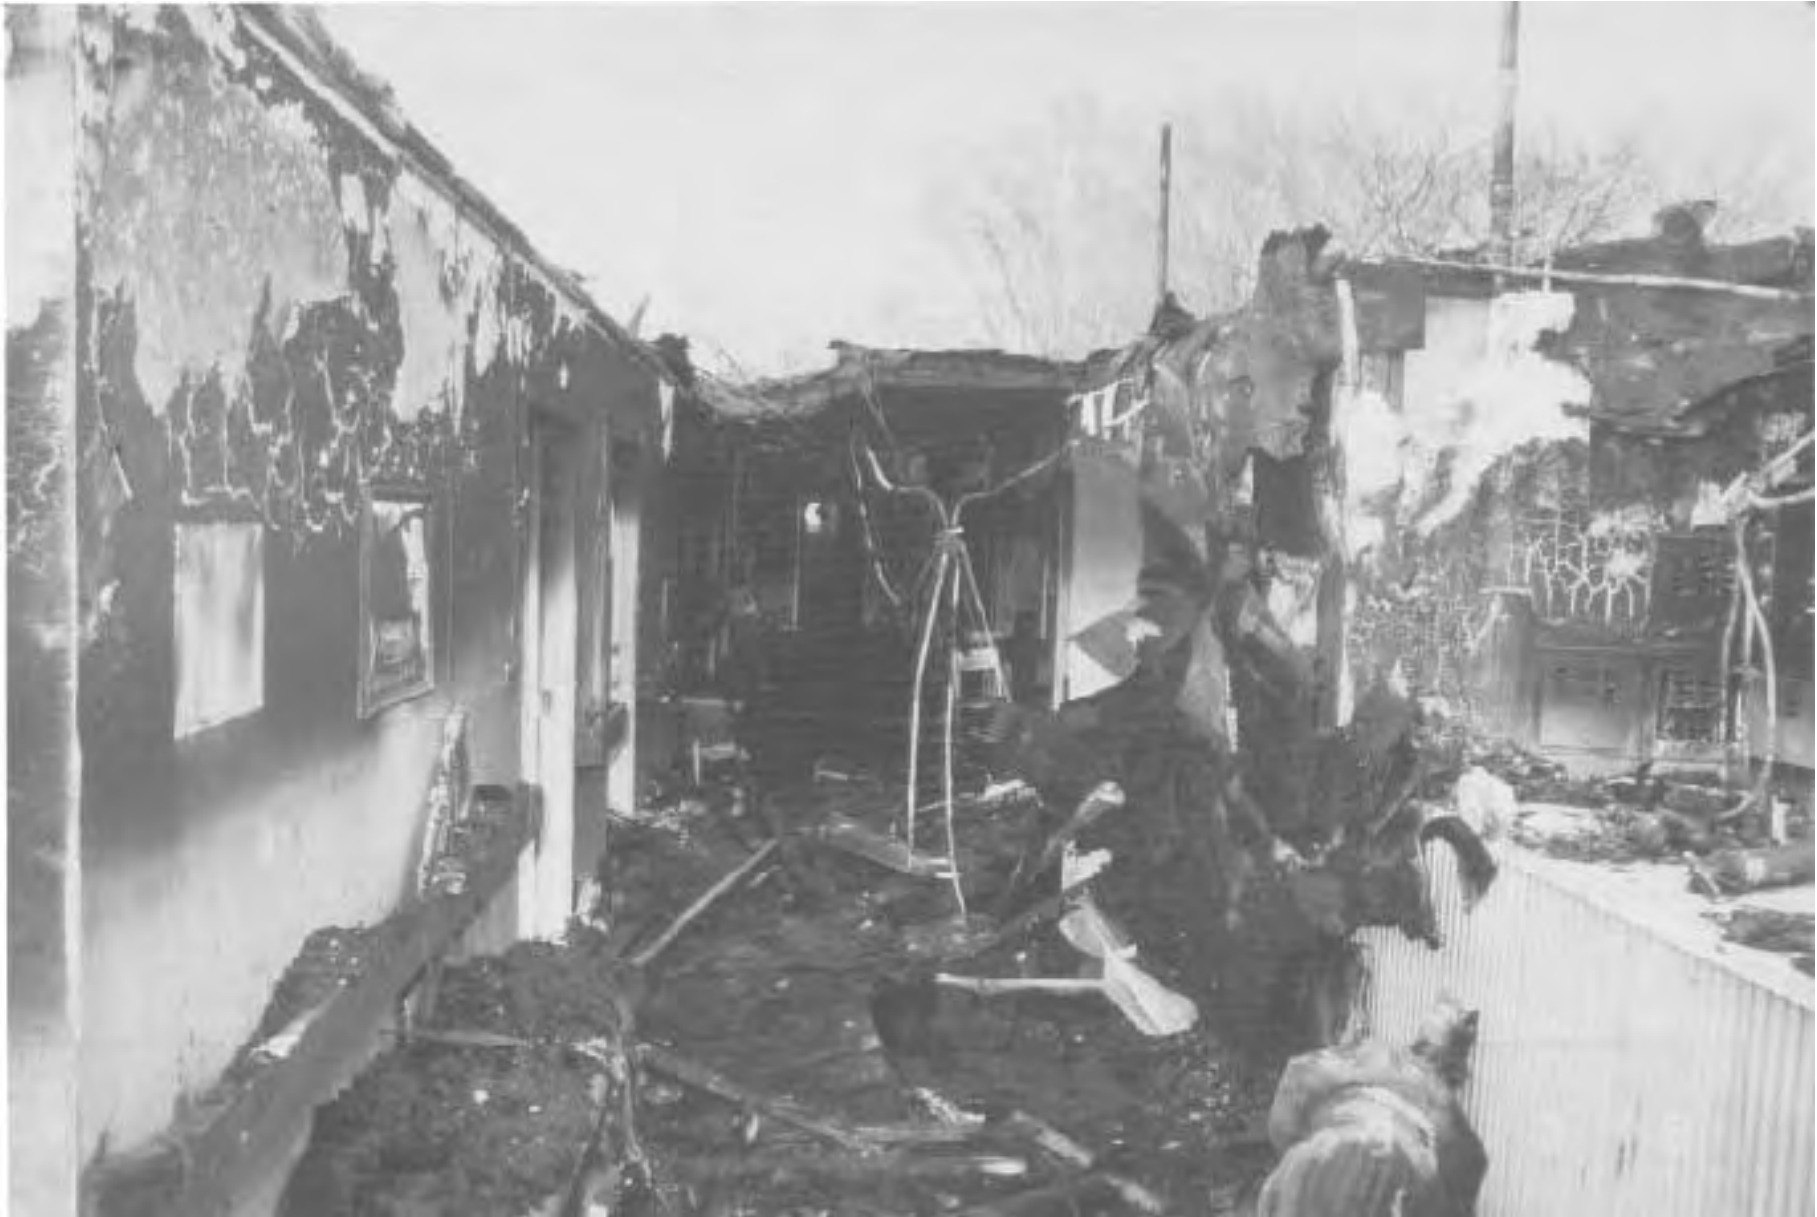
(Photo by Jack Yates)

Looking north from the entry area by the nurses' station down the hall. Note all overhead framing was destroyed.

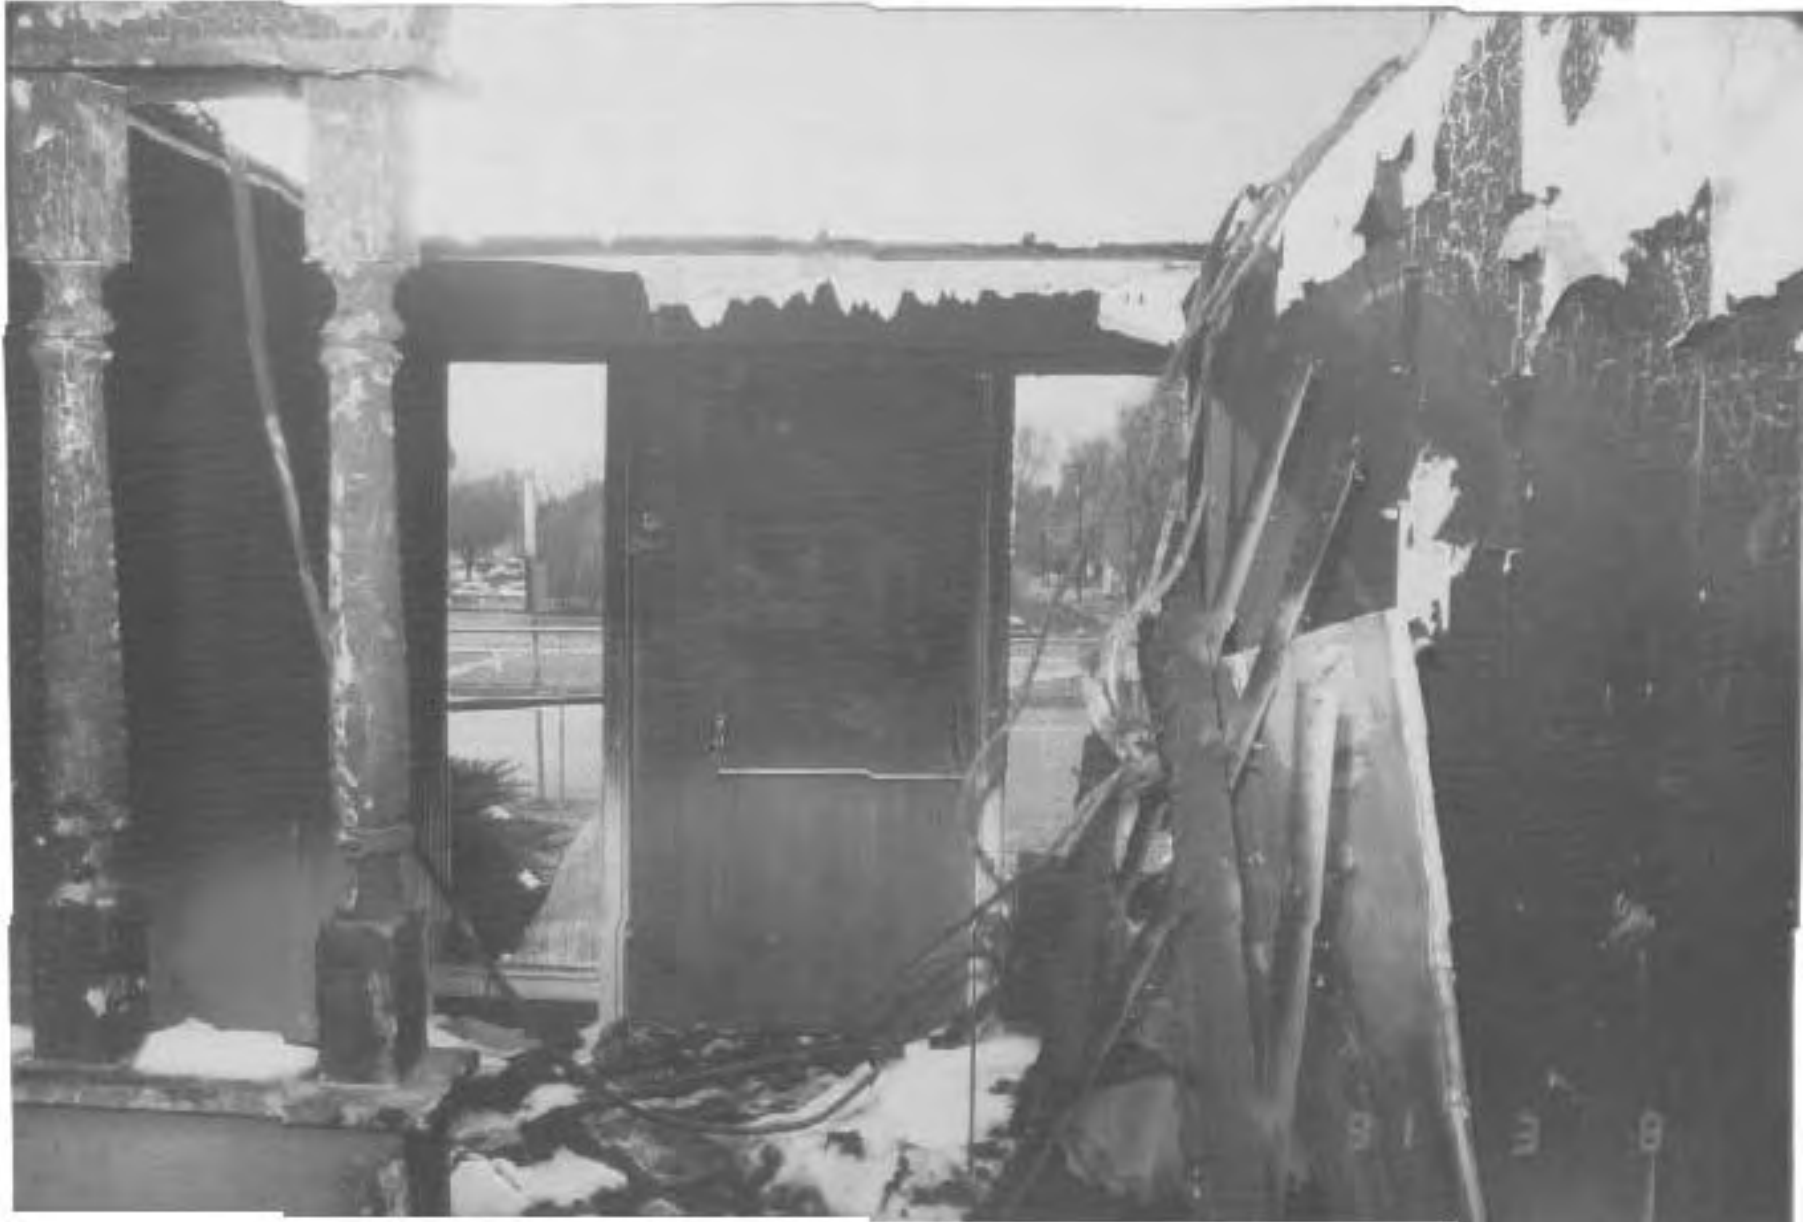
(Photo by Jack Yates)

Front door through which initial interior attack was made, located at the southwest corner of the structure. View is from the interior toward the west.
