Technical Report Series

Ten Elderly Victims from Intermediate Care Facility Fire Colorado Springs, Colorado

Ten Elderly Victims from Intermediate Care Facility Fire Colorado Springs, Colorado (March 4, 1991)

This is Report 050 of the Major Fires Investigation Project conducted by TriData Corporation under contract EMW-90-C-3338 to the United States Fire Administration, Federal Emergency Management Agency.

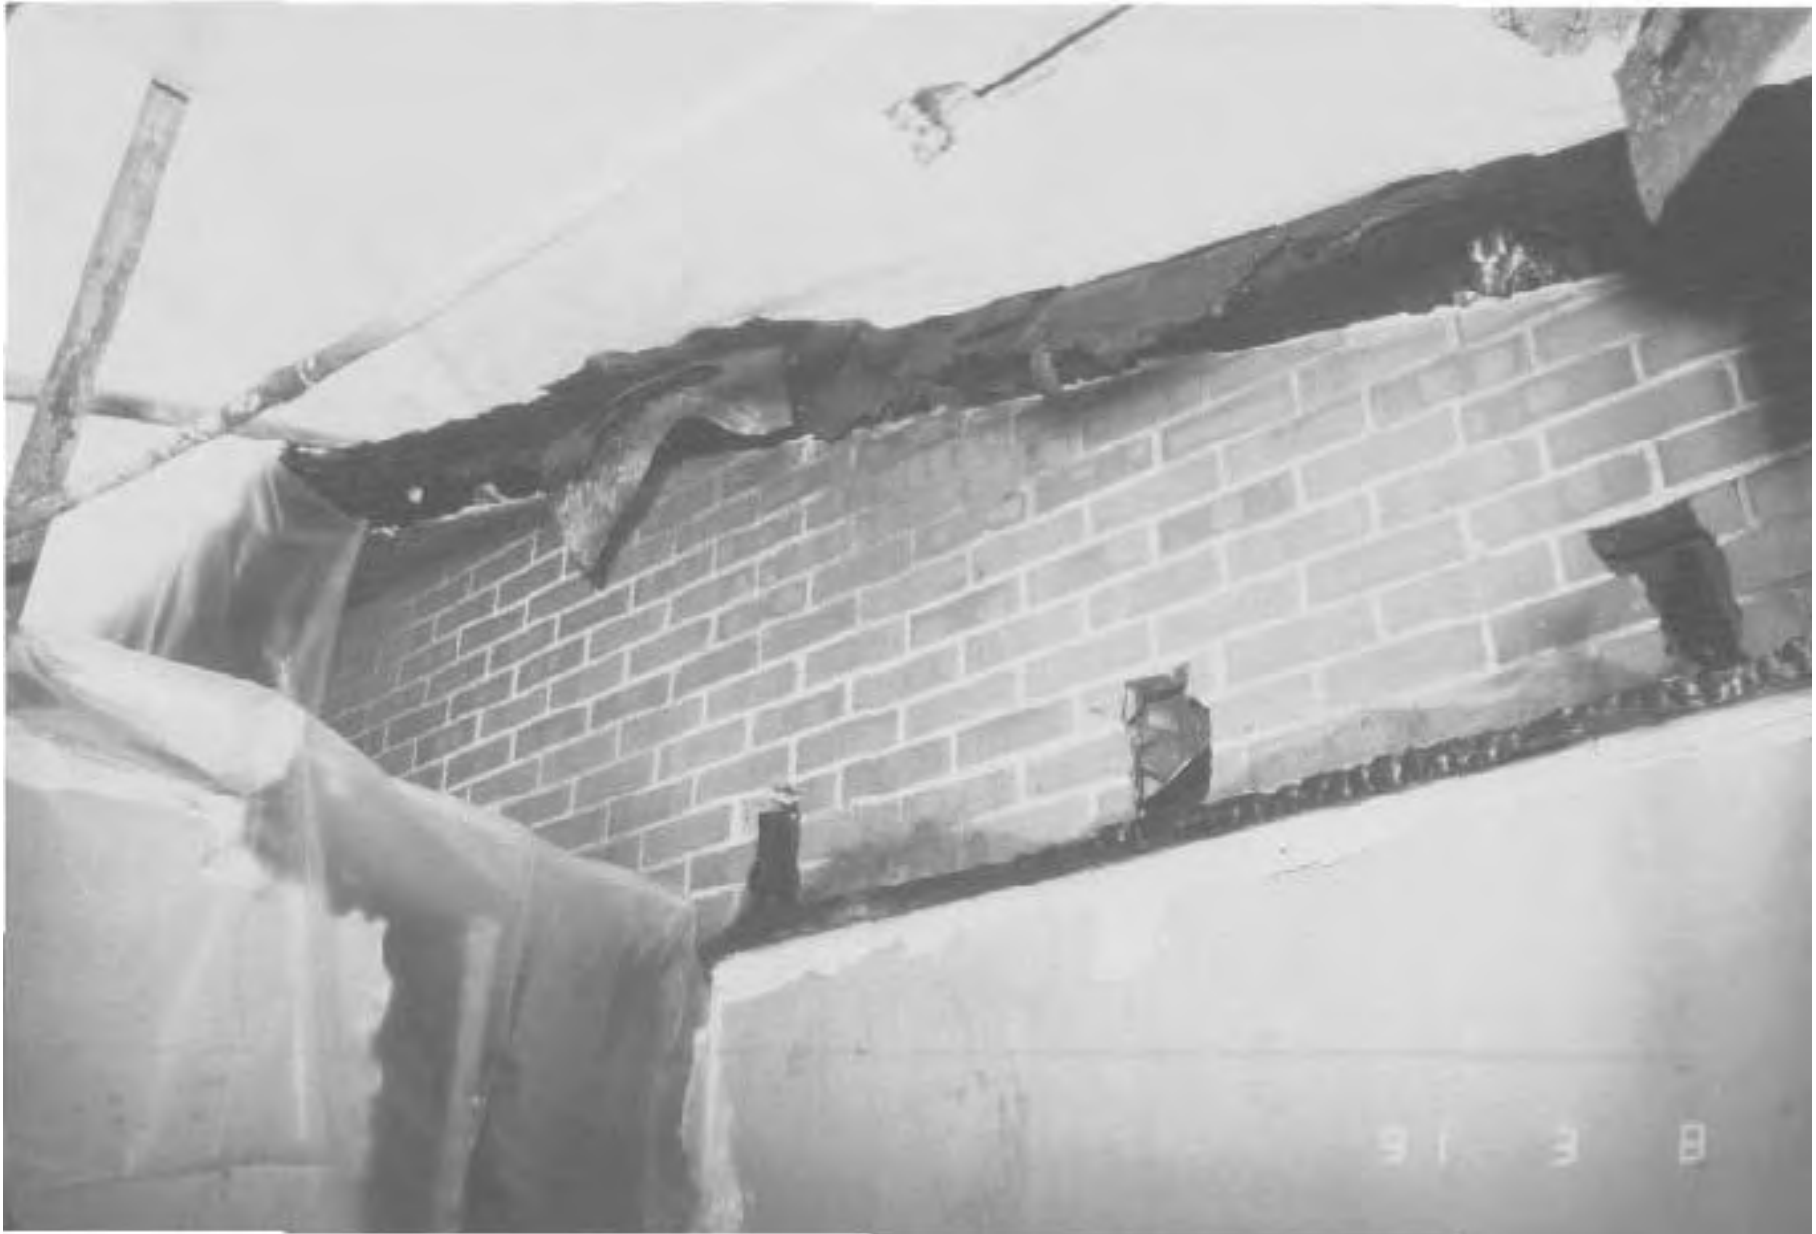
(Photo by Jack Yates)

However, the actual structure did not have safety features that originally were thought to be there; in particular, properly rated and designed firewalls. A wall at the east end of the dining area was thought at first to be a firewall, however, closer inspection revealed that a tongue-in-groove ceiling extended over the top leaving exposed wood to the outside. A cinder block wall was constructed adjacent to it, but the integrity of the wall was breached when holes were punched in in order to allow the ceiling joist for the east addition.

The east wall of the dining area. Note where holes have been punched in to put joists through. There was a cinder block wall behind this, but tongue-in-groove boards extended over the top exposing the boards to the brick area. Integrity of the firewall was breached from the holes and overlap of wood material.

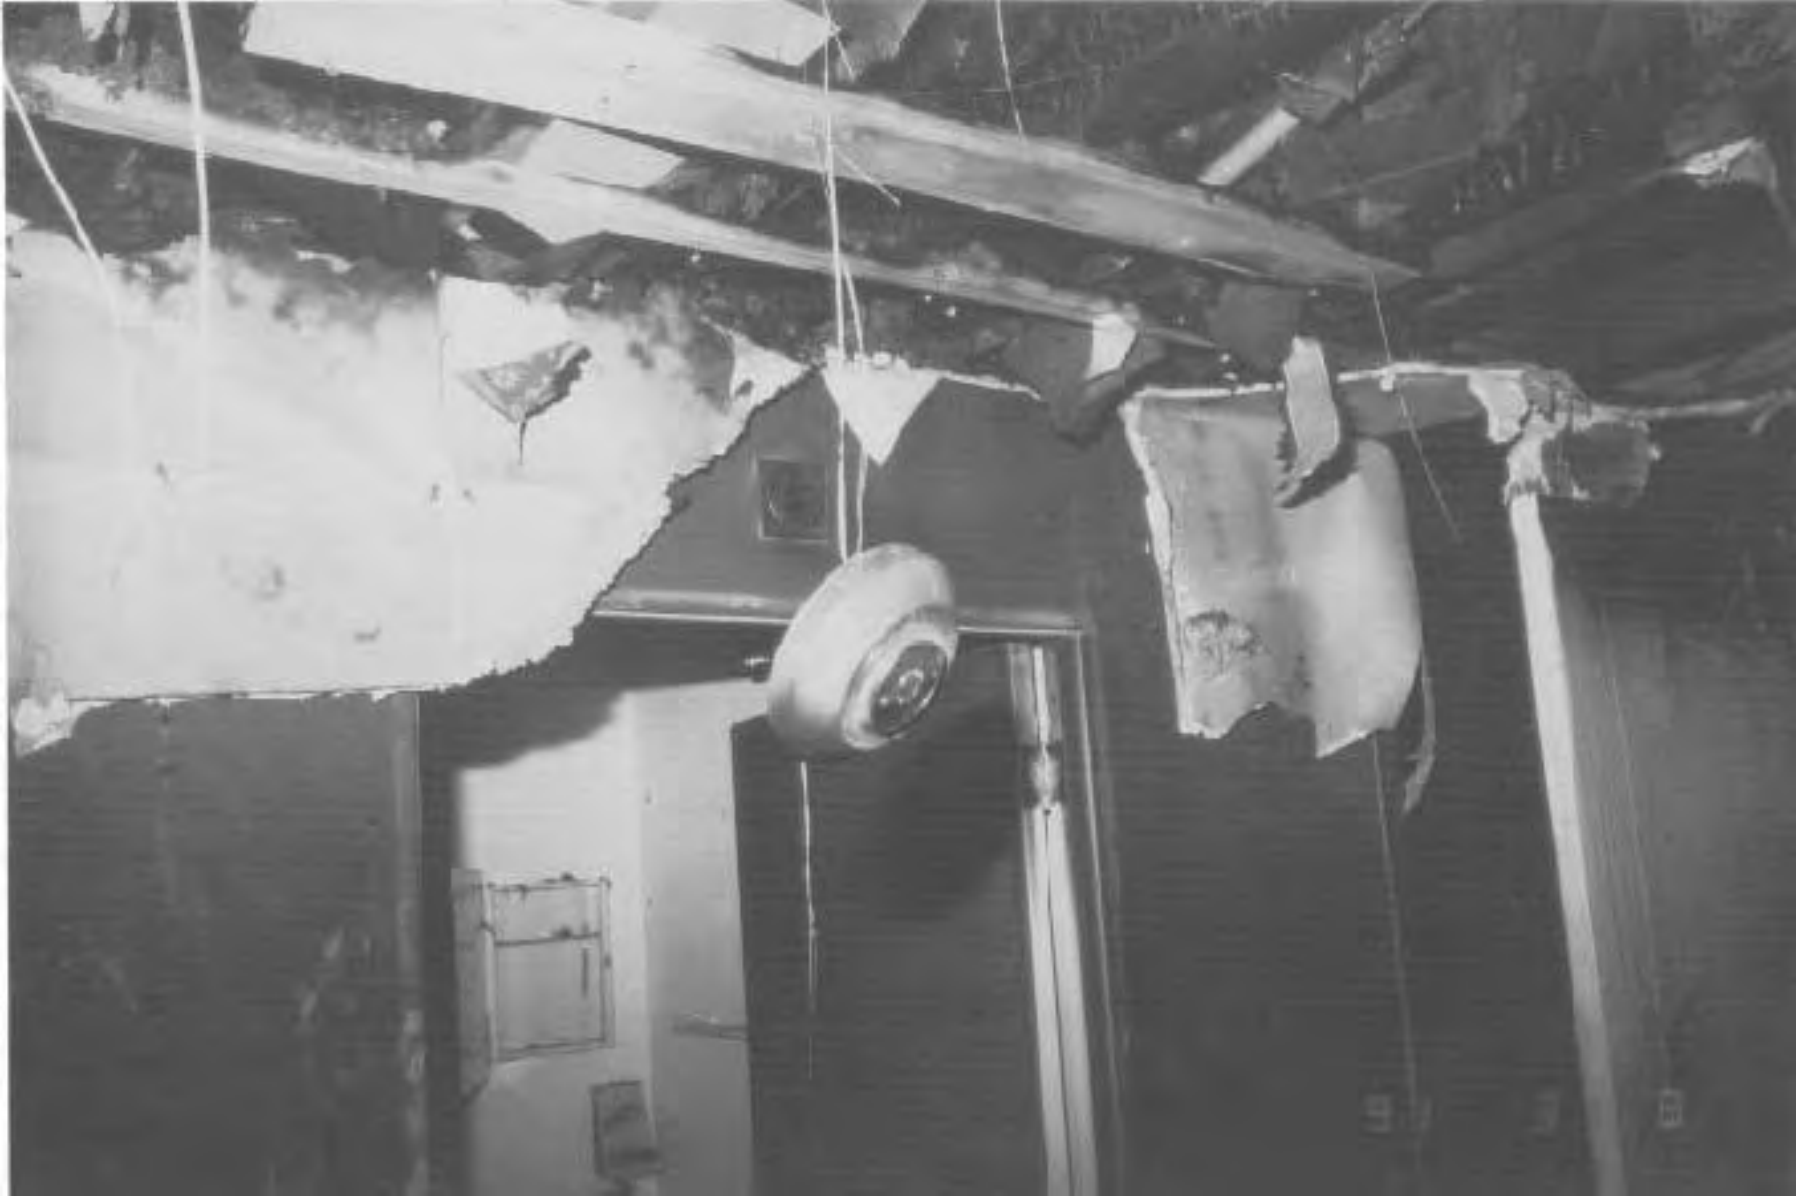
(Photo by Jack Yates)

It also appeared all systems were hard wired and were not battery backed.

Older existing smoke alarm in the structure, hard-wired, no battery backup.

All detection equipment in place must be kept in working condition. The system must be checked on a scheduled basis by trained personnel. Battery assistance to hard wired heat/smoke detectors offers the greatest safety. Although not a factor in this loss, the scenario of this incident illustrates the threat of loss of power.
