### **Seven-Fatality Fire at Remote Wilderness Lodge Grand Marais, Minnesota**

# **Seven-Fatality Fire at Remote Wilderness Lodge Grand Marais, Minnesota (July 12, 1991)**

**This is Report 055 of the Major Fires Investigation Project conducted  
by TriData Corporation under contract EMW-90-C-3338 to the United  
States Fire Administration, Federal Emergency Management Agency.**

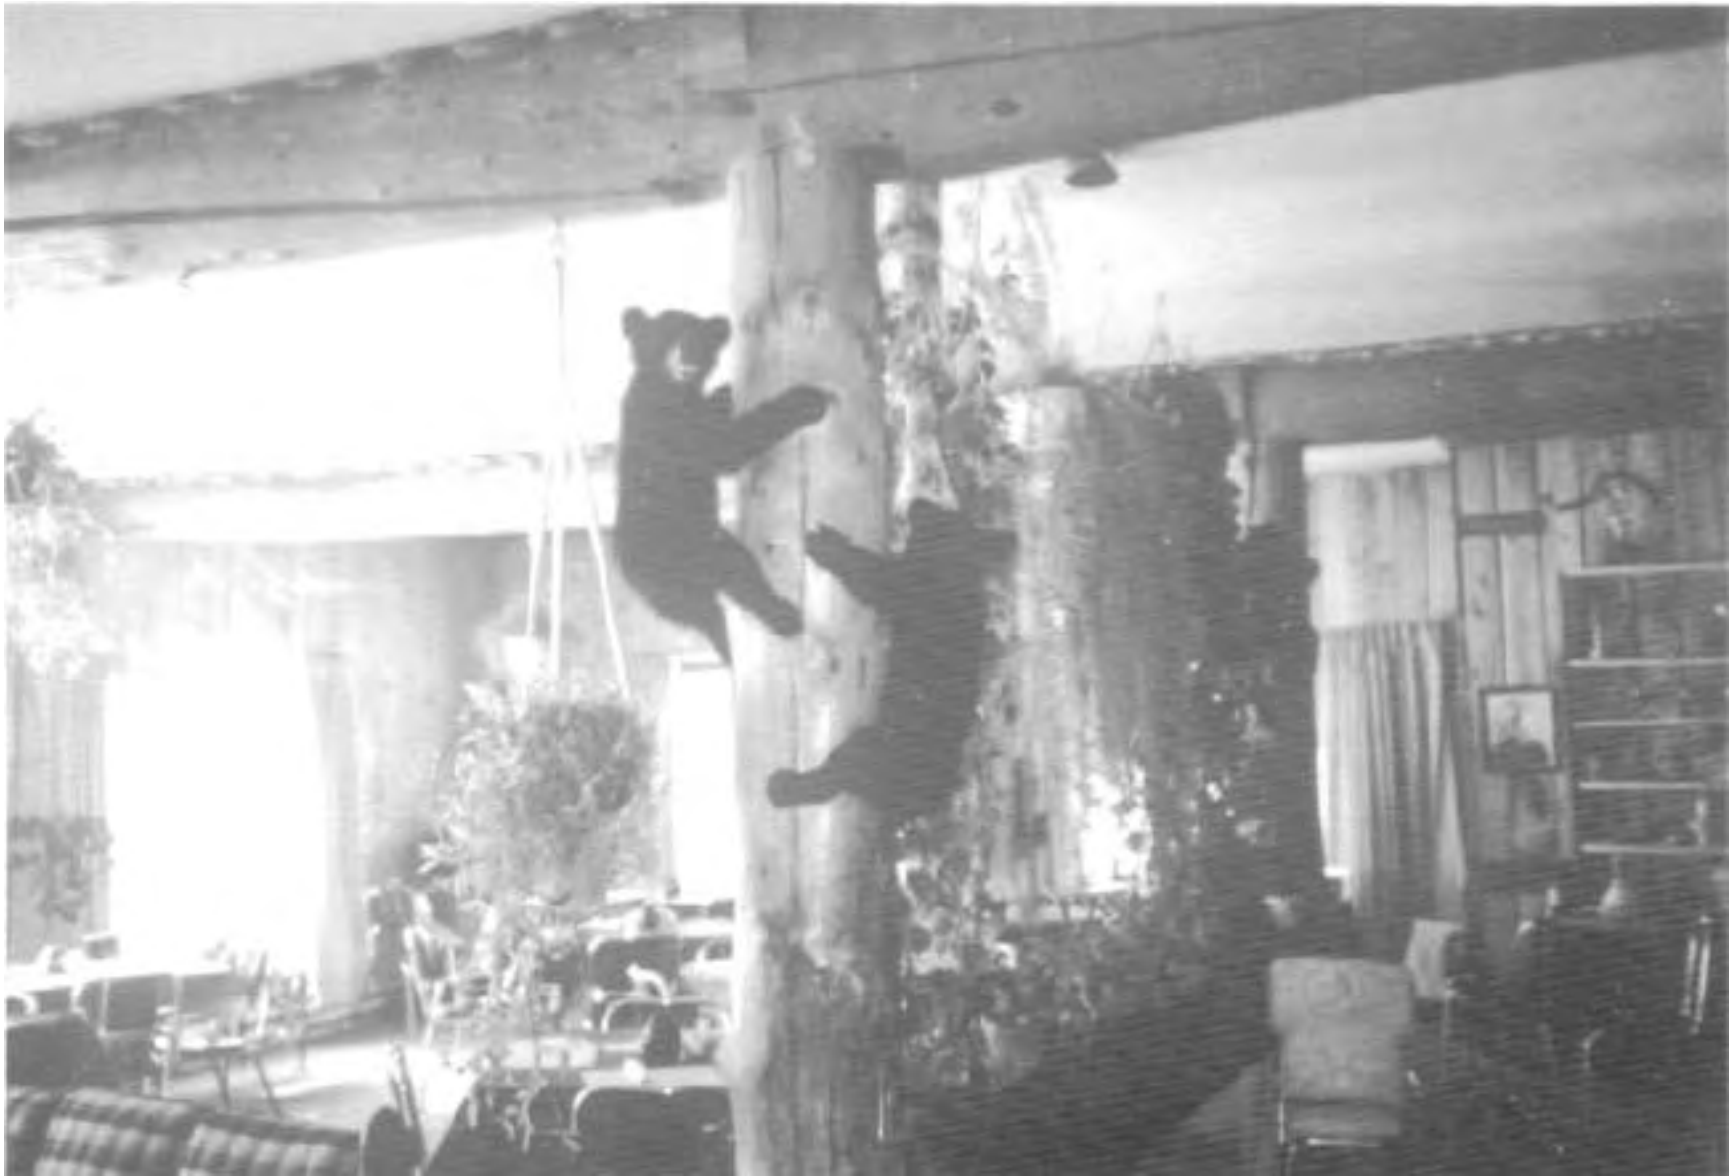
It was stated the ceiling construction on the first floor was sheet rock with exposed beams. However, there were indications from witnesses and photos that the sheet rock had large gaps where it met at the beams. This allowed fire to travel to the floor construction above and probably contributed significantly to the fire spread.

Dining room and lounge area on first floor. Note ceiling separations at log beams.

5. Decorative elements, such as the exposed ceiling beams in this case, require that special efforts be made to insure the fire-resistive integrity of the construction.

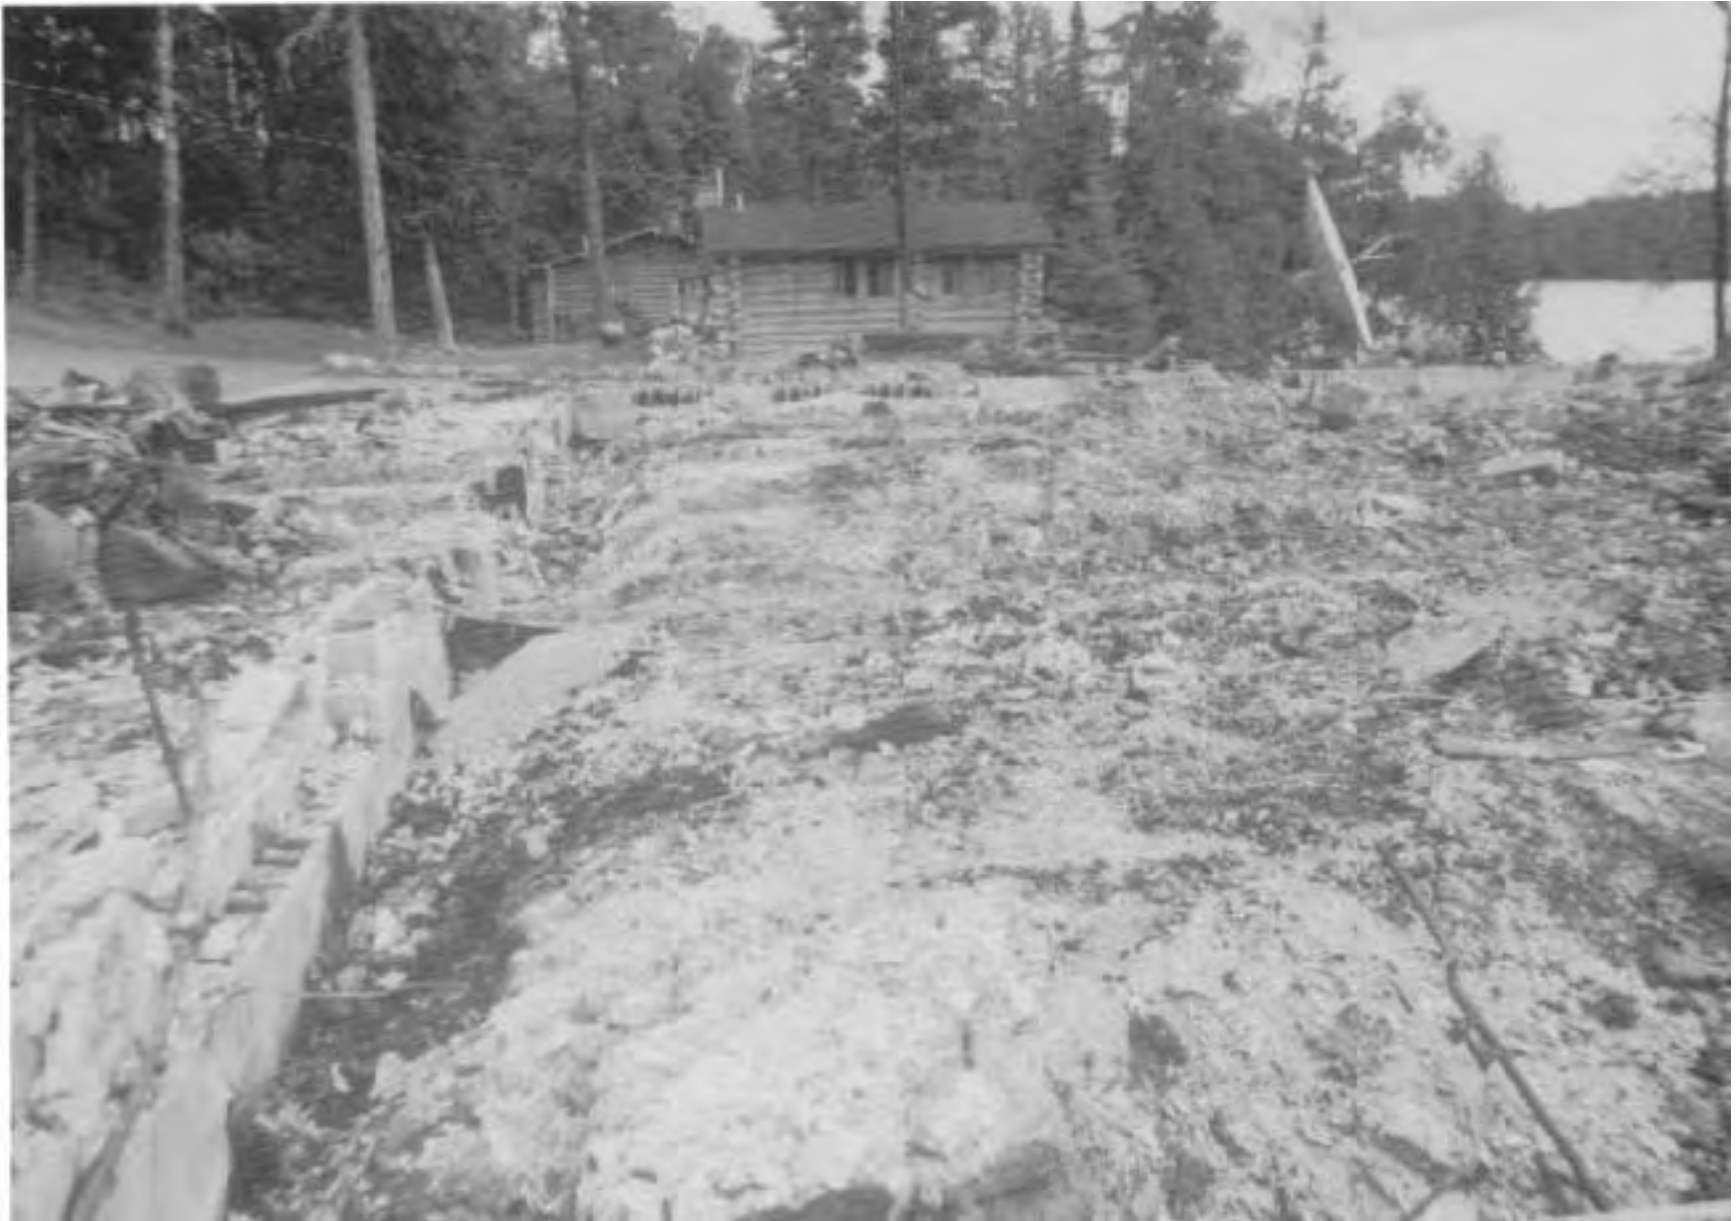
View along north foundation wall shows total destruction of lodge by the fire.

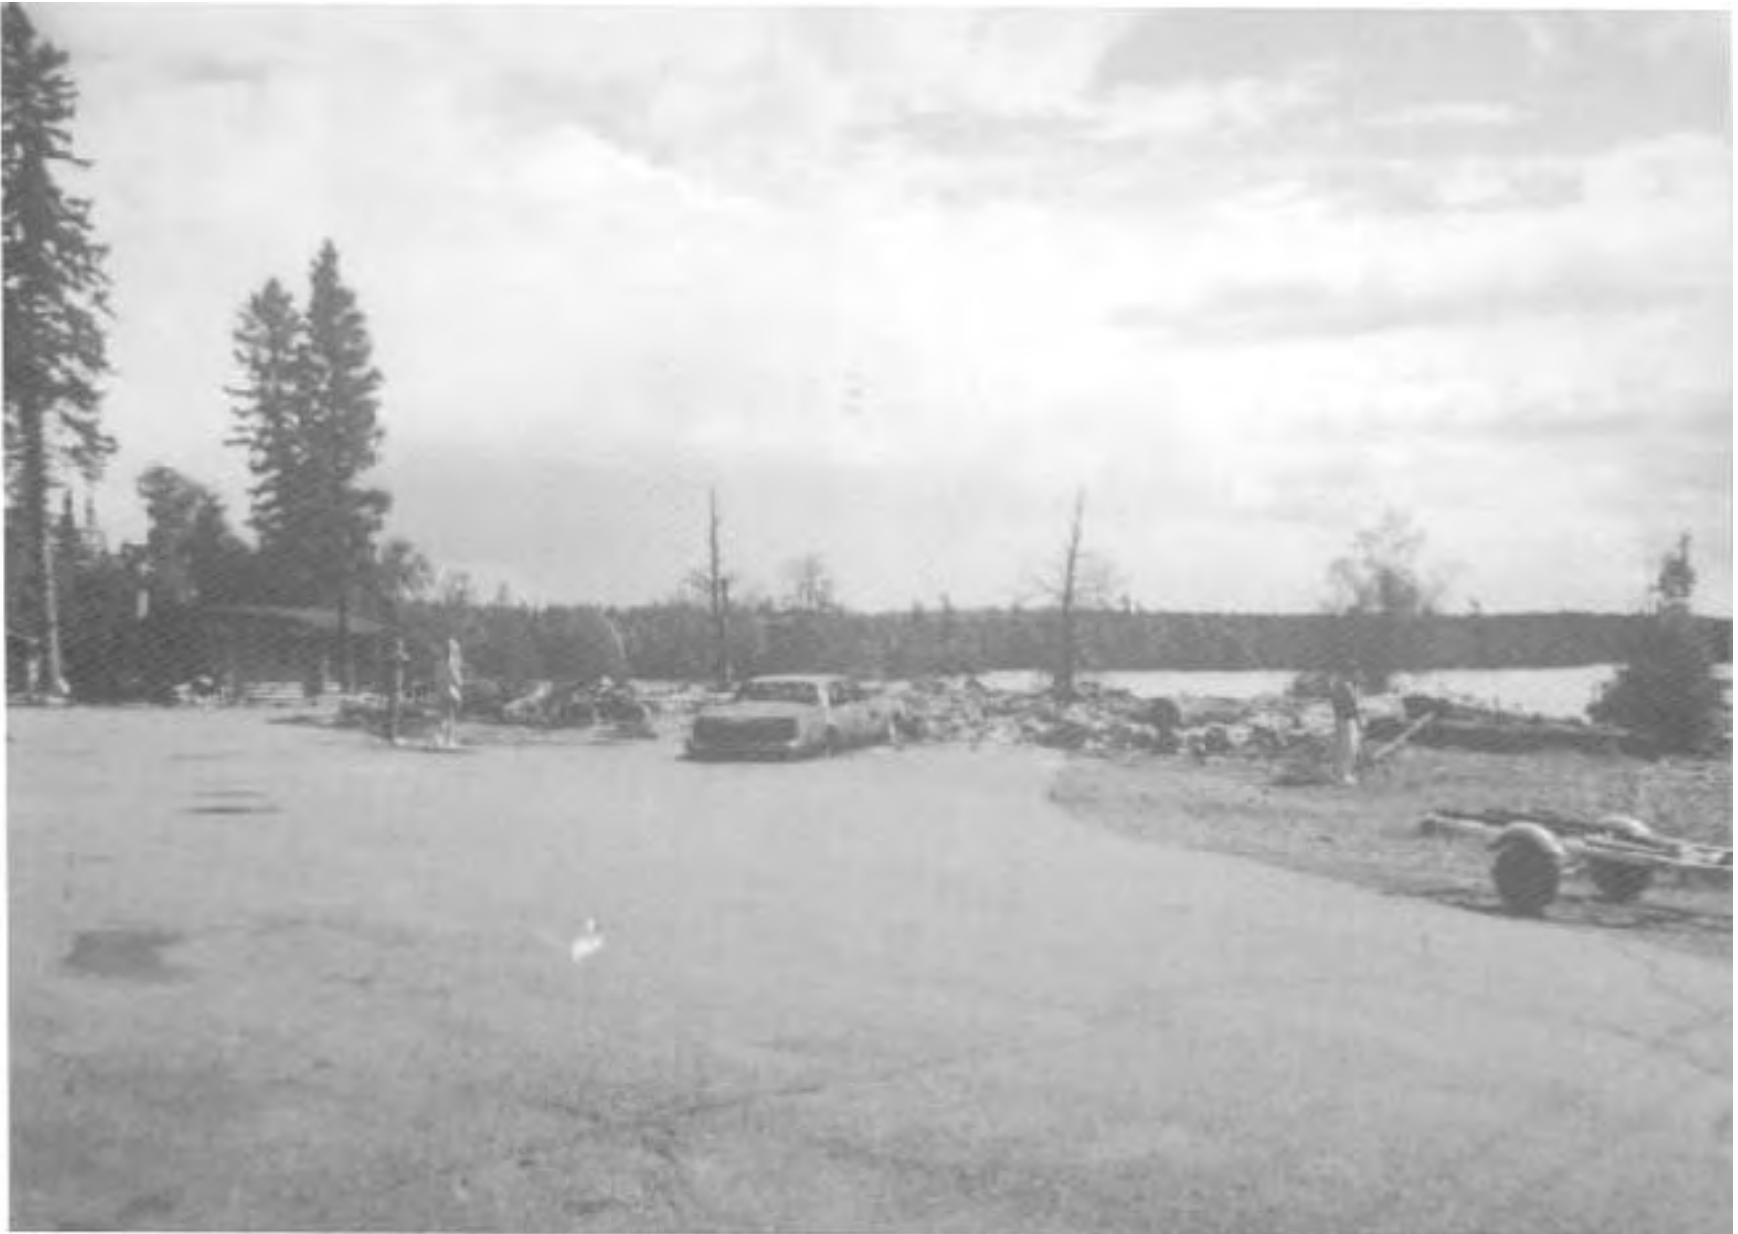
Remains of Lodge from west drive, facing lake.

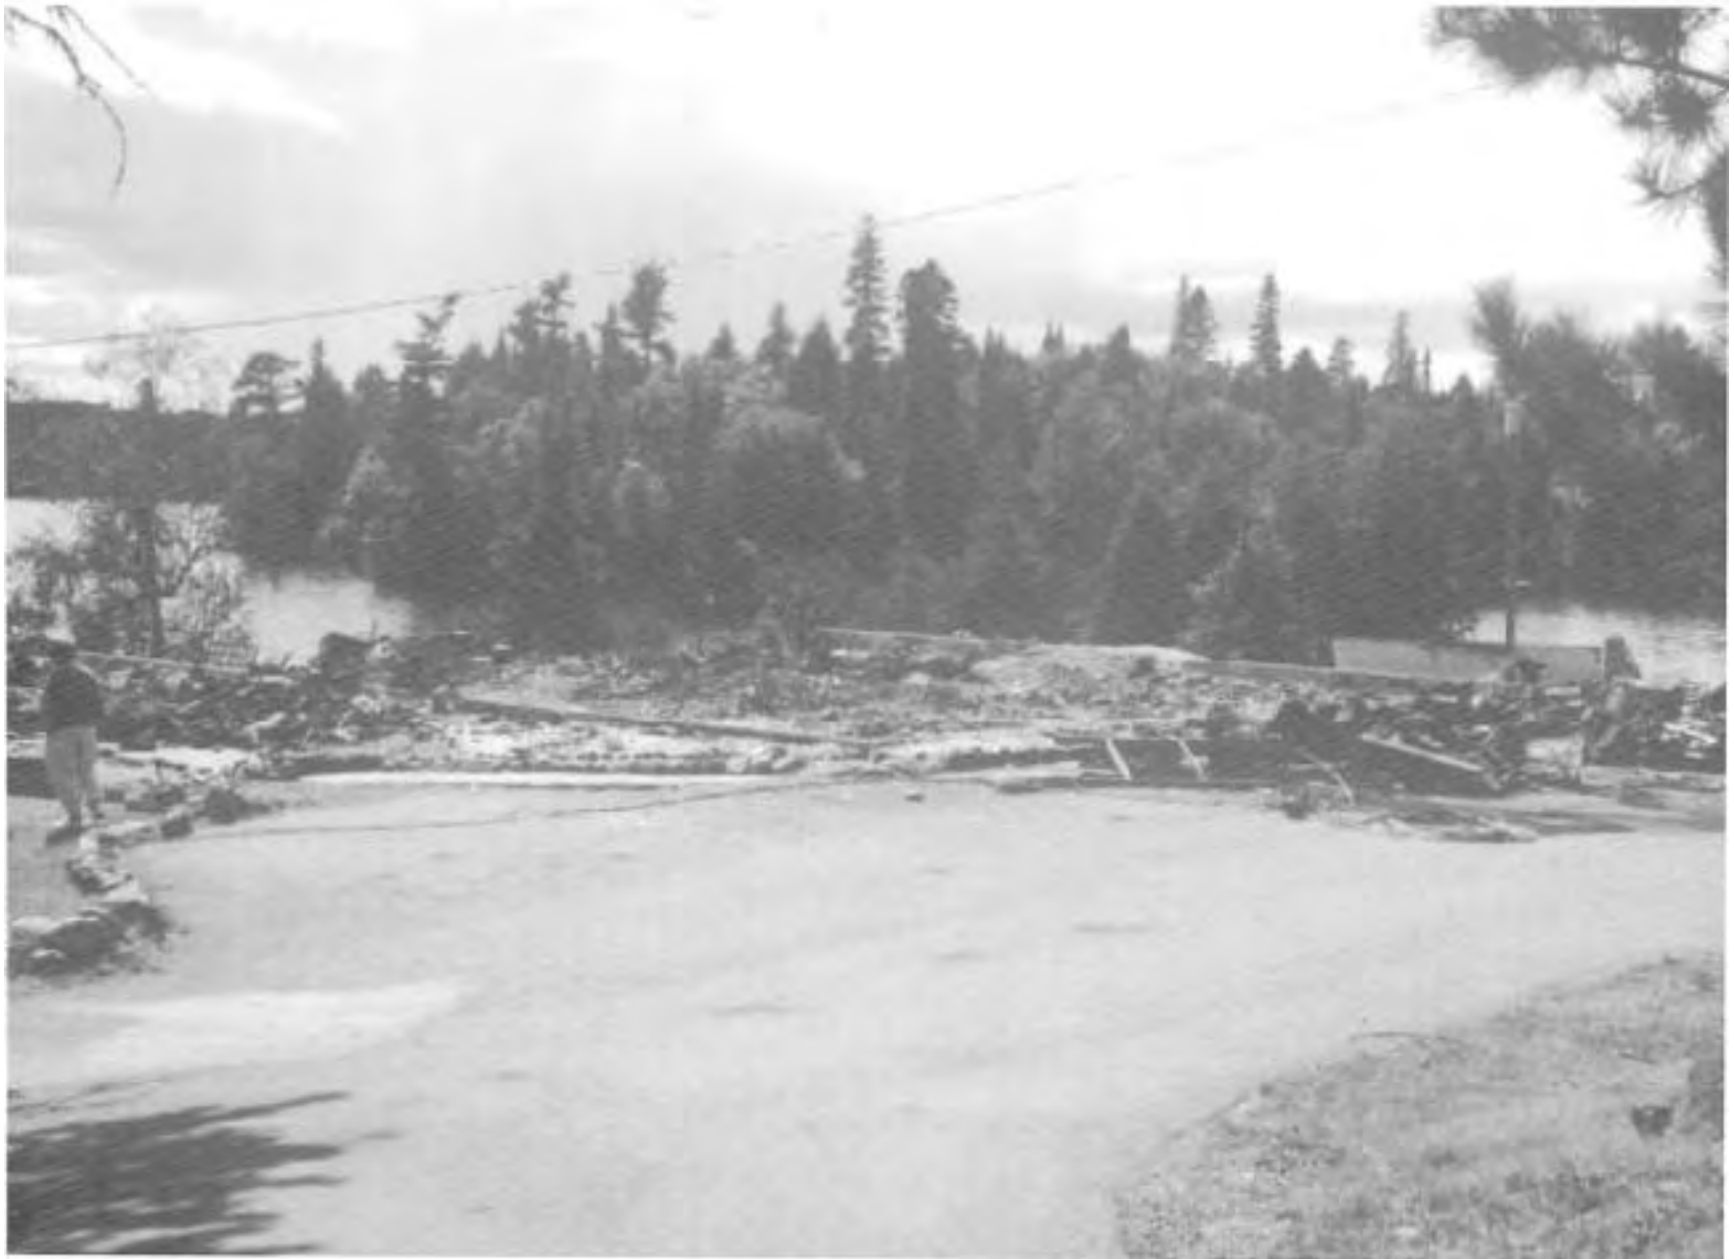
Remains of Windigo Lodge from east drive, facing lake.

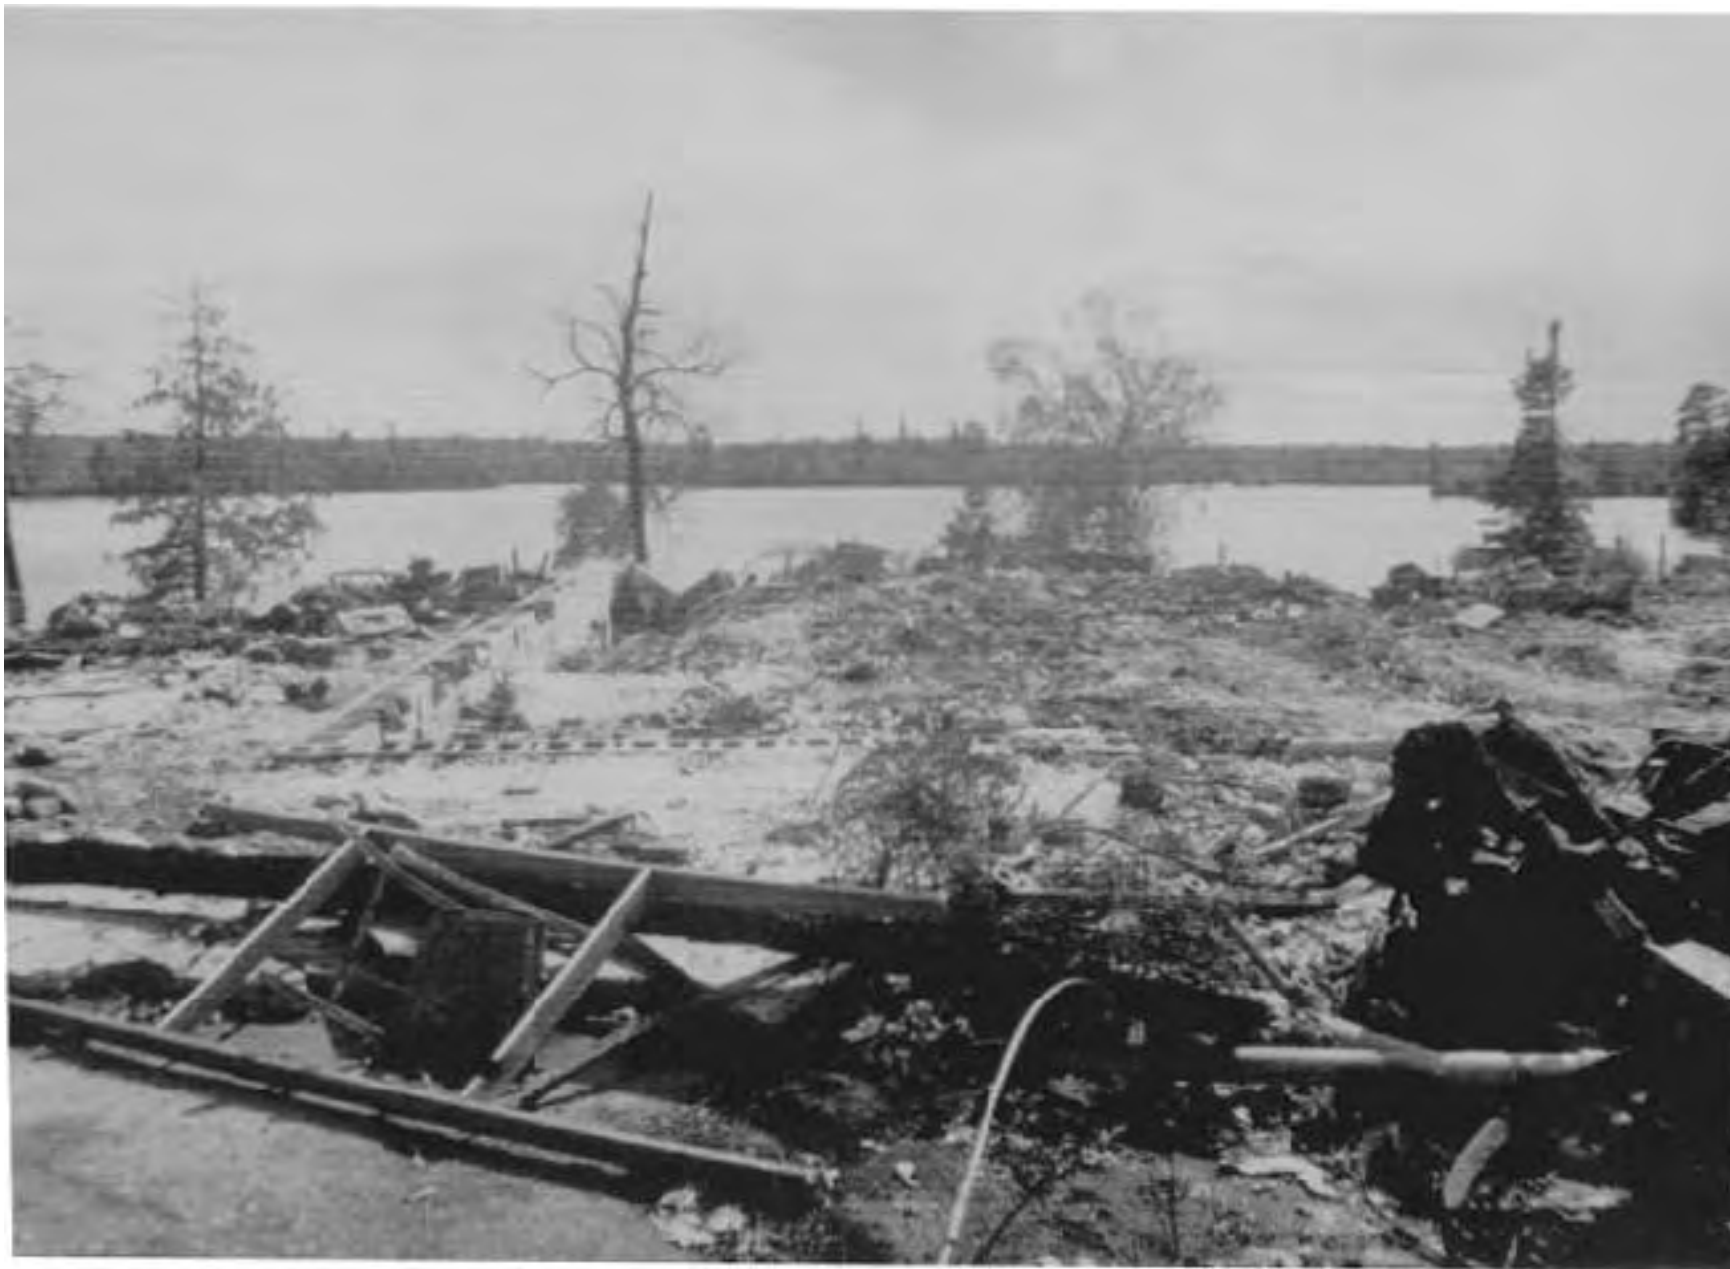
Entire structure was consumed by fire; east and north foundation walls shown here.

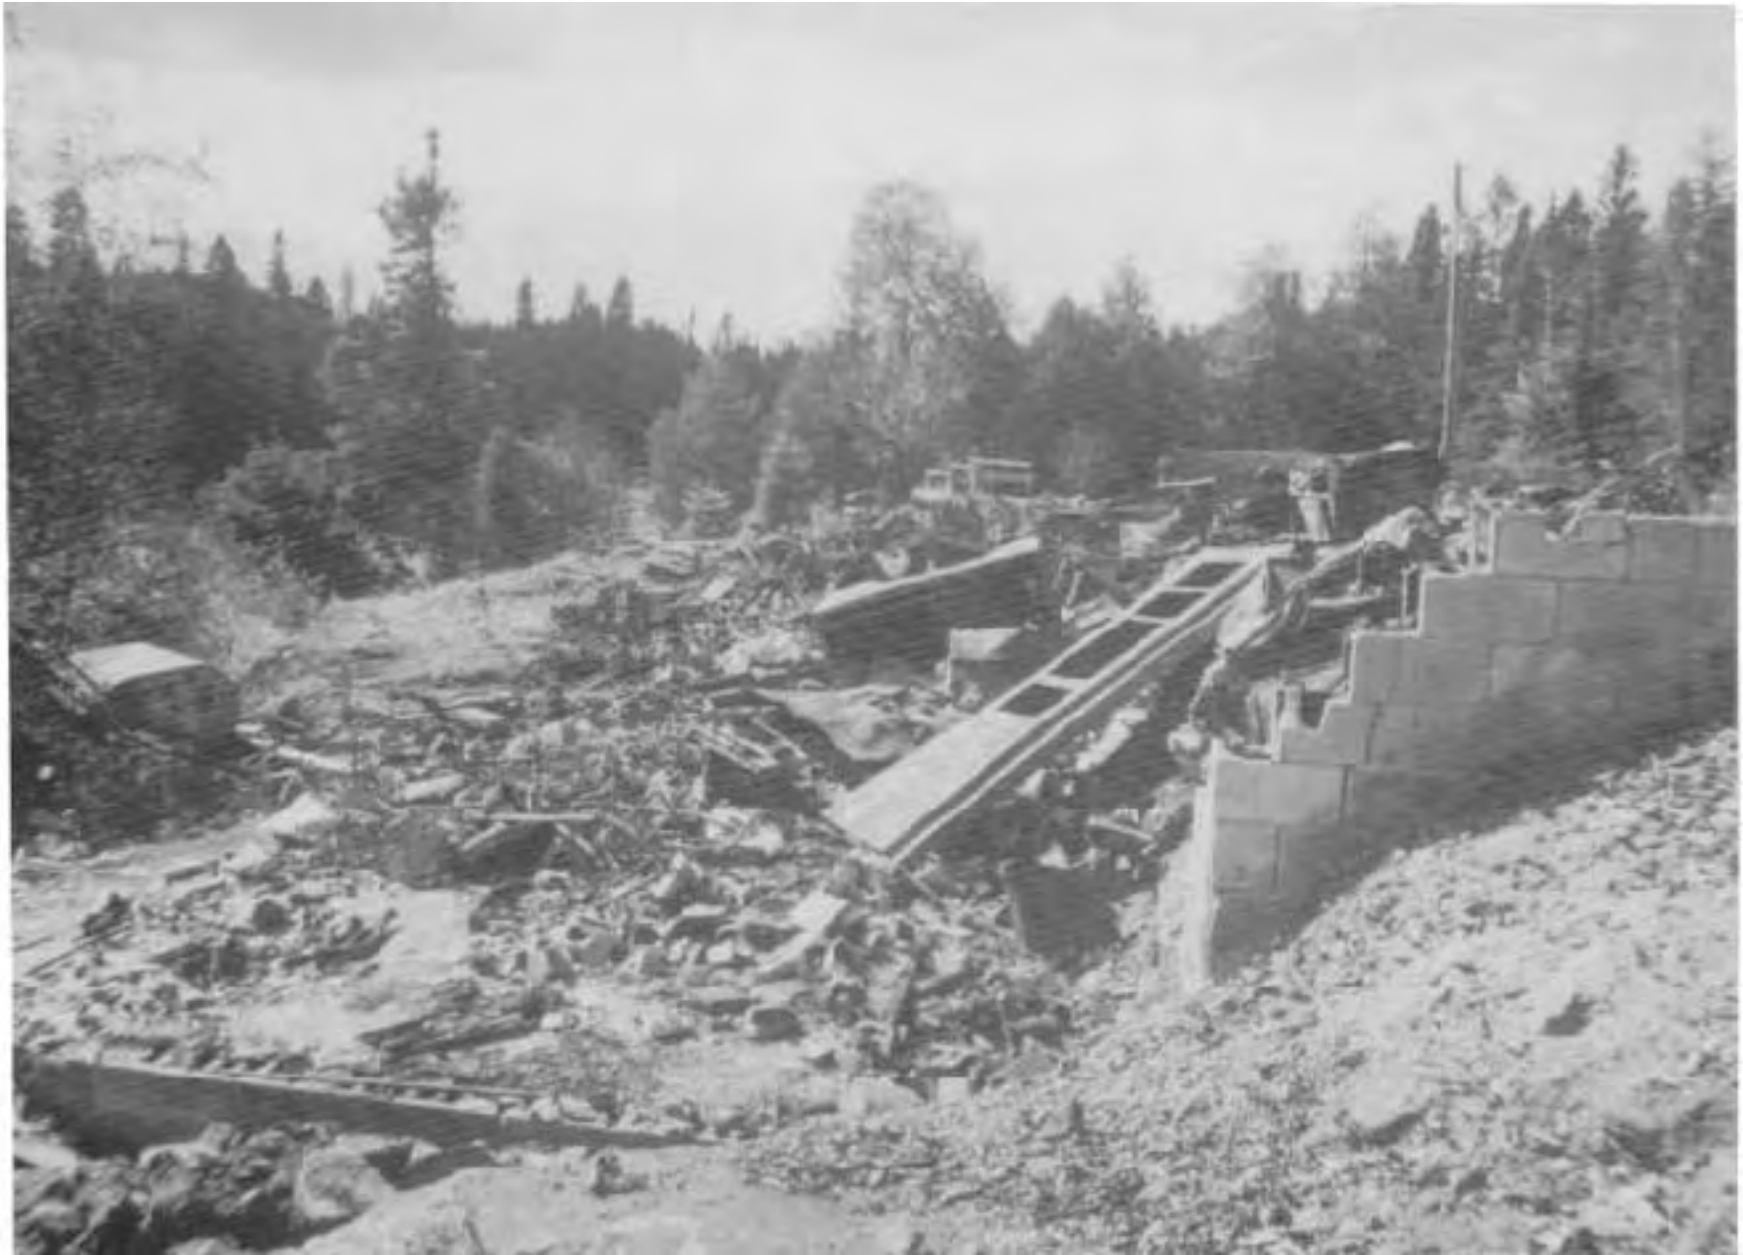
East foundation wall and basement walkout to lake (off photo to left);  
basement wood frame construction consumed by fire.

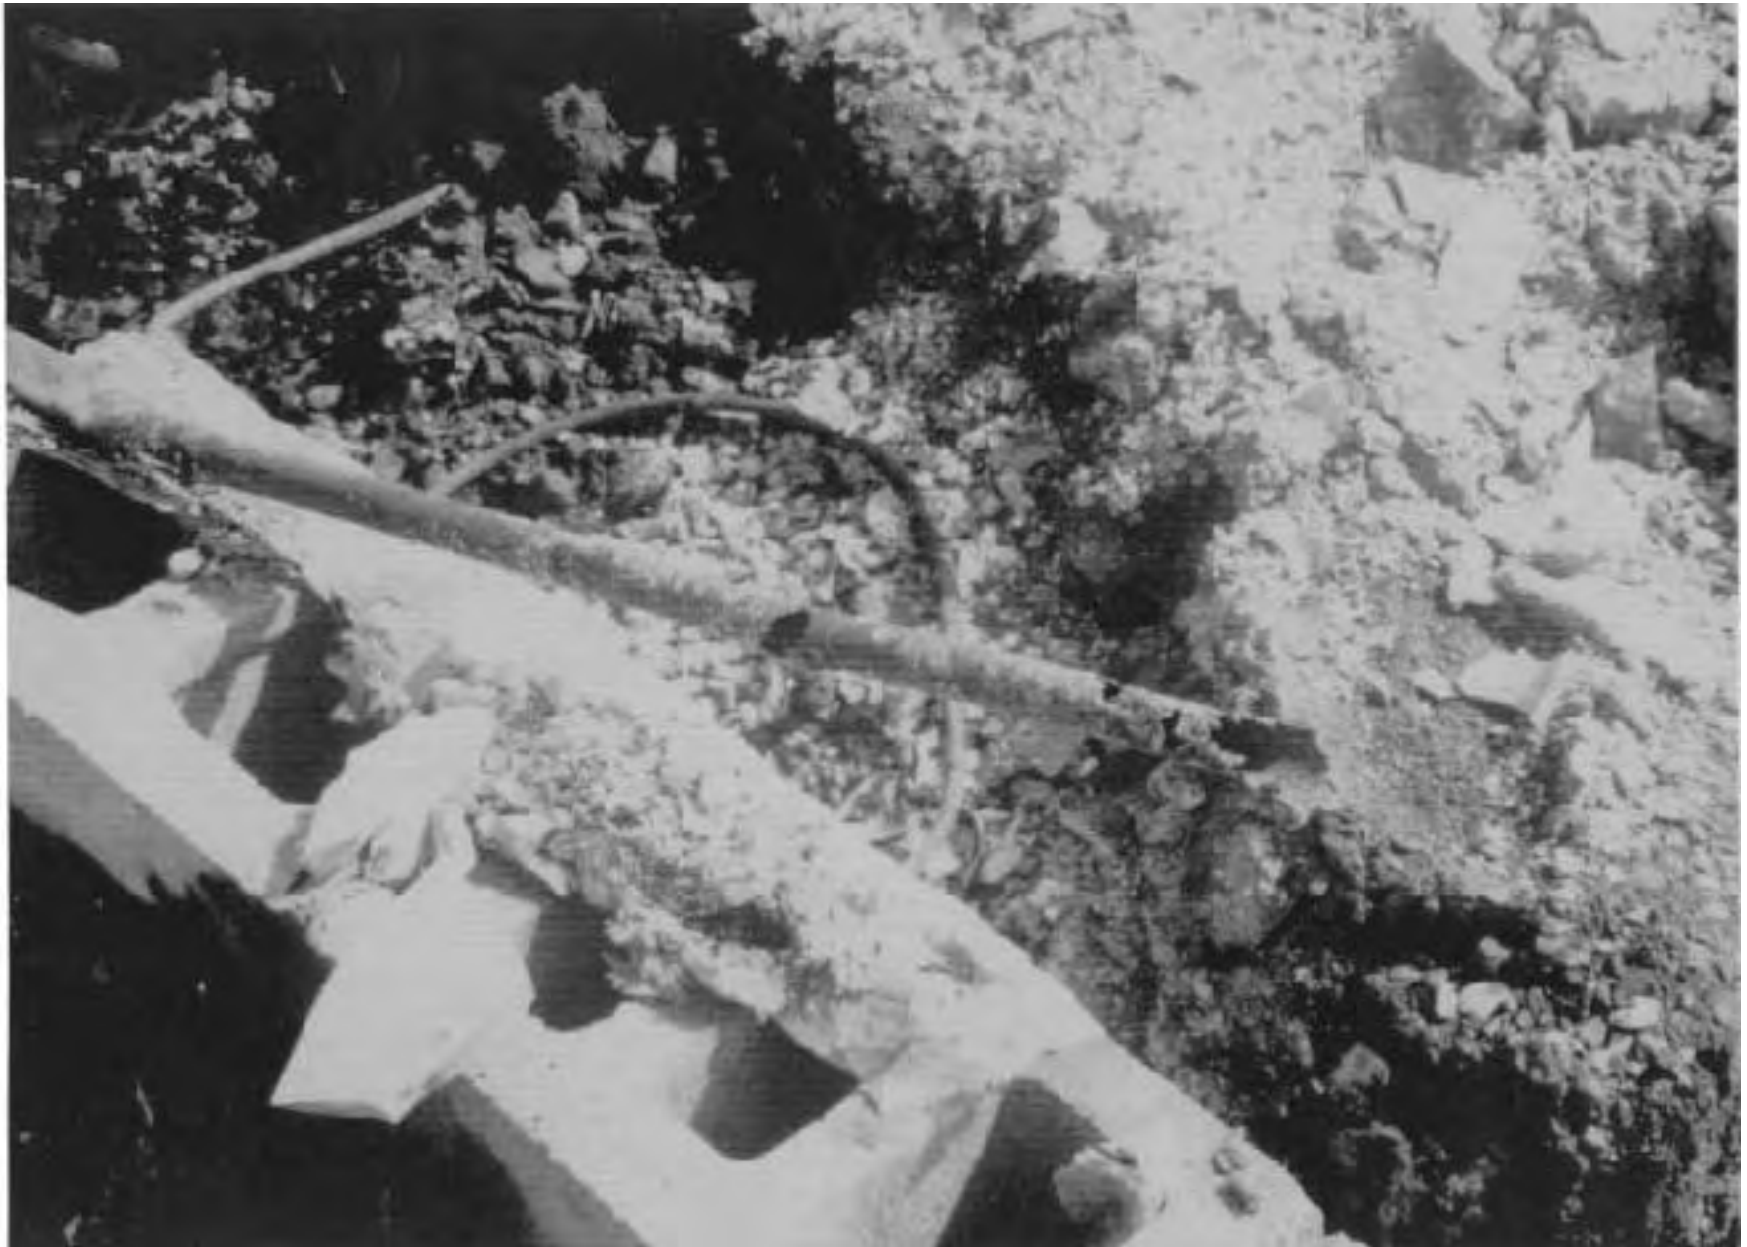
Damage to 3/4-inch copper water pipe from intense heat of the fire.
