Chicken Processing Plant Fires Hamlet, North Carolina, and North Little Rock, Arkansas

**Chicken Processing Plant Fires
Hamlet, North Carolina
(September 3, 1991)
North Little Rock, Arkansas
(June 7, 1991)**

This is Report 057 of the Major Fires Investigation Project conducted by TriData Corporation under contract EMW-90-C-3338 to the United States Fire Administration, Federal Emergency Management Agency.

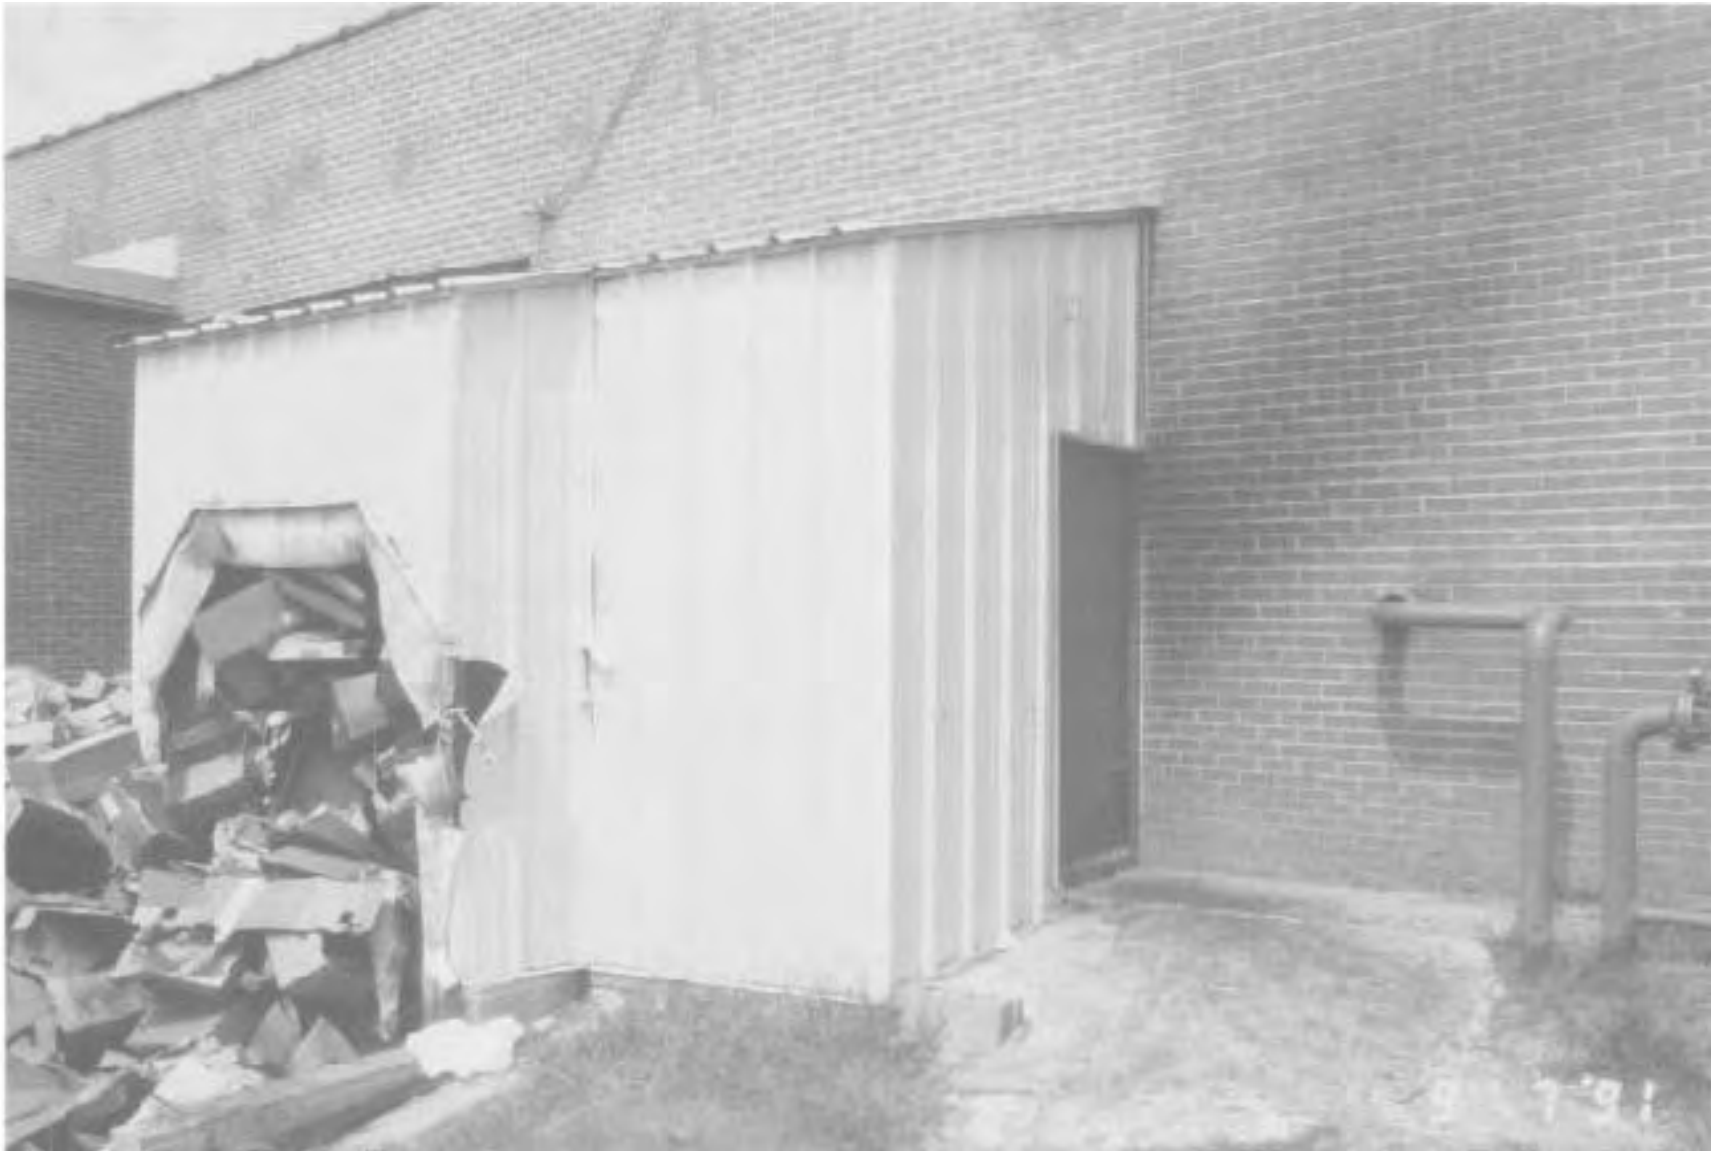
The compactor area and one of the exit doors that was locked.

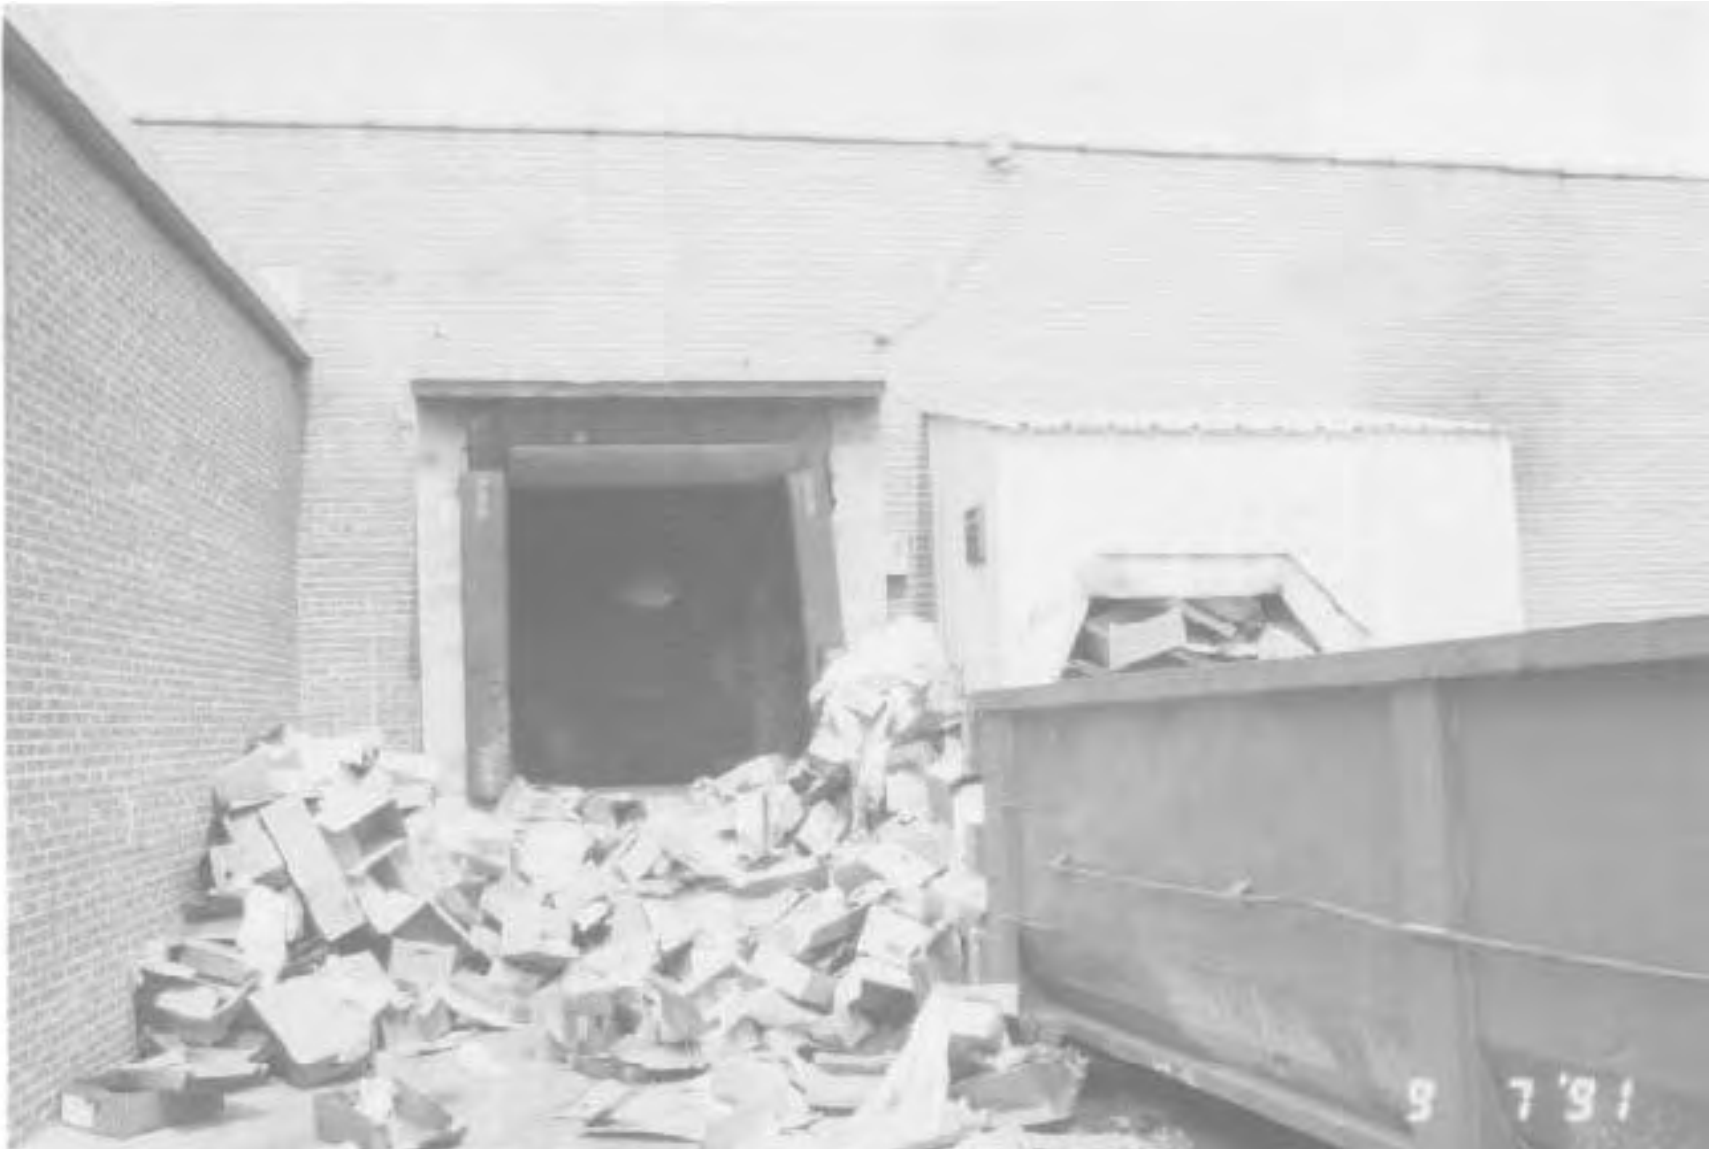
The loading dock area and sealed doors next to the compactor. The pads around the doors are designed to form a seal when the trailer backs into this dock.

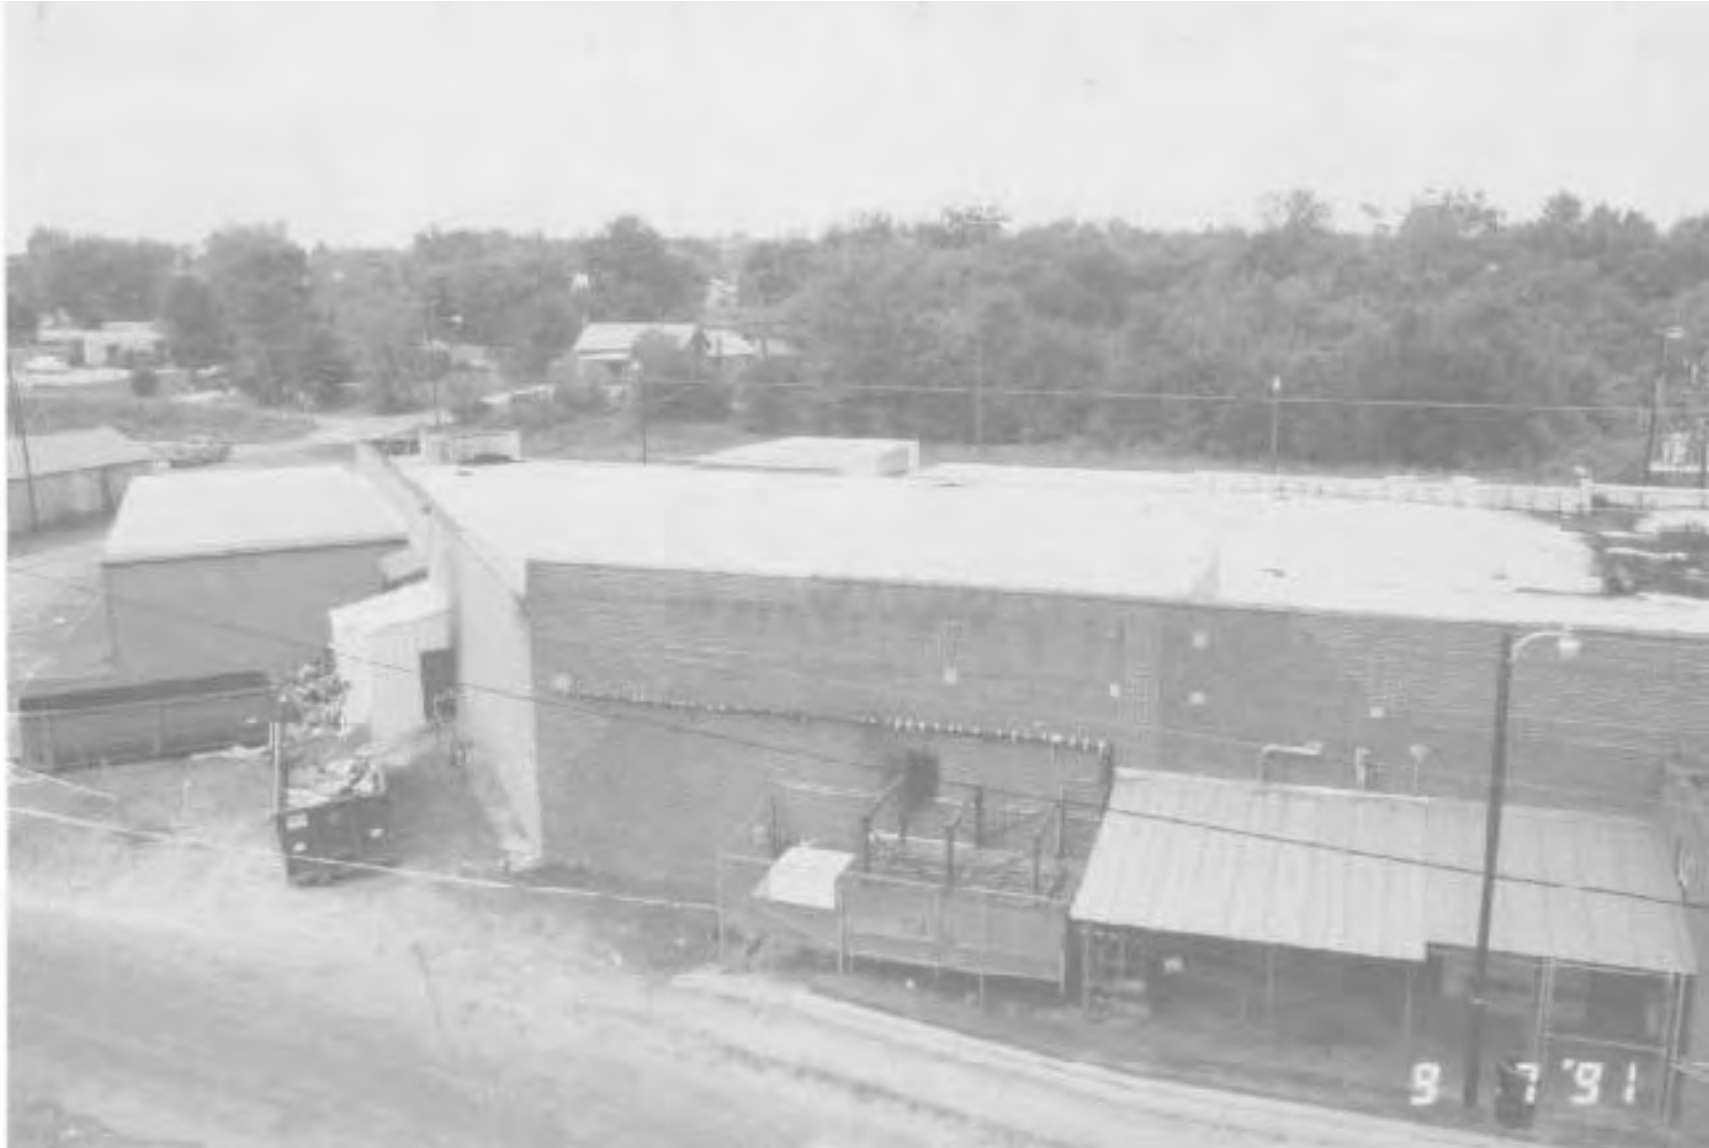
A view from an aerial ladder from the east looking southwest. Some roof damage is visible at the extreme right.

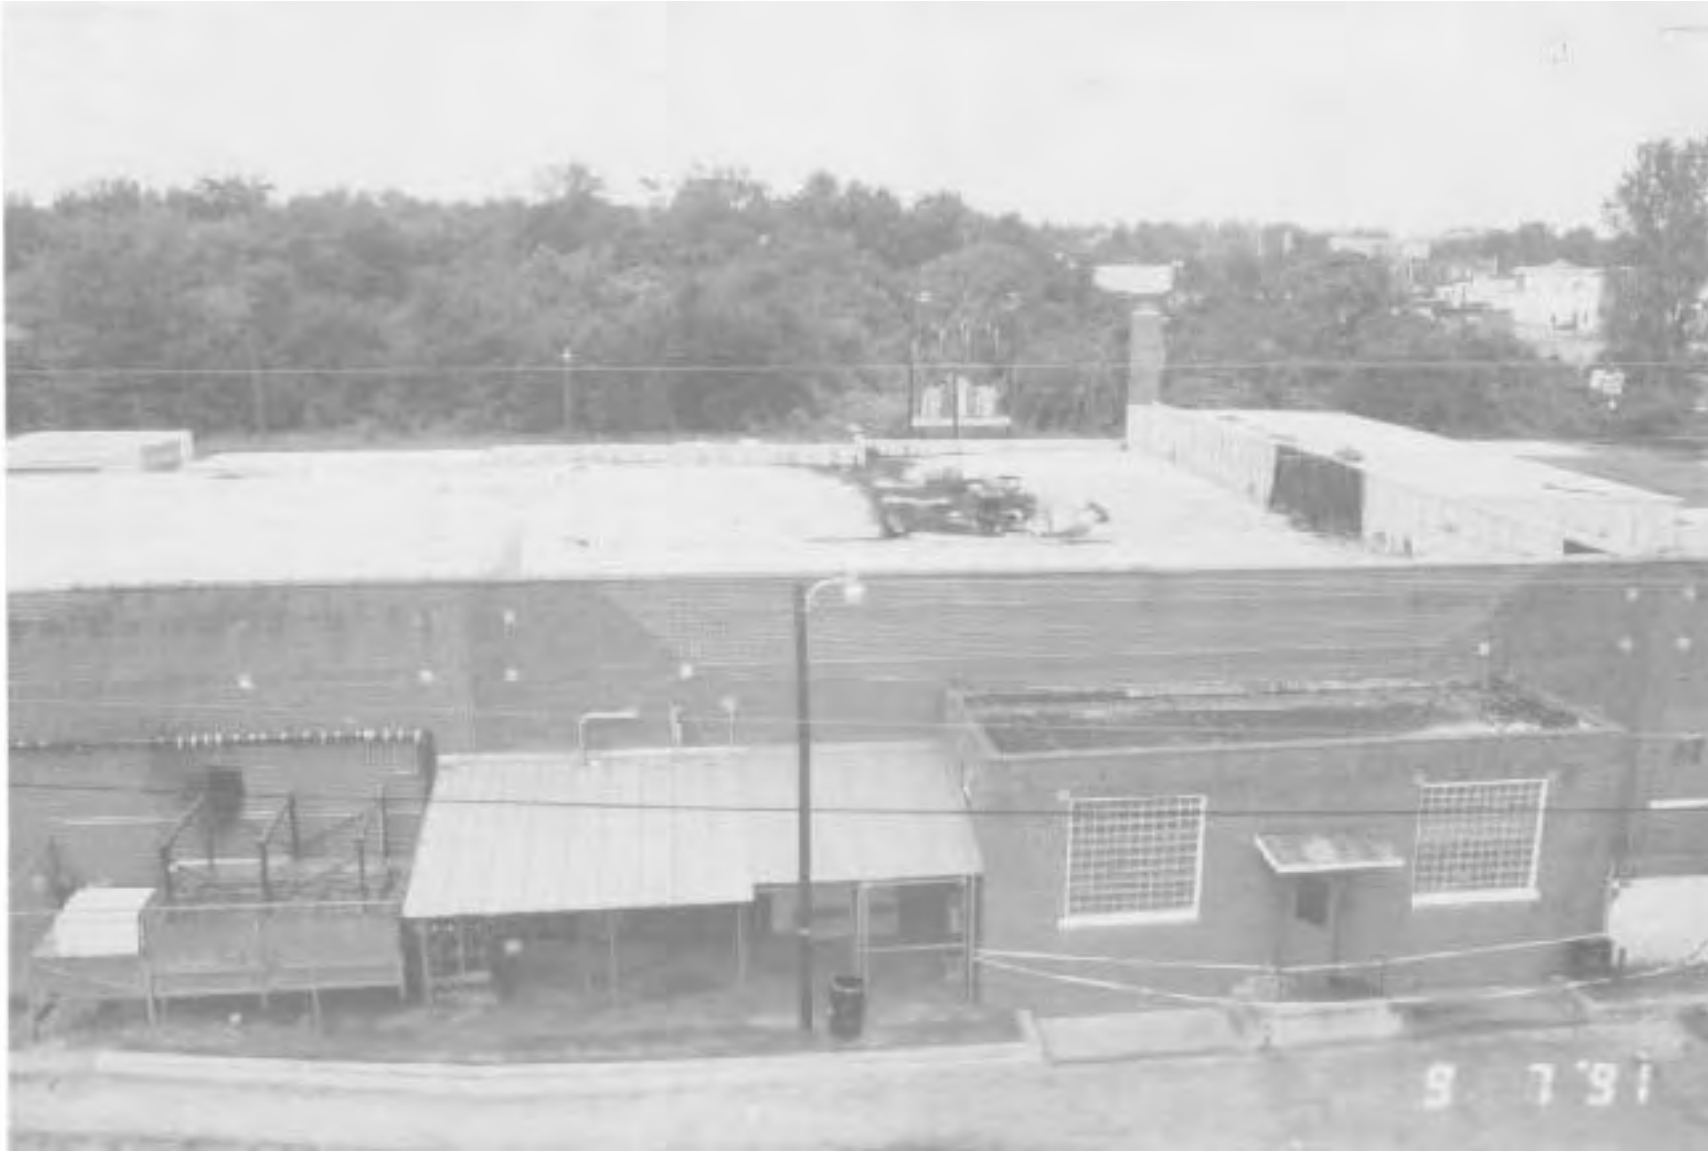
Another view from the aerial ladder from the east looking west, shows the portion of the roof collapsed over the area of origin.

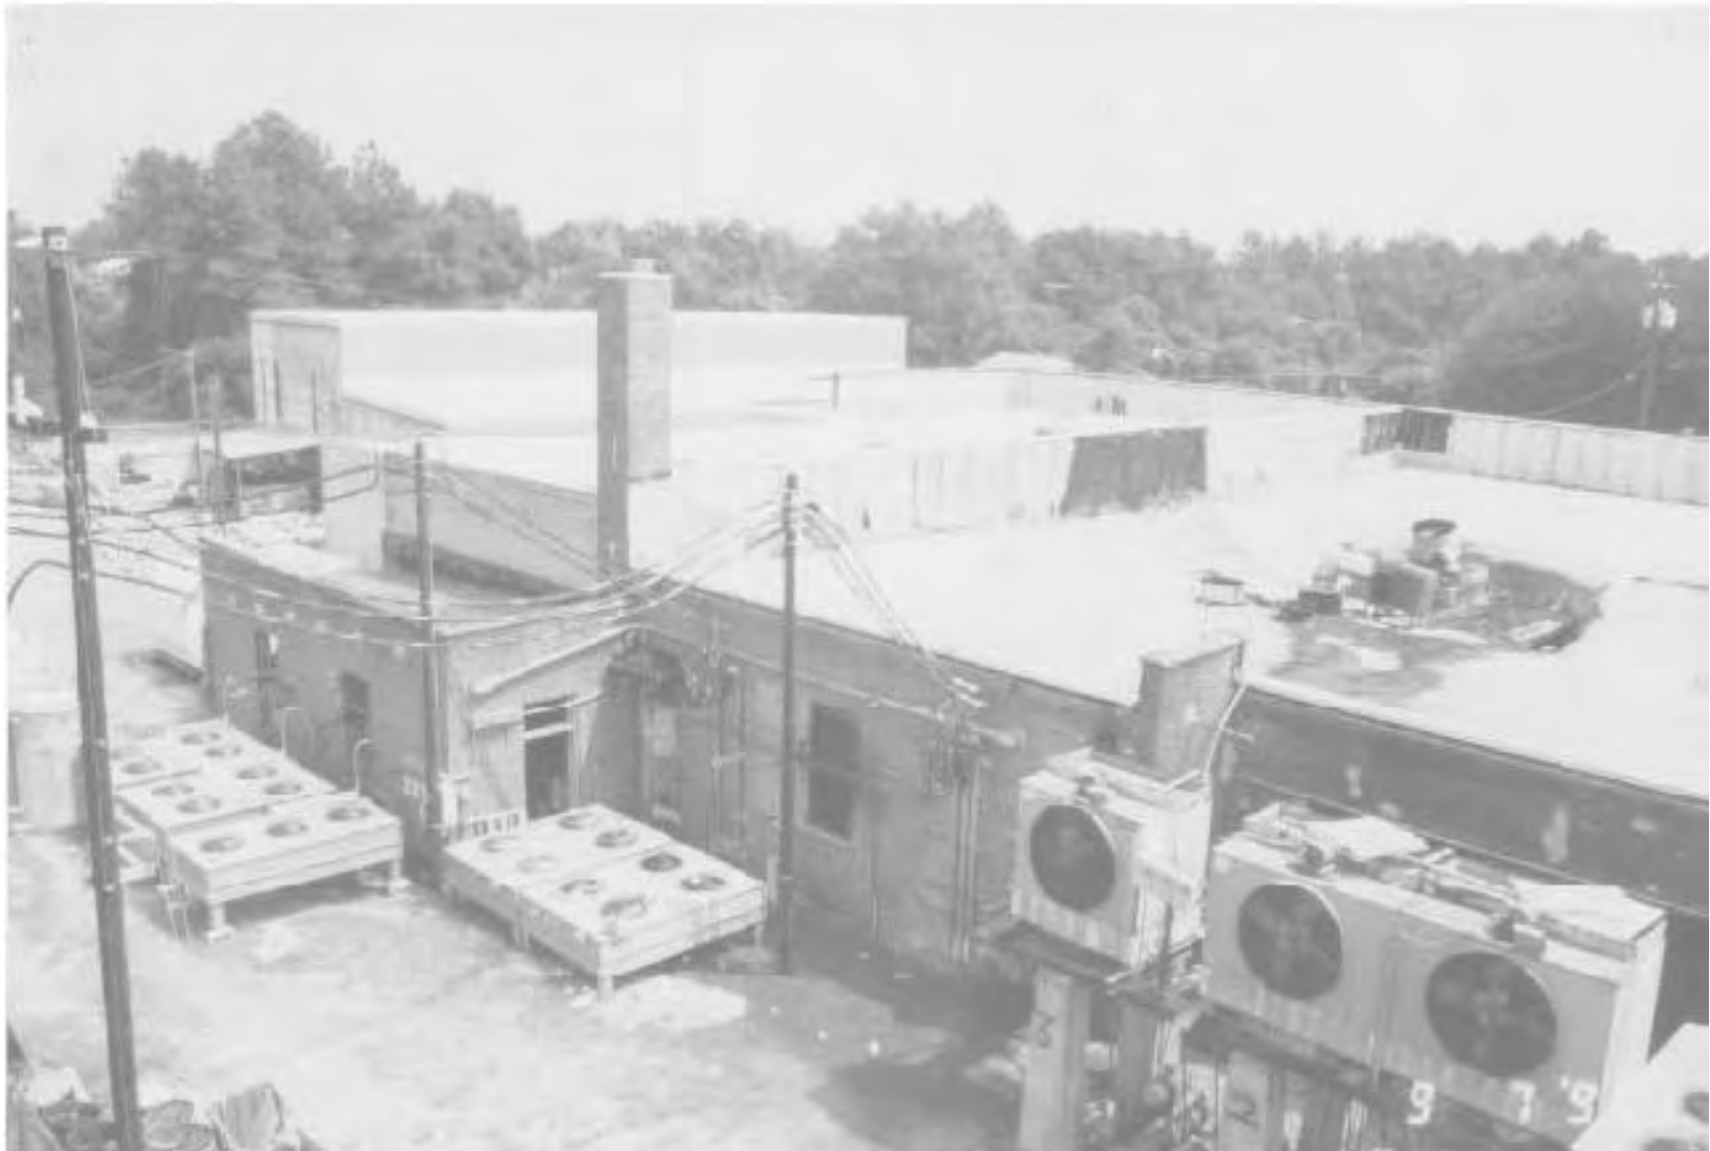
A view from the aerial ladder from the west side looking to the northeast. The roof collapse can be seen on the right, refrigeration compressor equipment is seen on the ground in the lower left.

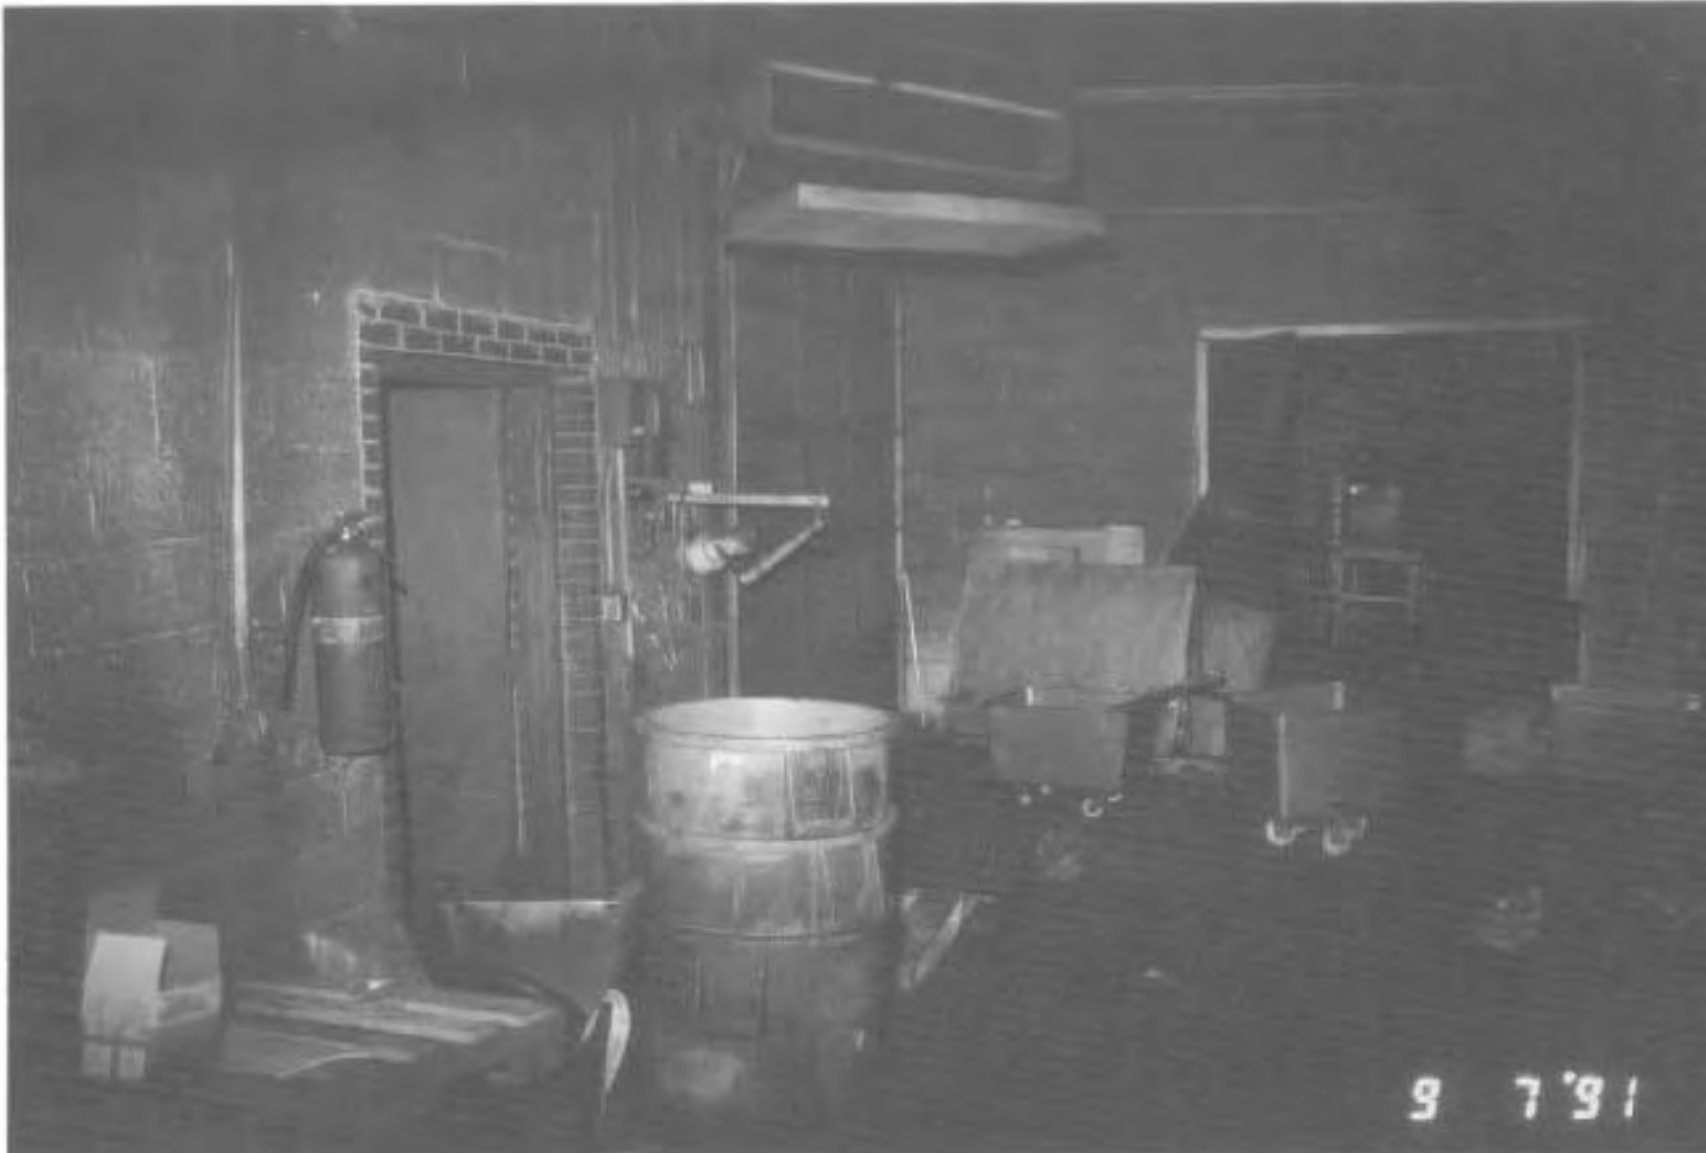
The trash and loading dock area. It was into this compactor area that several people tried to escape only to find the door to the outside locked. Upon coming back out of this area, they went through the large doors at the right which ultimately led to the large walk-in cooler where the largest fatality count was found. View is from the east toward the west southwest.

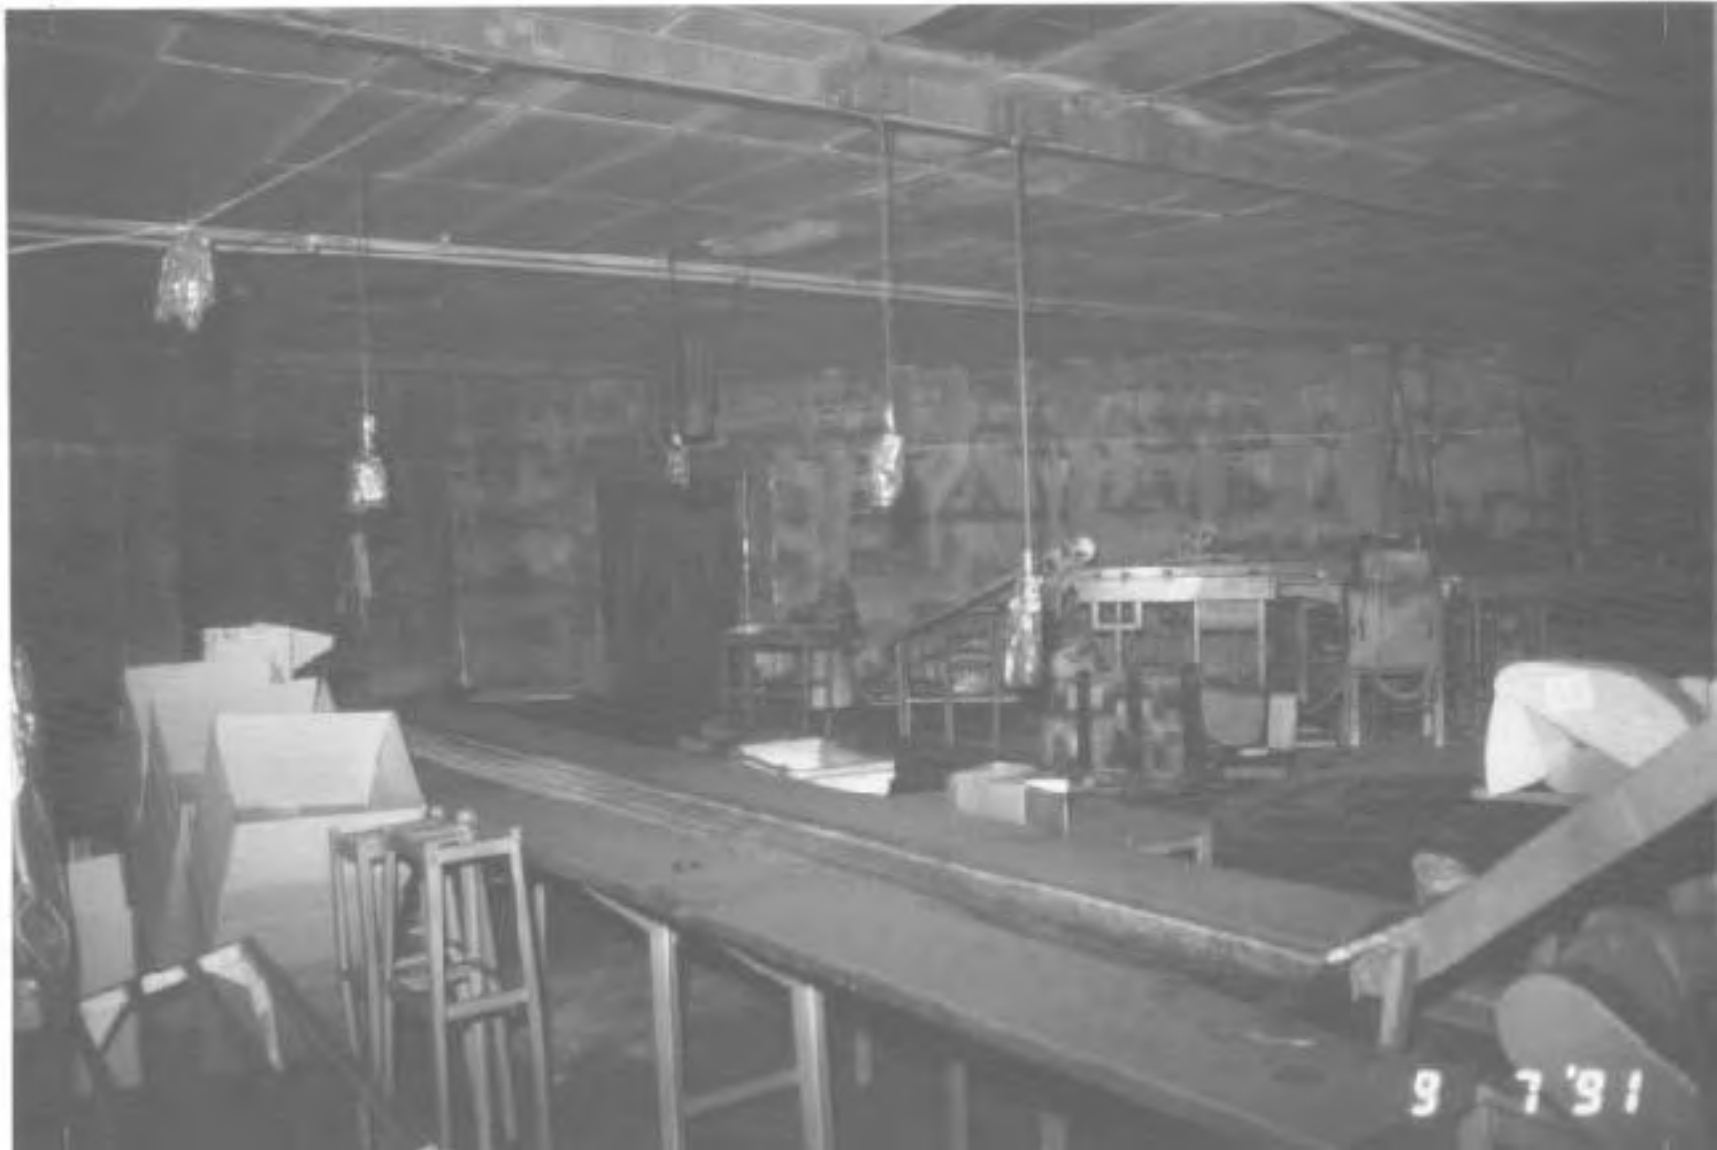
View showing the trim room as seen from the west center looking to the southeast. This view is looking toward the door to the cooler where the highest fatality count was located.

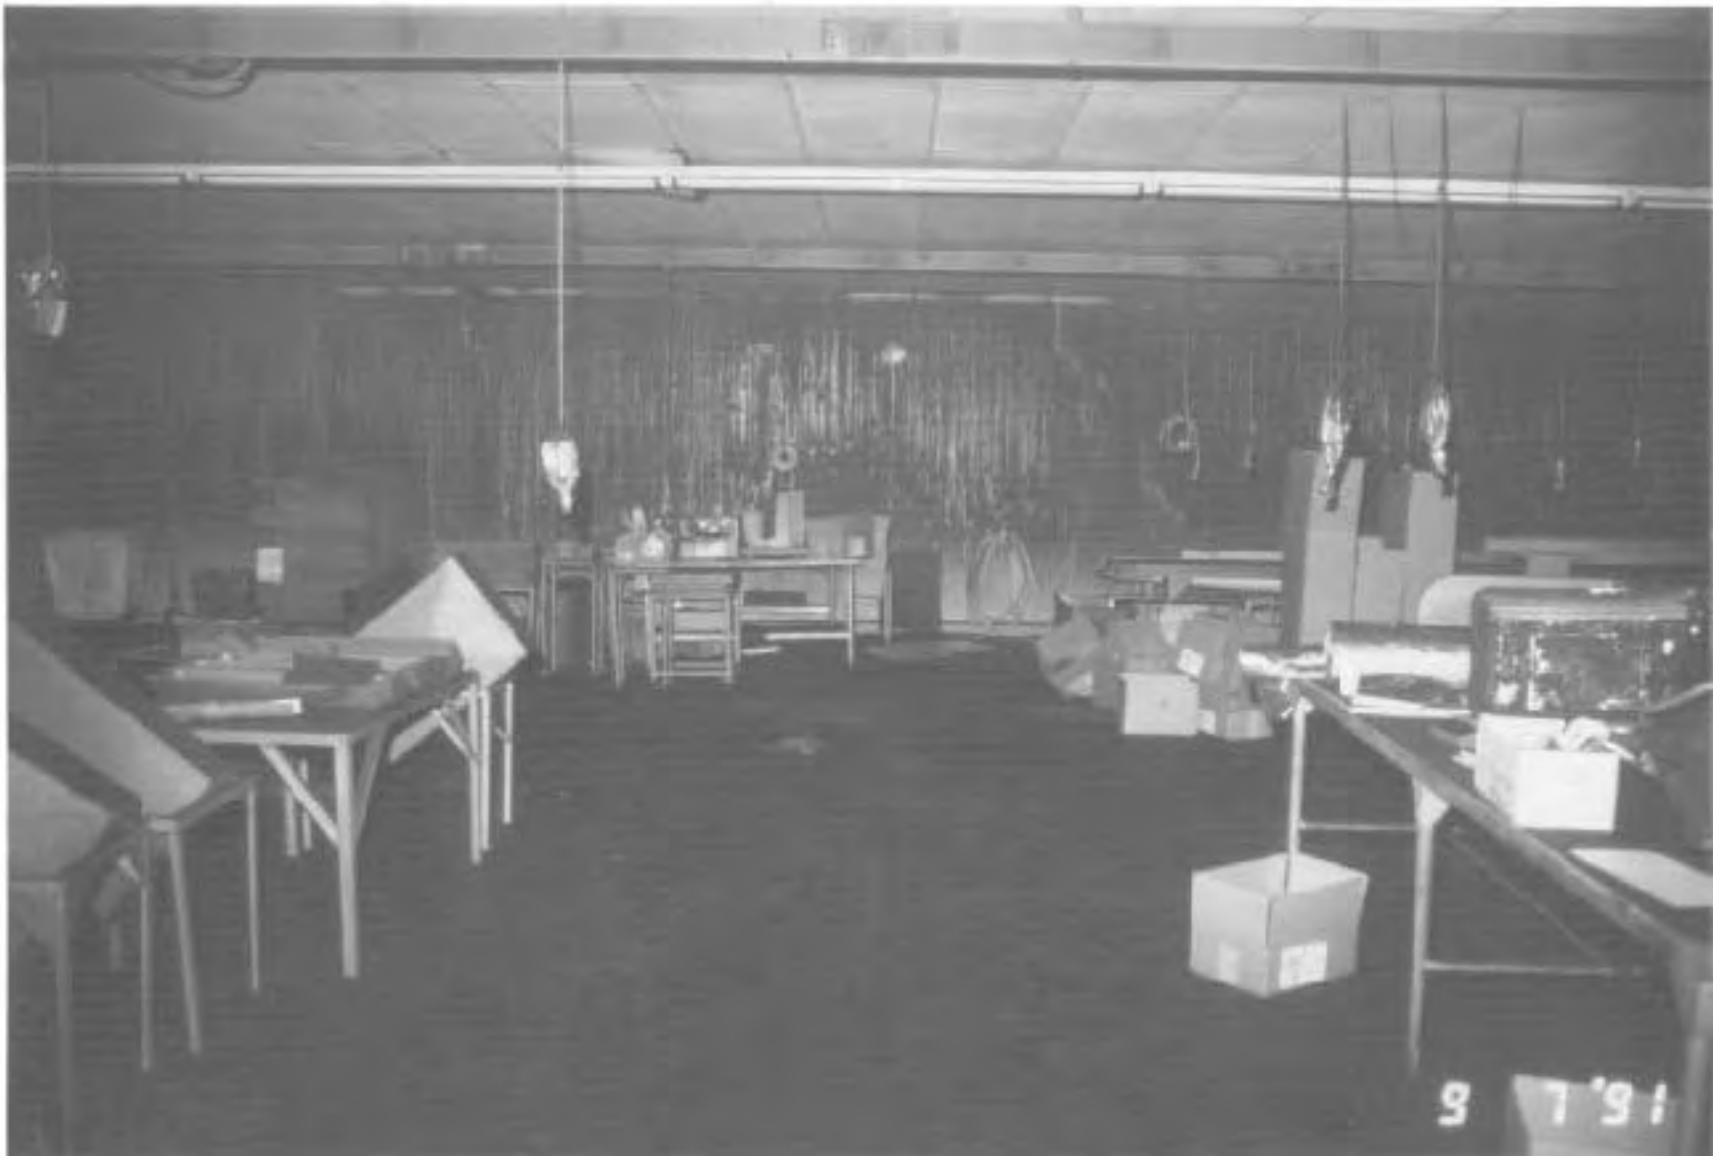
Inside the marinating and cutting room; no direct flame impingement actually entered into this area. View is from the east to the west.

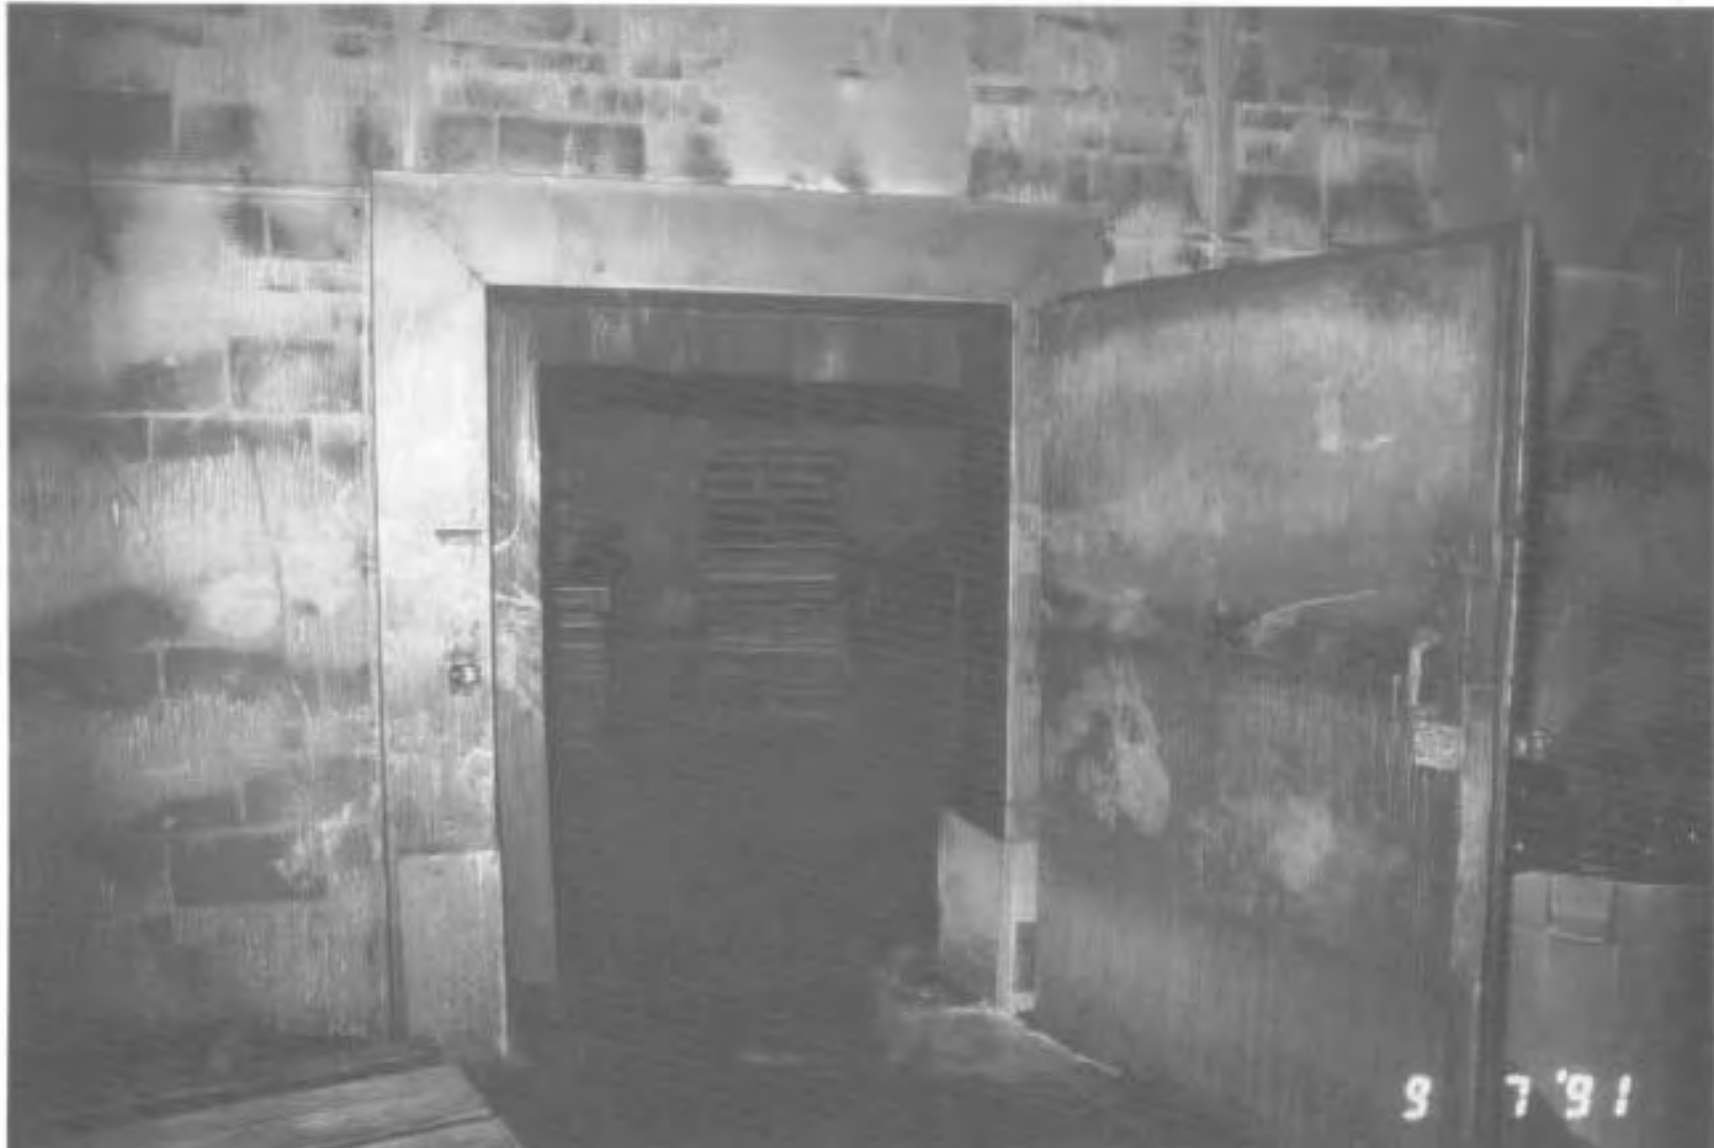
The cooler door, which was at the south end of the building, where the highest fatality count was found.

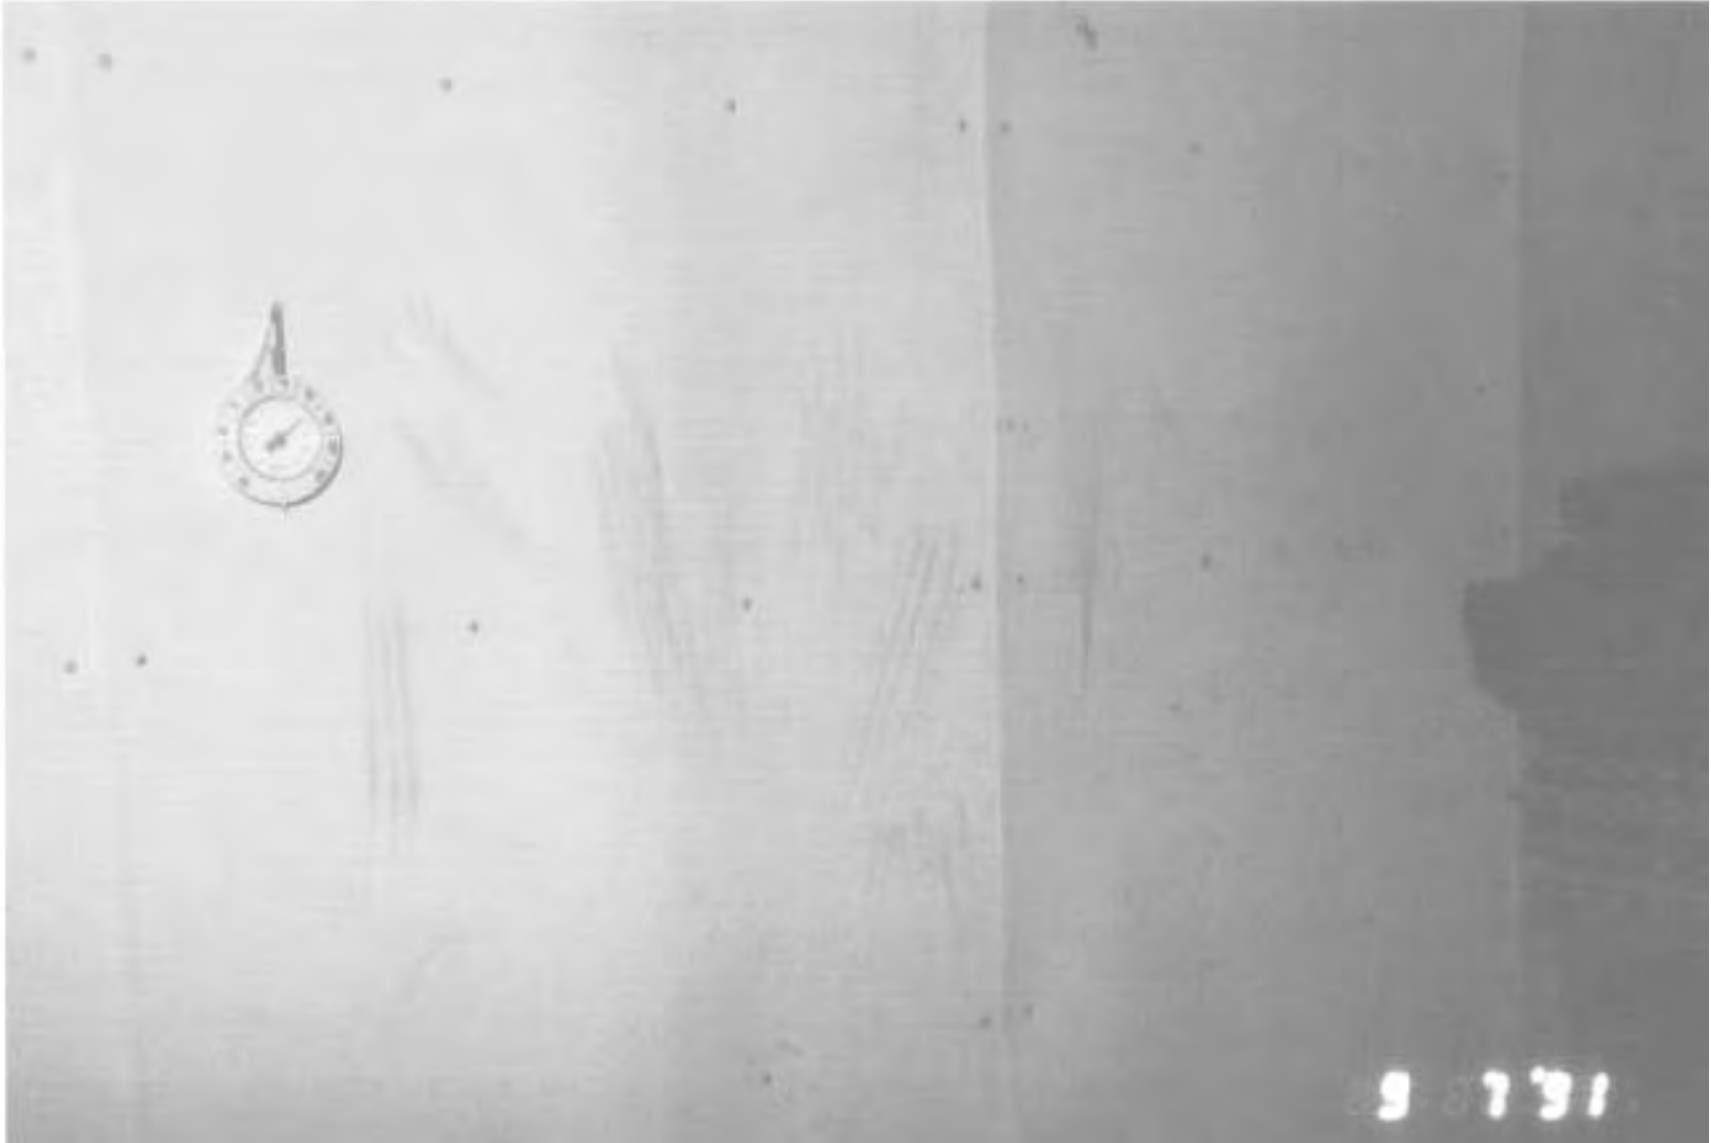
The west wall in the west portion of the cooler. Numerous handprints were found where people were trying to find escape routes.

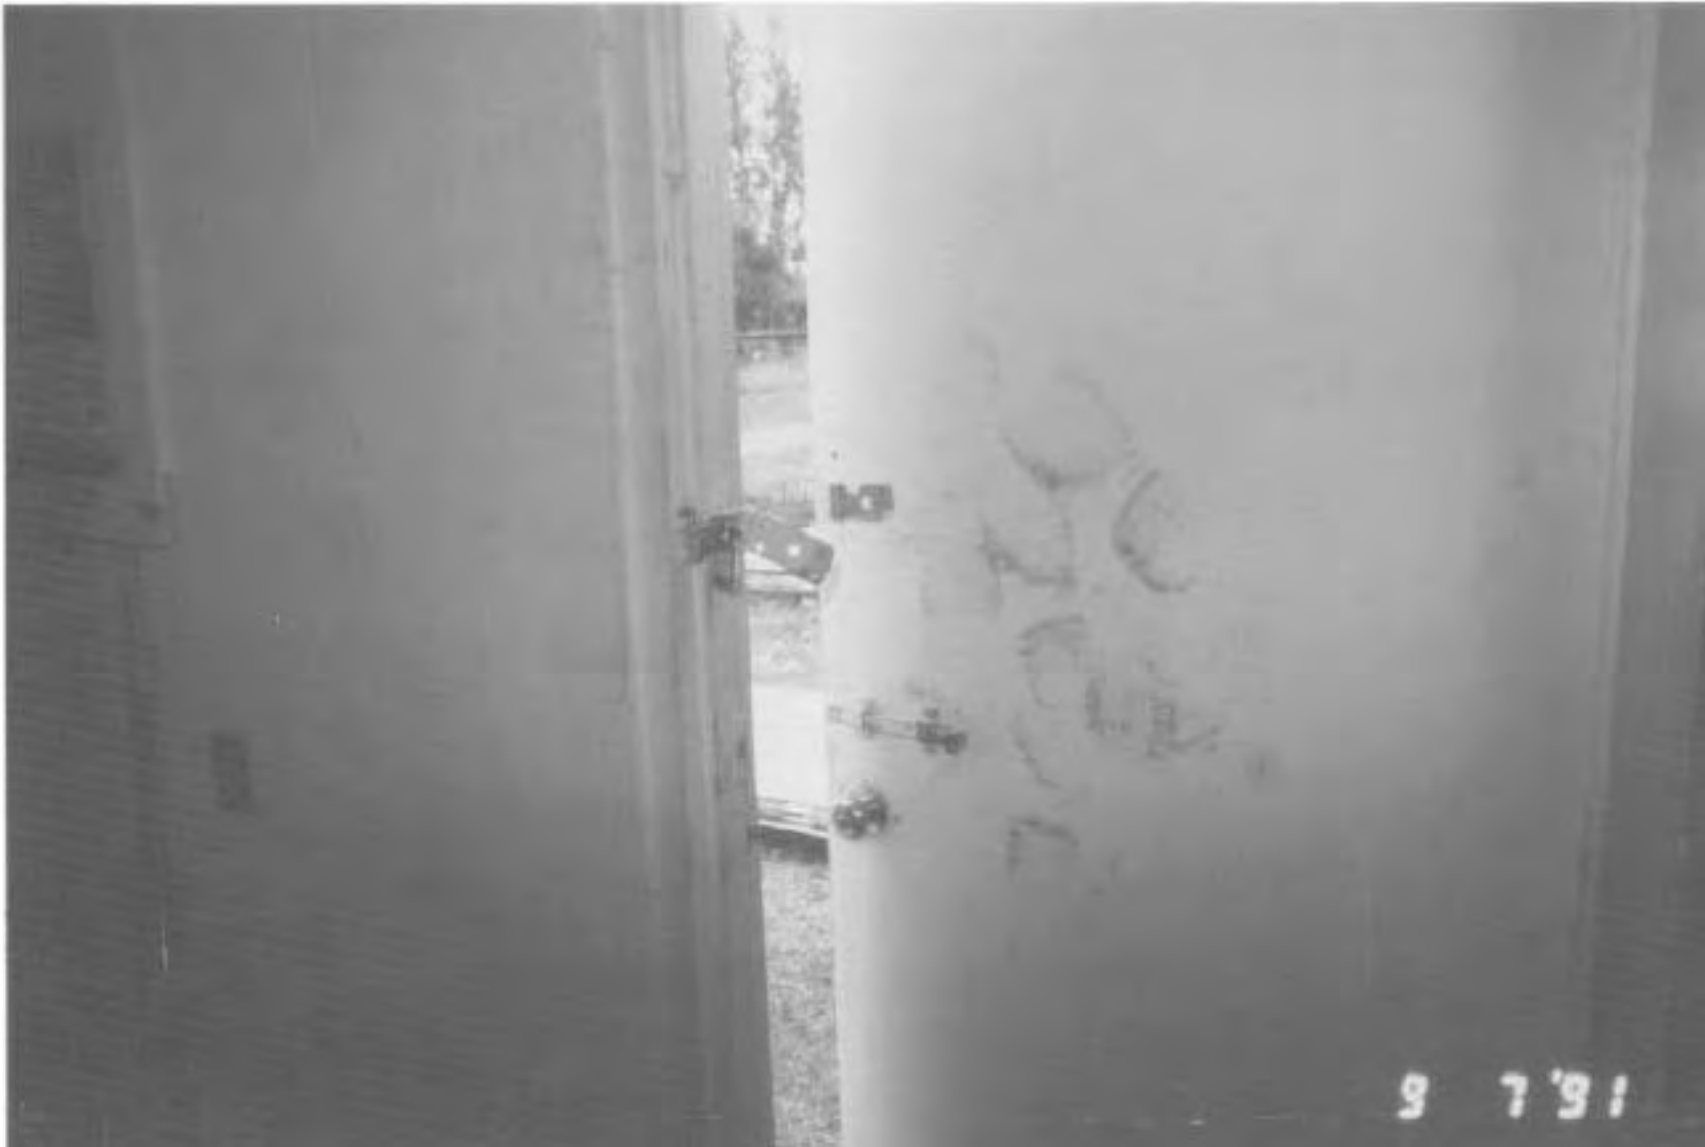
A close-up view of the north door to the break room. Note the footprints and padlock in place where the door was kicked; it was eventually opened for the escape of some personnel.
