Chicken Processing Plant Fires Hamlet, North Carolina, and North Little Rock, Arkansas

**Chicken Processing Plant Fires
Hamlet, North Carolina
(September 3, 1991)
North Little Rock, Arkansas
(June 7, 1991)**

This is Report 057 of the Major Fires Investigation Project conducted by TriData Corporation under contract EMW-90-C-3338 to the United States Fire Administration, Federal Emergency Management Agency.

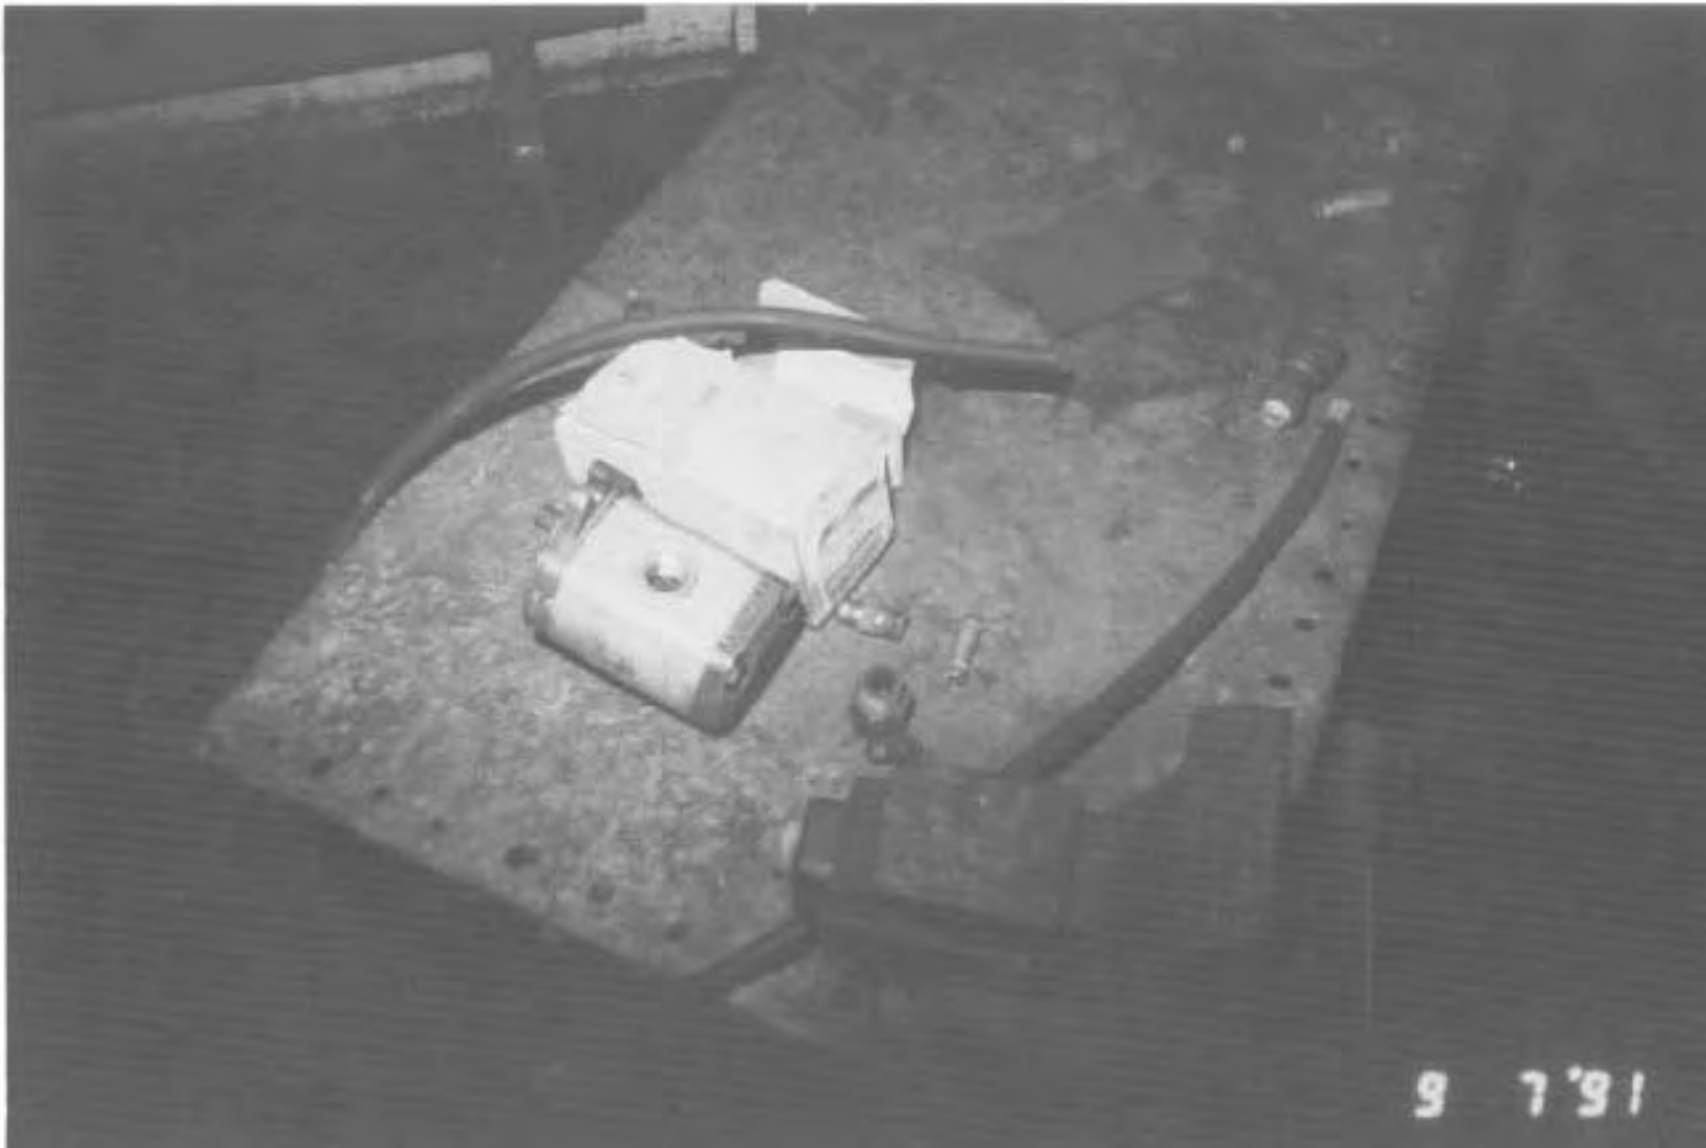
The factory prepared line, however, was found to be too long and would have dragged on the floor, possibly causing people working in the area to trip. So the maintenance worker reportedly asked for and gained permission to cut the factory prepared hydraulic line to an appropriate length, replaced the end connector with their own connector, and put the line back in place. This line has been described as a 3/4-inch flex line rated to carry 3,000 psi. Information from plant personnel indicated normal pressure was kept at approximately 800 psi, but it would at times fluctuate as high as 1,200 to 1,500 psi.

The hydraulic line was brought back to operating pressure. Shortly afterward it separated at the repaired connector point. The connector was some four to six feet above floor level with hydraulic fluid being expelled at a pressure of 800 to 1,500 psi. It obviously began to splatter off the concrete floor. Droplets were bouncing back onto the gas heating plumbs for the cooking vat, which turned them into vapor. The vapors then were going directly into the flame. The vapors had a much lower flashpoint than the liquid hydraulic fluid and therefore rapidly ignited.

In sum, the pressurization of the hydraulic fluid combined with the heat was causing an atomizing of the fuel which in all probability caused an immediate fireball in and around the failed hydraulic line and the heating plumbs.

The remains of the hydraulic line that had been cut by the maintenance worker for the repair process **that** took place just preceding the fire.

4. High pressure equipment maintenance and repairs must be limited to factory trained personnel and specifications.

Operations such as these plants have extensive hydraulic systems. They operate at considerable pressures and, as in these two cases, are integral parts of cooking processes. Moving parts and high pressures will naturally increase the likelihood of failure. Maintenance must be a constant ongoing process. For maximum safety, maintenance personnel must be trained by the factory representatives. If any parts are replaced, they must conform to factory specifications or not be used. If a maintenance division alters any part of the high pressure system, their alterations must meet or exceed factory specifications.

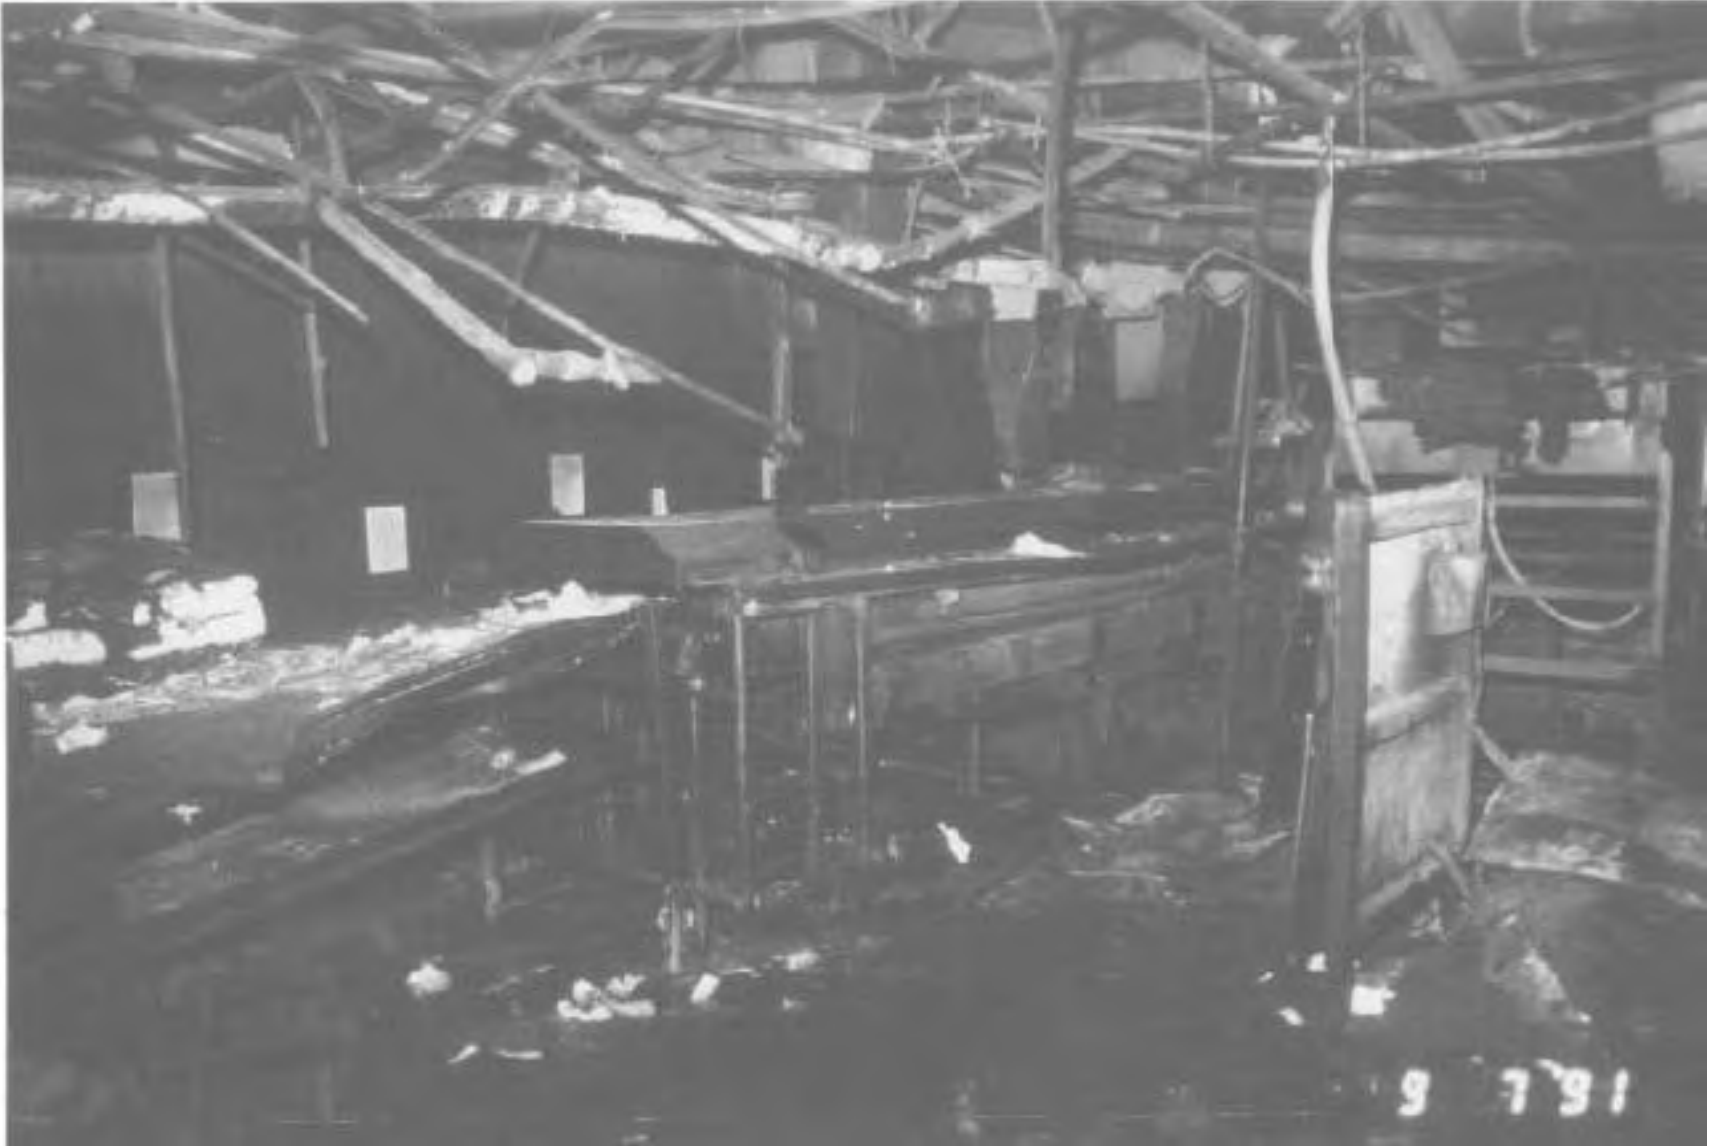
The area of origin viewed from the southeast to the northwest.

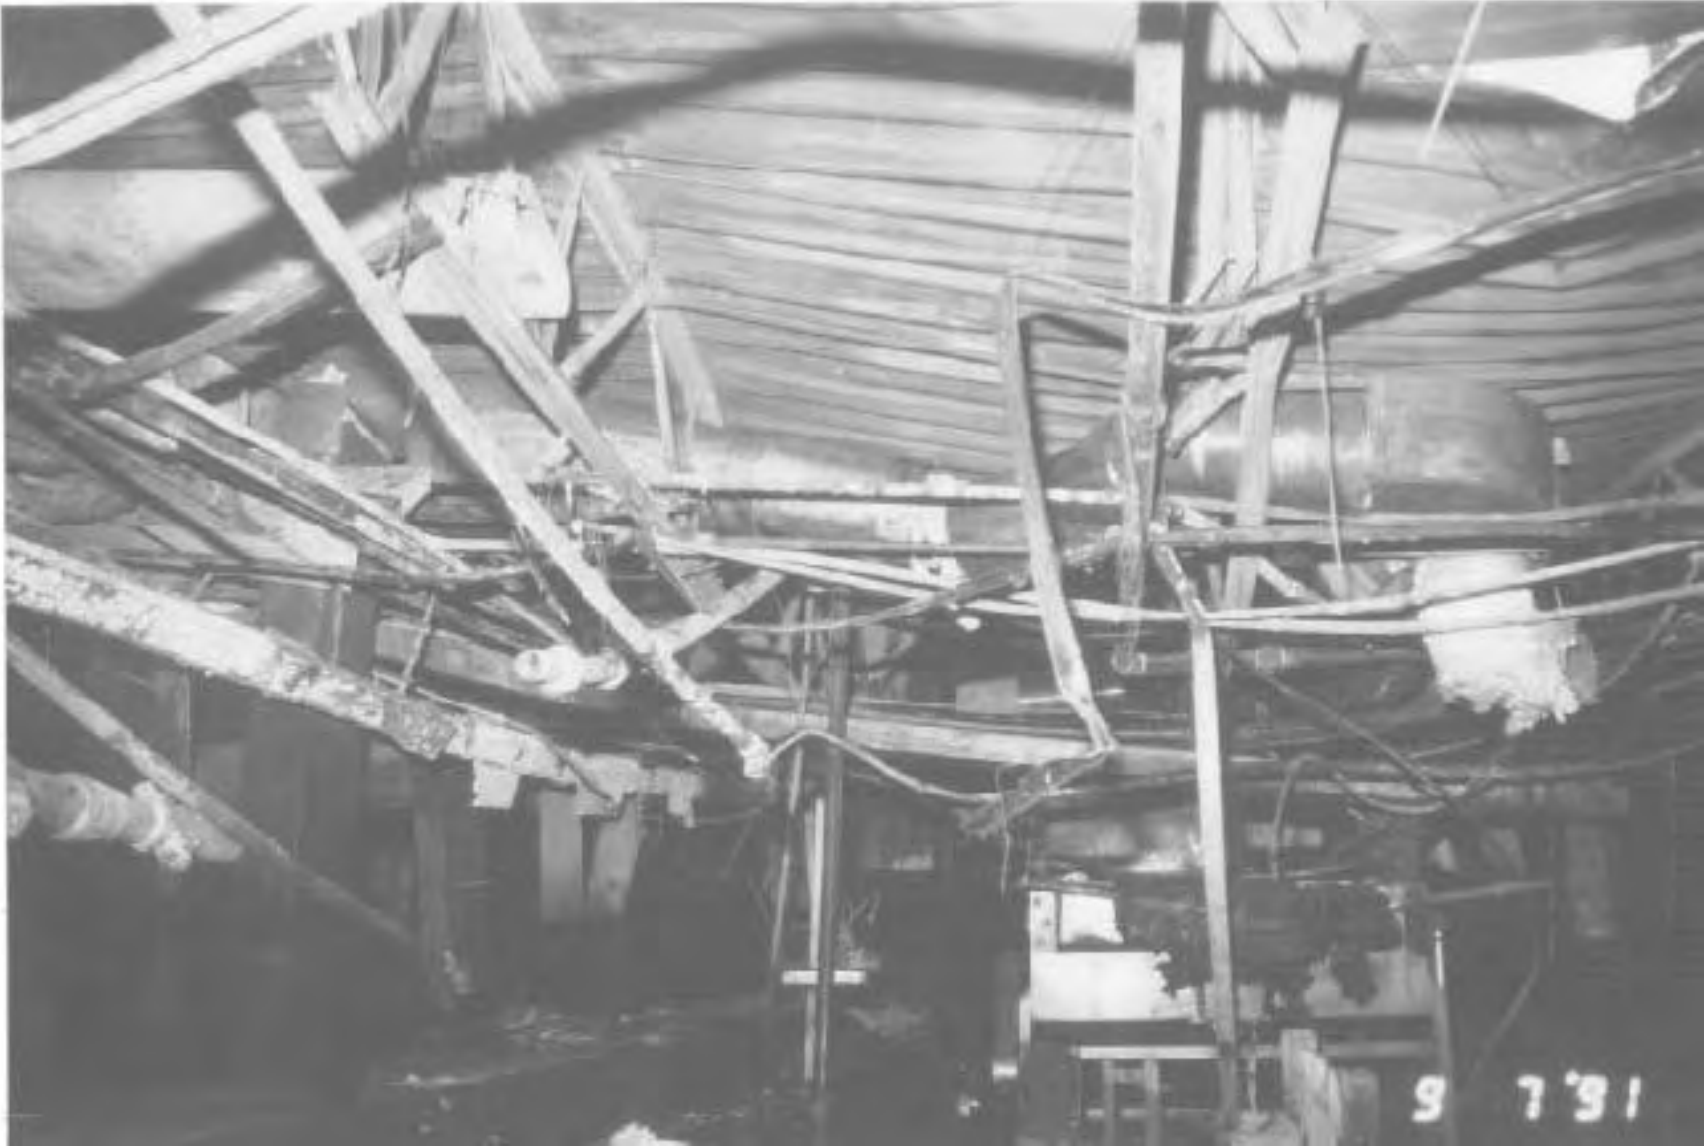
Damage to the steel girders and roof supports over the area of origin.
