# United States Fire Administration

## Technical Report Series

### Major Ship Fire Extinguished by CO<sub>2</sub> Seattle, Washington

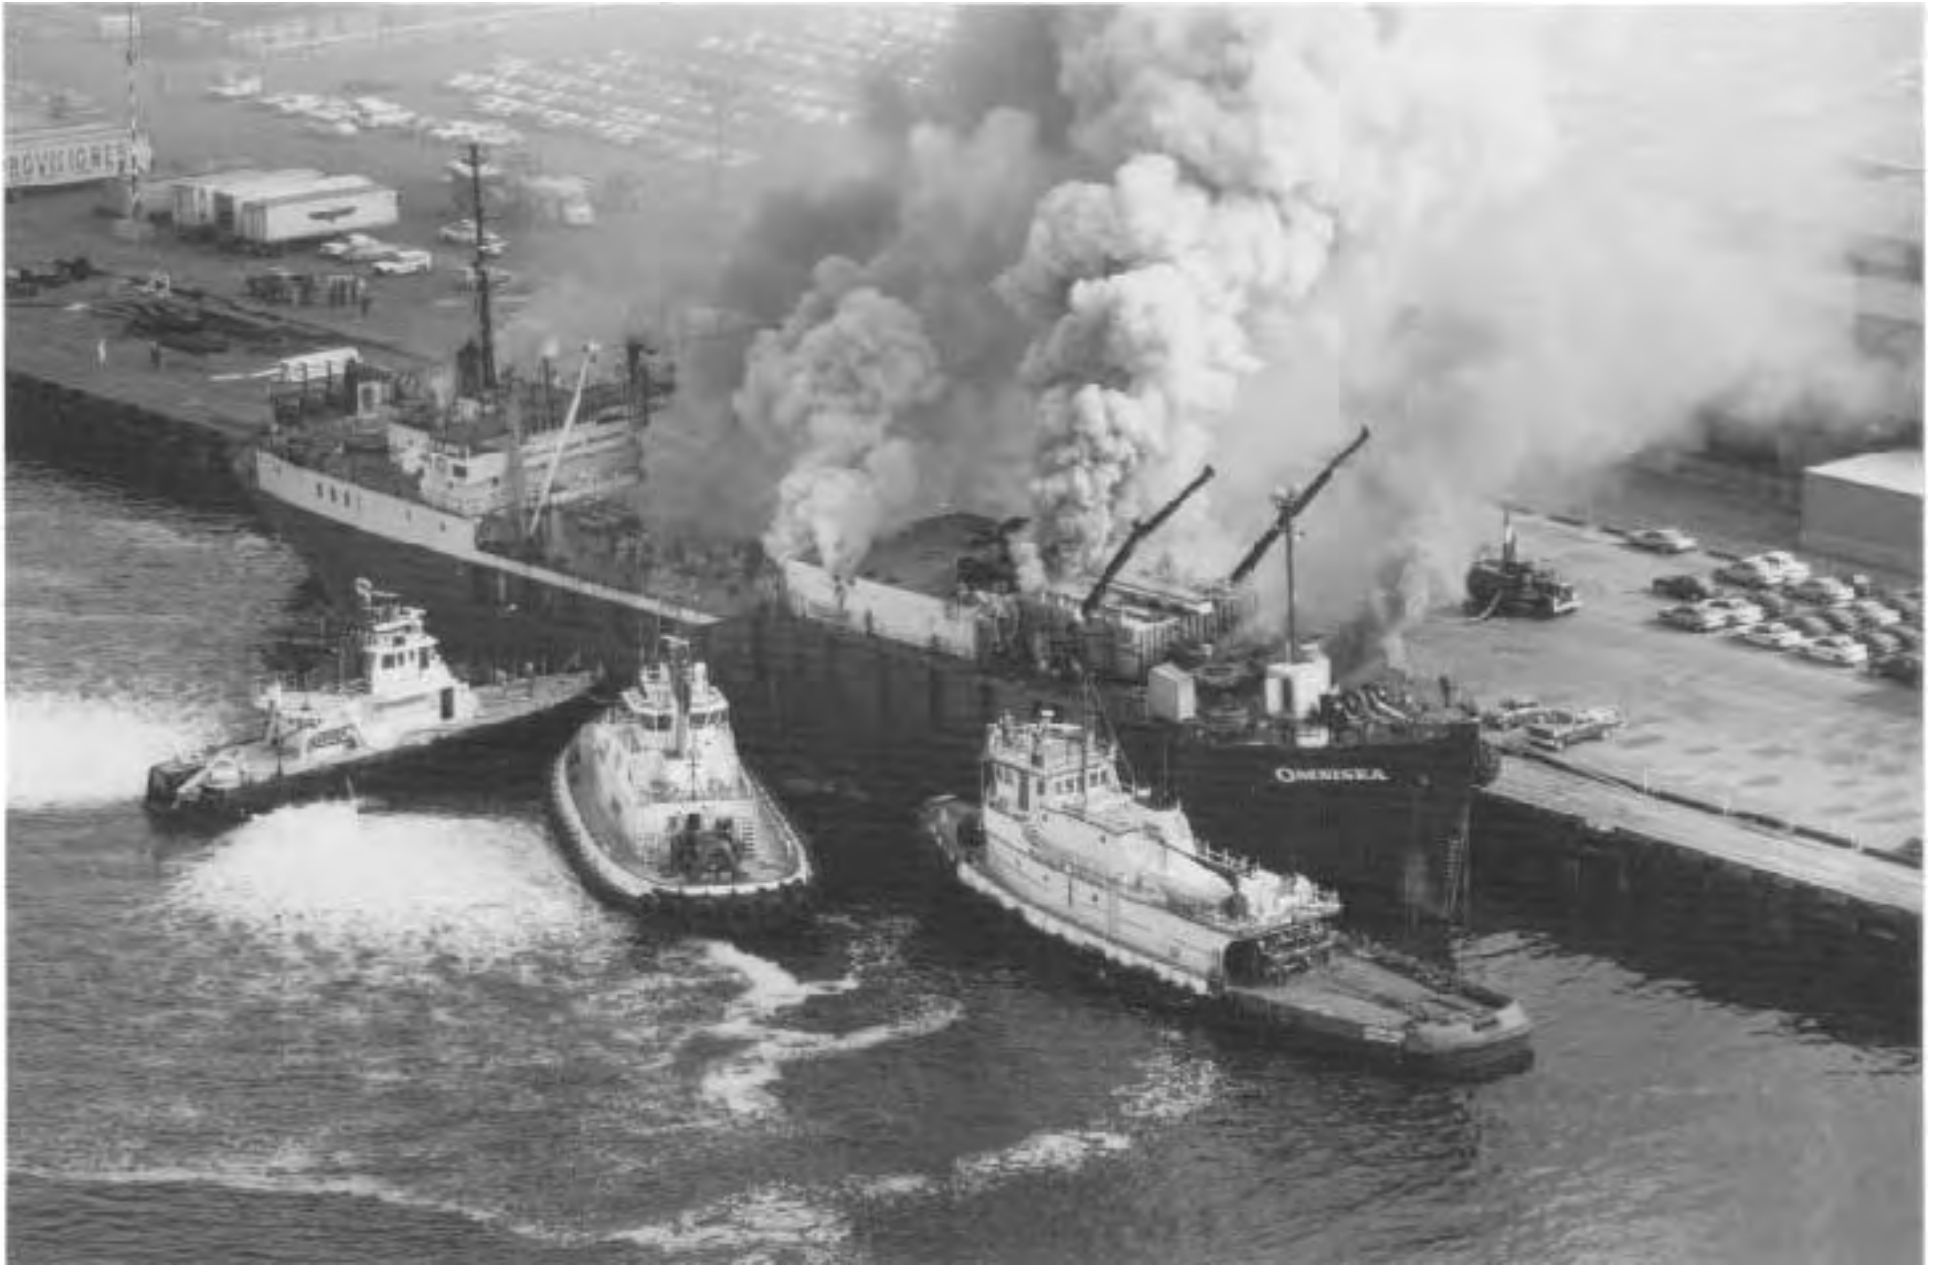
A tug and two fireboats alongside the *Omnisea* during the fire. Note at least nine firefighters visible on board on the starboard side amidships.

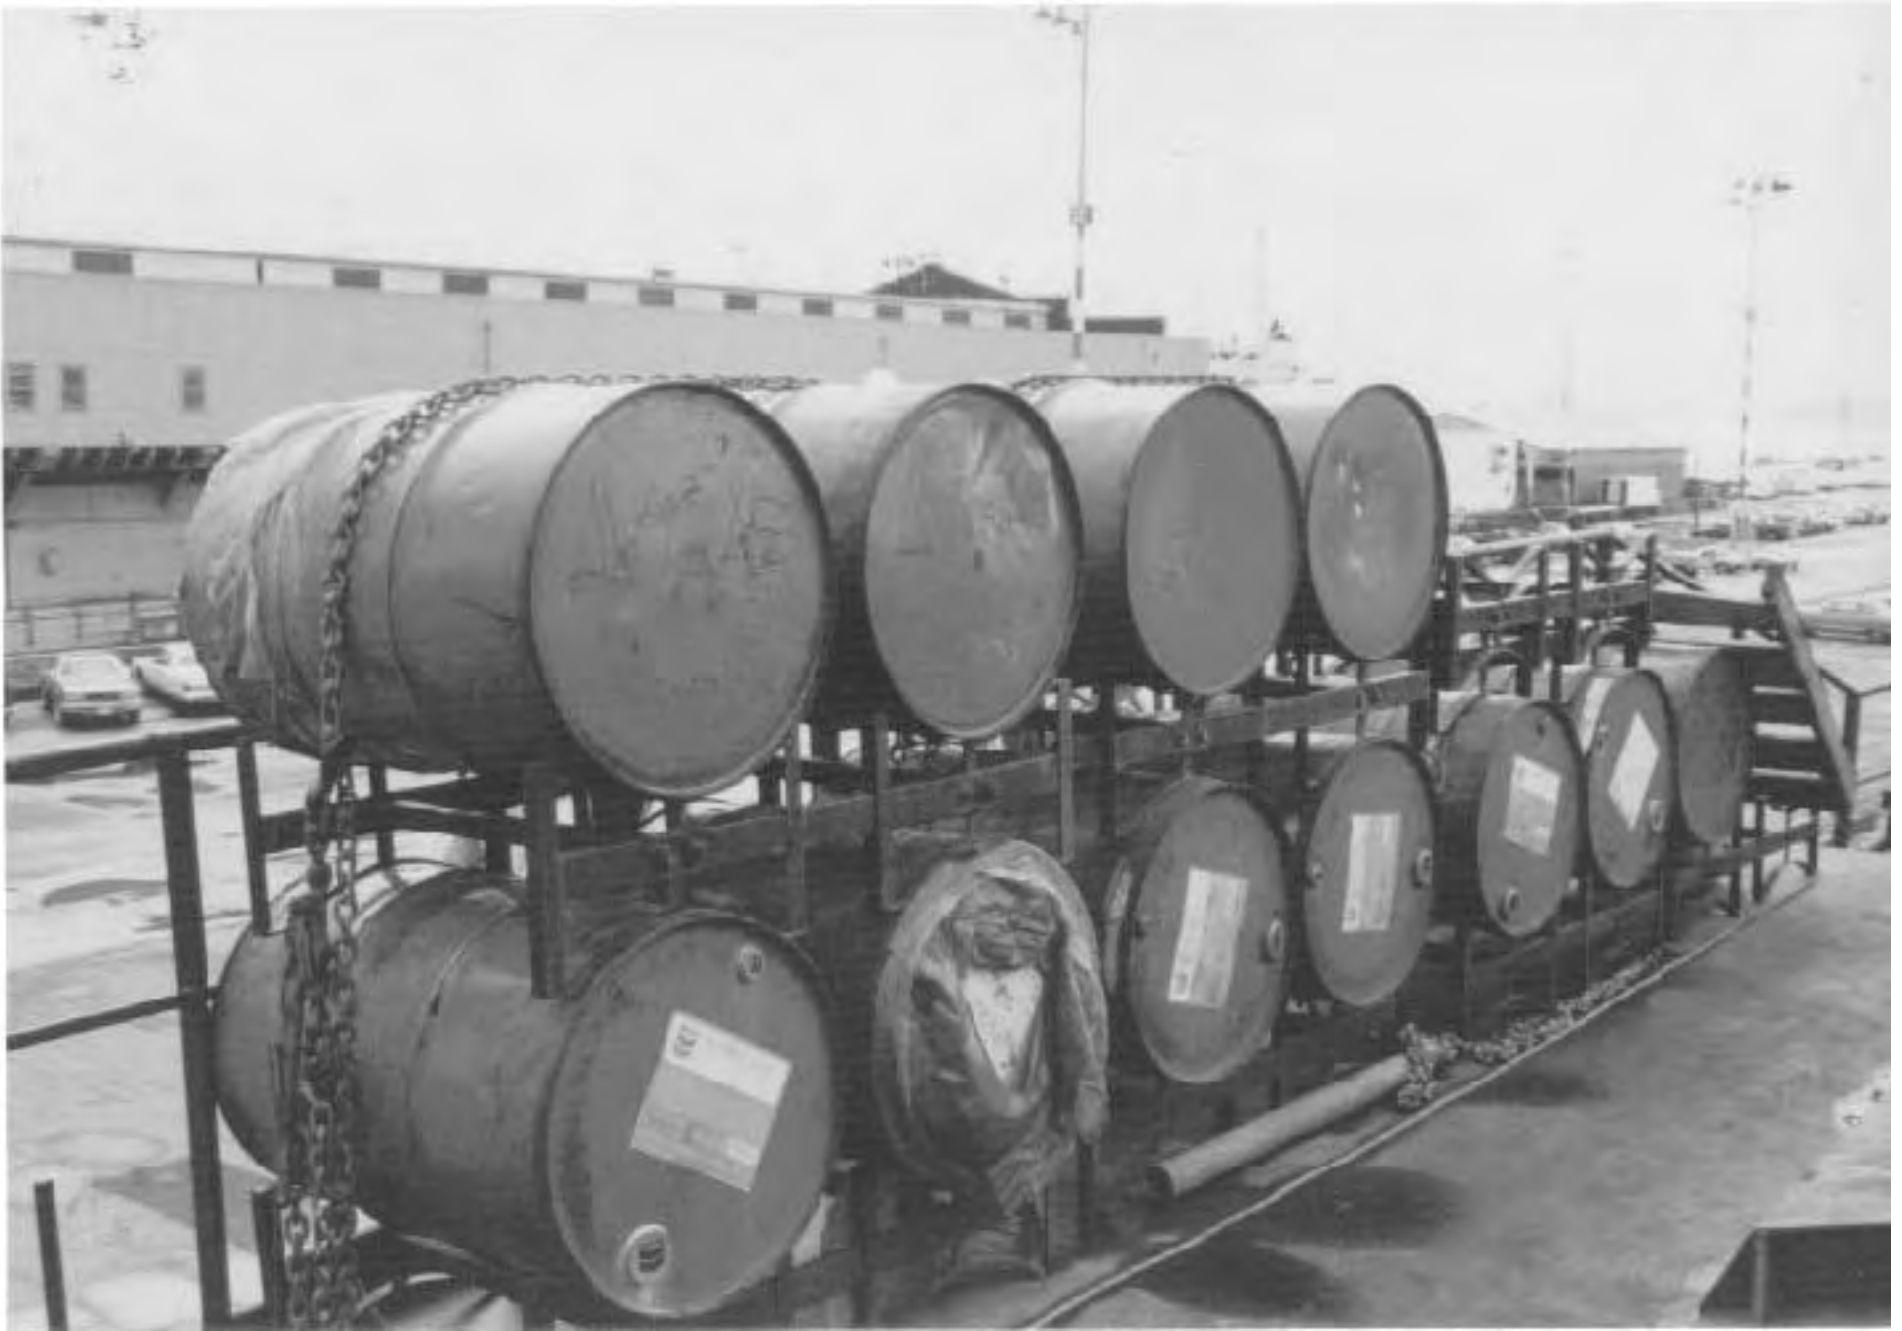
Drums of aviation gasoline and other petroleum products.

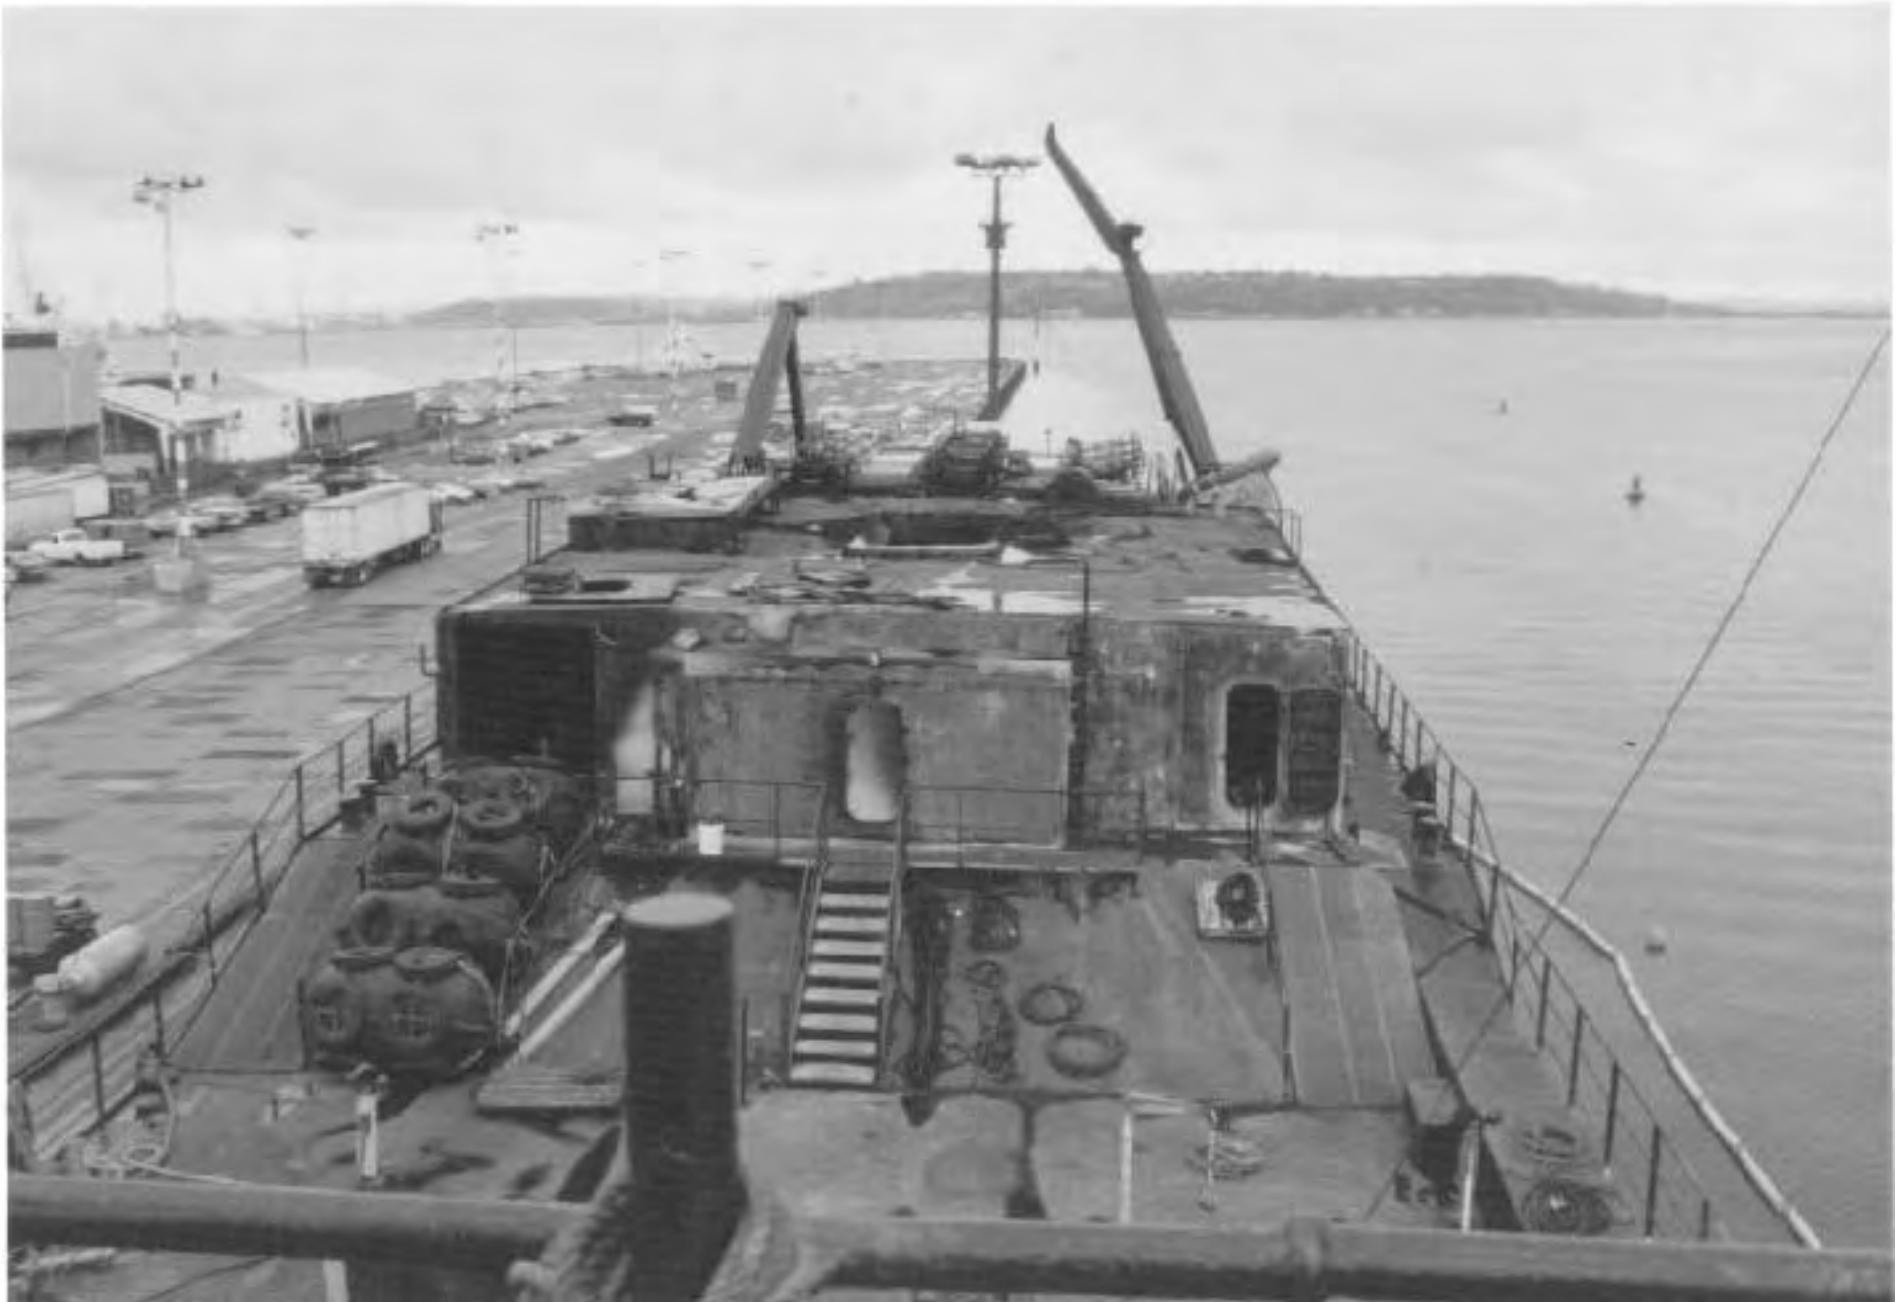
View from superstructure looking aft. Fish receiving house on deck. Major columns of fire and smoke came up from tween deck through square hole in the center of the "house." Another hatch and that hole had to be sealed.

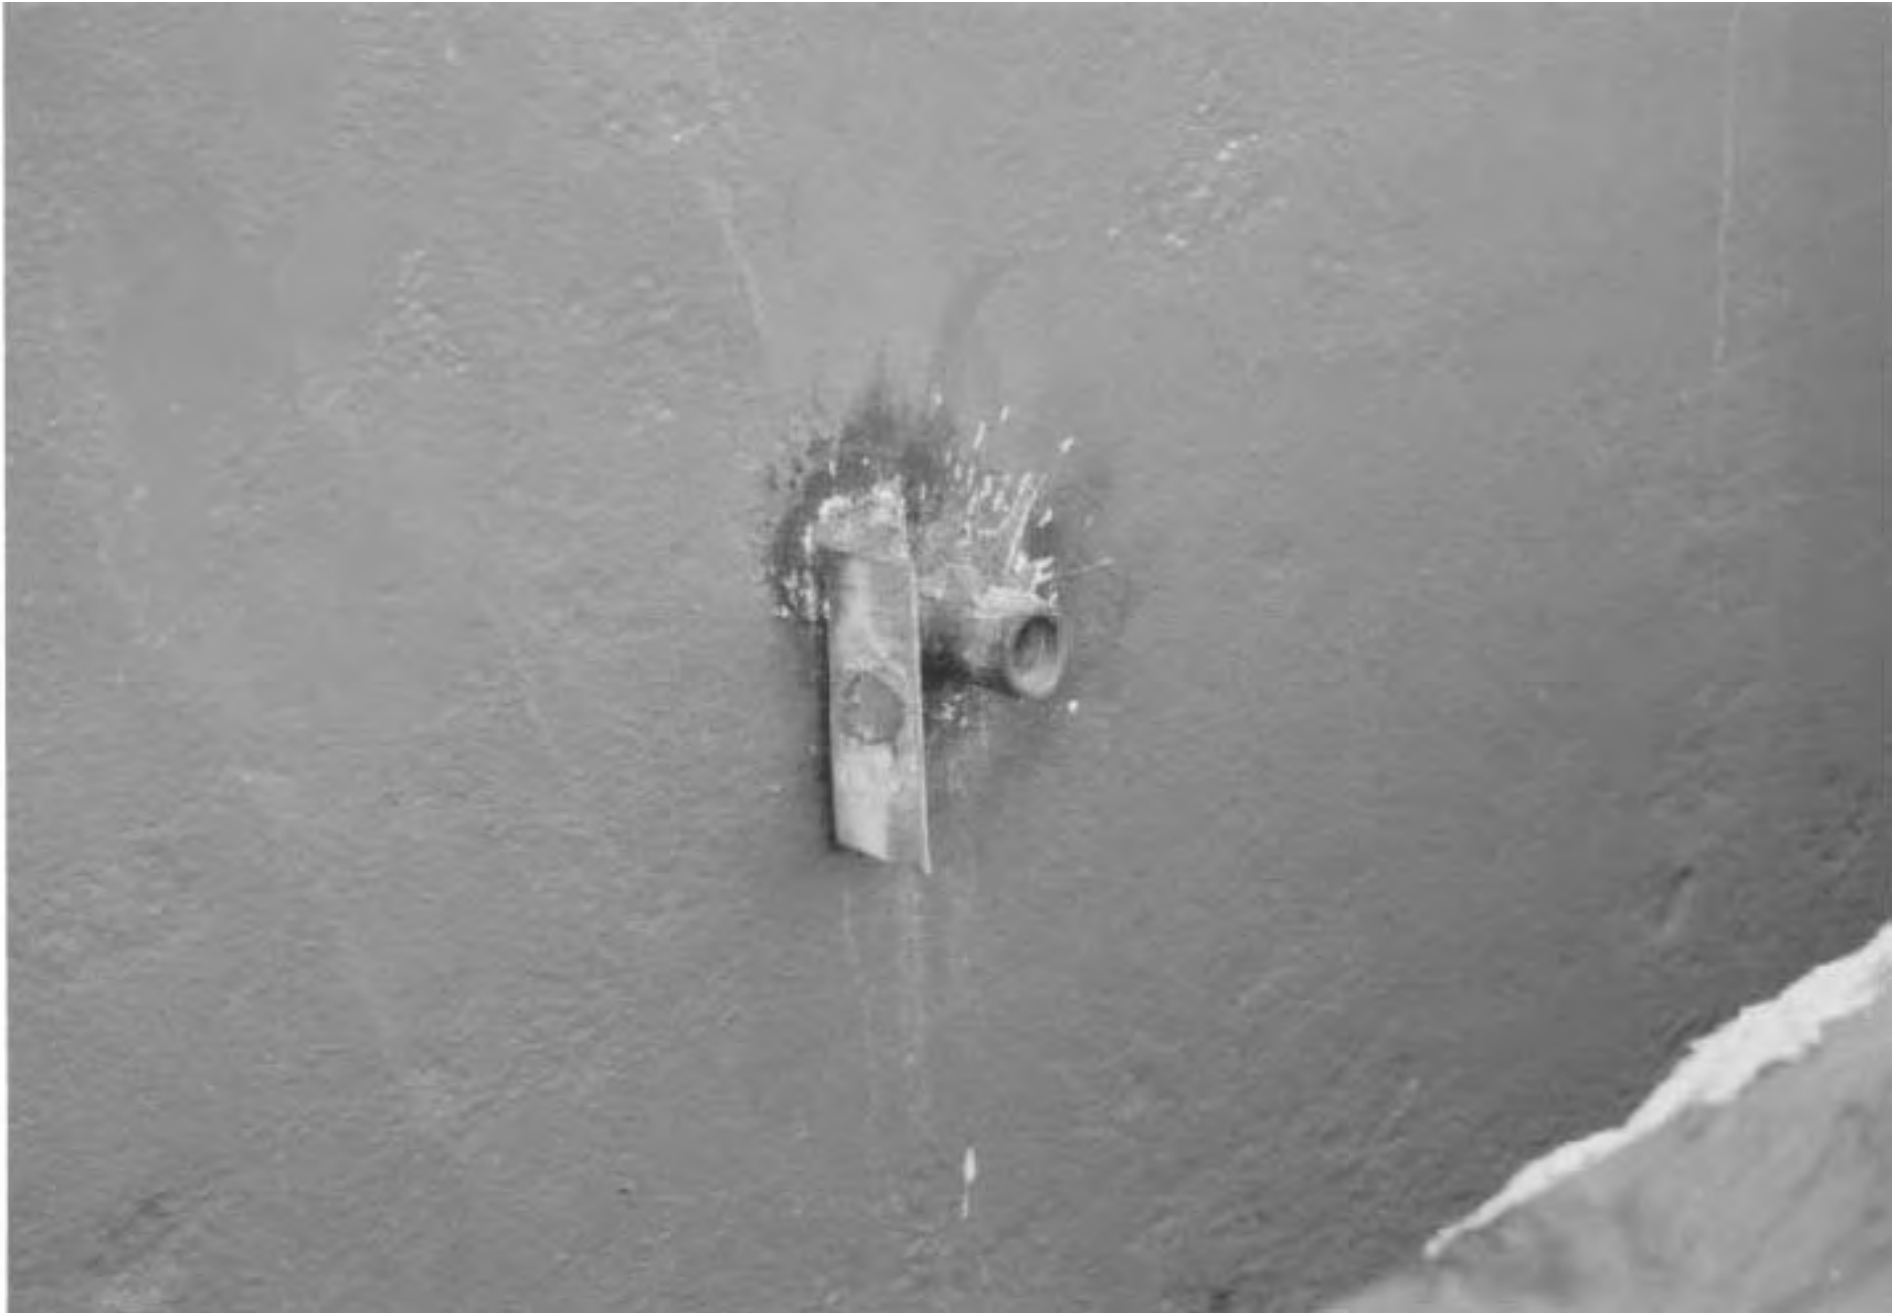
Closeup of hole used to insert CO<sub>2</sub>, with coupling welded into place.

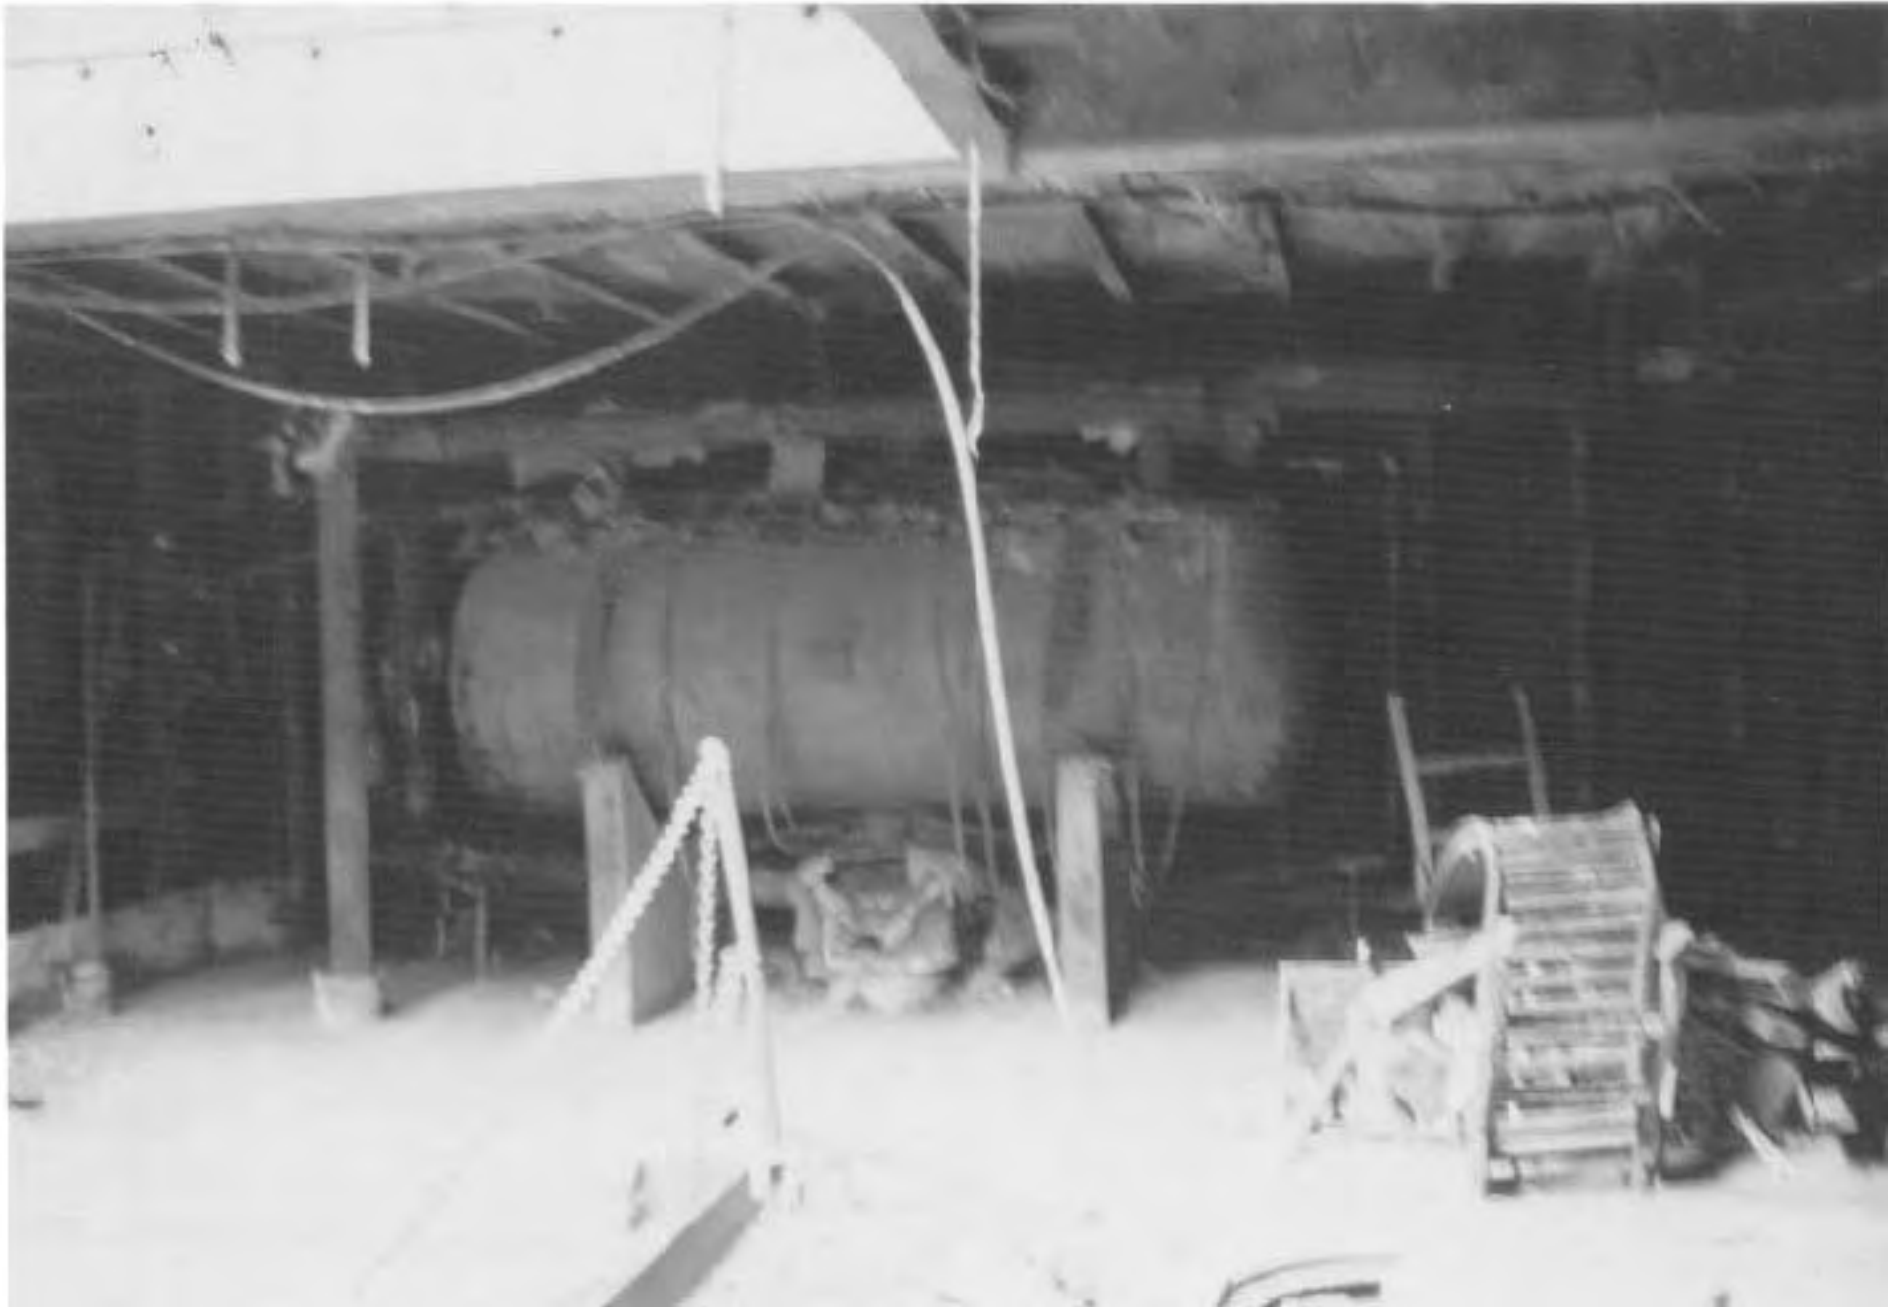
A concern during the fire was whether the CO<sub>2</sub> might accidentally be injected directly on the ammonia tank in the tween deck Number 3 hold and whether that would cause the tank to crack or lose strength and fail catastrophically. It turned out that they missed it by about five feet. The tank survived with its structure intact and was not deformed. The pressure relief valve apparently proved adequate for this size tank, though there also may have been ammonia leakage from piping damage during the fire; there was considerable fire damage to the piping, gaskets and valve.

Ammonia tank in hold near fire origin.

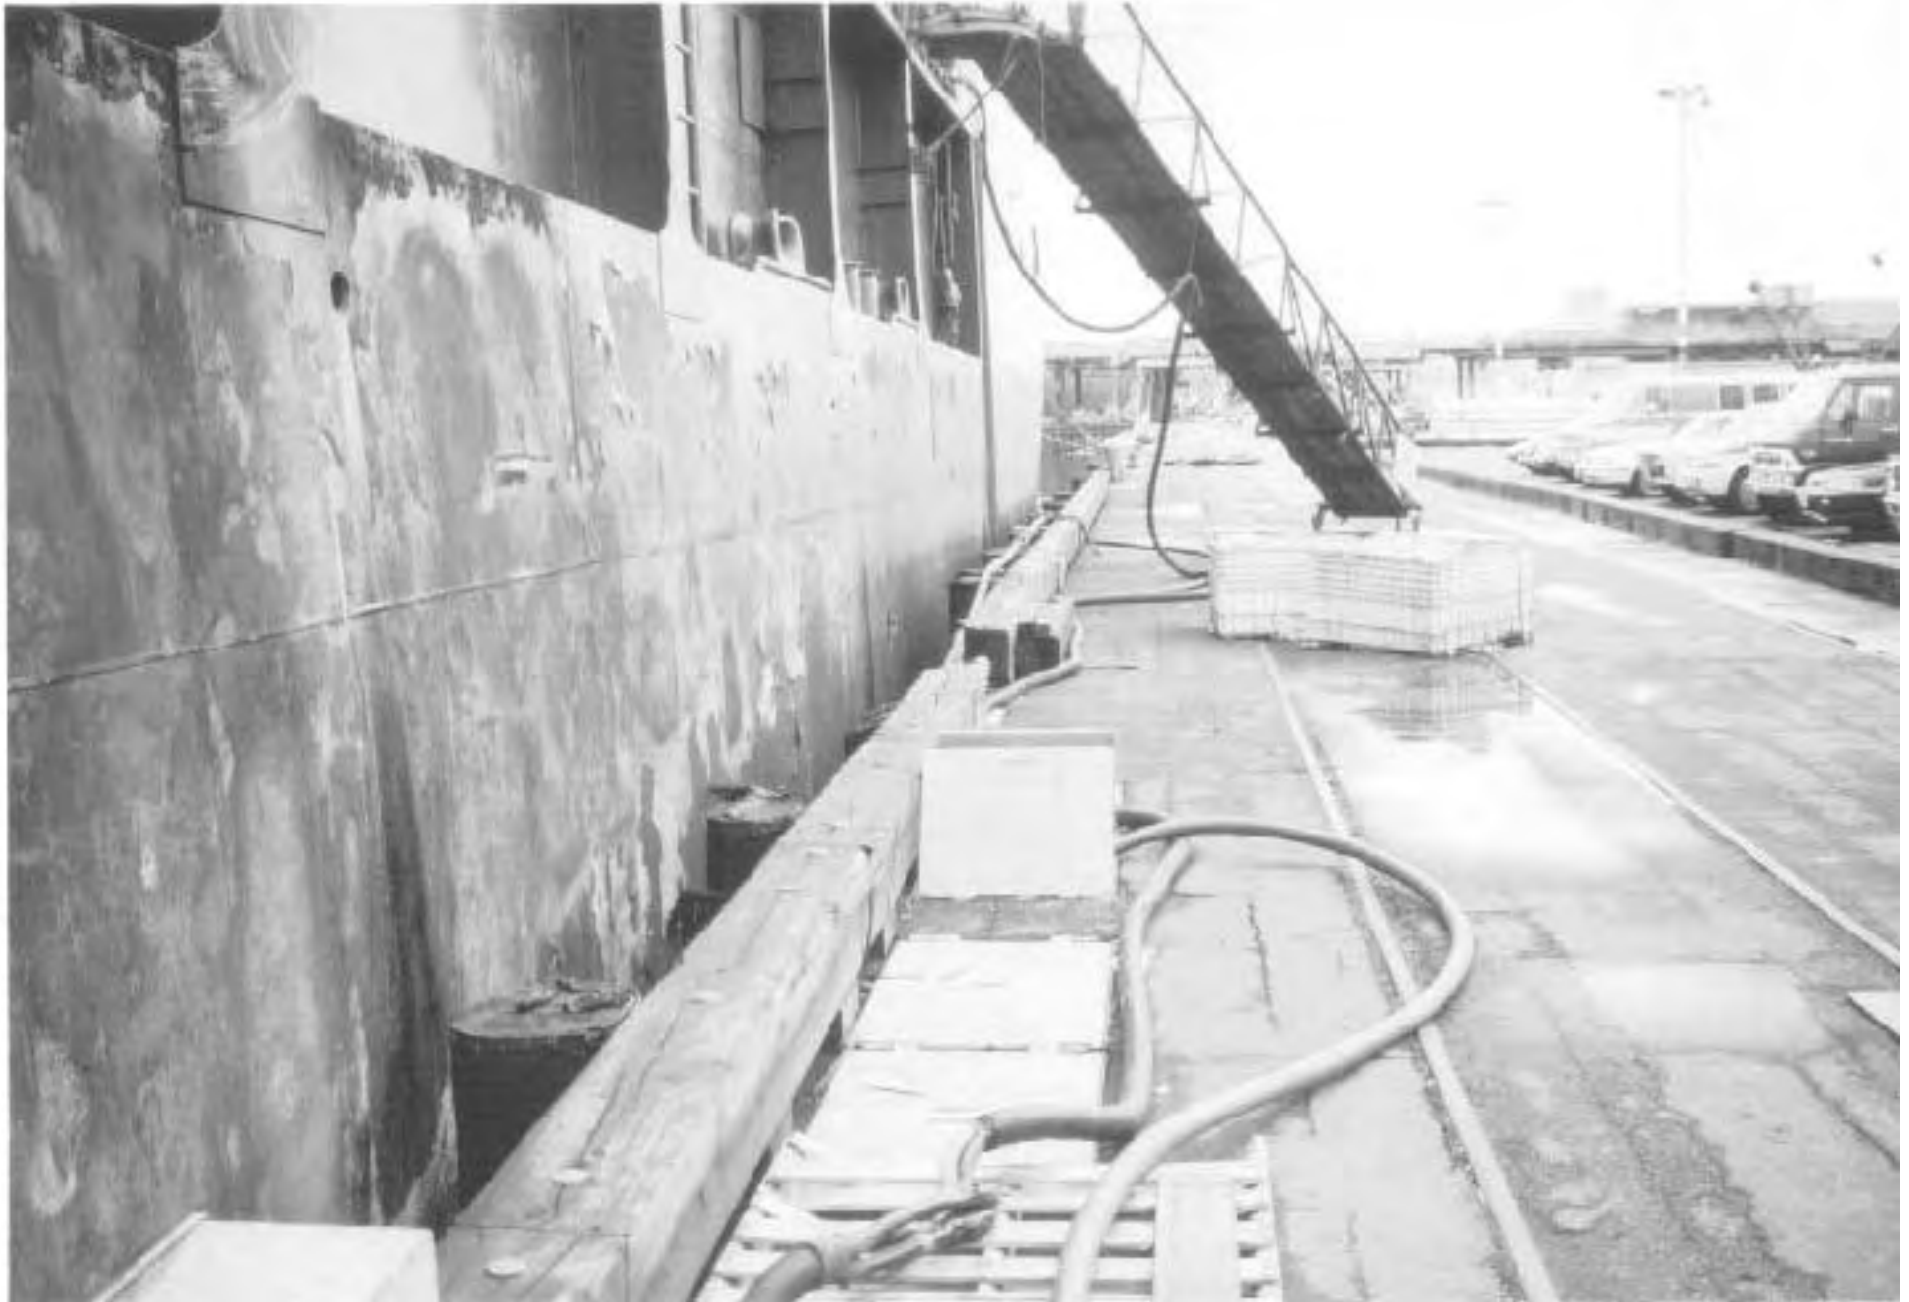
A line of demarkation on the hull is clearly seen at the 19' draft mark with the fire damage above. This is noted on the port side with the greatest amount of exterior hull damage at a point approx 210' from the bow. Starboard side damage mimics the port side but to a lesser intensity. Viewed from the port side, the greatest degree of damage to the hull is located amidships at a point approx 2 decks below the main deck.

Port side - maximum discoloration near Hold #3; paint in good condition toward bow; note that the hull did not buckle.

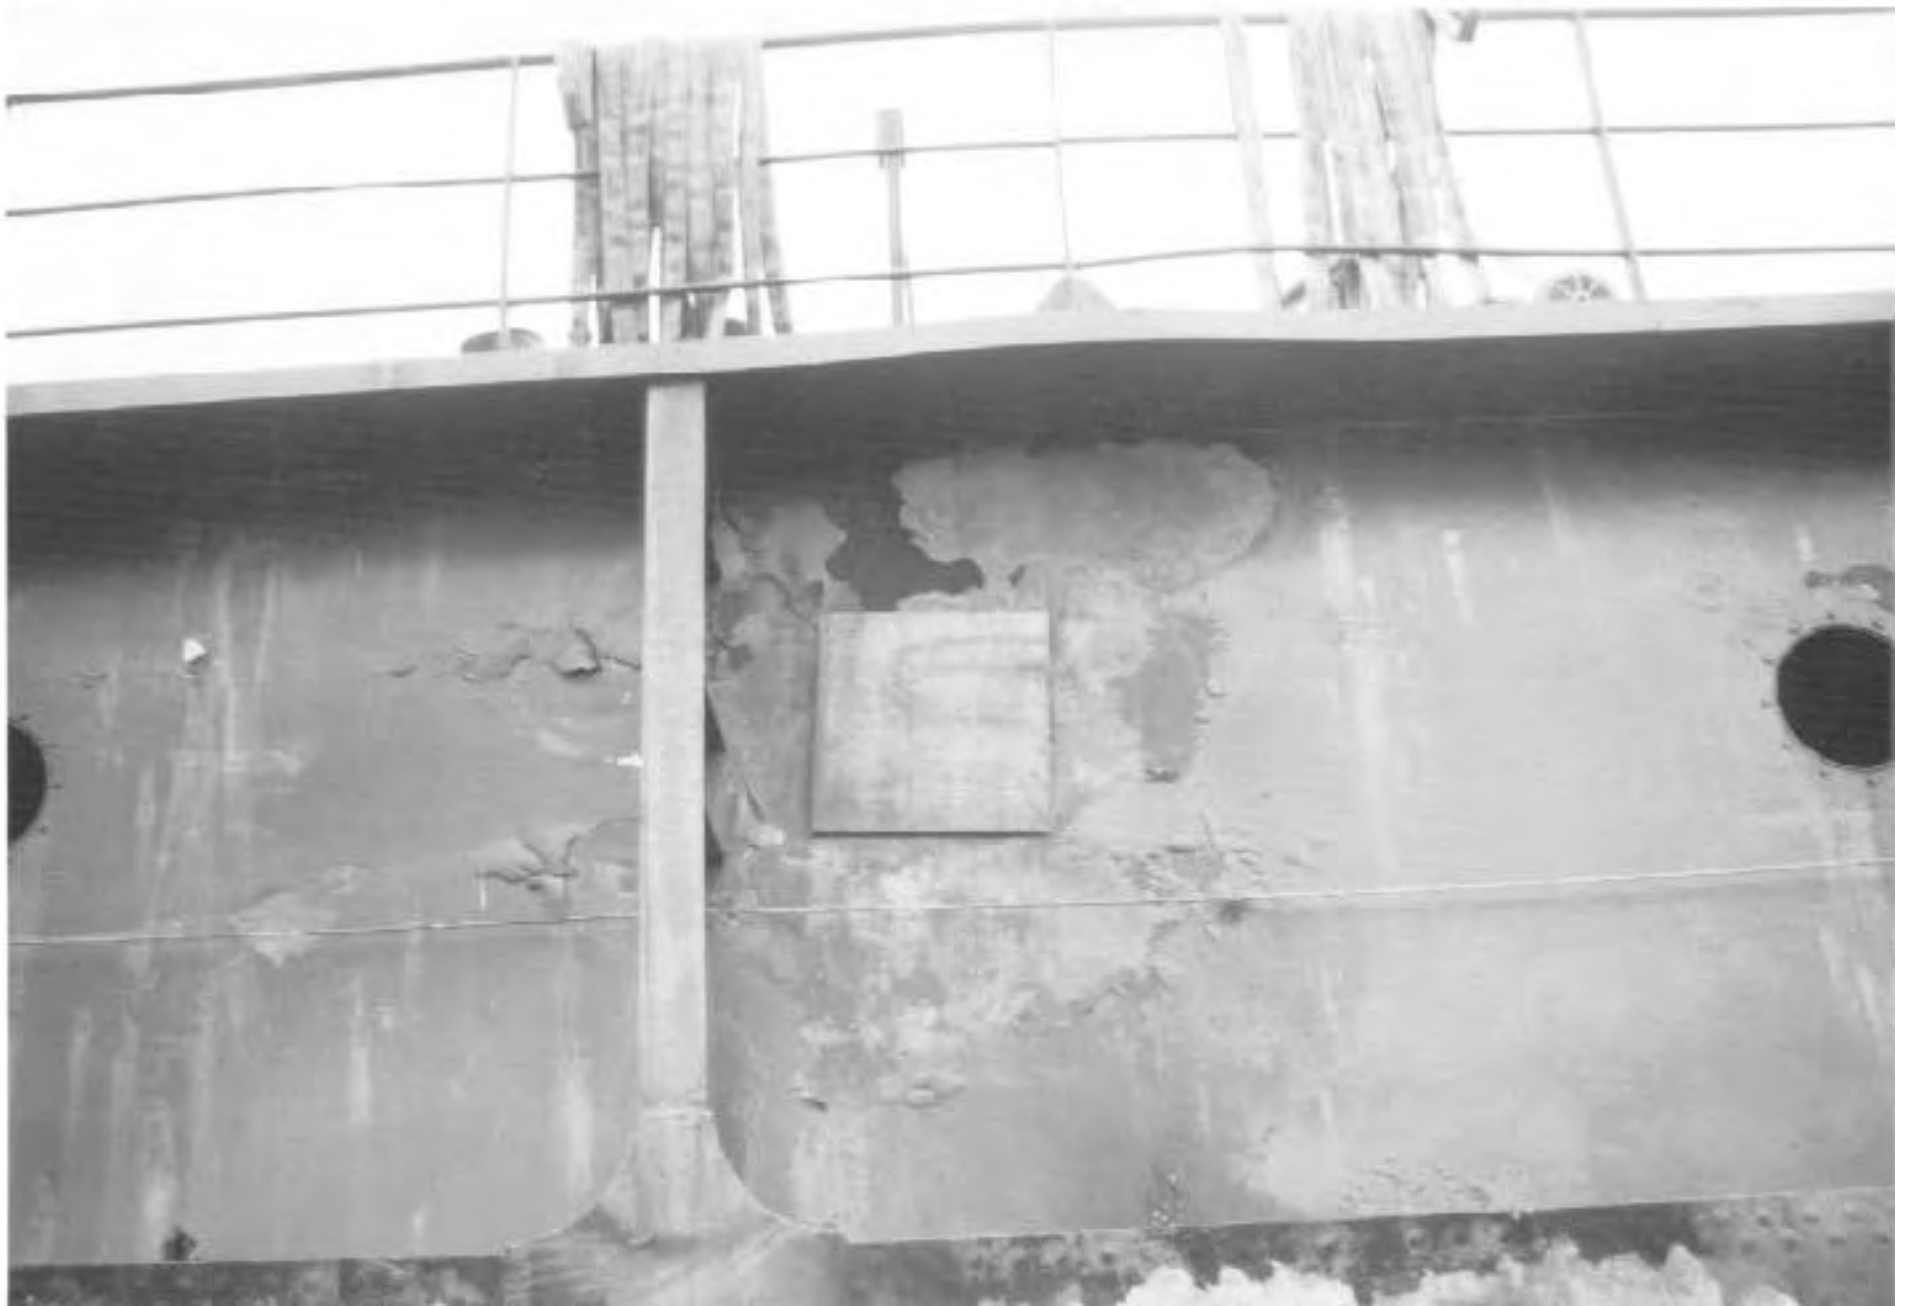
Steel plate welded over porthole as part of buttoning up the ship prior to CO<sub>2</sub> insertion. Adjacent portholes were stuffed with materials to seal them. Note buckling of deck and railing from heat.

Small steel plates also were cut and welded in place over broken portholes. Other portholes and small vents were covered or stuffed with tarpaulins and other handy materials.

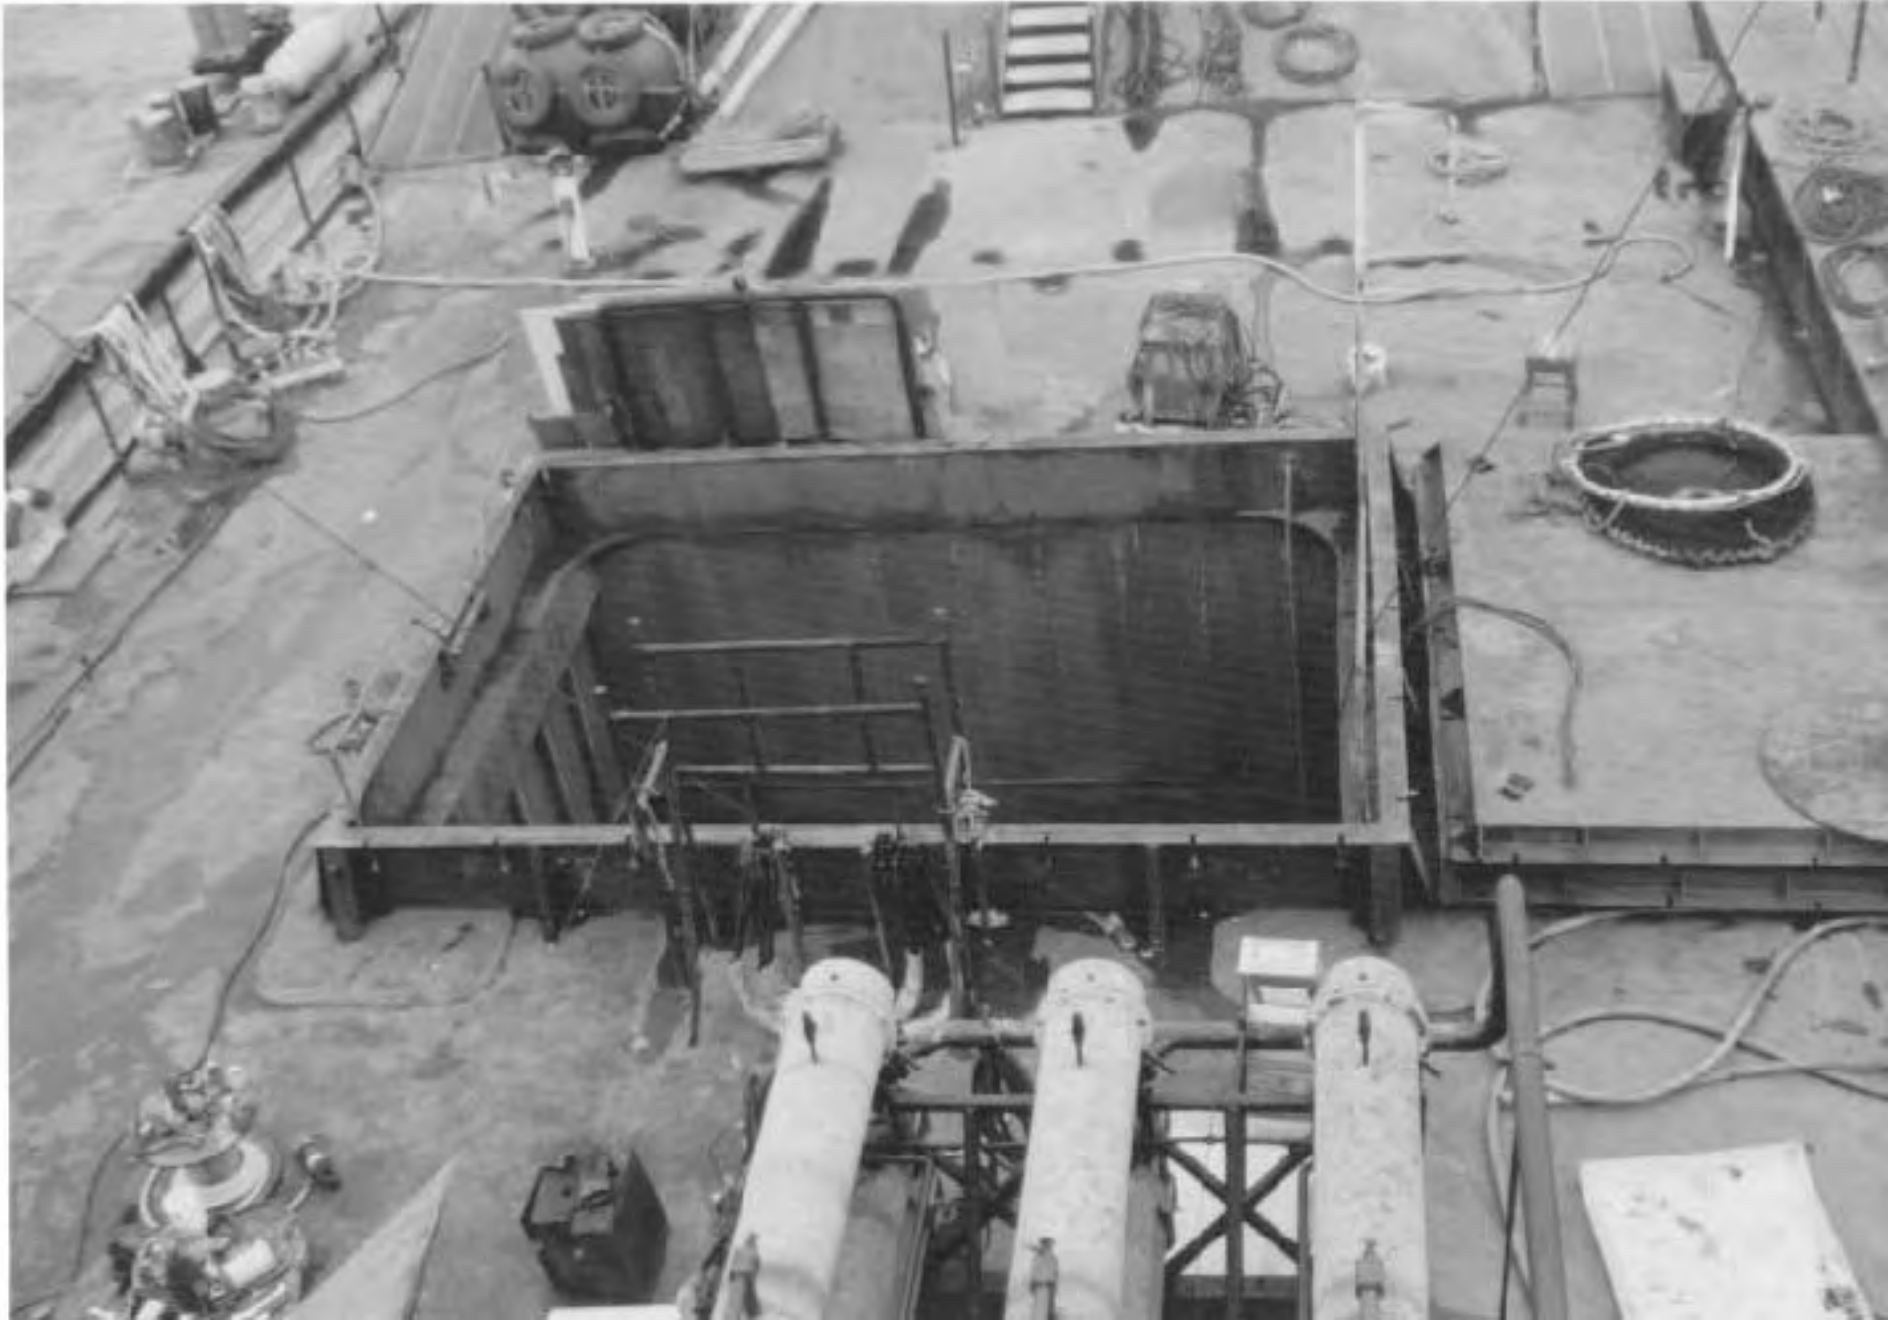
Hatch opening to holds; it, too, had to be sealed.

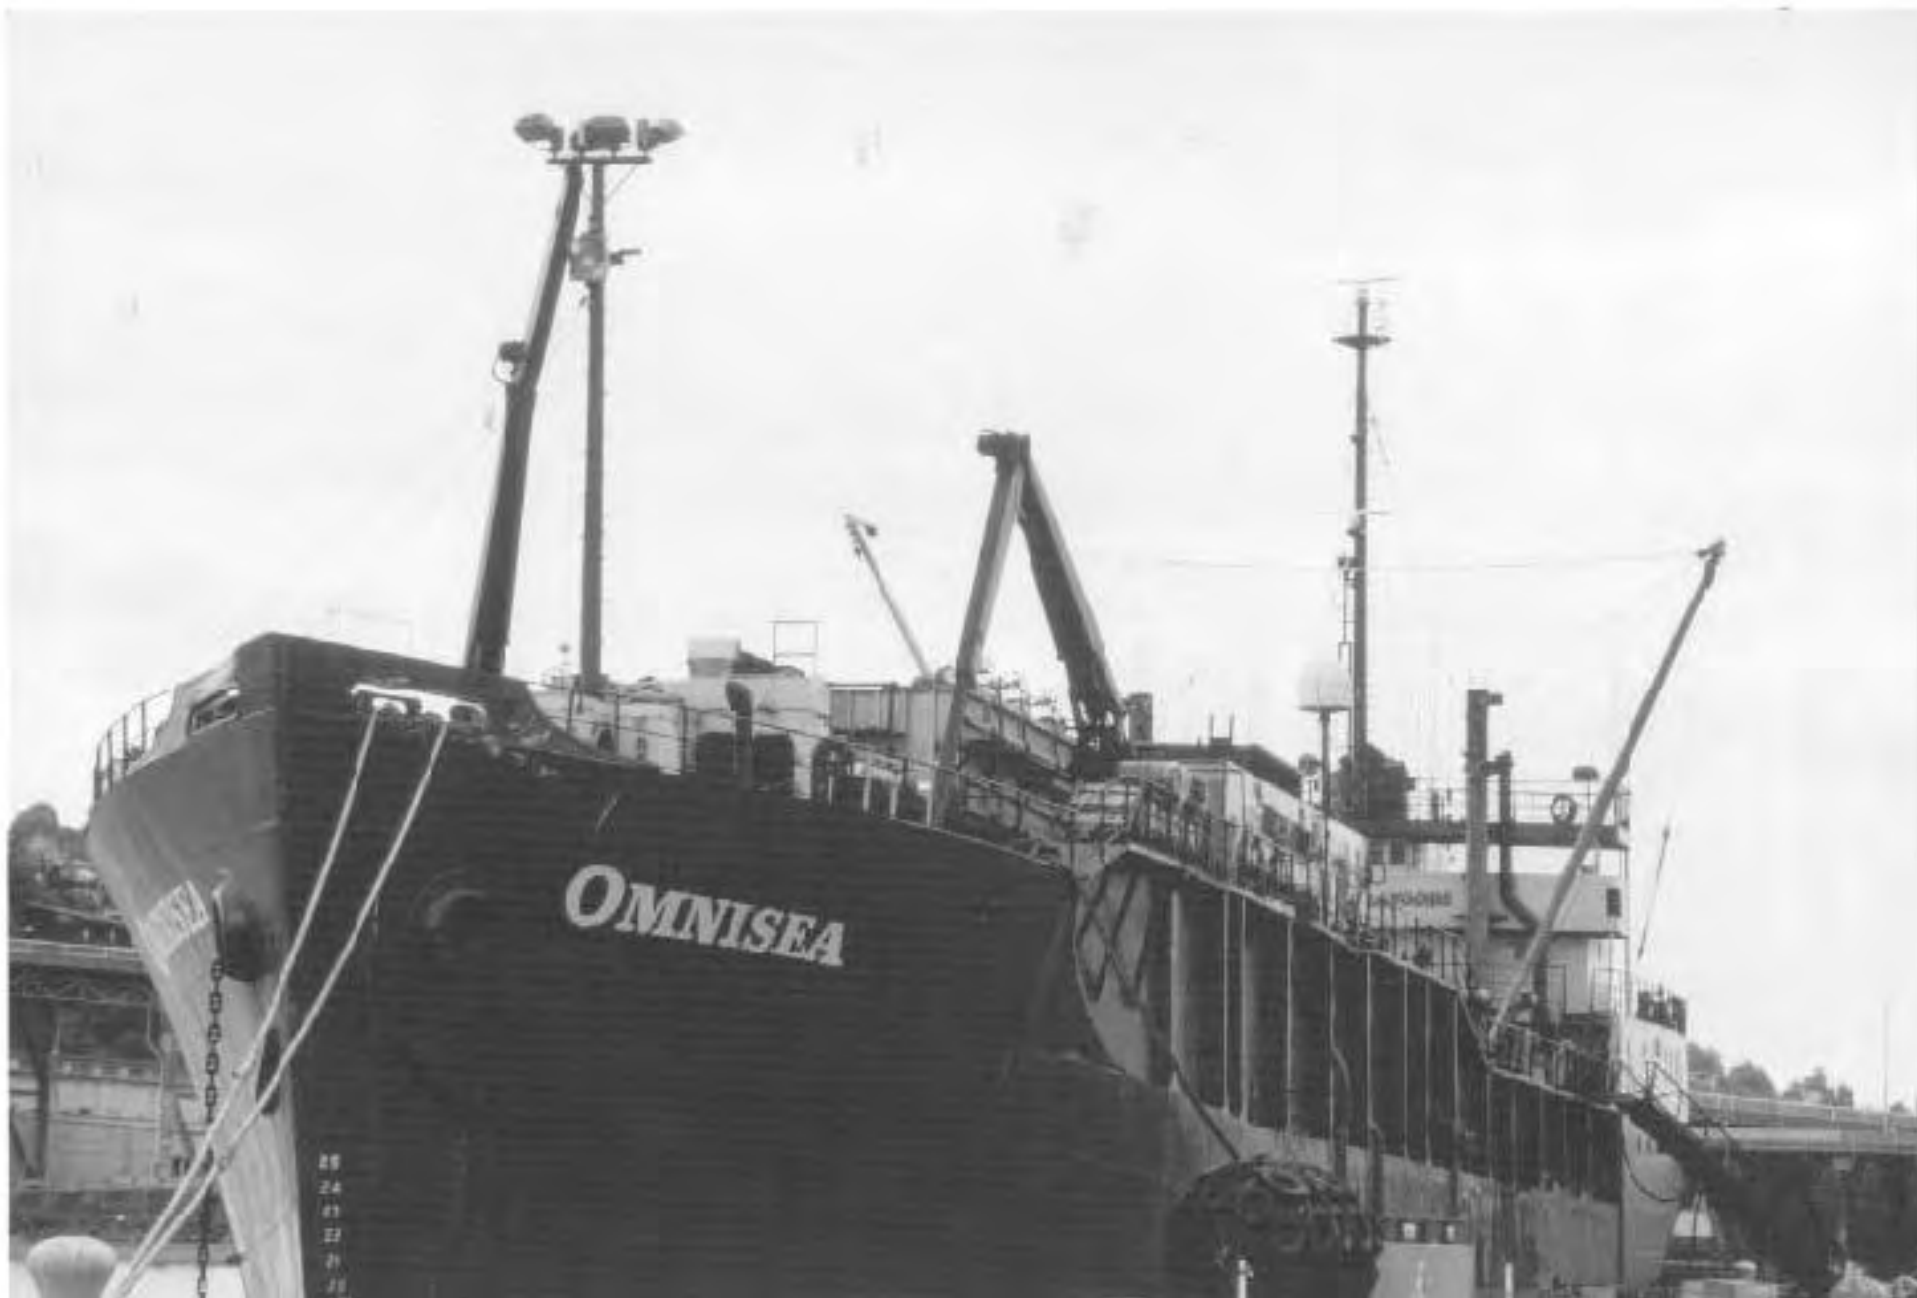
Bow of *Omnisea*. Note amount of compartments and equipment on deck - a complex area for fire fighting. (Photo by Philip Schaenman)
