# United States Fire Administration

## Technical Report Series

### Major Ship Fire Extinguished by CO<sub>2</sub> Seattle, Washington

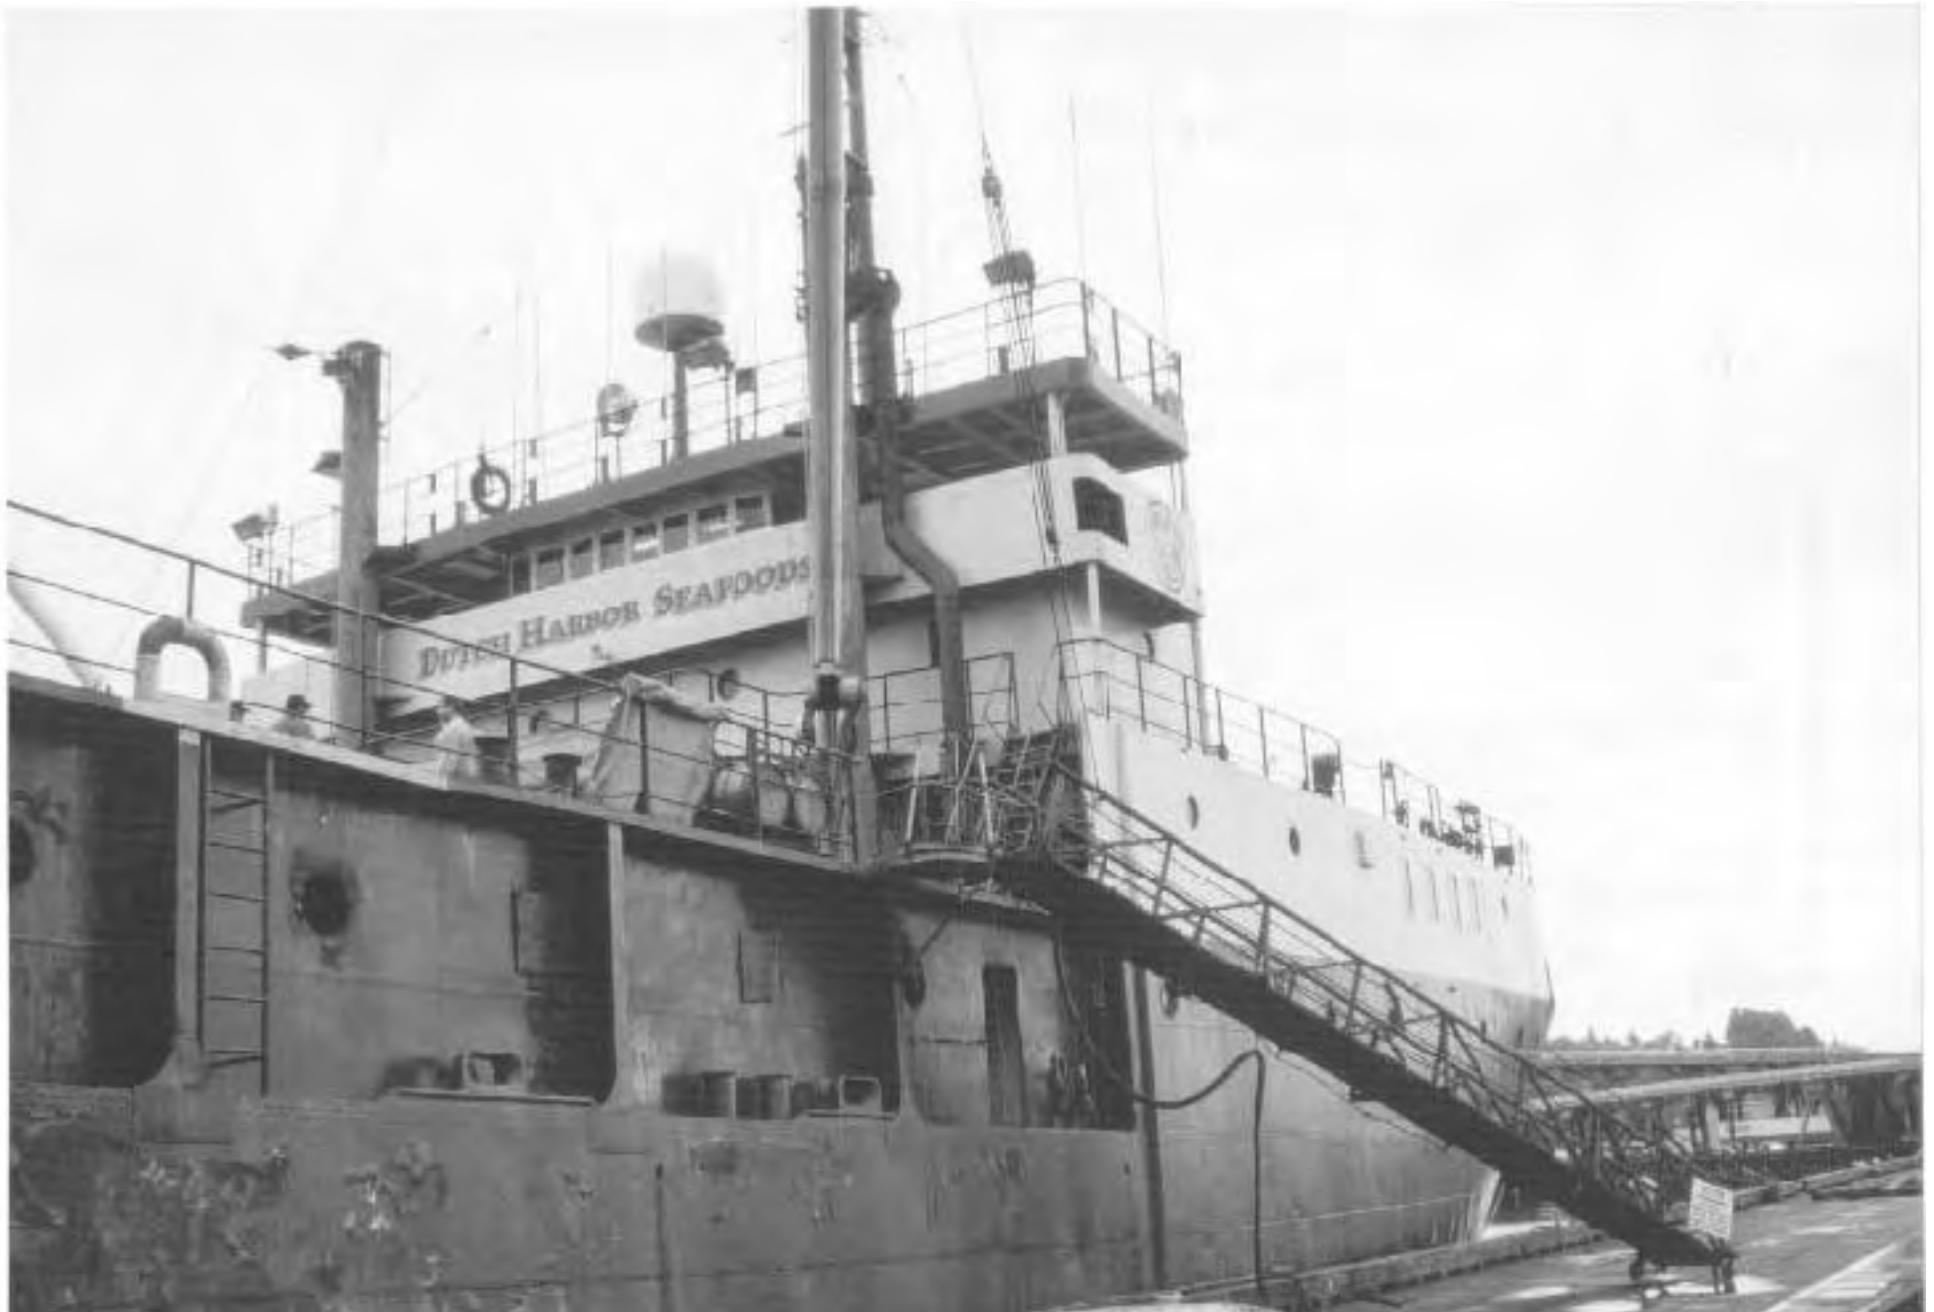
Aft third of the ship was saved, including ship controls, electronics, and engine room.
