Technical Report Series

Apartment Complex Fire, 66 Units Destroyed Seattle, Washington

**Apartment Complex Fire,
66 Units Destroyed
Seattle, Washington
(September 21, 1991)**

This is Report 059 of the Major Fires Investigation Project conducted by TriData Corporation under contract EMW-90-C-3338 to the United States Fire Administration, Federal Emergency Management Agency.

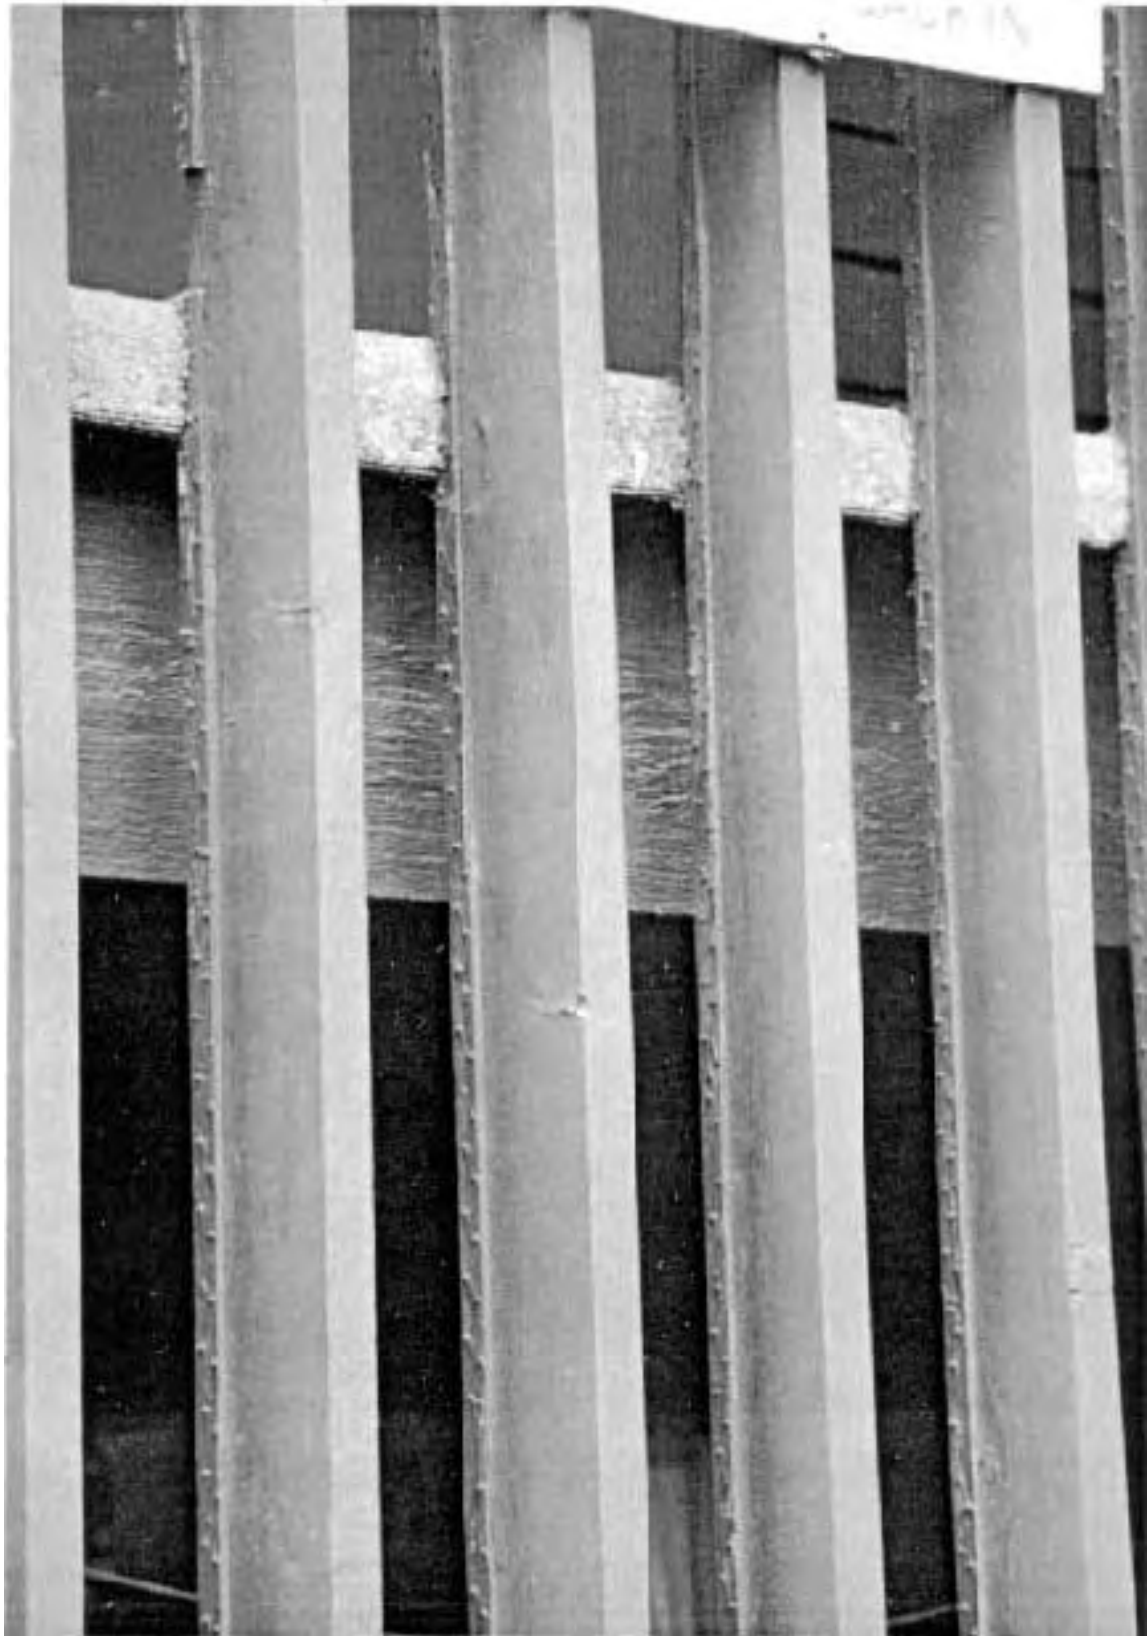
Close-up of the decorative cedar screen on the fronts of the buildings, which served a security purpose as well. Fire could race unimpeded up the wood 2 x 6's. The photograph shows the screen as it passes the outdoor carpeted floor of the walkway above.

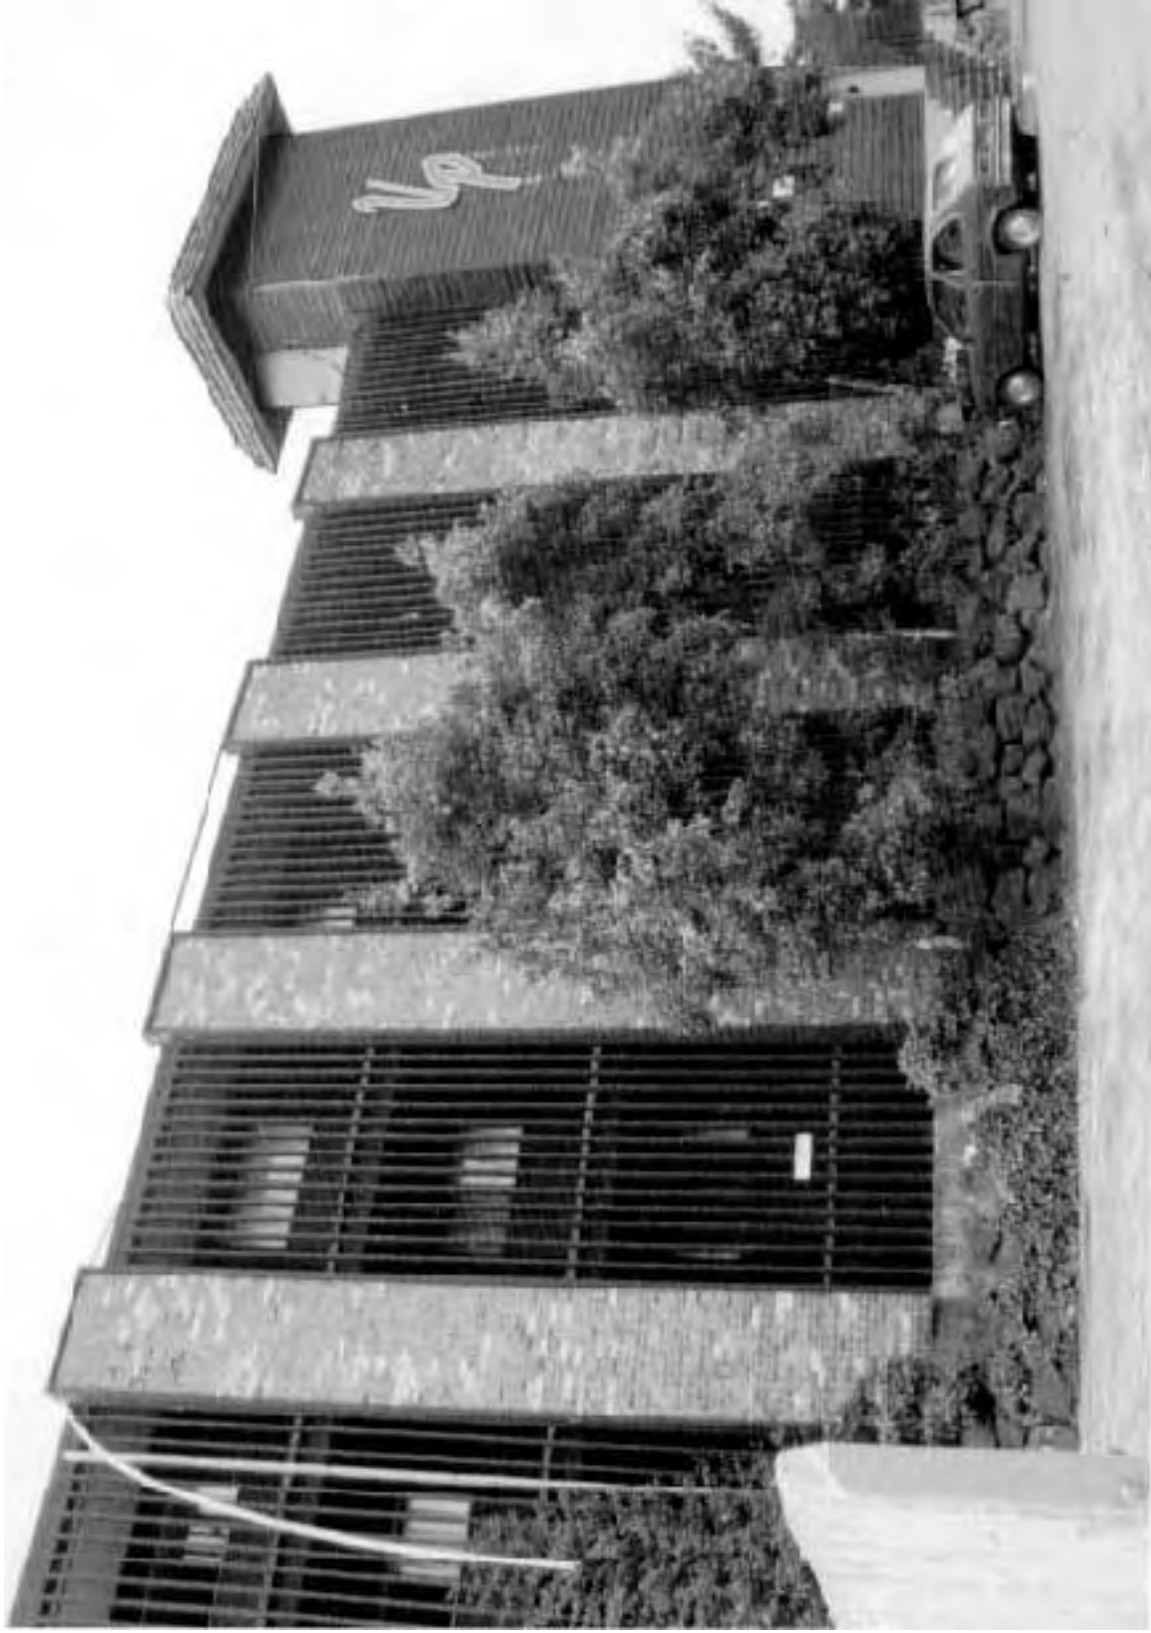
(Photo provided by Philip Schaenman)
Typical exterior construction, brick facia with 2" x 6" slated security fencing.

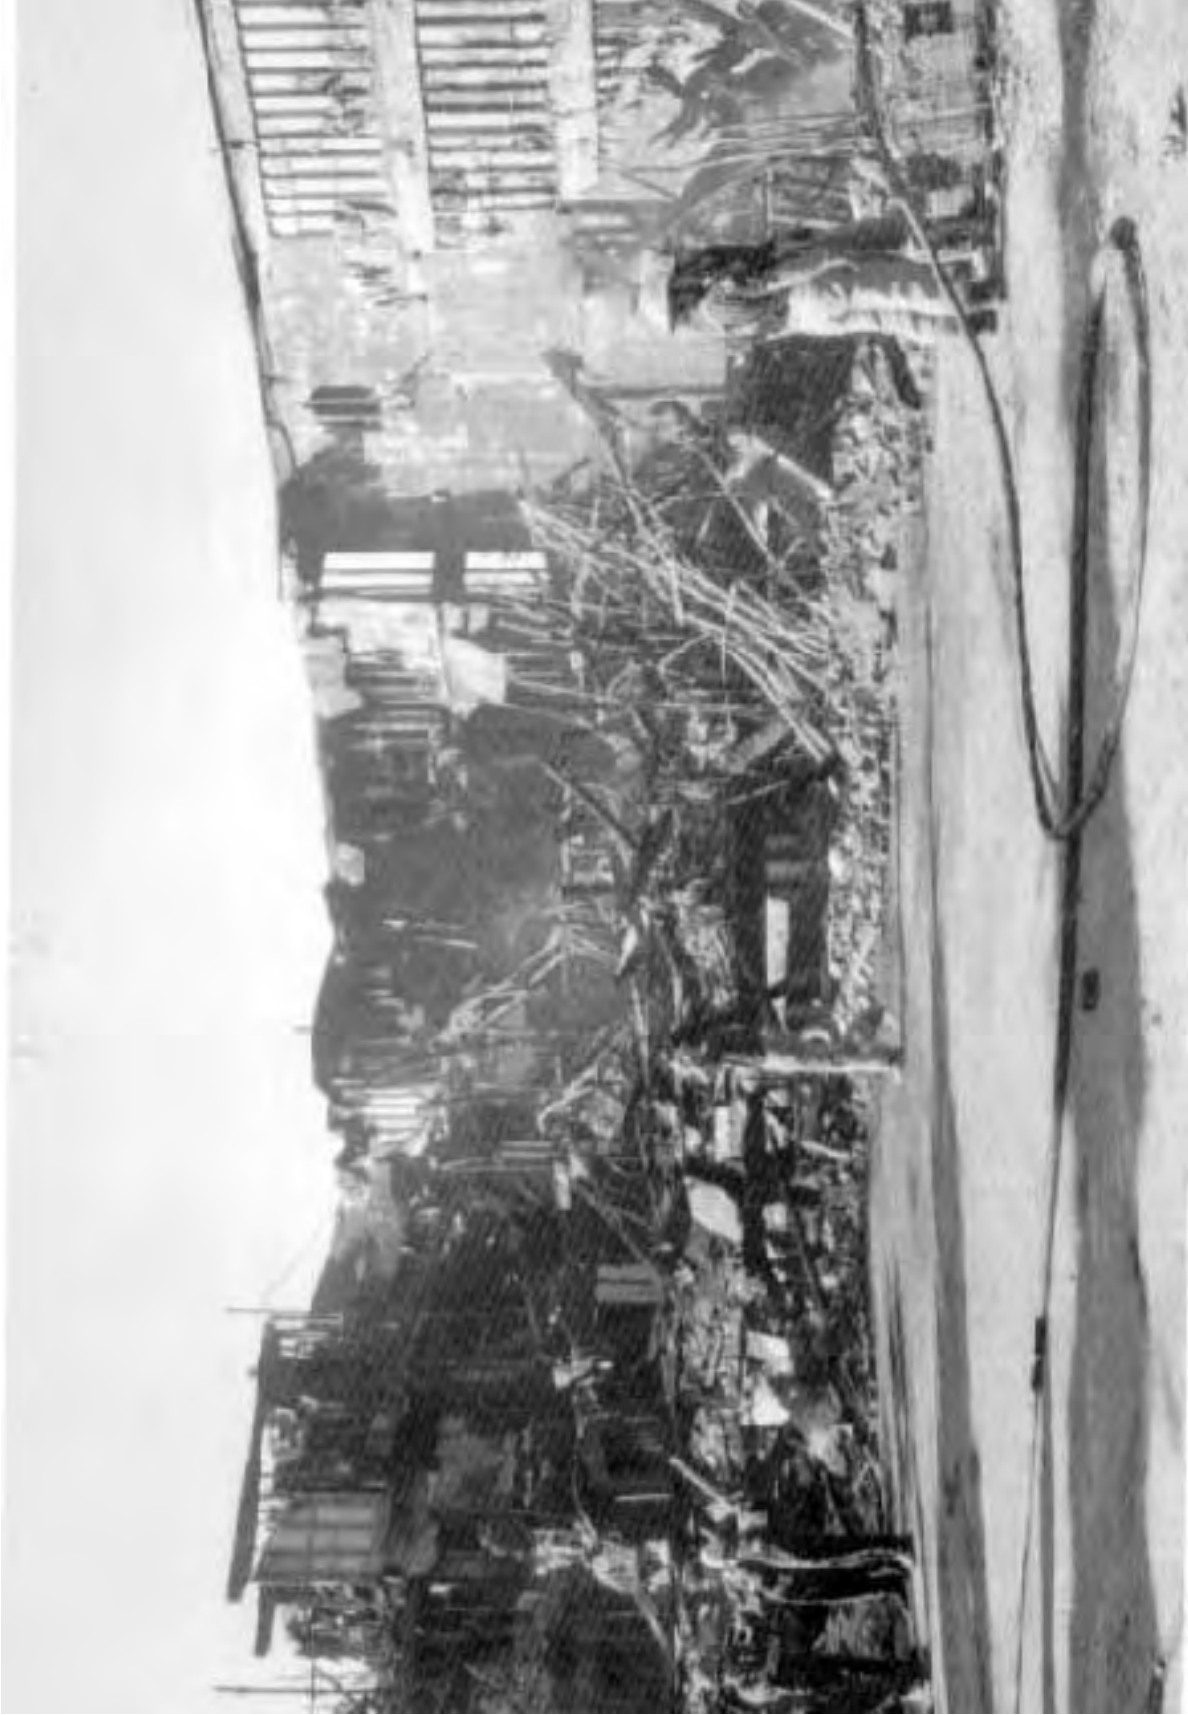
View from the southeast looking northwest.

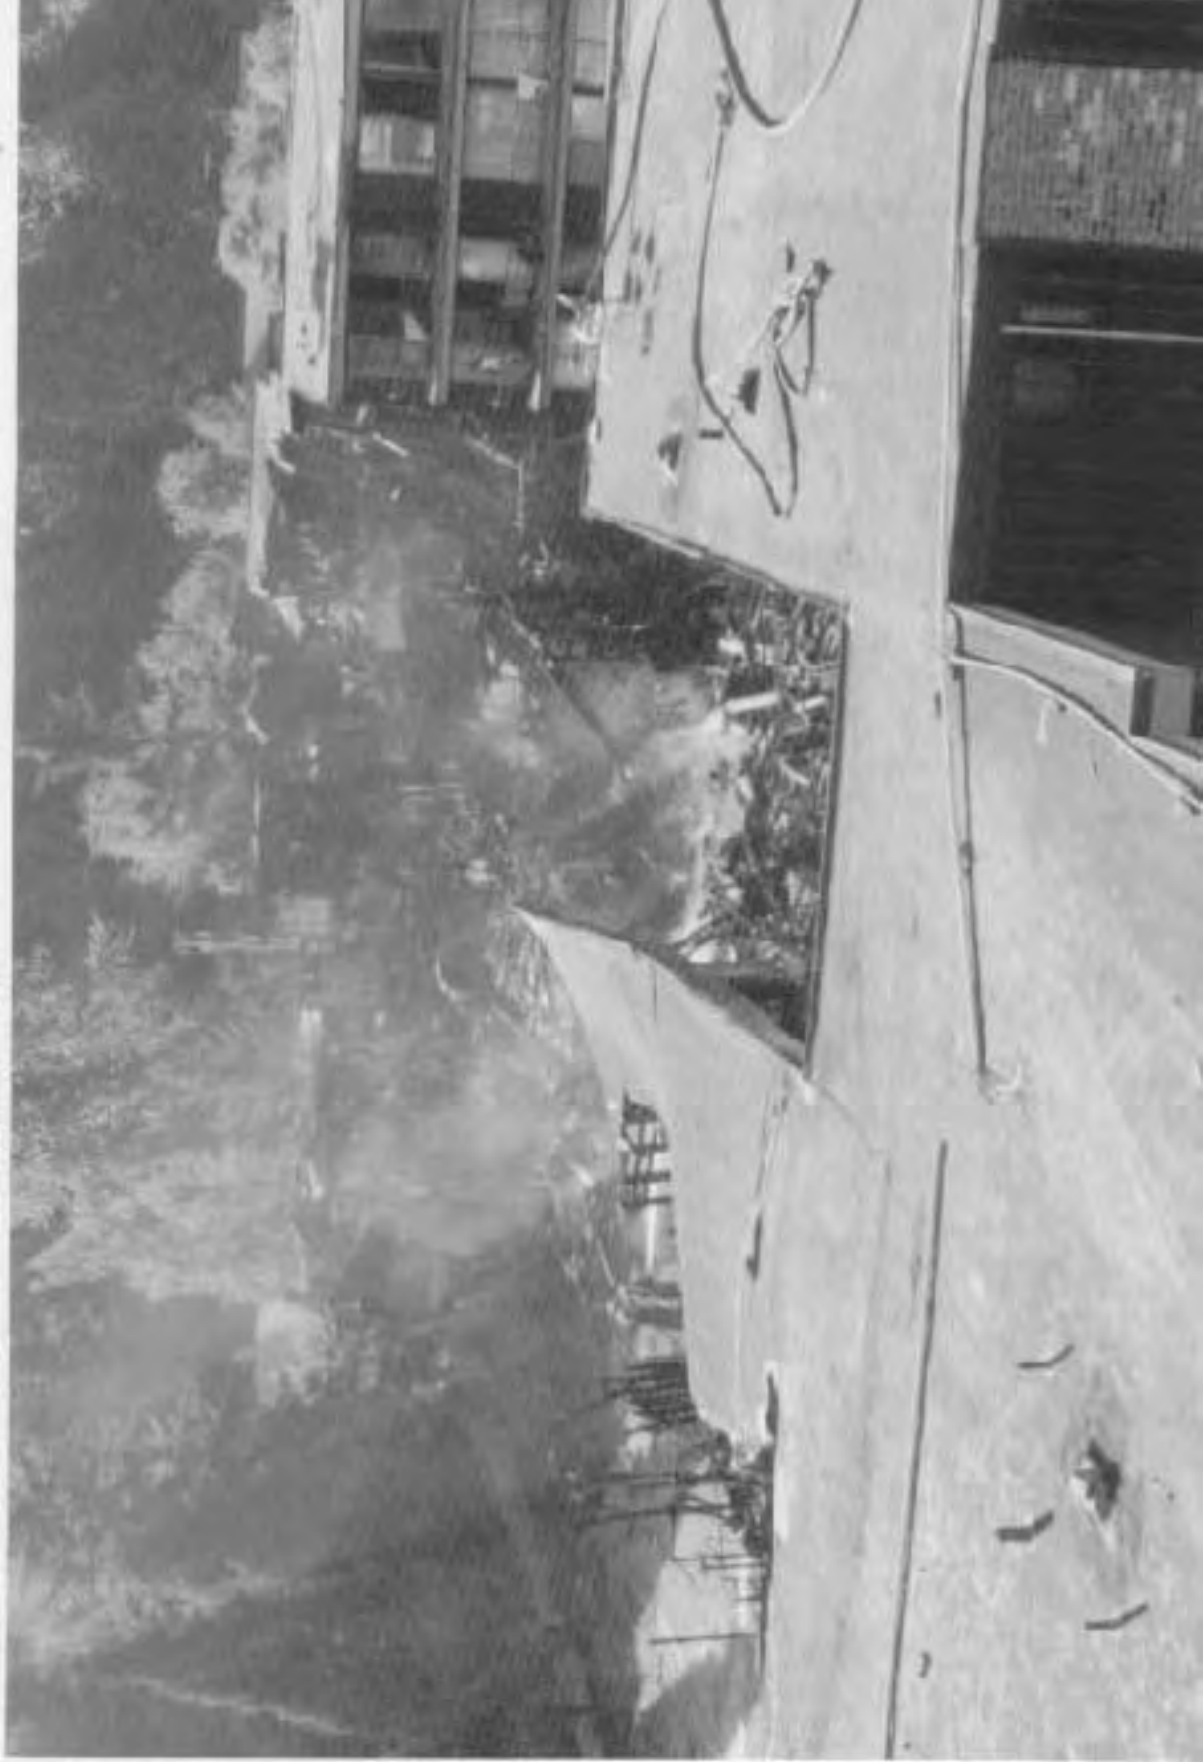
Overview of south wing looking west.

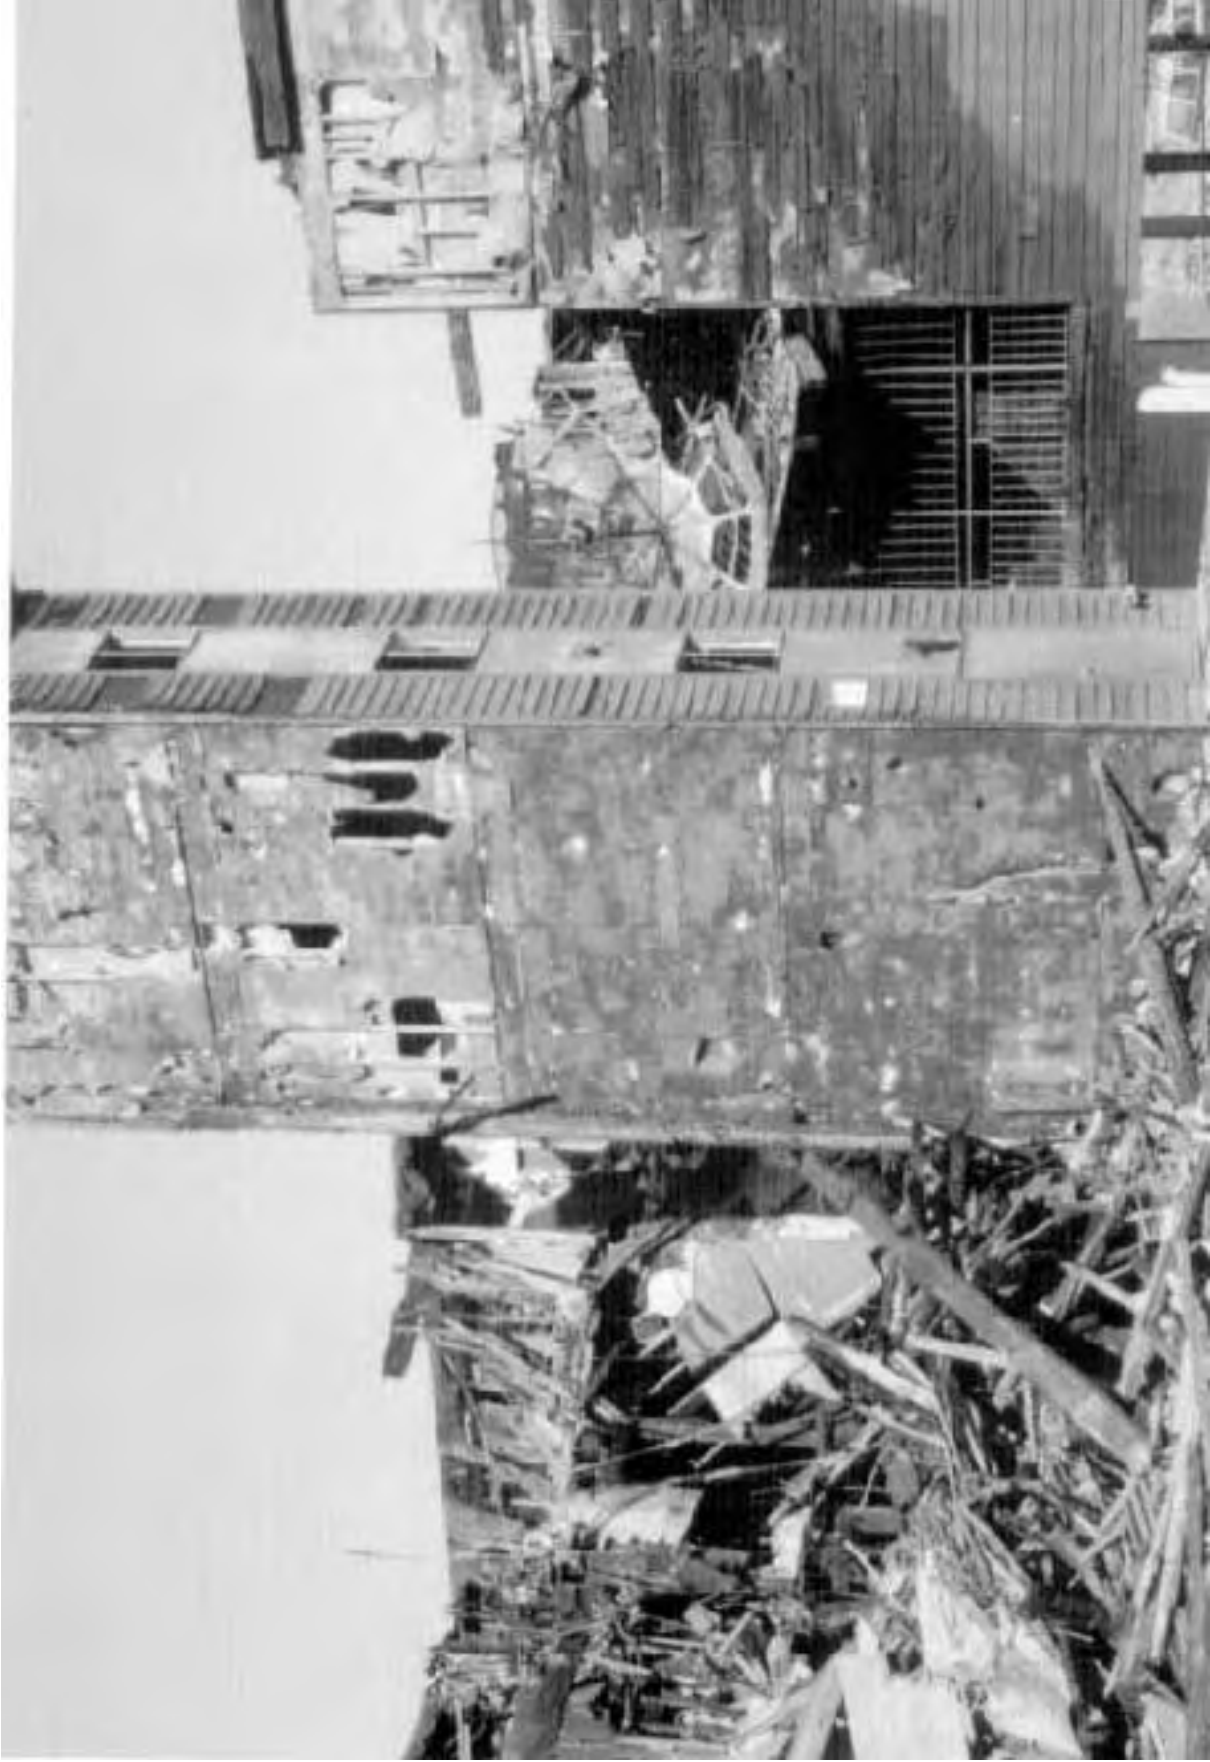
Easterly view showing stairwell enclosure that remained at the east end of the destroyed complex.

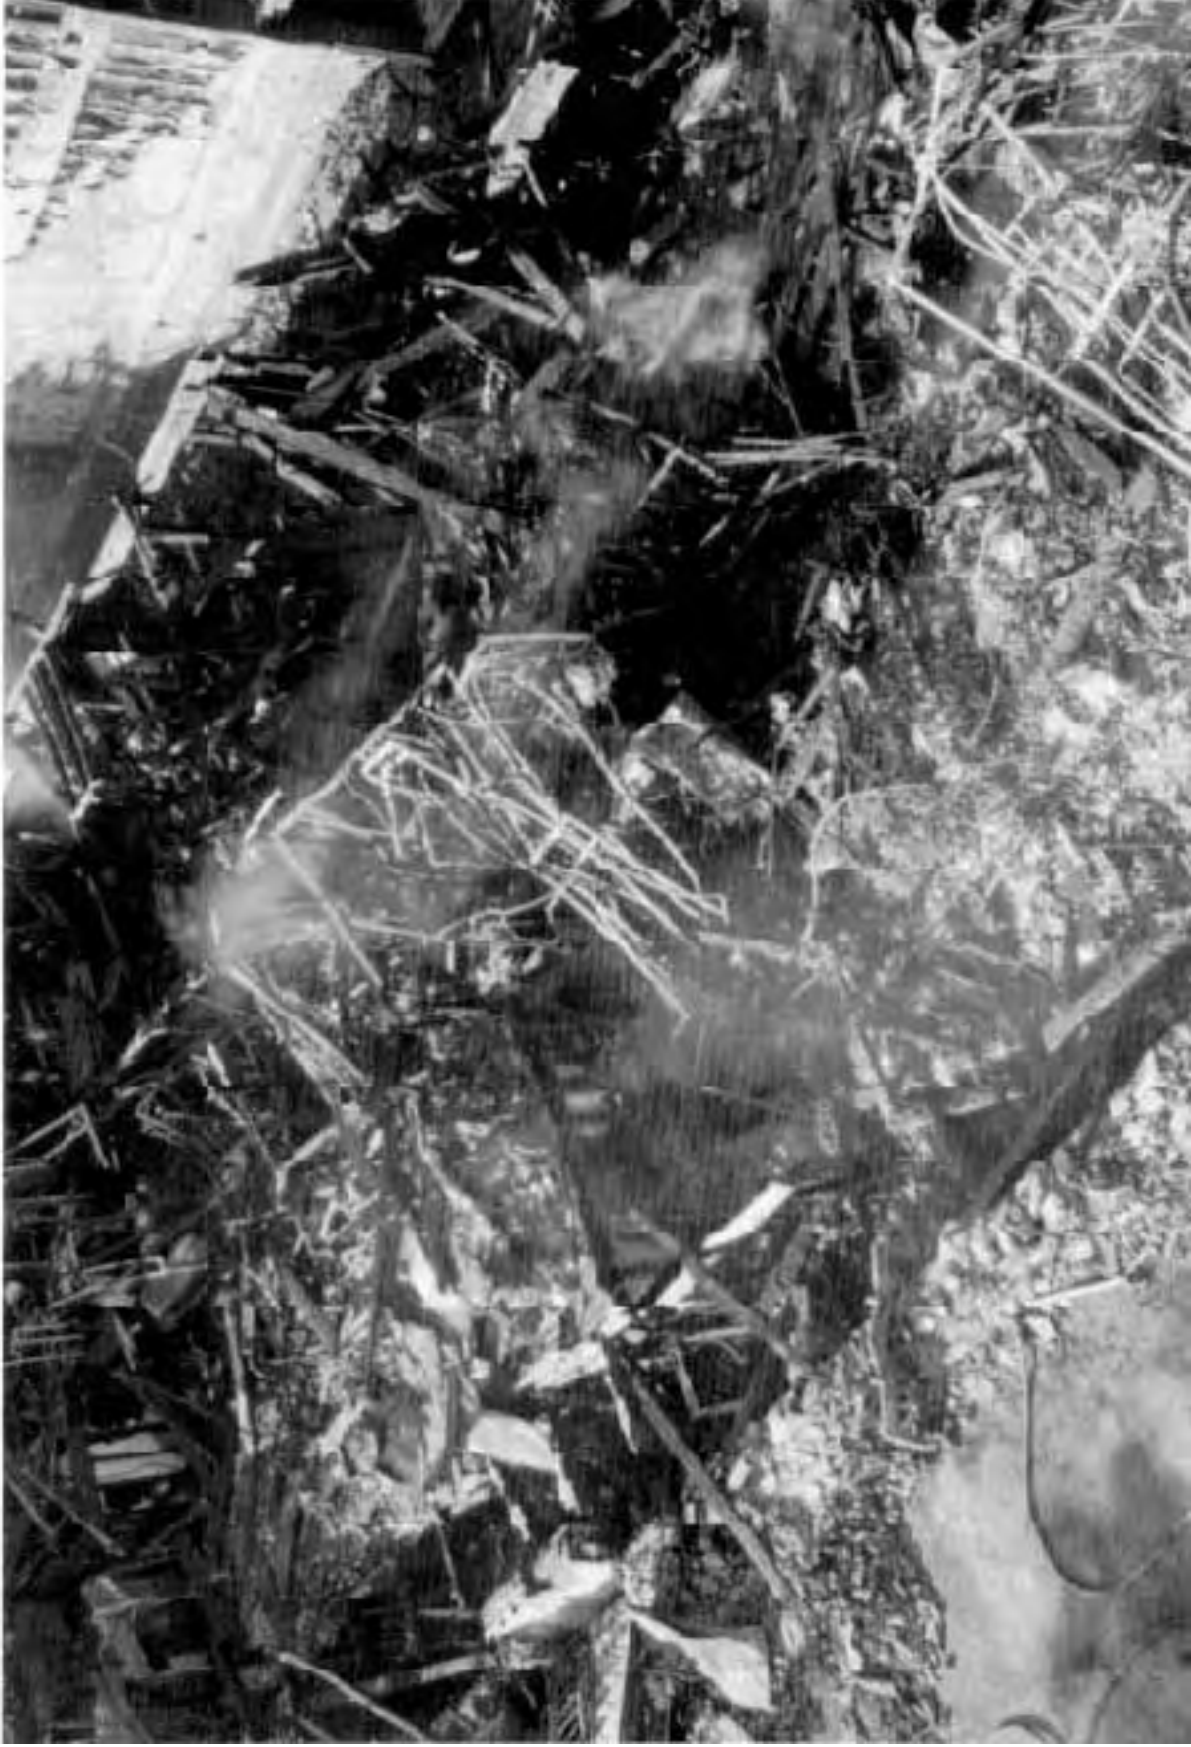
Based on the facts and observations noted in the body of this report, it is the opinion of the investigators that this is an accidental fire. It originated in apartment #115 in the east bedroom. The fire was a result of a tenants attempt to light the room with use of a candle due to disconnected electrical service to the apt. Paper was placed on dwindling candle in an attempt to provide a better light. This flame exceeded it's intended purpose and an attempt was made to blow it out. This attempt resulted in blowing burning paper debris onto the floor and behind the dresser igniting available combustible items.

Aerial view of area of origin (Unit 115).

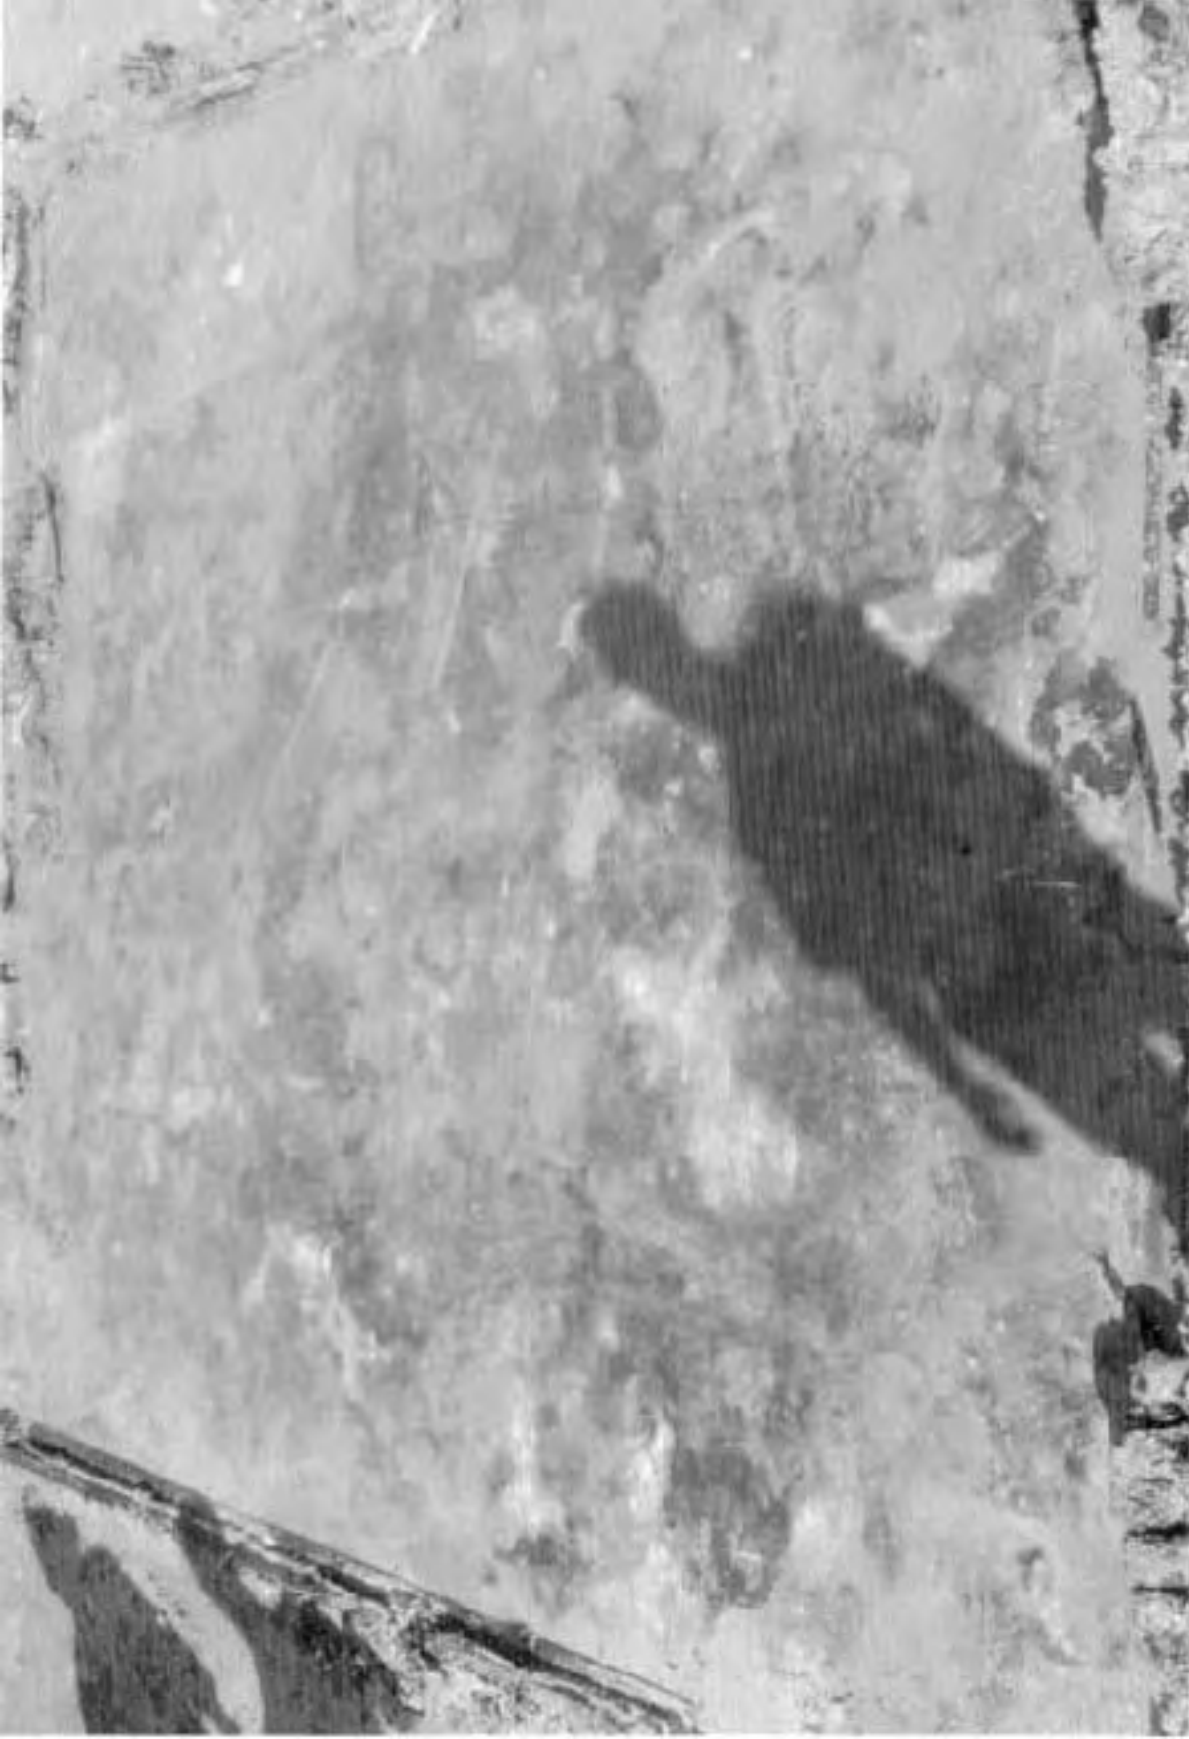
Excavation of the debris of apartment 115 failed to produce any electrical or gas appliances in the area of the master bedroom. A dinner plate was found in the area of the dresser where the occupant indicated the candle had been placed.

Slab of room of origin, southeast bedroom.

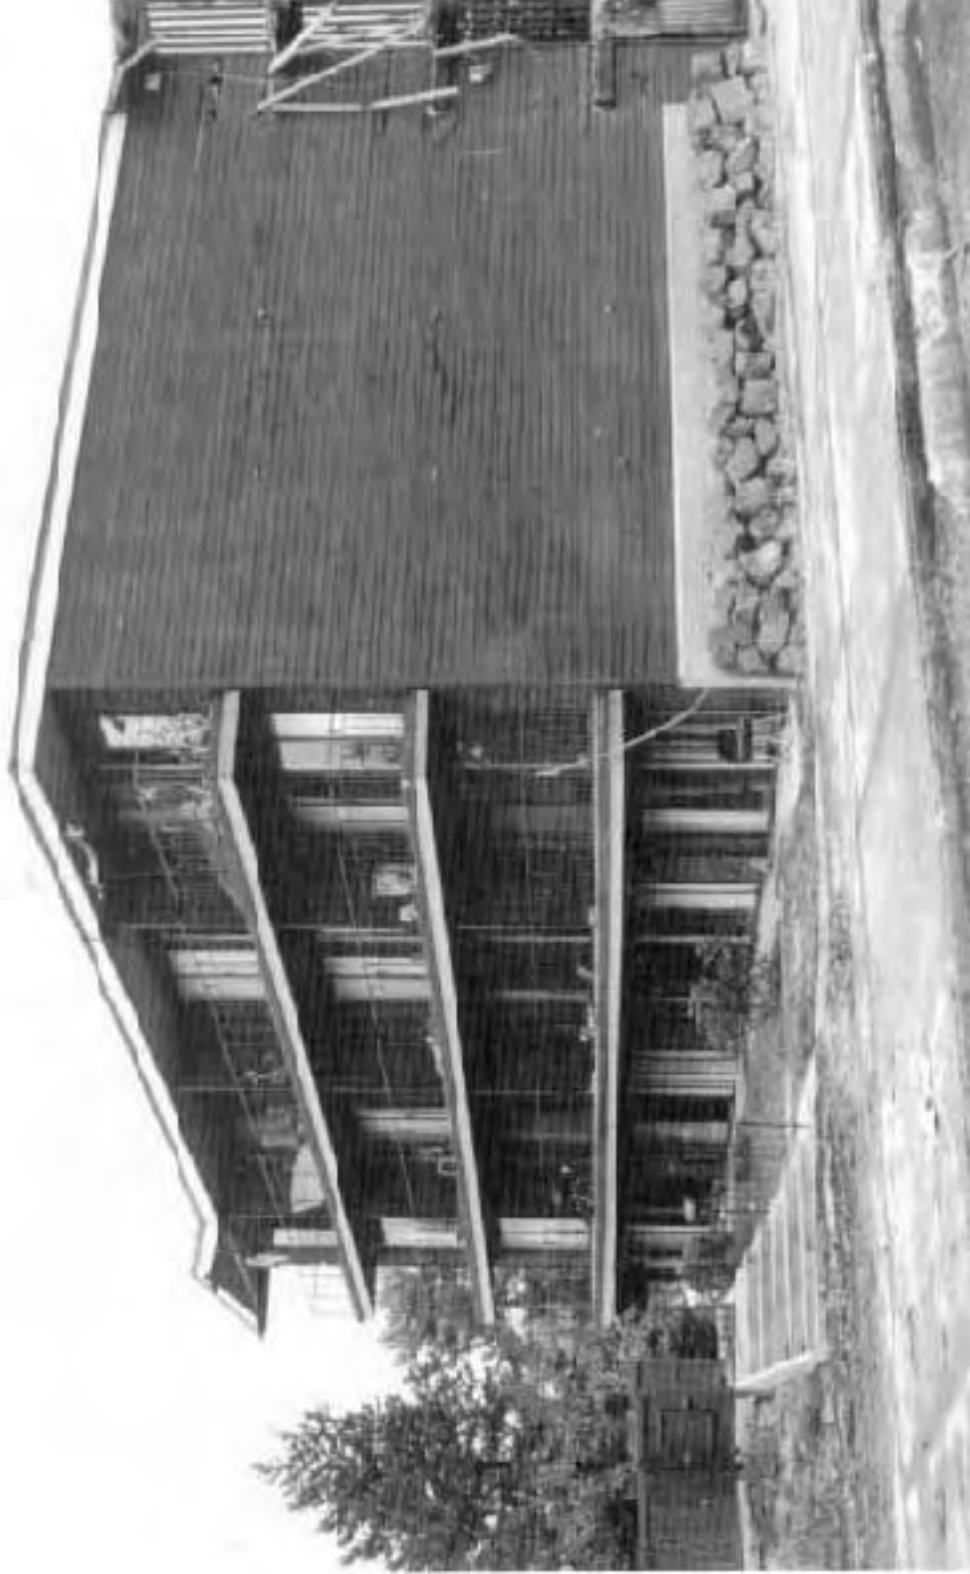
South and west sides of Building E. Note that only a small amount of damage was done to this building, at its southeast corner.

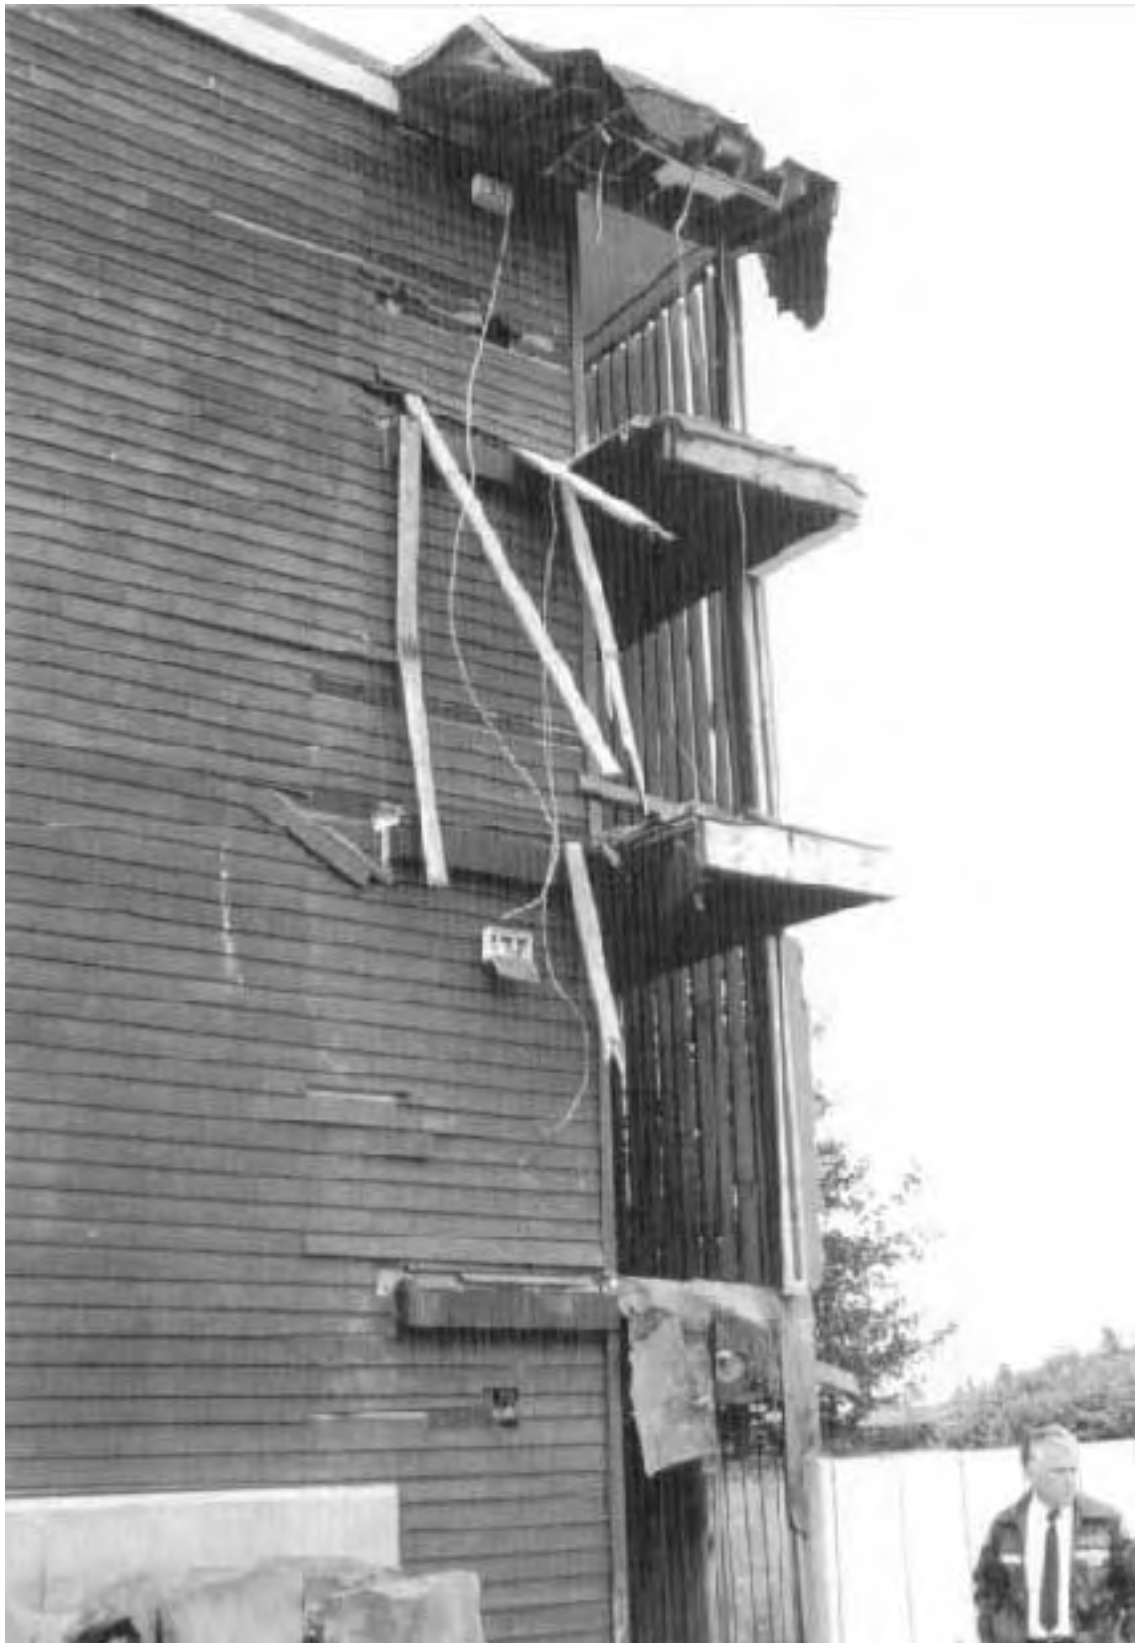
Closer view of damage of southeast corner of Building E. The wooden platforms jutting out on the right were part of the walkway attached to Building D, which was demolished.

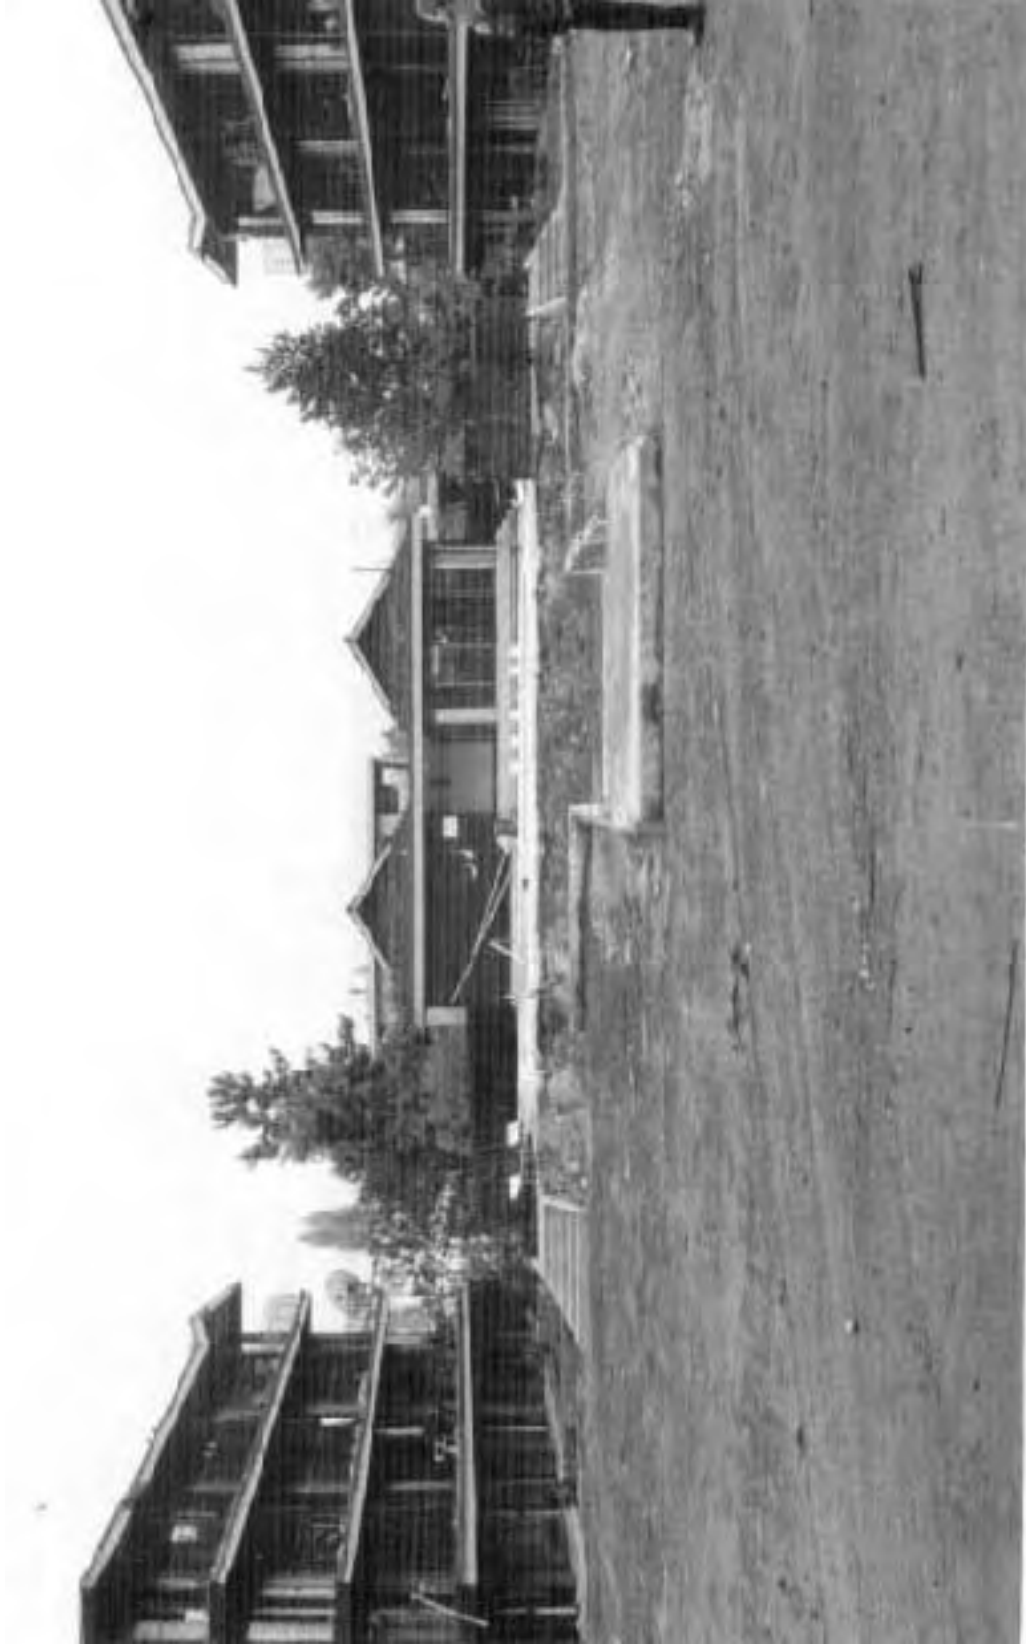
View of complex from south. Building A is on left, Building E on right. The small central building was a pool clubhouse. Buildings B, C and D were demolished and occupied the front (now vacant) space in the bottom third of the photograph.

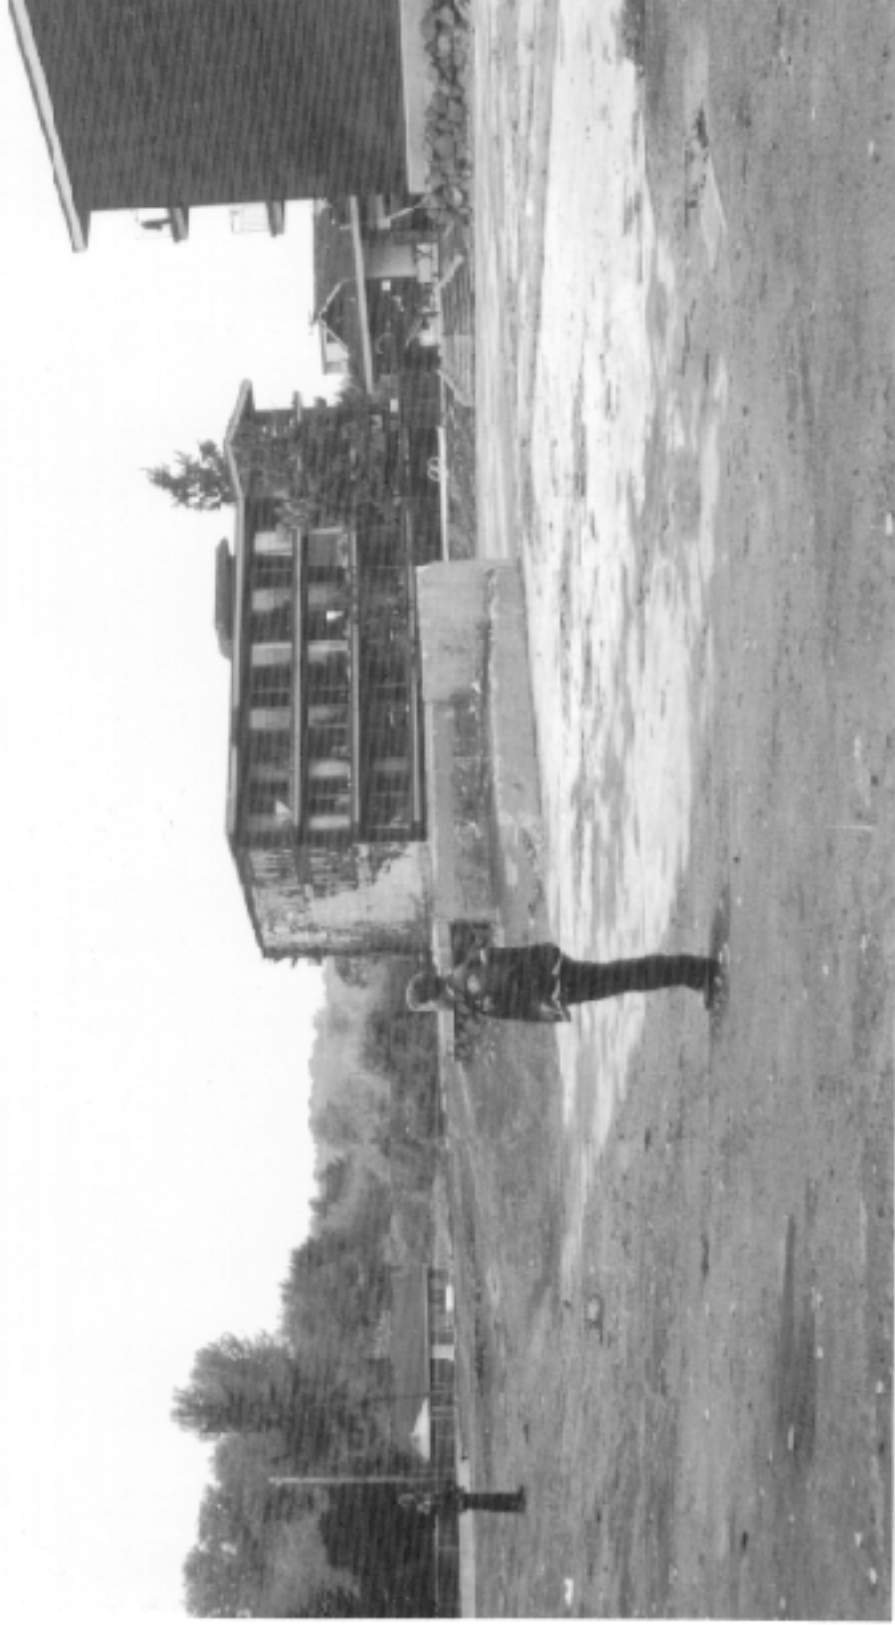
View of complex from southeast corner, looking northwest. The fire officer in the foreground is standing on the building line of what was Building D. The fire officer on the left is standing about where the first line and monitor were put into service by the first arriving engine company.

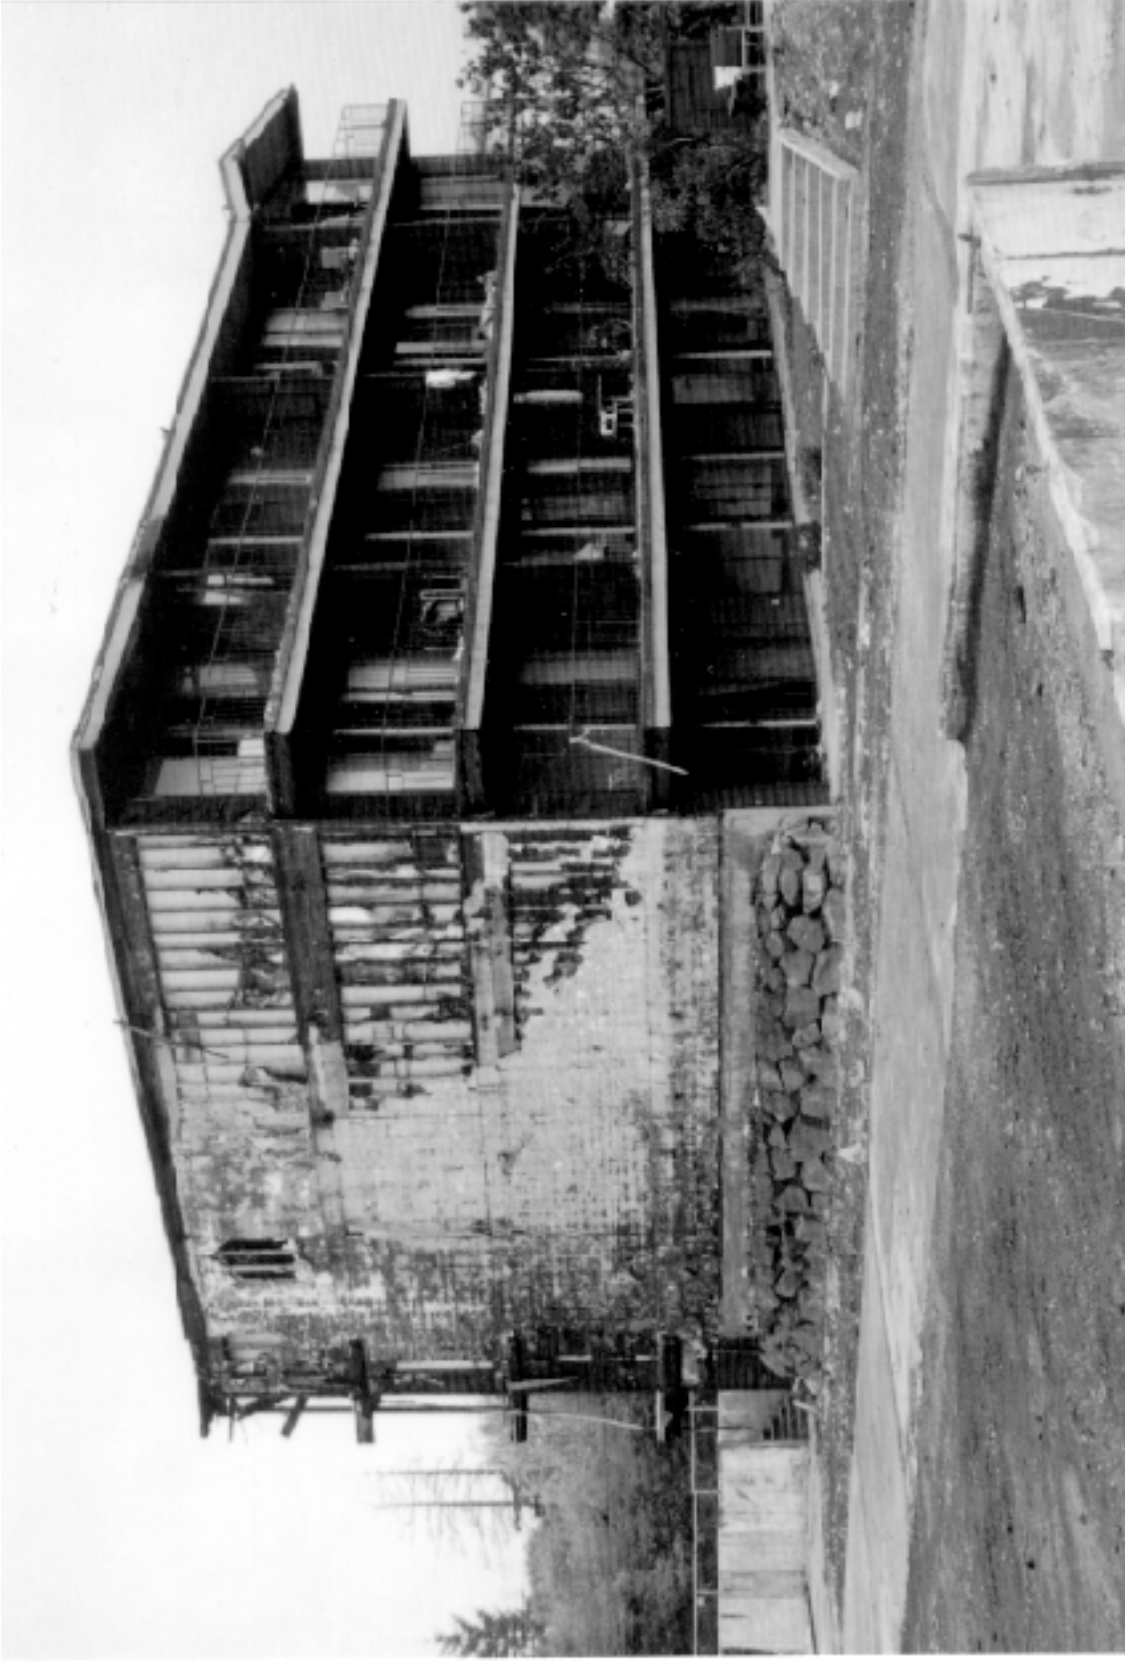
(Photo provided by Philip Schaenman)
South and east sides of Building A. This building was saved by an excellent exposure
defense. Note that it was burning on both its southwest and southeast corners.
