Technical Report Series

Apartment Complex Fire, 66 Units Destroyed Seattle, Washington

**Apartment Complex Fire,
66 Units Destroyed
Seattle, Washington
(September 21, 1991)**

This is Report 059 of the Major Fires Investigation Project conducted by TriData Corporation under contract EMW-90-C-3338 to the United States Fire Administration, Federal Emergency Management Agency.

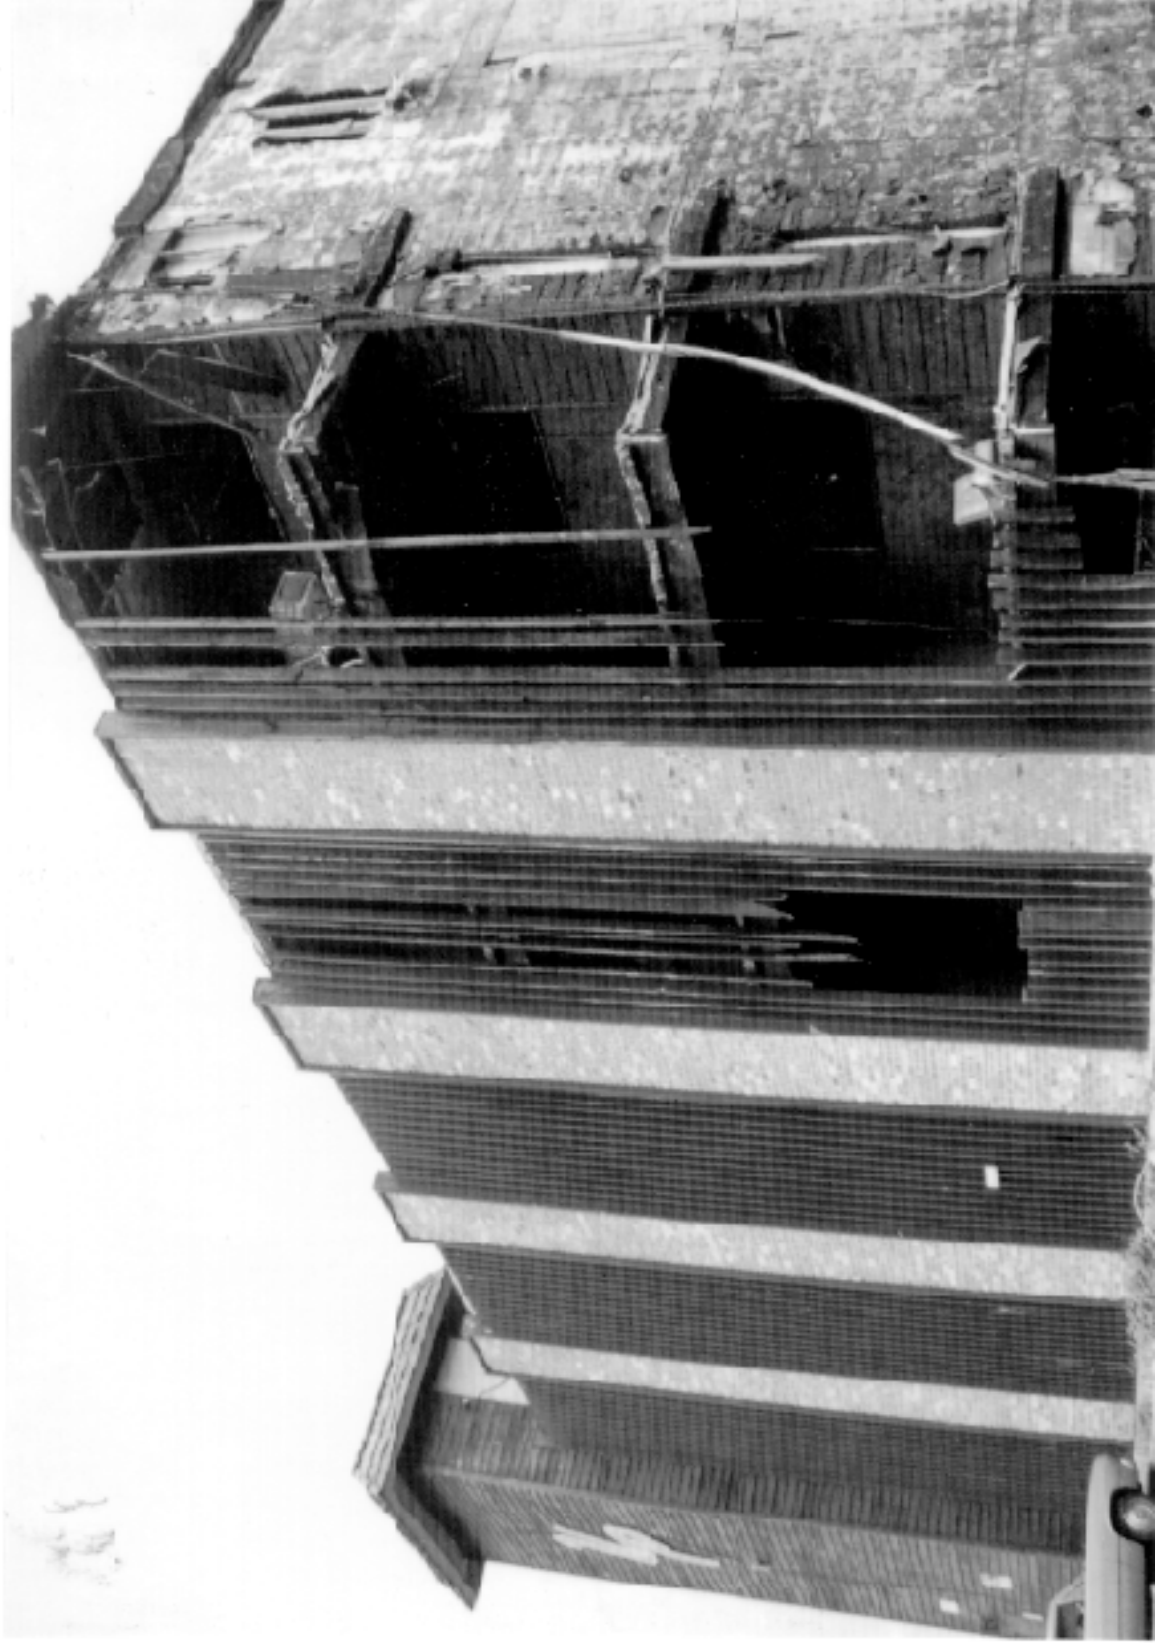
(Photo provided by Philip Schaenman)
Close-up of west facade of Building A; its southwest corner was damaged.

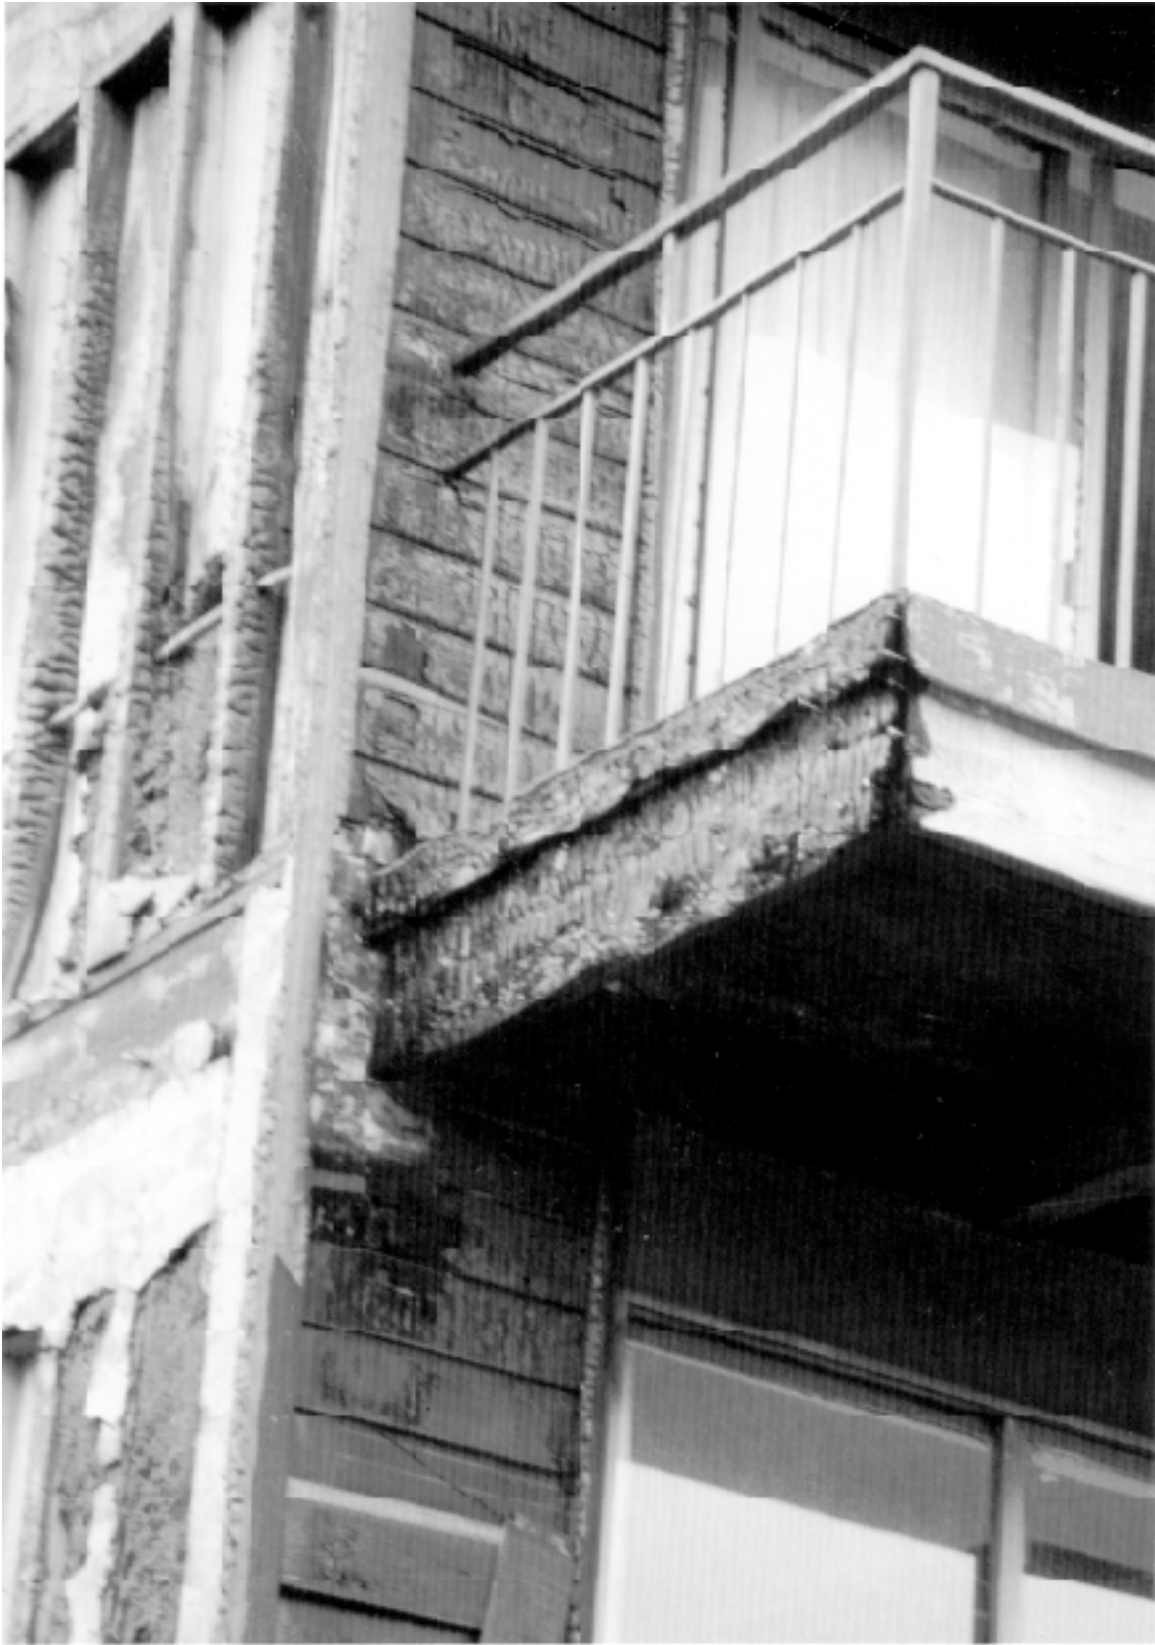
(Photo provided by Philip Schænman)
Detail of southeast corner of Building A.

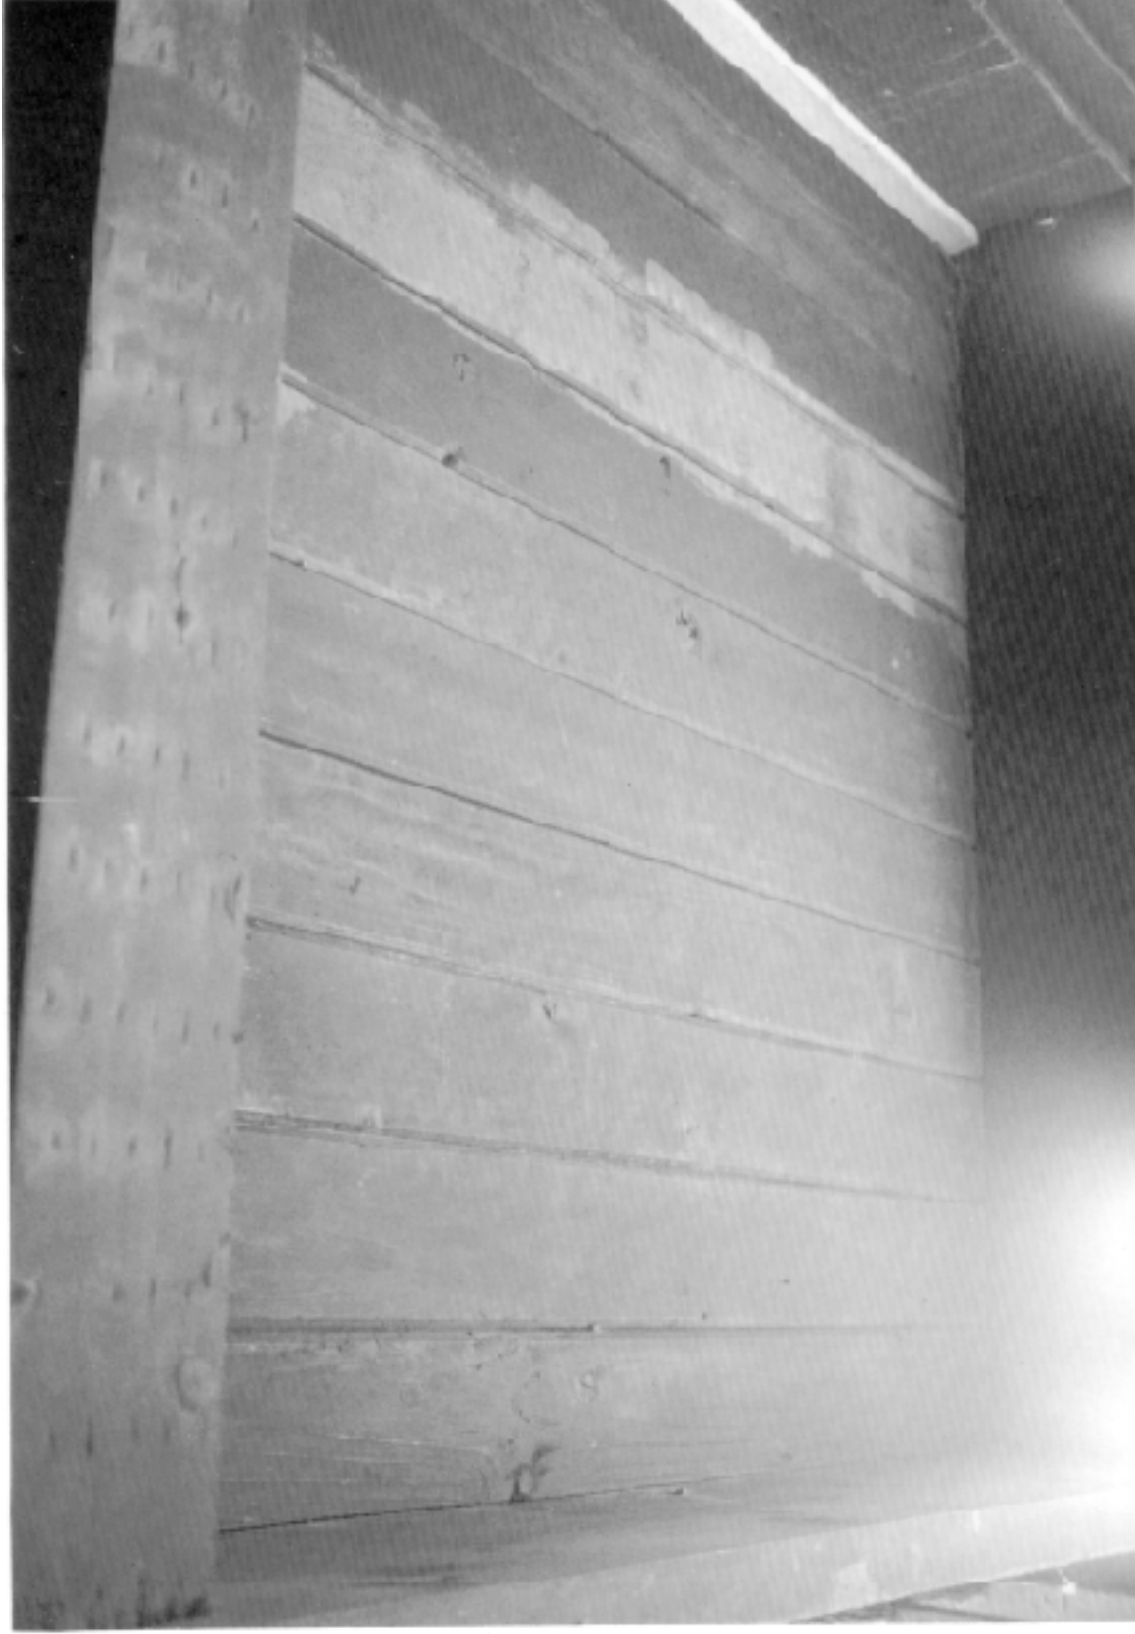
The ceiling of the exterior walkways on Floors 1-3 was an exposed tongue-and-groove cedar surface supported by 4" x 8" cantilevered wood beams. The walkways consisted of concrete covered by outdoor carpet. Fire doors had been retrofitted at intervals along the walkways.

Underside of walkway of basement level of Building E. The underside of all walkways on Floors 1-3 were similar and made of cedar. This was one of the avenues of flame spread.

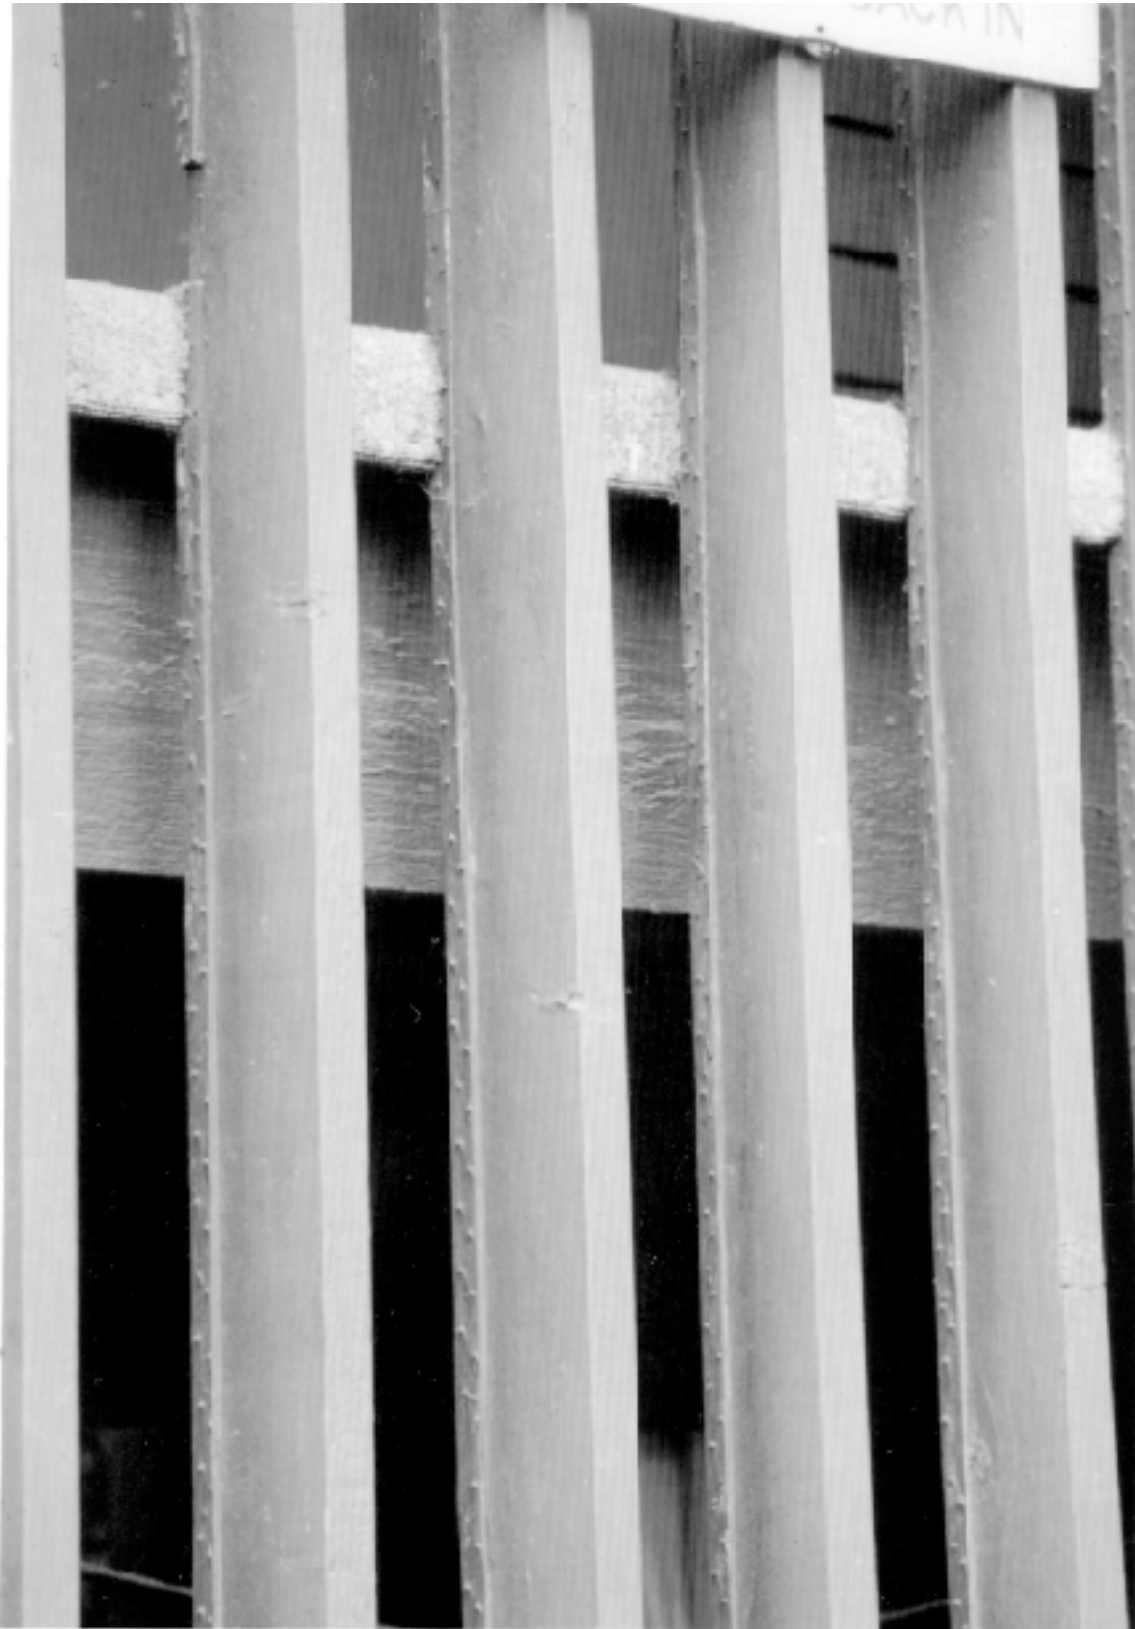
The exterior facades of the walkways on the fronts of the buildings were 4-story high decorative lattices comprised of 2" x 6" vertical cedar boards approximately on 9-inch centers. (The space between the vertical cedar boards was about seven inches.) The lattices had 10-foot widths separated by 5-foot brick fascia. These lattices were both for aesthetics and security. The wood had been covered with oil-based stain. The wood had dried out in the approximately 30 days without rain prior to the fire.

Close-up of the decorative cedar screen on the fronts of the buildings, which served a security purpose as well. Fire could race unimpeded up the wood 2 x 6's. The photograph shows the screen as it passes the outdoor carpeted floor of the walkway above.

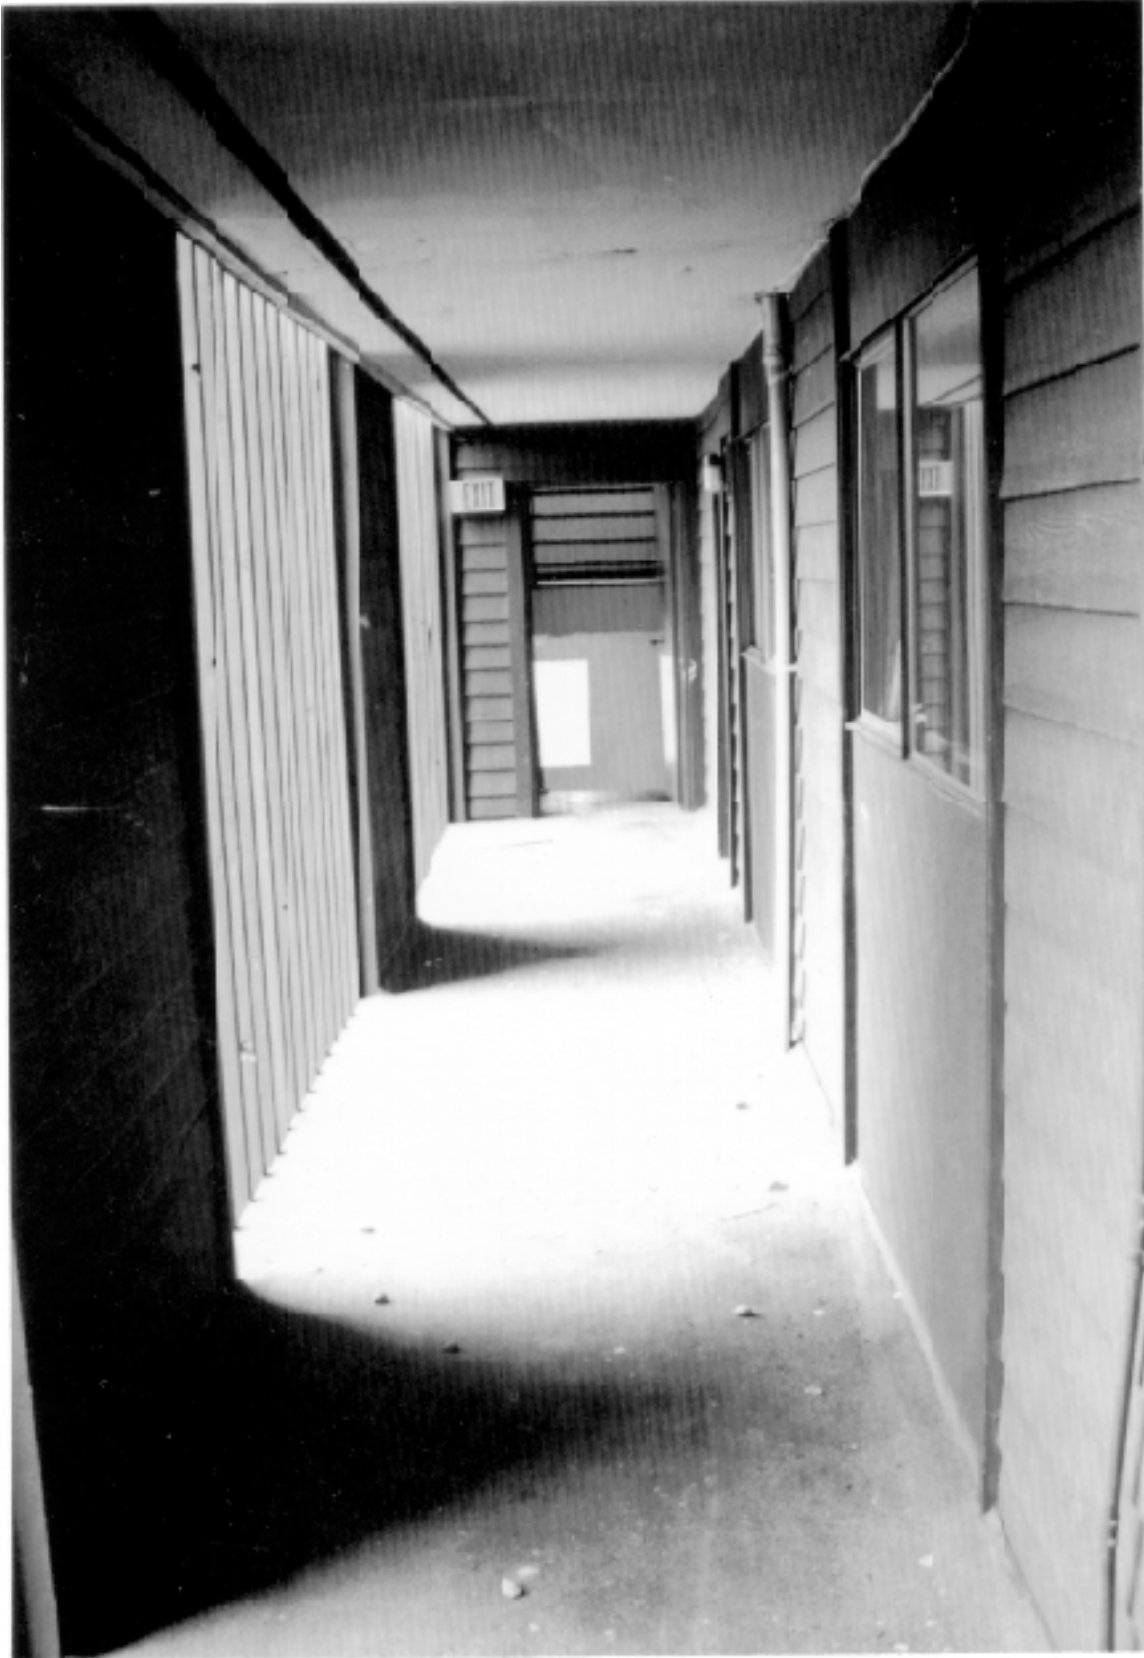
Top (fourth) floor walkway on western exterior of Building A. The ceiling of the fourth level was the only one not of cedar. The window shown is a bedroom window like the one that first blew out in the apartment of origin.

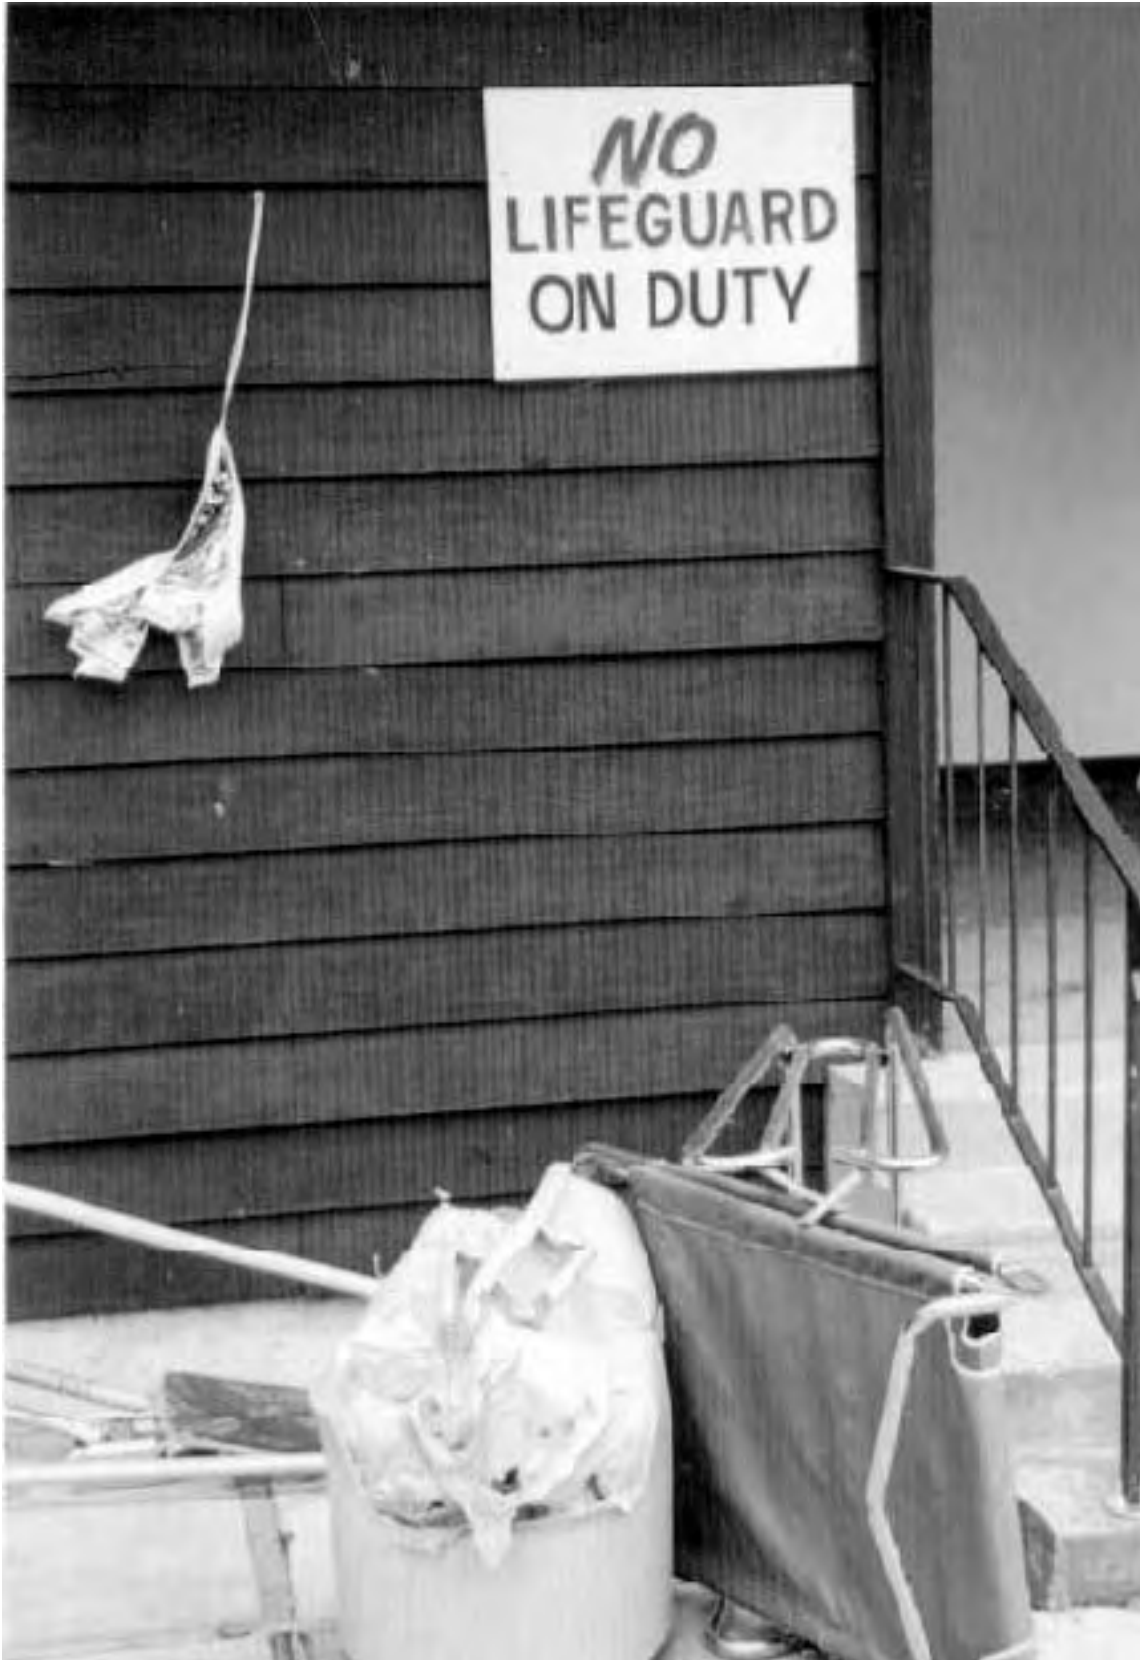
Melted plastic containers behind the swimming pool. Firefighters were operating in this area during the initial stages of the attack.
