## Four Firefighters Killed, Trapped by Floor Collapse Brackenridge, Pennsylvania

**Four Firefighters Killed,  
Trapped by Floor Collapse  
Brackenridge, Pennsylvania  
(December 20, 1991)**

**Investigated by: J. Gordon Routley**

This is Report 061 of the Major Fires Investigation Project conducted by TriData Corporation under contract EMW-90-C-3338 to the United States Fire Administration, Federal Emergency Management Agency.

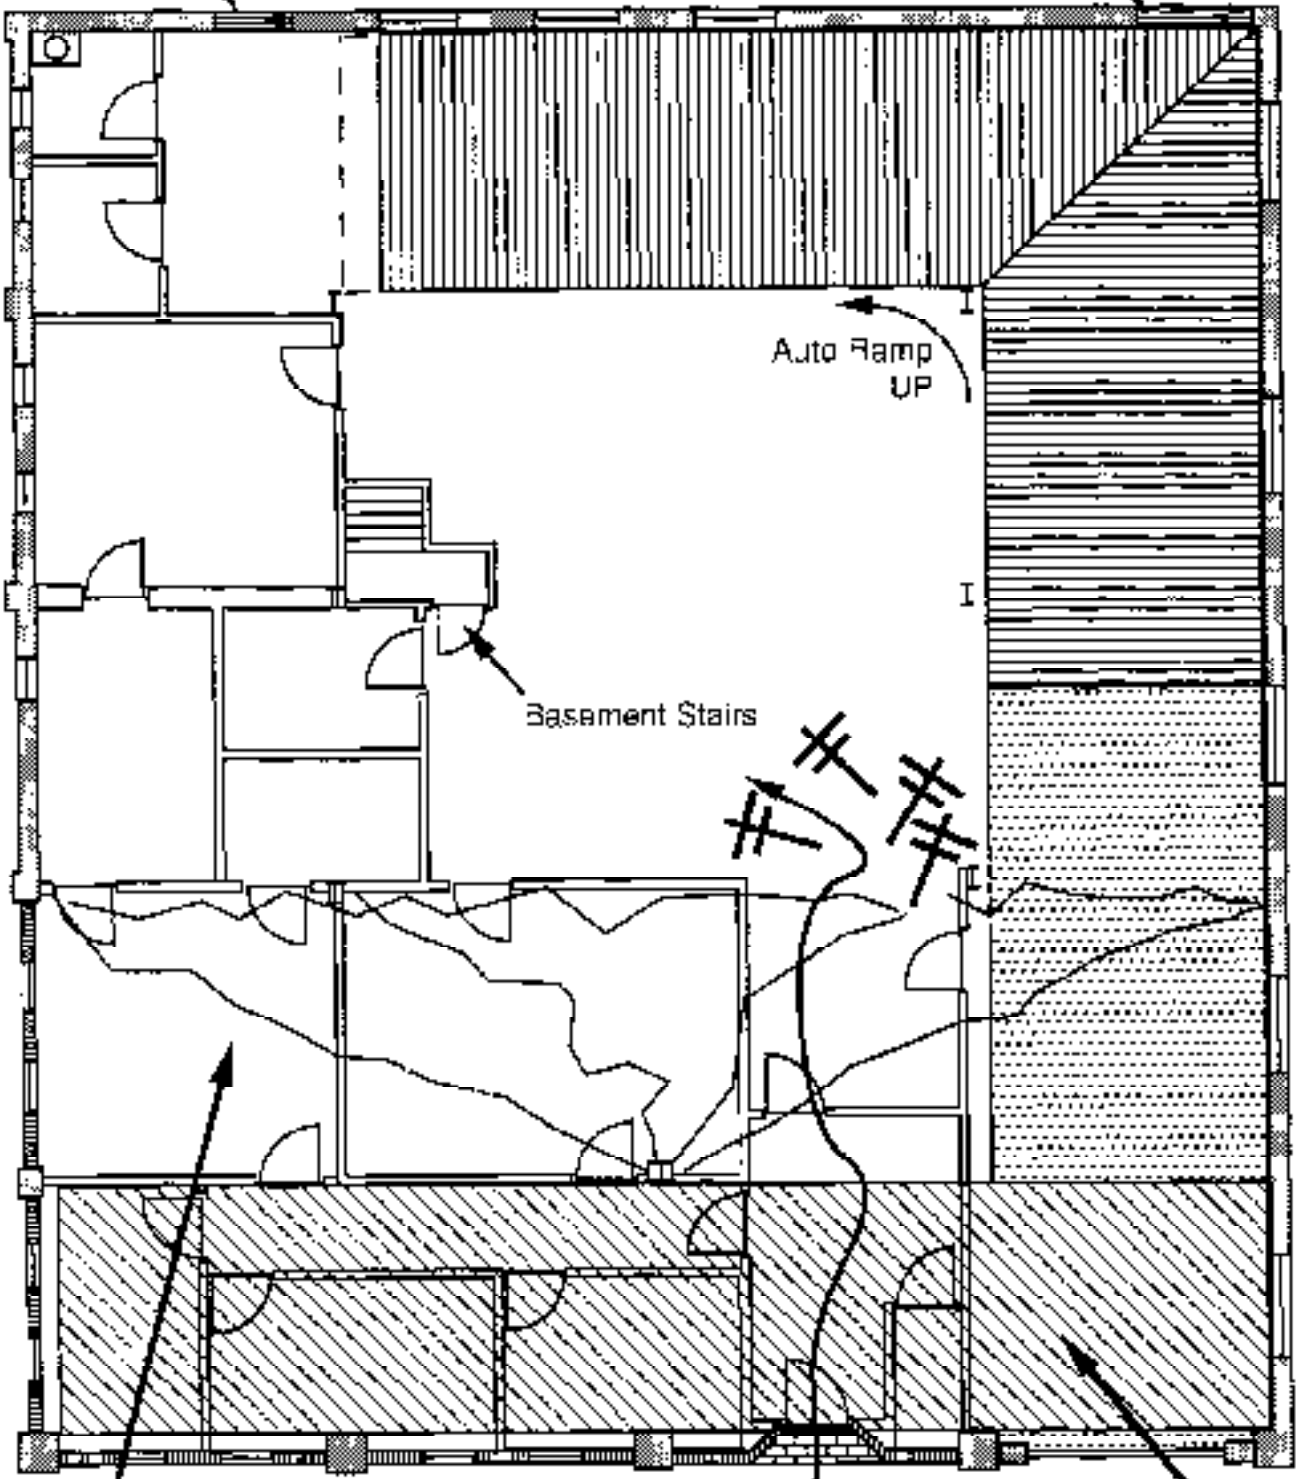
SECONDARY  
COLLAPSE AREA

PRIMARY  
COLLAPSE AREA

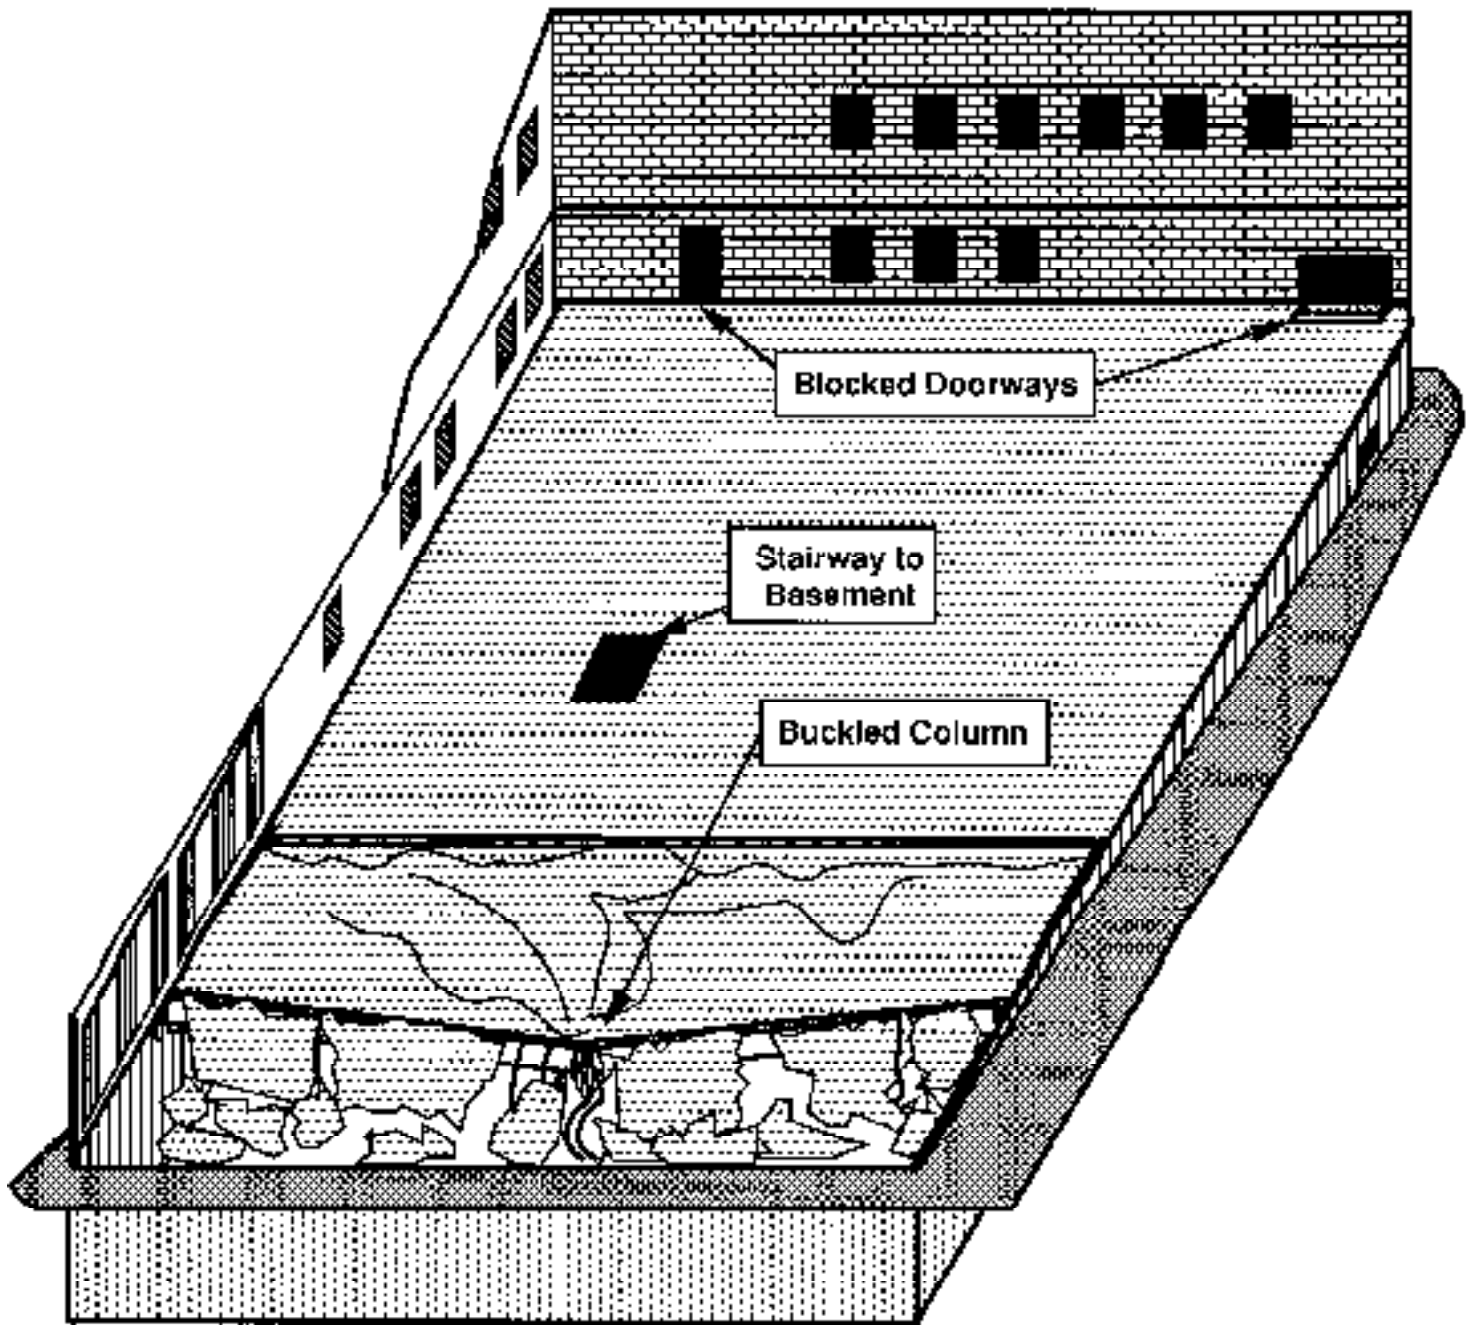
**CUT-AWAY VIEW**  
Showing Floor Collapse

The primary structural collapse was caused by the failure of the steel joists supporting the floor slab above the finishing room. All of the joists between the front wall and the first set of support beams failed and dropped the concrete slab into the basement. Examination of the joists found in the rubble indicates that all were severely warped and twisted from heat exposure. The slab broke near the mid-point of the span and some sections were left hanging vertically from the beams. This created an

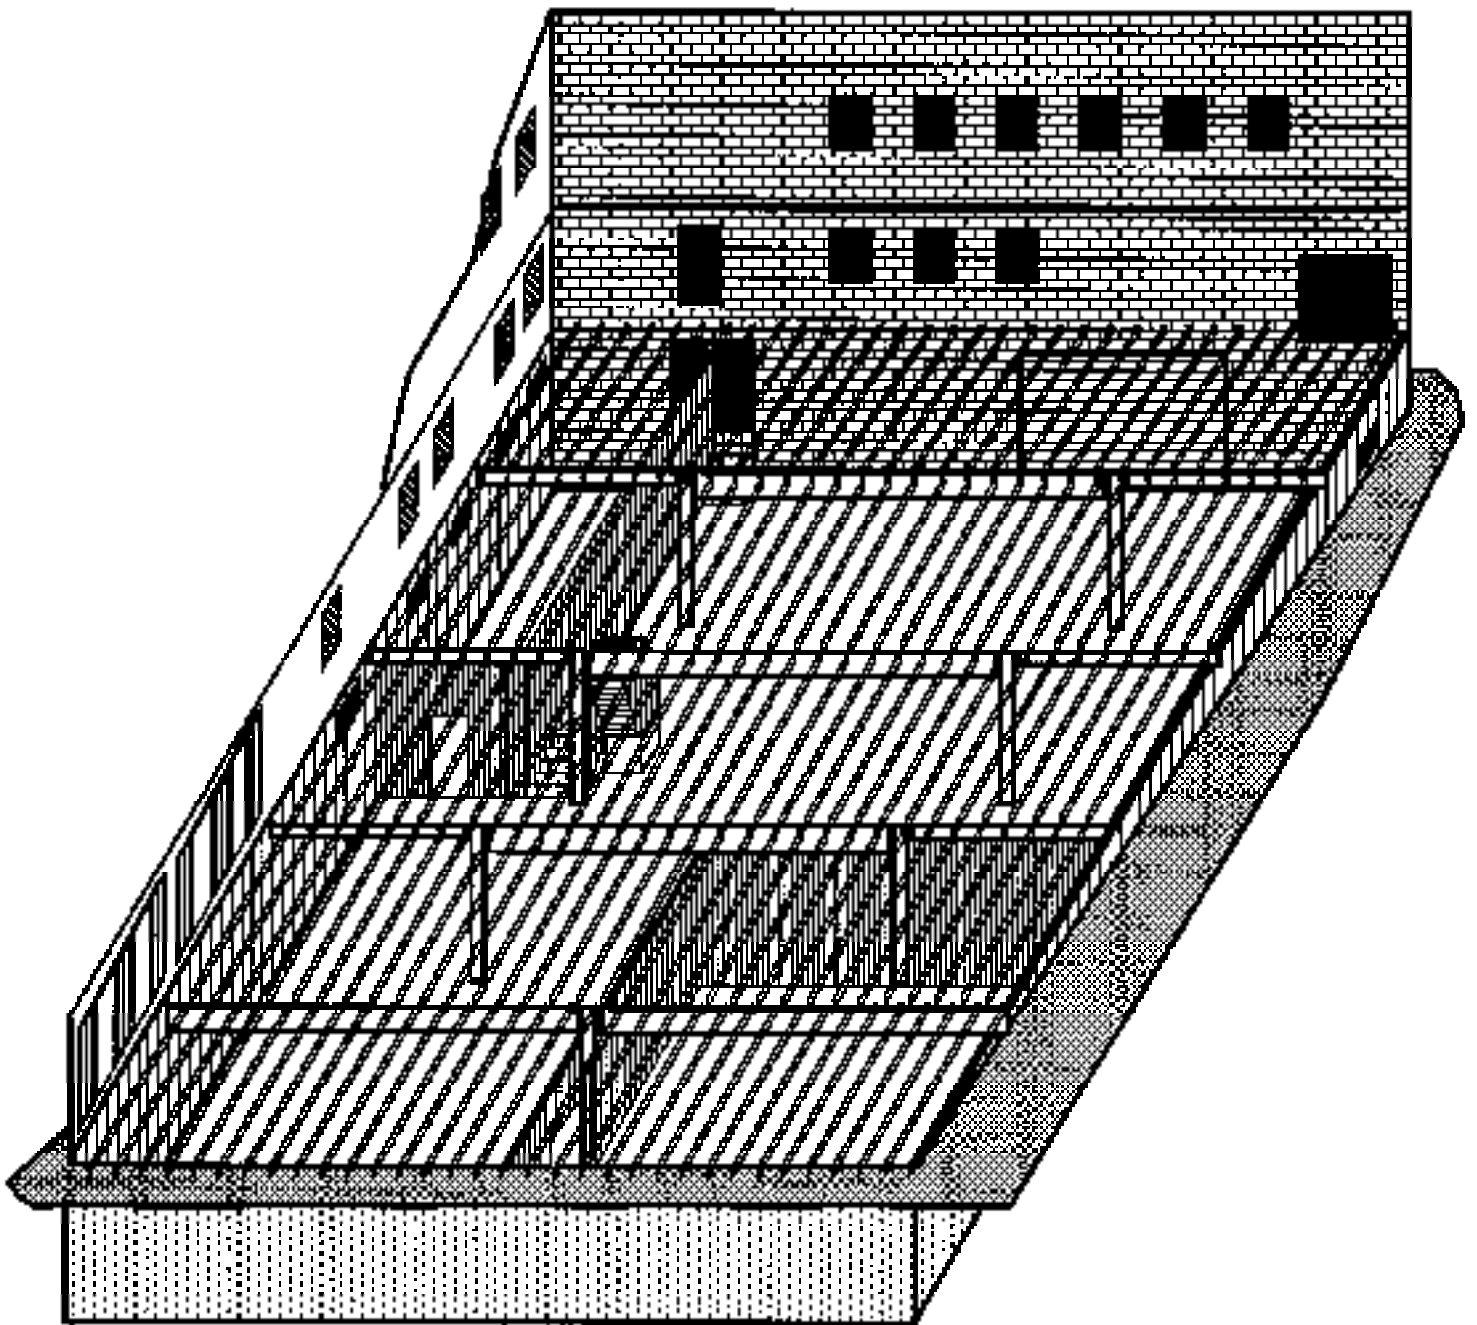
**CUT-AWAY VIEW**  
**Showing Ground Floor Joists**

The mass determines the time it will take for a member to be heated to its failure temperature when exposed to a fire. Light gauge members, such as the floor joists in this building, may be vulnerable to collapse with as little as three to five minutes of direct exposure to a fire, while heavier members may take 10 to 20 minutes to reach their failure temperature. Very heavy steel members may survive extended exposure to a fire environment.

The individual joists were probably heated to the point of failure well before the collapse occurred; probably before the Fire Department arrived. They did not collapse immediately, because they were supported by the rigidity of the combined joist and slab assembly and the manner of support at the basement wall.

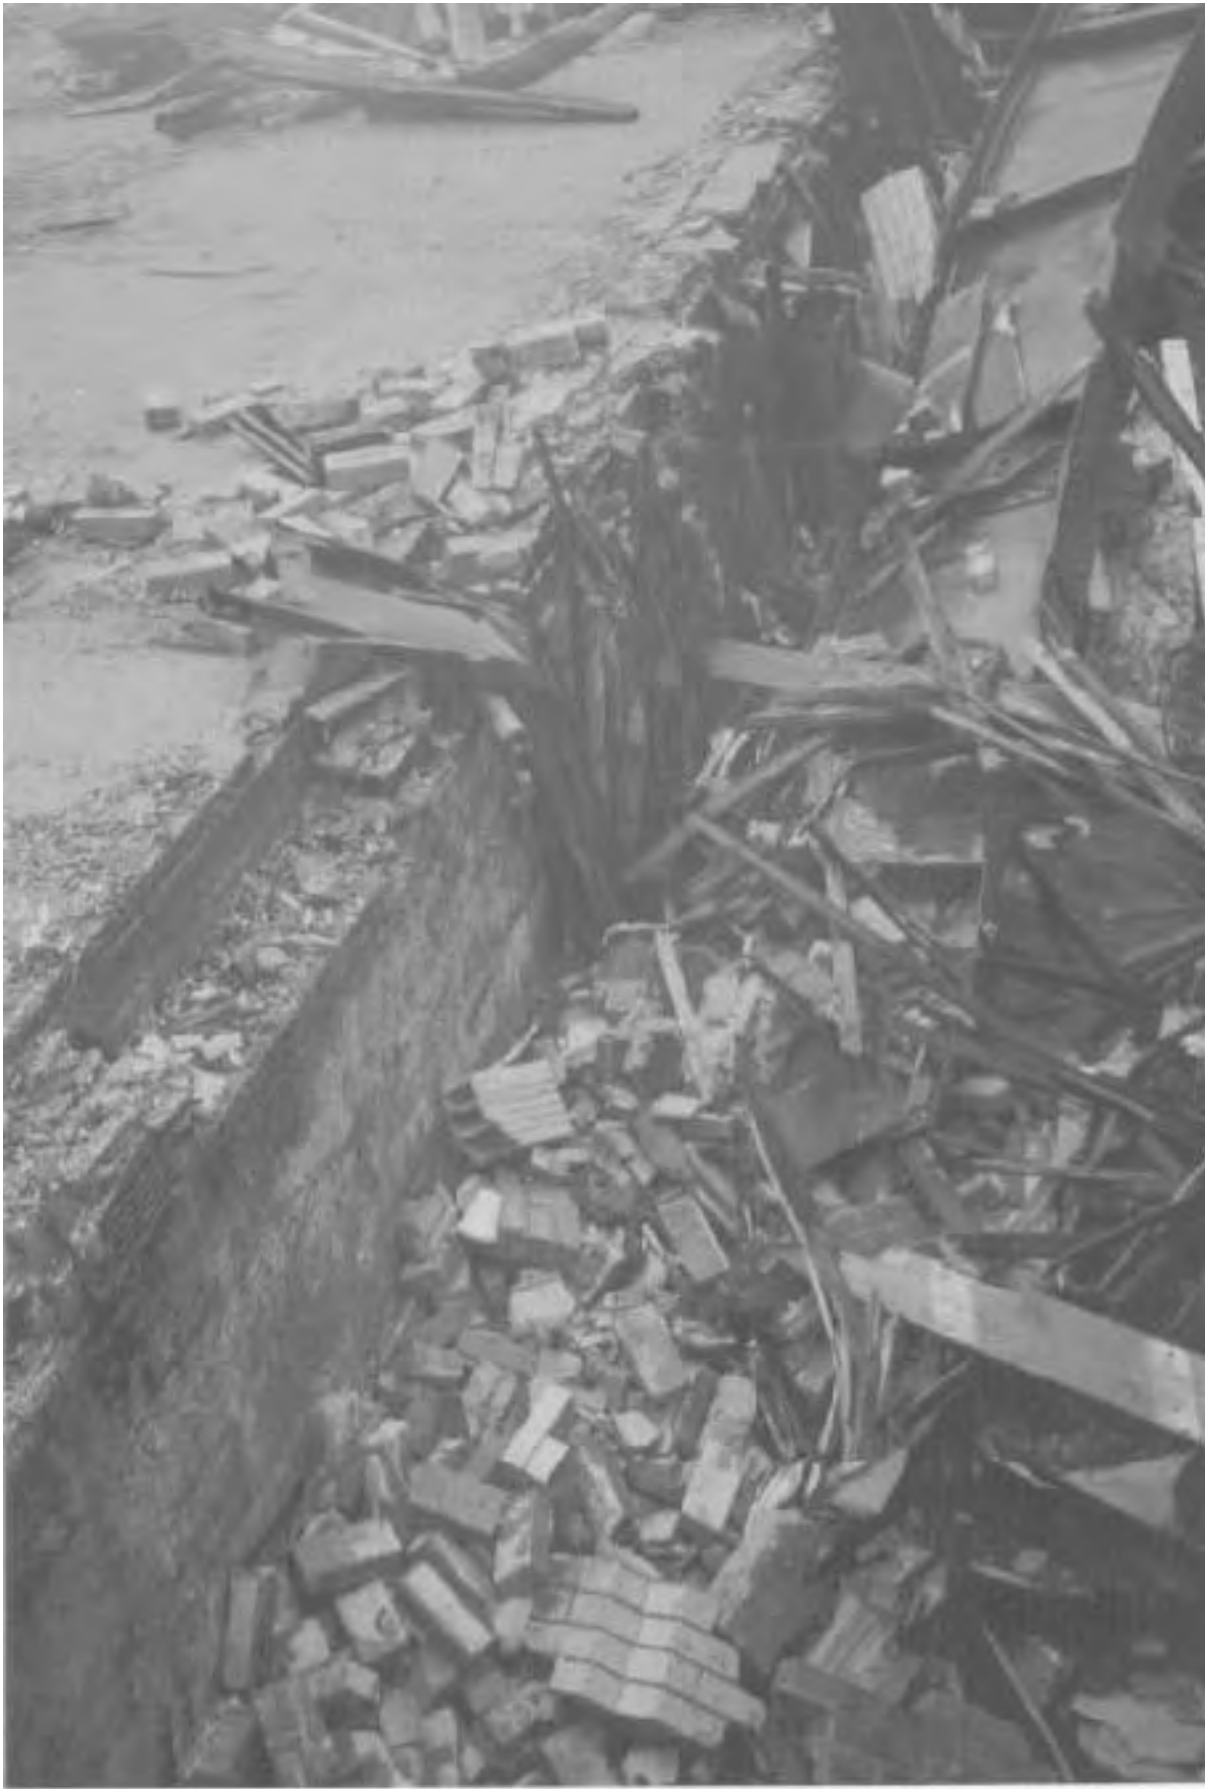
Looking toward Brackenridge Ave. from ground floor, near location where bodies were found. Debris in foreground is from first and second floors and from roof structure. Bent-over ends of floor joists are visible at the point of attachment to the basement wall.

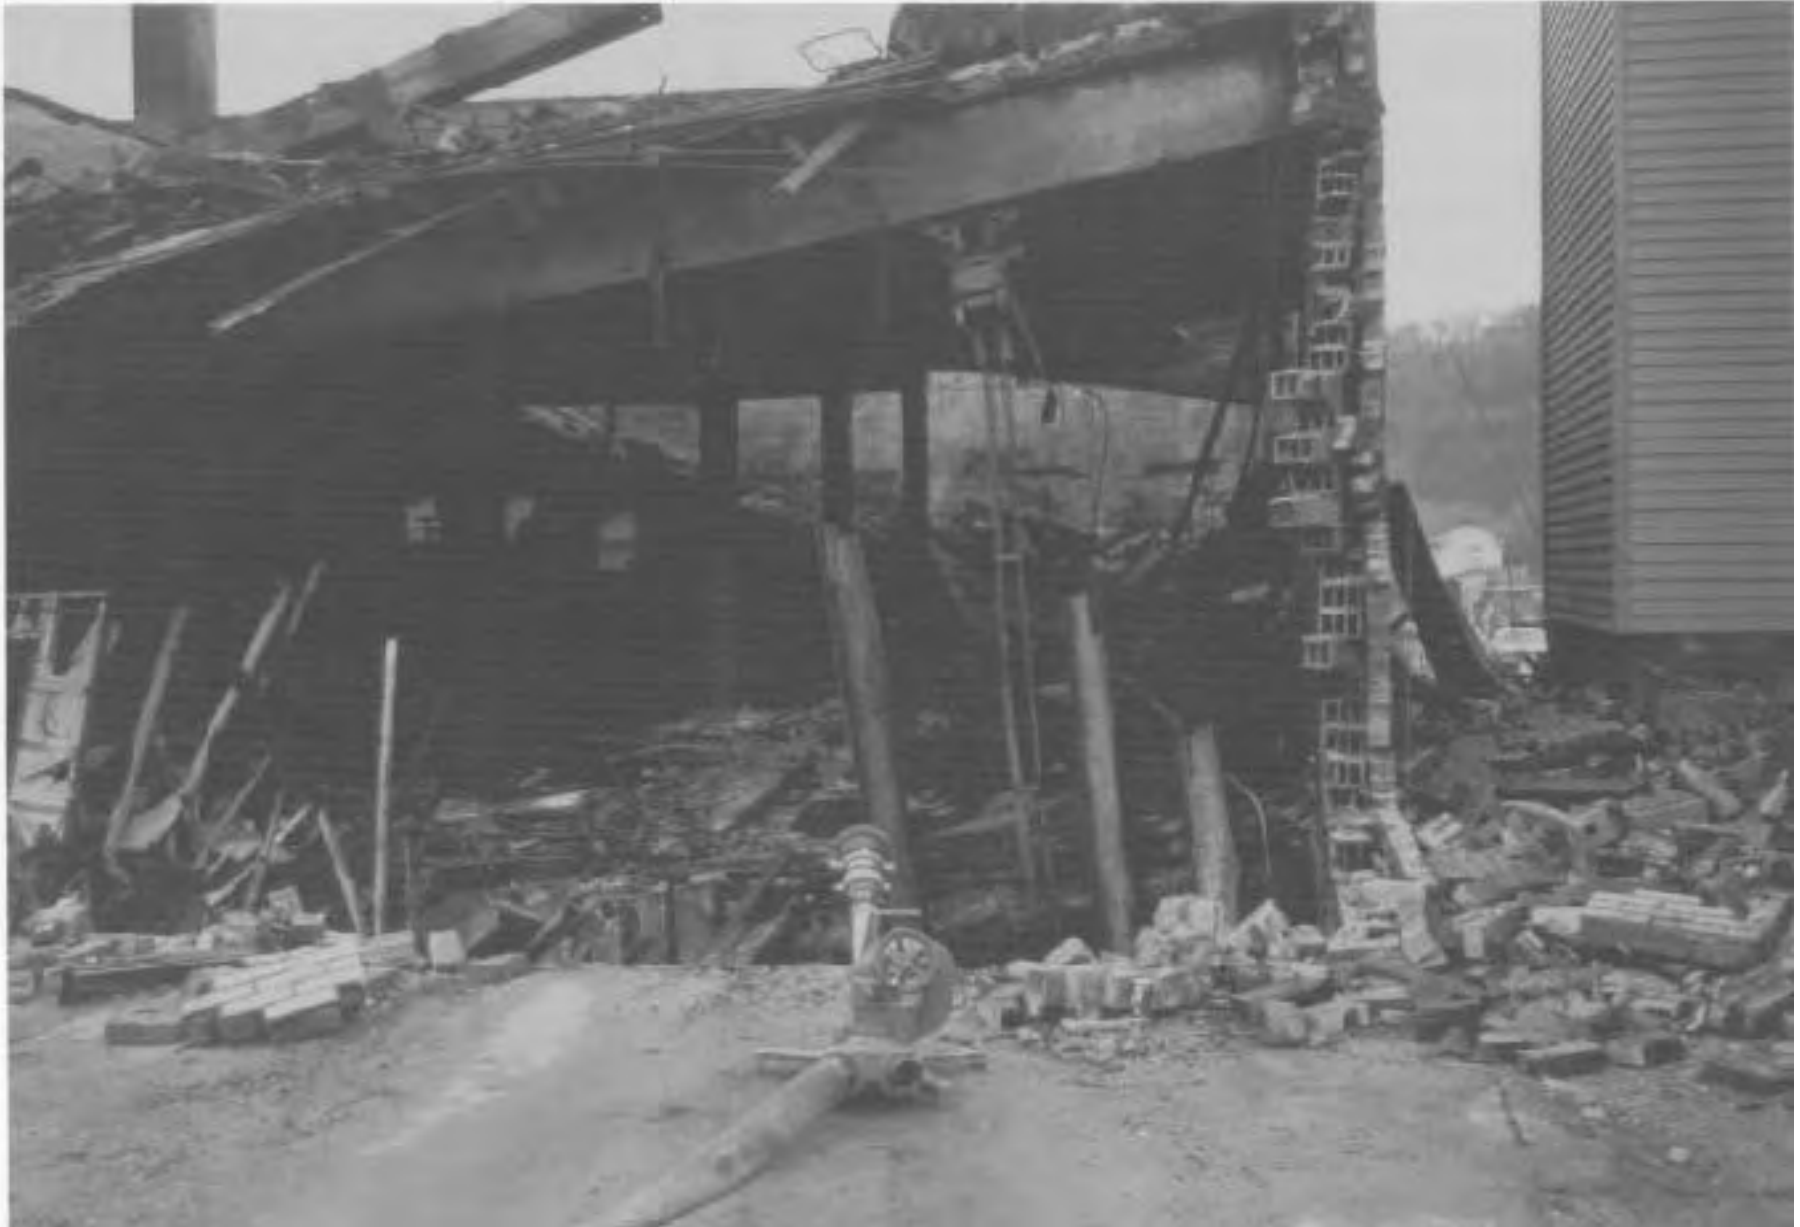
Point of rigid support for floor joists at front of building. Floor joists rested on concrete basement wall and were held in place by brickwork. (Steel girder is from roof structure.)

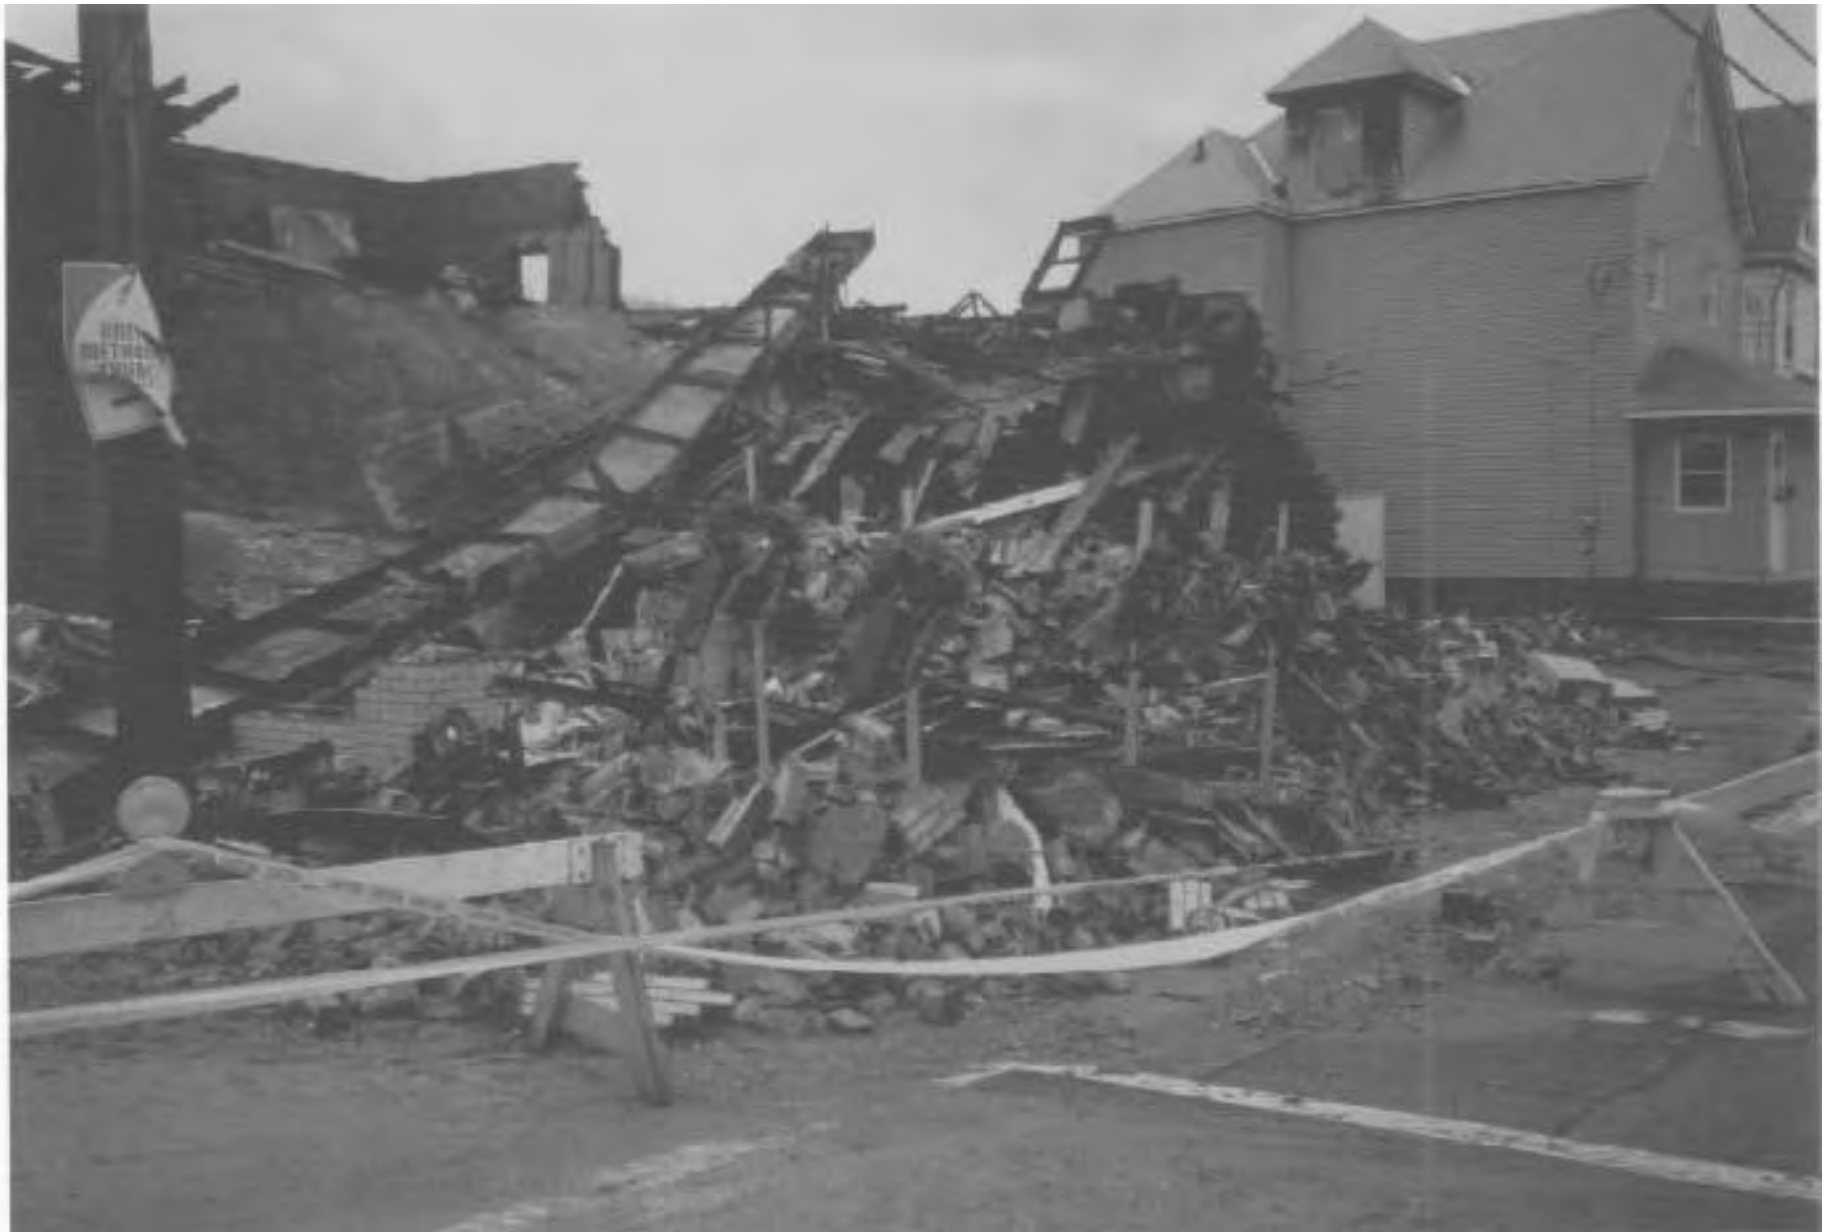
Ground floor area, showing unprotected steel column and ramp to second floor.

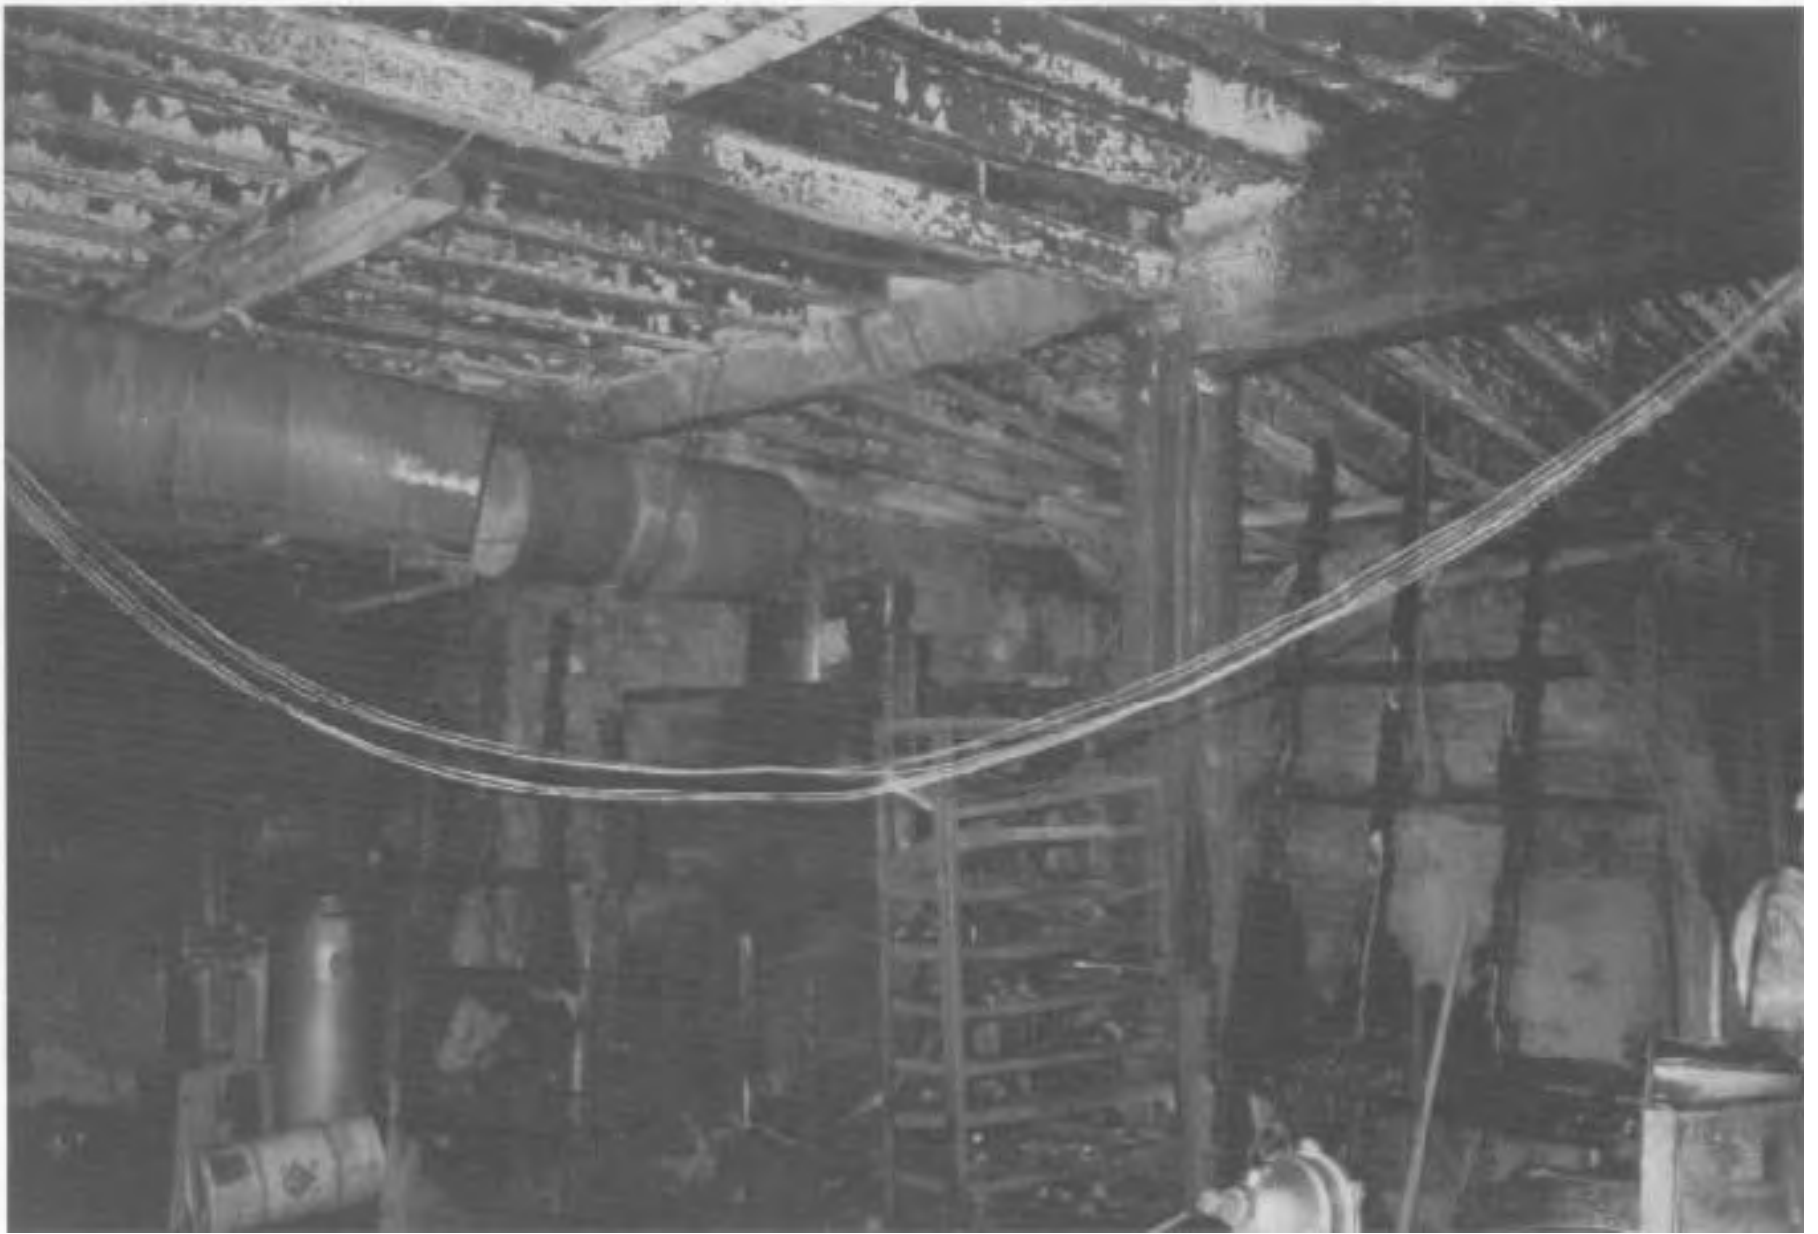
For code purposes, this building would have been classified as “unprotected non-combustible” construction. It had no fire resistance and should have been considered vulnerable to collapse from any significant fire exposure. (It should also be noted that automobiles are considered to be a relatively light load for design purposes.)

View from sidewalk in front of building (Brackenridge Ave.) looking into basement.  
Note thin concrete slab, supported by steel joists resting on steel beams.

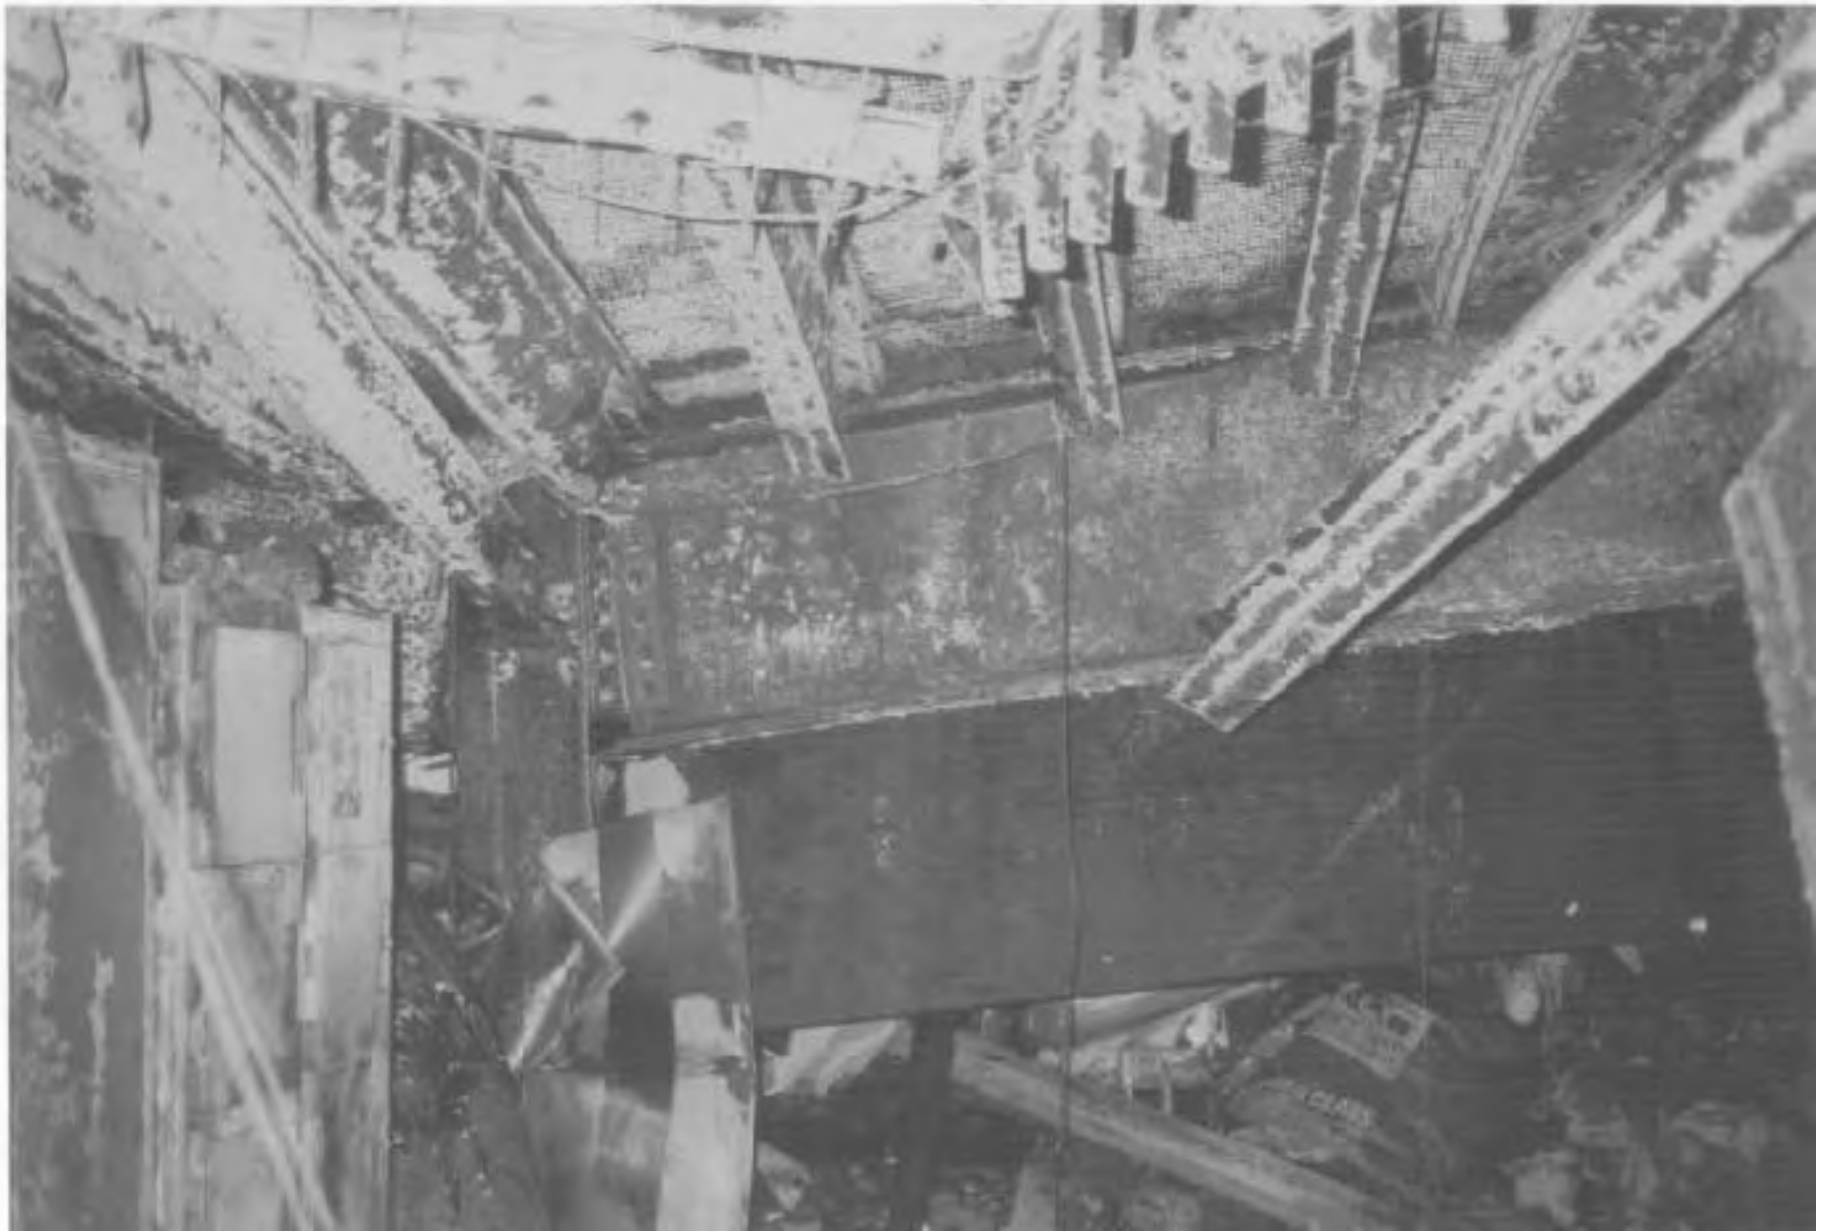
The fire originated in the basement finishing room, which is directly below the front entrance. The investigation indicates that the cause was most likely an accumulation of over-spray residue that was ignited by the electric heating unit. The alternative possibility of spontaneous ignition of chemicals used in the room could not be eliminated. The actual time of ignition is believed to have been as long as several hours before discovery. Investigators believe that the fire may have smoldered for several hours and may have gone through repeated stages of flaming and smoldering combustion, limited by the ventilation that was available to sustain flaming combustion.

Partial view of exhaust duct for spray booth air discharges. Rear of metal spray booths and remnants of enclosure wall are visible.

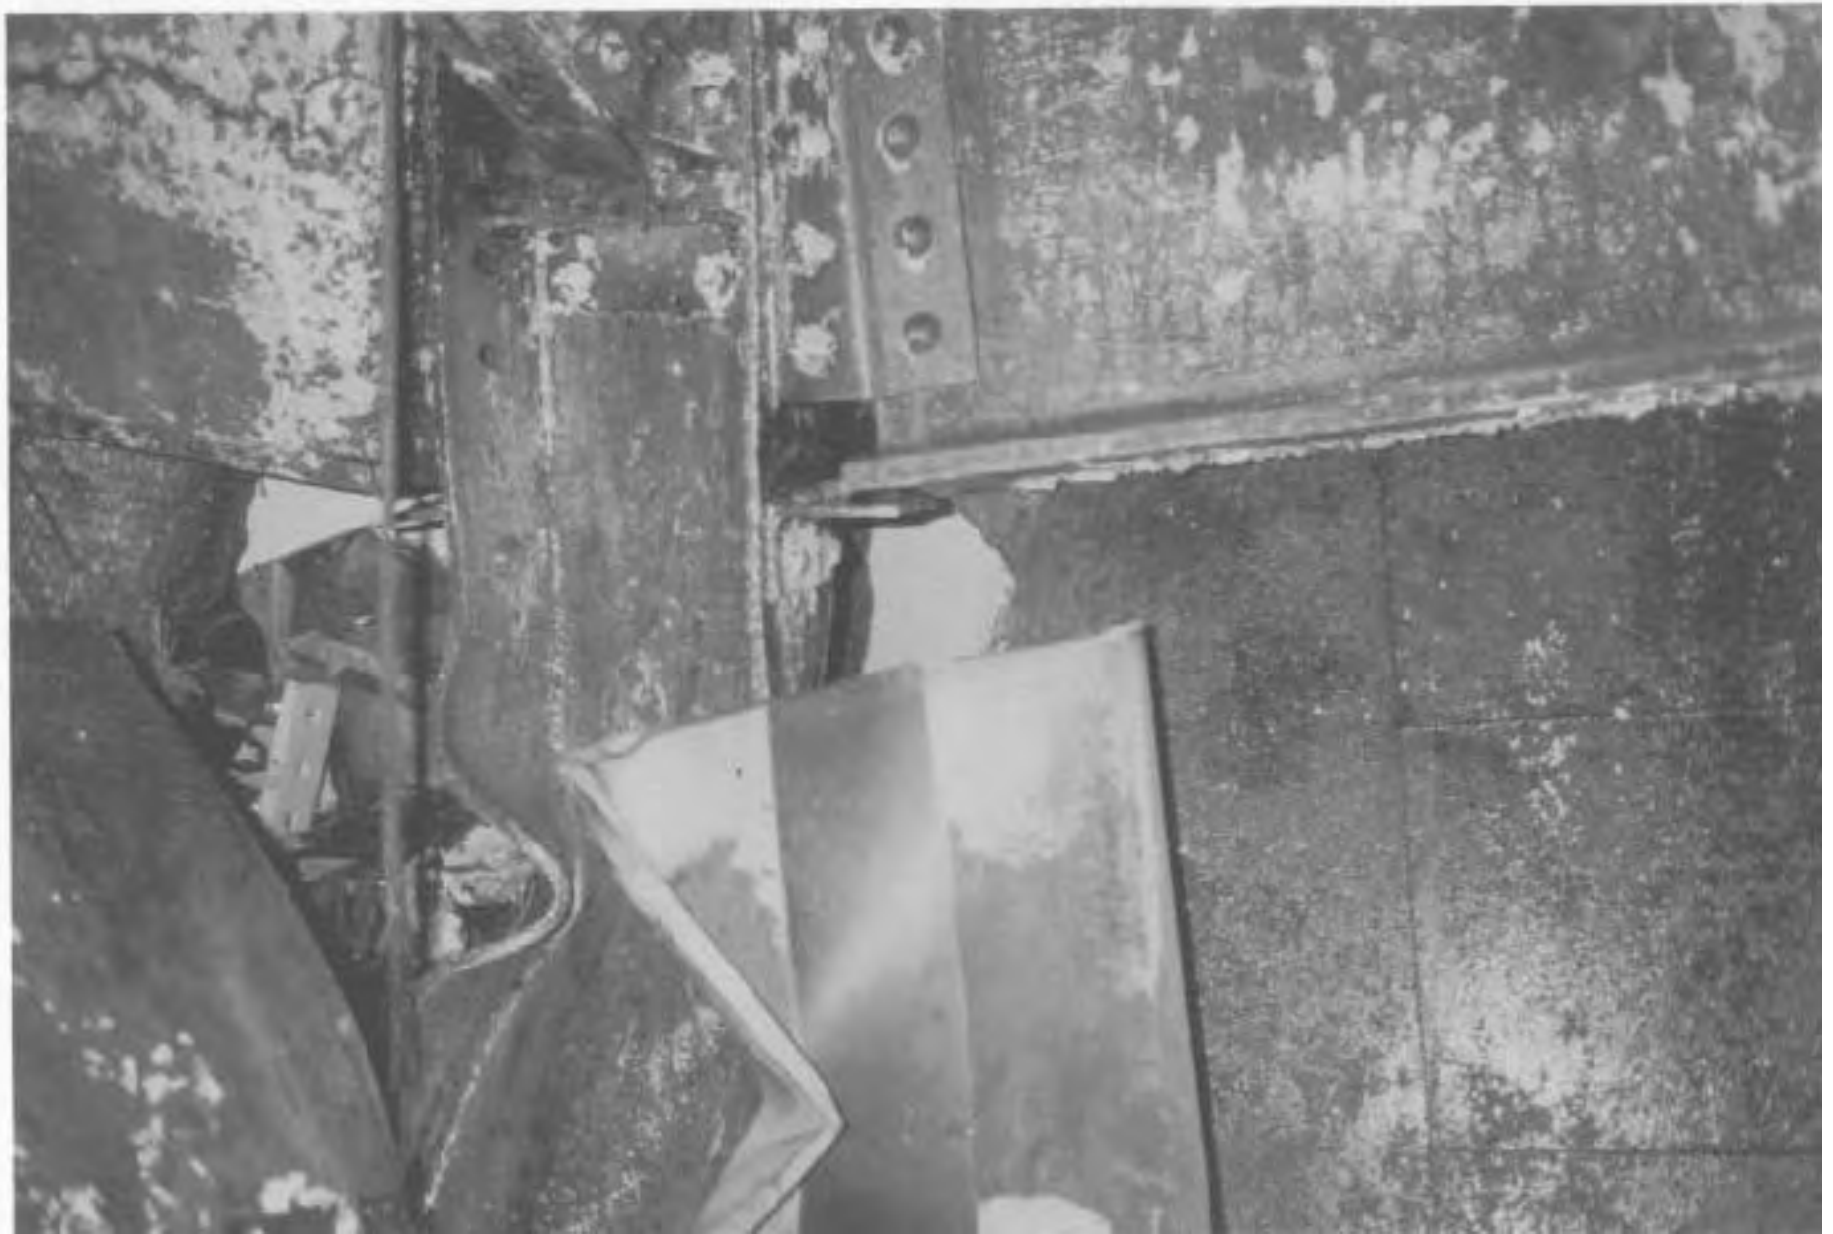
The middle column supporting the first set of beams was also buckled, although this appears to have been a secondary failure. The buckling of this column caused a secondary slab failure between the first and second sets of beams. The slab in the second bay sloped down toward the opening, with a low point at the center column, but did not drop into the basement. The remainder of the ground floor was not compromised.

Connection between buckled center column and main beam. Note floor section hanging from opposite side of beam.

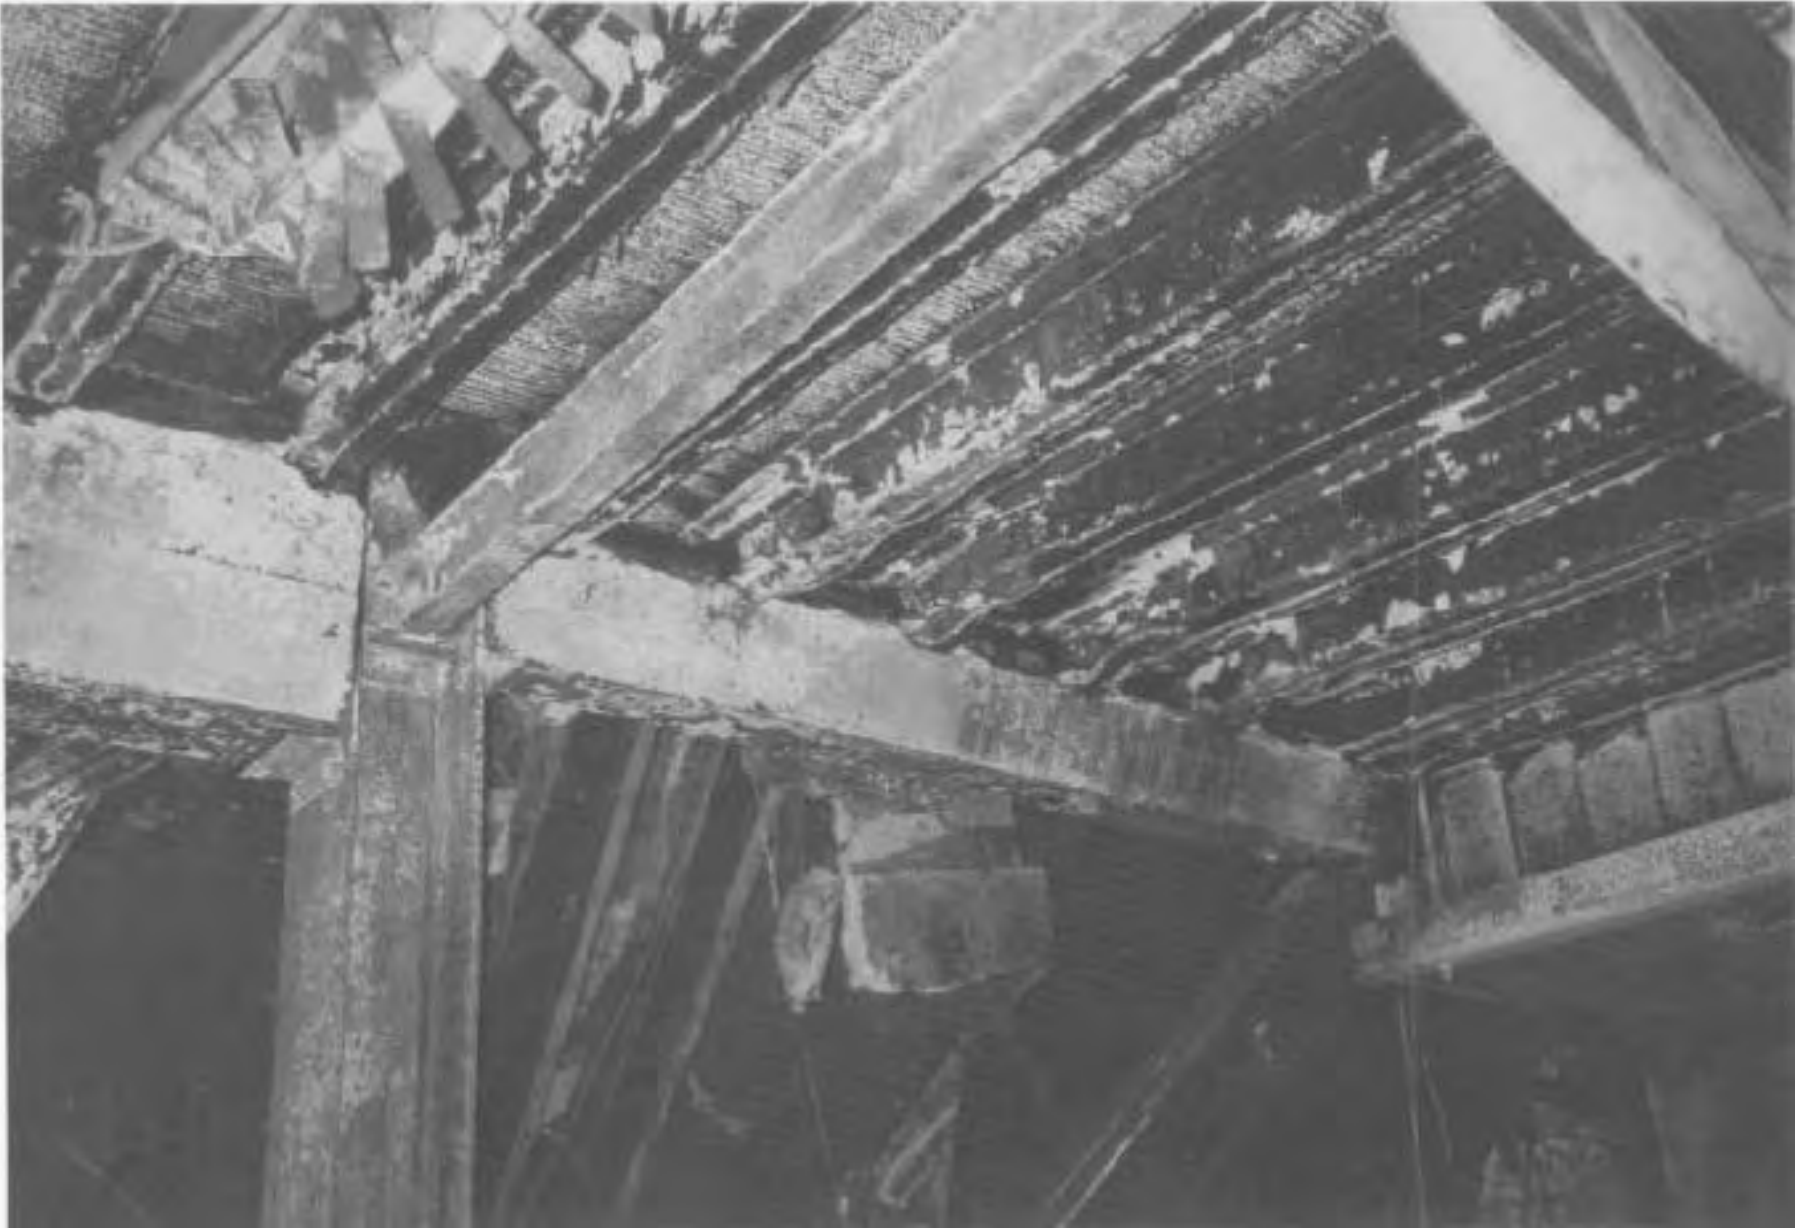
Detail of buckled center column, showing damaged connection of horizontal beam.
