## Four Firefighters Killed, Trapped by Floor Collapse Brackenridge, Pennsylvania

**Four Firefighters Killed,  
Trapped by Floor Collapse  
Brackenridge, Pennsylvania  
(December 20, 1991)**

**Investigated by: J. Gordon Routley**

This is Report 061 of the Major Fires Investigation Project conducted by TriData Corporation under contract EMW-90-C-3338 to the United States Fire Administration, Federal Emergency Management Agency.

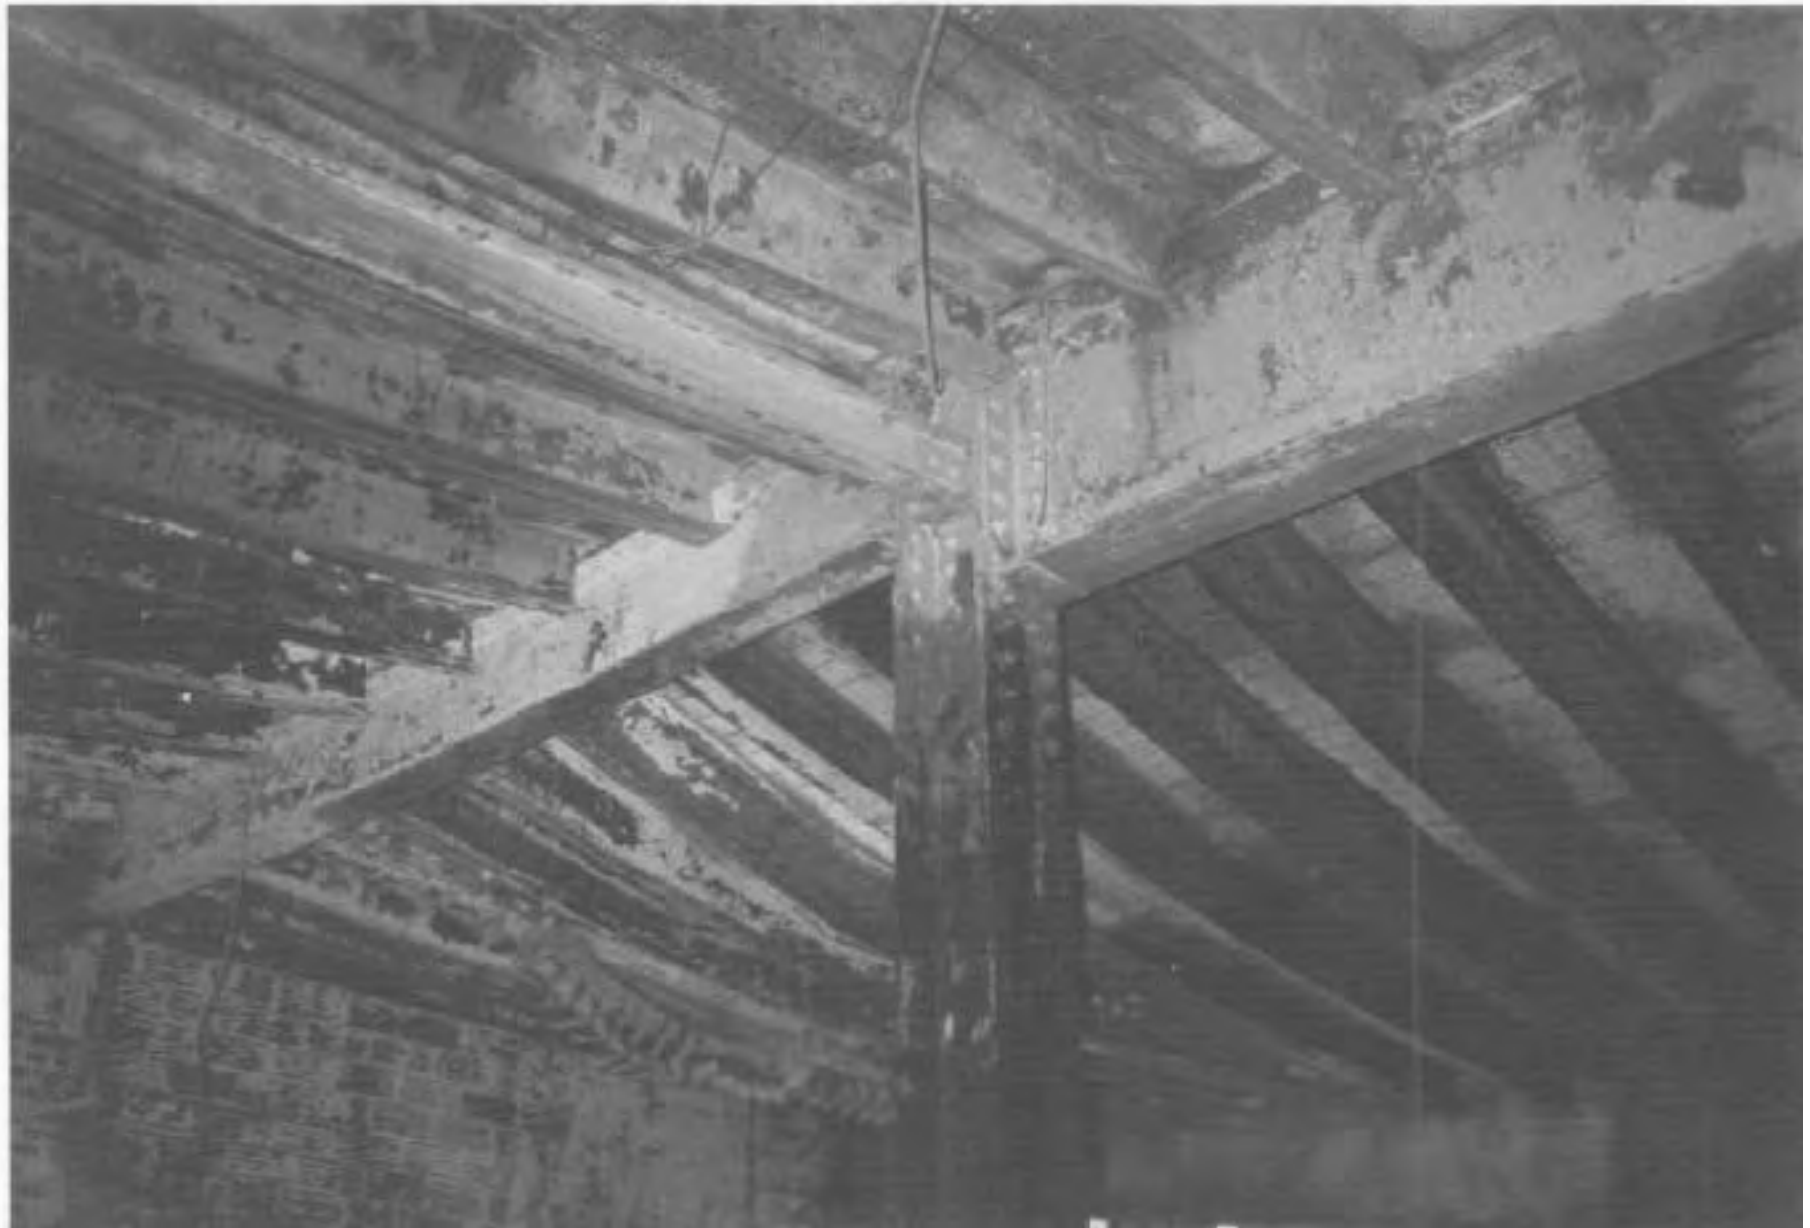
Basement steel beams, encased in concrete, on each side of unprotected column.

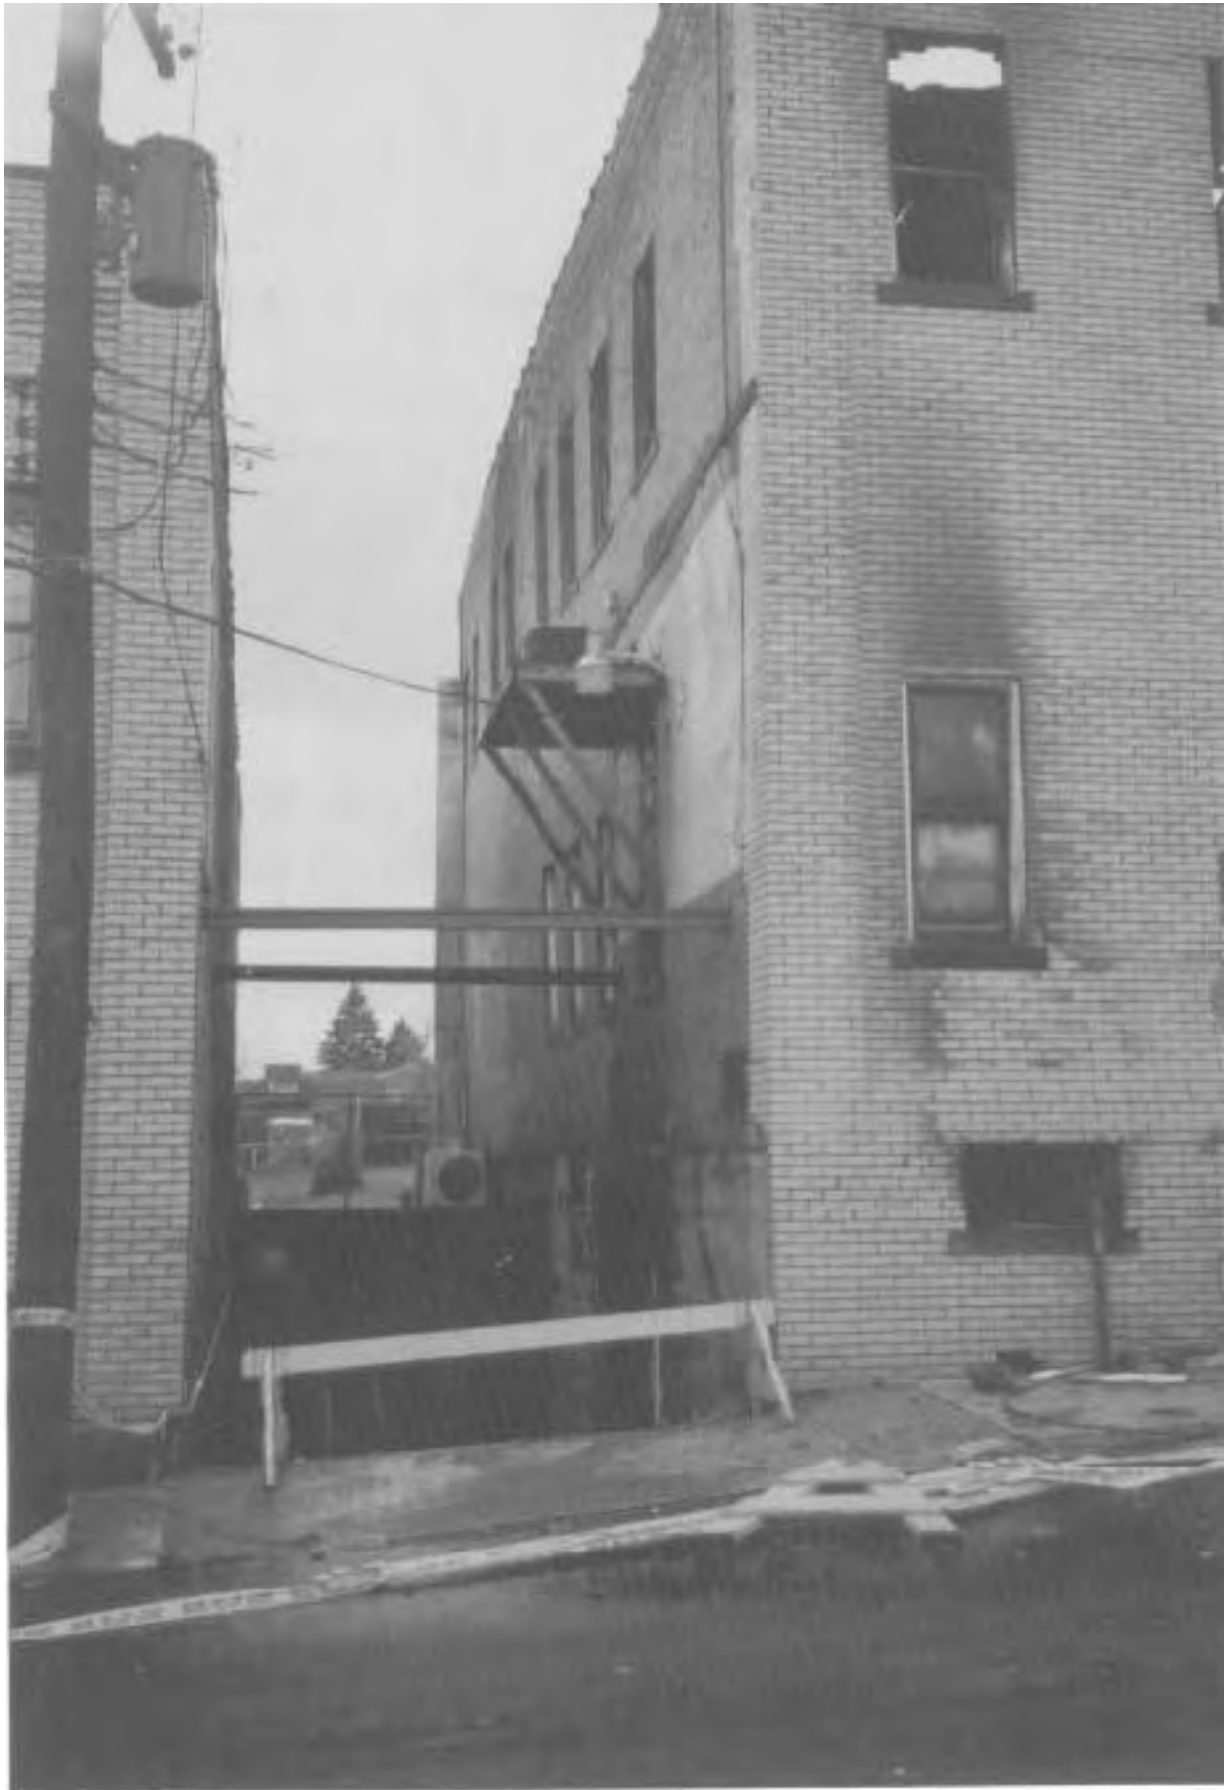
Roll-up door at the rear of the fire building has been cut with circular saws to allow crews to enter the basement.  
Initial entry by Eureka crew was through the bottom panels - larger opening was made later.
