Indianapolis Athletic Club Fire Indianapolis, Indiana

**Indianapolis Athletic Club Fire
Indianapolis, Indiana
(February 5, 1992)**

Investigated by: Mark Chubb

This is Report 063 of the Major Fires Investigation Project conducted by TriData Corporation under contract EMW-90-C-3338 to the United States Fire Administration, Federal Emergency Management Agency.

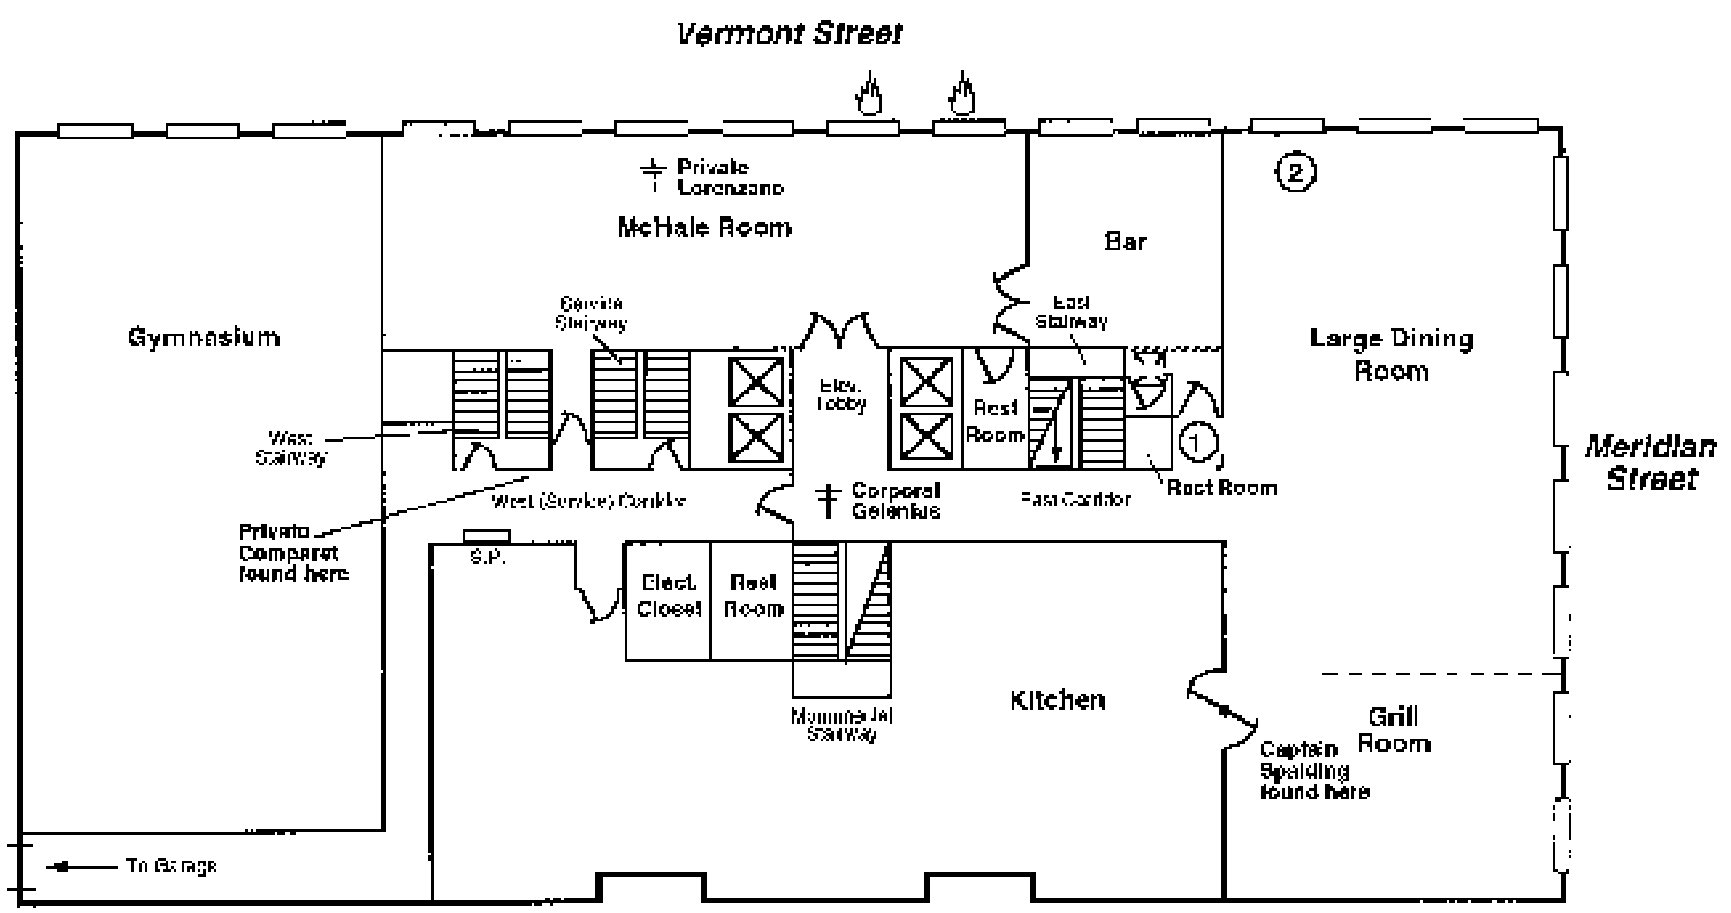
Floor Plan

The fire originated in the third floor bar due to an electrical malfunction in or near a refrigerator. A detailed chronology of the incident and the plan of the floor of origin are presented in Appendices A and B. Indianapolis fire communications received a 911 call at 12:06 a.m., February 5, 1992 reporting an odor of smoke in the lobby of the Indianapolis Athletic Club, a nine-story mixed use building. Within two minutes a first alarm assignment of four engine companies, two truck companies, and two chief officers was dispatched to the incident. A little more than a minute and a half later, the first company arrived on the scene and reported "nothing showing." What looked routine upon arrival would become tragic less than 20 minutes later when fire erupted from a concealed space on the third floor, resulting in a flash fire which claimed the lives of Corporal Ellwood Gelenius and Private John Lorenzano,

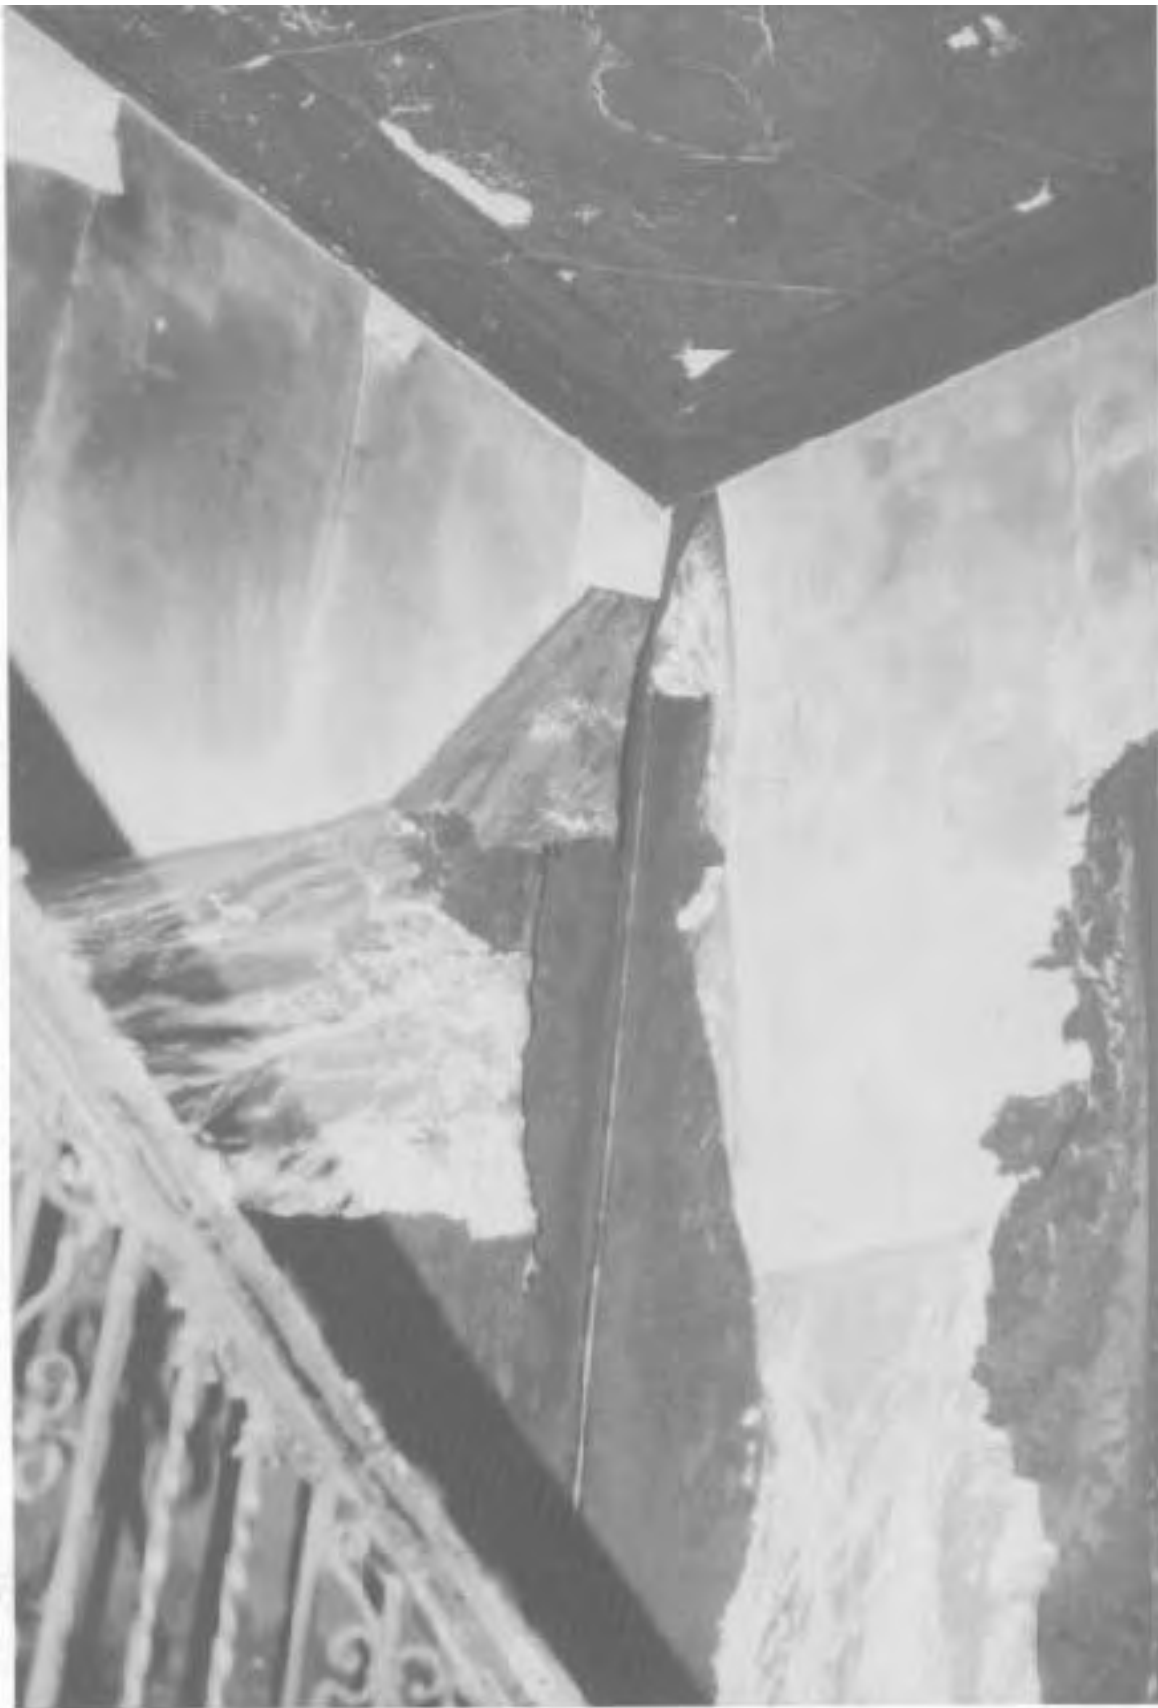
This view from the monumental stairway looking up toward third floor ceiling shows relatively light damage to the cornice, but heavy damage to the combustible foil-backed wallcovering.

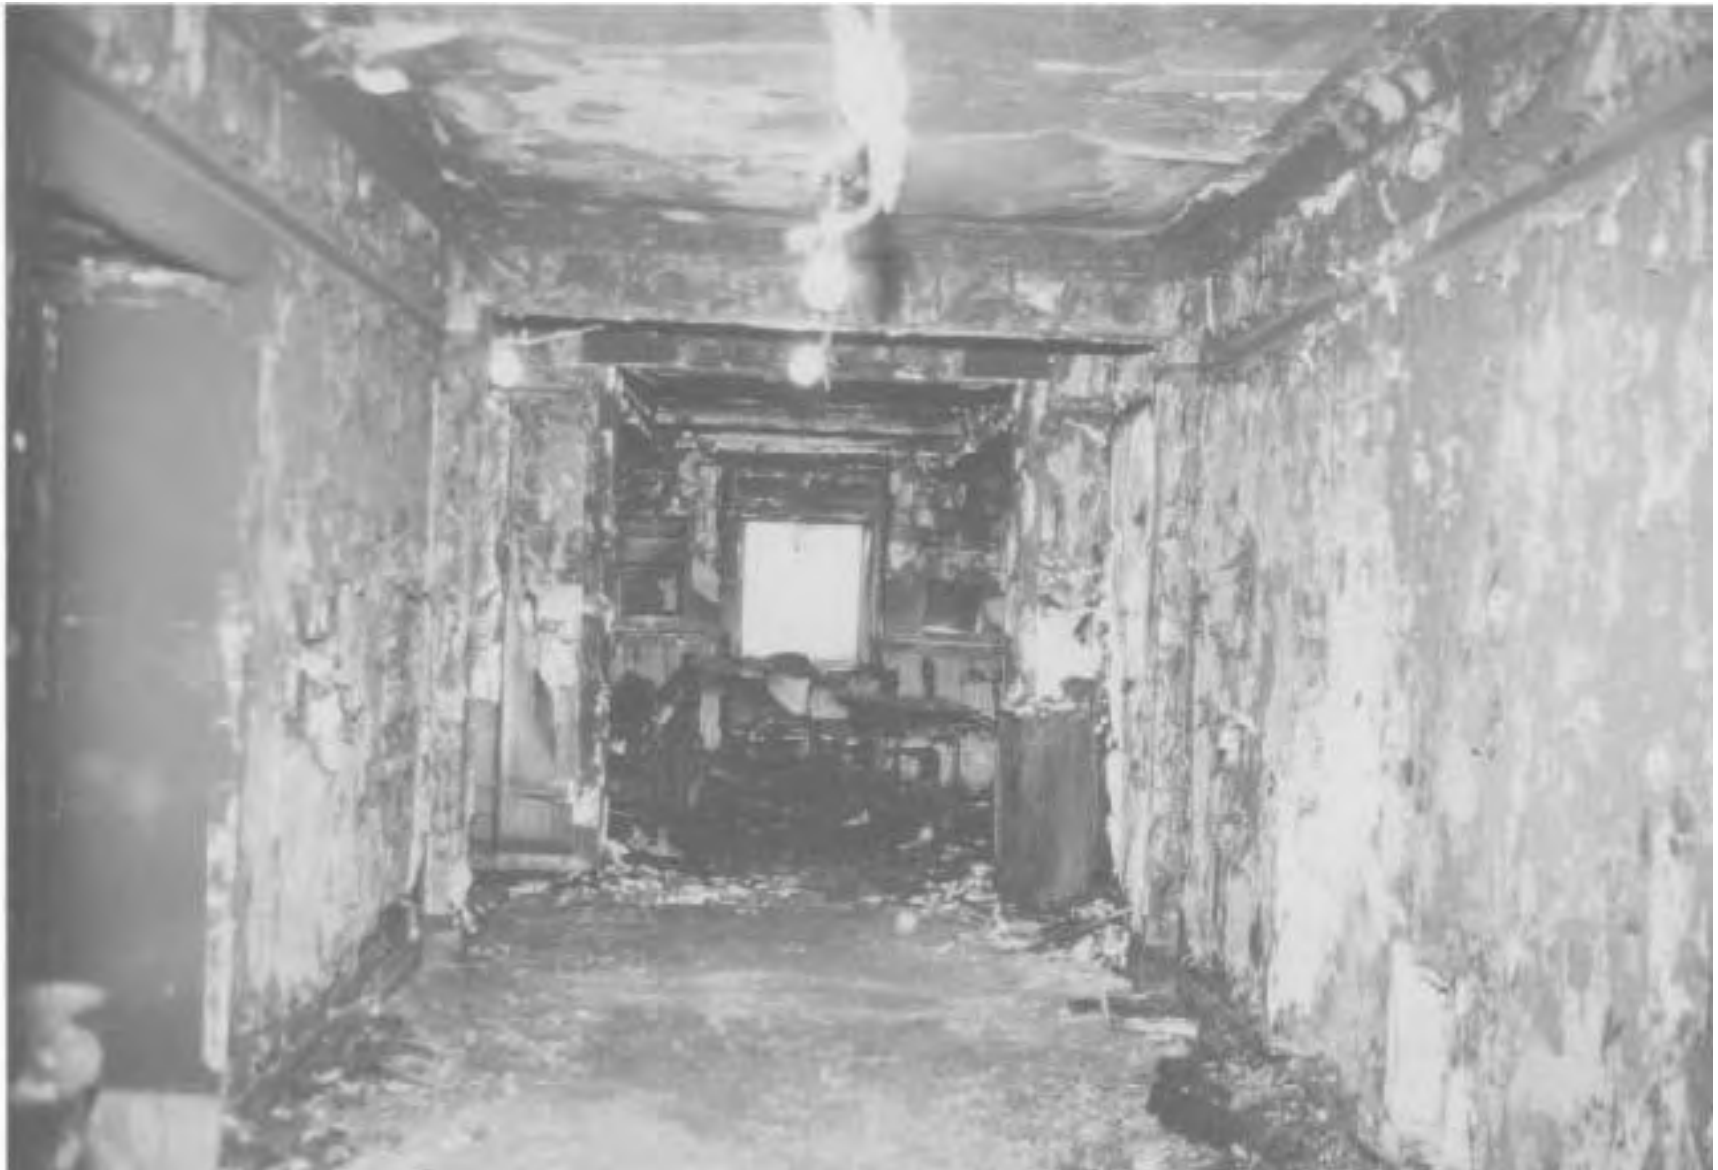
Like the ceilings, wall coverings had been successively replaced and modified. In the bar and McHale Rooms, 1/8-inch plywood paneling was installed on 1-inch by 3-inch furring strips. In corridors and the monumental stair leading from the lobby to the third floor, foil-backed vinyl wall coverings had been installed. The plywood paneling was labeled to indicate it had been tested in accordance with ASTM E84, *Test of Surface Burning Characteristics of Building Materials* and had a flame spread index rating of 150. The *Uniform Building Code* requires that interior finish material covering fire-resistive or noncombustible assemblies be attached directly to the assembly? Installing the paneling on furring strips instead of directly attaching it to the wall surface could be expected to significantly increase the material's flame spread index rating.

This view of the third floor corridor looking east toward the large dining room shows the extensive damage to combustible wallcoverings.

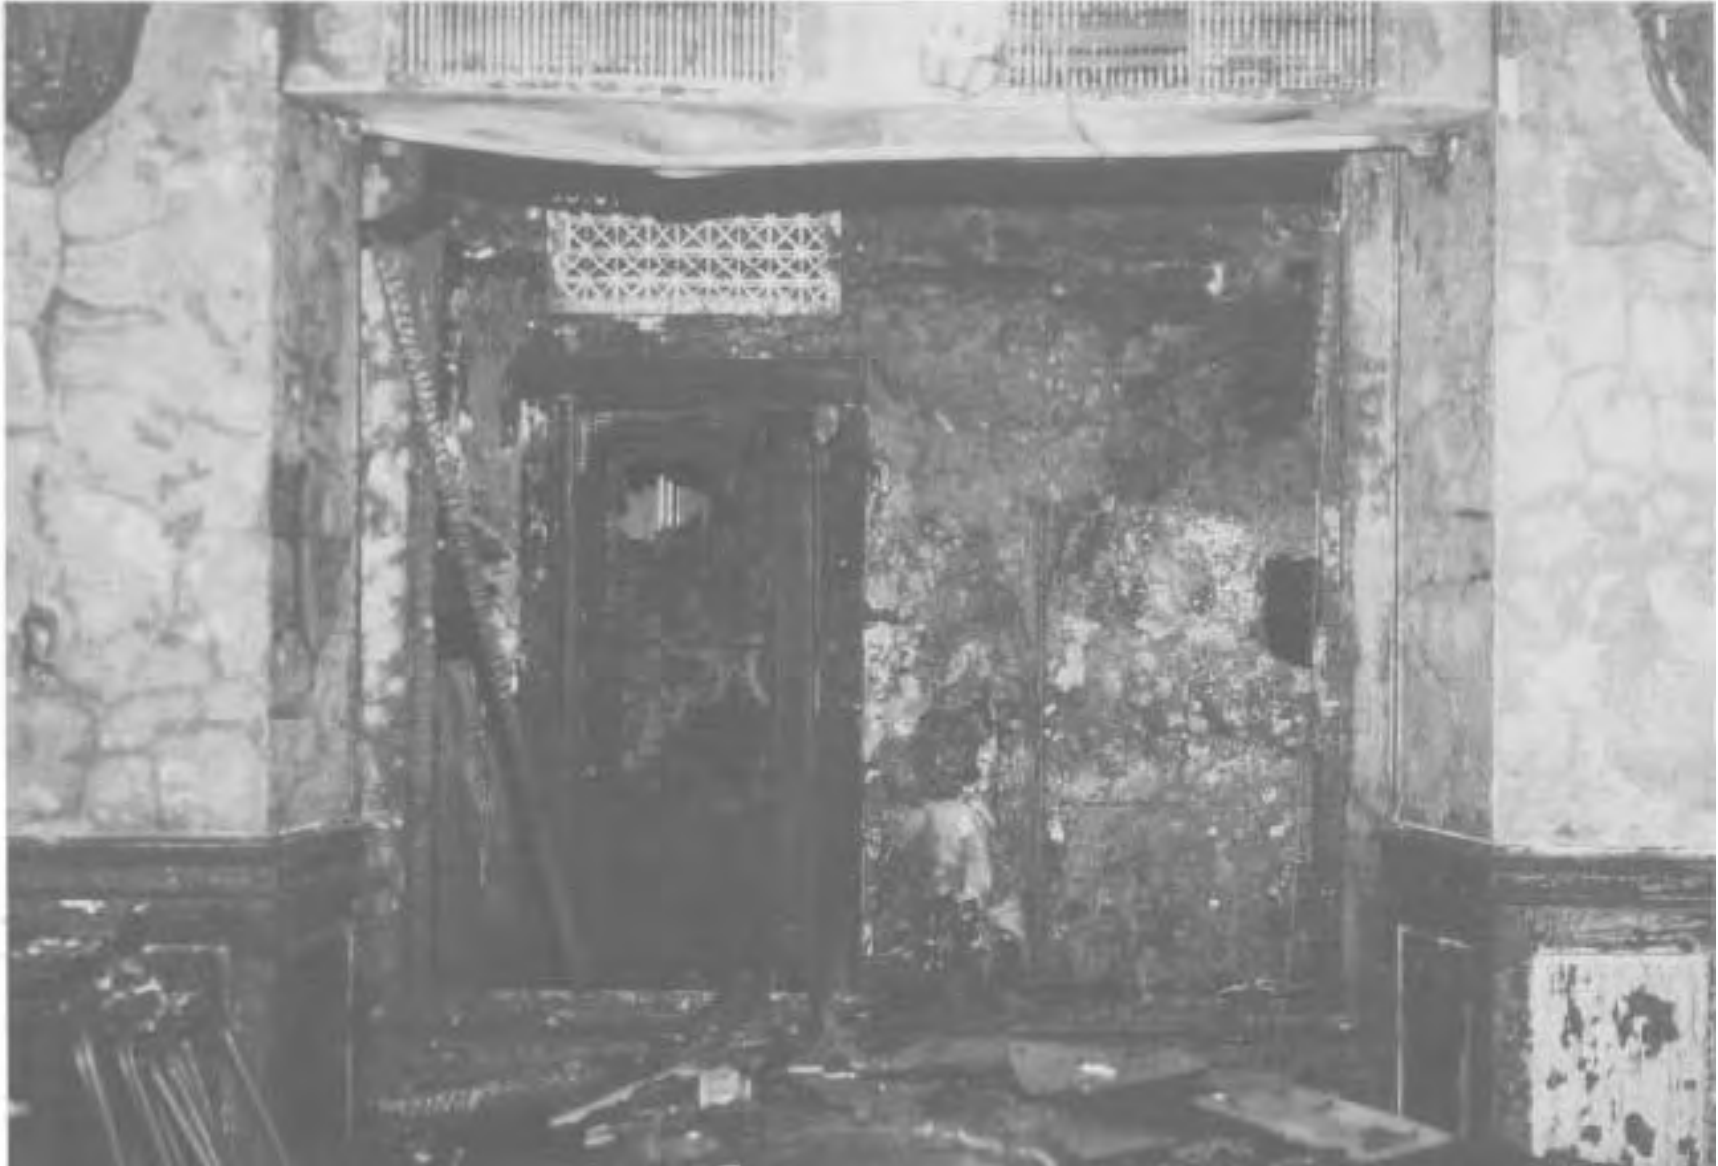
Entrance to ladies room adjacent to the dutch-style service door to the bar (room of fire origin). Note the air return register over the door and the air supply register over the opening to the dining room.

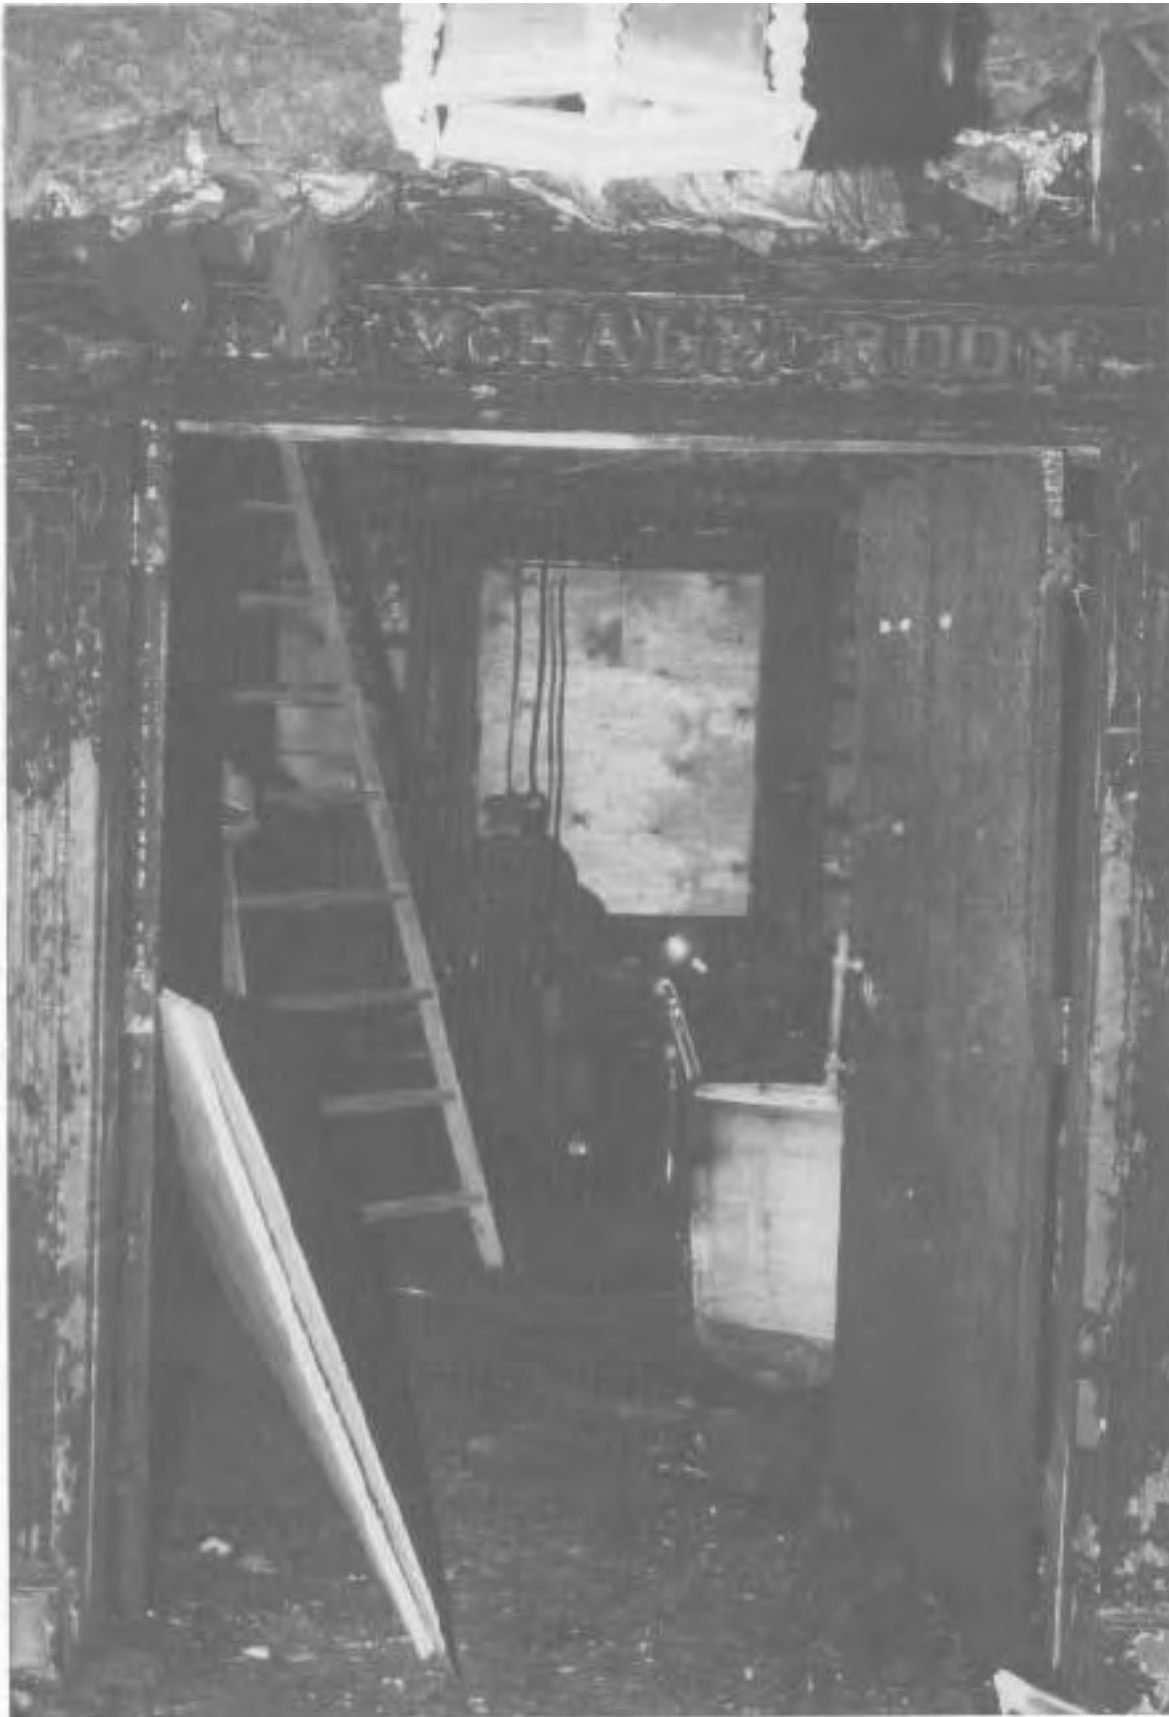
Entrance to the McHale Room looking north from the elevator lobby. Note the fire damage to the wall coverings above the door and the relatively light charring of the door frame.

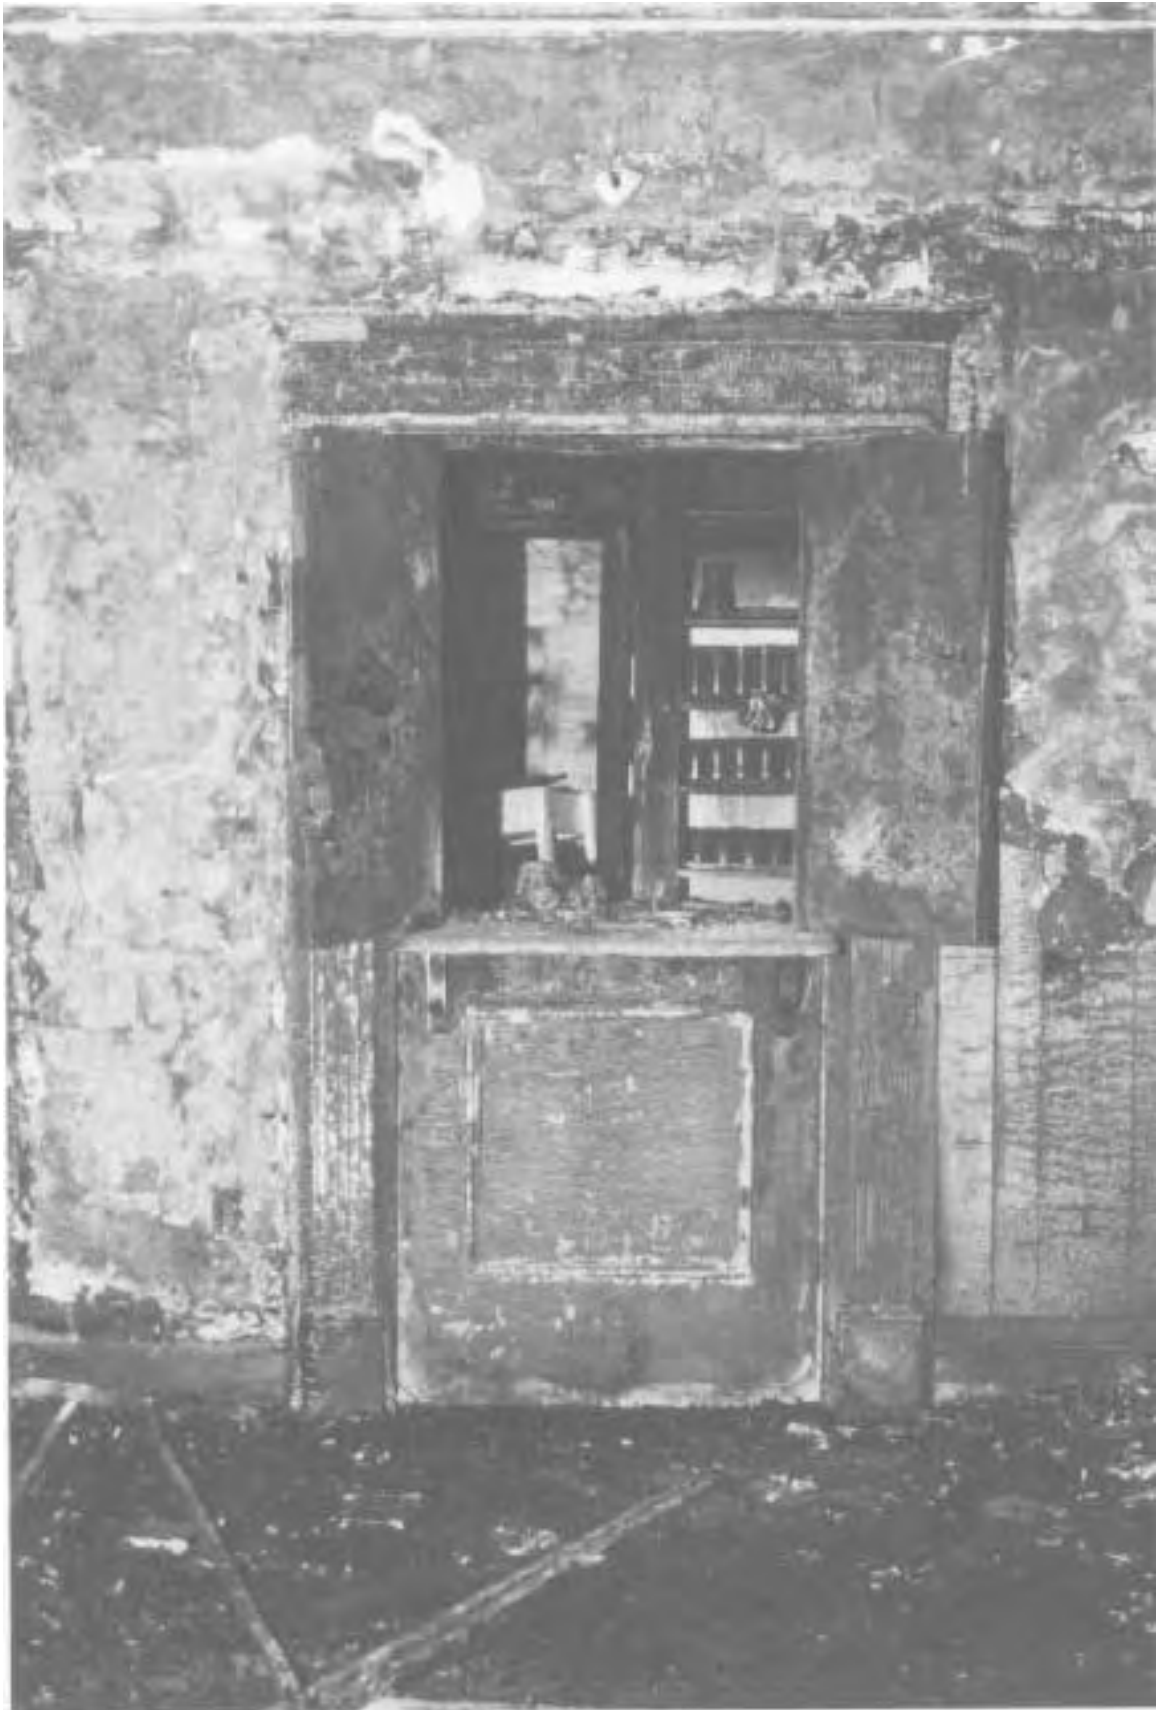
This view of the dutch-style service door to the bar room shows the deep charring to the door frame above the opening and the plywood paneling on the lower right side of the door opening.

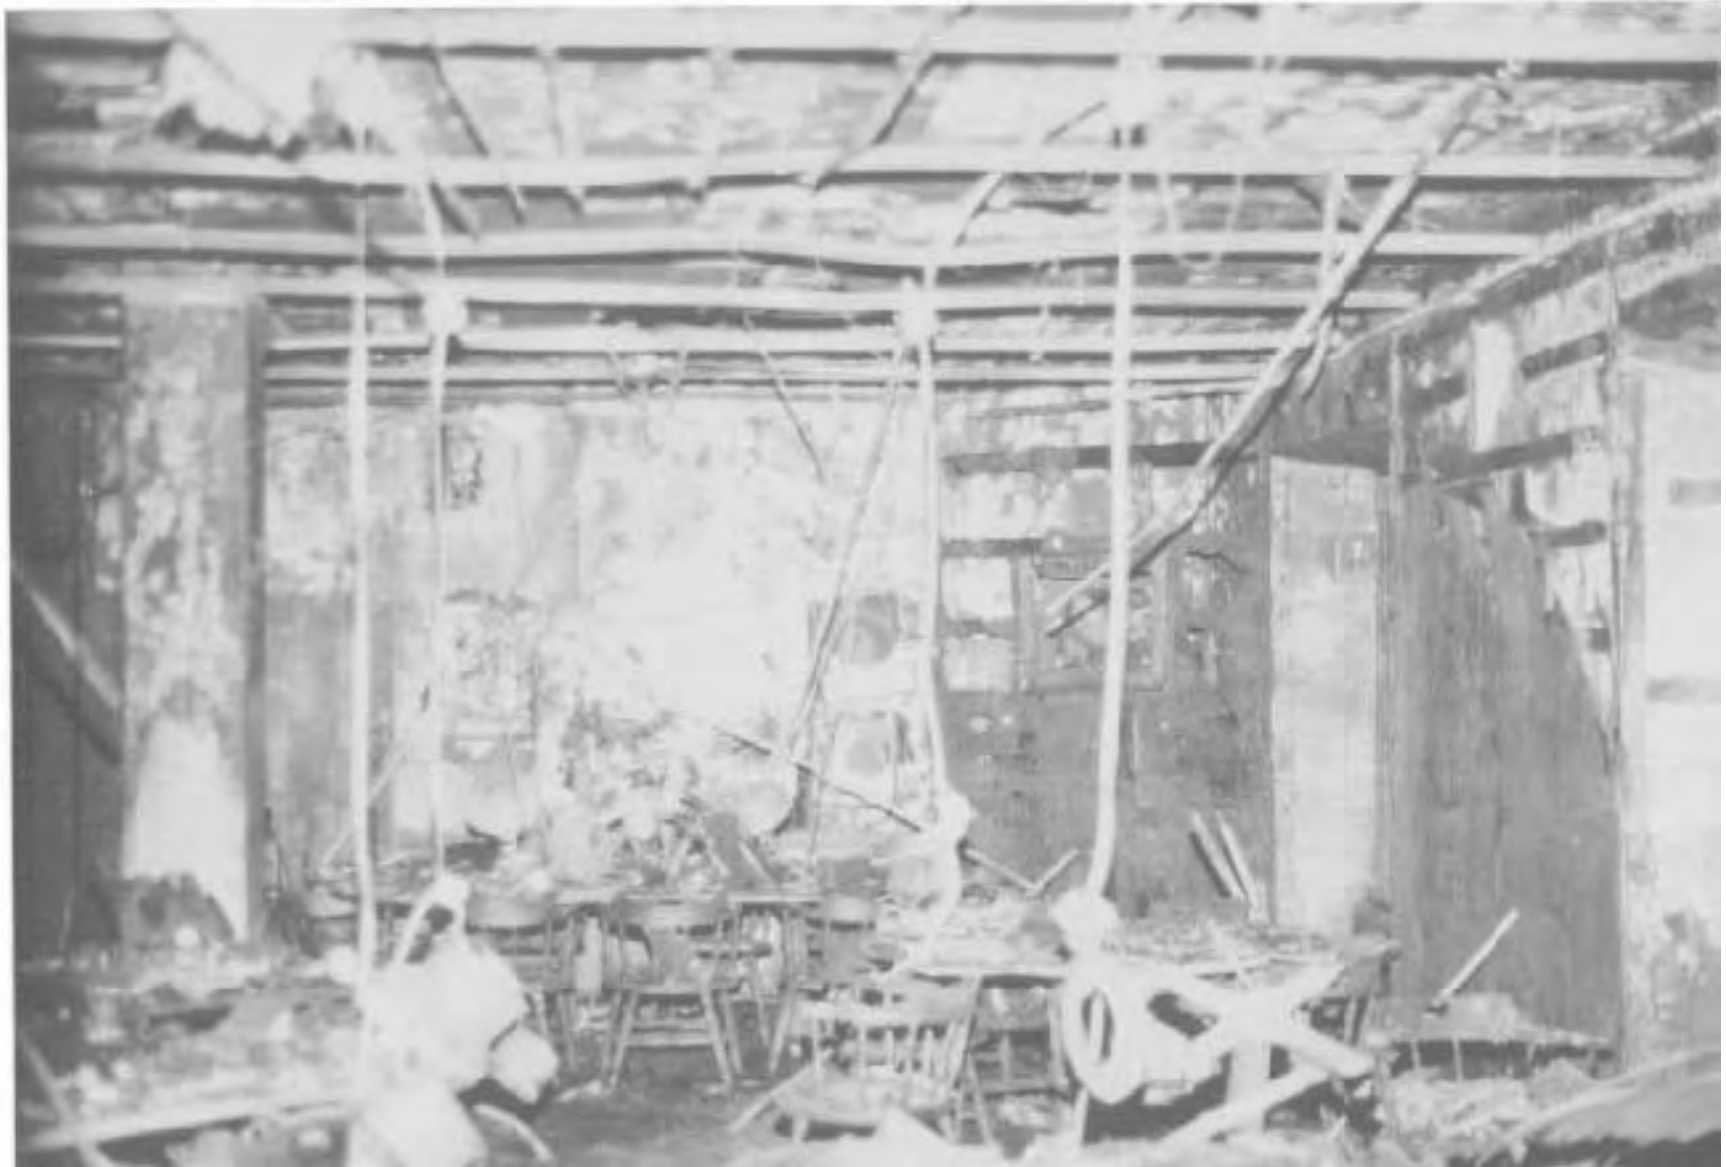
In this fire, extensive low burning indicative of a post-flashover fire was observed in the immediate vicinity of the bar and the opening between it and the McHale Room. In fact, much of the available fuel in the McHale Room at or below tabletop level remained unburned. Those fuels which were significantly consumed appeared to be relatively lightweight, with very high flame spread index ratings, and high surface to mass ratios. These materials consisted mainly of interior wall and ceiling finishes.

The inside of the McHale Room looking west. Shows the use of furring strips under the wall paneling. Much of the paneling at the remote west end of the room remains intact. Also note that the tops of the chair backs are only slightly blistered.

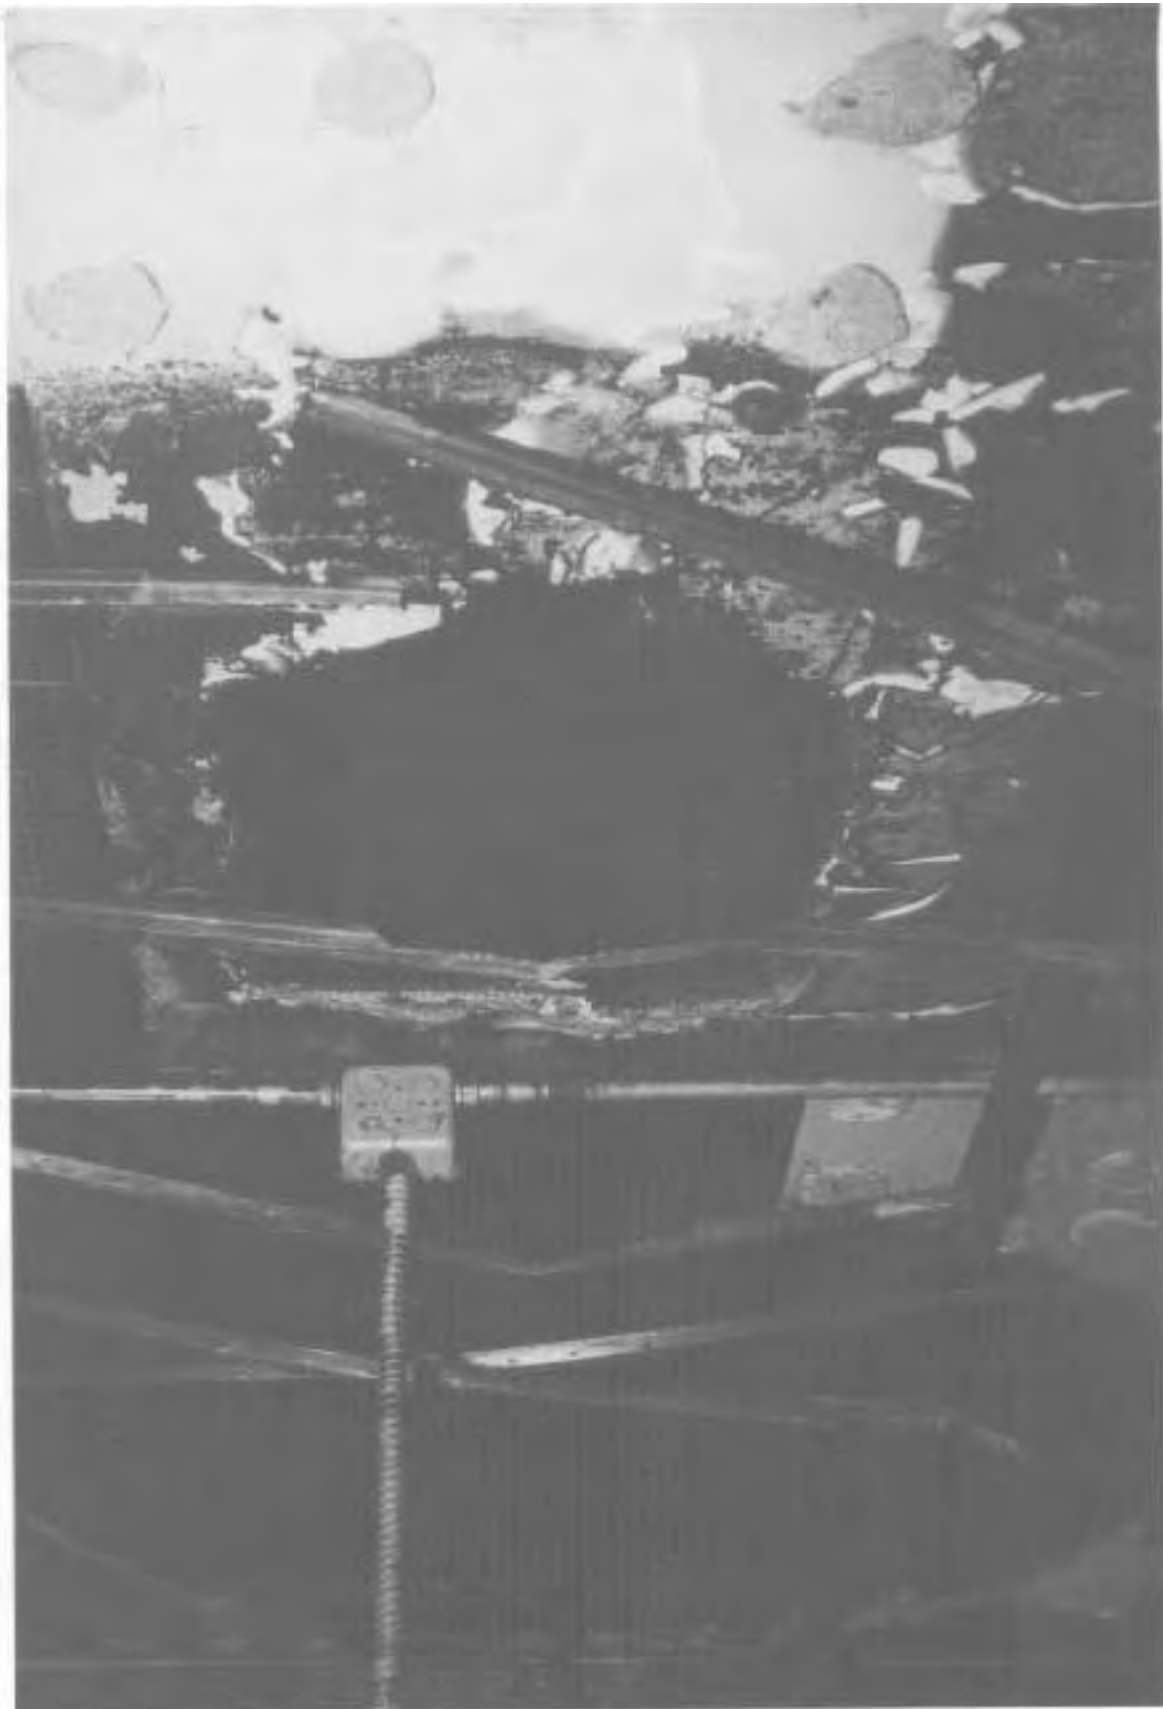
View of opening in suspended ceiling in the McHale Room. Note the charred 1-foot ceiling tiles (at left) glued to the underside of the plaster suspended ceiling and the remnants of the aluminum suspended ceiling frame.

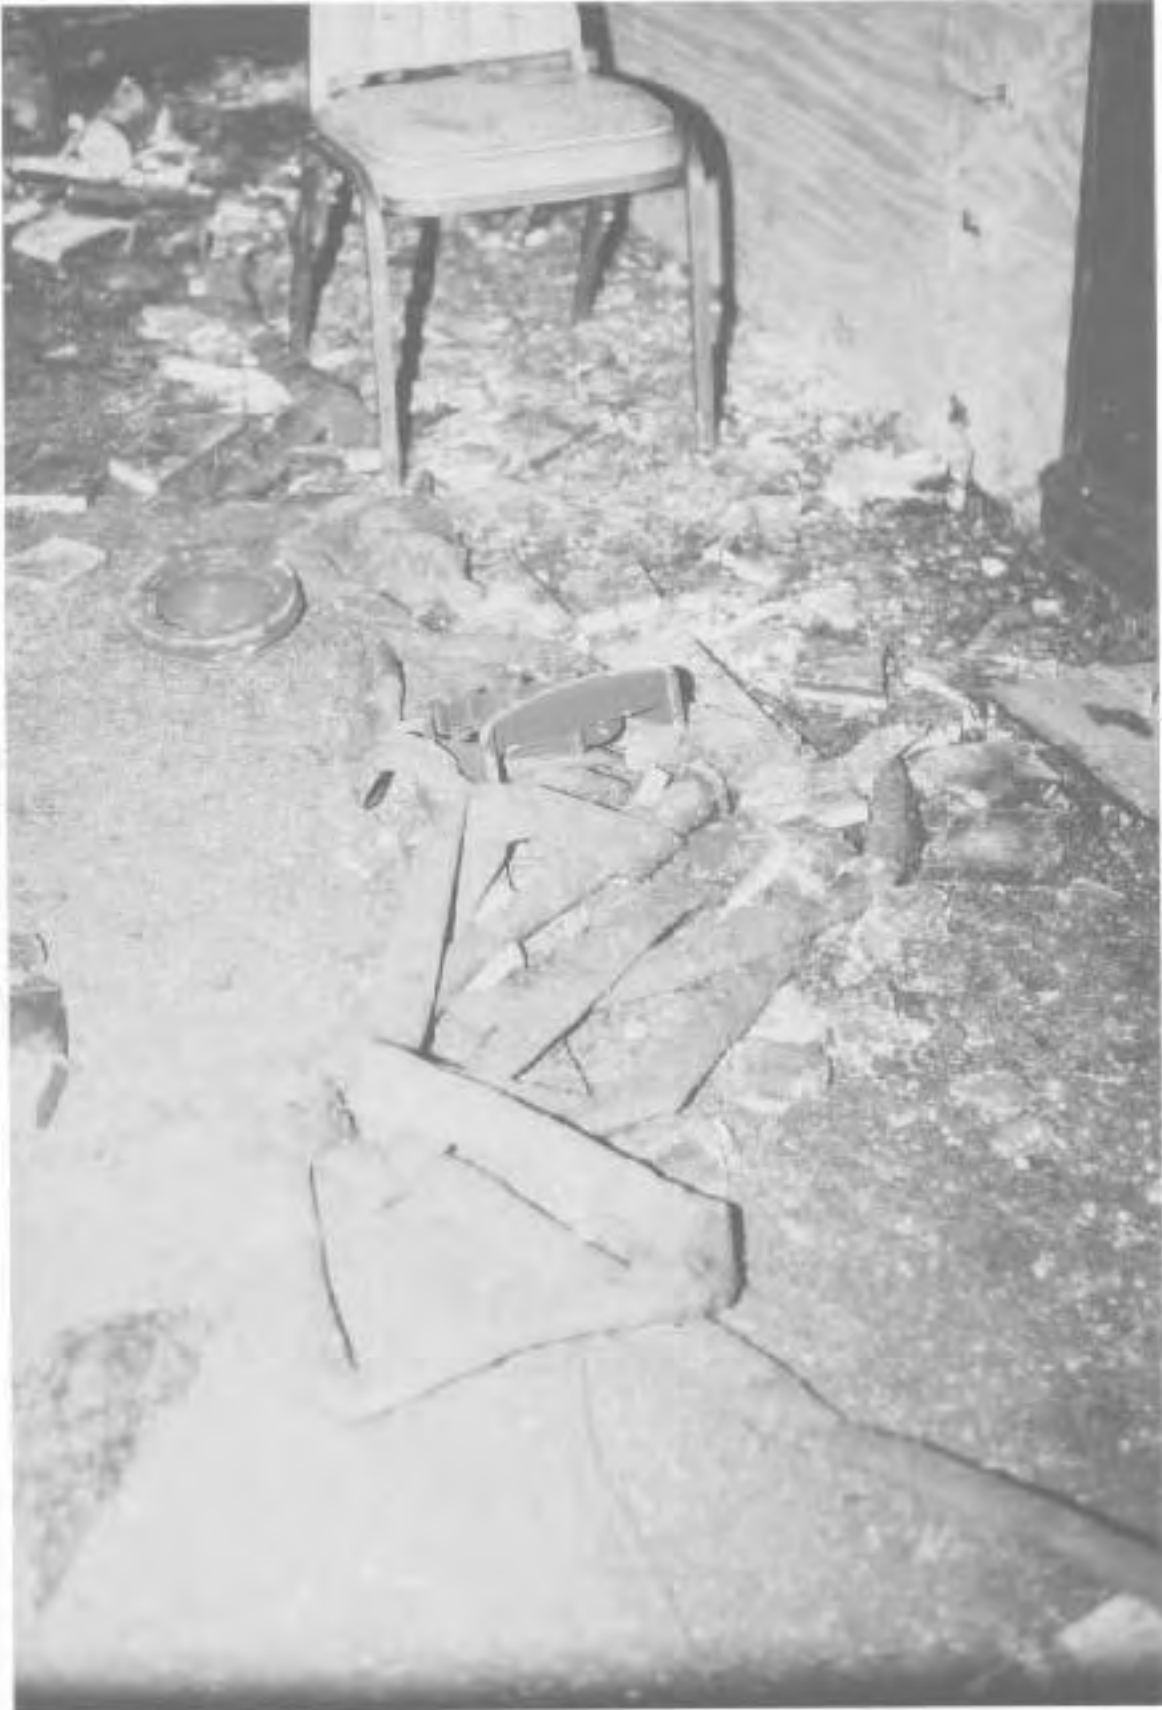
Remnants of occupant use standpipe hoseline used by Engine 7 and Truck 13 firefighters in the initial attack. Note the plastic adjustable-stream fog-nozzle attached to the end (near center of photo).

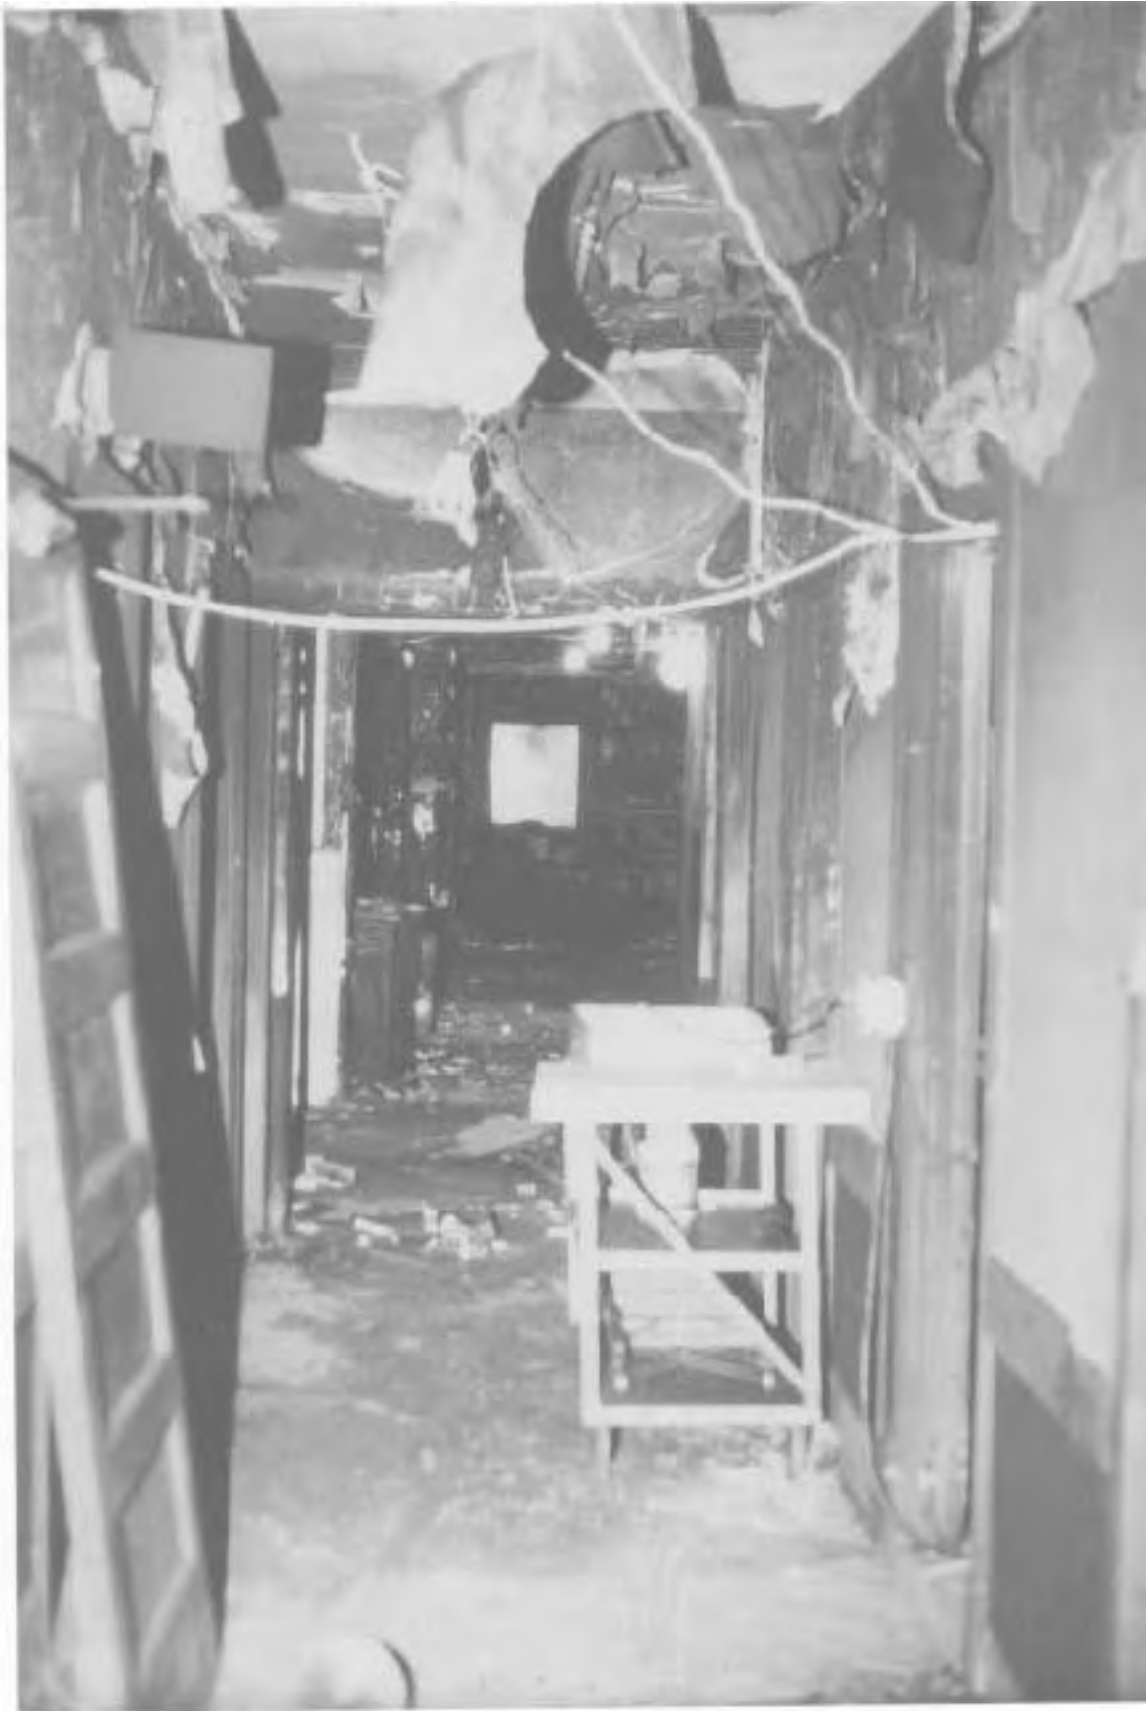
View of third floor service corridor looking east from standpipe cabinet. Note the relatively minor damage. Most of the damage is confined to wall and ceiling finish materials.

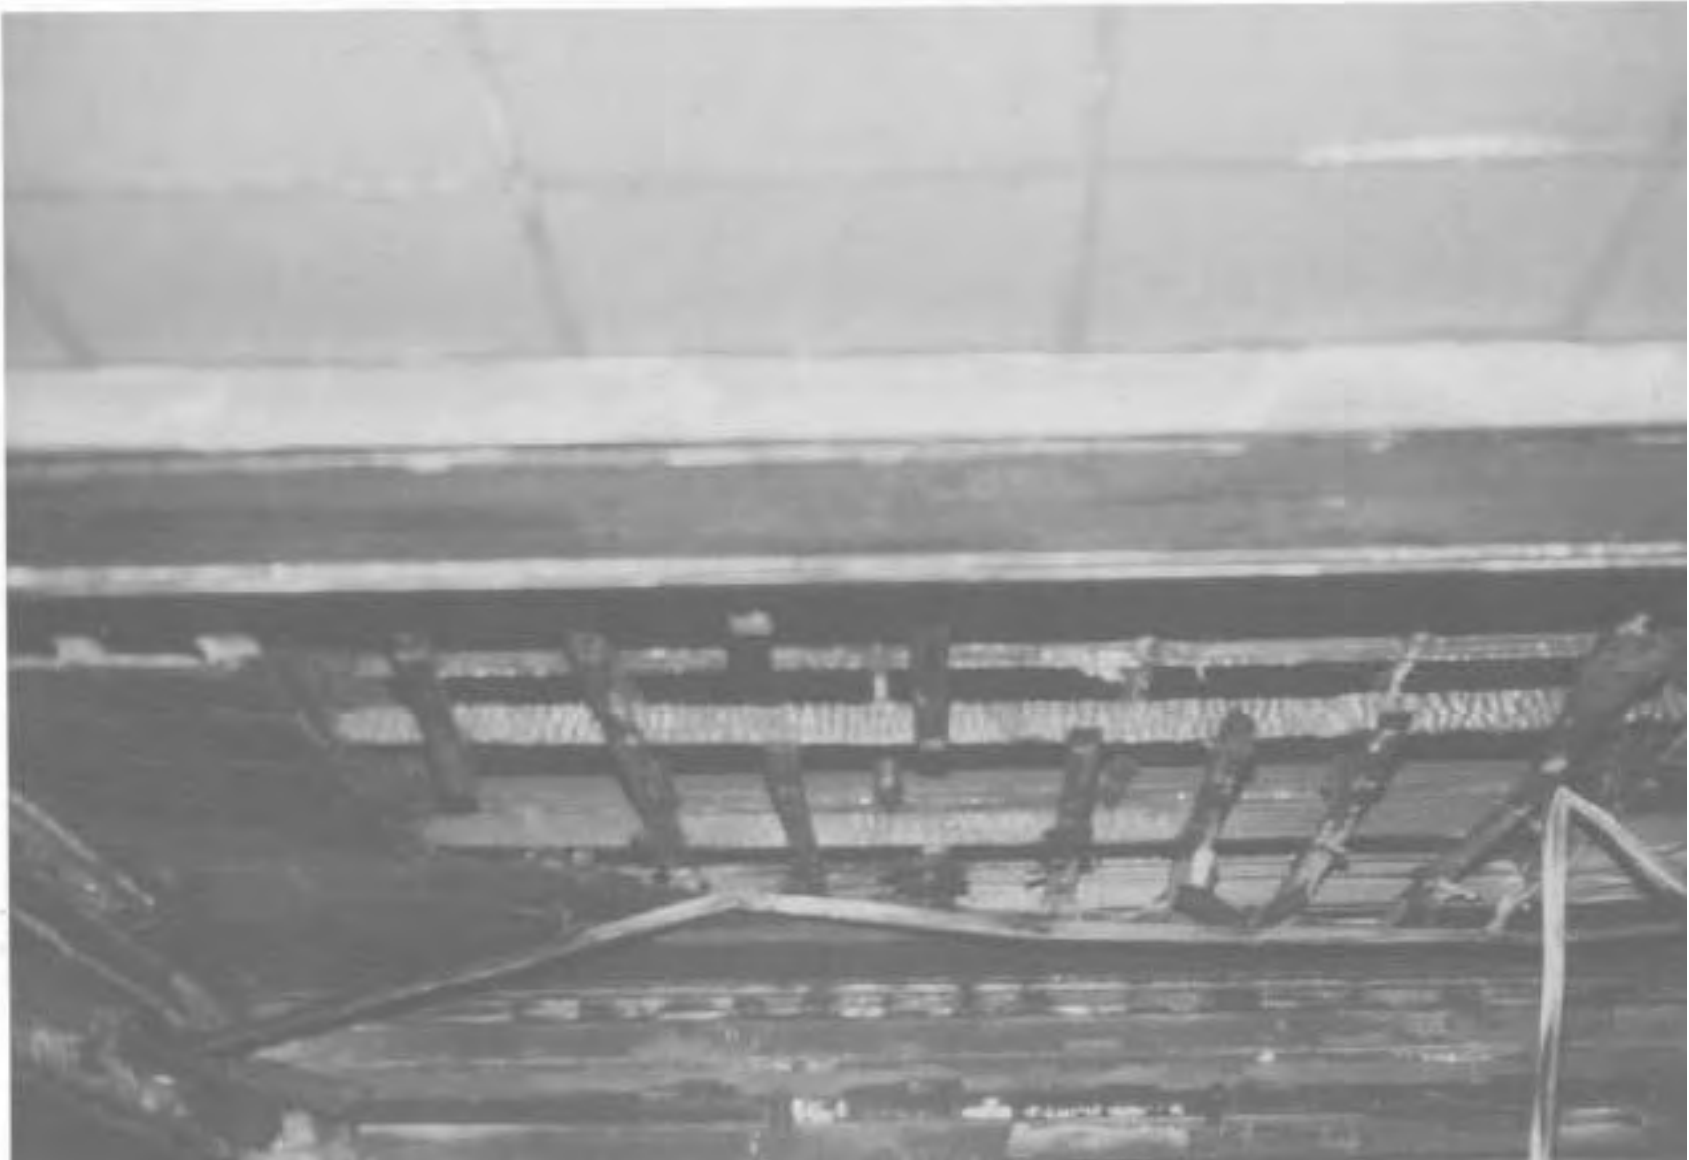
View of suspended ceiling damage above the location in the grill room where Captain Spalding was found unconscious and covered in debris.
