Indianapolis Athletic Club Fire Indianapolis, Indiana

**Indianapolis Athletic Club Fire
Indianapolis, Indiana
(February 5, 1992)**

Investigated by: Mark Chubb

This is Report 063 of the Major Fires Investigation Project conducted by TriData Corporation under contract EMW-90-C-3338 to the United States Fire Administration, Federal Emergency Management Agency.

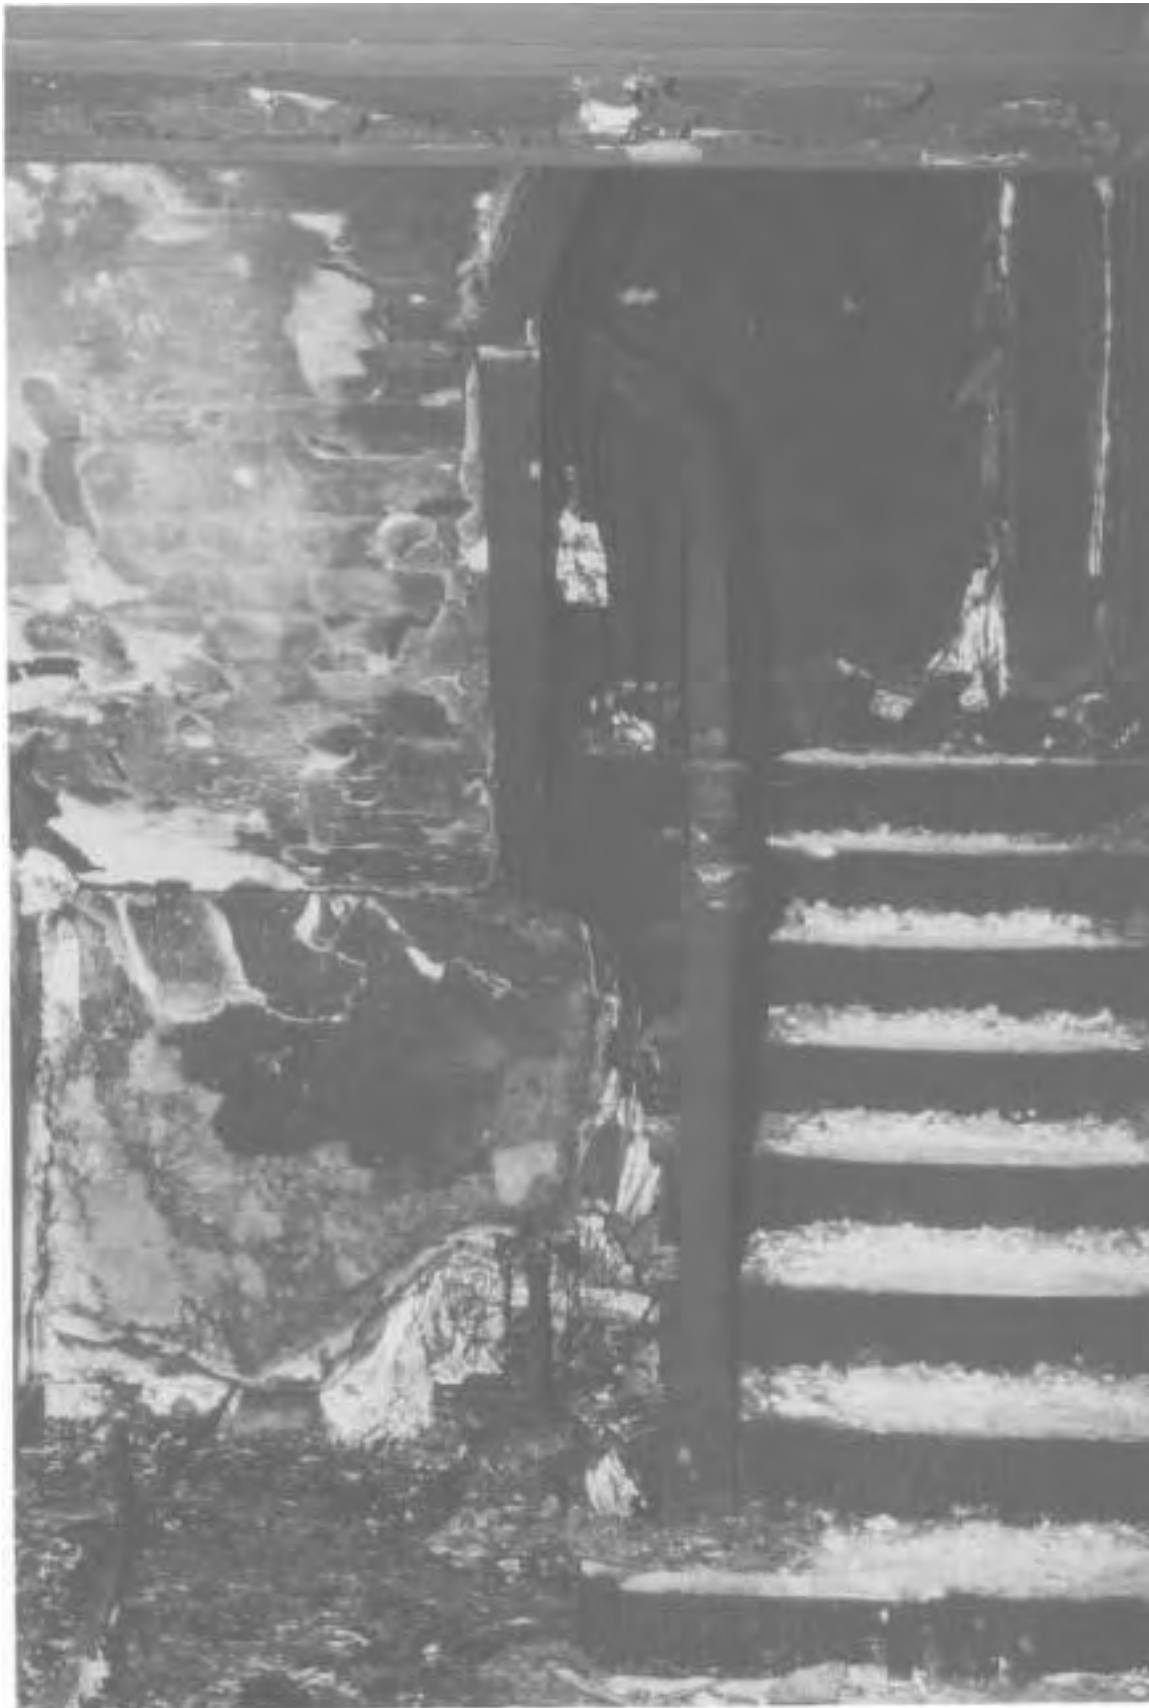
View of east stairway connecting third through ninth floors. This stairway was open on the third floor (shown here) and the fourth floor permitting the stairway to fill with smoke and the fire to spread vertically to the fourth floor.

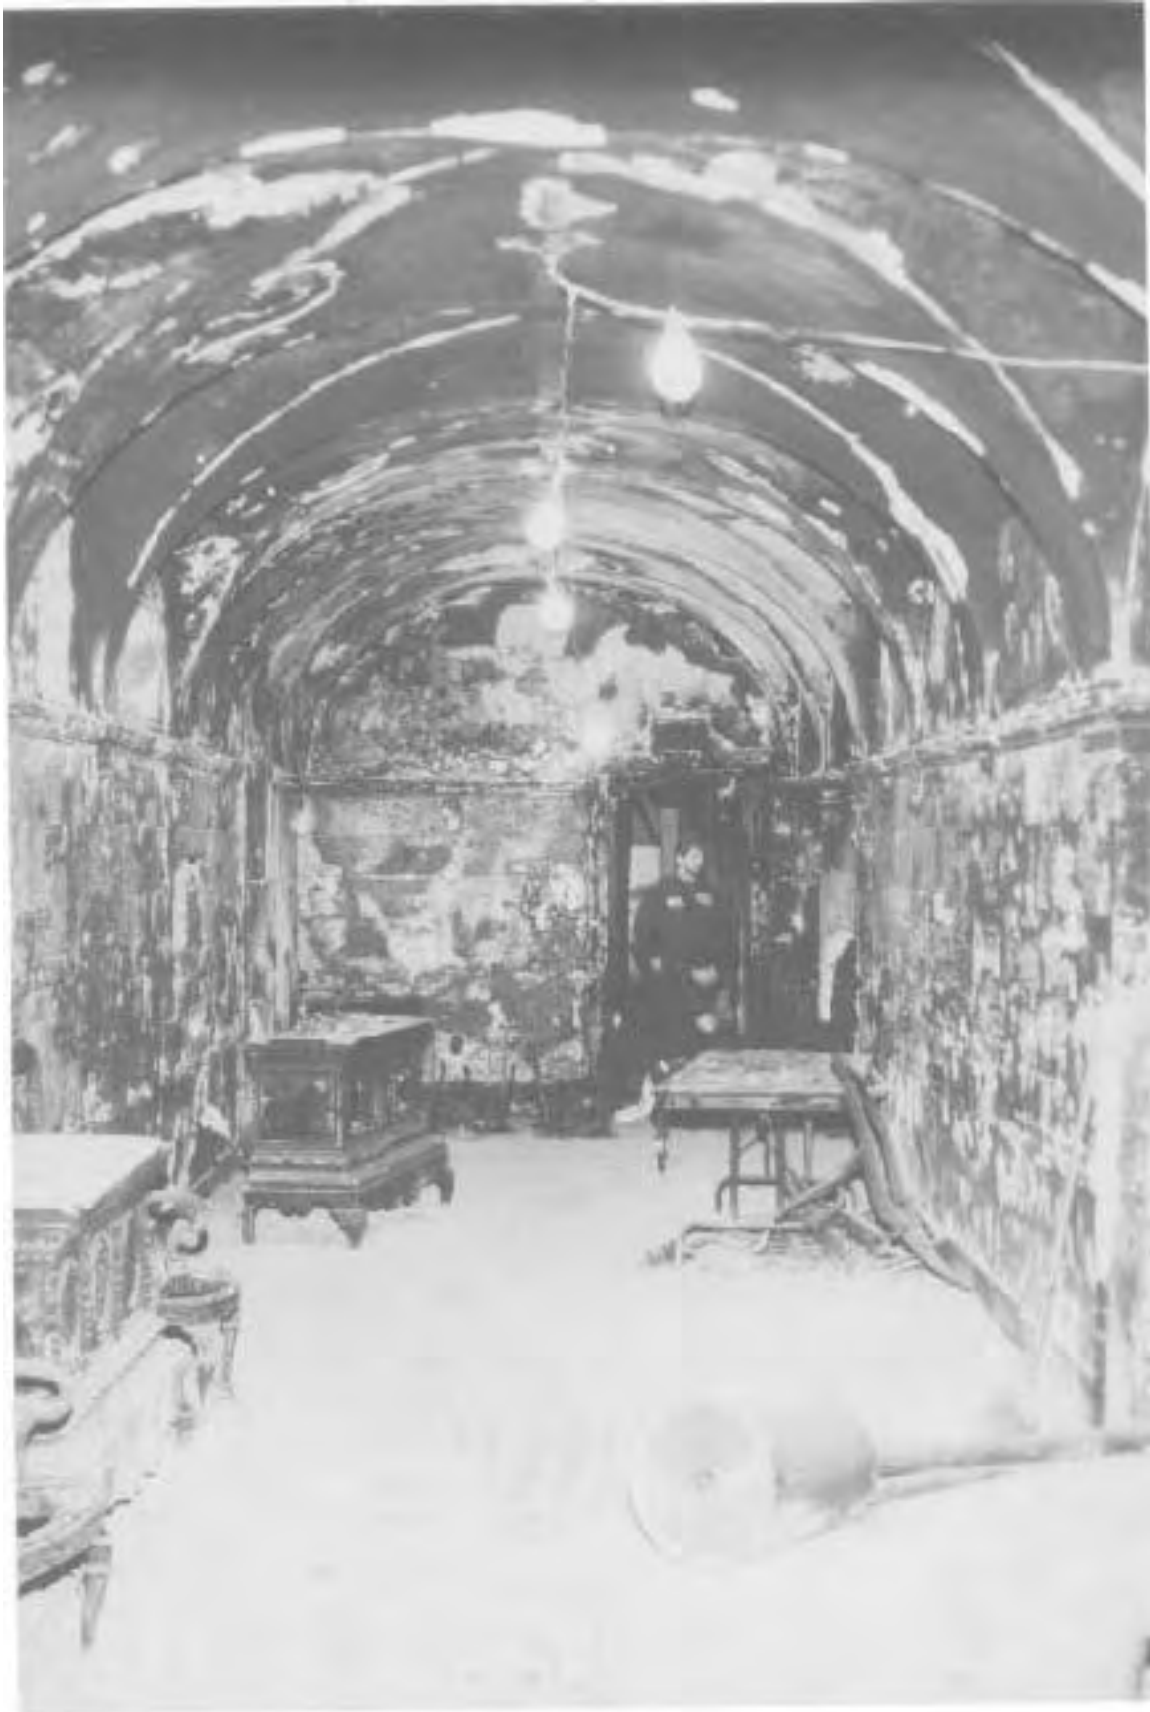
View of fire damage in the fourth floor corridor looking west toward the center of the building.

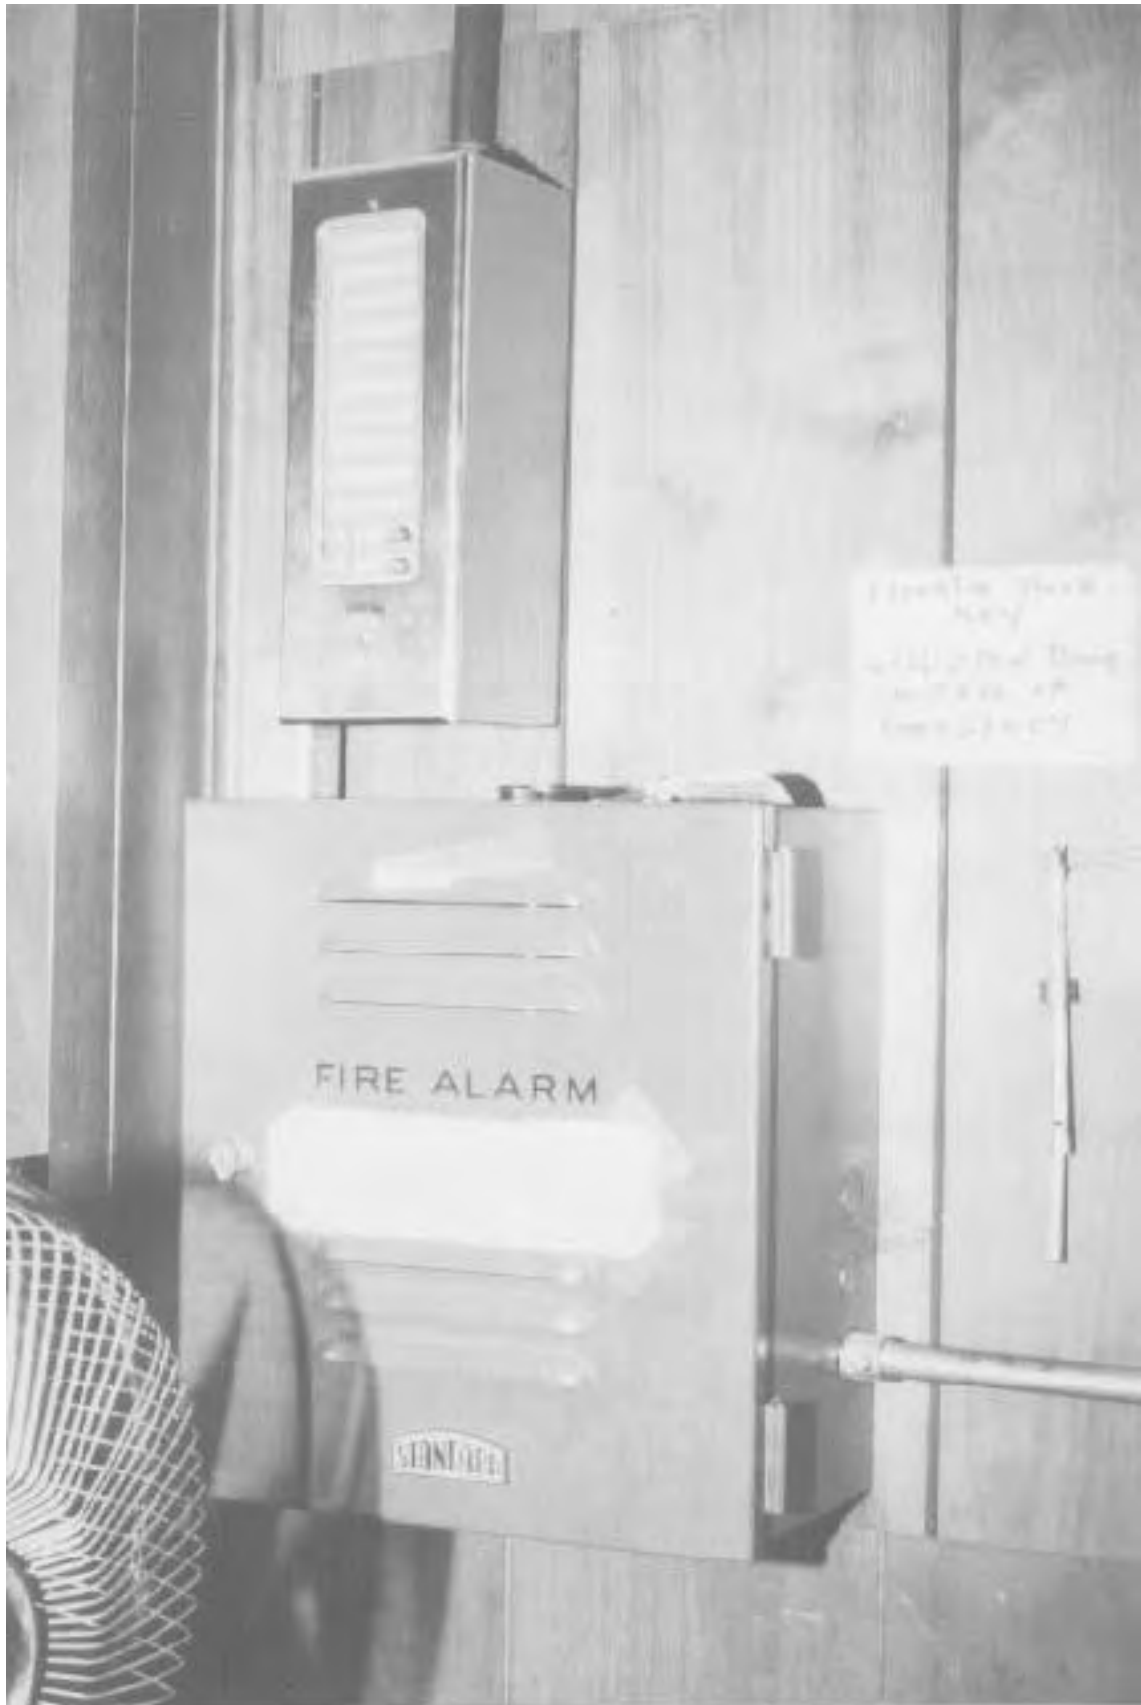
Manual fire alarm system cabinet and tabular fire alarm annunciator above. This system provided power to the fire alarm signals on all floors.

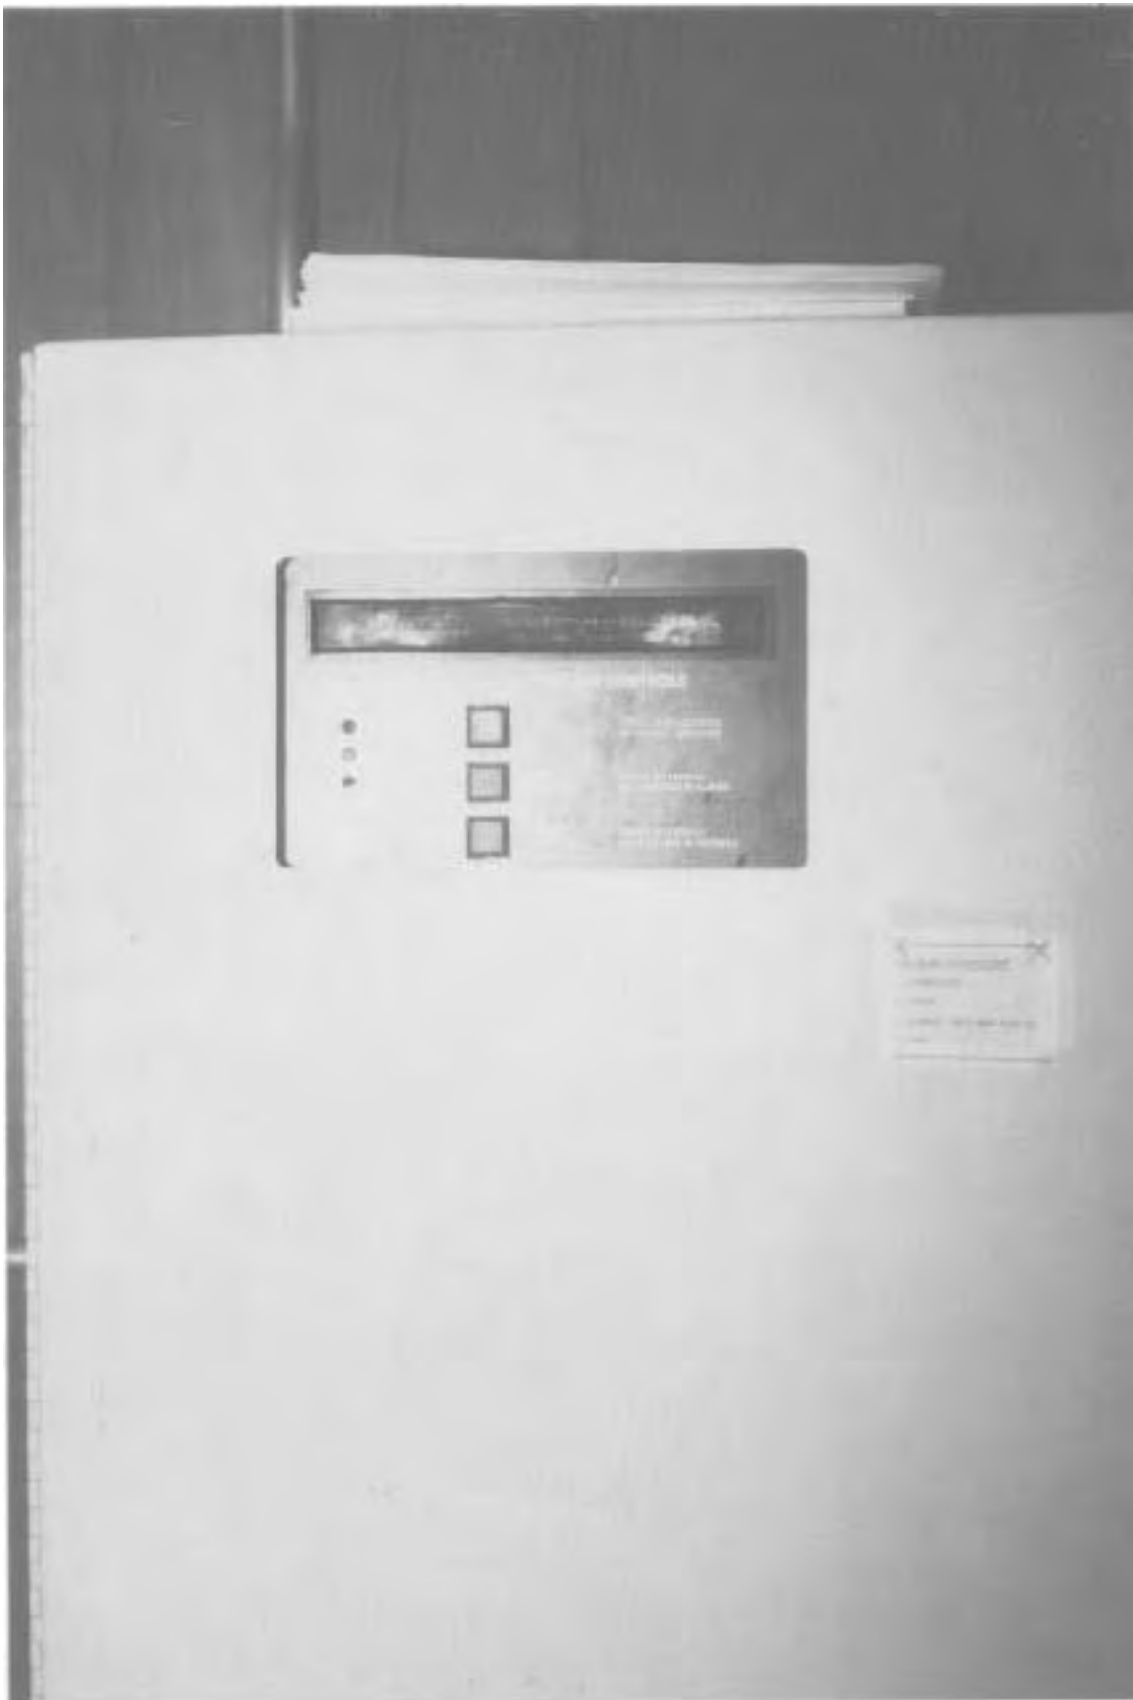
Analog addressable smoke detector control unit. This unit powered and supervised the in-room and basement smoke detectors as well as monitoring the conventional zoned control units which powered the corridor smoke detectors.
