## **Ten-Fatality Board and Care Facility Fire Detroit, Michigan**

# **Ten-Fatality Board and Care Facility Fire Detroit, Michigan (June 2, 1992)**

**Investigated by: Mark Chubb**

**This is Report 066 of the Major Fires Investigation Project conducted  
by TriData Corporation under contract EMW-90-C-3338 to the United  
States Fire Administration, Federal Emergency Management Agency.**

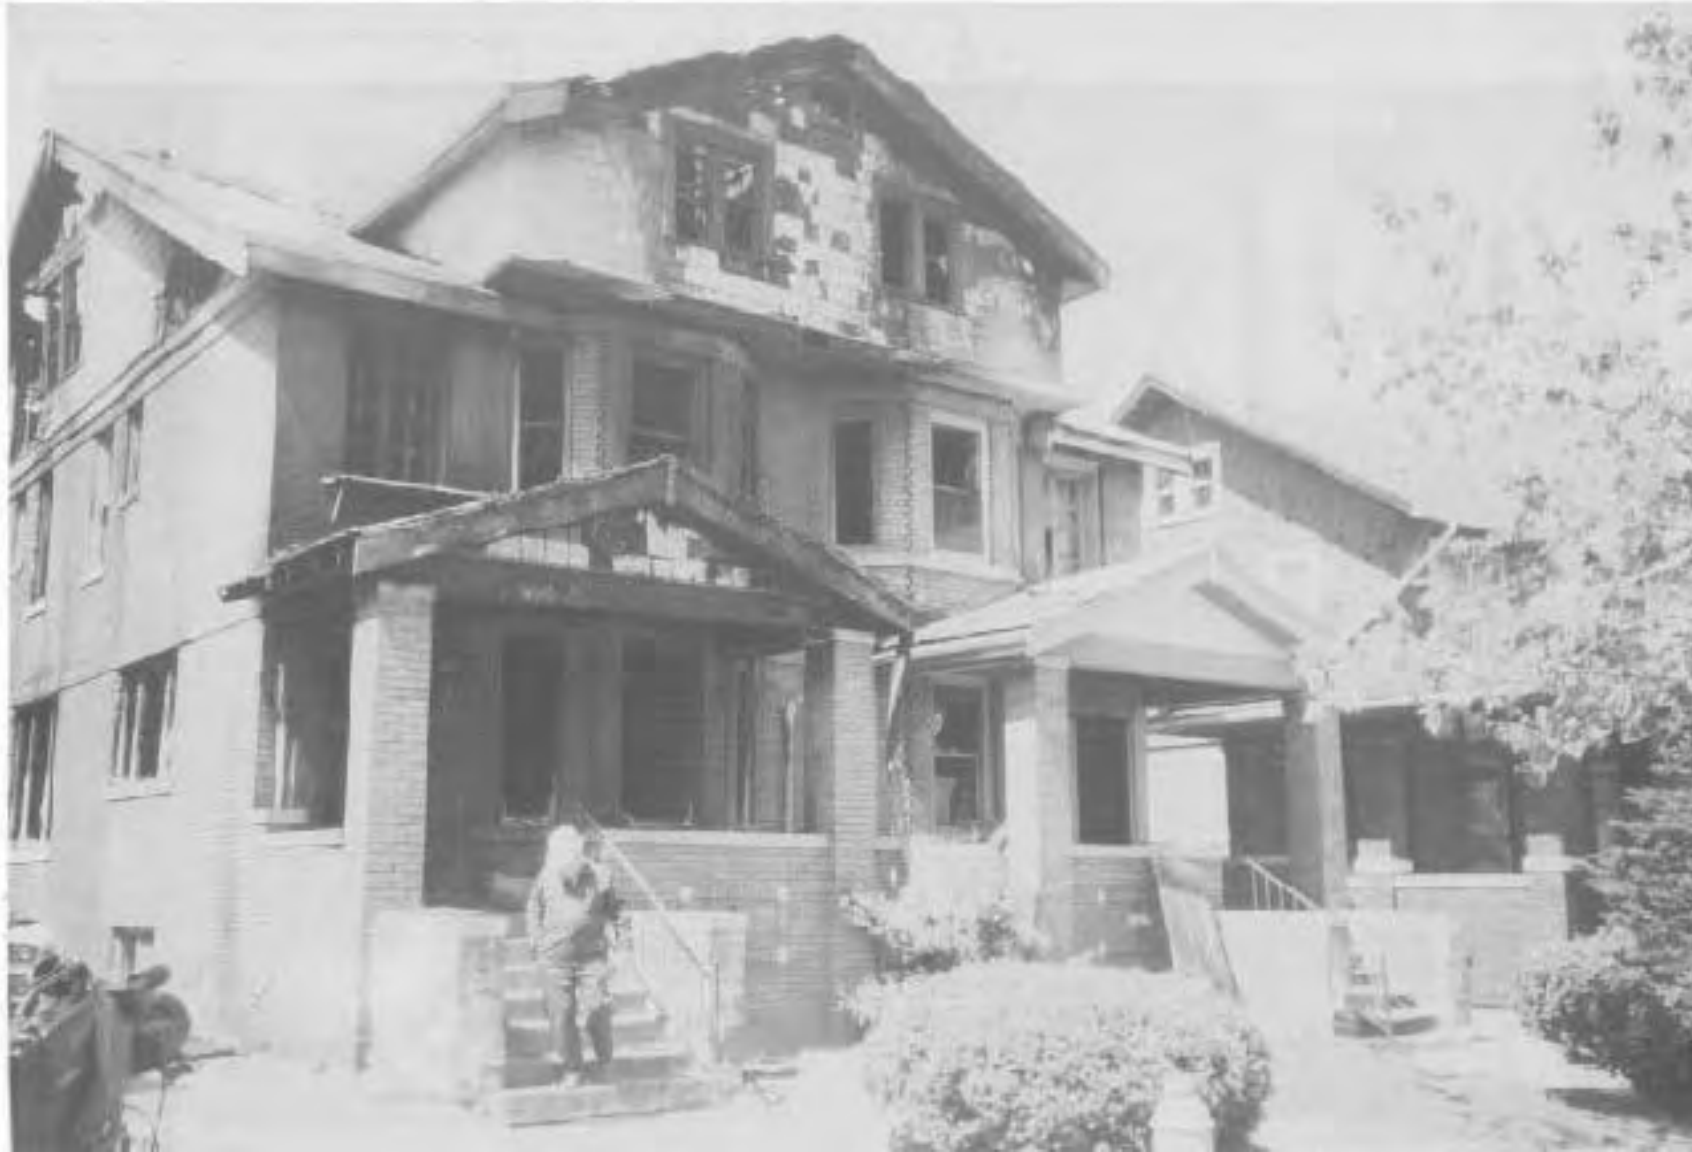
Exterior of 88-90 Pingree Street (structure faces south). Firefighters found fire showing from the first floor west and front, with heavy smoke showing from the second and third floors.

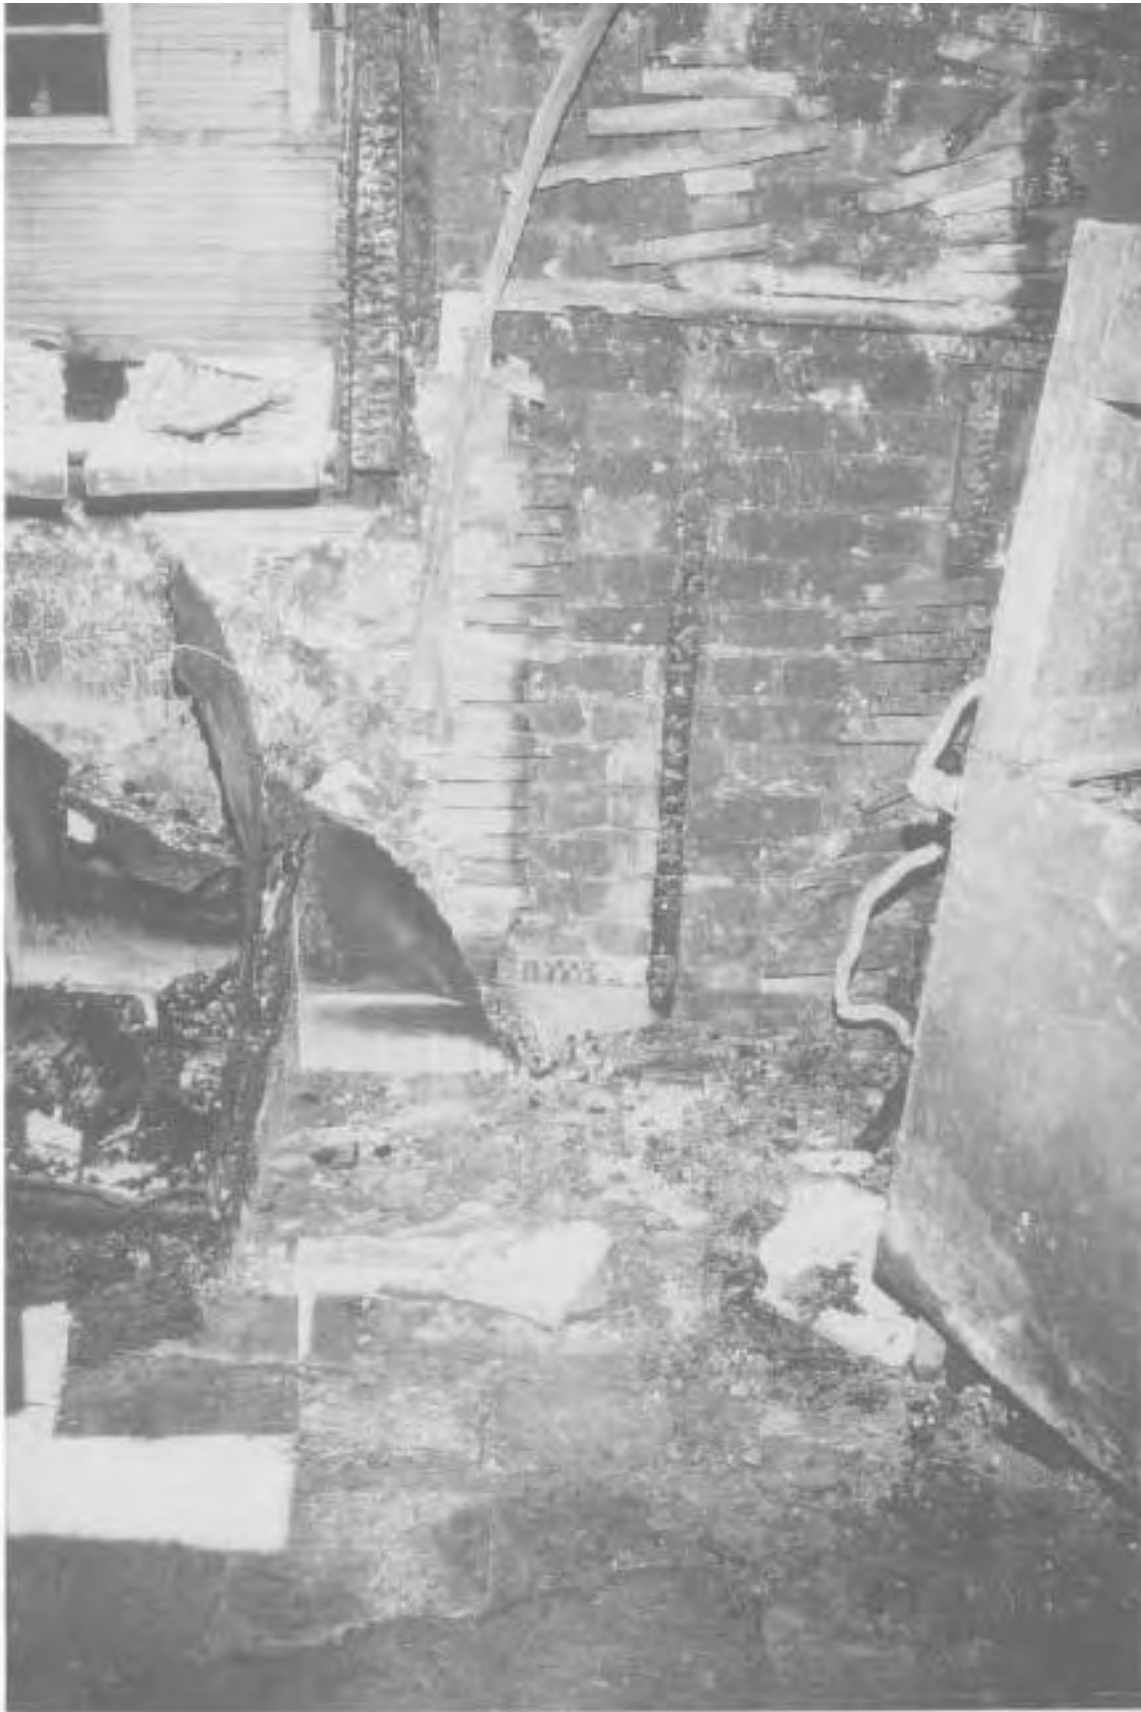
Detroit fire investigators believe the fire started when carelessly discarded smoking materials ignited trash in a kitchen waste receptacle. Investigation revealed that the fire started in the kitchen near the floor between the stove and kitchen counter on the east side of the room. (For floor plans, see Appendix A.) A distinctive V-shaped burn pattern was clearly evident on the outside wall adjacent to this area pointing to the likely point of origin. Combustible interior finish on this wall likely provided additional fuel as the fire grew and spread. Other combustibles, including containers of cooking fat on a shelf directly above the point of origin, 'probably became involved allowing the fire to grow rapidly. The

Point of origin in kitchen showing evidence of low burn near the baseboard.

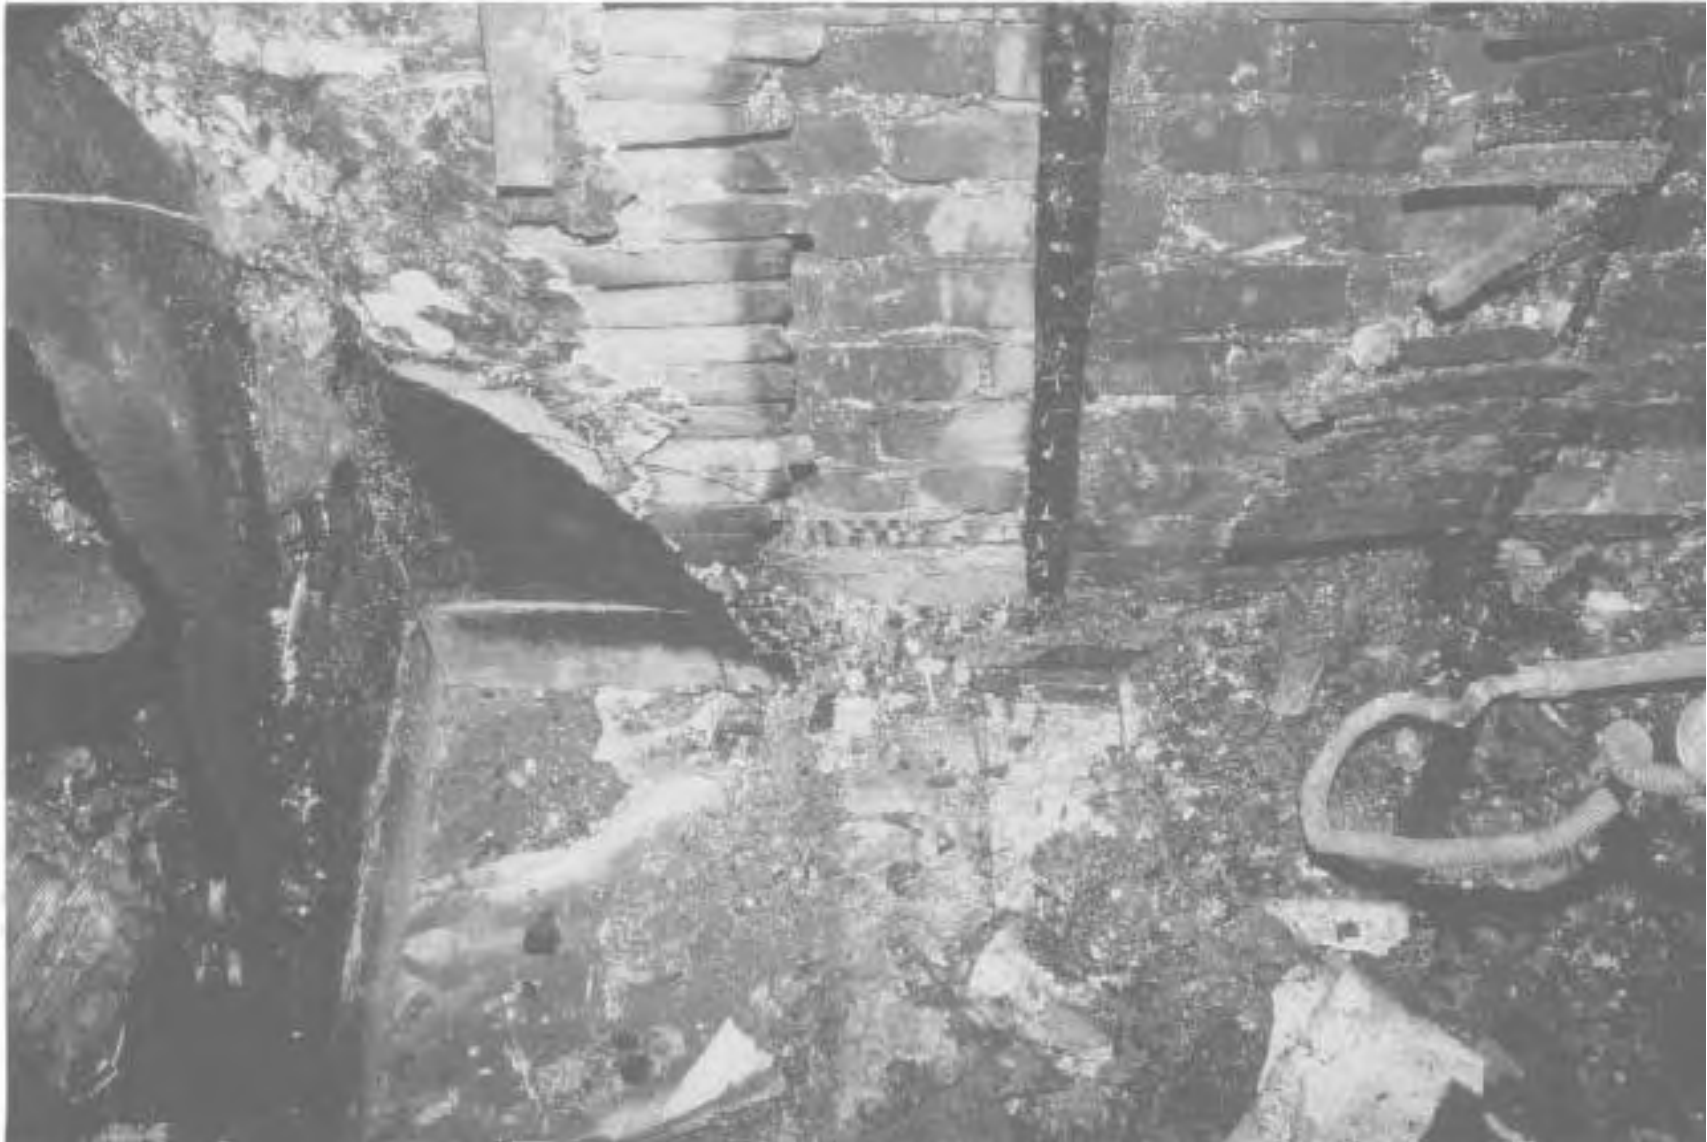
**Interior Finish** - Combustible interior finish had been installed in the kitchen and rear hallways during earlier renovations, possibly at the time the building was converted to an adult foster care facility. In most cases, the wall finish materials consisted of 1/8-inch plywood paneling. Investigators also uncovered 1/2-inch particle board behind the stove in the kitchen. Paneling was also found elsewhere in the occupancy, usually where there was evidence of remodeling work to cover cosmetic defects in the original construction. These materials generally have flame spread index ratings between 100 and 150, and appeared to contribute to fire growth in the kitchen and fire spread elsewhere in the occupancy.

Close-up of the point of origin. A small triangular section of the particle board installed over the plaster and lath remains in the lower center portion of the picture.

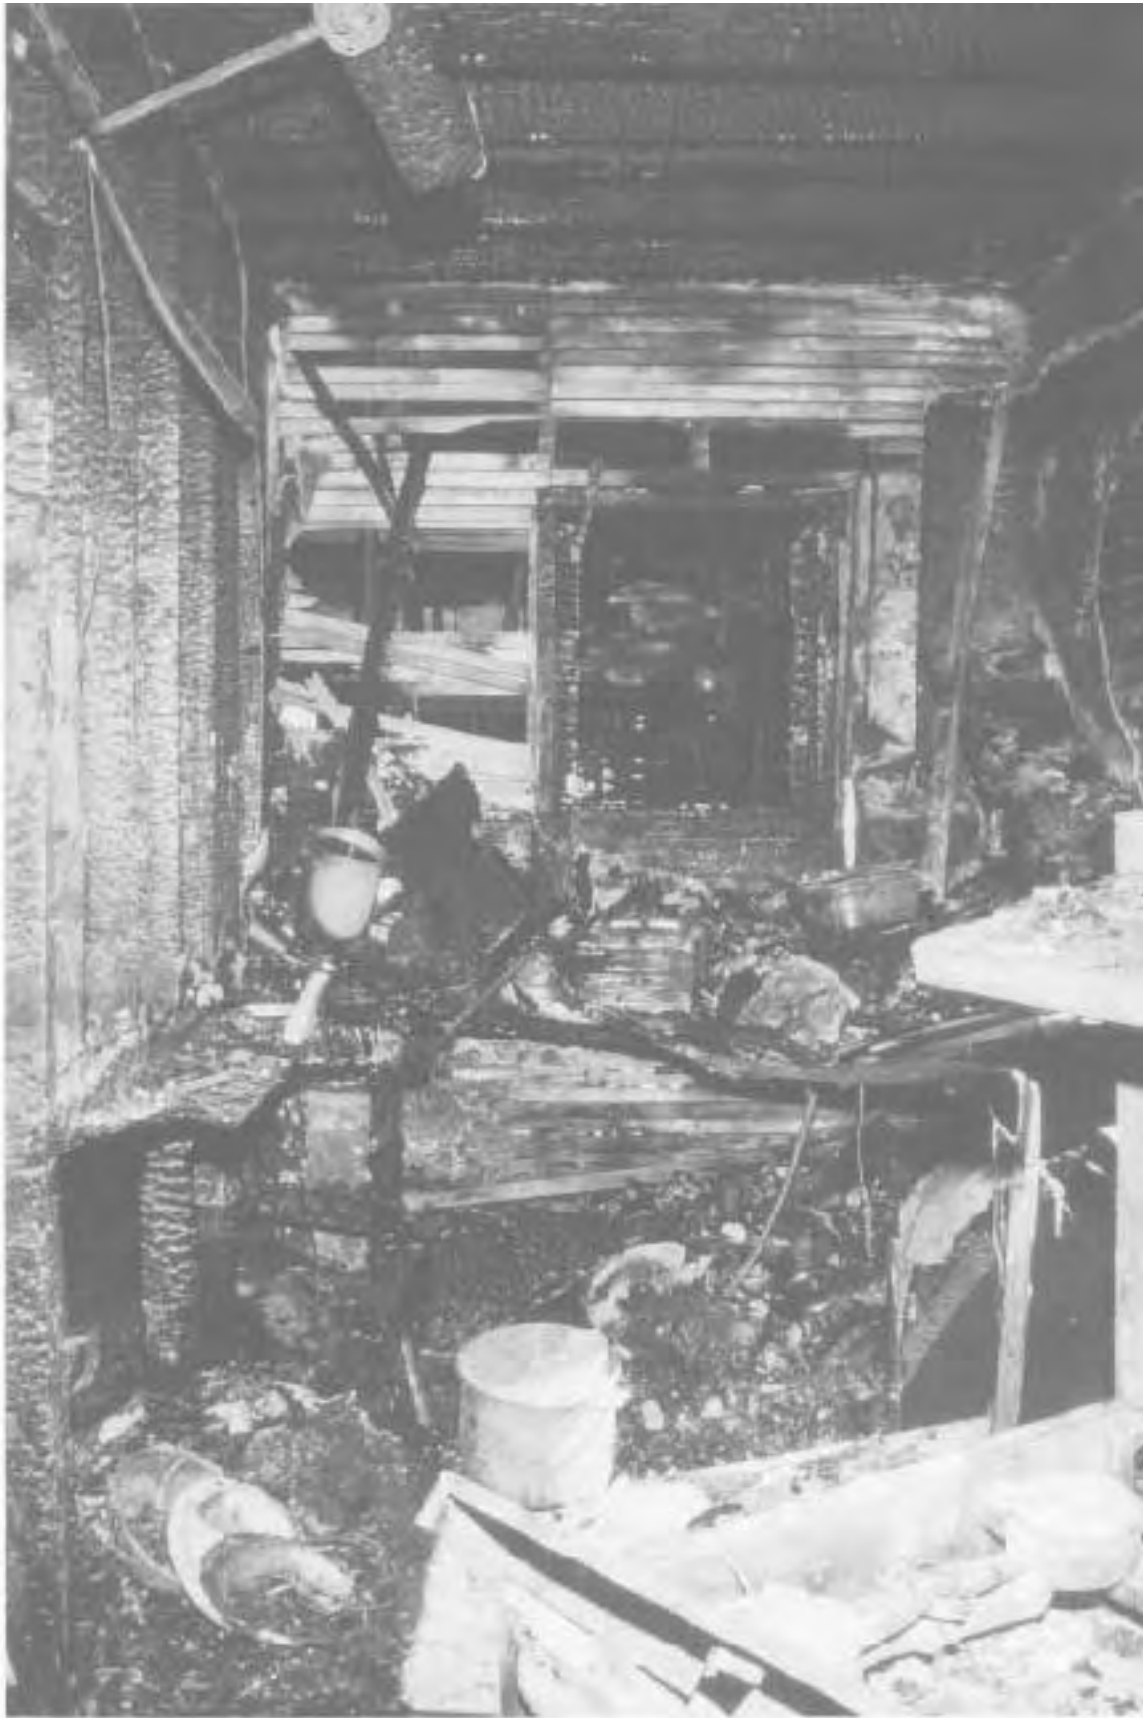
Sometime shortly after 2:00 a.m., Mr. Fluckes reportedly heard sounds in the kitchen and rose to investigate.’ Approaching the rear of the dwelling, he observed a large fire in the kitchen through a pass-through opening to the dining room. When he arrived in the rear corridor at the open door to the kitchen, he reportedly attempted to enter to fight the fire, beating back the flames with his hands in an unsuccessful attempt to reach the fire extinguisher in the northeast corner of the room.

View from the kitchen looking south through the pass-through window into the dining room. The fire was observed through this window by Mr. Fluckes and Mr. Gregory.

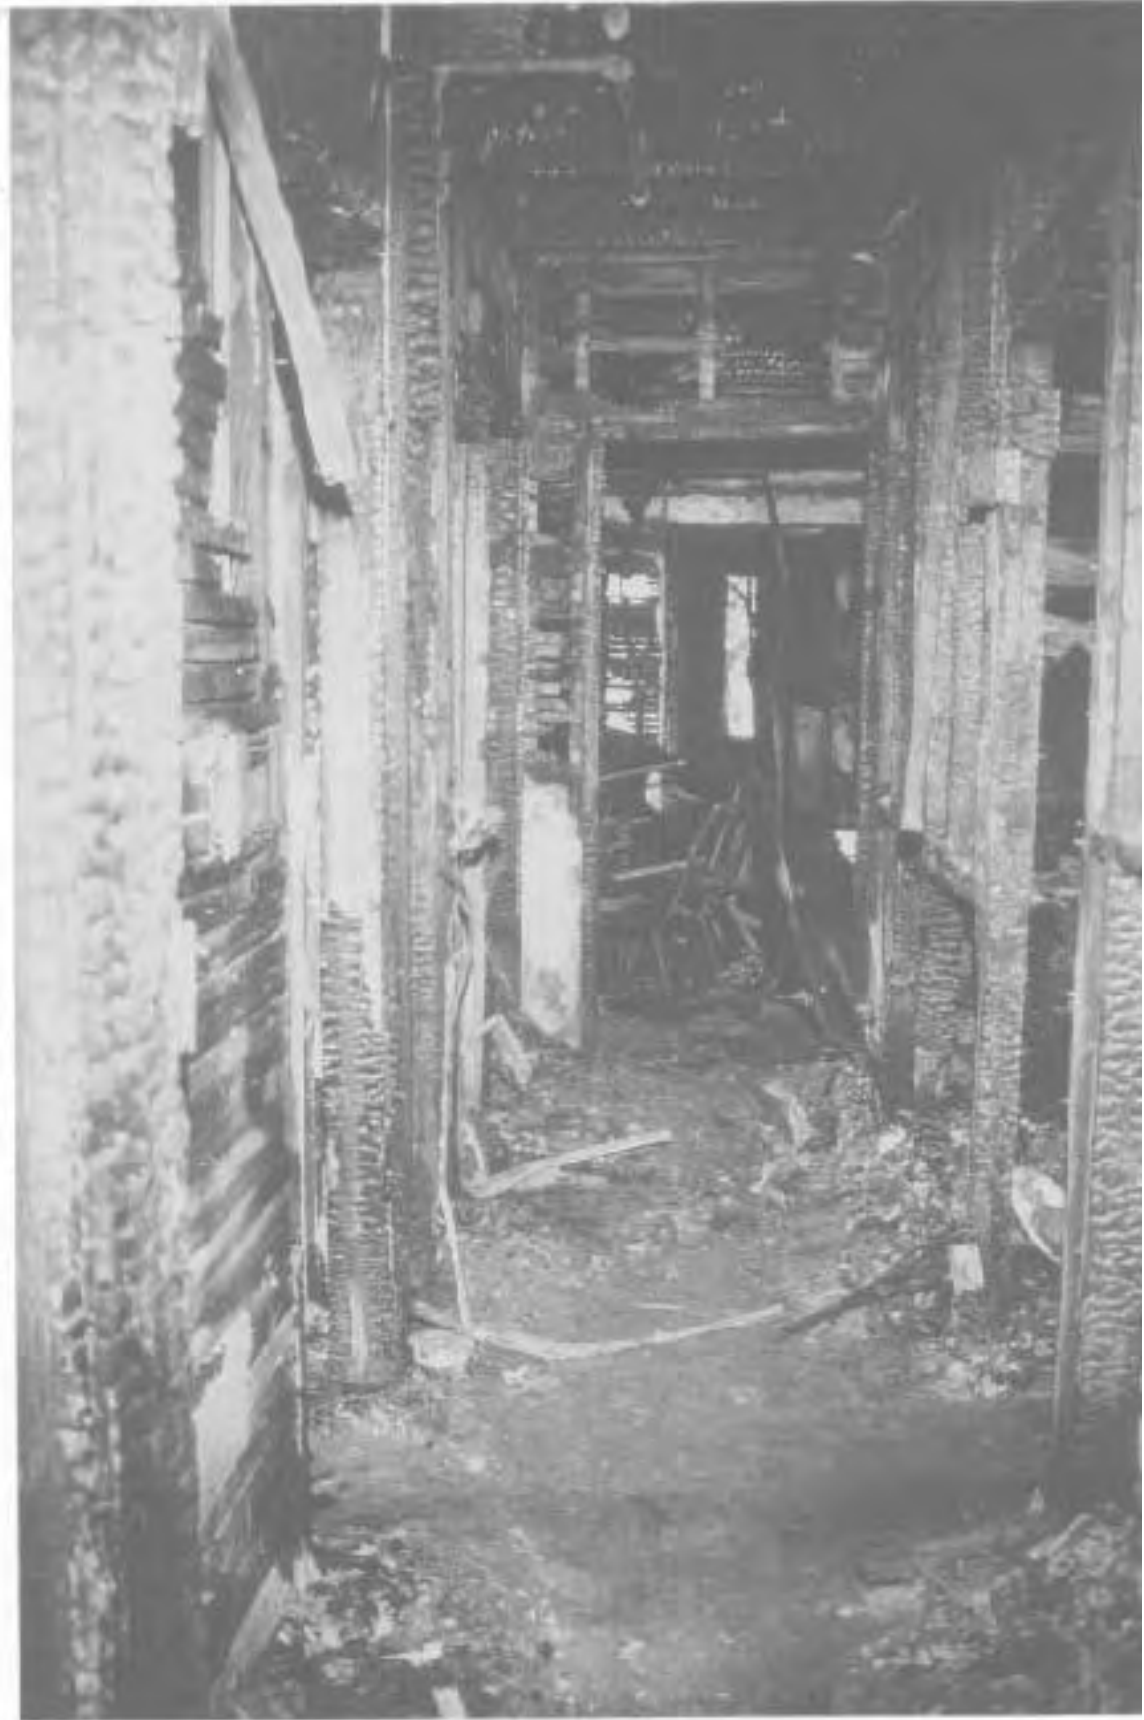
View looking south down the rear corridor adjacent to the kitchen showing heavy damage to the wall studs near the floor level. Also visible through the door opening at the south end of the corridor is heavy fire damage in the dining room.

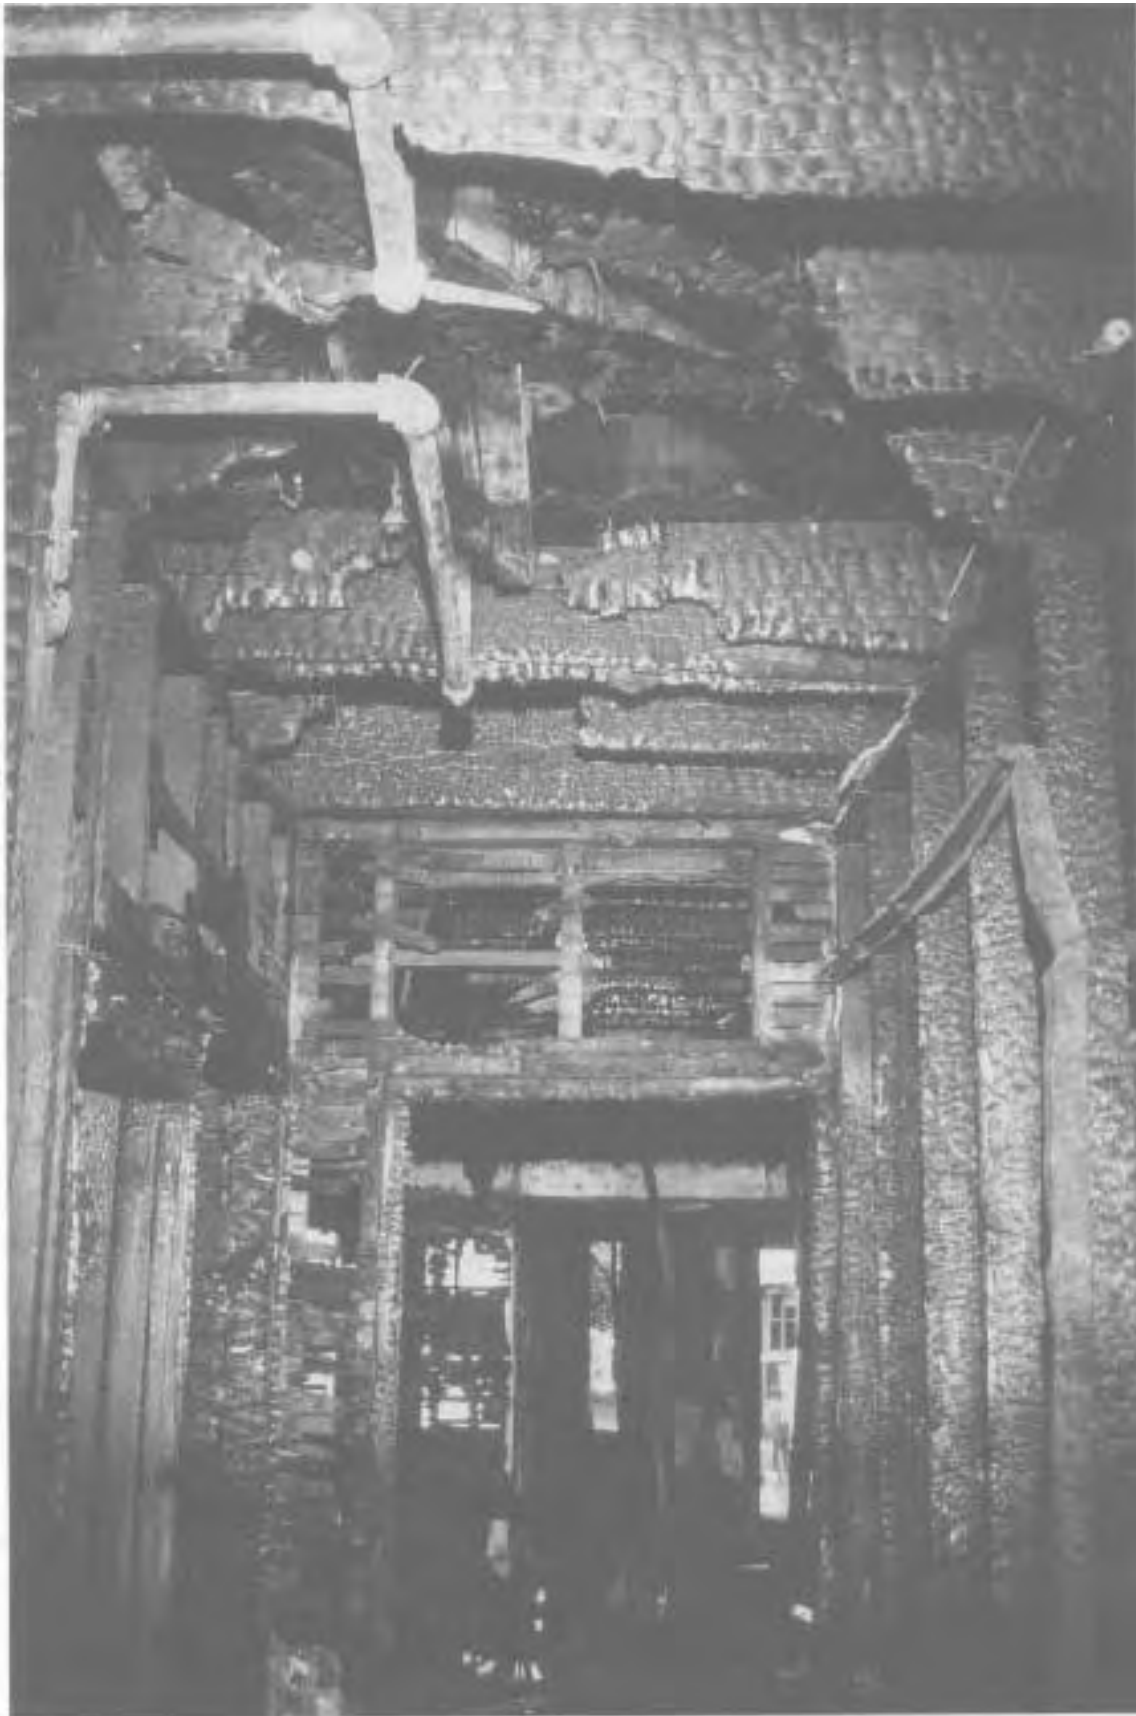
Openings in the party wall and voids in the floor and wall assemblies permitted the fire to spread vertically and horizontally after flashover occurred in the kitchen. Combustible structural elements, including floor joists and wall studs, exposed when the suspended ceiling in the kitchen and first floor rear corridor failed, fueled the fire as it advanced throughout the dwelling. Before firefighters brought the fire under control, approximately half of the third floor at the rear of the building the roof had collapsed.

Close-up of fire damage to the ceiling area in rear corridor next to kitchen. Pipe penetrations were one avenue of fire and smoke spread to the second floor.

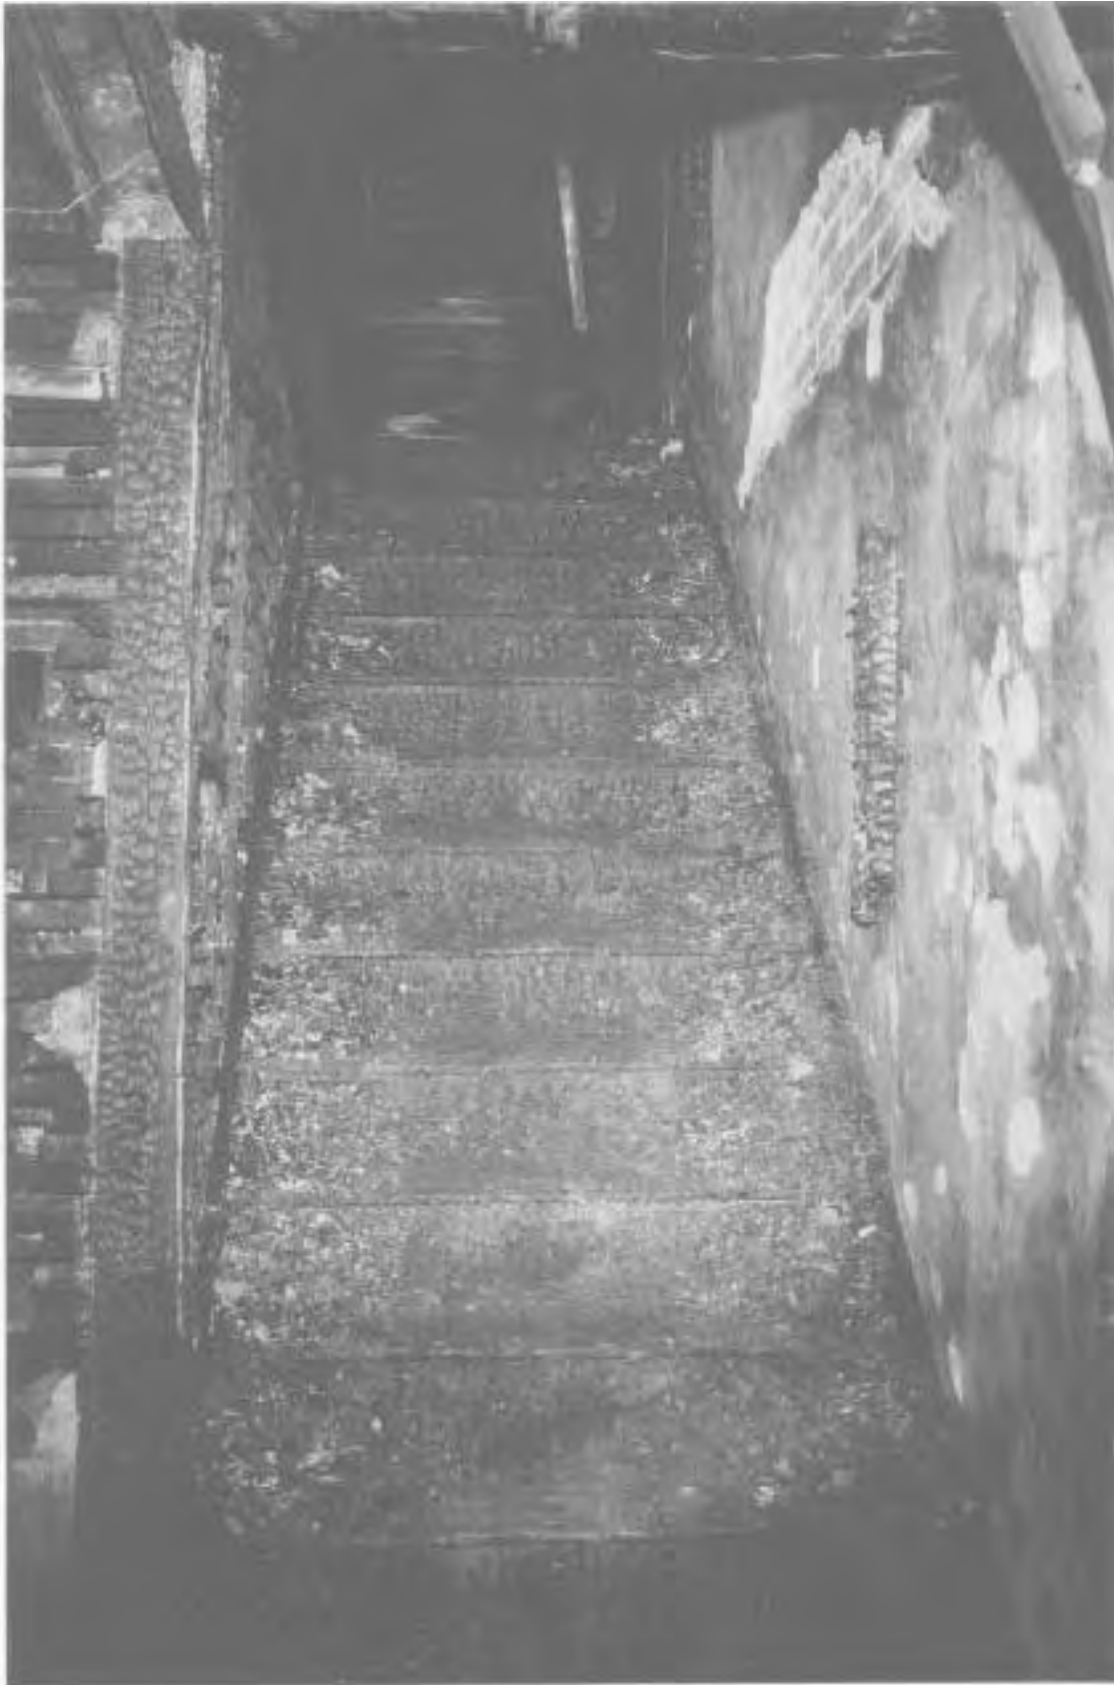
West stairway leading from the first floor living room to the second floor shows extensive charring to the stair risers, evidence of intense radiant heat exposure as the fire spread vertically cutting off the egress path.

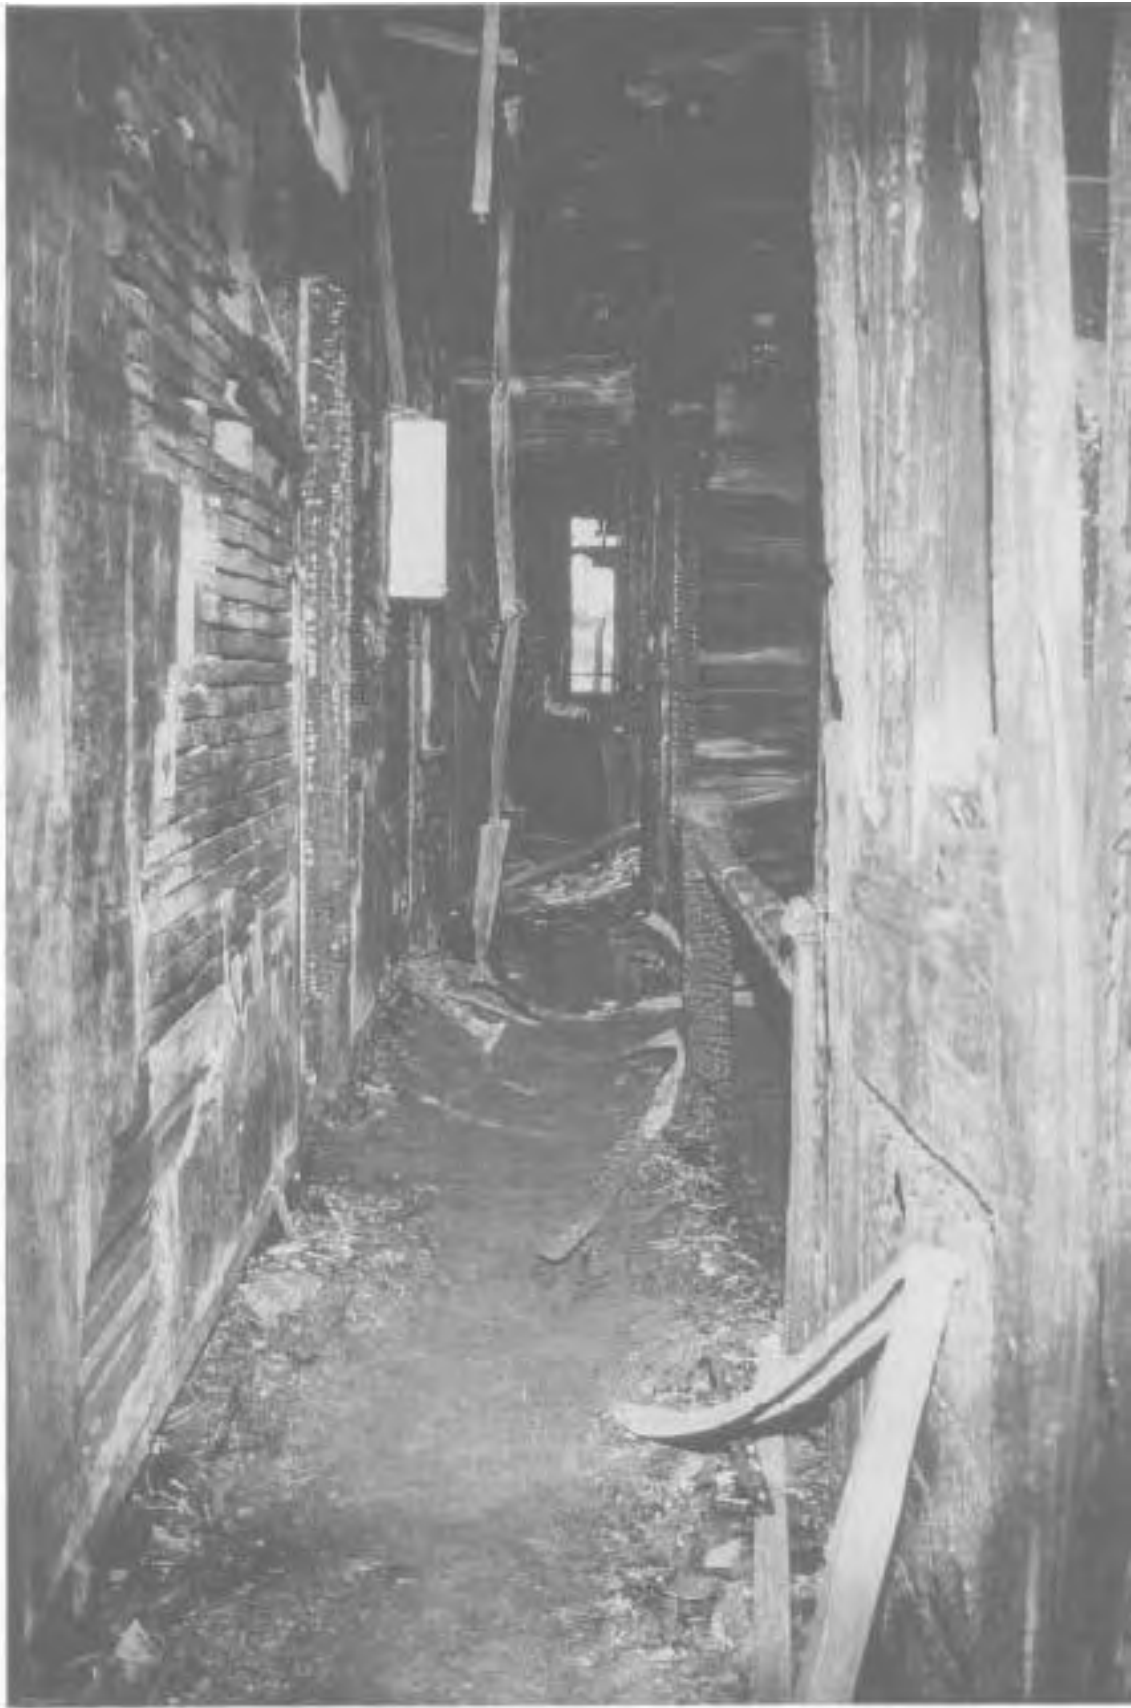
Second floor west corridor looking south shows the heavy fire damage resulting from vertical fire spread via the front stairway.

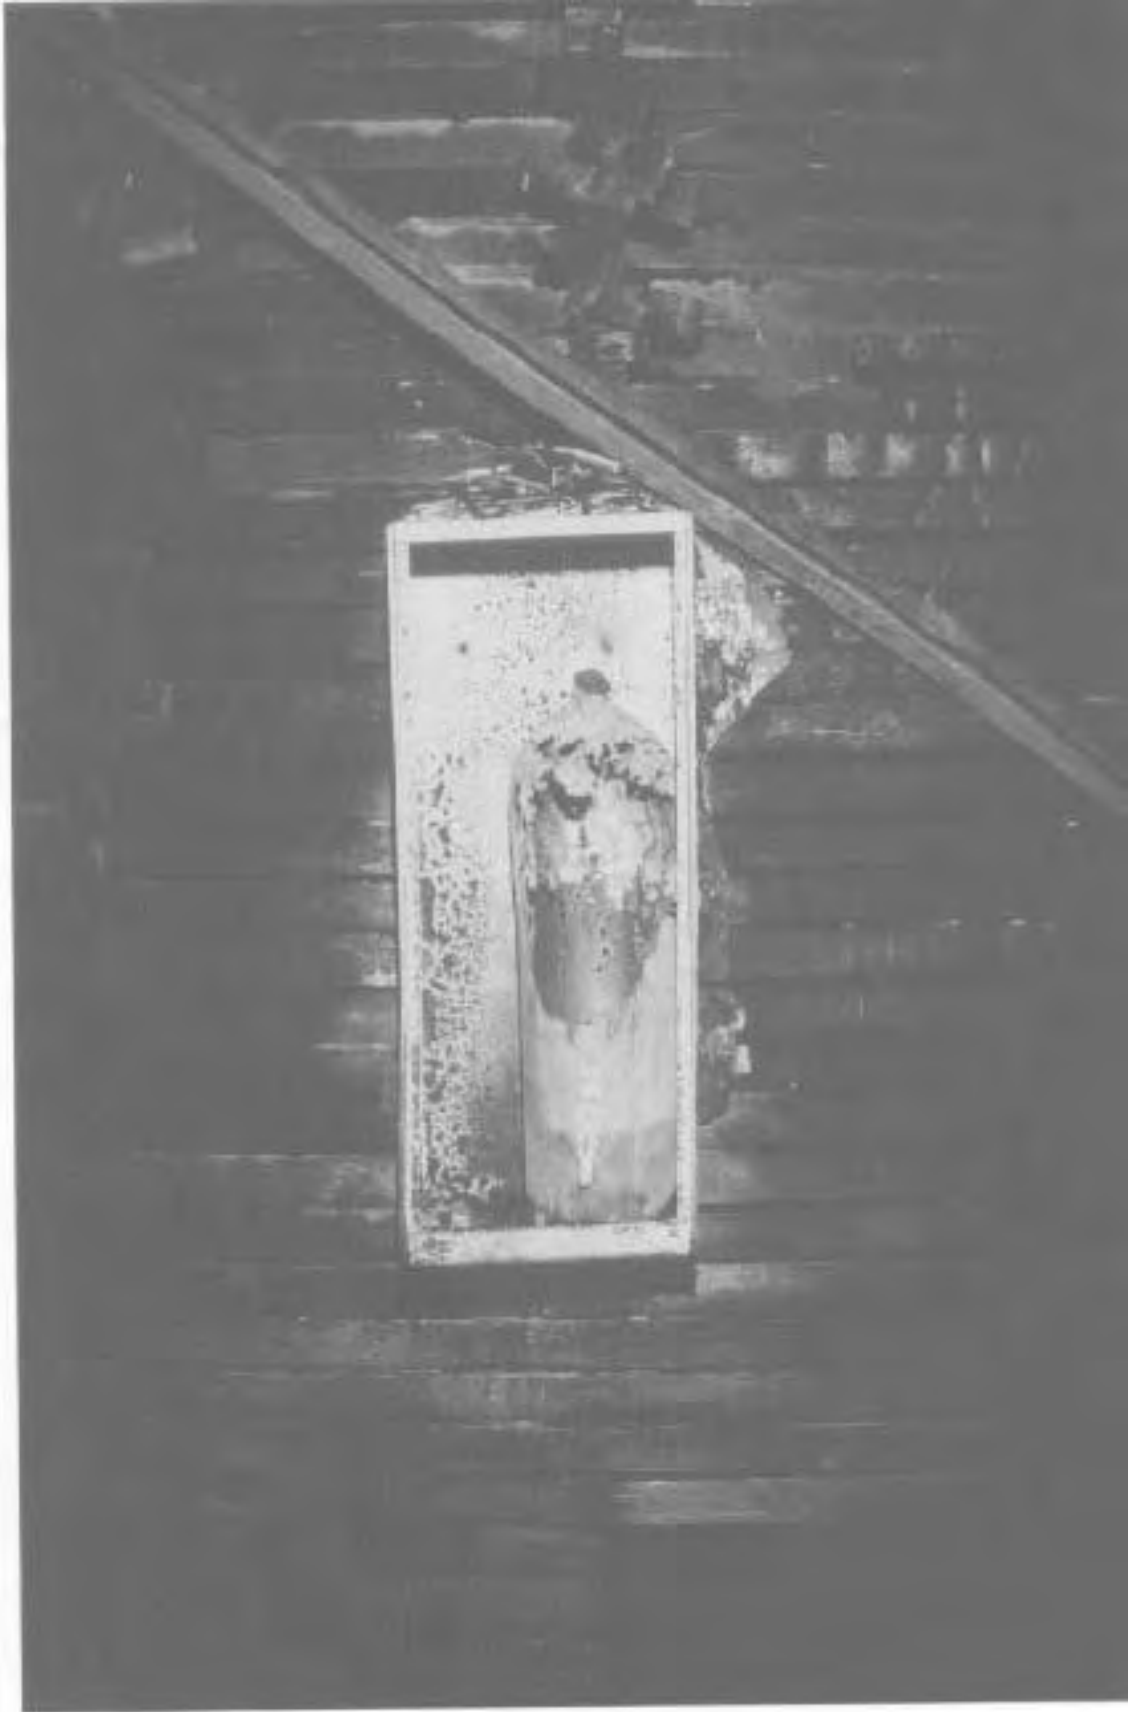
The remains of a melted aluminum fire extinguisher shell in a cabinet on the second floor west side.

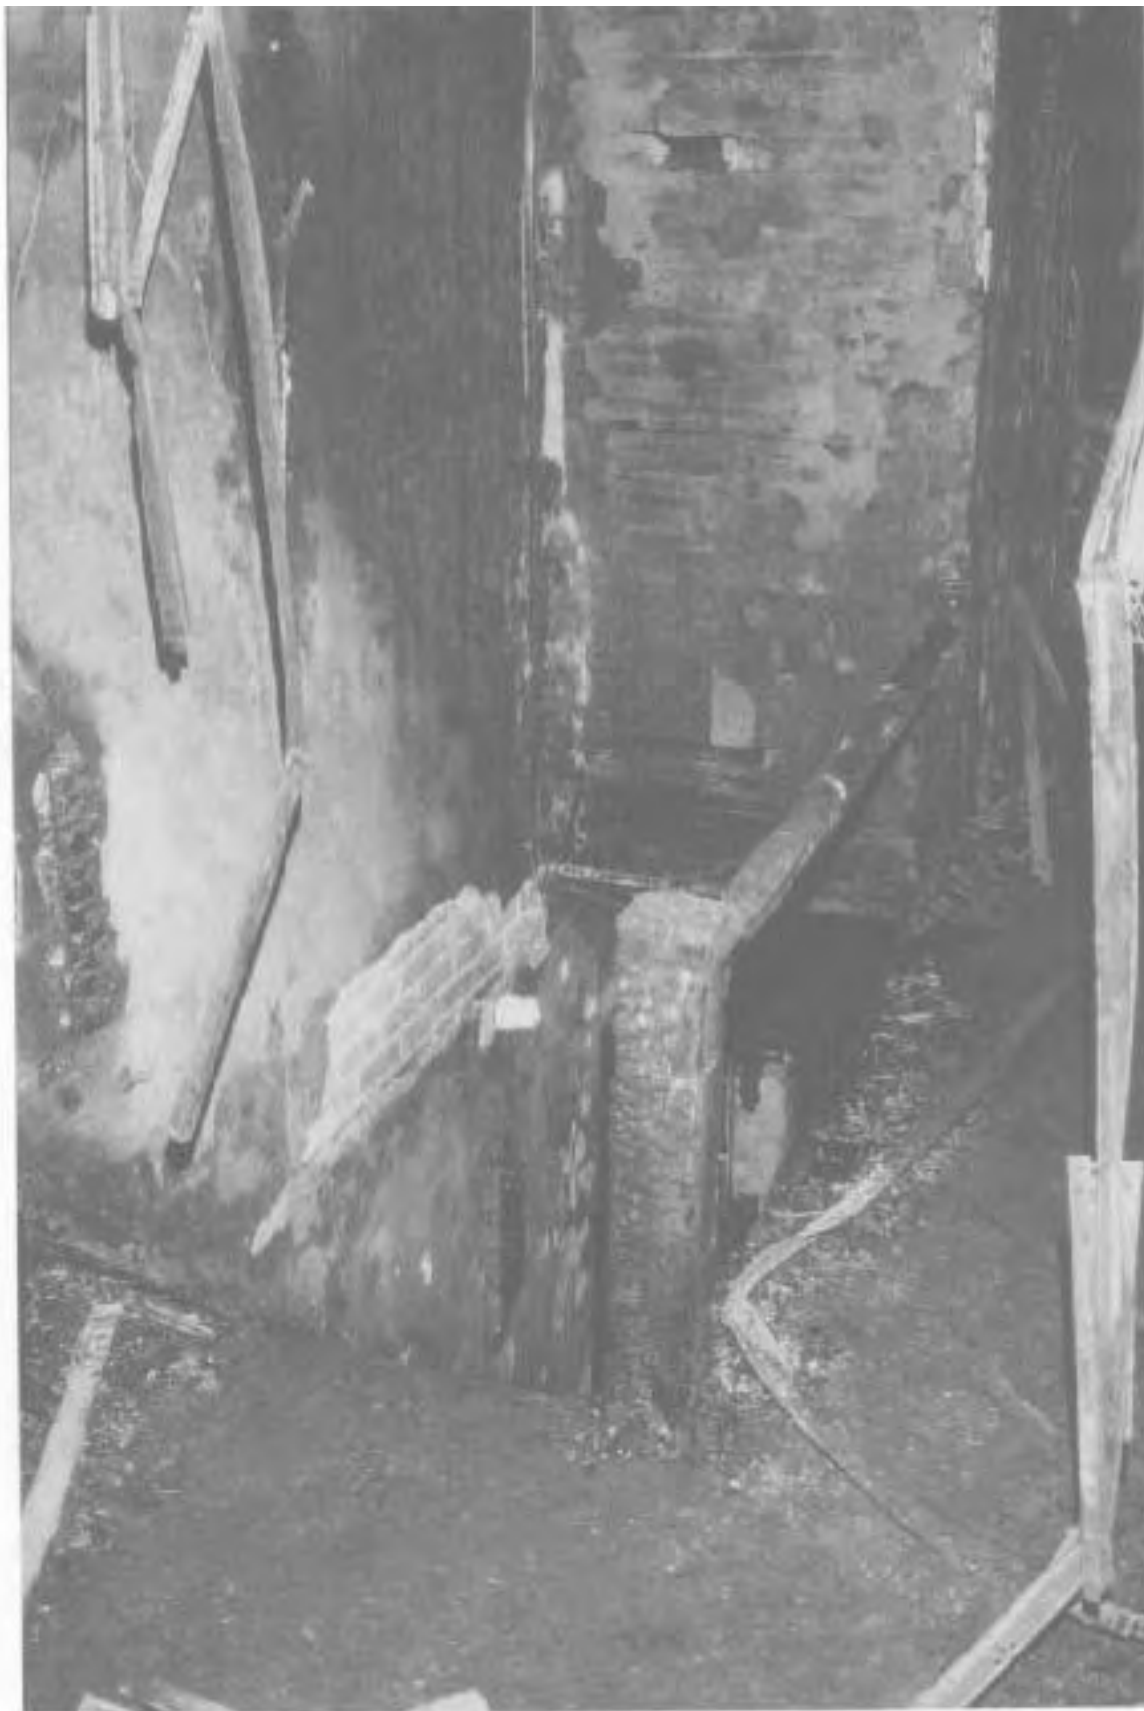
West side rear stairway looking down from second floor. Extensive charring and plaster spalling provide evidence of the fire spread which cutoff access to both the front and rear stairways.

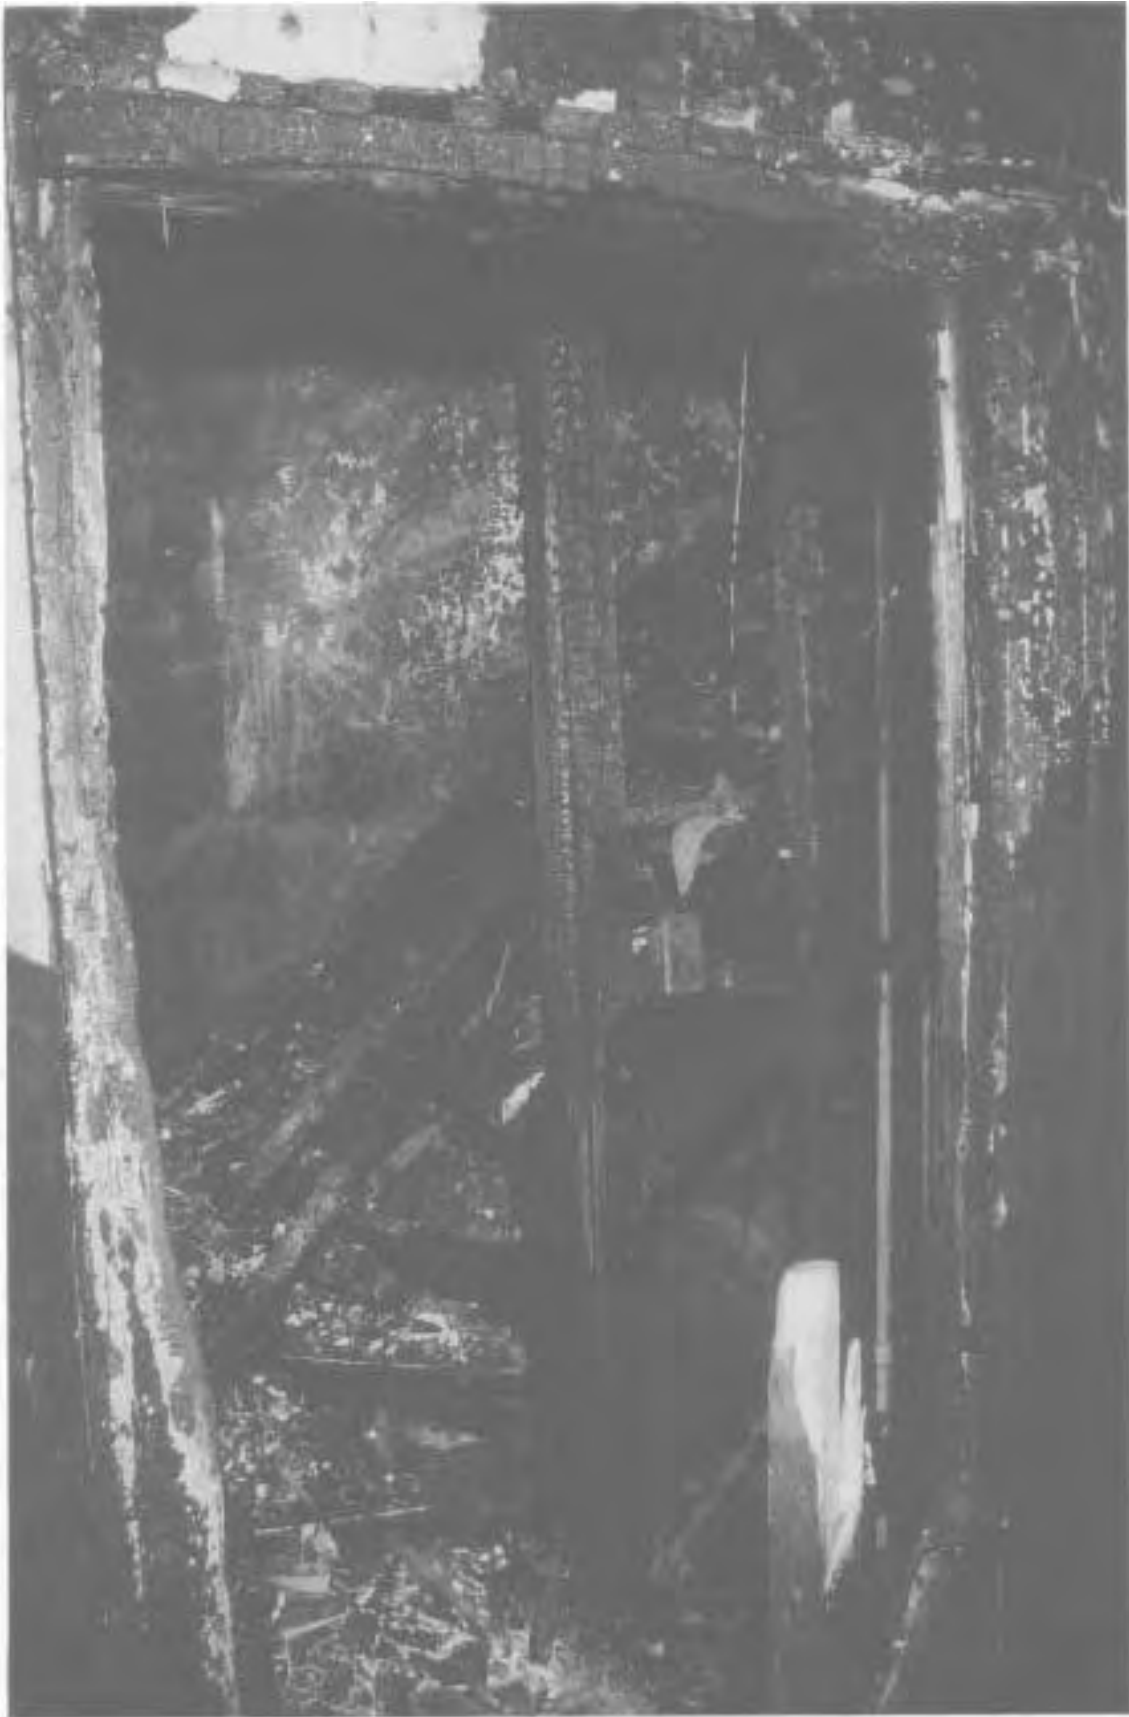
View of west side stairway leading to the third floor. Once again, heavy fire damage to the door lintel and framing indicate that fire spread via this route was extensive.
