## **Ten-Fatality Board and Care Facility Fire Detroit, Michigan**

# **Ten-Fatality Board and Care Facility Fire Detroit, Michigan (June 2, 1992)**

**Investigated by: Mark Chubb**

**This is Report 066 of the Major Fires Investigation Project conducted  
by TriData Corporation under contract EMW-90-C-3338 to the United  
States Fire Administration, Federal Emergency Management Agency.**

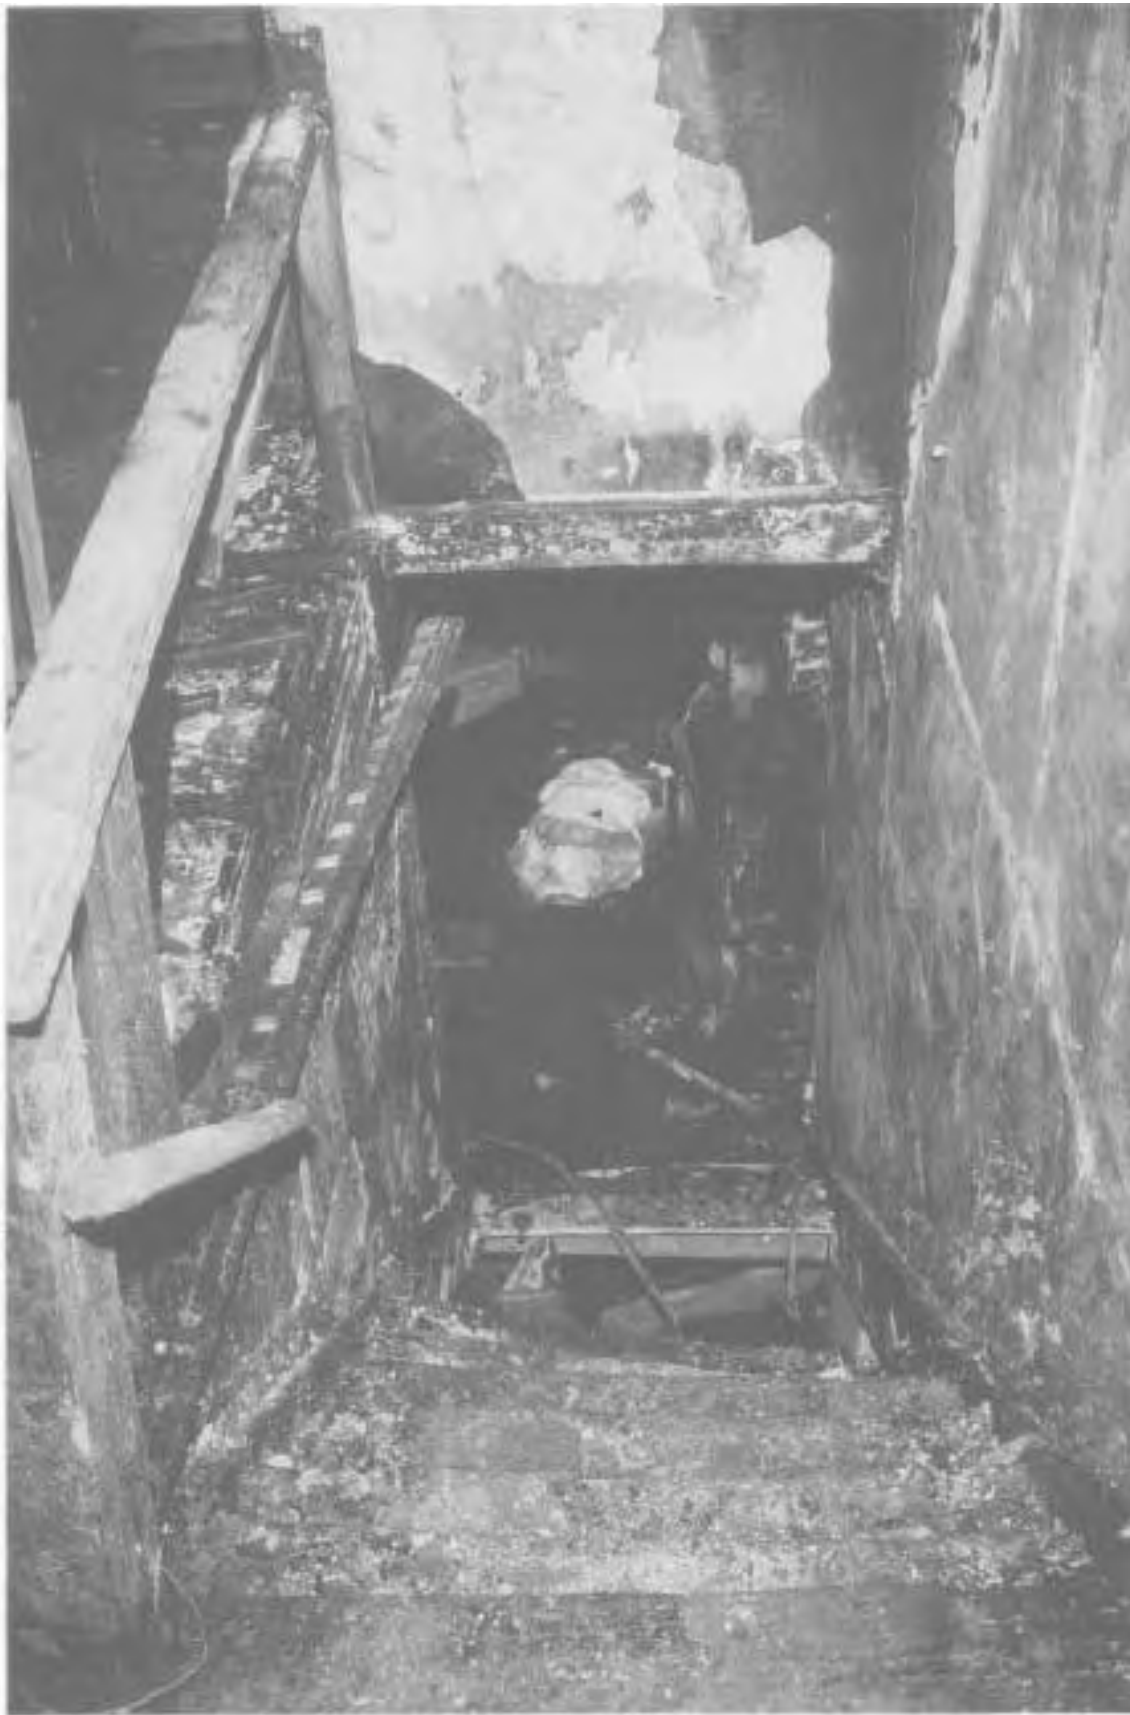
View of east side front stairway looking down from second floor. Although heat damage is slightly less intense here, evidence of extensive heat and smoke spread is clear.
