Technical Report Series

Wood Truss Roof Collapse Claims Two Firefighters Memphis, Tennessee

Wood Truss Roof Collapse Claims Two Firefighters (December 26, 1992)

Investigated by: J. Gordon Routley

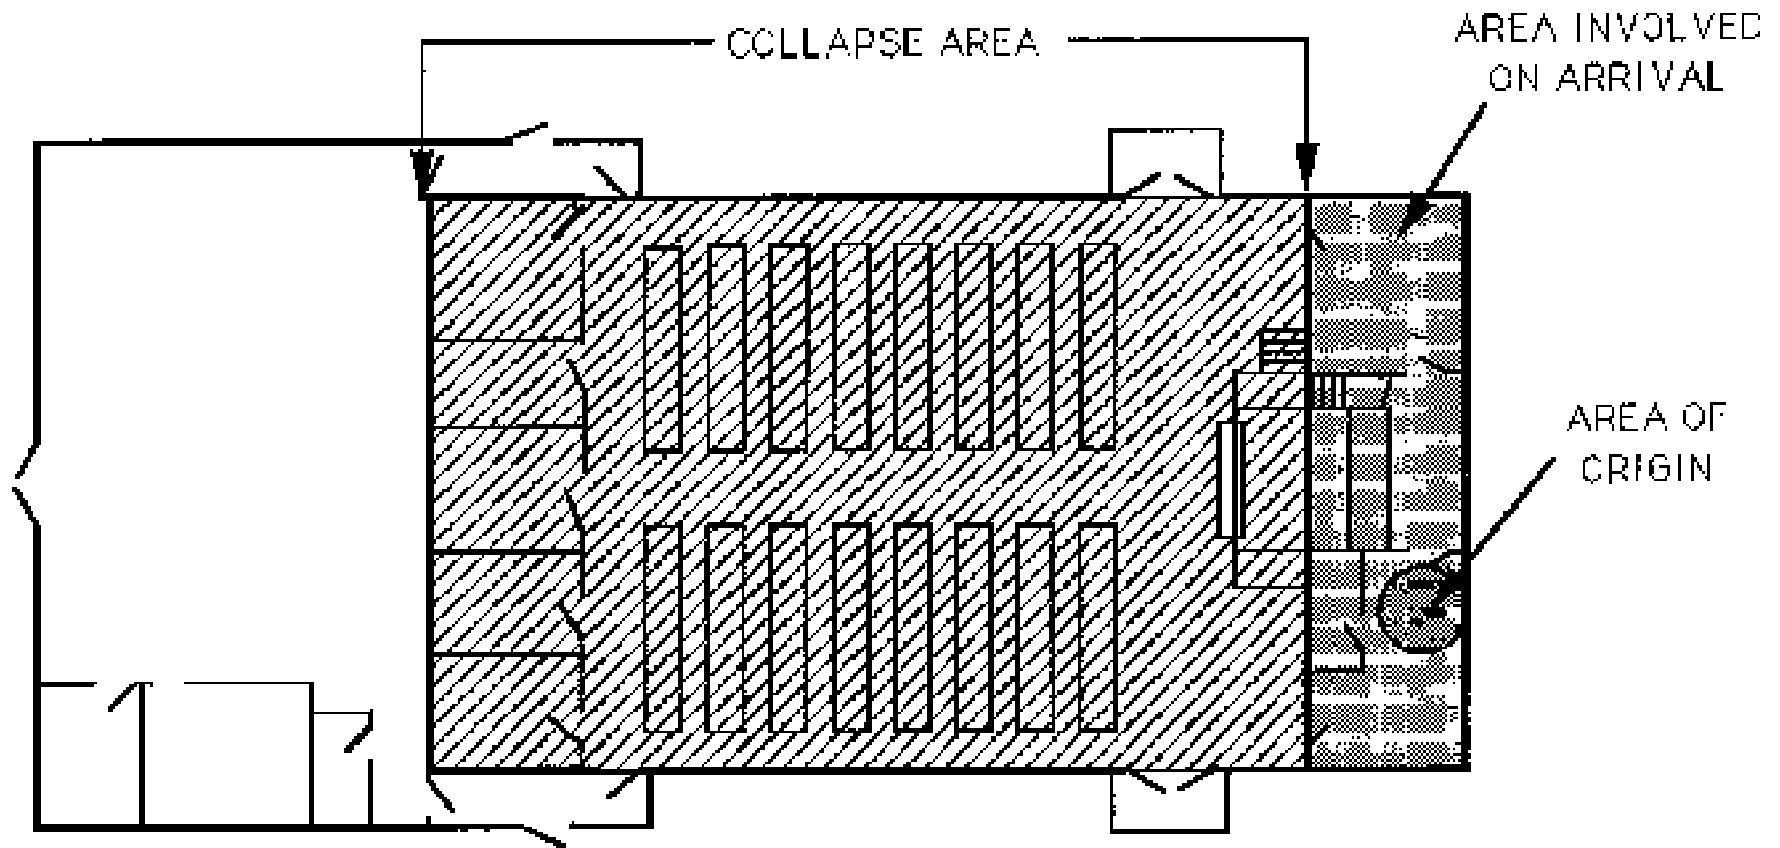
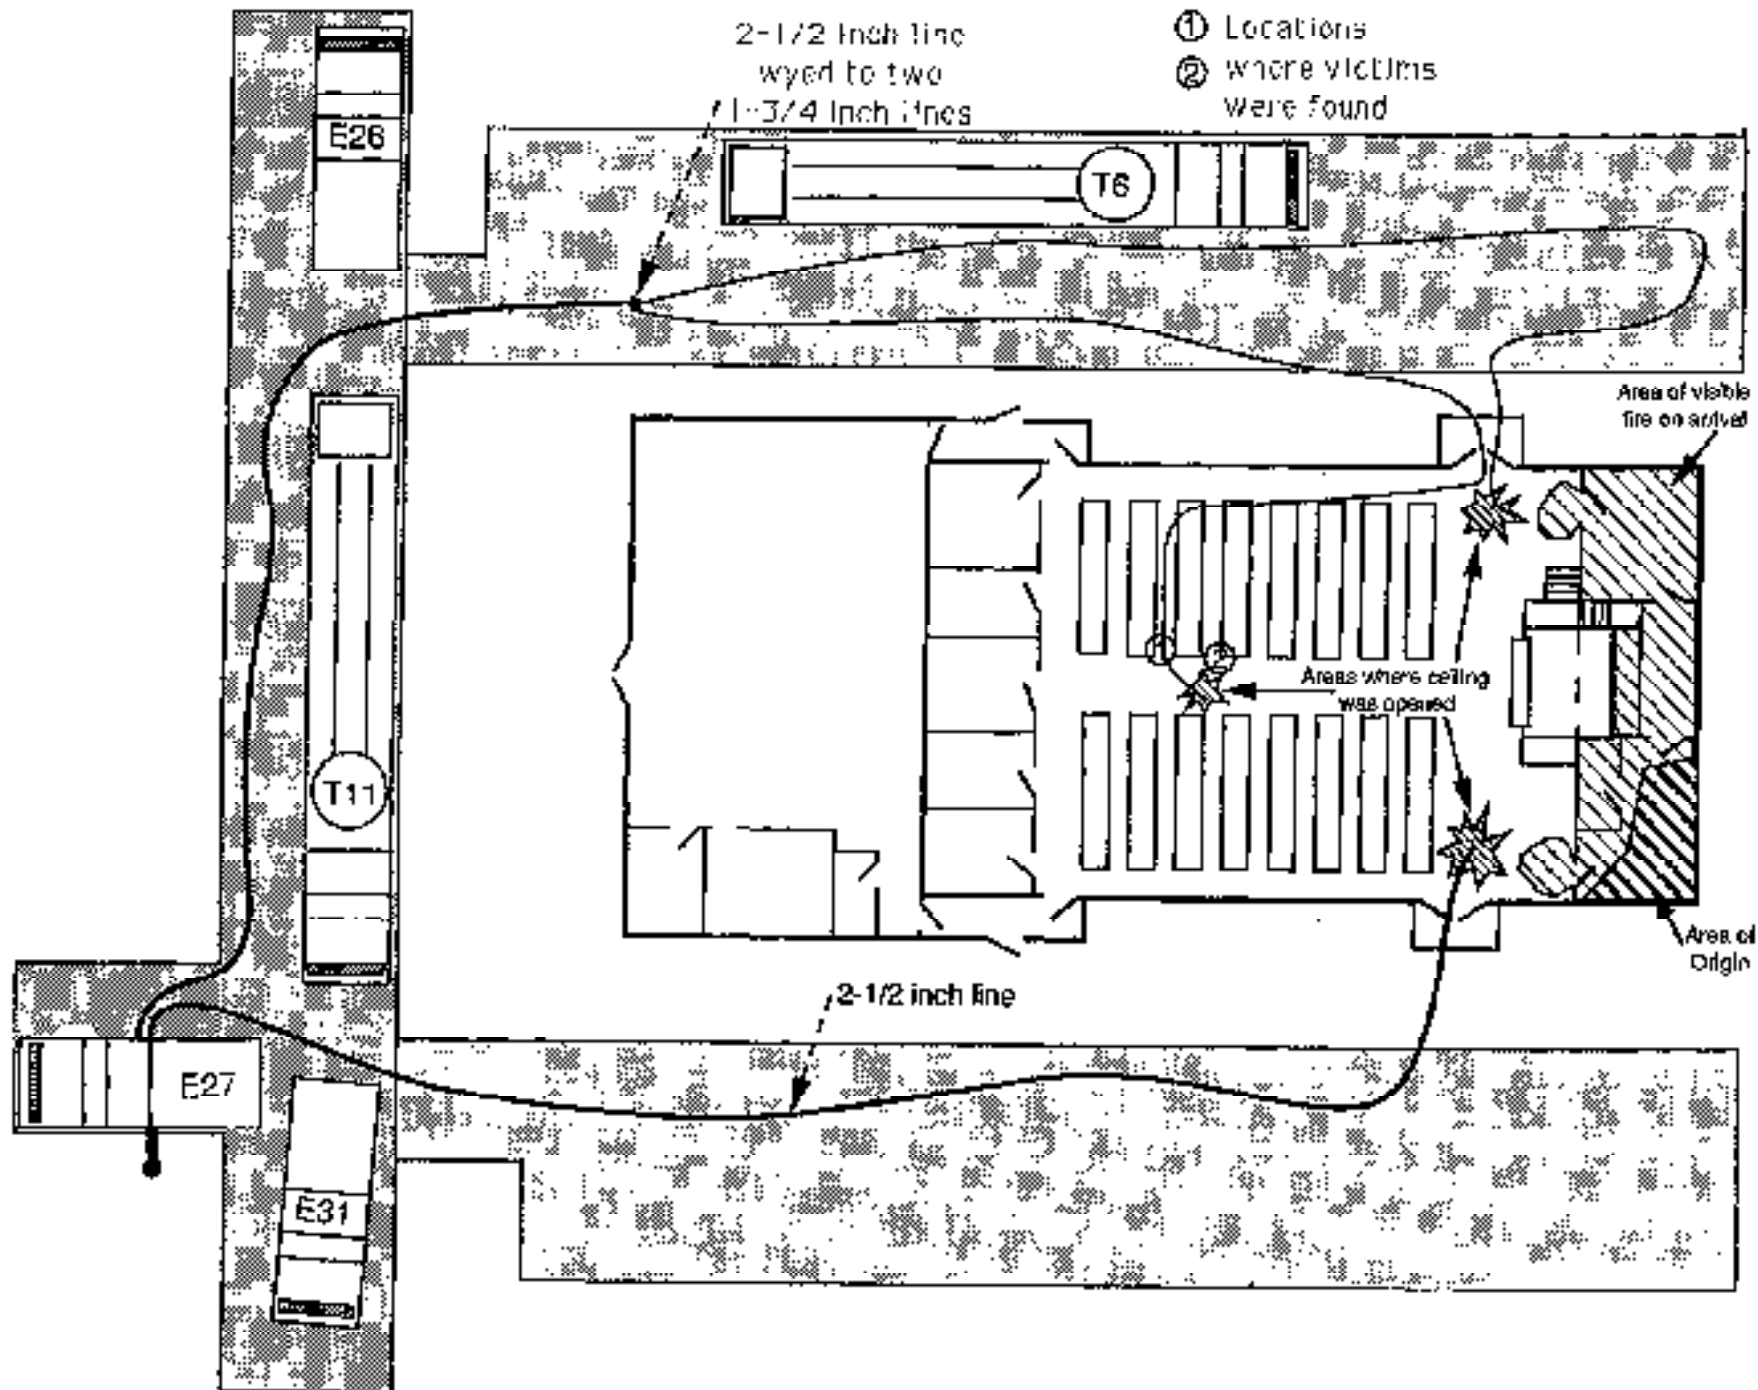
AREA OF FIRE INVOLVEMENT

A larger body of fire could be seen extending into the sanctuary at the opposite (south) side, near the south entry doors. The area where the fire was through the roof was entirely to the east of the sanctuary wall. The fire had melted connections in two of three gas lines, which supplied unit heaters located behind the wall, resulting in a particularly intense fire at the point of burn-through.

The fire originated in a room and extended to the attic via the void spaces between the 2x4 wall studs or through the ceiling. In either case the barrier was only a single layer of gypsum wall board which would have provided very limited resistance to the fire. The fire then involved the trusses and underside of the roof covering immediately above the area of origin. It is believed that the fire burned through the roof in this area before it was discovered. There is no way to determine if the fire spread laterally along the under side of the roof peak before it burned through the roof in the area of origin.

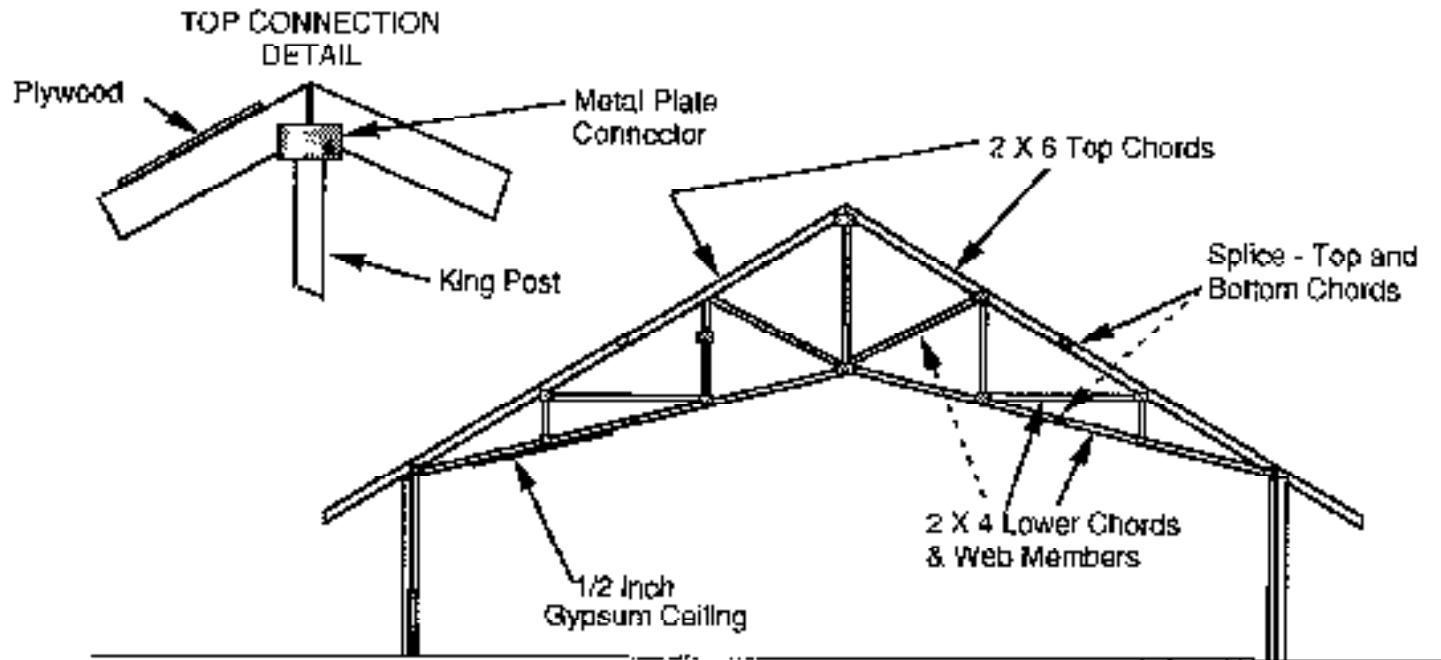
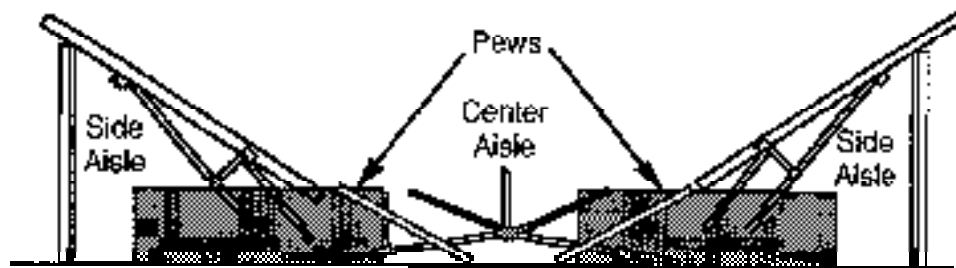
WOOD ROOF TRUSS DETAILS

The trusses were pre-engineered metal plate connected wood trusses, spanning a distance of 40 feet. The trusses over the main part of the church, where the collapse occurred, were scissors design (see diagram on the following page) to provide a slightly vaulted ceiling. The trusses over the adjacent areas were conventional peaked trusses with a horizontal bottom chord to create a flat ceiling. All of the trusses were spaced at 24 inch centers.

The trusses were shop fabricated from ordinary dimension lumber with 2X6 top chords; the bottom chords and web members were fabricated from

2X4 sections. All of the connectors were stamped metal gusset plates providing 3/8 inch penetration of the pointed ends into the wood. All observed connectors were fabricated with gusset plates on both sides of each connection point.

The attachment of the trusses to the 1/2 inch plywood roof decking maintained their alignment. There was no evidence of stringers or cross braces to maintain the spacing and redistribute loads among the trusses. Without cross bracing, the trusses were not constrained from roll-over, which can result in a “domino effect” collapse when a partial failure occurs. Cross bracing can allow a group of trusses to act as a system, with several trusses working together to support the load.

Cross bracing the trusses can reduce the probability of a sudden catastrophic failure and is more likely to result in visible sag before collapse. Without such load transfer mechanisms, the failure of any one truss can be sudden and catastrophic and can initiate the failure of a series of adjacent trusses in rapid succession, particularly if they are partially weakened and already close to their own point of failure.

The fire appears to have travelled along the underside of the roof, following the peak from east to west. The tops of all of the trusses were completely burned away for approximately 12 to 18 inches below the top connection point and could not be retrieved from the rubble. All of the lower connections could be located and most were still in tact. The depth of char varied from almost full depth on the remnants of the higher members near the center of the span to almost no sign of burning on the lower and outer sections.

All of the top and bottom chords had splices near the mid-span points on each side of the trusses and most of these splices had failed, dropping the center section all the way to the floor, while the ends only rotated on their wall supports.

Many of the gusset plate connectors had failed, either by completely disengaging from the wood or by allowing one or more of the members to work free from a connection point. At the higher points the wood was charred beyond the depth of penetration of the gusset plate points, leaving empty pits in the charred wood where the gusset plates had been attached. As noted previously, virtually all of the top connection points were completely burned away. Some of the kingpost members were charred to a depth of more than 1/2 inch before the remaining unburned wood had broken; the diminished cross section of unburned wood fractured when it

The roof collapse can be directly attributed to failure of the top connection points of the trusses, where the kingpost meets the top chord sections. It cannot be determined precisely which truss failed first and whether the gusset plates came loose from the top connection or the kingpost snapped and pried the gusset plates loose. The top connection is a critical point in each truss and its failure would result in the failure of that truss. It appears that several trusses failed in rapid succession - almost simultaneously following the first. All of the trusses would have been close to the point of failure and unable to support any additional load, so the load shift that occurred with the first failure probably caused several more trusses to collapse.
