## **New York City Bank Building Fire: Compartmentation vs. Sprinklers**

# **New York City Bank Building Fire: Compartmentation vs. Sprinklers (January 31,1993)**

**Investigated by: J. Gordon Routley**

**This is Report 071 of the Major Fires Investigation Project conducted  
by TriData Corporation under contract EMW-90-C-3338 to the United  
States Fire Administration, Federal Emergency Management Agency.**

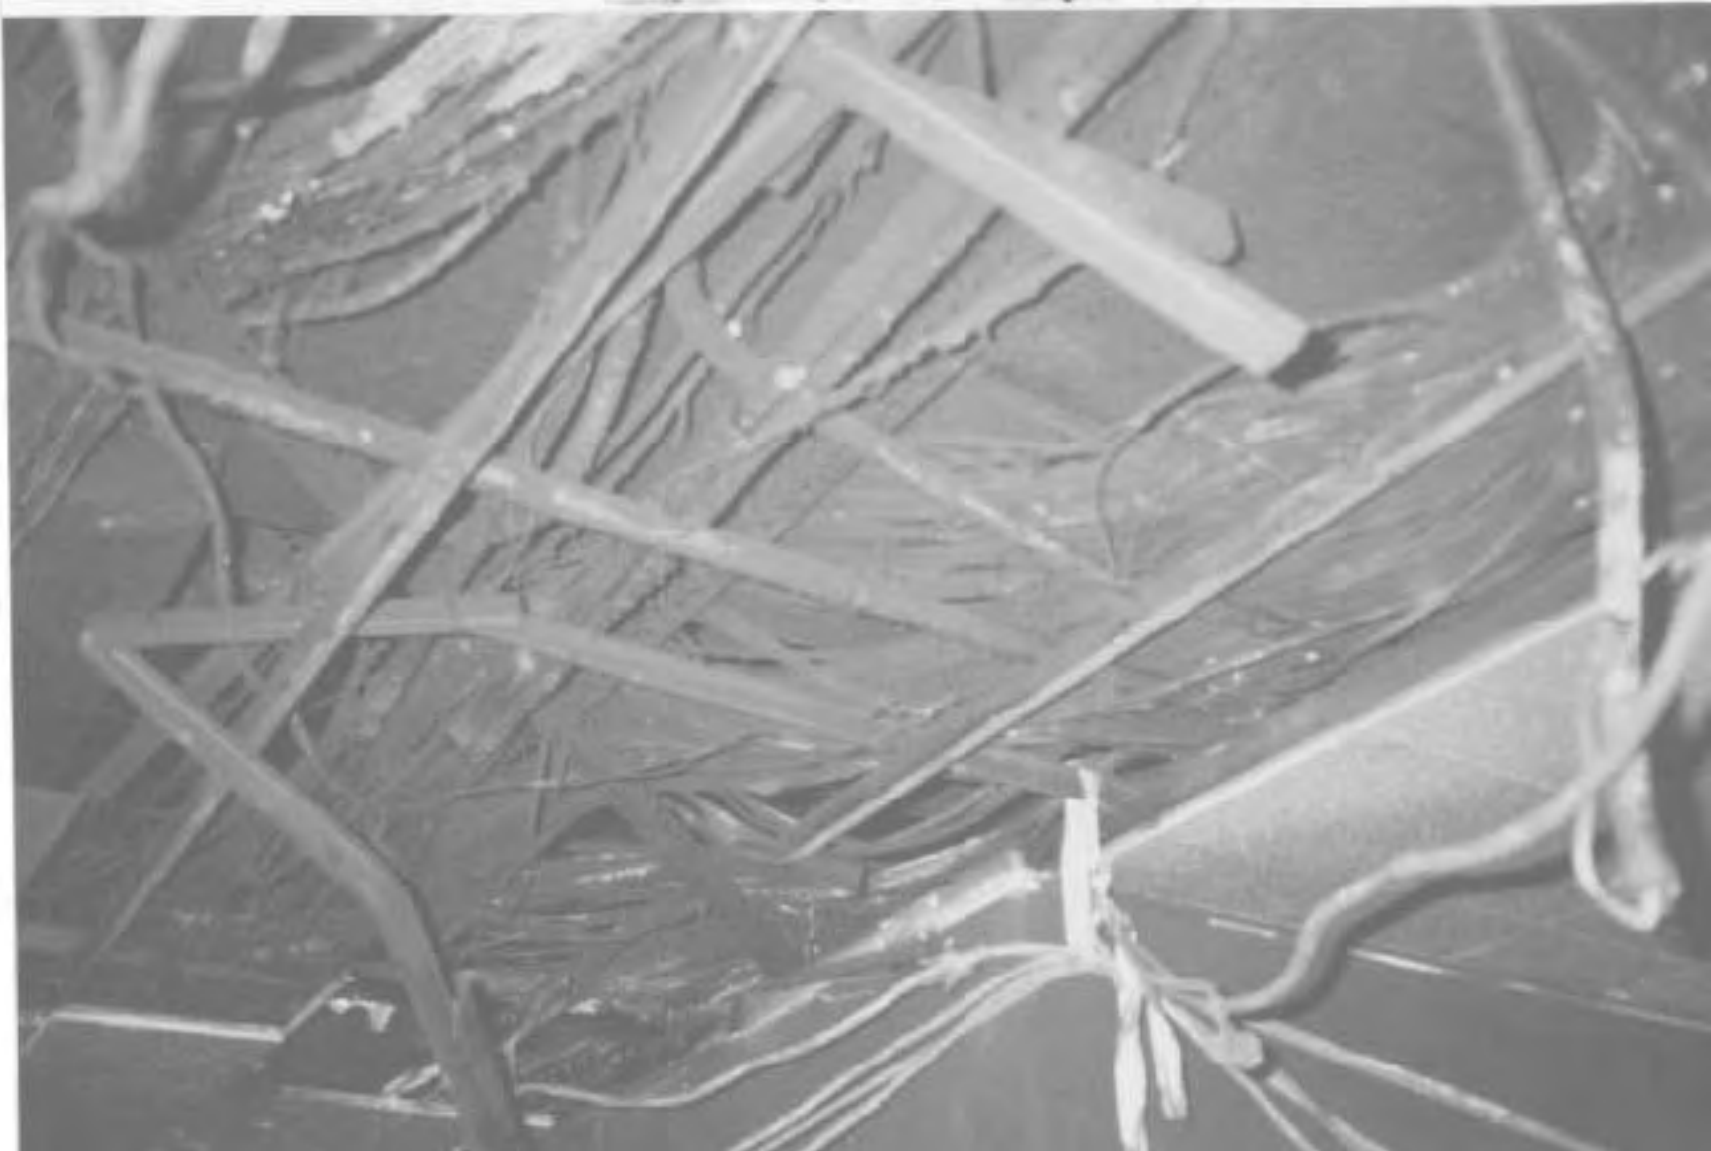
Photo shows the accumulation of combustible wiring that was in the ceiling plenum on the sixth floor at the edge of the fire area.

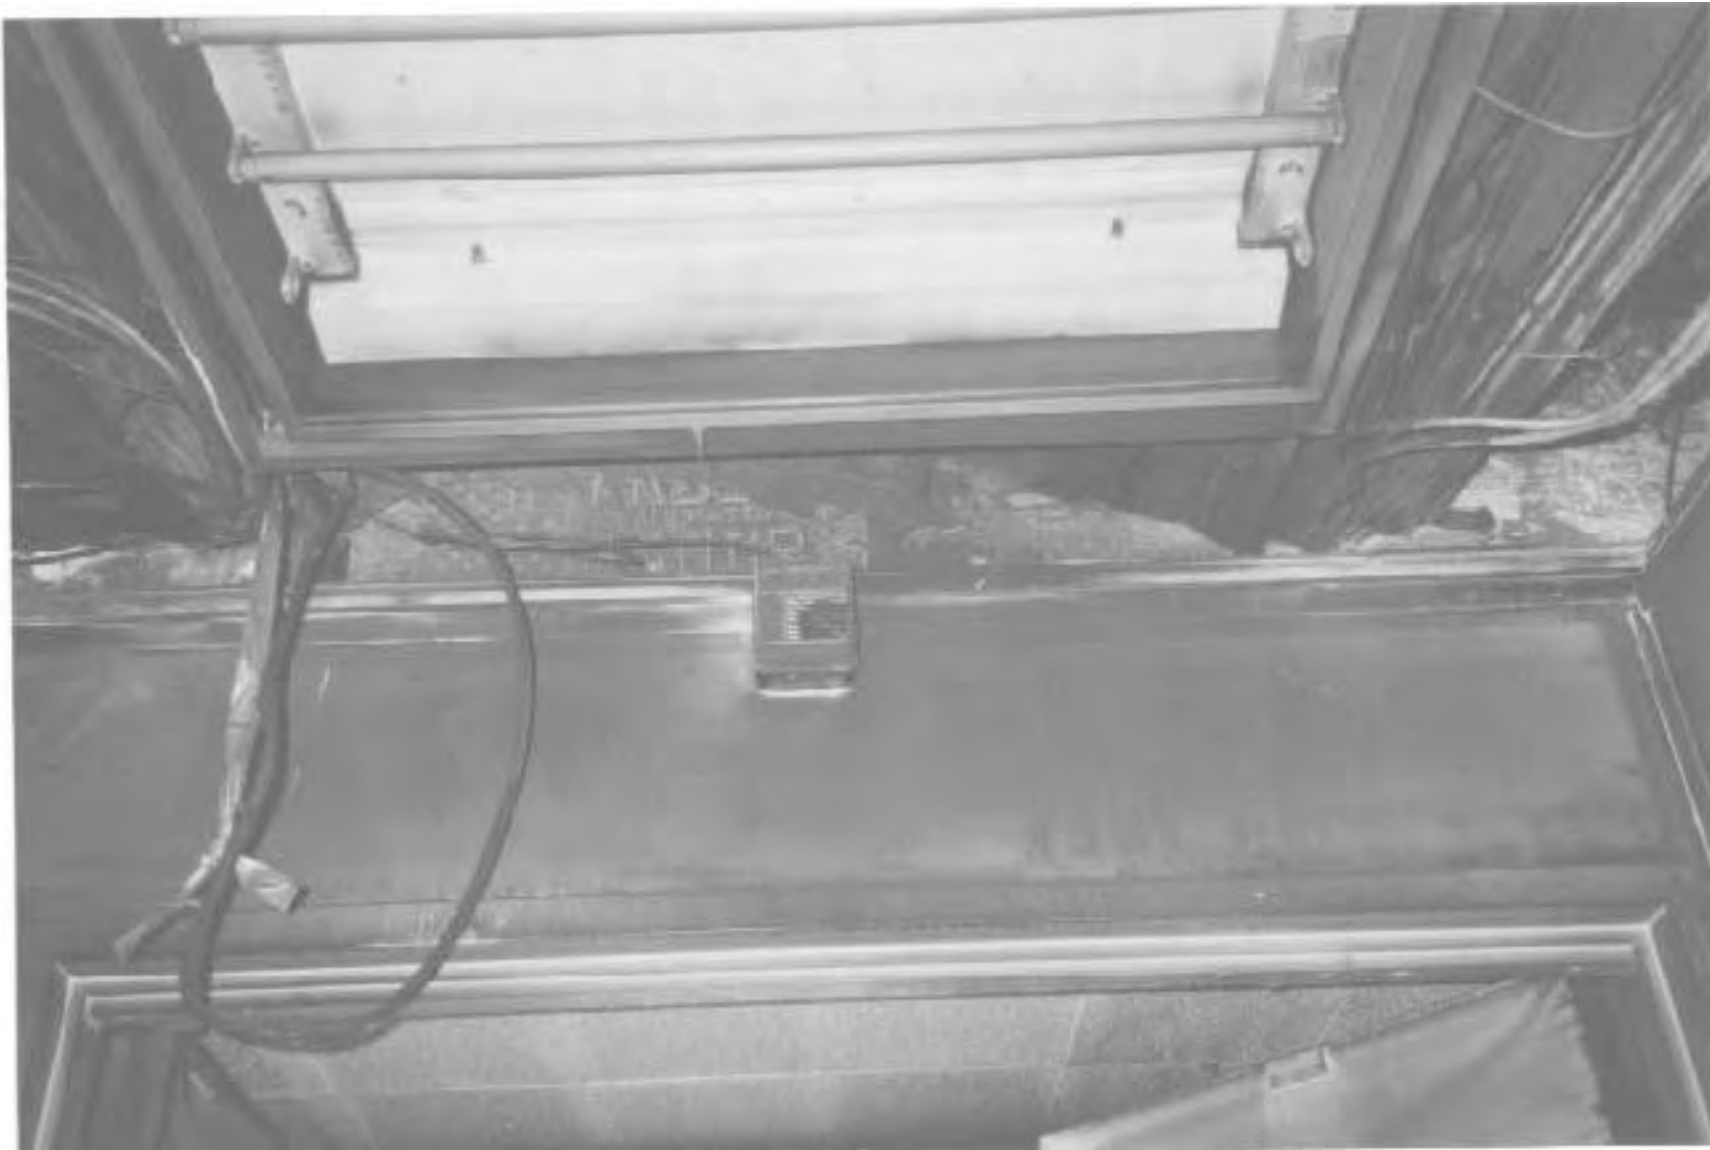
***Fuel Load in Ceiling Plenum*** — The space above the ceiling in the fire area and adjacent areas was used for electrical wiring and communications cables. The amount of communications wiring in this type of occupancy is often a problem. It appears that over the years the amount of communications wiring in the plenum has grown, as old runs have been replaced by new wiring, but the old cables were not removed. The fuel load provided by the insulation on the wires contributed to the fire origin and intensity. The cable runs also made it impossible to fully seal the openings in fire separation walls above the ceilings, allowing smoke to migrate from one compartment to another and contributing to the secondary damage.

View of the ceiling plenum at the fire division wall shows the accumulation of electrical and communication wiring that penetrates the interior fire division wall above the doorway on the sixth floor.

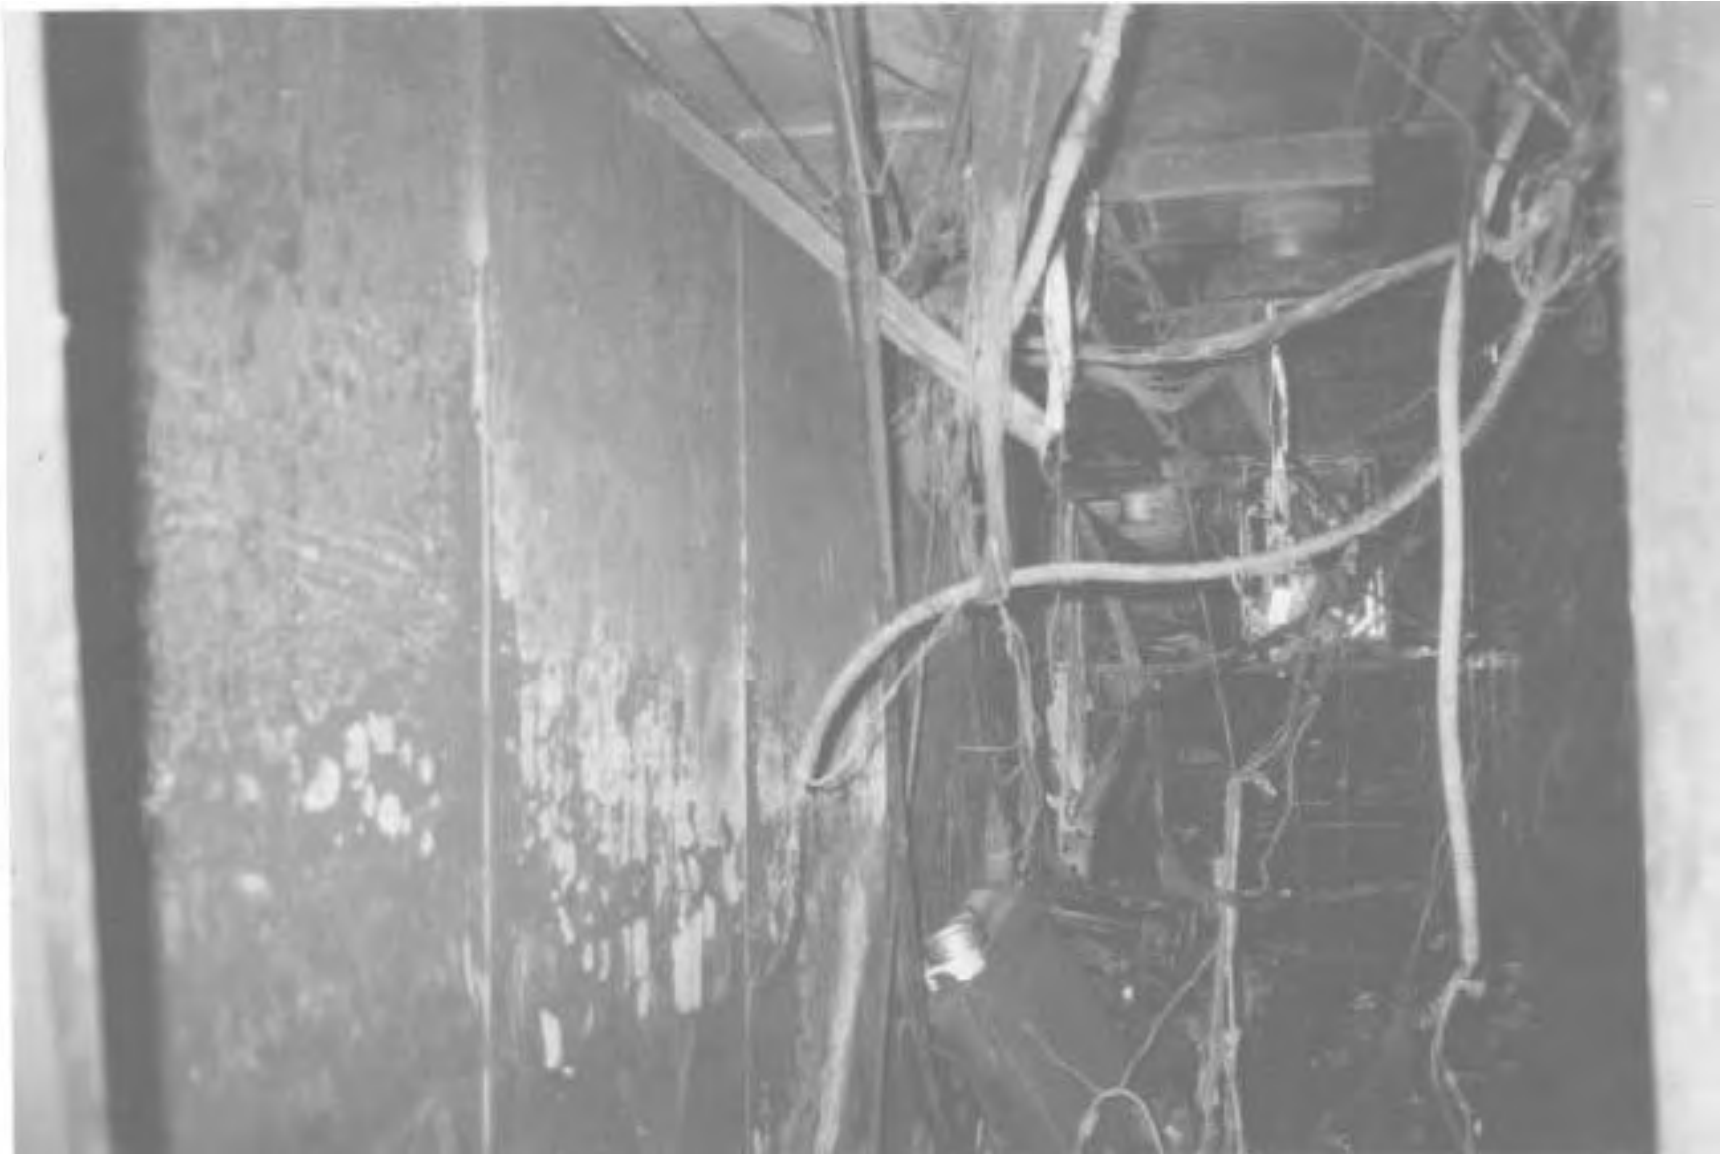
Corridor on the sixth floor where Engine 65 attempted to advance a 2 1/2 inch attack line.

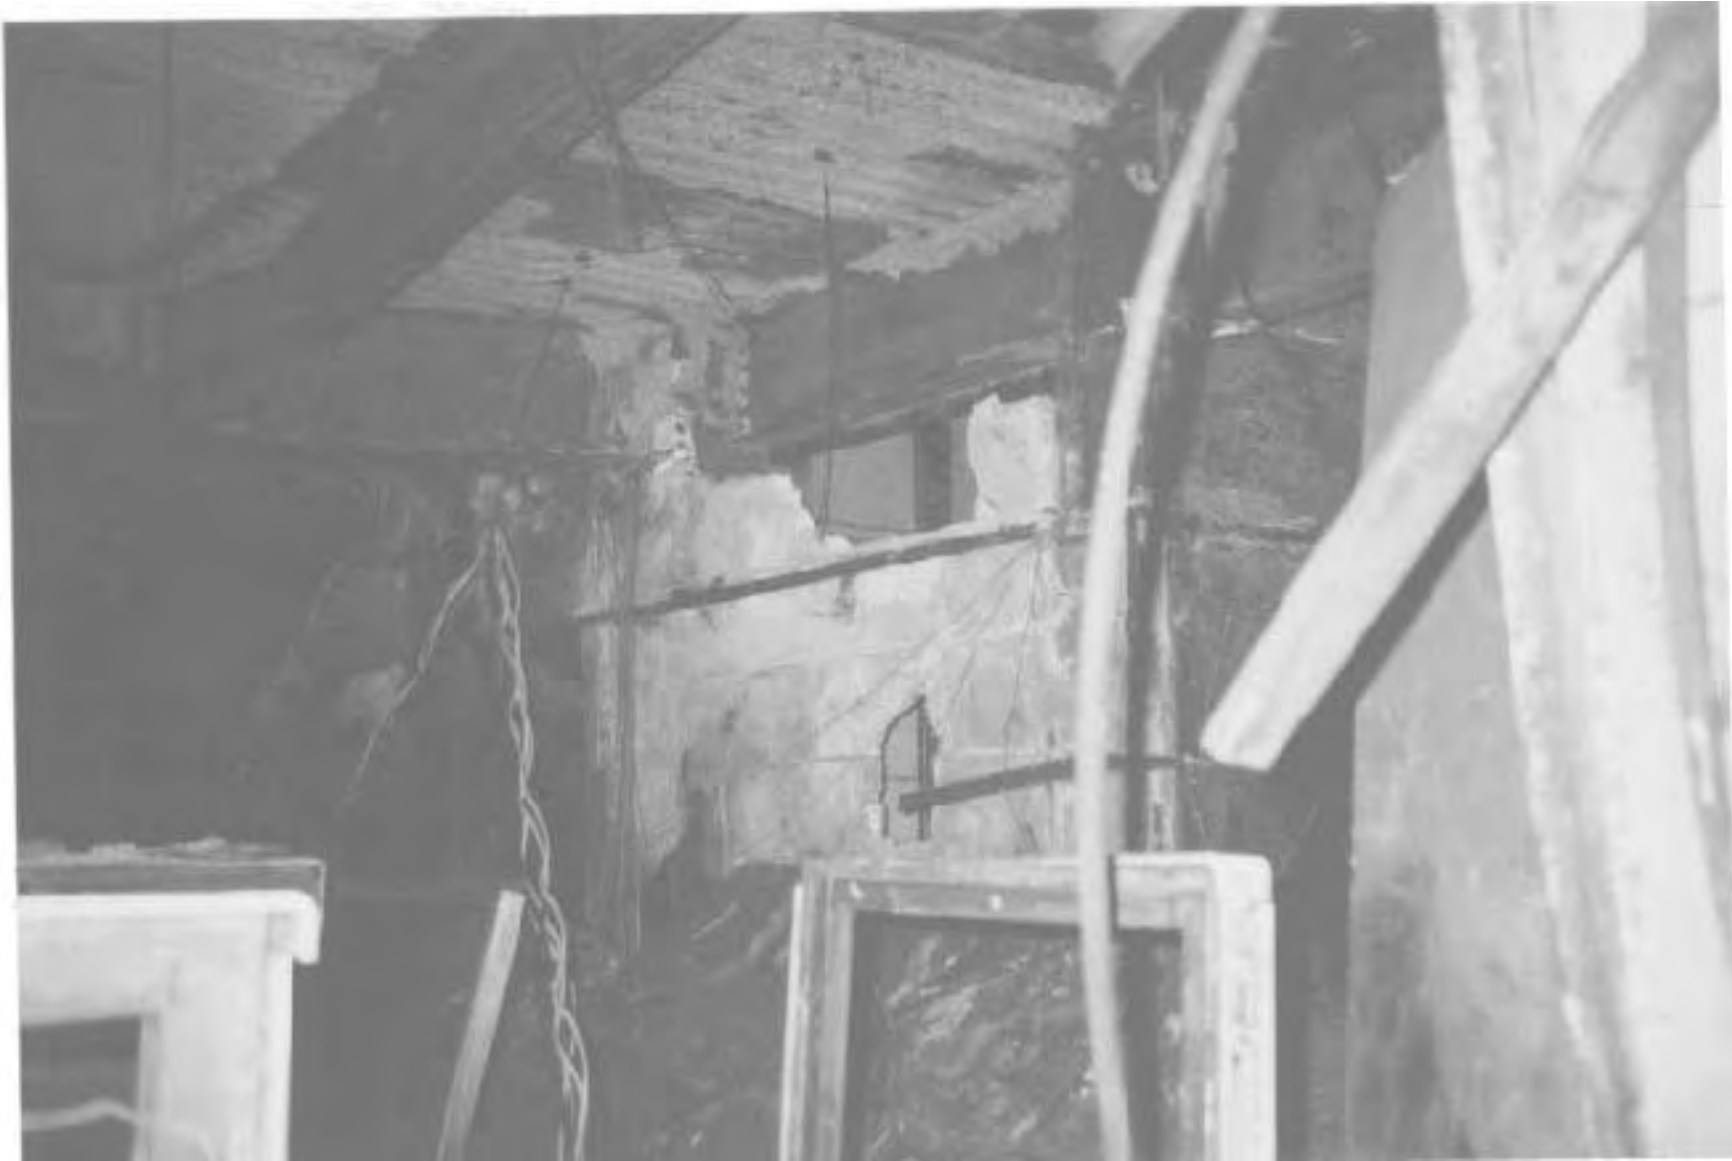
The master streams also punched a hole in the block wall enclosing the elevator shafts, directly opposite the windows, causing the blocks to fall on top of the elevator cars that were parked at the lobby level. Water runoff damaged most of the lower floors of the west tower. Electrical and telephone systems in the west tower were disrupted and needed major repairs.

Area on the sixth floor showing penetration into the elevator shafts caused by the high pressure master streams.

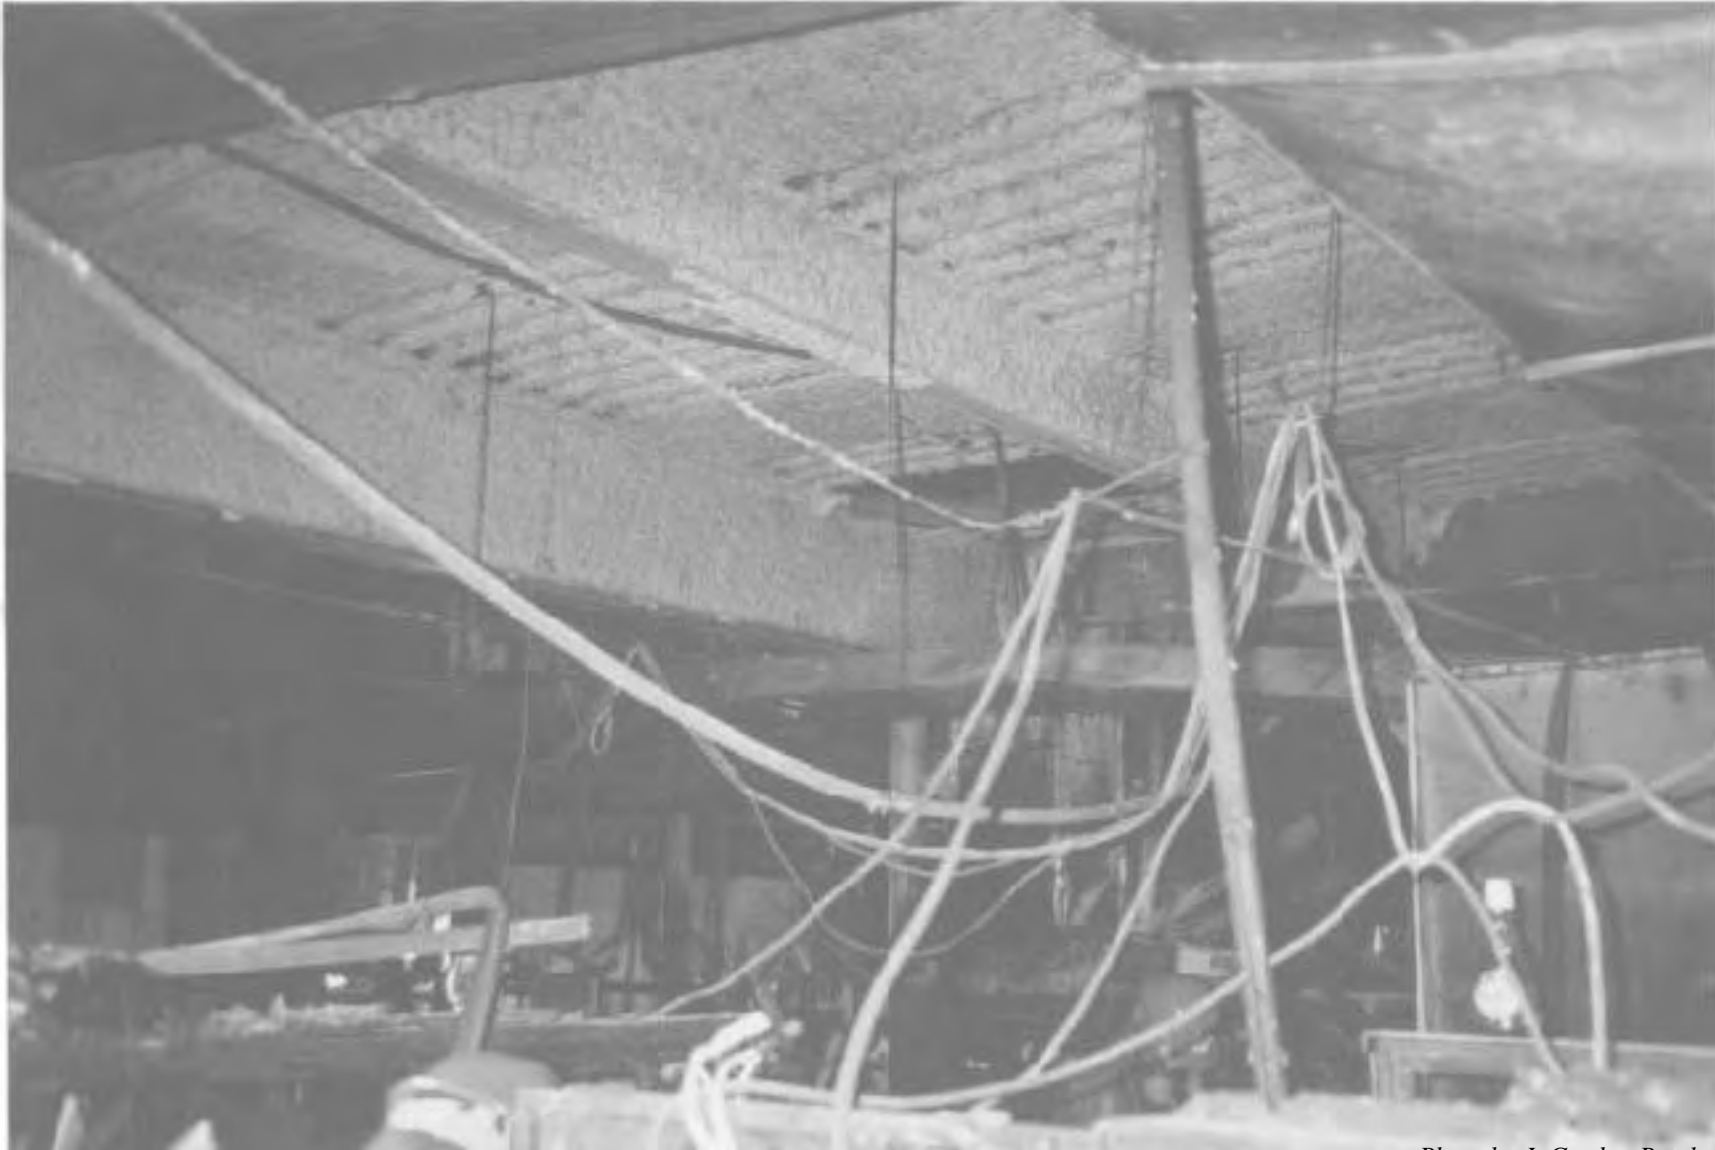
On the sixth floor, this is a view of the structural steel from the underside showing where the sprayed on asbestos fireproofing material remained attached to the steel in an area that was not exposed to water streams.

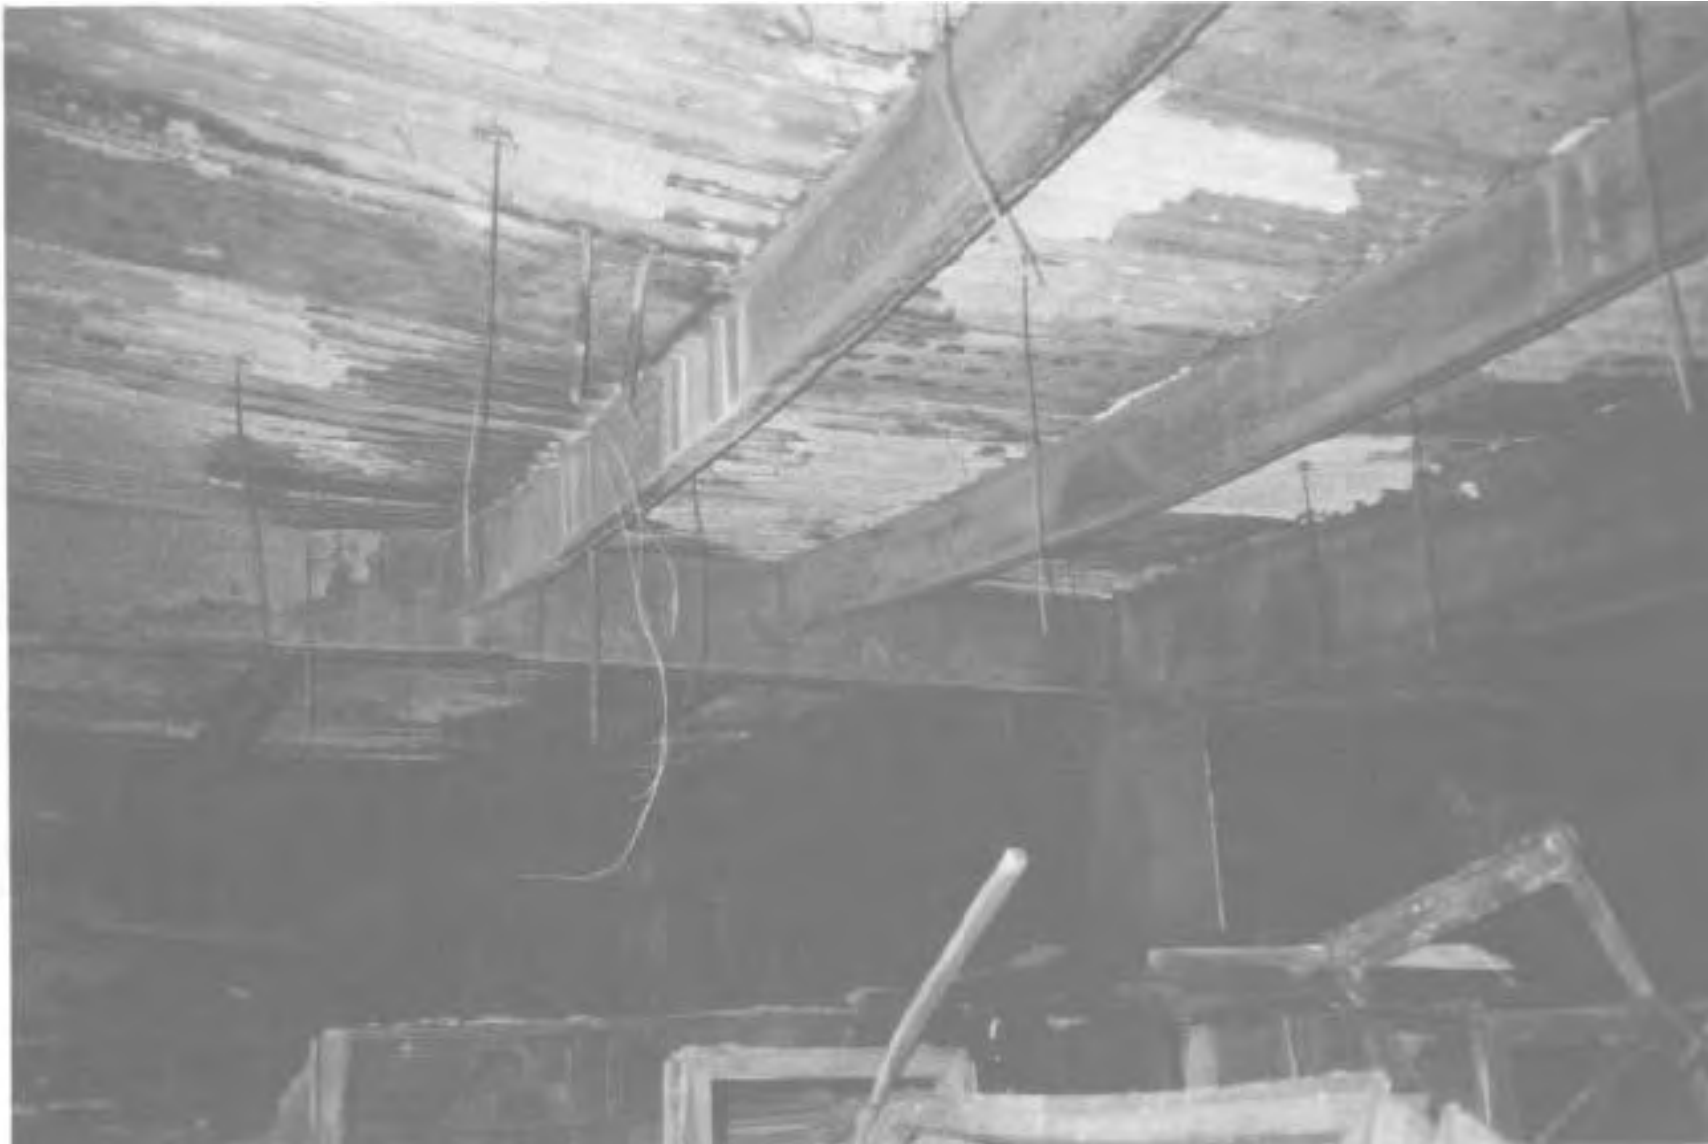
Most of the structural damage was confined to the underside of the seventh floor assembly. There was minor warping and sagging of the steel beams and larger girders, as well as sagging of the steel Q-deck between the beams. One of the smaller beams was detached from the supporting girder at one end of its span, apparently from the force of a master stream hitting it while it was heated. The deformation of the deck was most pronounced along the joints where fire had been observed extending through to the seventh floor; a variation in the floor level of three to six inches remained after the fire.

On the sixth floor, this view shows that virtually all the asbestos fireproofing was washed off the steel that was exposed to water streams. Photo also shows the deflection of the beams and floor deck above due to heat.

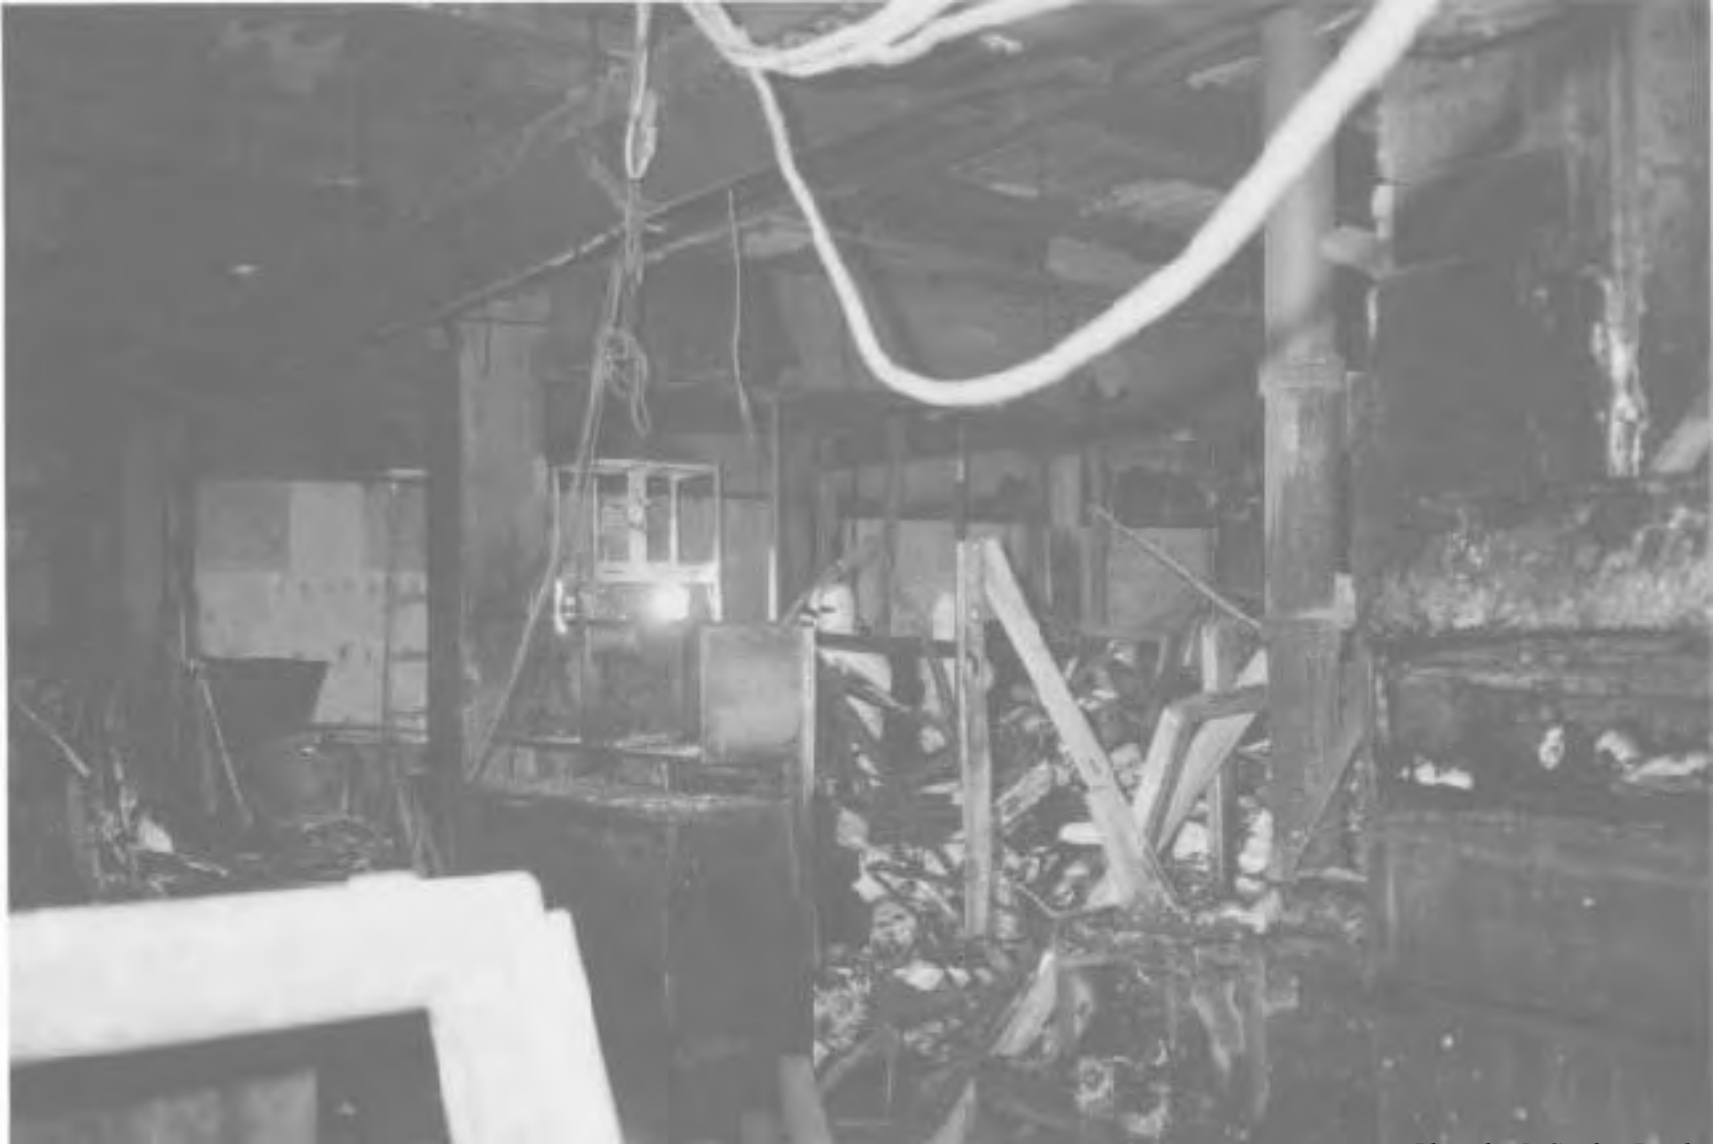
The main fire area on the sixth floor looking toward the windows on the 48th Street side of the building.  
Note the degree of fire damage to contents and exposure of the structural steel above the ceiling.

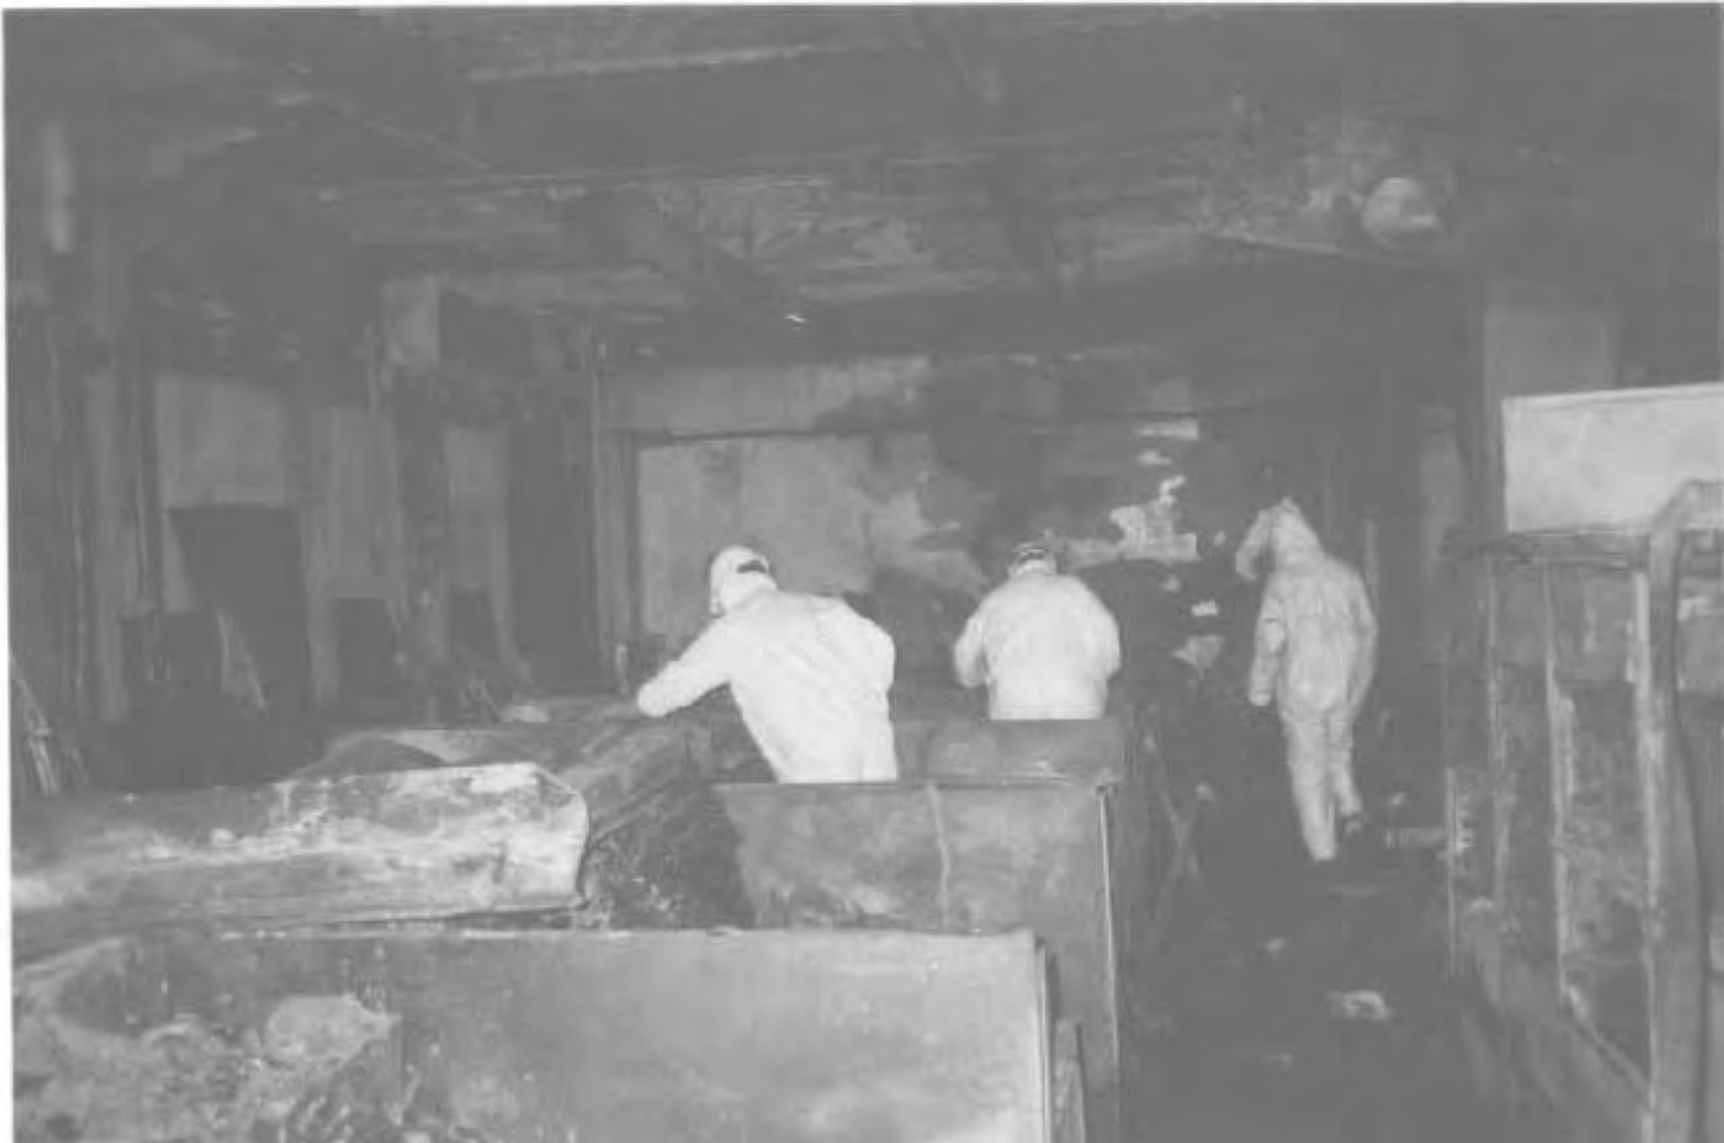
Investigators working in the area of fire origin wearing protective clothing due to asbestos contamination.
