Nine-Fatality Apartment House Fire Ludington, Michigan

**Nine-Fatality Apartment House Fire
Ludington, Michigan
(February 28, 1993)**

This is Report 072 of the Major Fires Investigation Project conducted by TriData Corporation under contract EMW-90-C-3338 to the United States Fire Administration, Federal Emergency Management Agency.

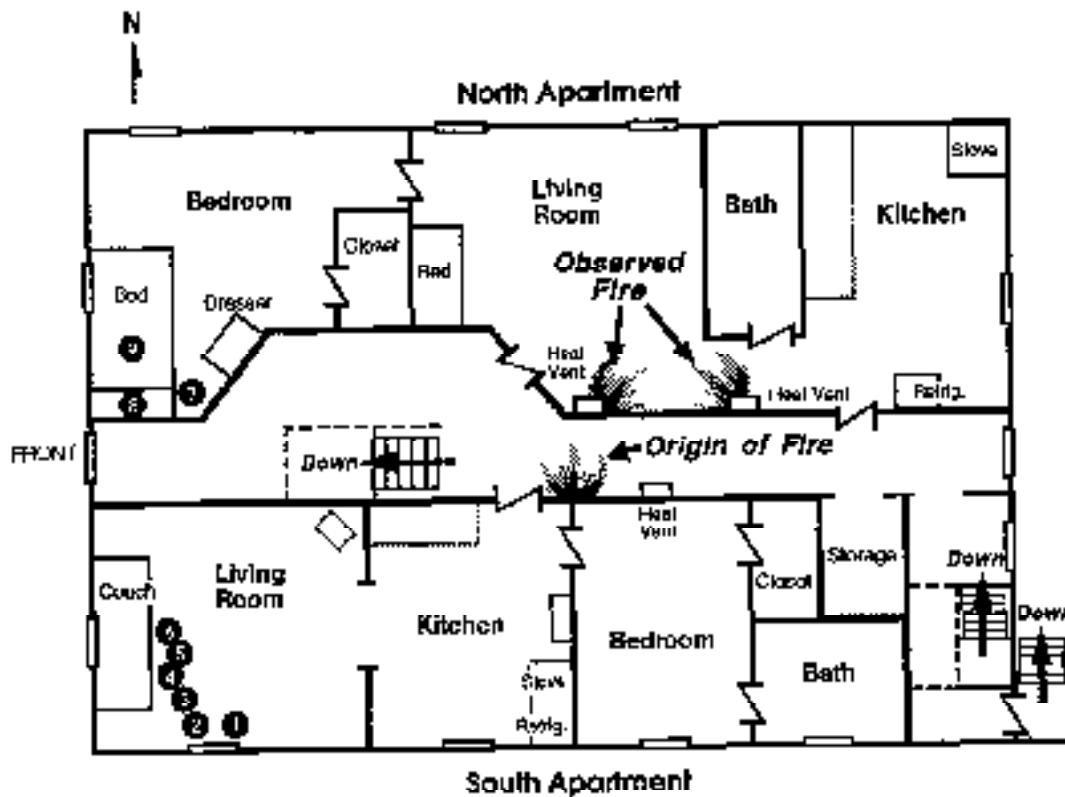
SECOND FLOOR PLAN

FATALITIES	
①	8-year-old girl
②	2-year-old boy
③	3-year-old boy
④	1-year old boy
⑤	6-year-old boy
⑥	48-year-old girl (babysitter)
⑦	1-year-old
⑧	10-year-old woman
⑨	2-year-old boy

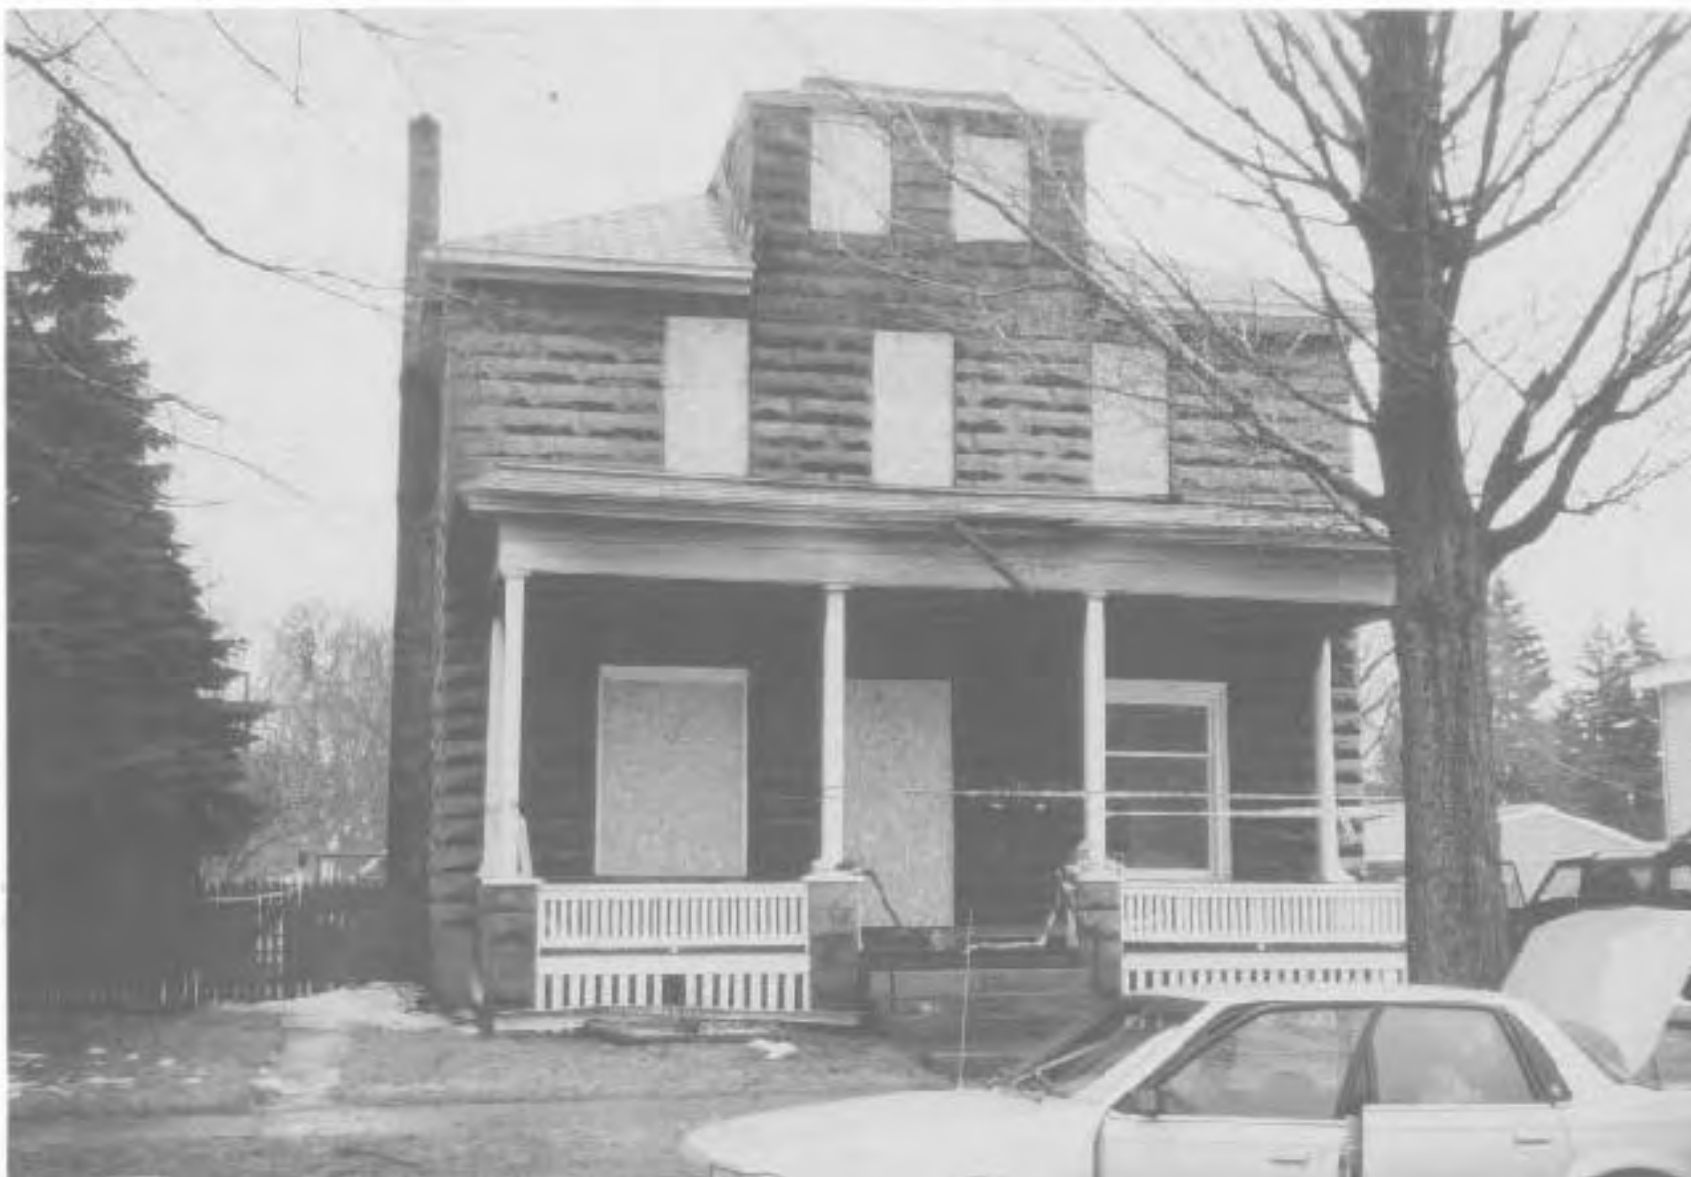
Front of building facing James Street.

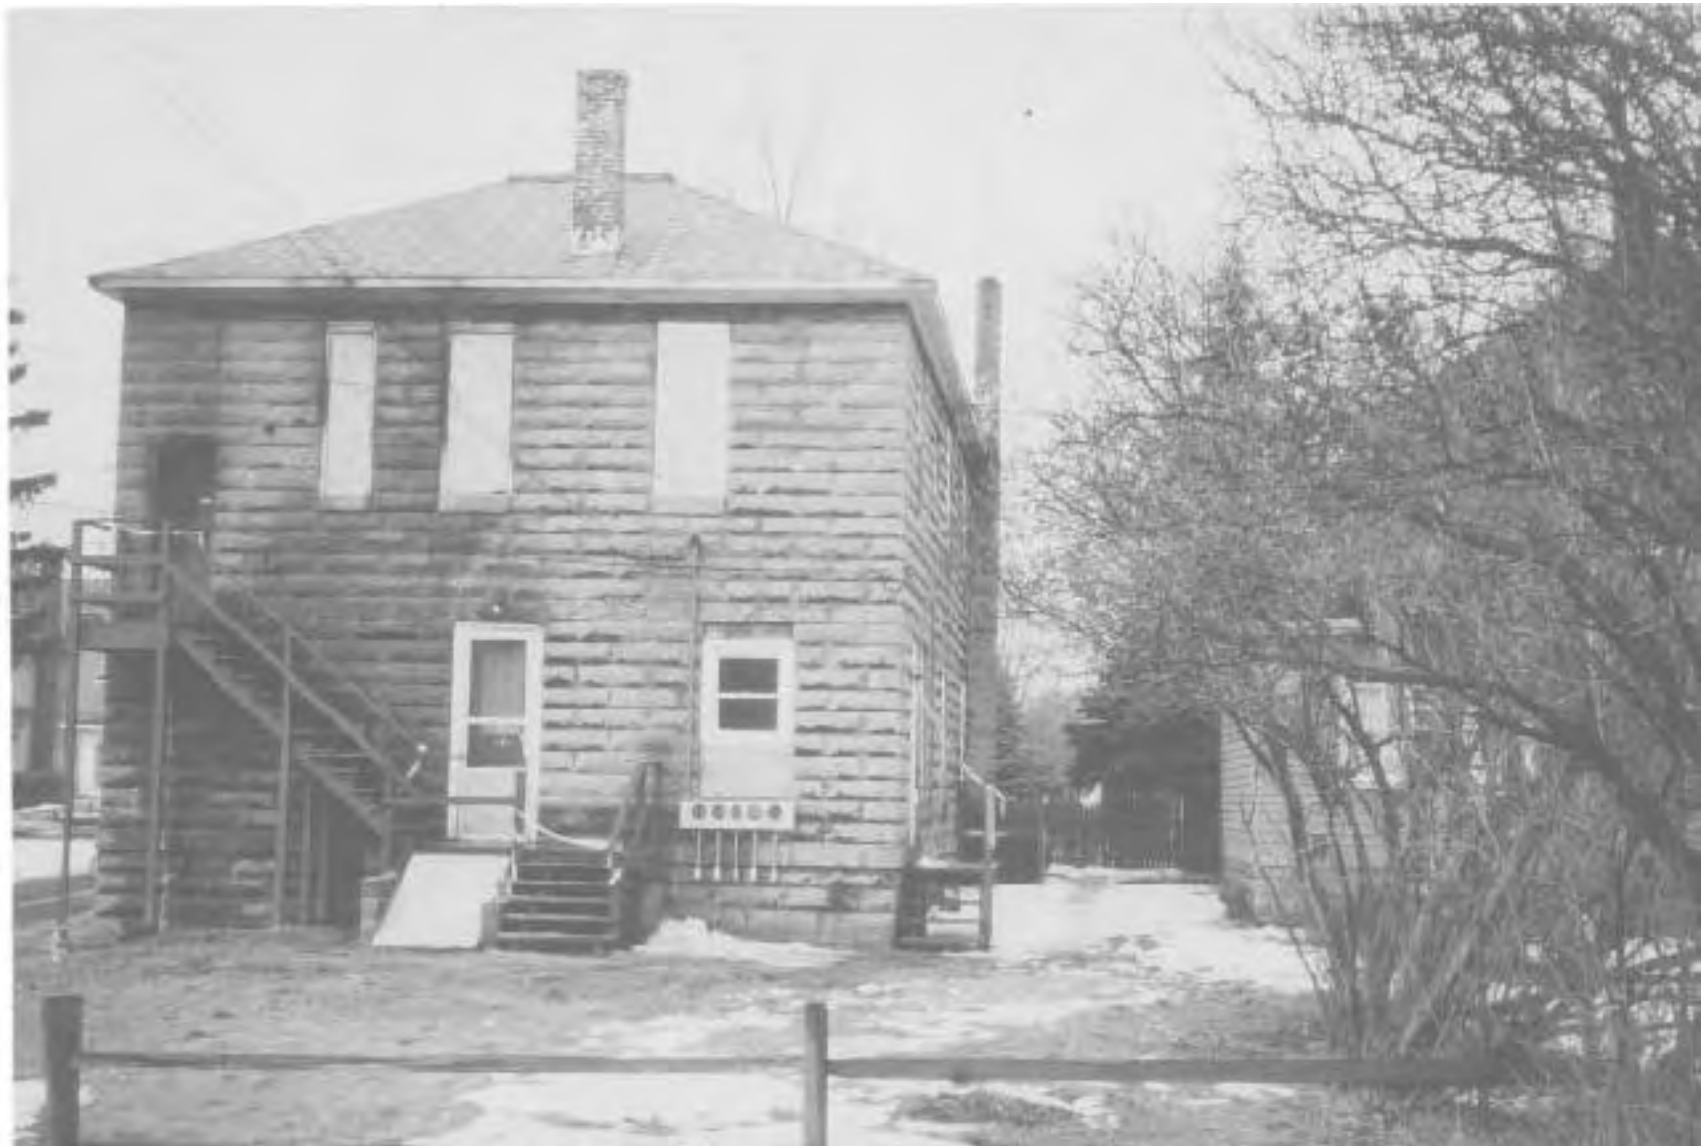
Separate entrance to first floor rear apartment and wooden fire escape to second floor.

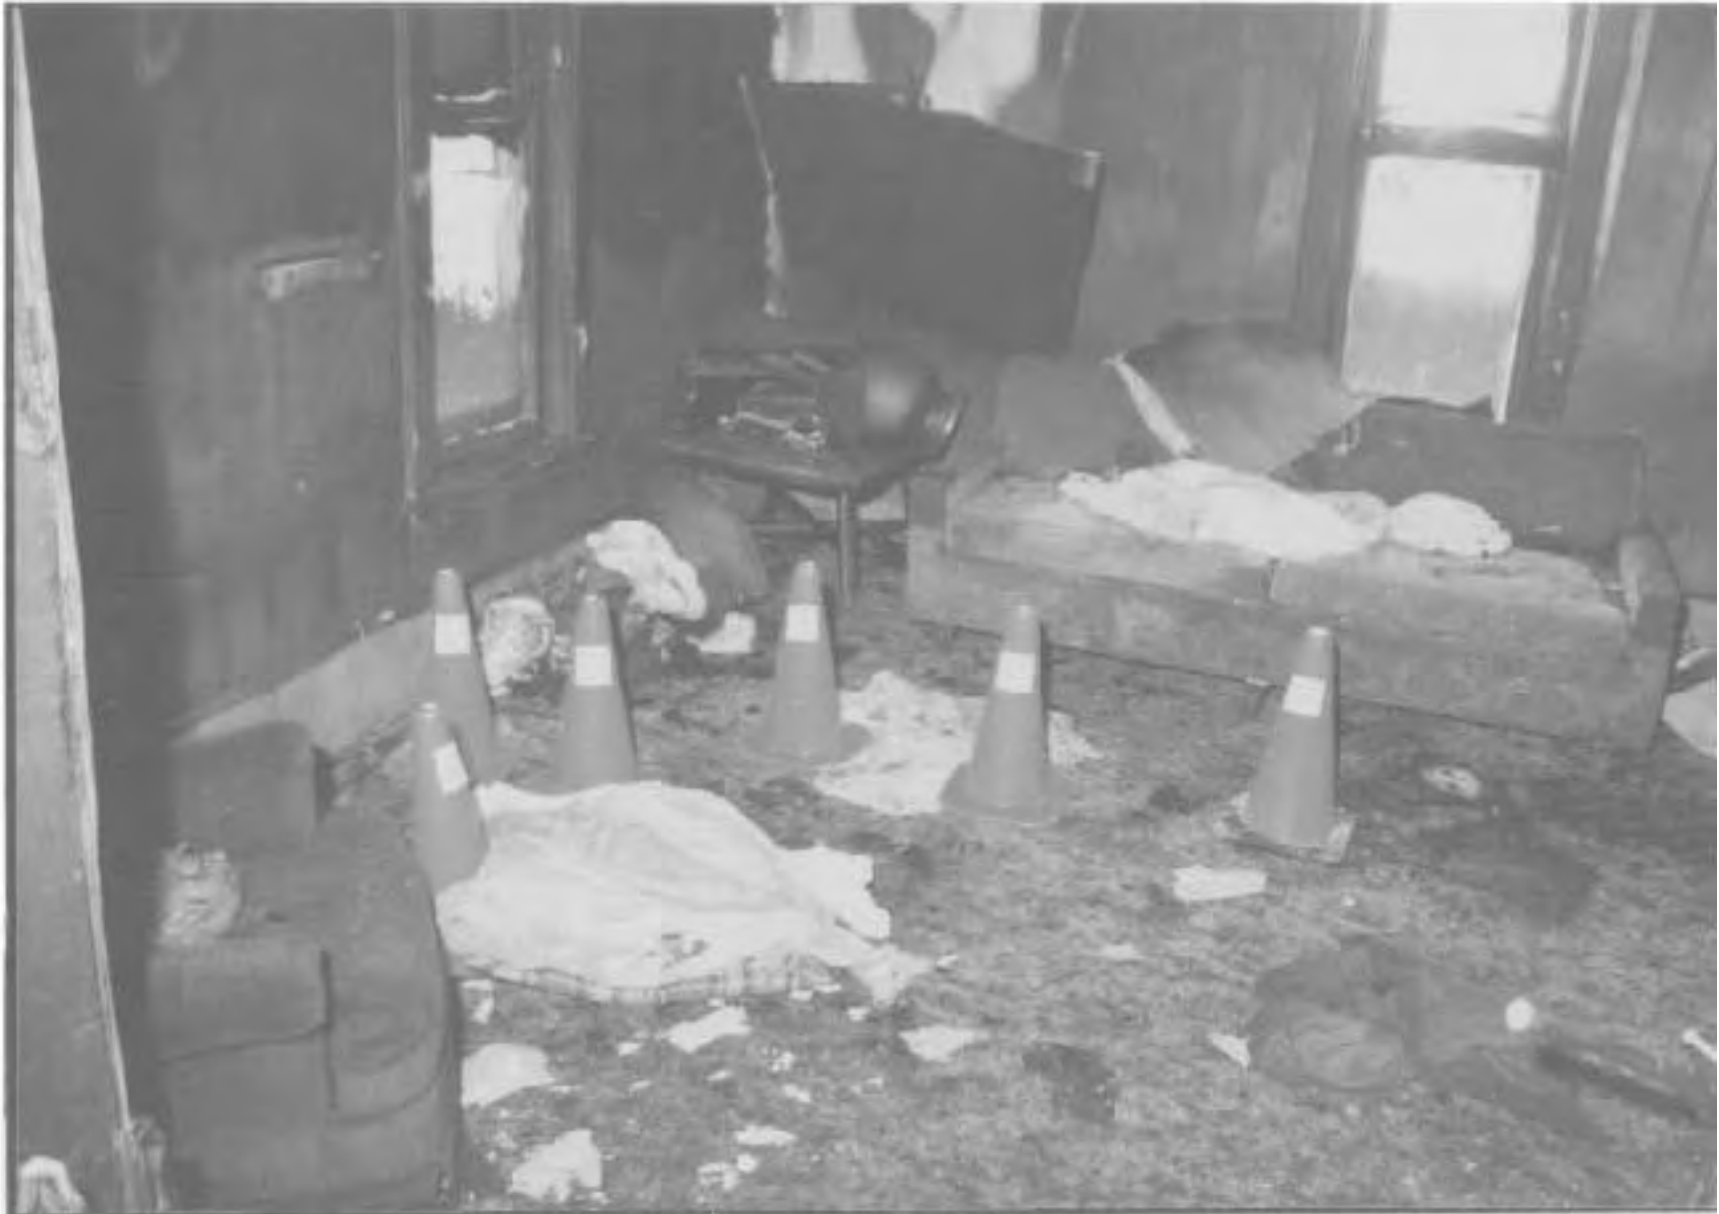
The positions of the victims located in the south apartment indicate, with one exception, that all were asleep on the living room floor and never woke up. Some were still clutching stuffed animals or other objects children normally sleep with.

Area on second floor south apartment living room where six fatalities were found. Notice little or no actual fire damage.

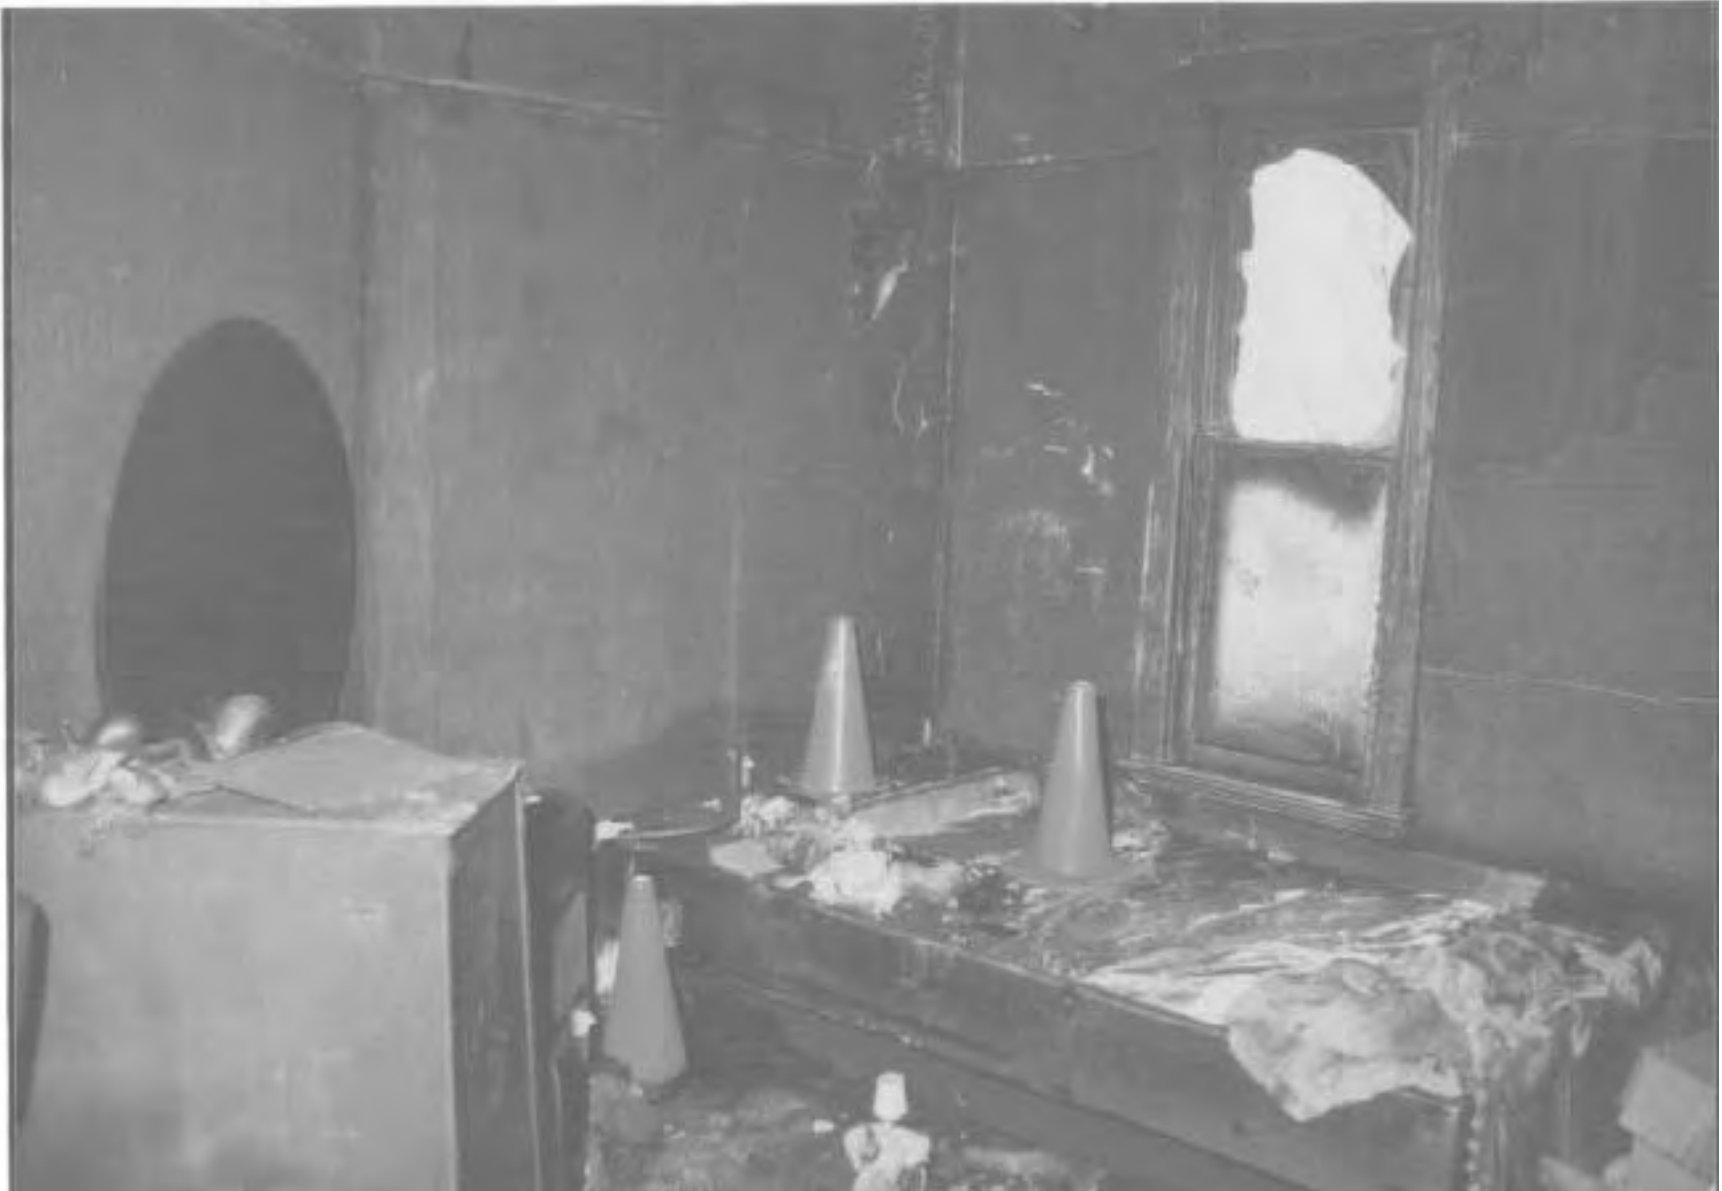
Bed in living room of second floor north apartment; area where three fatalities were discovered. Notice heat and smoke damage only.

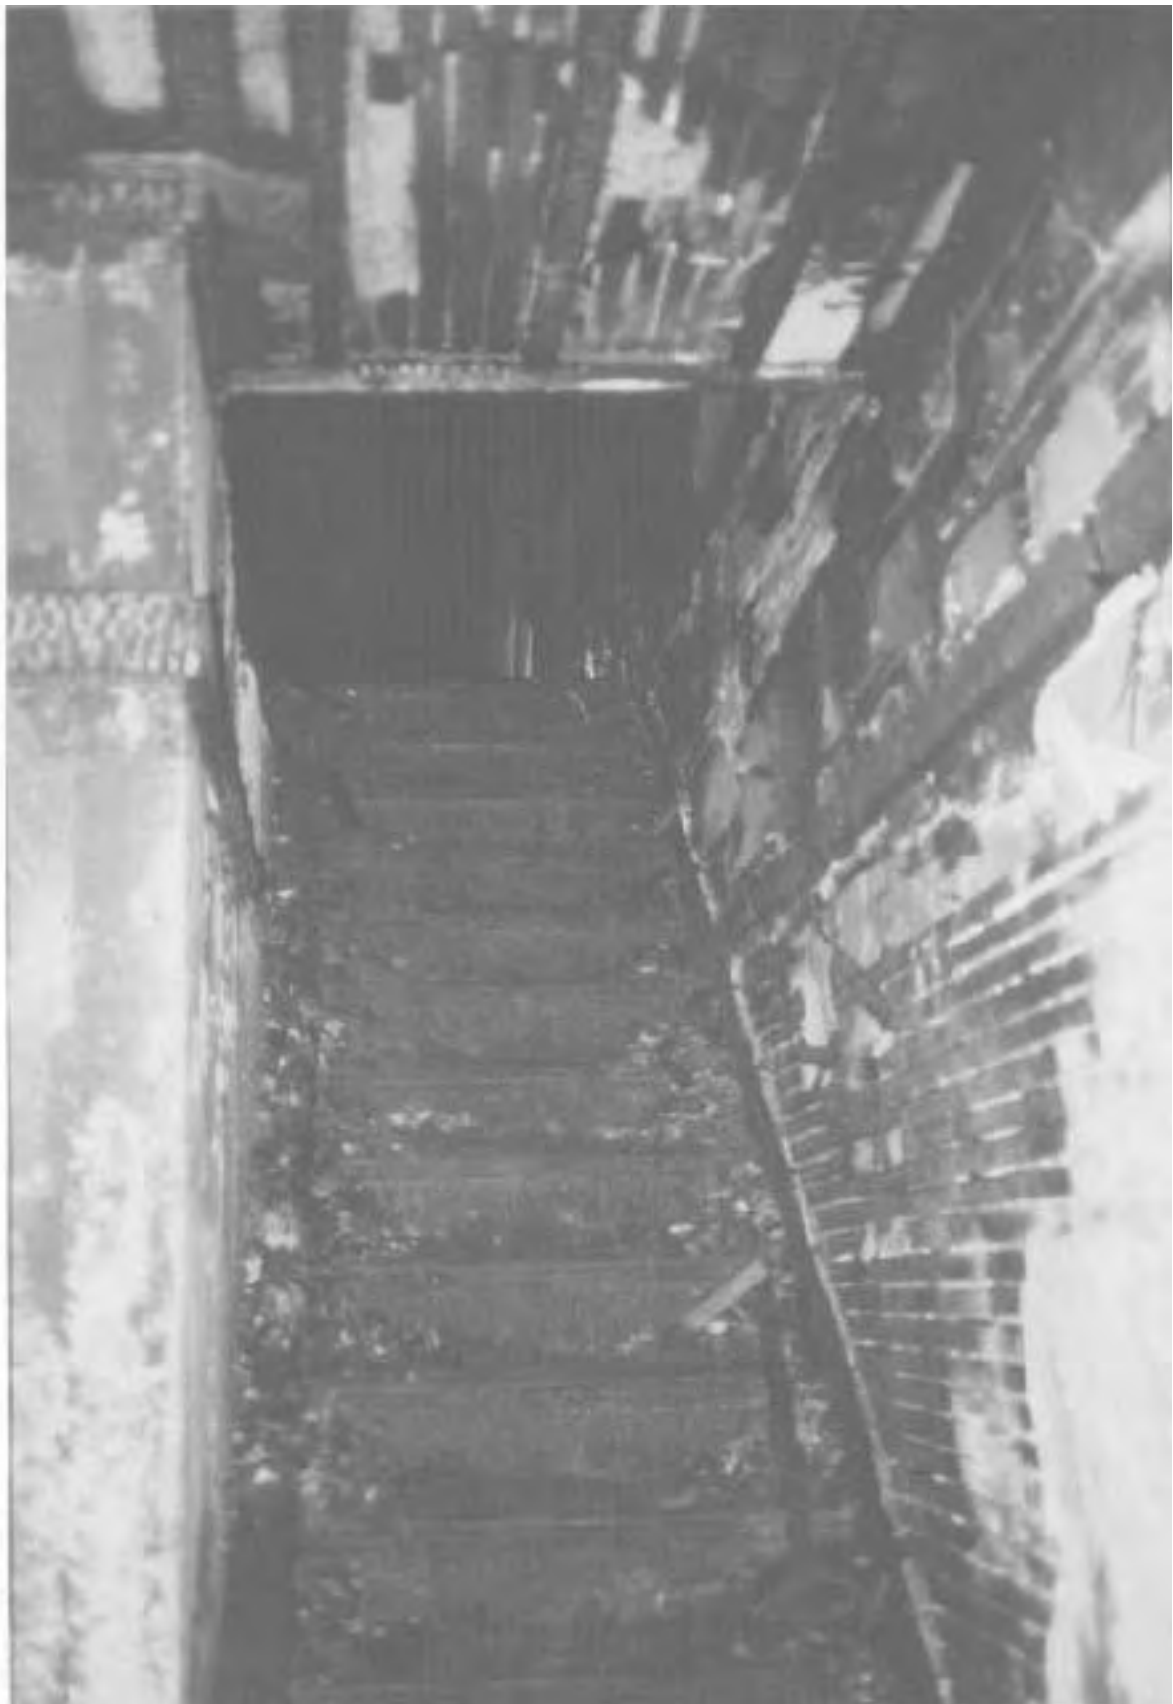
Stairway from first to second floor showing burn damage to staircase, wall, and ceiling.

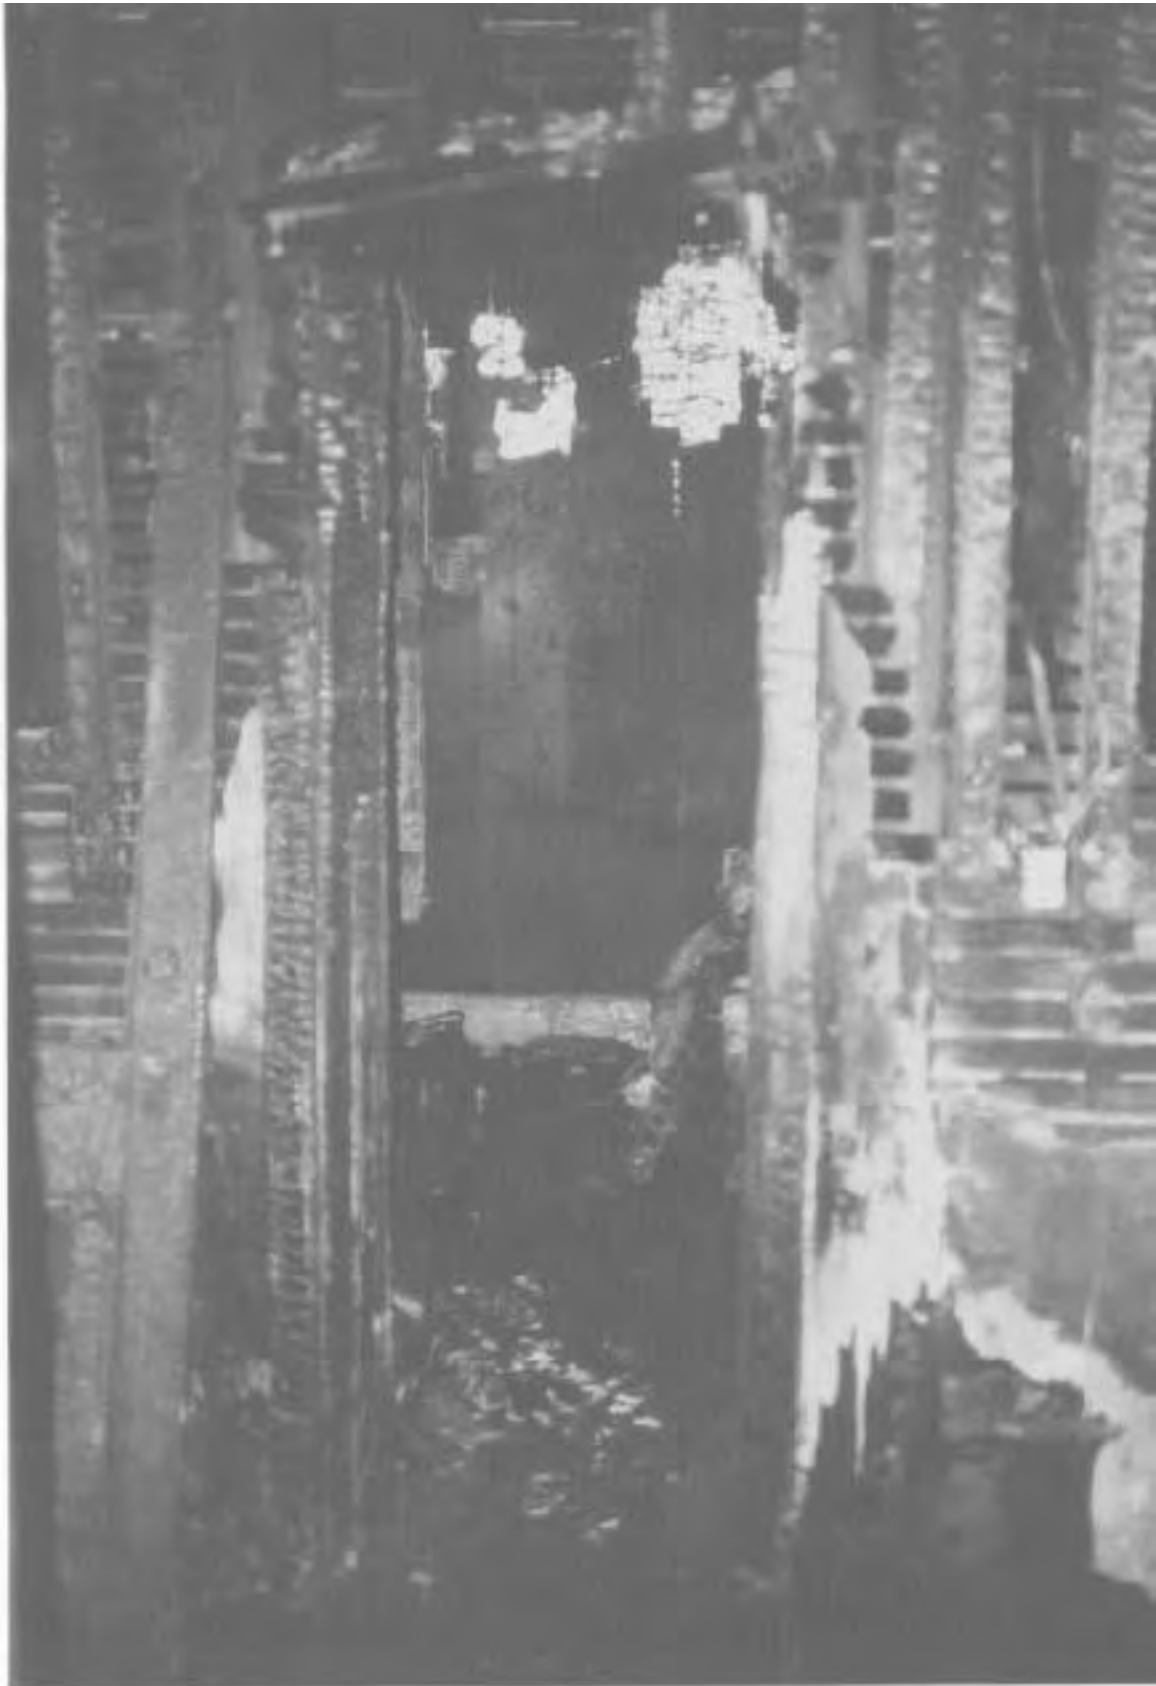
The fire is believed to have been of accidental nature, originating in or around a 2nd floor corridor wall light fixture located in the vicinity of the entrance door to the south apartment. Burn patterns reveal the source of the fire originating at this location and moving east down the corridor, igniting plywood paneling on the walls and combustible ceiling tiles. Fire developed very rapidly due to the presence of sufficient fuel and the lack of early detection. It quickly penetrated the upper ceiling joist area and gained entrance into the two 2nd floor apartments by way of the wood panel doors and in and around air-transfer vents that were exposed once the paneling had burned away.

Fire damage to entrance doorway and walls of the second floor north apartment living room. Notice height of burn patterns and suspected area of origin.

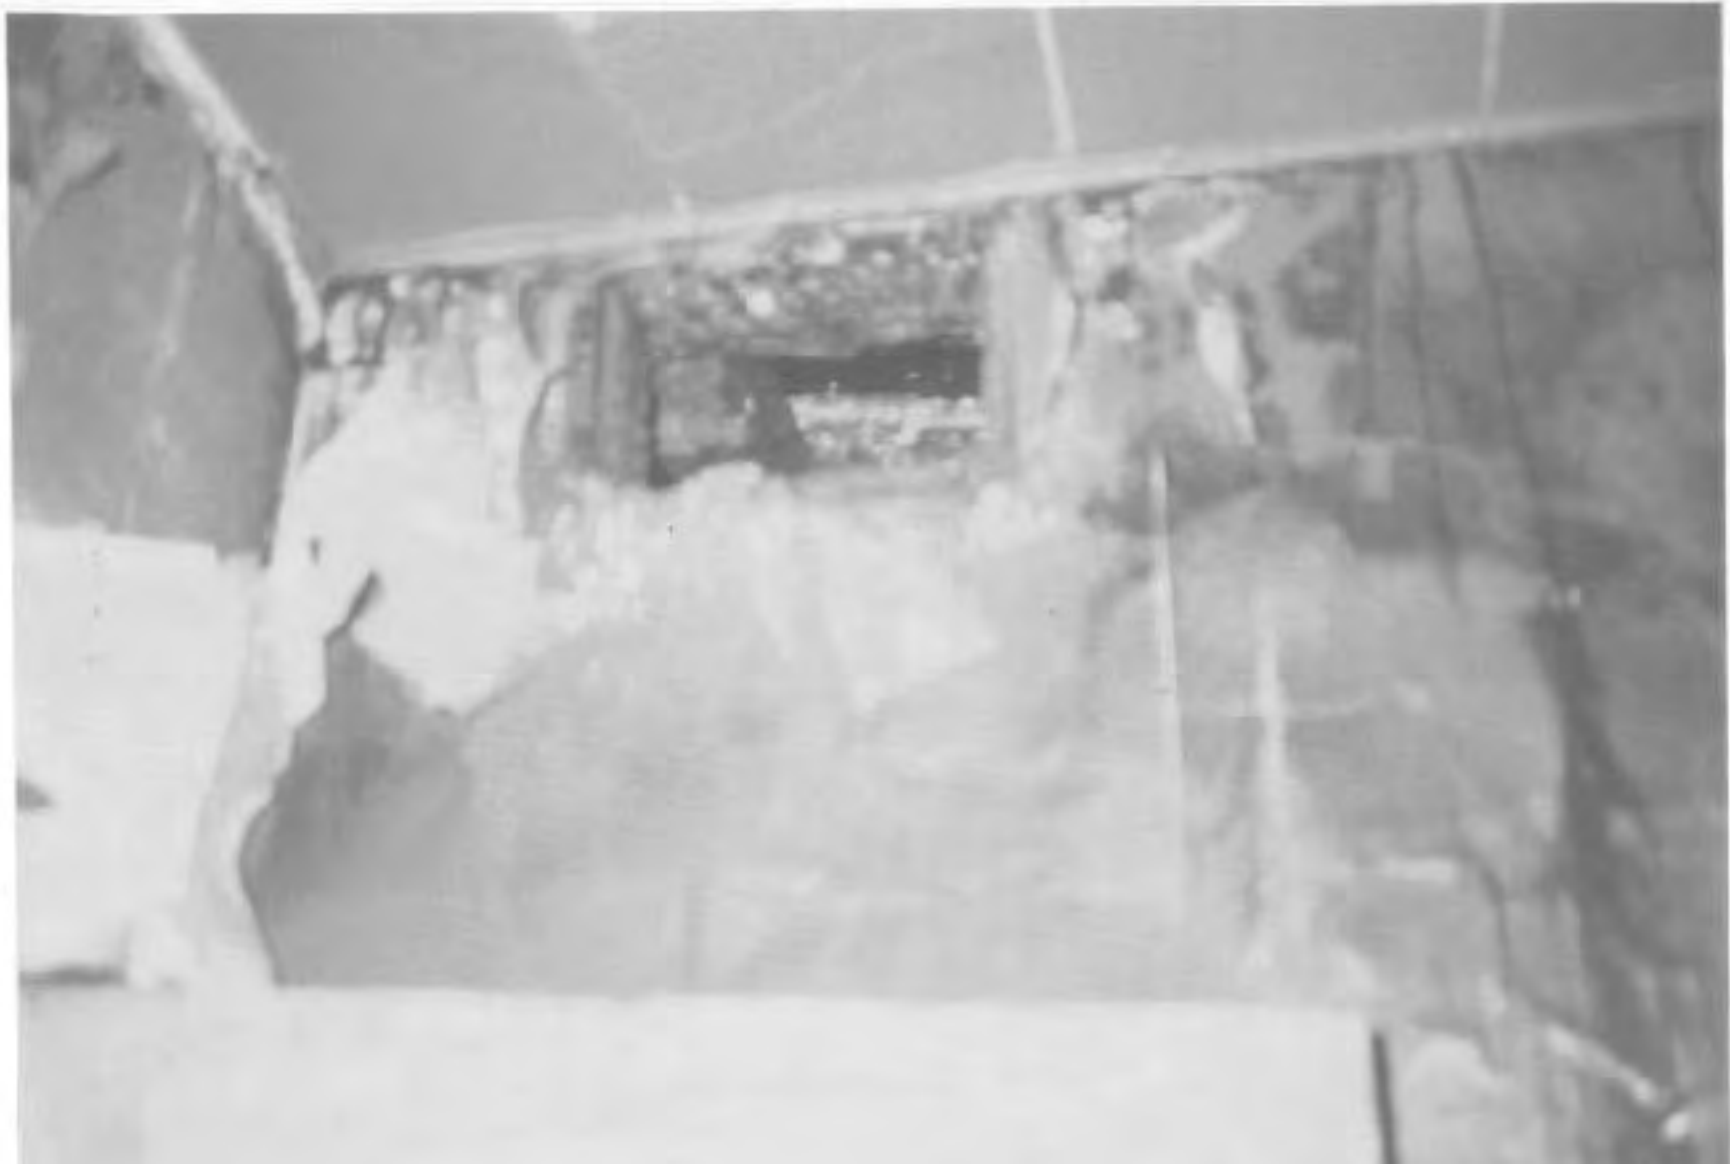
Smoke and heat traveled through air transfer vent from corridor to second floor south apartment bedroom.

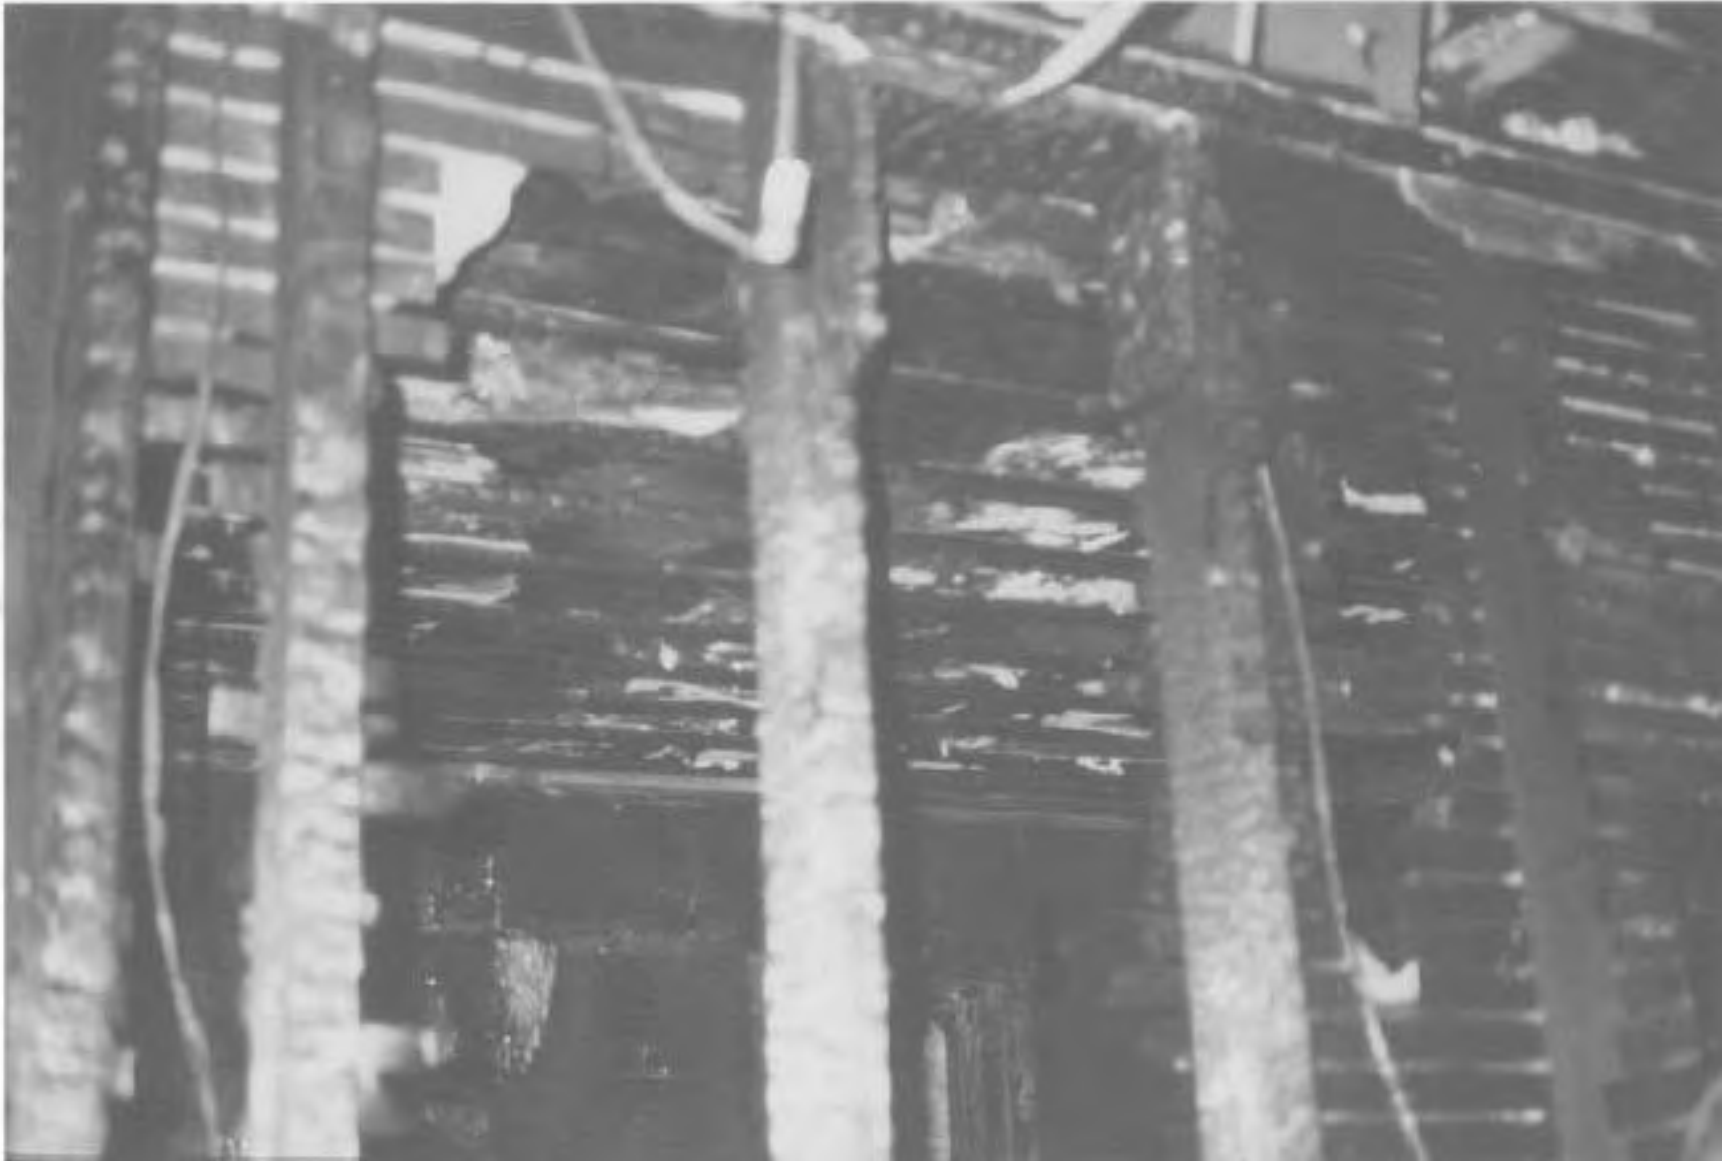
Fire traveled through air vent from suspected area of origin into second floor north apartment living room. Again, notice high burn pattern.

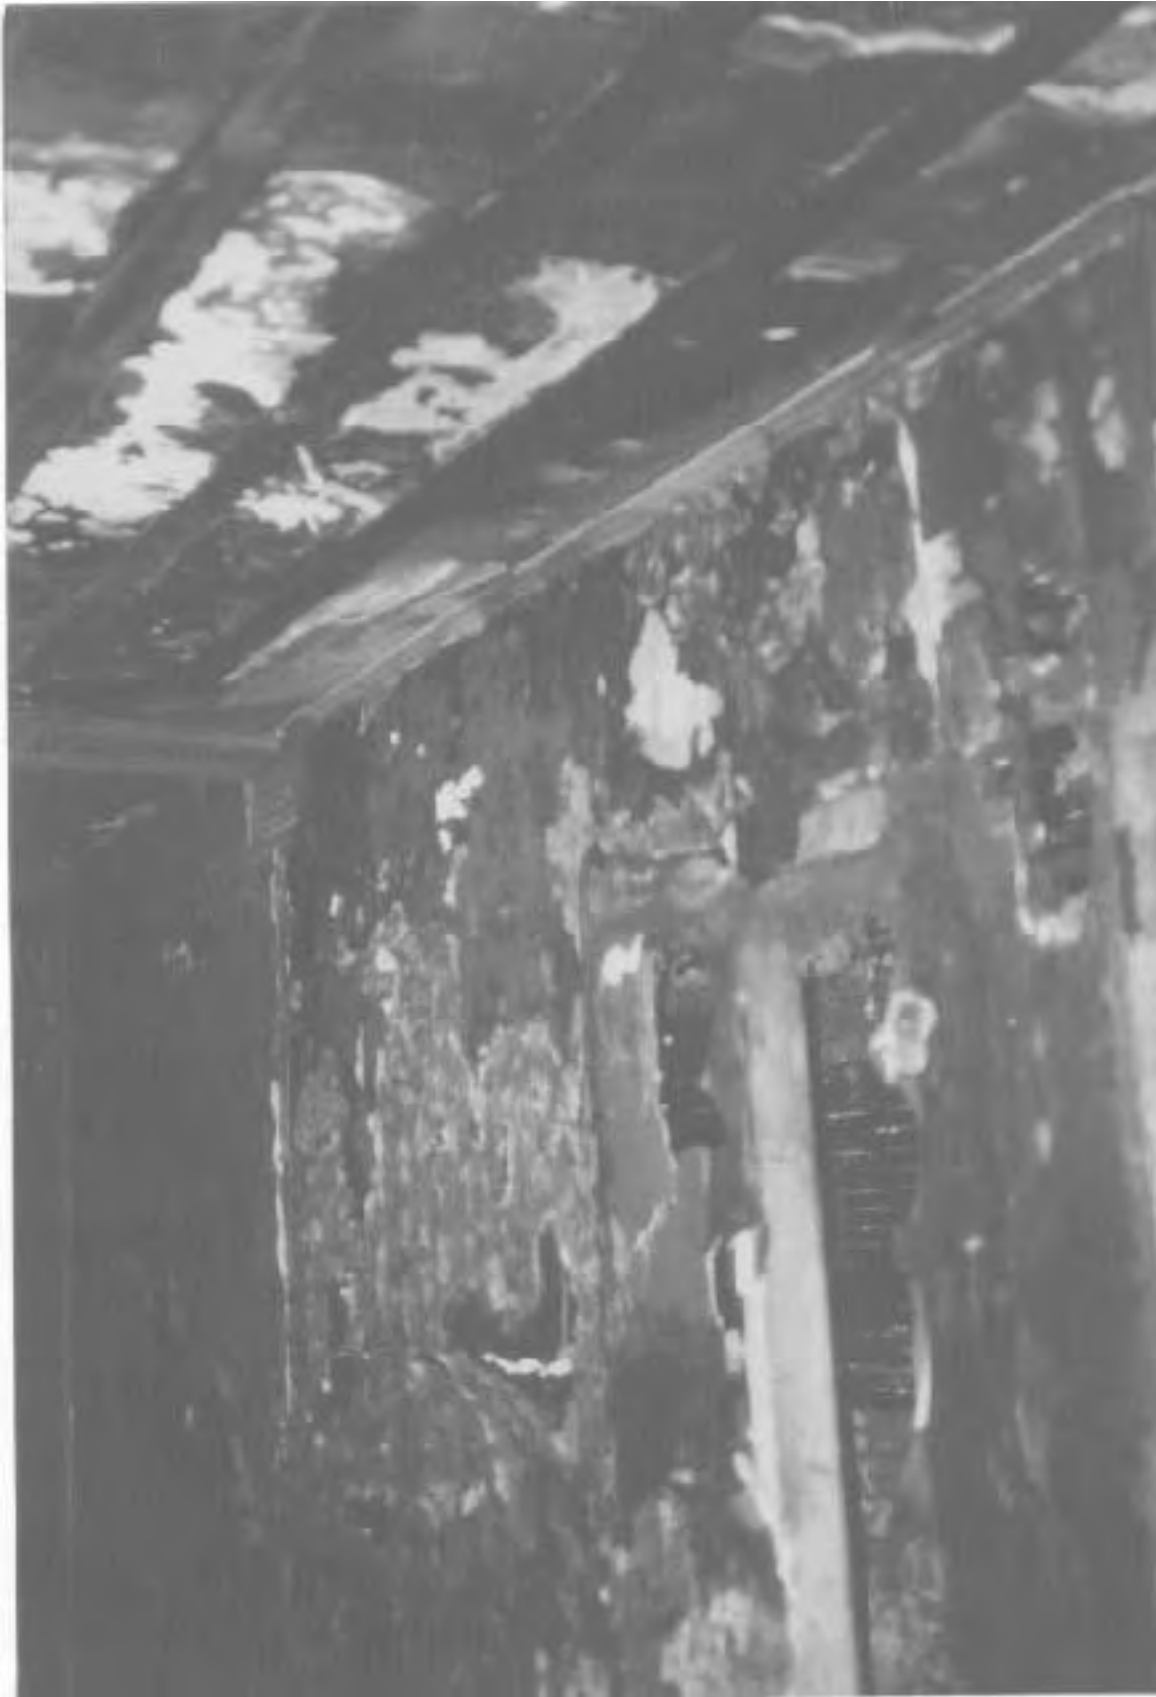
Fire damage to second floor corridor walls and ceiling.
Notice fire penetration through wall into north apartment.
