Floor Collapse Claims Two Firefighters Pittston, Pennsylvania

Floor Collapse Claims Two Firefighters Pittston, Pennsylvania (March 15,1993)

Investigated by: J. Gordon Routley

**This is Report 073 of the Major Fires Investigation Project conducted
by TriData Corporation under contract EMW-90-C-3338 to the United
States Fire Administration, Federal Emergency Management Agency.**

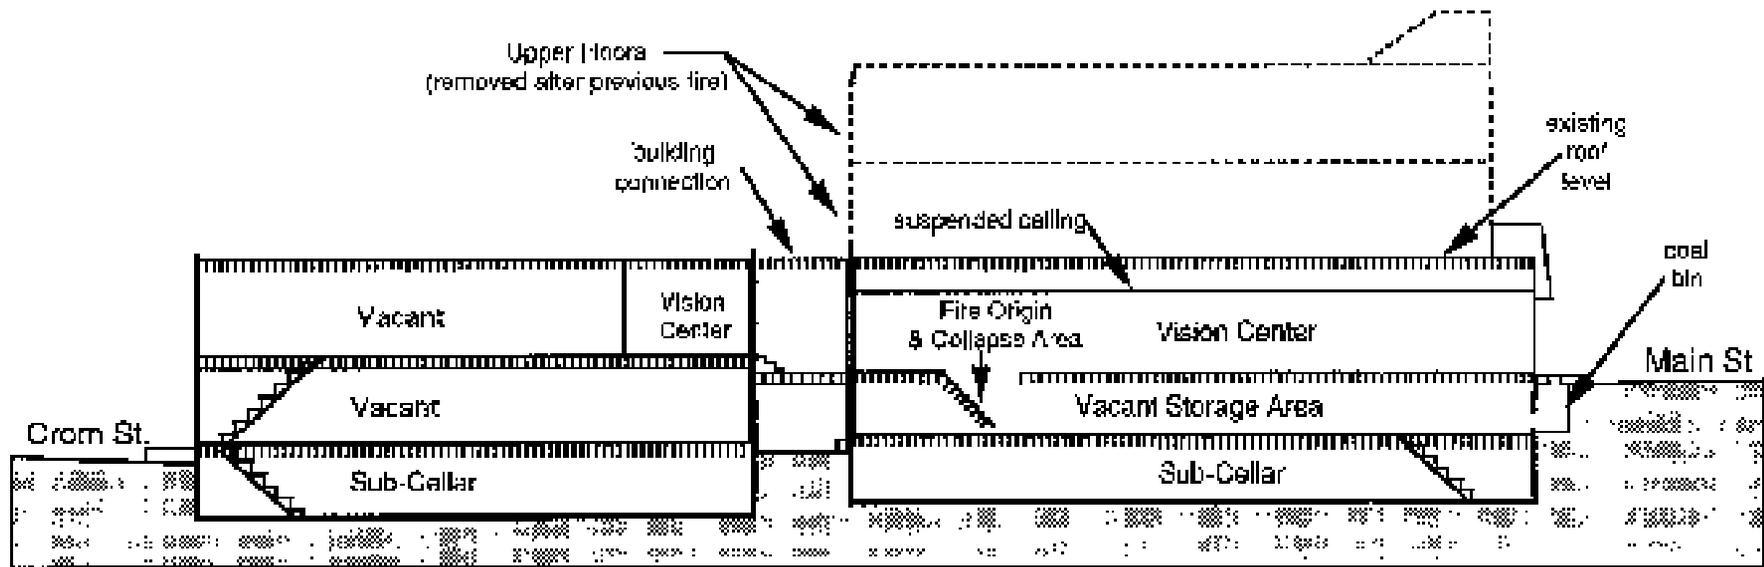
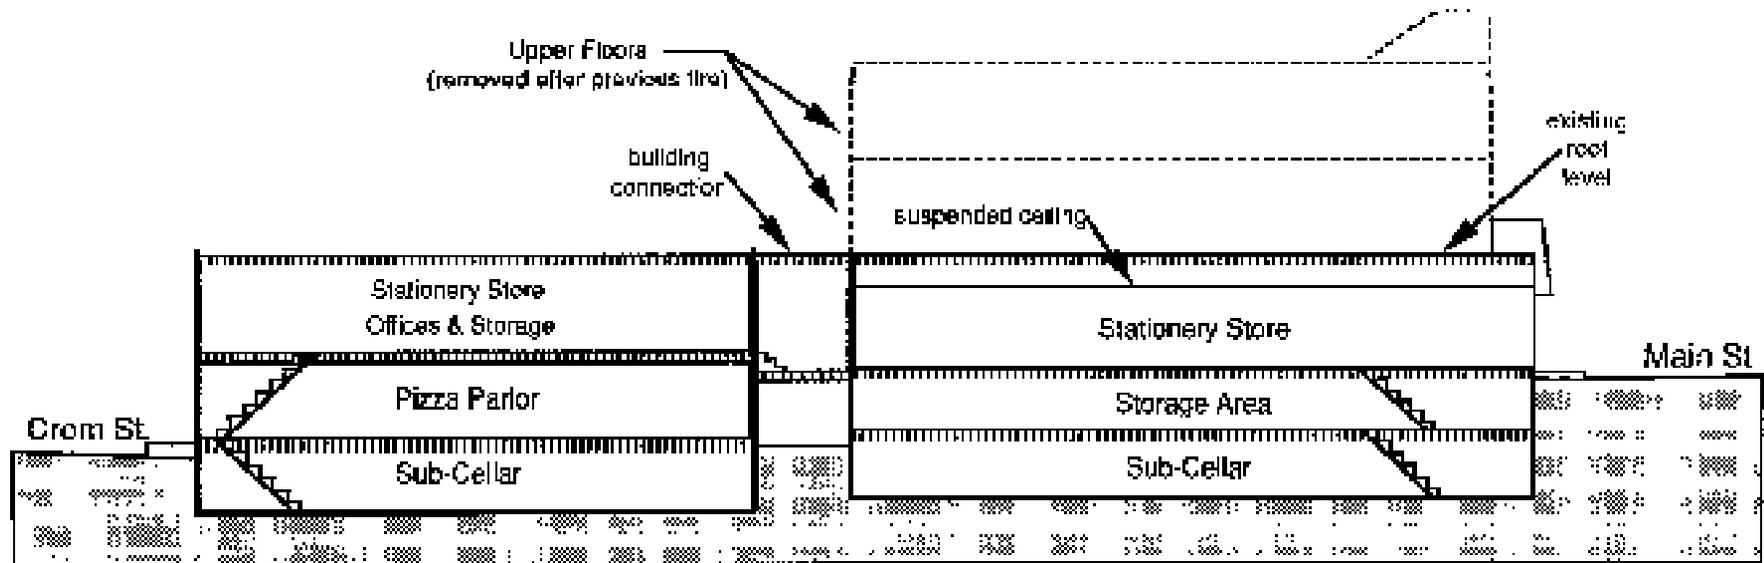
PITTSTON, PENNSYLVANIA
Cross Sections through Occupancies

narrow width appears to have been a detail necessitated by the construction method, since the floors and roof were supported by heavy wood joists spanning approximately 25 feet between the brick walls. The upper levels had included a public assembly occupancy that is reported to have extended through both buildings and there was evidence of several openings at the ground level that had existed at one time or another as the occupancy of the buildings changed.

Below the street level of these buildings was a basement level. The ground floors were wood supported by exposed 3 x 10 wood joists spanning the width between the brick walls under each occupancy. The clear height of this space was reported to be too short for normal occupancy, but it was used for storage. Under the vision center this space had been partially finished, but was unoccupied. Below the basement levels there were unfinished sub-cellars.

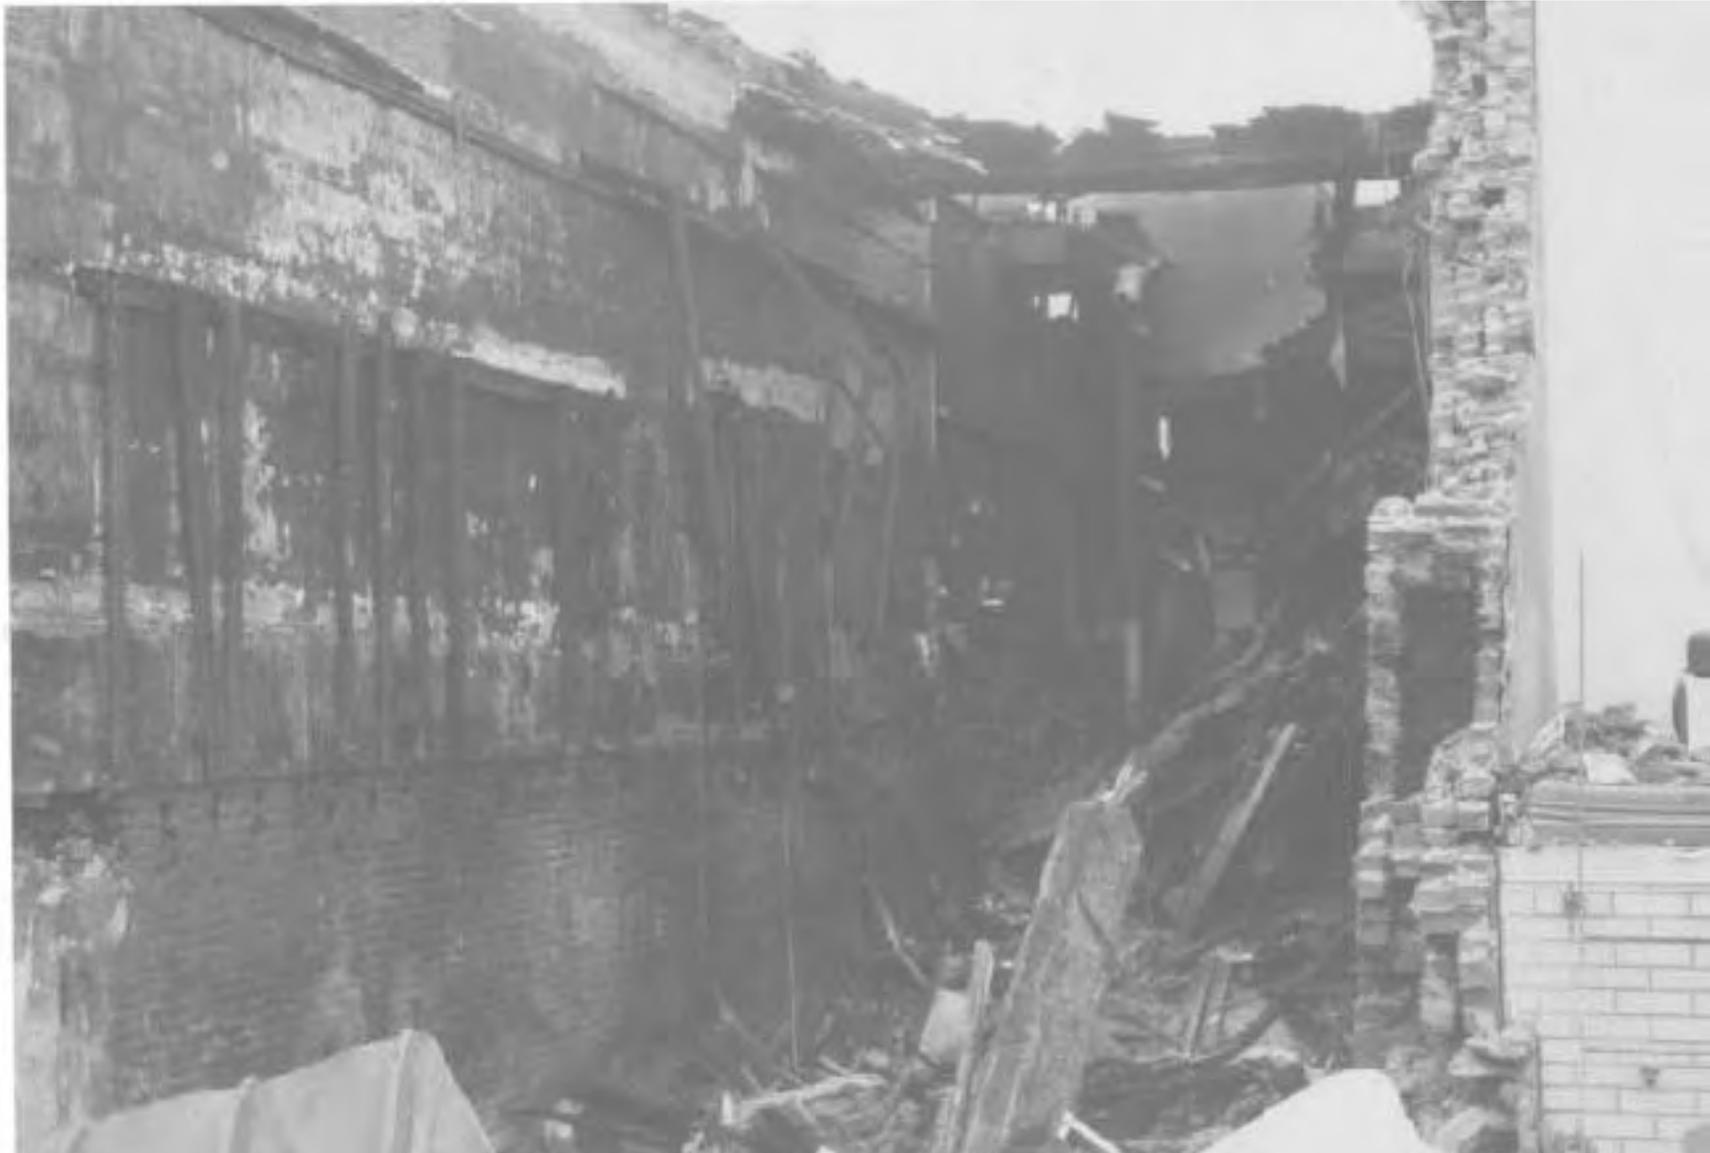
Void in brick wall (foreground) was a flue from a heating unit (previously removed) that may have allowed smoke from the basement to vent to the outside in the early stages of the fire.

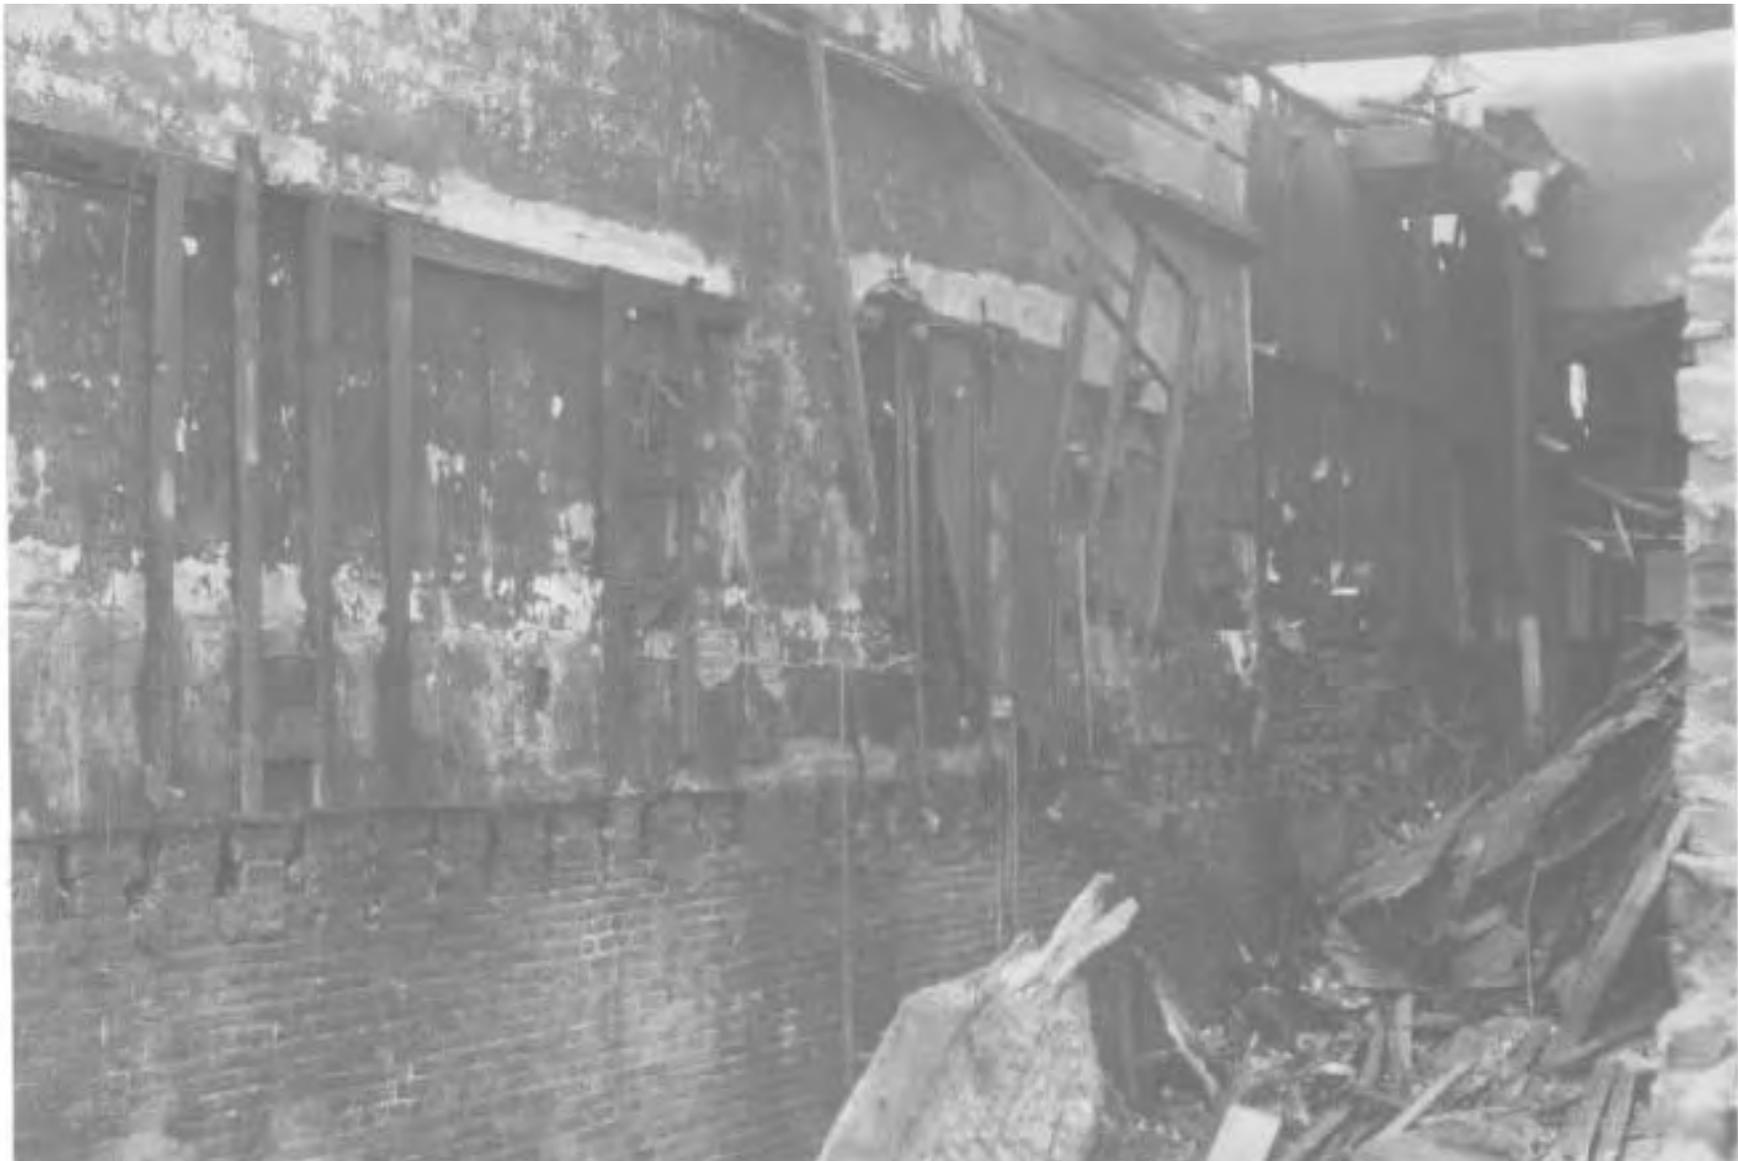
The wall of the front portion of the stationery store remains standing, although the interior is destroyed and the roof has collapsed.

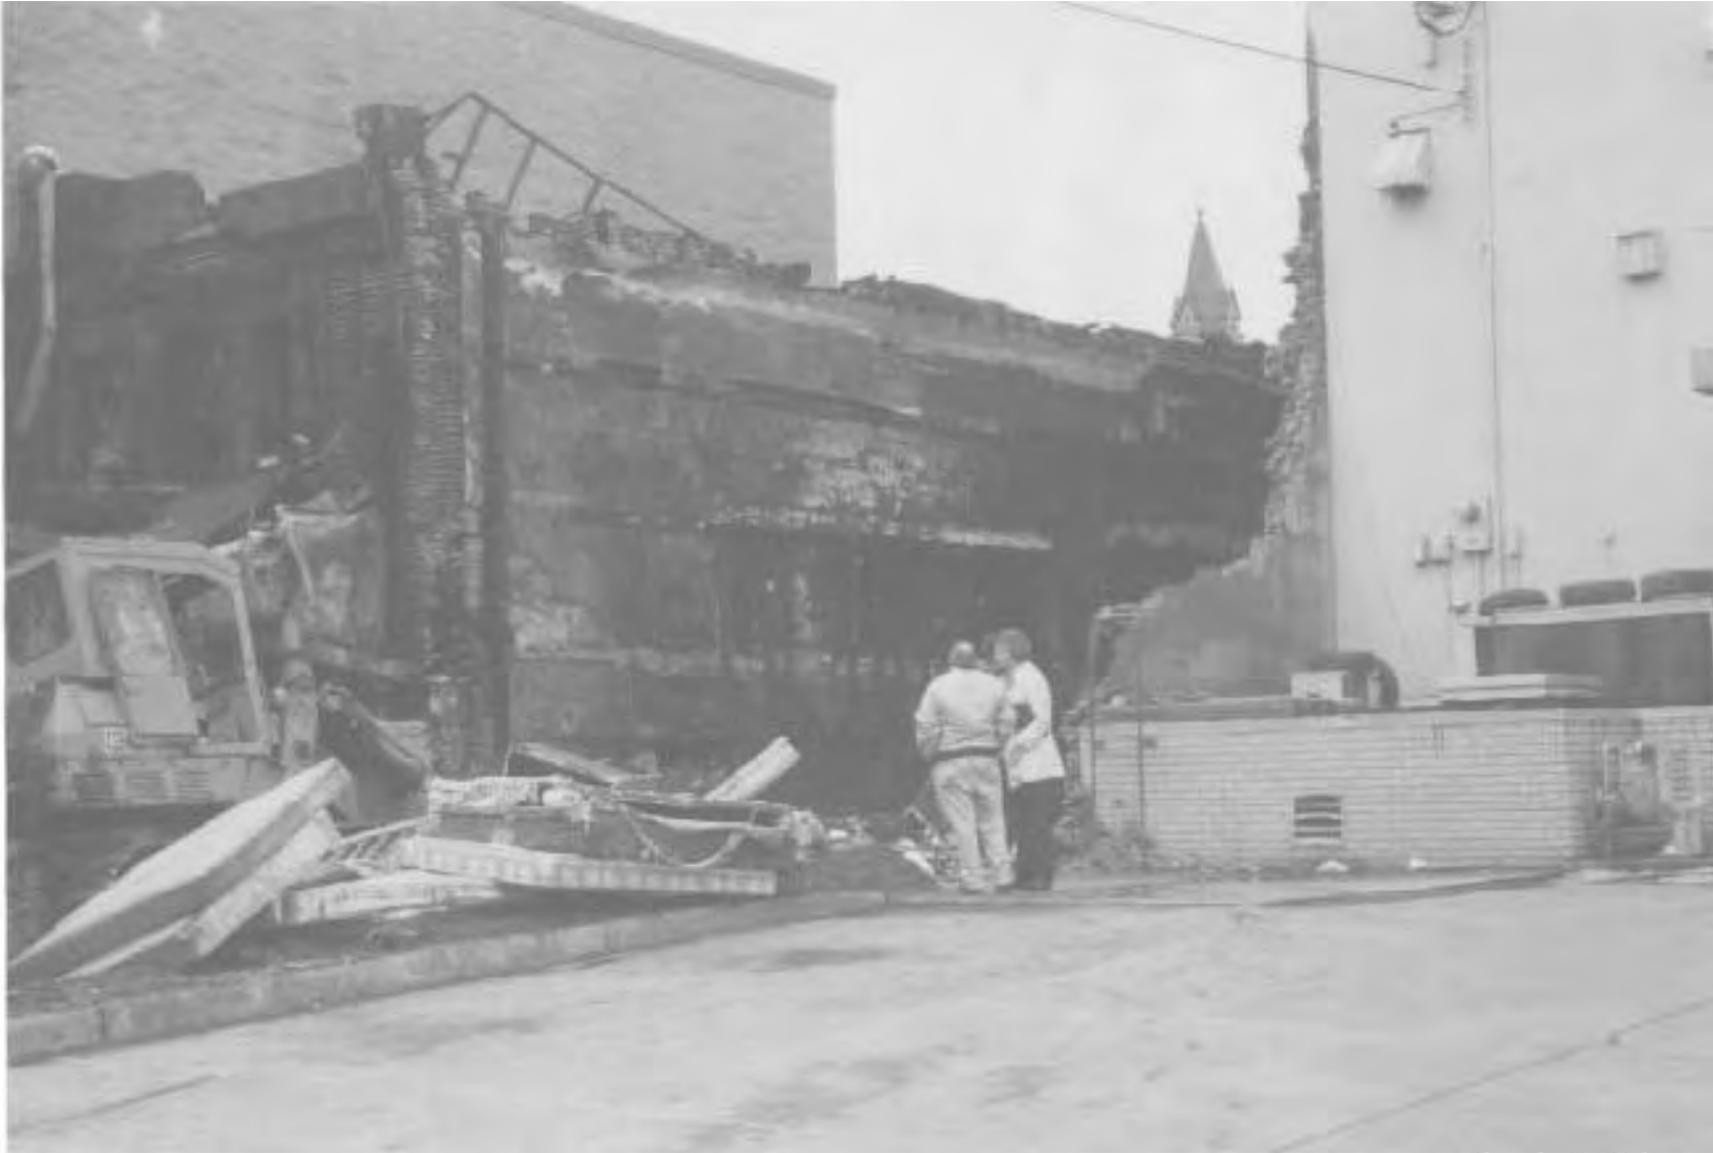
View of the area of fire origin and the area where the floor collapse occurred, after most of the debris has been removed. Indentations in the brick wall indicate where floor joists were supported.

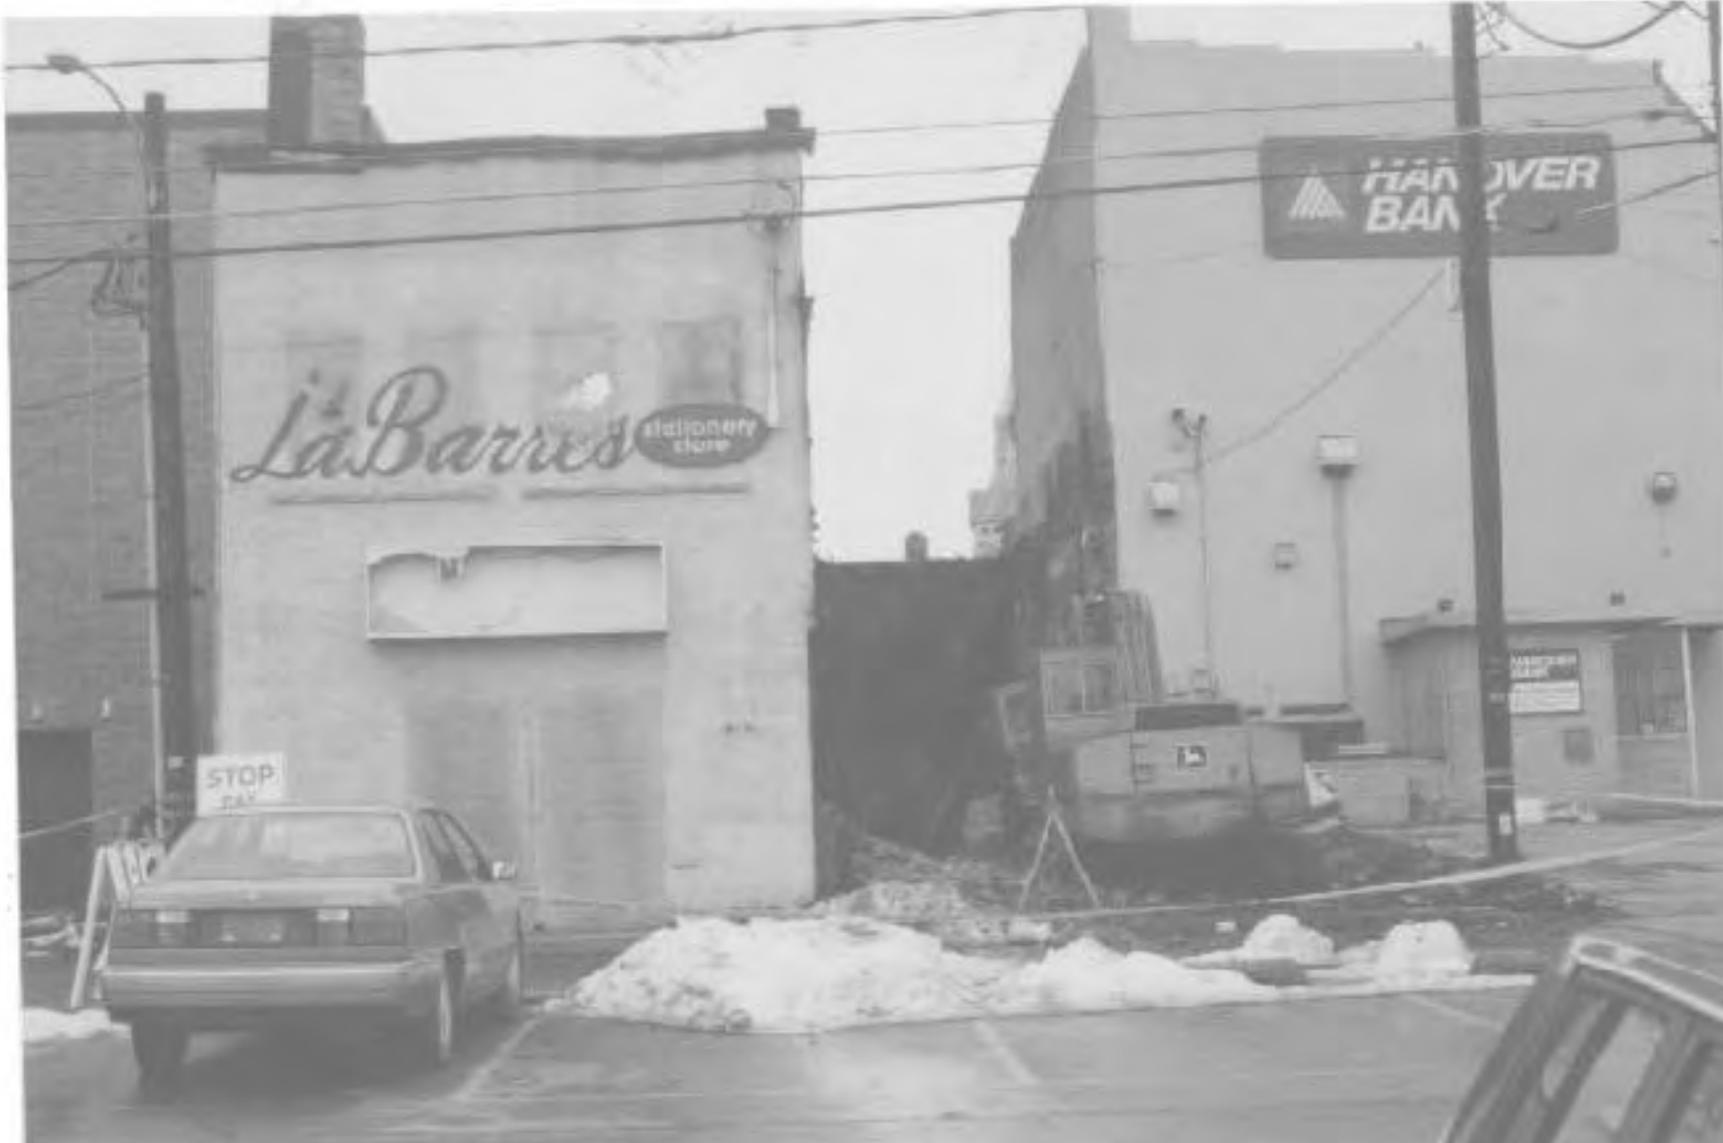
After demolition of the rear part of the fire occupancy, the narrow width of the fire buildings is evident. The demolition was necessary to allow investigators to access the area of fire origin. The boarded-up doorway was the entrance to the pizza restaurant.

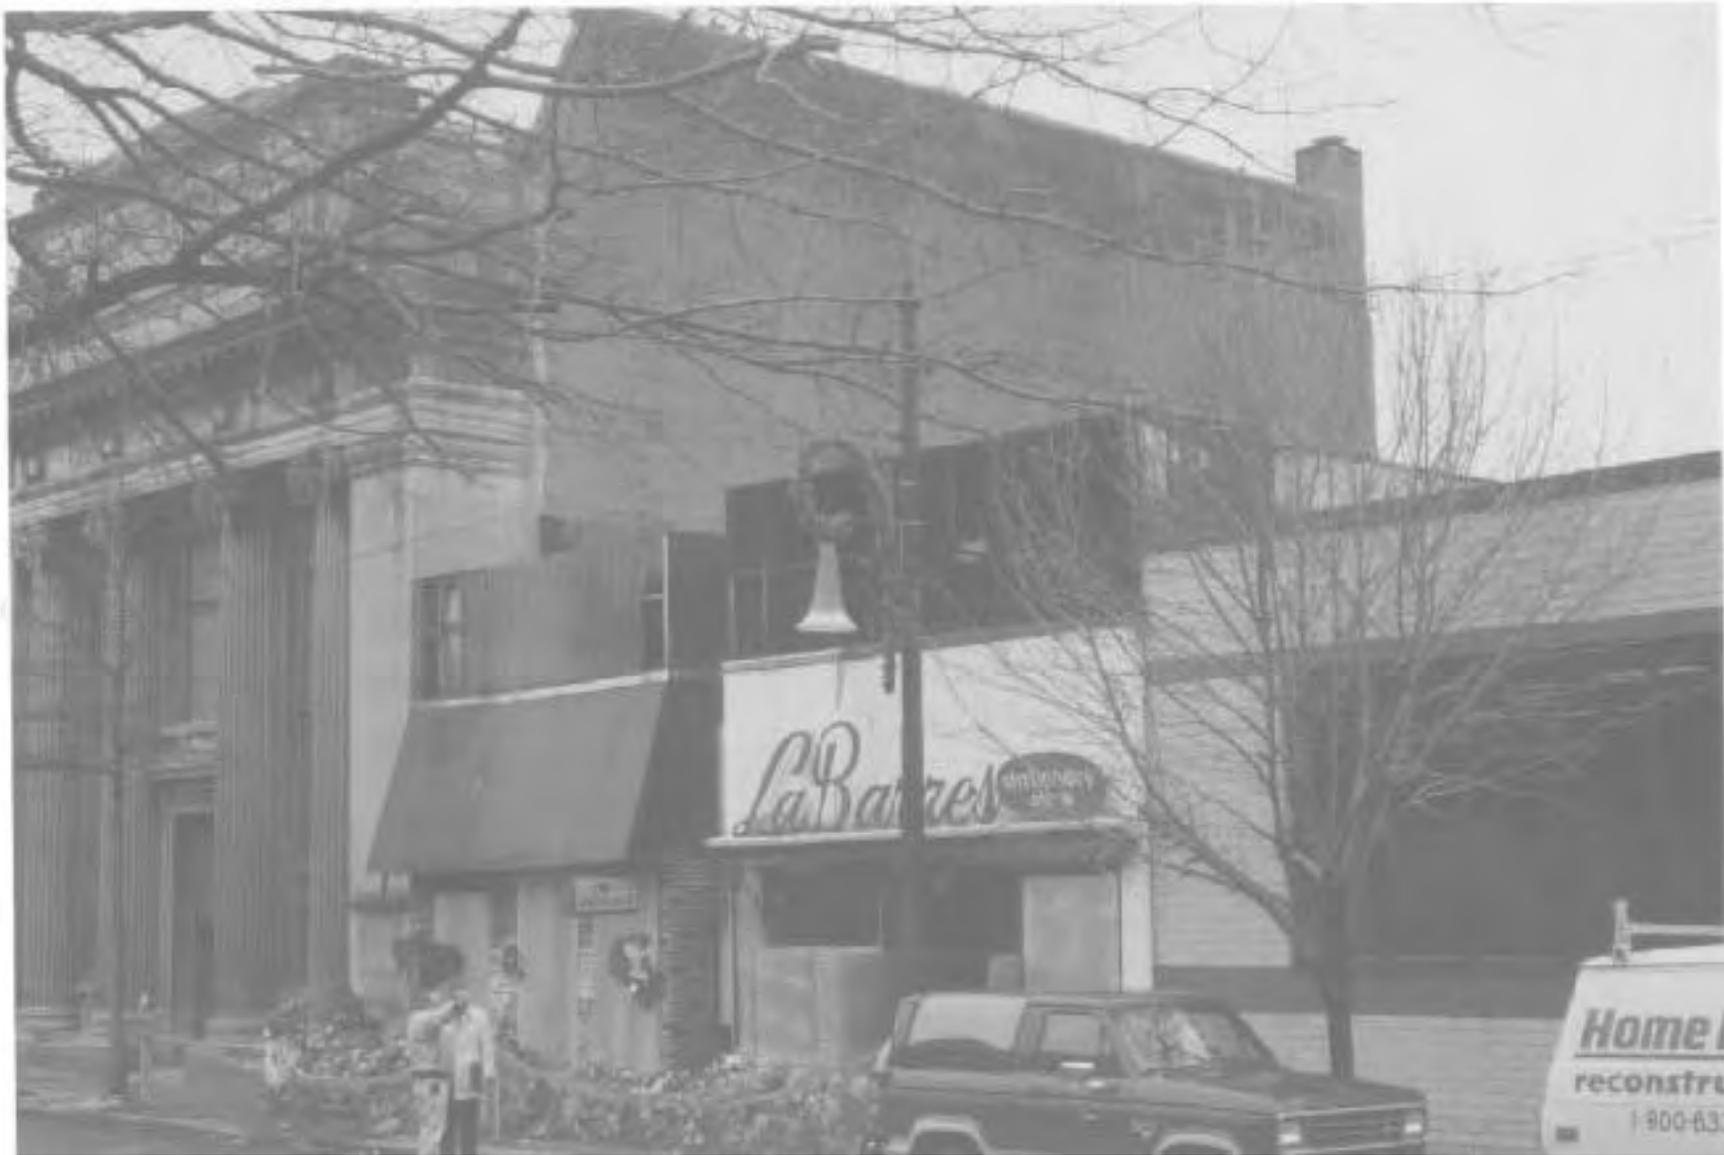
The outline of the upper floors of the original structures is visible in the wall separating the fire buildings from the exposed bank building (background). The void space above the entrances to the two buildings is also visible. The condition on arrival was smoke coming from this space.

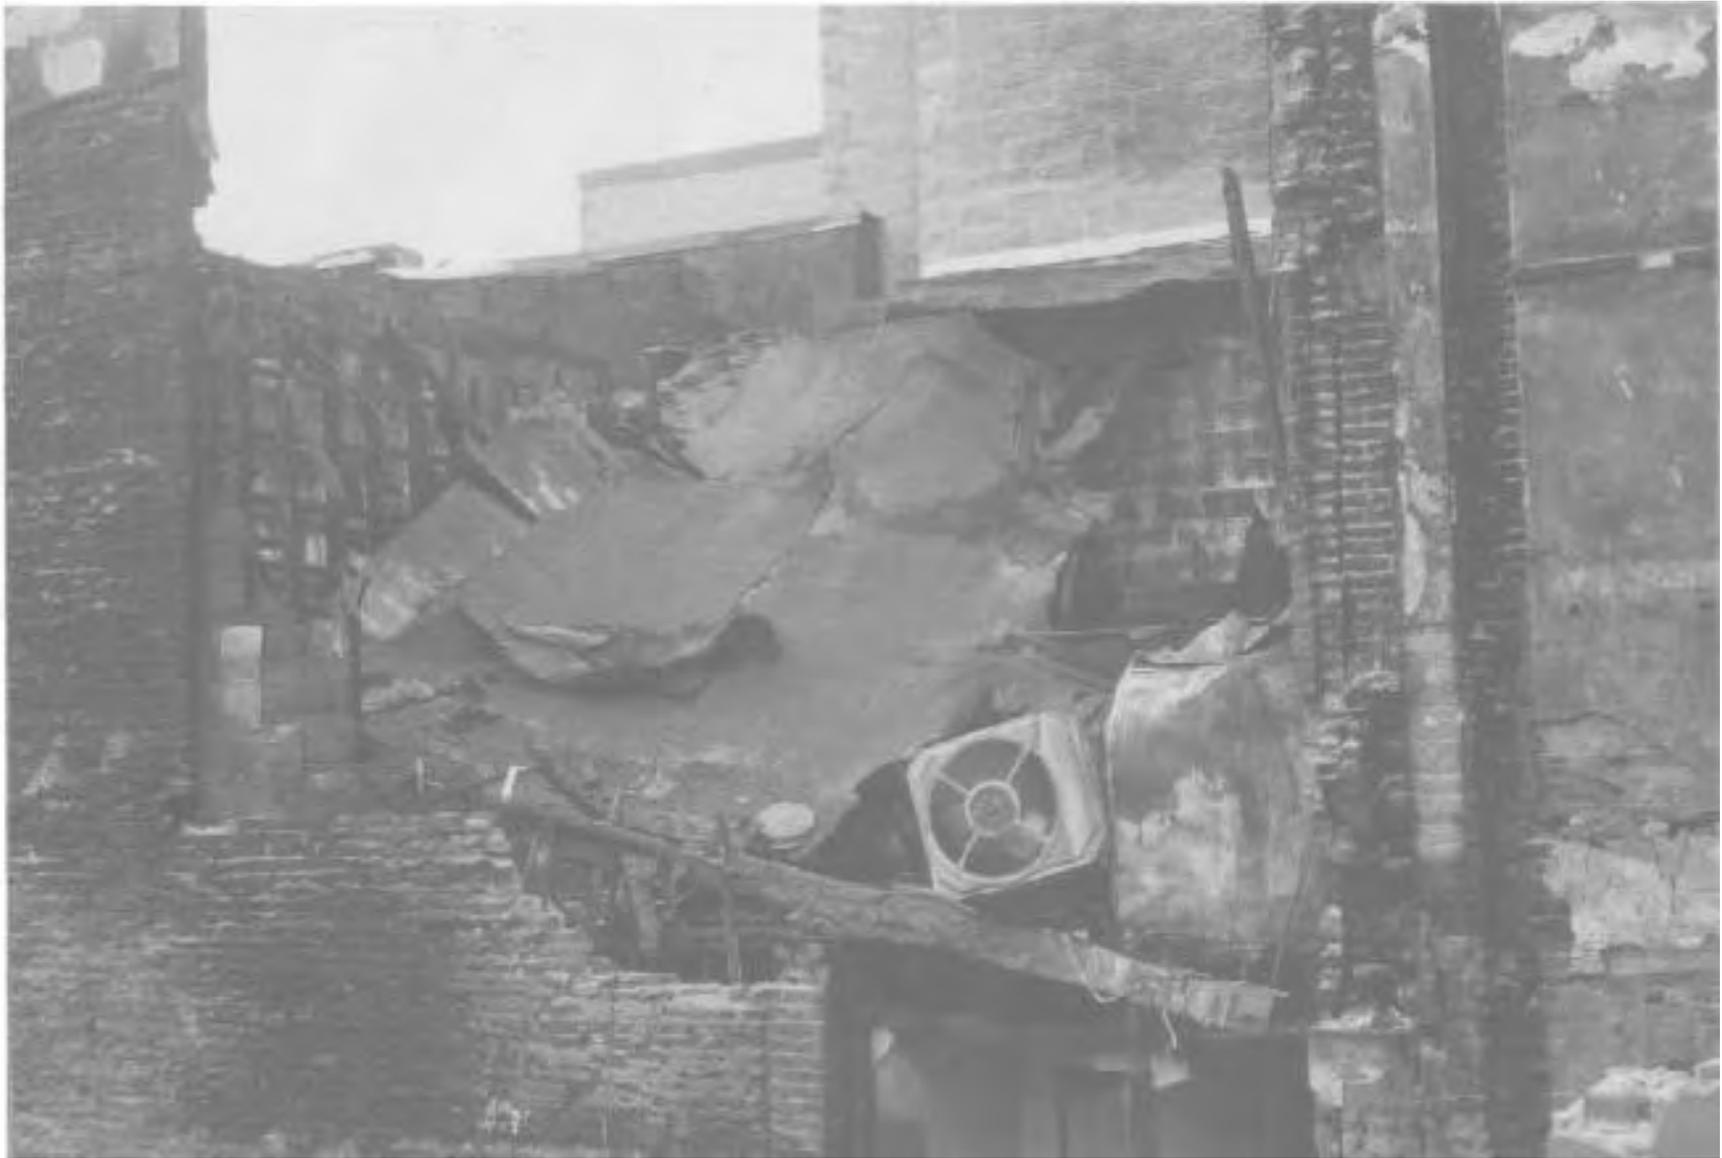
Collapsed roof section from the mid-section of the stationery store. The original walls of the front and rear buildings can be seen in this photo. The opening at the lower level is the original alley, which was filled in by construction joining the front and rear buildings. This opening provided an open path for fire extension between occupancies.

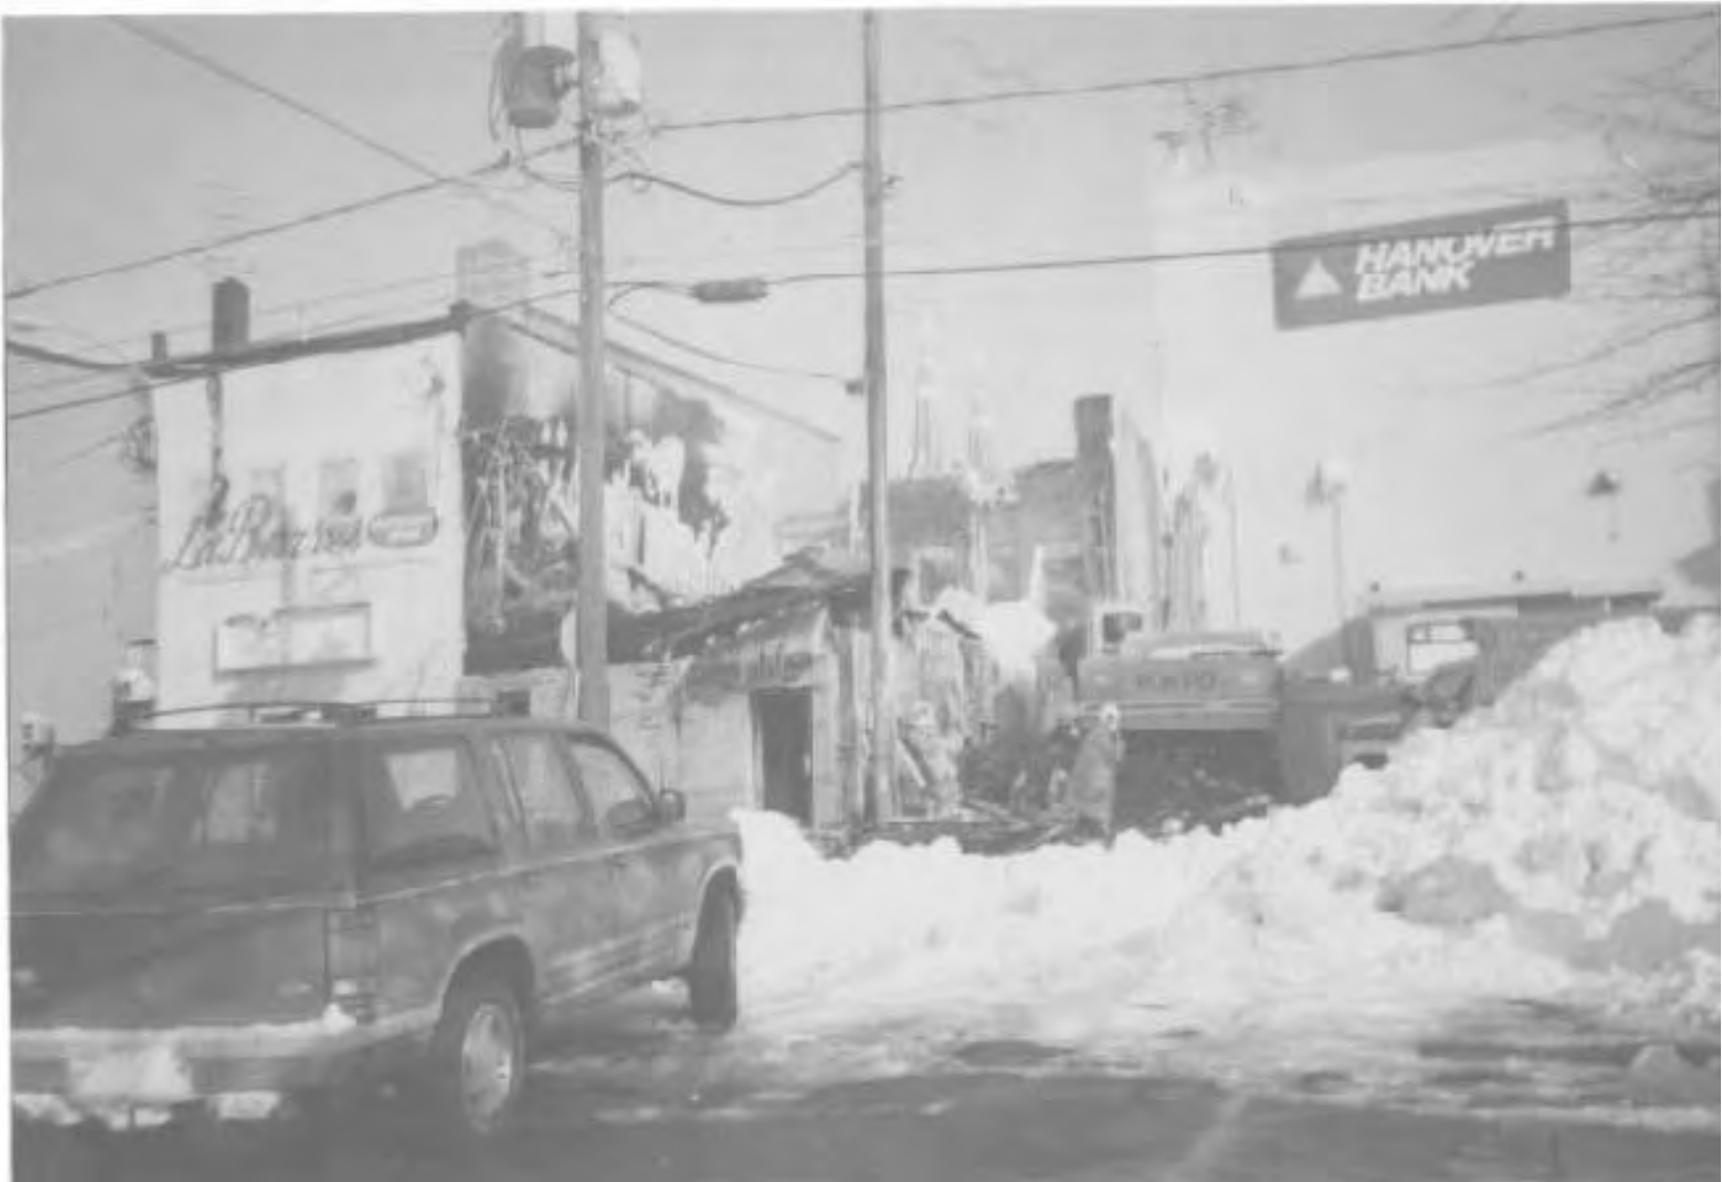
Approximately 16 hours after the fire the upper floor of the rear portion of the vision center building has collapsed and heavy equipment has been moved into the bank parking lot to begin debris removal. The door in the single story section that remains standing was the access to the vacant office occupancy. The rear wall of the front section of the building is also visible.

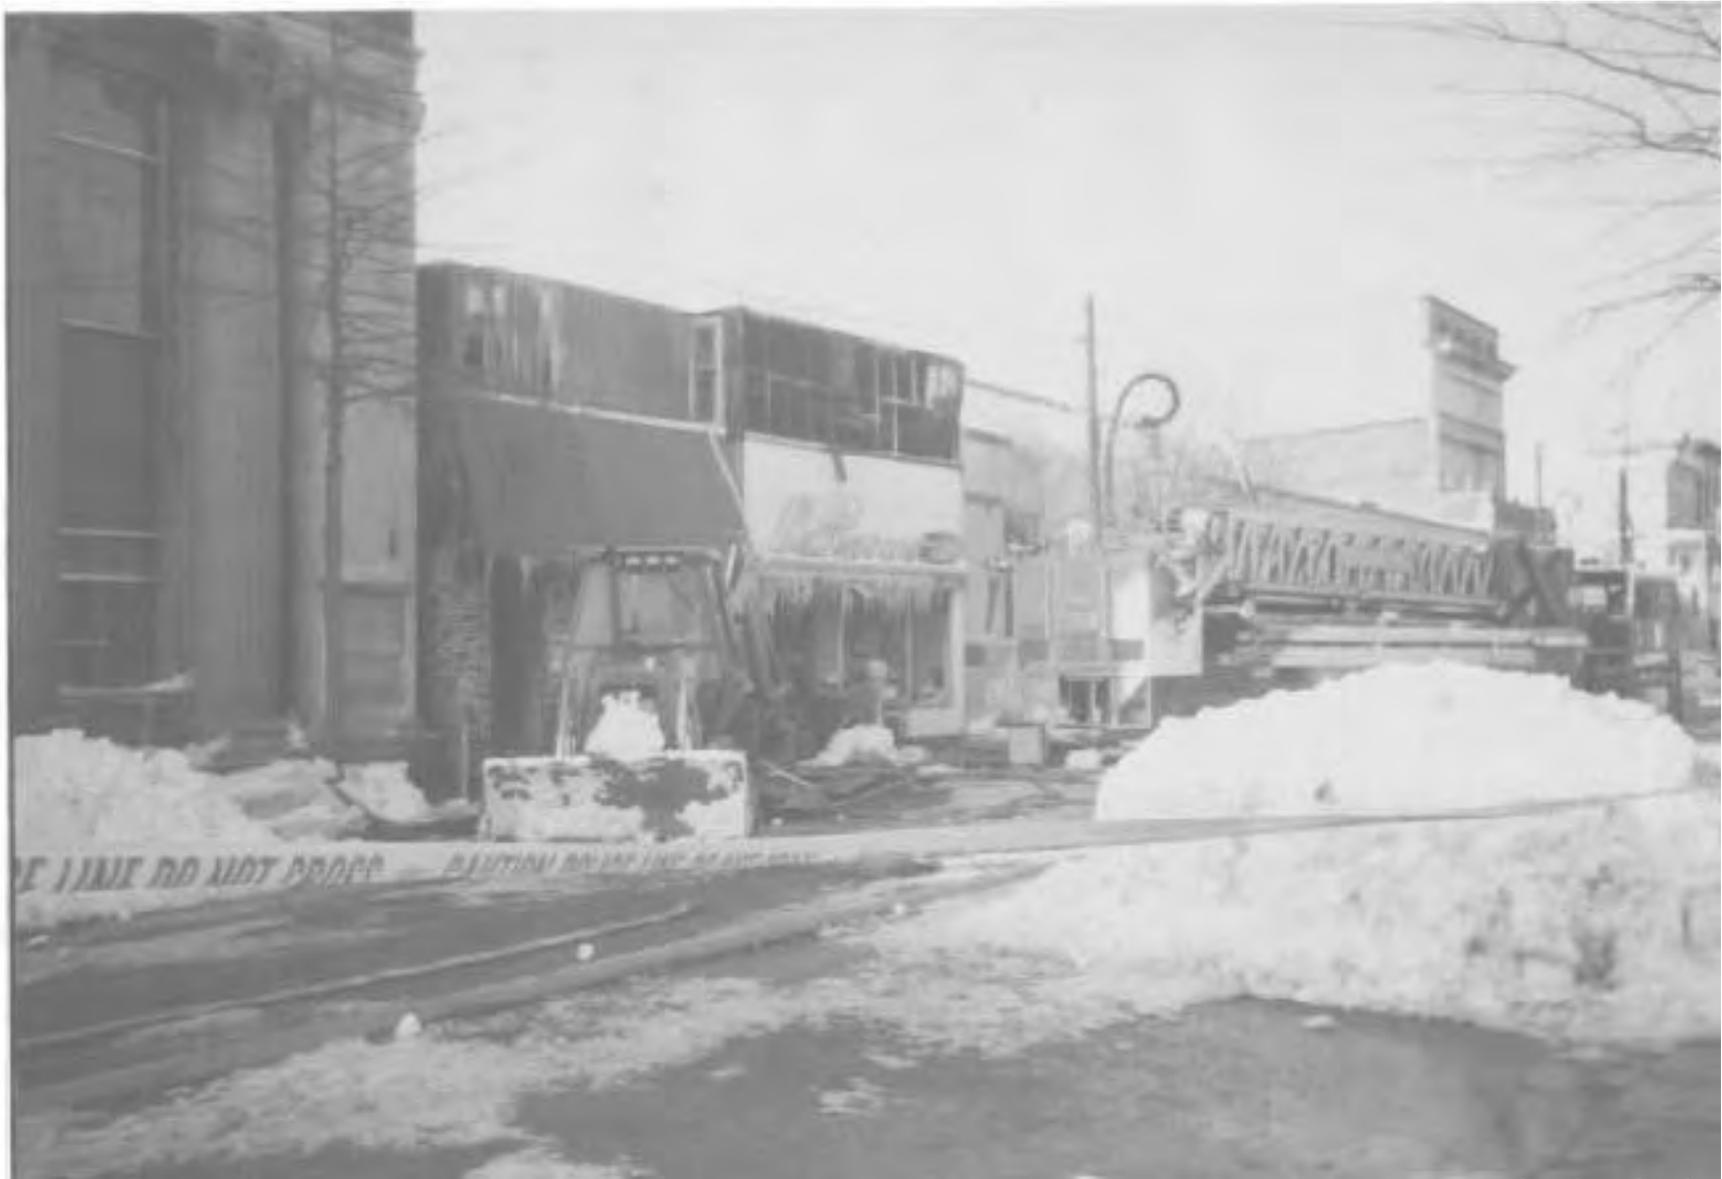
Approximately 16 hours after the fire, a backhoe is in front of the occupancy of fire origin to open an access to the coal bin under the sidewalk and provide access to the basement.
