Technical Report Series

Four Firefighters Die in Seattle Warehouse Fire Seattle, Washington

Investigated by: J. Gordon Routley

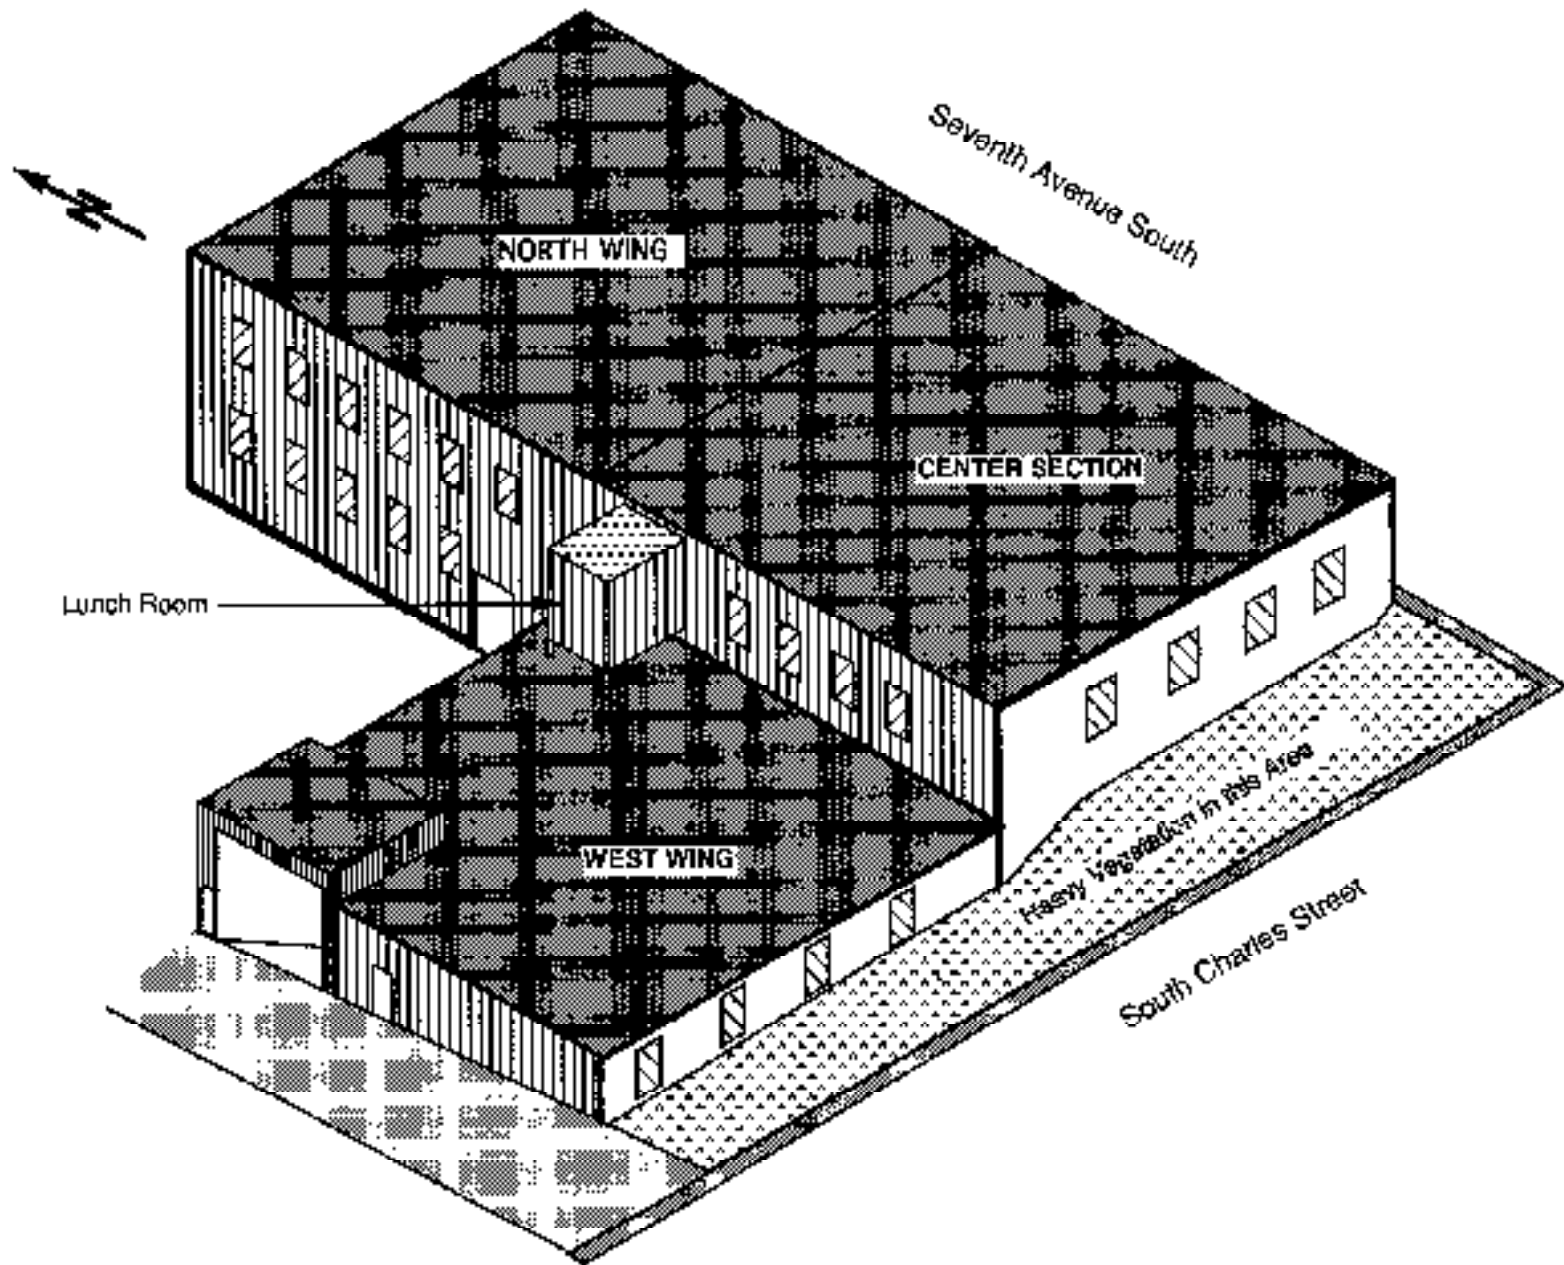
Figure 1A

MARY PANG BUILDING
View from South West

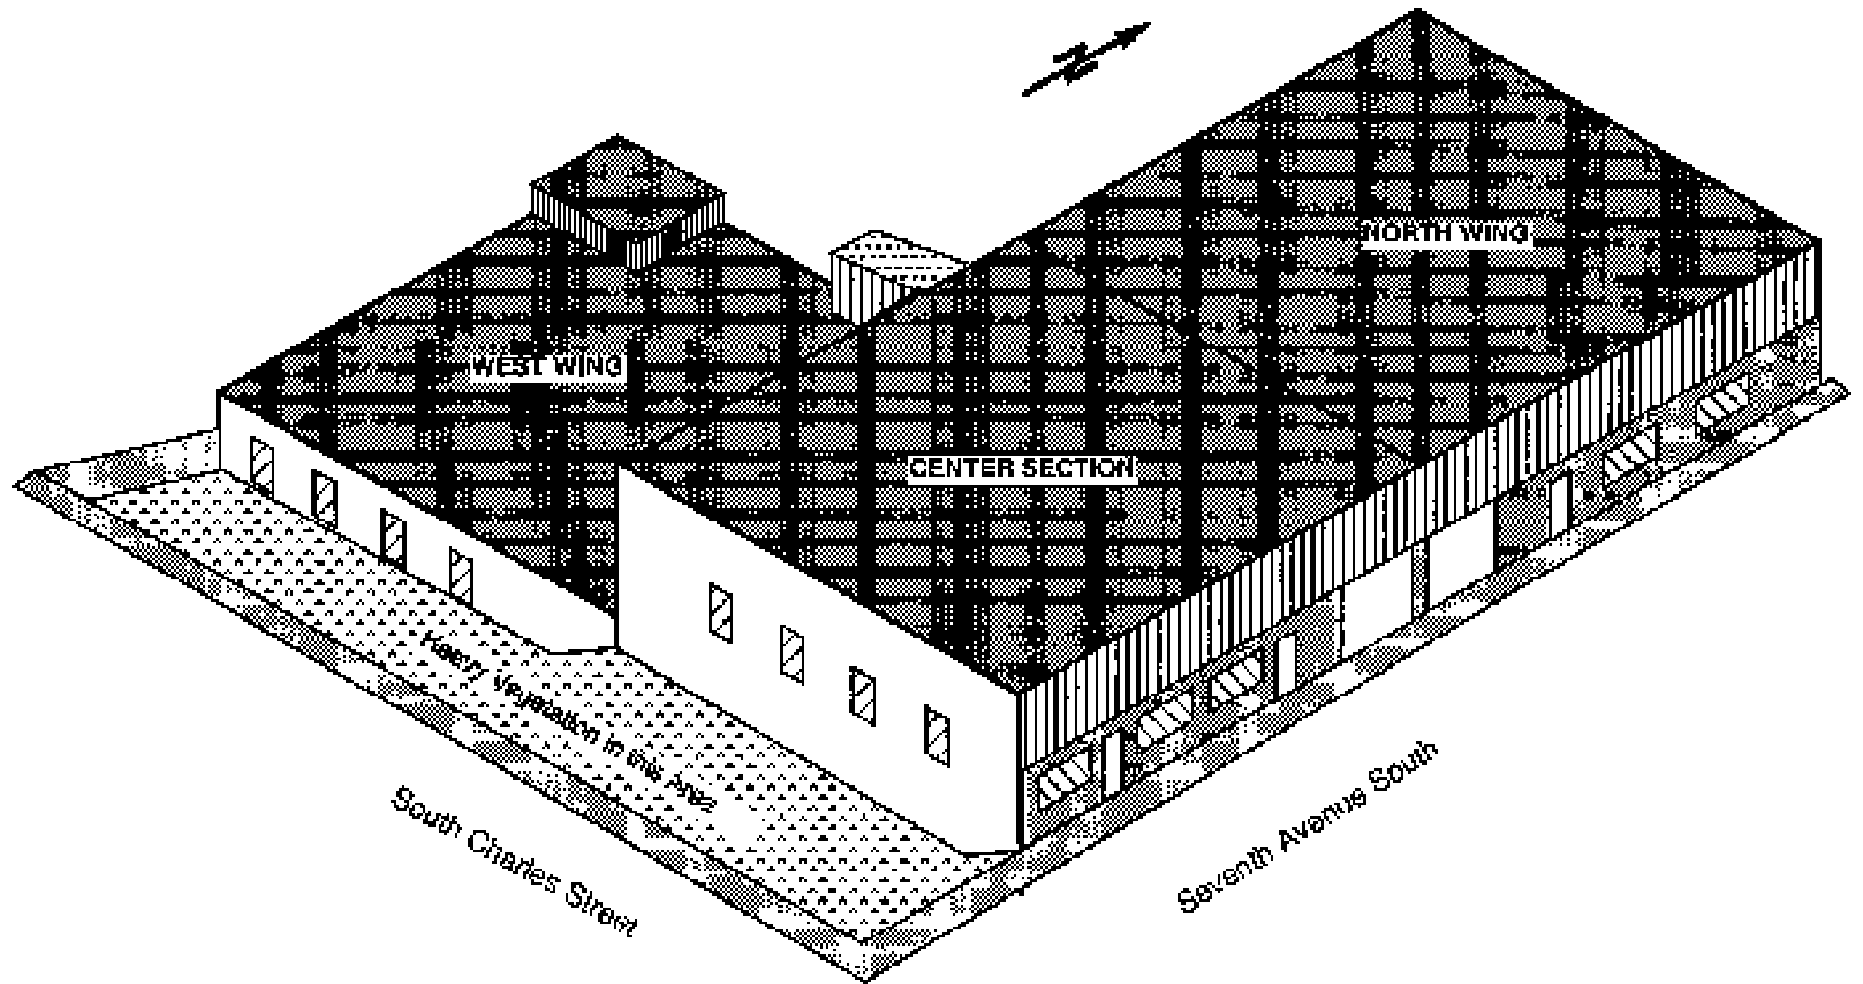
Figure 1 B

MARY PANG BUILDING
View from South East

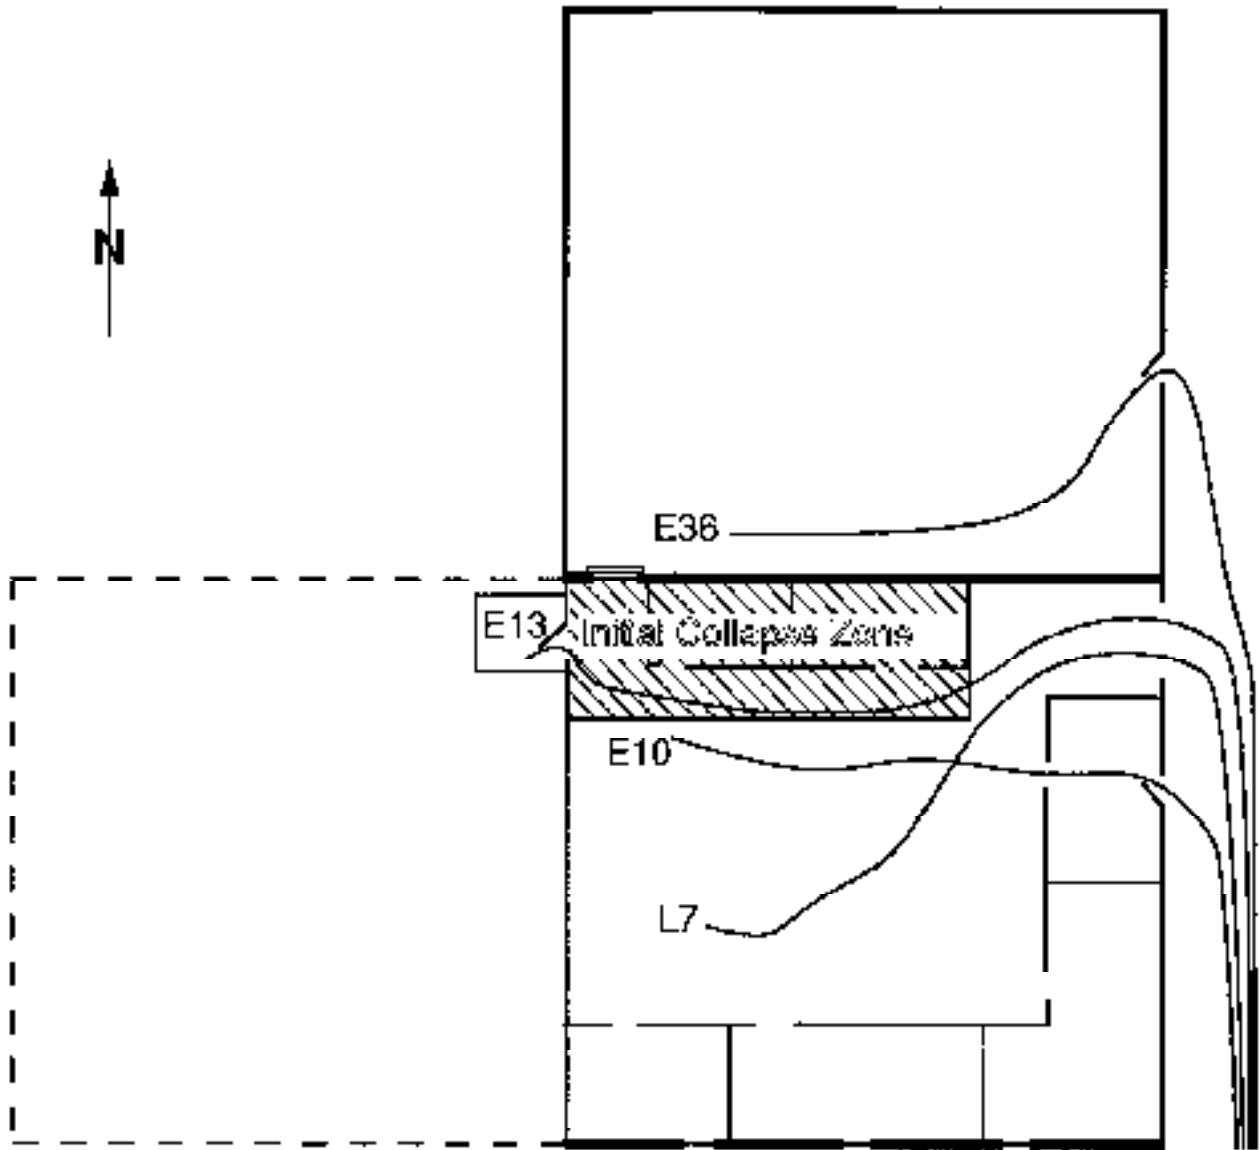
Figure 4

UPPER LEVEL FLOOR PLAN
Showing Attack Line Positions at Time of Collapse

4 Attack Lines
All 1 3/4 inch
Supplied by
E10 Manifold

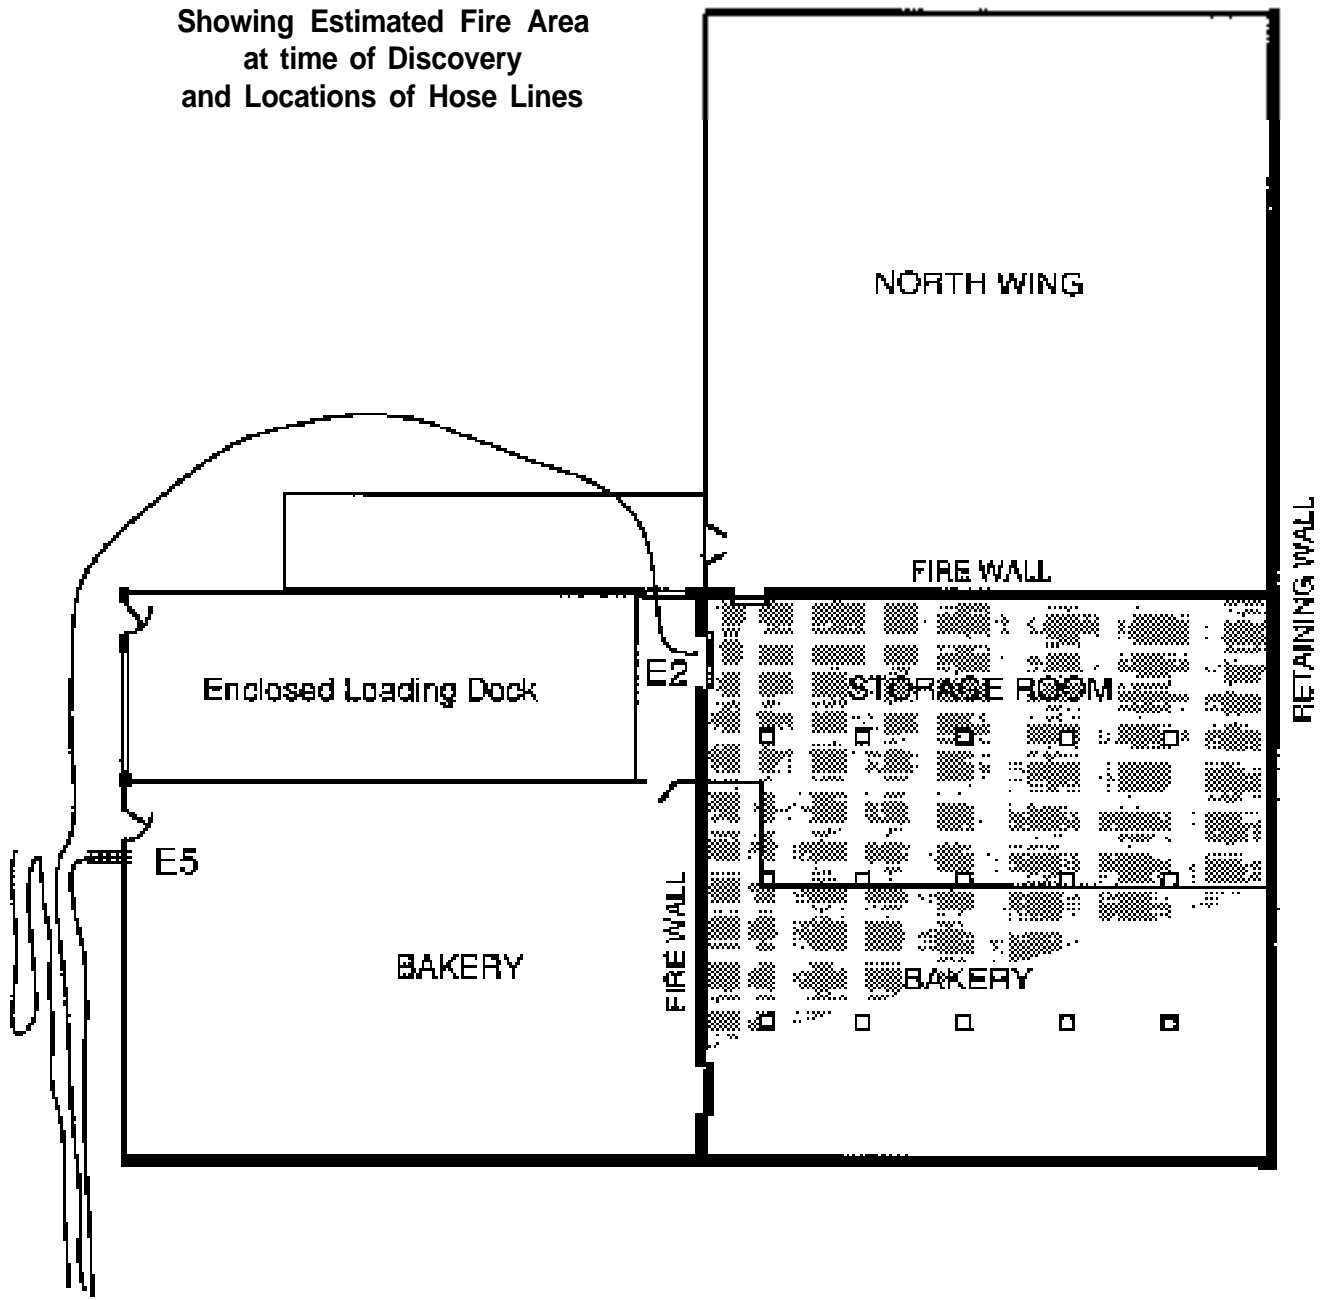
When they reached the loading dock they found the sliding fire door leading into the storage room partially open. The interior of the storage room was fully involved in fire; however, no smoke or flames were coming out of the doorway. The large fire was drawing air in through this opening. (This location is shown in Figure 4.)

LOWER LEVEL FLOOR PLAN
Showing Estimated Fire Area
at time of Discovery
and Locations of Hose Lines

1 3/4 inch Hose Lines
Supplied by
E5 Manifold

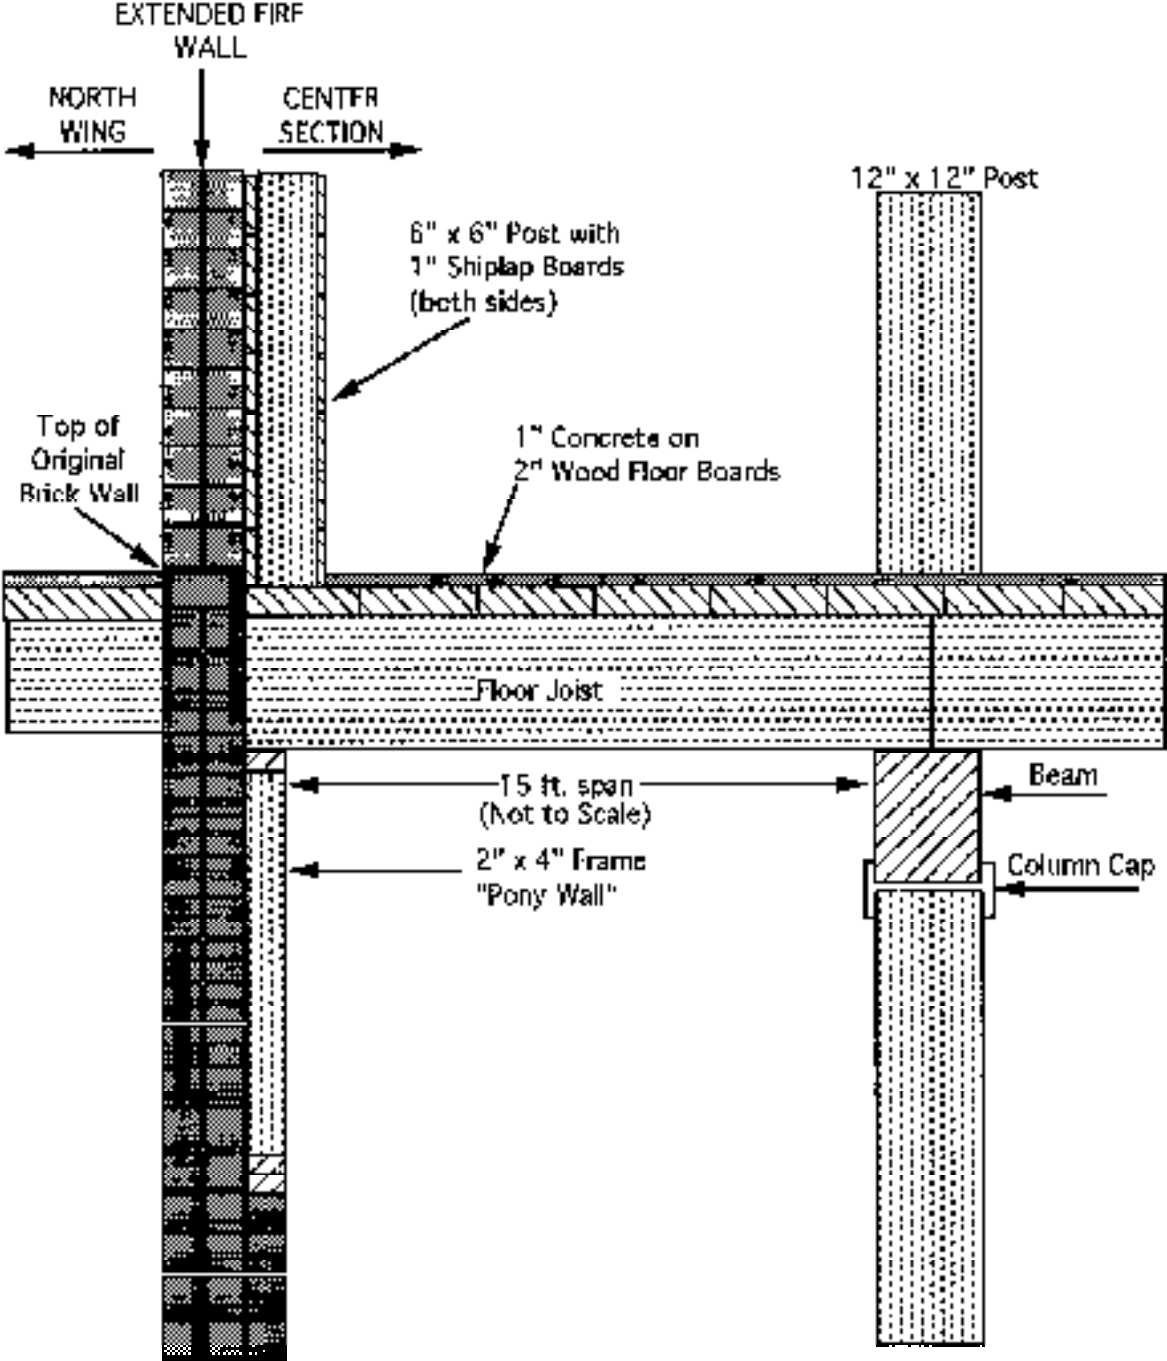
Figure 7

The hidden flaw in the structure was the support for the ends of the new floor joists along the north wall. The original roof was supported by a ledge that was incorporated in the brick wall. Because the new floor was four to five feet higher than the roof, a wood frame "pony wall" was fabricated from 2 x 4 inch wood members and erected on top of the ledge to support the ends of the new floor joists. This assembly did not have the inherent fire resistance of the more massive wood members and could be expected to fail rapidly under fire conditions. The failure of this assembly would release the ends of the floor joists and result in a sudden floor collapse.

CONSTRUCTION DETAILS AT INTERIOR FIRE WALL (ALL DIMENSIONS ARE ESTIMATES)

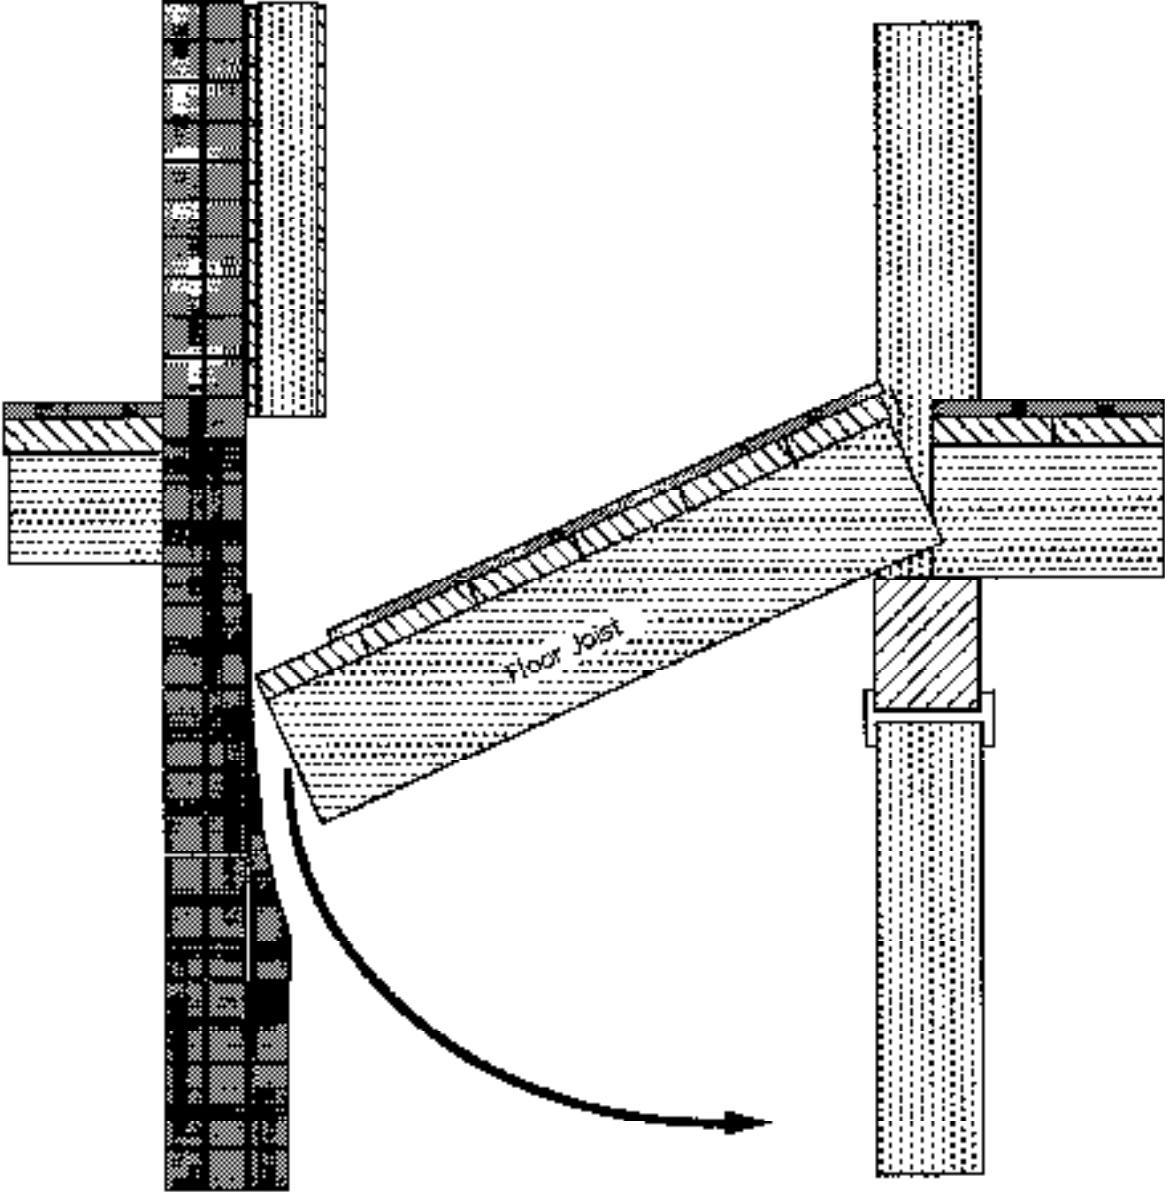
Figure 8

Seconds later the building rumbled and flames erupted from the basement as the floor began to collapse. It appears that the “pony wall” failed, dropping the ends of the floor joists. Sections of the wood and concrete floor hinged down into the basement. The flames coming from

**FLOOR COLLAPSE MECHANISM
UPON FAILURE OF PONY WALL**

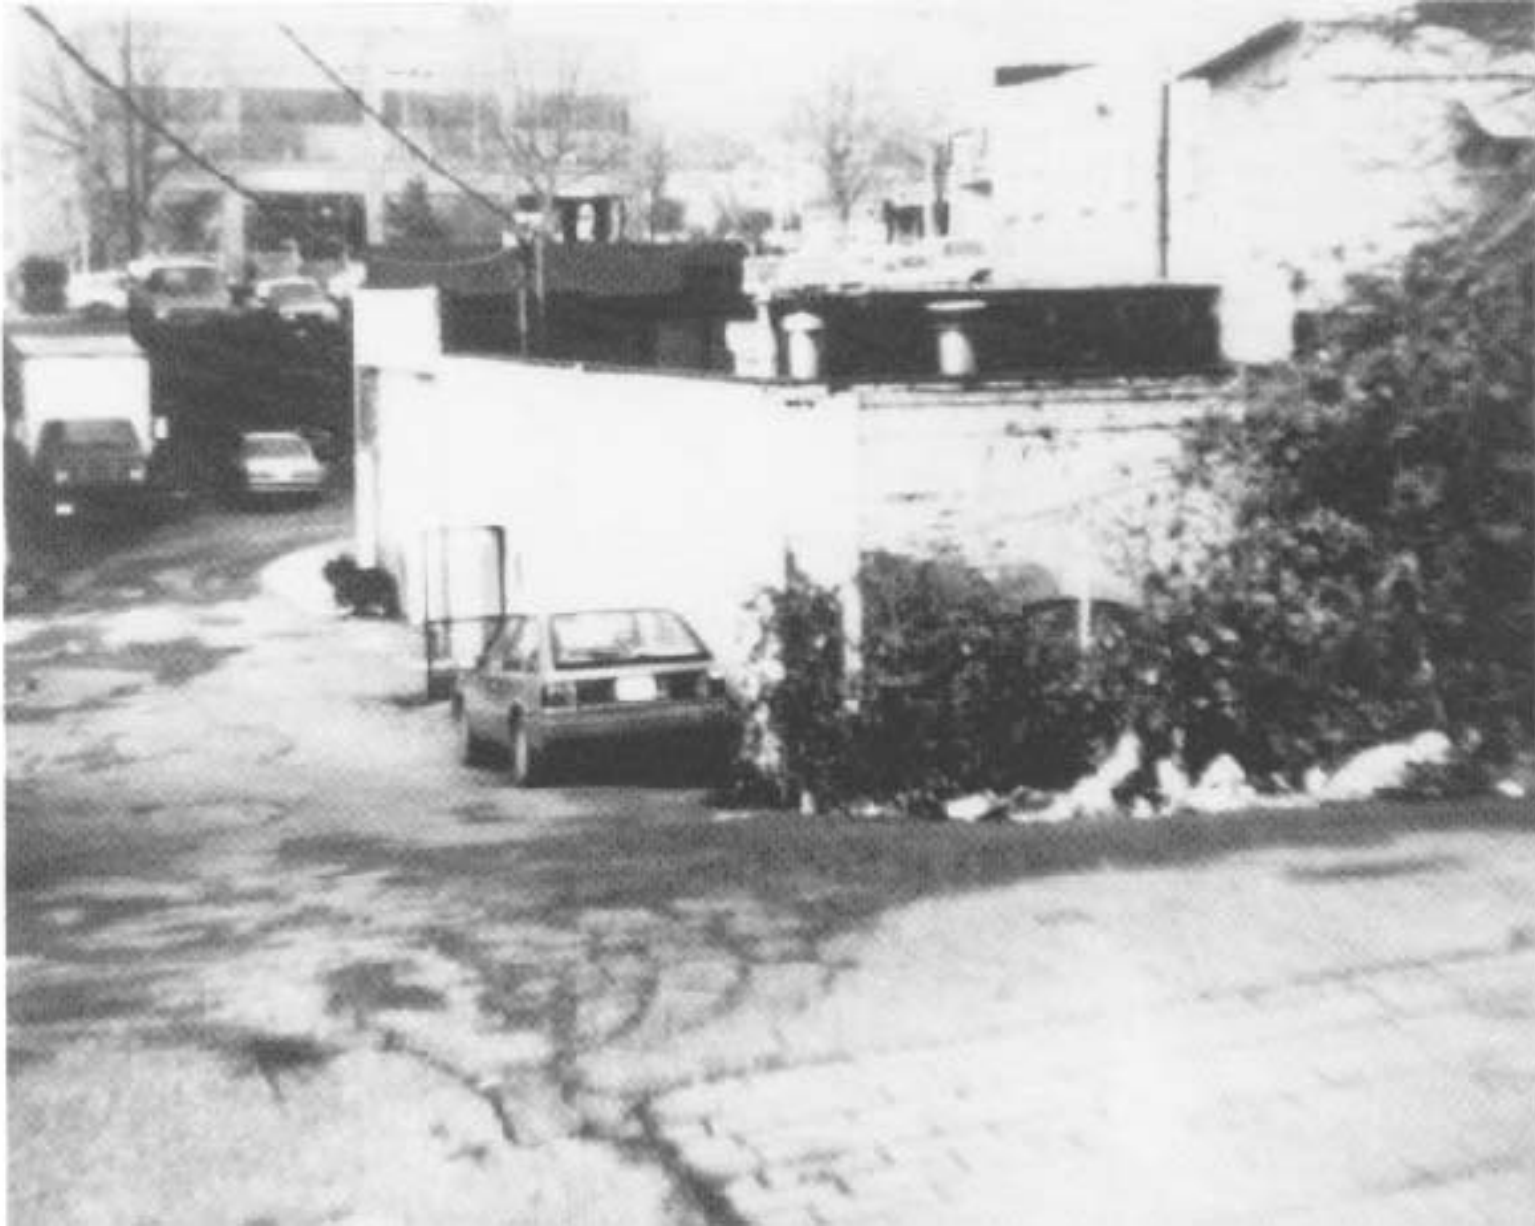
View from the rear (west side) of the Mary Pang building, looking from South Charles Street. The open door is the entrance to the bakery. The heavy vegetation between South Charles Street and the building can be seen on the right side of the picture.

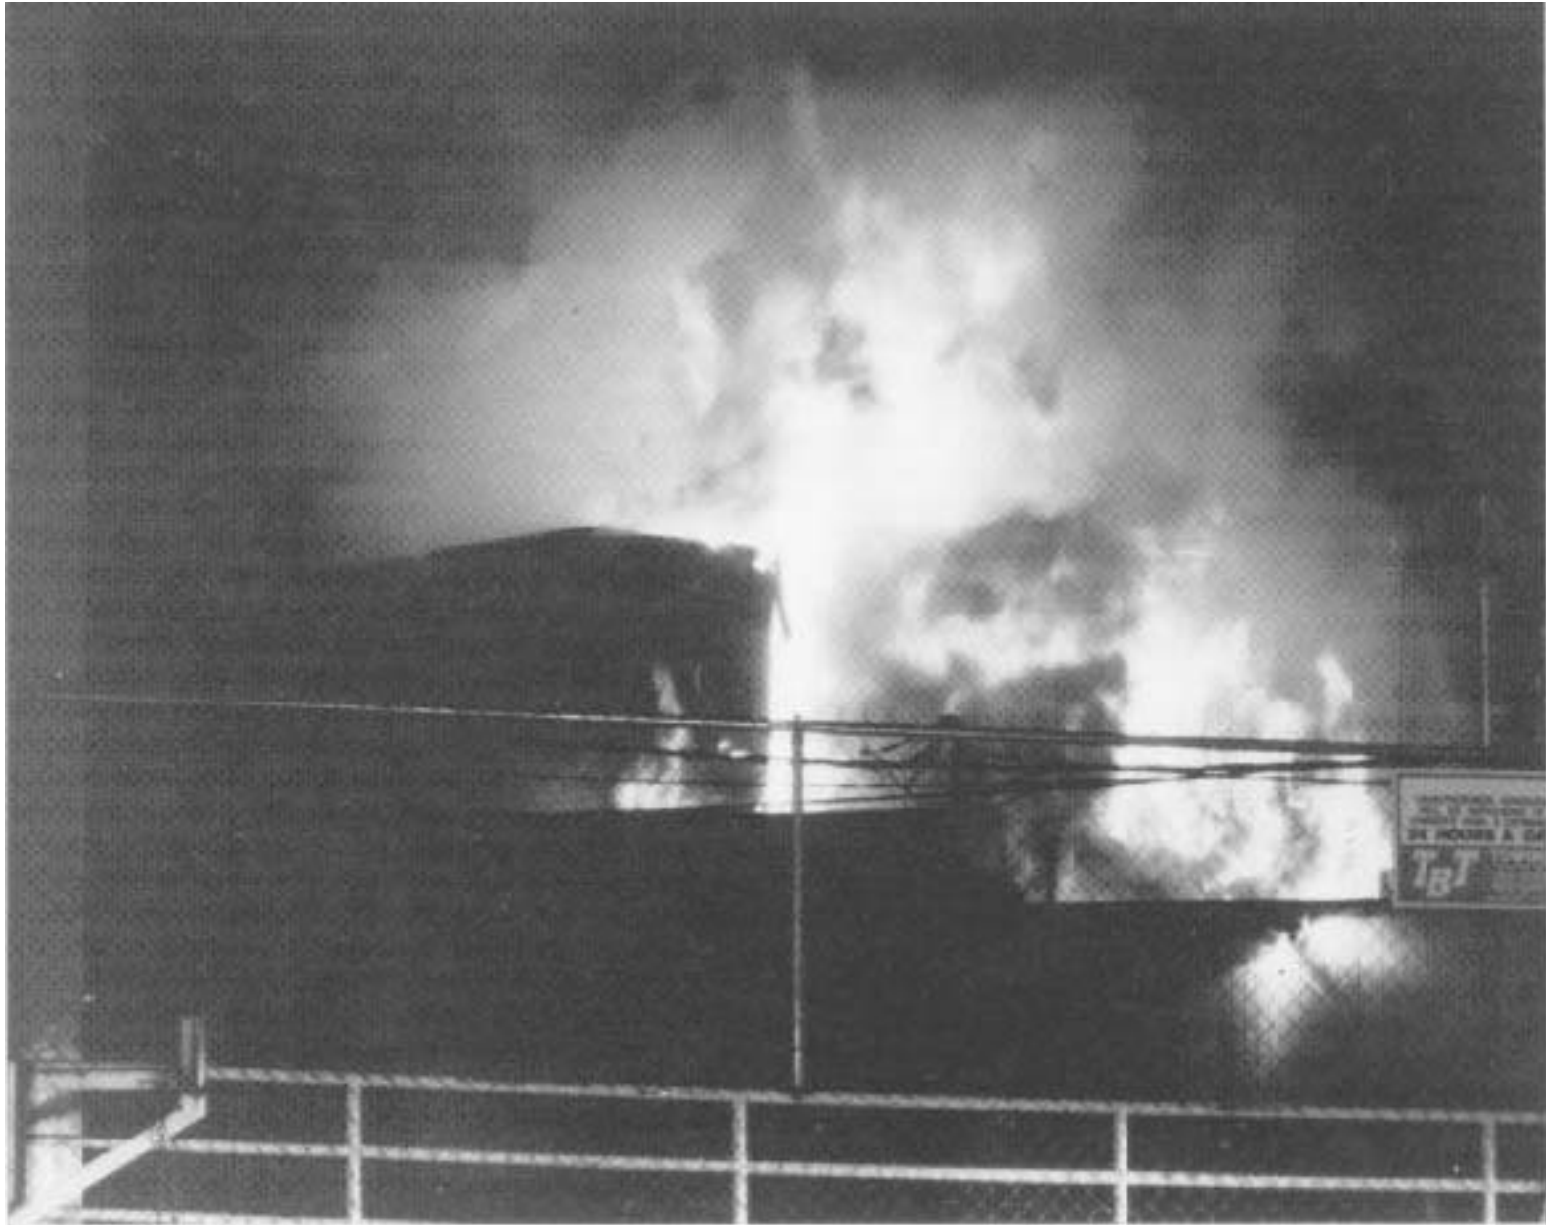
A large volume of fire was visible to units approaching from the west in the early stages of the incident. The outline of the lunchroom is visible next to the tallest flames.
