Three Firefighters Die in Pittsburgh House Fire Pittsburgh, Pennsylvania

United States Fire Administration Major Fire Investigations Program

Investigated by: J. Gordon Routley

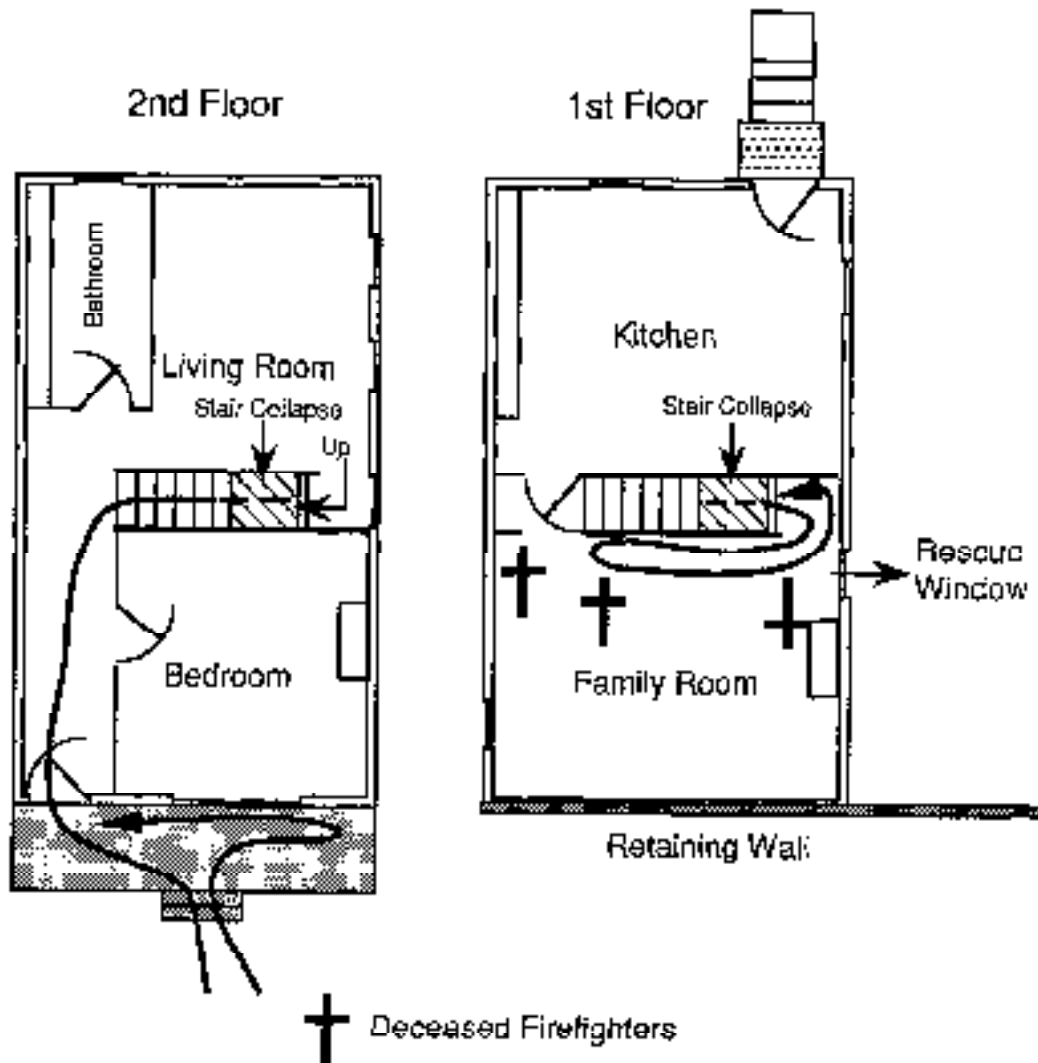
INTERIOR DETAILS - 8361 Bricelyn Street

Advancing into the family room, the crew from Engine 7 found the three unconscious personnel from Engine 17. (See diagram on the following page.) At 0139 hours the Incident Commander was informed that three additional firefighters had been found and were being removed from the building. Additional personnel responded to the urgent requests for assistance and the three firefighters were removed to the rear yard.

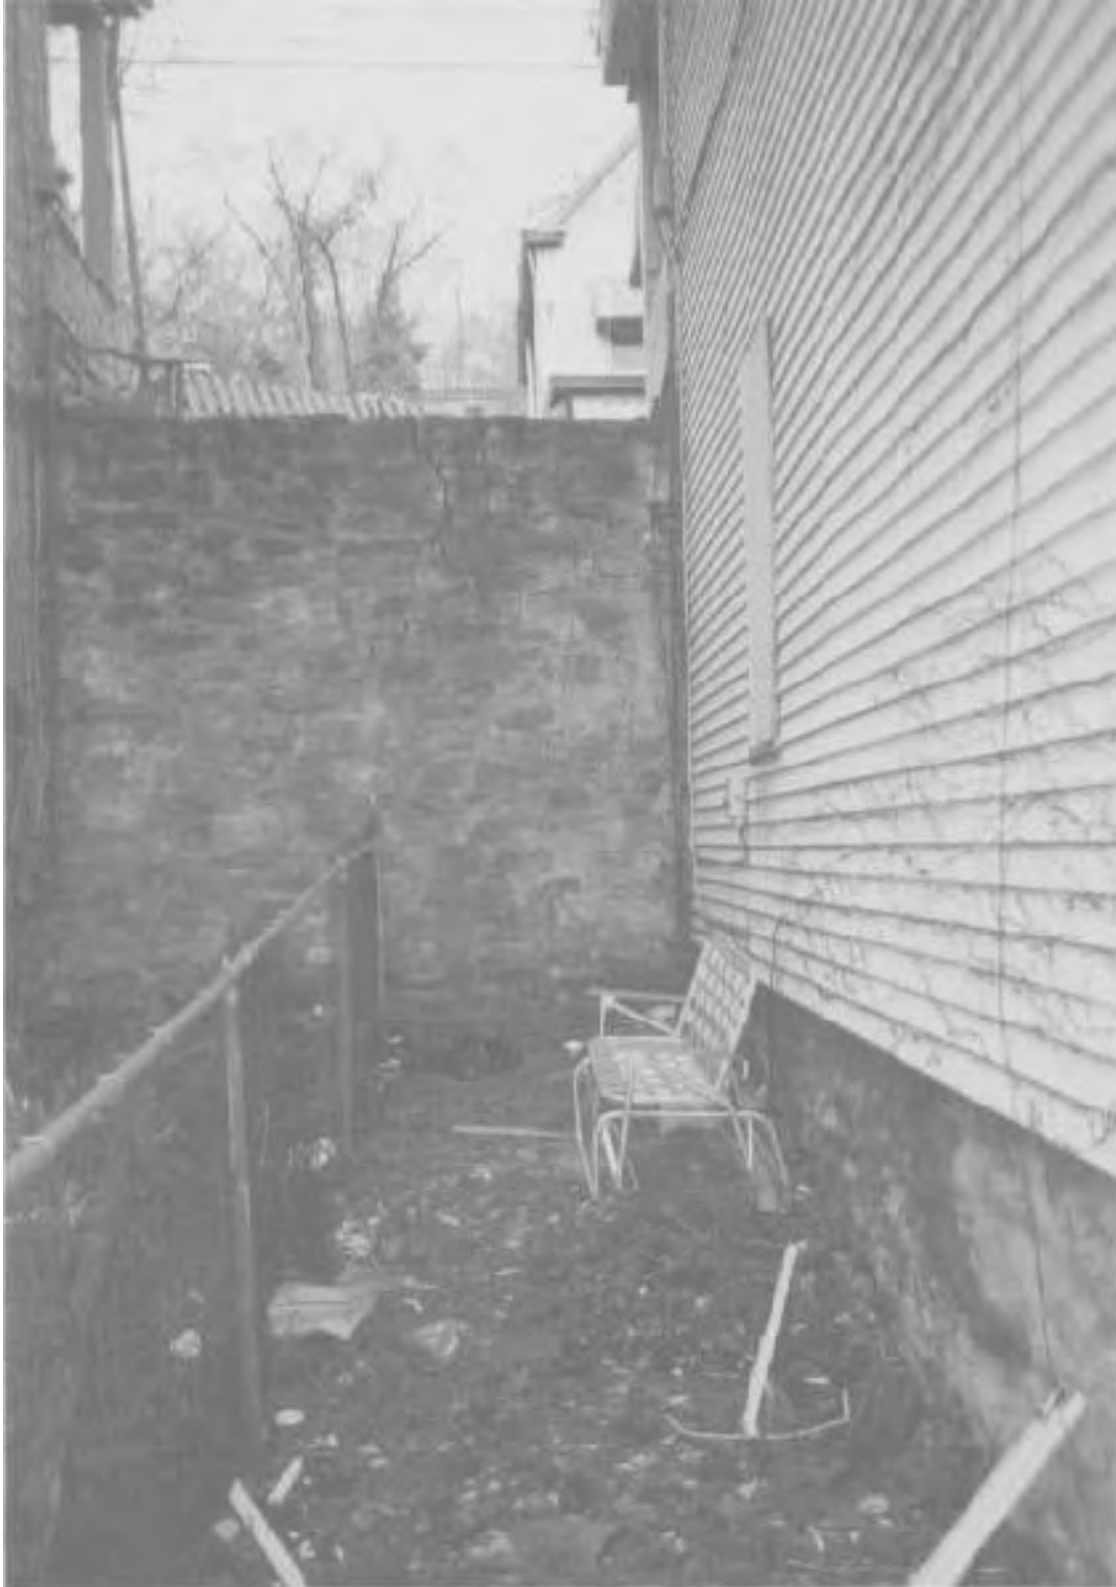
Side yard showing retaining wall and window where firefighters were rescued
(above lawn chair.)

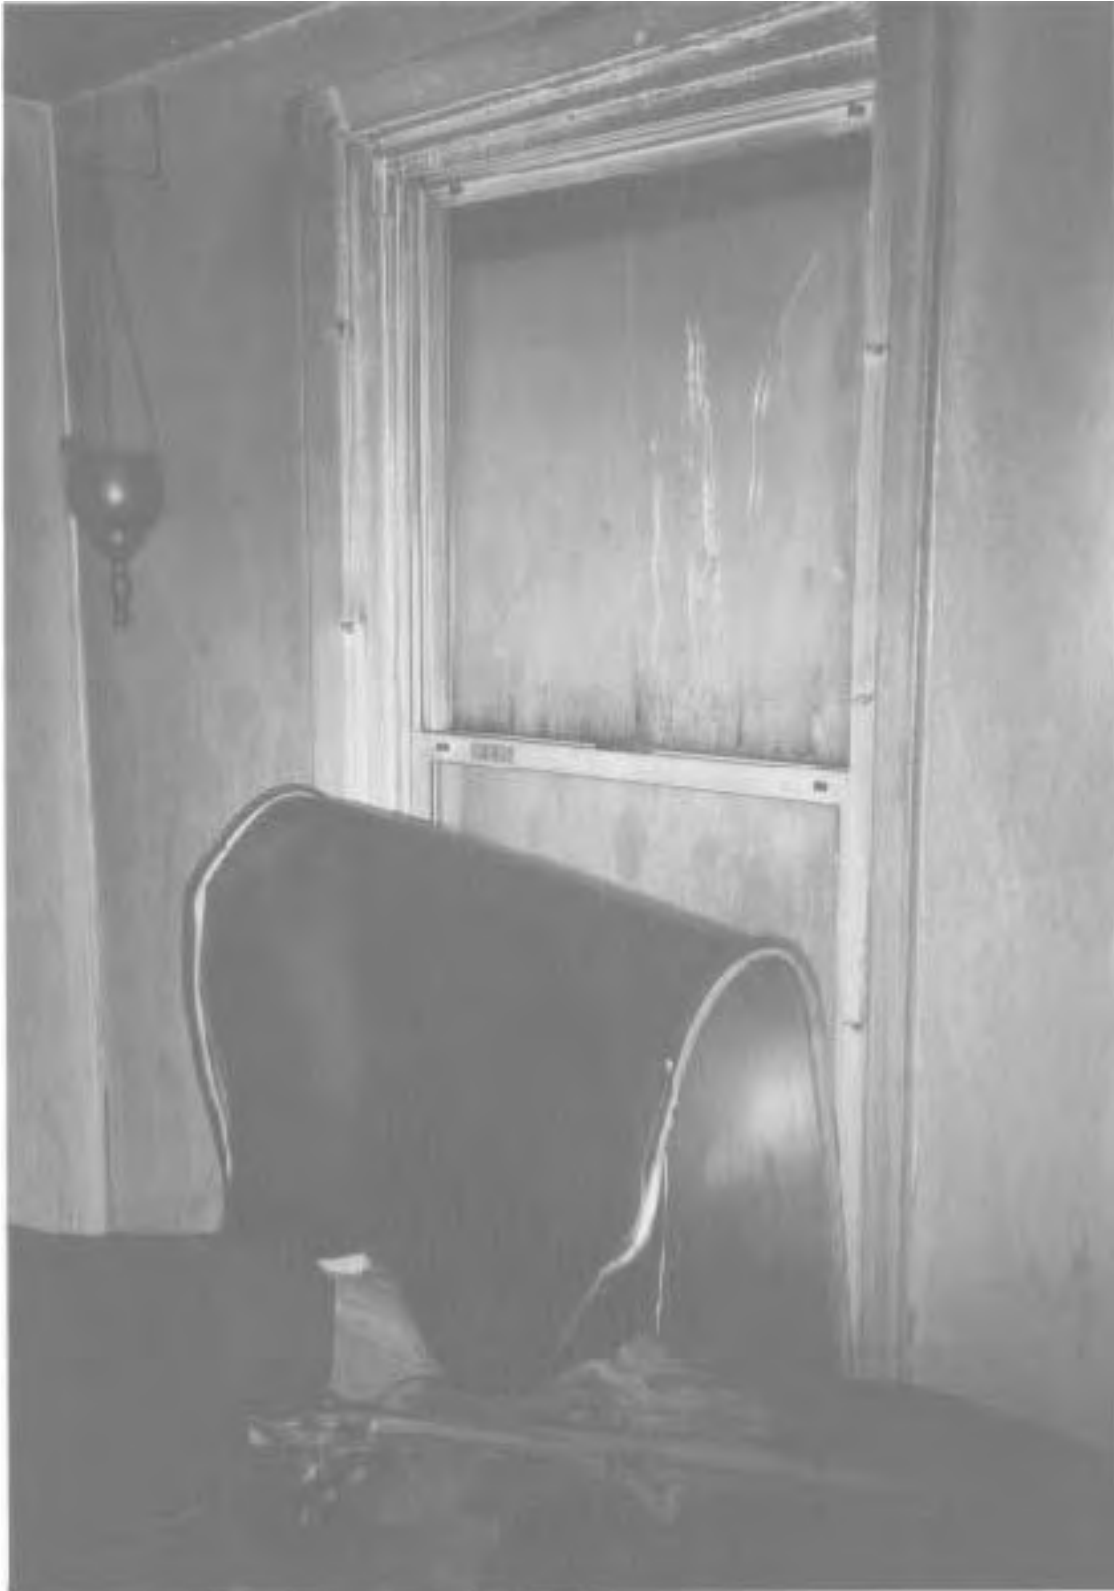
Window in corner of family room showing plastic panel which has partially melted and bent-over due to heat.

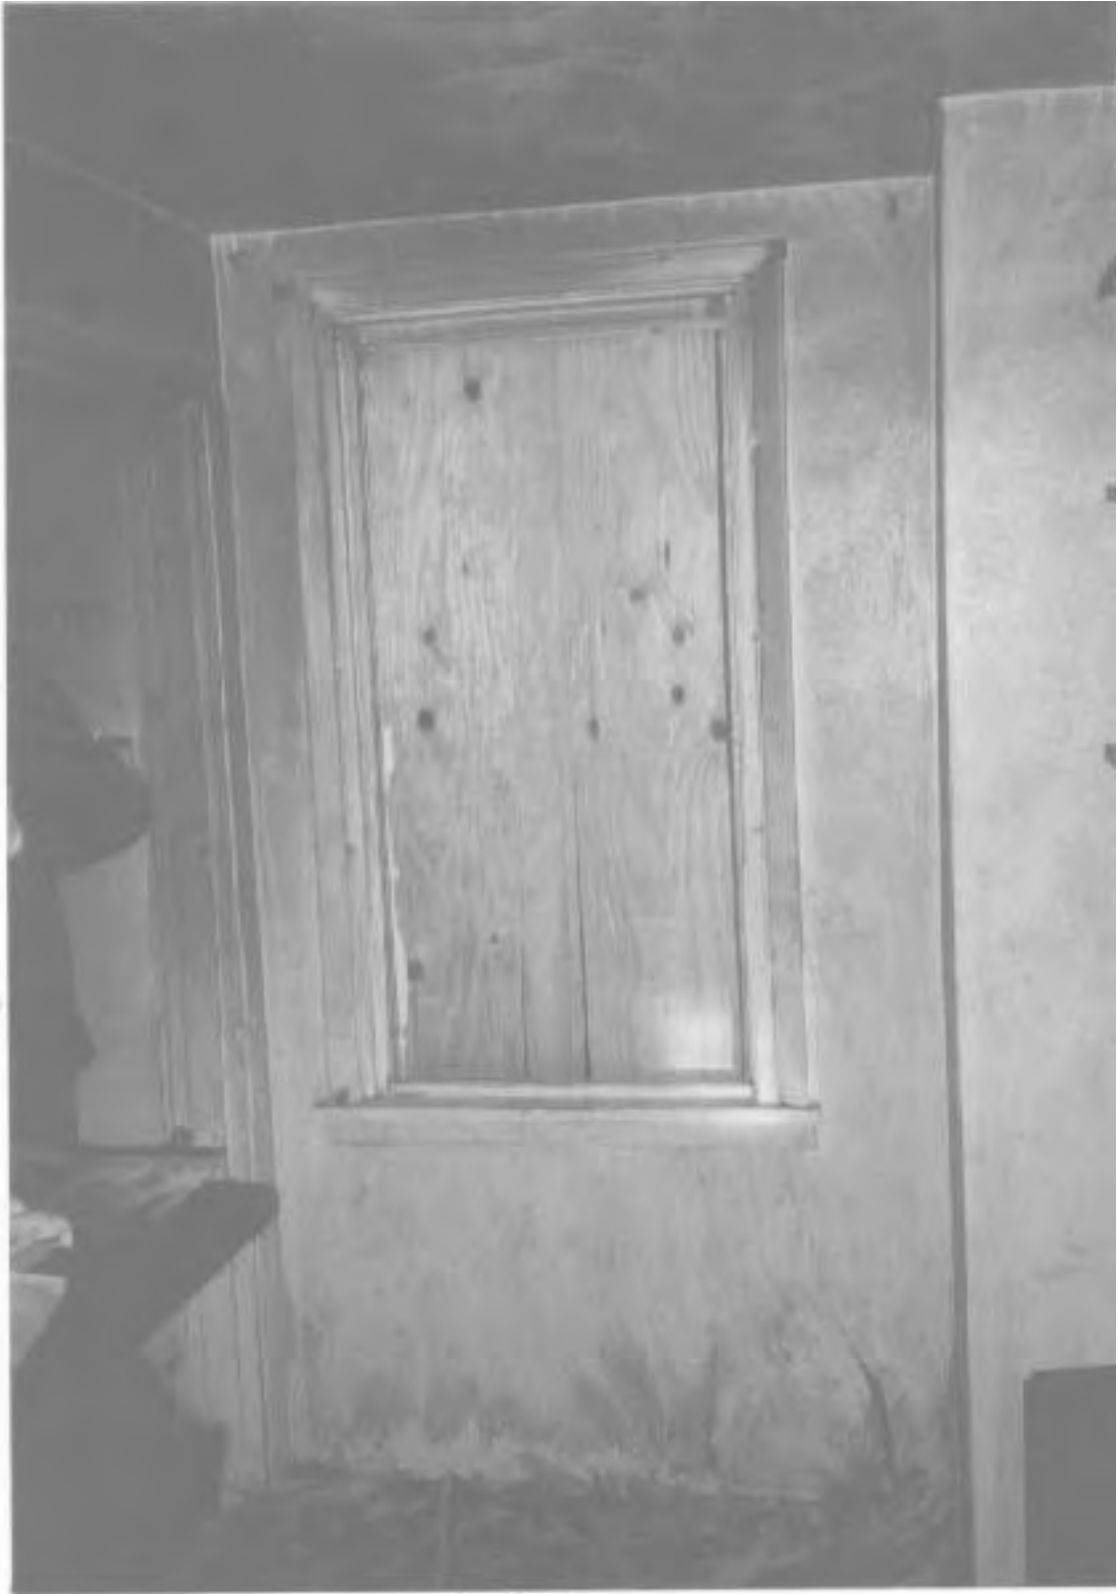
Inside view of window where firefighters were rescued.

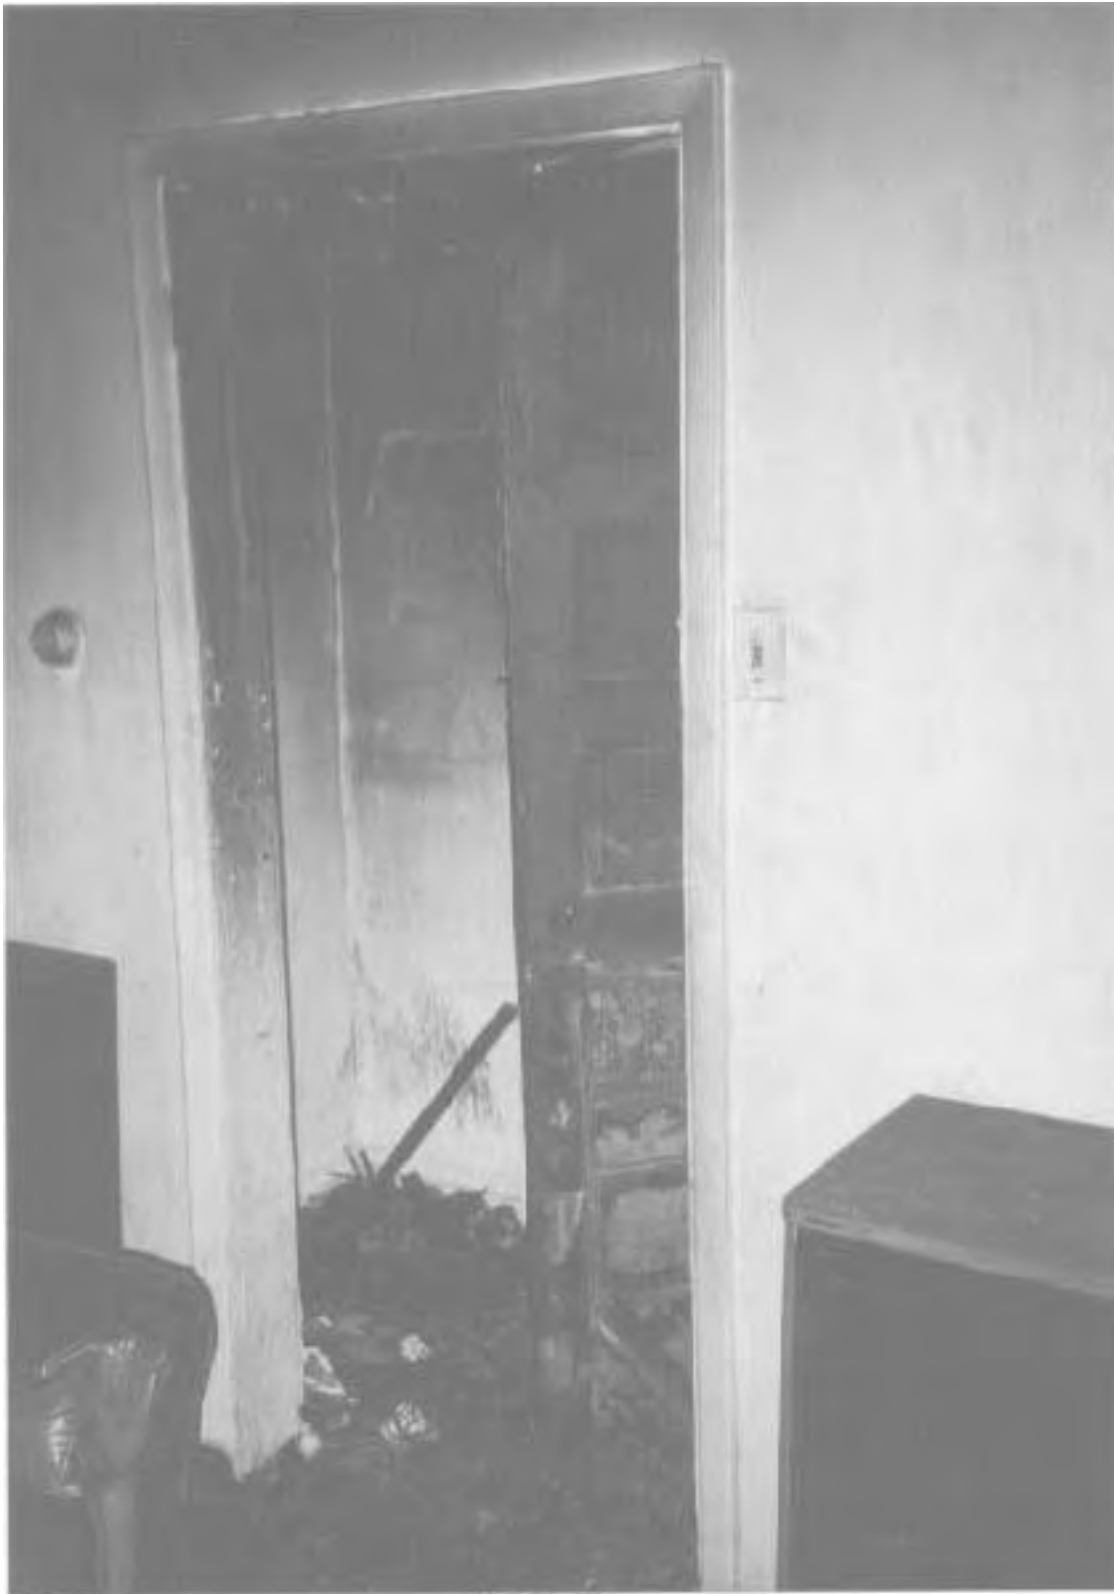
View from family room looking toward kitchen. Partially open door is at the top of the basement stairs.

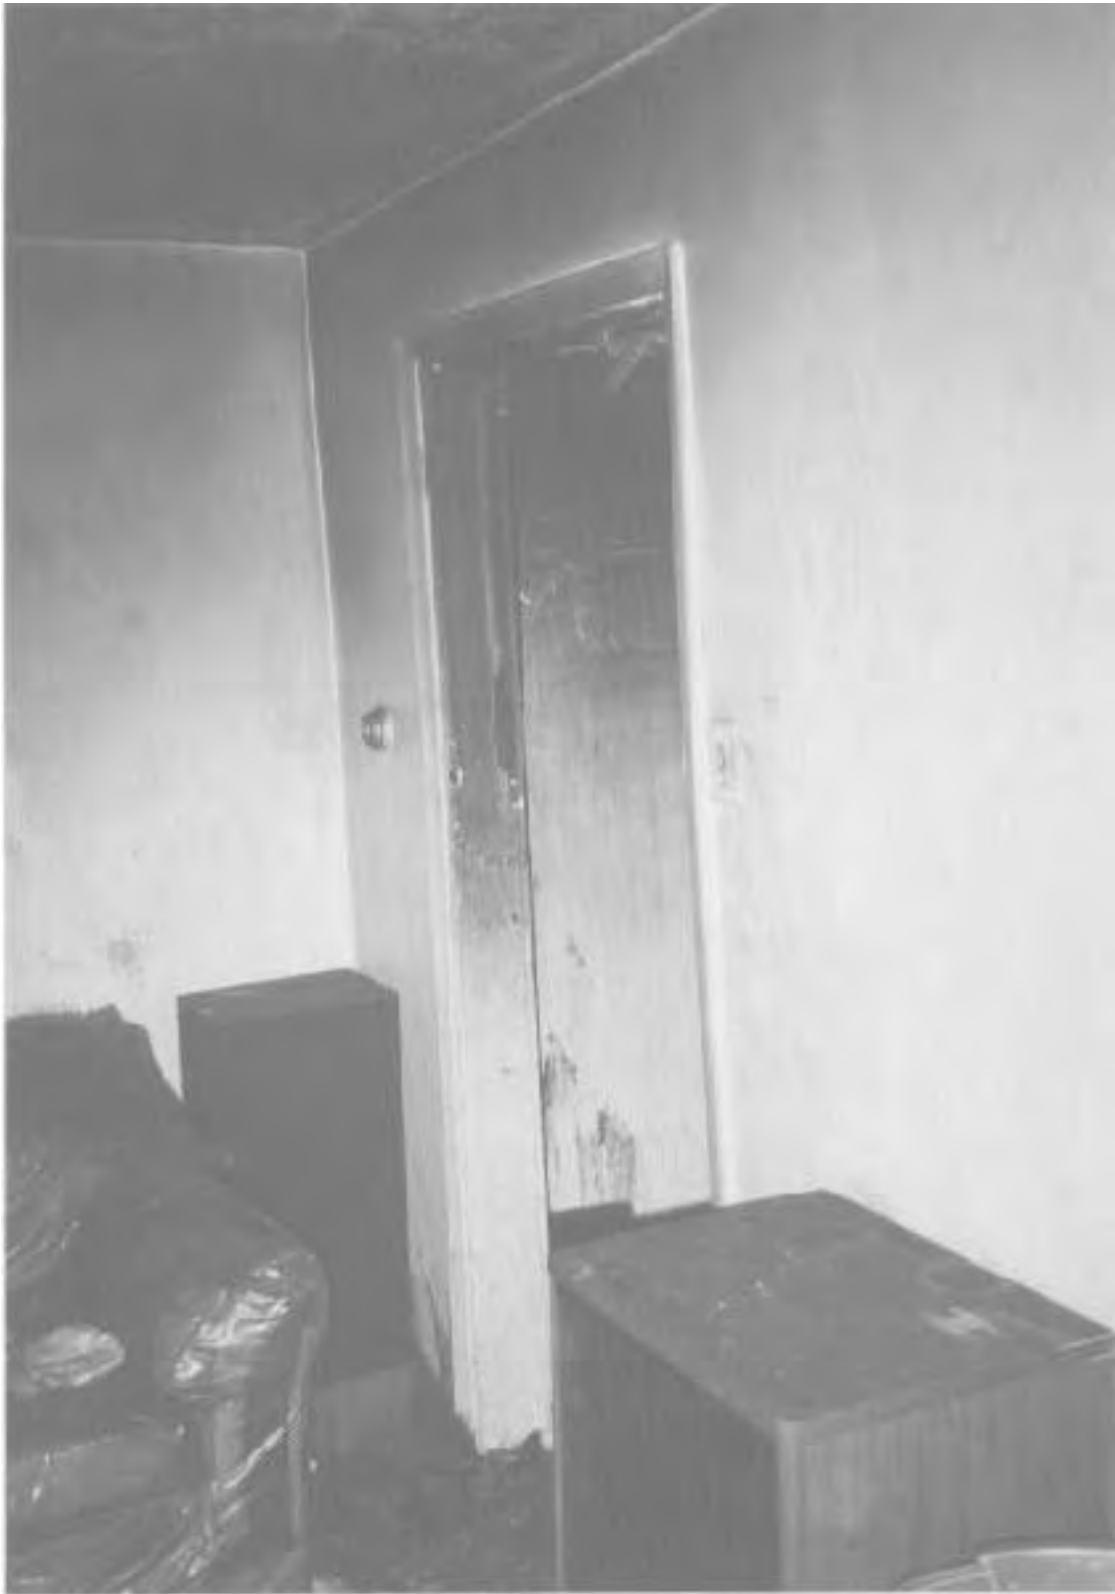
View of corner of the family room at top of basement stairs.
