Hospital Fire Kills Four Patients Southside Regional Medical Center Petersburg, Virginia

**Hospital Fire Kills Four Patients
Southside Regional Medical Center
Petersburg, Virginia
(December 31, 1994)**

This is Report 080 of the Major Fires Investigation Project conducted by Varley-Campbell and Associates, Inc./TriData Corporation under contract EMW-94-C-4423 to the United States Fire Administration, Federal Emergency Management Agency.

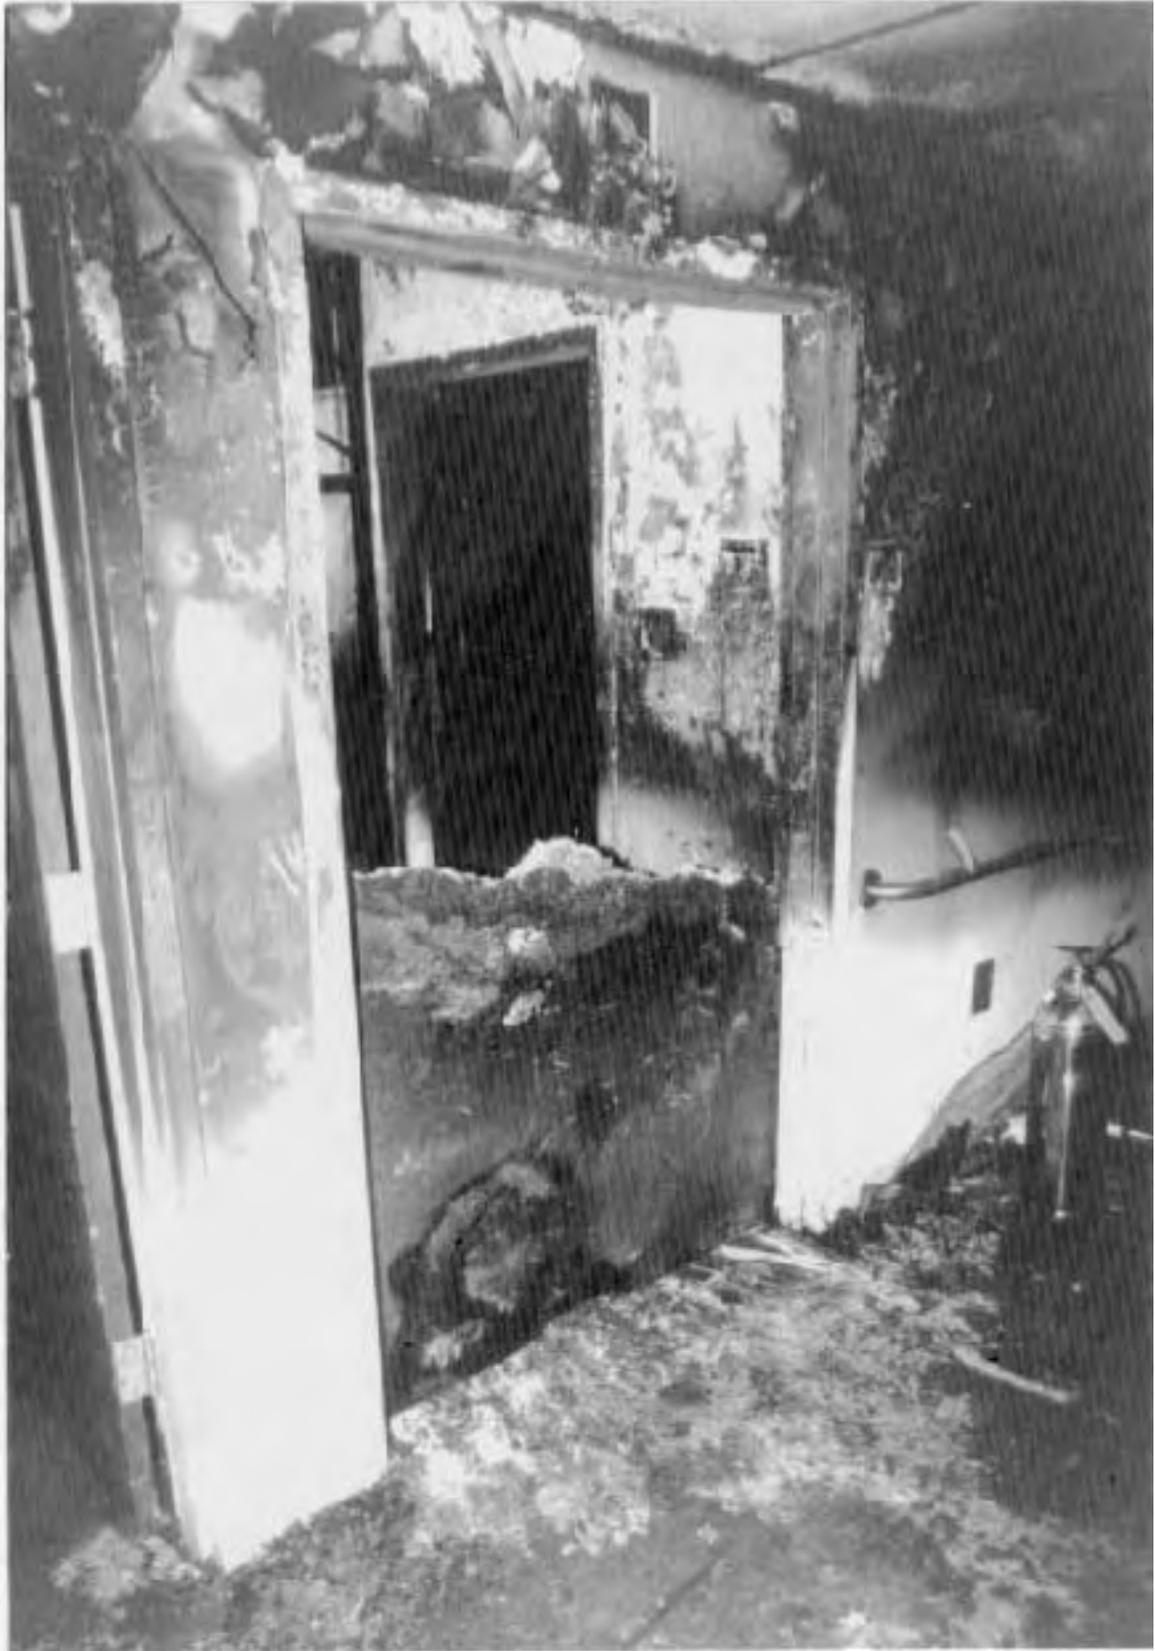
There was heavy smoke and heat damage around the door to the room of origin. The top portion of the door burned away in the fire.

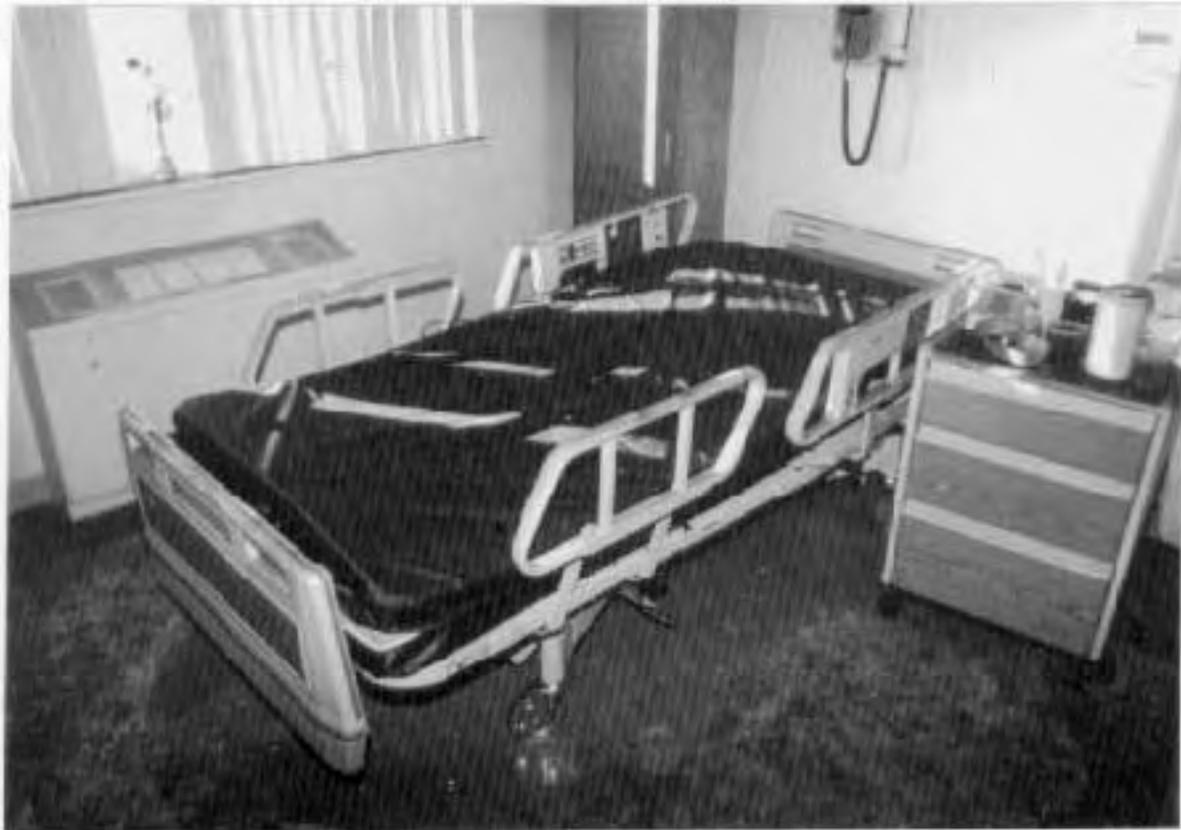
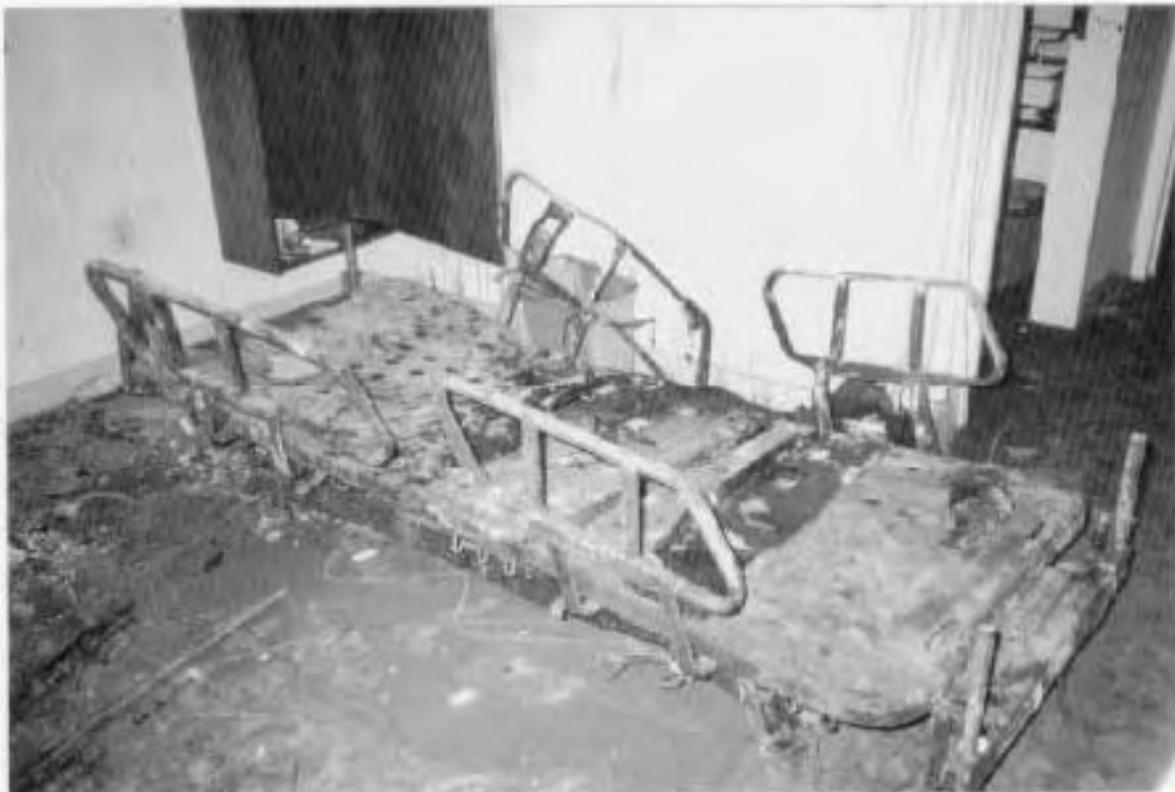
The beds in the hospital contained heavy amounts of plastic and foam parts. Only the metal frame of the patient's bed was recognizable in the room of origin.

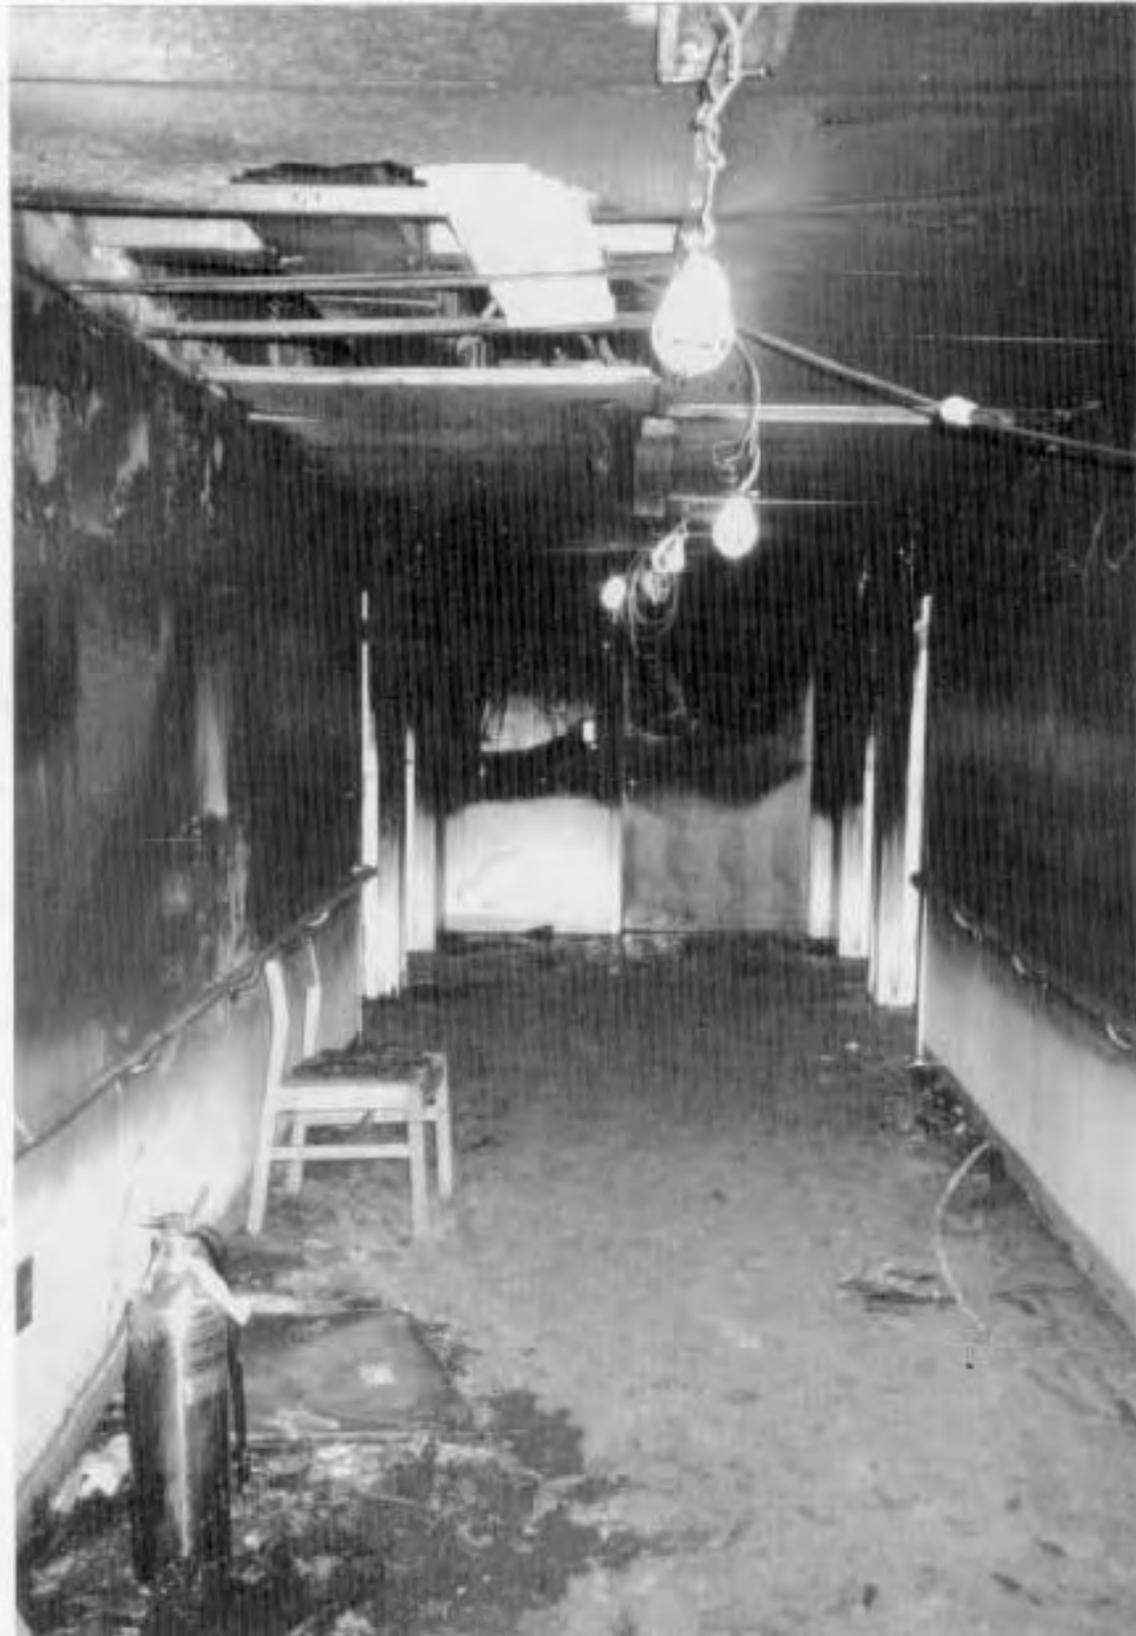
The extent of the smoke and heat conditions was evident after the fire. Heavy smoke stains were evident to within two feet of the floor on the south corridor. The smoke detectors and other plastic fixtures in the corridor melted. The smoke control doors separating the south corridor from the nurses' station protected the rest of the floor from major smoke and heat damage. Witnesses reported that there was heavy smoke in the area of the nurses' station and elevator lobby during the incident, possibly

This photo shows the extent of smoke spread in the south corridor, looking down from the room of origin. At the end of the corridor is an exit, a hose cabinet containing a Class 3 standpipe connection and occupant use-hose, and a fire extinguisher, as well as the manual pull station that was activated by a nurse.

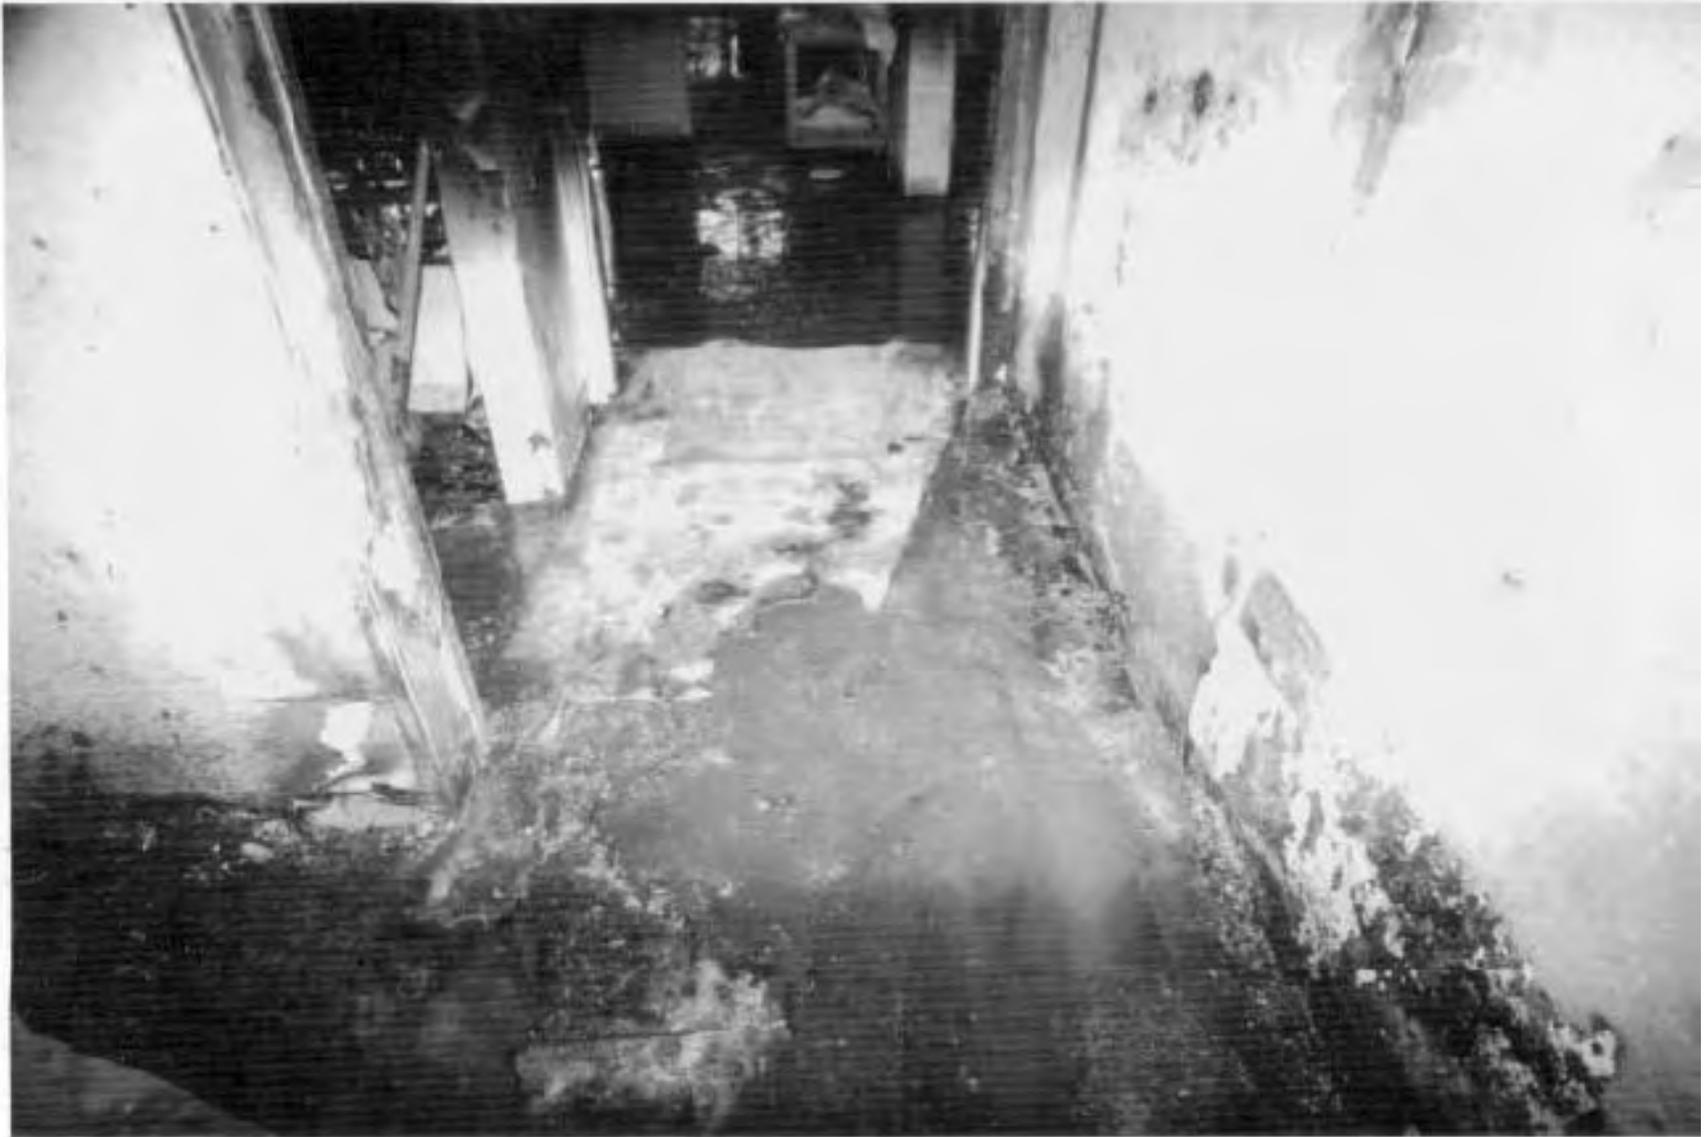
Room 418 and all of its contents were completely consumed. Only the metal frames of the beds and chairs remained. The suspended ceiling in the fire room collapsed during the fire. The unprotected steel trusses and the floor decking immediately above the suspended ceiling sagged slightly. The top half of the door to Room 418 was burned away. With the exception of a small area near the doorway, all of the floor tiles in Room 418 were consumed.

All but a small portion of the floor tile in the room of origin was consumed by the fire. This portion was partially shielded by the door to the room, which was open during the fire. The straight line pattern of burned away tile next to the right side of the doorway indicates the position of the door during the fire.

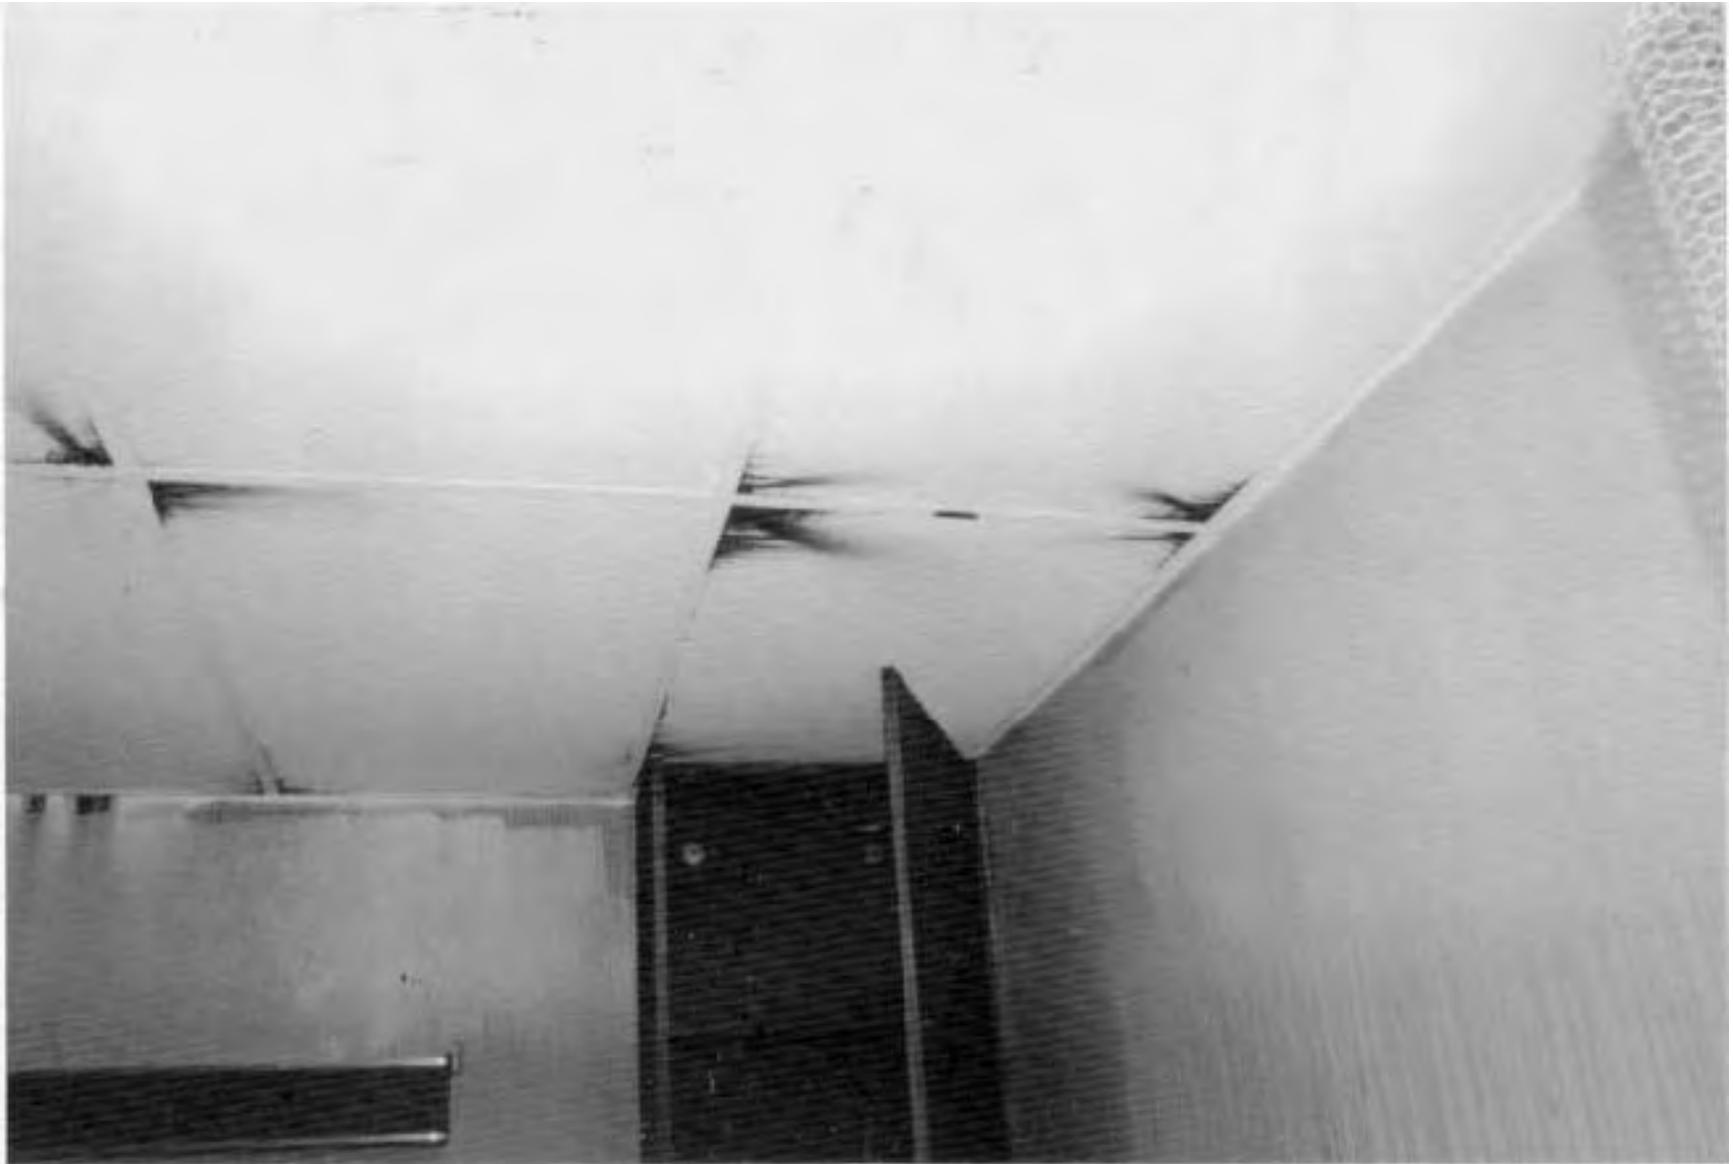
There was evidence of significant smoke spread into Rooms 416 to 421 via the common plenum space above the rooms. This was indicated by soot streaks on many of the ceiling panels, indicating that heavy smoke was leaking into the rooms via gaps between the ceiling panels and the suspension system. The ceiling above the fire failed, allowing smoke and heat to enter the plenum area. The smoke then leaked down through the ceilings, under pressure, into the adjacent rooms. The heat damaged some of the lightweight steel members in the floor assembly immediately above Room 418.

Smoke spread very rapidly, through the common plenum space above six rooms on the corridor due to rapid failure of the ceiling in the room of origin. This allowed smoke to fill the plenum space and to spread into adjacent rooms. Common plenum spaces allow for rapid smoke spread. Suspended ceilings should not be expected to contain smoke due to leakage between tiles and the ceiling frame.

Smoke streaks on the ceiling indicate that smoke was entering the rooms adjacent to the fire room through the ceiling suspension system.

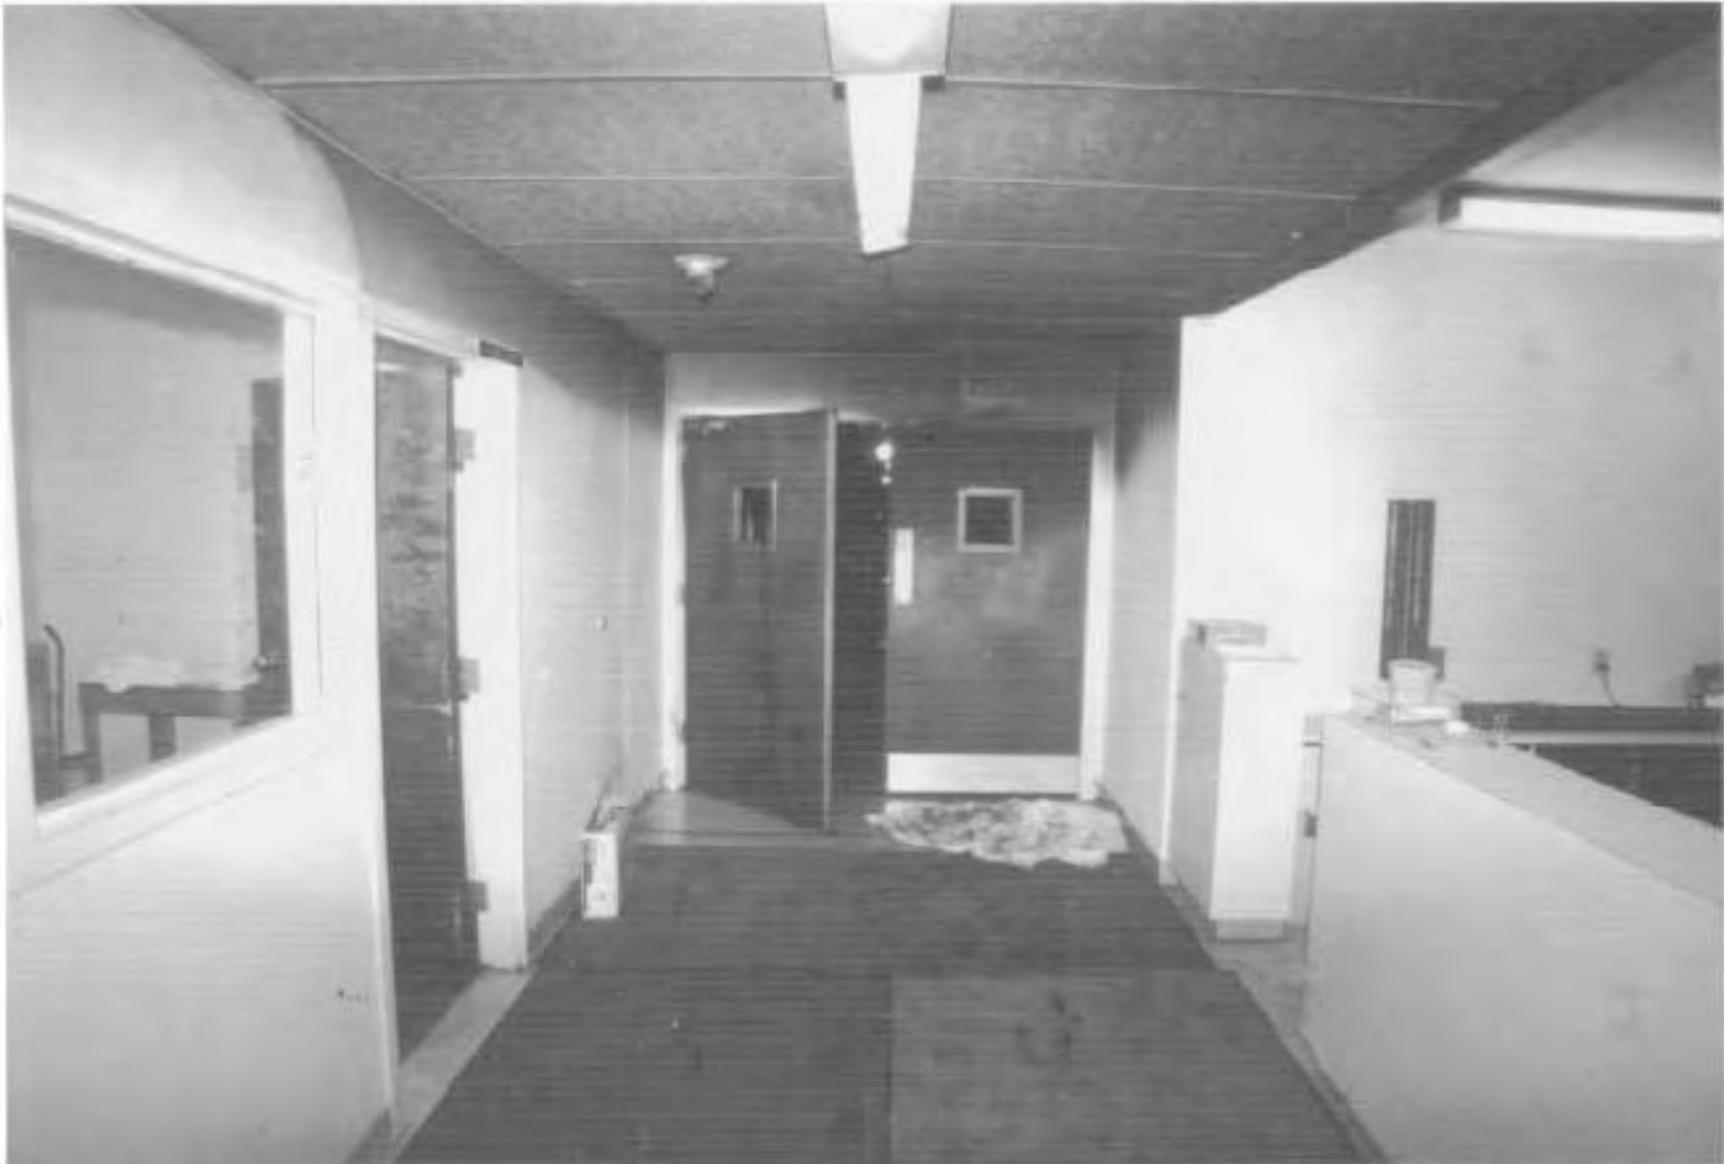
This fire demonstrated that smoke spread can be effectively controlled by smoke control doors and closed doors. Smoke spread via the corridor into other rooms on the corridor was controlled effectively by hospital personnel closing doors to patient rooms. The self-closing smoke control doors at one end of the corridor contained the heavy smoke damage to only one corridor on 4-South wing.

This photo looks down toward the south corridor with the nurses station on the right. The self-closing smoke control doors contained the bulk of the smoke and heat conditions to the corridor of origin, but some smoke escaped into the nurses station area as victims were evacuated through the doors.

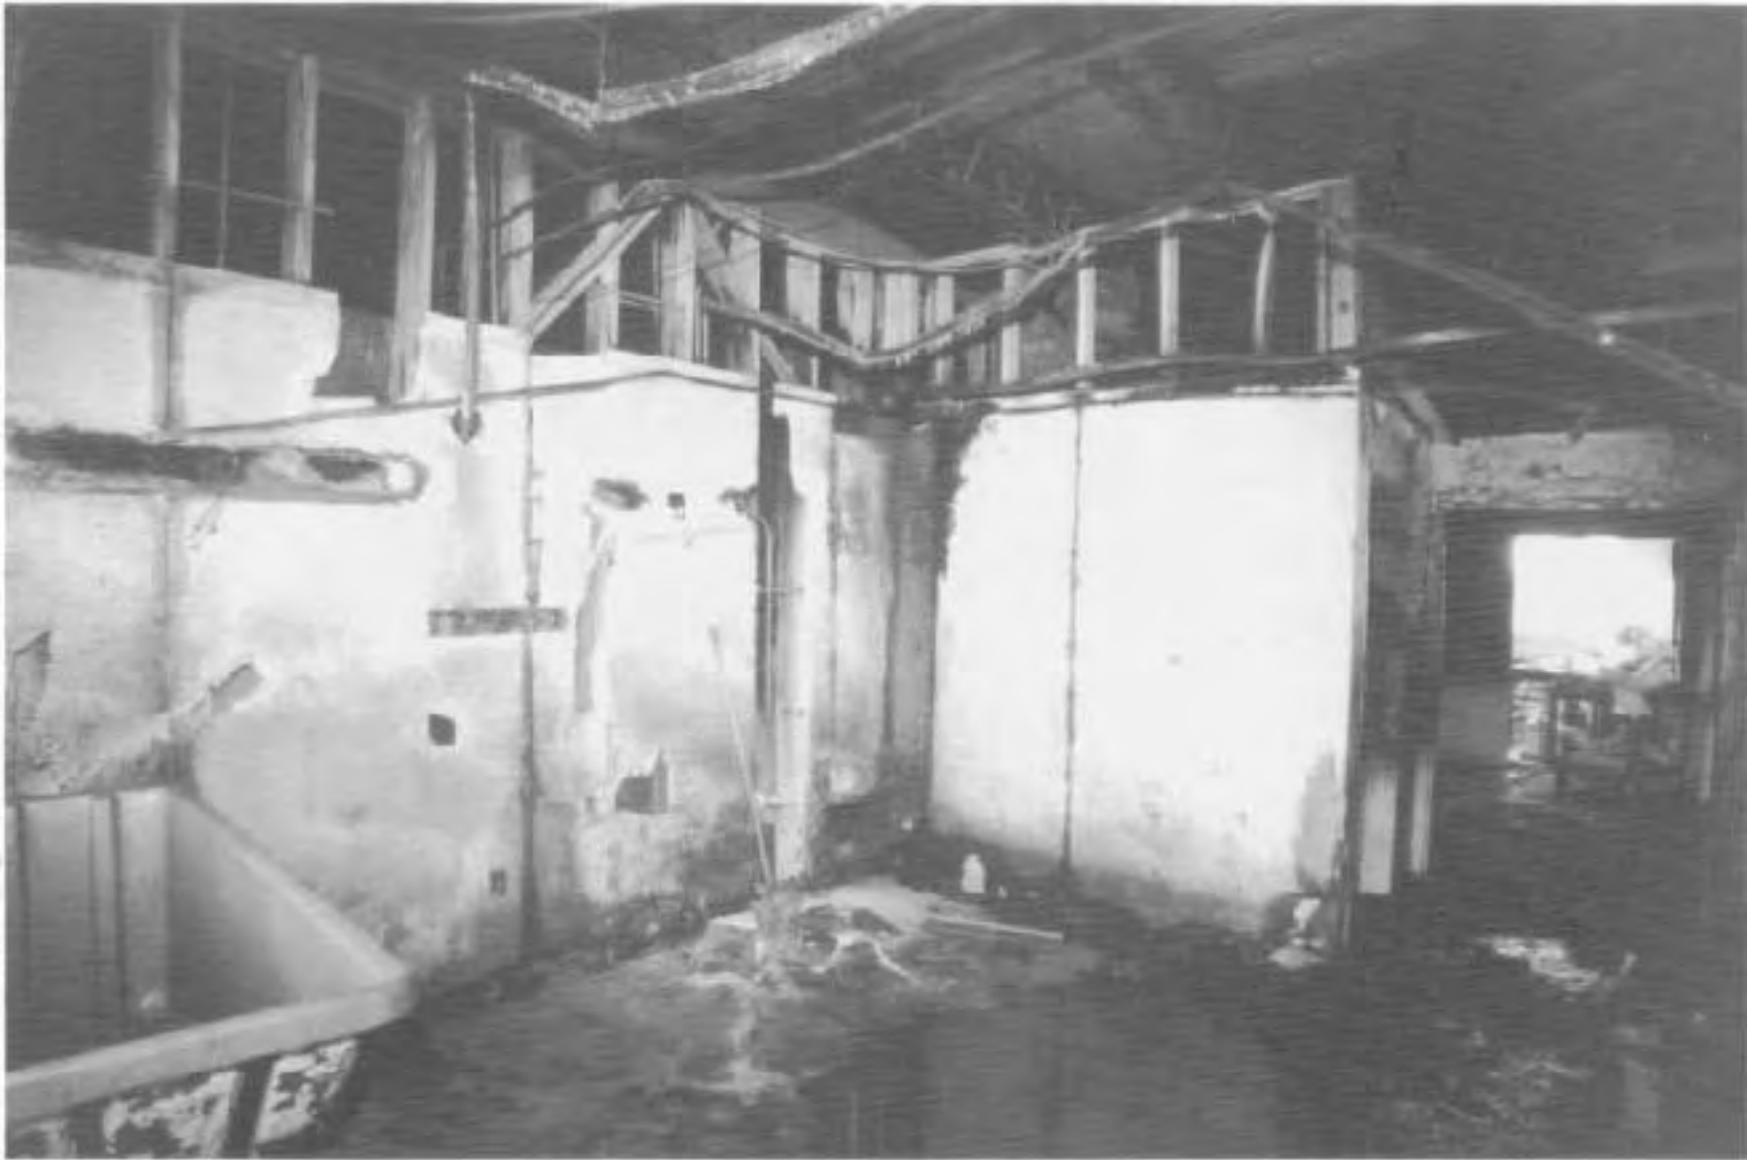
It is unclear why the ceiling assembly failed during the fire. The ceiling was part of a fire resistive floor ceiling system. One or more of the ceiling tiles, which must be secured in place with pins to function properly, may have not been secured, allowing them to be drawn up and out of the frame of the suspended ceiling by air drafts created by the fire. Due to the amount of damage to the ceiling, however, it was impossible to determine whether each ceiling tile was secured in place with clips.

There was very heavy damage to the room of origin. Some structural members were warped by heat after the suspended ceiling collapsed.

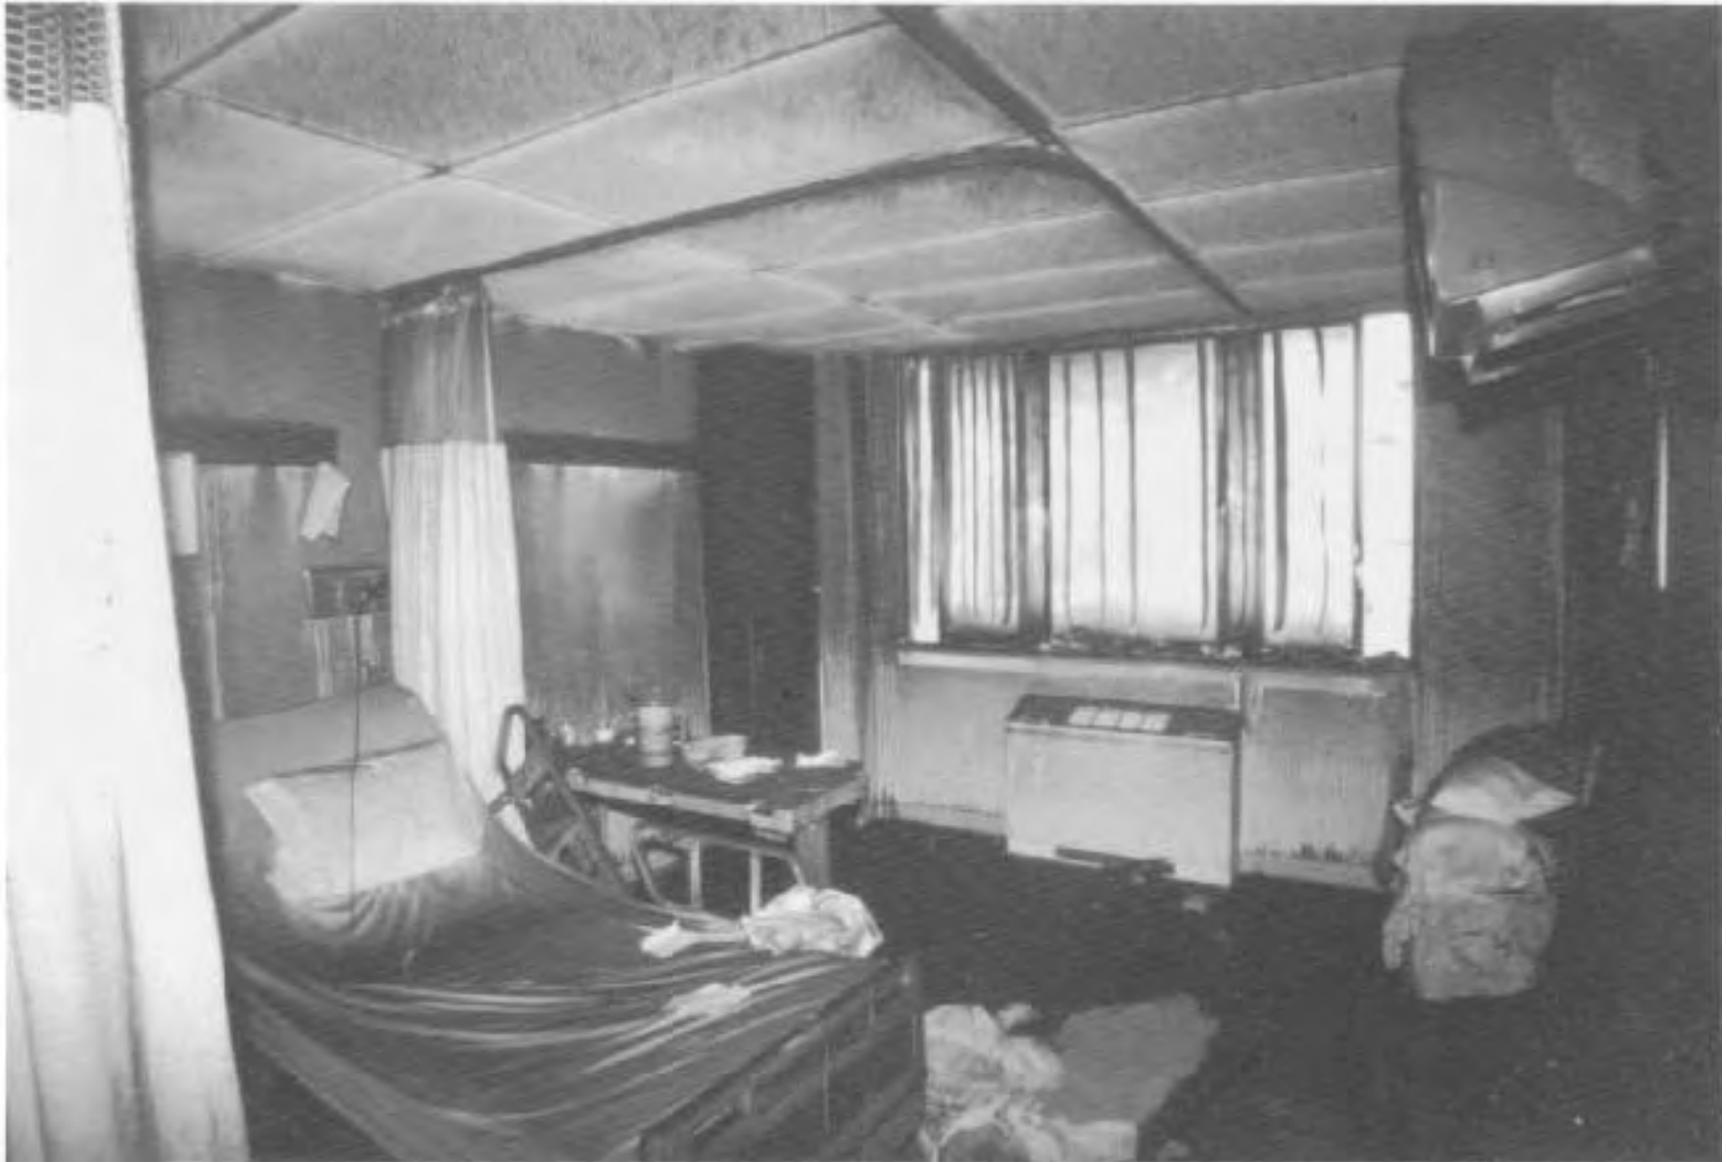
Smoke and heat damage to patient rooms on the south corridor varied significantly. Rooms 411 and 421 suffered heavy smoke damage, indicated by major soot stains on the walls and windows, because the doors to these rooms were open during the fire. The door to Room 411 was not closed by nurses because they had rescued the patient from this room and knew it was empty. The door to Room 421 was closed by nurses, but the patient apparently opened it while trying to escape and collapsed in the doorway.

Room 421 which was located on the south corridor suffered heavy smoke damage. Nurses closed the door to this room, however, investigators believe the patient opened the door while attempting to escape. The patient was found lying in the doorway by firefighters.

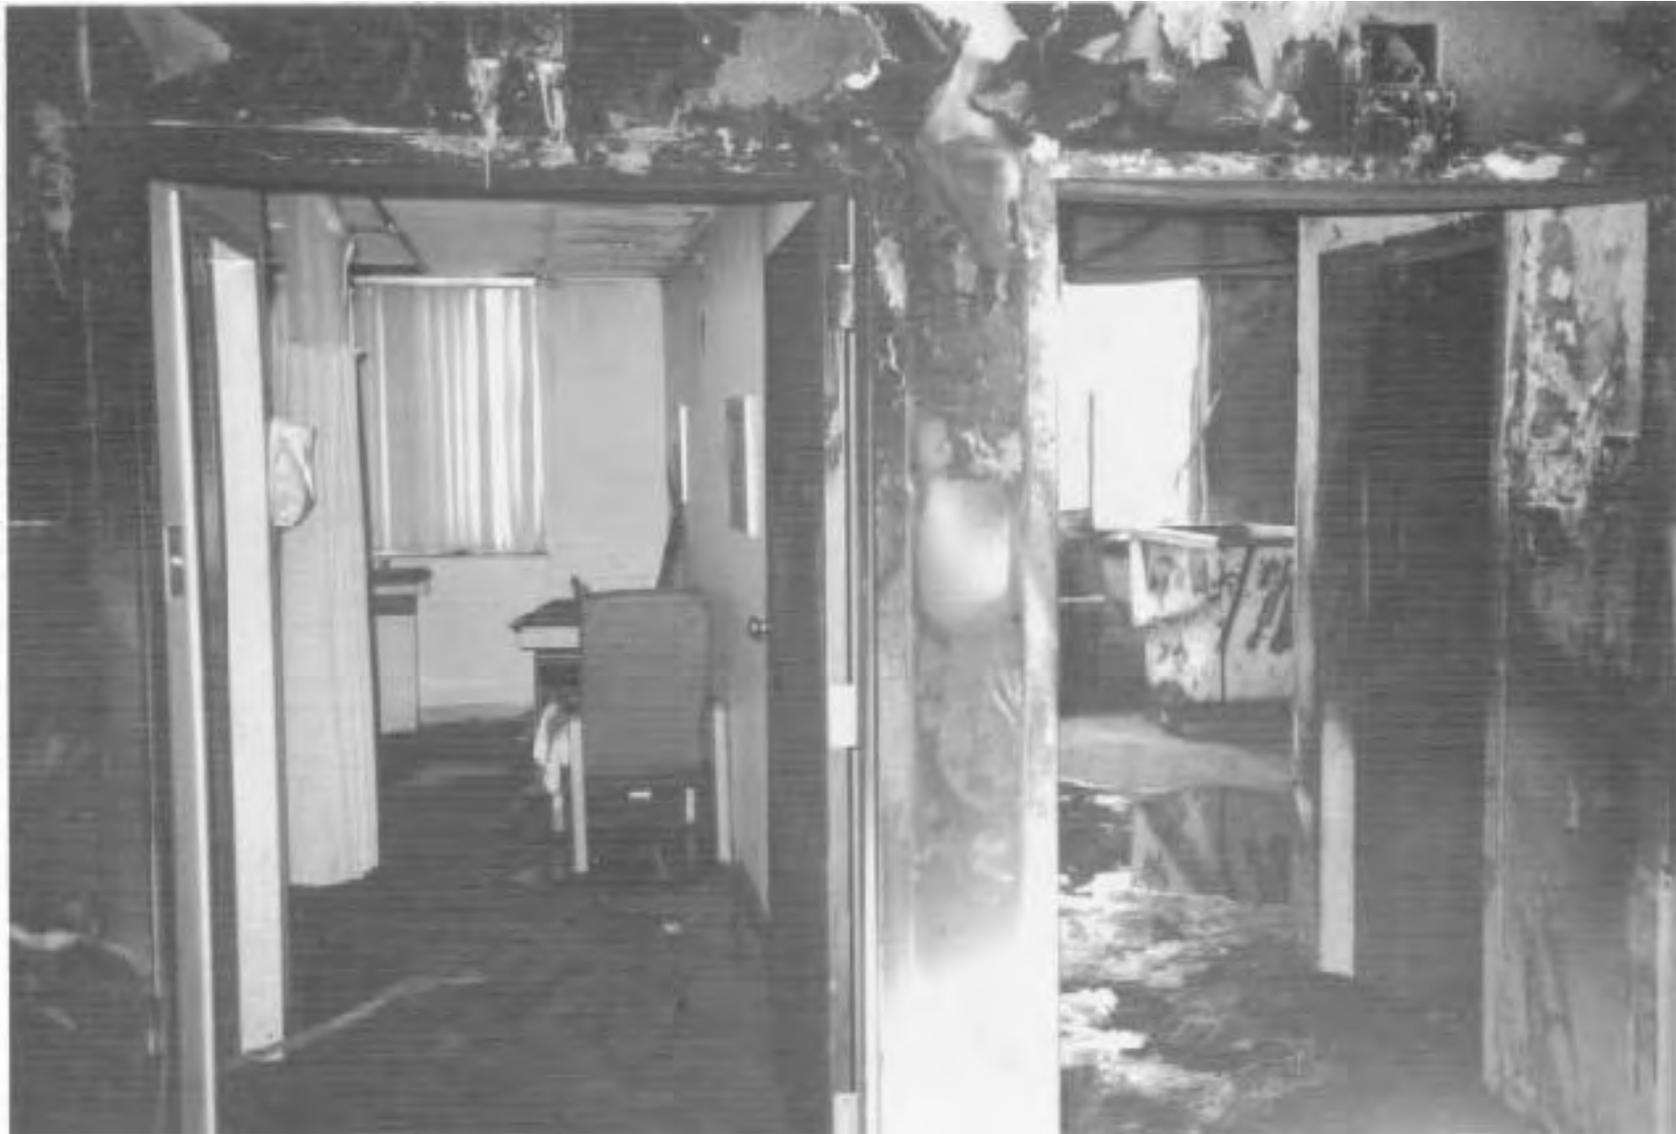
This photo shows the heavy damage to the fire room, Room 418 (on the right), and the adjacent room, Room 419 (on the left). Nurses closed the door to Room 419, but heavy smoke infiltrated the room through the suspended ceiling and cracks around the edges of the door. The patients in both of these rooms died.

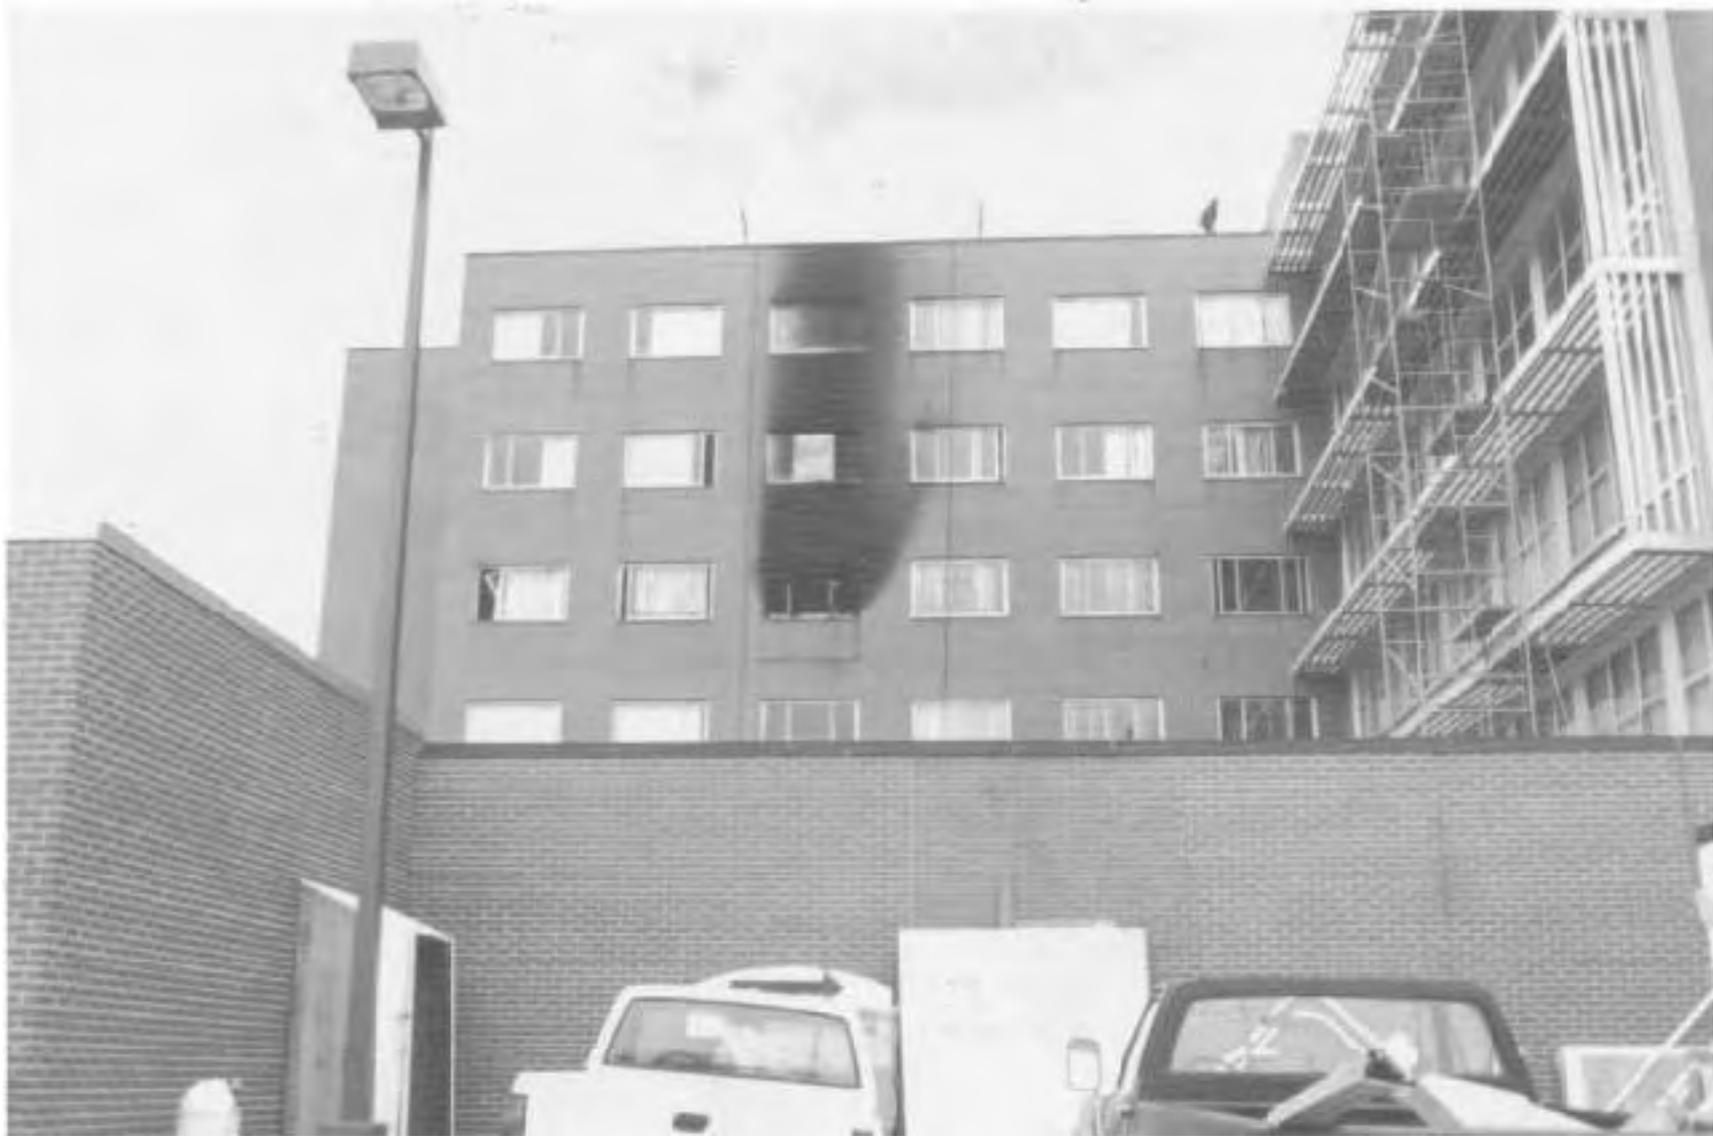
The first floor of the hospital extended out from the upper floors of the building, which blocked access to the fourth floor windows by an aerial ladder. Firefighters used a ground ladder from the roof of the single story wing to rescue a patient from a window located two rooms to the left of the room of origin.
