Aerial Ladder Collapse Incidents

Aerial Ladder Collapse Incidents (April 1996)

This is Report 081 of the Major Fires Investigation Project conducted by Varley-Campbell and Associates, Inc./TriData Corporation under contract EMW-94-C-4423 to the United States Fire Administration, Federal Emergency Management Agency.

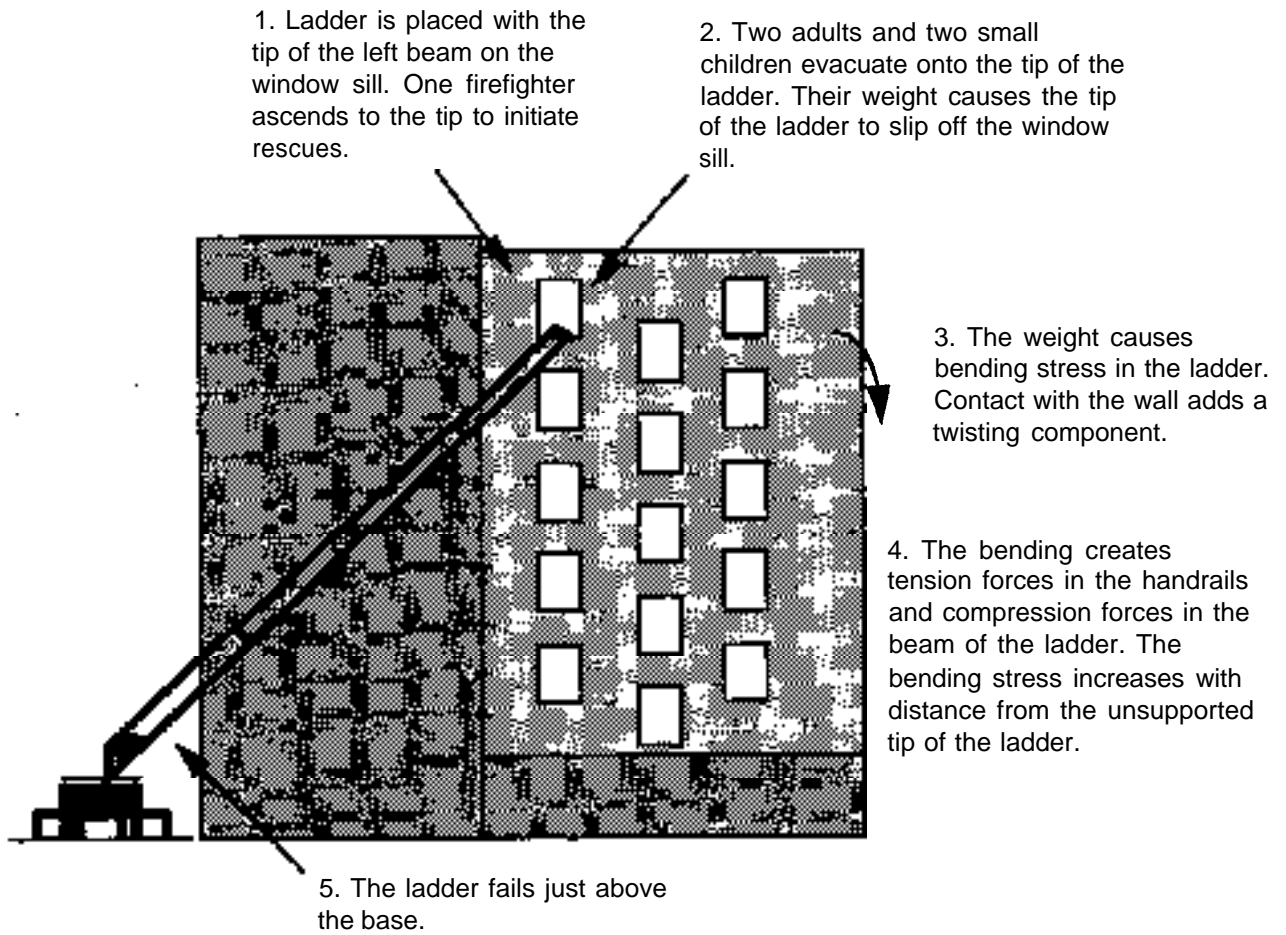
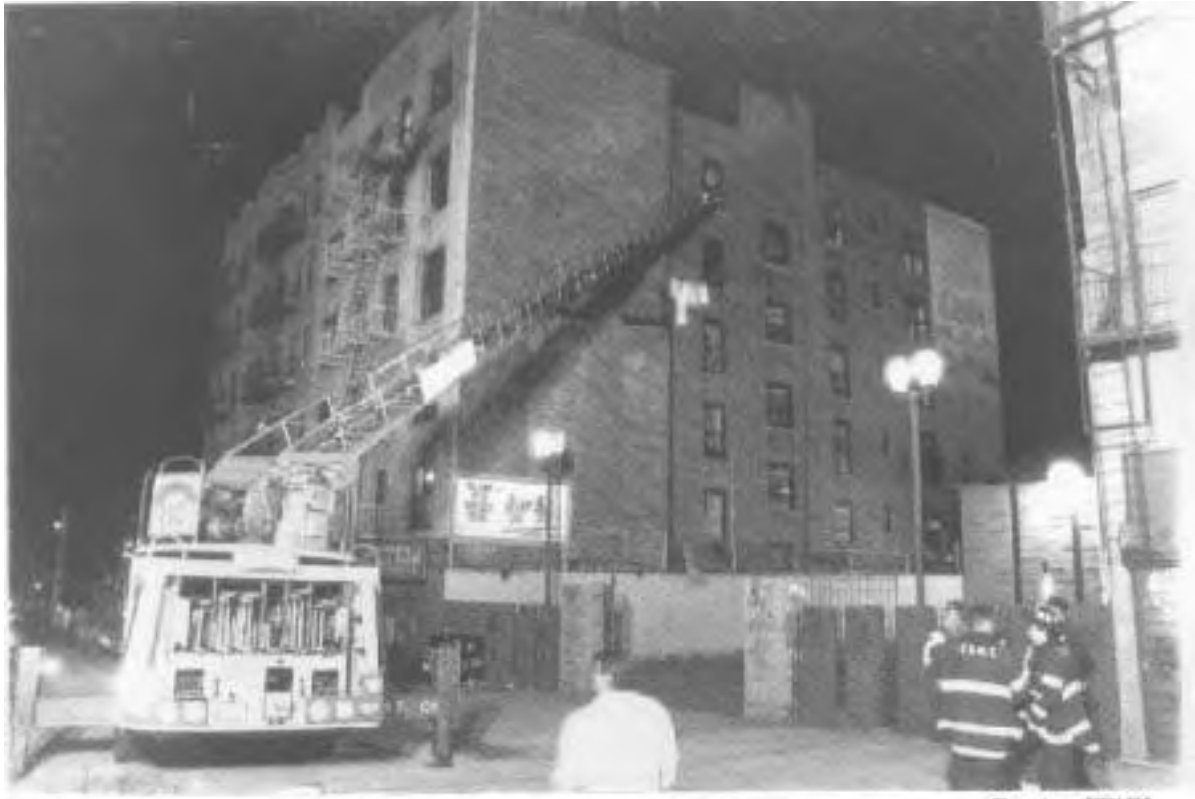
Figure 2. Sequence of Events at New York City Ladder Collapse

In a recreation of the FDNY Ladder 104 collapse scene, Ladder 112 is positioned with its ladder extended to the window where the occupants were trapped. The ladder is extended 91 feet at a 31 degree elevation angle.

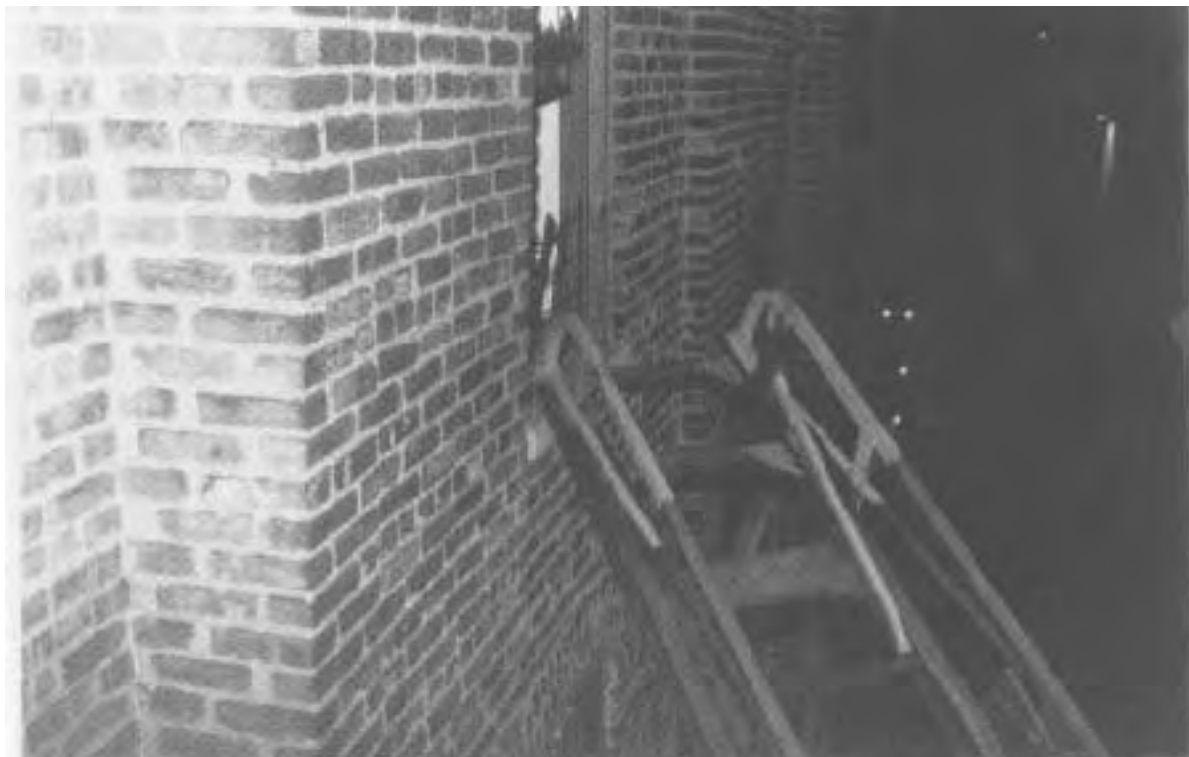
Prior to the collapse, the tip of the left rail rested on the window sill. The weight of the occupants caused a twisting force to the unsupported right side.

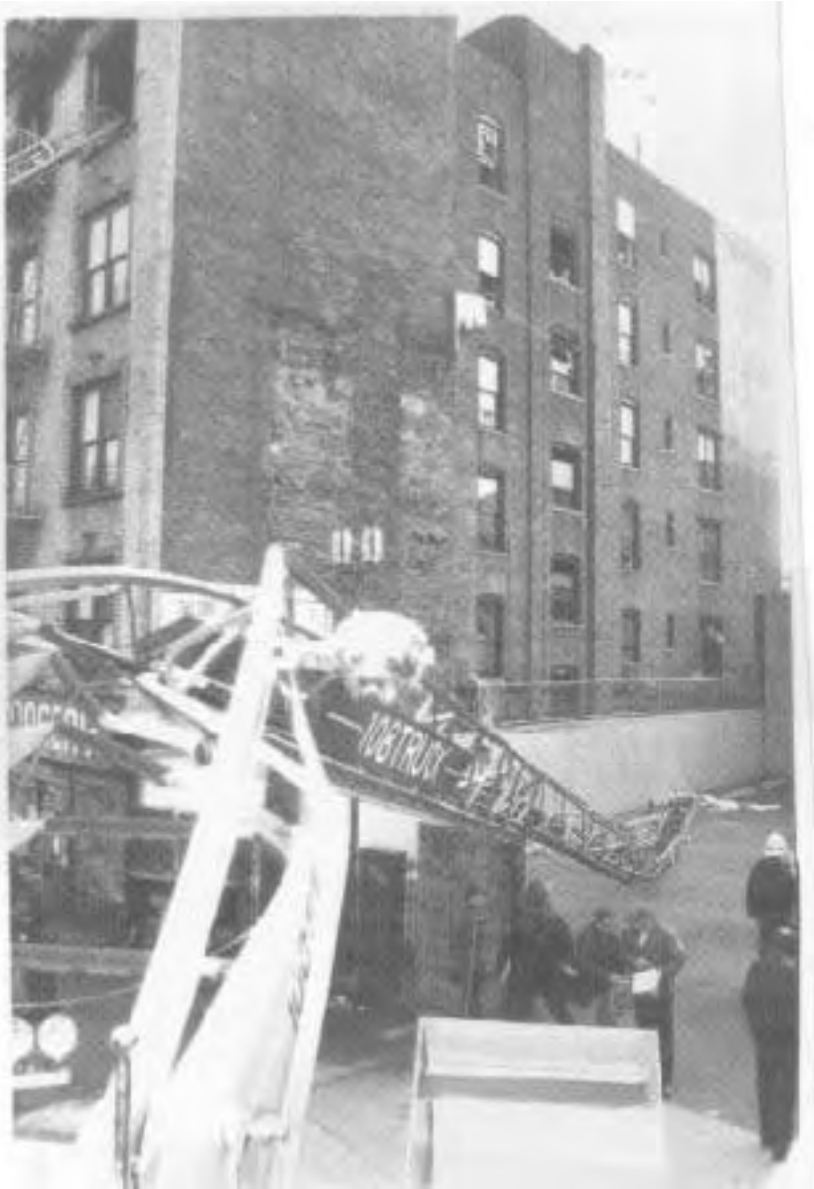
The twisting failure occurred in the lower right bed section, collapsing the ladder to the right side.

The primary structural failure occurred when the main beam on the lower right side of the bed section buckled inward, slightly above the point where it is supported by the ladder raising mechanism. This part of the ladder would be subjected to the maximum bending stress when the ladder is in a cantilever (unsupported) position. The buckling of the lower beam also crushed two of the rungs and caused a secondary buckling of the left main beam in the same area. The buckling indicates that the failure resulted from compression forces in the beam, which are caused by the bending stress in the ladder.

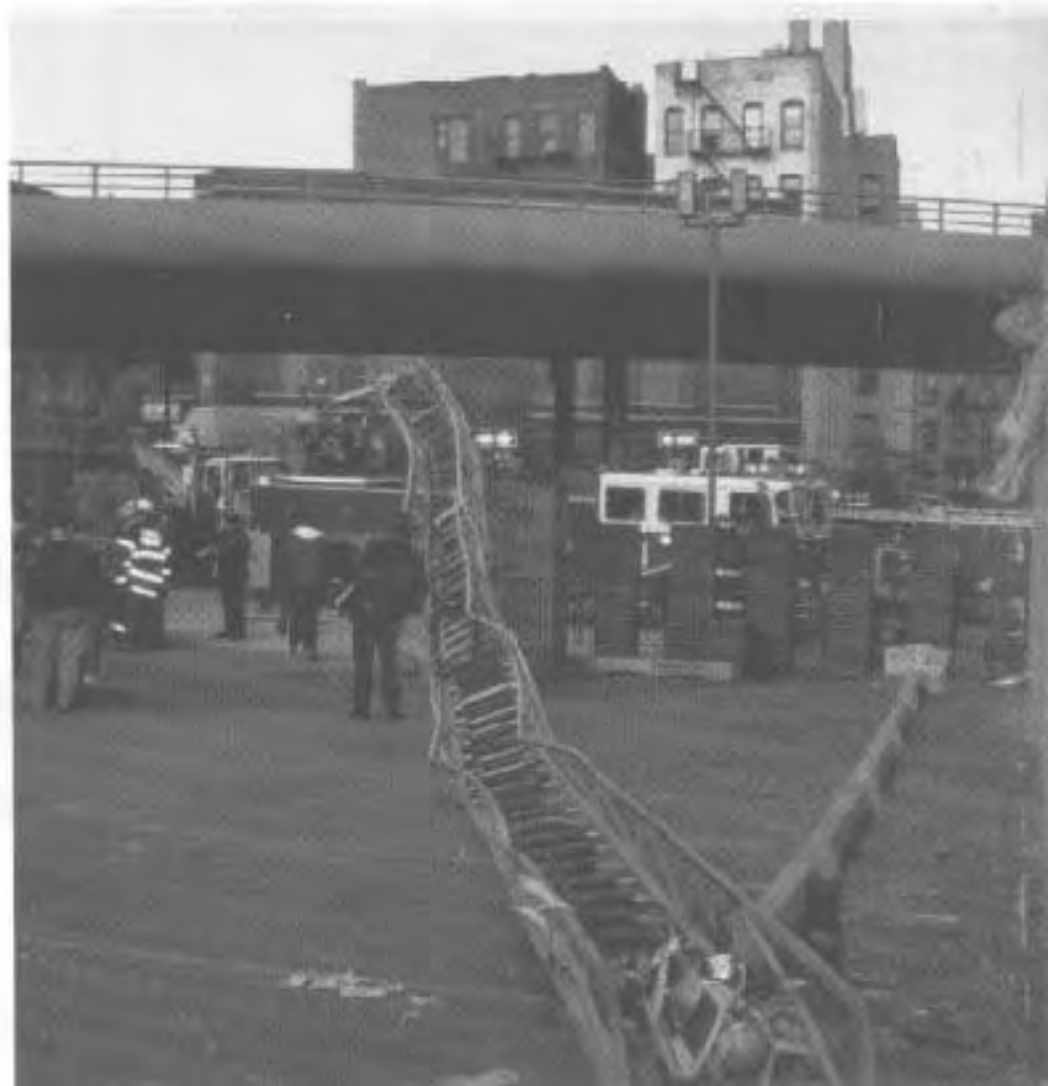
The primary failure in the bed section caused secondary failures in the fly sections.

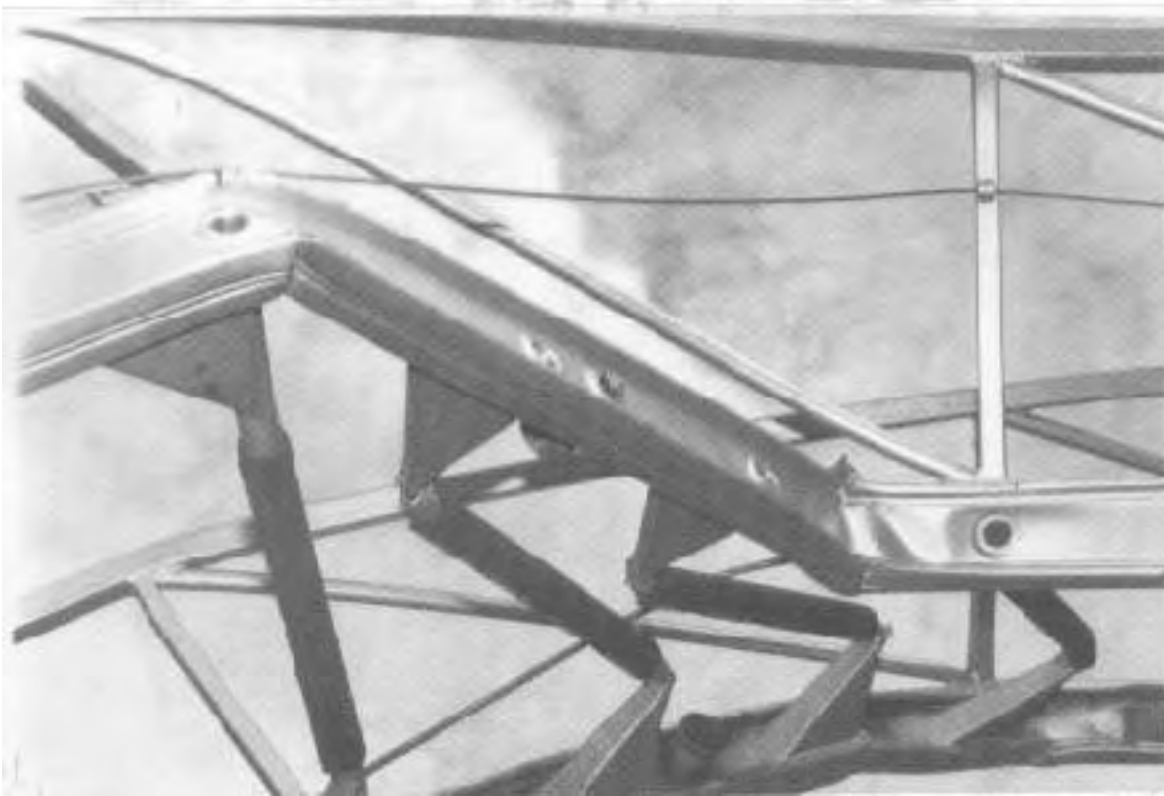
This close-up view shows the damage sustained by beams and rungs in the area of the primary failure.

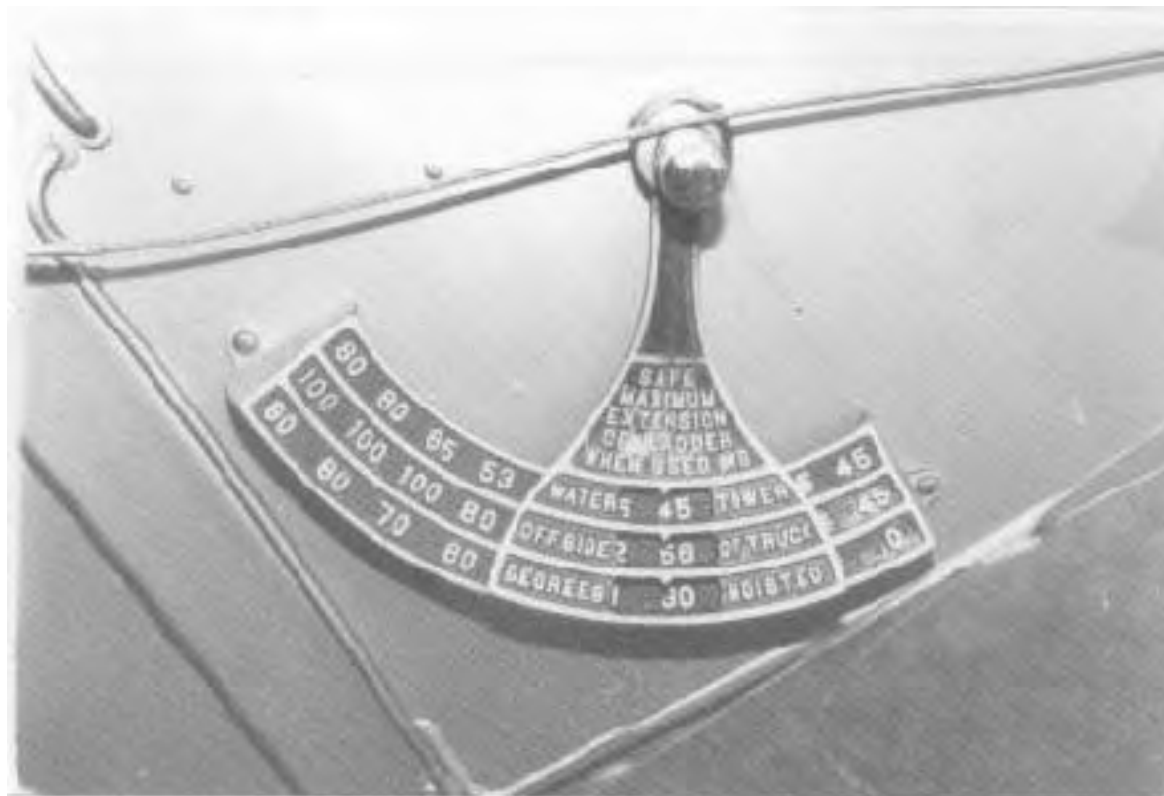
The inclinometer shows that the maximum safe distance of extension for the 31 degree angle is approximately 56 feet.

The inclinometer, which is mounted on the ladder, indicates the maximum allowable extension of the ladder at different angles of elevation. When raised to the position of Ladder 108 prior to its collapse, the inclinometer reading would allow 45 feet of extension for ladder pipe operations and 56 feet for use as a ladder only. The instructions state that these figures are based on an adequate margin of safety assuming that a person and/or ladder pipe is at the top of the ladder, which suggests that the ladder would be in an unsupported condition.

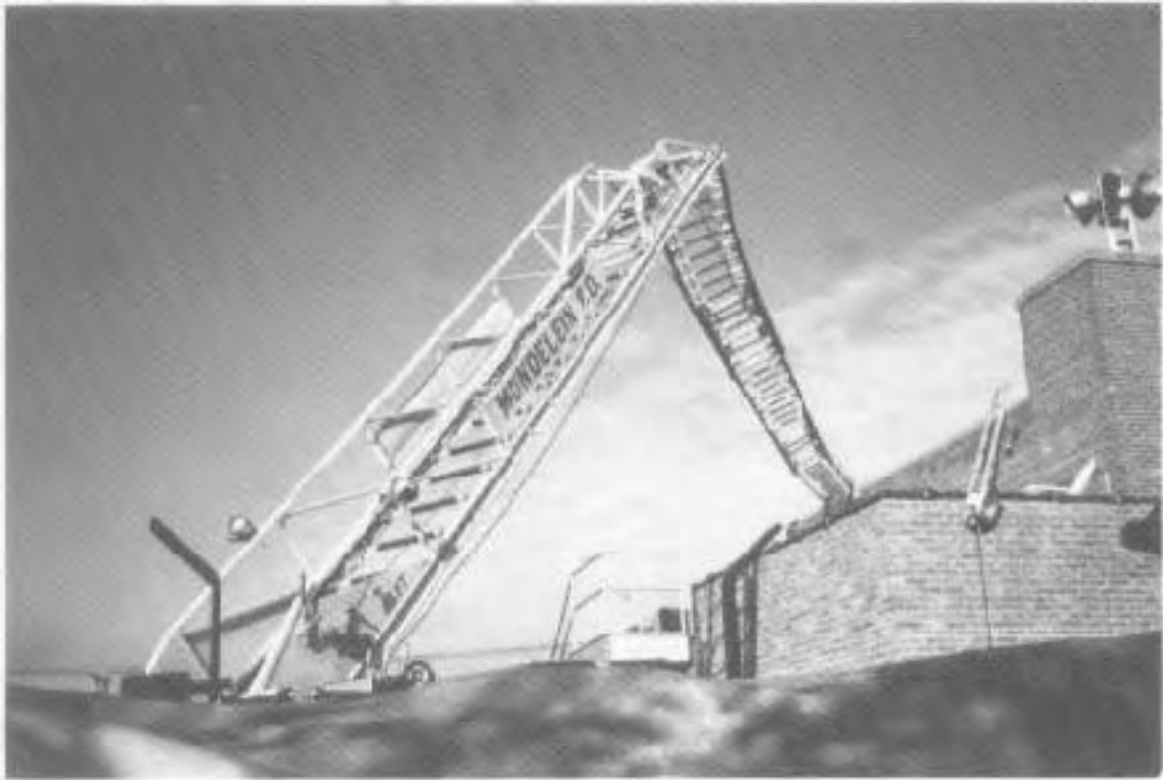
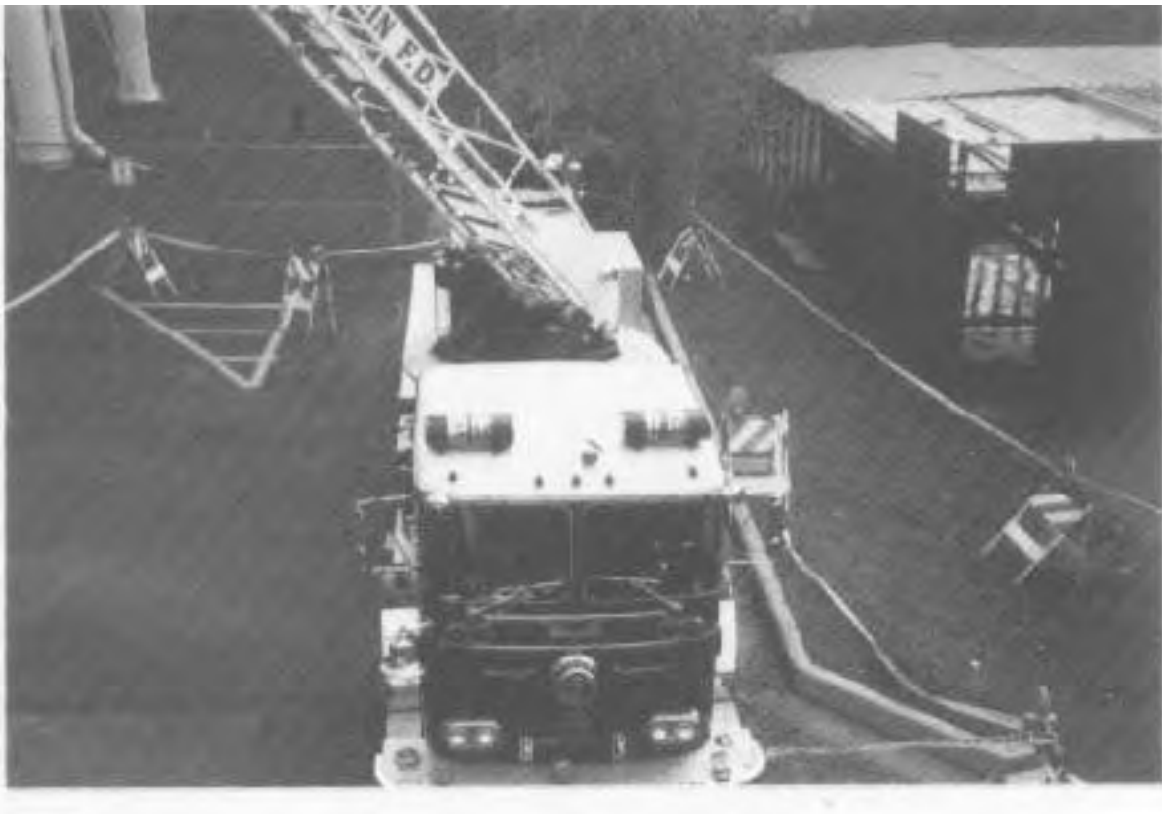
Firefighters in Mundelein, Illinois were practicing a stokes basket evolution when their aerial ladder failed just above the bed section. The firefighters had run a rope through pulleys attached to the tip and the front tow hook (seen below), and were attempting to raise the basket when the collapse occurred.

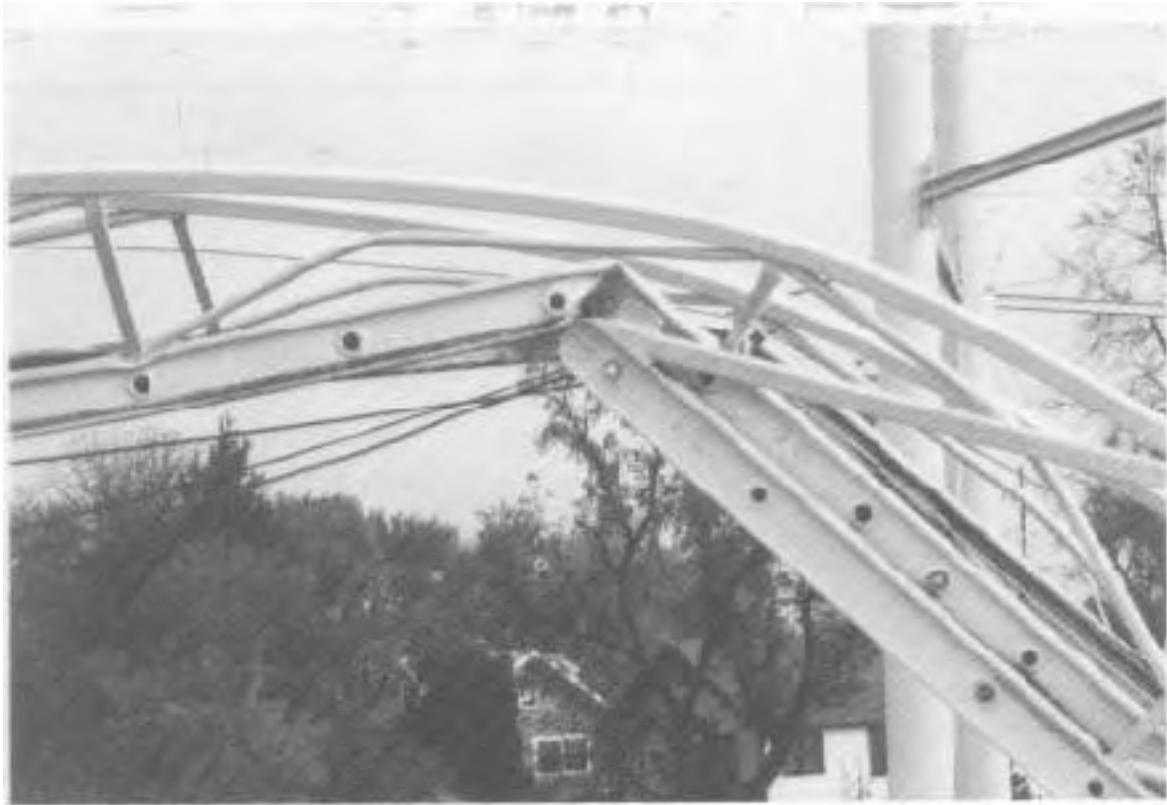
This photo shows a close-up view of the point of failure just above the bed section in the Mundelein incident. Ladder failures often occur at this point in the ladder.

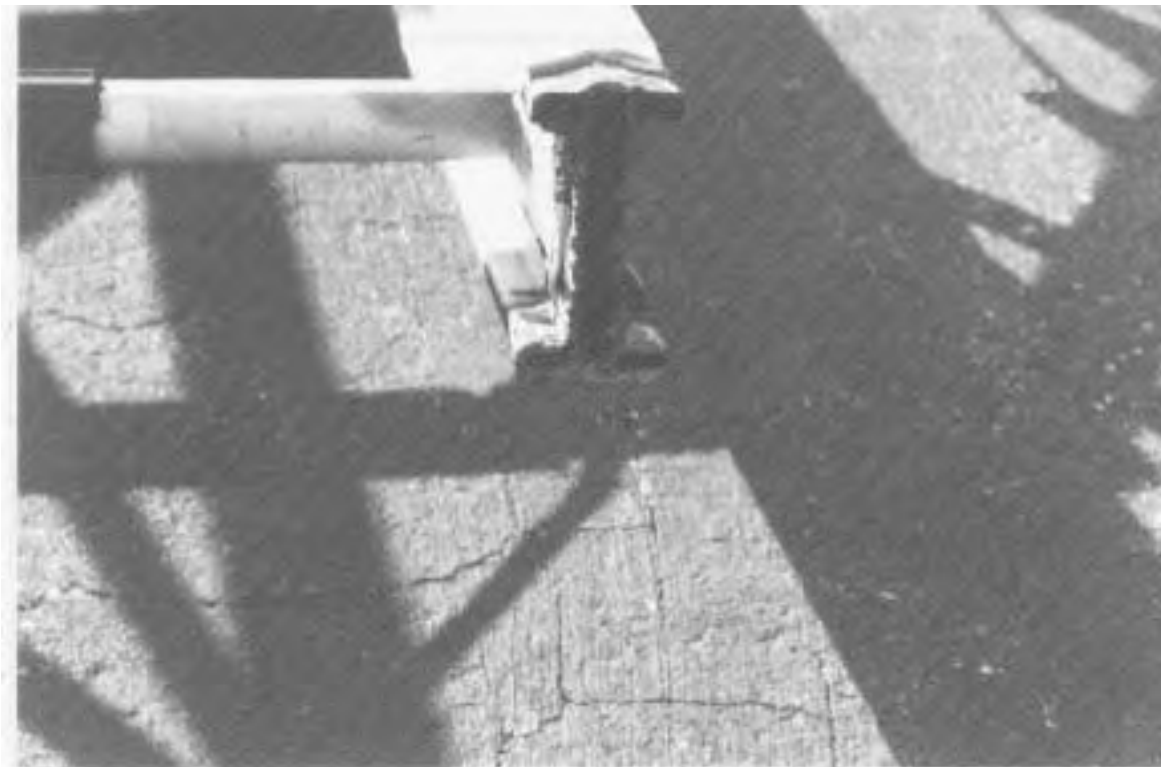
Cross section of the main beam of the Mundelein ladder after it was cut to remove the damaged sections. The beam is assembled from several section of flat steel strips which are bent to form the flanges and then welded together to create the I-beam shape. The interior of the beam is hollow.

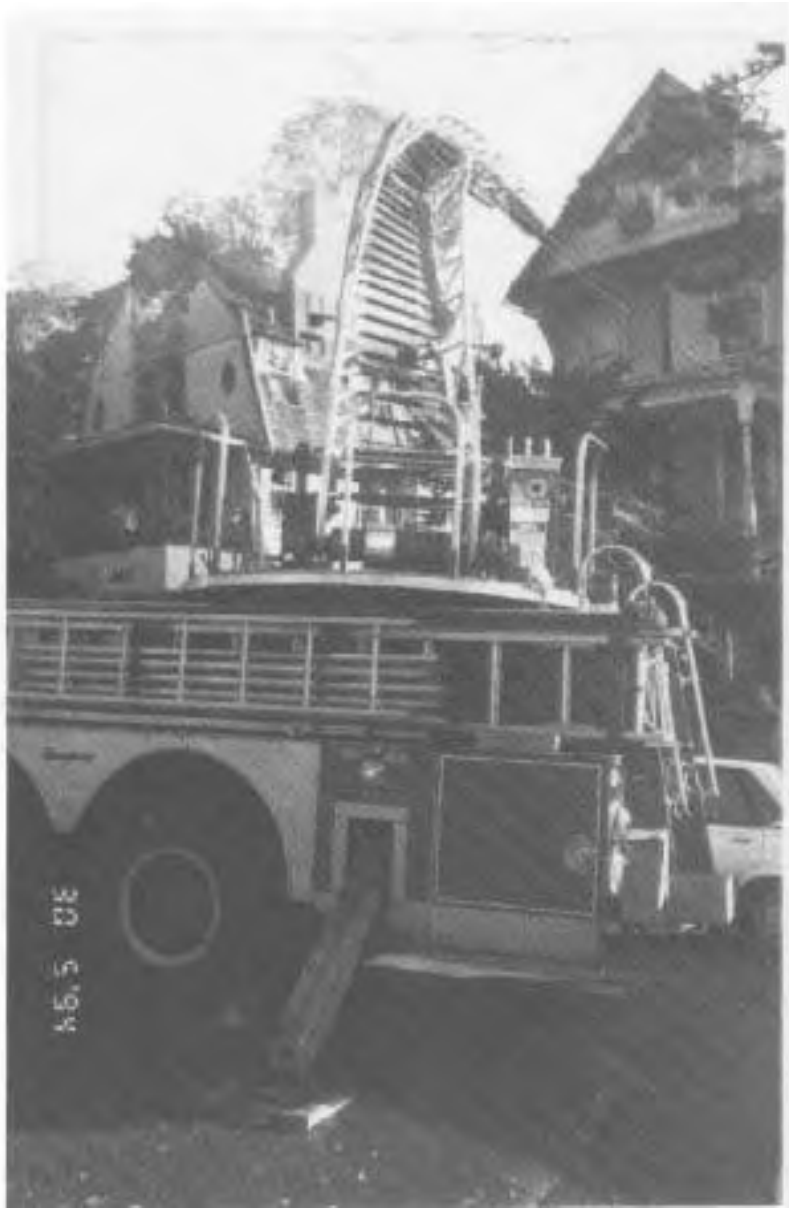
A Yonkers, New York aerial ladder failed during ladder pipe operations.

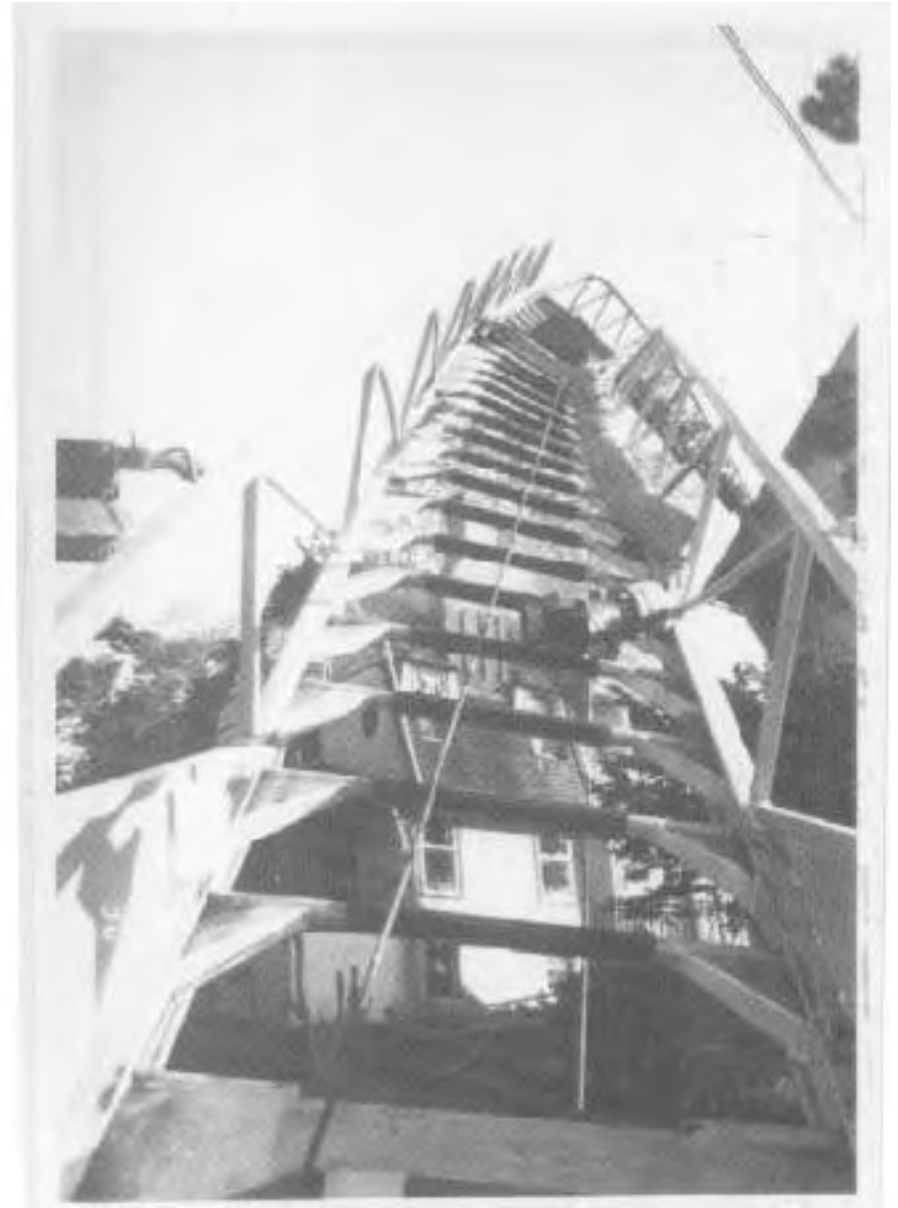
The ladder failed in the first fly section just above the bed section.

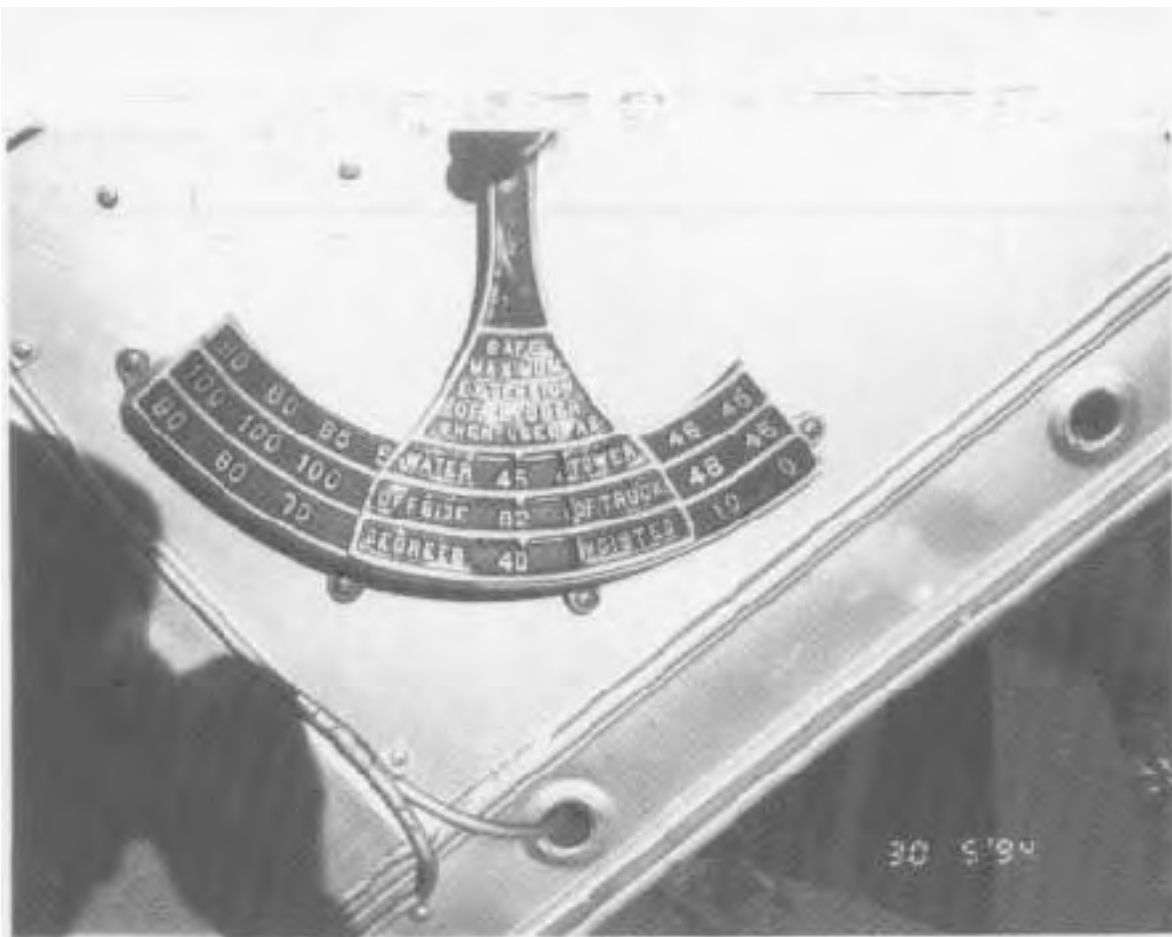
Although the exact angle of elevation at the time of the Yonkers collapse is unknown, the ladder was fully extended at an angle estimated at less than 50 degrees. The inclinometer shows that the maximum safe extension at 40 degrees elevation for a water tower operation is 45 feet.

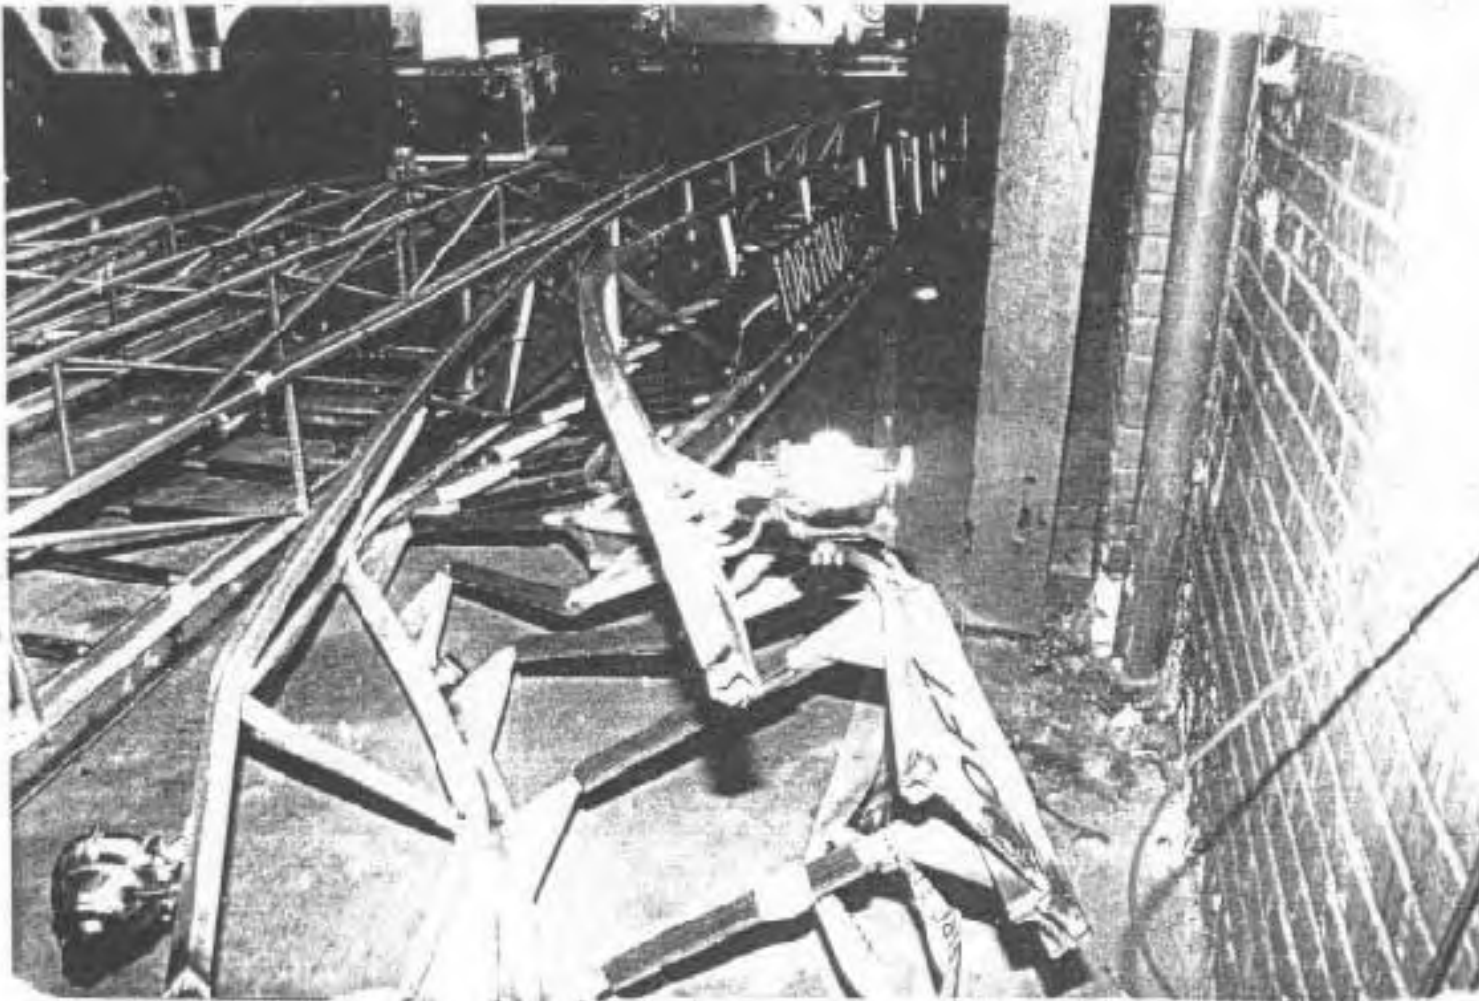
The bottom chord of the truss sides appears to be custom made and has the shape of a hollow I-beam section, Figure 2. Approximate dimensions of this cross section as well as the overall dimensions of the four ladder sections were made during examination of the ladder. For example, the I-beam chord has a flange width of a little over 2 inches and a height of between 4 and 4.25 inches. The railing, which forms the top chord of the truss, is a square tube section, 1.5 inches on a side at the bed section.

Figure 2. Photograph of Sections of the Failed Ladder after Disassembly and Storage. Bottom Chord Cross Section is Shown in the Lower Right Corner.

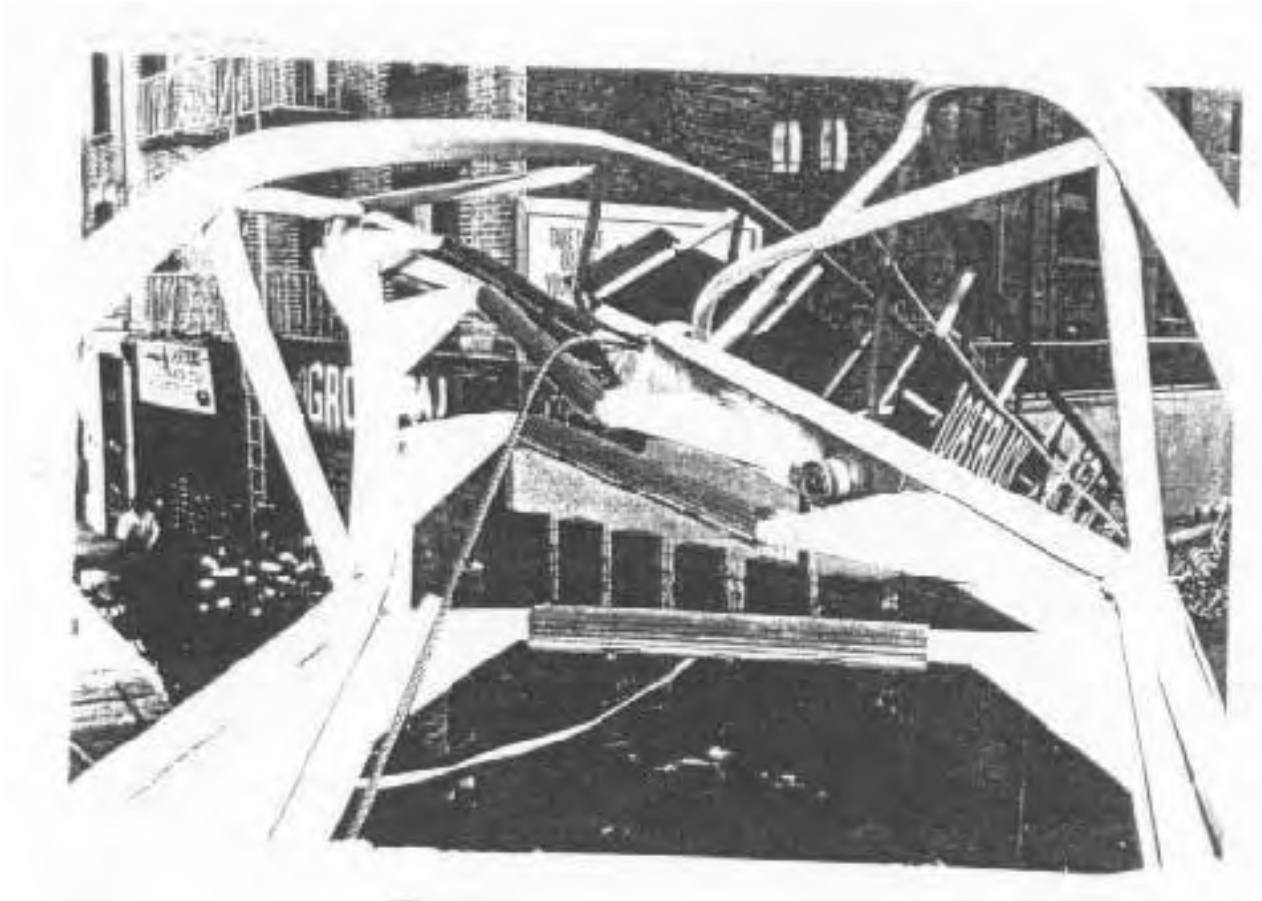
Figure 3. Photograph of the Buckled Bed Section in the Failed Ladder at the Site of the Accident.

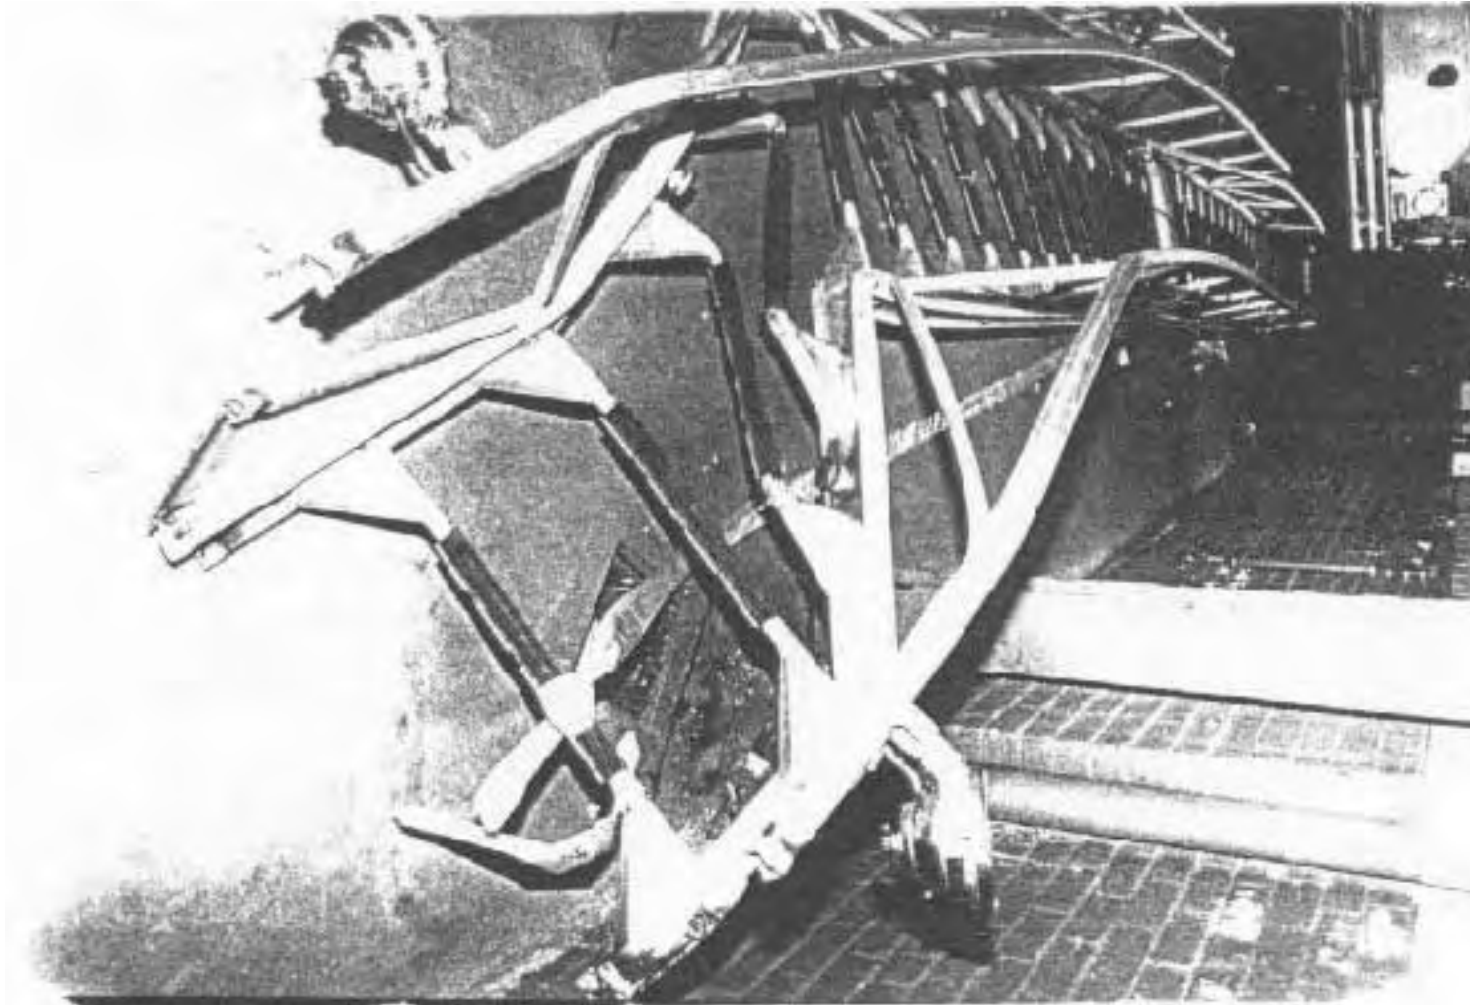
Figure 4. Photograph of the Bed Section of the Failed Ladder Showing the Buckled "Hinges" in the Right Bottom Chord.
