## Entrapment in Garage Kills One Firefighter

San Francisco, California

This is Report 084 of the Major Fires Investigation Project conducted by Varley-Campbell & Associates, Inc. under contract EMW-94-C-4423 to the United States Fire Administration, Federal Emergency Management Agency.

March 9, 1995

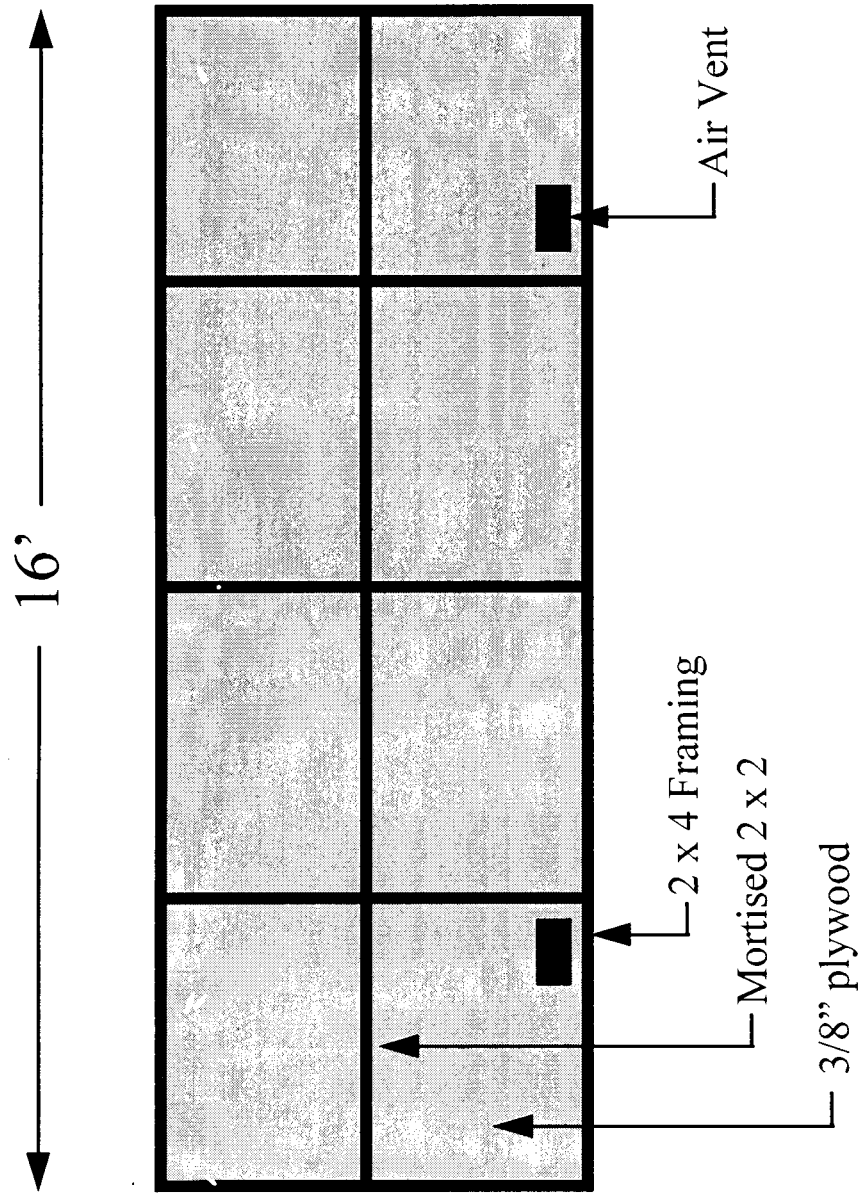
Figure 4

The garage door was a single panel, constructed of 3/8 inch plywood with 2x4 and 2x2 framing (Figure 4). This door was 16 feet wide, 7 feet high and weighed about 250 pounds. Connected to the door was a screw drive type mechanical garage door opener. The opener could be activated by a wall-mounted push button near the door leading to the entry hall (Figure 5) or either of two remote controls. The remotes were kept in the family cars.

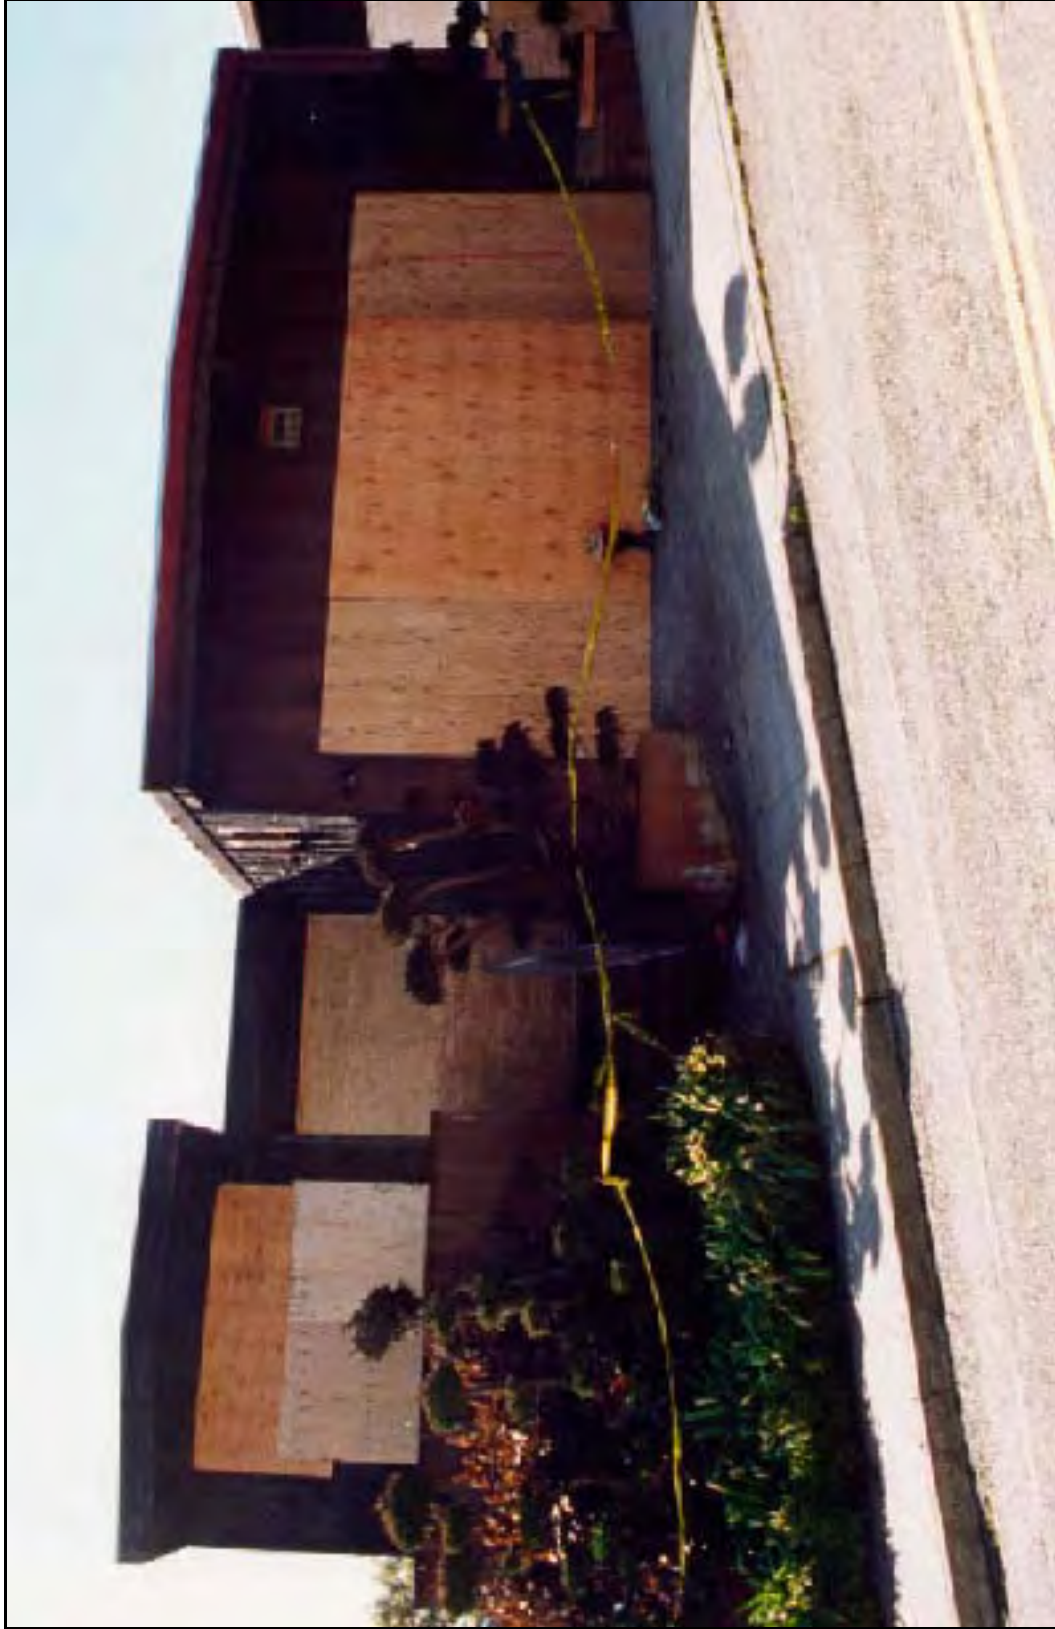
PHOTOGRAPH 1 The front of the house. The garage is to the right, the entryway door is in the center and the kitchen is to the left side of the photograph.

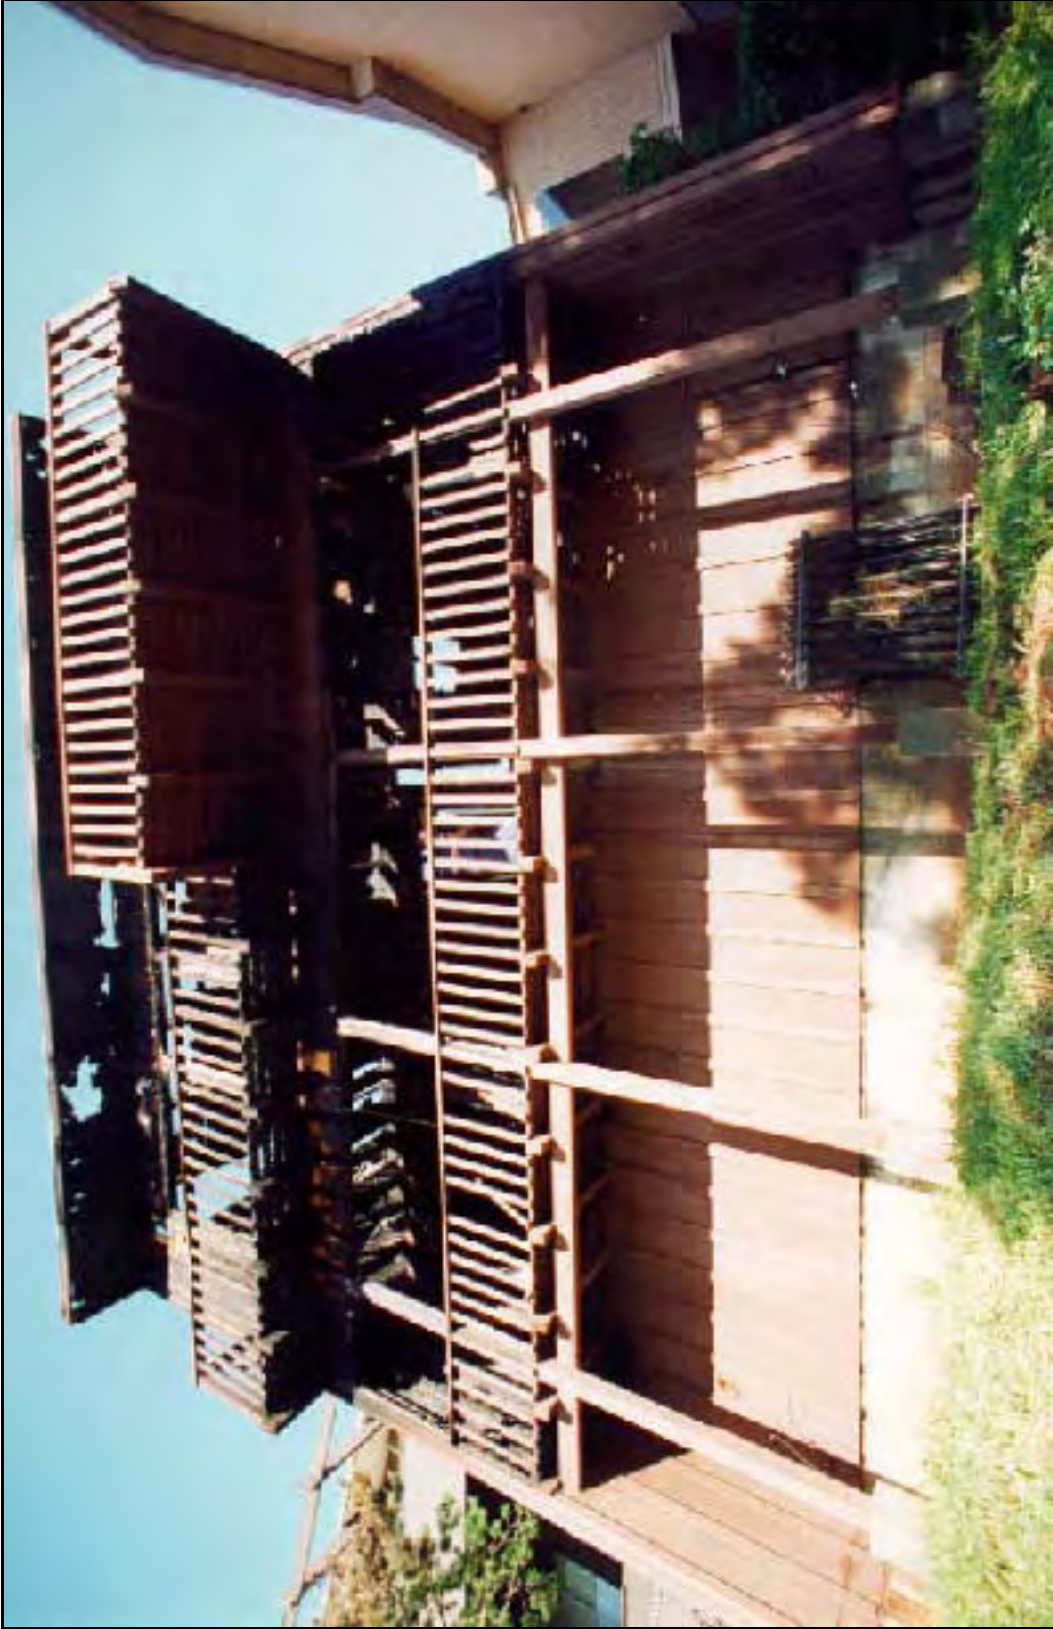
PHOTOGRAPH 2 The rear of the house as viewed from ground level. The fire started in the wall above the lower deck to the right center of the photograph.

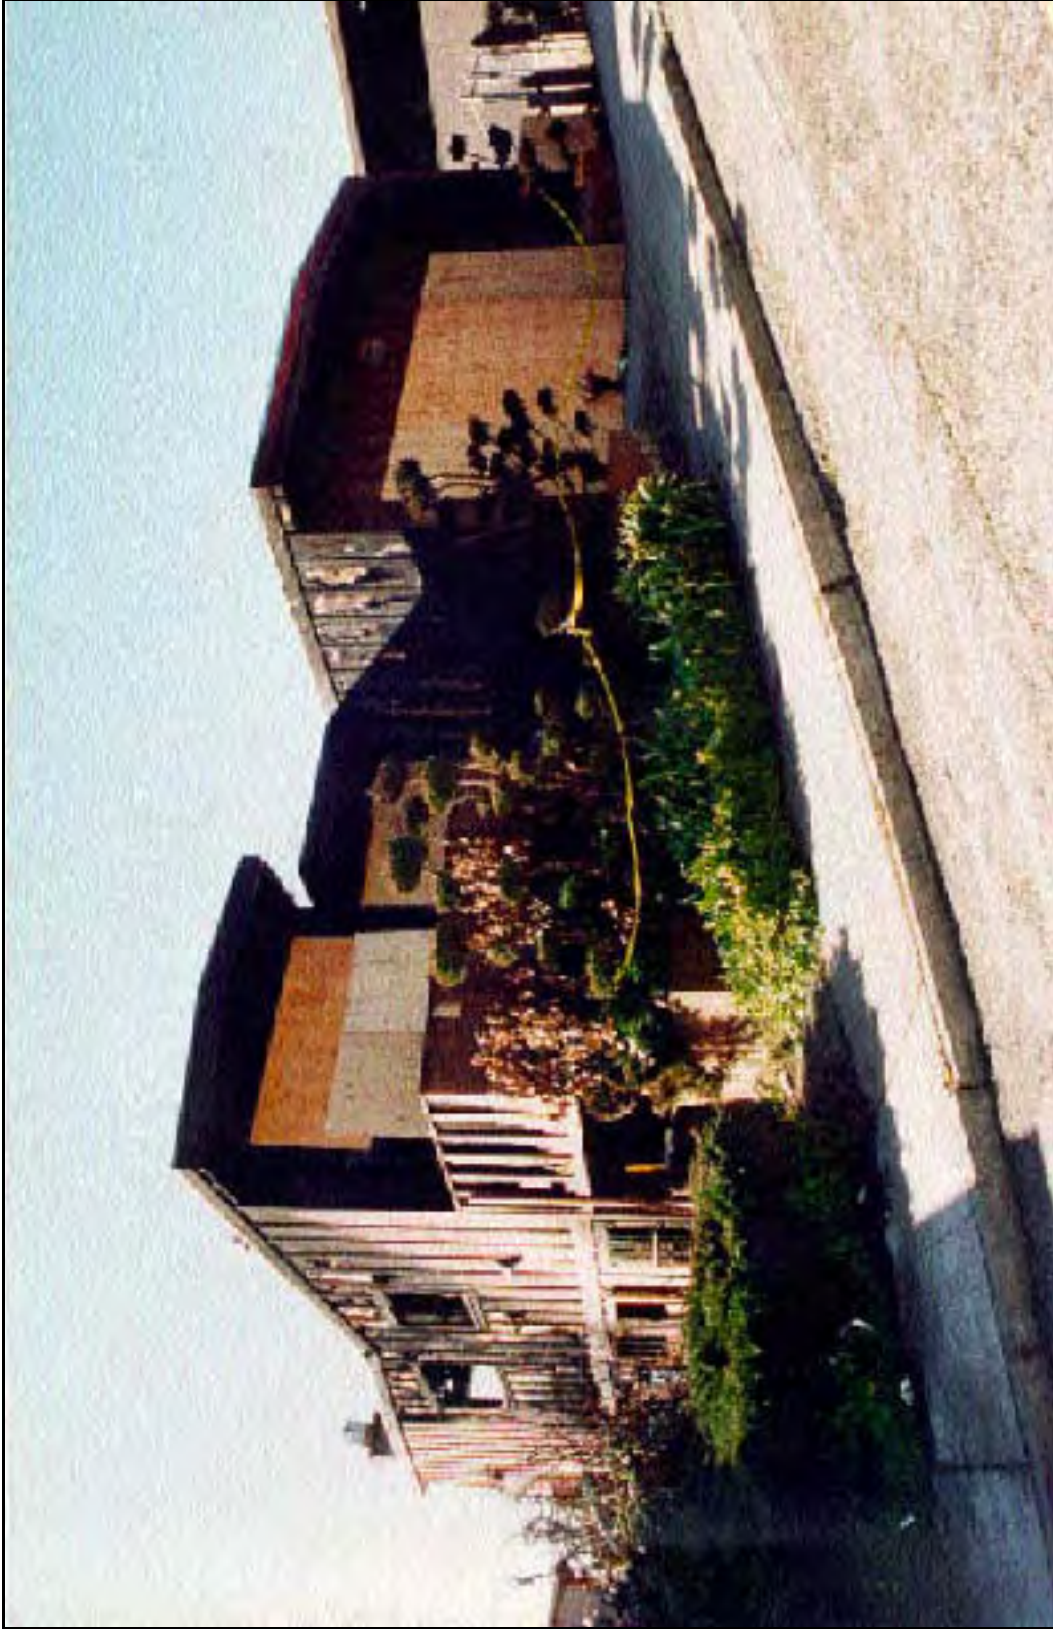
PHOTOGRAPH 3 The northeast corner of the house. Note the security gates on the lower level openings.

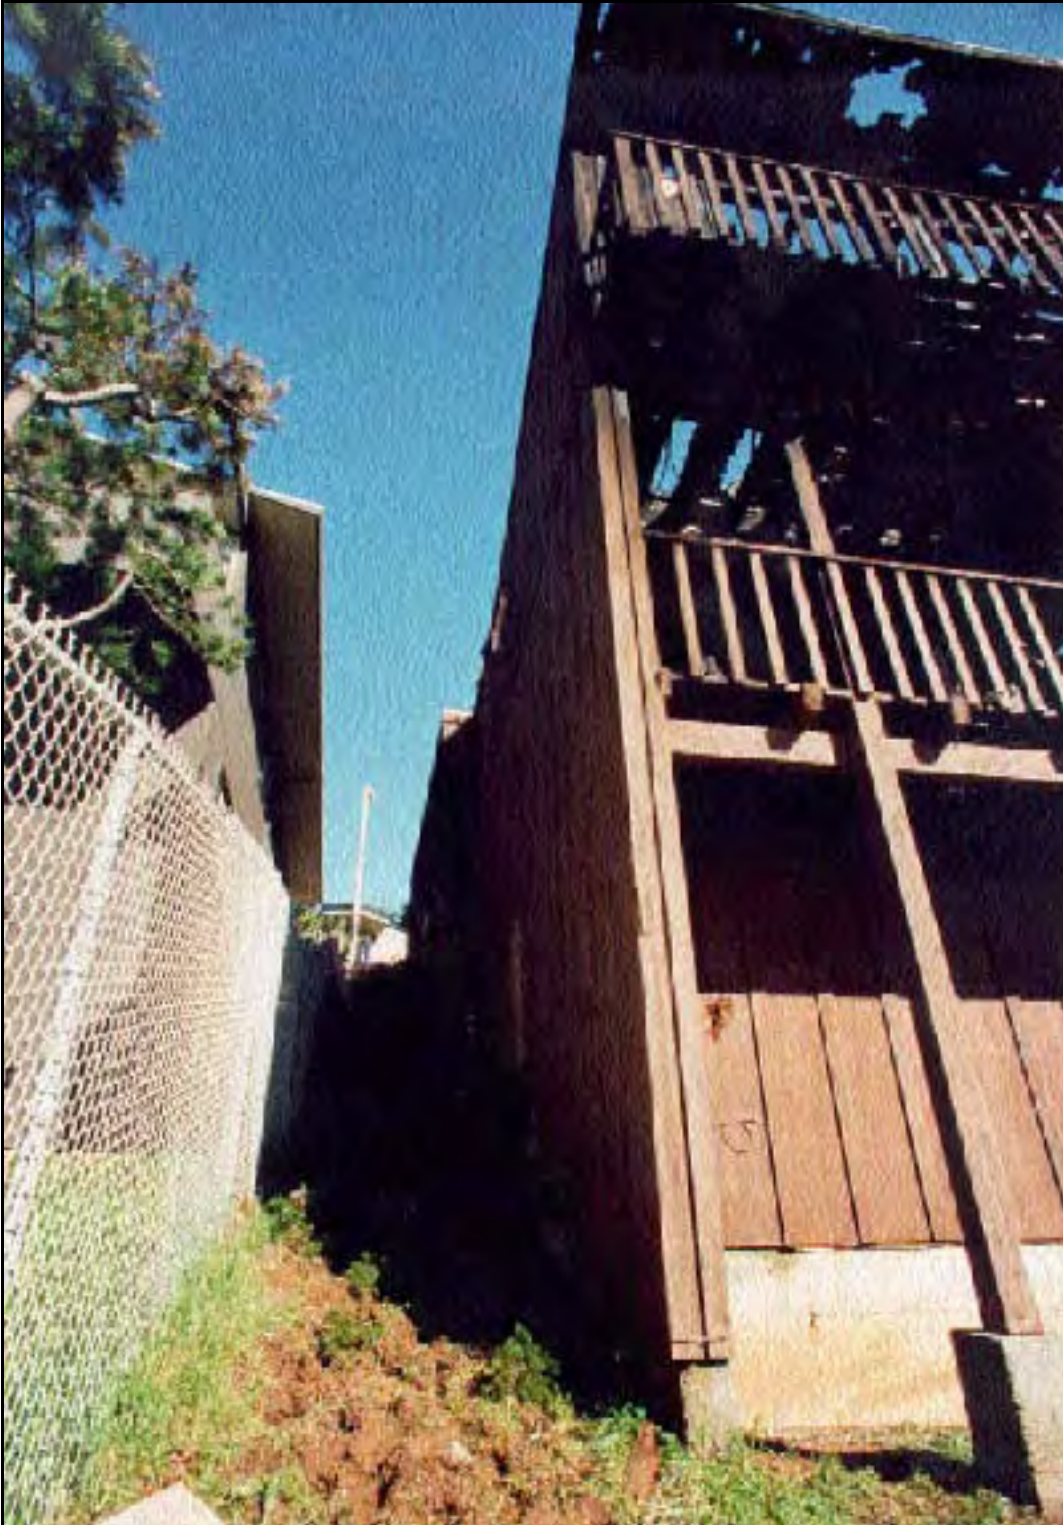
PHOTOGRAPH 4 The southwest corner of the house. Note the steepness of the building lot and the proximity of the house next door.
