**Logan Valley Mall Fire
Altoona, Pennsylvania**

**Logan Valley Mall
Altoona, Pennsylvania
December 16, 1994**

This is Report 085 of the Major Fires Investigation Project conducted by Varley-Campbell and Associates, Inc./JTriData Corporation under contract EMW-94-4423 to the United States Fire Administration, Federal Emergency Management Agency.

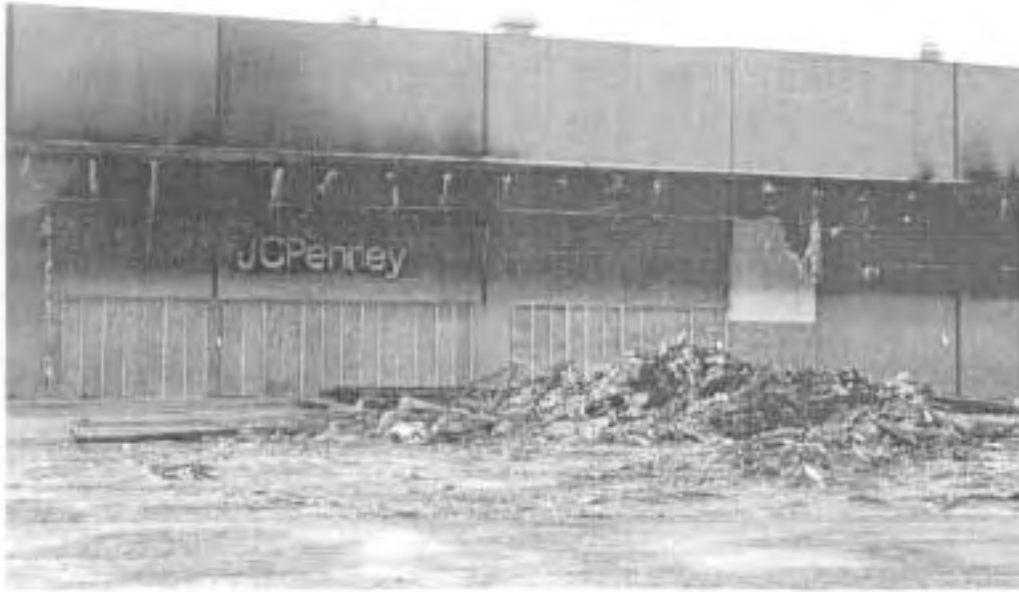
Photograph 1.

East wall of the J.C Penney Store where the westerly fire travel was stopped. Roof line of covered mall is identified by the dark black horizontal line. Glass entrance and show windows are behind the chipboard and wood studs.

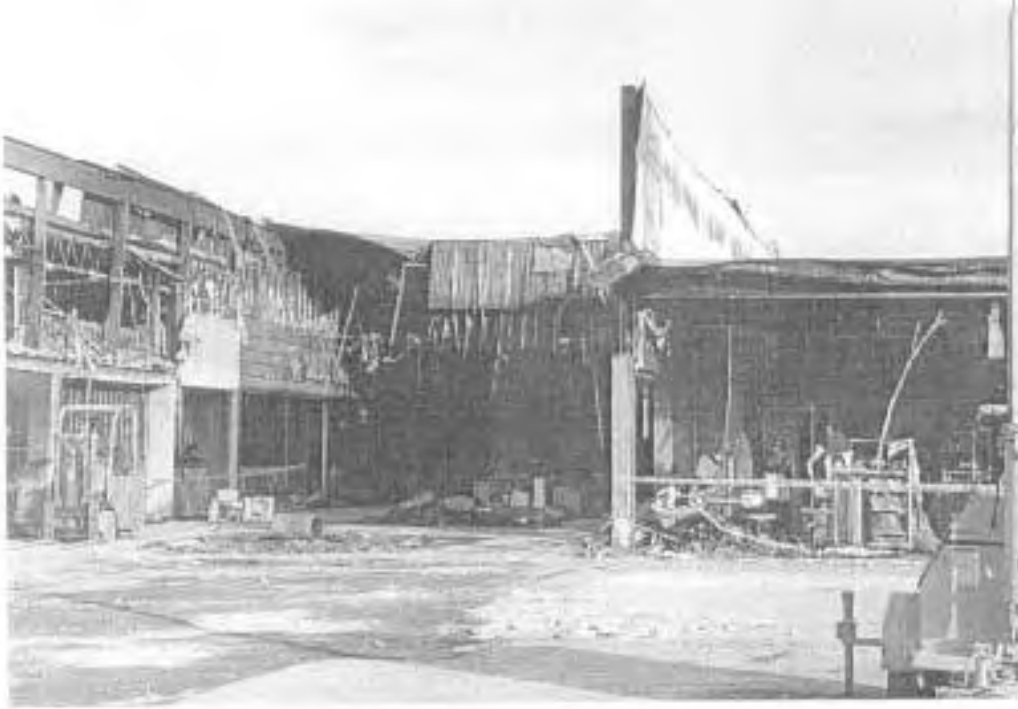
Photograph 2.

Covered mall to the east of the Murphy store and some of the stores adjacent to the covered mall. The three different roof heights and construction features are illustrated. The tenant separation wall for the right hand store has been removed.

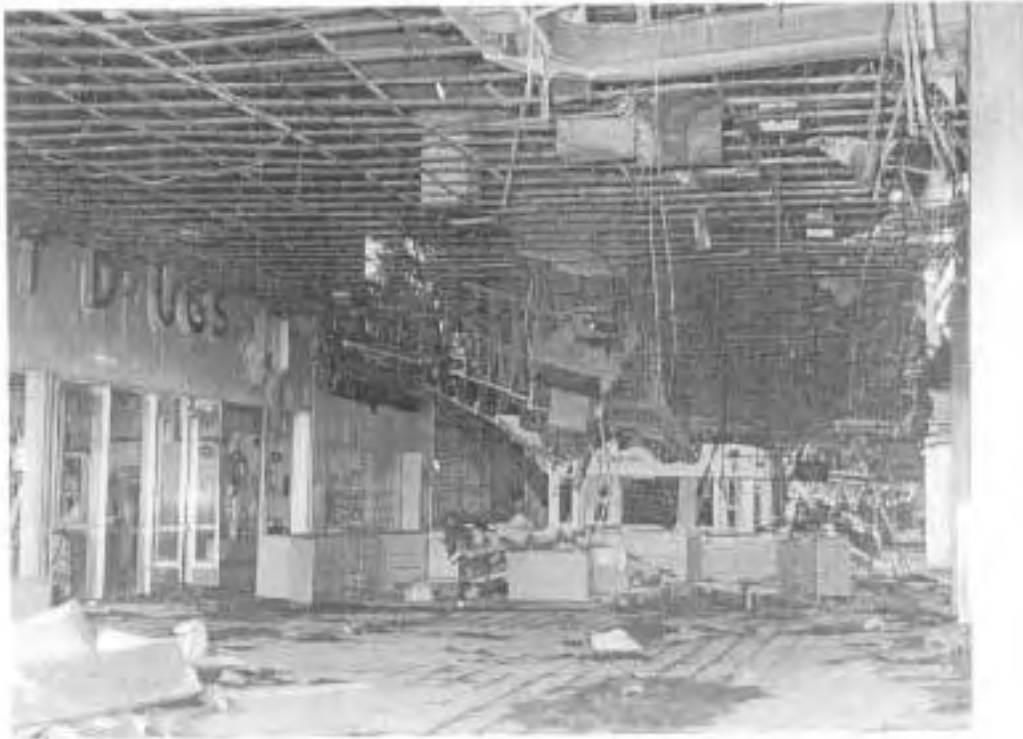
Photograph 3.

Looking east into the covered mall from about where the forklift is located in Photograph 2. The ceiling tiles were removed during the fire and the floor debris was removed before the photograph was taken. Note the partial roof collapse in the background

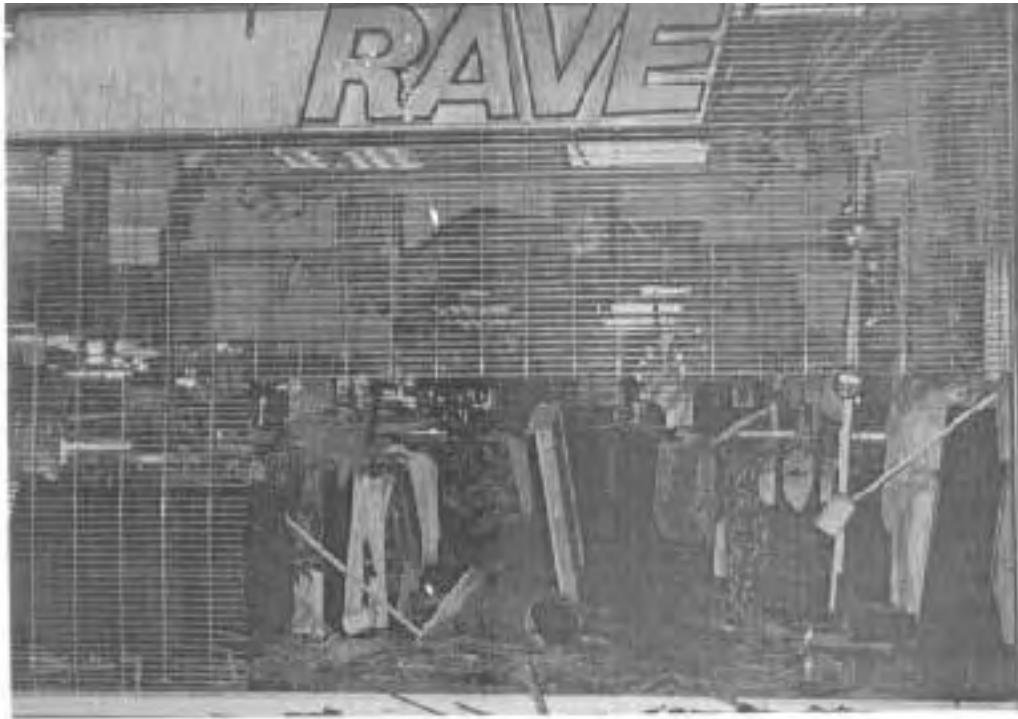
Photograph 4.

Open grill security separations allowed the free passage of smoke and heat into stores from the common, covered mall. This contributed to smoke and water damage to the stores' contents. Additionally, the forcible entry through these separations was more difficult and time consuming than for stores with solid separations. Smoke damage in a retail store is often as costly as direct fire damage. Controlling smoke travel is an important element in limiting damage. Rated fire resistance in the separation is not as important as a solid separation with minimal unprotected penetrations. NFPA 101, *Life Safety Code*, does not require separation between the covered mall and the tenant stores, but does require automatic sprinklers and a "smoke control system" within the covered mall. These systems were not present in this incident.

Store on the south side of the covered mall. Typical of the forcible entry work performed on the security grill and the damage to goods. This store had automatic sprinklers and the sprinkler heads at the front entrance operated.

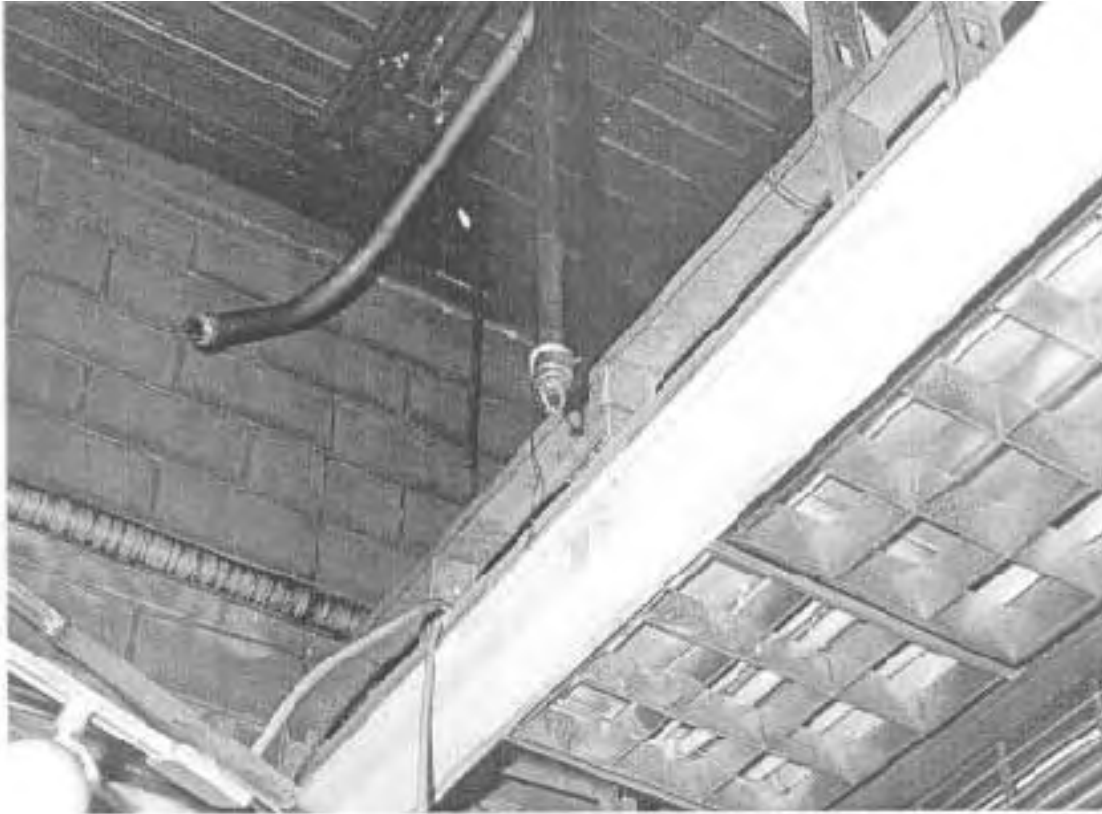
Photograph 5.

Open sprinkler head inside the store in Photograph 4. The ceiling tiles and grid around the head were removed before the picture. Typical concrete block tenant separation wall and metal deck roof construction in the older section. Interior tenant construction has used wood studs for the metal ones.

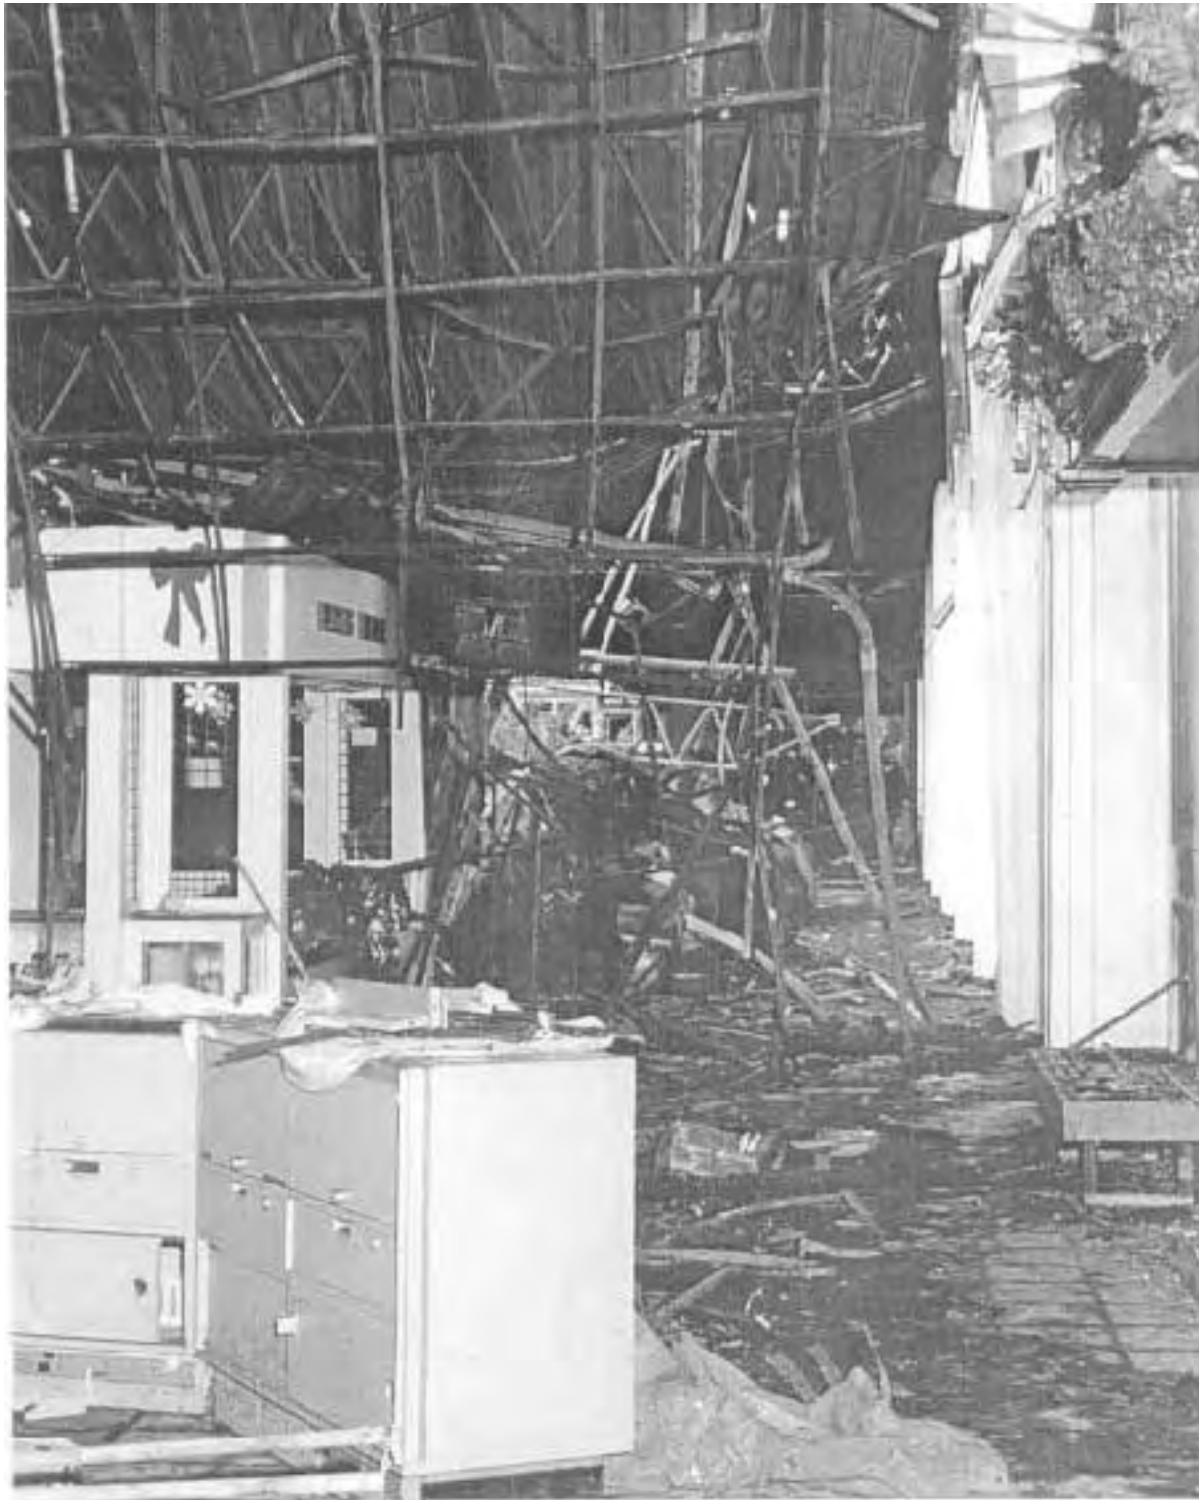
The fire damage and collapse of the covered mall roof was attributed to fire spreading under the metal deck roof. The fuel for this fire was the melted and vaporized asphalt from the adhesive and vapor barrier above the metal deck and under the roof insulation. This flammable vapor leaked into the building through the seams in the metal deck where it ignited. This combustion melted and vaporized more asphalt, creating a self-sustaining fire under the roof deck. The undamaged combustible kiosks at floor level further support this observation and also document the effectiveness of firefighter tactics and operations in this area.

Photograph 6. Moving further east in the covered mall, the counters in the foreground are also in Photograph 3. This area is where the metal roof began a partial collapse. The goods in the kiosks were either stored before the fire or removed prior to the picture.

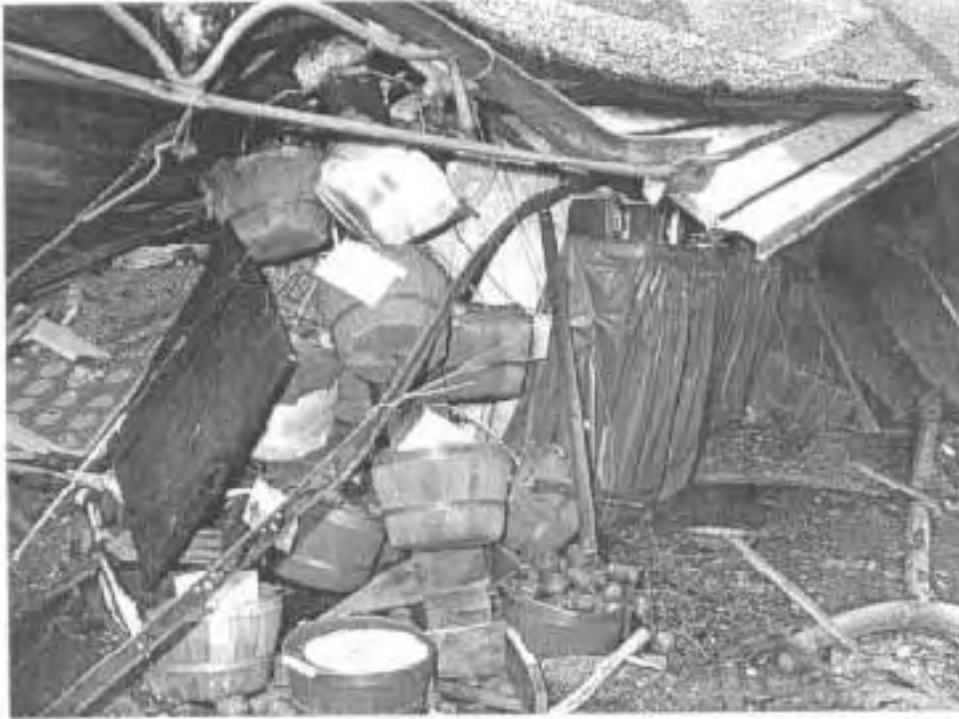
Photograph 7.

The fire and heat spread for a considerable distance in the covered mall area from in front of the G. C. Murphy store east to the food court. The covered mall's roof collapsed for about 60 feet to the east of the G. C. Murphy store. Further to the east, a roof section approximately 80 feet long was left standing but showed signs of burning on the underside of the deck. A kiosk below this section suffered only smoke and water damage. East of the standing section, another part of the roof collapsed in a lean-to fashion for a distance of approximately 60 feet. This collapse was due to the roof support beam on the south side rolling over. A candle kiosk under this collapse was not burned and the visible candles were not melted. One basket of candles was covered with melted tar, likely from the roof. (See Appendix F)

A candle kiosk under the roof collapse area shown in Photograph 6. Note that the candles, wicker baskets and table skirting are not melted or burned. Yet, the metal bar joist is severely deformed.

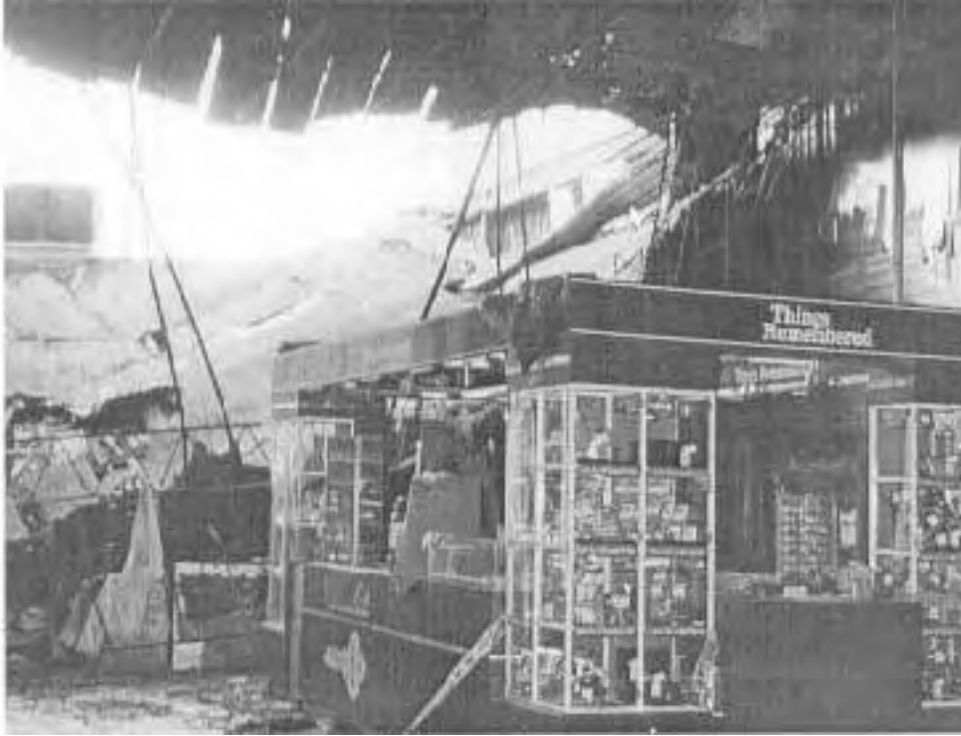
Photograph 8.

A front view of the partial roof collapse over the Things Remembered kiosk.

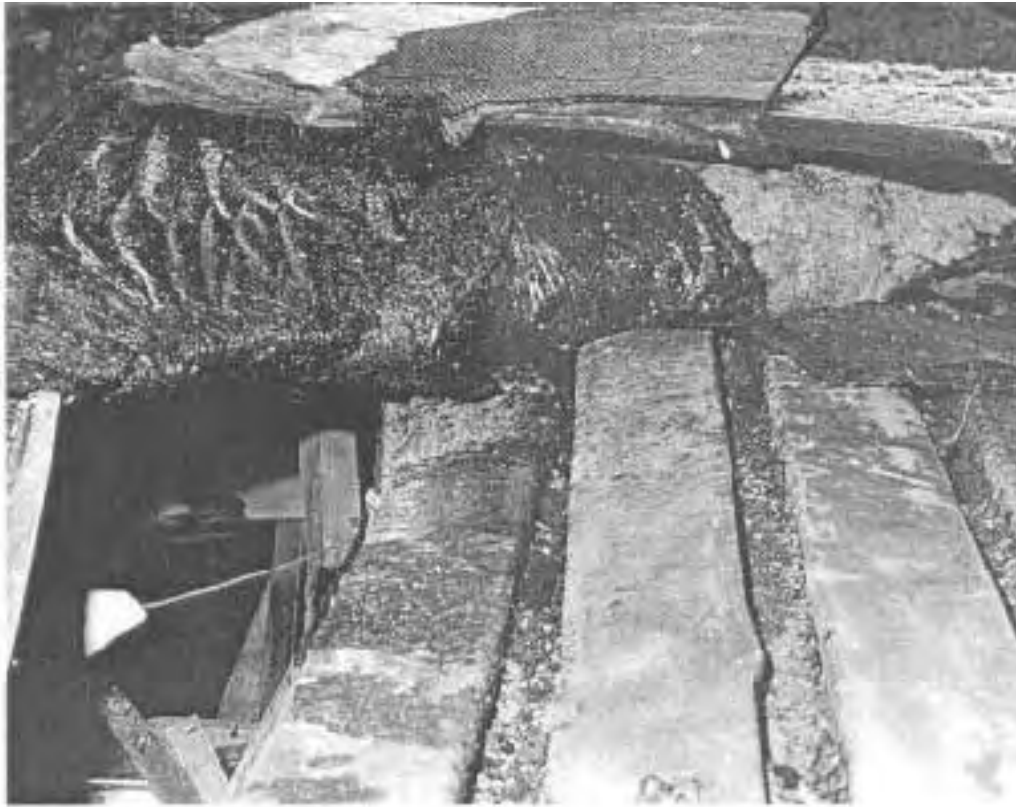
Photograph 9.

This hazard was first published following the 1953 fire in Livonia, Michigan and has reoccurred several times since. An exposure fire heating the corrugated metal roof deck melts and vaporizes the asphalt material commonly used as both the adhesive and part of the vapor barrier. The insulation board, laid into and on top of these layers, and the layers of felt and additional asphalt on top of the insulation do not allow the vapors to escape upwards. As a result, these flammable vapors are forced through the seams in the metal deck panels into the building. The fire inside the building ignites these vapors which continue the process of generating fuel and fire under the metal deck. The heavy black smoke produced often obscures the flames in such a fire. Large caliber hose streams are needed to cool the metal roof deck and supporting structures. Water must reach the deck; steam does not provide the required cooling. Where ceilings are installed, they need to be removed to provide access for cooling hose streams.

The top of the metal deck roof illustrating the insulation board, the vapor barrier under the board, the seam in the deck and the deformed condition of the metal. This section is in the partial roof collapse area shown in previous photographs.

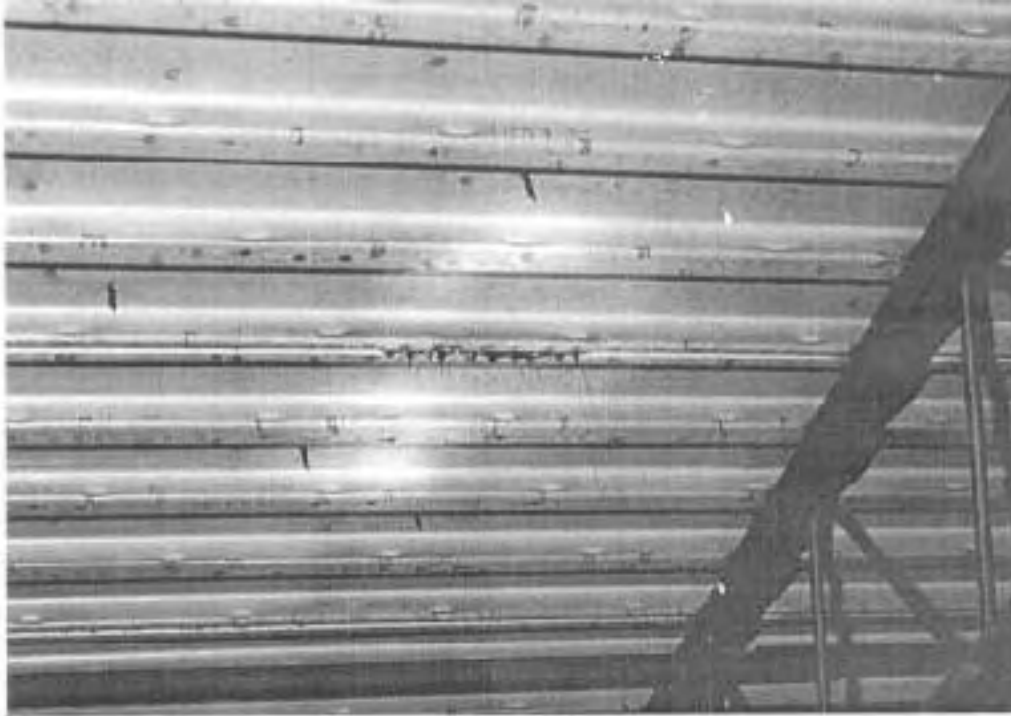
Photograph 10.

Recent reroofings involved tearing off the combustible roof materials and replacing them with a Class I roofing system¹ with mechanical fasteners for the insulation board. However, the complete removal of the combustible asphalt from the metal deck is difficult to accomplish.

Parts of the complex had new roof coverings which were specified to meet Factory Mutual requirements for a Class I roof covering. Inspections by FM Engineering report that the roofing contractor was following proper procedure for installing a Class I covering. Mechanical fasteners, used with such roof installations, were found in some metal roof deck panels after the fire. The problem is that asphalt remains attached to the metal deck and in the corrugation valleys even when the old roof covering is tom off. This melts and vaporizes, providing the fuel for a fire under the deck. The age and history of the structure's roofing need to be included in pre-incident planning.

The underside of the metal deck roof above one of the stores adjacent to the covered mall. Note the tar dripping through the seam in the valley between metal deck sections. You can also see three mechanical fasteners poking through ridges in the deck. Such fasteners are usually found when less combustible roofing methods are employed.
