Live Oak/Milstar Complex and Carpet Service Center

LaGrange, Georgia

UNITED STATES FIRE ADMINISTRATION FIRE INVESTIGATIONS PROGRAM

This is Report 086 of the Major Fires Investigation Project conducted by Varley-Campbell & Associates, Inc. under contract EMW-94-C-4423 to the United States Fire Administration, Federal Emergency Management Agency.

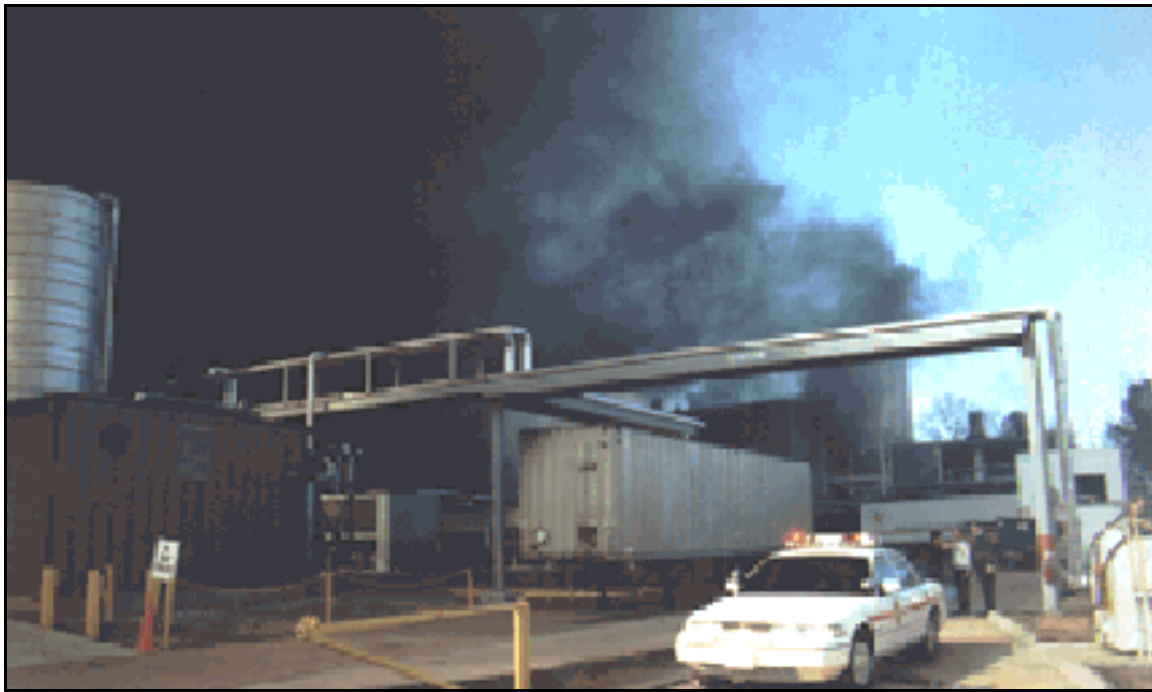
2. The location of Incident Command on the east side of the building. The truck trailer with the star (above the car's warning lights) is in photograph 1.

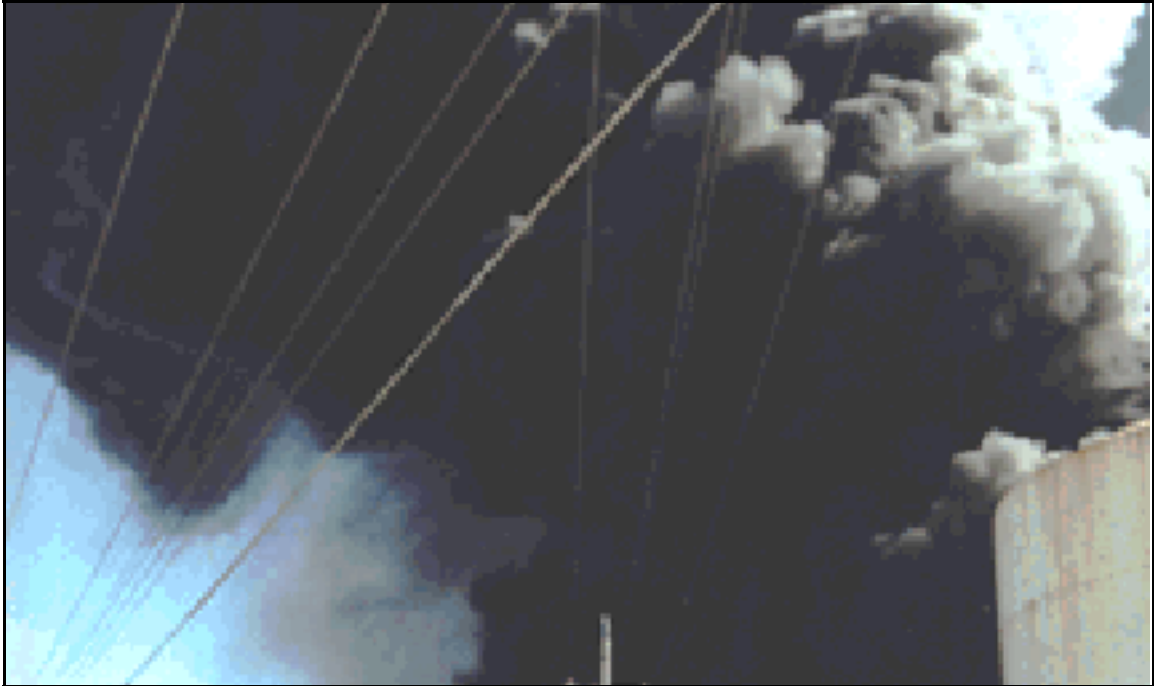
3. Conditions along the north side of the plant looking from west to the east. The photograph was taken very early in the fire and represents conditions not long after fire department arrival.

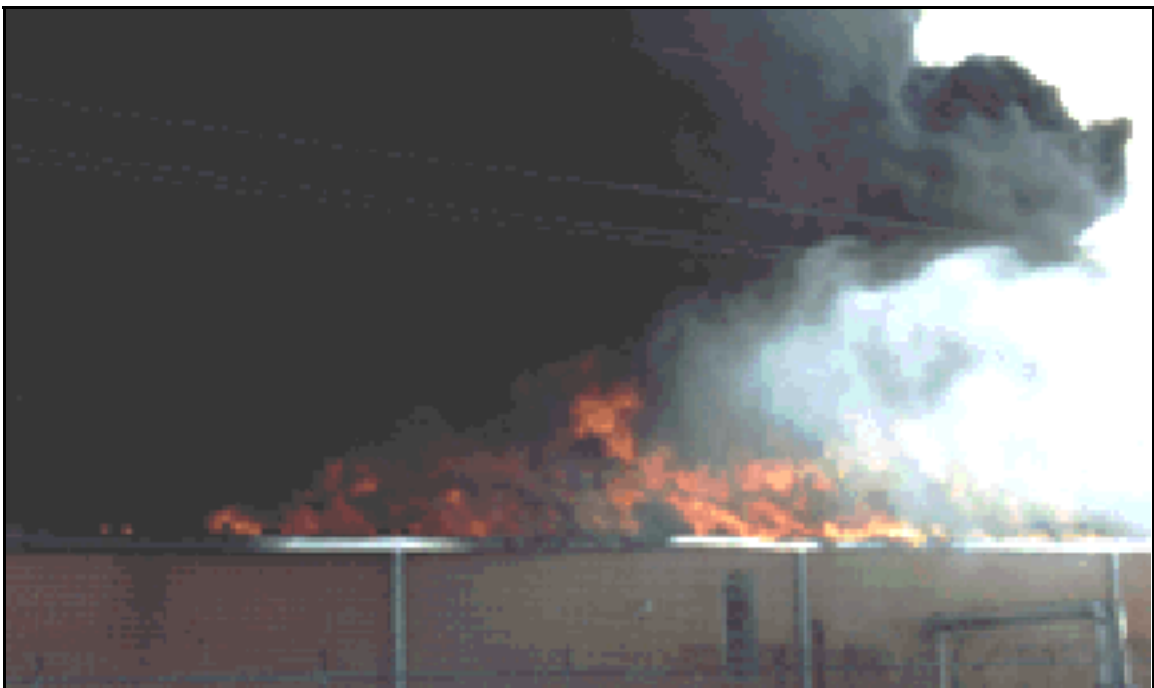
4. One of the early master streams on the fire on the north side. There is an elevation drop of 15 to 20 feet between street level and ground level at the brick wall. One of the heat transfer fluid boilers is in the background just off the engine's tail board.

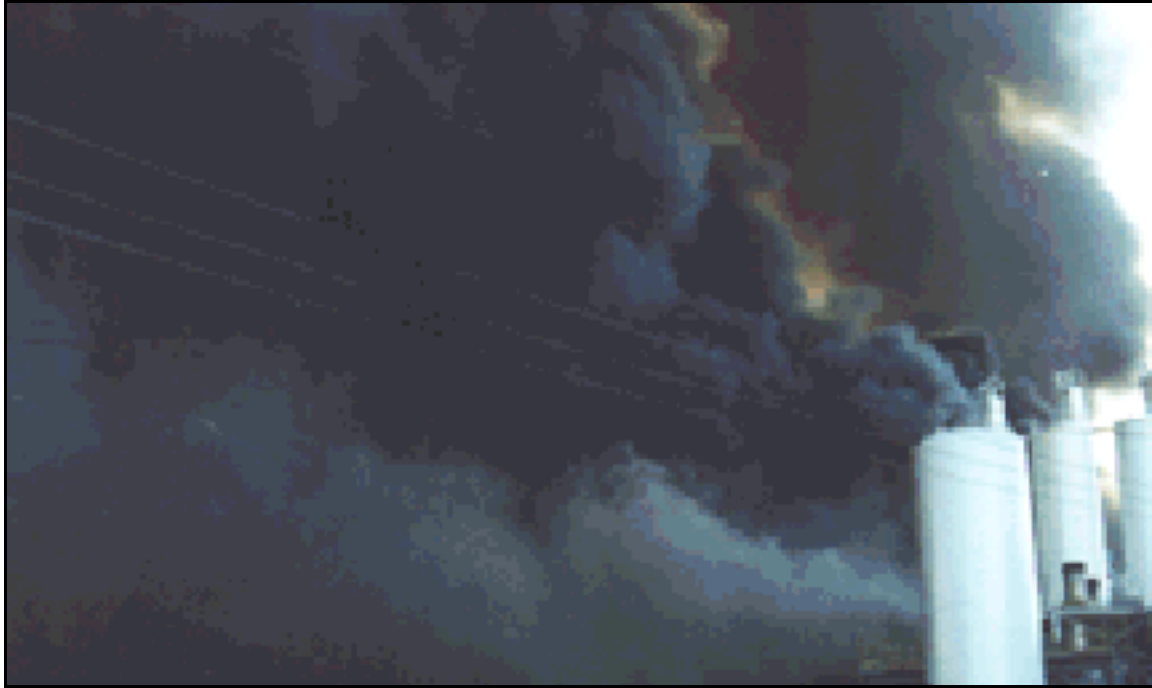
5. Conditions along Swift Street northeast of the plant. The large diameter supply line is in place to supply Engine 4 operating in the corner.

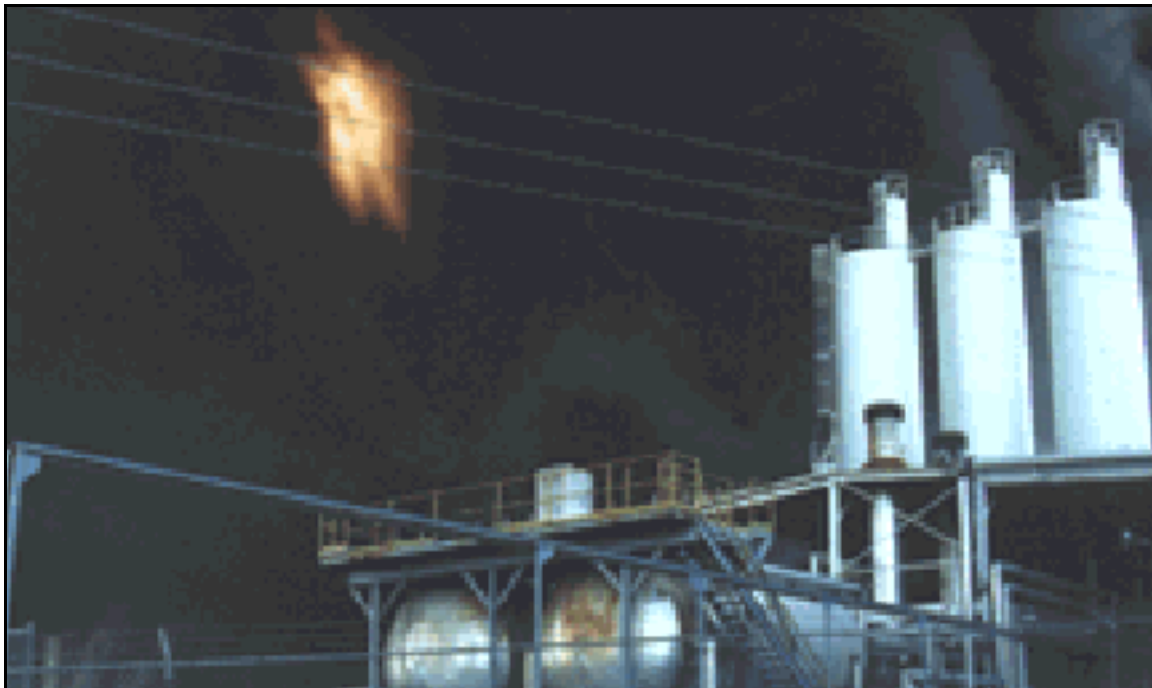
6. The two heat transfer fluid boilers and support equipment that supplied the carpet making range initially involved in the fire. Engine 4 is behind the concrete embankment.

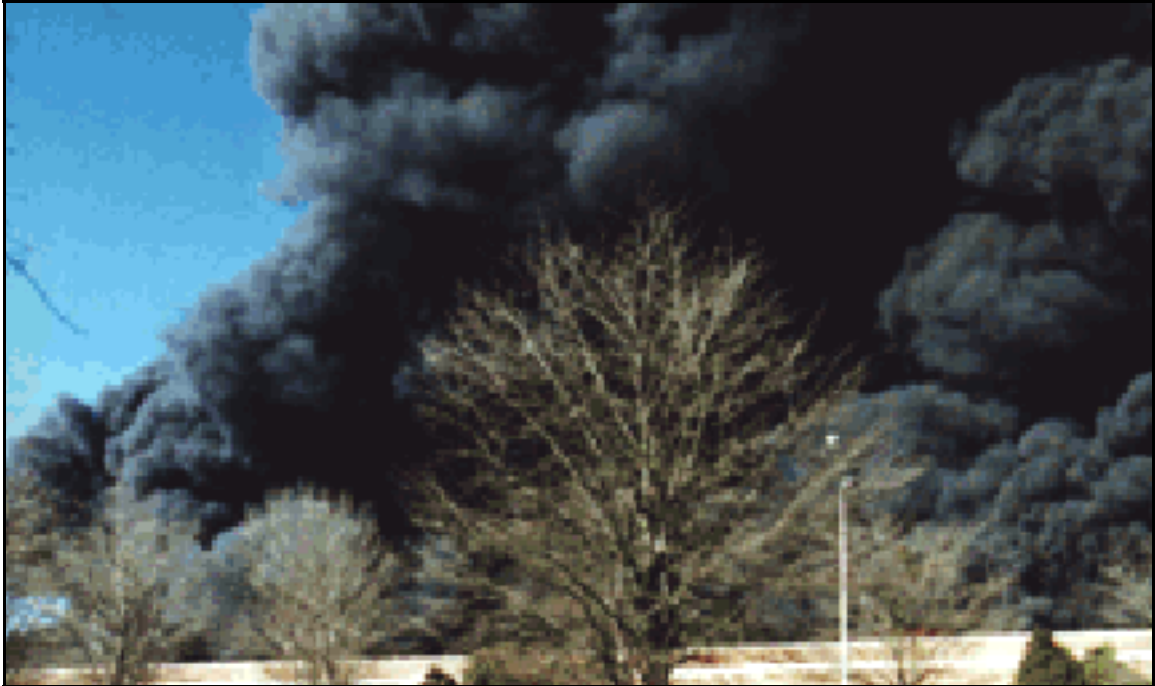
7. Conditions on the south side of the complex looking north from a position out from the northeast corner. At this point, the fire involves most of the 1972 addition.

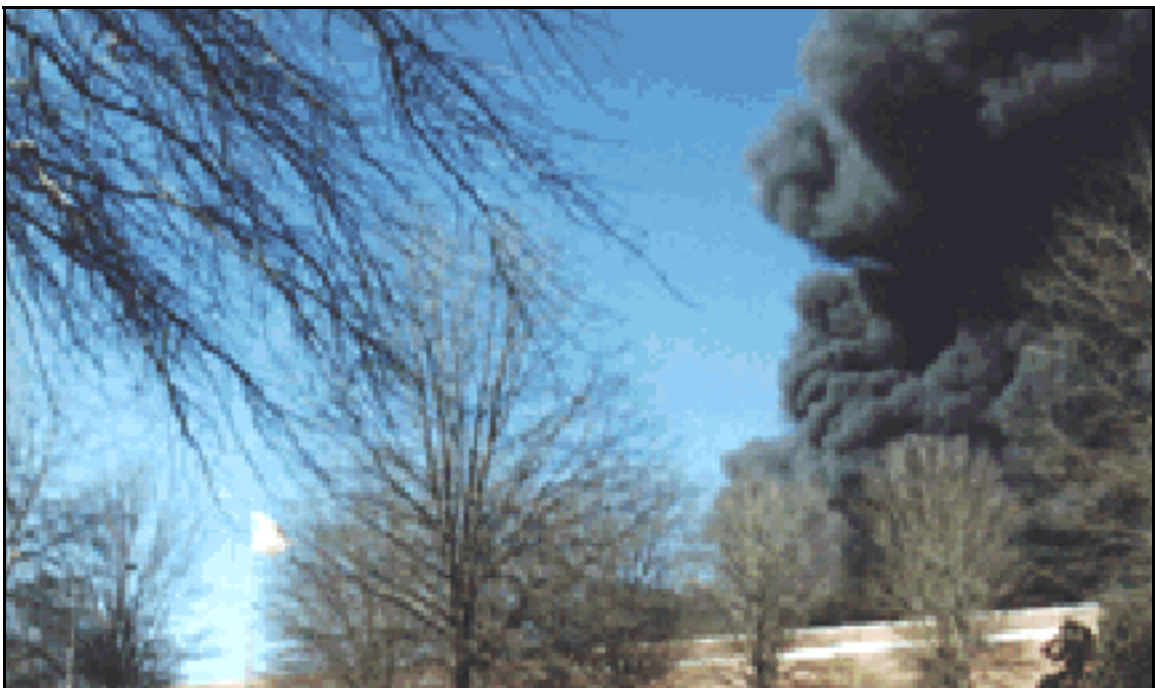
8. Conditions on the south side of the complex looking north from a position out from the northeast corner. At this point, the fire involves most of the 1972 addition.

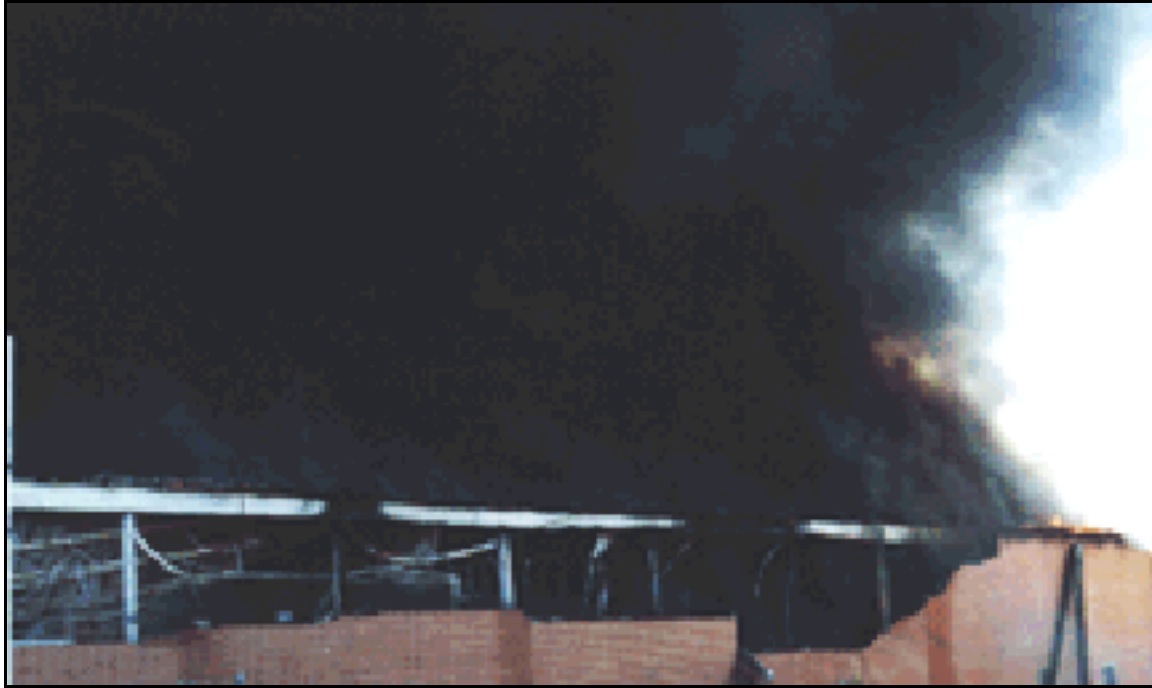
9. Conditions at the northwest corner of the building looking west from near Swift and Polk Streets. The outside post indicator valves (PIV's) and outside flow alarm bells for the sprinkler risers can be seen.

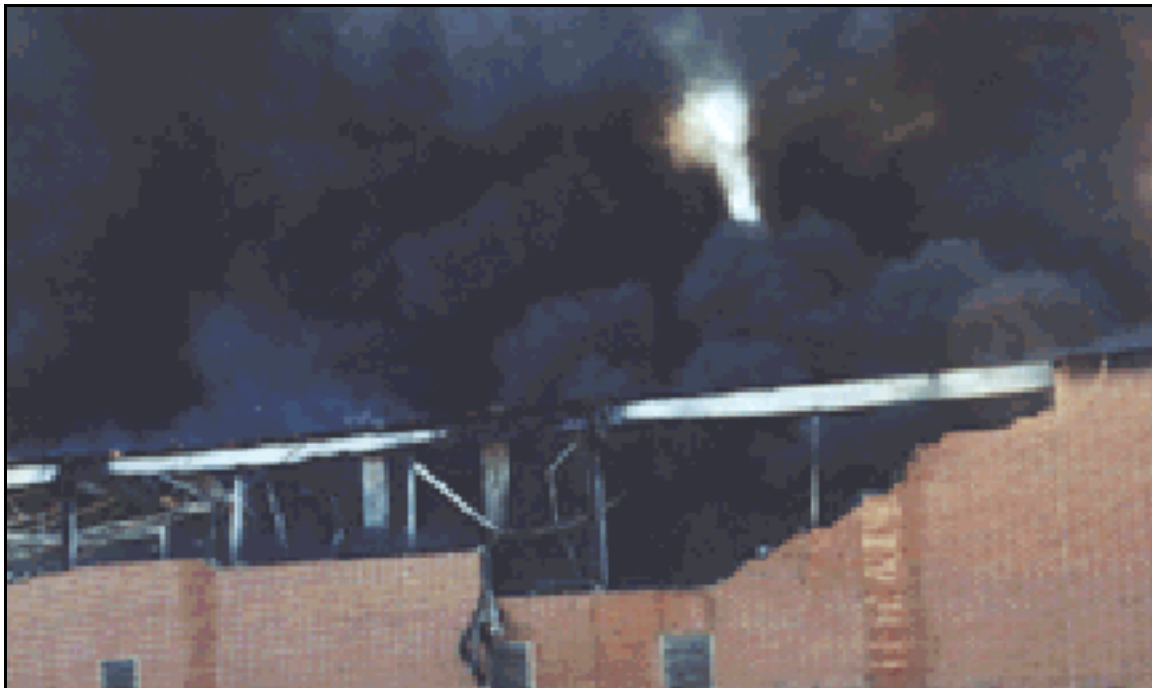
10. Close-up of the area in photograph 9. In addition to the flow alarm bells and PIV's, the top of a yard hydrant is in the lower left corner.

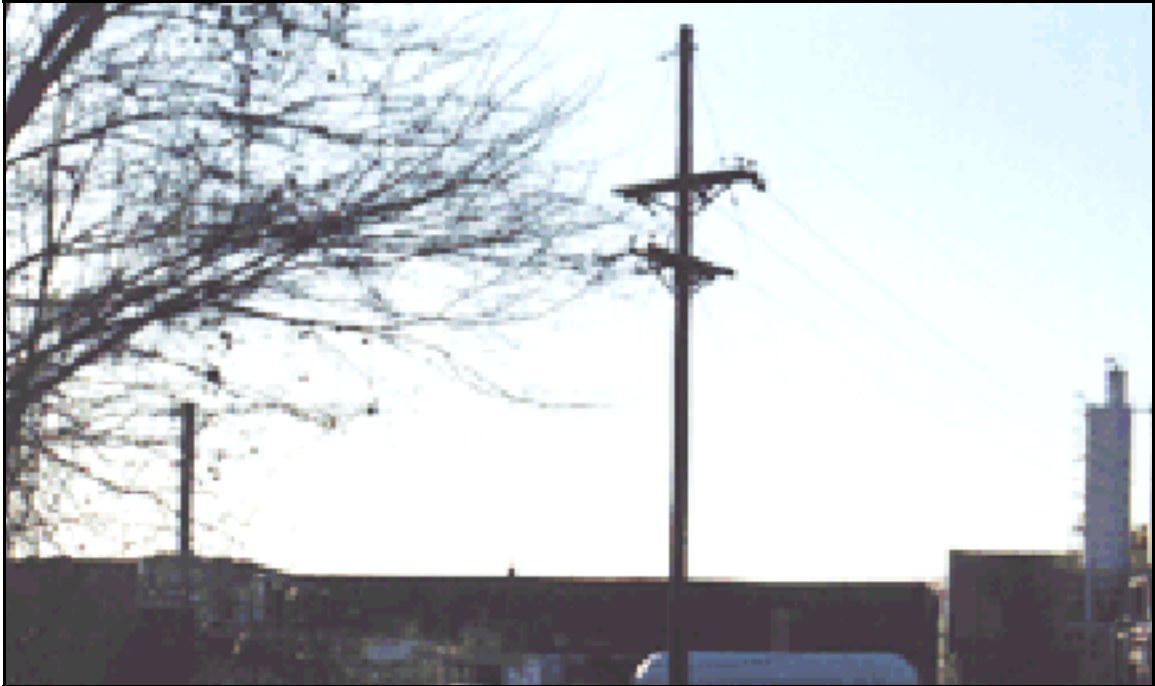
11. Several days after the fire, the northeast corner of the complex. The LP-gas storage tanks, raw material storage silos, and heat transfer fluid boilers and support equipment are shown. Taken from Swift Street looking west.

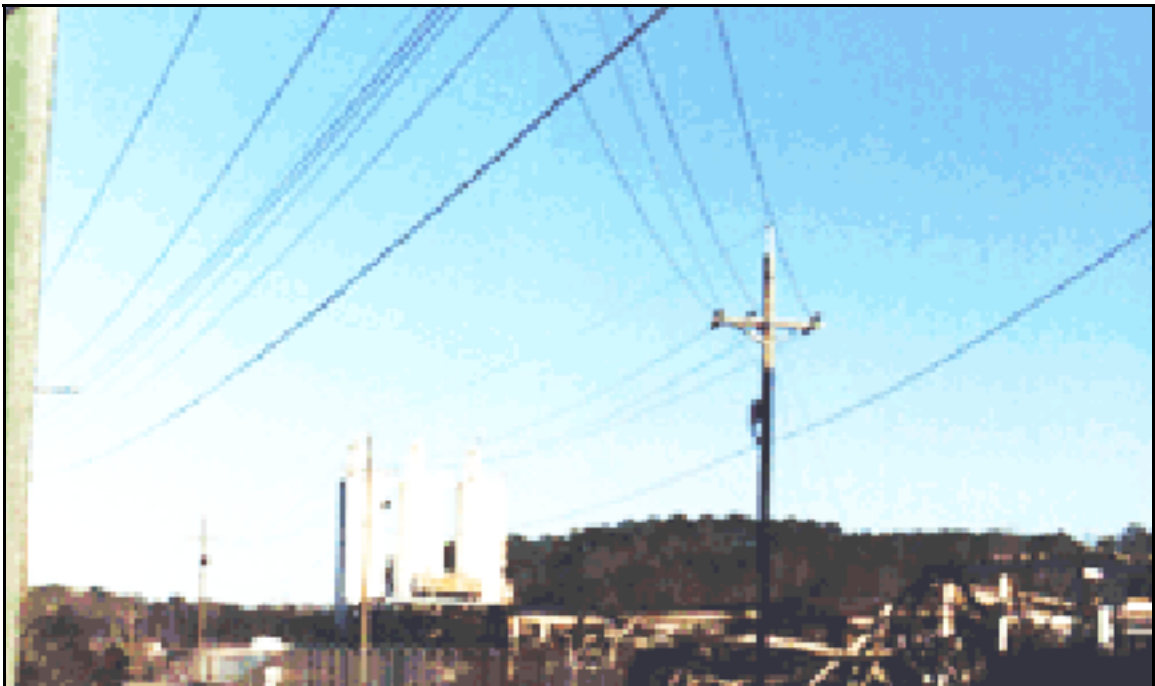
12. Nearly the same position as photograph 3. One of the fire protection water storage tanks is in the right hand side of the photograph. Taken looking east from near the intersection of Swift and Polk Streets.

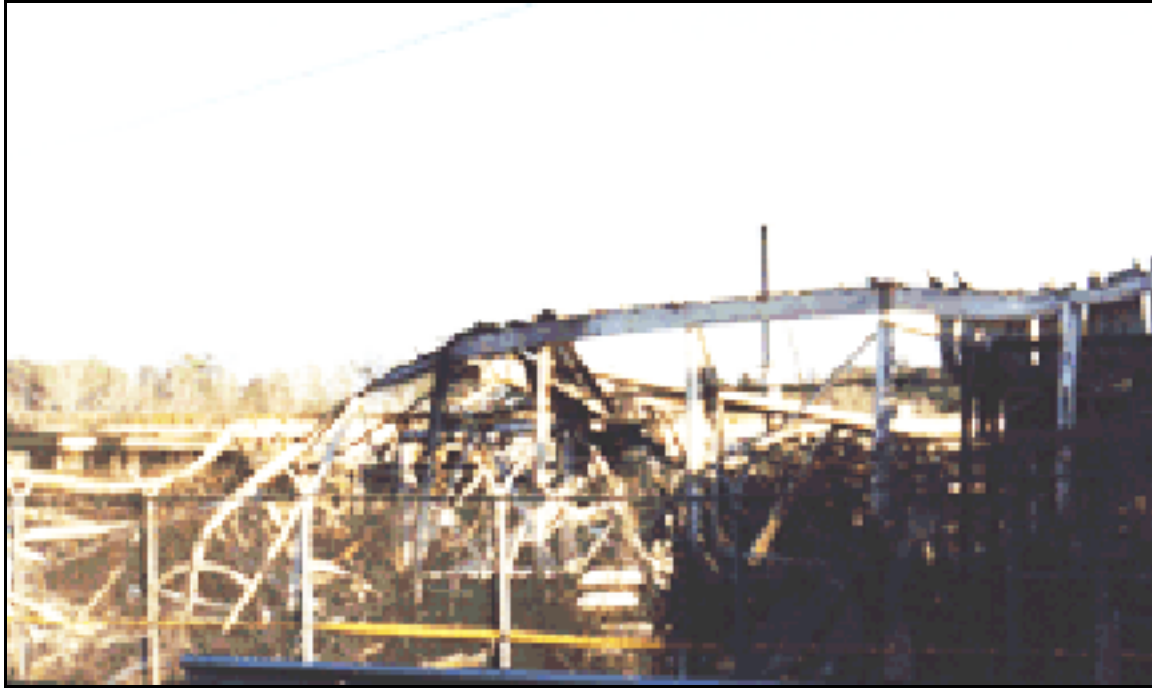
13. Some of the same area in photograph 4 but from a different angle and after the fire. In the bottom right hand corner is one of the heat transfer fluid boilers.

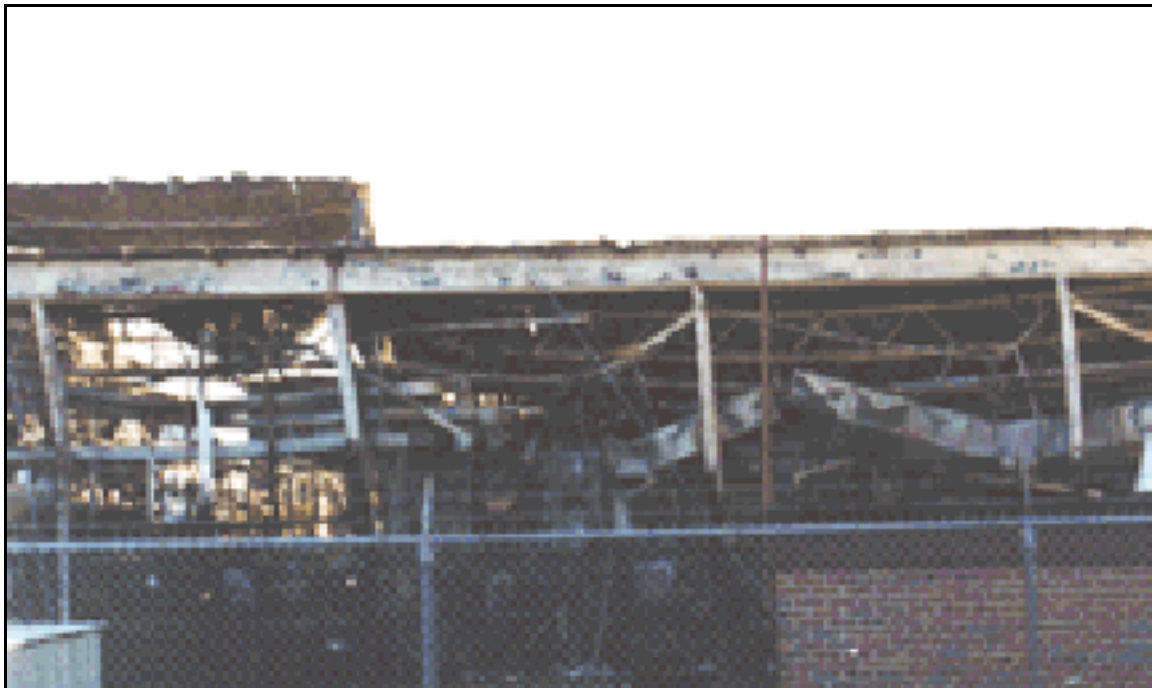
14. The east fire pump house and a view into the building showing some of the manufacturing equipment and ductwork. The west side of the heat transfer fluid boiler in photographs 4 and 13 is on the left edge of the photograph.
