## **Two Firefighters Killed in Auto Parts Store Fire Chesapeake, Virginia**

**Two Firefighters Killed in Auto  
Parts Store Fire  
Chesapeake, Virginia**

**(March 18, 1996)**

**This is Report 087 of the Major Fires Investigation Project conducted by Varley-Campbell and Associates, Inc./TriData Corporation under contract EMW-94-C-4423 to the United States Fire Administration, Federal Emergency Management Agency.**

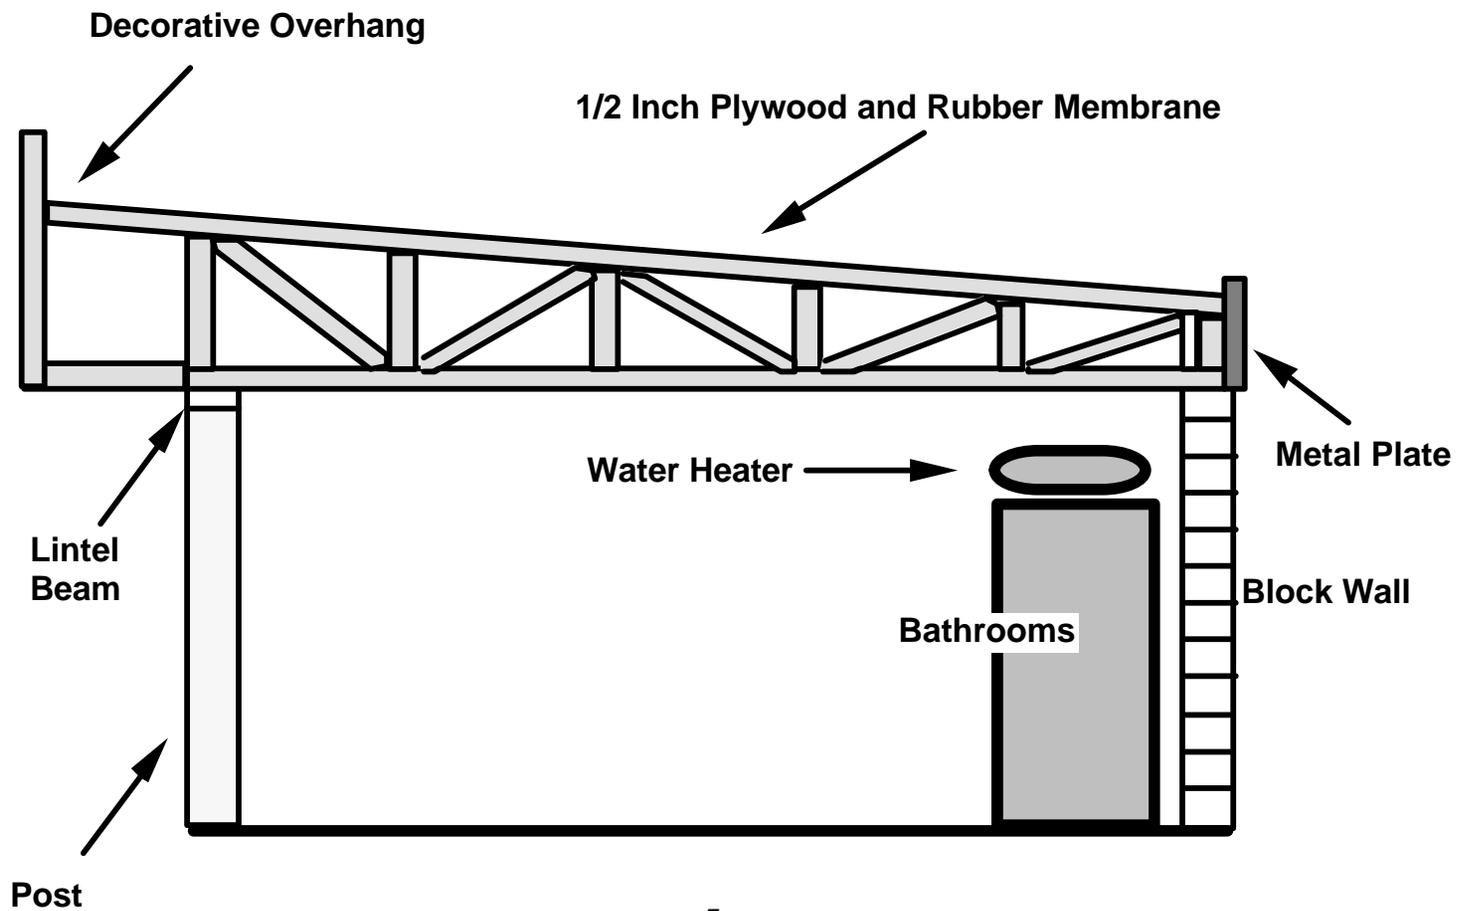
**Figure 2**  
**ADVANCE AUTO PARTS STORE**  
Dissection of the truss roof as viewed from front to back  
of the building.

Post-incident investigations indicate that this truss assembly may have been weakened by deficiencies in the connection of the trusses to the beam on the east side of the building. Also, the dead load of the three air conditioning units may have contributed to the rapid failure of the roof.

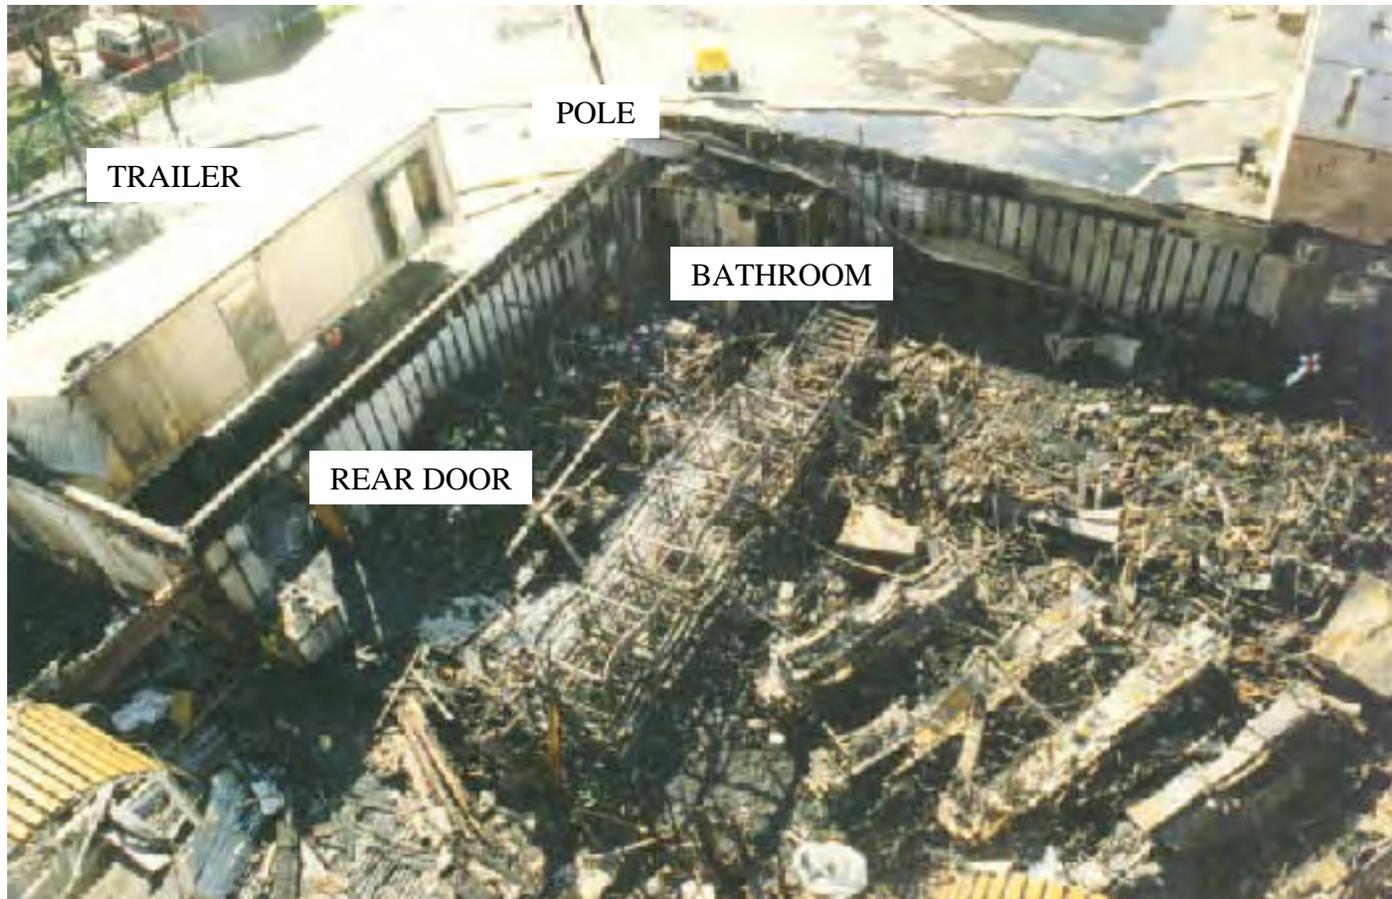
An elevated view of the rear of the store, showing (1) the door in the rear where the firefighters entered with the 1 3/4 attack line; (2) the trailer that blocked the view of the rear entrance; (3) the location of the utility pole; and (4) the employee bathrooms where the fire was originally discovered. *(Photo courtesy of the NFPA)*

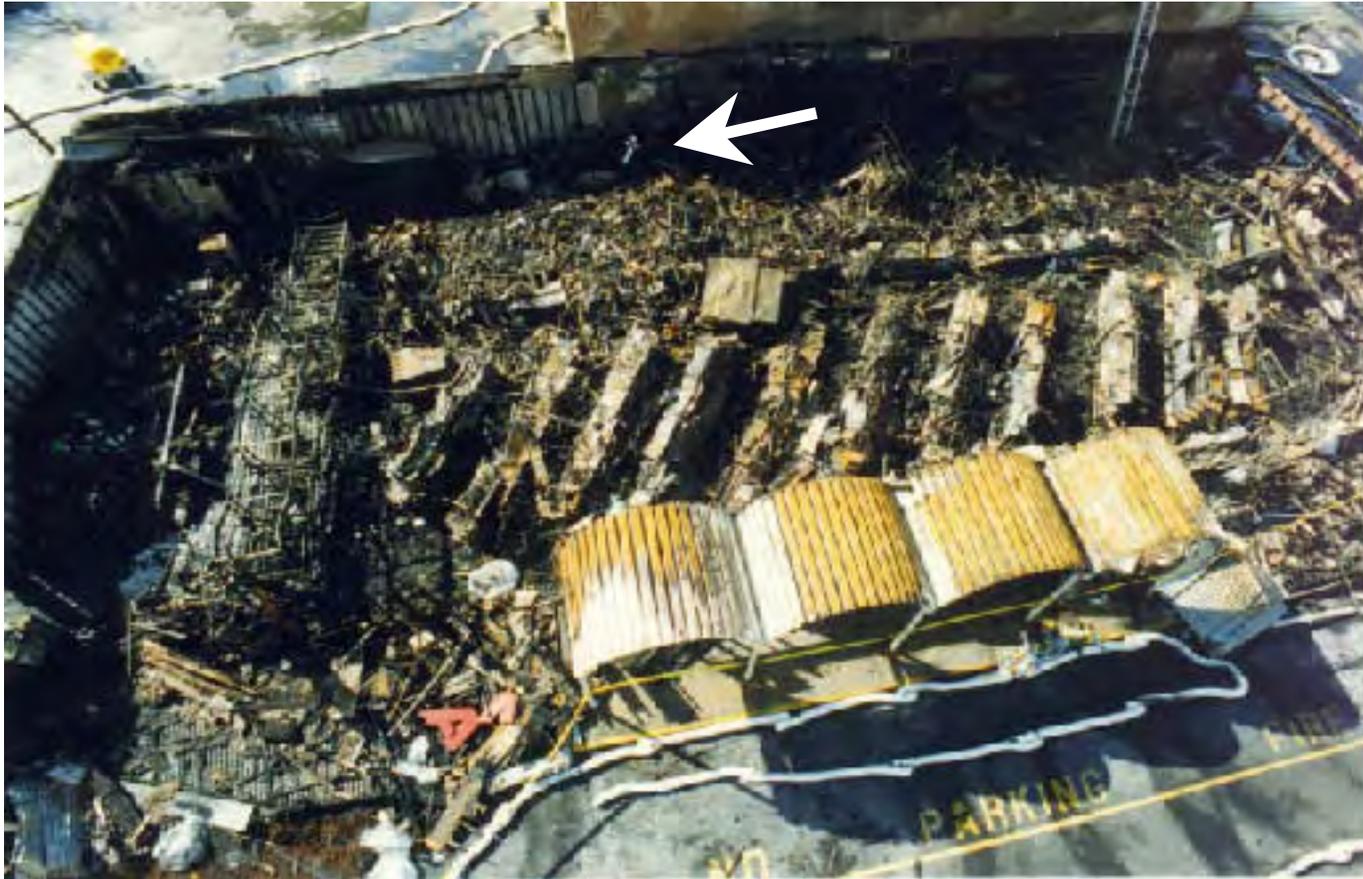
Photo of interior of the store from an elevated position on side two. The white cross (arrow) indicates where both firefighters were found. *(Photo courtesy of the NFPA)*

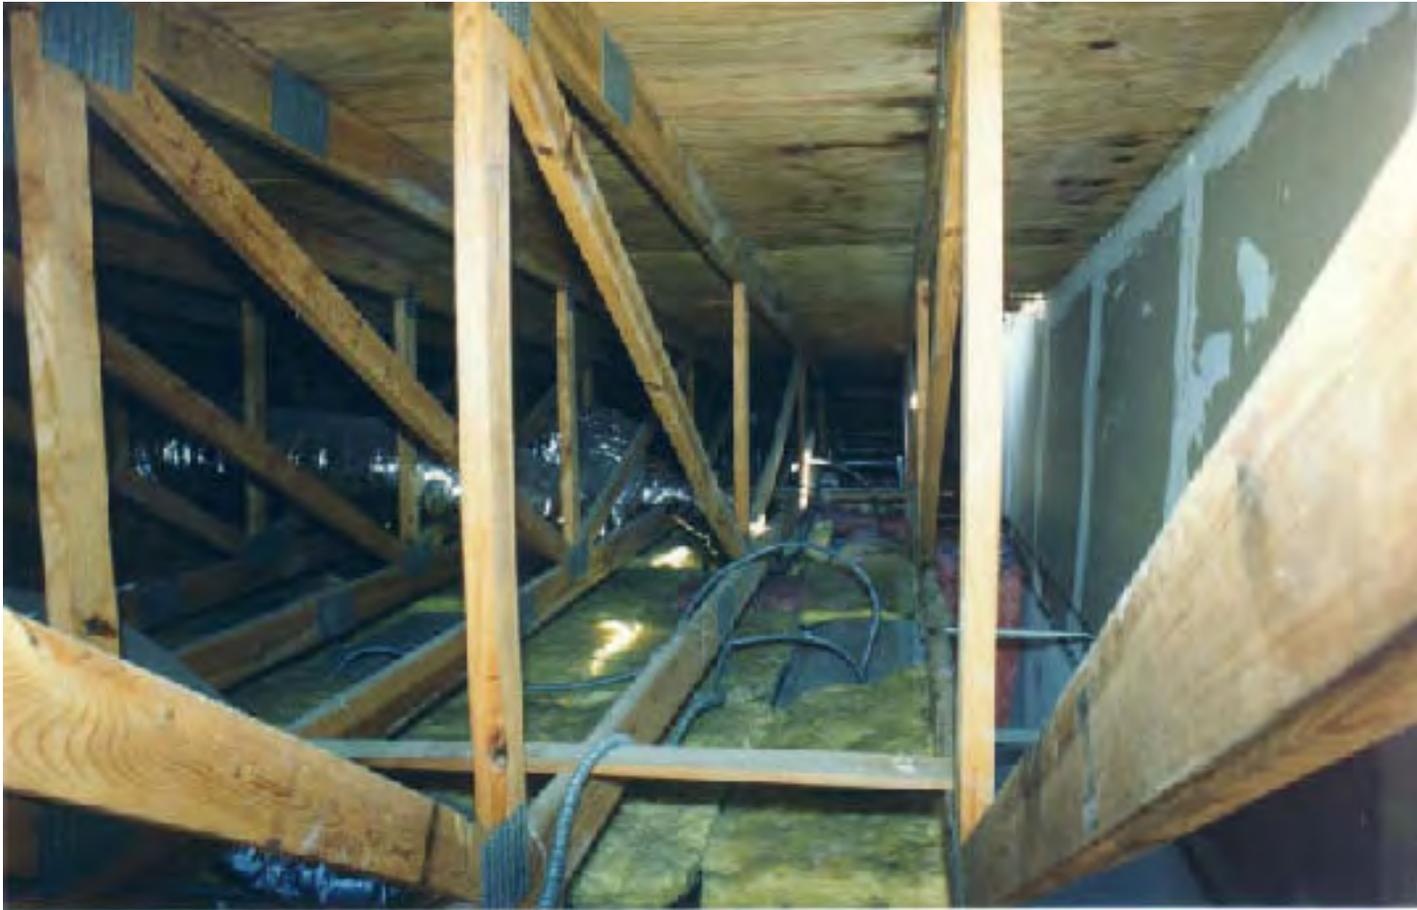
The truss loft area in another part of the Indian River Shopping Center. *(Photo courtesy of the NFPA)*

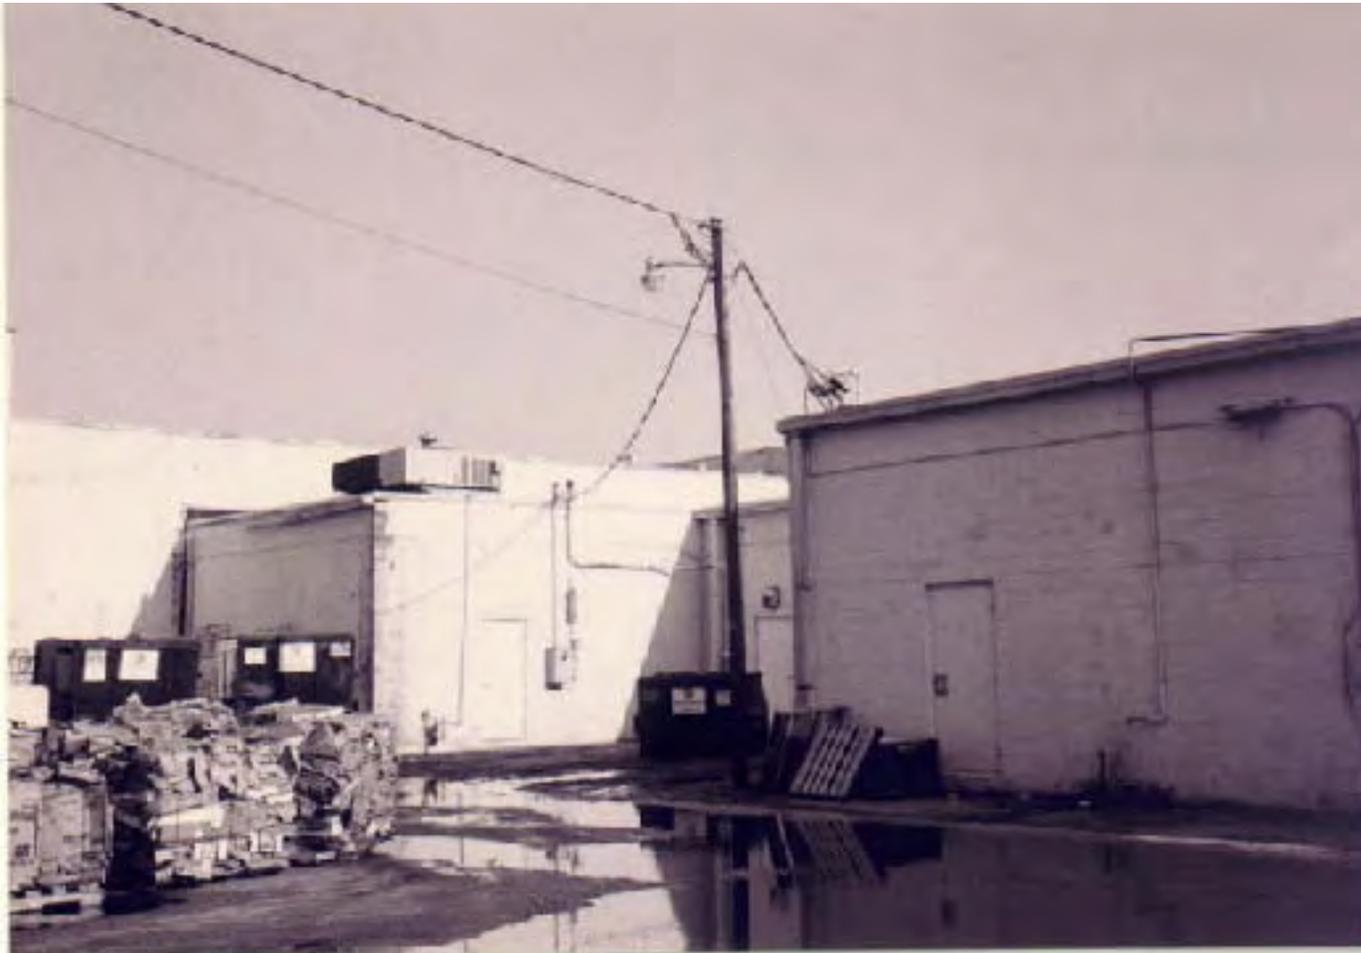
The fire was caused by the electrical short created when the power company truck struck the power line to the building. Investigation by the City of Chesapeake Electrical Inspector after the fire revealed that the meter contained wiring that appeared to have been tampered with and did not comply with the electrical code. Several connections at the meter had been double-lugged, connecting multiple wires to single terminals. Additional investigation by Virginia Power revealed that the building may have been improperly grounded, leading to numerous hot connections when the short circuit occurred. The main fuse did not trip at the breaker panel and the wiring on all three air handling units had been fused. This probably resulted in the ignition of multiple spot fires in the truss loft above the store.

Utility pole connecting power to a meter at the rear of the Indian River Shopping Center. (*USFA file photo.*)

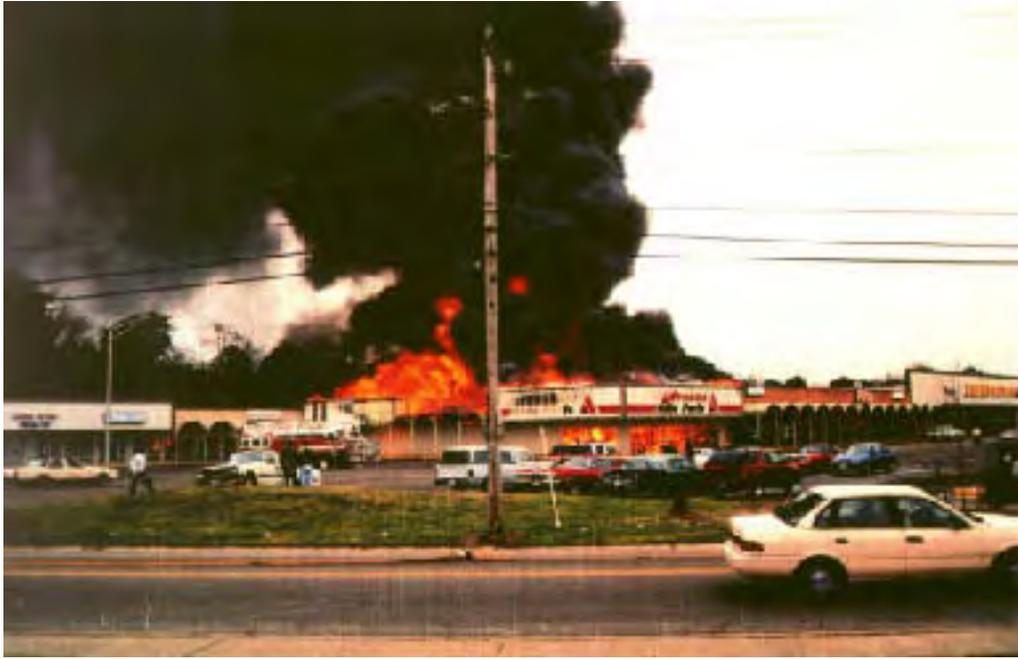
Ladder 2 is shown in its initial position on side two. Time of the photo is estimated between 11:50 and 11:52 a.m. (*Photo courtesy Chesapeake Fire Department*)

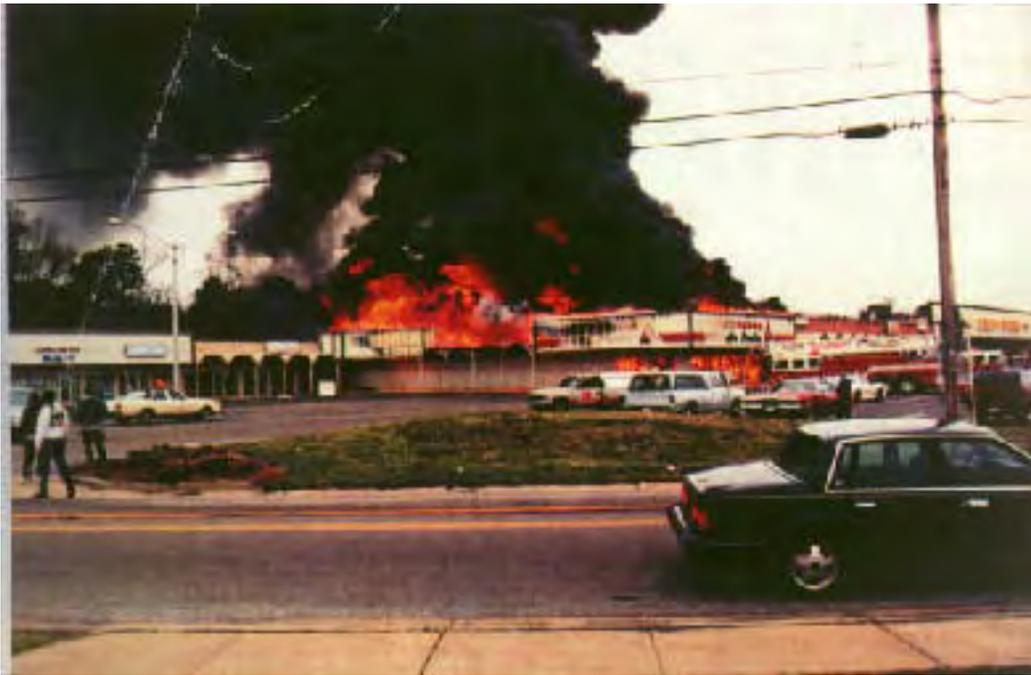
Ladder 2 is shown in position on side one. Time of the photo is estimated at 11:52 a.m. The supply line in the front of the picture is from Engine 1. (*Photo courtesy Chesapeake Fire Department*)
