## Two Fatality Board and Care Facility Fire Salvation Army Rehabilitation Center

Miami, Florida

This is Report 090 of the Major Fires Investigation Project conducted by Varley-Campbell & Associates, Inc. under contract EMW-94-C-4423 to the United States Fire Administration, Federal Emergency Management Agency.

November 11, 1995

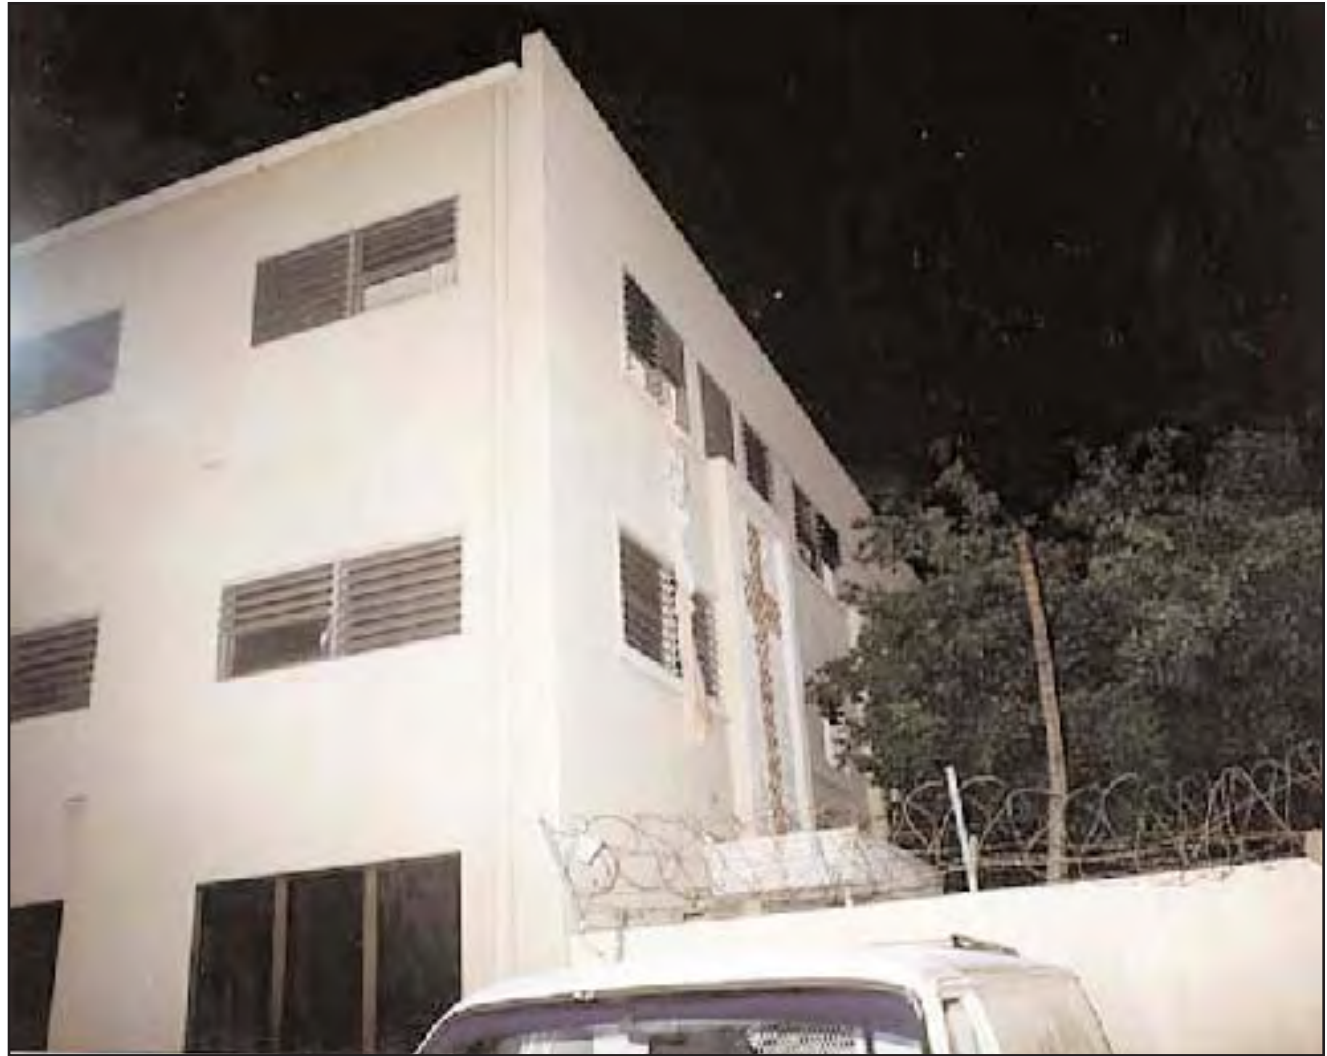
The building was equipped with hurricane shutters which were installed on the outside of the building over the glass windows. The shutters hampered the residents attempting to exit through the windows, when the corridors became impassable because of heavy smoke conditions. Some residents used furniture to break out the shutters. There were instances of persons becoming stuck in windows from which the shutters had only been partially removed.

Each of the windows in the building was equipped with a permanent hurricane shutter. Installed on the outside of the operable glass windows, the shutters consisted of several interlocking metal louvers mounted on two vertical tracks. They could be opened and closed from the inside with a crank and lever mechanism, similar to awning windows. The shutters effectively precluded egress from the windows without their forcible removal. (See Appendix B, photograph 1.)

1. Southeast corner of the Rehabilitation Center. Front entrance is just north of the razor wire topped wall. Note permanent hurricane shutters installed on the outside of the windows. Some residents tied sheets together and climbed from the windows after breaking out the shutters.

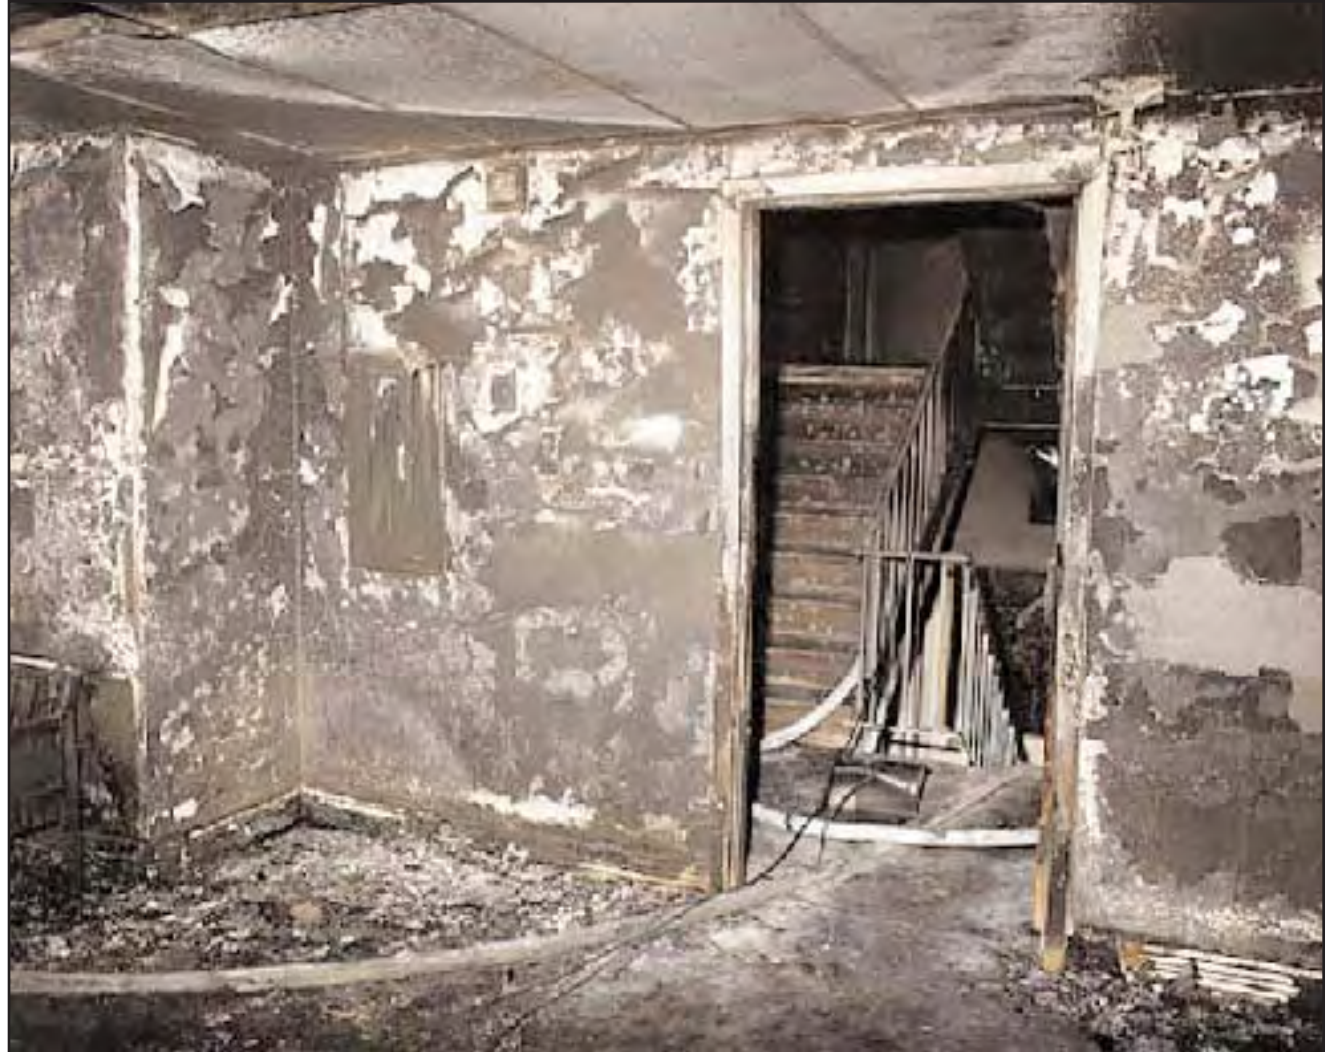
2. Doorway opening from SE stairway into office waiting area on second floor, adjacent to where investigators determined the fire originated.

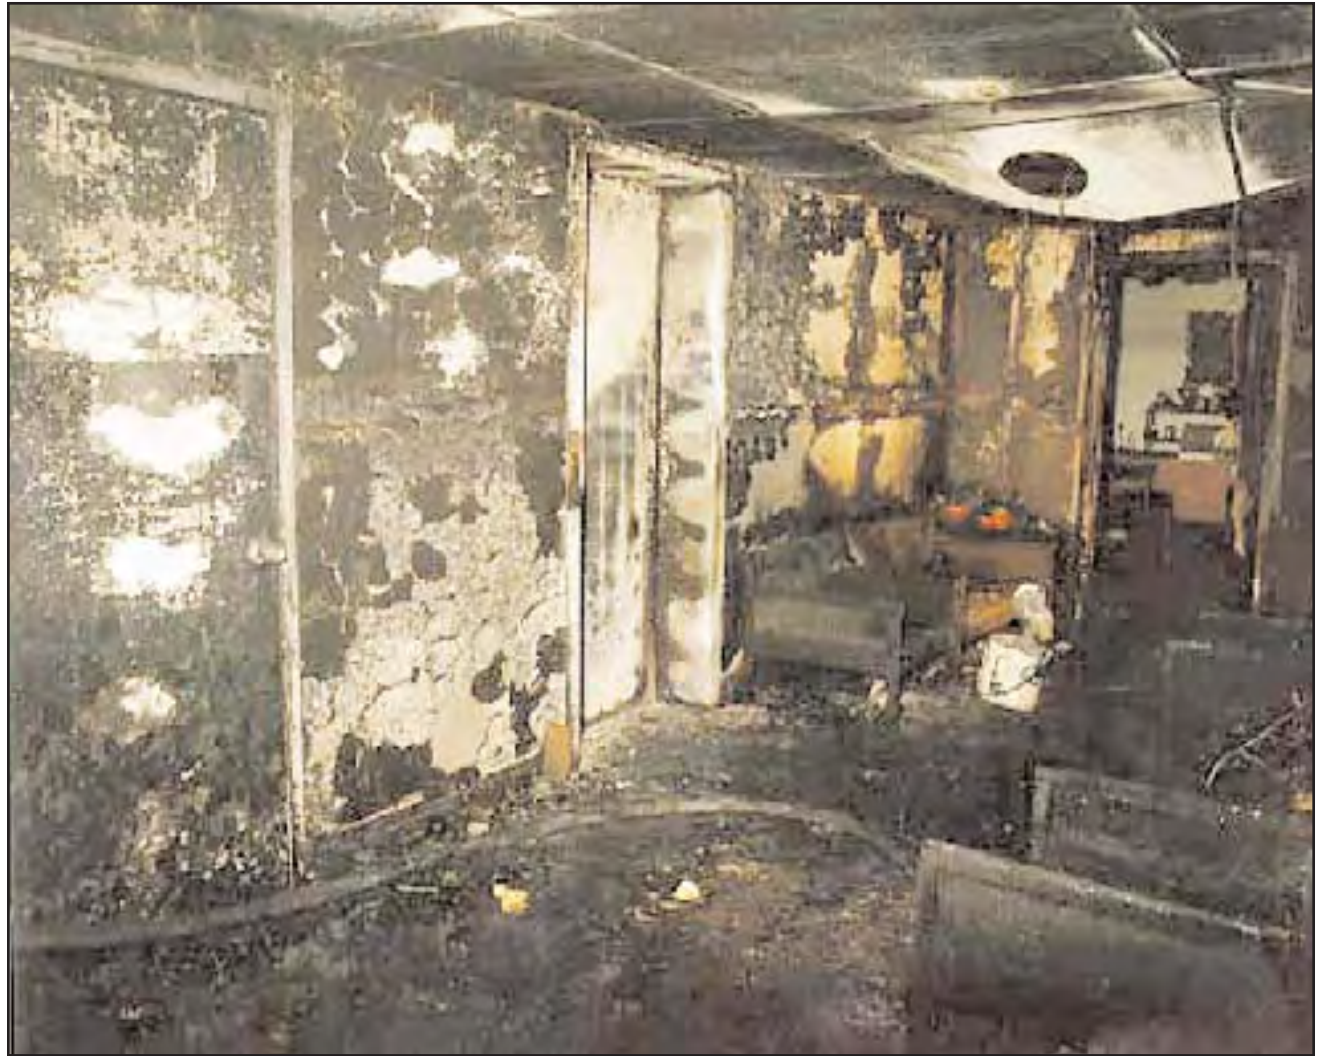
The office waiting area on the second floor where the fire originated was furnished with upholstered chairs, end tables and racks of magazines and promotional literature. Chair cushions were shown to be highly flammable in tests conducted by the fire department after the fire and shown to produce large quantities of thick black smoke.

3. View of office waiting area on second floor from the SE stairway door.

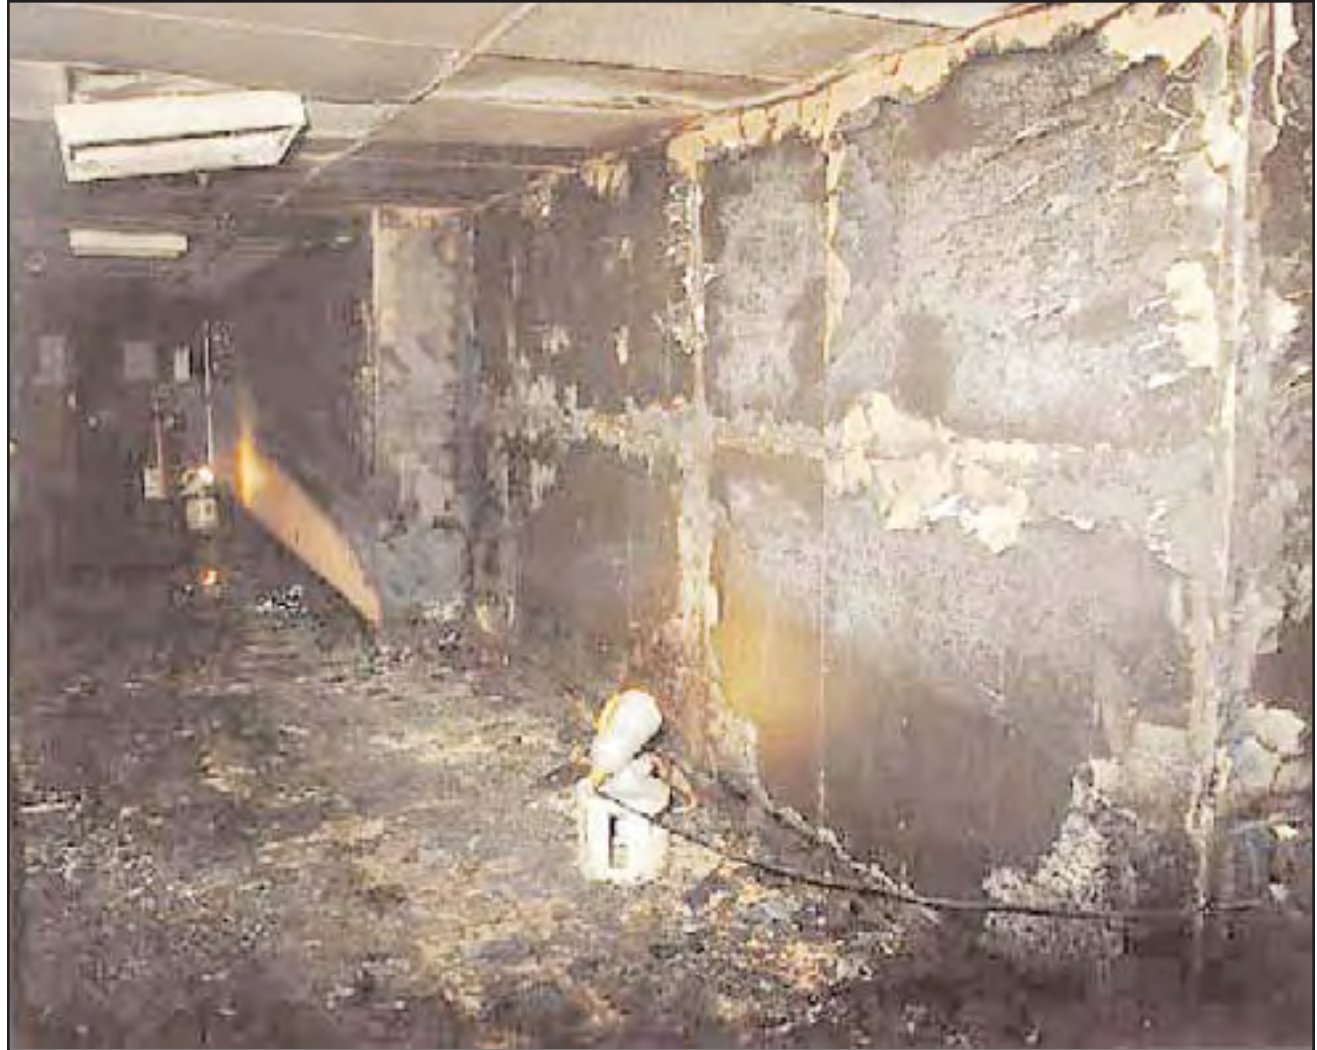
Wallcoverings in the Center varied from plywood paneling and painted gypsum wallboard to vinyl wallcoverings. Investigators observed that the vinyl wallcovering in the area of origin, and leading down the second floor hallway from the area of origin, was completely burned away.

4. First view of hallway leading from office waiting area to residential areas of the second floor.

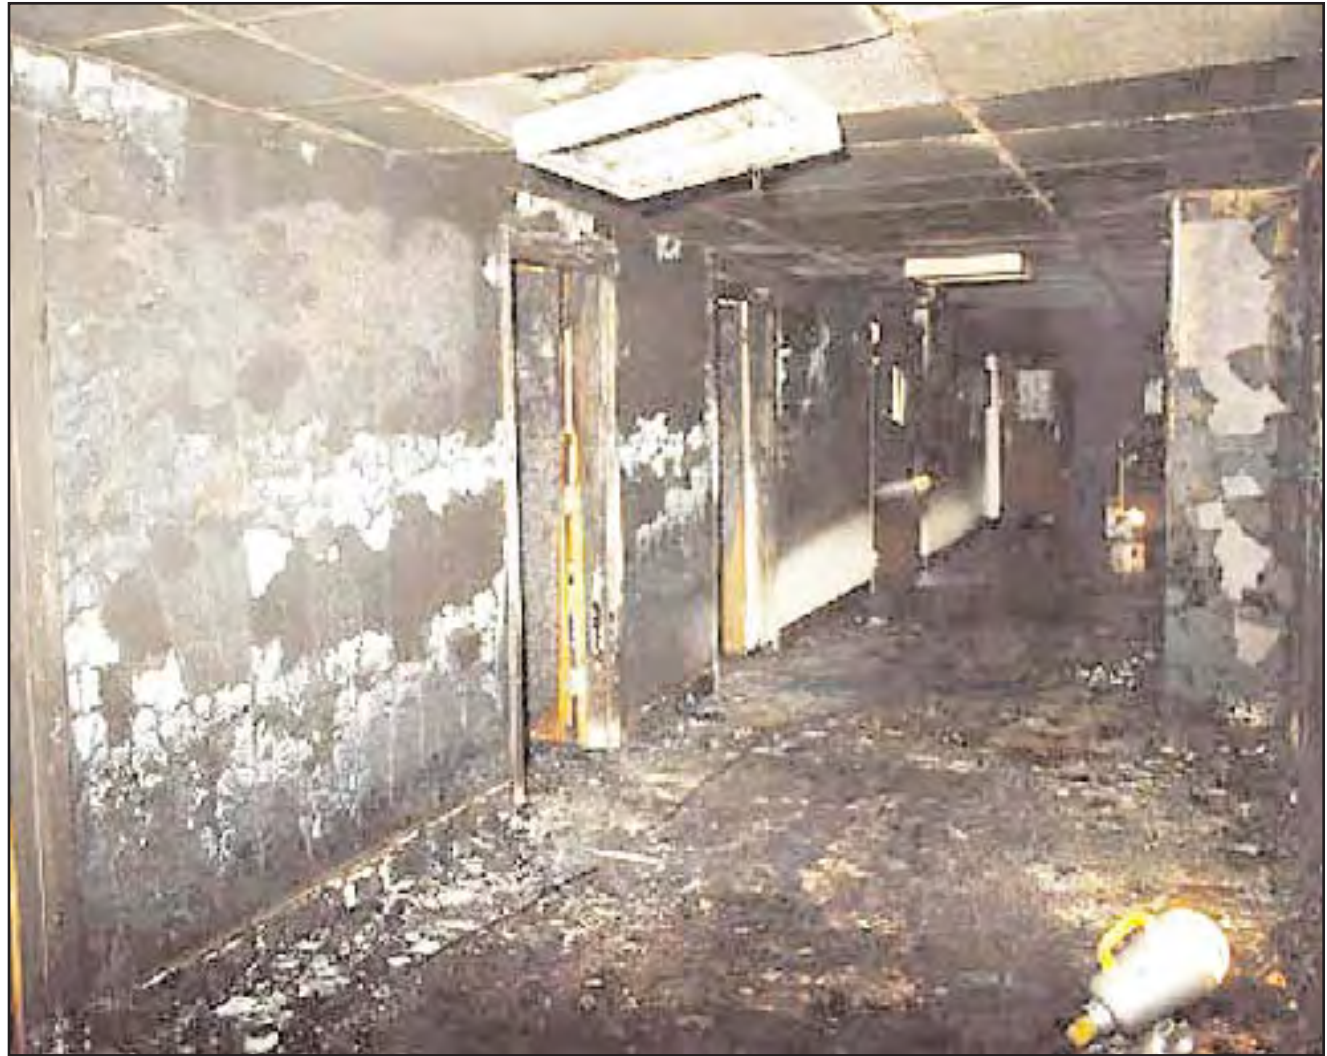
5. Second view of hallway leading from office waiting area to residential areas of the second floor.

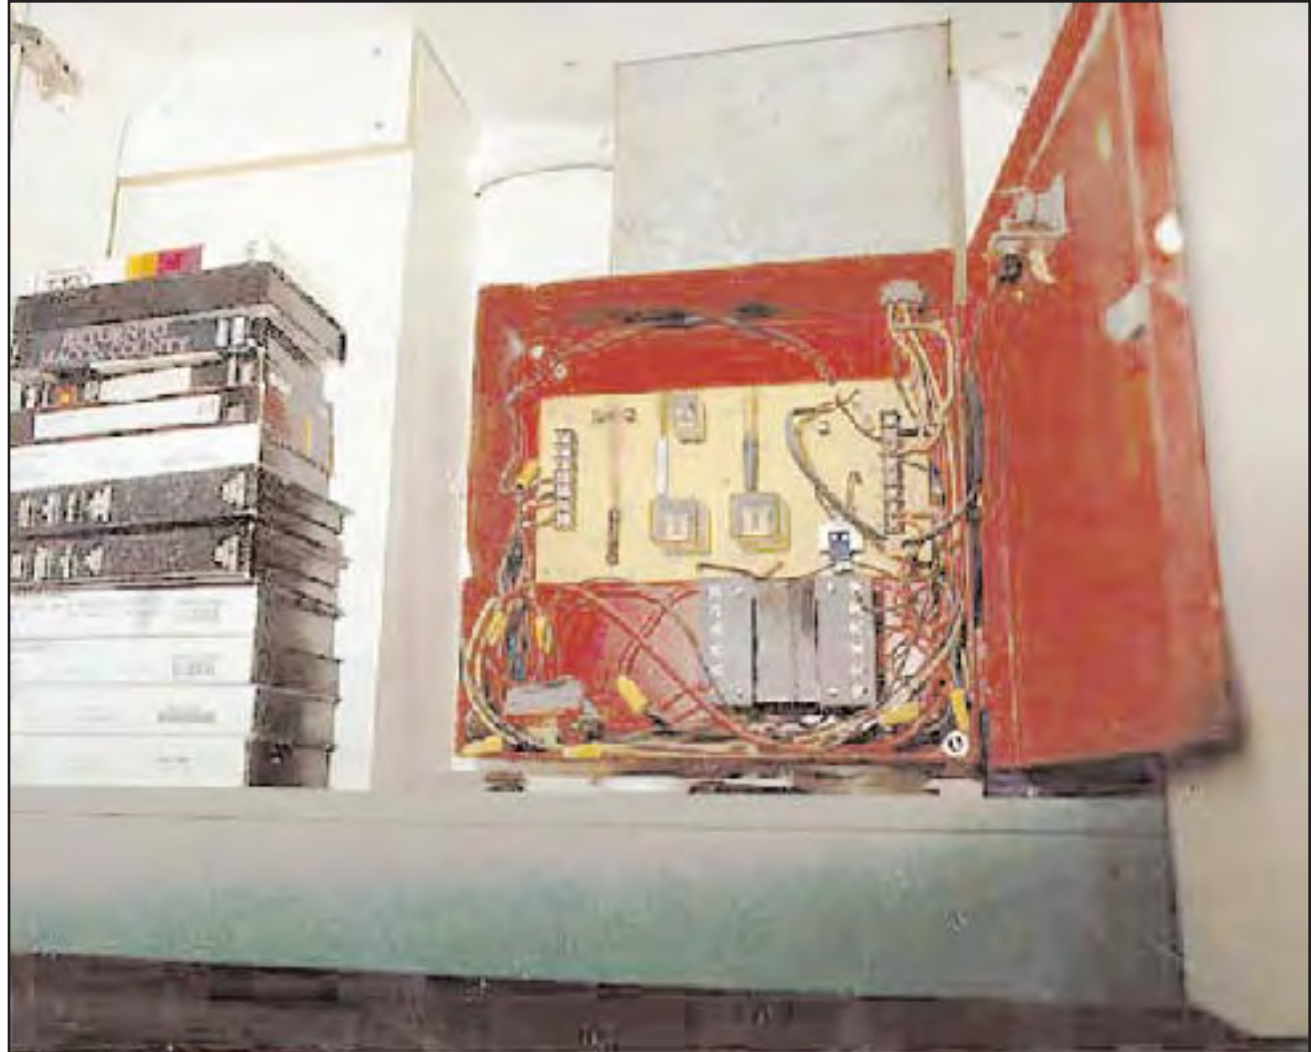
The fire alarm system control panel was mounted on a wall in a storage cabinet in the first floor watch room. The control panel was completely out of sight, hidden behind closed cabinet doors with cleaning supplies stacked in front of it. The Center staff, when questioned, was unaware of its existence. A switch of the type normally used as a wall switch had been installed in the control panel, providing an on/off switch for the system. When located after the fire, the switch was found in the "off" position.

6. Fire alarm control panel. The panel was located inside a cabinet in the first floor front office. Note the on/off switch in the bottom left hand corner of the box.
